POSTIRRADIATION EVALUATION
OF ZIRCALOY-2 PRTR PRESSURE TUBES

L. J. DEFFERDING

NOVEMBER, 1962

POSTIRRADIATION EVALUATION
OF ZIRCALOY-2 PRTR PRESSURE TUBES
PART I

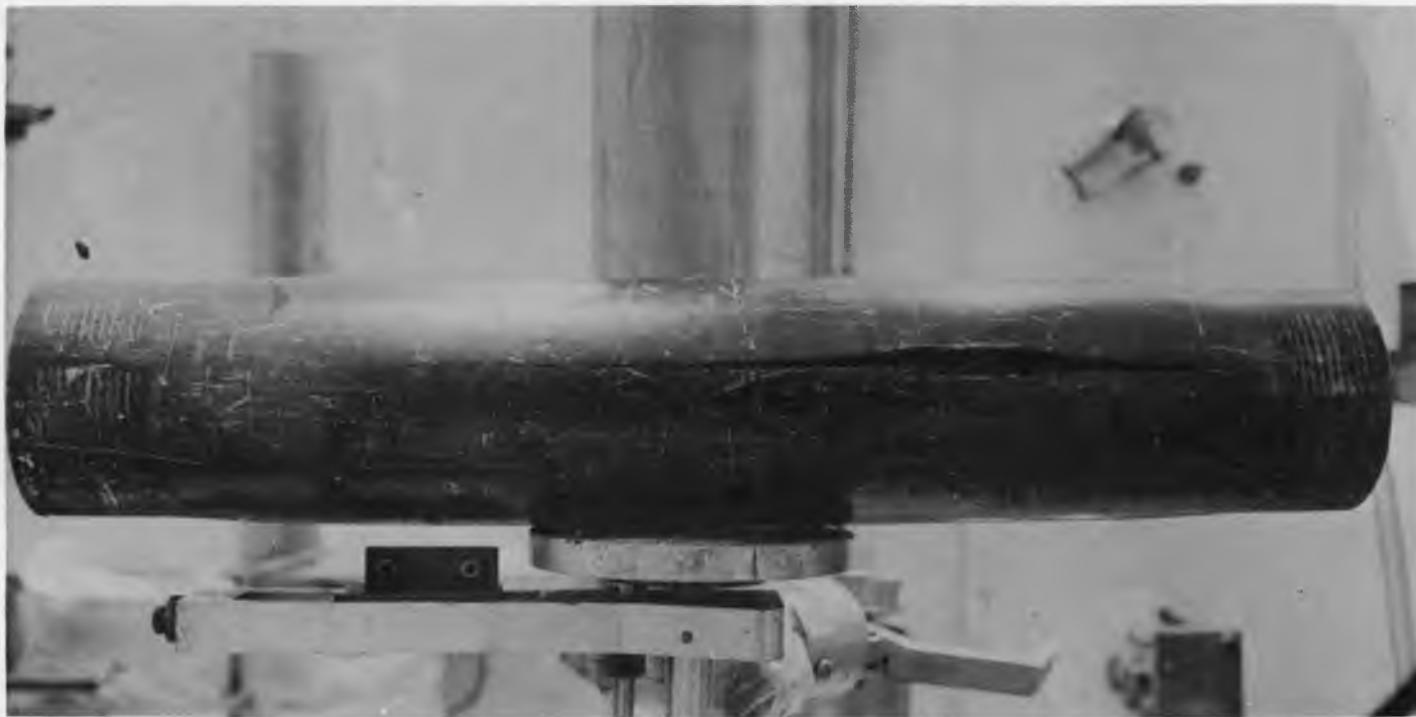
FIGURE 4

Room Temperature Burst Test Sample from Pressure Tube 6100,
Location A, Removed After 2 Weeks Operation. 0.35X

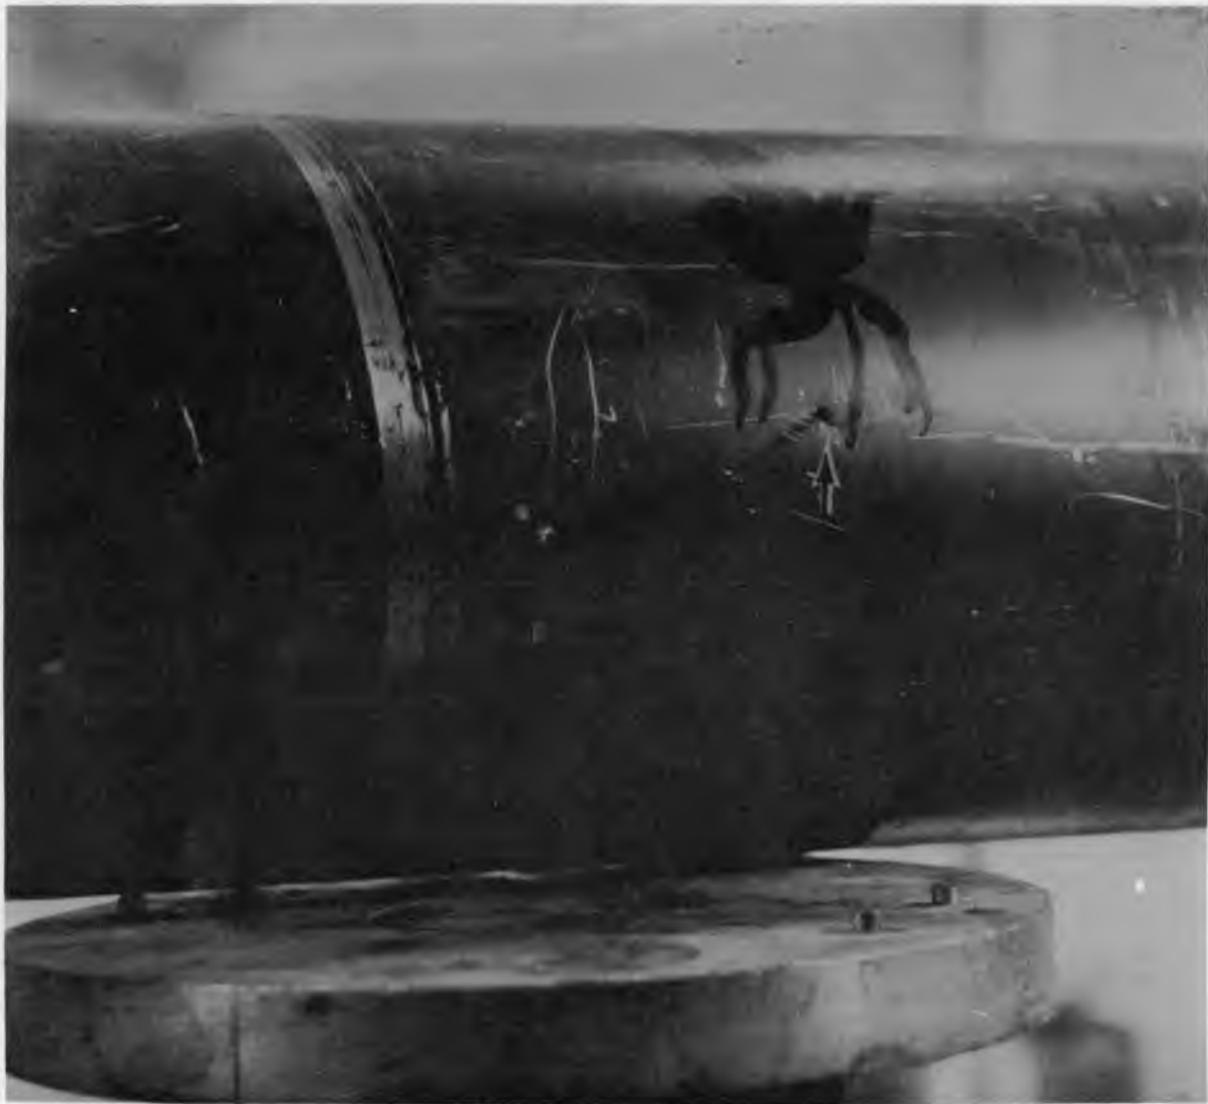
FIGURE 5

In none of the three tests of sections from Location A did the presence of fretting corrosion marks from contact with lower fuel end brackets affect the failure characteristics of the tubes. However, a fretting corrosion mark from a bundle wire wrap in a section from Location B of Tube 6100

did initiate the tube failure. The lack of local bulging preceding fracture and the slightly lower burst strengths of the samples from Tube 6100 are indicative of failure initiated by a defect in the tube wall. Detailed examination of the section from Location A failed to detect any defect. Examination of the inner surface of the section from Location B revealed the fretting corrosion mark in the region of the crack shown in Figures 11 and 12. This mark was caused by contact between the pressure tube and the bundle wire wrap of a UO_2 fuel element. The corrosion mark is 3 mils deep and there is a 2-mil-deep layer of hydride under the mark. Apparently the deformation of the tube wall behind the hydrided area caused the many small cracks shown in Figure 12, most of which penetrate only through the hydride layer (Figure 13). As the stress increased several of these cracks began to propagate through the tube wall. Failure occurred when one of the cracks penetrated the wall. The crack was arrested even though the stress in the tube wall was at least 85% of the ultimate strength of the metal, which indicates that the tube behaved in a ductile manner. Theoretically, a short defect that propagates through a tube wall will end up with an effective crack length of twice the wall thickness at the time it penetrates the wall.⁽³⁾ Crack arrest tests have been run on unirradiated tubing whose ductility was reduced by prior cold working by 50% reduction in area. The tests were run at room temperature. A crack twice the wall thickness in length was introduced into the tube wall while the tube was pressurized. When the pressure was equal to 80% of the tube ultimate strength, the crack propagated full length of the specimen.⁽⁴⁾ When the pressure was 70% of the ultimate strength, the crack did not propagate. The irradiated sample from the annealed section exposed to 1×10^{19} nvt ($E > 1$ Mev), exhibits a greater fracture toughness than the unirradiated cold-worked tubing that was tested. The local yielding or wall thinning around the crack, as shown in Figure 5, is another indication of the degree of ductility that this tube has shown.

When the small crack popped through the tube wall, the pressure started to drop and the pump was turned off. The pressure within the tube decreased to 2500 psig at which time the leakage rate was less than could

be measured with our present equipment. Apparently the local yielding around the crack at the high stress was sufficient to cause the crack to close when the stress was reduced by the drop in pressure. The 2500 psig that the tube maintained is greater than twice the operating pressure of the reactor.

Room Temperature Burst Test of Tube 6100, Location B,
Immediately Above the Sample in Figure 4
(Failure occurred when a crack that started in a wear
corrosion mark propagated through the tube wall. The
crack is about 3/16-inch long on the outer surface of
the tube.)

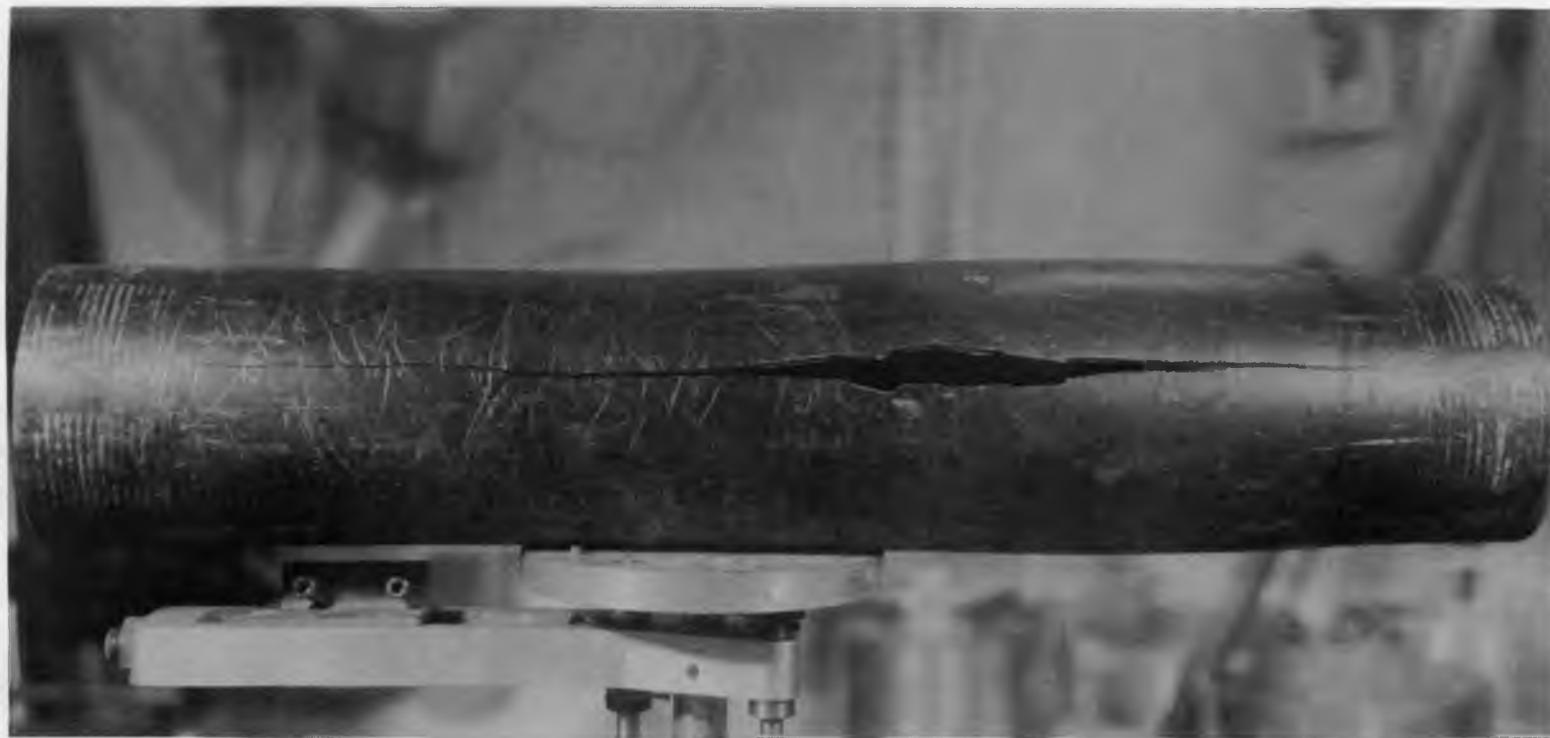
FIGURE 6

Room Temperature Burst Test Sample from Pressure Tube Number 6061, Location A,
Removed After 1-1/2 Months of Operation. 1/2X

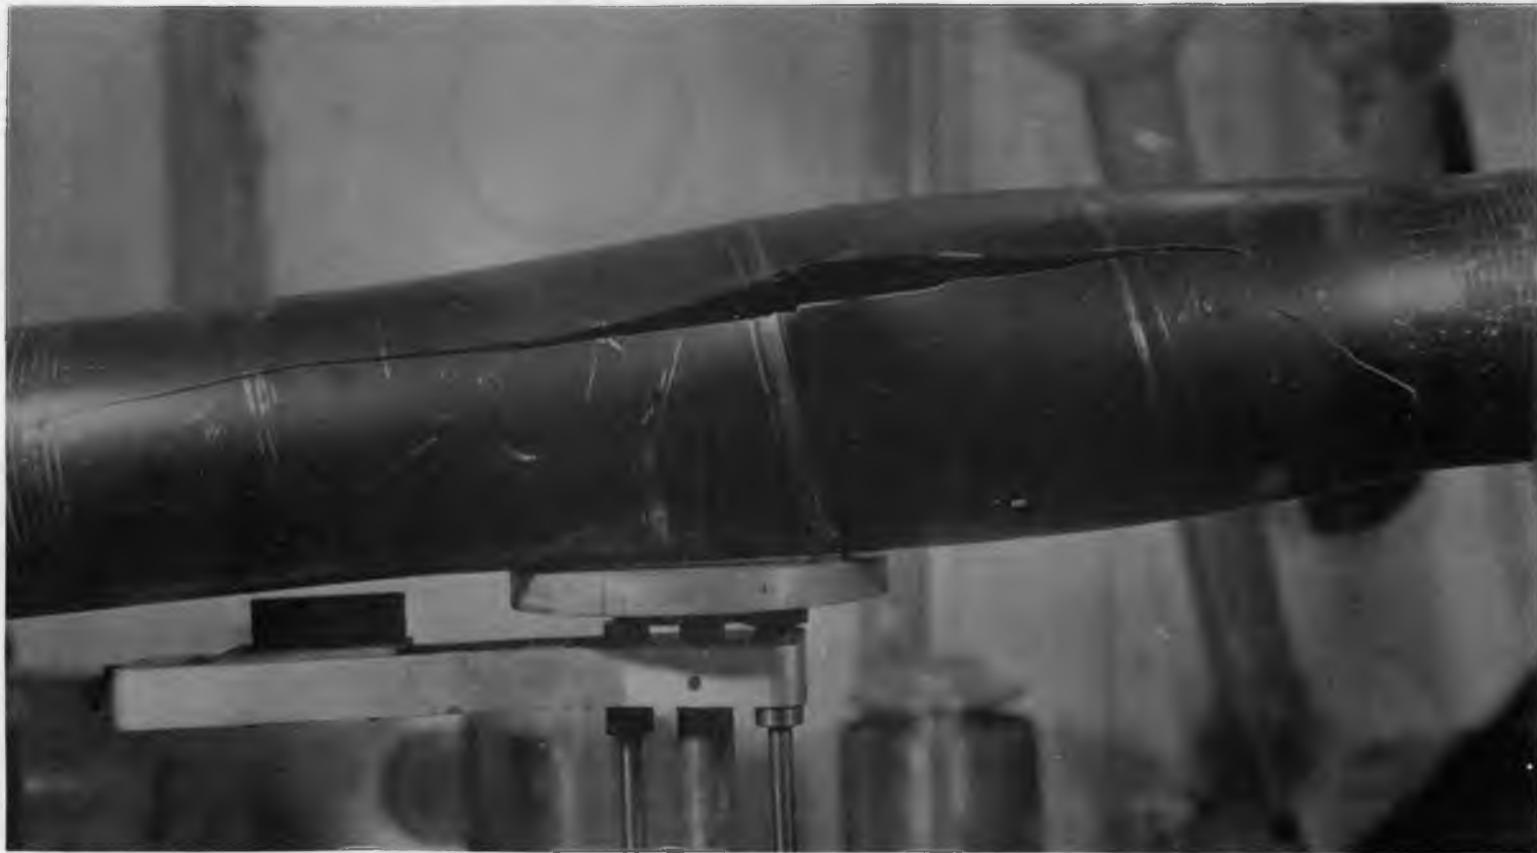
FIGURE 7

Room Temperature Burst Test Sample from Pressure Tube Number 5529, Location A,
Removed After 2-1/2 Months of Operation. 1/2X

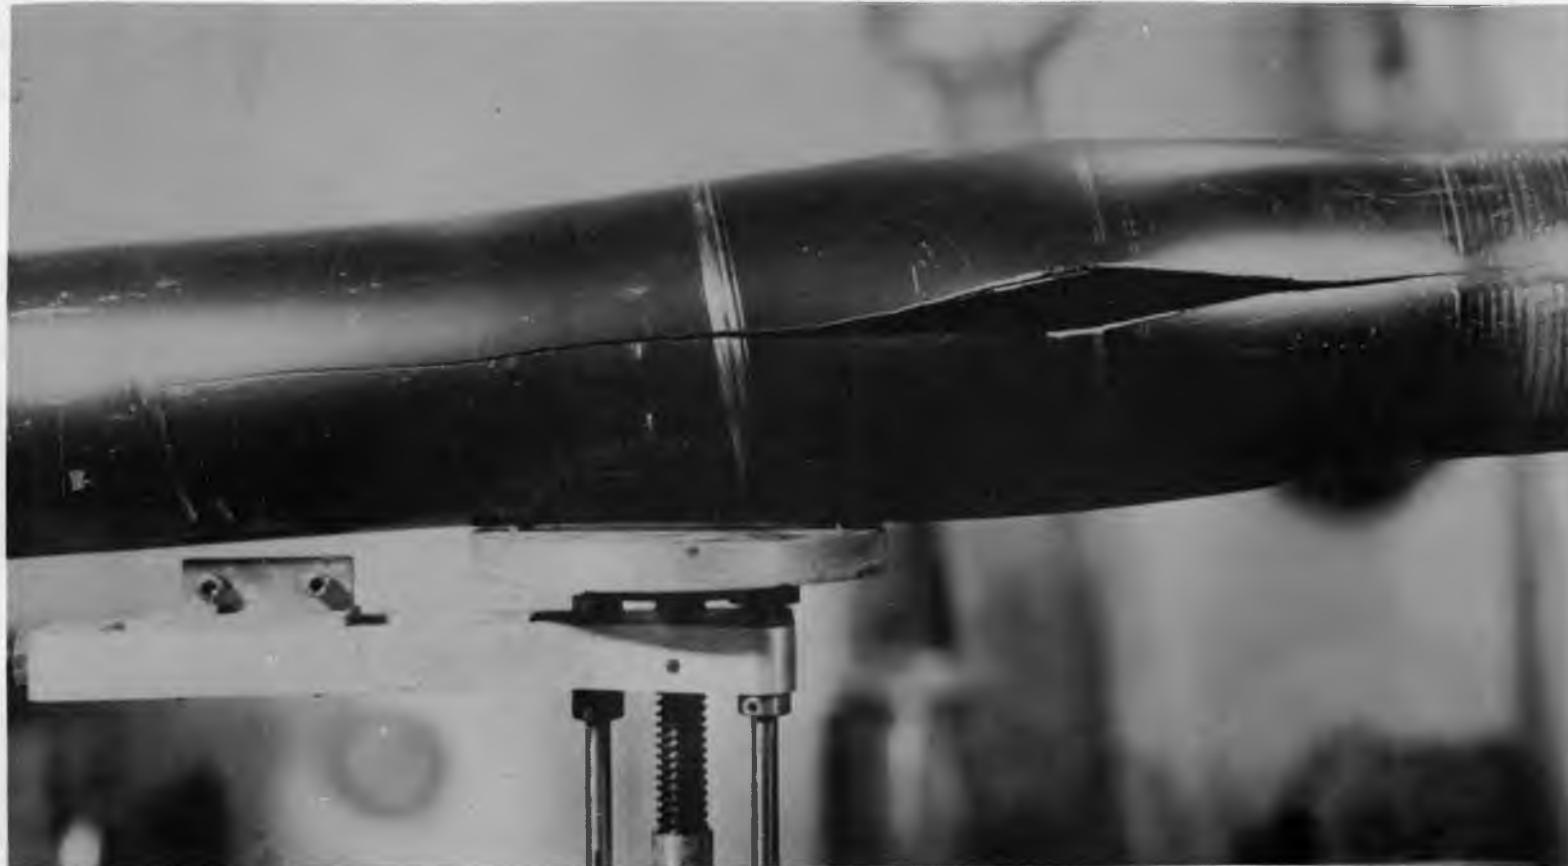
FIGURE 8

Room Temperature Burst Test Sample from Tube 5529, Location B,
Immediately Above the Sample in Figure 7

(This sample had the highest accumulated fast neutron exposure of the burst test sections.) 1/2X

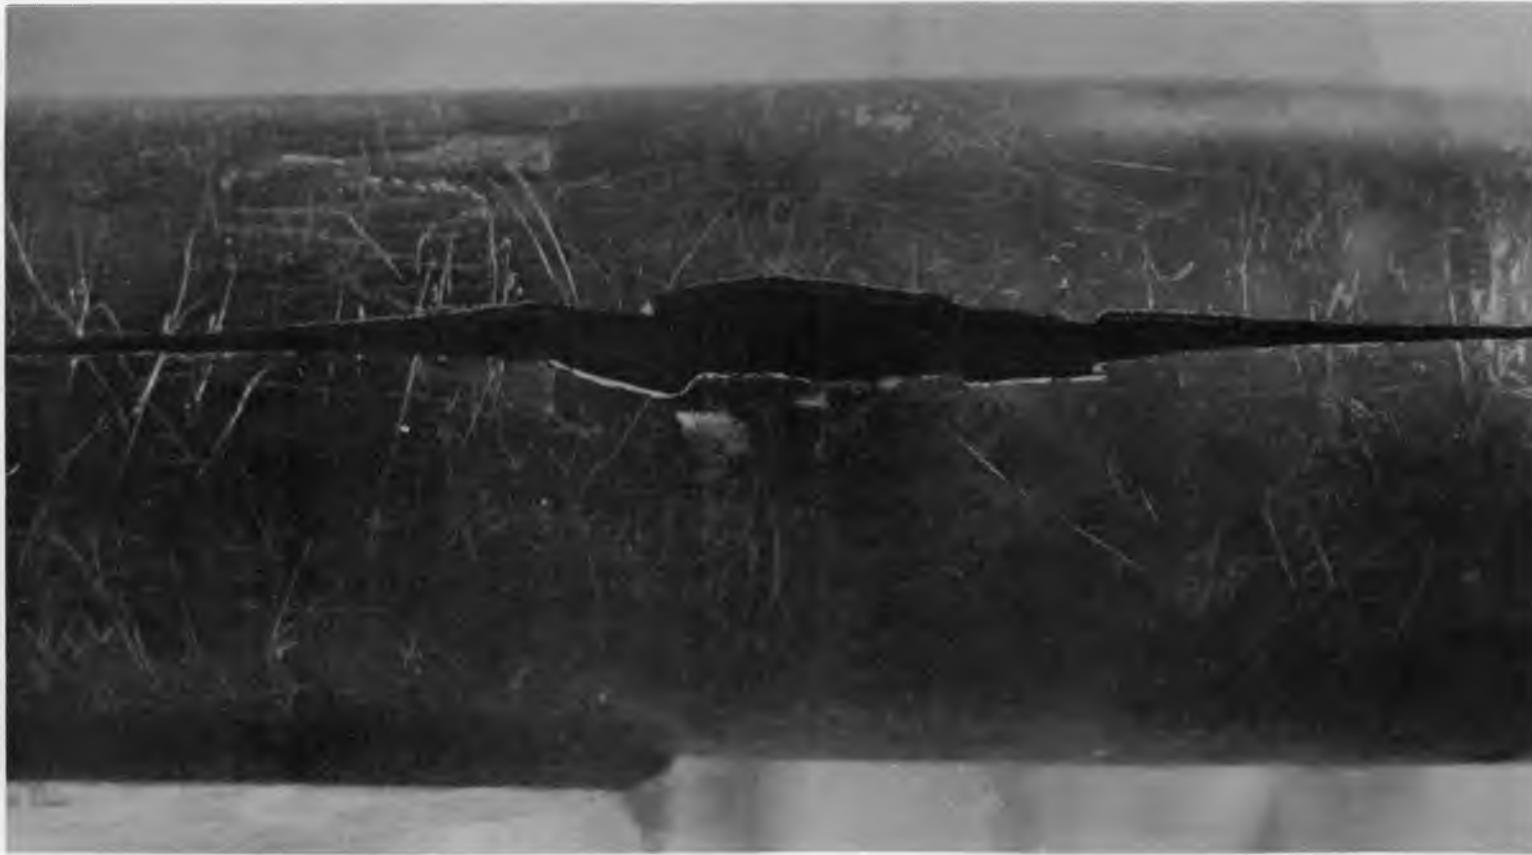
FIGURE 9

Close-Up of Fracture from Burst Sample in Figure 6
(This tube appeared the least ductile of any sections tested.) 1X

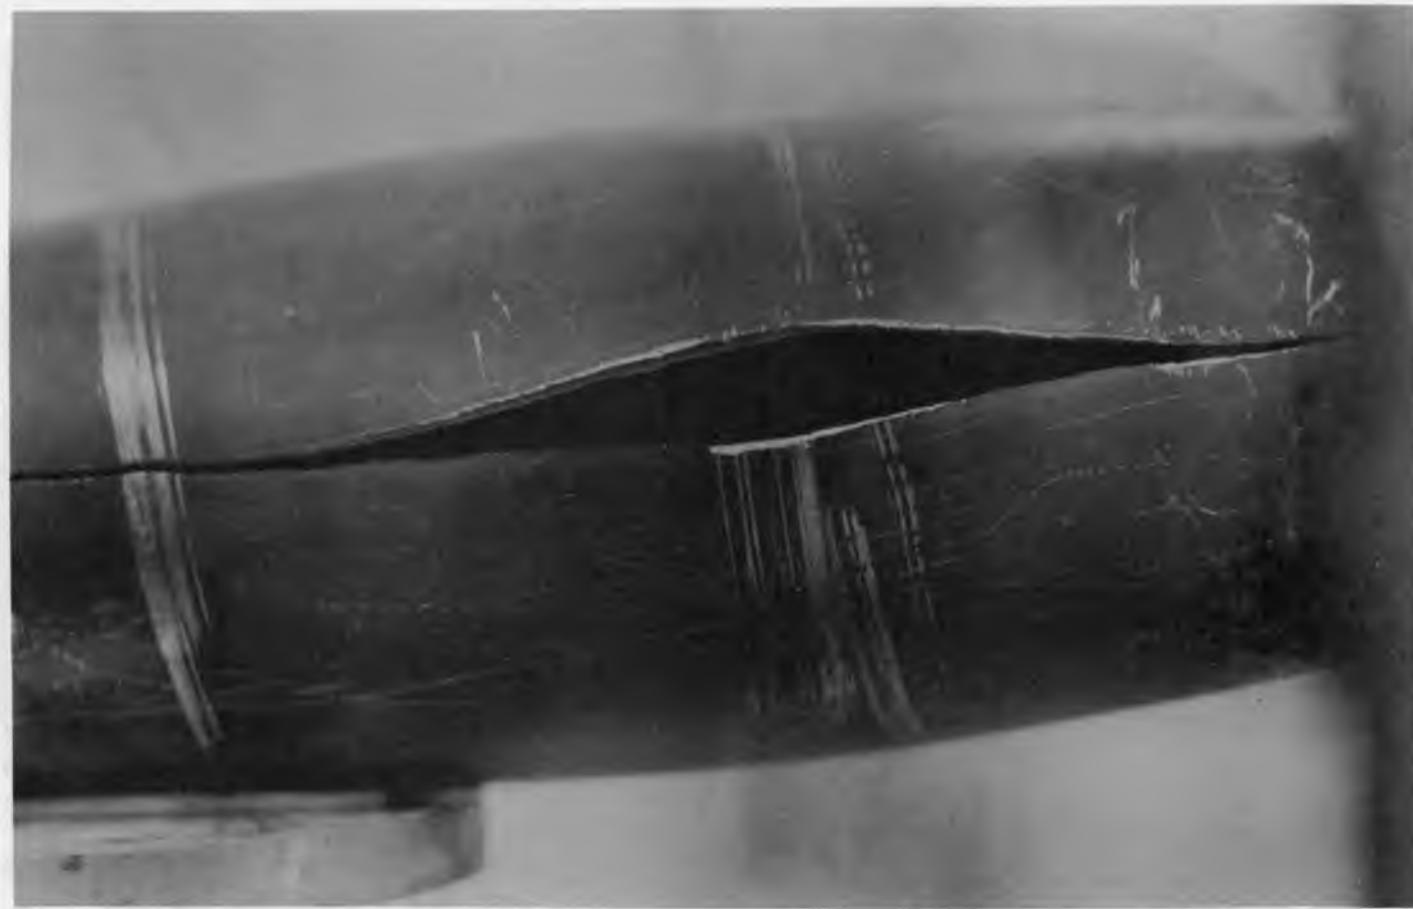
FIGURE 10

Close-Up View of Fracture Area from Figure 8
(Note shear area on inner and outer surface near point of failure,
estimated to be 30% of wall thickness.)

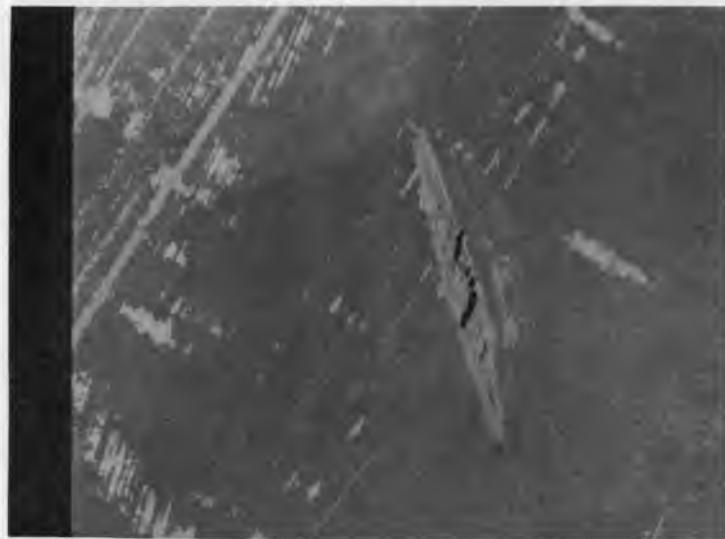
FIGURE 11

Wear Corrosion Mark on Inner Surface
of Tube Caused by Bundle Wrap
(Sample is from pressure Tube 6100 shown in Figure 5.) 2X

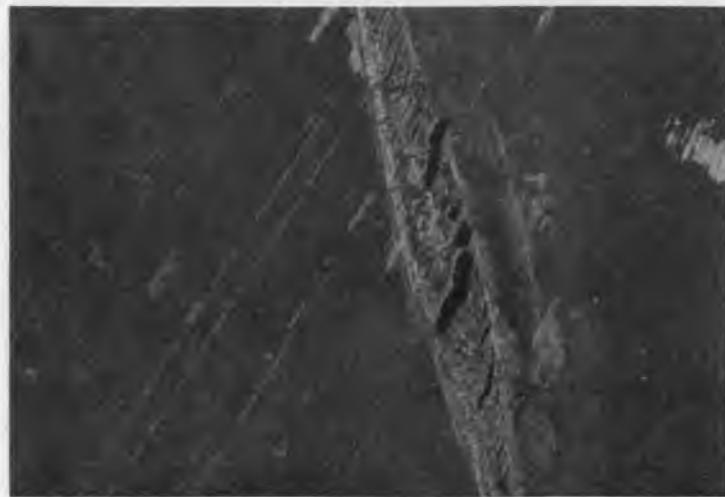
FIGURE 12

Same Area Shown in Figure 11
(Large cracks continue through the wall. Smaller
cracks extend the depth of the 2-mil-deep hydride layer
under the corrosion mark.) 4X

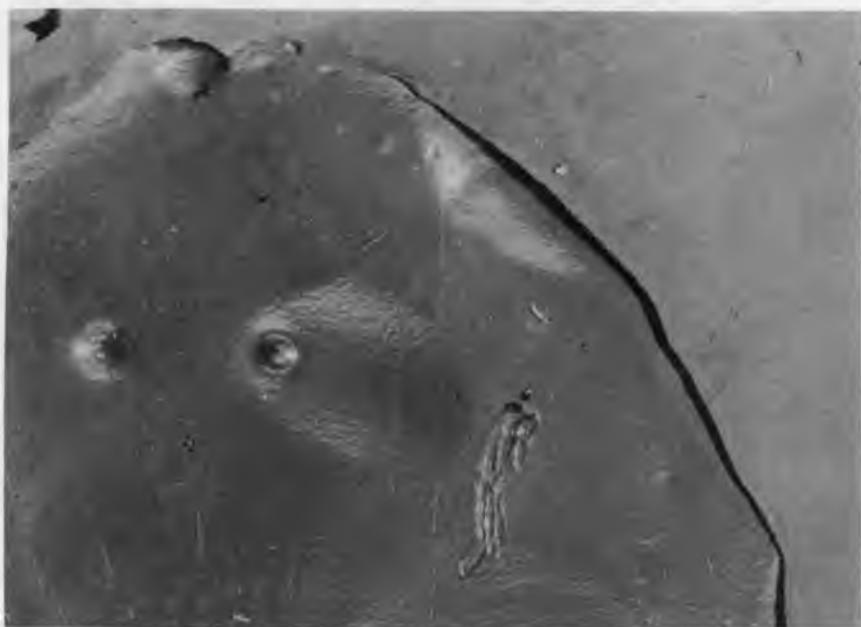
FIGURE 14

Replica Made of Gouged Area
in the Tube Wall of Process Tube 6100
(Maximum depth, 2-3 mils) 3X

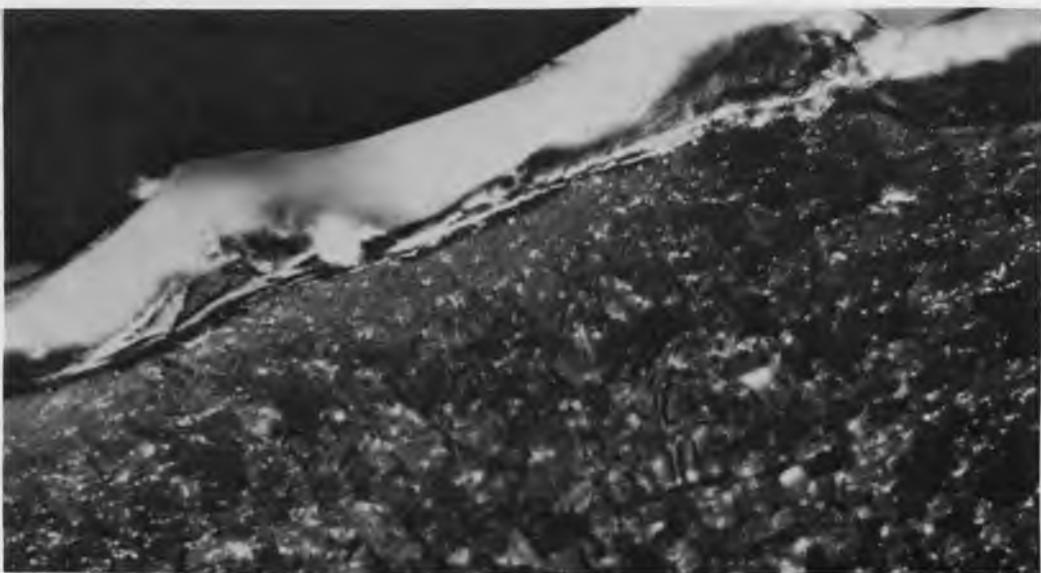
FIGURE 15

Grain Structure Under Gouge Shown in Figure 14
(Cold-worked structure at surface is 1-mil deep.) 500X

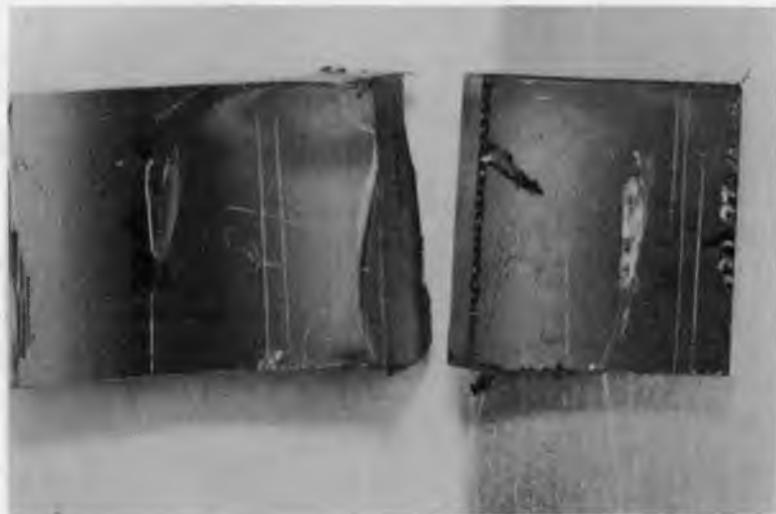
FIGURE 16

Process Tube 6100 Wear Corrosion Marks
with Individual Rod Wire Mark on Left
(Two distinct wear areas show the fuel element shifted during
operation. Depth is 2 mils. Upper fuel element support mark
is on the right. Note white corrosion product.)

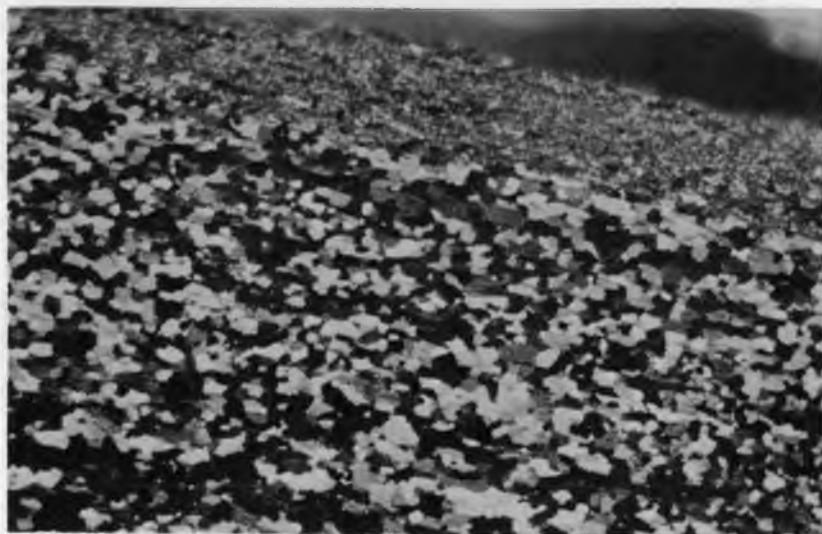
FIGURE 17

Longitudinal Section Through Upper Fuel Support Mark,
B Etched and Anodized
(Area near the top with no grain structure is layer of hydrides.)
Polarized Light, 250X

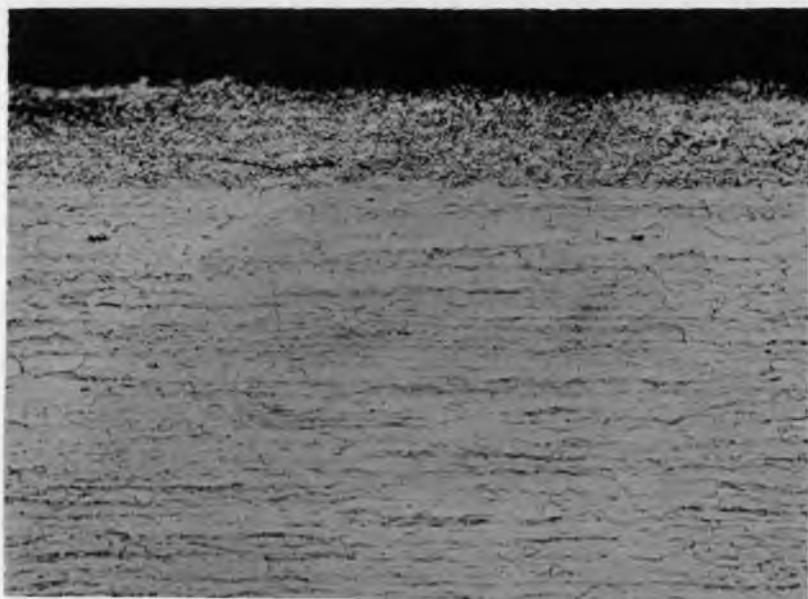
FIGURE 18

Same Area as Figure 17
(Layer near the top of picture
shows massive hydrides. Depth is 2 mils.)
Bright Field, 250X

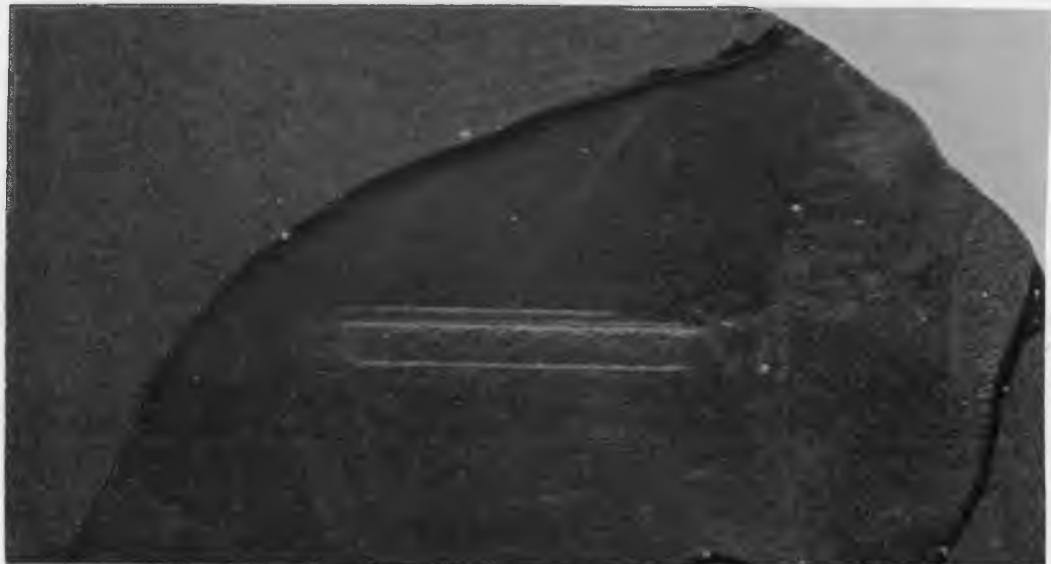
FIGURE 19

Replica of Lower Fuel Element Support Mark on Process Tube 6100
(Depth is 4-5 mils.) 5X

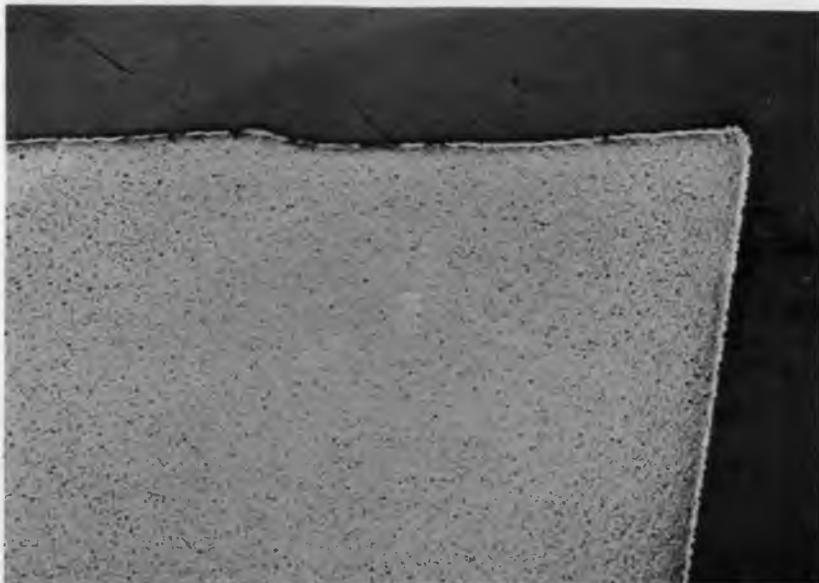
FIGURE 20

Transverse Section Through Localized Corrosion Area
at Lower Fuel End Bracket Support Mark from Figure 19
(Maximum depth at this point is 2-3 mils.)
Bright Field, 50X

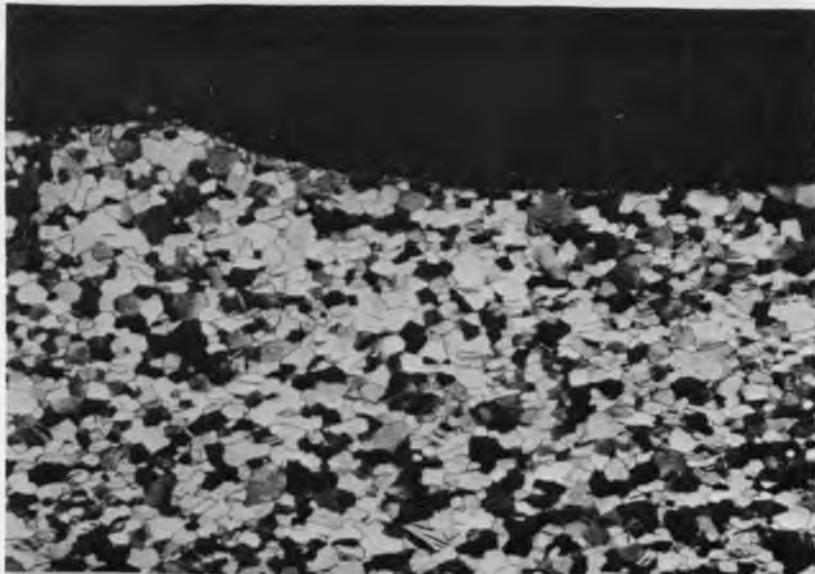
FIGURE 21

B Etched and Anodized Edge
of Corrosion Area from Figure 20
(Compare with Figure 17.)
Polarized Light, 250X

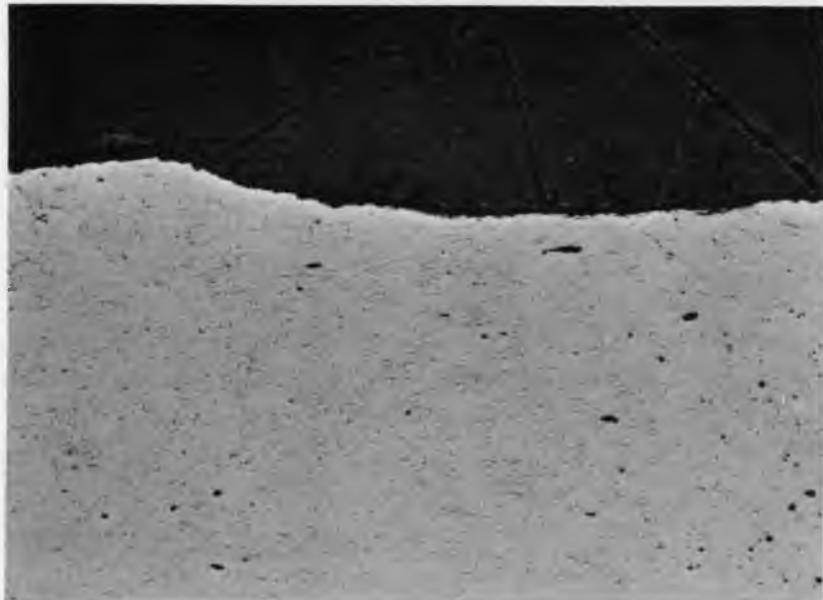
FIGURE 22

Same Area as Figure 21
(No hydrides are visible in this area.)
Bright Field, 250X

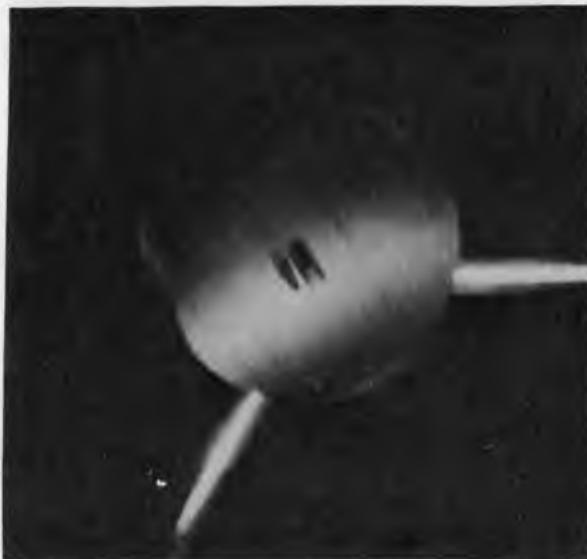
FIGURE 23

Process Tube 6061 Wear Corrosion Area
from the Upper Fuel Element Supports
(Maximum depth is 3 mils.)

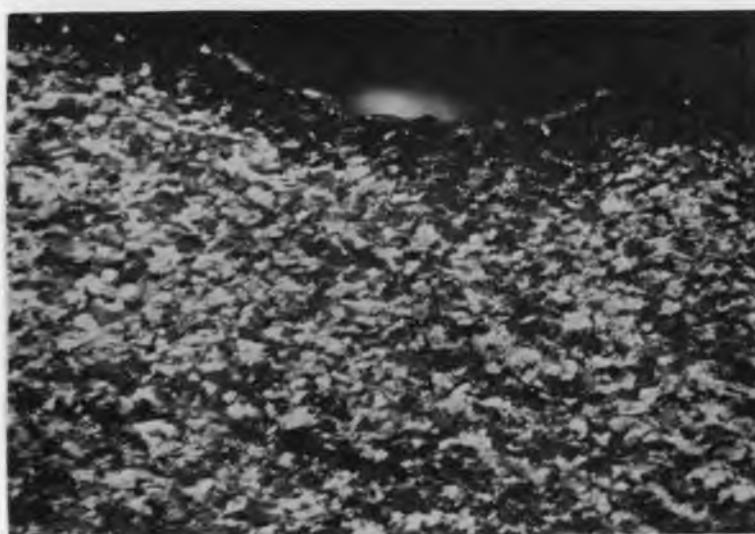
FIGURE 24

Transverse Section Through Upper Fuel Support Mark
Shown in Figure 23
(Typical Cold-Worked Structure. B Etched)
Polarized Light, 250 X

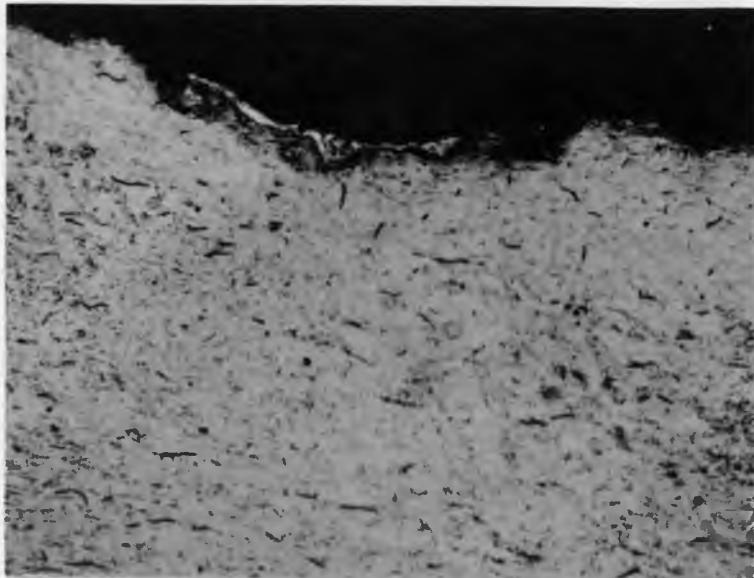
FIGURE 25

Same Area as Figure 24
(Note the slight increase in hydrides under corrosion area.)
Bright Field, 250X

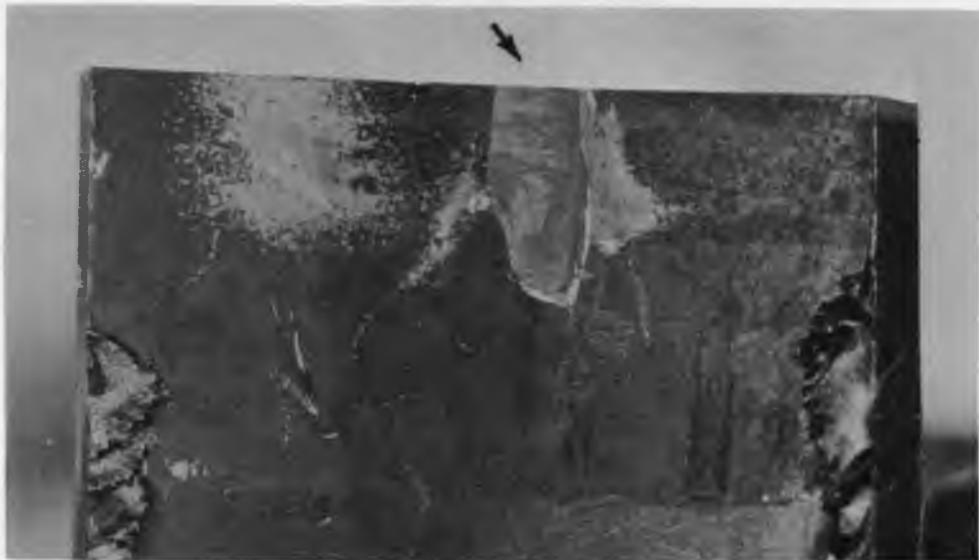
FIGURE 26

Process Tube 6061 Lower Fuel Element Support Mark
(The corrosion mark in the center of the sample is 6.5 mils deep.
This occurred during the first two weeks of operation and was
caused by the 1/16-inch wide supports.) 4X

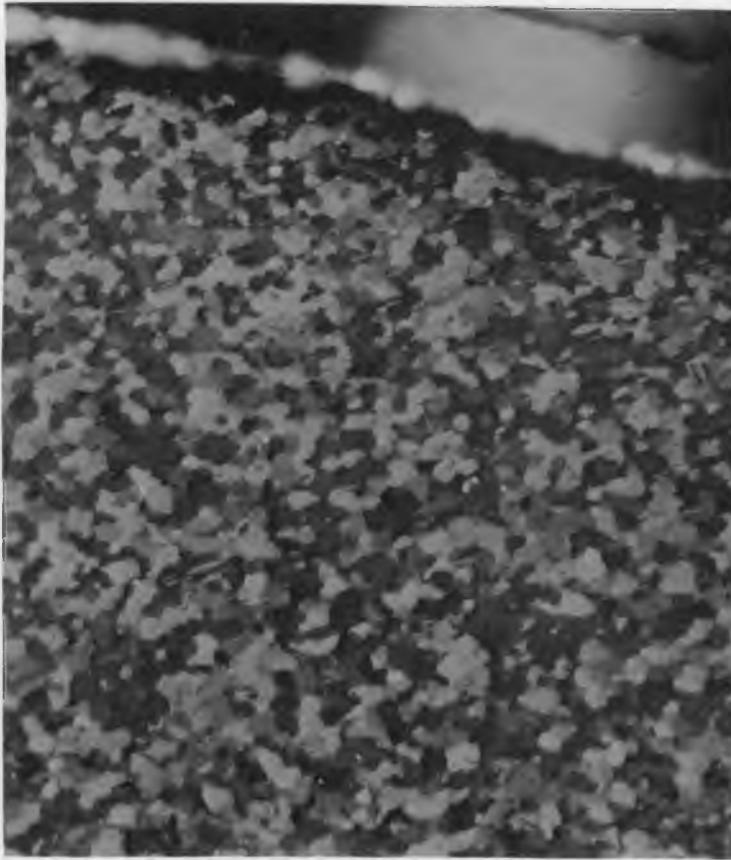
FIGURE 27

Transverse Section of the Shallow End
of the Corrosion Mark from Figure 26
(Typical Annealed Structure
Found in the Lower Half
of the Pressure Tube. B Etched)
Polarized Light, 250X

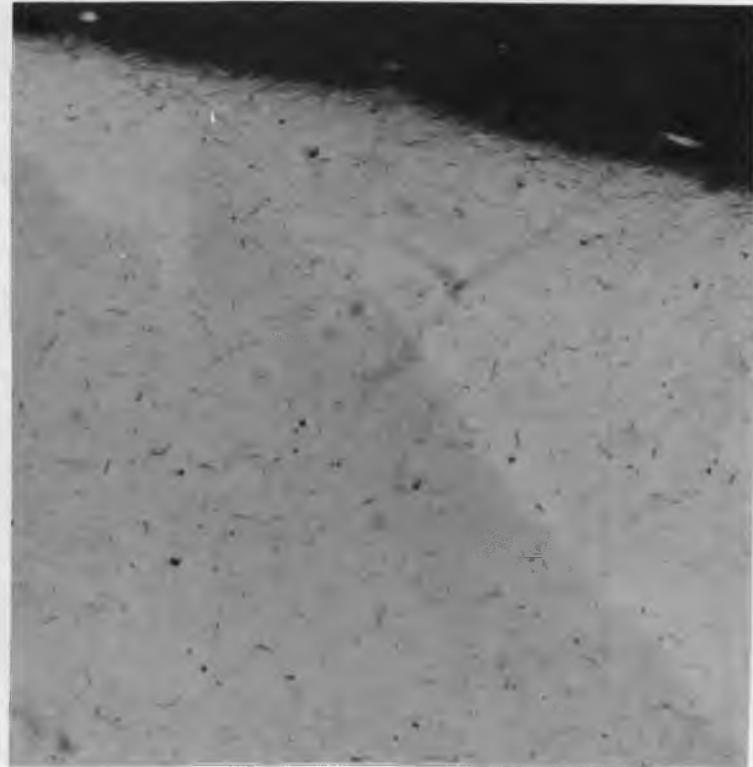
FIGURE 28

Same Area as Figure 27
(Very Few Hydride Platelets
Under Corrosion Area. B Etched)
Bright Field, 250X

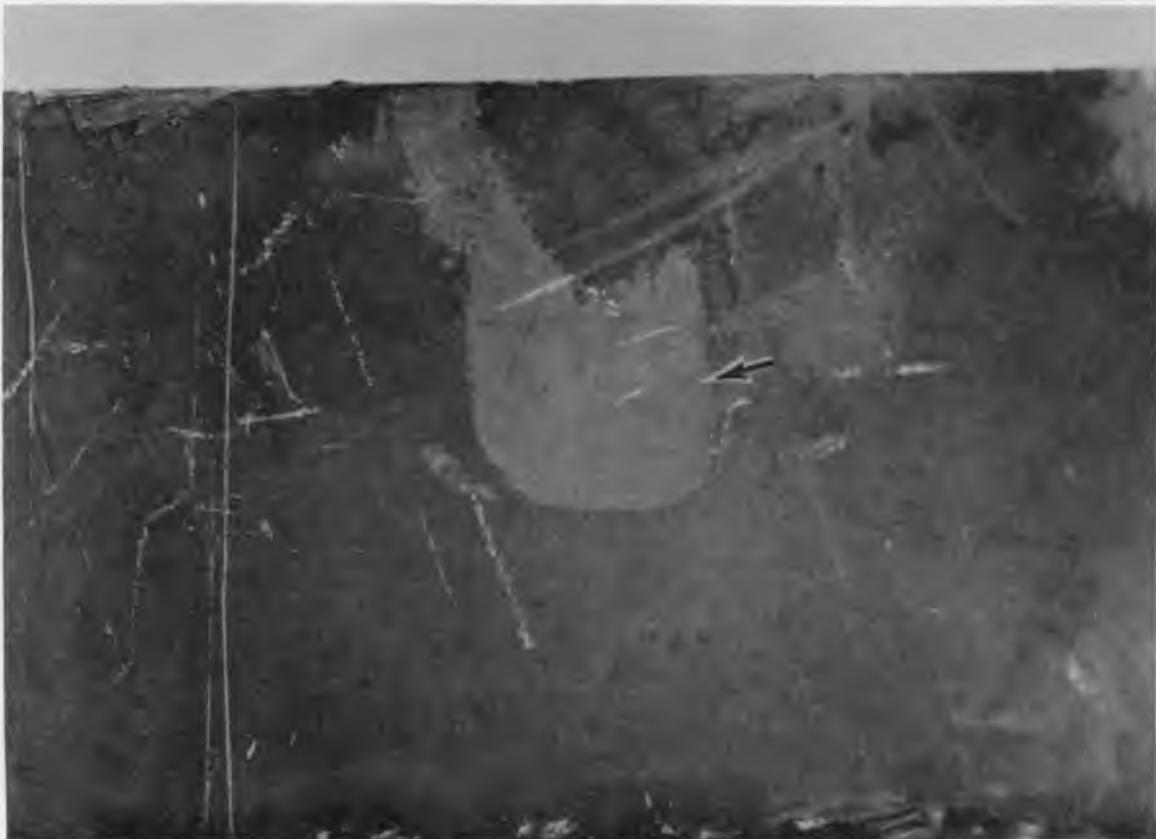
FIGURE 29

Typical Wear Corrosion Marks on Process Tube 6061
from 1/4-Inch-Wide Fuel Supports

(One Pu-Al element was equipped with special 1/4-inch-wide supports to determine the effect on wear corrosion. The maximum penetration that occurred was less than 1/2 mil during a two-week operating period.)

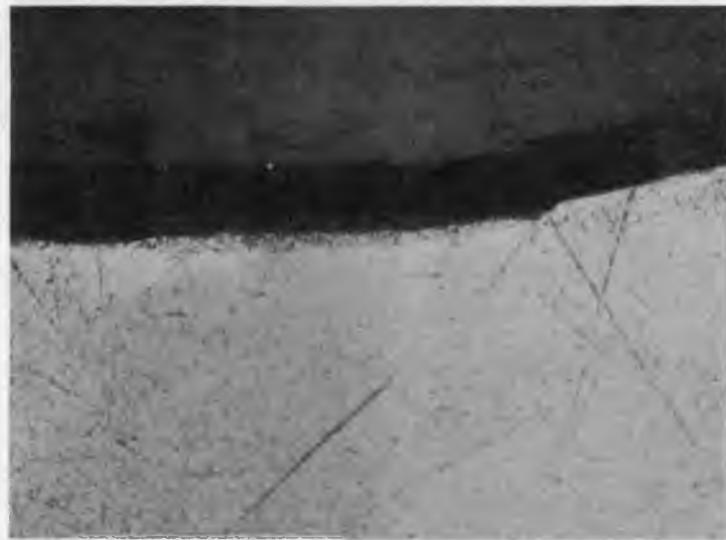
Tube 5529. A lower fuel element end bracket support mark and an individual rod wire wrap mark near the lower support mark were examined. Both marks had the appearance of a contour relief map with three plateaus. The maximum depth of the support mark was 5 mils. A layer of massive hydride about 2 mils deep was found under the support mark (Figures 30 and 31). Only a slight increase in hydrogen was found under the wire wrap mark.

FIGURE 30
Wear Corrosion Mark
from Lower Fuel Element Support in Tube 5529
(Maximum depth was 5 mils.) 50X

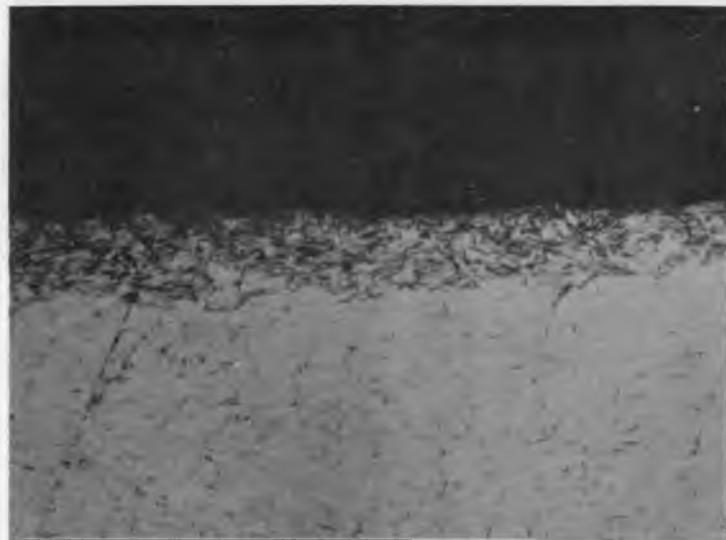
FIGURE 31
Same Area as Above
(Layer of massive hydrides is 2-mils deep. B Etched)
Bright Field, 250X

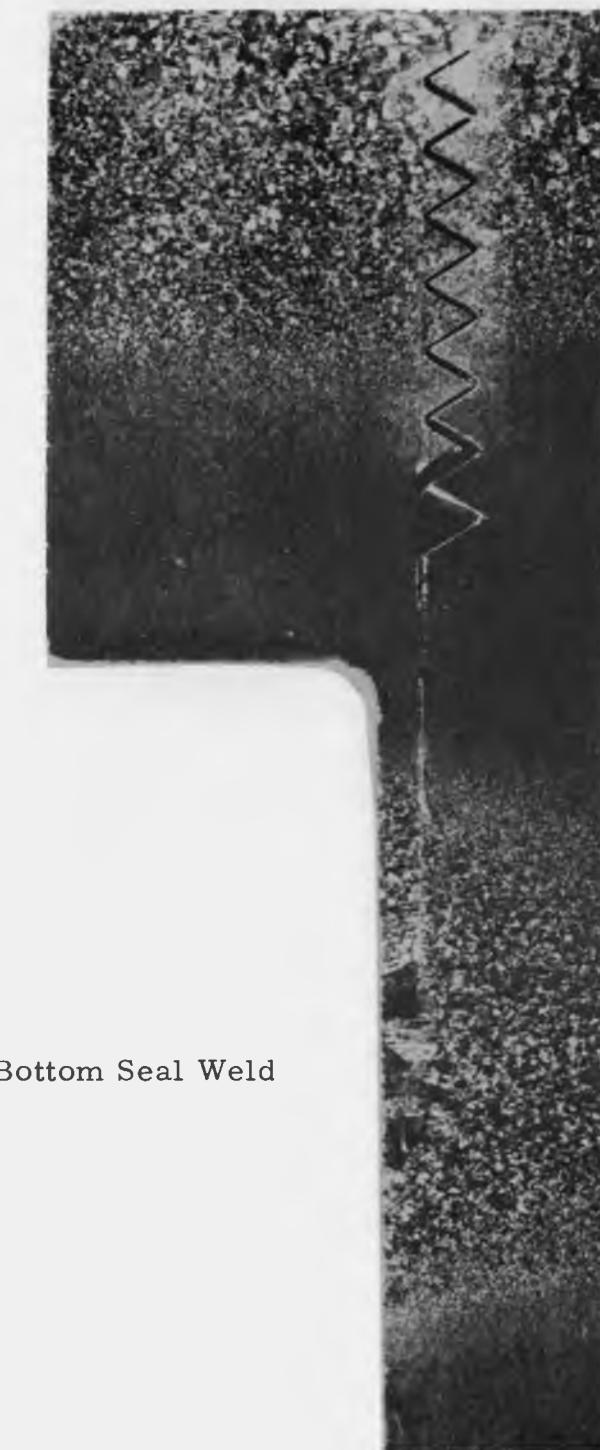
FIGURE 32

Figure 32 shows a typical cross section of a flange. This is a screwed flange with two seal welds. The top weld has a minimum of 0.020-inch penetration and is in contact with the primary coolant. Excessive corrosion at the top seal weld could penetrate into the threads and possibly cause a blow-out of the lower seal weld.
