POSTIRRADIATION EVALUATION
OF ZIRCALOY-2 PRTR PRESSURE TUBES

L. J. DEFFERDING

NOVEMBER, 1962

POSTIRRADIATION EVALUATION
OF ZIRCALOY-2 PRTR PRESSURE TUBES
PART I

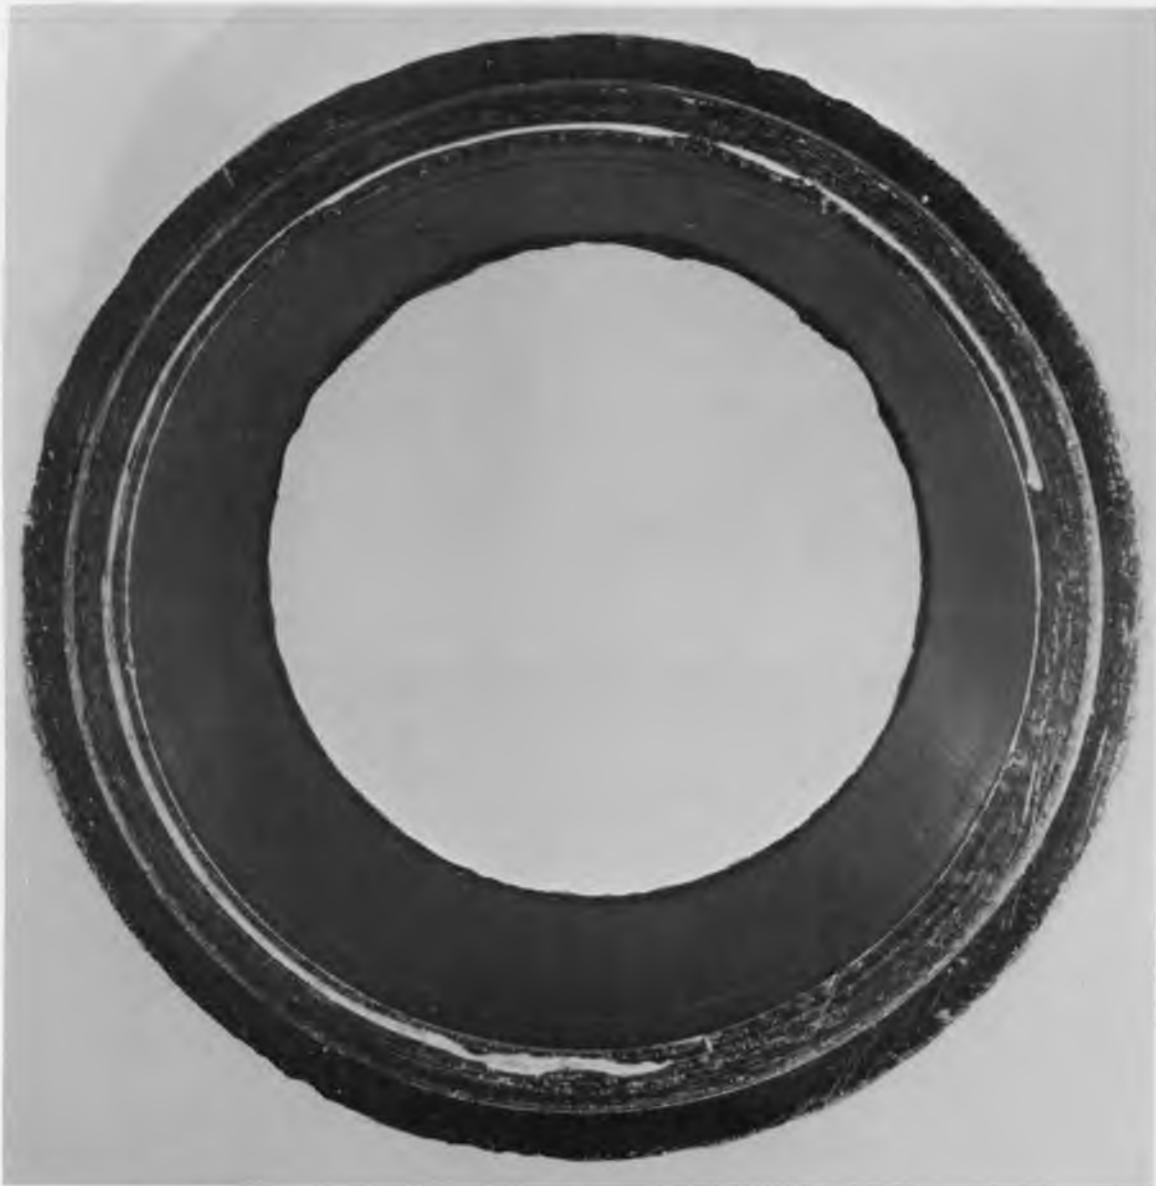
FIGURE 33

The flanges from tubes numbered 6100, 6061, and 5529 were destructively examined. The corroded areas from the flange from Tube 6100 was 2 to 4 mils deep with 3 to 4 mils of massive hydride directly under the corroded area (Figures 33 and 34). Several areas of porosity were noted in the seal weld on the top surface of the flange. One of these holes had corrosion product in it and an associated layer of hydrides (Figures 34 and 35). Similar areas were examined from Tubes 6061 and 5529, however, no hydrides were found beneath corroded areas. From the examination of these three flanges, the extent of corrosion in these areas does not appear to be increasing at a measurable rate.

Top Flange from Tube 6100
(Heavy white ring is corrosion product. Light rings are places where
the gasket has cut through the oxide film.) ~2X

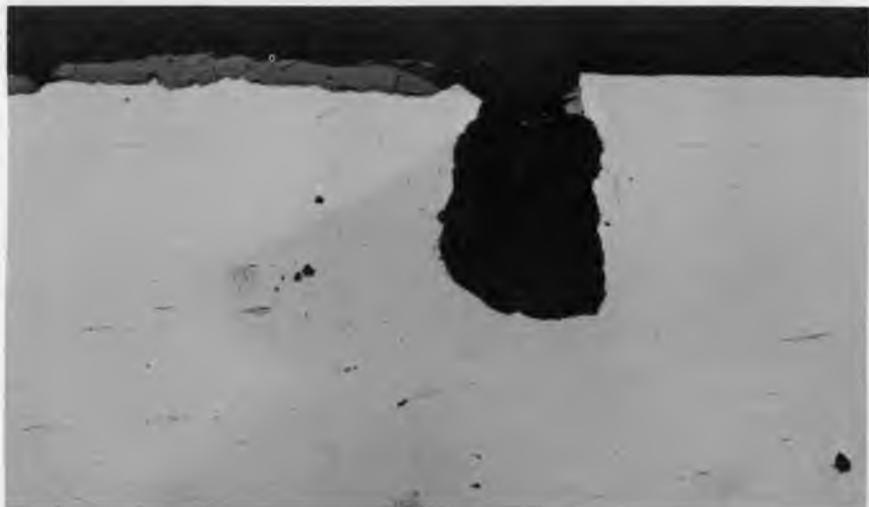
FIGURE 34

One Corrosion Area from Figure 33, Showing Gray Layers of Oxide (Upper Left) and Gas Pocket in Seal Weld with Gray Layer of Oxide at Lower Right in the Hole. As Polished, 100X

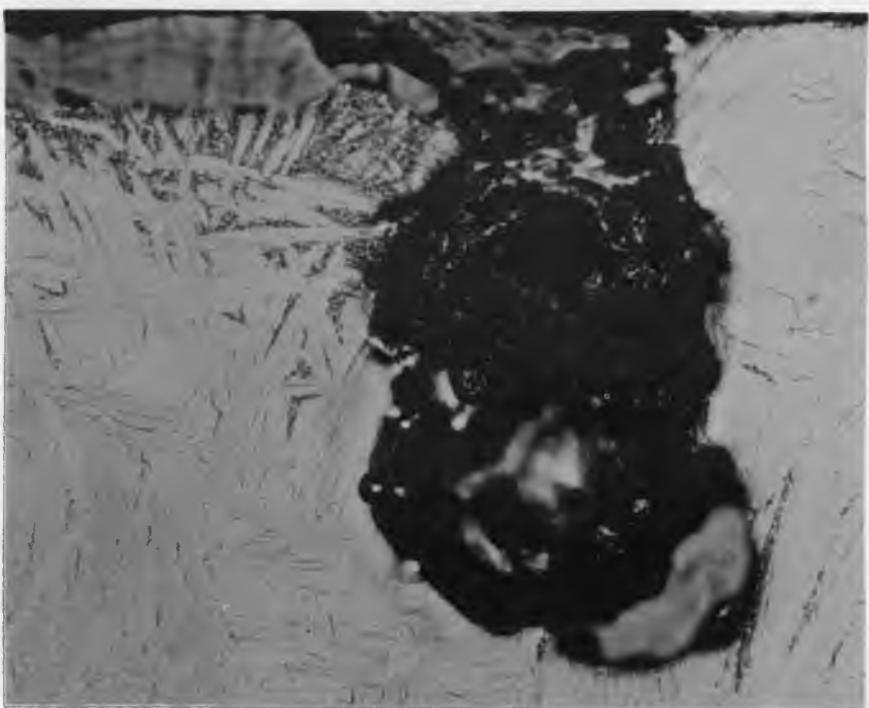
FIGURE 35

Same as Figure 34
(Note massive hydrides in beta phase structure beneath oxide at upper left and at lower right in the hole. B Etched)
Bright Field, 250 X
