# Shippingport Operations

**FROM POWER OPERATION AFTER FIRST  
REFUELING TO SECOND REFUELING**

**MAY 6, 1960 TO AUGUST 16, 1961**

*Prepared by*  
**DUQUESNE LIGHT COMPANY**  
*and*  
**BETTIS ATOMIC POWER LABORATORY,  
WESTINGHOUSE ELECTRIC CORPORATION**

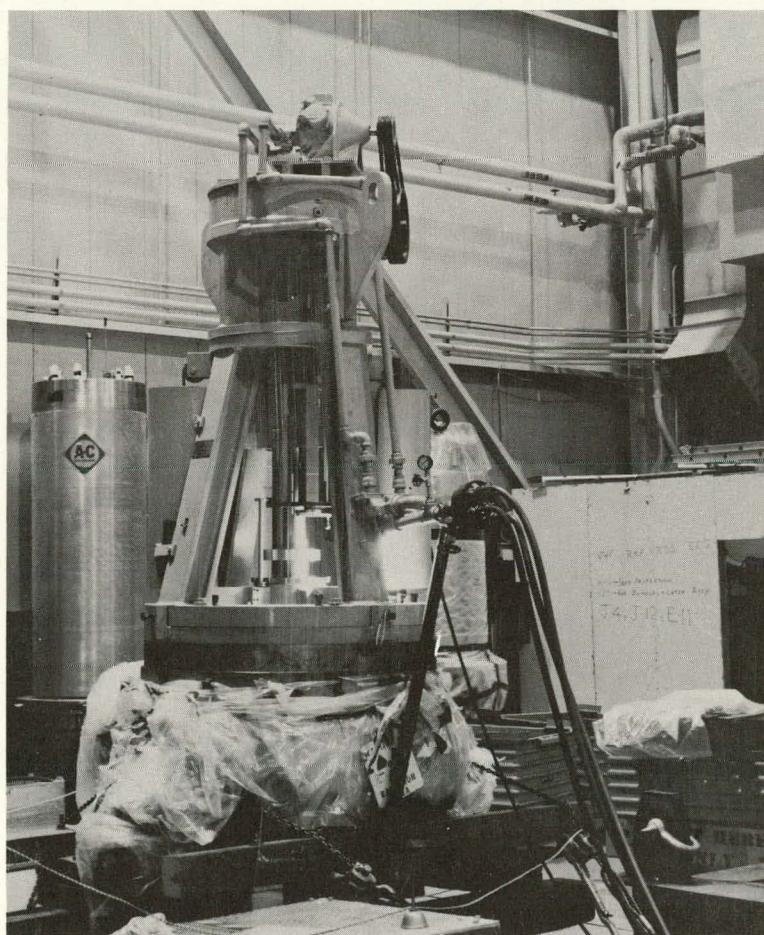
At the completion of the boring operation, a dye check of the volute casting was performed. Numerous indications of flaws appeared in both the inside and outside of the volute. One crack in the shroud ring was ground to a depth of 1-1/8 inches before the crack disappeared. The ground area of the shroud ring was filled with weld material to the contour of the shroud ring and successfully dye checked. Most of the flaws were removed by grinding the surface area. Two areas inside the volute were filled with weld material, ground, and dye checked. These two areas were ground out to a depth of 1/2 inch to remove the flaws.

Figure I-9. Portable Boring Machine Mounted on the Pump Volute.

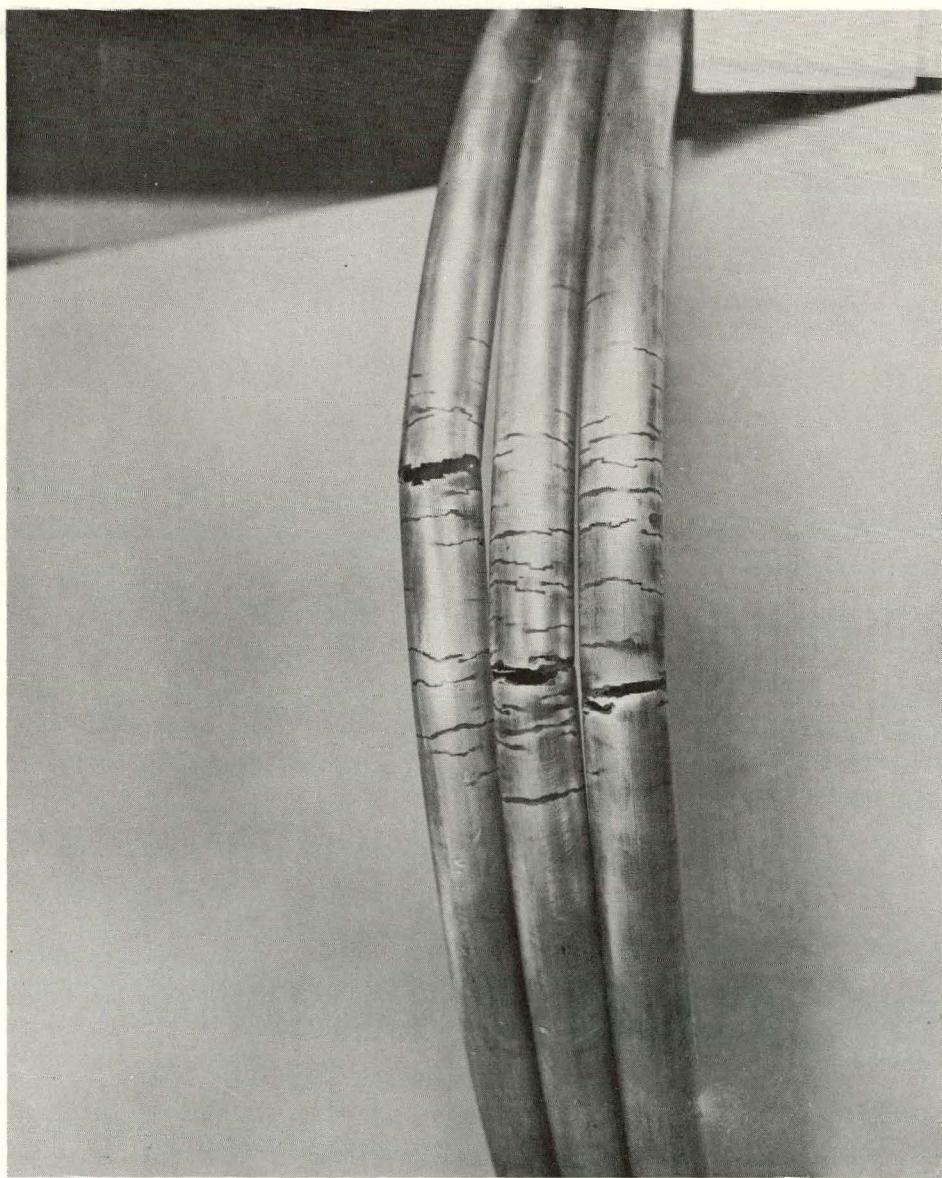
Figure V-25 Circumferential Cracking -- 1A Feedwater Heater.
