ENRICO FERMI ATOMIC POWER PLANT

CURRENT EXPERIENCE SERIES

COMPILED OF CURRENT TECHNICAL EXPERIENCE AT ENRICO FERMI ATOMIC POWER PLANT NOVEMBER 1968

PREPARED BY
Atomic Power Development Associates, Inc.
with the Cooperation of
Power Reactor Development Company
and
The Detroit Edison Company

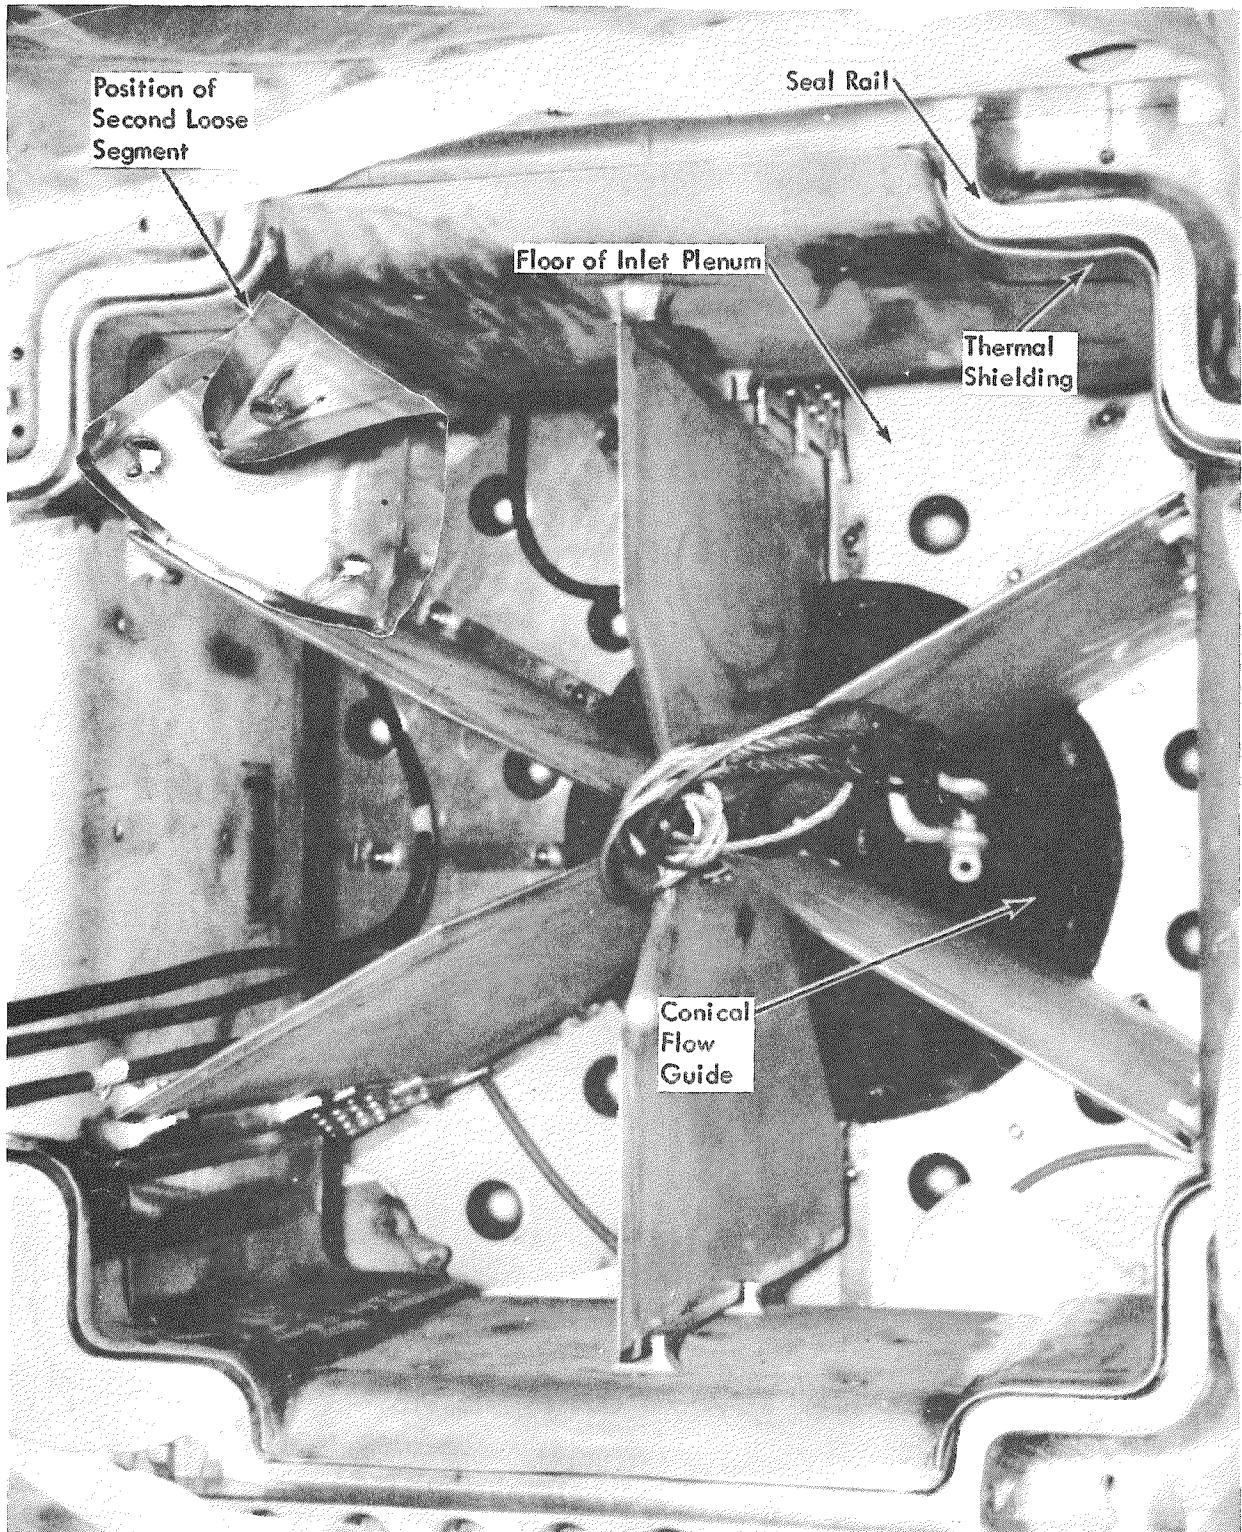
segment, like the first one removed, was observed to be bent. Its position is shown in Figure 1, a construction photograph of the core flow inlet chamber above the inlet plenum. It is not known what held the segment against the underside of the support plate. A possible explanation is that it wedged between the top edge of the thermal shielding and the bottom of the lower support plate, which rests on the seal rail to form a seal between the core inlet and the blanket inlet plena.

FIG. 1 CORE FLOW INLET CHAMBER IN CONSTRUCTION STAGE

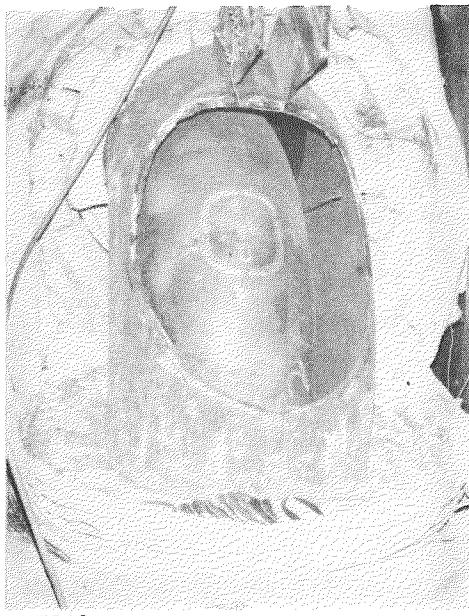
**FIG. 4 PATCH REMOVED FROM SECONDARY
CONTAINMENT ELBOW IN 14-INCH INLET LINE**

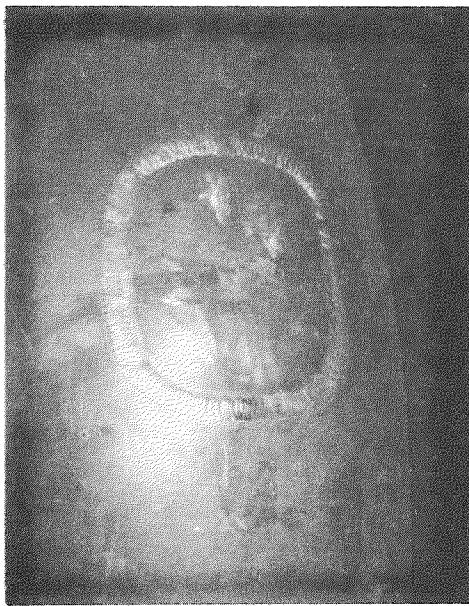
**FIG. 5 PATCH WELDED IN PRIMARY PIPE ELBOW PRIOR TO REMOVAL
FOR WITHDRAWAL OF REMAINING SEGMENTS**

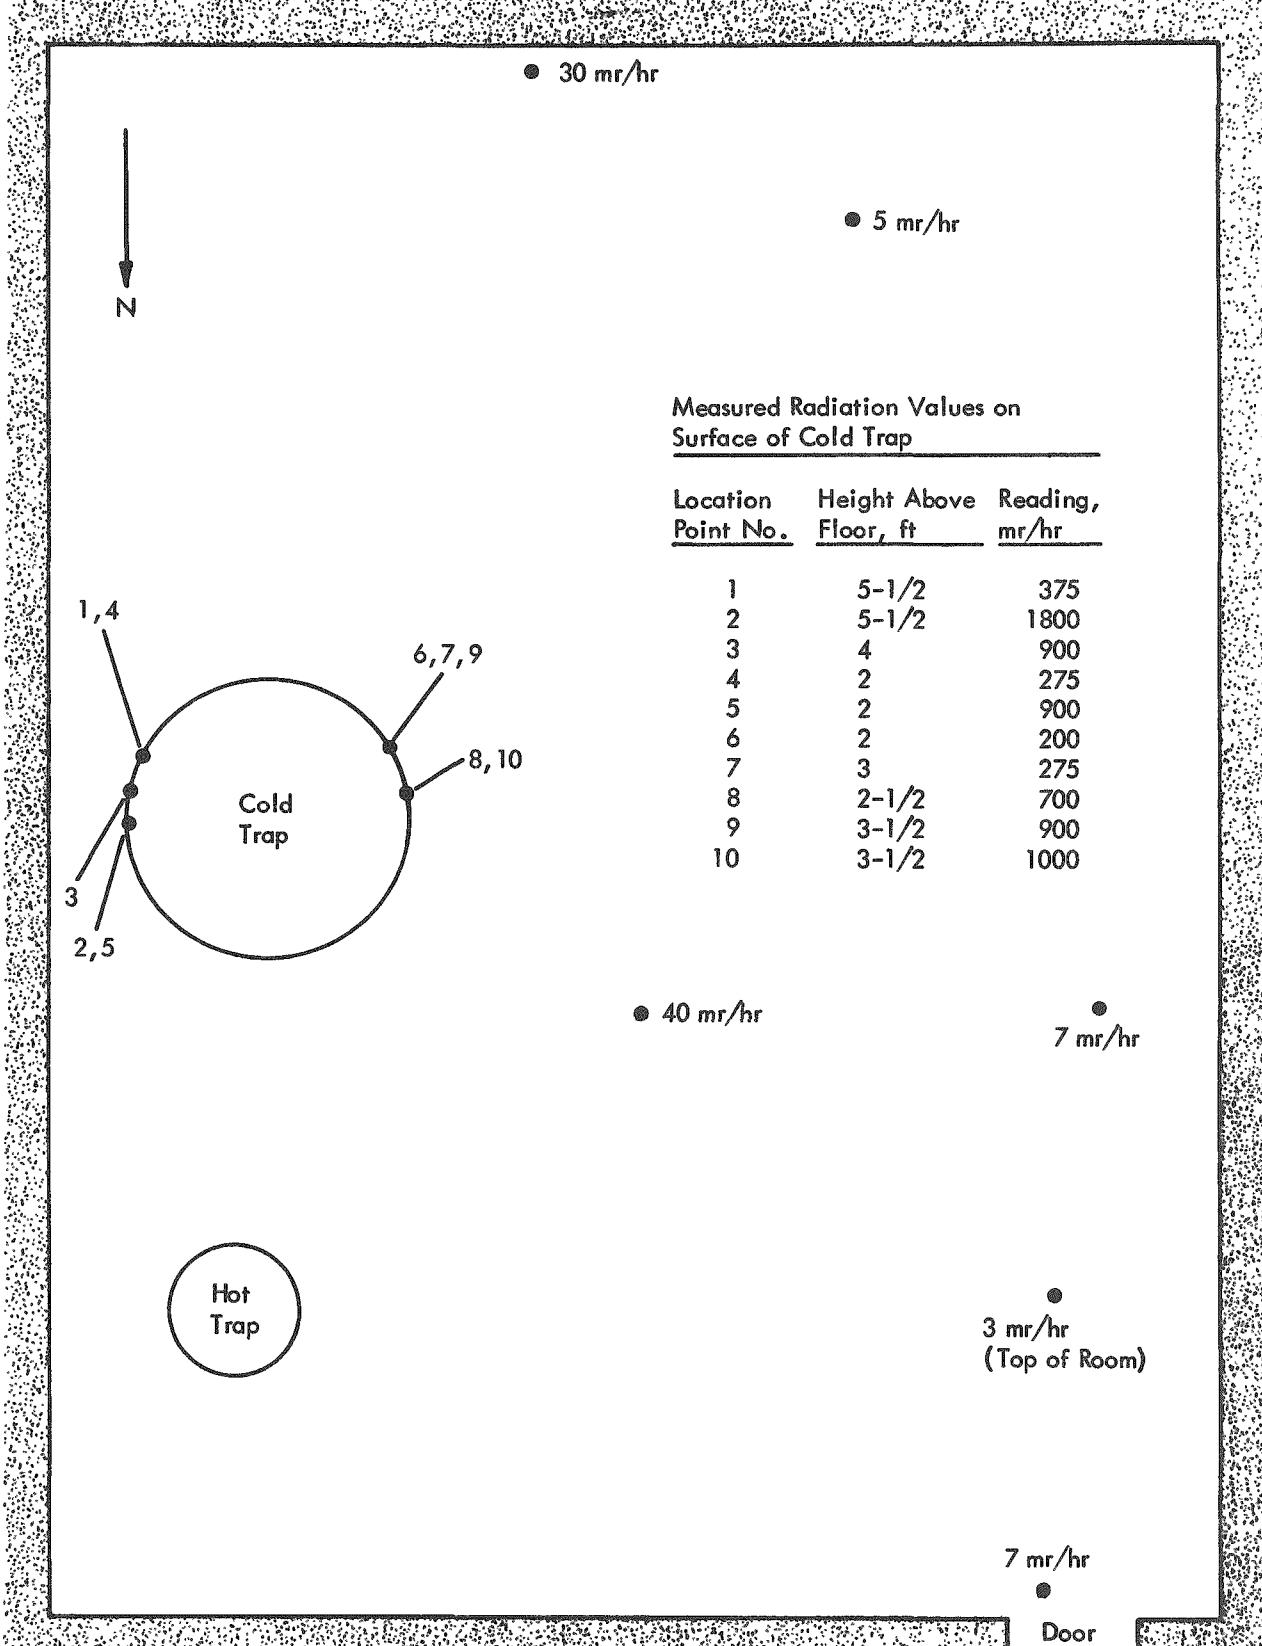
After entry into the cold trap room to investigate an indicated leak in the bellows of valve V502-1,*** a radiation survey was conducted in the cold-trap room. Figure 10 shows the radiation levels at various points on the outside surface of the cold trap and at about waist elevation elsewhere in the cold-trap room inapproximate locations as shown.

FIG. 10 RADIATION SURVEY OF COLD TRAP ROOM

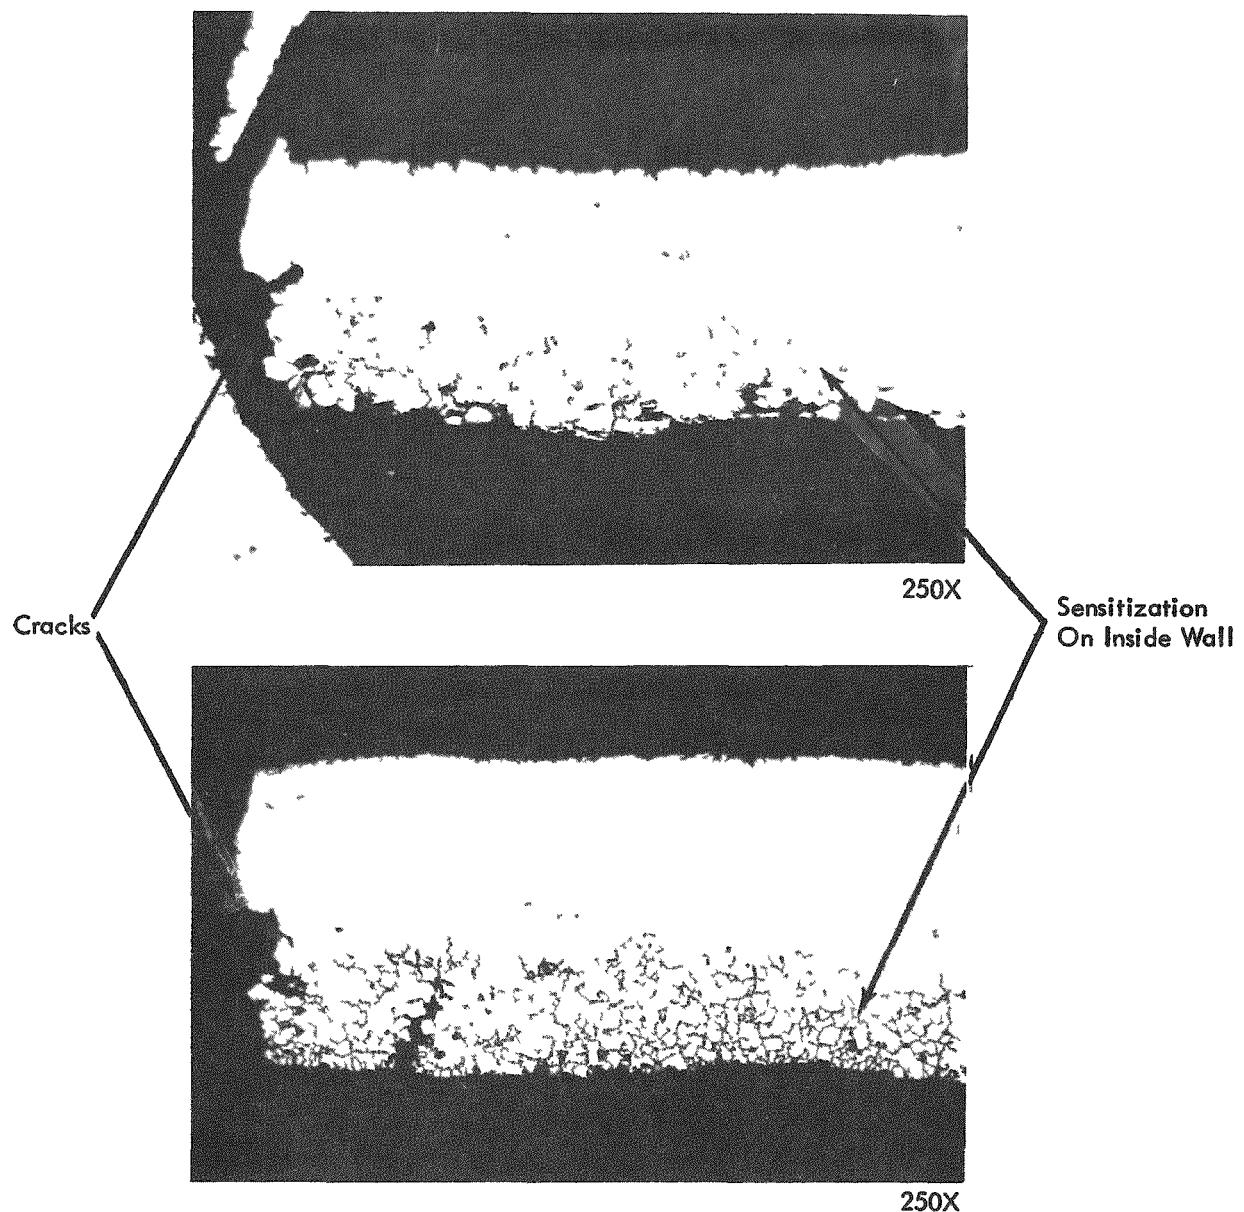
V 502-1	1968	Crack initiated from inside bellows; it is likely that crack was produced when bellows was formed and that stress relief eliminated evidence of cause; in service 8-1/2 years
V 516	1968	Same comment as for V502-1; in service 8-1/2 years

FIG. 14 FAILURES IN BELLows FROM VALVES V516 (TOP) AND V502-1

A review of the bellows failures to date raised concern for those failures, namely in valves FCV 506, FCV 508, V502-1 and V516, where cracks were initiated from the inside or gas side of the bellows and where carburization was found on the inside surface. It was concluded that the cause of failure in these instances existed prior to the installation of the valve in the sodium system. From what is known of fabrication procedures, it was further concluded that carburizing contamination of the bellows could have occurred during fabrication which could lead to the type of failures experienced. Figure 13 shows a failure in the bellows from valve V516. Photomicrographs showing failures in V516 and V502-1 are given in Figure 14. Presently a program is underway to prepare new specifications for the fabrication of bellows for sodium valve service. These specifications will require ultrasonic cleaning which is not now included in the fabrication procedures.
