ENRICO FERMI ATOMIC POWER PLANT

CURRENT EXPERIENCE SERIES

COMPILED OF CURRENT TECHNICAL EXPERIENCE AT ENRICO FERMI ATOMIC POWER PLANT MARCH 1969

APDA-CFE-31
APDA-CFE-31
APDA-CFE-31

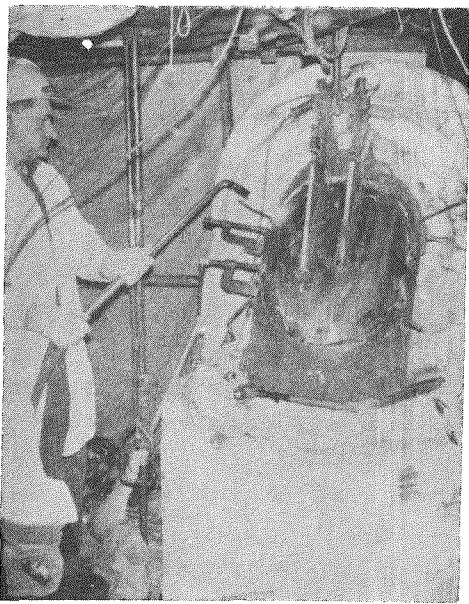
**FIG. 1 HEAT-FORMING CONTAINMENT
PATCH TO CUT-OUT**

Last month, the patch in the 14-inch primary line penetration was replaced and its integrity checked by X-ray, dye-penetrant, mass-spectrographic, and ultrasonic examination (see APDA-CFE-30, Sec. II. D). Welding of the secondary containment pipe patch was begun on March 11 and completed March 19 (Figures 1 through 4). Interferences caused by the re-installation of a pipe hanger attached to the secondary containment pipe prevented mass-spectrographic testing of the patch weld; however, the final weld was checked by dye-penetrant and ultrasonic examinations. Four 2-inch-diameter holes were drilled in the patch to allow visual examination of the integrity of the primary pipe patch following sodium refill. The insulation and induction heating coils were re-installed over the secondary containment patch to avoid creation of a cold spot at this location. The viewing holes were not covered. An inspection at the end of the month, following sodium refill (see Section III. B), revealed no evidence of sodium leakage through the primary pipe patch weld. The viewing holes will be plug-welded when the inspection is completed, and the plug welds checked by dye-penetrant and ultrasonic examination.

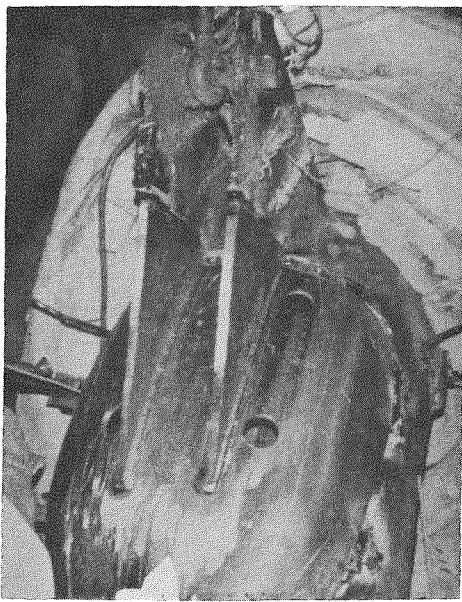
**FIG. 2 CLOSE-UP OF VIEWING
HOLES IN PATCH**

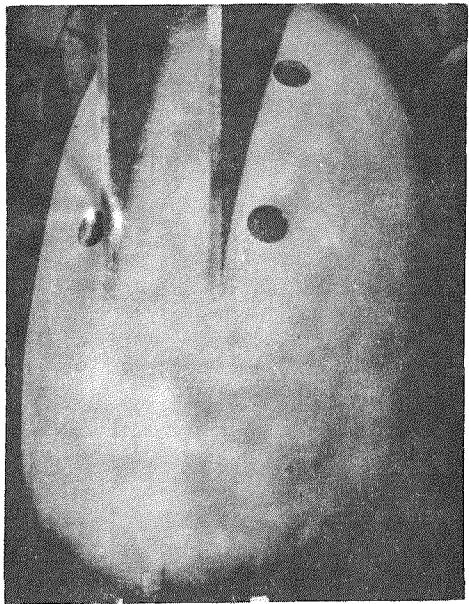
**FIG. 3 DYE-PENETRANT TEST
OF PATCH**

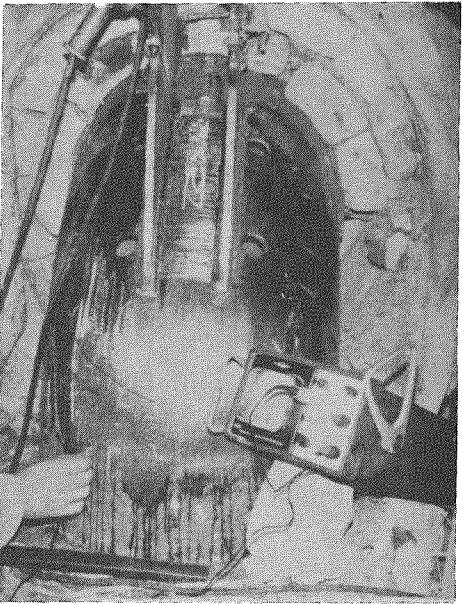
FIG. 4 ULTRASONIC TEST OF PATCH

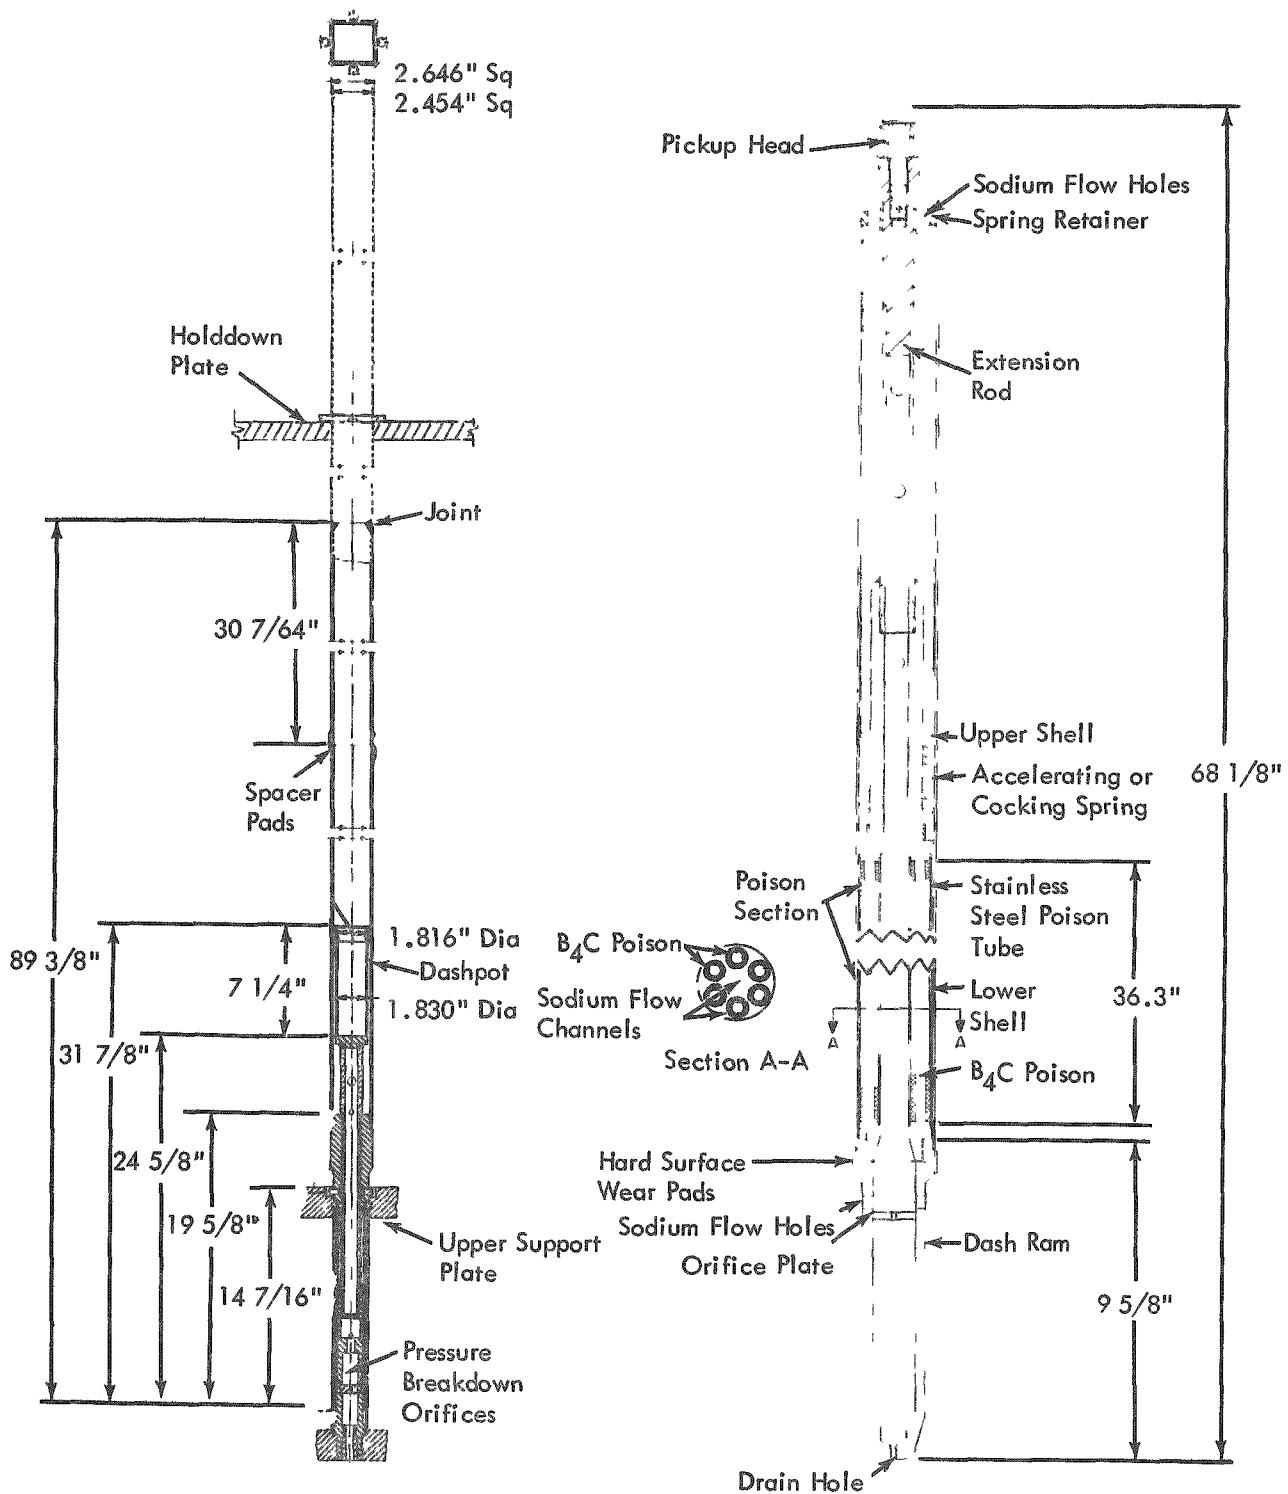
SAFETY ROD ASSEMBLY

On March 24, early in the fuel loading program, an attempt was made to transfer safety rod No. 90 from position N02-P02 to P02-P02 using the OHM; however, an interference encountered during OHM rotation indicated that the lower safety rod guide tube had probably been picked up together with the safety rod. The safety rod and guide tube were subsequently returned to their original position. The possibility of this occurring was anticipated and precautions were being taken at the time to rotate the OHM by hand to allow detection of any interference and to avoid damage if it occurred.

The design of a safety rod and its associated guide tube is shown in Figure 6. The safety rod is 68 inches long, whereas the lower guide tube, which separates from the upper guide tube when the holddown mechanism is raised, is approximately 91 inches long, slightly less than the 96-inch length of a subassembly; consequently, when withdrawing a safety rod from the reactor, the OHM carrying elevation is only 70 inches compared to the 98 inches used for a subassembly transfer. If a lower guide tube were stuck to a safety rod during transfer, it would extend down into the core almost two feet below the elevation of the surrounding subassembly handling heads. In the attempted safety rod transfer, calculations had previously been made of the positions at which interferences with subassemblies would occur if the guide tube was

The attempted transfer of the safety rod from guide tube No. 1 to guide tube No. 3 was not related to the fuel handling requirements for the holddown mechanism inspection program. The transfer was being made now, as a matter of convenience, because it is planned that the No. 1 lower guide tube will be replaced by a new tube at a later date to allow examination of the original guide tube. Therefore, following the attempted safety rod transfer, fuel handling to complete the core configuration for the HDM inspection was completed normally. The reactor will next be drained and the HDM inspection program will proceed as planned. In the meantime, a tool is being developed which can be inserted through the rotating shield plug for use in removing the rod from its guide tube. The rod stripping tool is being designed so that a differential pull can be applied between the rod and guide tube, i. e., such that a downward force can be exerted on the guide tube while the rod is simultaneously pulled upward. If the rod can be removed in this manner with a lifting force of less than 150 lb, it will be transferred to the No. 3 guide tube using the tool.* Replacement of the No. 1 lower guide tube will then be made as originally planned. Alternately, if the lifting force required to strip the rod is more than 150 lb, which could indicate rod damage as well, the rod and guide tube will be removed together using the OHM and be placed in the transfer rotor container.

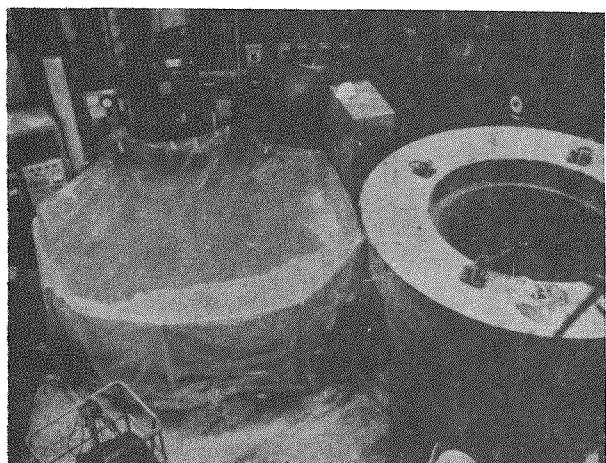
Last month the coring and burning of the two 12-inch-diameter holes for the two loading ports and the 6-inch-diameter hole for the rotor shaft of the auxiliary fuel storage facility (AFSF) had been completed through the shield plug of equipment decay tank No. 2 down to the elevation of the 7-inch-thick layer of steel plates which line the bottom of the plug (see APDA-CFE-30, Sec. VII.C). This month the holes through the bottom layer of steel were completed using the oxygen lance, as shown in Figures 10 and 11. The shield plugs have since been removed from the decay tank and are temporarily located on the operating floor while work progresses on removing the chemically resistant paint from the inside of the decay tank by means of steel shot blasting (Figure 12). This is being done to prevent the possibility of offgassing occurring during the use of the tank as a high temperature fuel storage facility. The paint removal has proven to be difficult because the paint is so firmly attached.

**FIG. 12 STEEL SHOT BLASTING OF PAINT
FROM DECAY TANK**

Use of liquid paint removers was attempted, but they were found to be unsatisfactory. One week has been spent on the job and the work is about 40% complete.

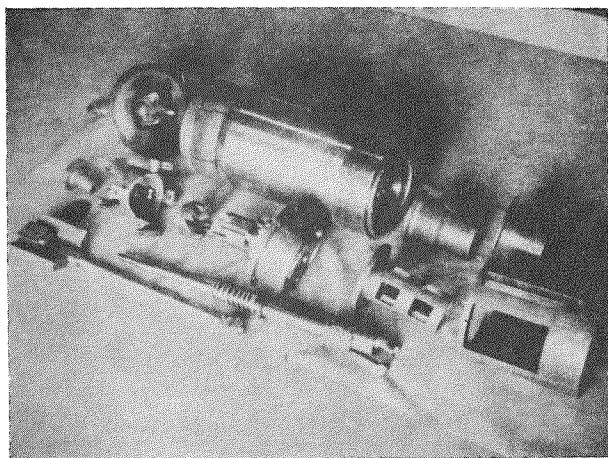
The gripper was returned to the dry loading tunnel the first week in March. The safety rod was removed from the gripper by partially disassembling the gripper manually behind the temporary shield wall erected last month. The safety rod was then deposited in a transfer pot in the tunnel and the gripper removed from the tunnel for complete disassembly and detailed inspection (Figure 14).

**FIG. 14 STEAM-CLEANING CHAMBER
GRIPPER DISASSEMBLED**

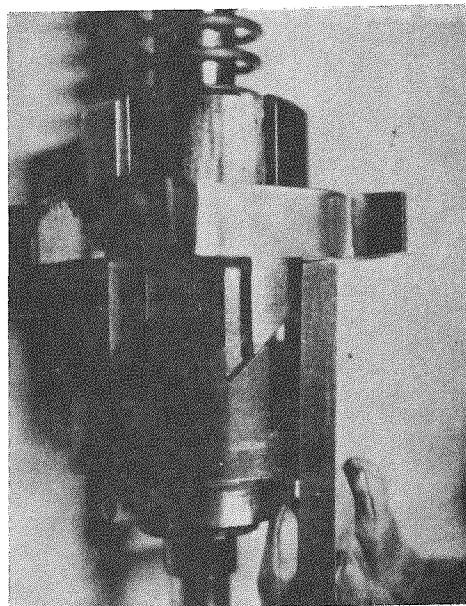
The failure to delatch was determined to have been caused by a sticky cam operating shaft (Figures 15 and 16). The lift rod, which actuates the gripper fingers, was found stuck in the up position (gripper closed) and accounted for the inability to unlatch from the safety rod. Once the lift rod was freed, the gripper functioned satisfactorily. Foreign material from steam-cleaning operations is thought to have caused the problem. Gripper operation was restored by polishing the shaft and bearing surfaces of the components in the gripper and bushing using emery cloth and India stone. Following reassembly, the gripper was cycled numerous times using a dummy subassembly and dummy safety rod handling head (Figures 17 and 18). No failures to latch or delatch occurred. The gripper was reinstalled on the gripper cable, and the steam-cleaning machine restored to service

FIG. 15 GRIPPER CAMS CLOSED

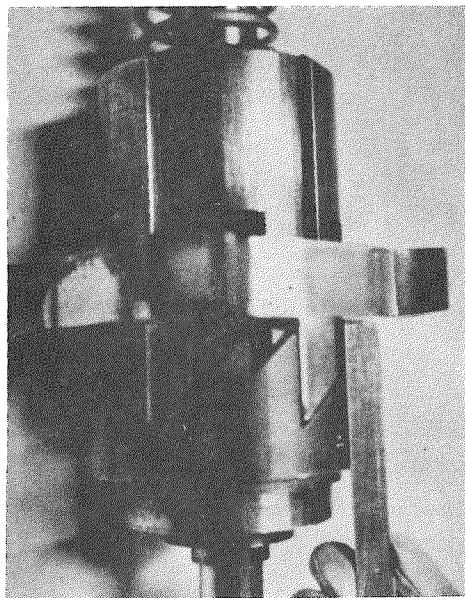
FIG. 16 GRIPPER CAMS OPEN

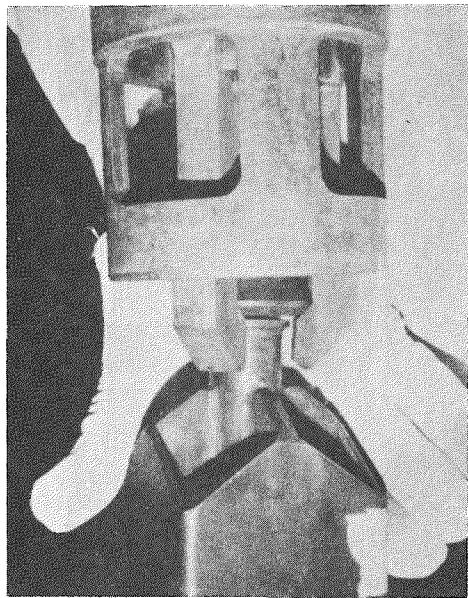
**FIG. 17 TESTING GRIPPER ON
DUMMY SUBASSEMBLY
HANDLING HEAD**

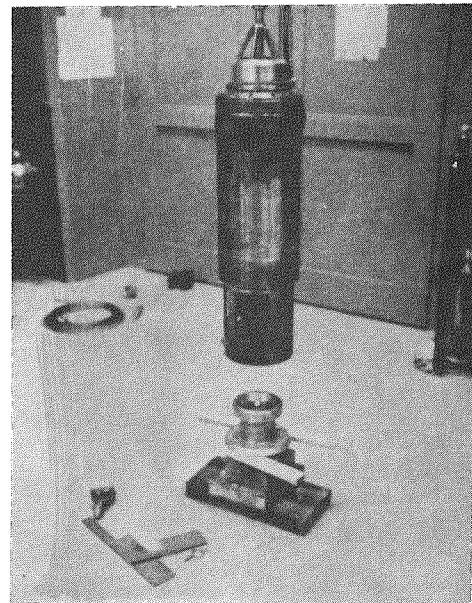
**FIG. 18 TESTING GRIPPER ON
DUMMY SAFETY ROD
HANDLING HEAD
(INSIDE DUMMY
POT HEAD)**

on March 11, 1969. The safety rod was deposited back in the transfer tank in sodium in a new safety rod pot. No difficulties were observed with the operation of the gripper during the transfer. The safety rod will subsequently be returned to the reactor.

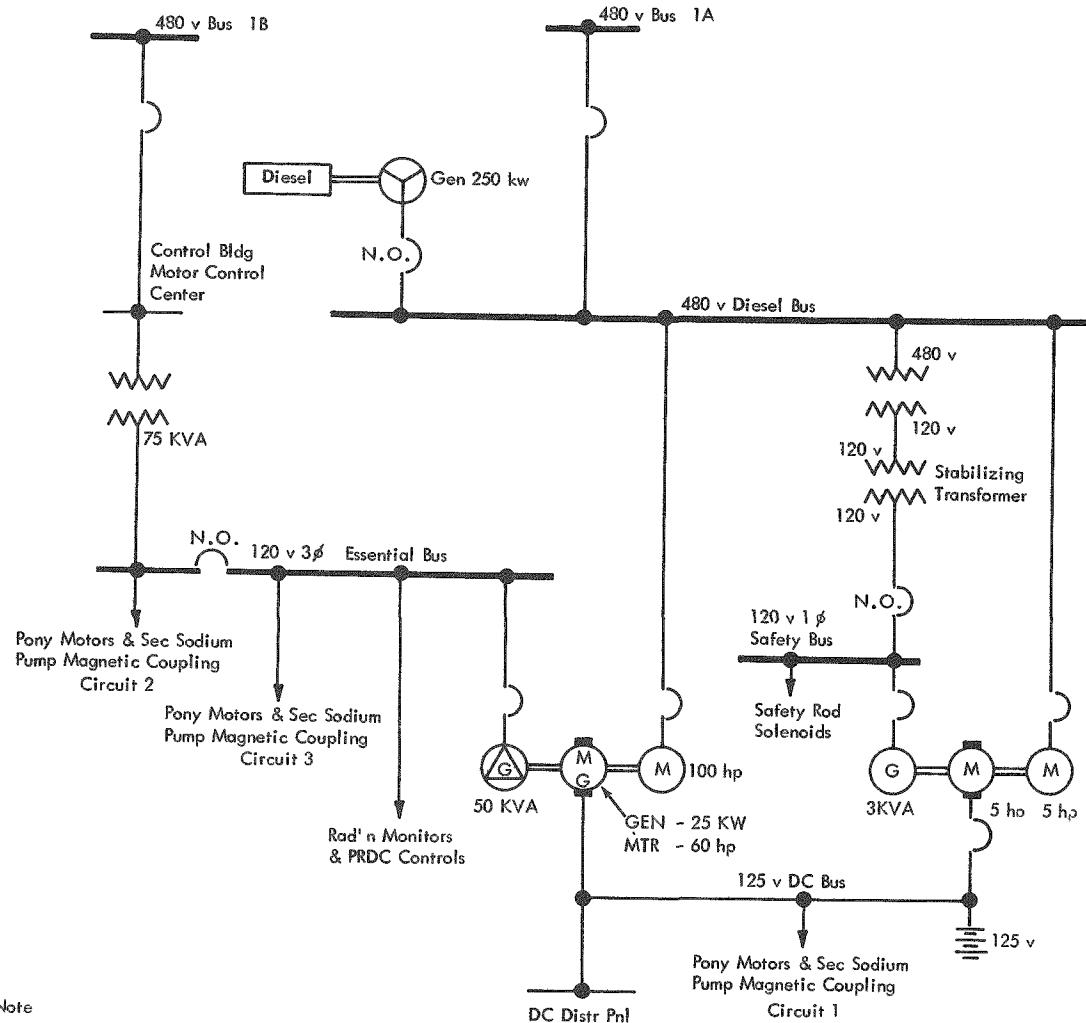
FIG. 19 EMERGENCY AUXILIARY POWER SYSTEM

On March 4, 1969, a burned closing coil was found in a closing relay to a circuit breaker in the a-c alternator feed to one of the two plant essential buses. Since the affected circuit breaker is normally energized and closed, the power supply to that section of the essential bus was not interrupted. However, repair of the defective relay required the bus to be de-energized for a short time. In addition, the defective relay blew the control fuses in the d-c feed to the affected circuit breaker and in the feed to the tie breaker (normally open) used to connect the two sections of the essential bus in emergencies. This prevented the automatic throwover of the first bus to the transformer feed of the second bus in the event of the failure of the a-c alternator to deliver power to the first bus.

The burned relay closing coil and two 30-amp blown control fuses to the essential bus sectionalizing circuit breakers were found by the plant operators during routine plant patrol. The defective relay coil had been in service about 9 years. To allow repair of the defective relay, the MG set was manually shut down and a manual throwover of essential bus A from MG set feed to bus B transformer feed was made.

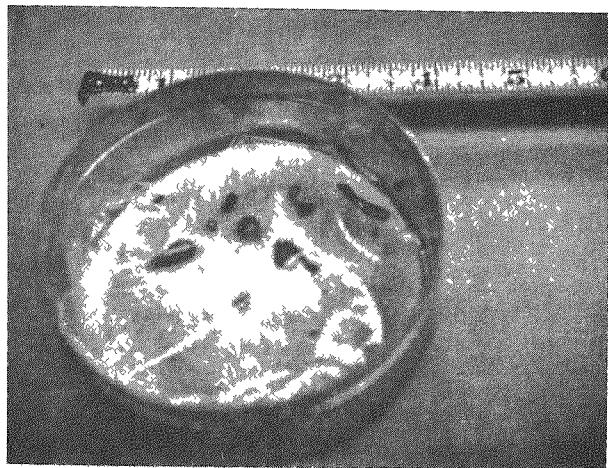
The debris trap in the converted arc-melt tool vacuum cleaner (see APDA-CFE-29, Sec. III. B) used to vacuum the lower plenum following zirconium segment removal, was opened and examined this month. The debris found in the trap is shown in Figure 20. Six pieces of spherical and flattened metal about 1/4-inch in diameter were found in addition to several smaller pieces. The debris was identified as weld slag resulting from the arc melting of the zirconium screwheads and welding of the screw shanks on the flow cone (see Sec. II. E of APDA-CFE-27 and 28).

**FIG. 20 DEBRIS FROM DEBRIS TRAP OF
VACUUM CLEANER**
