TID-16764

**A SUMMARY OF INCIDENTS INVOLVING USAEC
SHIPMENTS OF RADIOACTIVE MATERIAL, 1957-1961**

D. E. Patterson

V. P. DeFatta

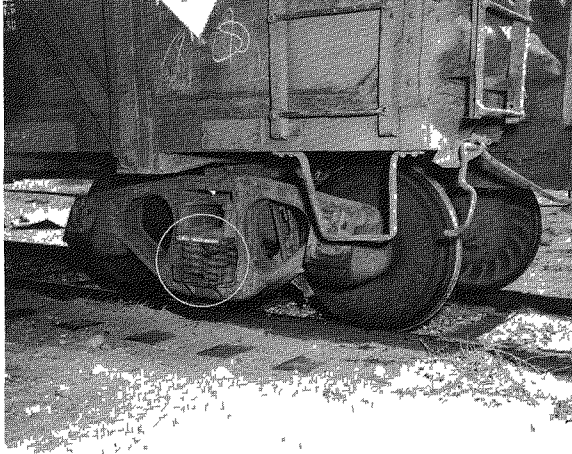
Replacement Springs and Jury-Rigged Spring Plank.

Later, a stop was made to transfer three cars to another line. During this delay, the guards thoroughly inspected the remaining cars and discovered that a spring plank and several springs had broken. It was determined that the missing part of the plank cut the airhose. Twelve springs and the spring plank were replaced at this stop. The train proceeded to its destination.

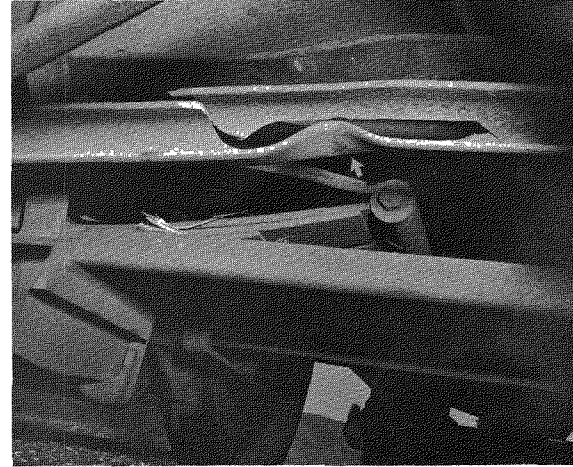
Damage to Undercarriage of Car Caused by Steel Debris.

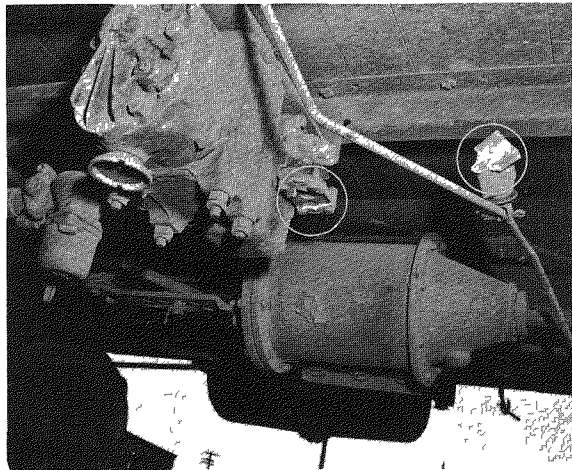
Shattered Air Fitting on Left Side of Courier Caboose.

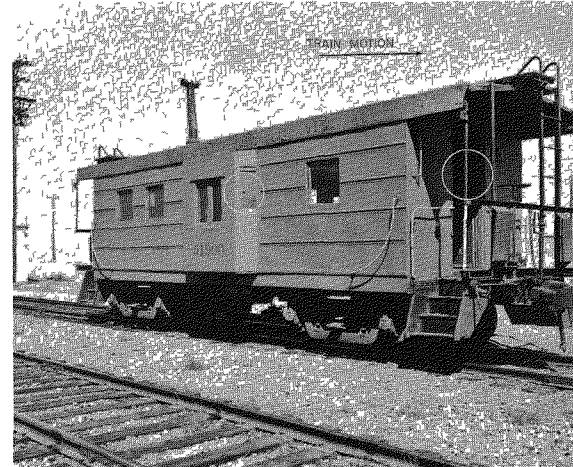
Broken Windows in Caboose Caused by Flying Stones.

Damage to caboose had to be repaired before shipment could proceed. Shipment was delayed three times.

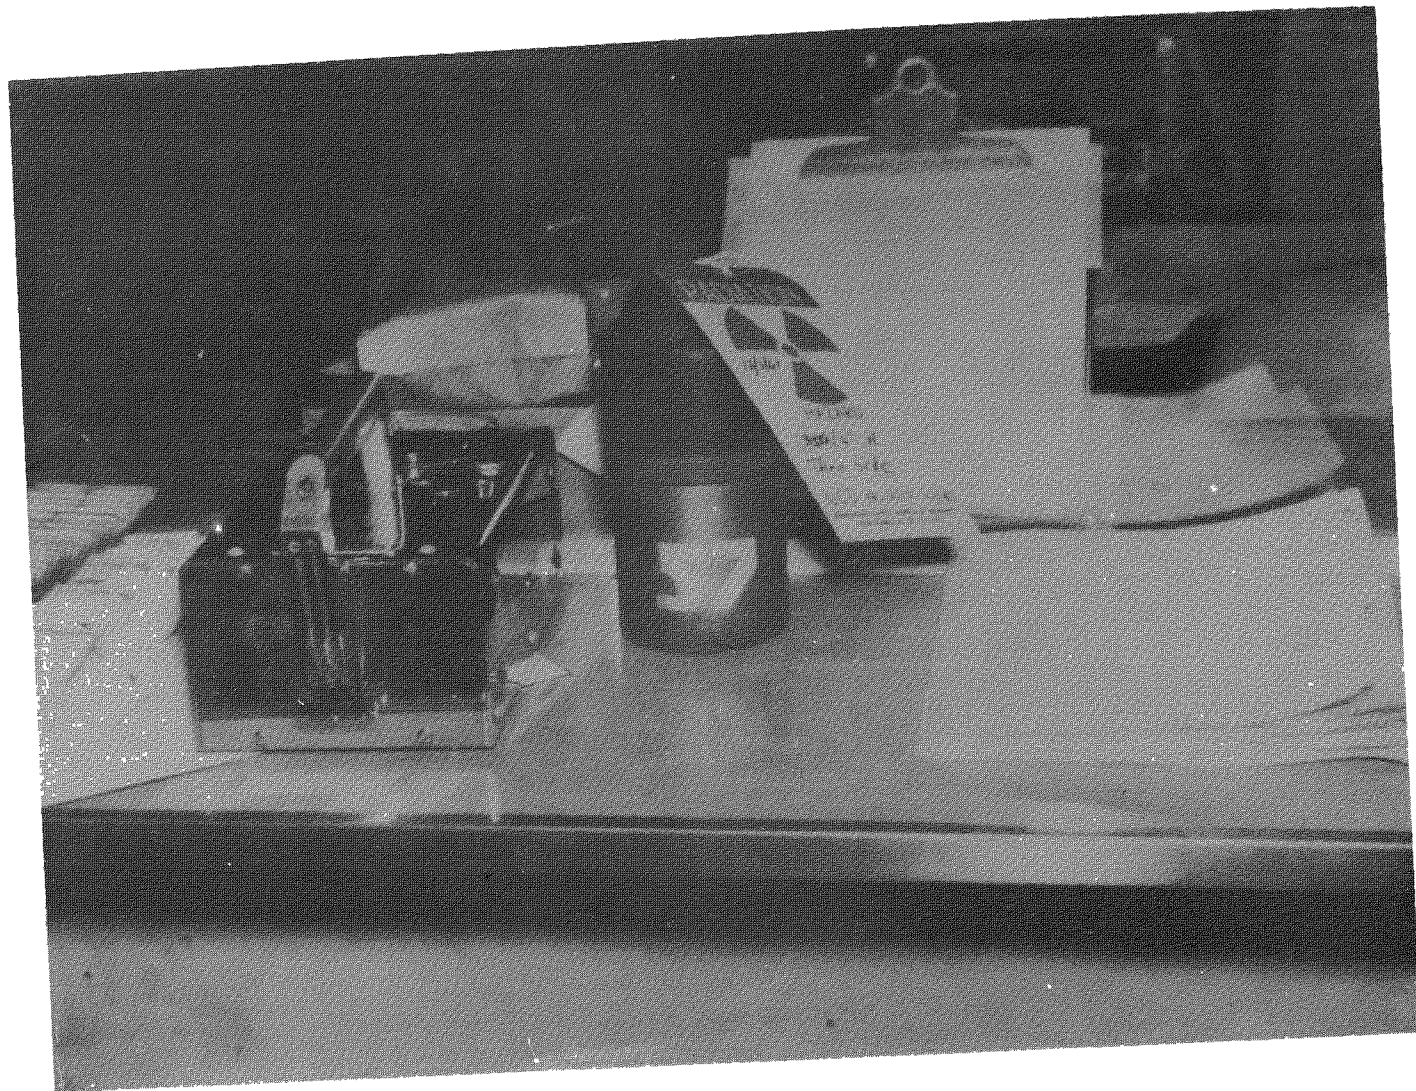
The Inner Container as Found, After Being Tagged by Radiological Assistance Team.

No radioactive material was released. The inner container remained intact; however, the radiation level at the surface was found to be 350 mr/hr rather than 200 mr/hr as specified by the ICC Regulations.

This case indicates the need for labeling inner containers to provide proper identification where such containers may become separated from the package.

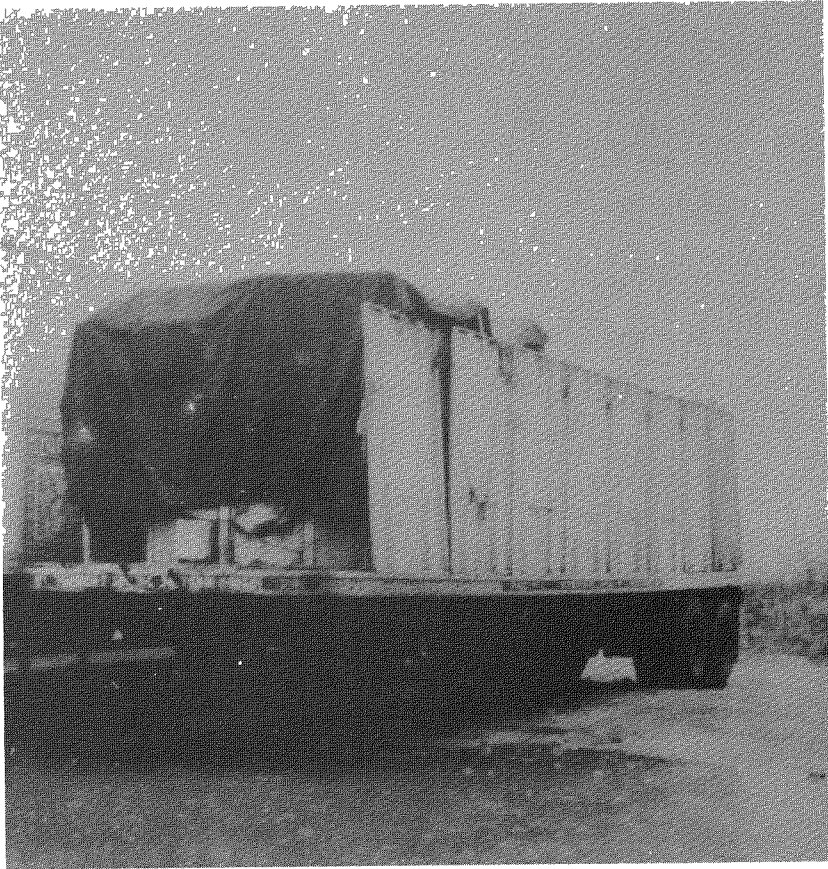
Front View of Trailer After
Incident.

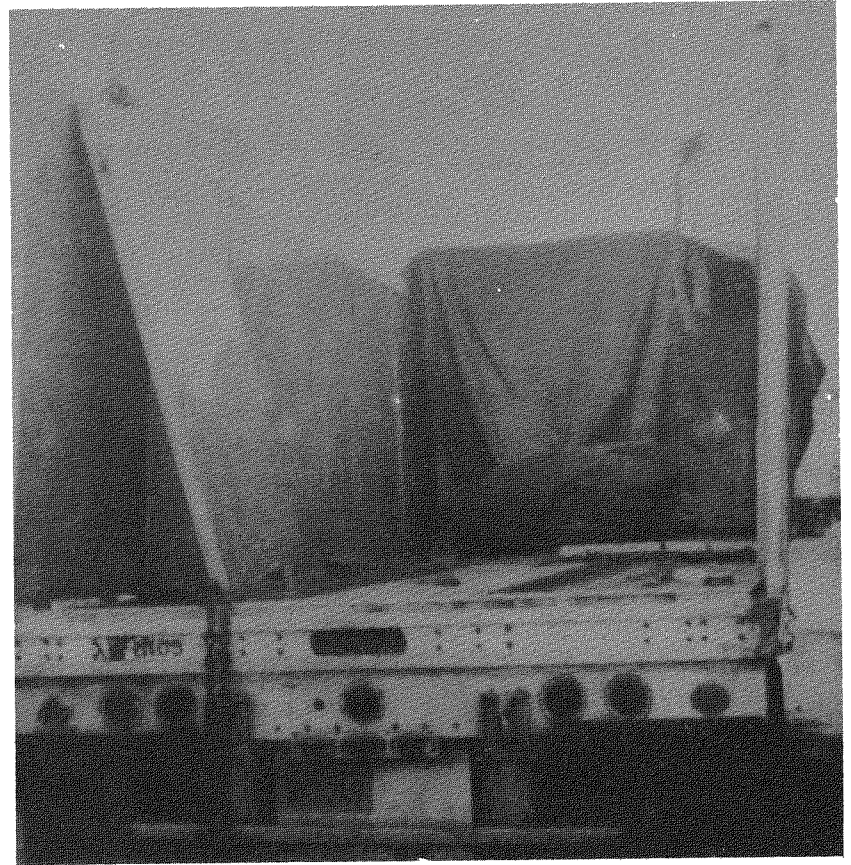
Rear View of Trailer After
Incident.

At the next terminal, the trailer was declared unroadworthy and the cask had to be transferred to another trailer. On this second leg of the shipment, the couriers noted a small liquid leak from below the cask resulting in a small damp spot on the trailer floor.

At destination, the bed of the trailer was found to be contaminated up to 250 mrep/hr. After unloading, the trailer had to be decontaminated. A radiological assistance team assisted the carrier in his decontamination operations, which consisted of washing the bed and sides of the trailer and replacing several sections of the wooden floor.

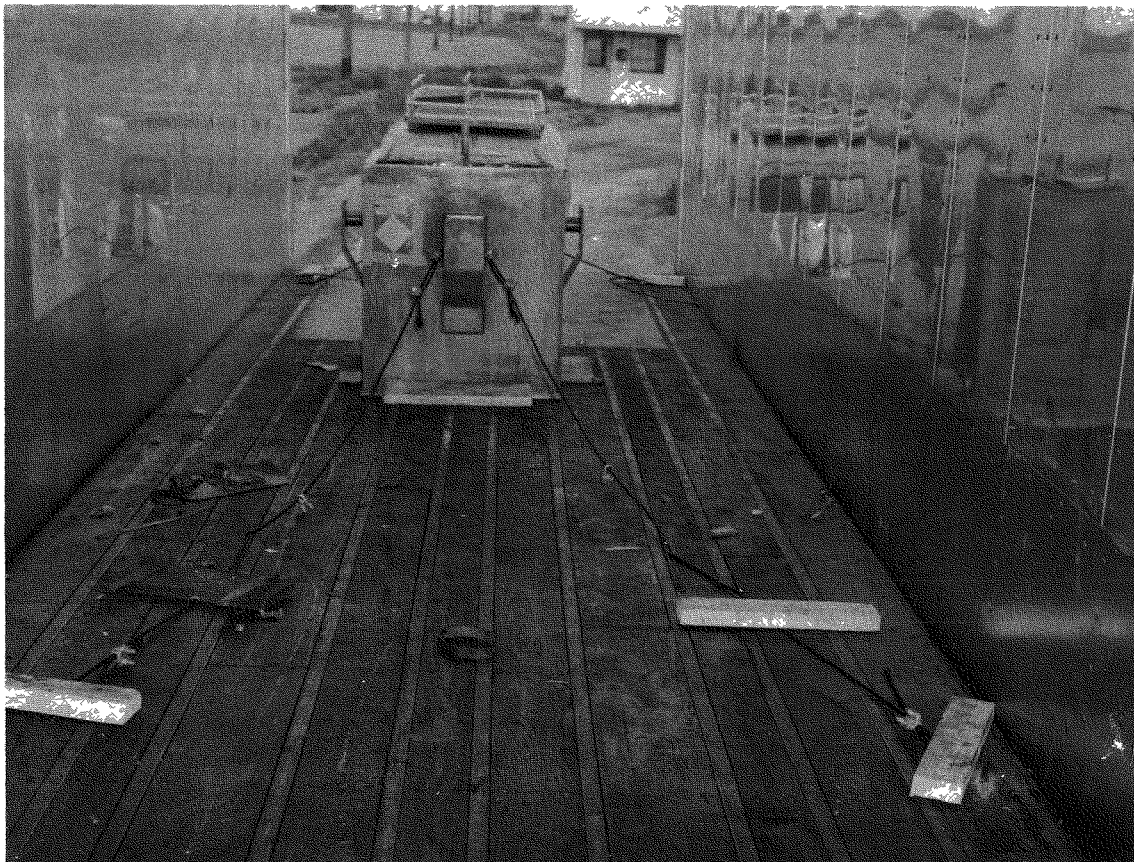
Photo for Class III Case 2 (See Facing Page).

The cask lid was contaminated to approximately 48,000 c/m/100 cm², beta-gamma. Contaminated areas totaling an estimated 15 sq ft were found on the trailer bed. Dose rates from the trailer bed ranged from 20 mrad/hr at 1 ft to a maximum of 125 mrad/hr at 4 in.

At destination, it was discovered that the wood blocks had pulled loose and the container had shifted in transit. Apparently, residual water in the cask had splashed out during transit while the cask was shifting about and was the source of contamination.

In order to decontaminate the trailer, some of the wood flooring was stripped off leaving readings of 0.4 mrad/hr. At one point, a small hole was cut completely through the floor of the trailer where it appeared that liquid had entered a crack. Dollar value of the loss was not reported.
