# OPERATION **PLUMB BOB**

NEVADA TEST SITE  
MAY-OCTOBER 1957

Project 30.2

RESPONSE OF DUAL-PURPOSE  
REINFORCED-CONCRETE MASS SHELTER

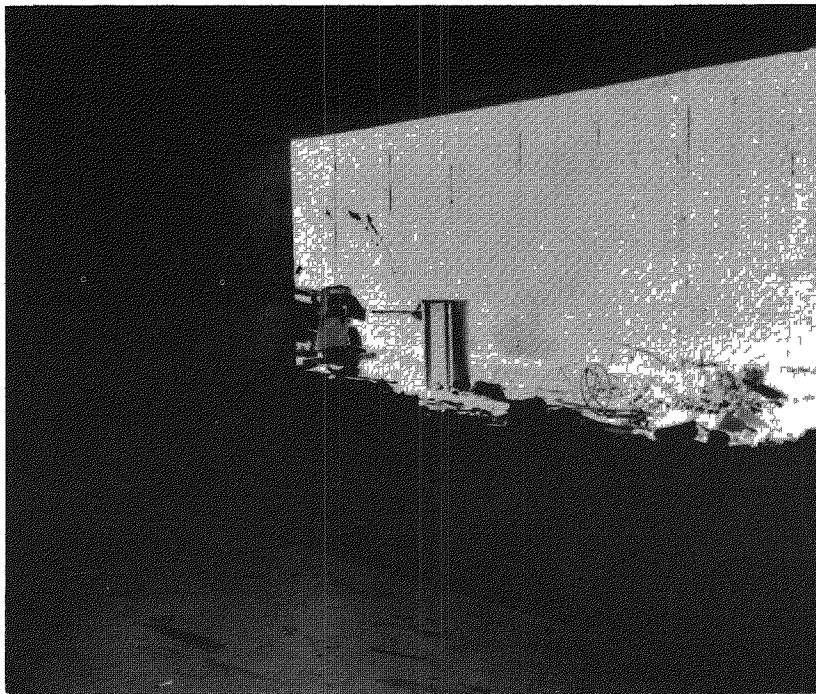
The exposed wall of the garage withstood the blast with no damage. The ramp wall at column line F had several large cracks between the end wall and a point about 30 ft up the ramp (Fig. 3.1). The top of the ramp side wall opposite the door entrance was pushed into the earth about 1 ft at the end. The top edge of the ramp wall farther up the ramp showed little

Fig. 3.1—Cracks in ramp side wall opposite door. View from interior of garage through door opening (postshot).

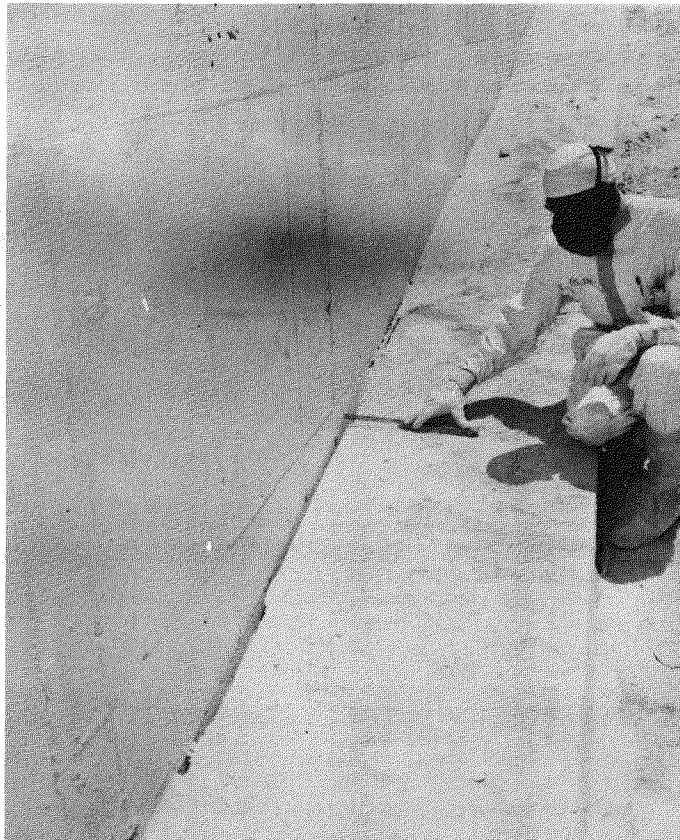
apparent displacement. Although there was no visible damage to the ramp slab, the slab was separated up to  $\frac{1}{2}$  in. from the main garage structure at the expansion joint (Fig. 3.2), and the  $\frac{1}{2}$ -in. joint filler was blown down or out. Gravel backfill was sucked through the weepers onto the ramp (Fig. 3.3). More gravel was found opposite the weepers at the mid-length and toward the top of the ramp than opposite the weepers at the lower end.

Fig. 3.2—Open joint between ramp slab and wall of main garage structure (postshot).

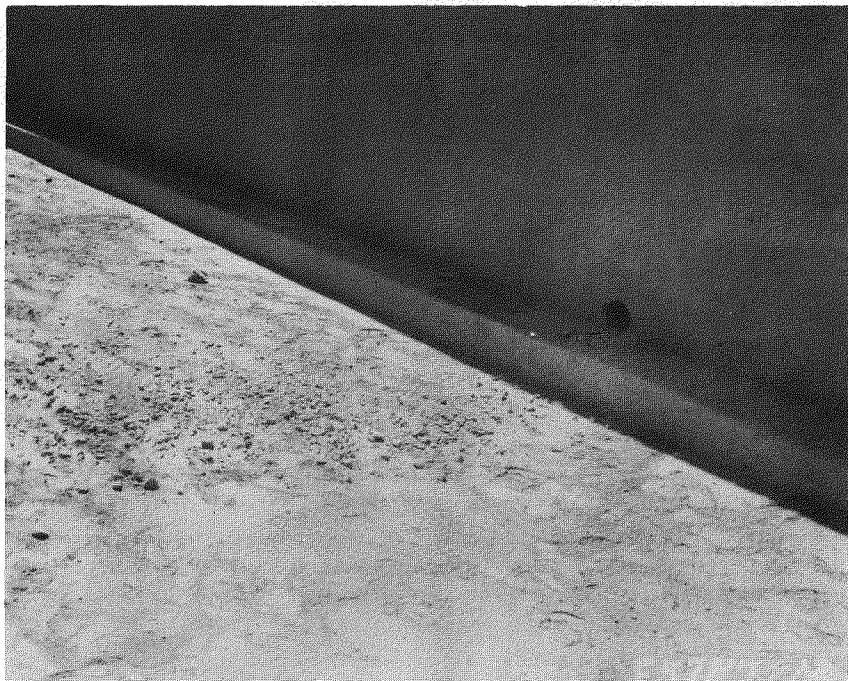
Fig. 3.3—Gravel backfill at weepers (postshot).

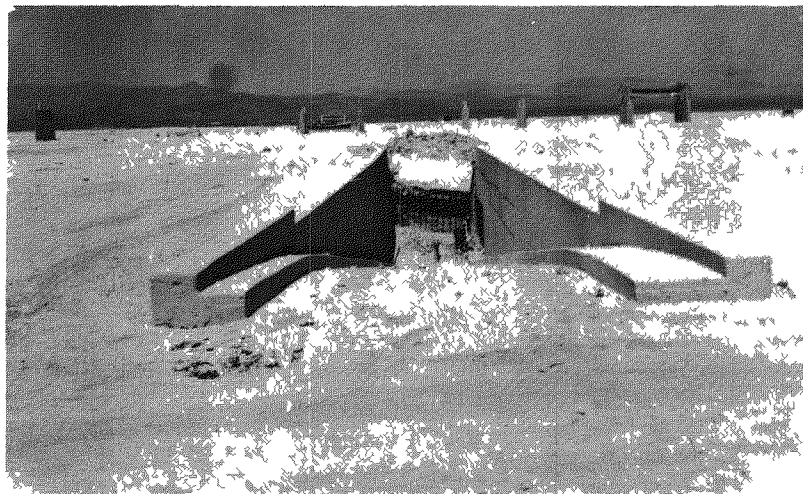
The end wall of the ramp was the only area badly damaged (Figs. 3.4 and 3.5). The top 8 ft of the end wall was broken off as a single unit on a nearly horizontal plane at the top of the splice of the vertical steel. It tipped into the backfill and slipped over the lower section until it wedged tightly between the garage wall and the longitudinal wall of the ramp. It was torn

Fig. 3.4—View of ramp looking toward damaged end wall (postshot).

The only substantial damage noted in connection with this project was to the retaining wall at the end of the ramp where damage was expected (see Sec. 1.4). The peak average pressure on the end wall was 188 psi (110 psi at the top and 266 psi at the base), considerably higher than the peak free-field side-on pressure of 39 to 40 psi recorded at the ground surface. This was due mainly to reflections and the added effect of the dynamic pressures, which were much higher than the side-on pressures at this range. The dynamic-pressure gauge at the base of the ramp was packed with debris and did not record. However, the dynamic-pressure gauge at the surface did record a peak dynamic pressure (corrected) of 112 psi. A peak pressure of 105 psi was recorded on the door (12 ft from the end wall), and the electronic side-on gauge (25 ft from the end wall) recorded a peak pressure of 54 psi. These gauge records are of appreciable significance; however, gauge P4 had a faulty connection and, as a consequence, the pressure back-up in the ramp was not fully defined. Blast results were not successfully recorded by the Carlson gauges behind the ramp retaining walls or the deflection gauges on these walls.

There is evidence that at the time of detonation the upper several feet of backfill behind the end wall was not compacted in accordance with the specifications because of excavation and backfilling for an instrumentation cable trench after original backfilling had been completed. Such a condition would mean that greater deflection would be required before the maximum passive resistance of the soil was developed. Although the damage to the end wall is not important in connection with this project, the mode of failure is technically interesting. Because of its orientation and high pressure loading, the wall was expected to deflect into the backfill by yielding of the reinforcement; however, the concrete and reinforcement were expected to remain bonded together, although the concrete would be badly cracked. The complete separation of the top half of the end wall from the bottom, disintegration of the lower portion into loose rubble, separations along the planes of the reinforcement, and failure of the splices without yielding of the steel can be partially attributed to the poor adhesive quality of the concrete in place. However, the mode of failure also may have been influenced by the rapid blast loading and the probability that the strength of normal splices under such loading may be much lower than under static loading. Laboratory data to verify splice efficiencies under dynamic loading would be highly desirable. The ductility of the wall would be greatly increased by raising the splice point, welding the splices, using full-length bars (thus eliminating the splice), and by providing a vertical expansion joint at the intersection with the longitudinal wall. High door pressures would have been avoided if the ramp had been of a symmetrical through type without an end wall. However, a through type ramp, although desirable to minimize blast effects, is often not economical or practical.

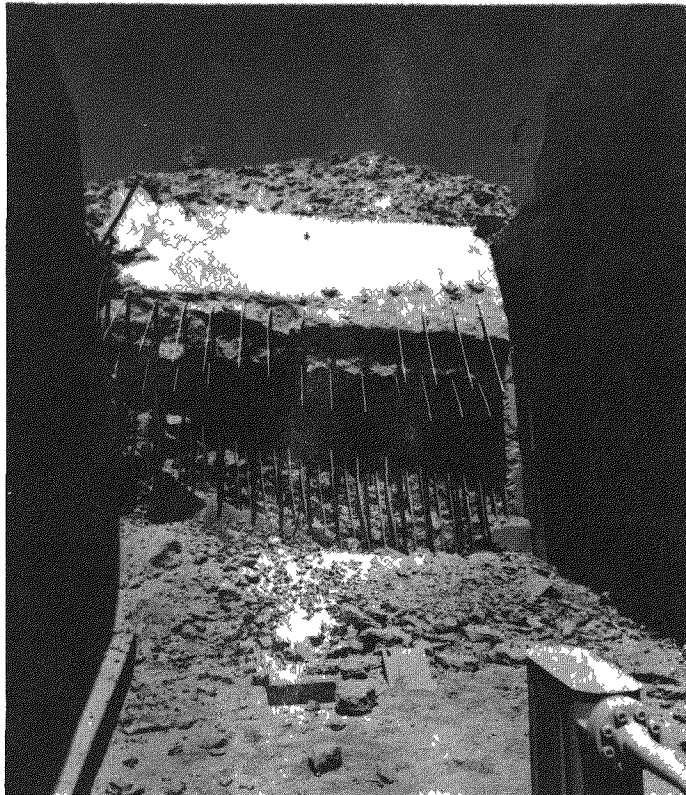
The end corner of the 1-ft 3-in. parapet wall at the lower end of the ramp was cracked as shown in Fig. 3.5.

Fig 3 5—Close-up of damaged end wall (postshot)

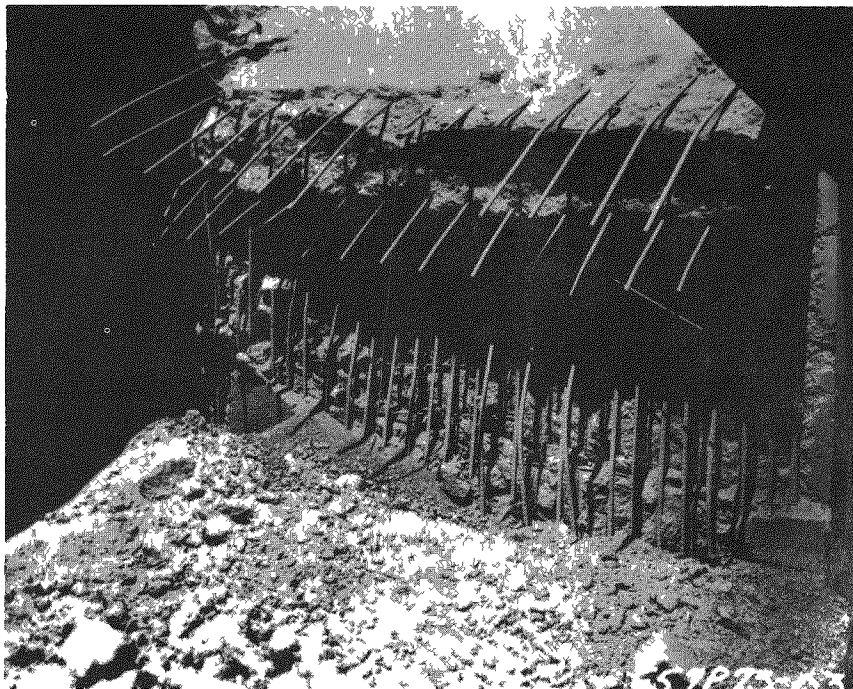
loose on a diagonal through the corner at its junction with the longitudinal retaining wall. In its final position the top was displaced approximately 5 ft 6 in. into the earth backfill, which was pushed up and mounded. It was estimated that it may have been displaced approximately 8 ft before sliding back. The concrete cover had split off most of the lower section, and the bars had separated at the splice, apparently without having developed their yield strength. Near the middle of the panel where the concrete had not split, three bars had fractured after necking down at the top of the splice (Fig. 3.6).

Fig 3 6—Detail of failure showing fractured bars (postshot)

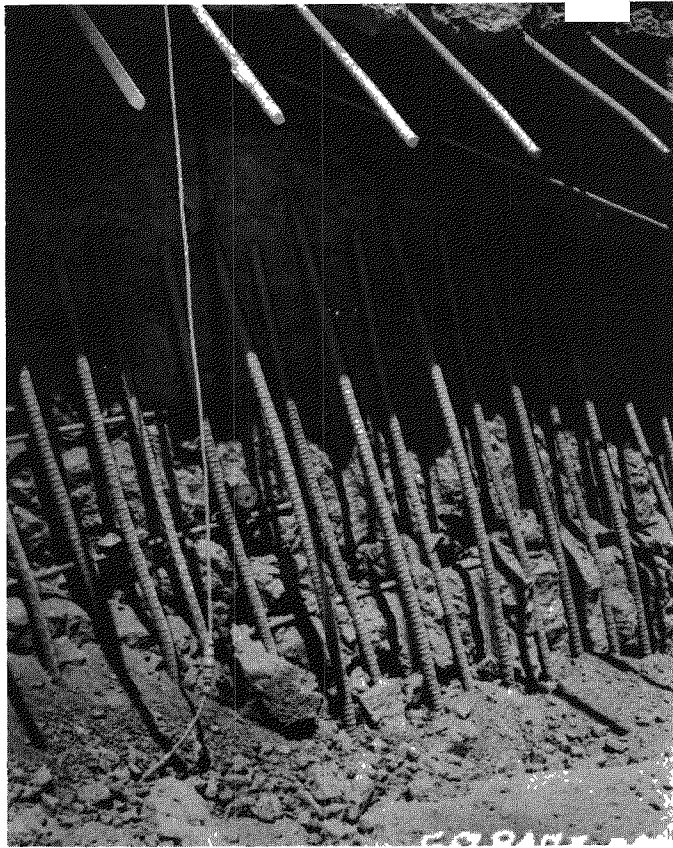
The bars in the lower section were bent away from the displaced concrete; the cover was deposited at the base (Fig. 3.7). The remaining concrete behind the bars was reduced to rubble, which varied in size from 6 in. to 3 ft in diameter. Fractures, including the one at the bottom of the top section of the damaged end wall, revealed no breaks through the aggregate. The concrete had also separated on the plane of the rear-face reinforcement.

Fig. 3.7—Detail of lower portion of wall (postshot).

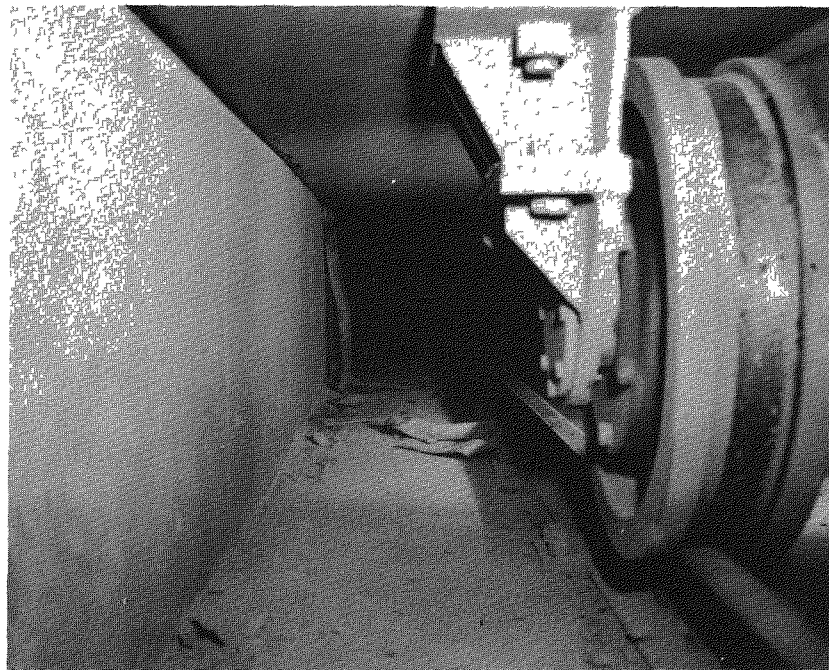
Fig. 3.10—Wheel assembly and rails, door partly open (postshot).

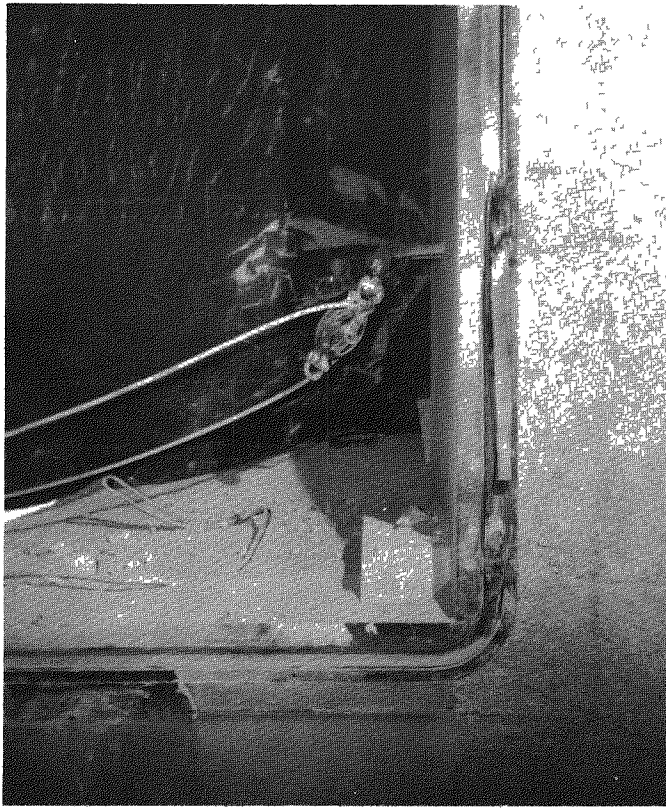
The pneumatic gasket around the door frame was blown in and torn apart by the blast pressure (Fig. 3.11). The gasket had a slow leak prior to the shot, and a compressed-air cylinder was installed outside in the doorway recess to maintain the air pressure. The cylinder and air hose were sandbagged and were not damaged by the blast. No information is available regarding the condition of the gasket at shot time.

Fig. 3.11 — Damaged gasket at lower corner of door opening (postshot).

The as-built clearances between the door and frame were as high as  $\frac{13}{16}$  in., more than three times that shown on the plans; therefore the pneumatic seal would have been ineffective even in good working condition. To prevent excessive infiltration of the blast pressures, clearances at the base were reduced prior to the shot by 3- by 3- by  $\frac{3}{8}$ -in. angles; one leg was inserted vertically into the opening, and the other was bolted to the frame. The blast pressures still entered the joint and forced the gasket toward the interior of the shelter, stripping and tearing it along its entire length. It is not known whether or not the compressed-air cylinder placed prior to the test was adequate to maintain pressure in the gasket up to shot time.

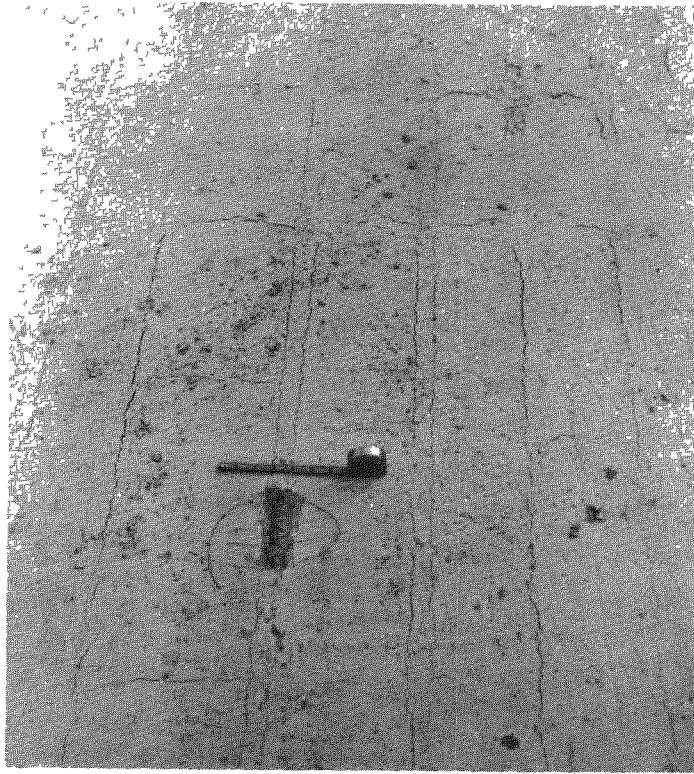
Fig. B.29—Shrinkage cracks in root-slab concrete.

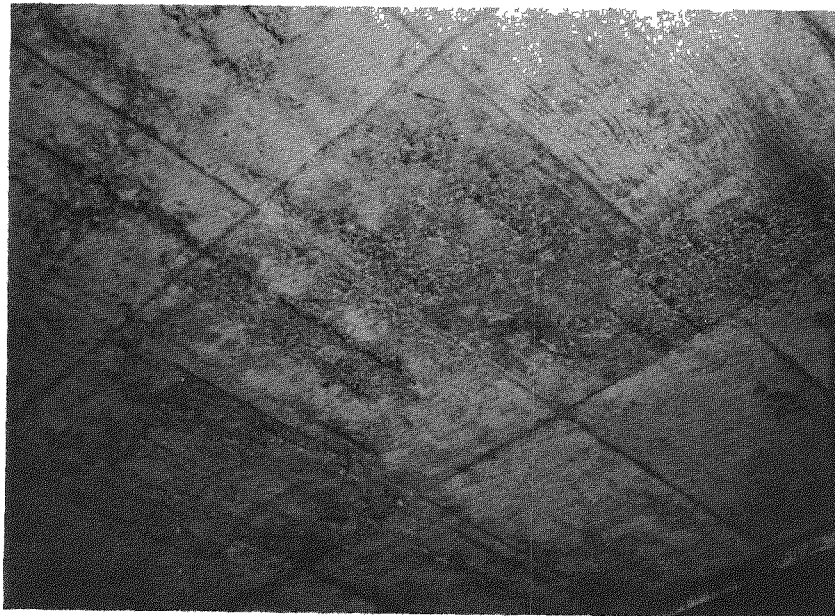
Fig. B.30—Honeycombed area on underside of roof slab.
