OPERATION BUSTER

PROJECT 9.1 a

F.C.D.A. FAMILY SHELTER EVALUATION

ARCHIE P. FLYNN

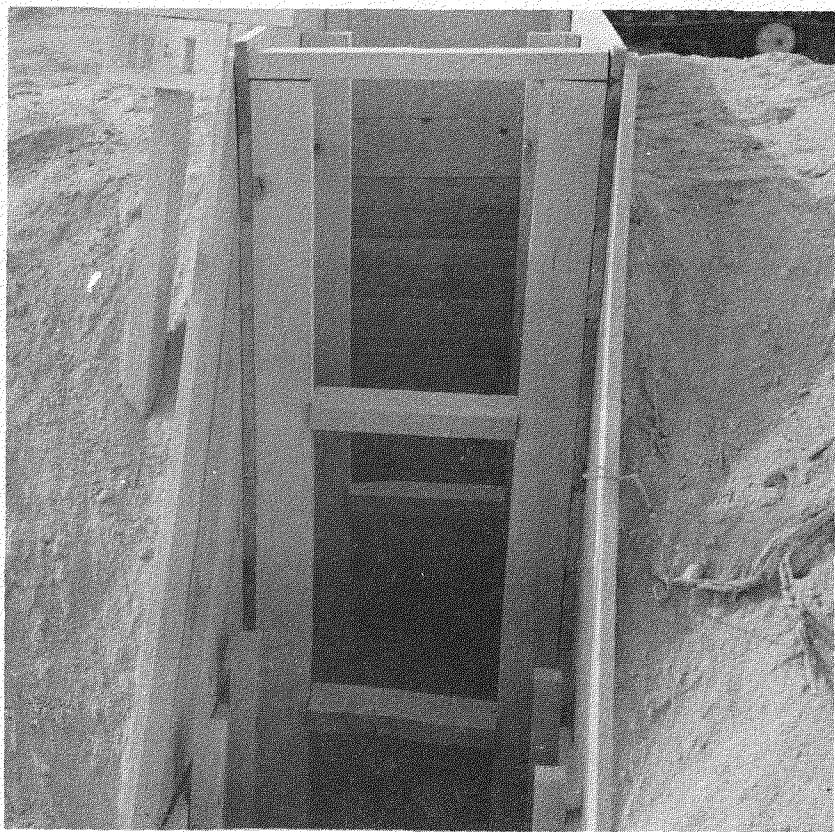
One of the studs in the entrance section of shelter B-1 was cracked in backfilling and additional spreaders were placed as shown. (Fig. 2.10).

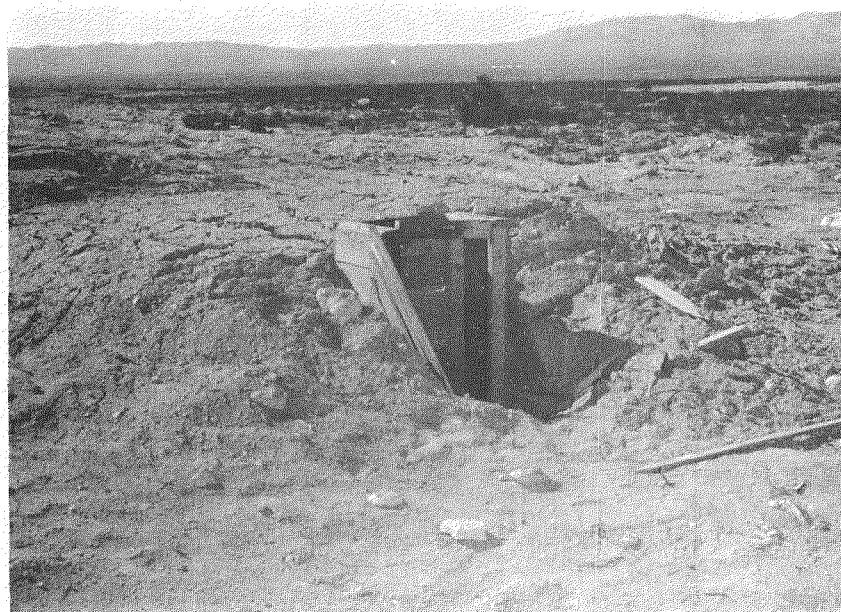
The basic covered-trench shelters (A-1 through A-4) which conformed with designs prepared by Lehigh University Institute of Research fared well with damage confined to above-grade entrance construction. Earth cover was lowered 6 to 12 inches. The extent of damage to basic below-grade structures is shown in Figs. 4.1, 4.2, 4.3, and 4.4. Greatest damage was suffered by Shelter A-4, the entrance facing the blast. With the exception of A-4, damage to entrance construction was confined to spreaders and batterboards (Fig. 4.4). The entrance of A-1 which suffered more damage than A-2 was not as well protected with earth cover (Figs. 4.1, 4.2, 2.5 and 2.6).

Fig. 4.1 Damage to Structure A-1 Due to Shot Baker
(covered-trench below-grade)

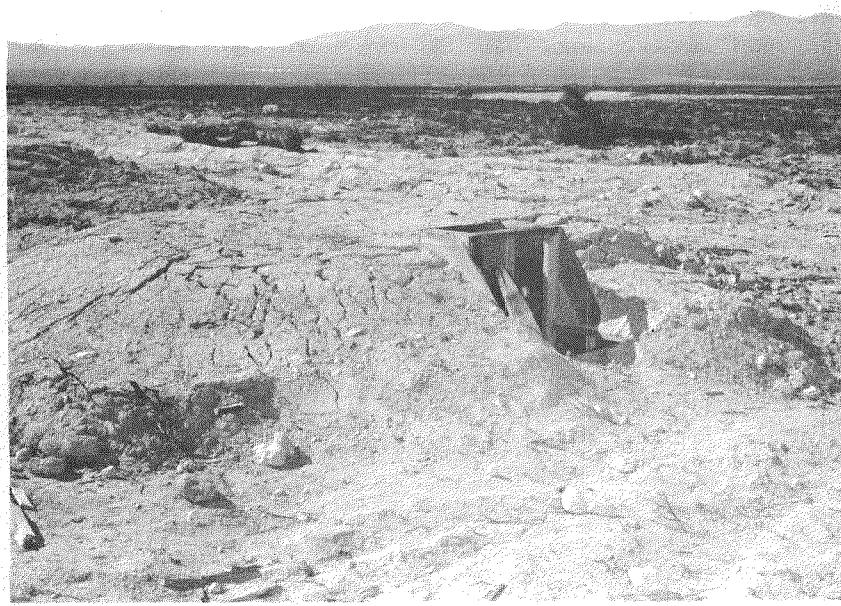
Fig. 4.2 Shelter A-2 After Shot Baker (covered-trench below-grade)

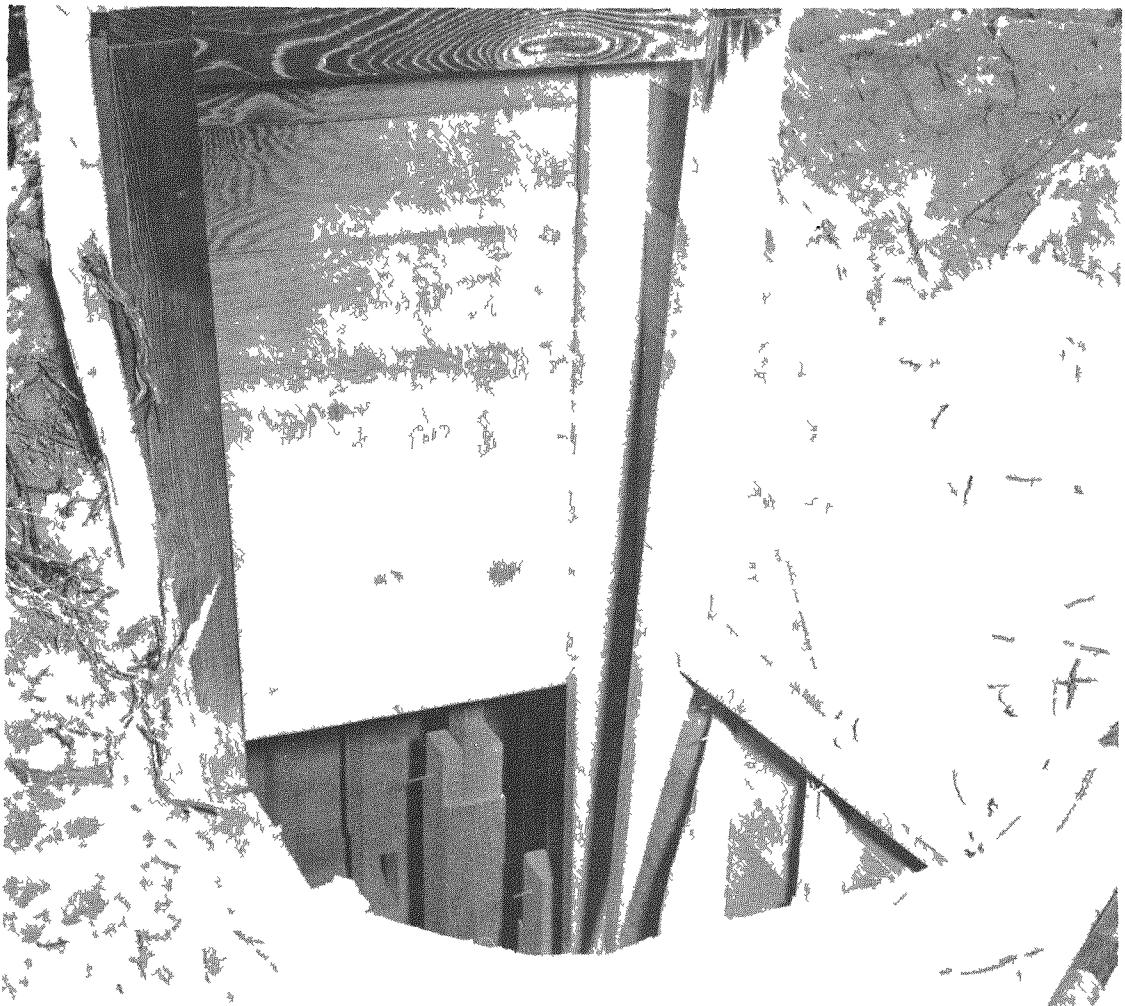
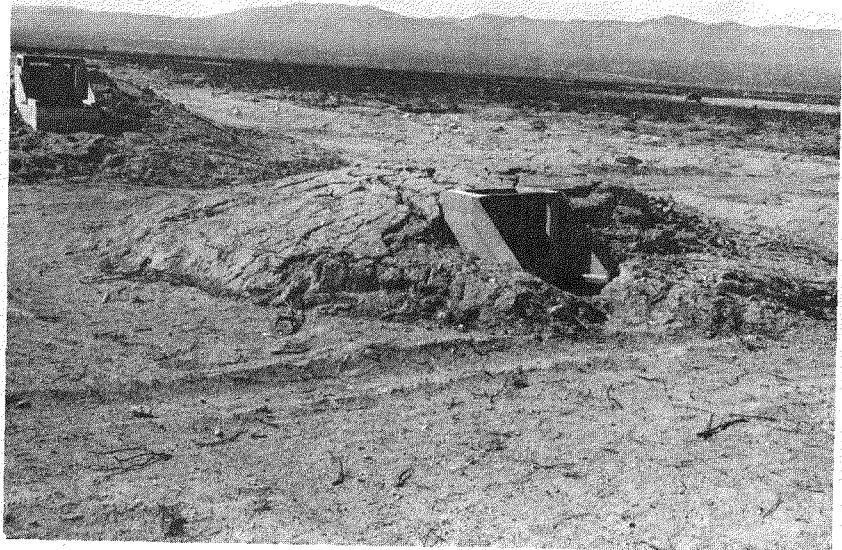
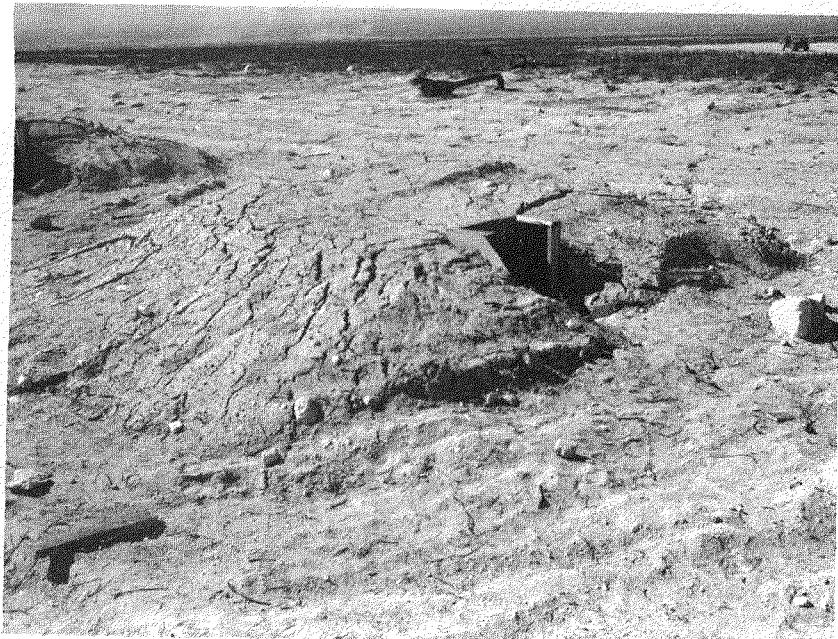
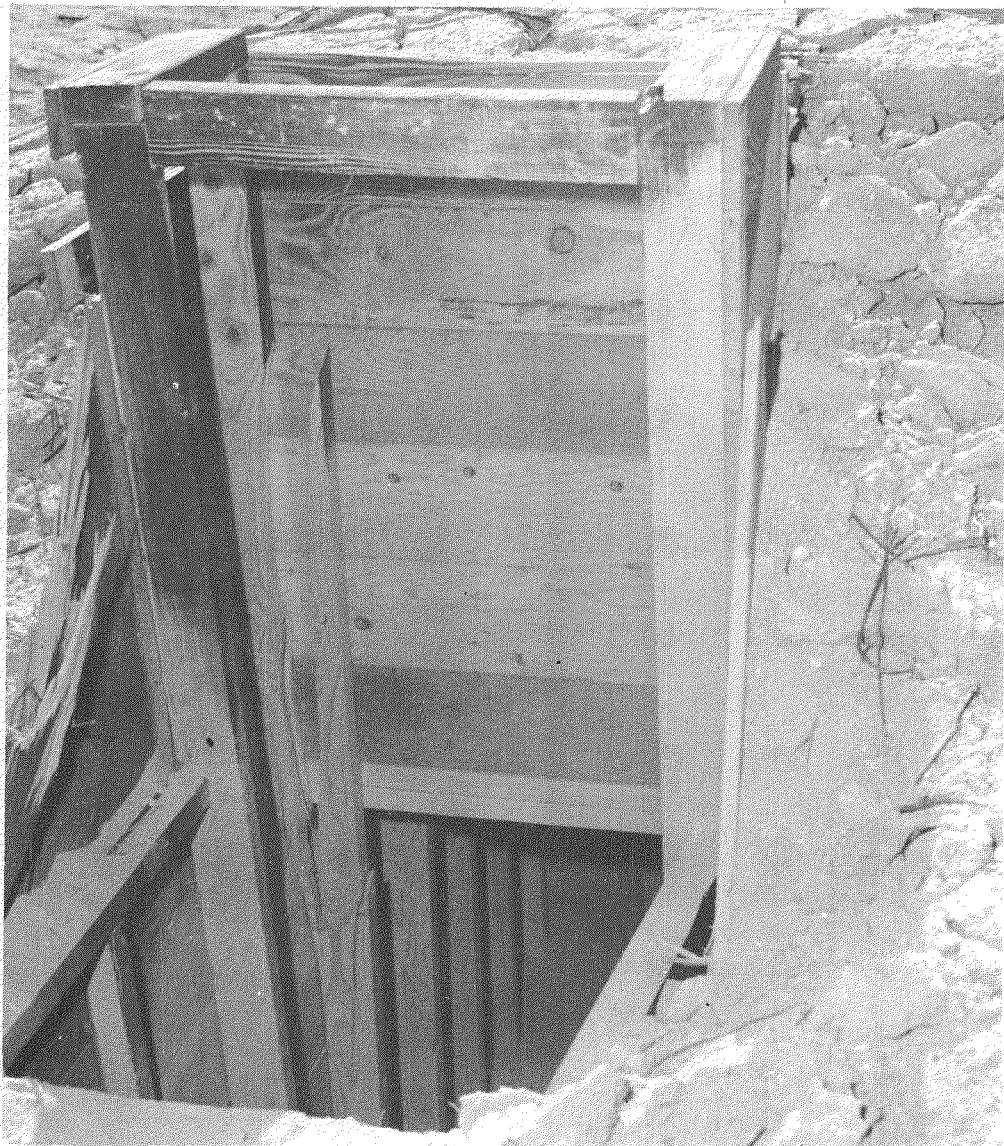
Below-grade covered-trench shelters, weakened by increased spacing and reduced structural members, did not fail, but were damaged more than the basic structures. Front and end walls showed a tendency to give where they were joined to the roof section. Some roof joists were cracked and in two shelters studs on the front side were broken. Structure A-6, designed to carry little more than the dead load of earth cover, continued to hold although its center roof joist had been cracked in backfilling operations. Figures 4.5, 4.6, 4.7, and 4.8 show the nature of external damage suffered by these structures.

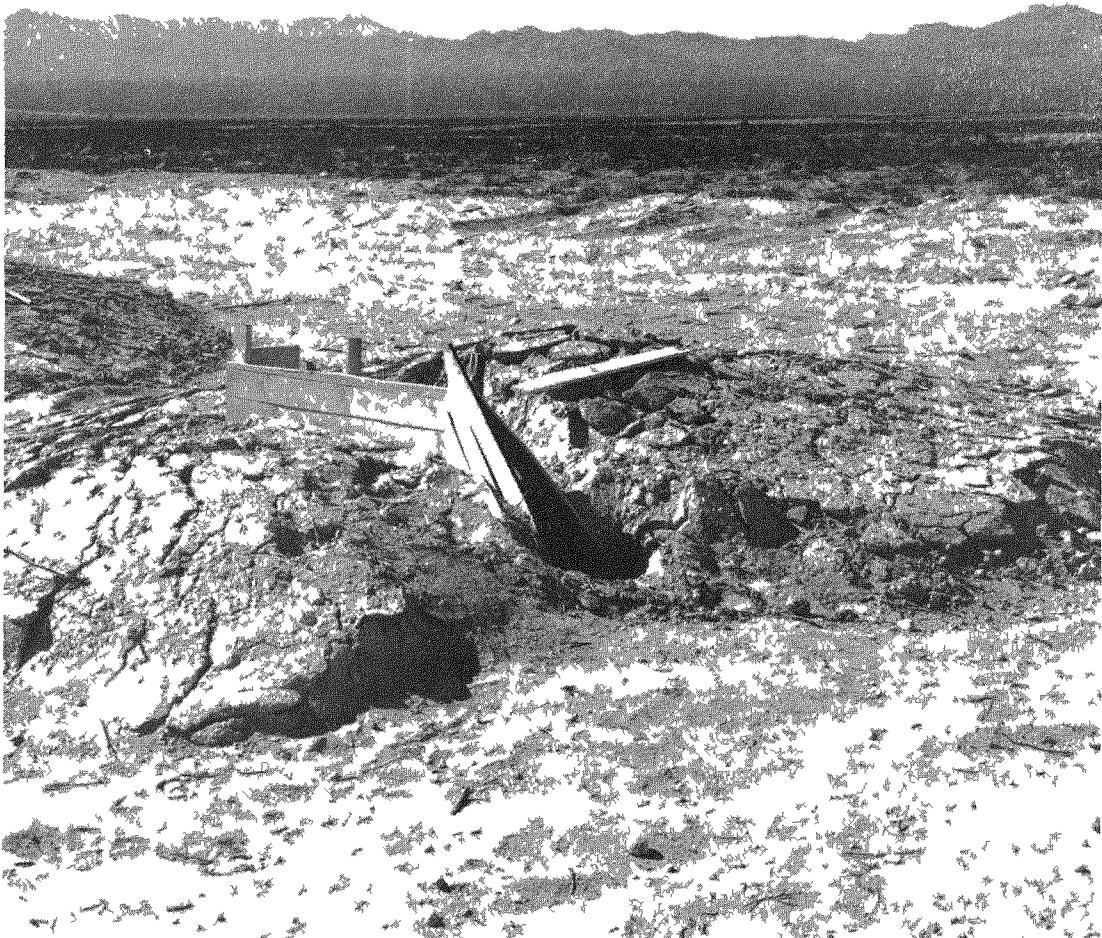
In addition to extensive damage to entrance construction, partial failure occurred in the end section of the only completed metal-arch shelter. There was also evidence of a slight shifting or twisting of the arch on its foundation, but structural damage was insufficient to prove hazardous to an occupant. Figure 4.13 shows collapsed entrance structure and spreading of earth cover. Effects of blast on metal-arches are shown on Fig. 4.14. The earth cover on this structure was lowered appreciably.

Fig. 4.13 Shelter B-1 After Shot Baker (basic below-grade metal-arch shelter)

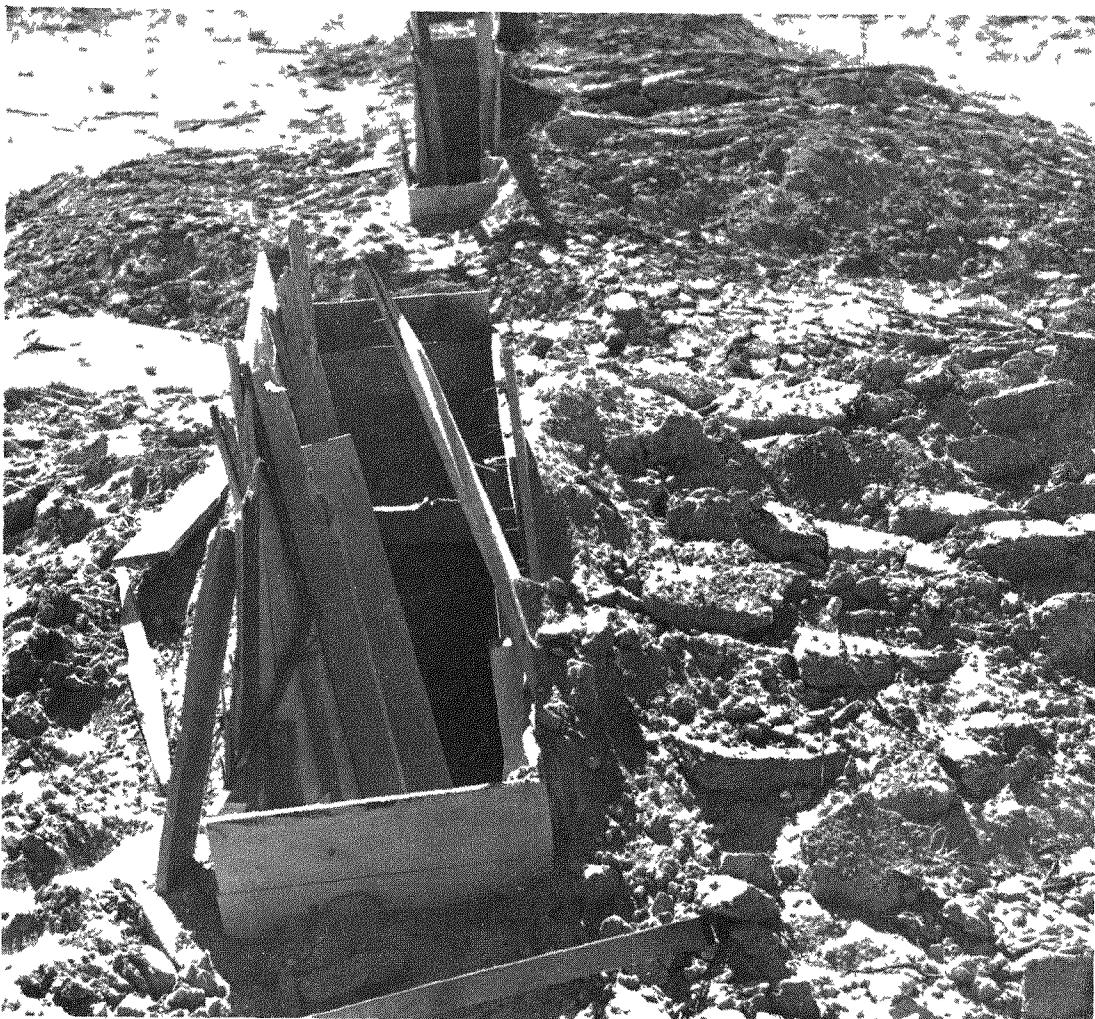
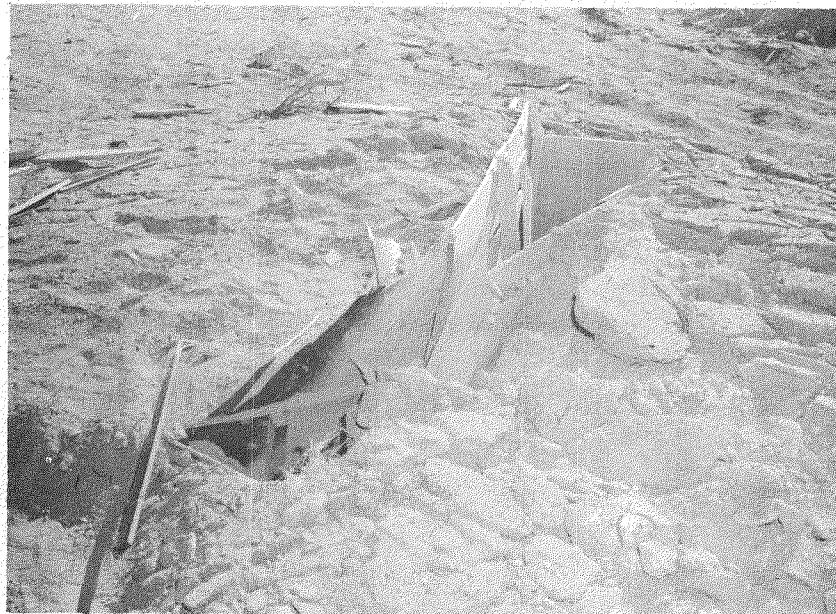
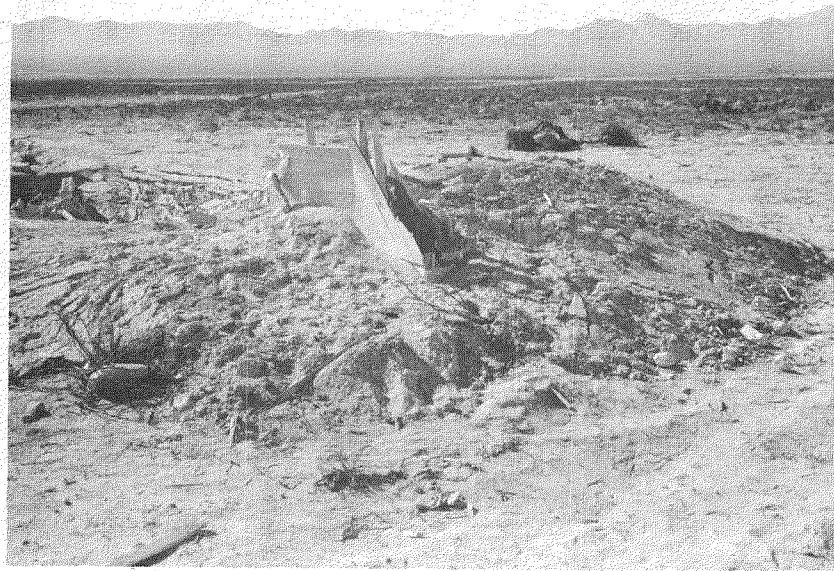
Damage to wood-arch shelters is partially shown in Figs. 4.15, 4.16, and 4.17. Entrance structures were severely damaged and were almost impassable. The wood-arch and wall of all structures remained intact, but in C-4, the end section gave way.

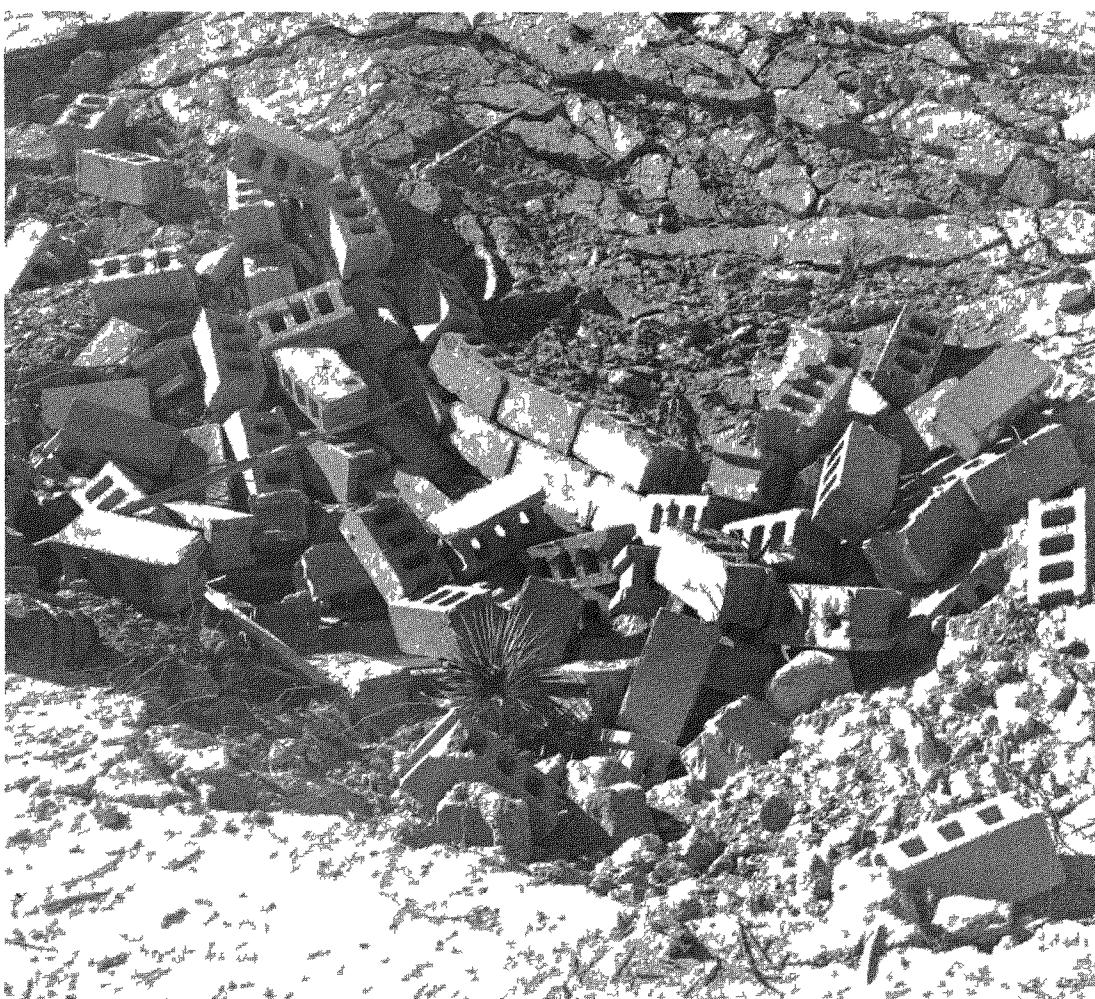
The complete destruction of simulated basement lean-to shelters (D-1 and D-2) is shown in Fig. 4.18. These structures were designed to determine whether fastening a lean-to section to a basement wall would afford greater protection than if the top of the lean-to were left free. However, destruction was so complete, no information could be obtained on wall failure or reaction of the lean-to.

Fig. 4.18 Remains of Structure D-1 After Shot Baker (simulated basement lean-to)

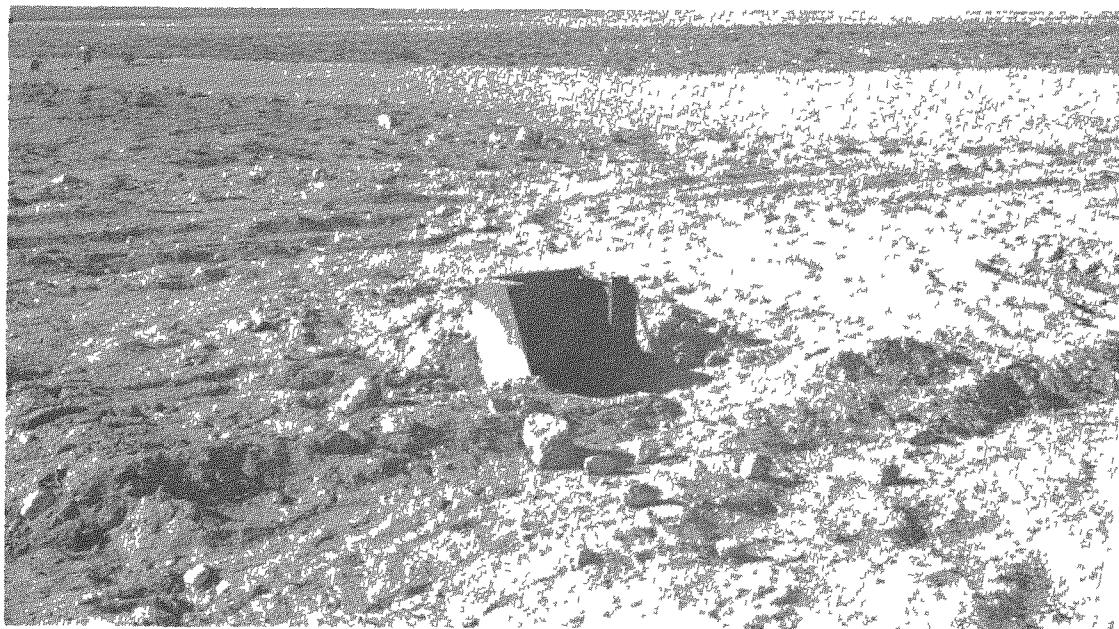
Damage to basic below-grade covered-trench shelters (A-1 through A-4) was confined principally to above-grade entrance construction (Figs. 5.1 and 5.2). Shelter A-4, with the front end facing the blast, was damaged slightly more than shelters of similar construction. In reduced strength below-grade shelters blast had approximately the same effect on earth cover and entrances (Fig. 5.3). Although, none of these structures failed, studs and roof joists were broken. There was also evidence of weakness where studs in the front and end sections were tied into the roof section.

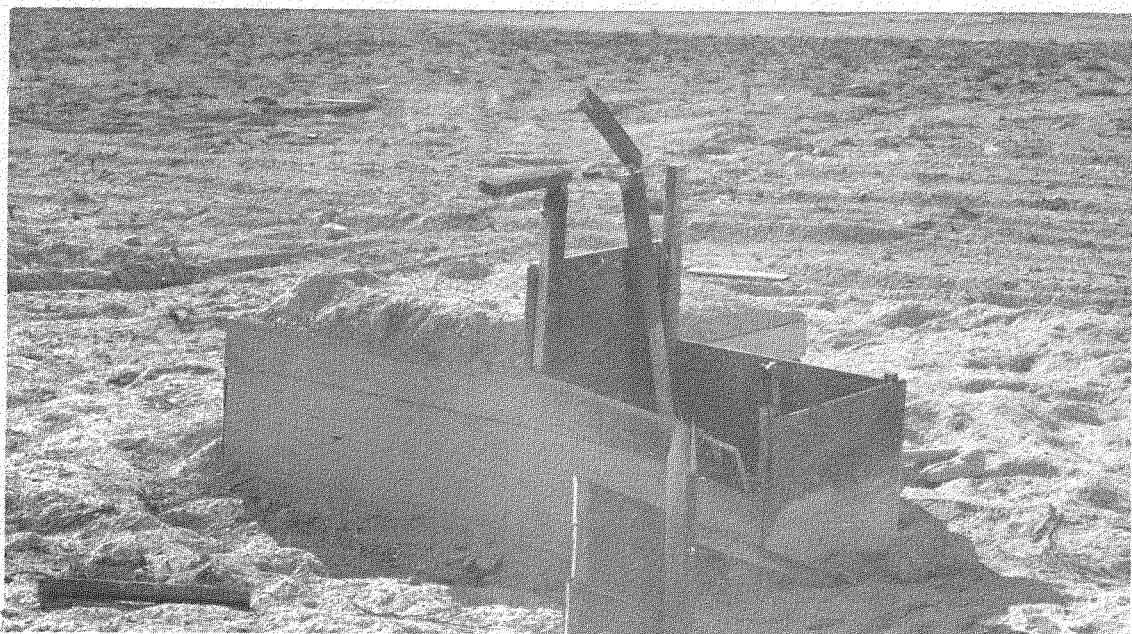
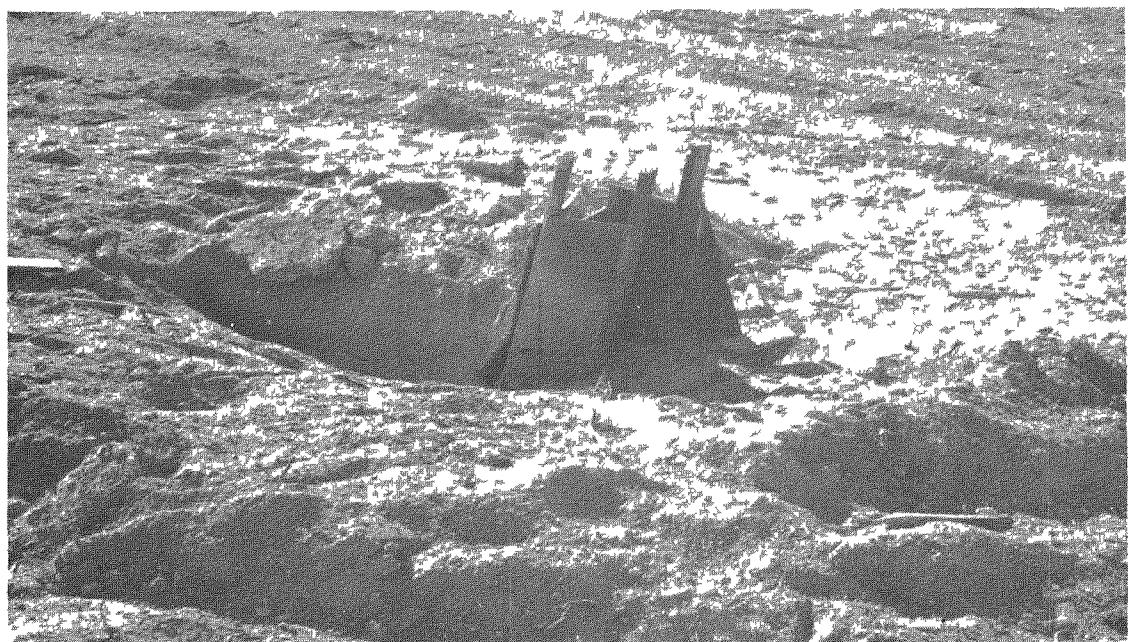
The partly above-grade covered trench shelters suffered much more damage. Although the structures remained intact, earth cover was swept down to natural grade (Fig. 5.4). Entrances suffered greater damage (Figs. 5.5 and 5.6).

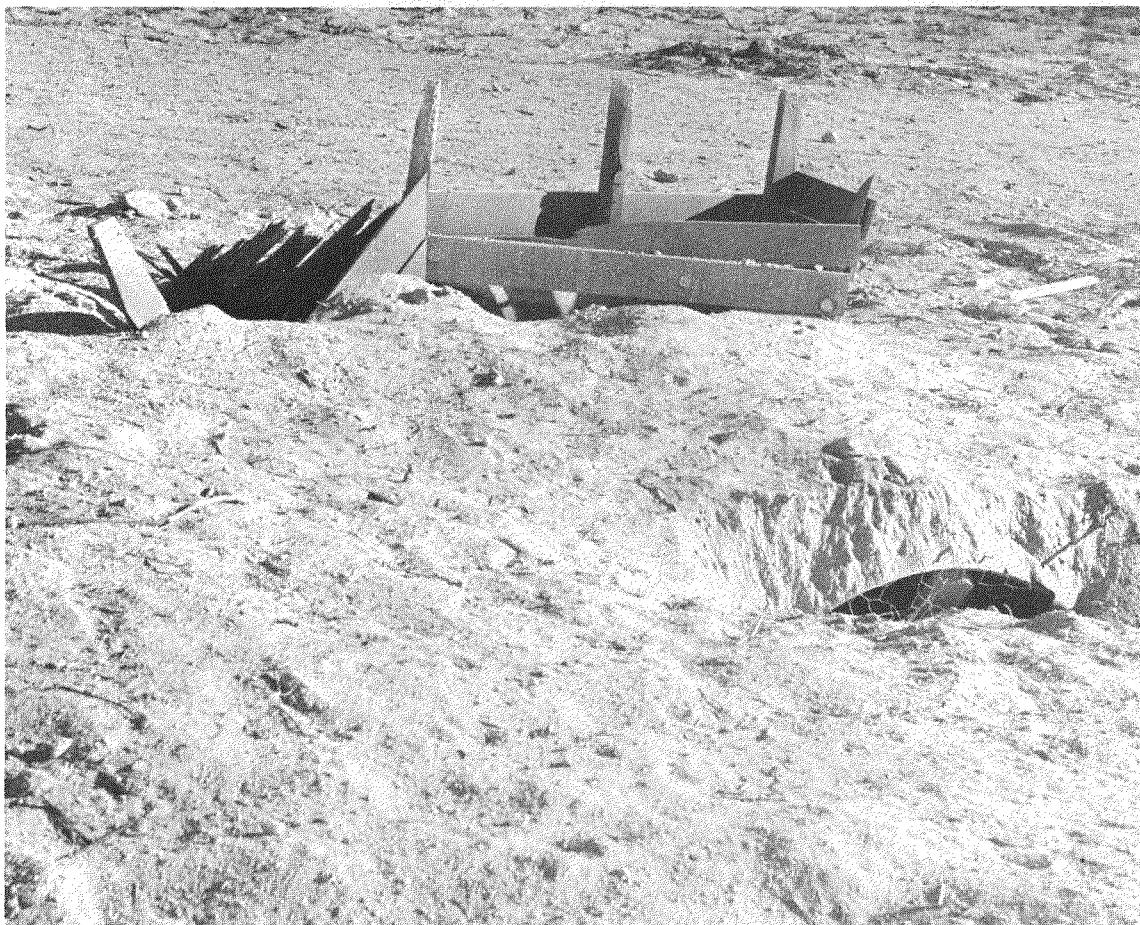
Failure of stakes to hold the end section of the metal-arch shelter in the previous explosion contributed to its destruction (Fig. 5.7). Entrance sections were weaker than those of the covered-trench type, but the metal-arch and walls survived.

Fig. 5.7 Shelter B-1 After Shot Charlie (metal-arch shelter below-grade)

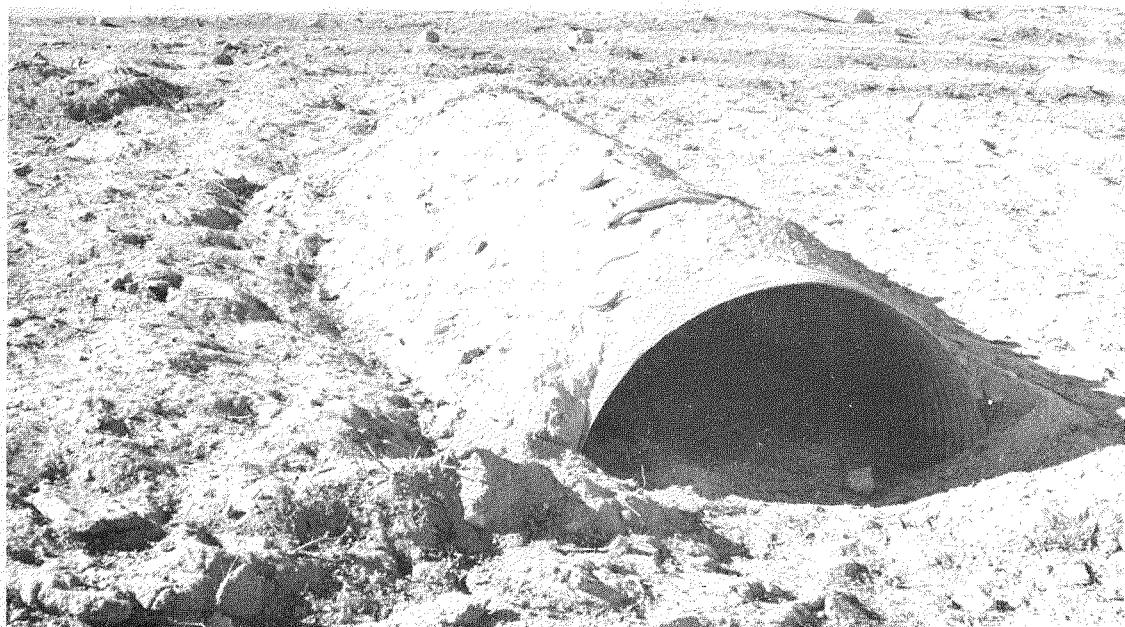
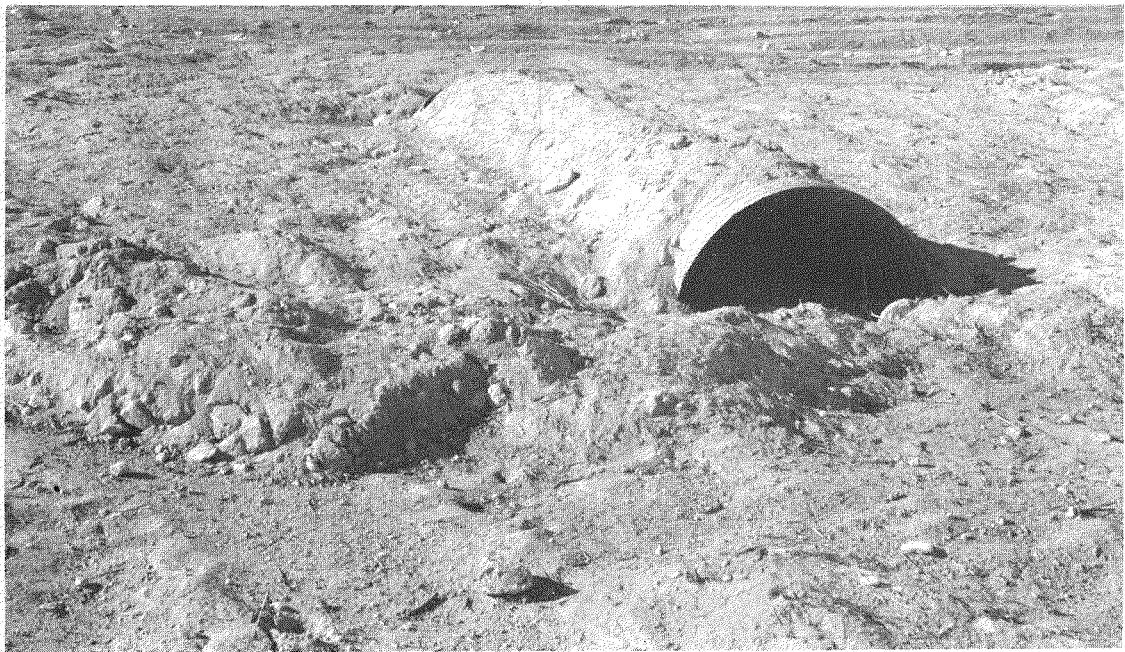
Figures 5.8 and 5.9 show effects of the blast on metal-arch sections in a ground level concrete footing. Virtually all cover was swept away, but the metal arch was not affected by blast.

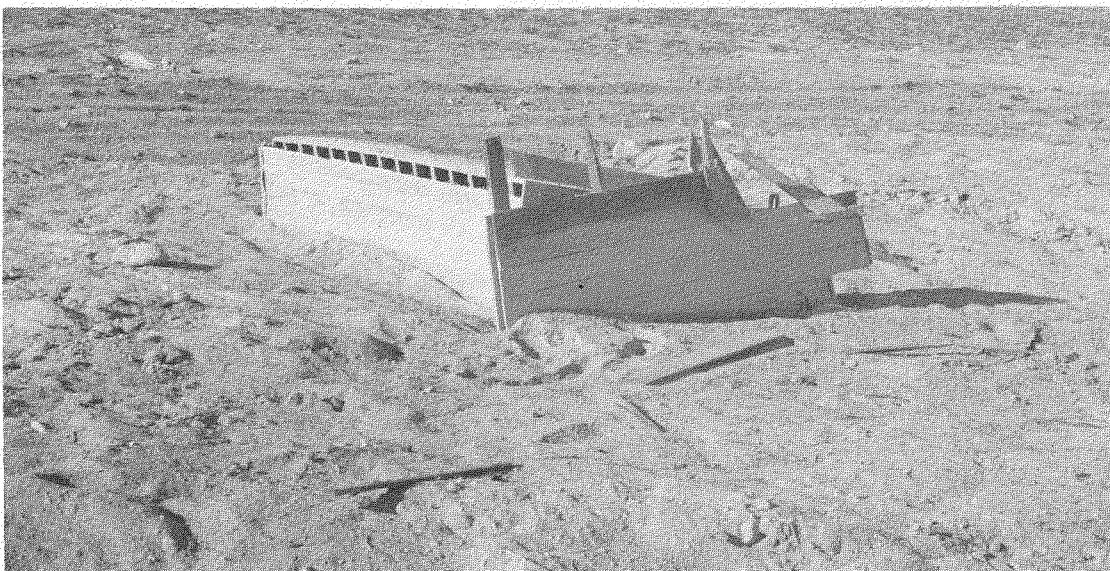
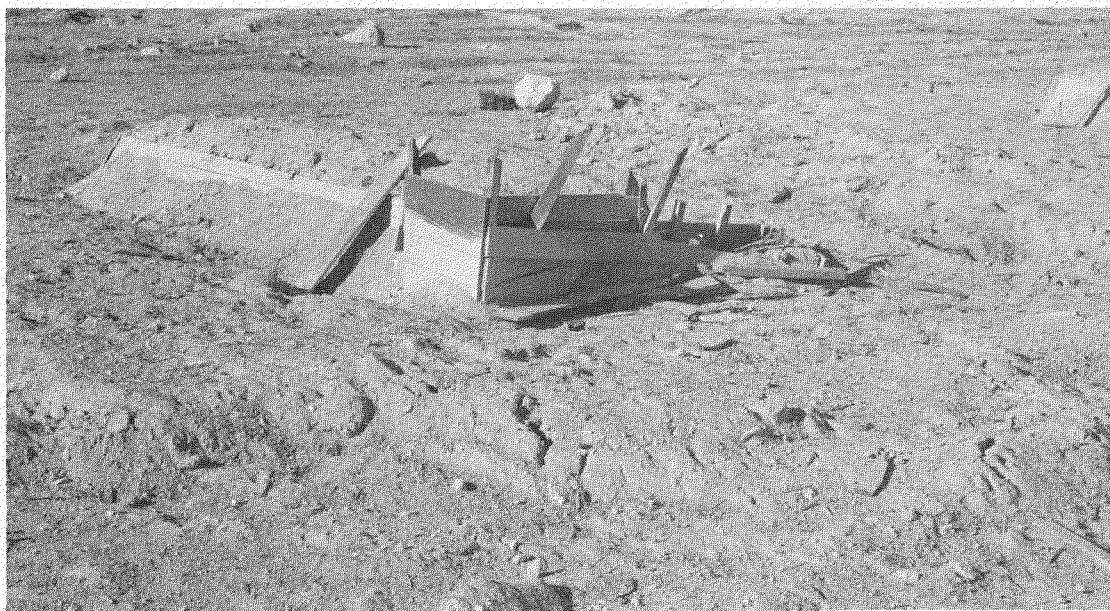
Earth cover was swept away to ground level and wood-arch shelters collapsed completely as a result of Shot Charlie (Figs. 5.10 and 5.11). Arch folded and in some cases pulled sidewalls in with them.

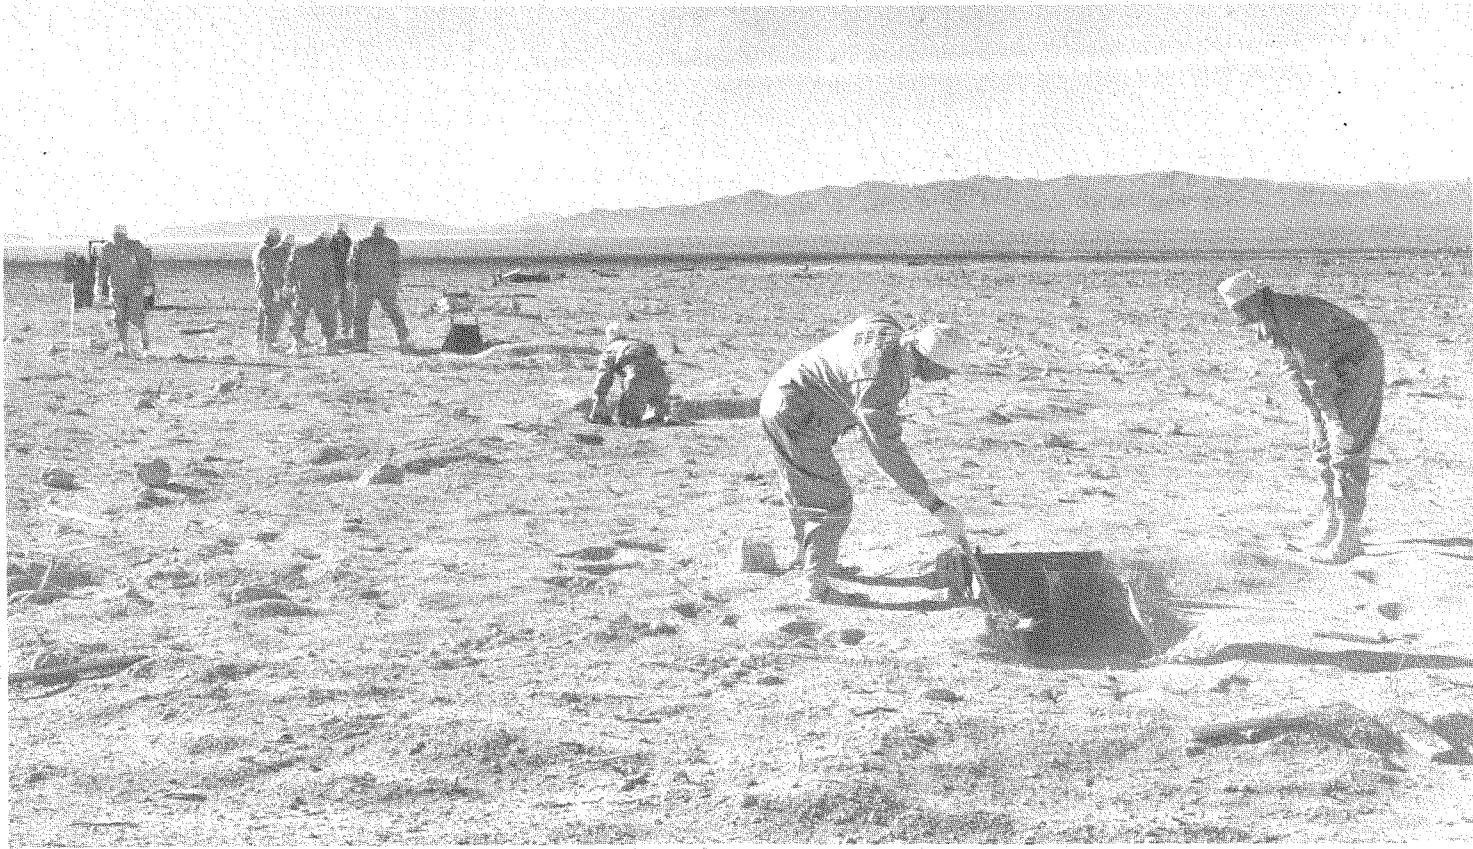
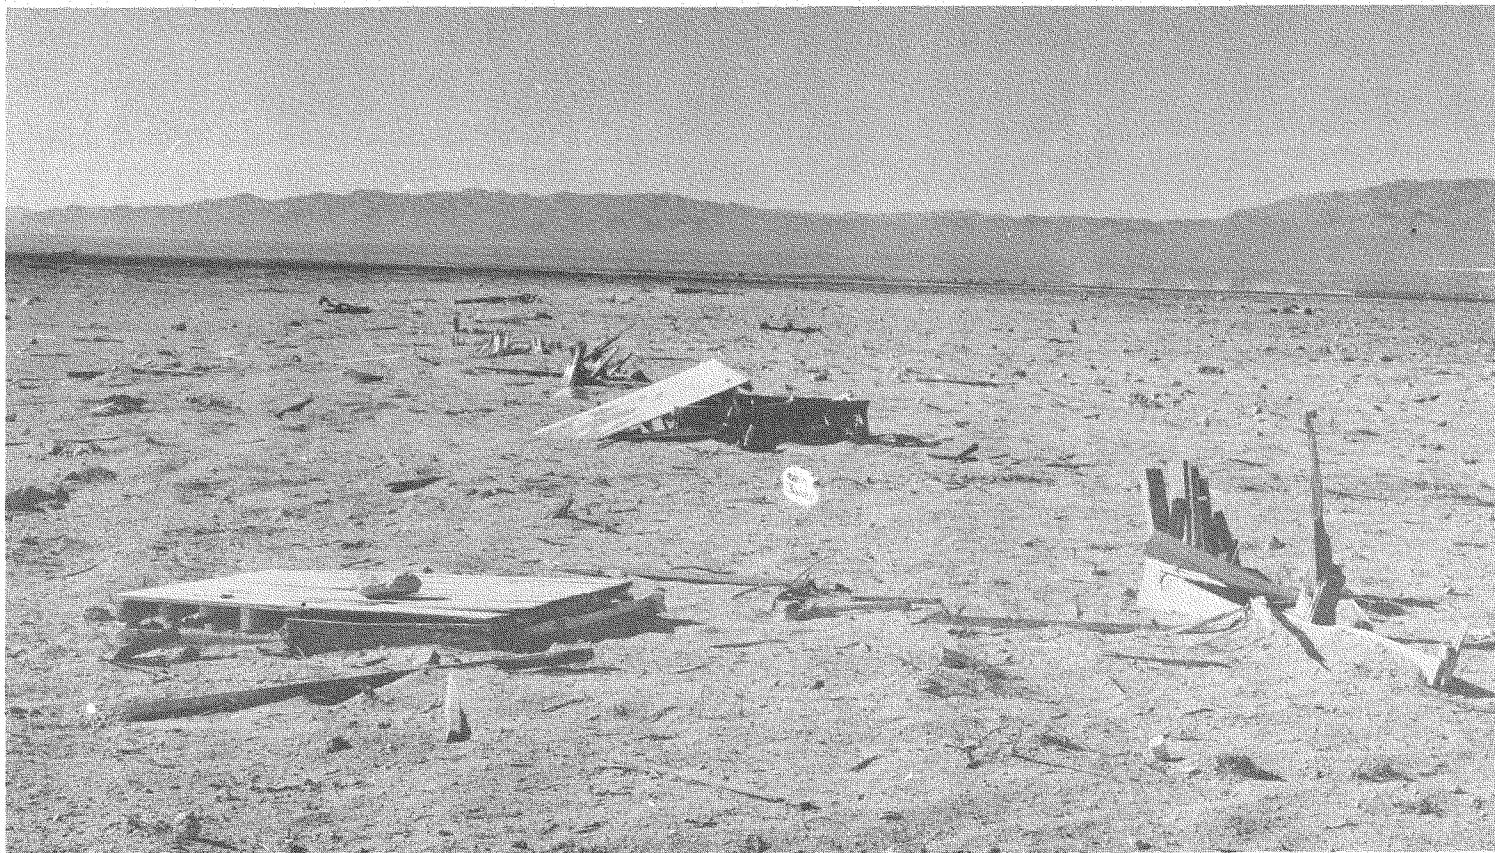
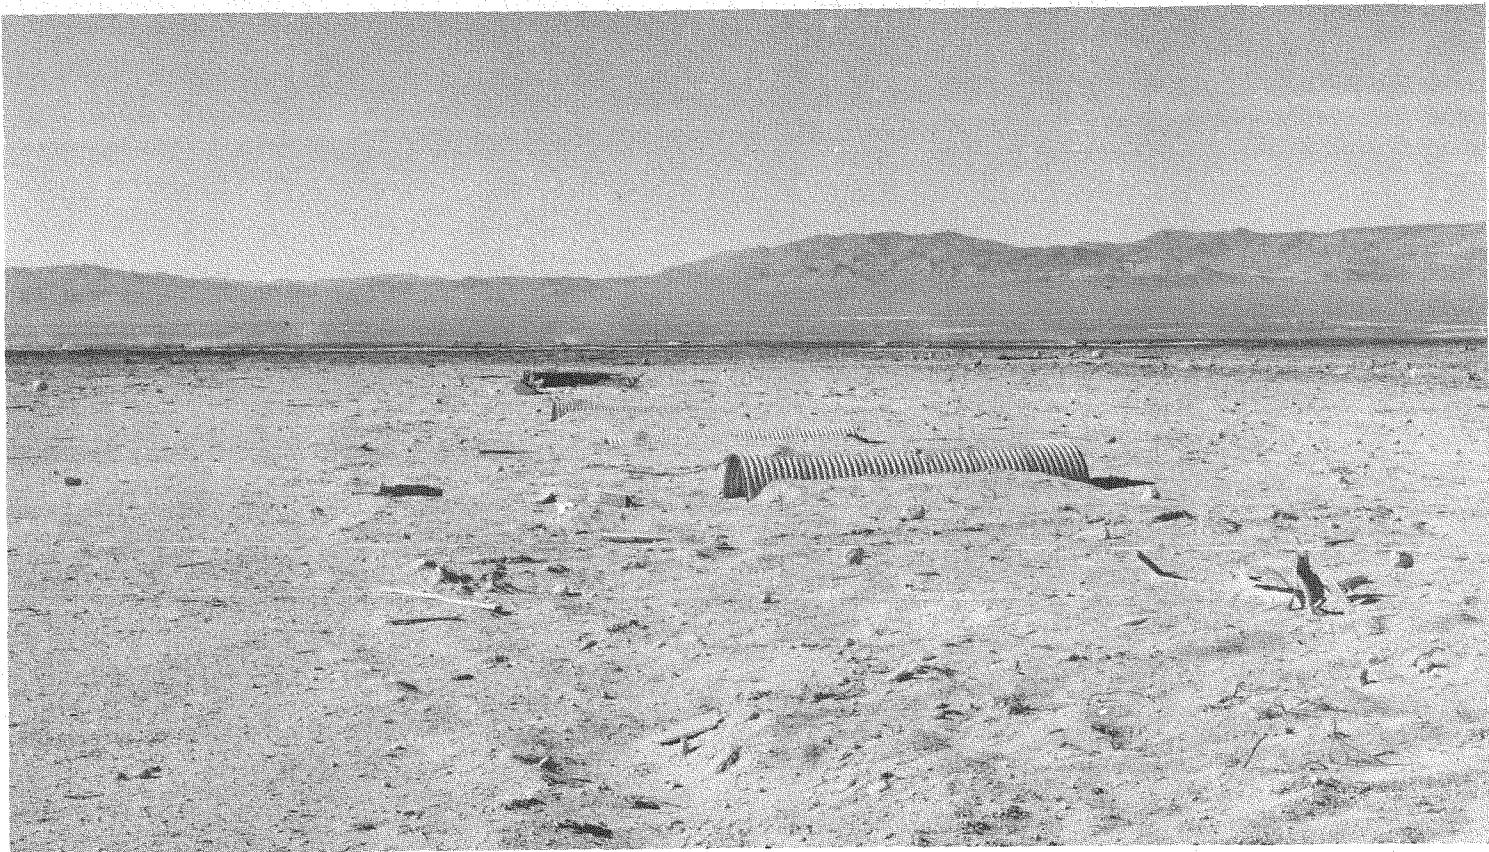
The below-grade covered-trench, as well as the metal arches set in concrete, withstood the blast in spite of the lack of protective covering. All other structures were almost completely demolished. Damage is shown in Figs. 6.1, 6.2, and 6.3.

In below-grade covered-trench shelters, entrance construction, which was above the natural grade, was almost completely blown away. Considerable material was blown into the shelters and soil seeped through damaged structures. Debris, however, was stopped in the entrance areas. Deflection devices were generally not disturbed. In reduced-strength shelters partial failure of the front and end sections occurred when studs were joined to the roof section.
