OPERATION  
**PLUMB BOB**

NEVADA TEST SITE  
MAY-OCTOBER 1957

Project 30.7

TEST OF GERMAN UNDERGROUND  
PERSONNEL SHELTERS

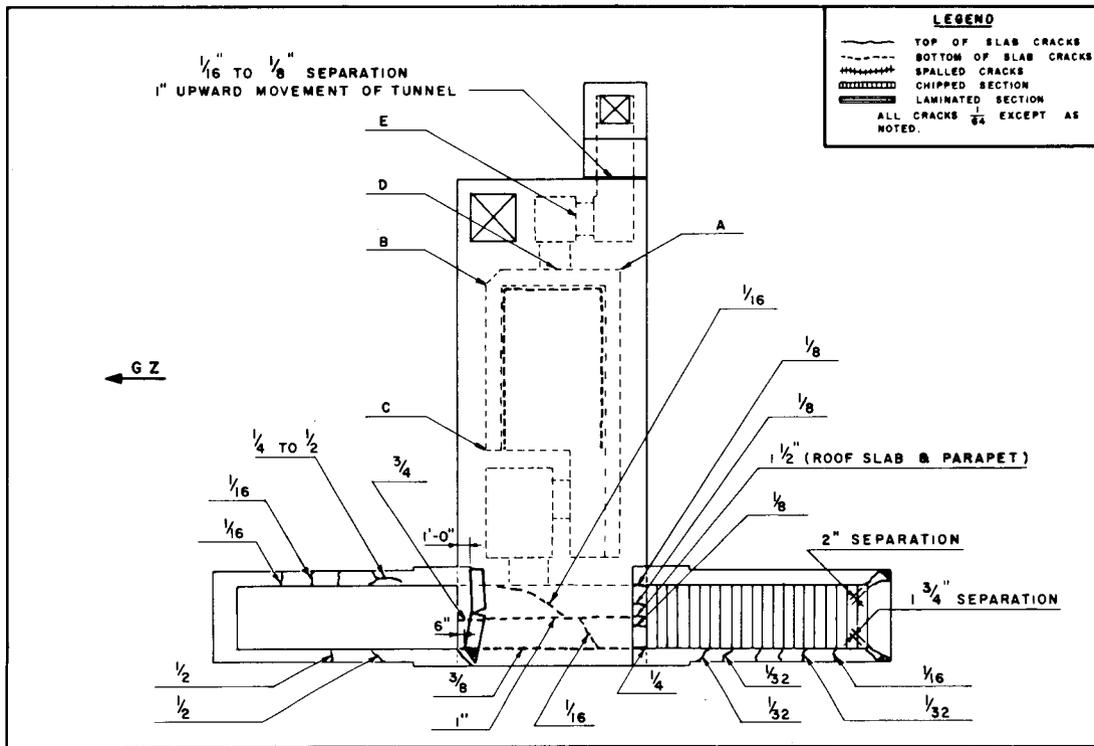
(c) *Main Chamber.* Hairline cracks were formed at the intersection of the roof slab and the haunches along the rear and side walls of the main chamber. The intersection of the walls located at points A, B, and C of Fig. 3.1 had continuous hairline cracks the full height of the walls. Diagonal hairline cracks were formed at the four corners of the door opening located at point D. Numerous transverse and longitudinal hairline cracks were produced on the floor slab of the main chamber. No cracks were present in the floor slab of the main chamber adjacent to the main seal door.

Fig. 3.1—Roof-slab crack pattern (structure RAa).

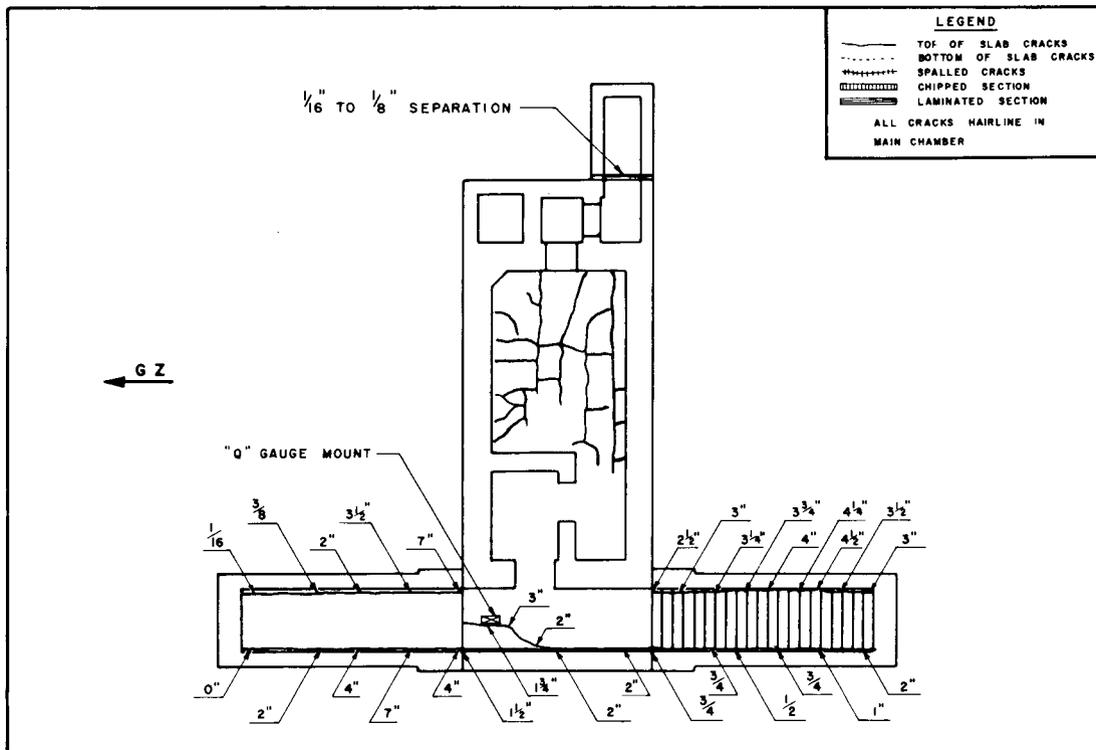
Fig. 3.2—Floor-slab crack pattern (structure RAa).

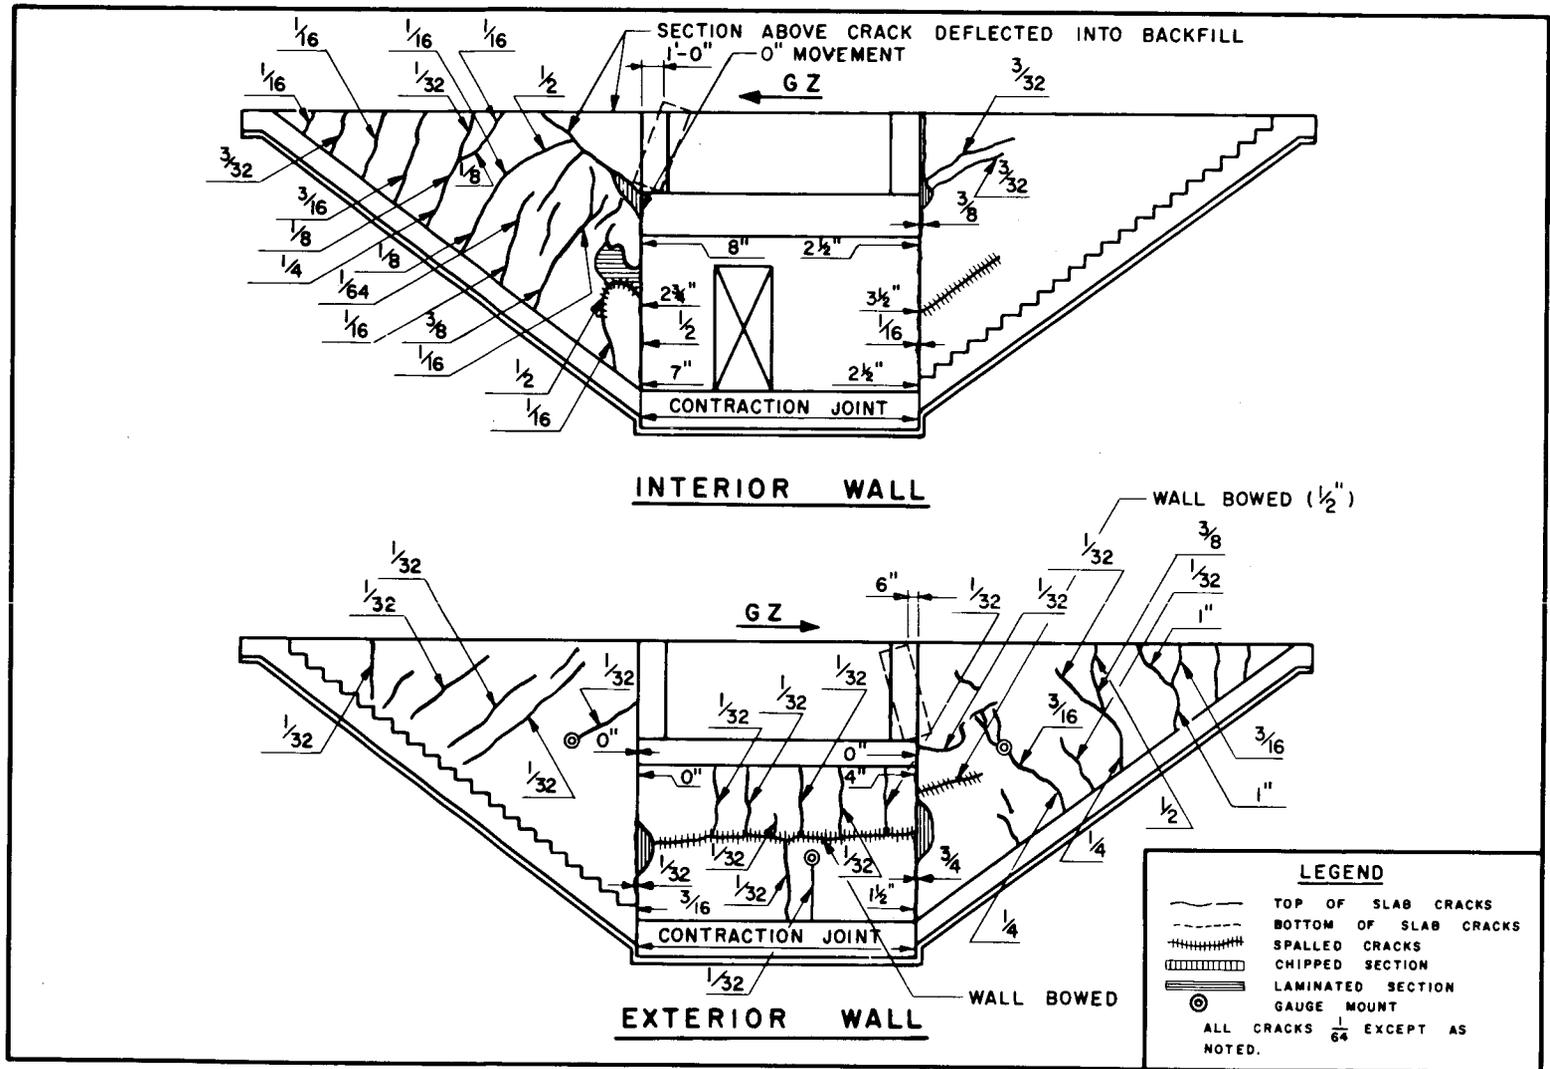
(a) *Entranceways.* In the ramp entrance facing JZ separations formed at the intersections of the interior and exterior walls with the ramp slab. The interior wall was pulled away from the slab 7 in. at the bottom and  $\frac{1}{16}$  in. at the top of the ramp. The intersection of the ramp and exterior wall was similar to that at the interior wall; that is, the crack varied from 4 to 7 in. near the bottom to zero inches at the top of the ramp. Bowing of the interior wall into the backfill was produced at the quarter-height along the contraction joint. A  $\frac{1}{16}$ - to  $\frac{1}{2}$ -in. vertical crack was formed near the bottom of the ramp. This crack terminated at a laminated area located at the mid-height of the wall. There was spalling on both sides at the upper section of the crack. Cracks varying from  $\frac{1}{16}$  to  $\frac{3}{8}$  in. in width, perpendicular to the plane of the ramp, were located approximately 2 ft on center along the length of the wall. The majority of these cracks ran the full height of the wall. A crack starting at a chipped-out section located at the intersection of the end of the roof slab and the interior wall ran diagonally toward the top of the wall. The section of the wall above this crack was deflected back into the fill. The exterior wall damage was similar to that described for the interior wall. A chipped section of the exterior ramp wall was located approximately 4 ft above the landing at the contraction joint. A horizontal crack, with spalling on both sides, above this section produced a  $\frac{1}{2}$ -in. bow in this wall. There were numerous diagonal cracks perpendicular to the plane of the ramp located approximately 2 to 3 ft on center in the upper two-thirds of wall. These cracks varied in size from  $\frac{1}{32}$  to 1 in. in width. The top of the parapet located above the landing roof slab that faces GZ was deflected into the backfill 6 in. at the intersection of the exterior wall and 1 ft at the interior wall. The corners of the parapet and side walls were chipped, and the reinforcement was exposed.

A 3-in. crack in the landing floor slab ran from the contraction joint at the bottom of the ramp along the center line of the slab to the Q-gauge mount. There it became a 2-in. crack, running diagonally to the exterior wall. A  $1\frac{1}{2}$ - to 2-in. crack was located along the intersection of the floor slab and the exterior wall. The crack was continuous the full length of the landing. The roof slab had a continuous longitudinal 1-in. crack along its center line. Two diagonal cracks  $\frac{1}{16}$  in. in width branched off the main crack, one terminating at the interior wall and the other at the exterior wall. A  $\frac{3}{8}$ -in. crack was produced along the intersection of the roof slab and the exterior wall. The exterior wall was badly damaged, having a longitudinal crack located at the mid-height of the wall. Spalling of 2 to 3 in. on each side was observed along its entire length.

Fig. 3.3—Entrance crack pattern (structure RAa).

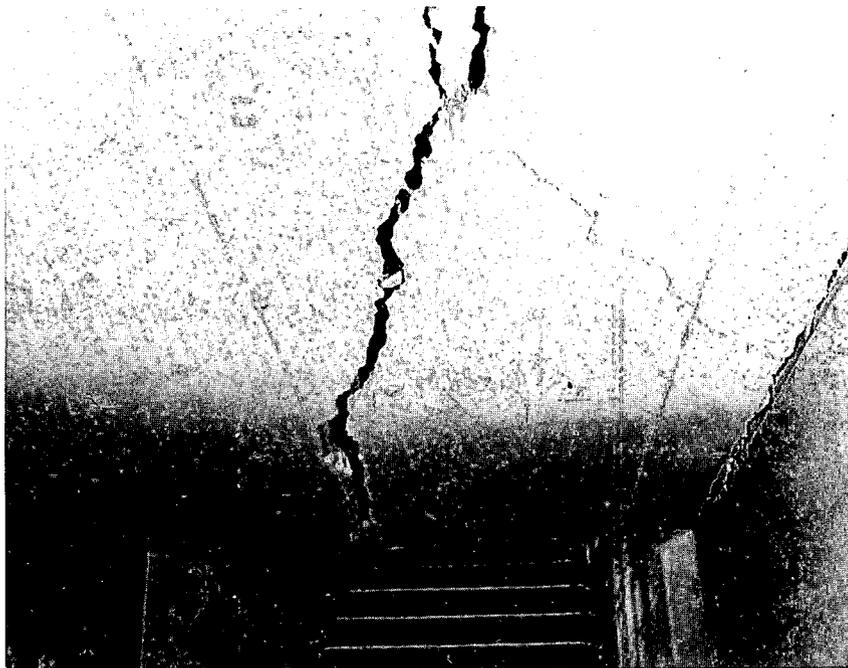
Fig. 3.9—Cracks along center of landing roof slab and at intersection with exterior wall (structure RAa).

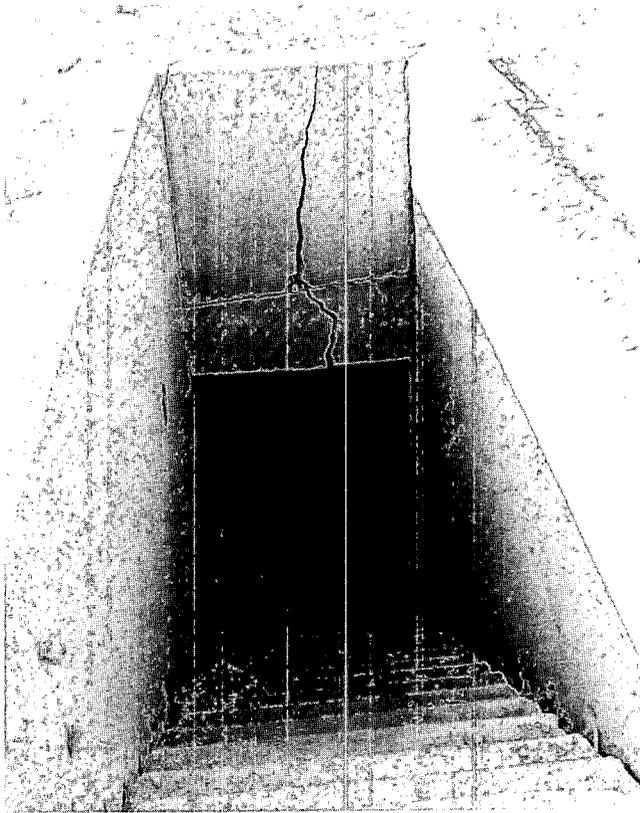
Fig. 3.11—Cracks in parapet wall and end of landing roof slab at entrance facing away from GZ (structure RAa).

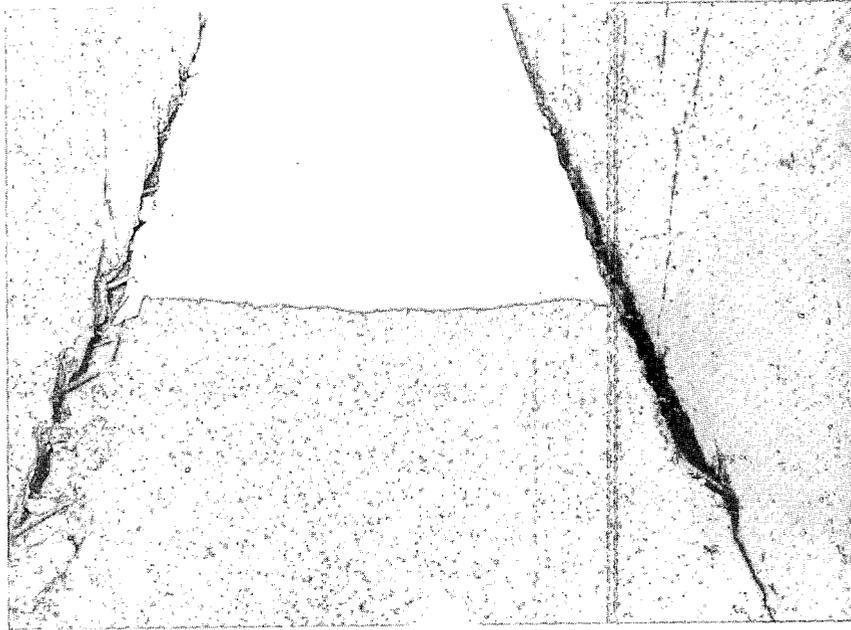
Fig. 3.12—Details of separations between ramp slab and interior and exterior walls facing toward GZ (structure RAa).

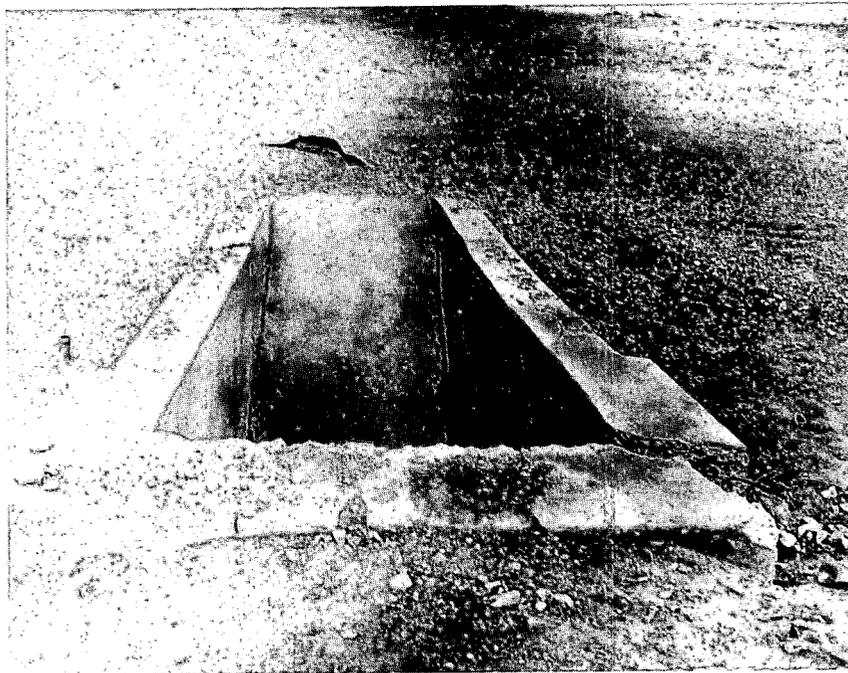
Fig. 3.13—Blast damage to ramp walls of entrance facing GZ (structure RAa).

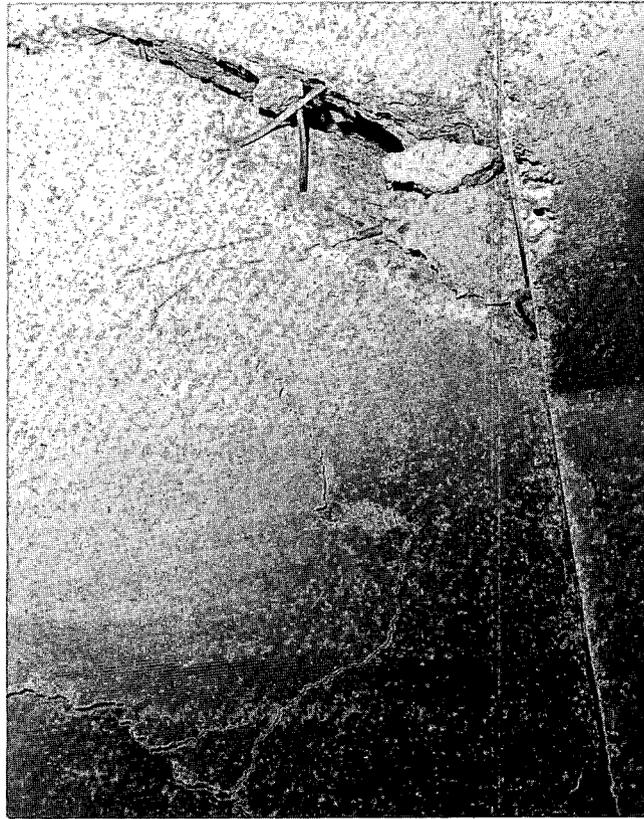
Fig. 3.16—Detail of cracks and spalled and laminated area in interior wall at contraction joint at entrance facing toward GZ (structure RAa).

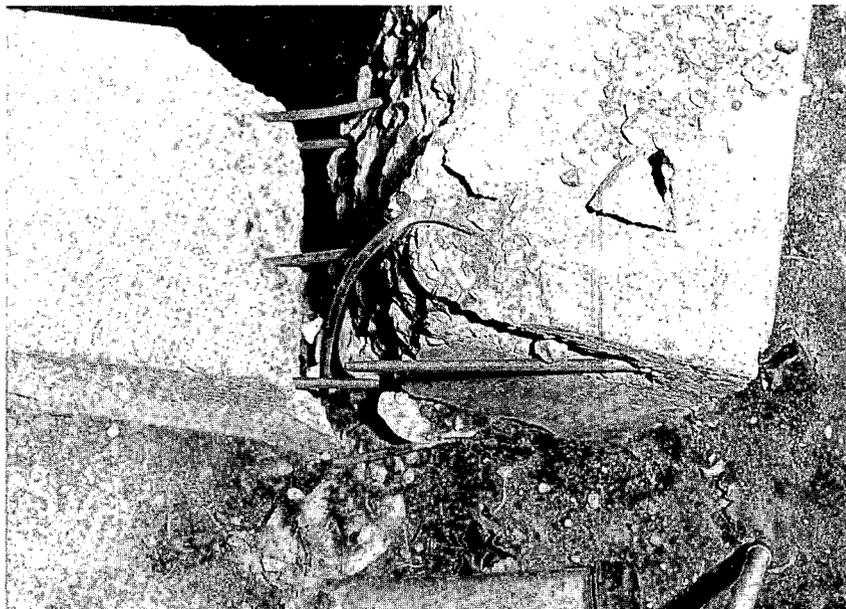
Fig. 3.17—Detail of crack at intersection of exterior wall and parapet wall facing toward GZ (structure RAa).

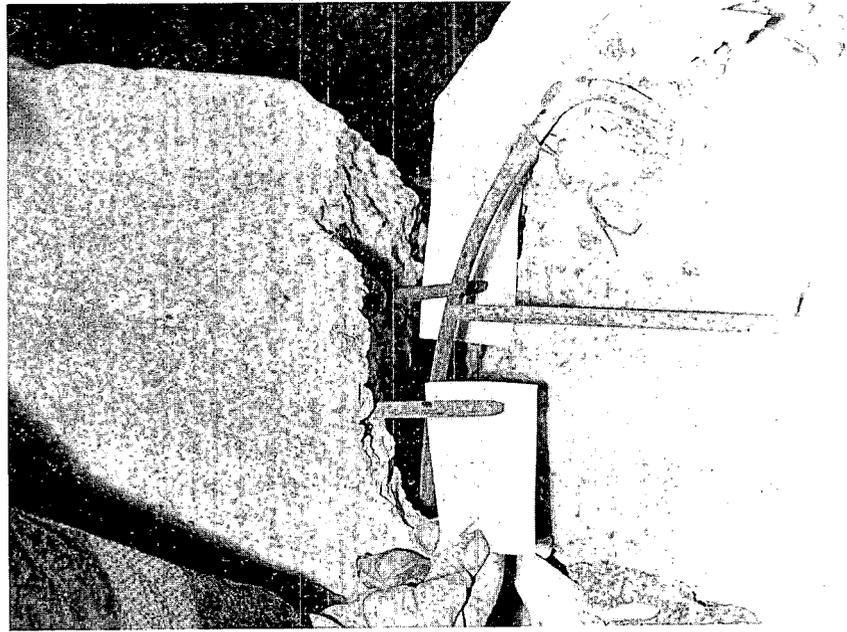
Fig. 3.18—Detail of necked-down reinforcement at intersection of exterior wall and parapet wall facing toward GZ (structure RAa).

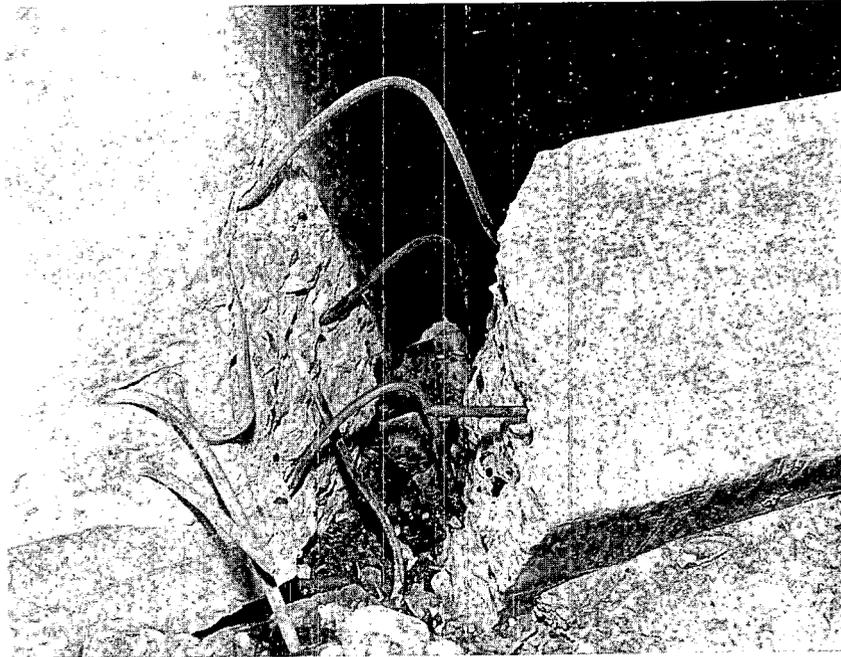
Fig. 3.19—Detail of crack at intersection of interior wall and parapet wall facing toward GZ (structure RAa).

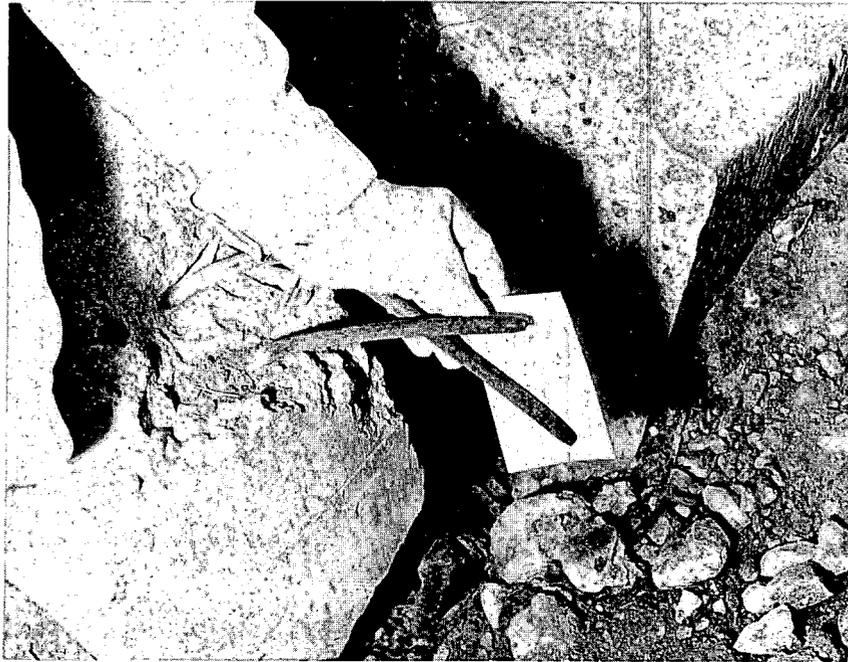
Fig. 3.20—Detail of necked-down reinforcement torn from parapet at interior wall (structure RAa).

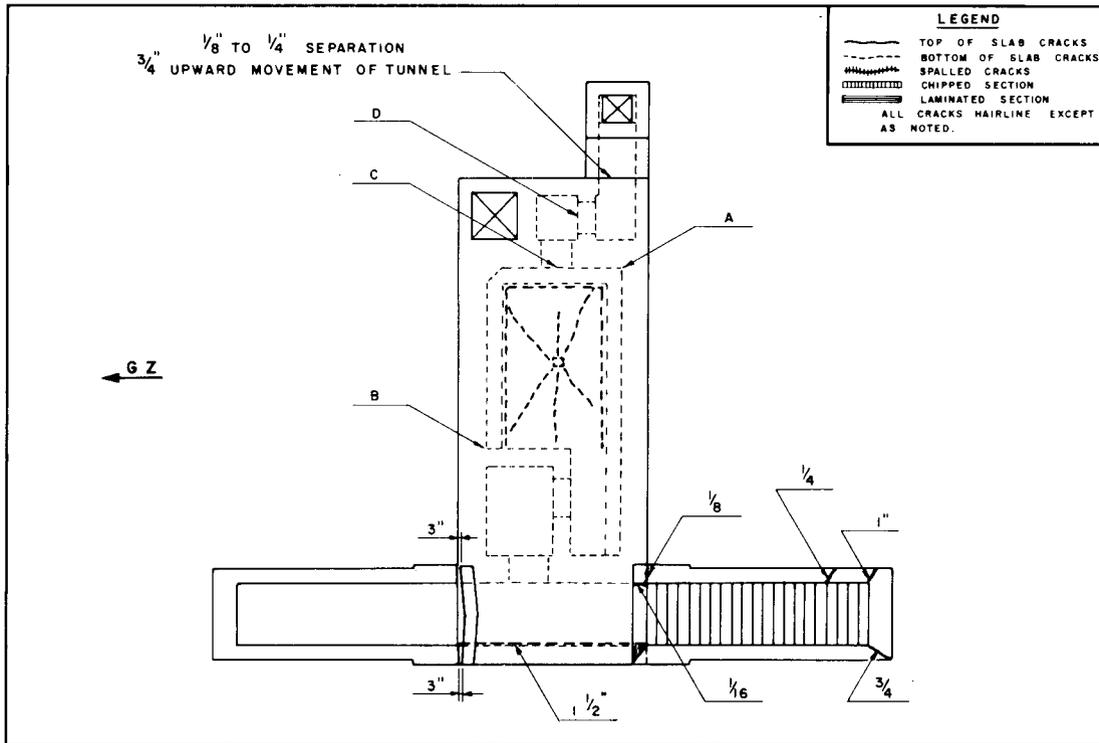
Fig. 3.25—Roof-slab crack pattern (structure RAb).

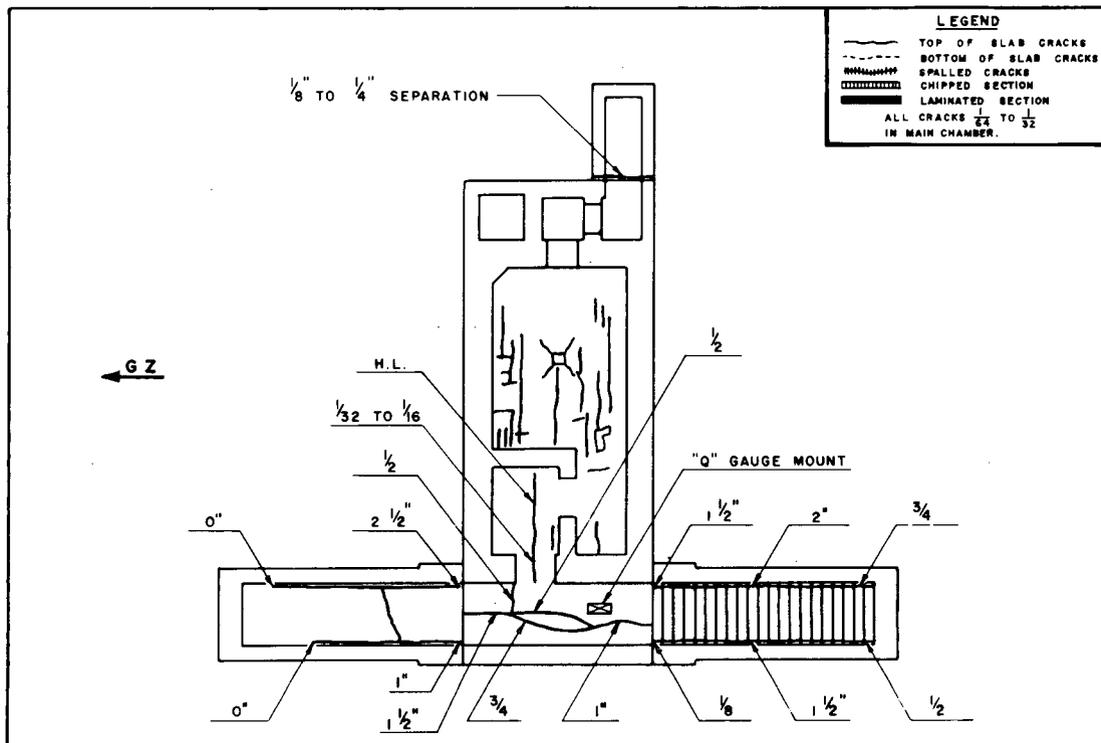
Fig. 3.26—Floor-slab crack pattern (structure RAb).

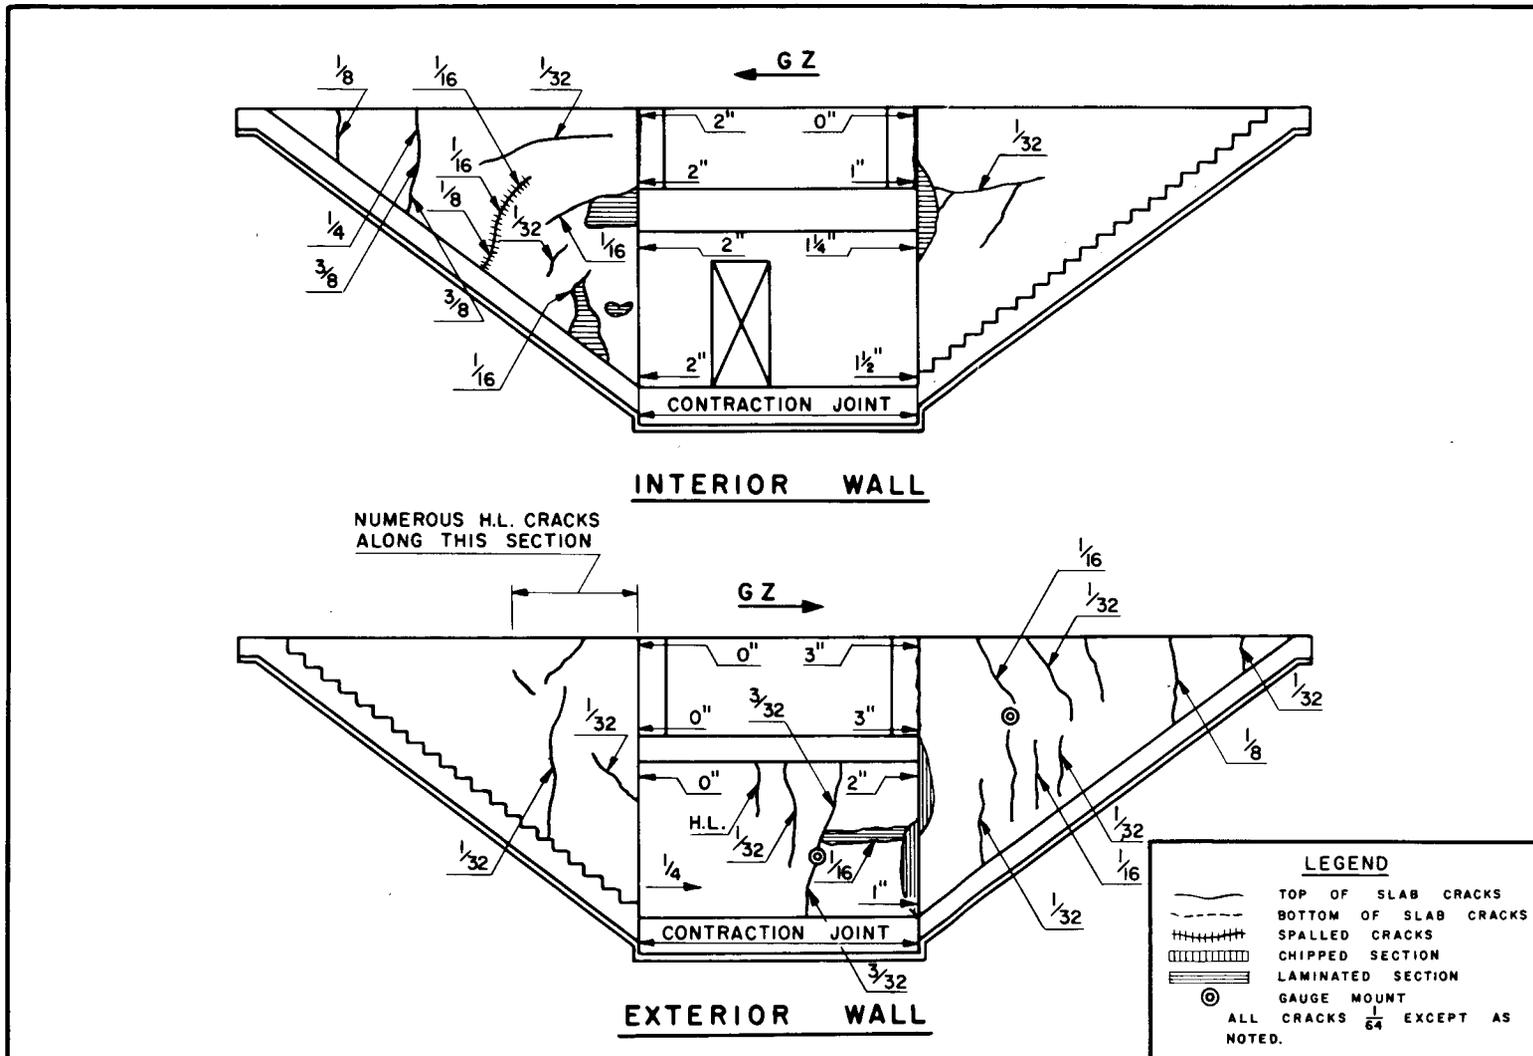
Fig. 3.27—Entrance crack pattern (structure RAb).

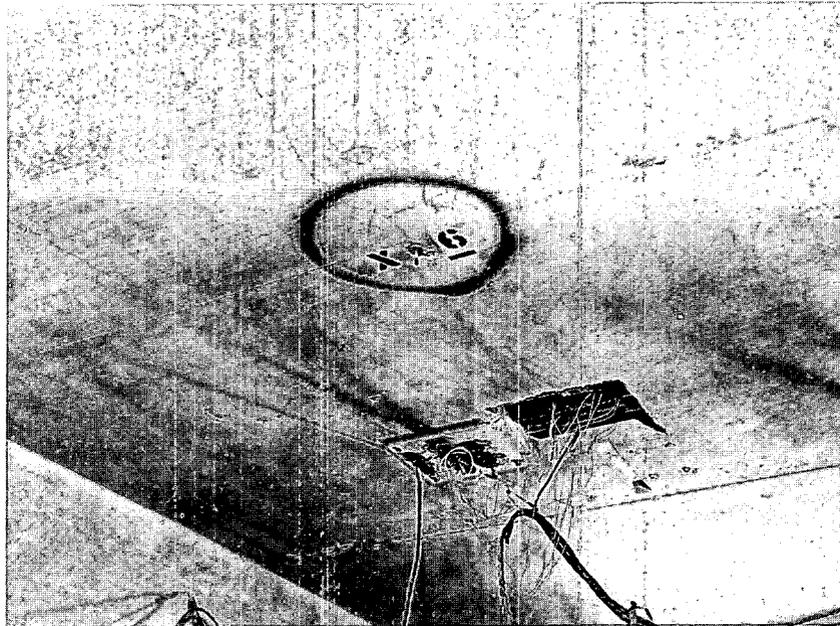
Fig. 3.29—Cracks, strain-gauge recess, and survey point in roof slab of main chamber (structure RAb).

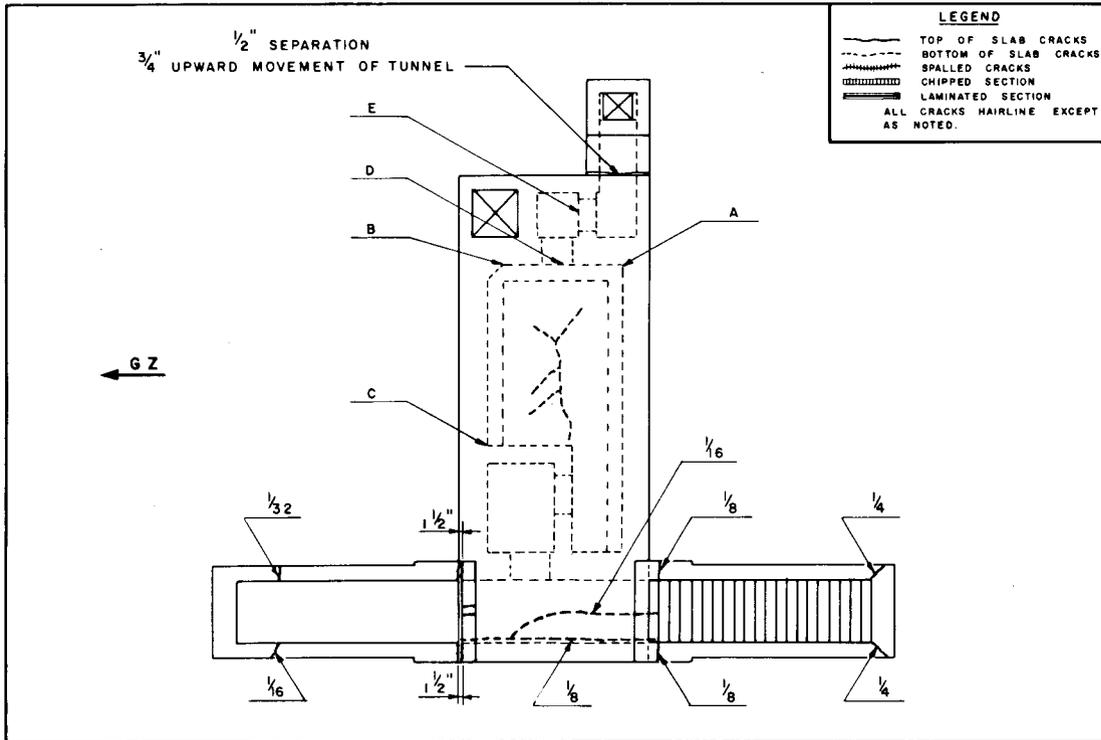
Fig. 3.33—Roof-slab crack pattern (structure RAc).

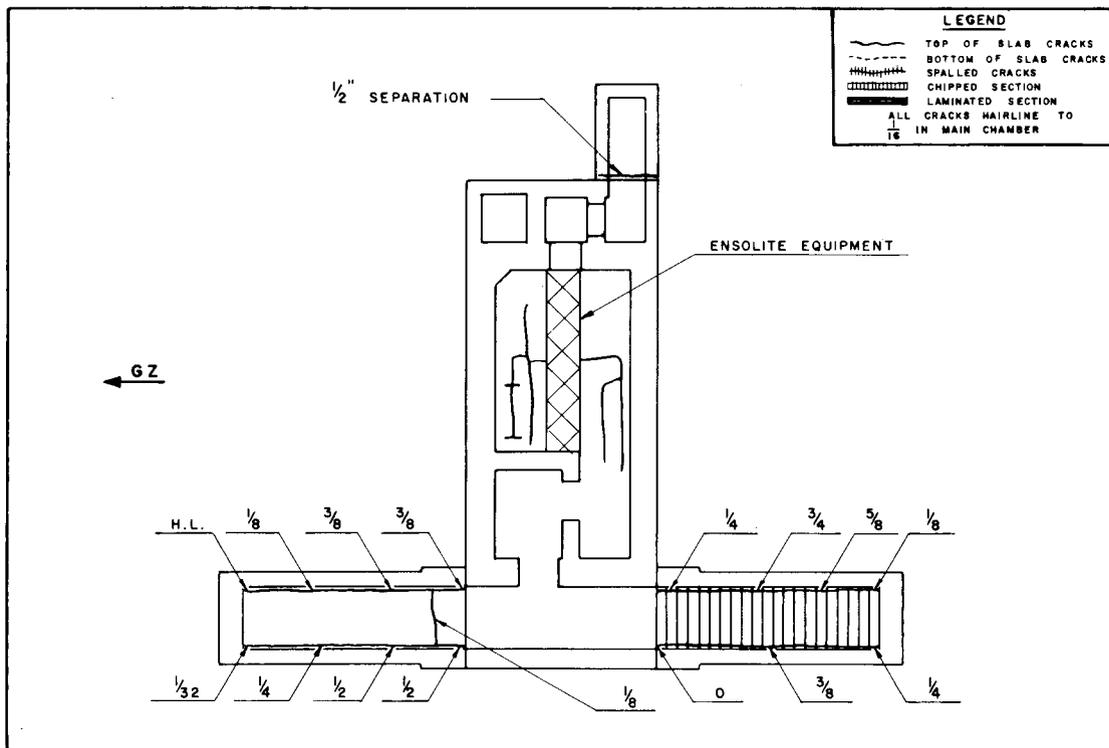
Fig. 3.34—Floor-slab crack pattern (structure RAc).

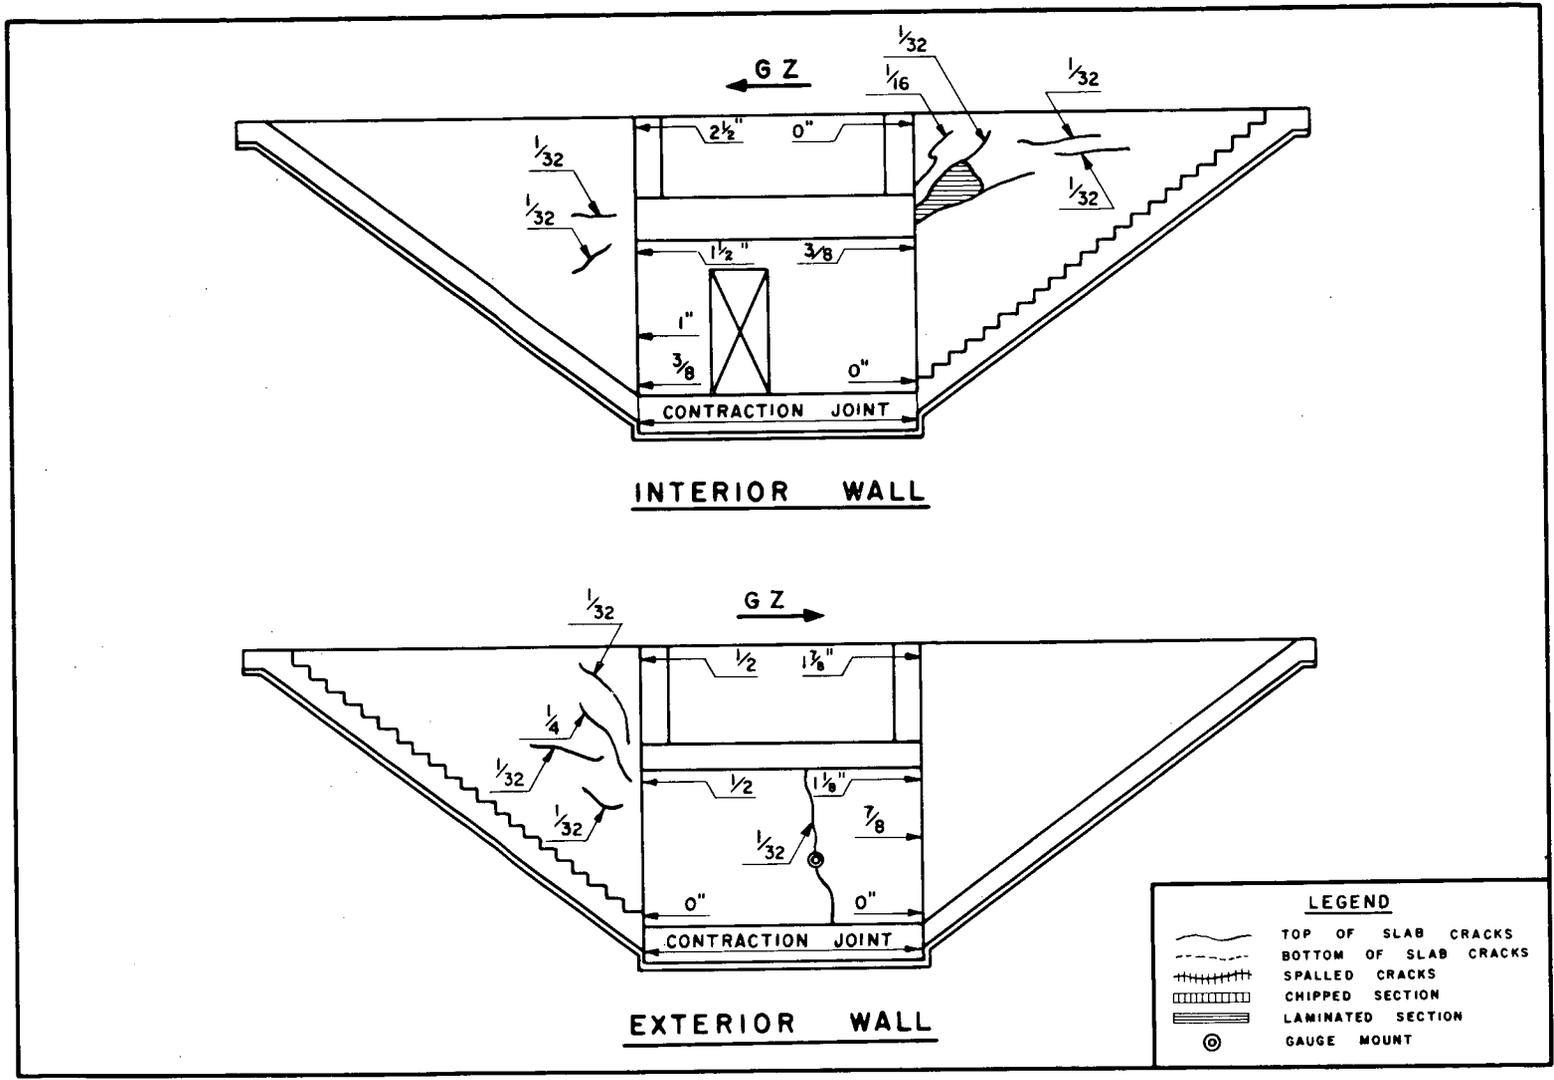
Fig. 3.35—Entrance crack pattern (structure RAc).

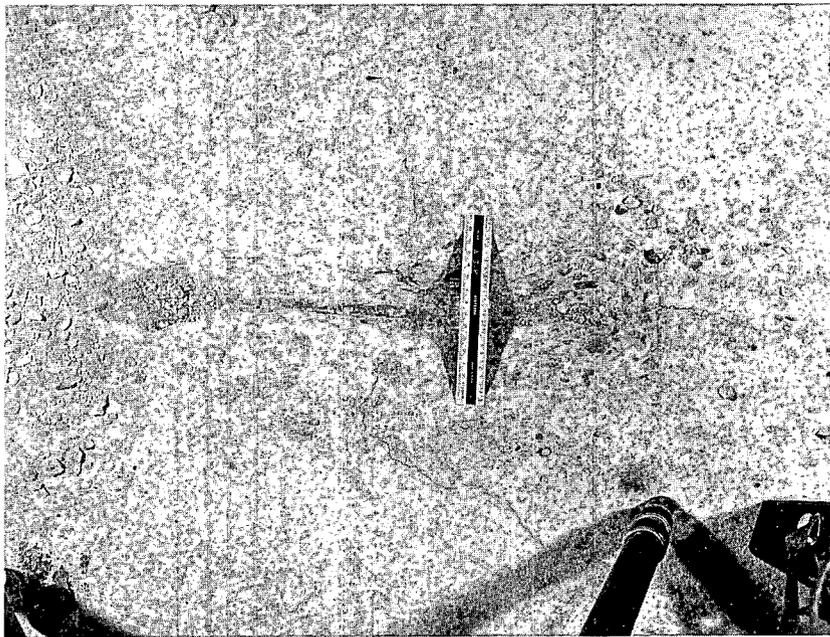
Fig. 3.38—Over-all view of chipped-out section with associated crack pattern (structure RAc).

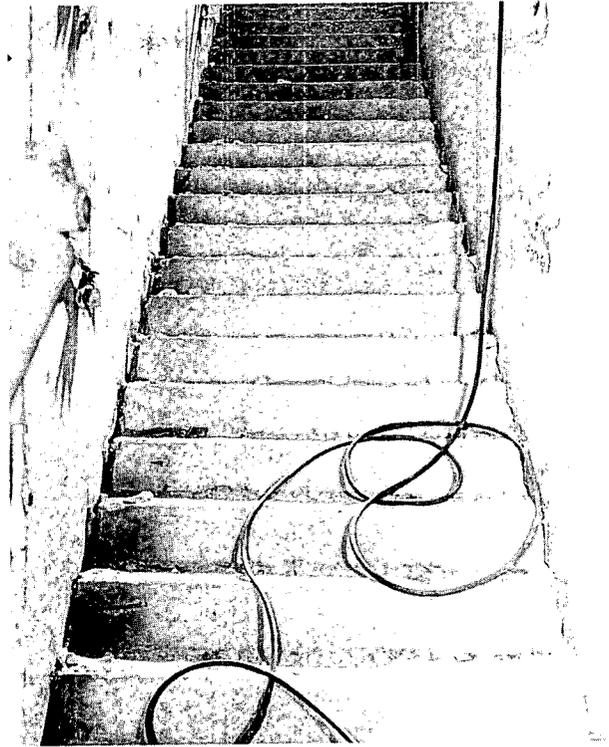
Fig. 3.46—Looking up stairs facing away from GZ, showing separations between stairs and interior and entrance walls (structure RAc).

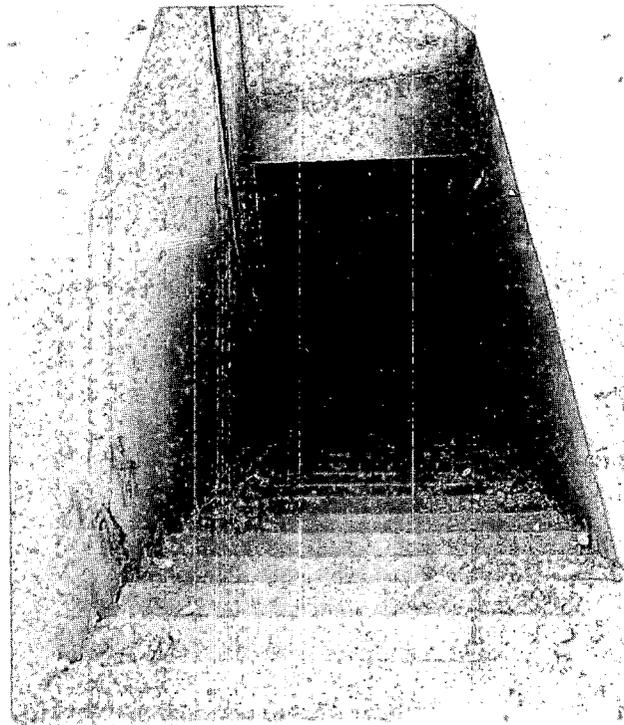
Fig. 3.47—Looking down entrance facing away from GZ, showing cracks between parapet wall and interior and exterior walls (structure RAc).

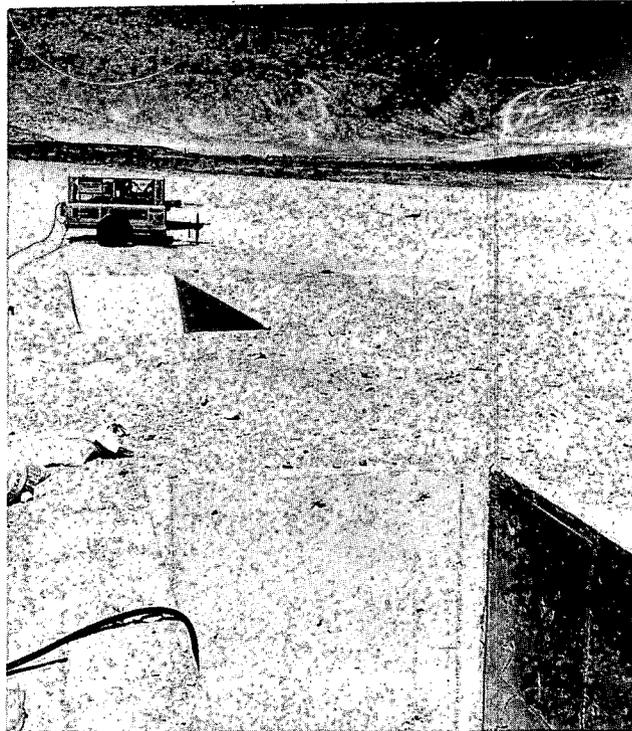
Fig. 3.48—Detail of cracks at intersection of parapet wall and interior wall and entrance facing away from GZ (structure RAc).

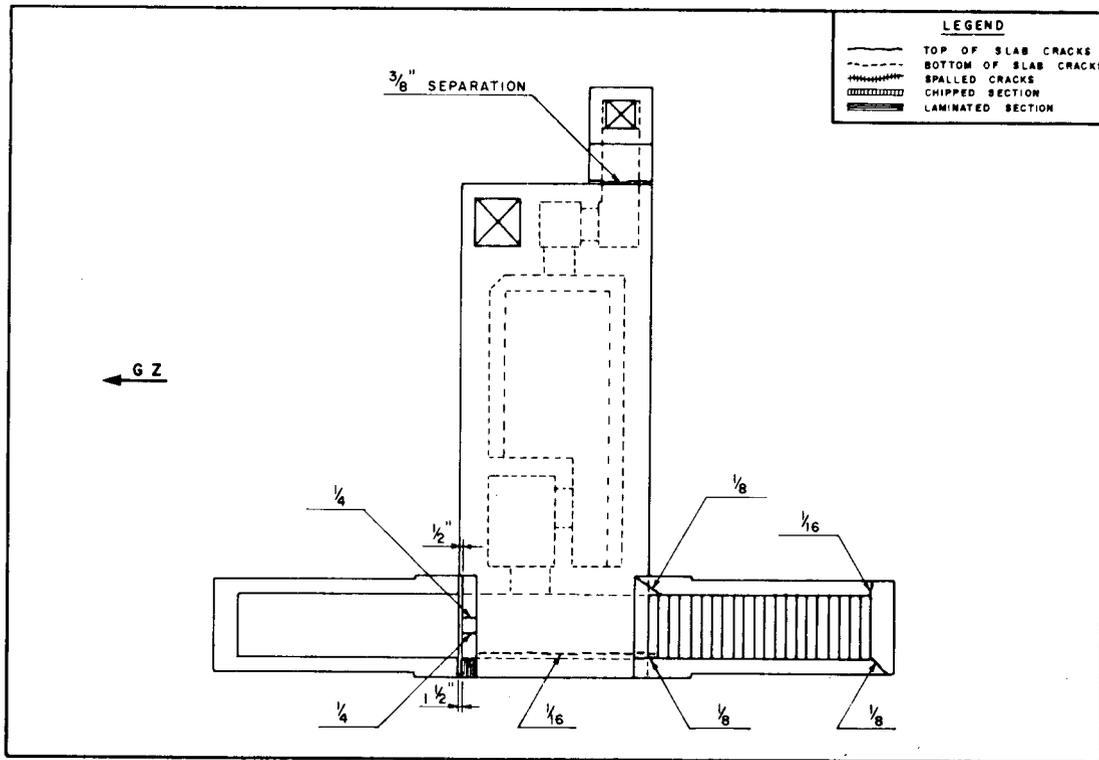
Fig. 3.54—Roof-slab crack pattern (structure RAd).

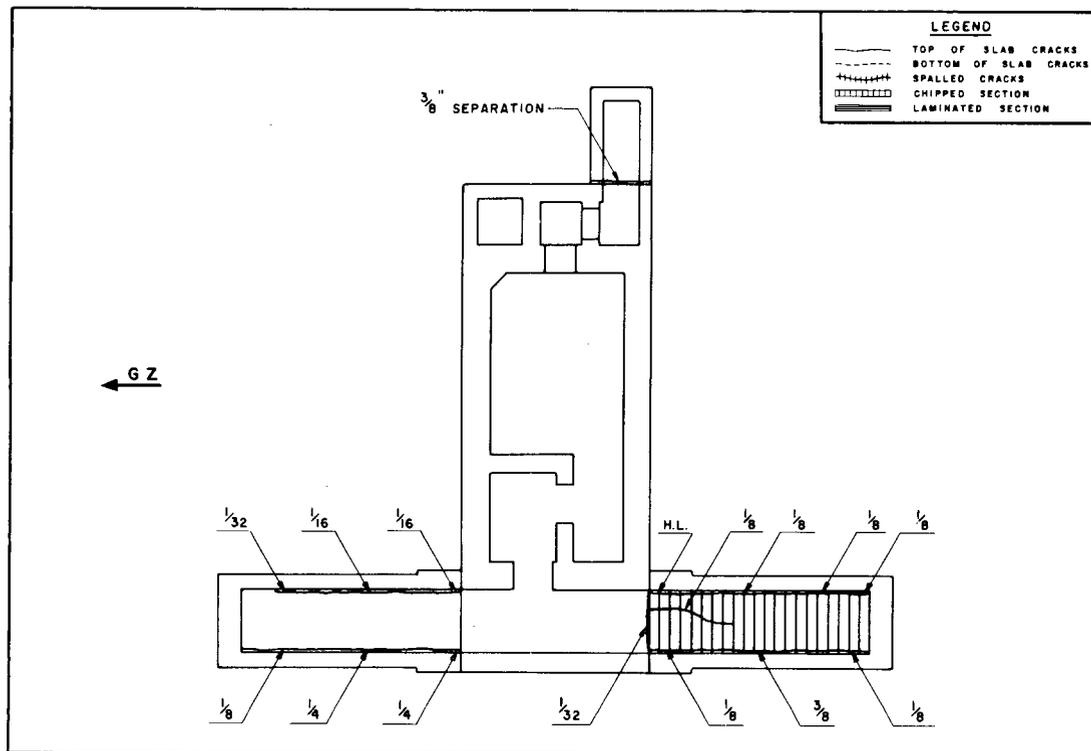
Fig. 3.55—Floor-slab crack pattern (structure RAd).

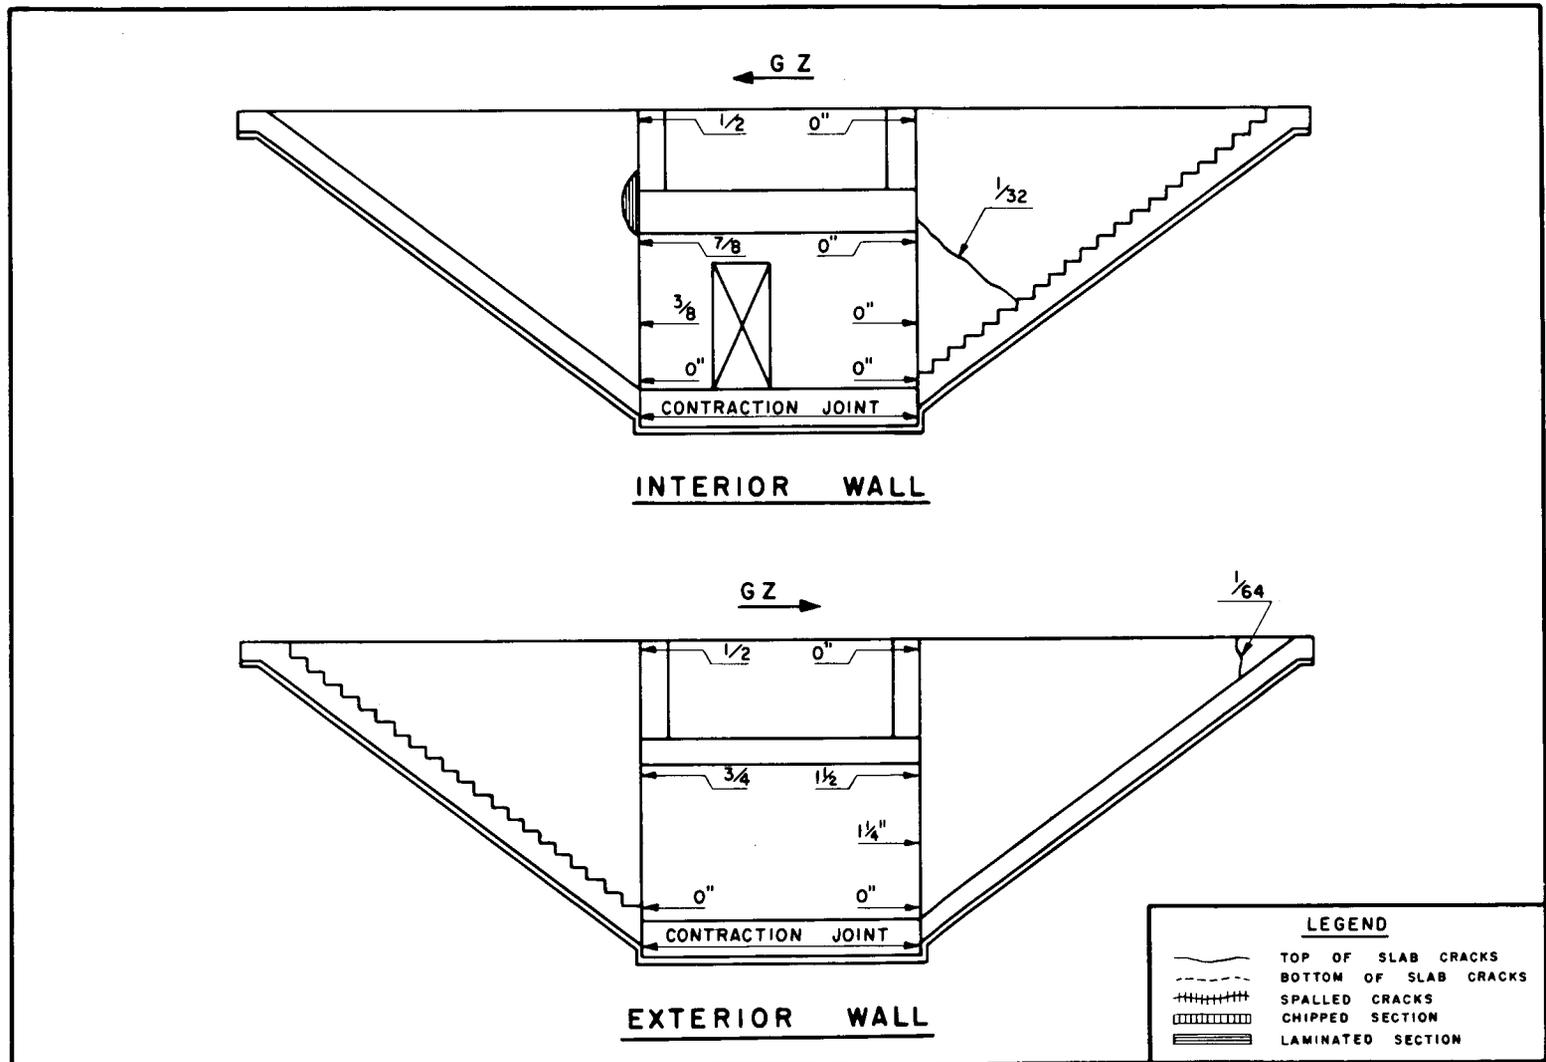
Fig. 3.56—Entrance crack pattern (structure RAd).

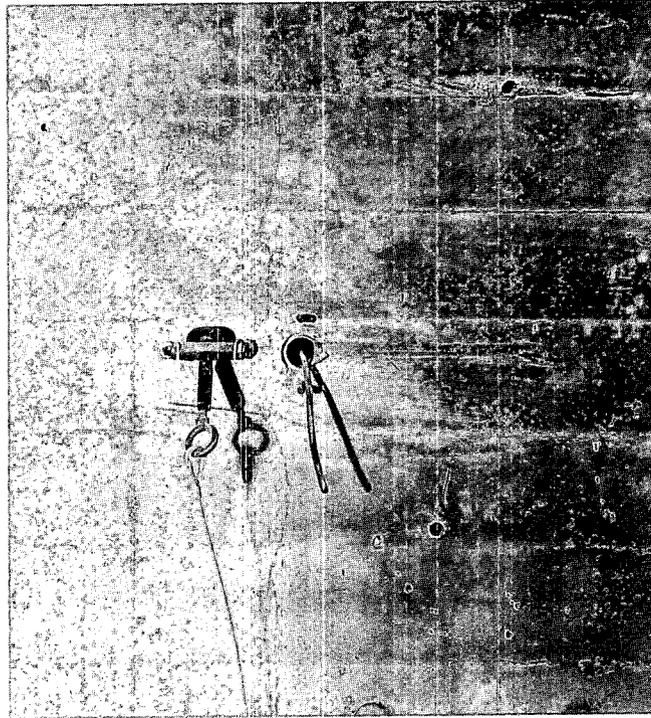
Fig. 3.65—Crack in side of main chamber facing away from GZ (between displacement gauge tie point and Carlson gauge) (structure CAa).

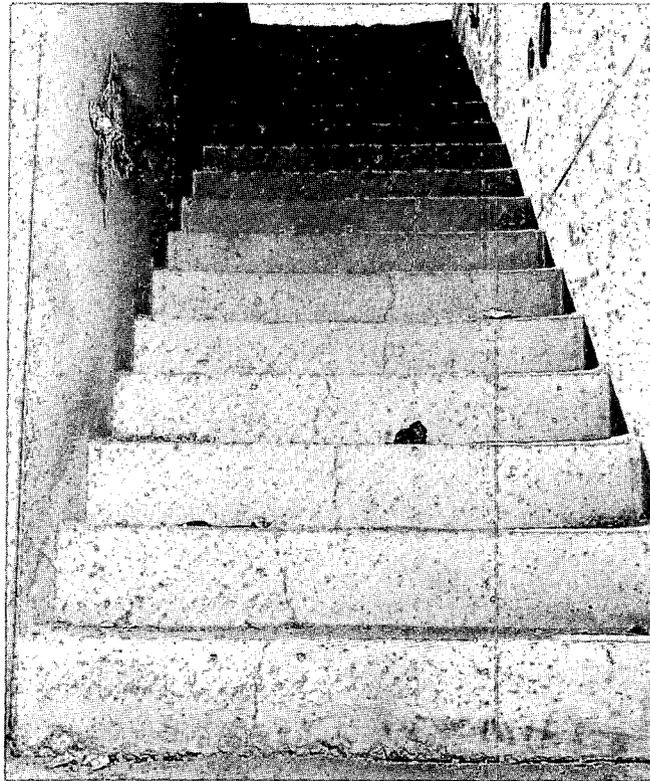
Fig. 3.71—Looking up stairs facing away from GZ (structure CAa). Note crack running up stairs and separation of construction joint.
