OPERATION  
**PLUMB BOB**

NEVADA TEST SITE  
MAY-OCTOBER 1957

Project 30.7

TEST OF GERMAN UNDERGROUND  
PERSONNEL SHELTERS

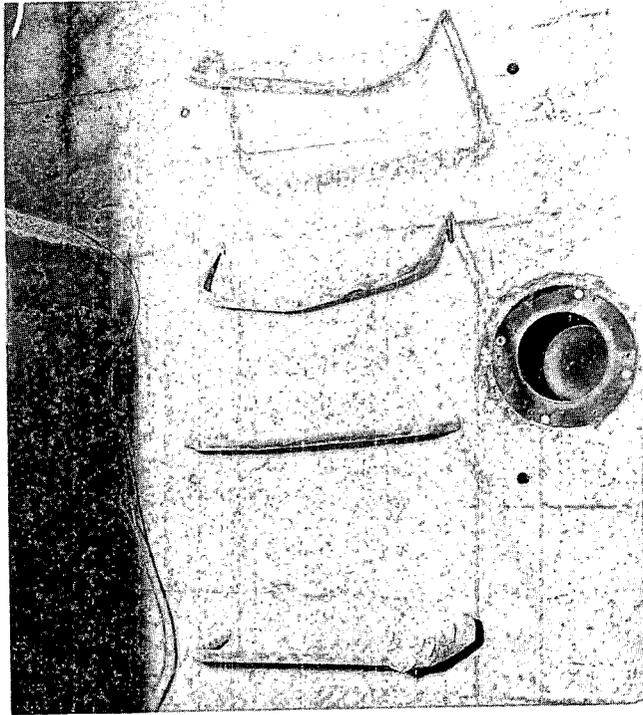
Fig. 3.78—Looking into emergency-exit shaft from chamber between small blast and gastight doors (structure CAb). Note climbing rungs deformed by blown-in match cover.

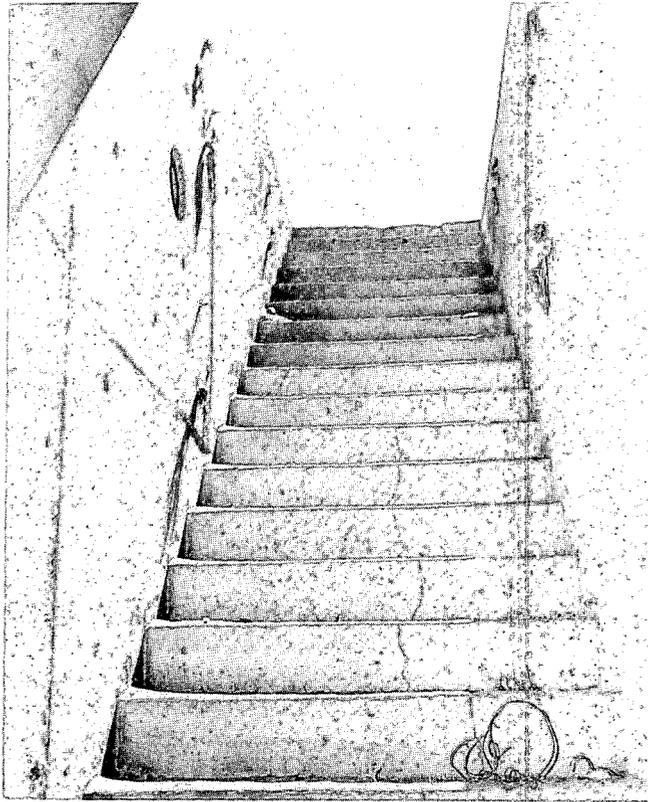
Fig. 3.80—Looking up stairs facing away from GZ (structure CAb). Note crack running up stairs.

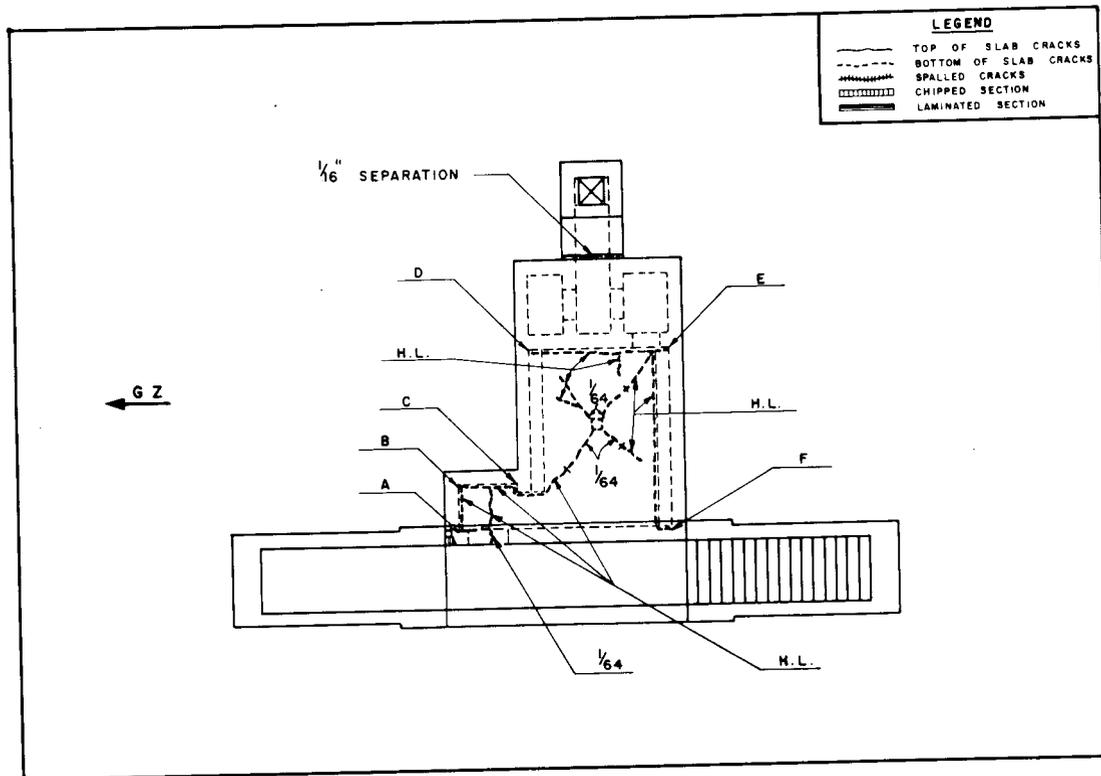
Fig. 3.82—Roof-slab crack pattern (structure RCa).

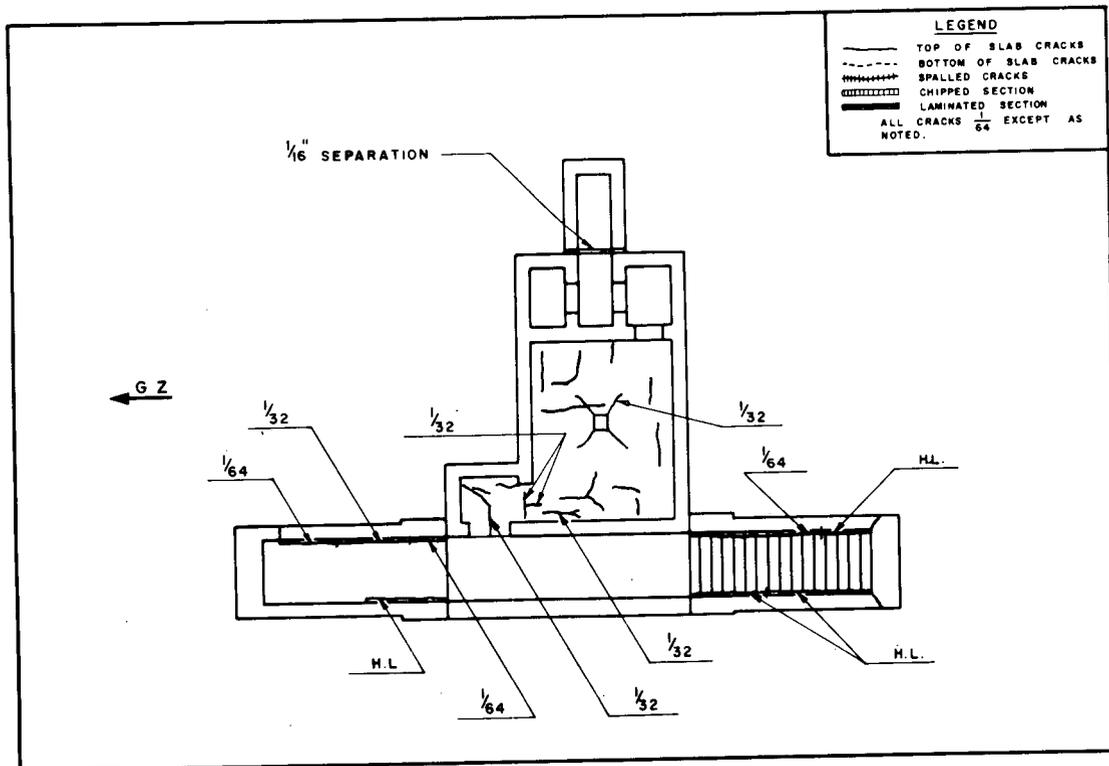
Fig. 3.83—Floor-slab crack pattern (structure RCa).

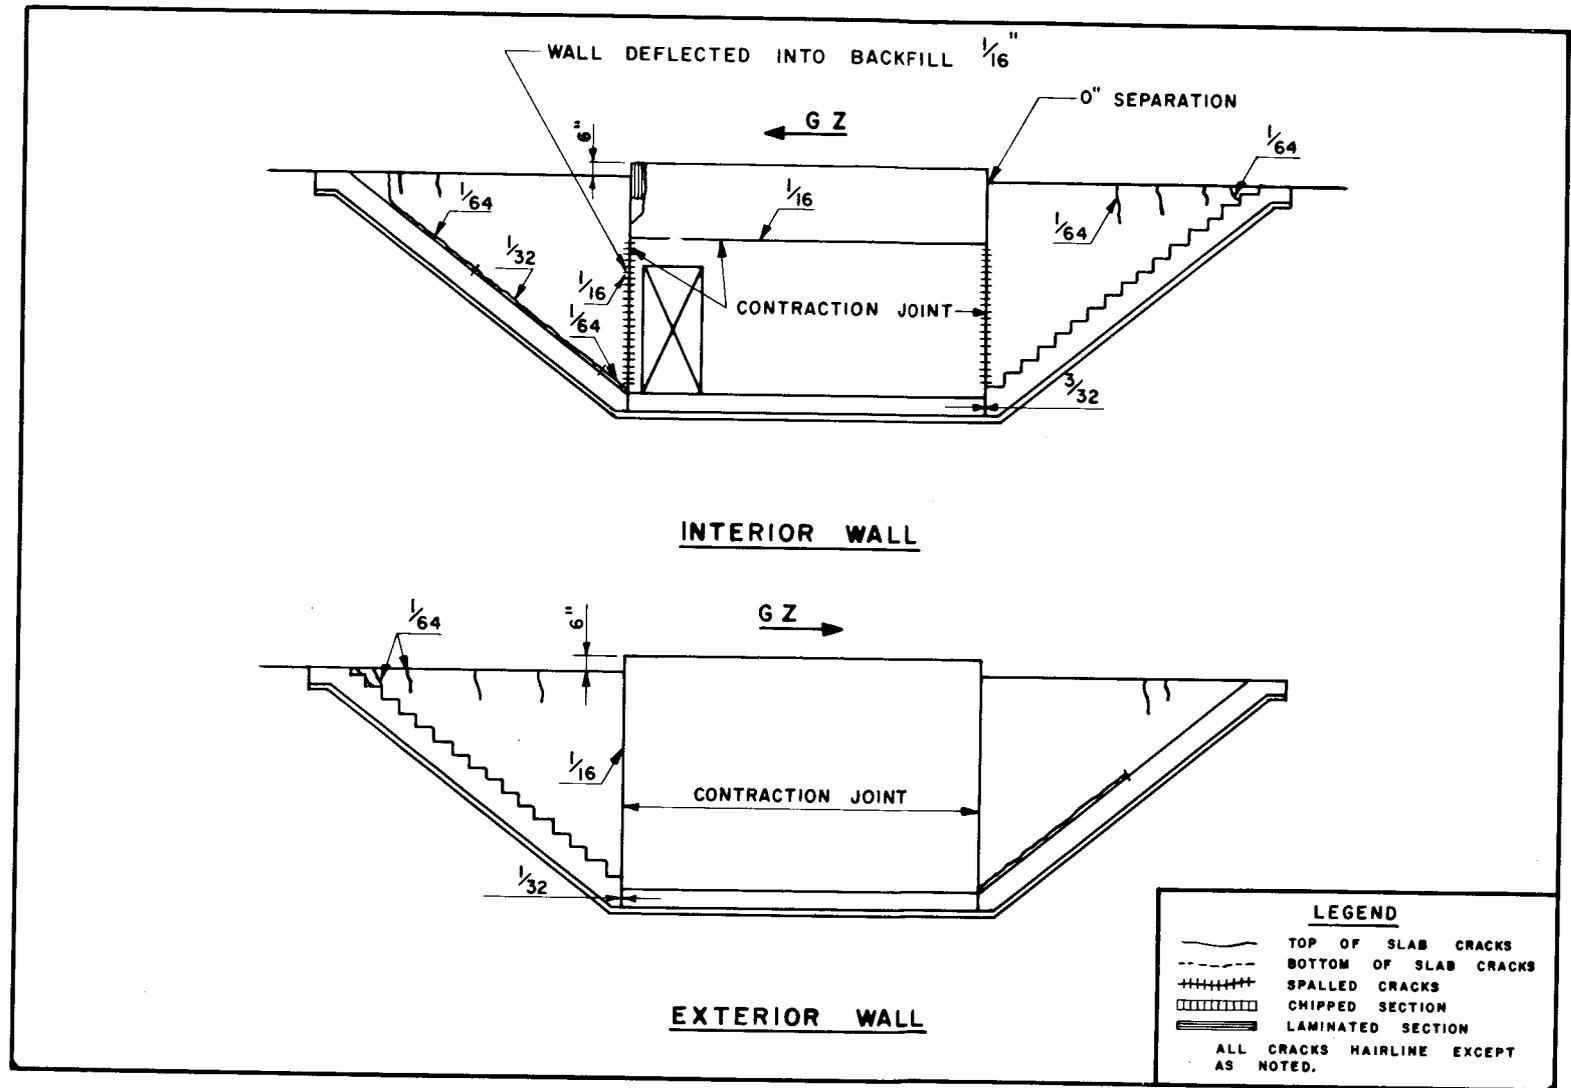
Fig. 3.84—Entrance crack pattern (structure RCa).

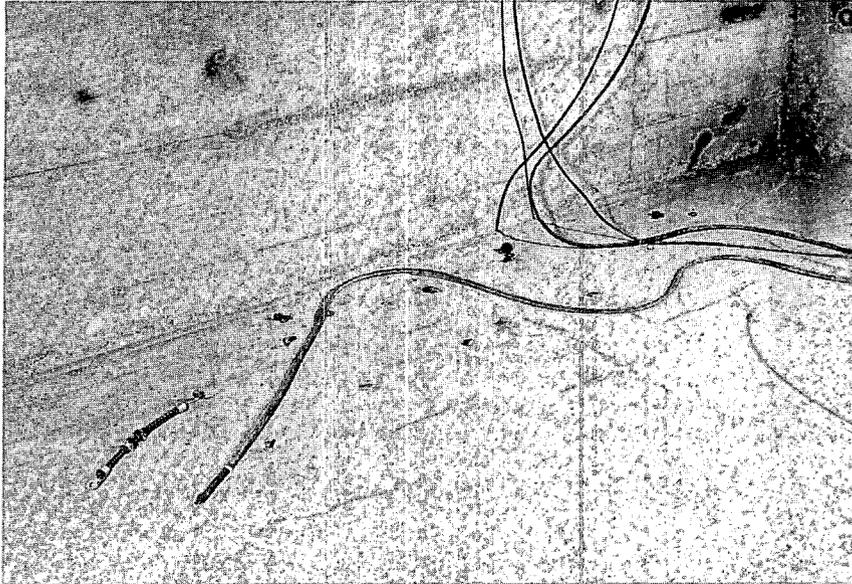
Fig. 3.85—Cracks in floor slab of main chamber looking toward emergency-exit corner of wall nearest GZ (structure RCa).

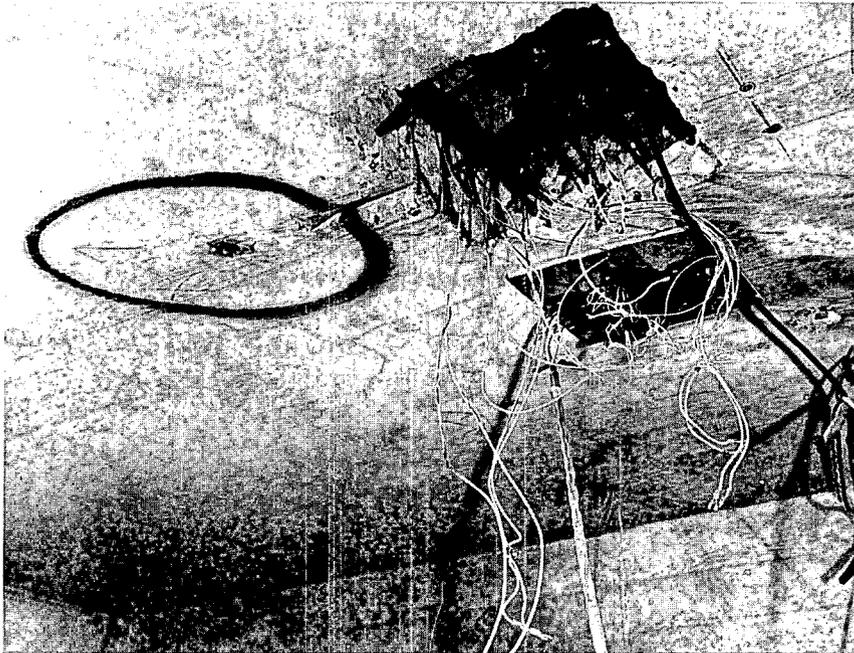
Fig. 3.86—Cracks in roof slab of main chamber, looking toward emergency-exit end of wall facing away from GZ (structure RCa).

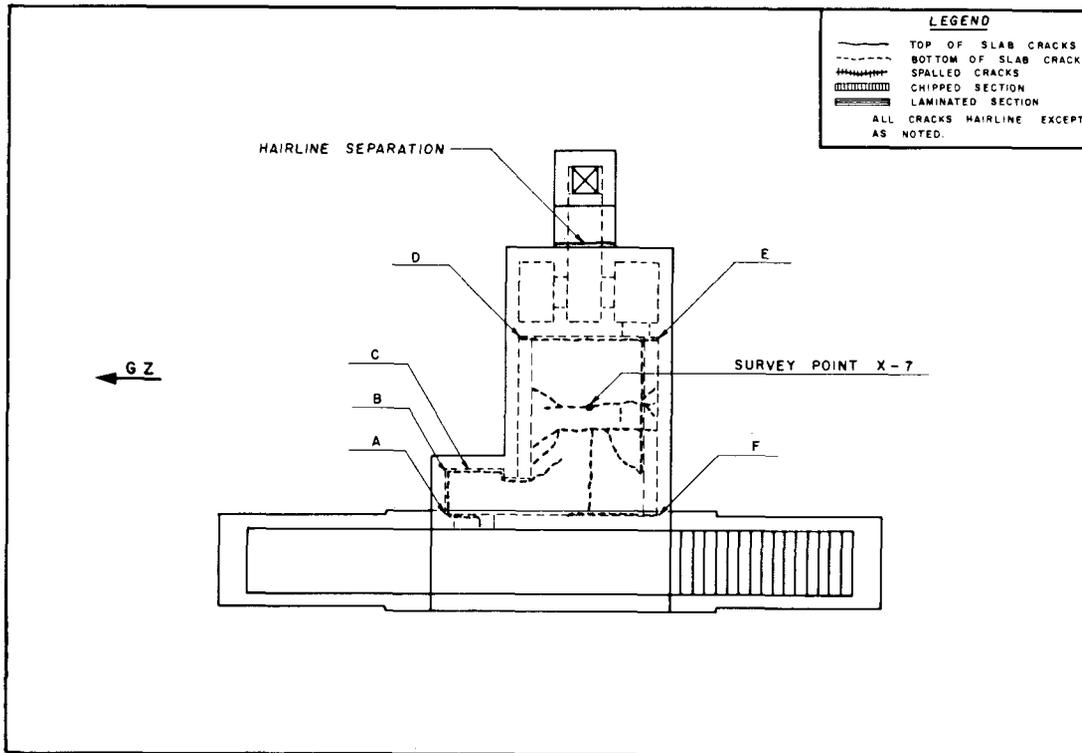
Fig. 3.92—Roof-slab crack pattern (structure RCb).

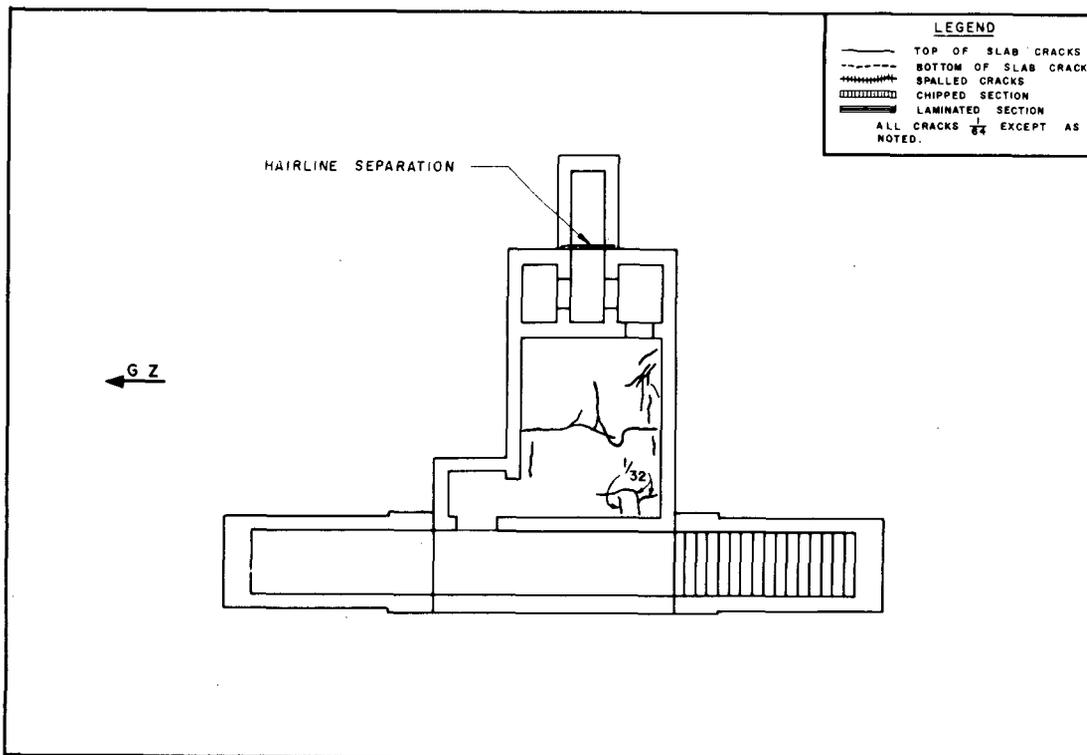
Fig. 3.93—Floor-slab crack pattern (structure RCb).

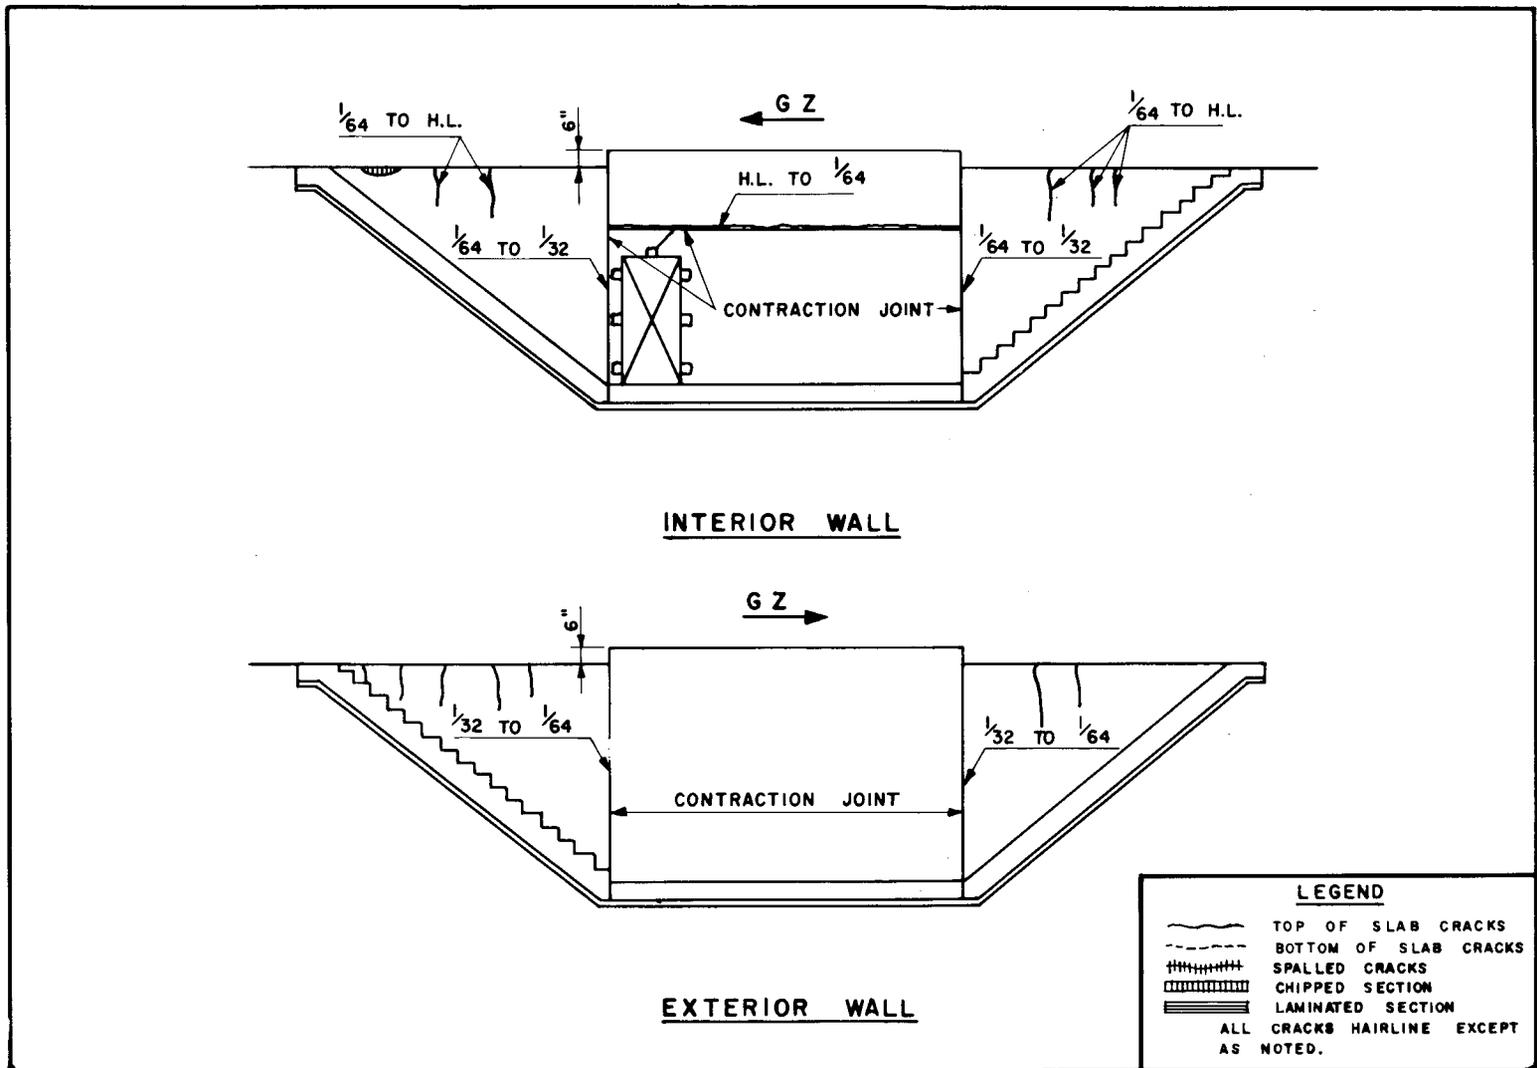
Fig. 3.94—Entrance crack pattern (structure RCb).

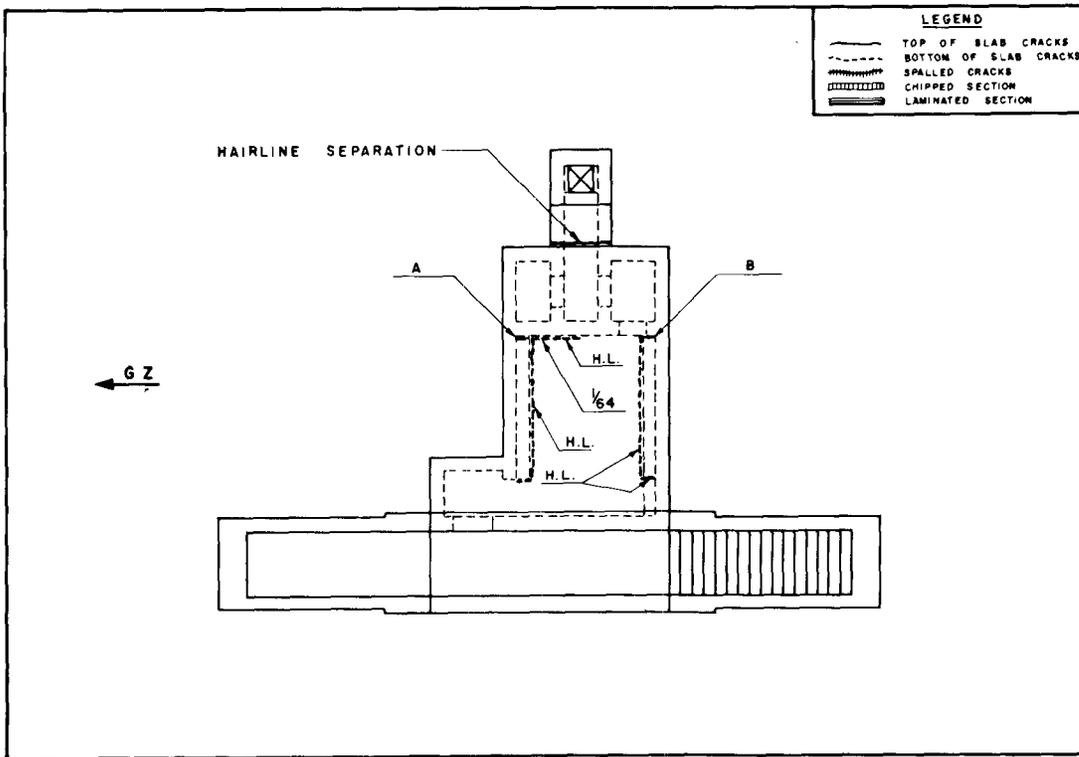
Fig. 3.99—Roof-slab crack pattern (structure RCc).

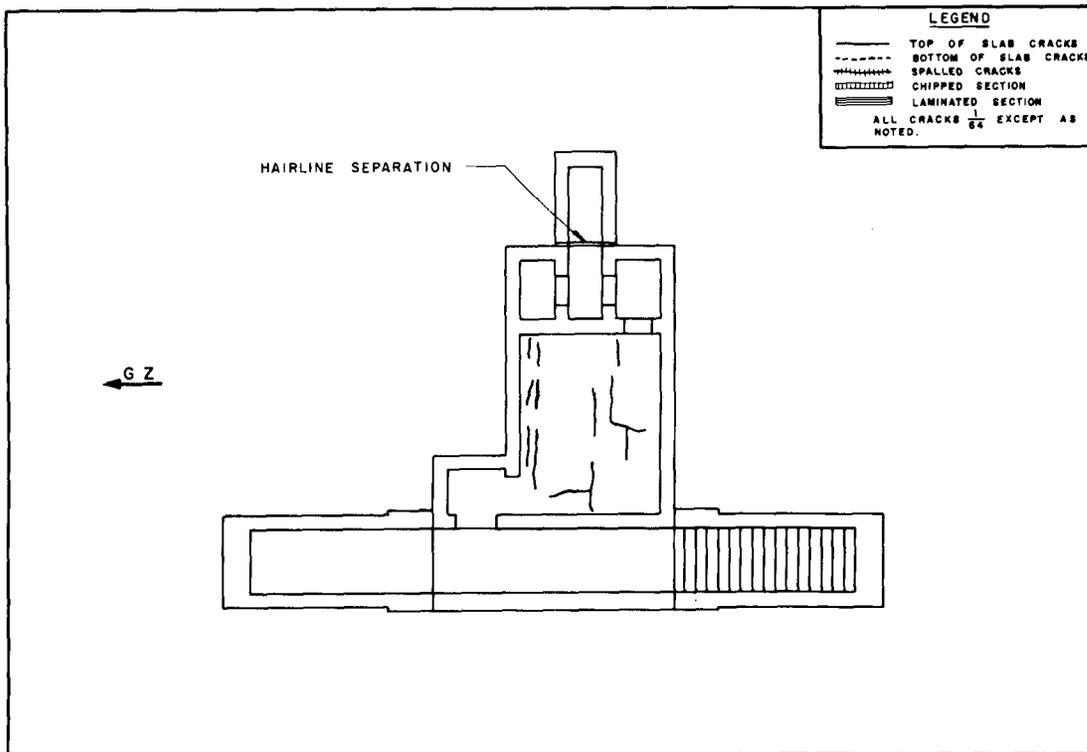
Fig. 3.100—Floor-slab crack pattern (structure RCc).

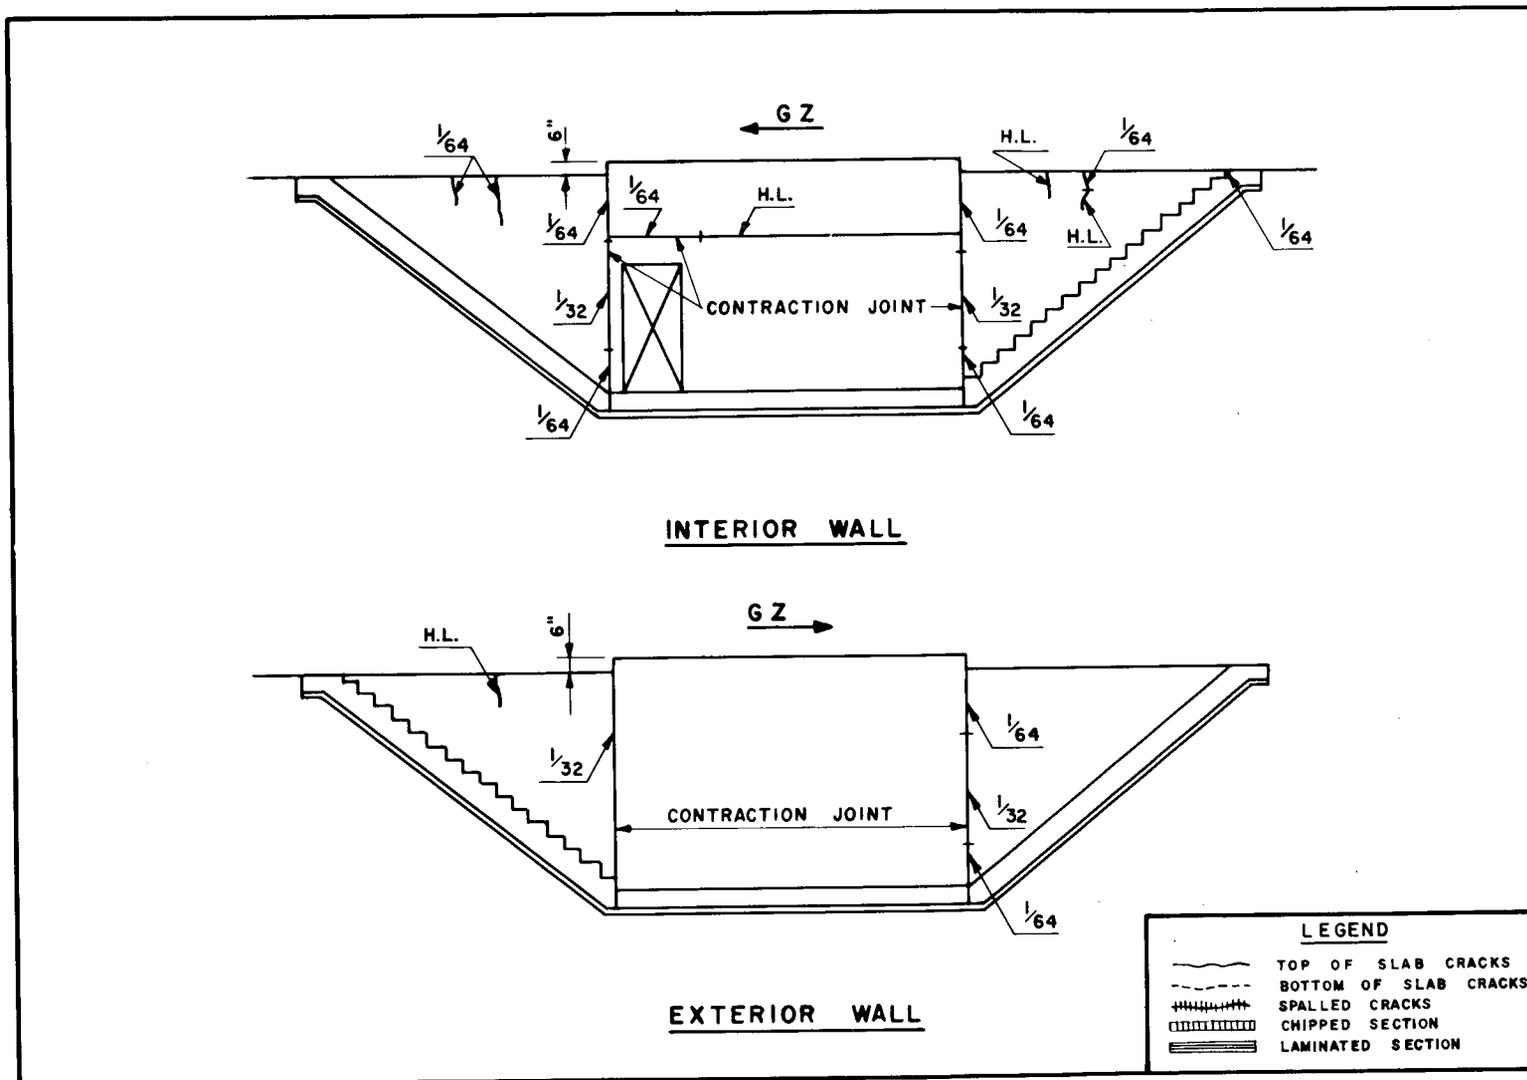
Fig. 3.101—Entrance crack pattern (structure RCc).
