Report IDO-19308

INTERNATIONAL ATOMIC ENERGY
AGENCY SYMPOSIUM ON REACTOR
SAFETY

**SOME
ASPECTS
OF THE
WTR & SL - I
ACCIDENTS**

SOME ASPECTS OF THE WTR AND SL-1 ACCIDENTS

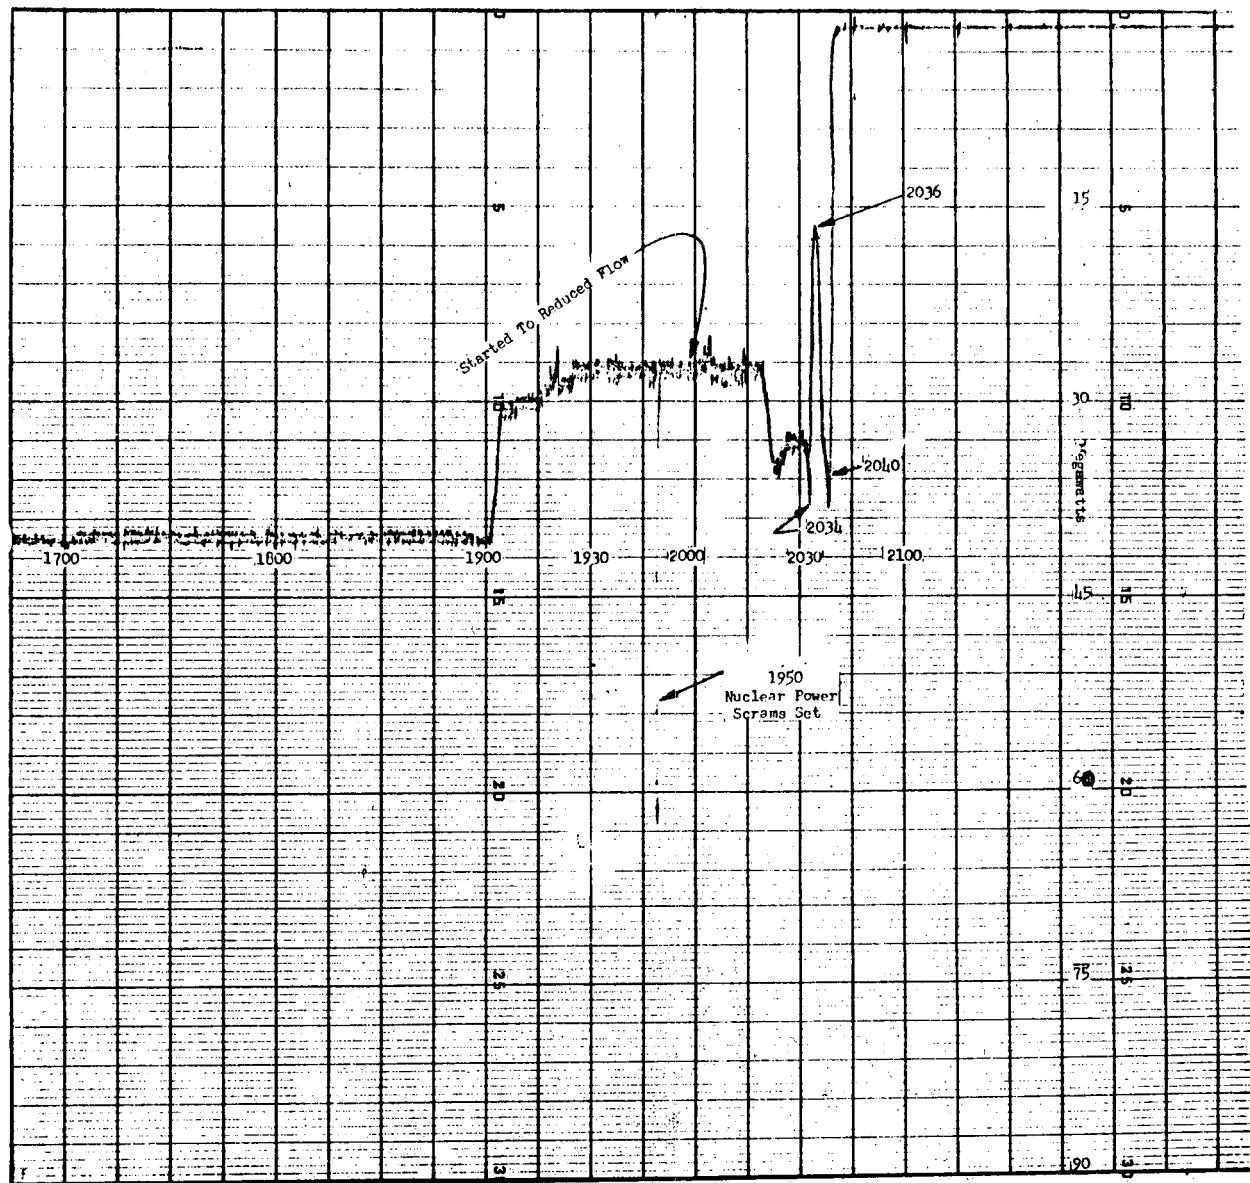
Figure 4 WTR Neutron Power Level Recorder Chart
Night of April 3, 1960

recording of power levels observed is shown on Figure 4. At 8:33 p.m. the power demand was adjusted to raise the power to 40 MW. At 8:35 p.m. the power level began to drop rapidly, going down to 17 MW over a period of about two minutes for no apparent reason. During this period, the control rod on automatic control withdrew to its upper limit. The other control rods were withdrawn on manual control in order to maintain power, and on reaching approximately 17 MW, power level started to increase on approximately a 60-second period or greater. The power returned to approximately 38 MW. At 8:40 p.m. the radiation detector monitoring the demineralized water supply alarmed. This was followed by further alarms from other radiation monitors within a minute. Power was lowered to 15 MW and at 8:44 p.m. the reactor was scrammed manually as radiation levels continued to rise.

The power reduction, shown in Figure 4 is believed to have occurred as a result of a decrease in reactivity caused by the fuel element failure meltdown and subsequent blockage of the coolant channels. Production of steam and bulk boiling in the blocked element voided the water channels. It was calculated that reactivity loss by voiding the water channels and possibly by the loss of a small amount of fuel

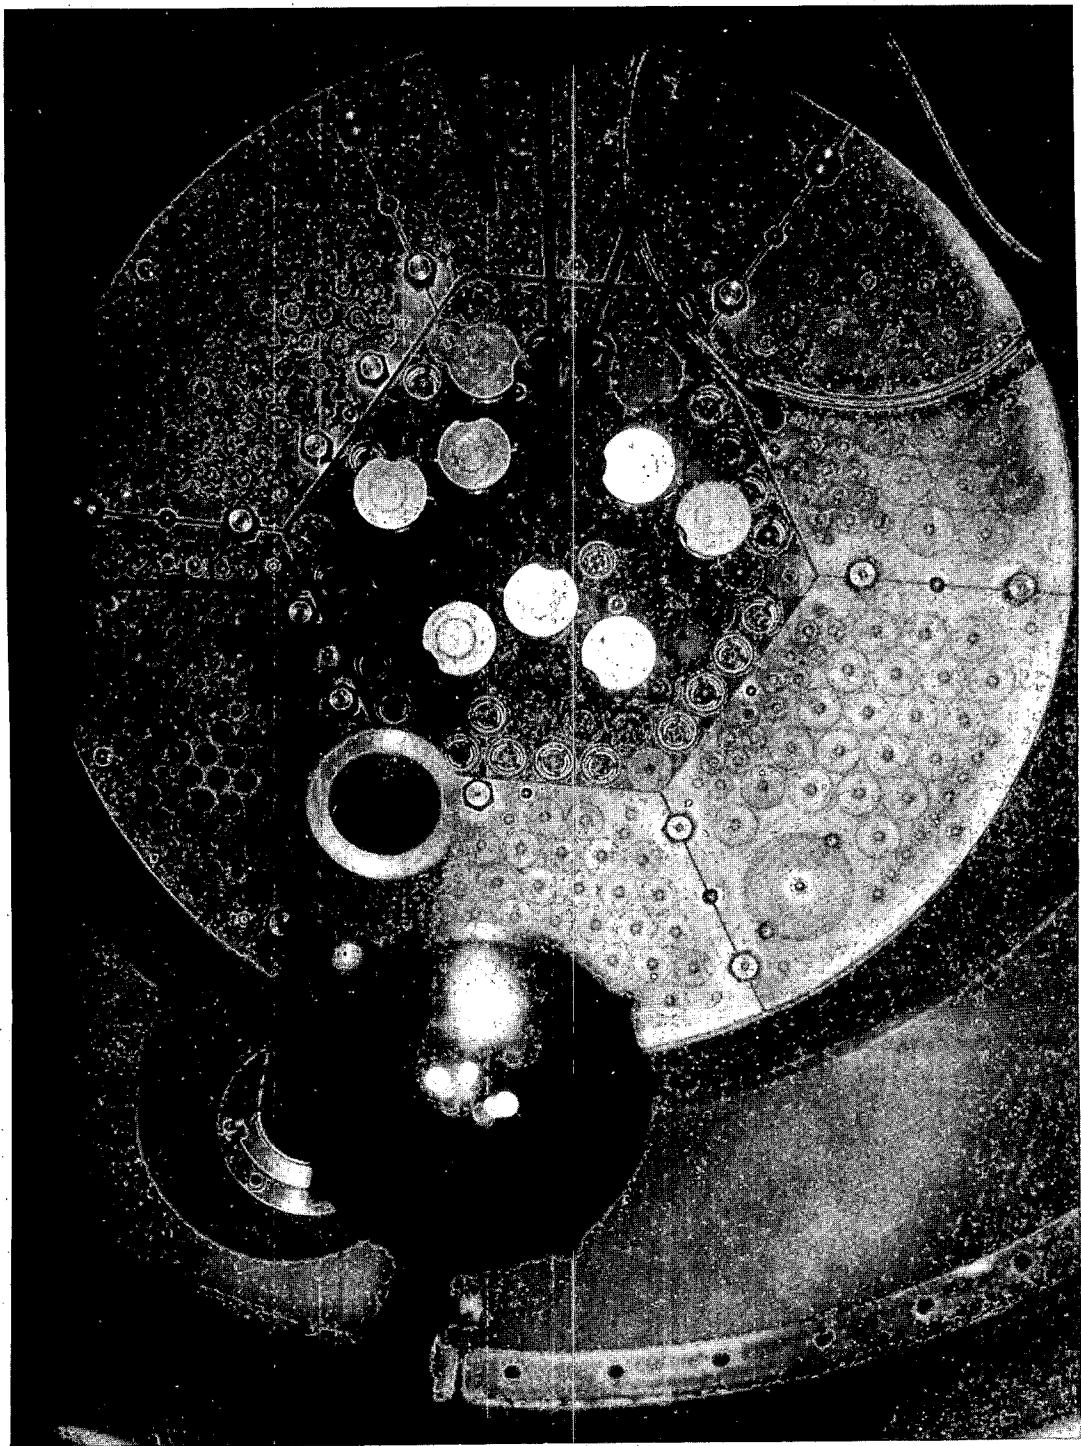
Figure 6 View of WTR Core - April 11, 1960

the core and to begin unloading the core. On April 11, the head was removed. Figure 6 shows a photograph of the core taken on this date. No visible damage was apparent at this time.

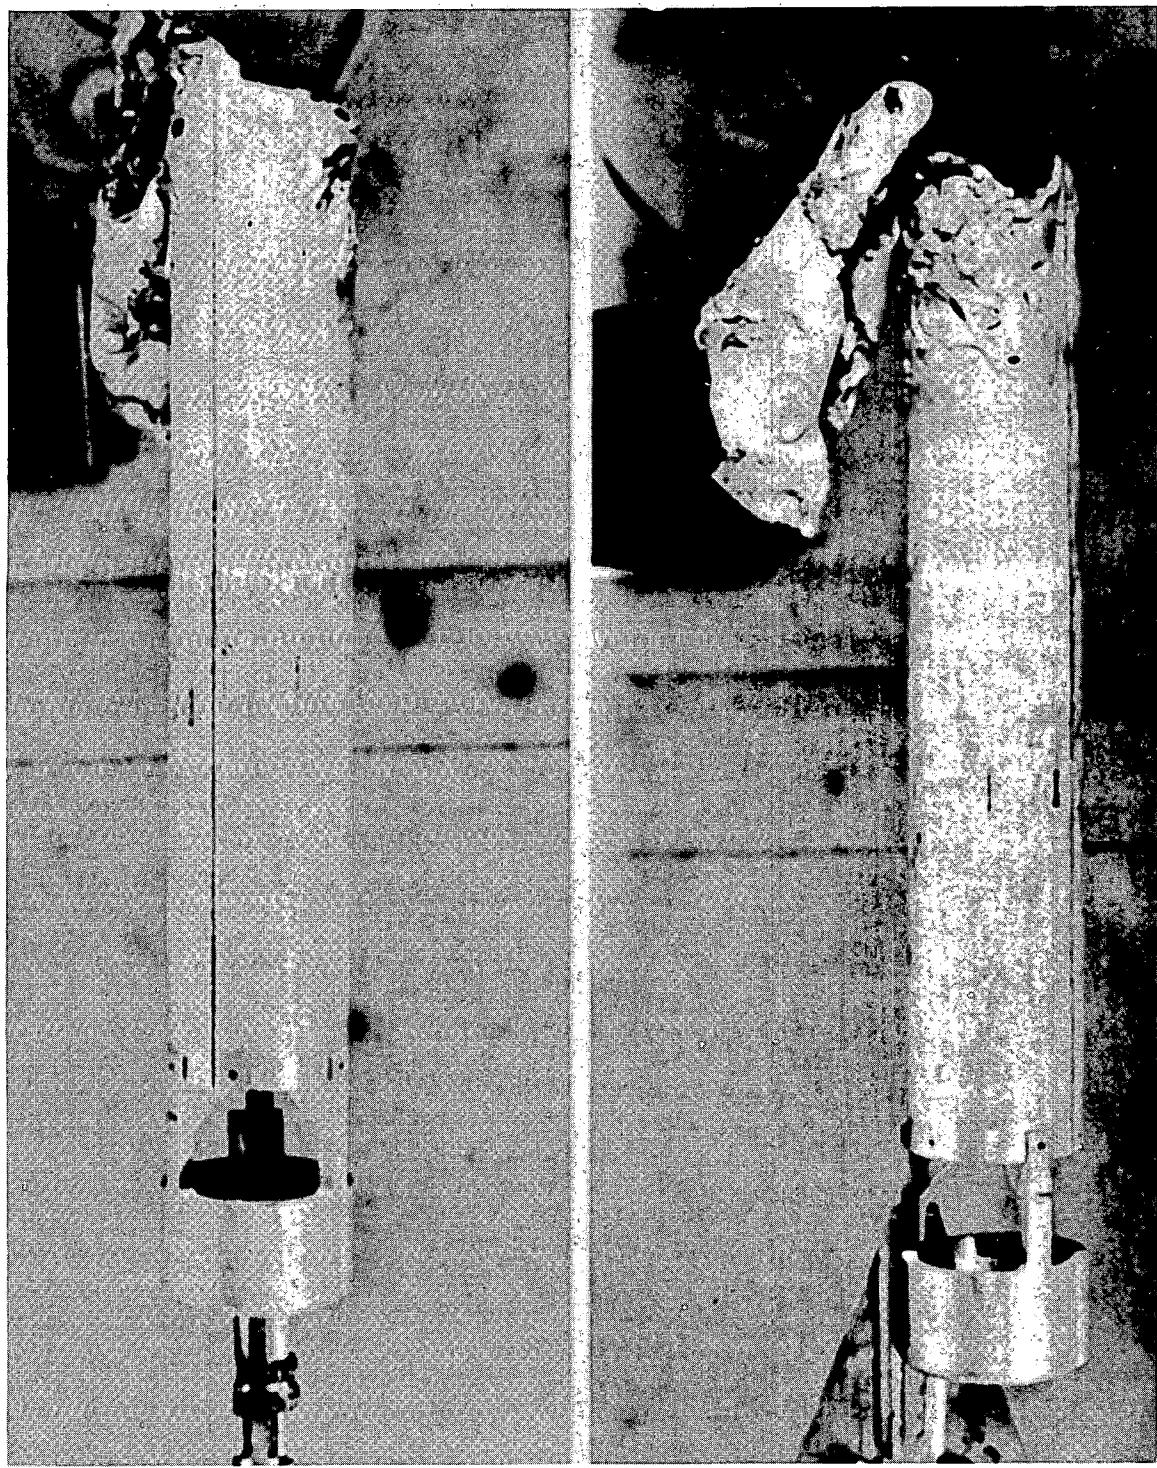
Upon examination, all fuel elements thus removed from the core appeared discolored but without apparent physical damage. The stuck element was finally removed by a 500 pound force and only the upper third of the element came loose (Figure 7). The bottom end of the shroud tube appeared to be solidly plugged. Finally by using a specially fabricated core drill, the final portion of the damaged element was removed. A visual examination of the shroud holes and a later check with a sizing tool indicated that the core structure had not been damaged.

Visual observations of the failed fuel element disclosed some evidence of poor bonding; hence a program was instituted to reinspect the unused cold fuel elements on hand. A mechanical inspection of these elements disclosed many small deviations from specifications and a few elements with serious bows in the tubes or with visible blisters. An ultrasonic inspection revealed dozens of imperfections (Figure 8). The defects ranged in size from a few thousandths of an inch to greater than 1 inch in diameter.

Figure 7 Damaged WTR Fuel Element

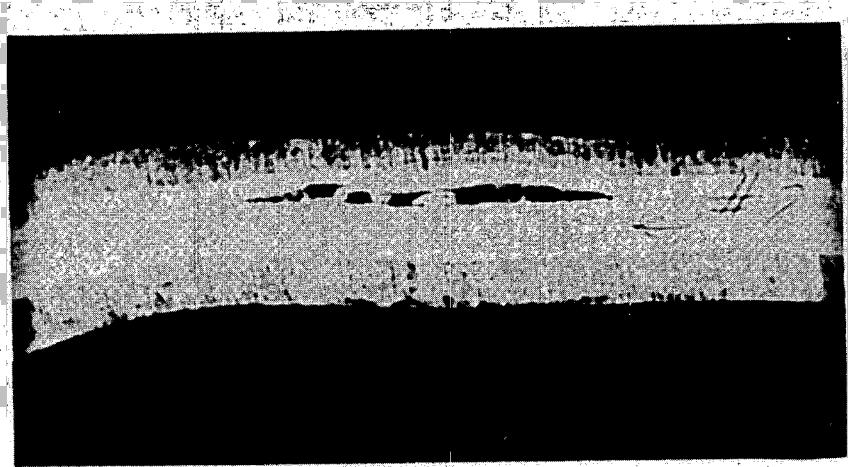
Figure 8 WTR-Typical Ultrasonic Trace with Defect Photo

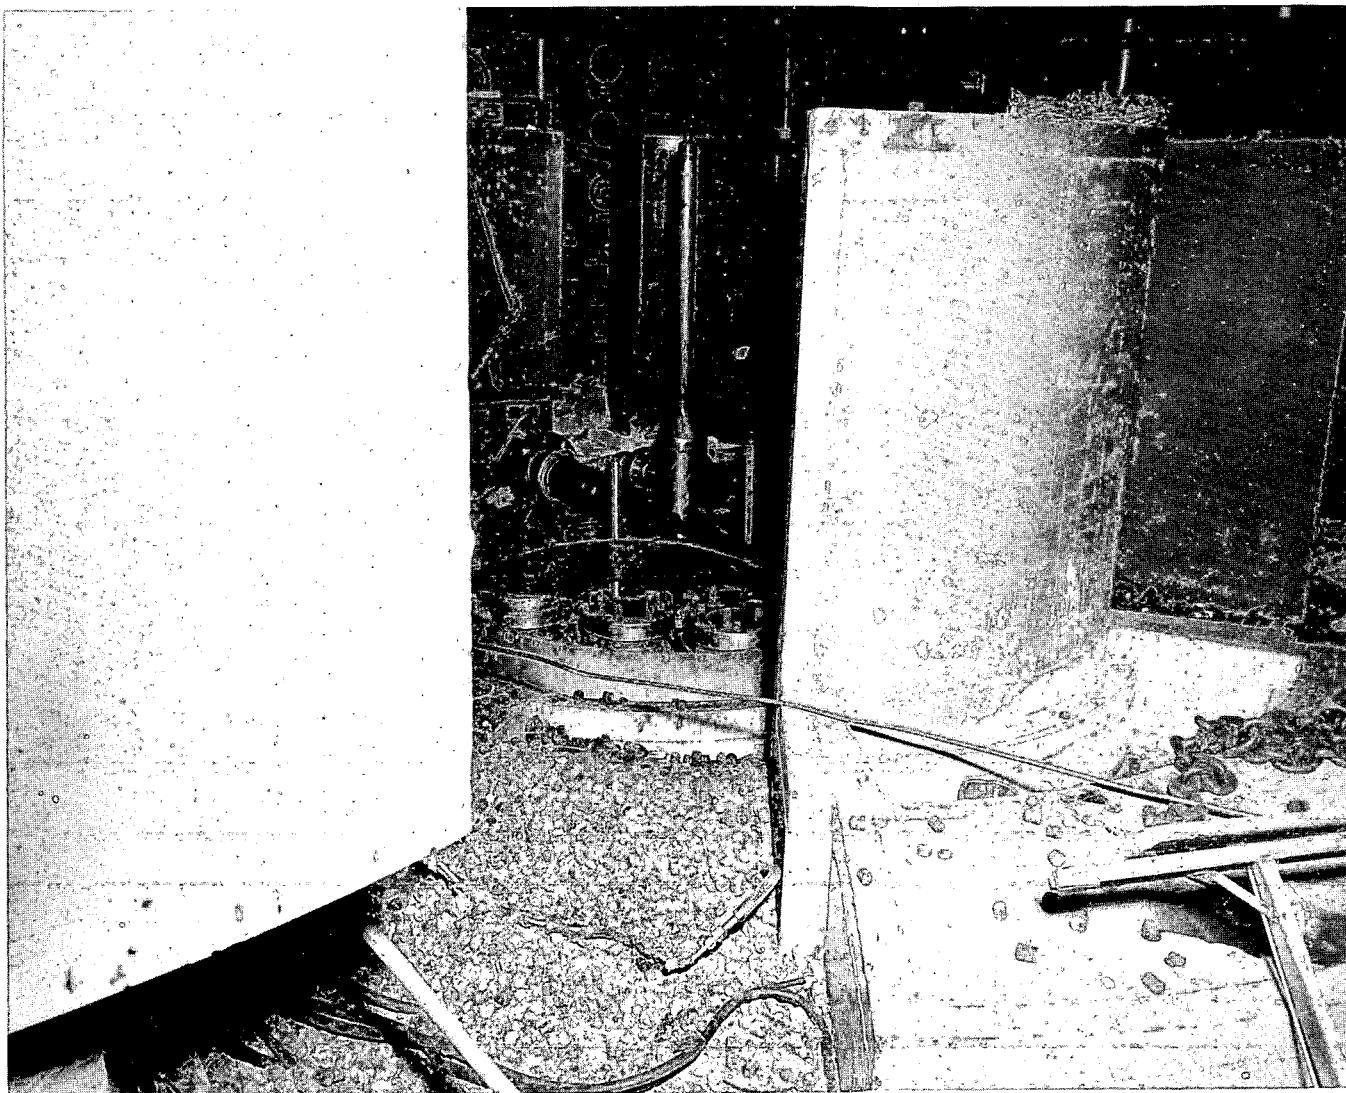
Other photographs taken during this phase of operation indicate physical damage, other than to the pressure vessel and core, was confined to the area directly above the reactor. Tools lying on the shielding blocks were essentially unmoved and only one light located directly above the reactor head was broken.

Figure 17 View of SL-1 Reactor Head Area After Accident

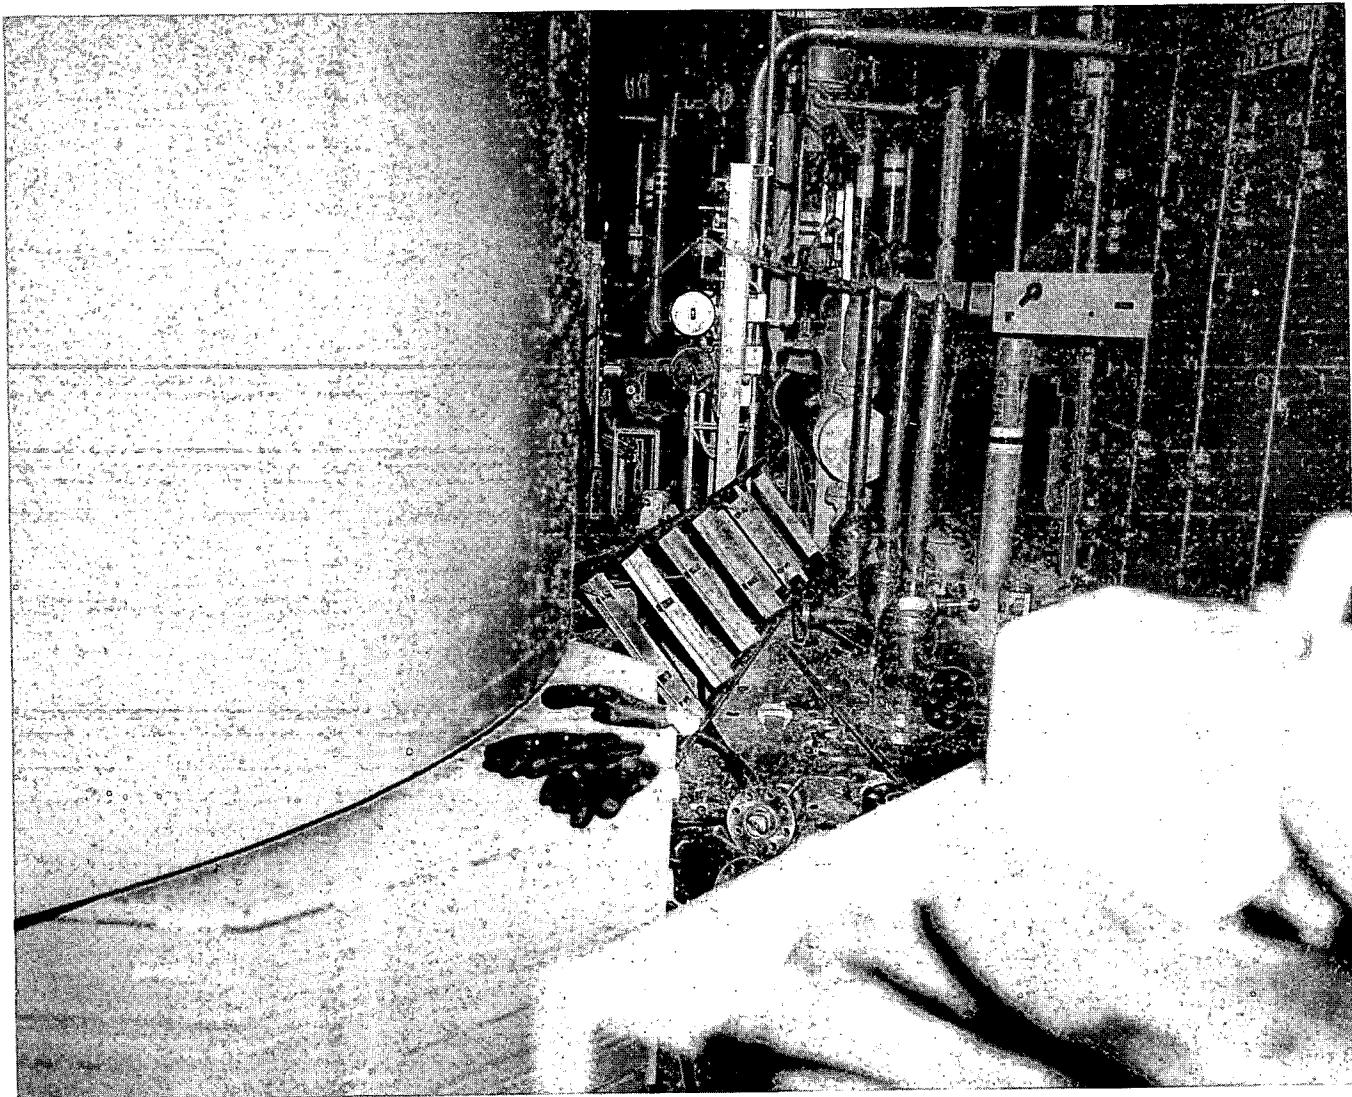
Figure 18 View of SL-1 Reactor Room After Accident

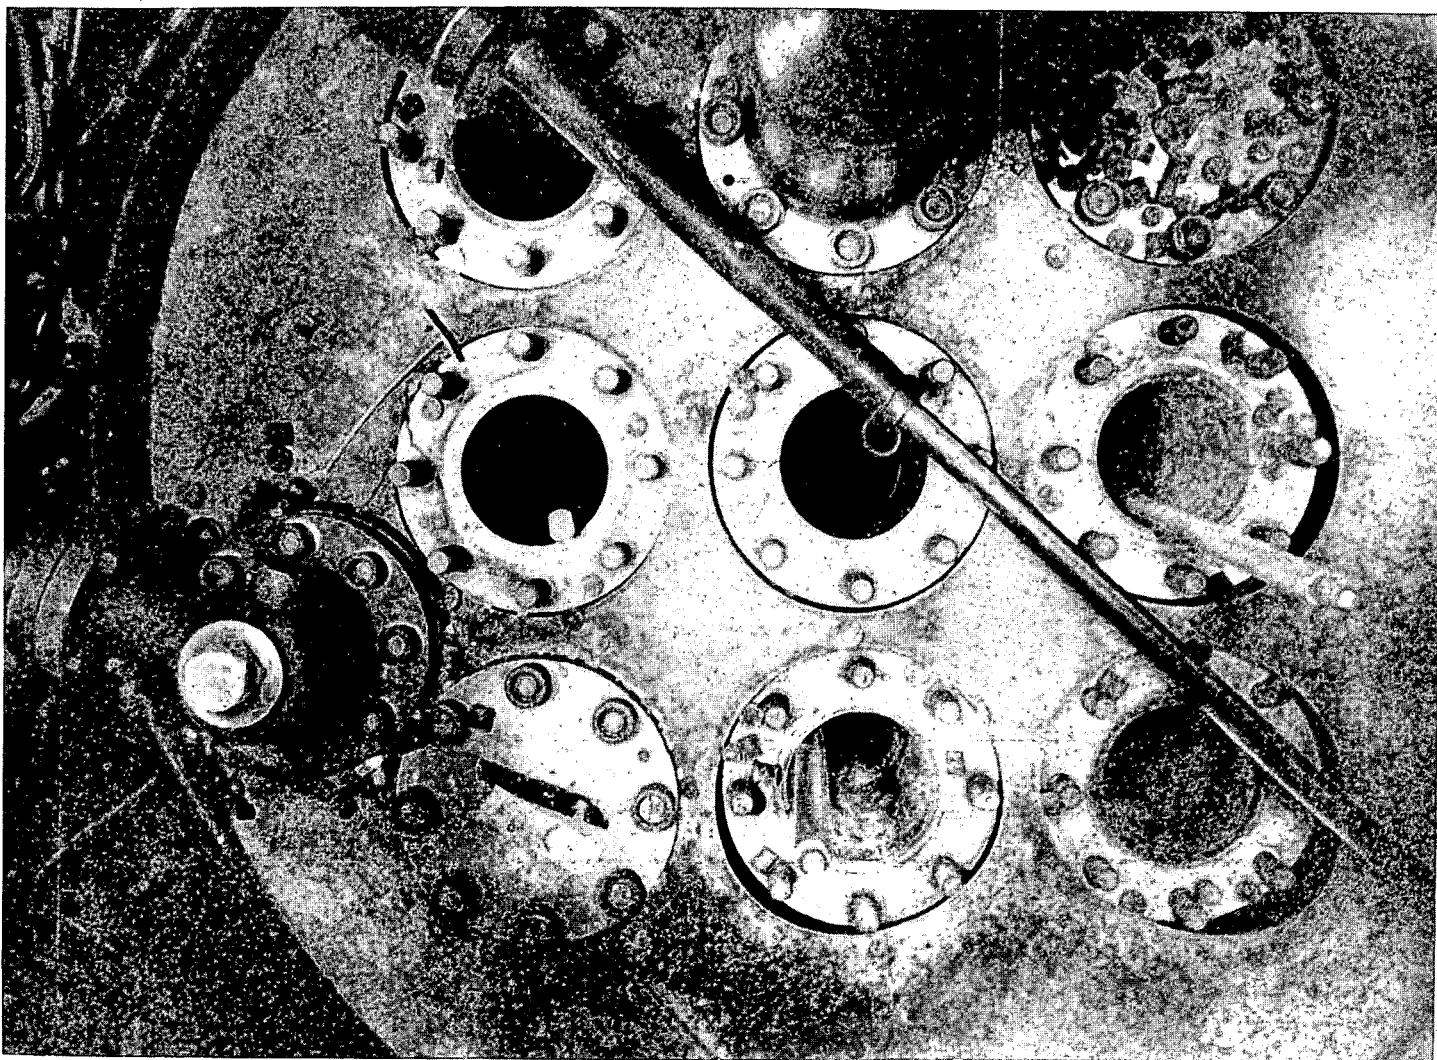
Figure 27, a frame from the first movies taken directly over the reactor head, indicated that six nozzles were open to the atmosphere and that nozzle No. 8 appeared to be free of any obstructions. Hence most of the remote penetrations into the pressure vessel were made through No. 8. Although the television shots were not too clear, valuable information was obtained as to the condition of the core. Photographs taken of the core using a Minox miniature camera added significantly to our knowledge of the condition of the core (Figure 28).

Figure 27 View of SL-1 Reactor Vessel Head After Incident

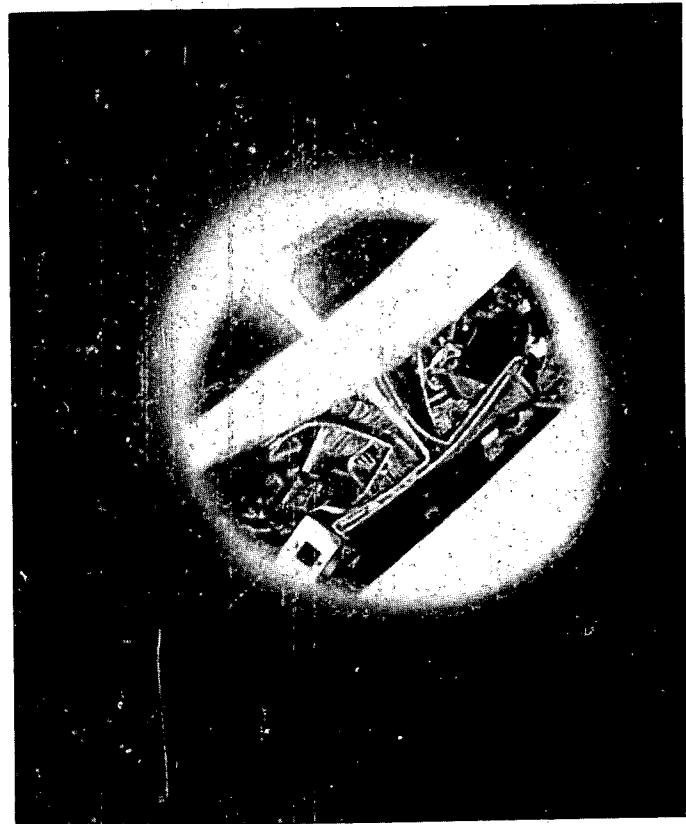
**Figure 28 Photographic Evidence of Chemical Probe Penetrating
Core Structure Through Control Rod Shroud No. 8**

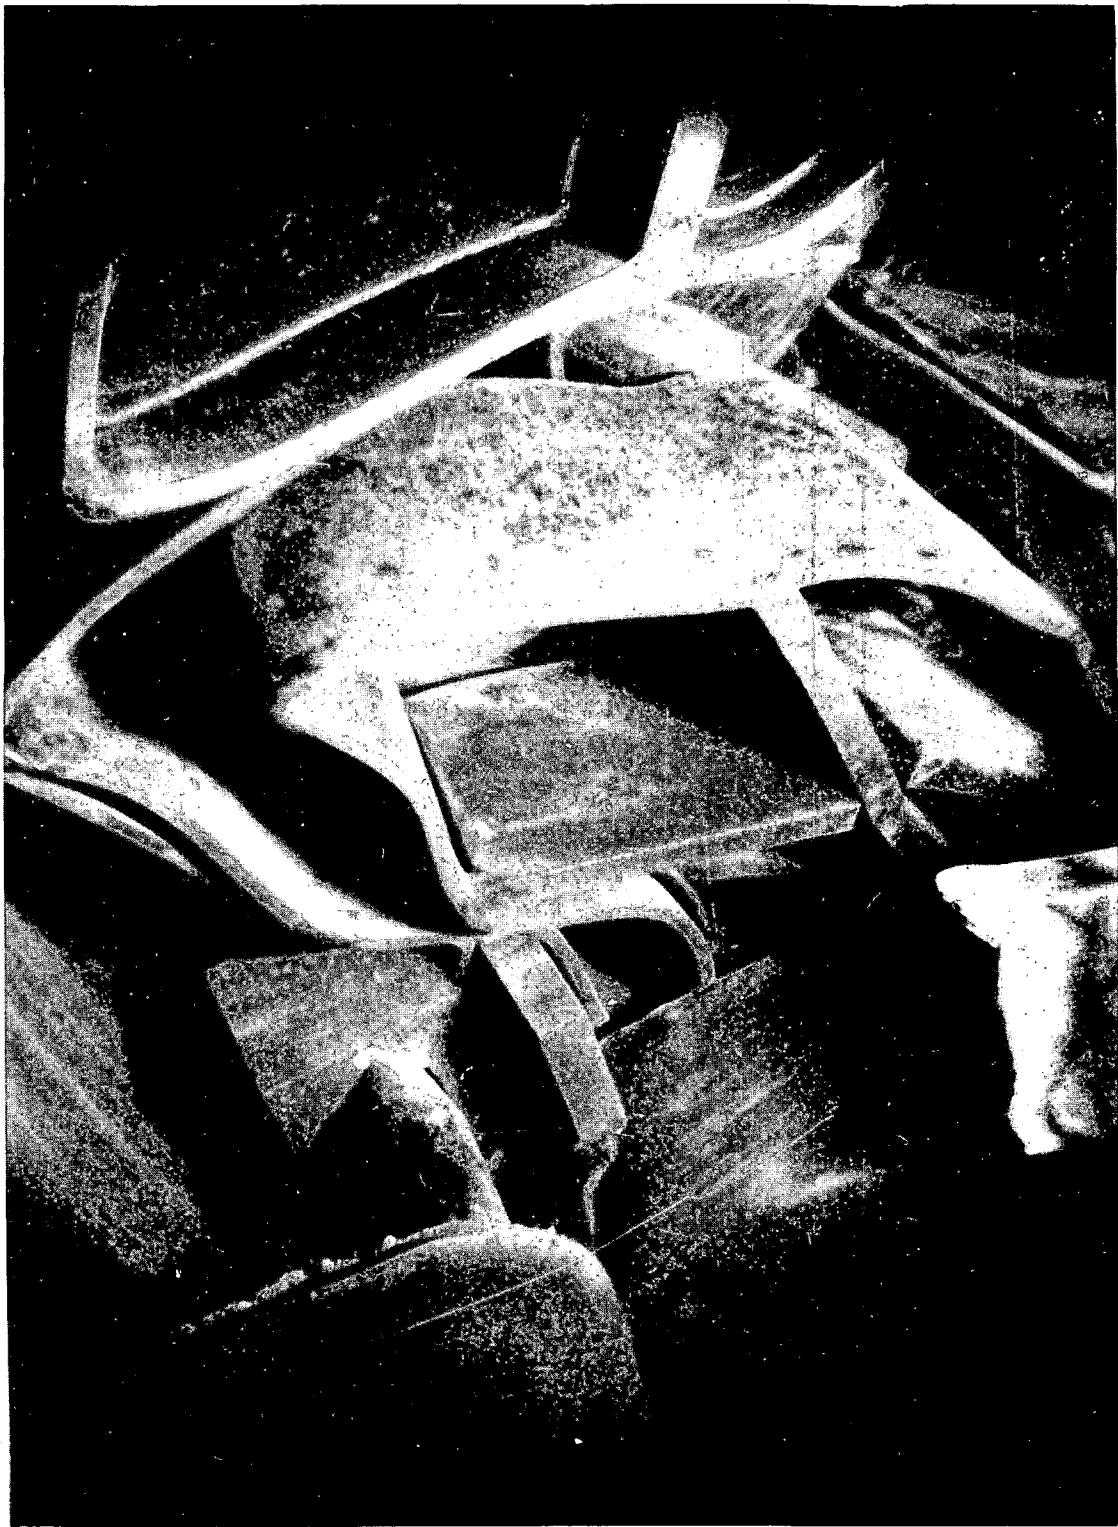
**Figure 31 Underside of Core Showing Location Where Core
Has Been Lifted from Support Bracket**

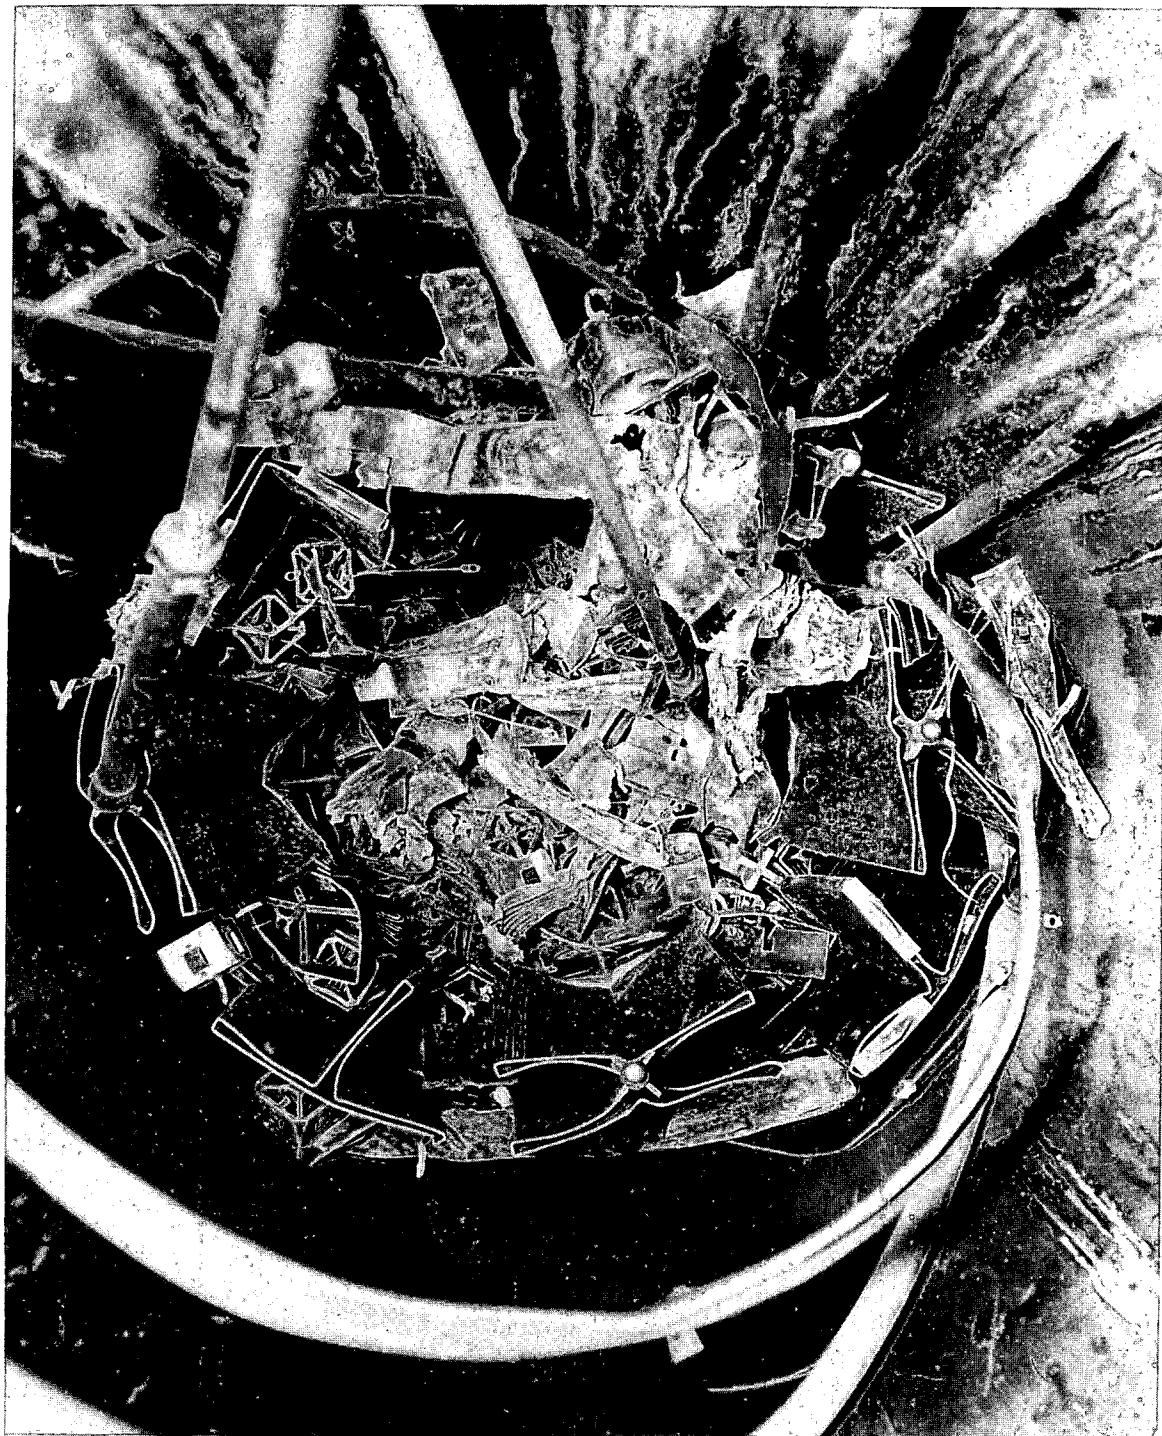
In January 1962, preliminary hot cell examination of the pressure vessel and core disclosed that the vessel was not ruptured but was bulged about 4 inches in diameter just below the head flange and was bulged about 1 inch above and below the core (Figure 33). The reactor head nozzles were also found to be bulged. The pressure vessel flange was so distorted that the head could not be raised off the head bolts after the nuts had been removed. It was necessary to force the head upward using wedges. After the reactor head was removed, it was clear that the central rod, within its own shroud, was entirely out of and above the core. The rod with shroud was lying approximately 45 degrees to the horizontal across the top of the core (Figure 34). When the central rod and shroud were removed, it was quite evident that the center of the core suffered severe melting and destruction (Figure 35).

Figure 35 View of Core After the No. 9 Shroud was Removed

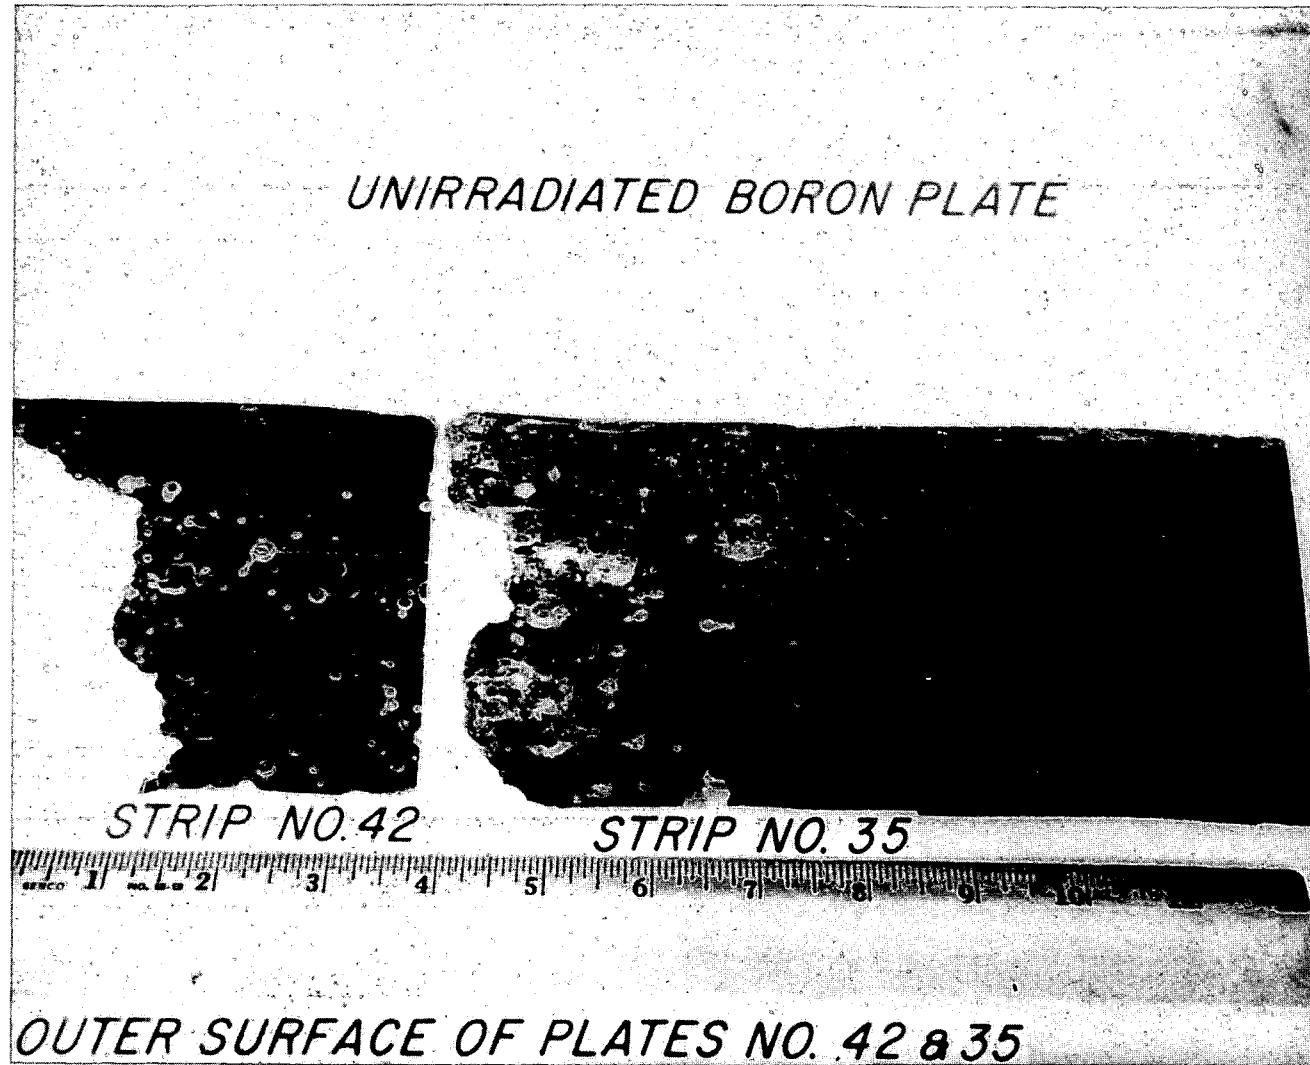
In the operation of the SL-1 reactor, there had been considerable concern that swelling of the aluminum fuel elements might occur as a function of irradiation damage. A schedule for the removal and inspection of selected fuel elements was established to check for fuel element swelling. During such an inspection in August 1959, the aluminum fuel elements were in good condition, but there were indications that the boron strips were bowing. During a similar inspection in August 1960, the boron strips had bowed between the weld joints and had wedged the elements tightly together. Much force was required to remove one of the center fuel elements. On one element it was found that boron side strips had bowed up to 170 mils between the welds. This element, photographed under water above the core, is shown in Figure 36. On another element, both the half length and full length boron strips were missing when removed. Portions of these strips plus a loose boron strip from an adjacent fuel element were subsequently recovered from the core. The appearance of these strips, in comparison with an unirradiated strip, is shown in Figure 37.

Figure 37 Comparison of Remaining Pieces of Boron-Aluminum
Strips with Unirradiated Strip - August 1960

In September and October 1960, an experimental and analytical program was conducted to investigate the reactivity gain and the corrosion of the burnable poison. As a result, additional shutdown margin was provided by the addition of 60 mil cadmium strips in two of the T slots. It was estimated that this increased the shutdown capability of the reactor by approximately 1 percent reactivity.

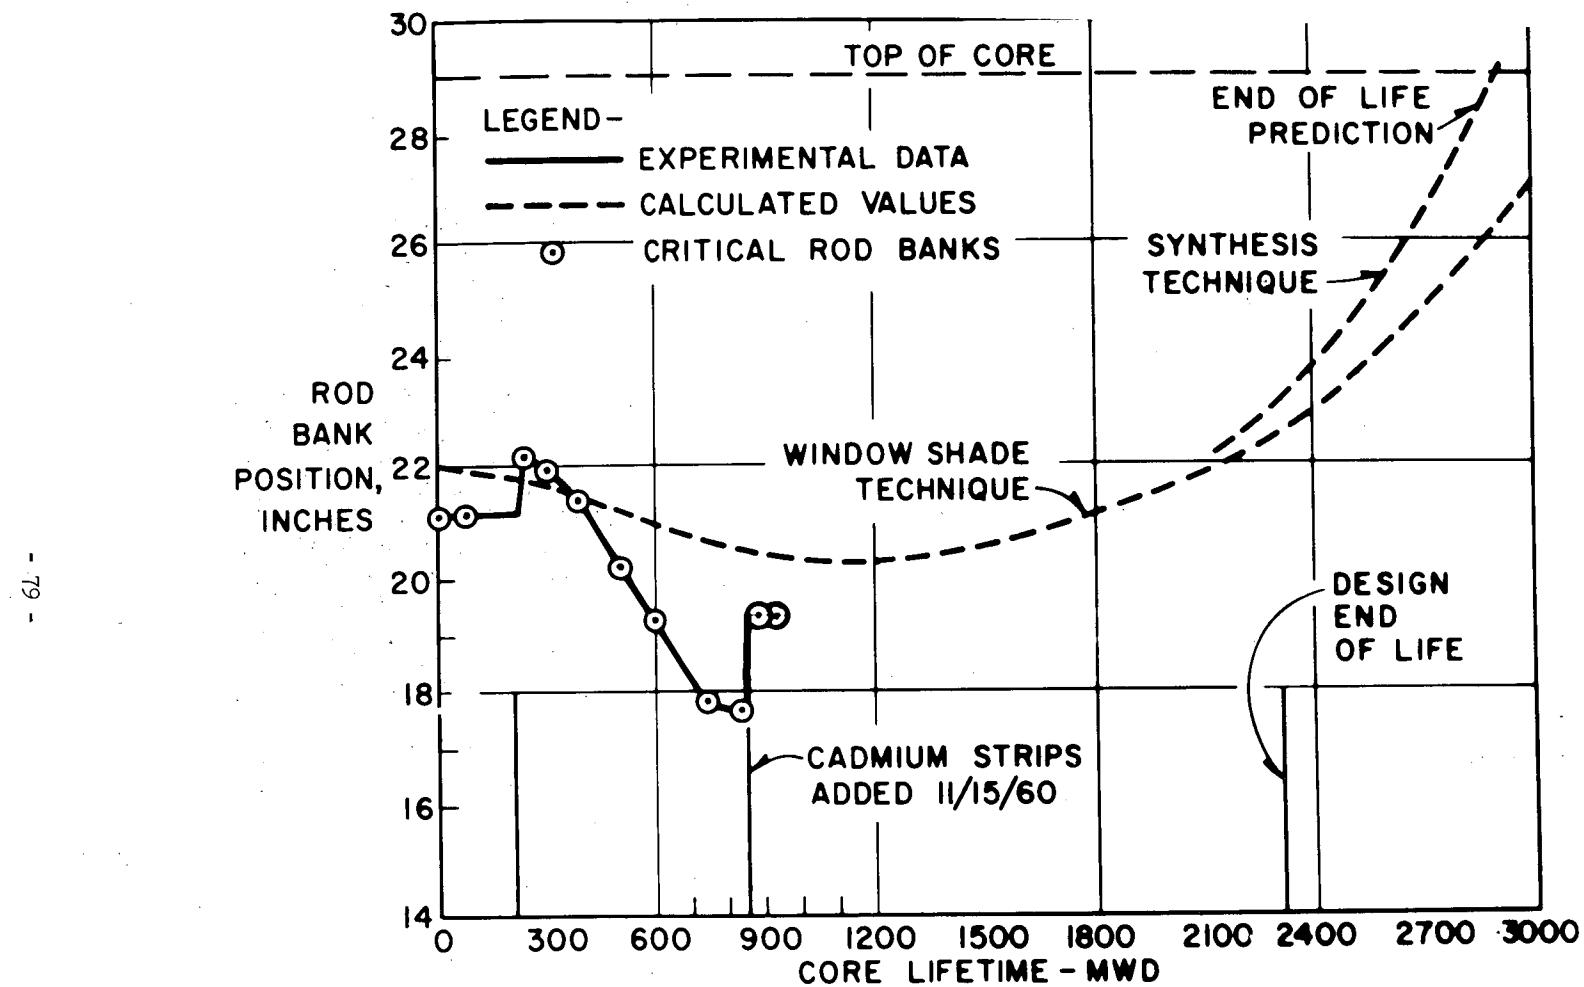
Figure 38 Critical Rod Bank Position with Equilibrium
Xenon Concentration at 2.56 MW

Prior to finding the corroded boron strips, it was noted that the operating rod positions were deviating from those that had been predicted analytically by the window shade technique (Figure 38). It has been calculated that over the core life the rod bank positions would first move in, then level off, then move out. Actually, the bank positions were moving in but at a faster rate than expected, indicating a more rapid gain of reactivity than expected. This could have been caused by the loss of some of the boron.

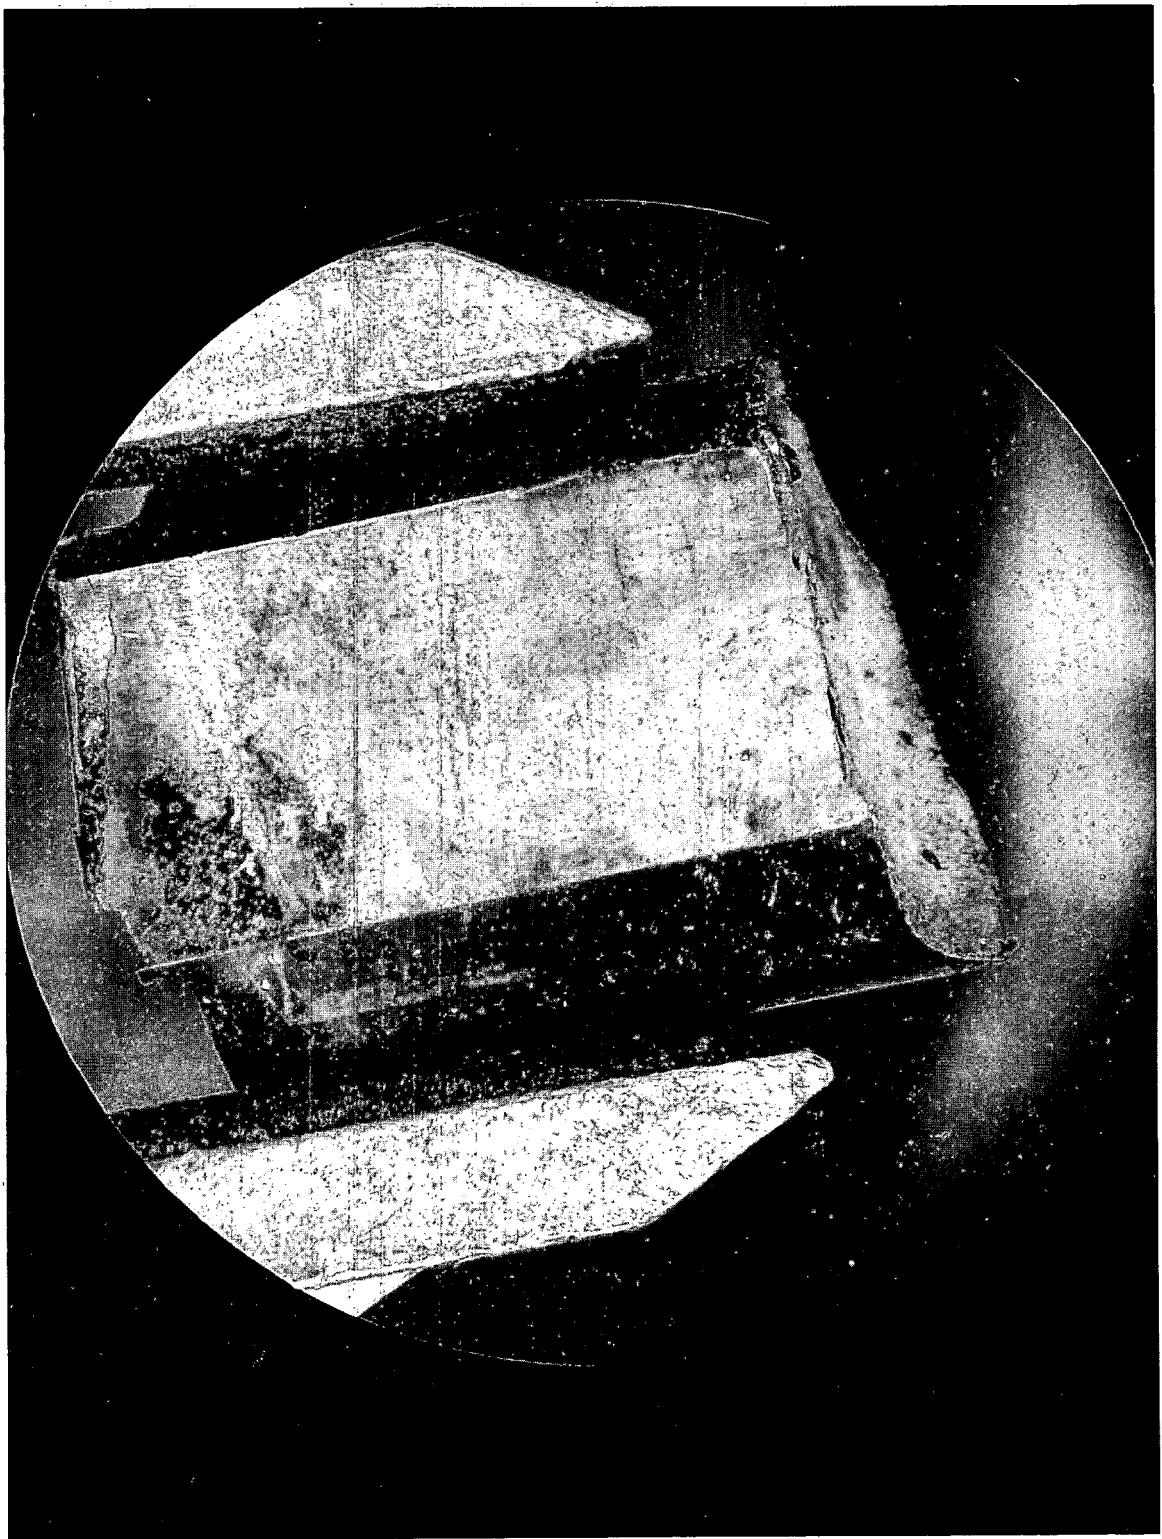
The use of 17-4 PH steel in the fabrication of some of the SL-1 control rod drive components was consistent with the state-of-the-art at the time. The control rod racks recovered from the SL-1 reactor building subsequent to the accident show many surface cracks. In other reactors, it has recently been found that 17-4 PH steel can only be used in reactor components if it is fabricated and processed through carefully controlled heat treatments and manufacturing procedures. Otherwise, progressive stress cracking leading to eventual failure might occur. This was not known when the SL-1 was constructed. Some of the components in SL-1 showed stress cracking (Figures 40 and 41), but so far there is no evidence any cracks had progressed to the point of failure.

**Figure 40 Recovered Gear Rack Showing Transverse Stress
Cracks on Flat of Rack**

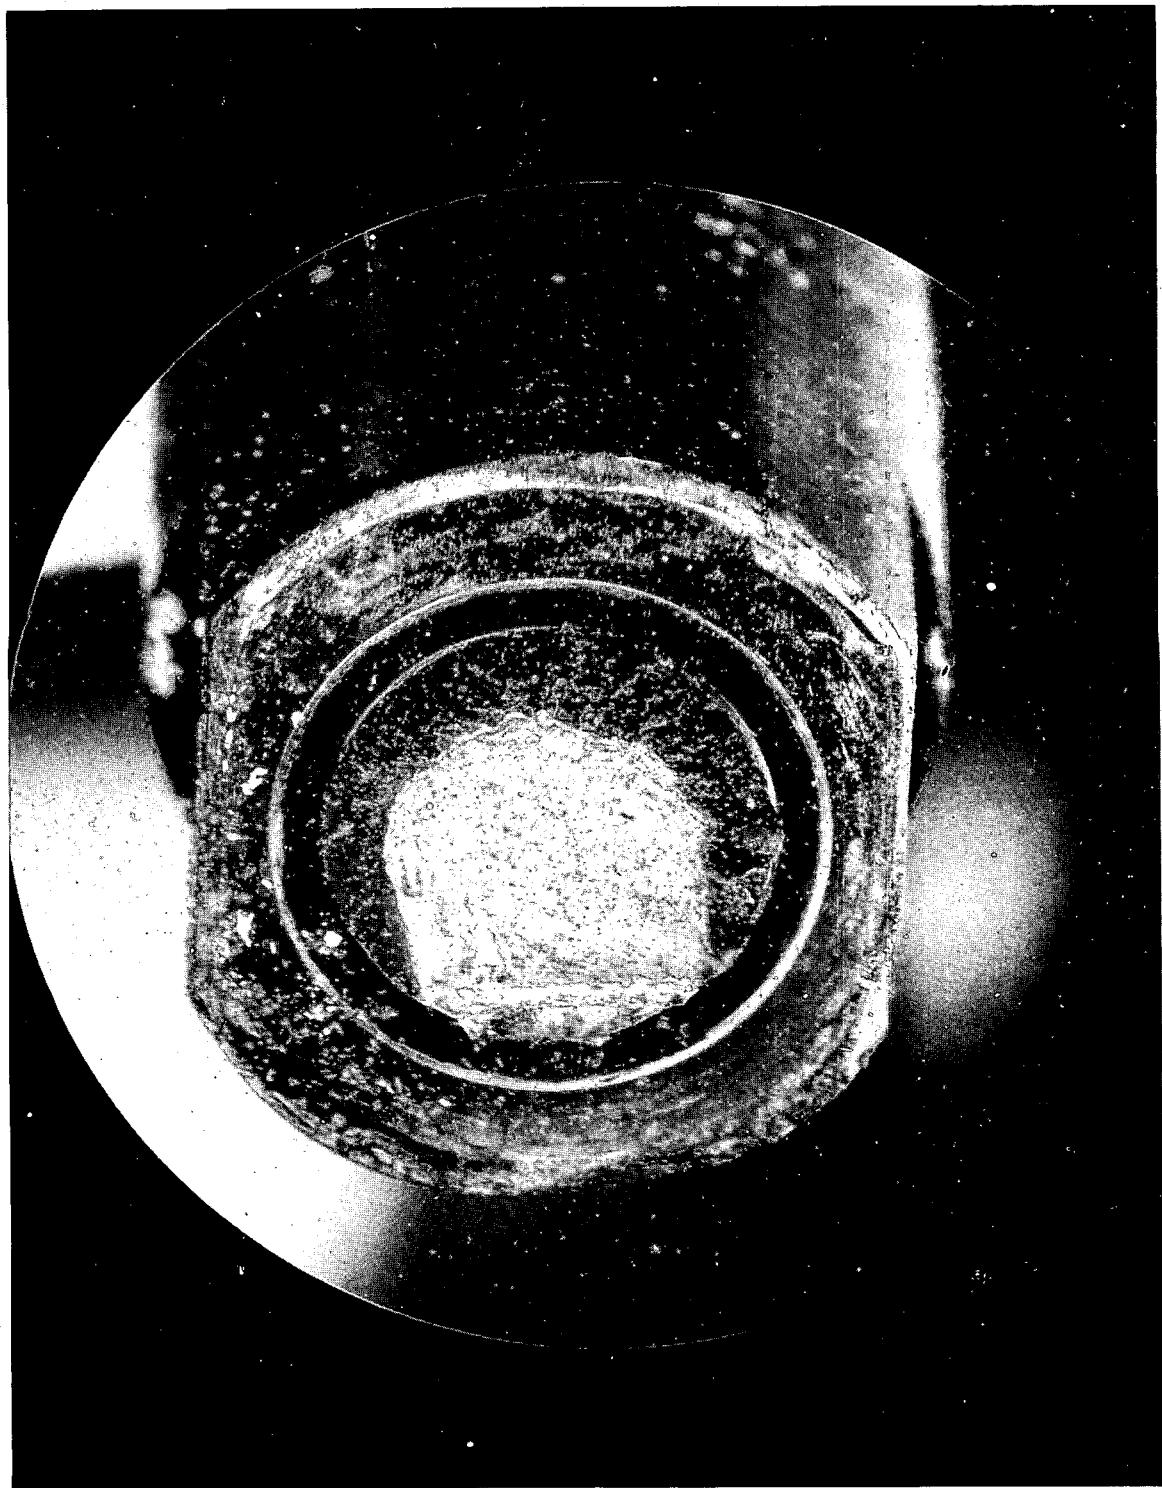
Figure 41 Recovered SL-1 Control Rod Extension Showing Fracture. Dark Outer Area of Fracture Caused by Pre-Accident Fatigue. Bright Area Caused by Impact Tensile.
