Presented: Univ. of Kentucky Ash Utilization Conf.
Oct. 23-25, 1995

Landslide Remediation on Ohio State Route 83 Using Clean Coal Combustion By-Products

Renee Payette, *District 5, Ohio Department of Transportation, Jacksontown, Ohio*; Xi You Chen, William Wolfe, *The Ohio State University, OH*; Joel Beeghly, *Dravo Lime Co., PA*

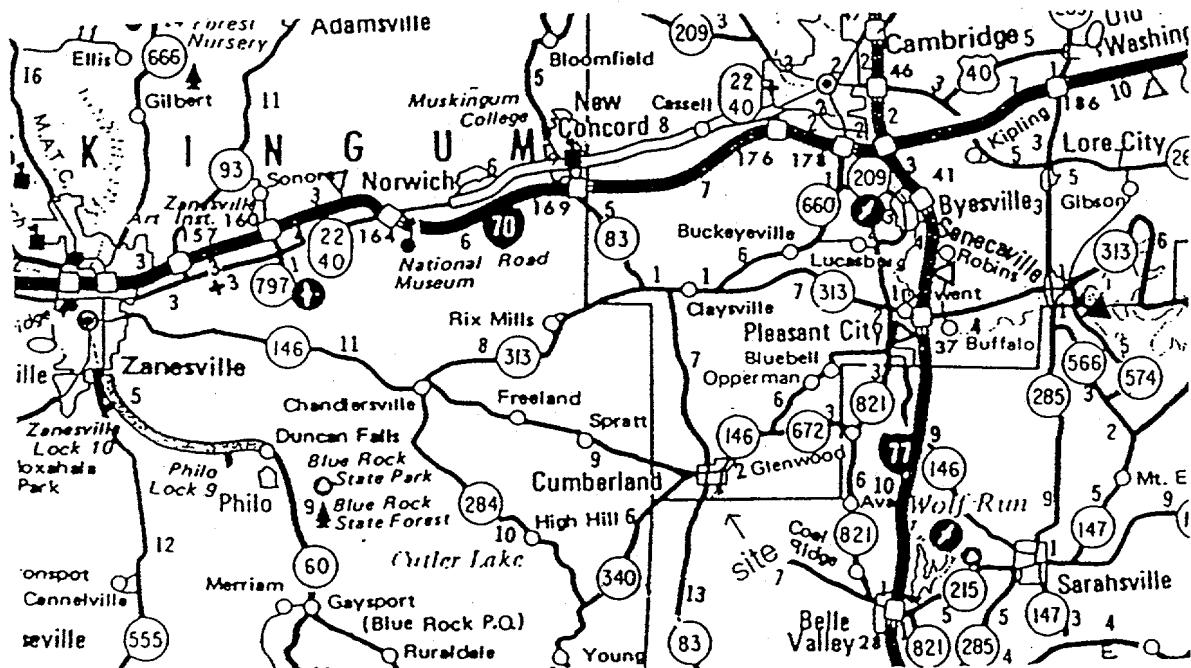
Figure 1. SR 83 site map

Site History. Ohio State Route 83 runs approximately north to south for nearly the entire length of the state. Central Ohio Coal operates an active strip mine in the area and the section of the highway studied carries a large number of loaded coal hauling tractor trailers. The portion that failed is an embankment about 15 meters high and 1000 meters long located just south of Cumberland, and has, according to area residents, caused problems for local traffic for 25 years. In the past five years, state crews have had to patch the pavement two to three times a year. In the late spring of 1993, a site inspection identified a one to two inch vertical offset along the centerline. An investigation of the slope revealed a hummocky terrain indicative of land slippage.

Embankment Repair. The repair of the failed section was completed in three stages. The initial stage consisted of the excavation of the embankment and removal of the failed material. Approximately 11000 yd^3 totaling eight to ten feet of embankment material were excavated in late October, 1994. Because the failure plane was not encountered, an additional trench on the upslope side of the roadway was excavated. The trench was backfilled with compacted FGD ash to form a key that a slope stability analysis indicated would provide an adequate factor of safety against sliding. Upon completion of the trench, drain lines and fabric drain boards were installed to keep groundwater out of the ash. The key was placed in 12 to 18 inch lifts, spread using a small bulldozer, and rolled with a single drum sheepfoot roller. The remainder of the embankment was then divided into four separate sections. At both the north and south ends of the repair, control sections consisting of recompacted natural soil were constructed. These two sections were placed in accordance with standard ODOT construction procedures. Between the two control sections, a third test section consisted of a mix of FGD ash and natural soil. A final section of only FGD ash was also constructed. The FGD/soil mixture was to be placed as close to 50% soil, 50% ash as field mixing conditions would allow. The section was built up in lifts of 8 inches of the soil/ash mix. Compaction was achieved with the same equipment as had been used

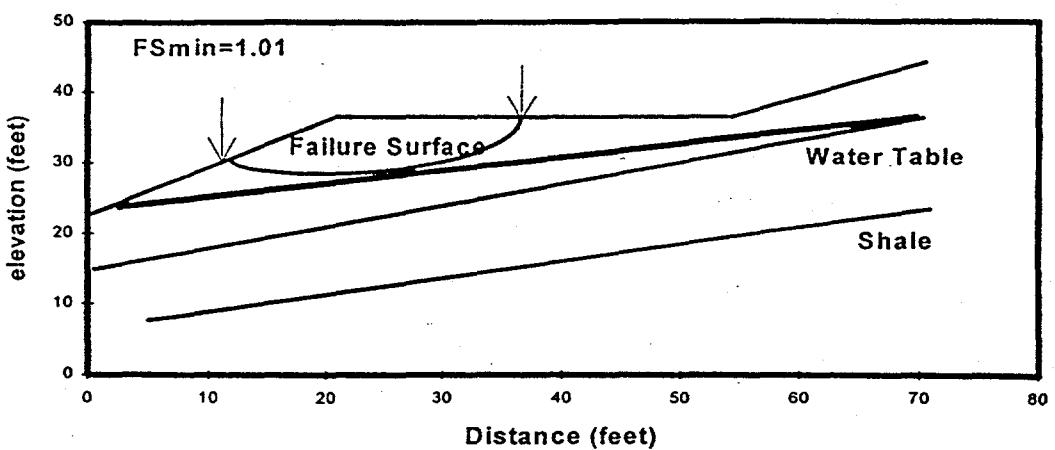
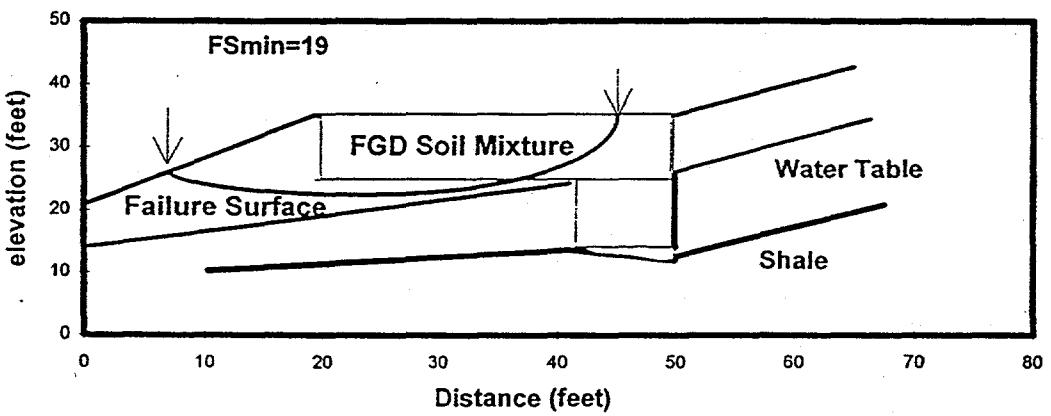
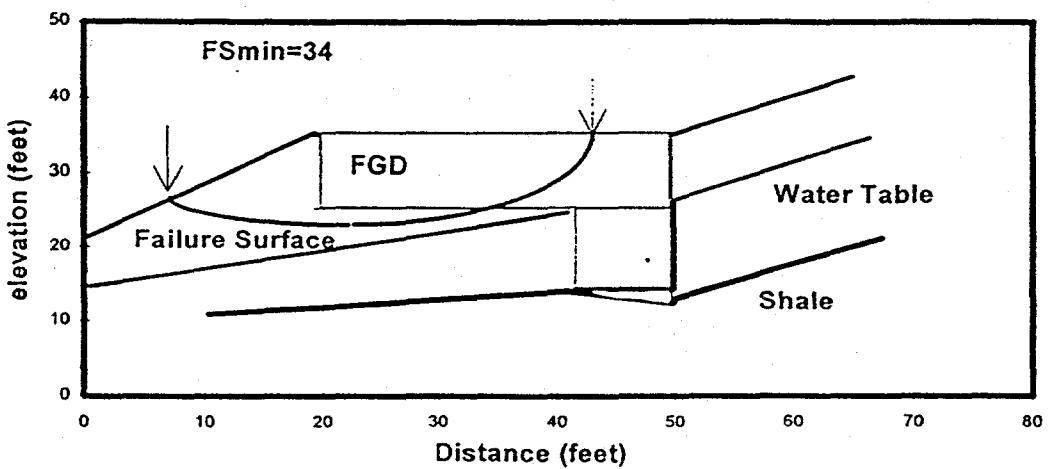
Stability analyses of the three different reconstruction configurations were performed using the slope stability program PCSTABL (Lovell, 1988). The locations of structural features as determined in the borings and verified during the construction were included in the computer models of the three sections. Figure 2 shows the critical surface and calculated factor of safety for the soil only sections. The presence of the FGD key has forced the potential failure surface away from the hillside with the result that the most likely failure is fairly shallow but still is one with a low safety factor that may involve the highway. Figure 3 shows the analysis conducted on the FGD-soil repair. The strength properties used were measured on laboratory prepared FGD-soil samples. Note that for this case the critical failure surface would pass through the FGD-soil mix but the lowest factor of safety is 19 indicating a very low probability of failure. Figure 4 presents the

results of the stability computations for the FGD only section. As in the case of the FGD-soil mixture, the critical failure surface passes through the FGD. Also, as was found with the mixture, the minimum Factor of Safety is very high, in this case in excess of 33. It is clear that the use of FGD or FGD modified soil can significantly improve the safety and stability of hillside construction of the type found on Ohio SR 83.
