Common Causes of Material Degradation in Buried Piping (U)

C. F. Jenkins

Westinghouse Savannah River Company

A document prepared for ASME PRESSURE VESTER & PIPING CONFERENCE at Orlando, FL, USA from 7/27/97 - 7/31/97.

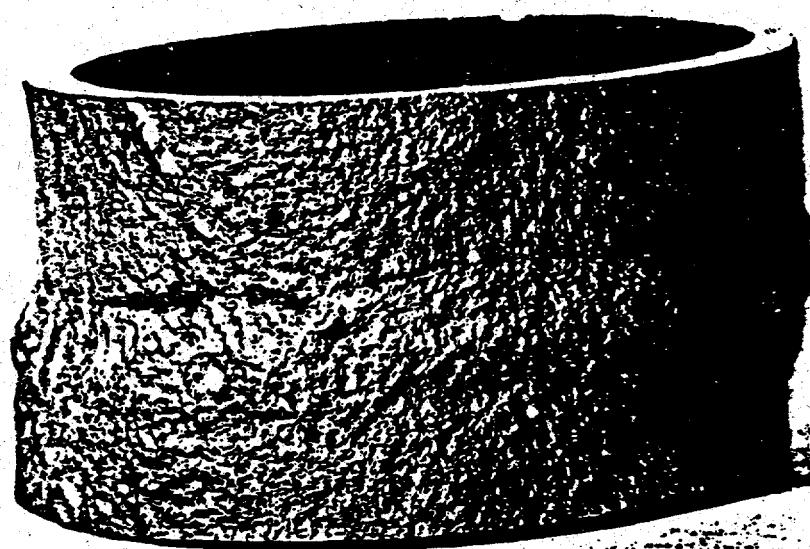
1. A 2-inch, schedule 40 pipeline, 150 psi steam, buried in a powdered insulation, failed at an elbow. The hole occurred at a weld joint due to erosion from the inside. Significant misalignment and a step in the weld joining the elbow and pipe (Fig. 2) led to the erosion. The outside surface exhibited considerable corrosion, possibly due to entrapment of the escaped steam in the insulation envelope. The line was buried for about 2 1/2 years, but was in steam service only 14 months, indicating that corrosive attack had been very rapid.

Figure 2. Misalignment of pipe and elbow segments in a failed steam line. Wet steam erosion occurred at the resulting step on the inside. Exterior was blast cleaned to reveal corroded surface.

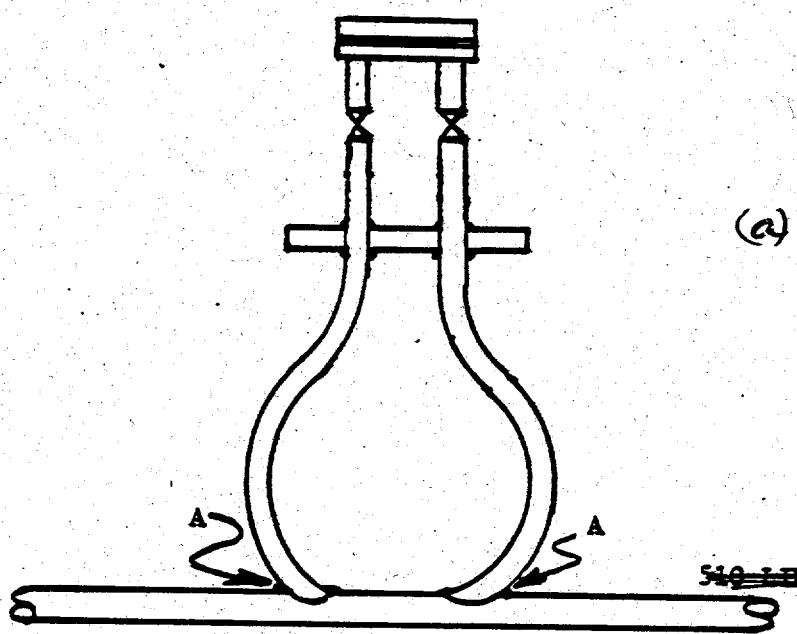
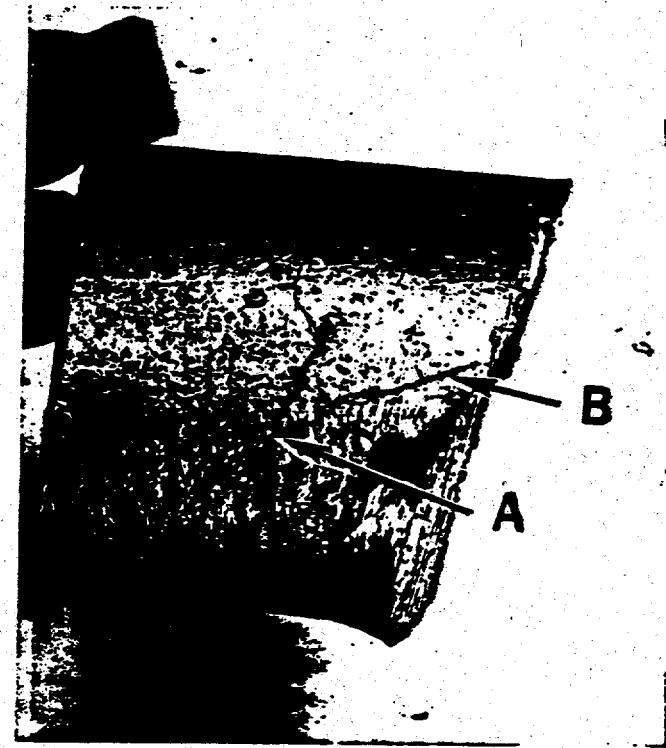
4. A 1-inch, sch. 10 stainless steel pipe contained within a 2-inch carbon steel pipe developed a leak. Monitoring of the annular space detected the leak. Investigation revealed chloride stress corrosion cracking (CSCC) in a cold formed, long radius elbow section of the pipe (Figs. 4, 5), and for 3 to 4 feet along the horizontal extension from the long elbow. Although the hydrotest water was drained, the pipe was not put into service for several years and some water remained trapped in small pockets in the section. Moreover, for 6 months during the lay up period, a steam leak from a nearby underground pipe elevated the temperature in the vicinity, thus enhancing the corrosion process. The carbon steel jacket pipe was contained in a powdered thermal insulation backfill. It showed some corrosion but was generally acceptable for continued use.

Figure 4. (a) Cleanout port detail, illustrating crack (CSCC) locations in stainless steel catheter pipes.
(b) Outside surface of failed catheter, showing CSCC leak site.

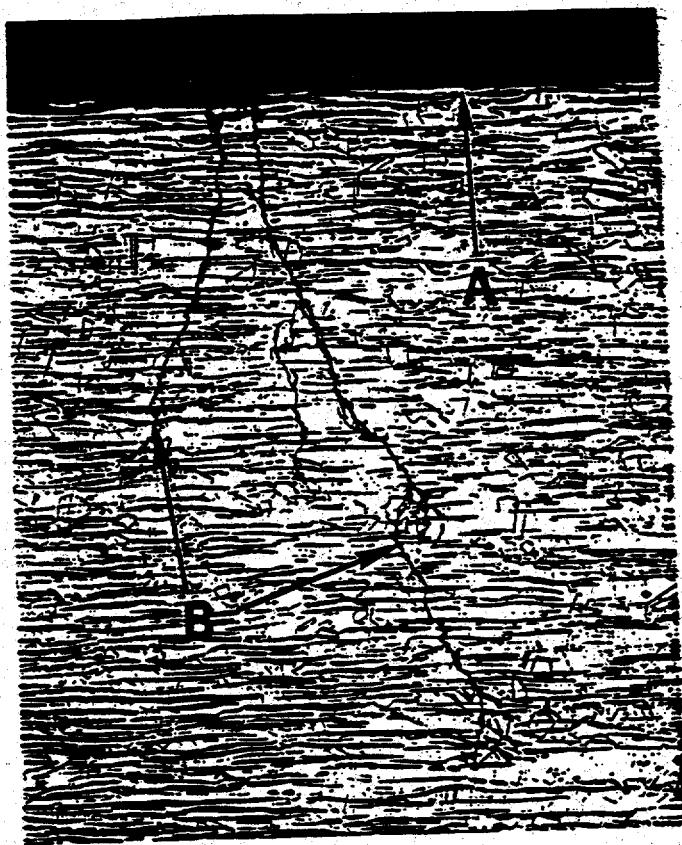
Figure 5. CSCC in second catheter, illustrating origin at inside surface.
Magnification: 50X.

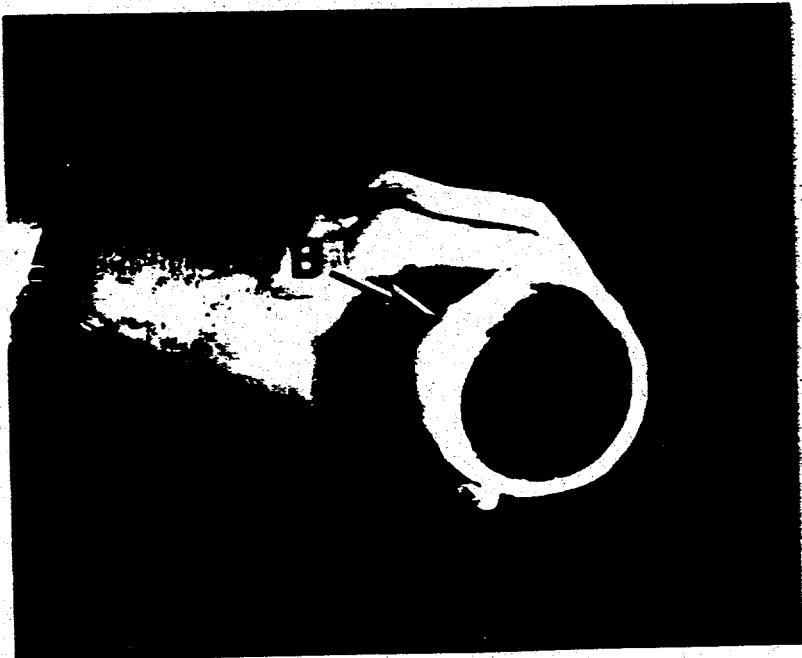
Figure 8. Cross sectional view of pipe in Figure 7 shows pit depth is approximately equal to full wall thickness.

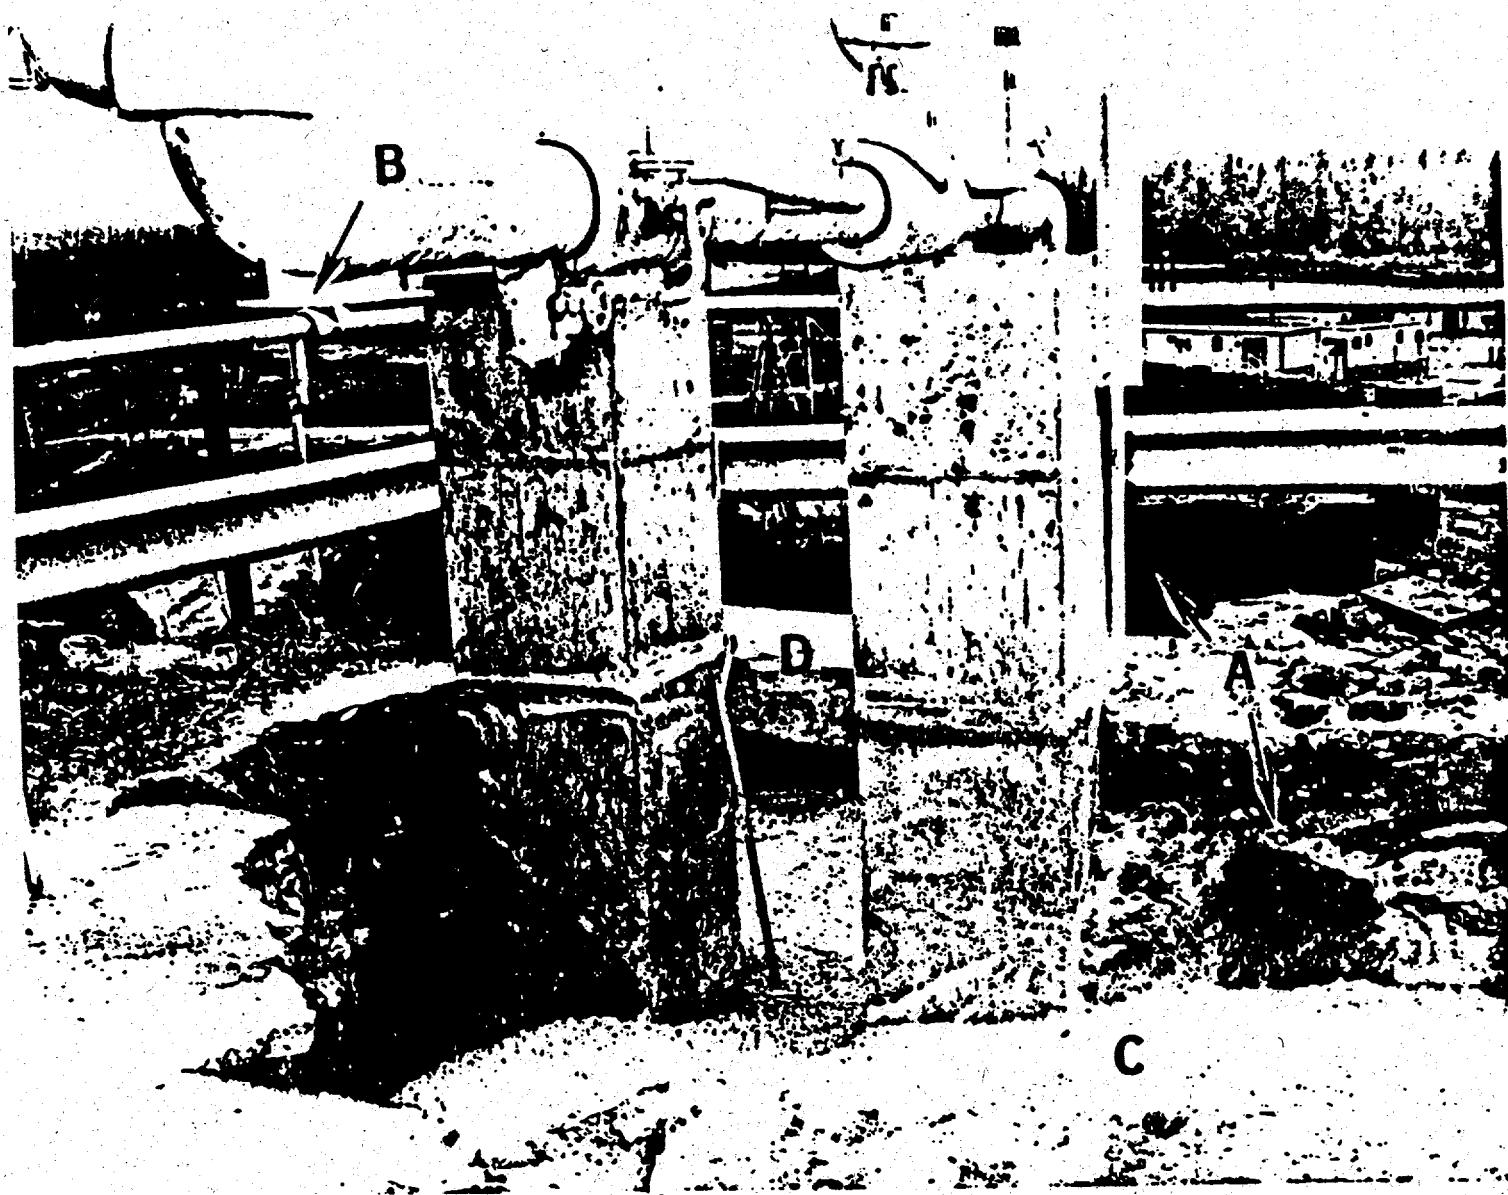
11. A 3-inch cast iron pipe broke and water washed out a hillside (Fig. 9). A crack occurred in the pipe as a result of heavy traffic on grade and variable soil support. A concrete slab beneath the pipe probably contributed to the break. Pits on the outside surface along the crack (Fig. 10) are associated with seepage at the crack before it encircled the pipe and opened up.

Figure 9. Steam equipment at edge of hill. Large washout (A) occurred due to broken underground water pipe 300 ft. away. The pillar supporting the steam pipe at B fell into the hole and is buried in the aggregate C. Slab D bridges a gap created by the washout. Several buried pipes on the hillside were exposed.

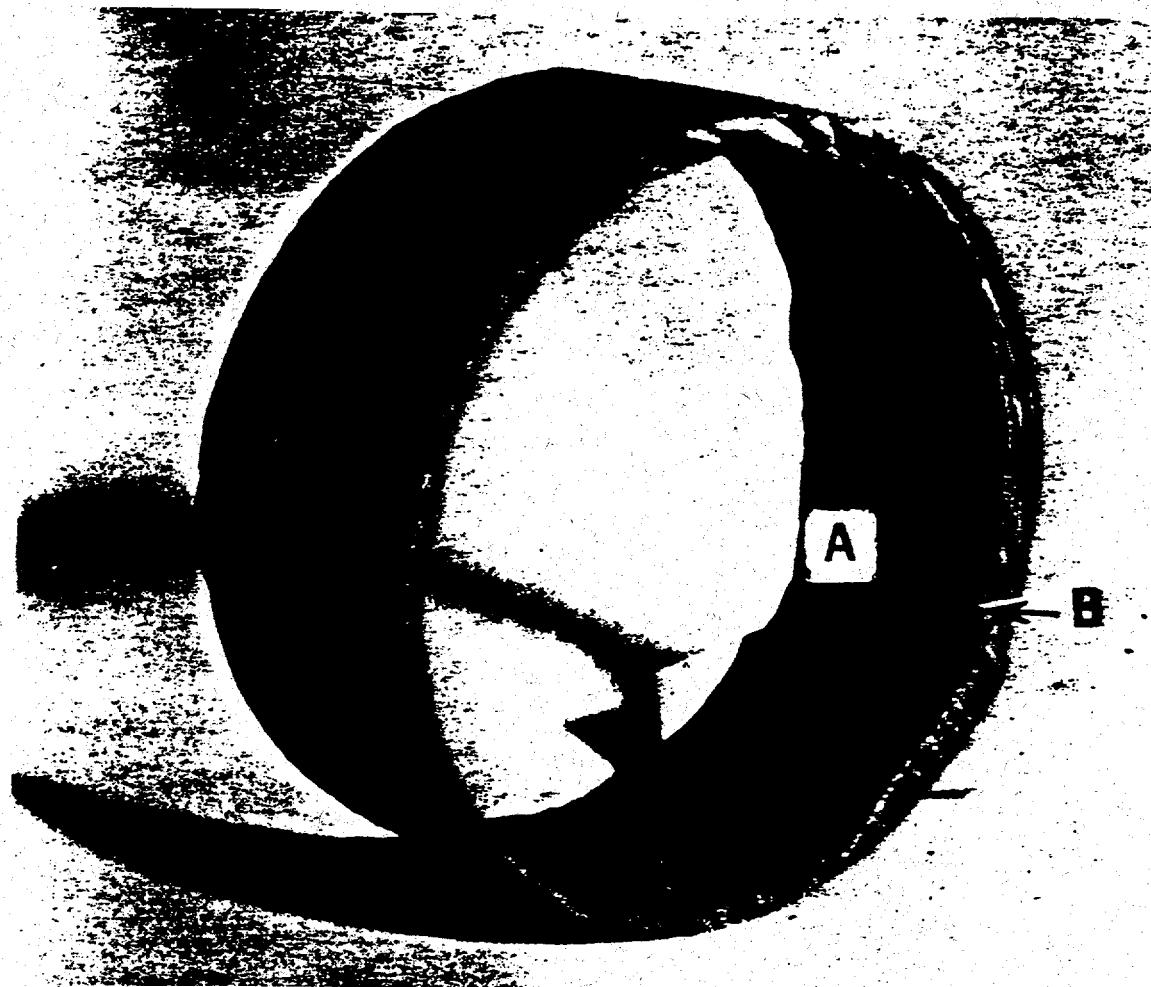
20. A 2-inch, sch. 40 steel pipe teed to a 6-inch cooling water supply failed by erosion/corrosion. Leaks occurred at the impact location on the downstream surface at the turn. Severe wall thinning occurred (Fig. 14).

Figure 14. Severe erosion (A) and erosion-corrosion in a 2 in. water pipe at its connection to a 6 in. header. Metal loss due to water impact at the junction. Location B shows full wall thickness.

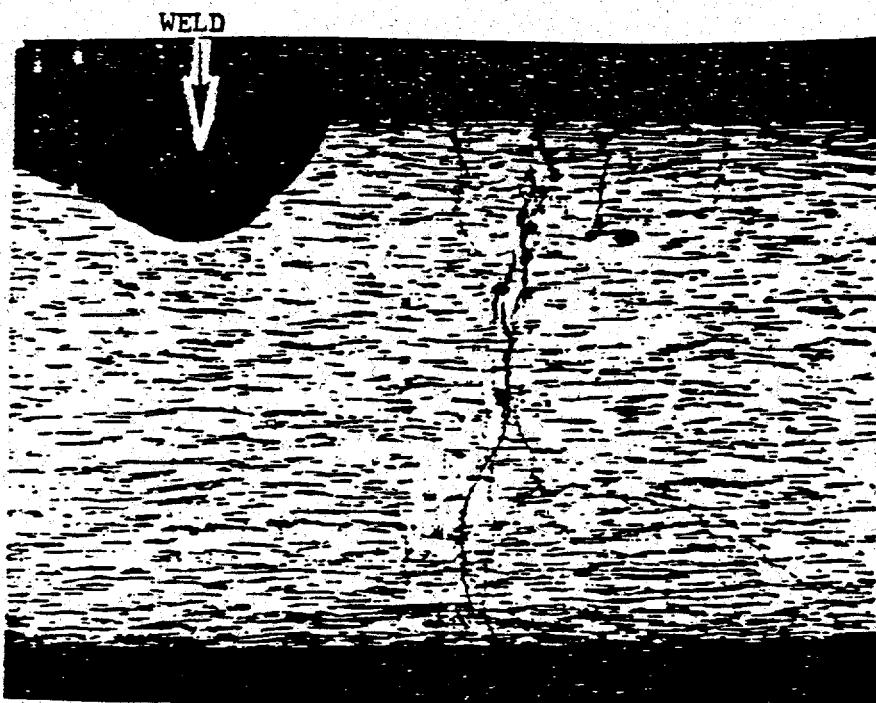
21. An insulated stainless steel pipe failed by CSCC from the exterior (Figs. 15, 16). Although this case did not involve buried pipe, it is included because the problem relates to use of insulation containing leachable chloride ion, and the application could just as well have been underground. Moreover, the same phenomenon has been observed with carbon steel pipe. Water penetrates the insulation, extracts chlorides from the material, and exposes the pipe surfaces to the wet chloride environment. Chloride cracking of the stainless resulted.

Figure 16. Chloride stress corrosion cracking in stainless steel pipe initiated under an ID tag on the external surface. Source of the chloride was external thermal insulation. Magnification: 20X.
