CORROSION PROBLEMS IN Ti/KClO<sub>4</sub> LOADED DEVICES WHEN SUBJECTED TO HUMID ENVIRONMENTS\*

T.M. MASSIS, J.T. HEALEY, D.H. HUSKISSON and W.G. PERKINS  
Sandia National Laboratories, Albuquerque, NM 87185\*\*

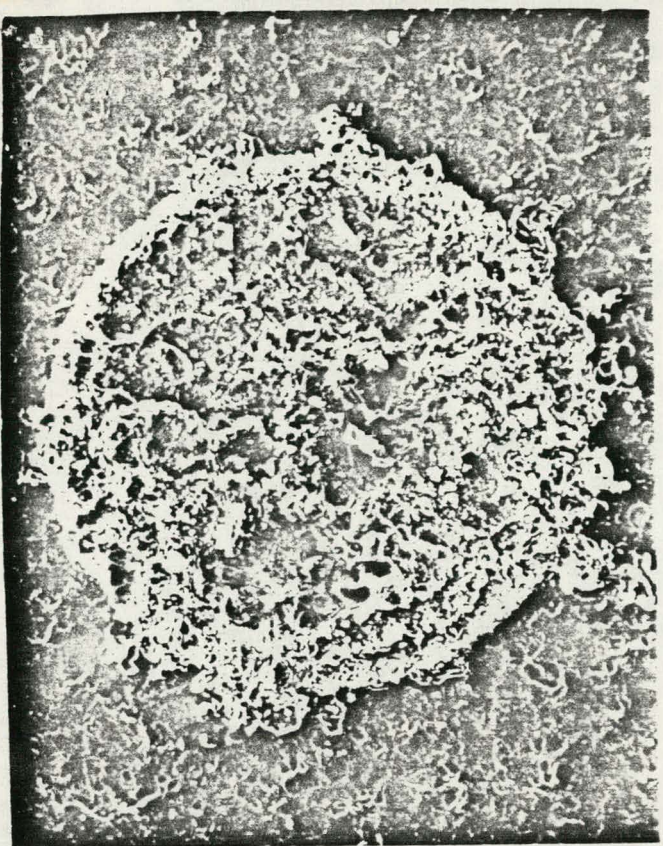
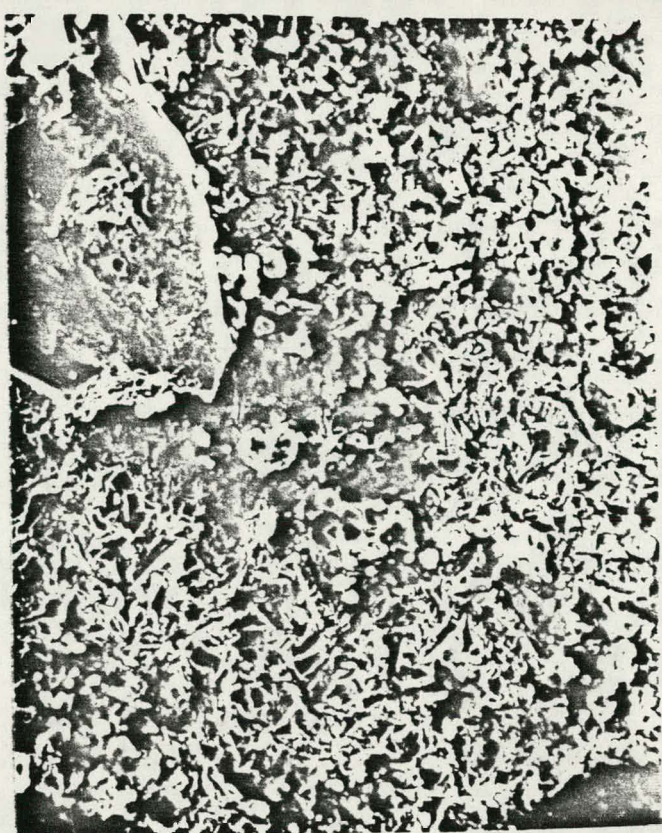
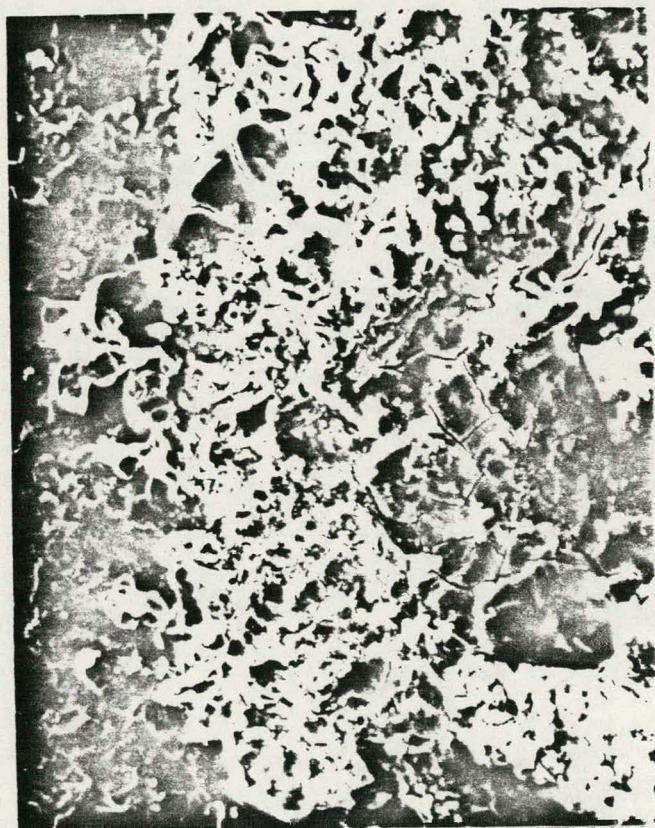
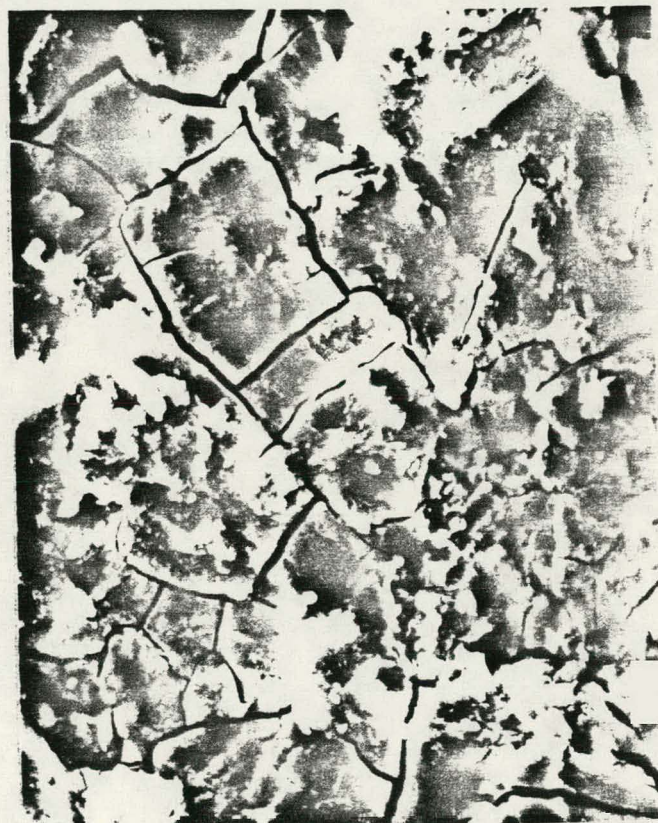
FIGURE 2

Optical and scanning electron microscopy (SEM) of the previously mentioned lot of igniters revealed nearly 100 percent corrosion of the electrode pin surfaces as shown in Figure 2. In nearly half the units, the bridgewire was detached from the electrode pin at the weld interface. Evidence of pin corrosion in the weld area was apparent (Figure 3). No corrosion of the bridgewire was observed except for an isolated area near the weld. Energy dispersive x-ray analysis ( $Z \geq 11$ ) of the pin corrosion product revealed major concentrations of the Kovar pin constituents with minor concentrations of chlorine.

SEM OF ELECTRODE PINS FROM  
CORRODED IGNITOR LOT

Hermetically sealing the igniter was not possible due to design requirements. A simple change in the packaging, shipping, and storage procedures was implemented such that the units were constantly under desiccation before assembly into the dry thermal battery unit. As a precaution, the same was implemented for the piston motors. Examination of units stored in this manner has shown no corrosion.

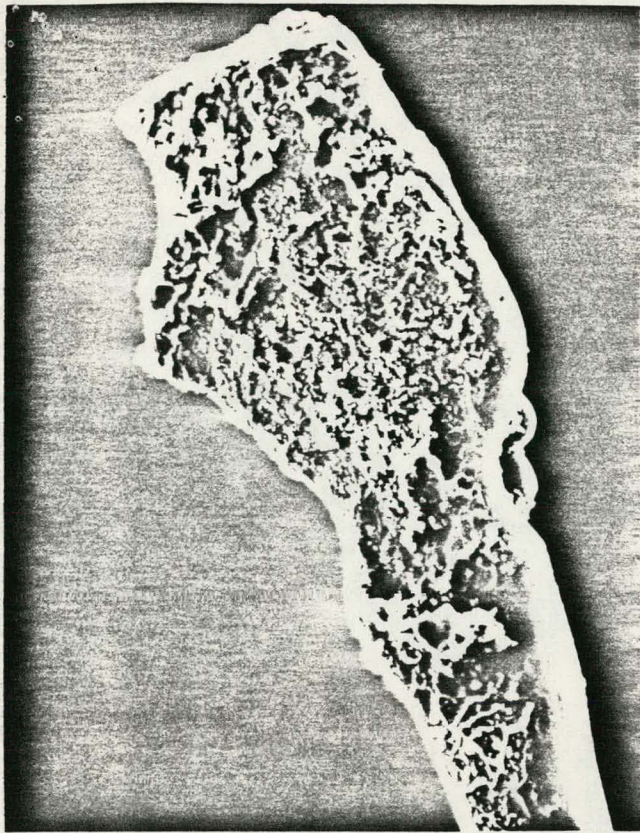
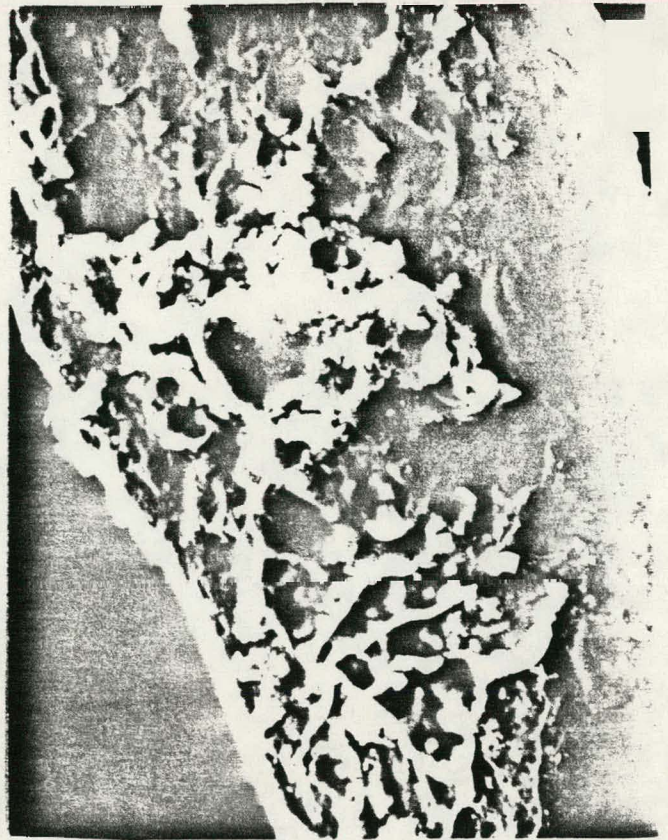
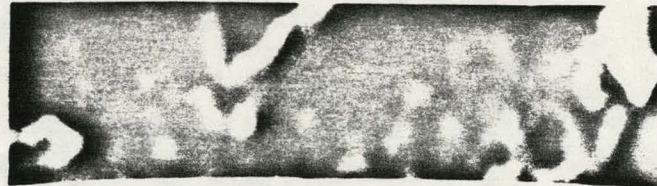
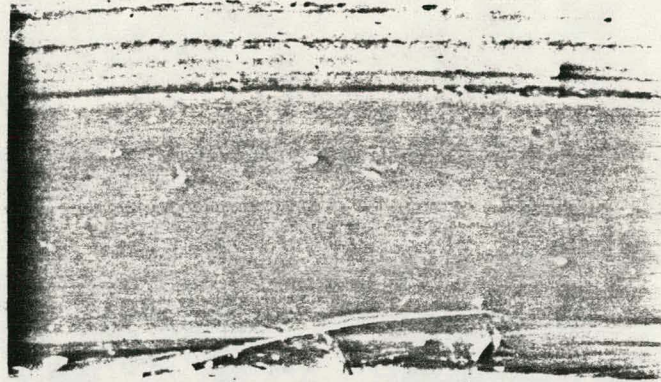
FIGURE 3

SEM OF BRIDGEWIRE AND WELD  
INTERFACE FROM CORRODED  
IGNITOR LOT

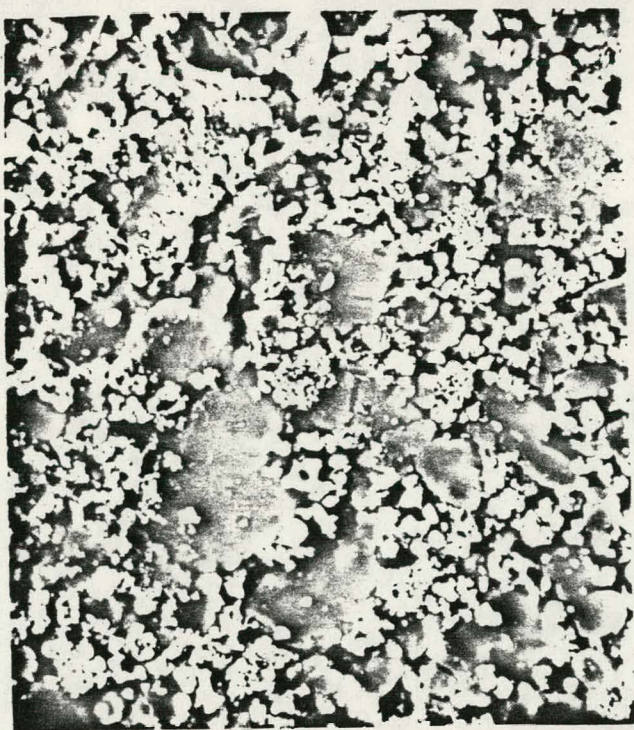
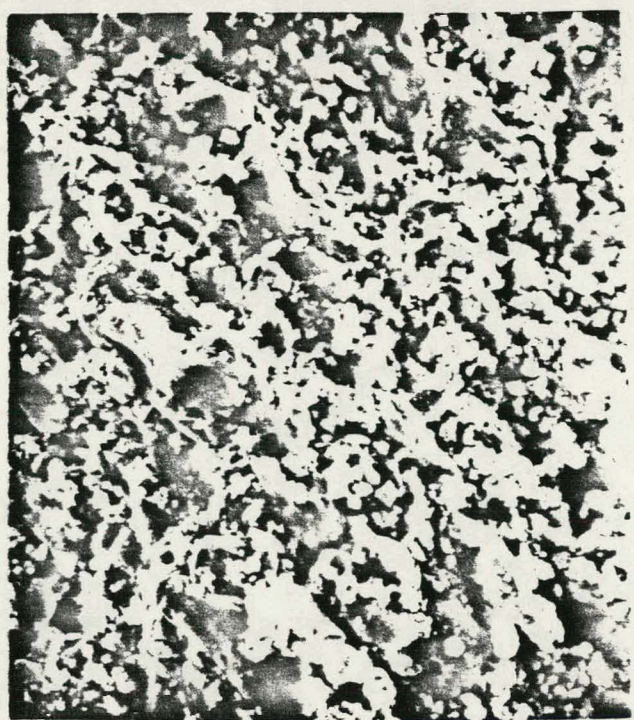
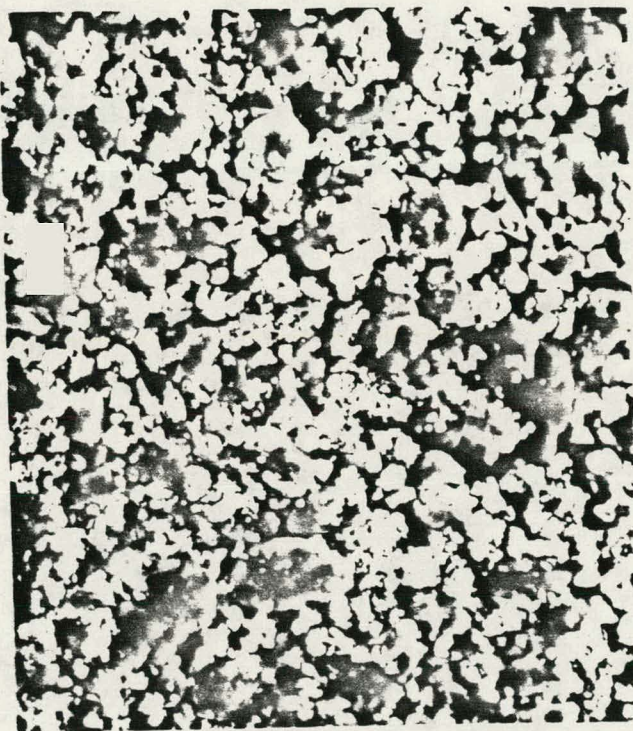
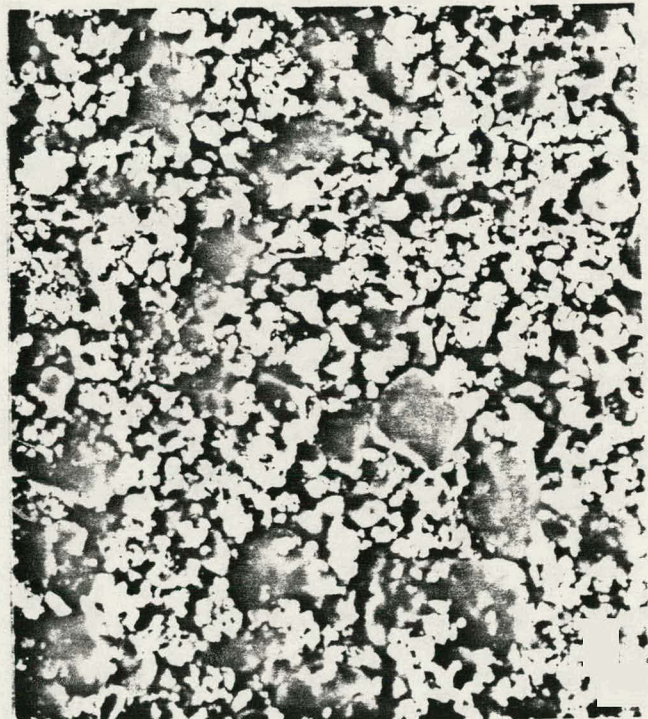
FIGURE 4  
SEM OF  $\text{Ti}/\text{KClO}_4$  POWDER FROM  
CORRODED IGNITOR LOT  
(BULK AND PIN INTERFACE)

Examination of the pyrotechnic powder interface in contact with the electrode pins revealed no morphological alteration of the potassium perchlorate (KClO<sub>4</sub>) when compared to the bulk powder away from the pins as shown in Figure 4. This is contrast to the previous observations with the Ti/KClO<sub>4</sub> valve actuator where morphological alteration of the KClO<sub>4</sub> was observed whenever corrosion was present (ref. 4). Based on this observation, it was concluded that the pyrotechnic blend, and in particular the KClO<sub>4</sub>, was not playing a primary role in the corrosion mechanism of the igniter.

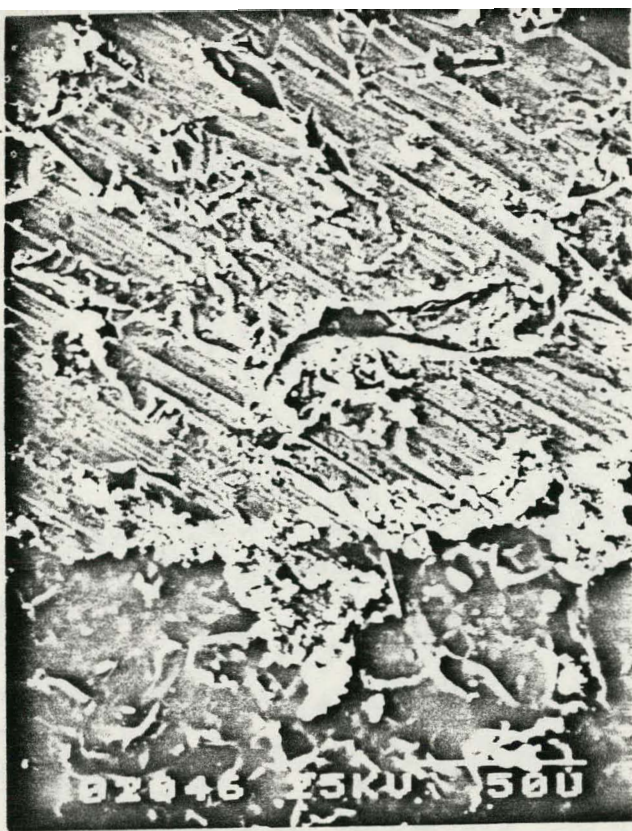
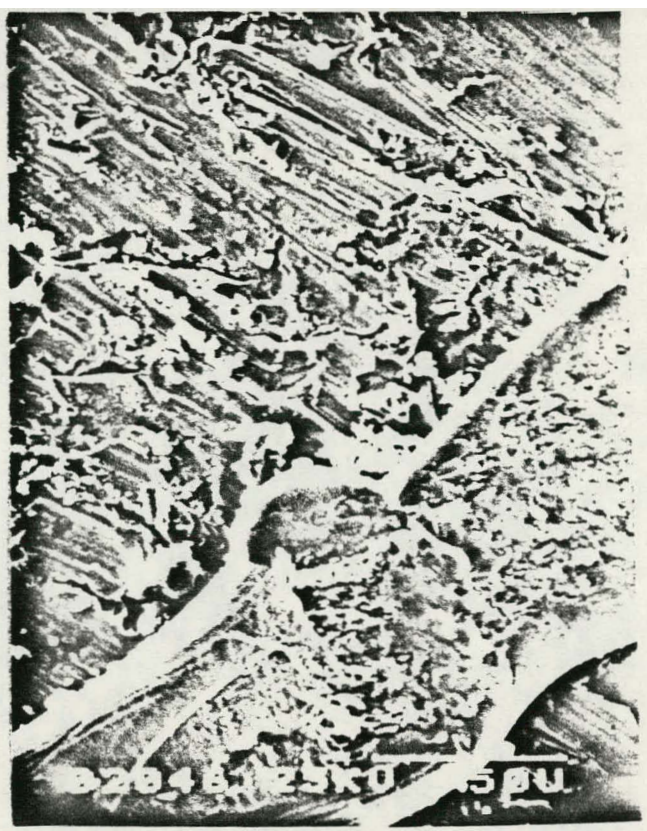
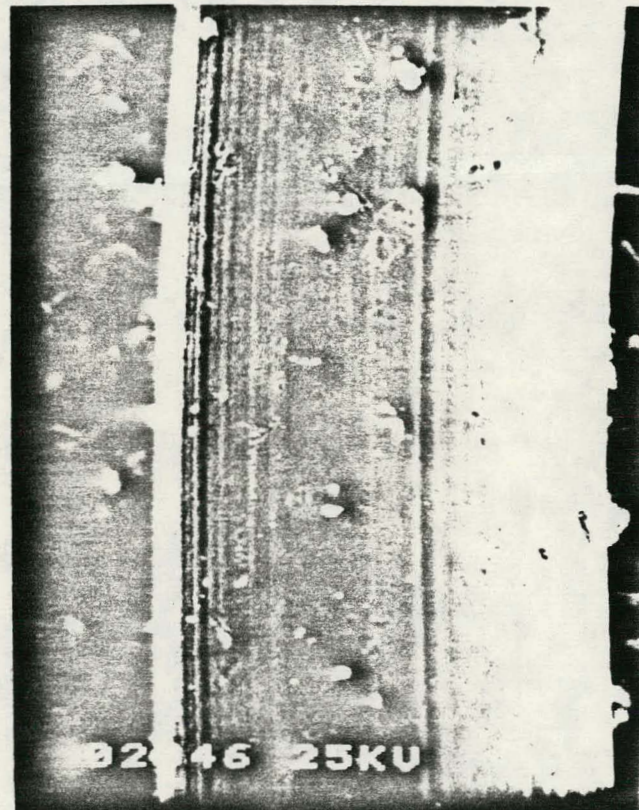
FIGURE 5

Further evaluation of other production lots of the igniter produced prior to this lot revealed levels of corrosion ranging from none in some lots to the occurrence of small, isolated corroded areas in other lots. No corrosion of the weld areas was apparent. Except for one bridgewire where a single area of corrosion was found, no bridgewire corrosion was observed. Figures 5 and 6 are typical SEM photomicrographs of the pins and bridgewires from these production lots.

SEM OF ELECTRODE PINS AND  
BRIDGEWIRE FROM A NON-CORRODED  
IGNITOR LOT

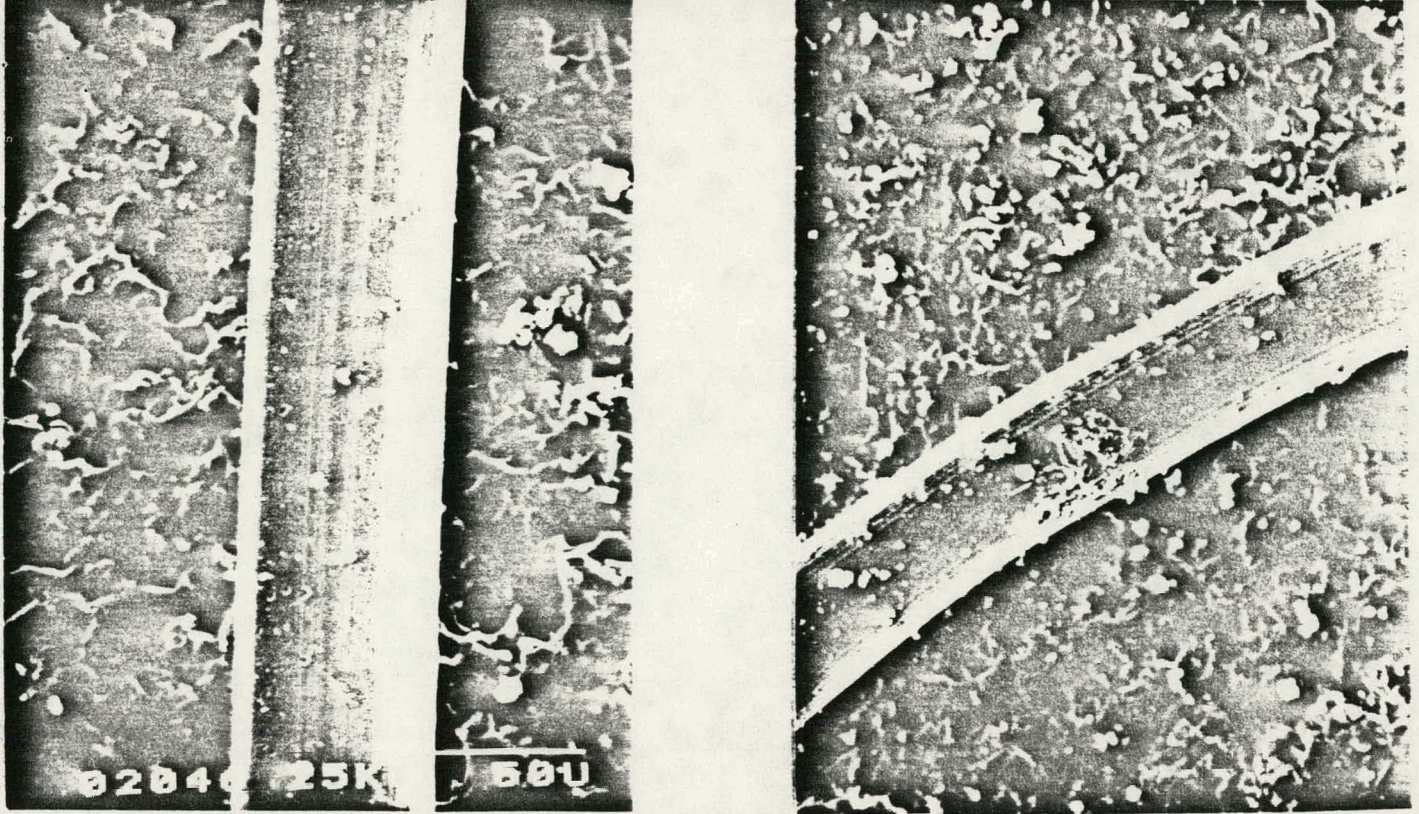
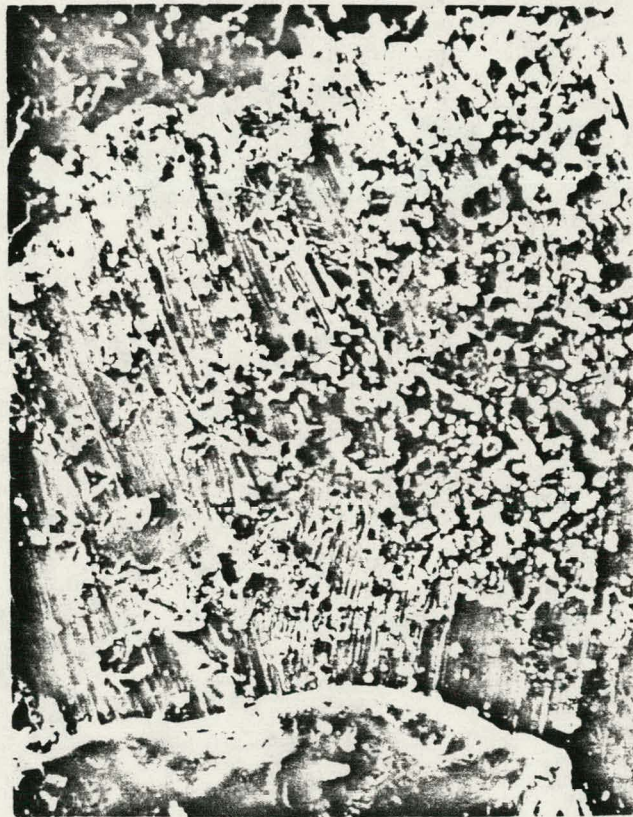
FIGURE 6

SEM OF ELECTRODE PINS AND  
BRIDGEWIRE FROM A PARTIALLY  
CORRODED IGNITOR LOT

The variation of the corrosion observed between lots of the igniters was really a function of their storage environments prior to the next assembly rather than any inherent difference between the lots. After manufacture the igniters were placed in nondesiccated bags, packaged and shipped to the thermal battery manufacturer. There they were unpacked and stored undesiccated in open atmospheres that had the potential for the presence of high humidity. Once installed in the thermal battery assembly, the high humidity environment was eliminated as a result of the highly desiccated nature of this assembly. If corrosion had started, it then ceased due to elimination of the moisture environment in this next assembly. The variation in corrosion depended upon storage time between manufacture and next assembly and the ambient humidity conditions during that time.

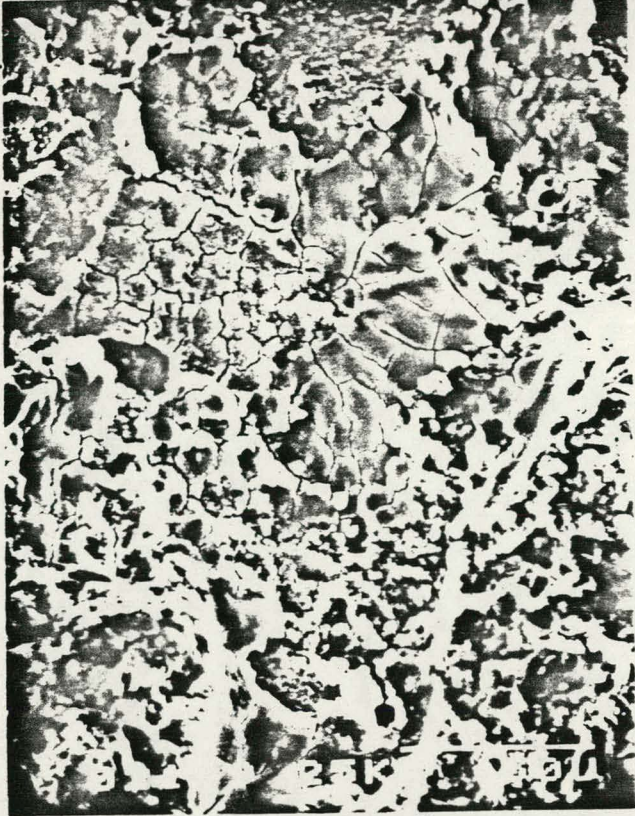
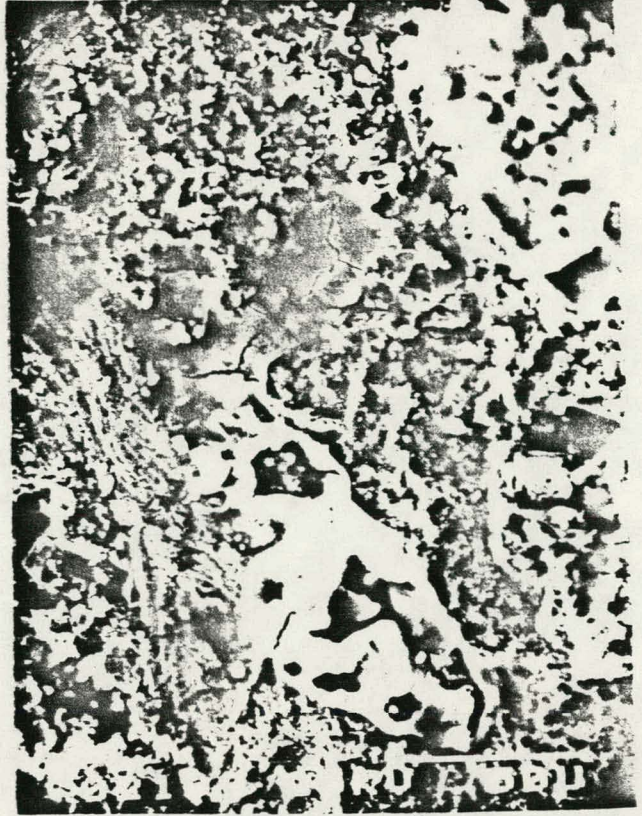
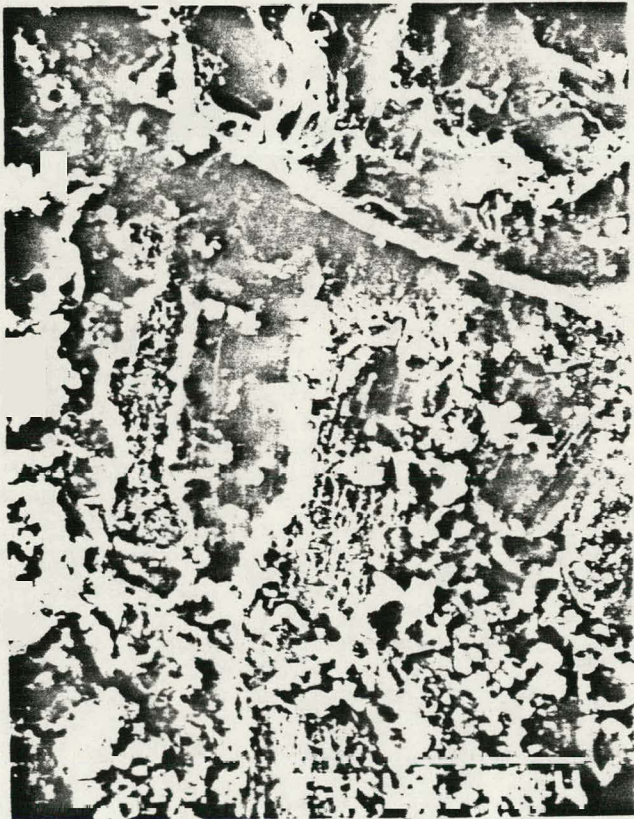
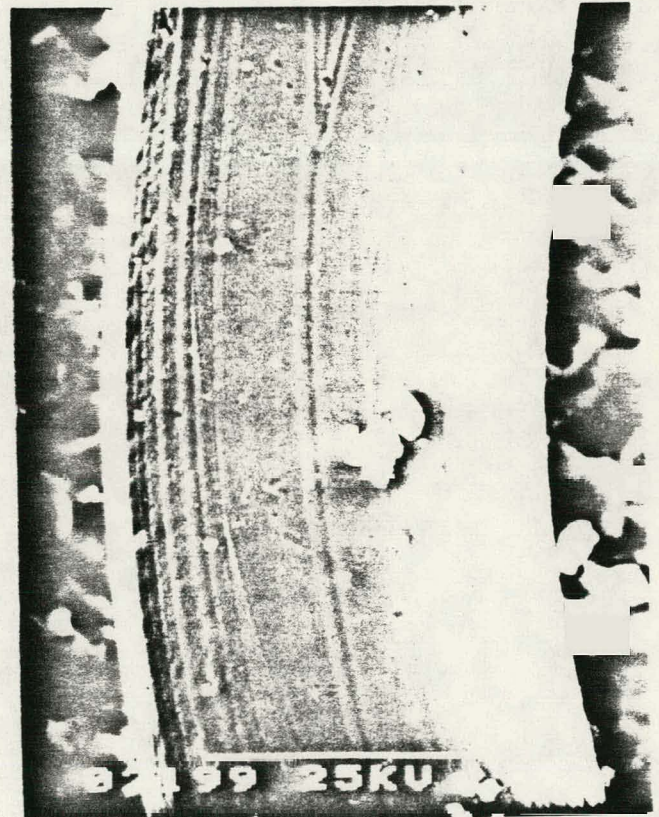
FIGURE 9

Disassembly and evaluation of the header revealed massive corrosion of the electrode pins (Figure 9). Nearly all of the surface was corroded. Either one or both of the bridgewire/pin welds were detached at the weld interface in one-half of the units evaluated. Optical and SEM examinations revealed similar corrosion of the electrode pins and weld areas as previously found for the thermal battery igniter. No bridgewire corrosion was observed. Similar units subjected to the same thermal cycle but without the humidity environment were found not to be corroded.

SEM OF ELECTRODE PINS AND  
BRIDGEWIRE FROM PISTON MOTORS  
EXPOSED TO HUMIDITY CYCLE

A design change was necessary to eliminate the corrosion and stress corrosion cracking problems in the piston motor. A hermetically sealed version was designed and built for application with a humidity requirement. In units where the leak rate was less than  $10^{-8}$  atm cc/sec, either no corrosion or minimal corrosion was observed when

subjected to the humid environment. Significant to extensive corrosion was present in those units that had leak rates in excess of  $10^{-8}$  atm cc/sec.

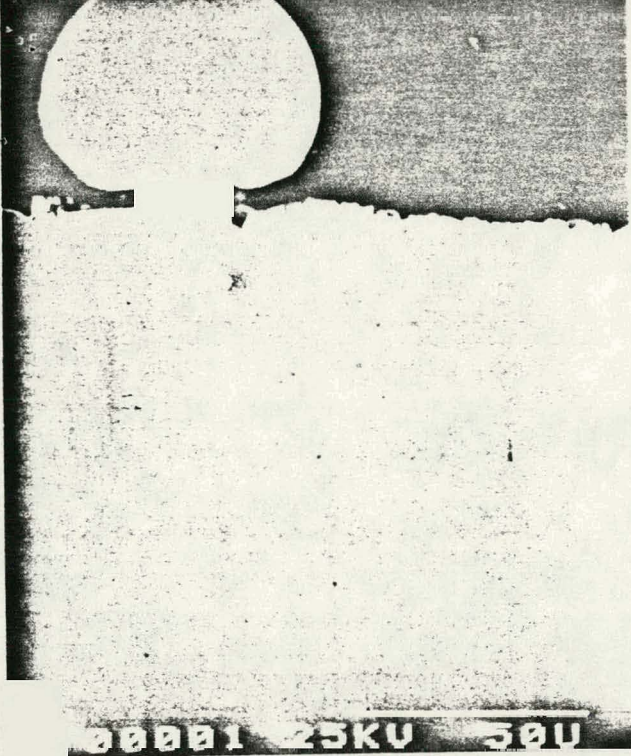
THERMAL CYCLE - No STRESS  
CORROSION CRACKING

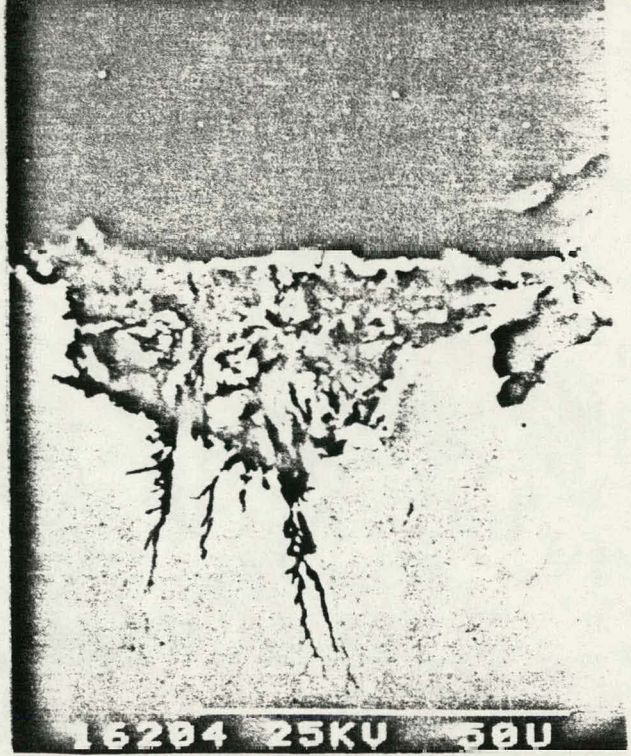
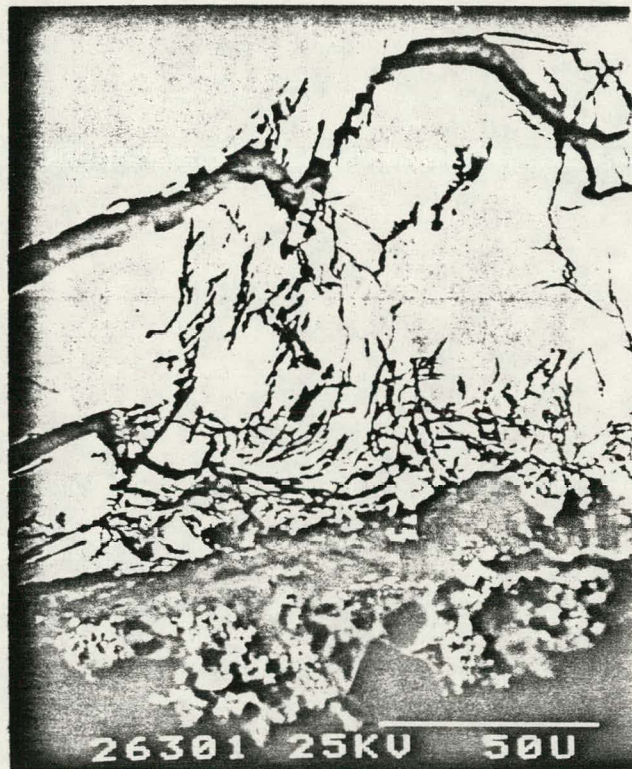
FIGURE 10  
SEM OF CROSS-SECTIONED HEADER PINS  
FROM PISTON MOTOR  
(THERMAL AND HUMIDITY CYCLED)

Corroded and uncorroded units were sectioned through the pins and weld area to determine the depth of the corrosion and also to determine the mechanism of the bridgewire/pin separation. Figure 10 shows examples of these sectioned units. The corrosion was over 100 μm deep, and sharp cracking of the Kovar pin was observed proceeding around the weld effected area. Energy dispersive x-ray analysis ( $Z \geq 11$ ) revealed the presence of chlorine in the surface corrosion product and also in the corrosion product within the cracks, even at the crack tip. Eventually this cracking coalesced and resulted in separation of the weld area from the pin. No surface corrosion or cracking was observed on those units previously identified as uncorroded.

HUMIDITY CYCLE - SHOWING CHLORIDE  
ASSISTED STRESS  
CORROSION CRACKING

The piston motor which shows significant corrosion in all lots subjected to the severe humidity/temperature cycle was not originally hermetically sealed in the next assembly. As a result, the device was constantly exposed to humidity which permeated the silicone seal and affected the internal environment. The corrosion in these units, therefore, continued to increase with time. The separation of the bridgewire weld was the result of stress corrosion cracking of the Kovar. Weirick (ref. 12) has previously shown the susceptibility of this alloy to chloride assisted stress corrosion cracking in a humid environment. The above was similar. The source of the stress could be the residual stresses in the Kovar pins as a result of the welding process as evidenced by the fact that the cracking proceeds around the weld affected area. The source of the chlorine was surface contamination not cleaned from the units which has been observed on unloaded units. It was not from a reaction of the  $KClO_4$ .
