Defect Characterization by Acoustic Holography  
Volume 1: Imaging in Field Environments

NP-1534, Volume 1  
Research Project 605-1

Final Report, September 1980

COE ASSOCIATES  
2672 Bayshore/Frontage Road, Suite 1000  
Mountain View, California 94043

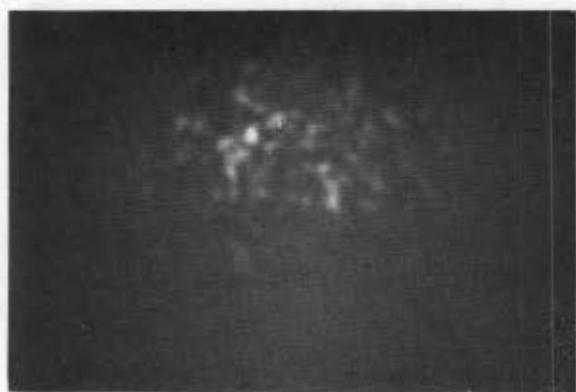
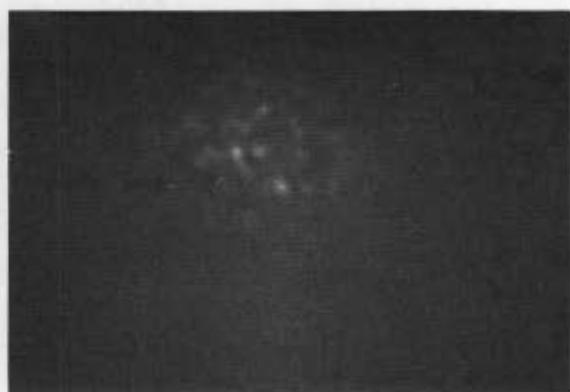
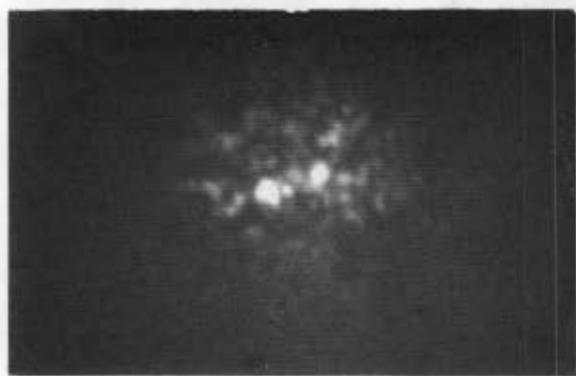
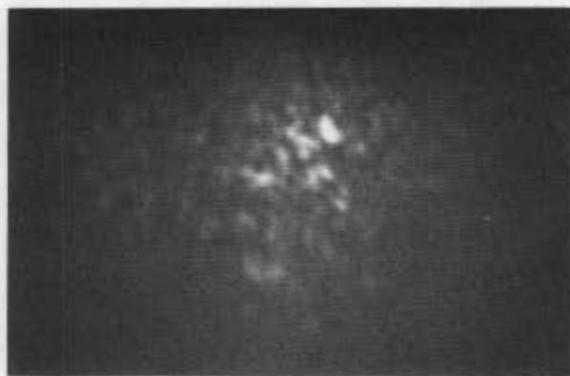
Figure 3-3 Typical AH Images

The radiographic results indicated extension of some of the defects into the weld zone. The AH results did not show any extension into the weld zone. Subsequent destructive tests verified the AH results. AH results also differed from radiographic results in that the AH images indicated many discontinuities, whereas the radiographic results showed one defect. Destructive tests showed that there were clusters of defects. The destructive tests also indicated that there was a large intense flaw which was masked by the defect clusters and did not show on the AH images. While such masking can be analytically predicted, the practical consequence is that such large flaws would always be masked in such situations, i.e., an alternative technique would be required to define the large flaw.

An incident beam angle of 45 degrees was used for the AH studies. The beam angle and approximate position of the defects in the AH images are shown in Figure 3-2. Typical results obtained with the AH equipment are presented in Figure 3-3.

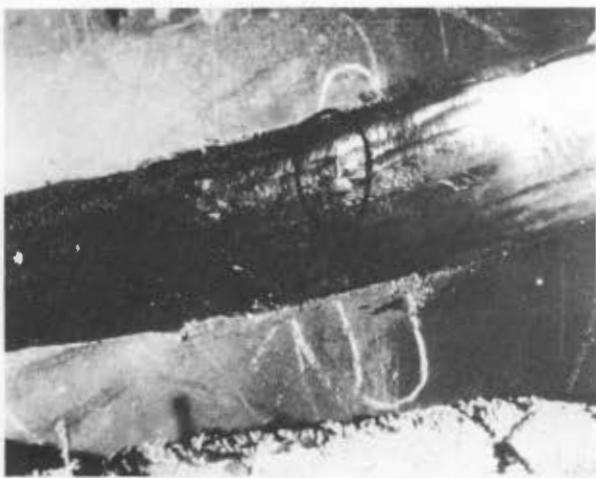
(a) Cavity Depth 4"  
Crack  $1/16" \times 3/4"$

Area Immediately Above Crack  
Has Numerous Pinholes

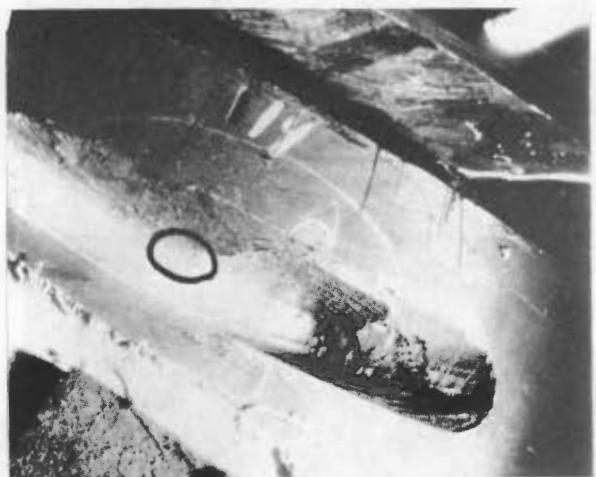
(b) Cavity Depth  $4 \frac{1}{4}"$   
Two Voids  
 $1/2" \times 1/2" \times 1/4"$

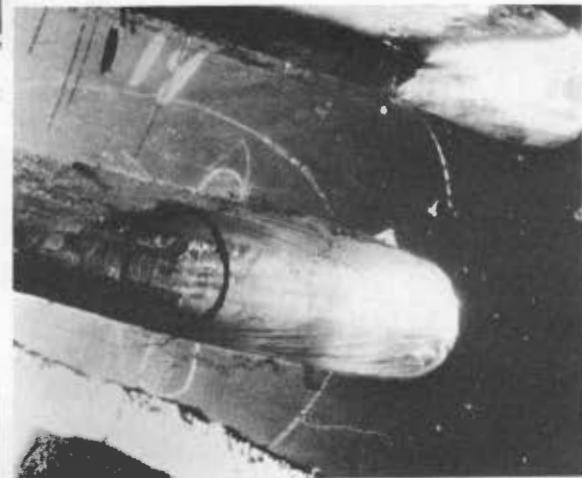
(c) Cavity Depth  $4 \frac{1}{2}"$   
Pinholes and Cracks

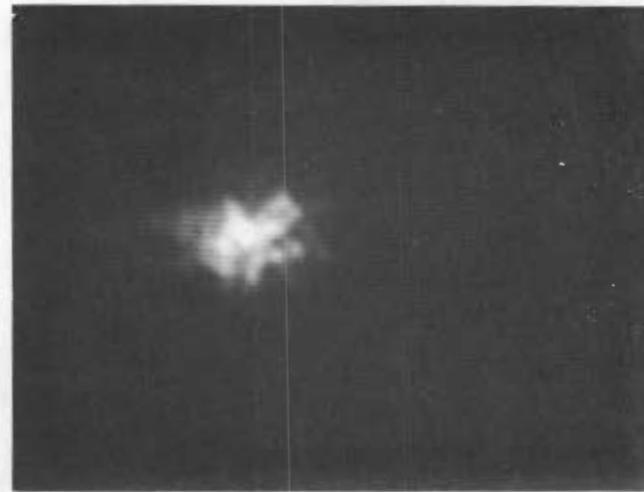
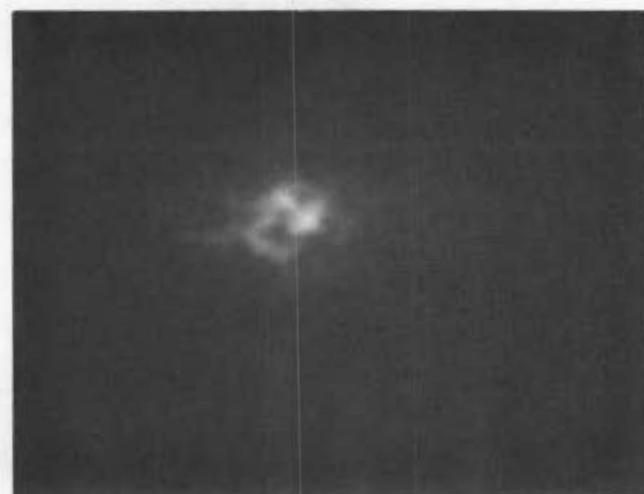
Figure 3-7 AH Images of Nozzle Defects

The AH tests were successful in accurately detecting and characterizing the defects. The tests were conducted in a field environment with an acceptable time span for implementation of the tests.

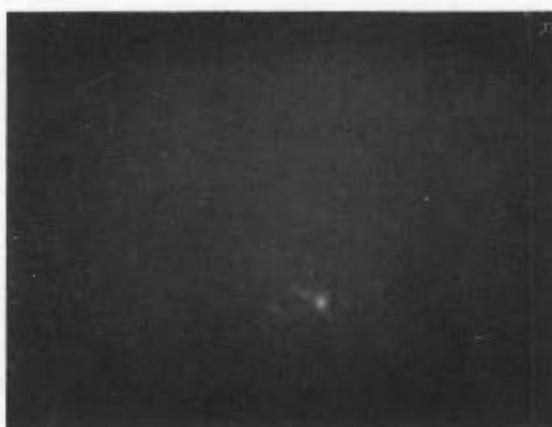
(b) Defect #21

Figure 3-10 AH 3MHz Images - Circle Seam Defects

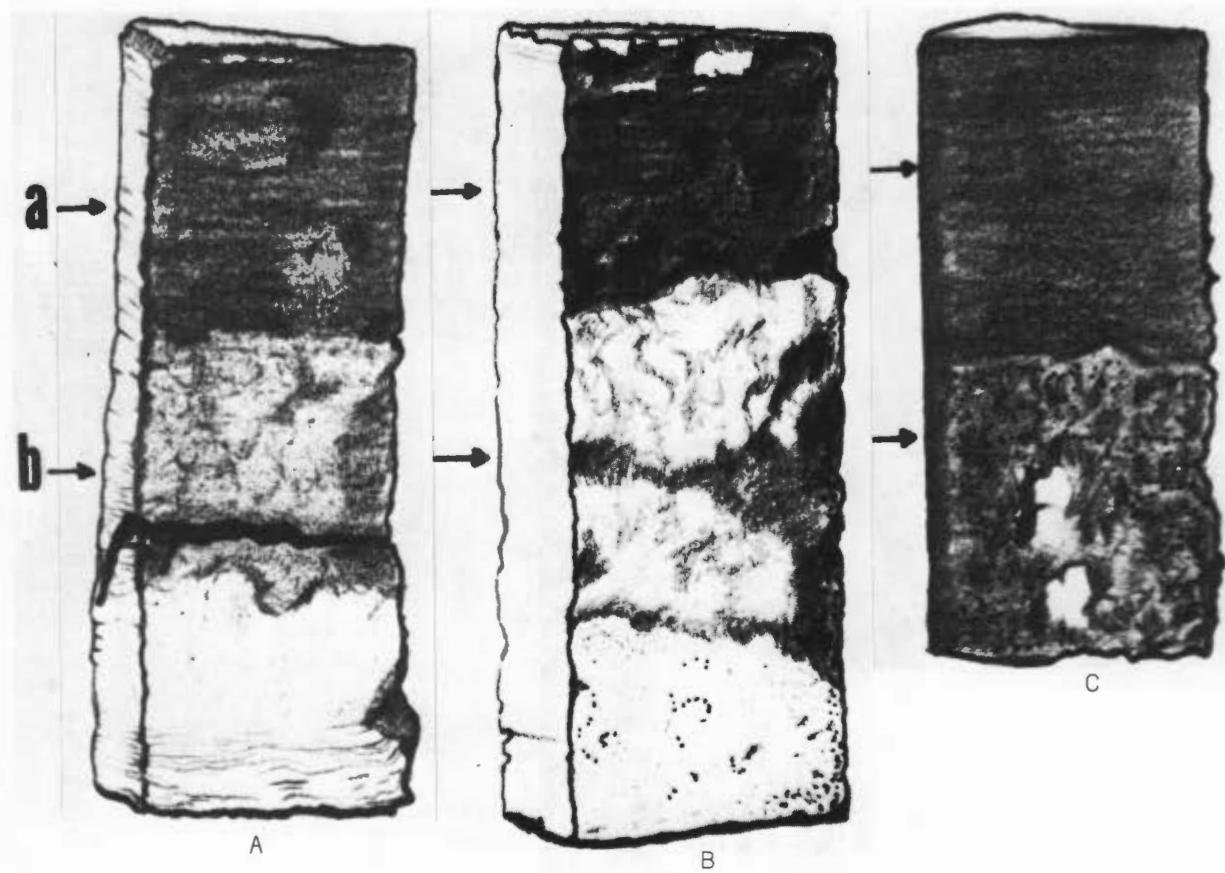
Figure 4-9 Cross-section of HSST#2 Core Samples

ARROWS POINT TO EXTENT OF EB WELD AREA (a)  
AND EXTENT OF CRACK AREA (b)

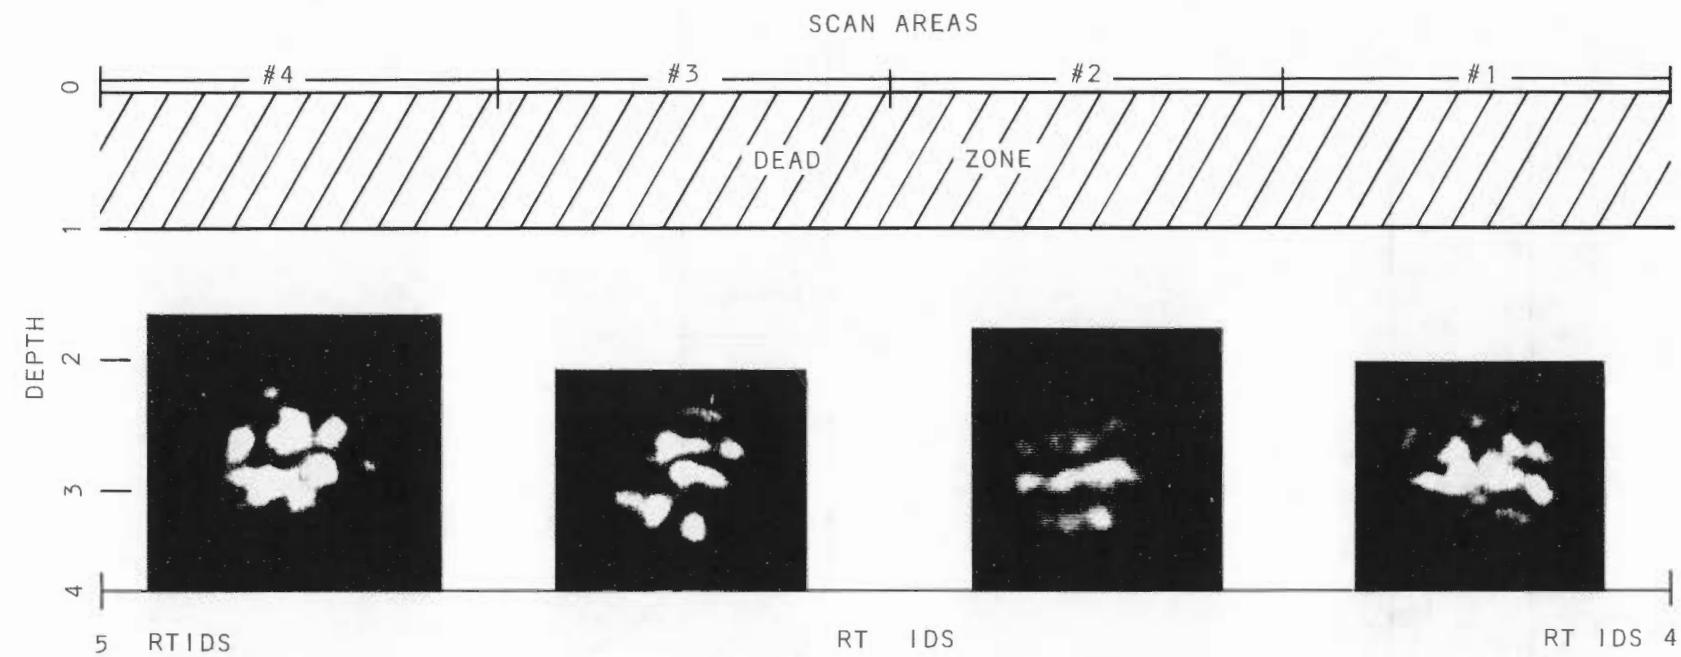
Figure 4-14 AH Images of Defect #2, Prior to Hydrotest

AH images of defects No. 2 and No. 4, prior to hydrotest, are shown in Figures 4-14 and 4-15, respectively. These images were obtained at a frequency of 1 MHz. Post hydrotest AH images of defect No. 2 are presented in Figure 4-16, for a 1 MHz beam. Both the acoustic emission and AH procedures indicated that hydrotest did not induce defect growth. This finding was corroborated by the subsequent destructive tests. Detail differences between the initial and final AH images was attributed to minor changes in scanner orientation with respect to the defects. The overall dimensions for both set of images was in agreement.

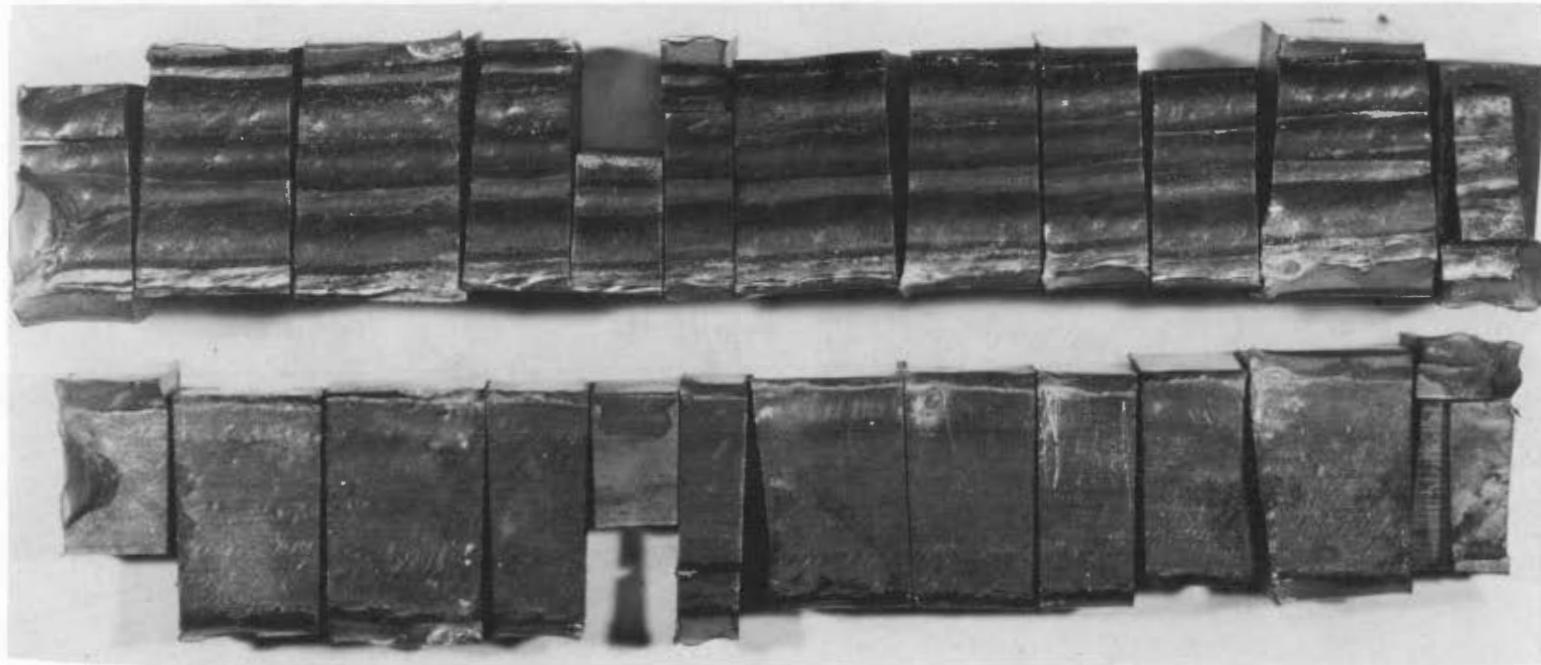
Figure 4-17 Full Length Fracture Surface of Defect #2

The destructive tests were performed by removing 0.5 inch samples from the ends and middle of the defects. Composite photos of the total fracture of defects No. 2 and No. 4 are shown in Figures 4-17 and 4-18, respectively.

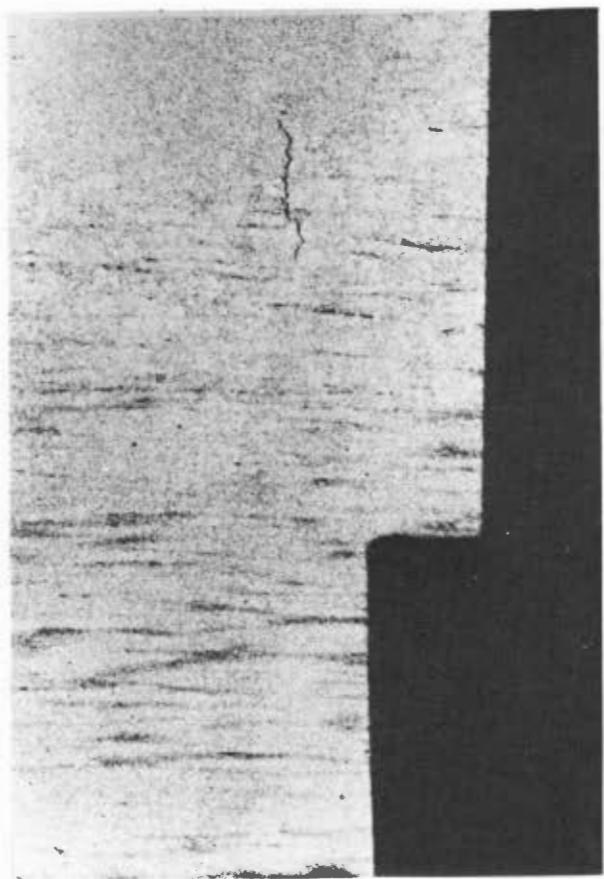
Figure B-1 Crack in Sample D X10 Ref: 140/10/76

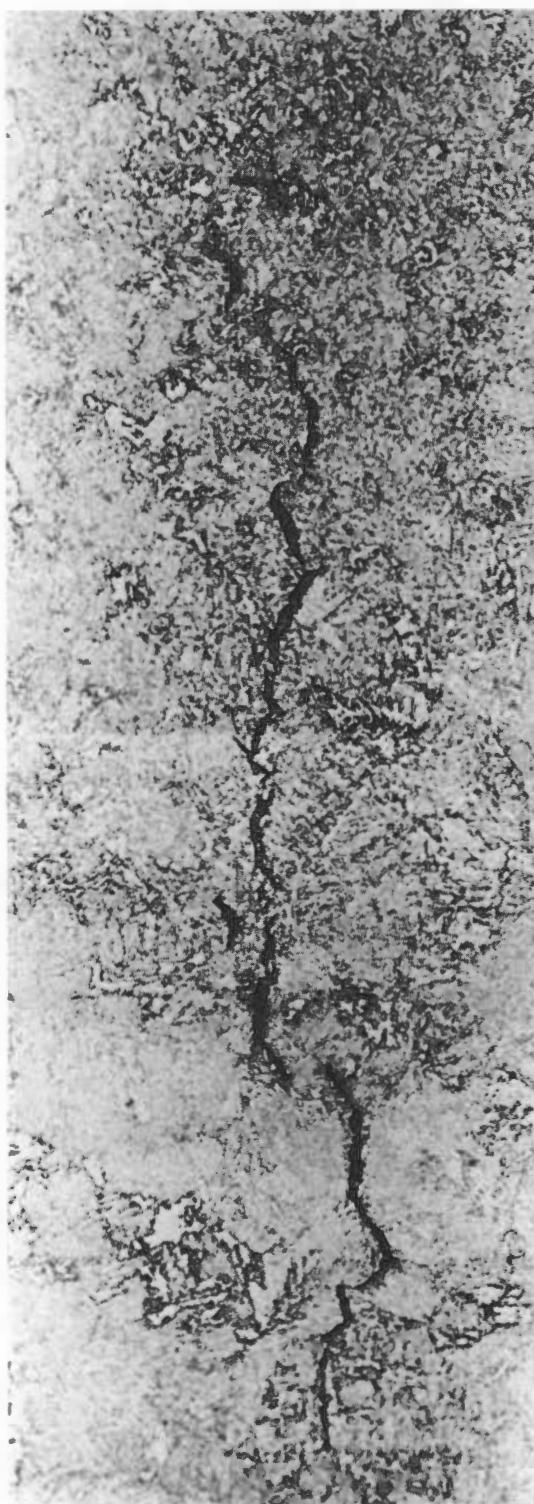
Figure B-2 Montage of Crack in Sample D X100  
Refs: 111/10/76 & 112/10/76

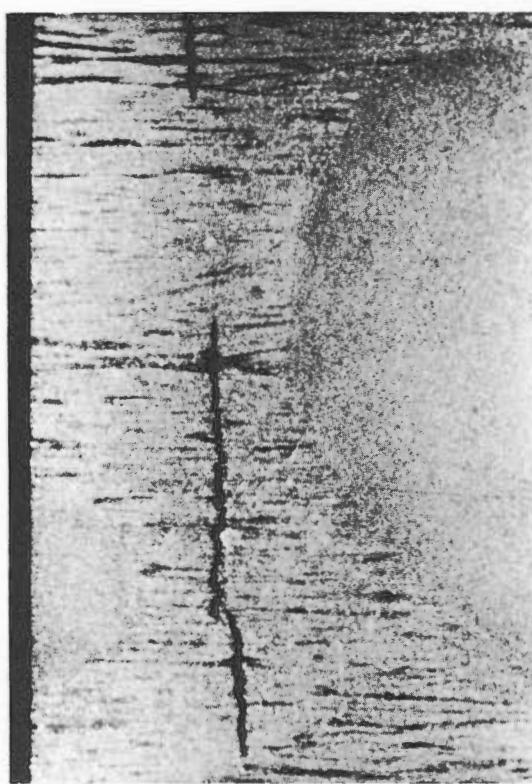
Figure B-3 Cracking in Sample E X6 Ref: 141/10/76

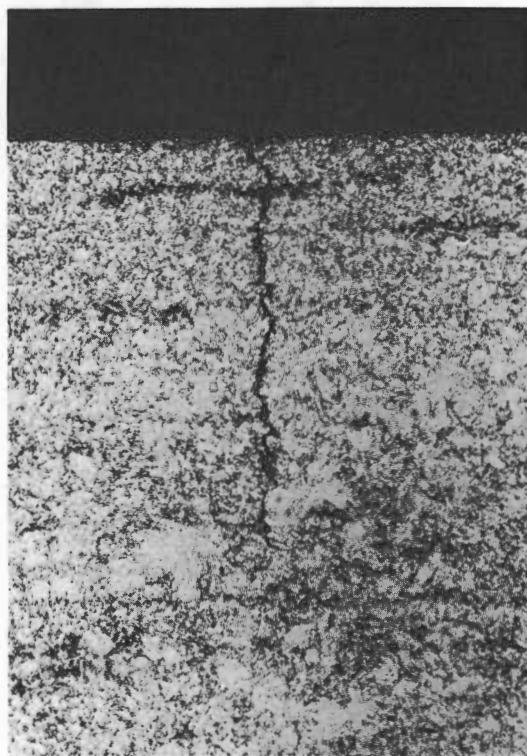
Figure B-4 Smaller Crack in Sample E X25 Ref: 92/10/76

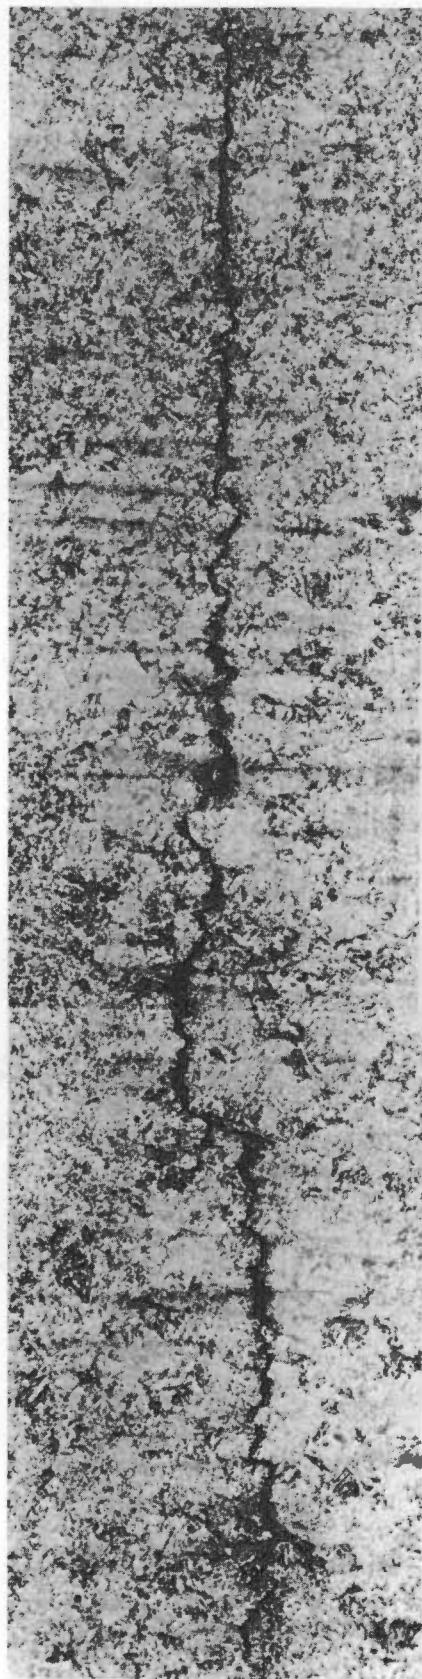
Figure B-5

Montage of Largest Crack in Sample E X25

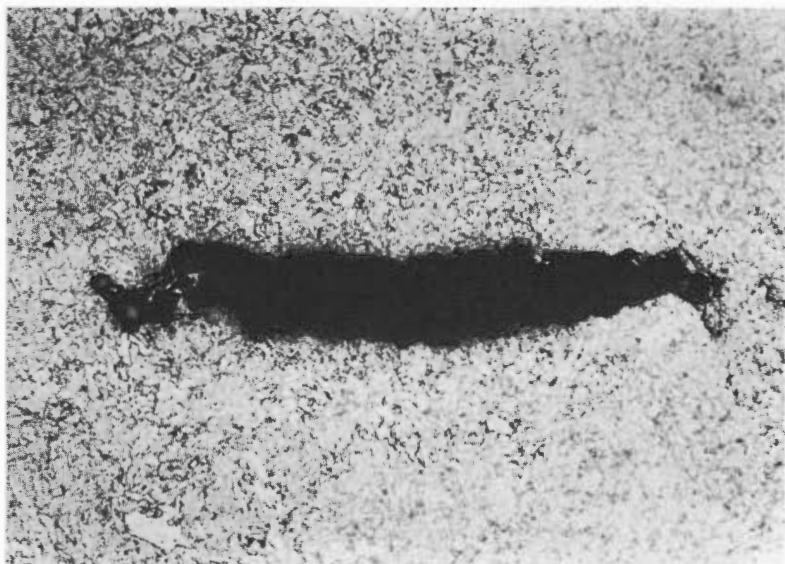
Figure B -6      Third Crack Found in Sample E   X100   Ref: 84/10/76

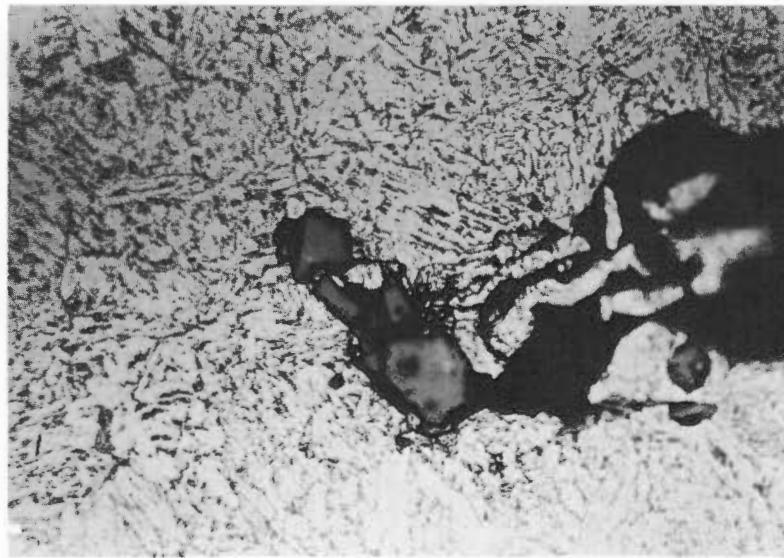
Figure B-7      Alumina Inclusion Associated with Crack   X1000  
Ref: 88/10/76

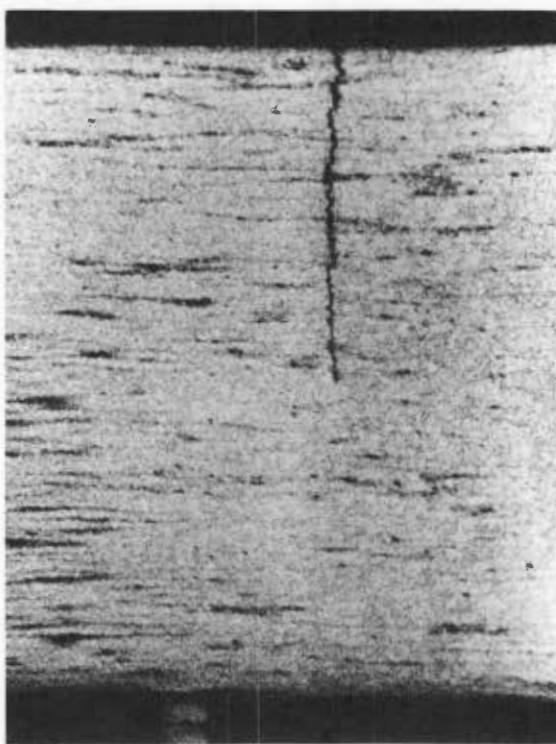
Figure B-8 Crack in Sample F X10 Ref: 142/10/76

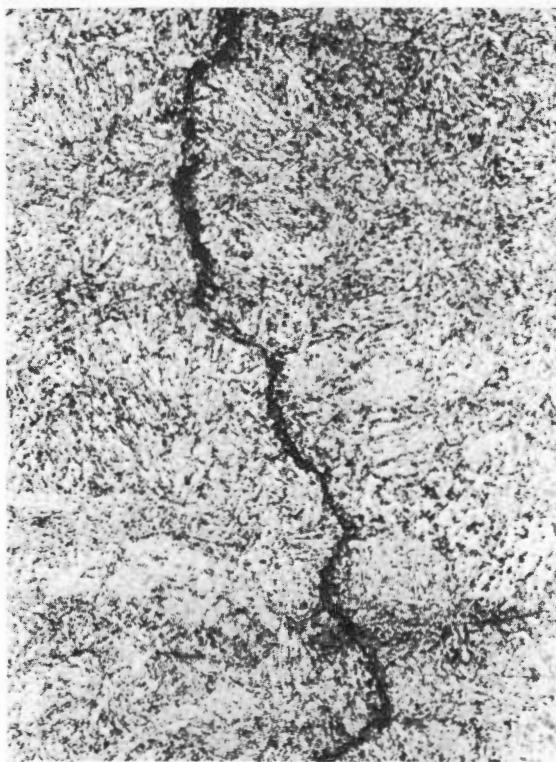
Figure B-9 Intergranular Nature of Crack in Sample F X1000  
Ref: 73/10/76
