NUREG/CR-1665
UCRL-53005

Response of El Centro Steam Plant Equipment During the October 15, 1979 Imperial Valley Earthquake

T. A. Nelson, R. C. Murray, J. A. Young, R. D. Campbell, J. A. Martore,
H. A. Levin, L. Reiter

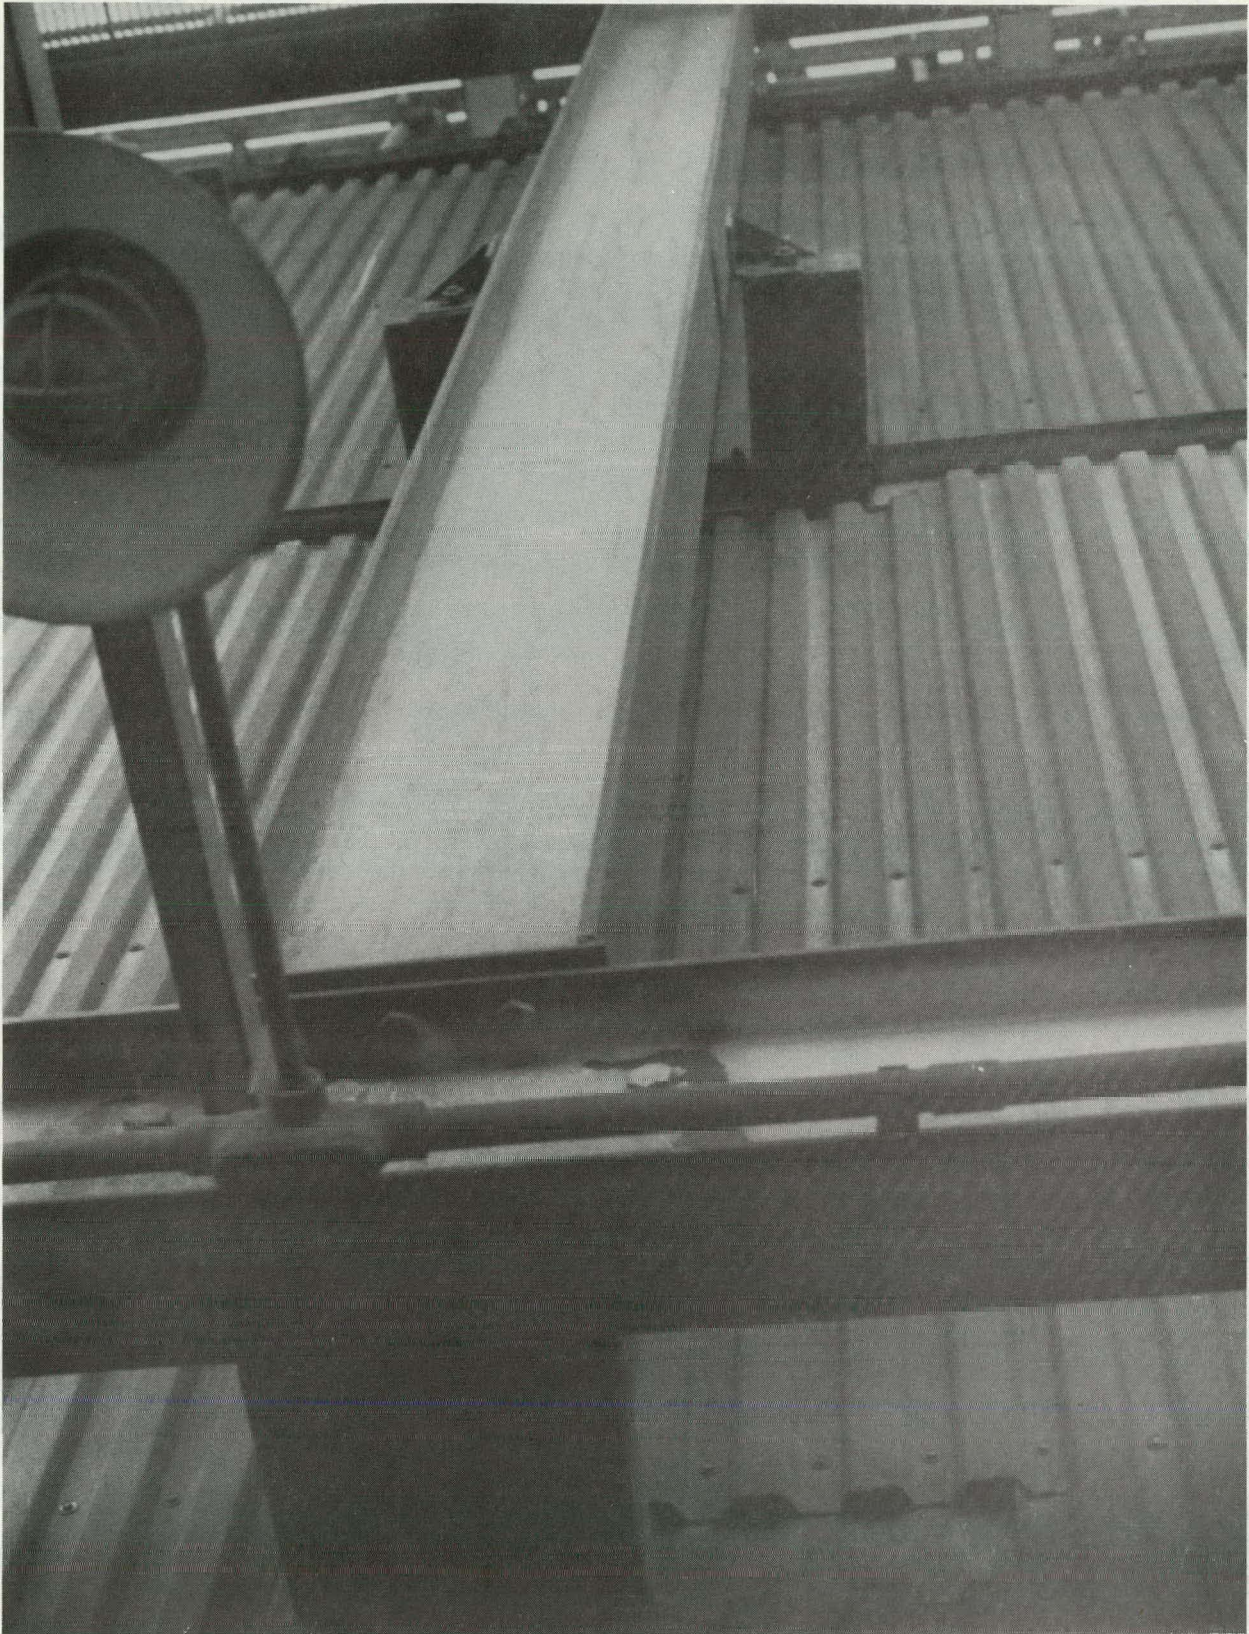
One of the few areas where structural damage was observed was the Unit 4 boiler, which is hung in a pendulum fashion using rods supported by a braced frame. Lateral seismic restraints are mounted on the braced frame to minimize excessive motion of the freely supported boiler. Travel through the restraint gap was evidenced by paint chipping in the area and permanent deformation of the restraint (Fig. 6). In addition, three diagonal bracing members on the boiler frame buckled (Fig. 7), apparently due to excessive compressive loads. These diagonals were later replaced.

Fig. 6. Earthquake-induced motion of the Unit 4 boiler--which is suspended from a support structure--widened this seismic restraint on the east side approximately 2 in. by bending the cantilever beams (from Ref. 6).

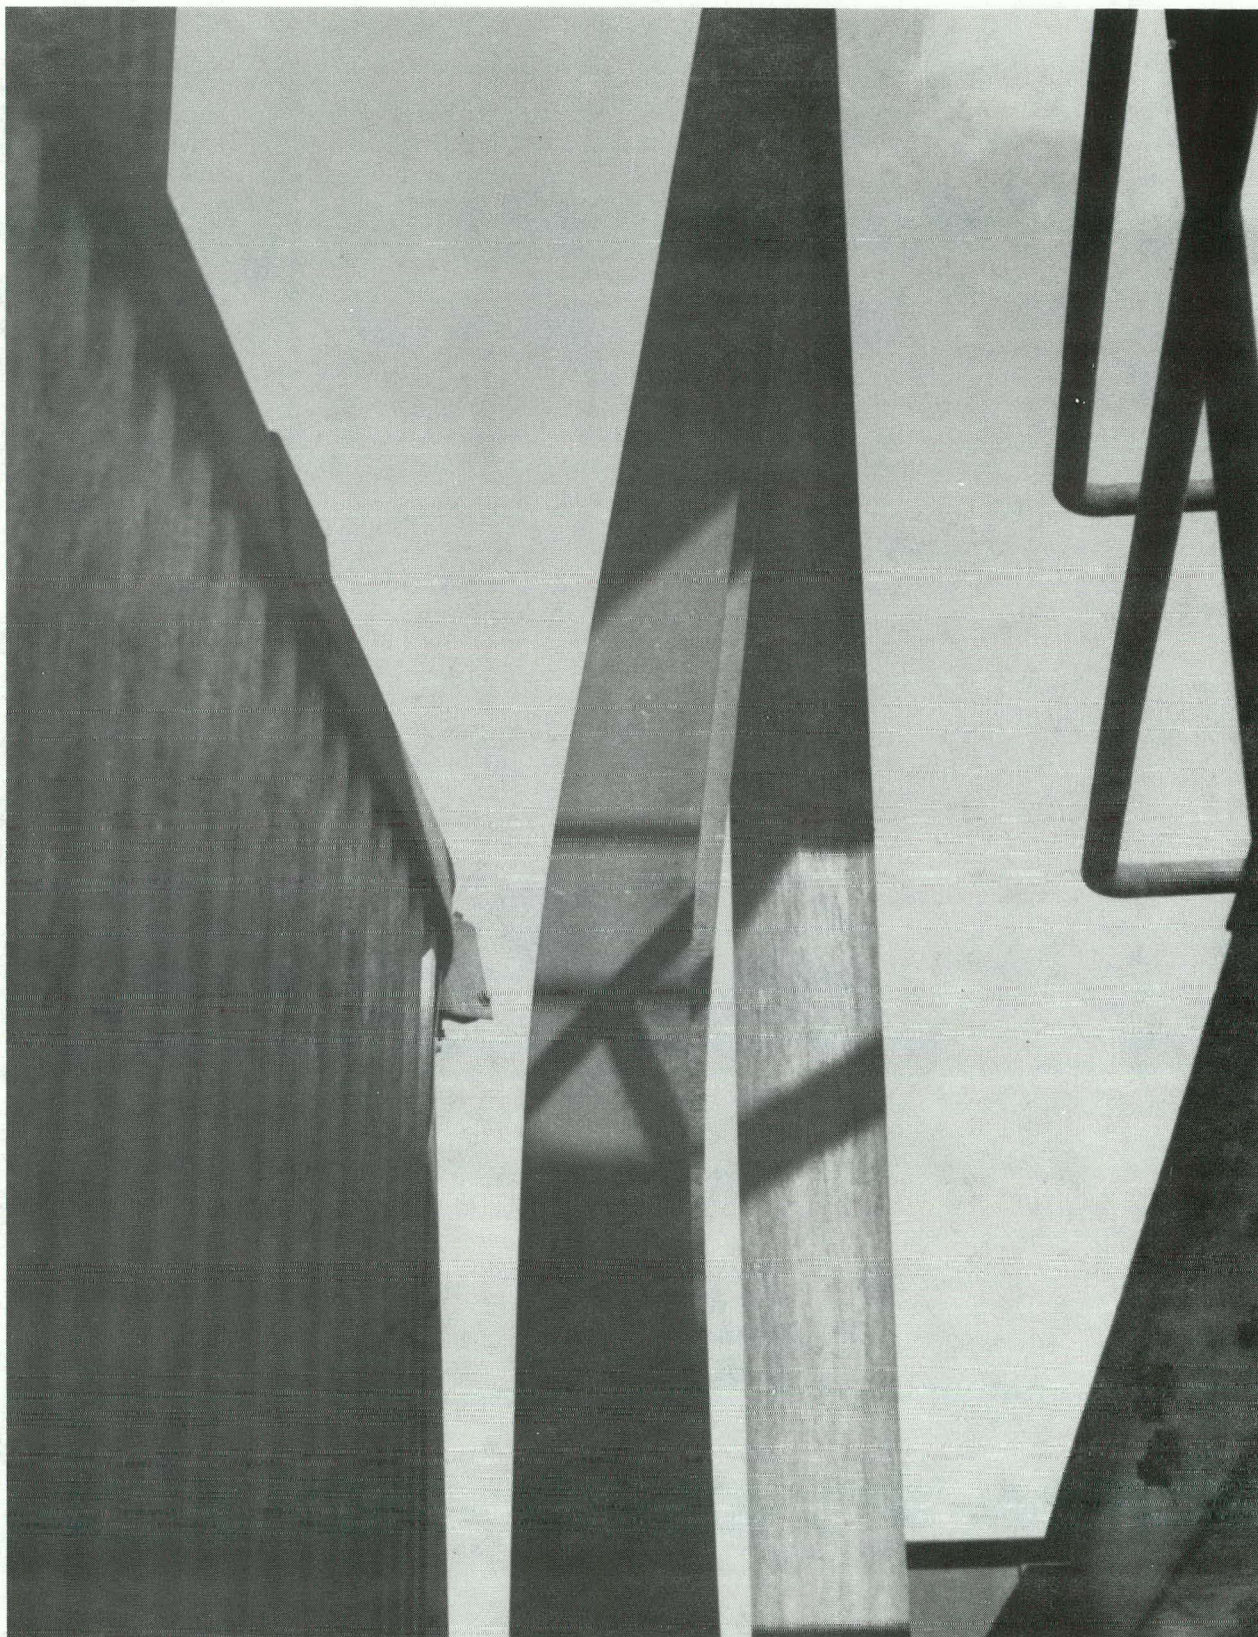
Fig. 7. Diagonal braces on the Unit 4 boiler support frame buckled and had to be replaced.

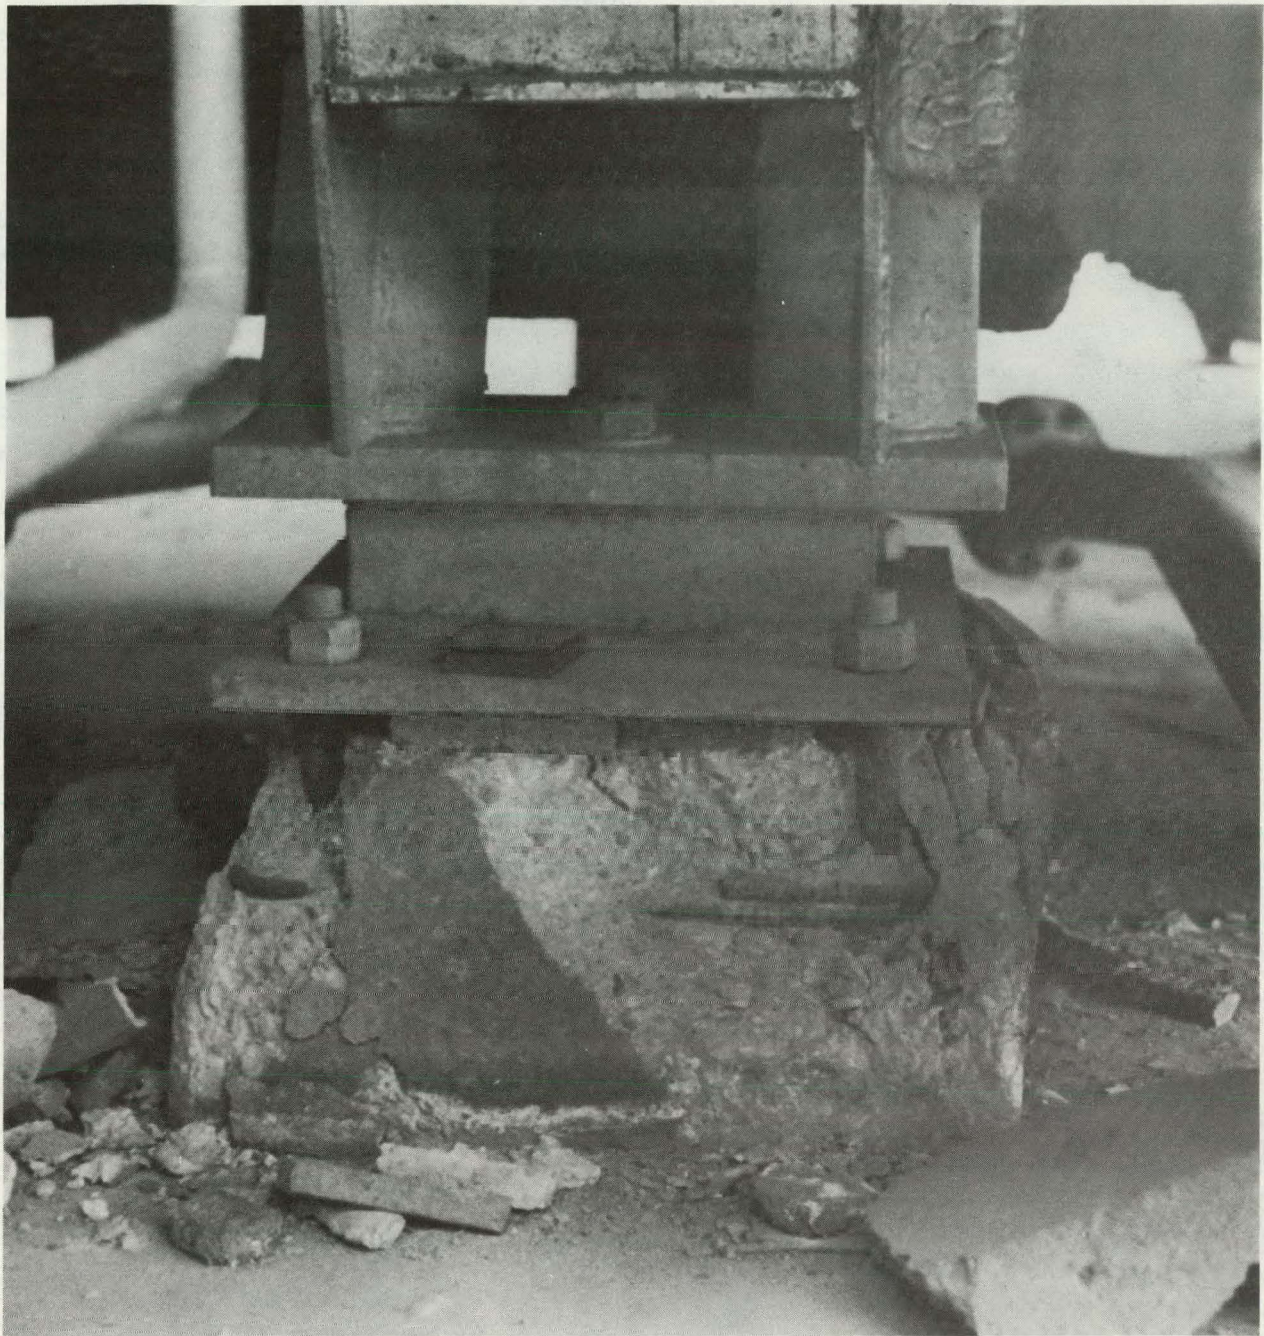
Unit 4 Air Preheater Foundation - One of the concrete foundation support pads had partially crushed but was still functional, and had not been replaced (Fig. 8).

Fig. 8. A concrete foundation support pad on the Unit 4 air preheater foundation was partially crushed but remained functional.

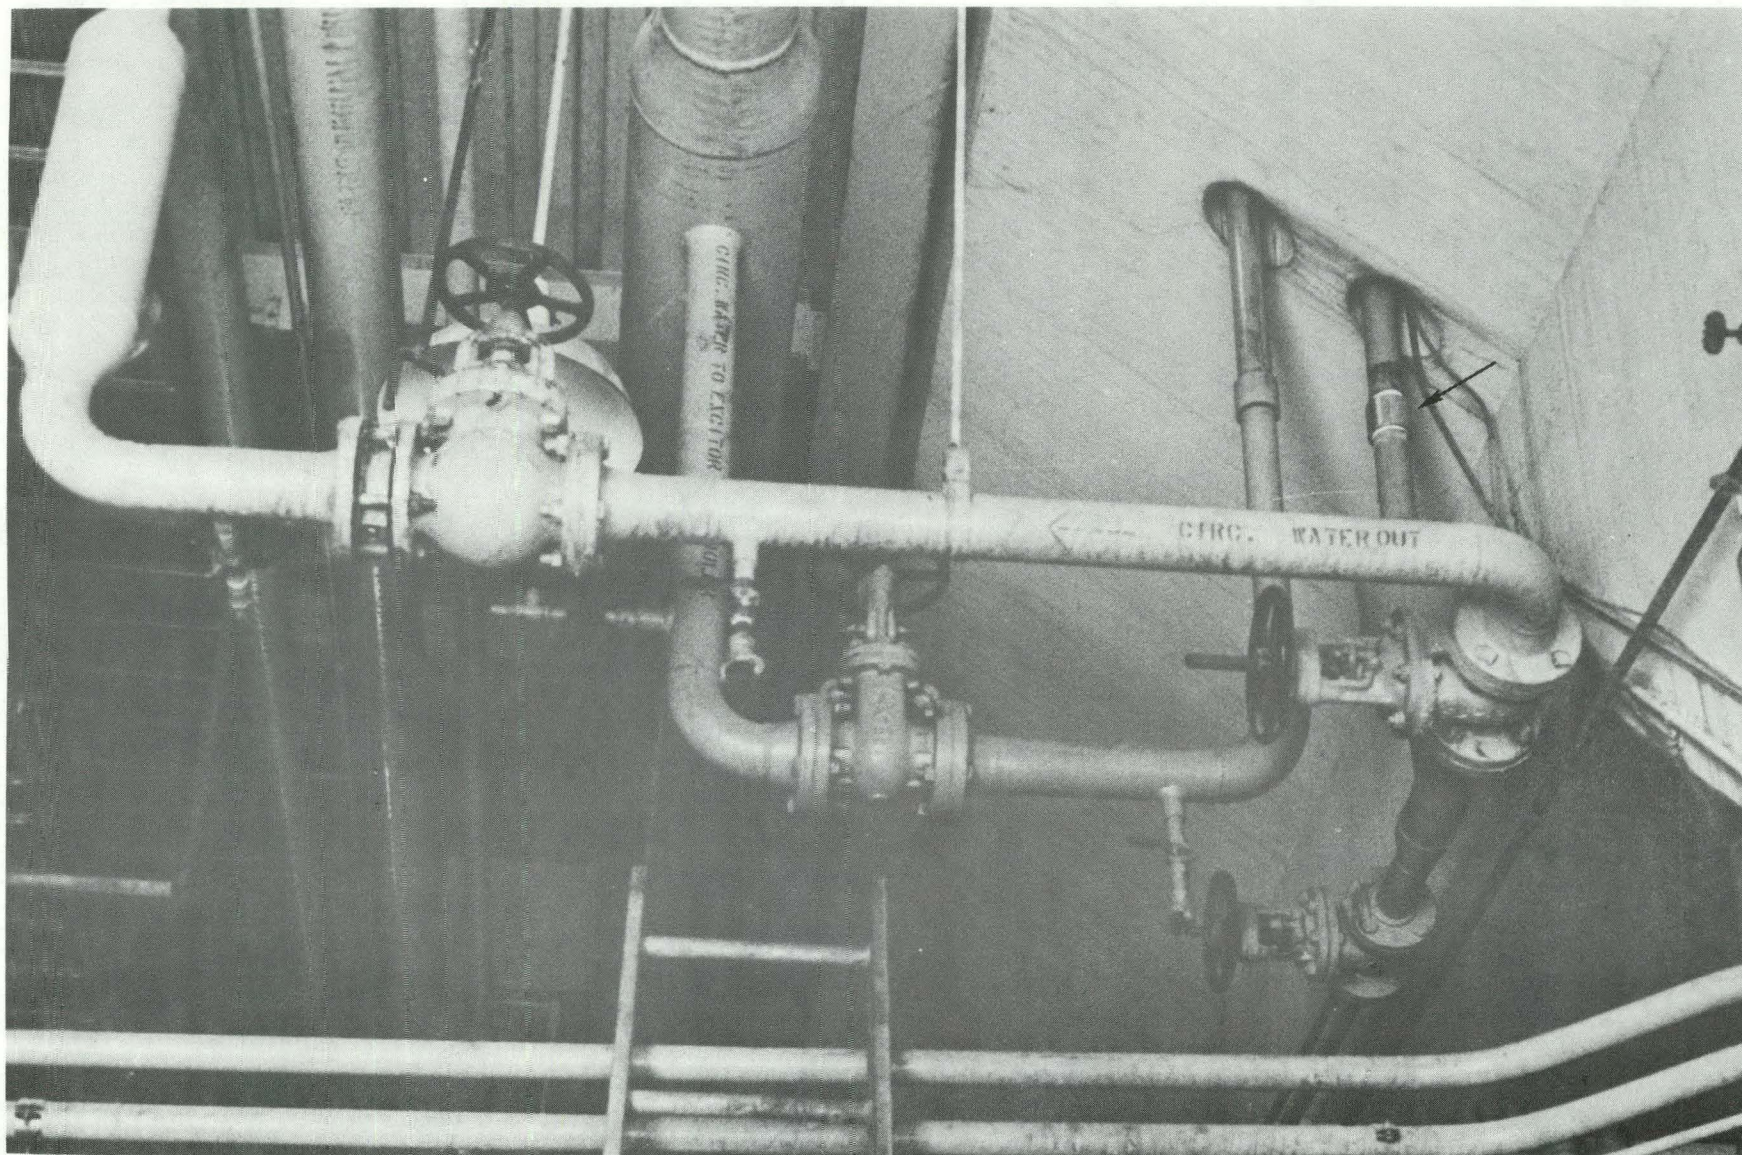
No high-temperature or high-pressure piping failed during the earthquake. However, a Victaulic coupling on a straight section of a 2-in.-diam cooling water line was damaged (Fig. 9). Additionally, 3- and 4-in.-diam water treatment and hydrogen cooling water lines in Units 3 and 4 failed in straight runs in areas which had been either weld repaired or excessively corroded. Circumferential cracks in these corroded lines, apparently caused by the earthquake, were observed; however, leakage was minimal since the cracks were later found to be essentially closed.

Fig. 9. Unit 4 developed leaks in the cooling water piping for the exciter cooler, shown here. Leaks occurred in locations weakened by corrosion. Arrow points to new Victaulic coupling.

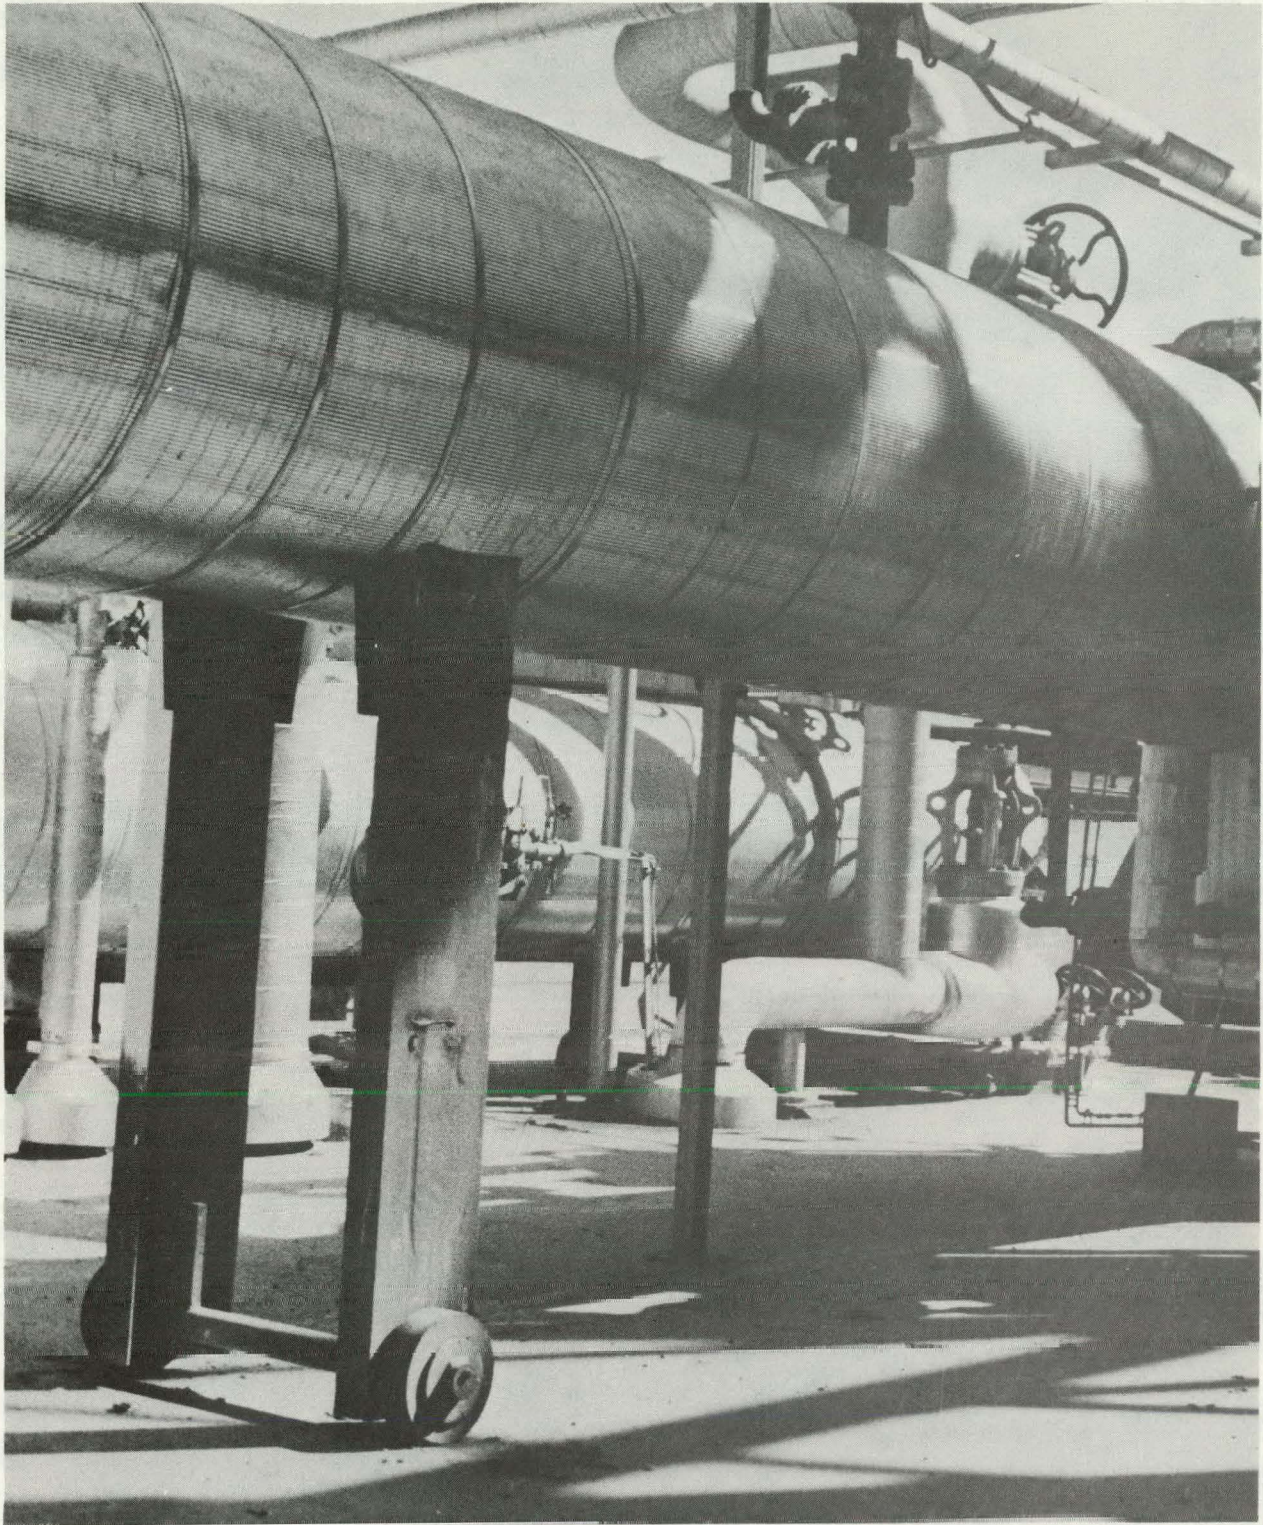
Two items in Unit 3 were not securely anchored and moved during the earthquake. The turbine oil cooler was not anchored to its support pedestal and moved about 1/4 in. The feedwater heater, located on the roof was anchored on one end only with rollers on the opposite end. The unanchored roller supports appeared to have slid laterally (E-W) about 3-5 in. (Fig. 10). Apparently these deflections were adequately tolerated by the attached piping since no evidence of cracking was observed at the nozzles or other discontinuities in the piping. A lateral support has since been added.

Fig. 10. A feedwater heater on the roof of Unit 3 was anchored on one end, but the unanchored end shown moved about 4 in. laterally. Note: wheels are about 6 to 8 in. in diameter.

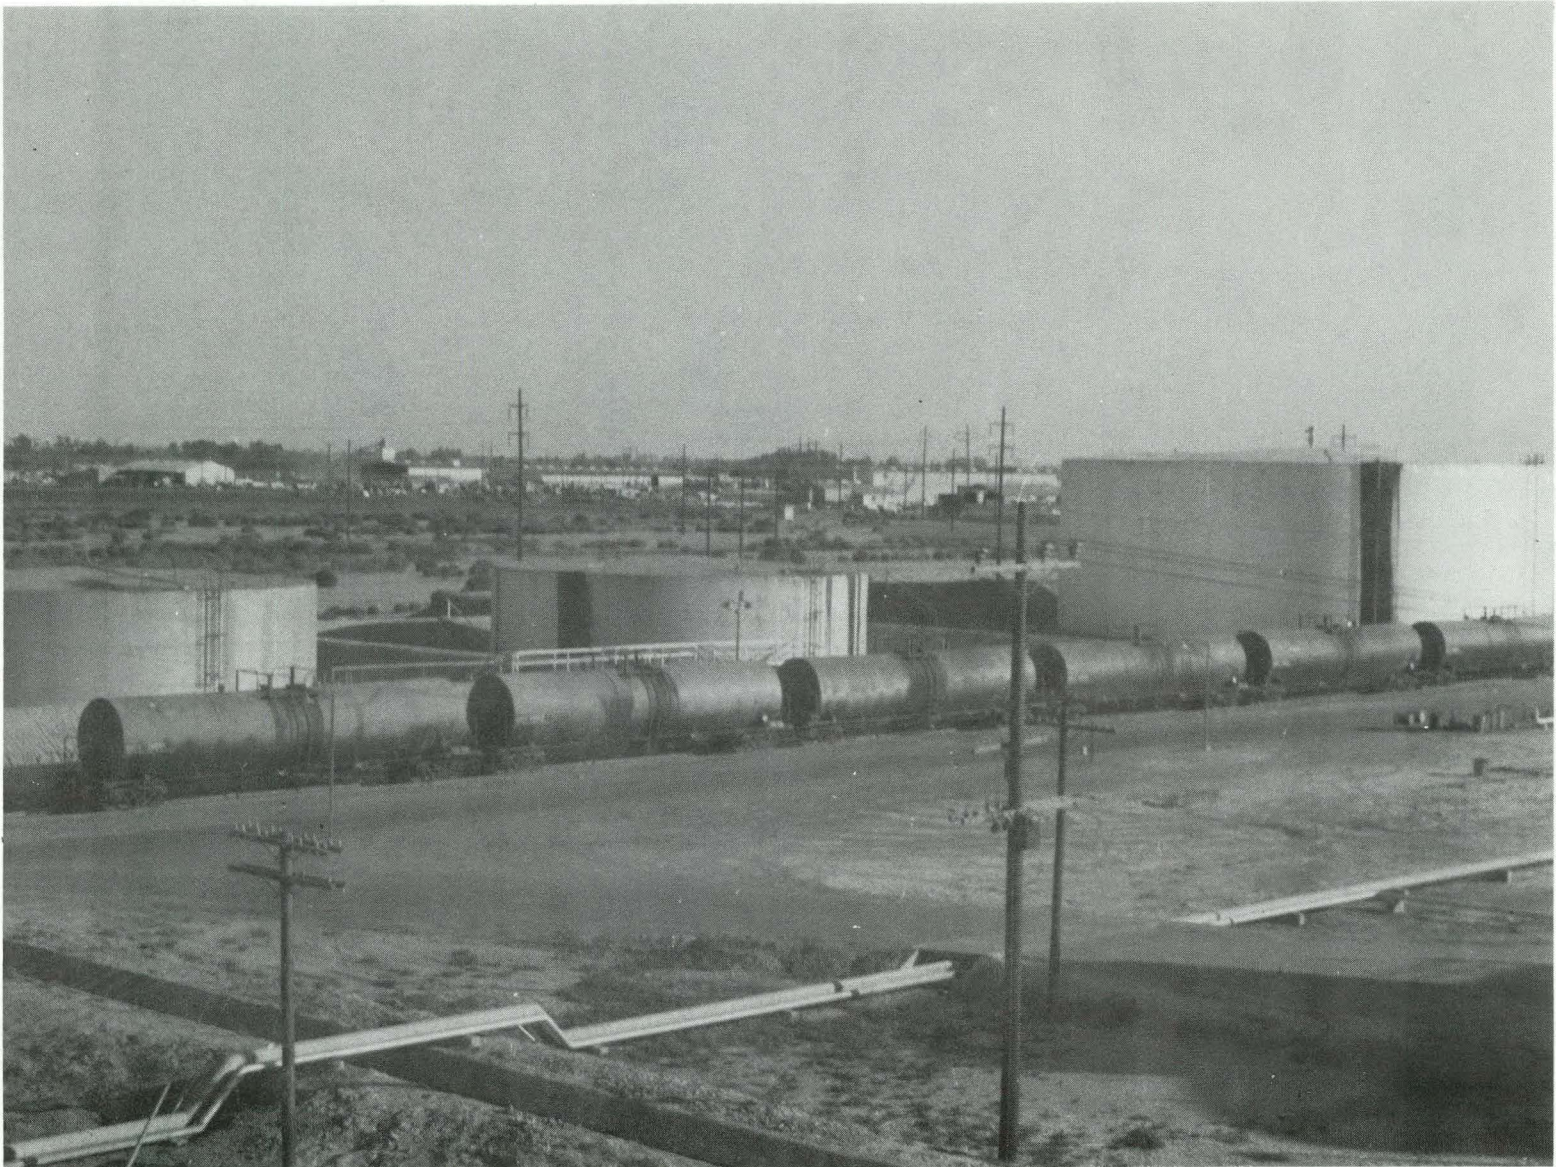
Fig.11. All oil storage tanks except No. 4 were damaged at the roof and leaked oil from the top (from Ref. 6).

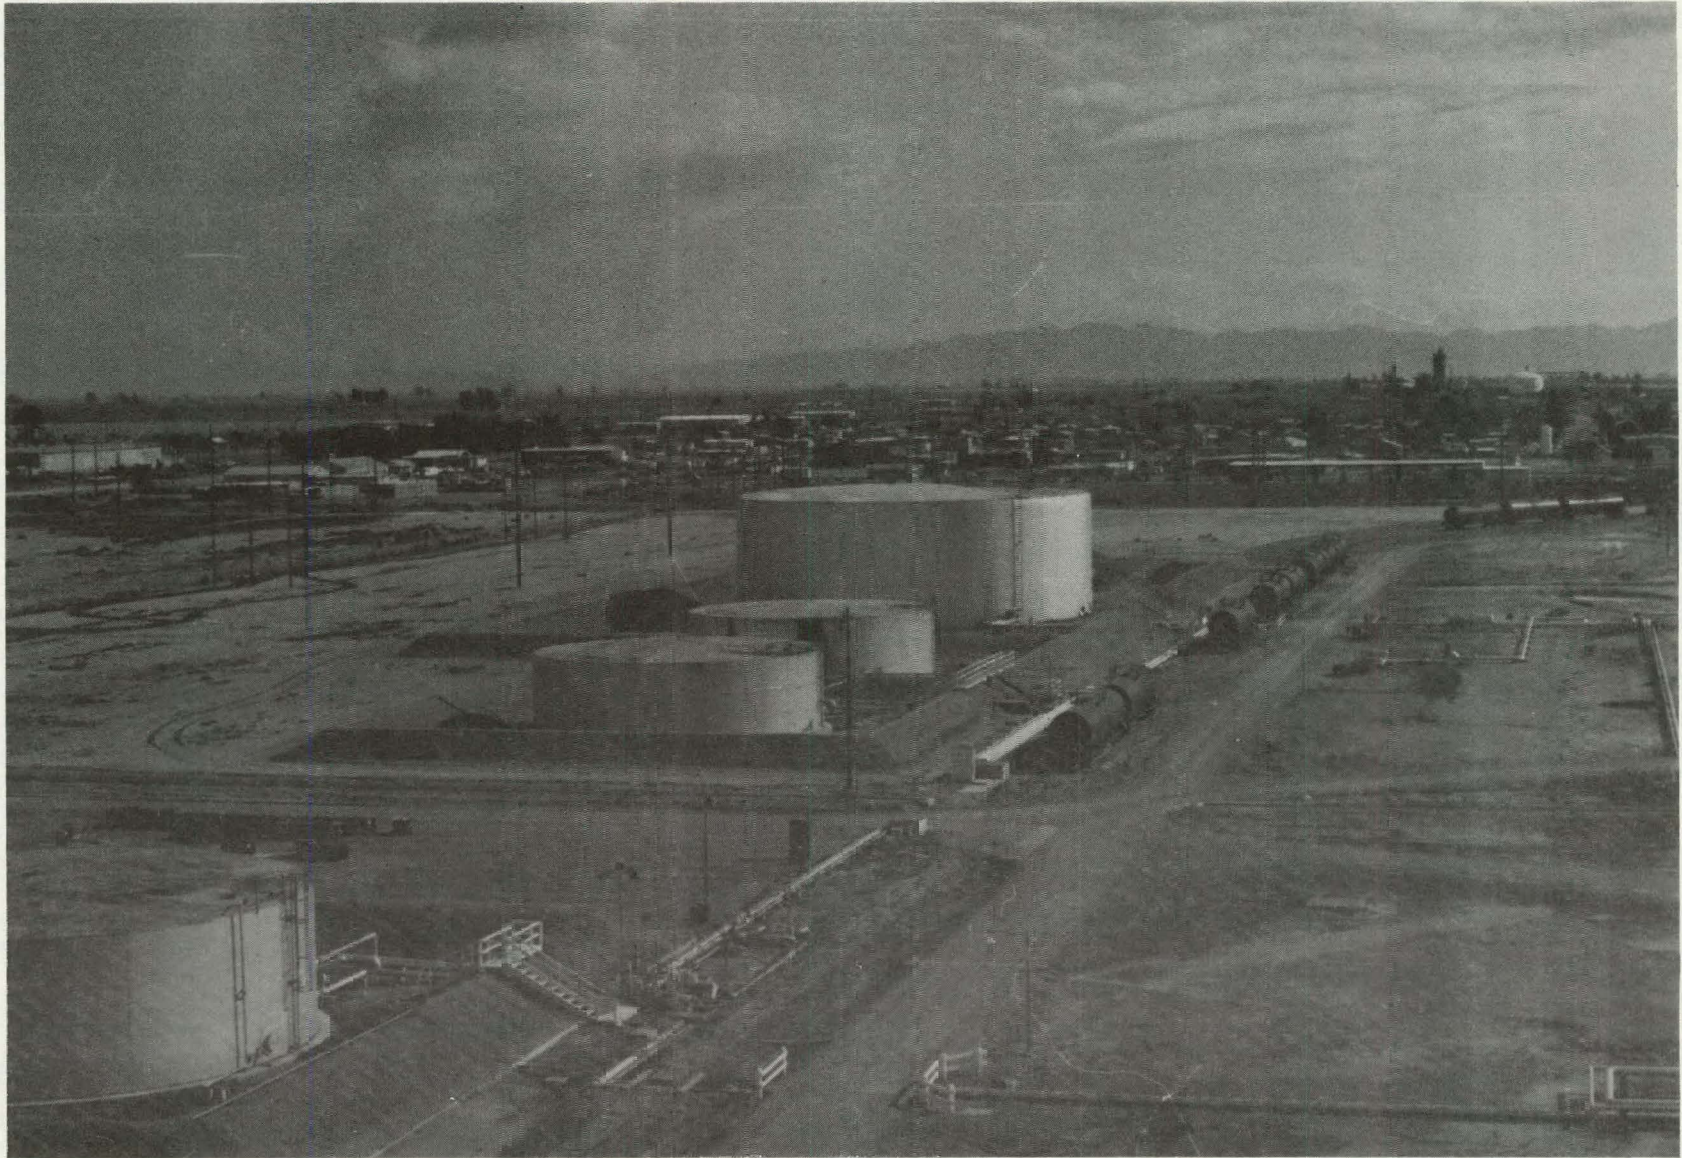
Fig. 12. The large 135-ft-diam tank No. 6 was the most badly damaged.

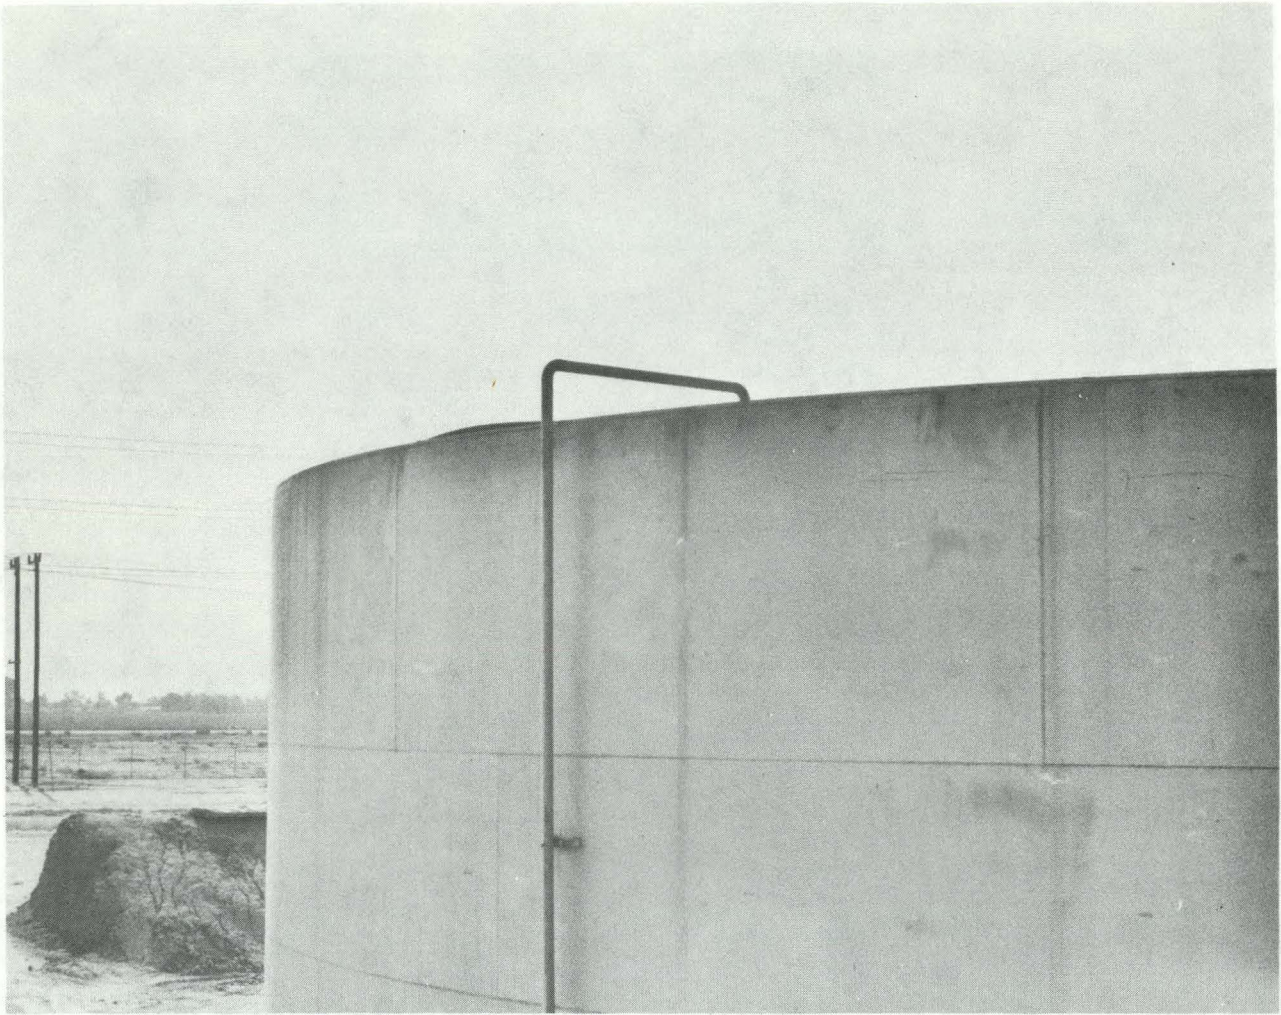
Fig. 13. Tank No. 3 was drained and entry was made during the August site visit. Of the 5 columns supporting the roof, one was badly buckled, causing the roof to sag locally. At about 90° from the buckled column, the roof-to-tank wall weld joint had failed, opening up a crack several feet long where fuel oil sloshed out.

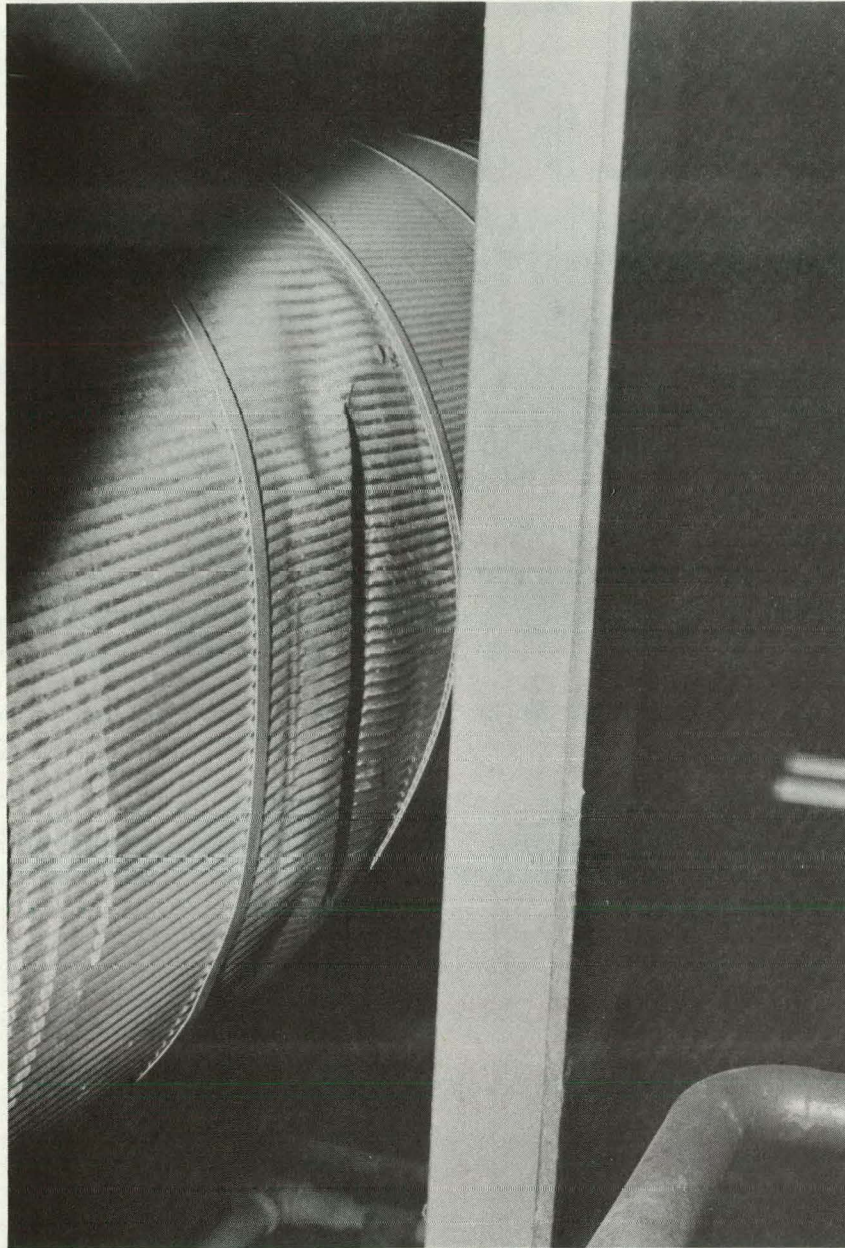
General observations indicate that the piping systems are hung in a more flexible manner than that which would be required by current NRC criteria. For example, the Unit 4 main steam line moved about 1.5 in., impacting a structural steel member and denting its insulation. In most cases, the piping is supported in a similar manner to older operating nuclear power plants, and it may be inferred that the seismic response would be similar. These observations are, on the surface, encouraging since in all cases the circumstances leading to failure are dissimilar to nuclear applications in that damage occurred at weld repaired areas of past corrosive attack or at nonwelded pipe joints.

Fig. 14. The Unit 4 main steam line moved about 1.5 in., hitting a structural member and denting insulation.
