PERFORMANCE EVALUATION OF AUTOMATIC EXTRACTION SYSTEM

VOLUME II - PERFORMANCE EVALUATION OF THE AES

FINAL TECHNICAL REPORT

CONTRACTOR - THE DEPARTMENT OF MINERAL ENGINEERING
THE PENNSYLVANIA STATE UNIVERSITY

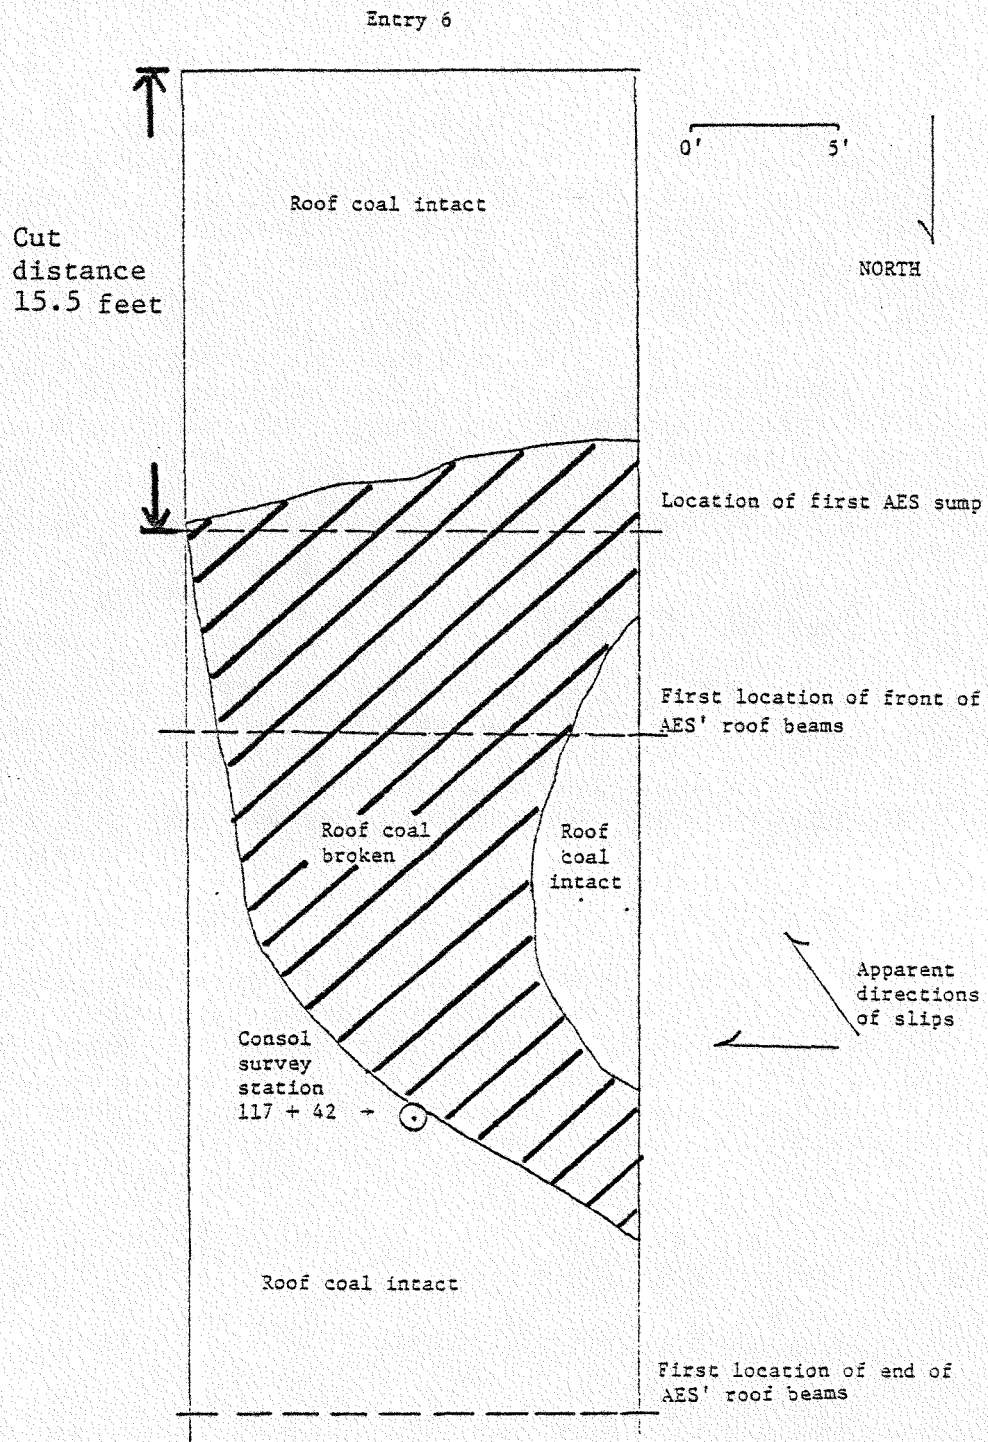
Figure 21

A stress crack, which developed because unusually high pressures were created when the beams were pressed against the roof over one

Roof Deterioration in Face of Entry 6 -
 Influenced by Action of Roof-Beam Assembly
 on May 24, 1978.

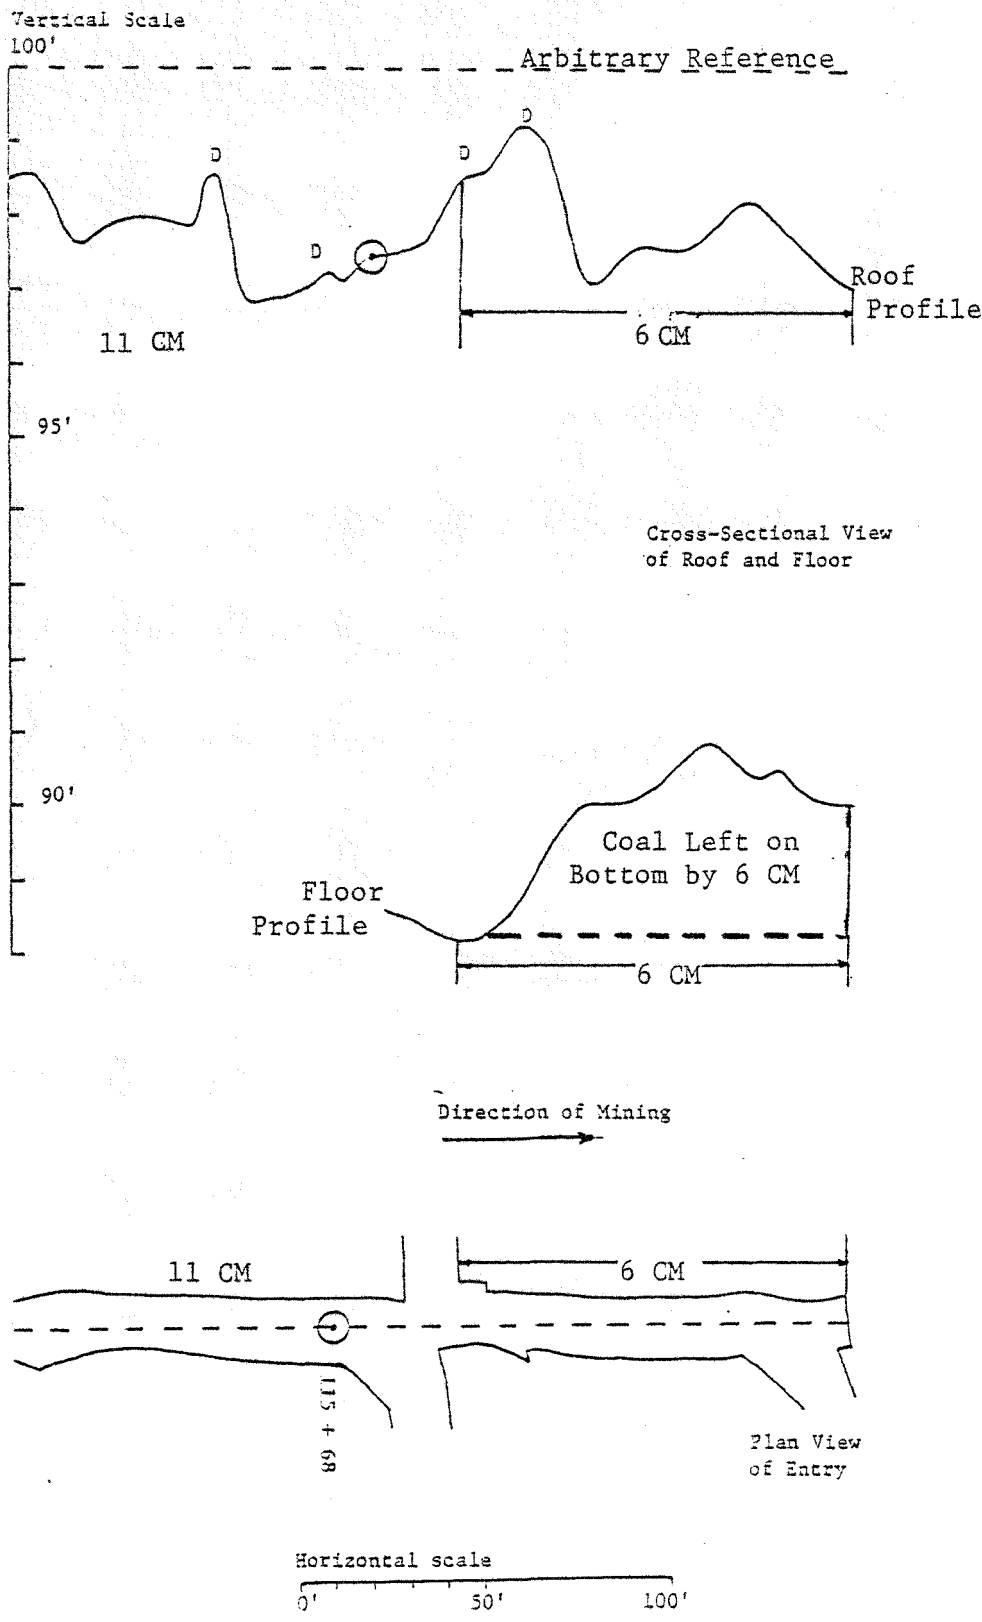
Figure 22

Roof and Floor Profile Entry 4

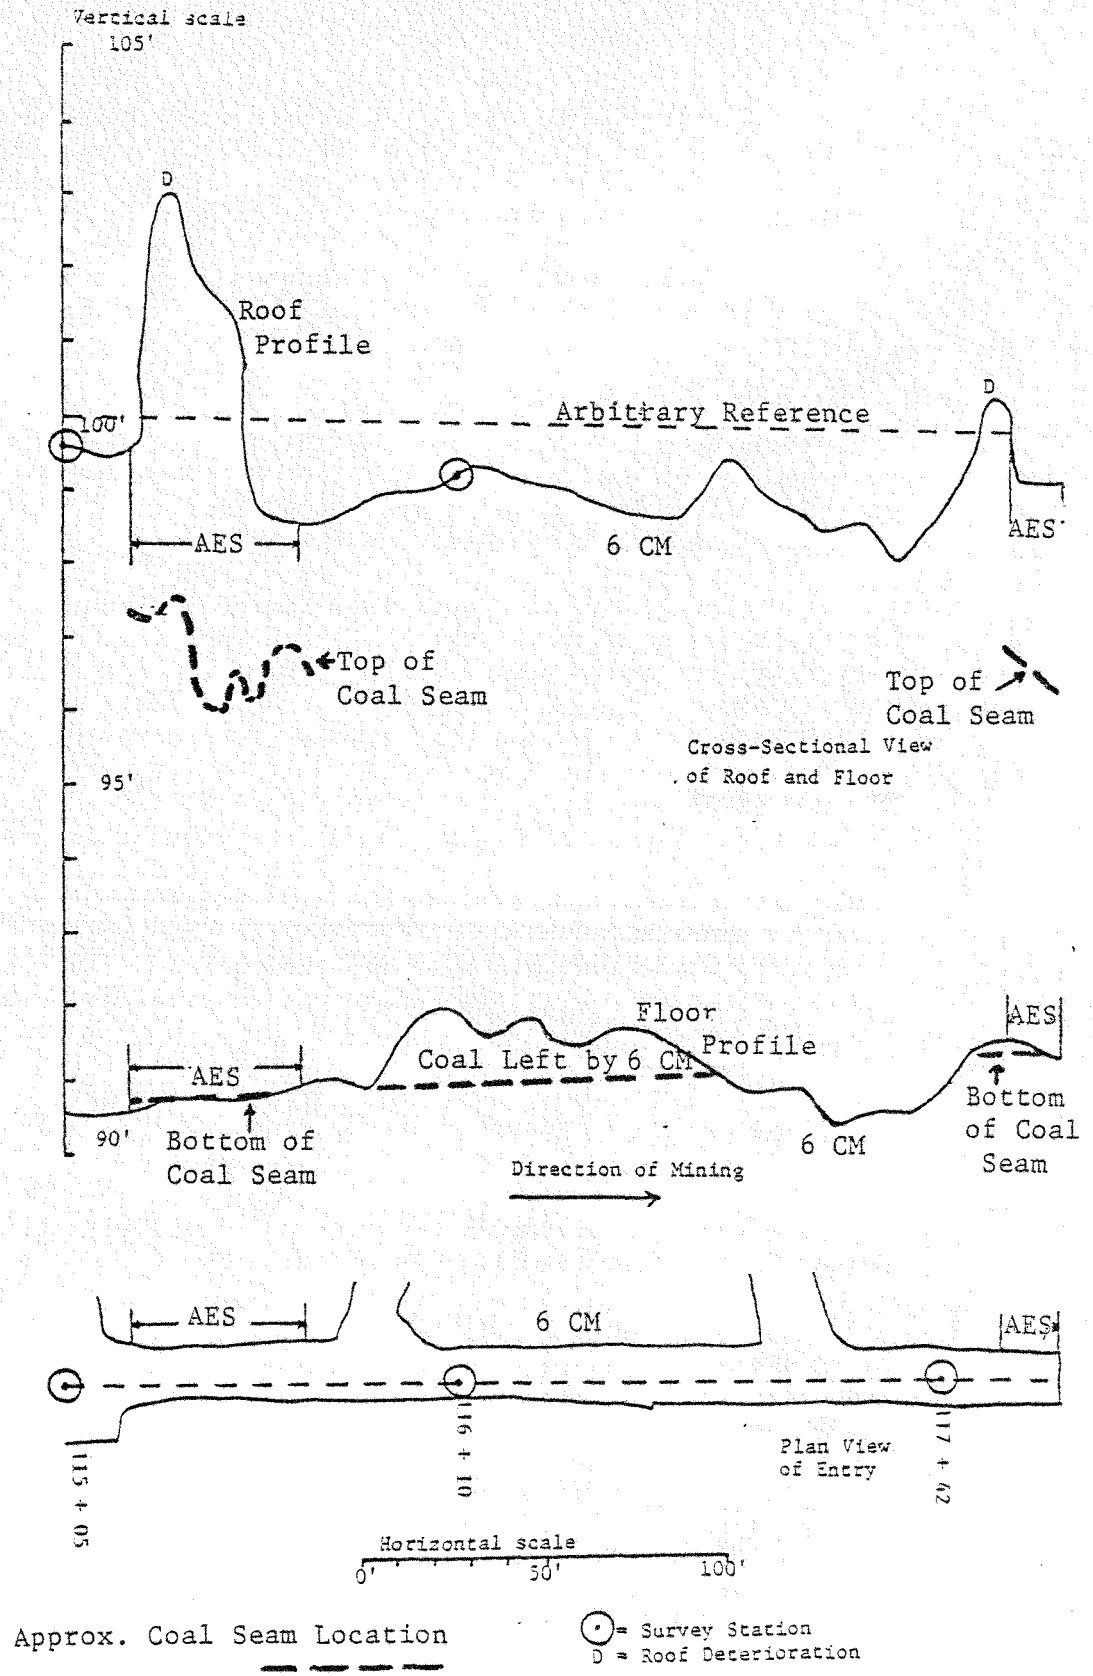
Figure 24

Roof and Floor Profile Entry 6

The floor in the area mined by the AES just inby Survey Station 115+05 is noticeably lower, and the floor in the area mined by the 6 CM is higher in order to allow the 6 CM to reach the roof coal.

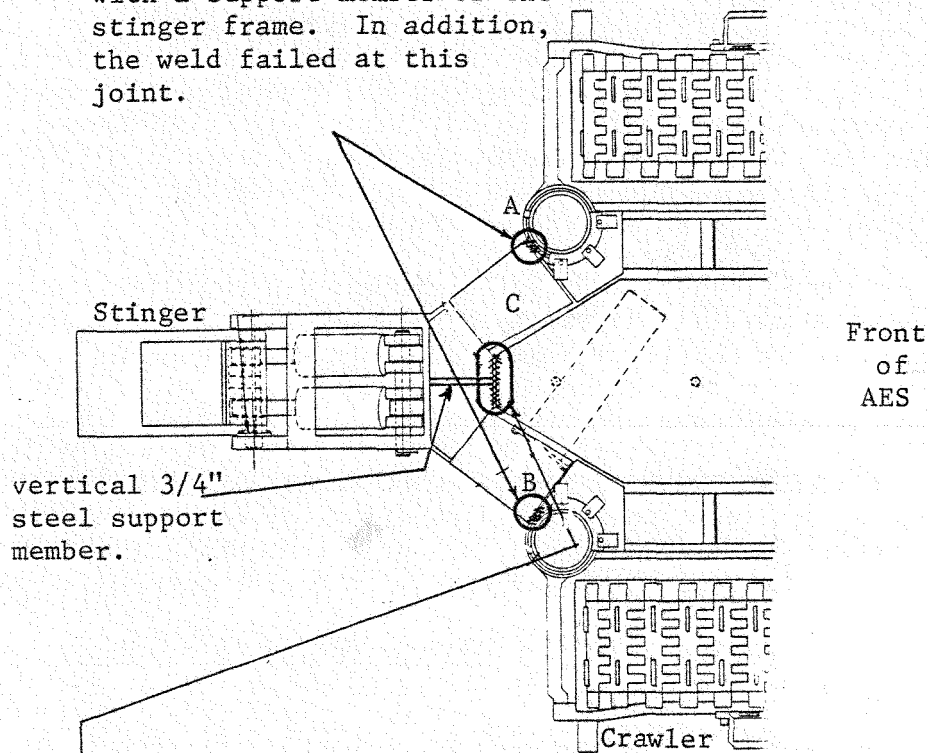
Figure 32

On the eighth week (the final week before the modification period), 117 raw tons of coal were produced on two shifts. But, a major maintenance problem occurred when a crack developed in the stinger frame which required over 18 manhours to repair. Also, a major geological problem was created when the roof fell at the end of the week.

On October 14, 50 raw tons of coal were mined with an advance of approximately 10 feet. During mining, the main frame failed in three places where the stinger assembly is attached (see Figure 32). The

A and B - Roof beam support bowl fractured at the joint with a support member of the stinger frame. In addition, the weld failed at this joint.

C - The 3/8" steel plate fatigued in the cross hatched area. Also, the weld on a 3/4" thick vertical steel support member failed allowing the support member to separate from the main frame.

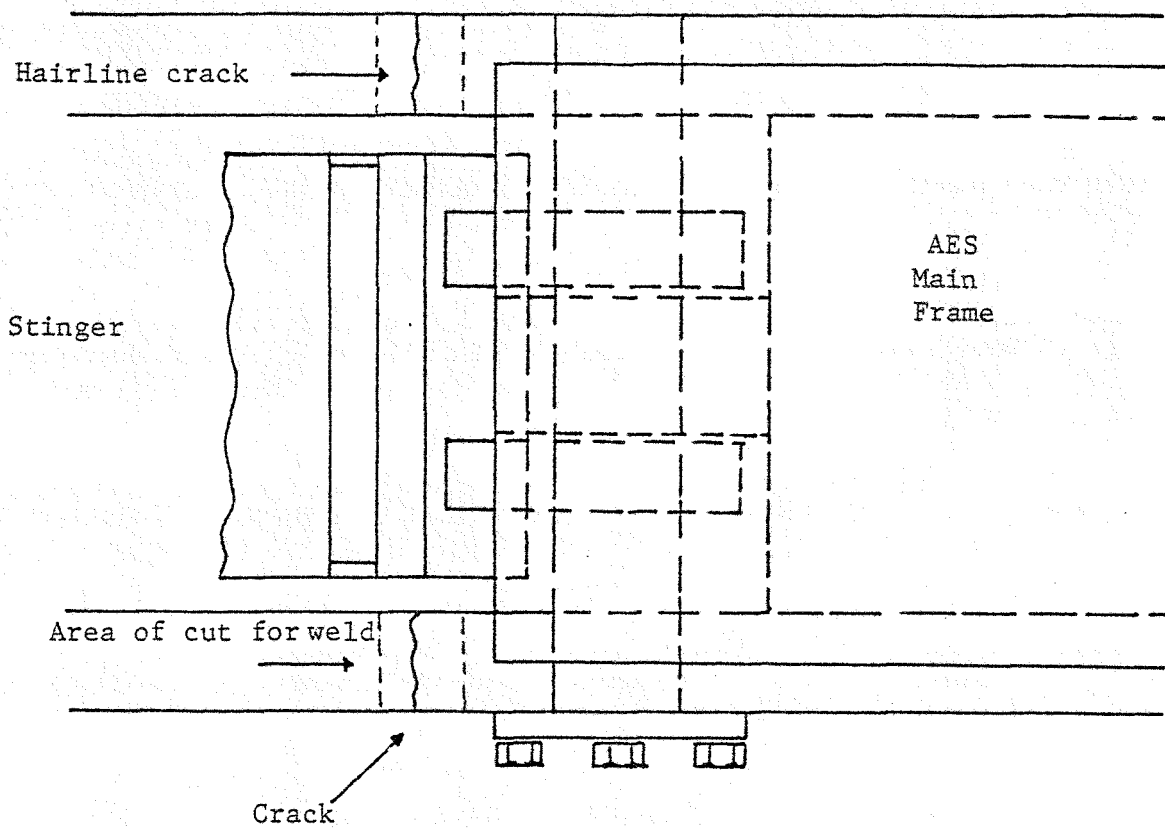
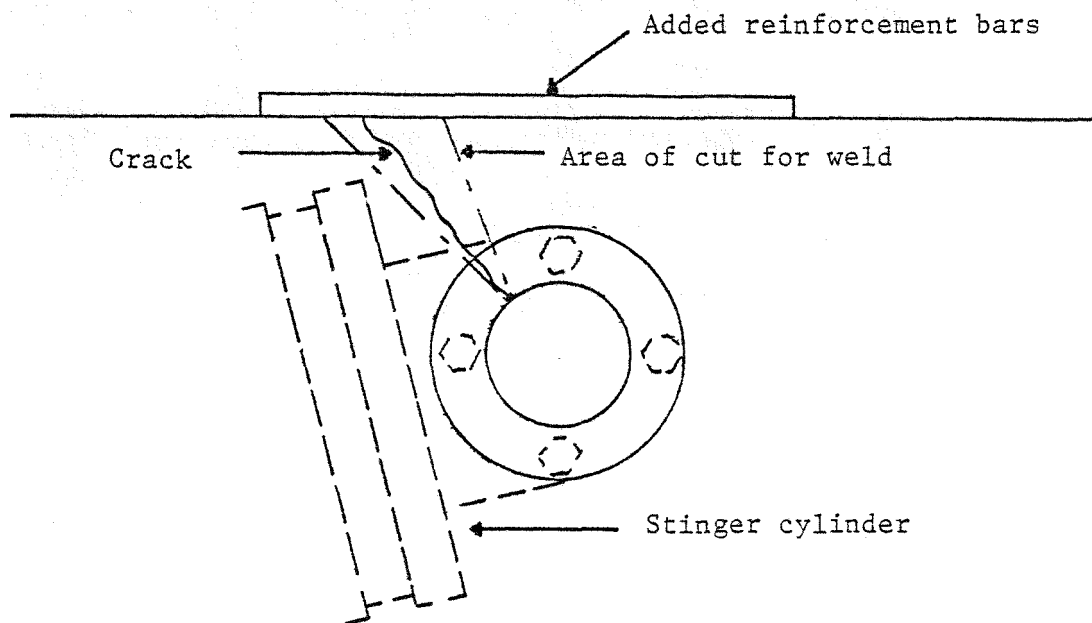
Figure 33

Structural Damage to the AES at the Stinger
(After Modification)

The crack in the stinger was welded on April 13 as shown in Figure 33. The sump counter was repaired by replacing a defective microswitch. The right front and both left dust-collector couplers were replaced. An oil leak was discovered on the left-inner drill-mast but not repaired because of the lack of replacement parts.
