Investigation of Stainless Steel Clad Fuel Rod Failures and Fuel Performance in the Connecticut Yankee Reactor

EPRI NP-2119
Project 1758-1
Final Report
November 1981

Prepared by
Battelle, Columbus Laboratories
Columbus, Ohio

NP-2119
Research Project 1758-1
NUSCO-130

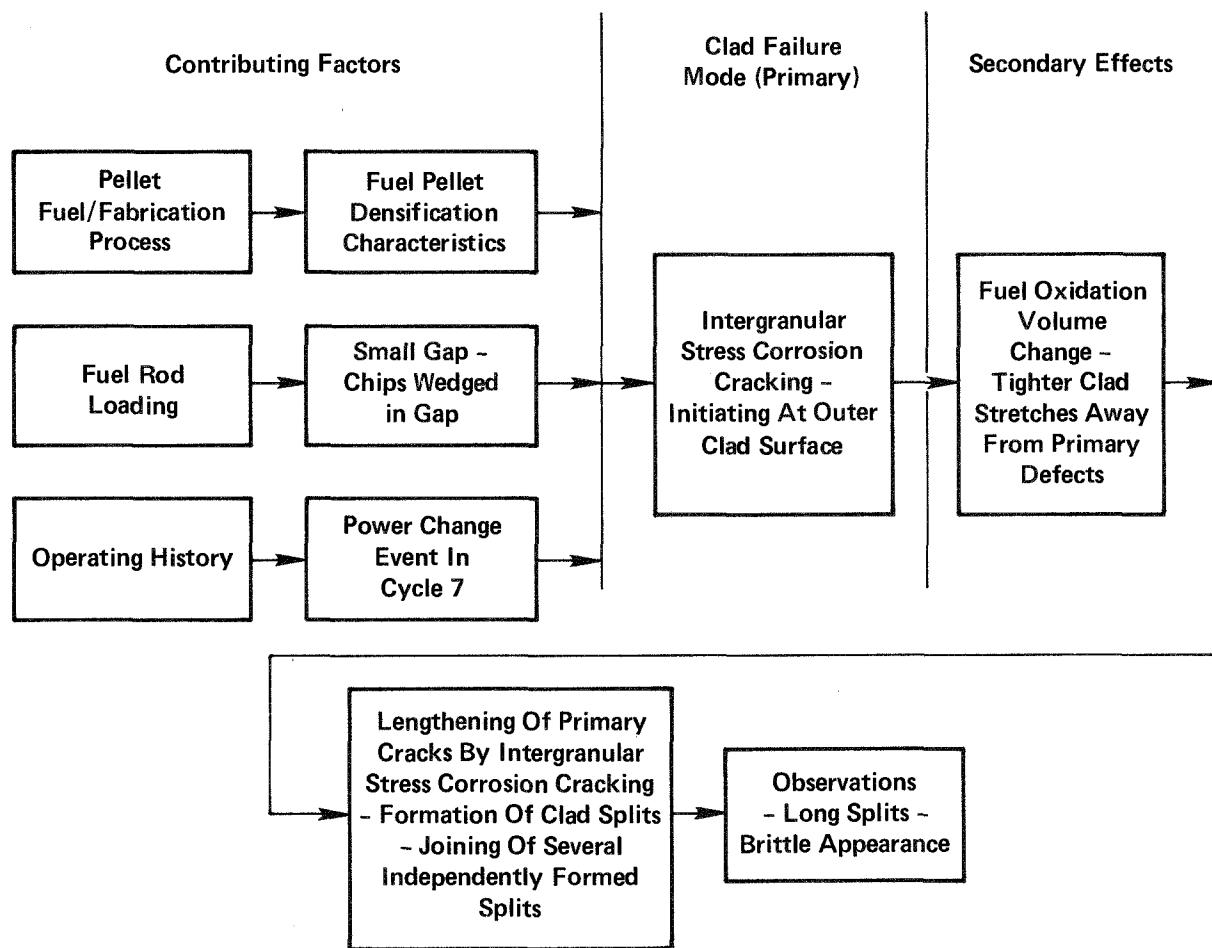
The sequence of events leading to the observed failures may be summarized as shown in Figure S-1.

FIGURE S-1. Batch 8 Fuel Rod Failure Event Tree

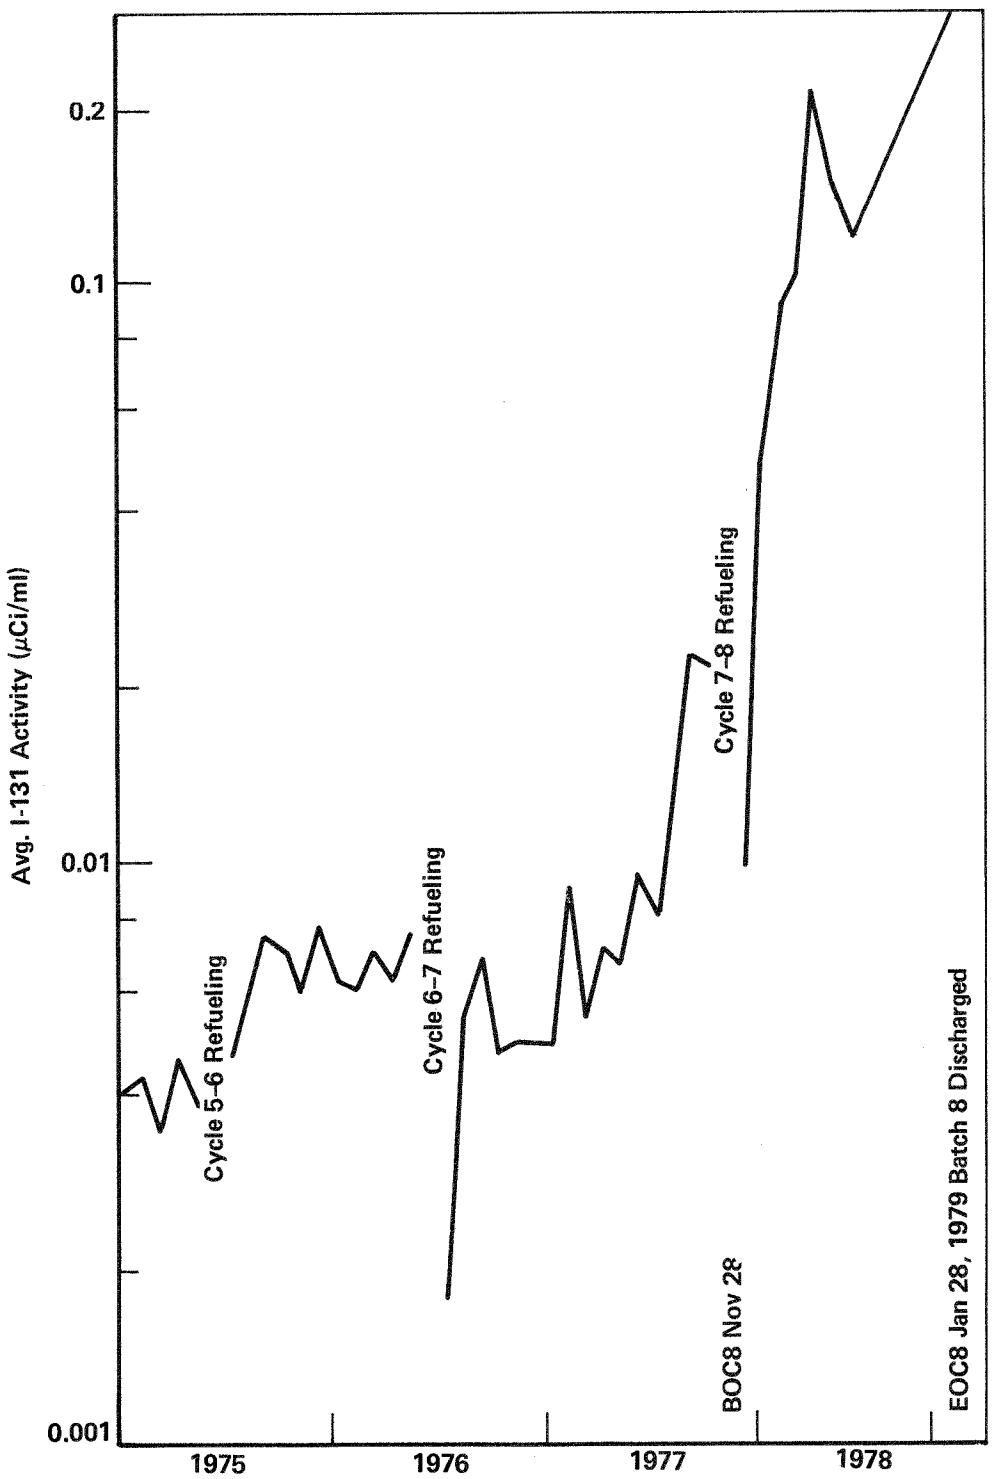
FIGURE 1. Iodine-131 Activity In Primary Coolant of Connecticut Yankee Reactor

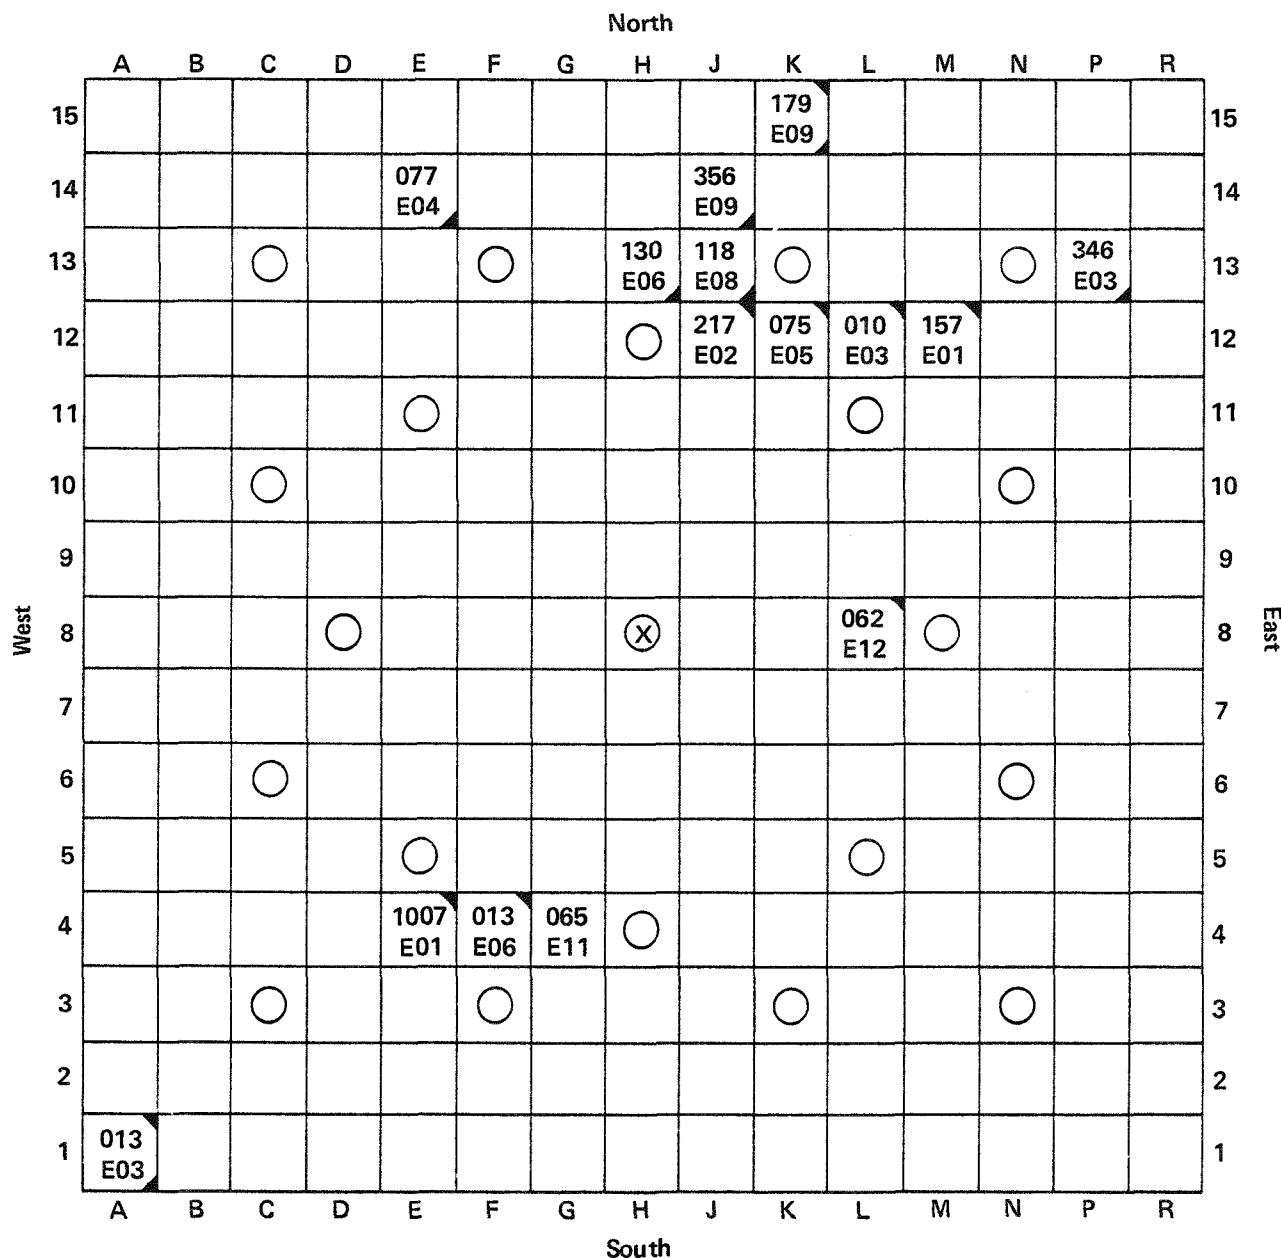
Failed rods

Rod removed for examinations

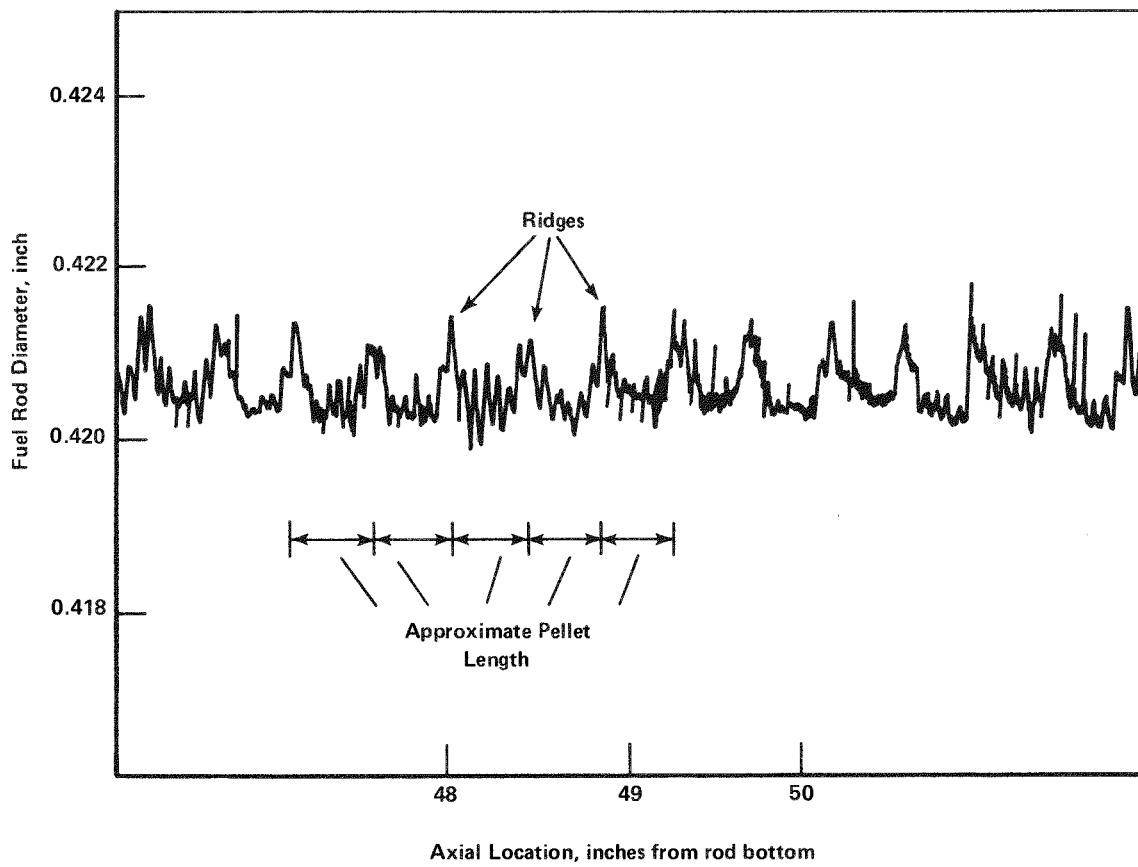
**FIGURE 3. Profilometer Scan Showing Typical Ridging Observed
In The Unfailed Batch 8 Rod 062E12**

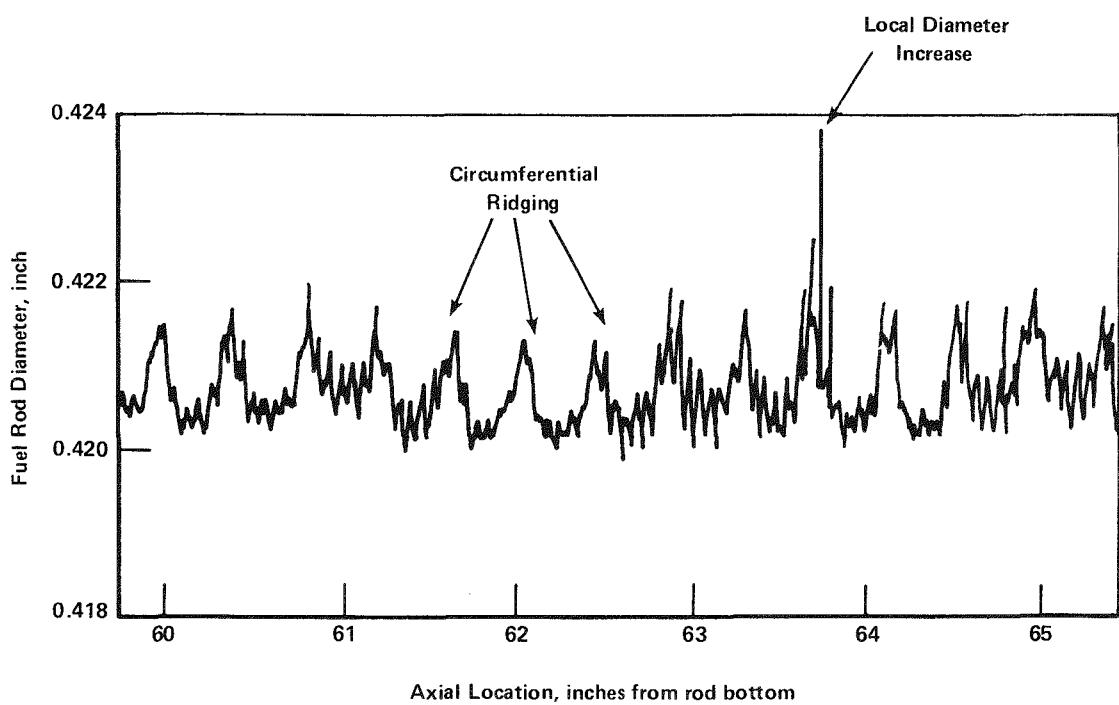
**FIGURE 4. Small Diameter Increase Observed At 63-3/4 in. From Rod Bottom
In The Unfailed Batch 8 Rod 157E01**

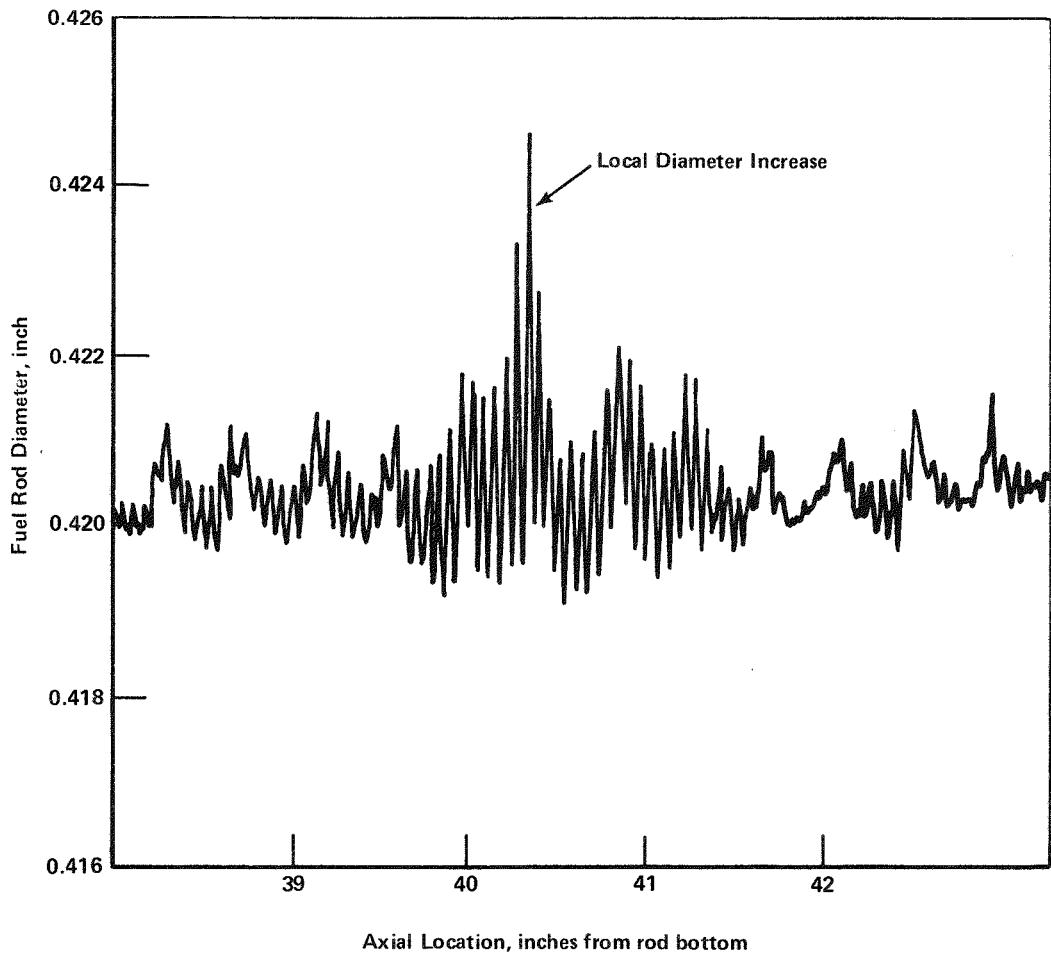
FIGURE 5. Local Diameter And Ovality Increase Observed In Unfailed Batch 8 Rod 062E12

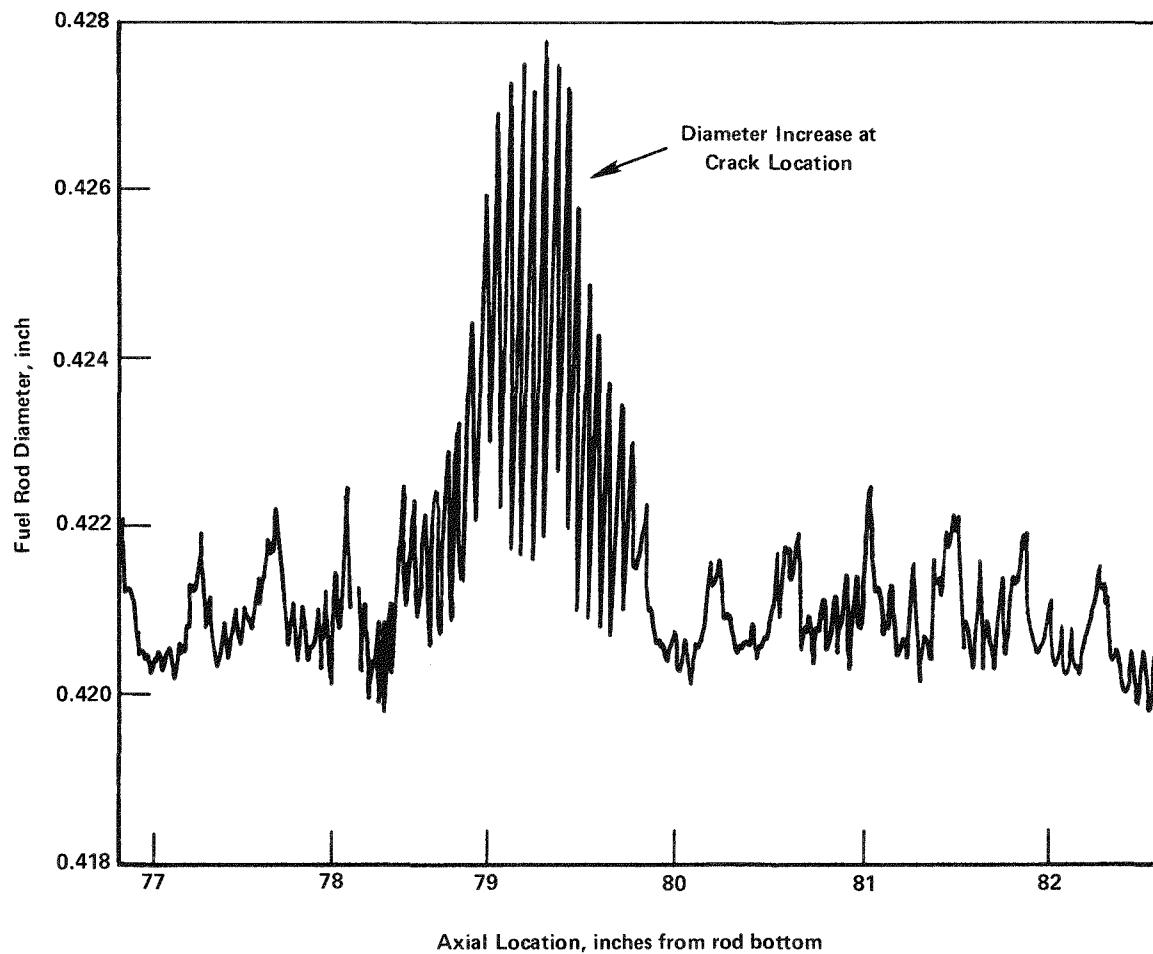
FIGURE 6. Diameter Increase At The Location Of Tight Axial Crack Observed In The Failed Batch 8 Rod 013E03

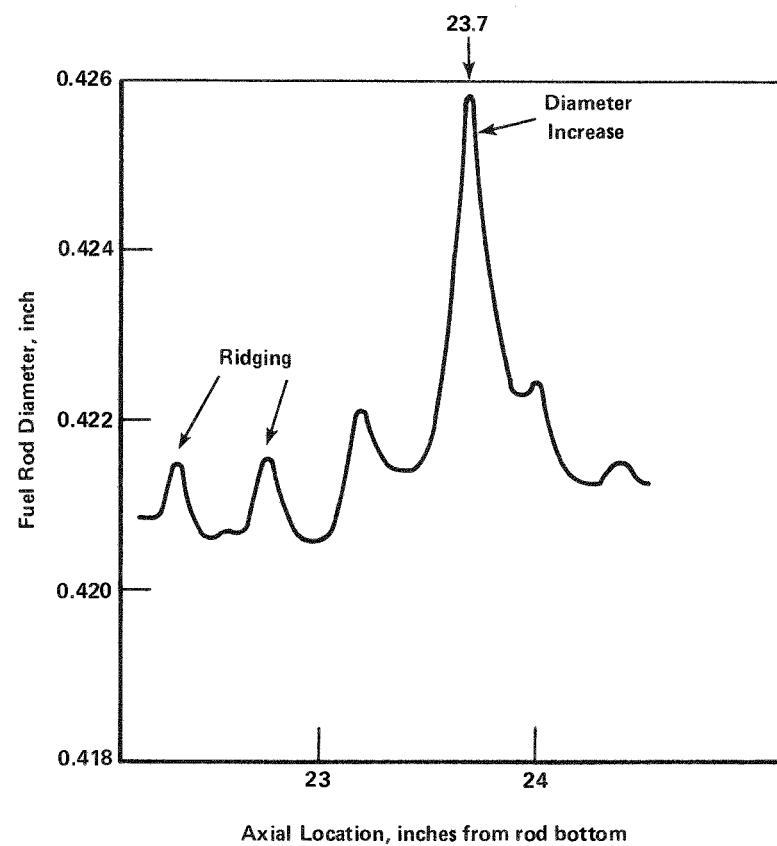
FIGURE 7. Examples Of Ridging And Diameter Increase Observed In Unfailed Batch 8 Rod 157E01 By Linear Profilometry Scan

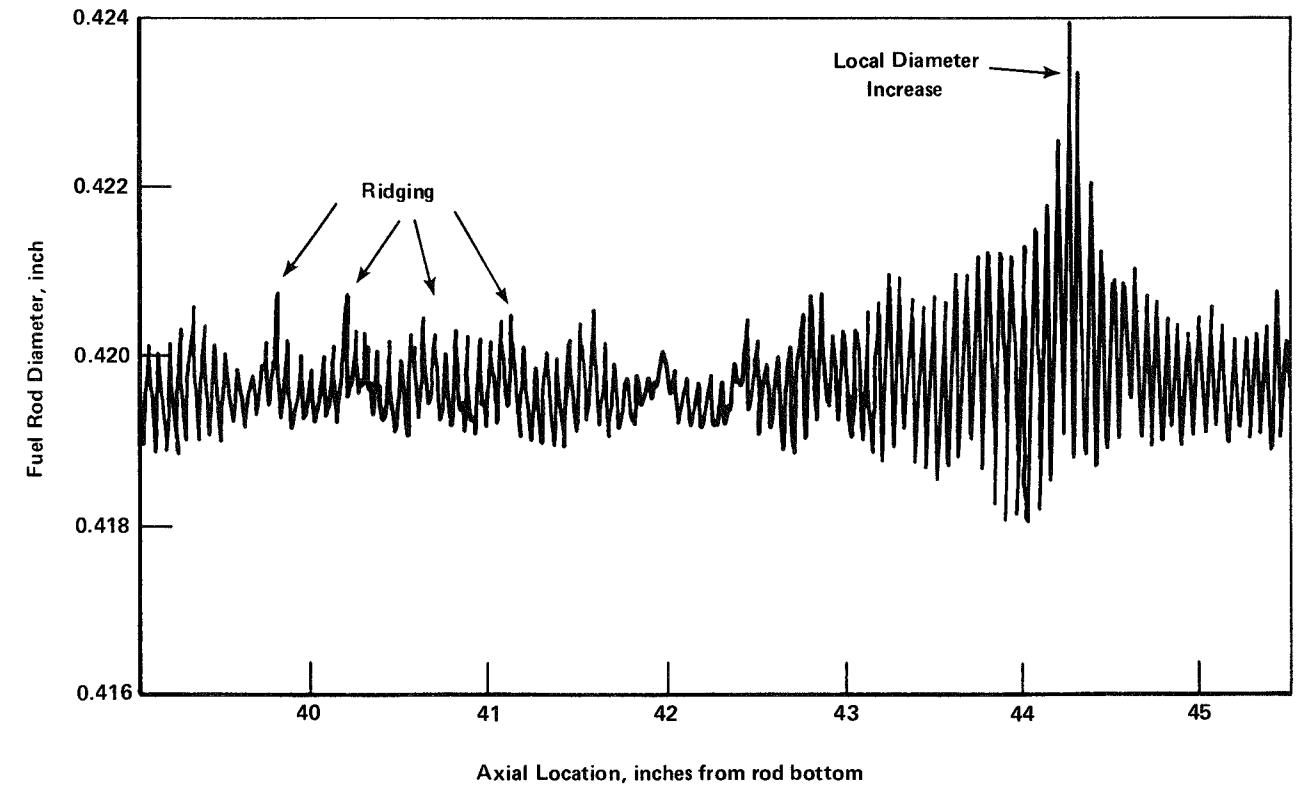
**FIGURE 8. Example Of Ovality And Ridging And Local Diameter Increase
Observed In The Unfailed Batch 7 Rod 595A10**

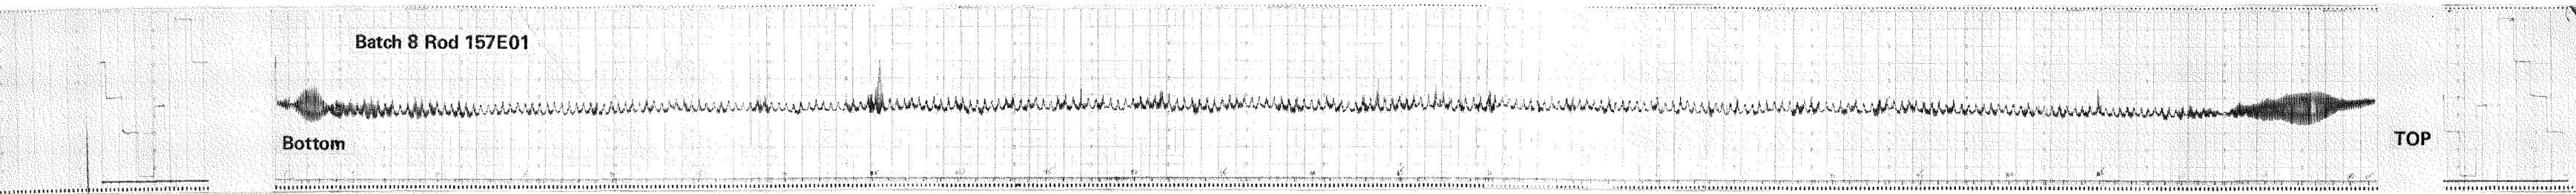
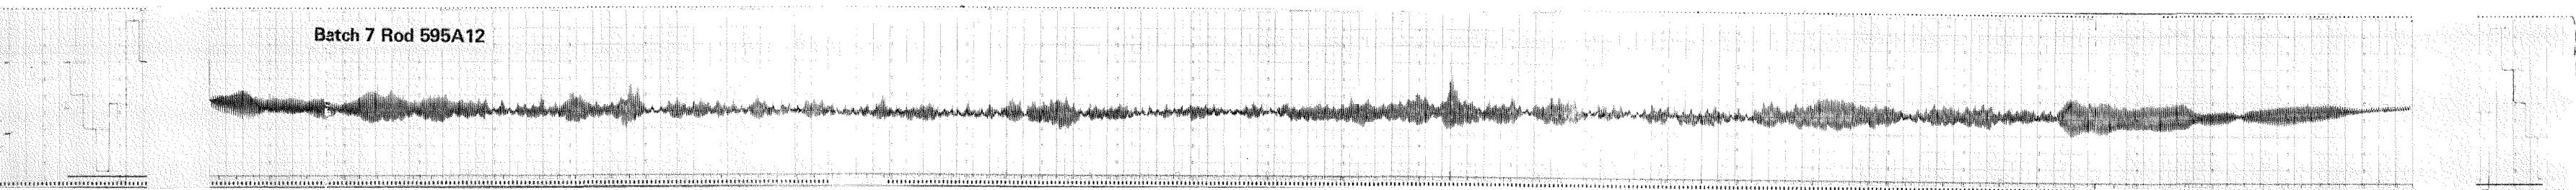
FIGURE 9. Full Length Spiral Profilometry Chart Obtained On Batch 8 Rod 157E01 And Batch 7 Rod 595A12

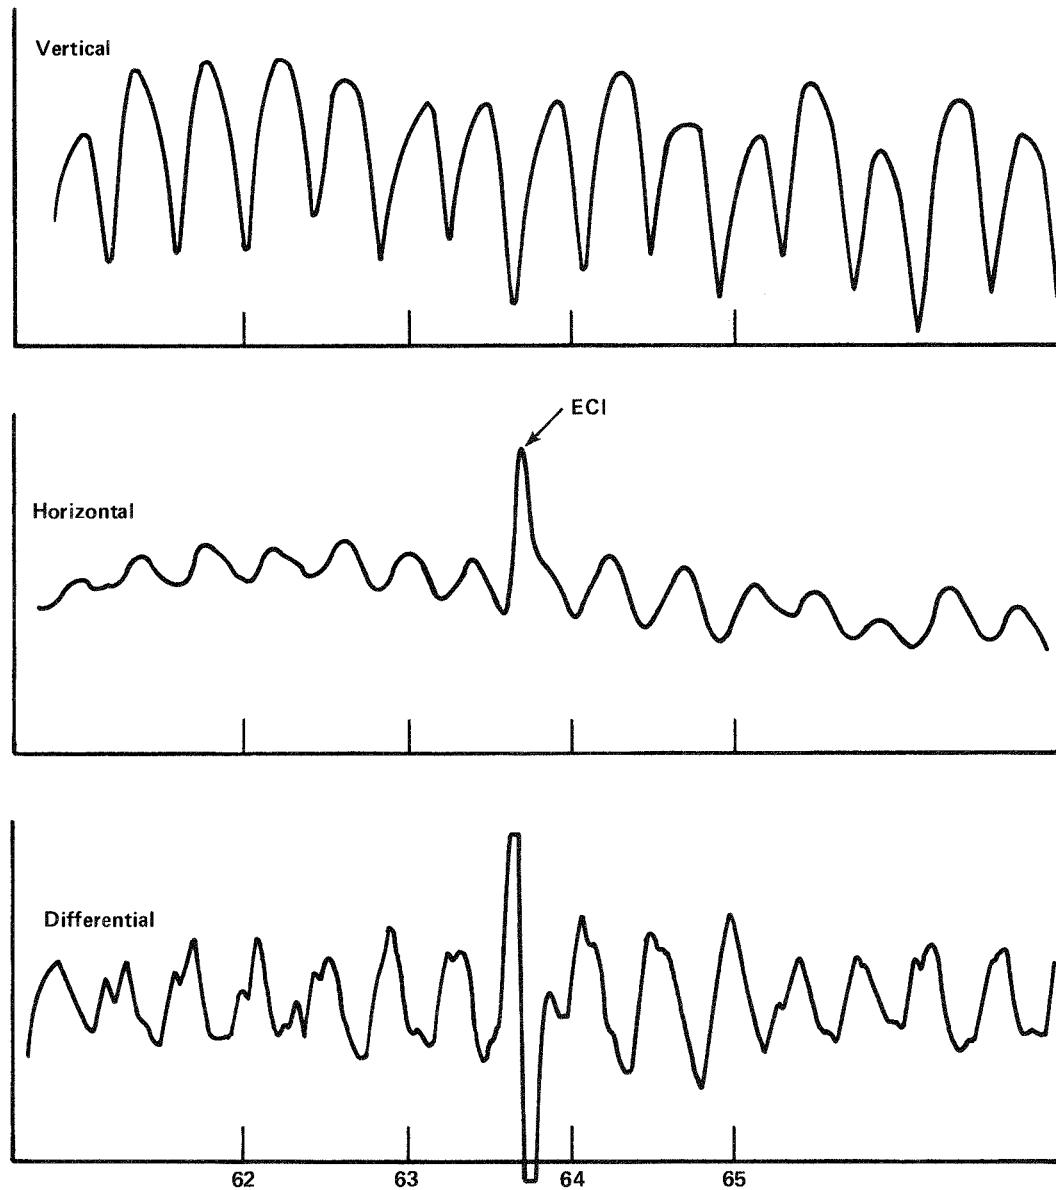
**FIGURE 10. Eddy Current Indication At The Location Of Diameter Increase
Observed In The Unfailed Batch 8 Rod 157E01**

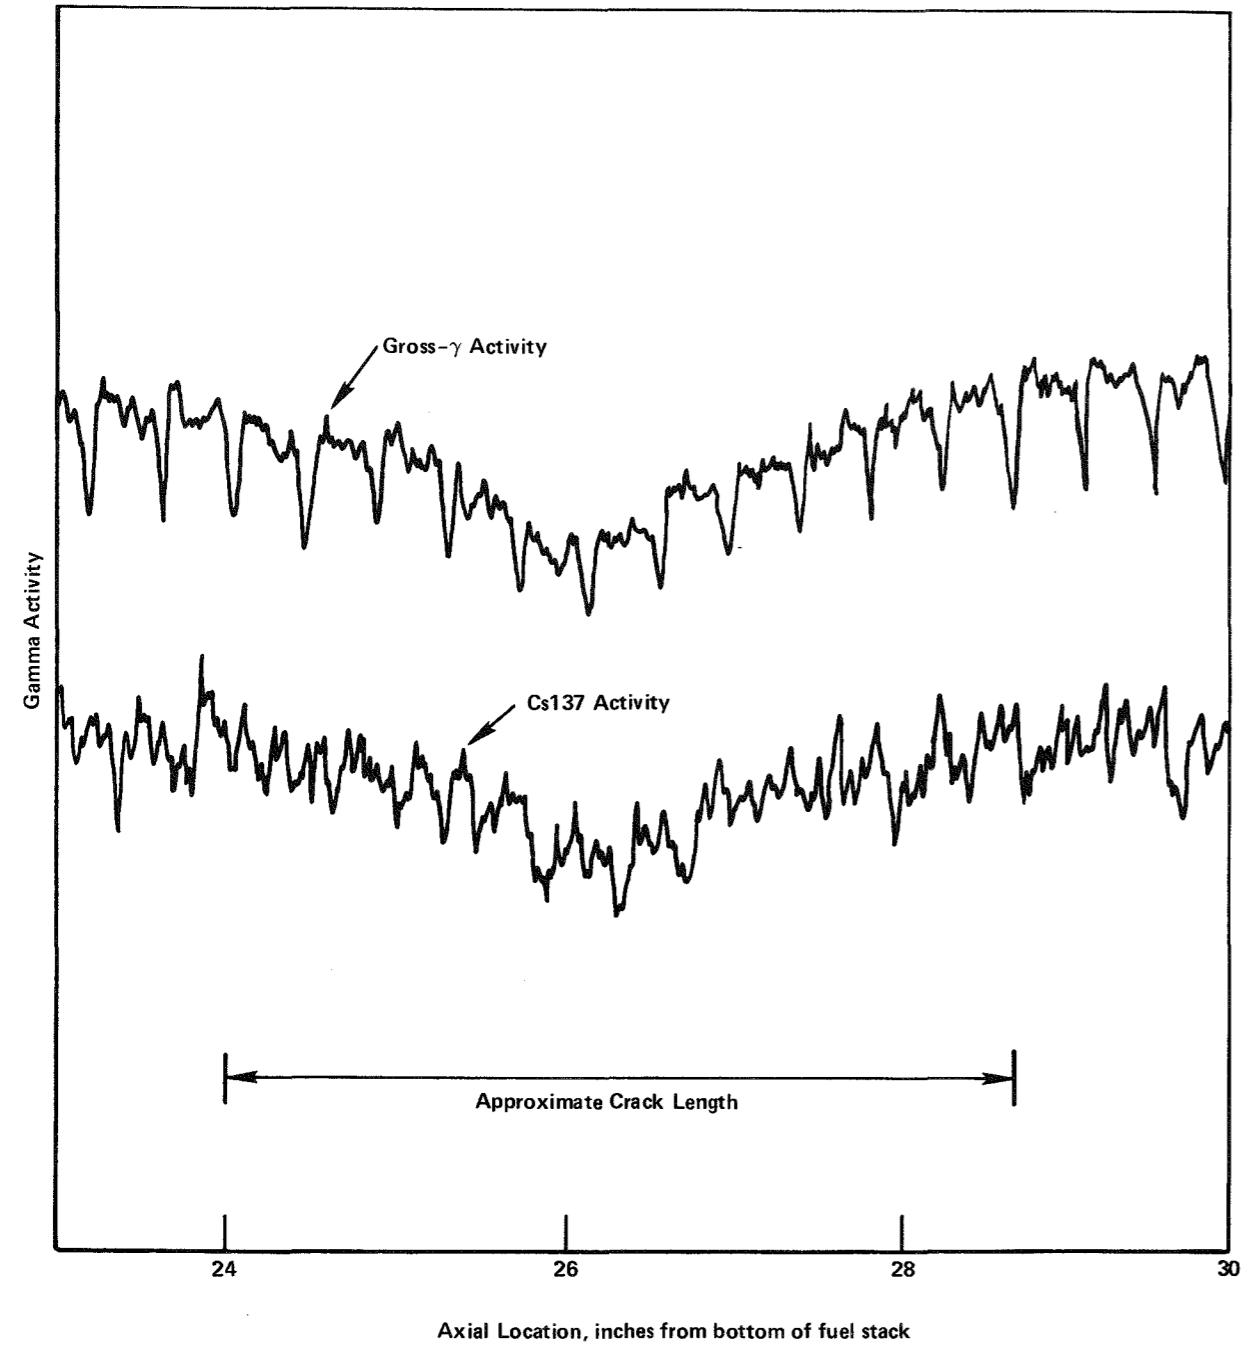
FIGURE 11. Gamma Scan Data Showing Depression In Activity At The Location
Of The Cladding Crack In The Failed Batch 8 Rod 013E03

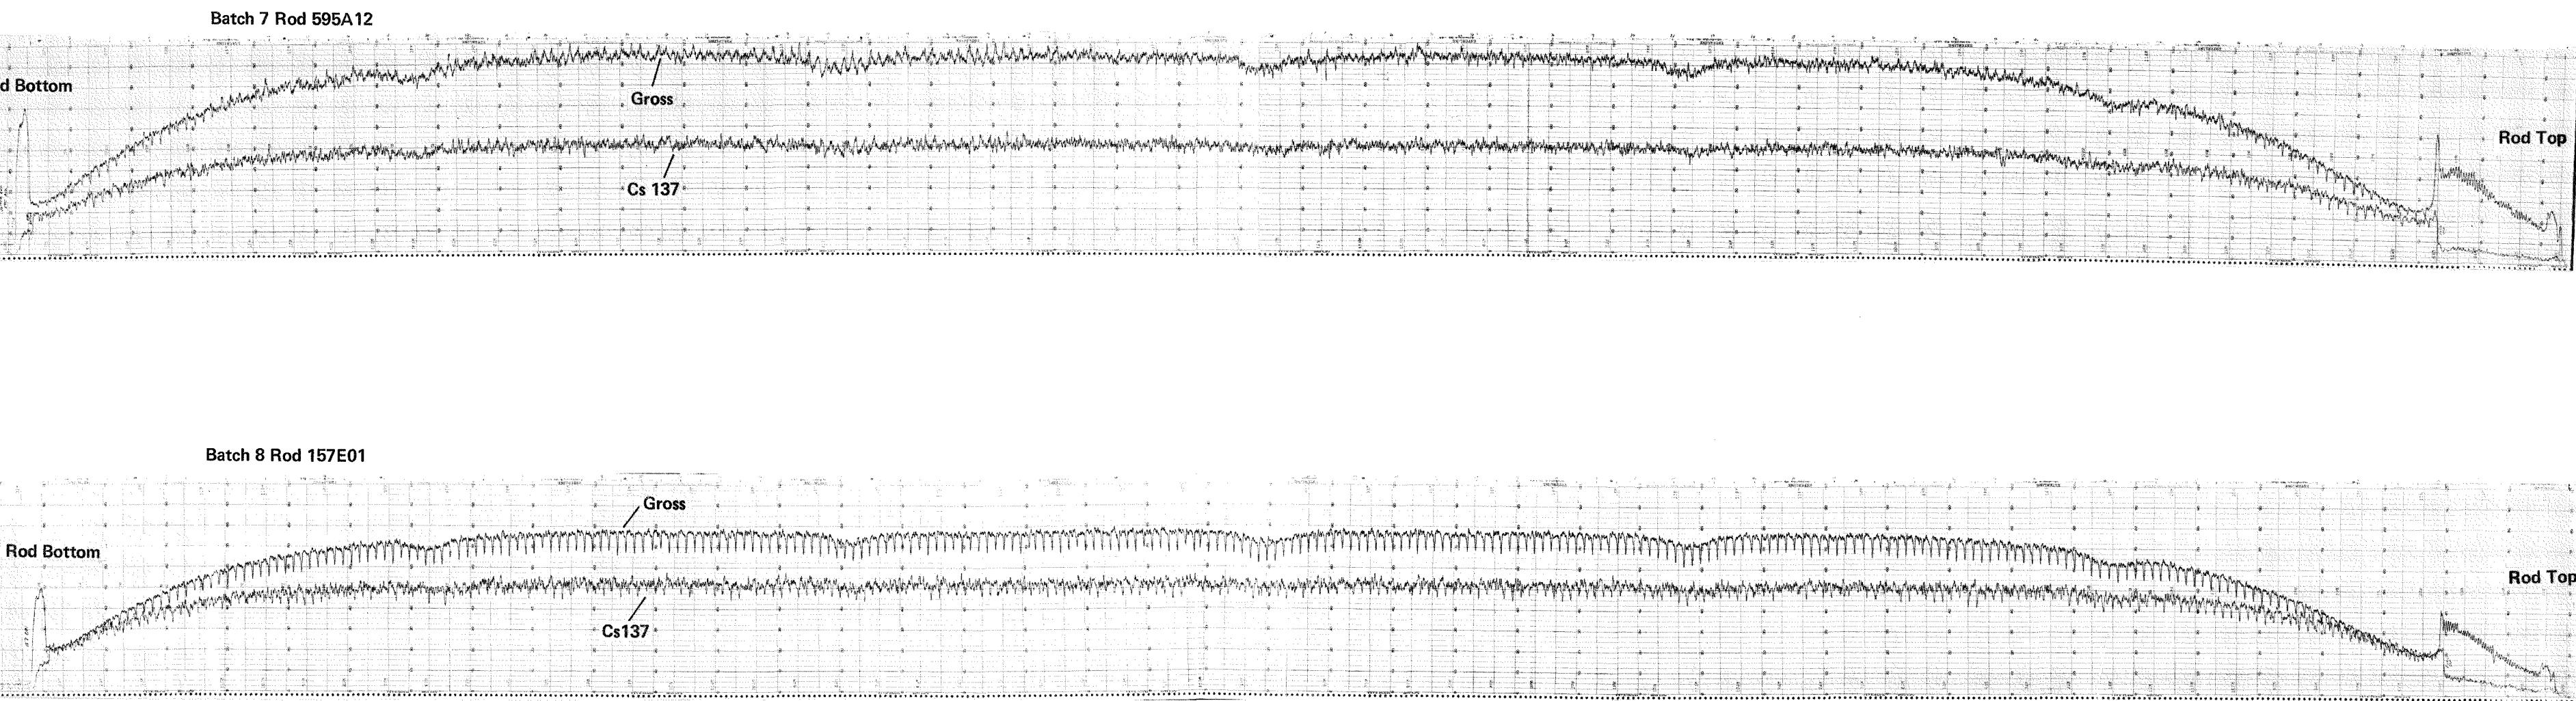
FIGURE 12. Gamma Scan Charts From Batch 7 Rod 595A12 And Batch 8 Rod 157E01

(Note: Lack Of Activity Depression At Pellet Interfaces In Batch 7 Fuel Rod)

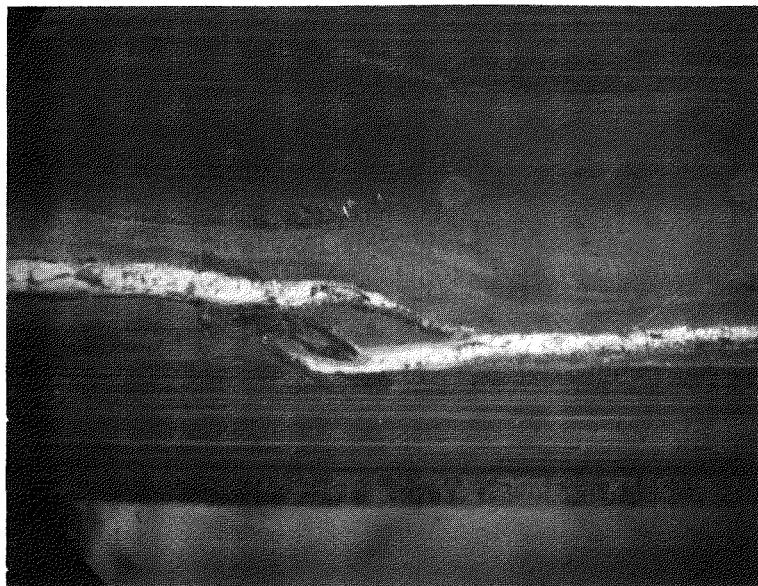
FIGURE 15. Appearance Of The Longer Of The Two Cracks Observed In Failed Rod 013E03 At ~25 Inches From Rod Bottom

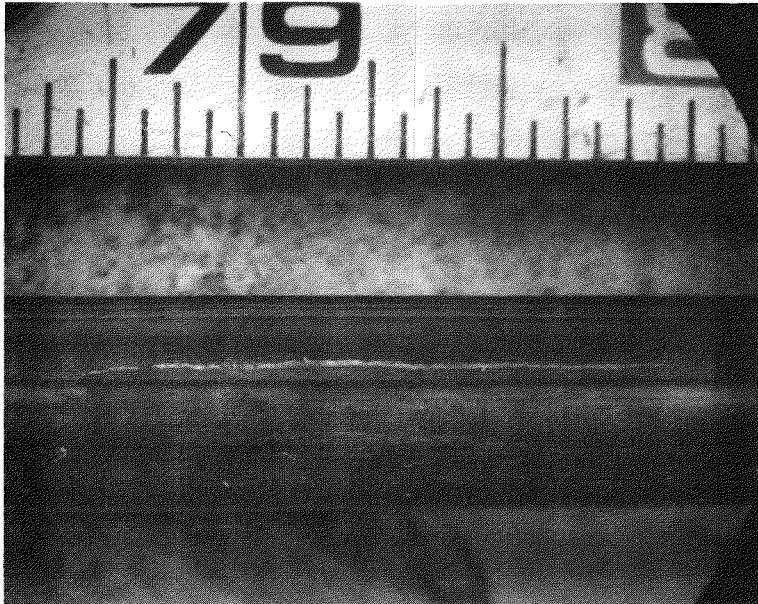
FIGURE 16. Appearance Of The Tight Crack In Rod 013E03 At 79 Inches From Rod Bottom

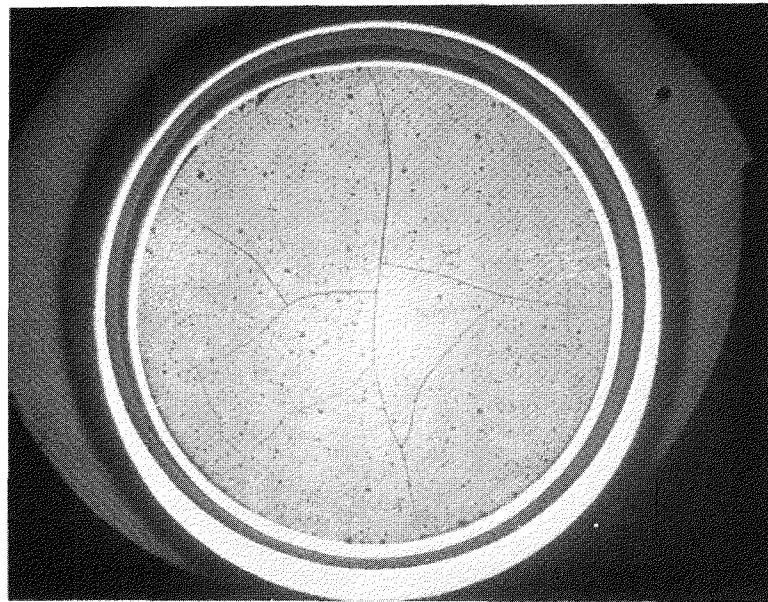
**FIGURE 17. Photomicrograph Showing The Location
Of Fuel Pellet-Chip In Batch 8 Rod
157E01 At 64 In. From Rod Bottom**

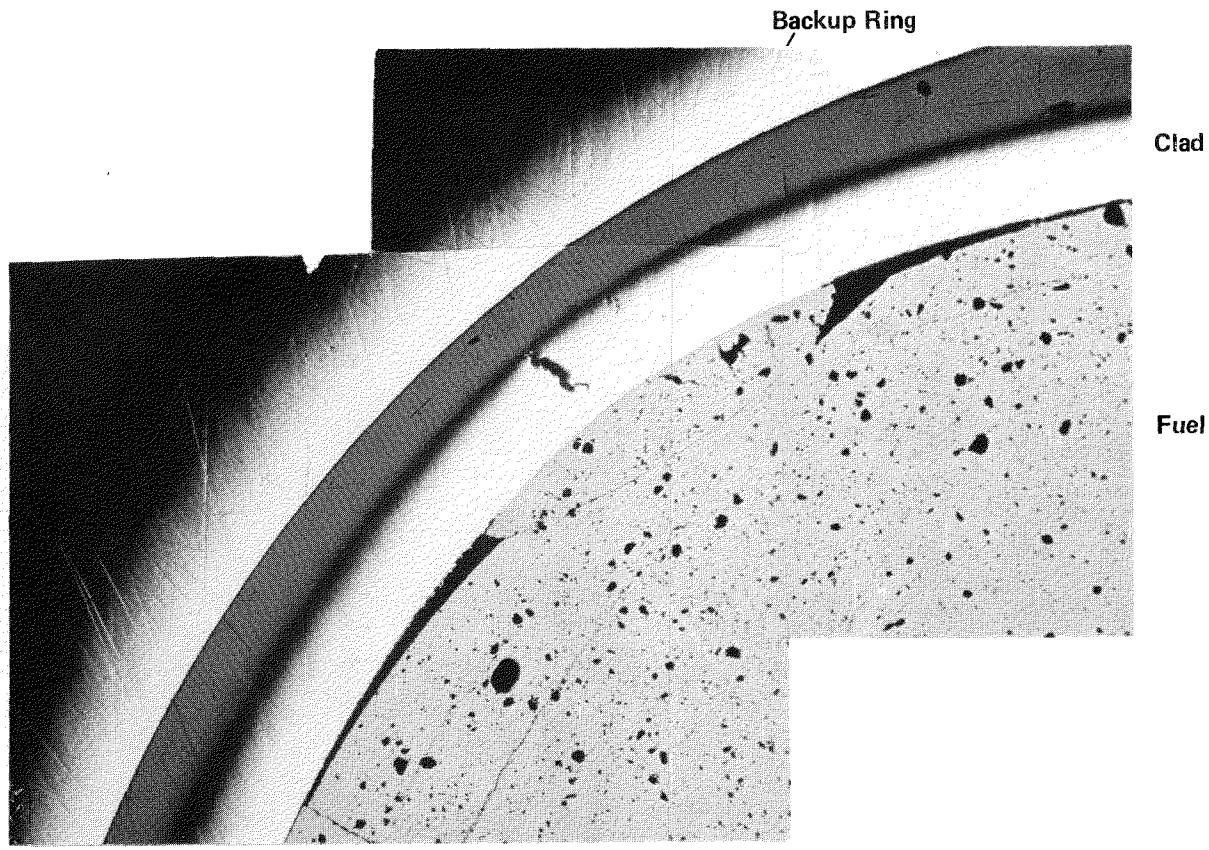
**FIGURE 18. Appearance Of Incipient Cladding Crack In Rod 157E01
64 Inches From Rod Bottom**

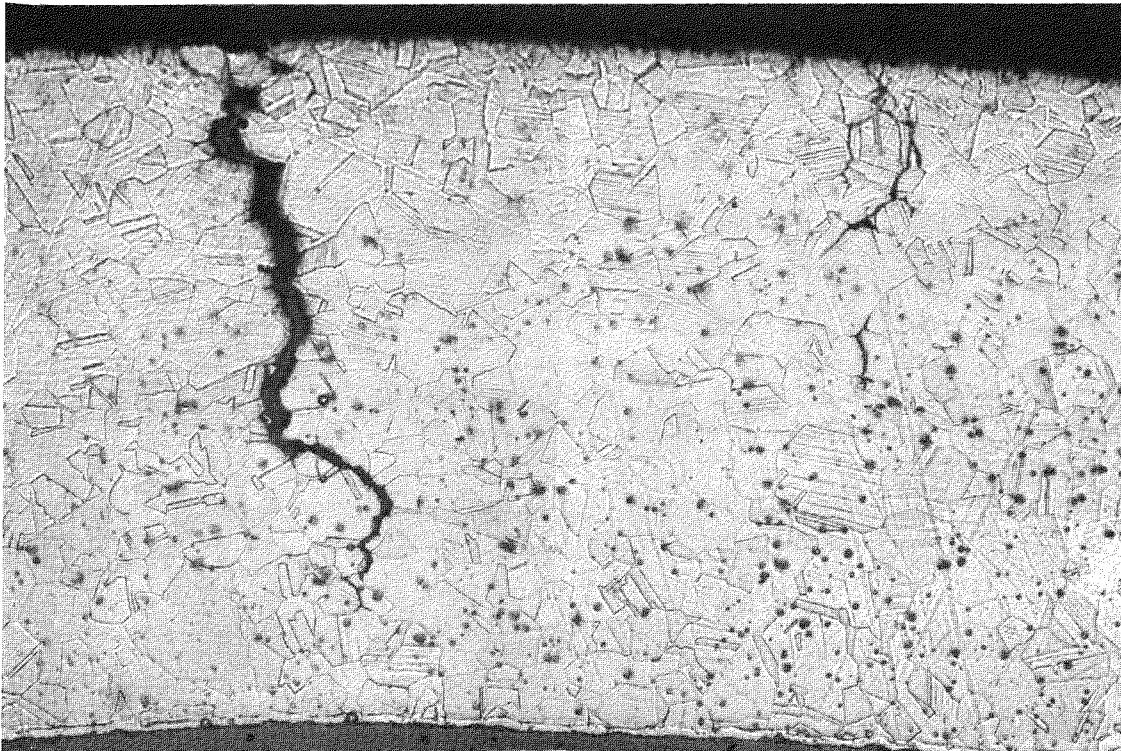
**FIGURE 19. Appearance Of The Two Cracks In Rod 157E01 At 64 Inches
In Etched Condition (Etchant — Glyceregia)**

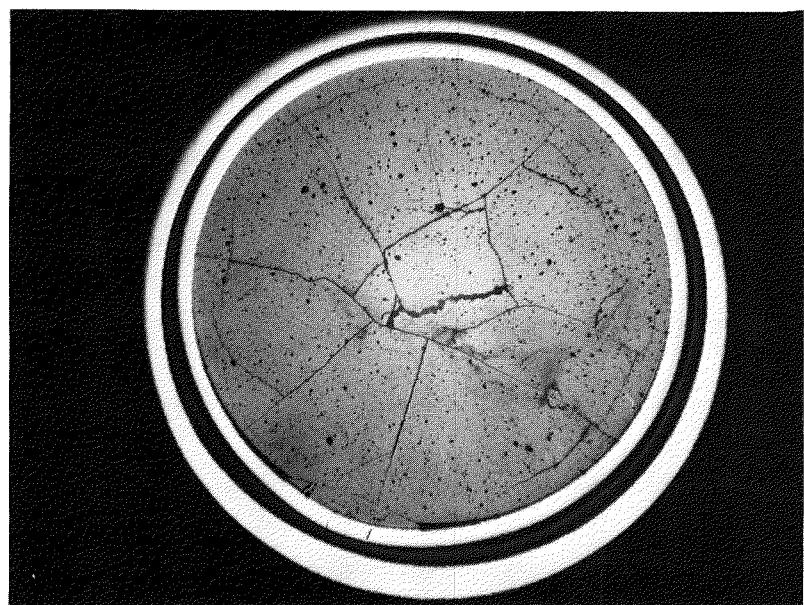
FIGURE 20. Photomacrograph Of Fuel Chip And Cladding Crack Observed In Batch 8 Fuel Rod 217E02

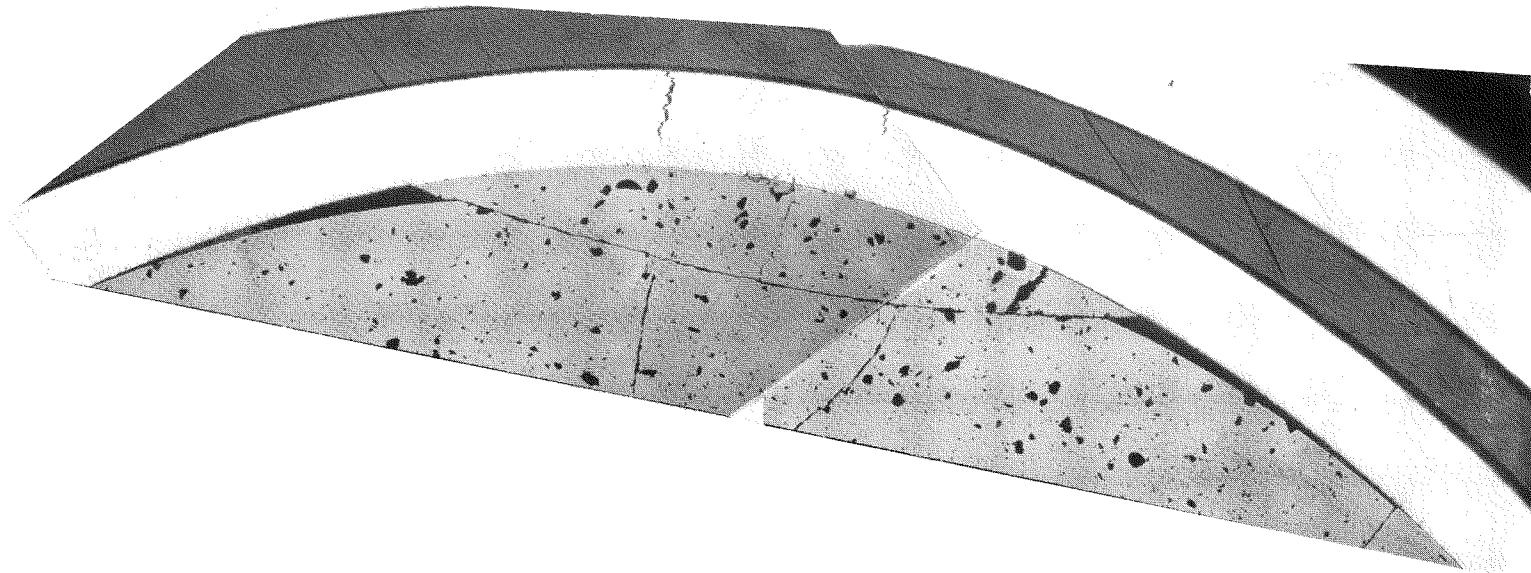
FIGURE 21. Photo Montage Of Incipient Cladding Crack In Rod 217E02 At 24 Inches From Rod Bottom

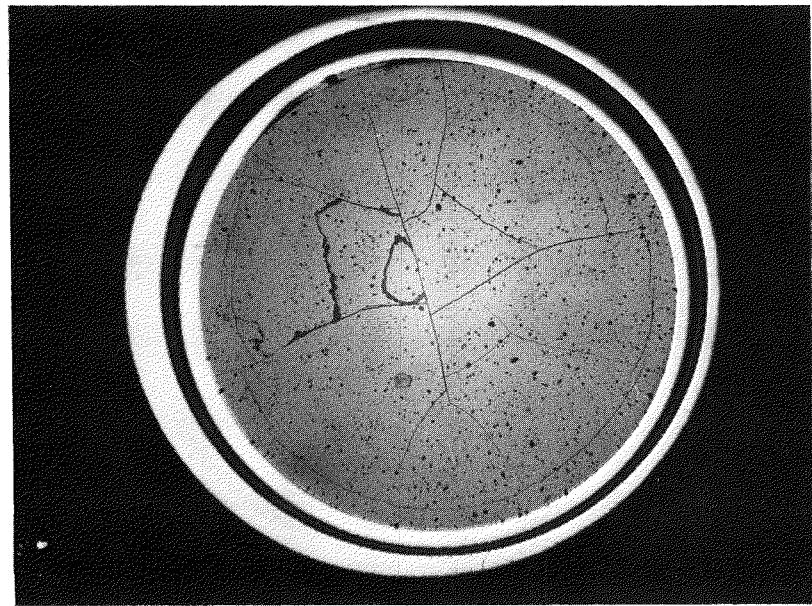
FIGURE 22. Photomacrograph Showing The Location Of Fuel Chip In The Unfailed Batch 8 Rod 157E01 At ~35-3/4 Inches From Rod Bottom

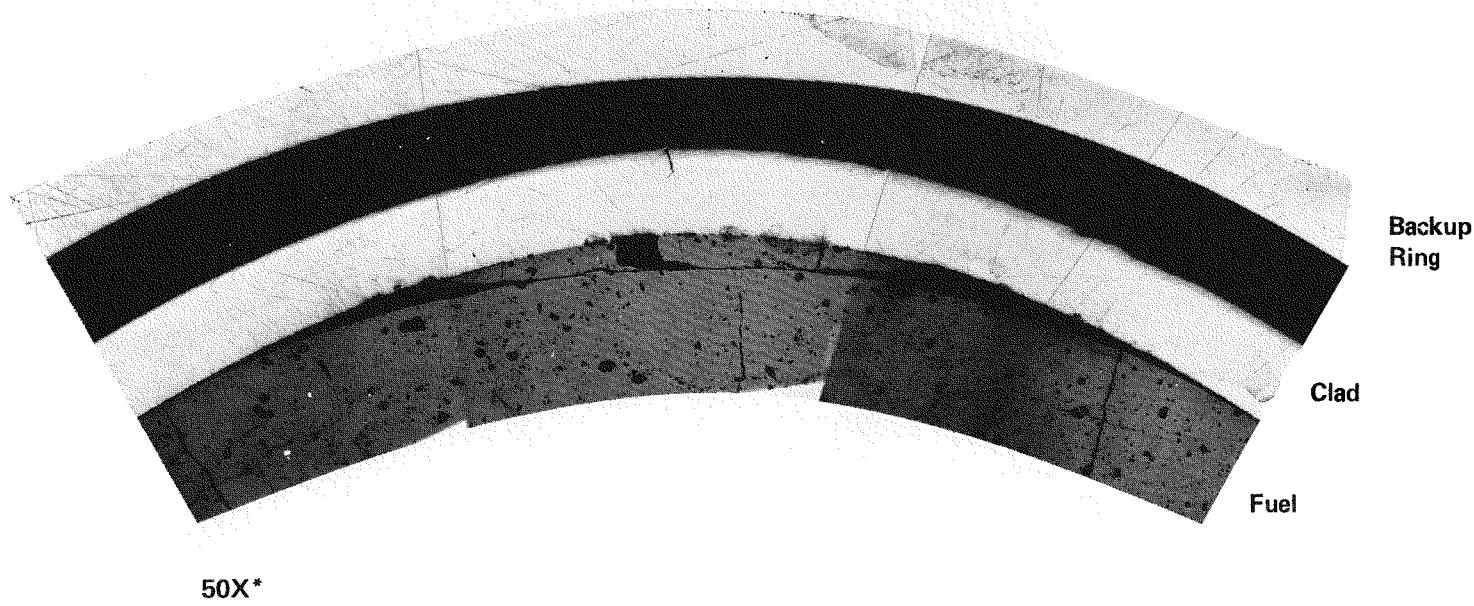
**FIGURE 23. Photo Montage Of Incipient Cladding Crack Observed In Rod 157E01
At ~35-3/4 Inches From Rod Bottom**

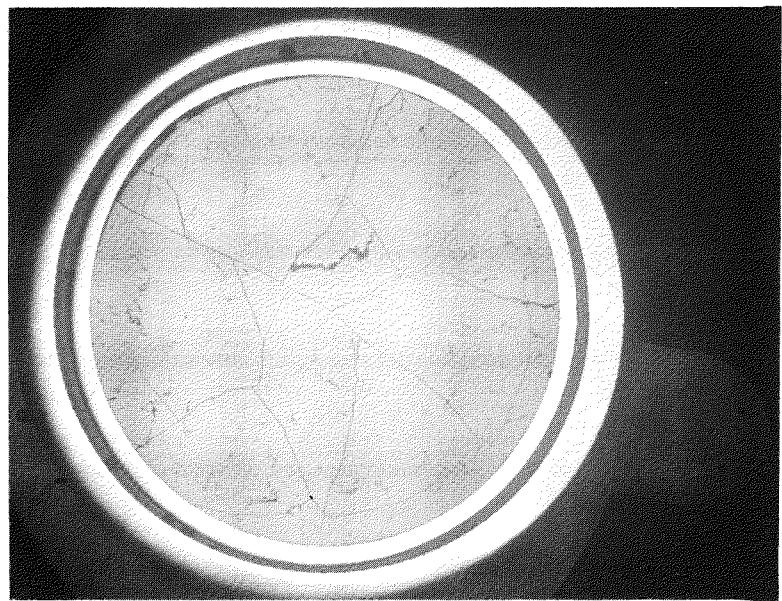
**FIGURE 24. Photomicrograph Showing The Location Of
Fuel Chip In Batch 7 Fuel Rod 595A10**
