Investigation of Stainless Steel Clad Fuel Rod Failures and Fuel Performance in the Connecticut Yankee Reactor

EPRI NP-2119
Project 1758-1
Final Report
November 1981

Prepared by
Battelle, Columbus Laboratories
Columbus, Ohio

NP-2119
Research Project 1758-1
NUSCO-130

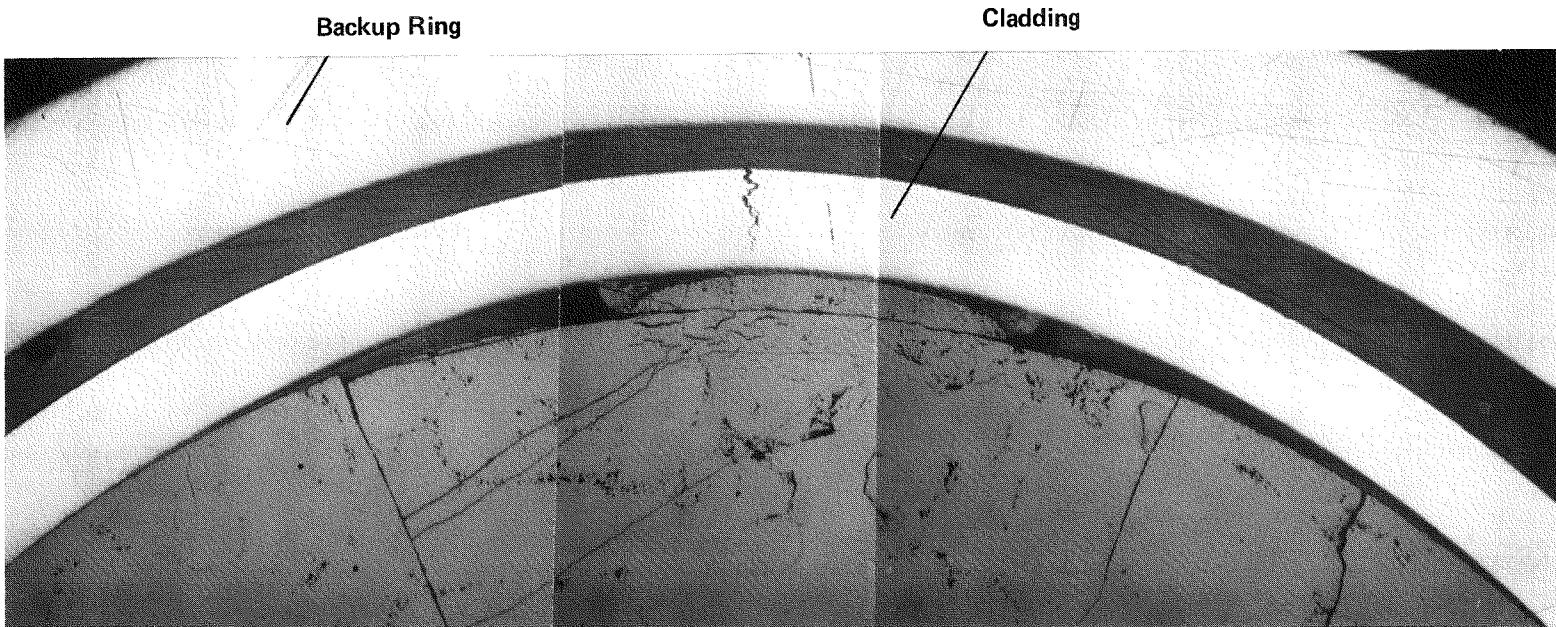
FIGURE 25. Appearance Of Cladding Crack And Fuel Chip In Batch 7 Fuel Rod 595A10

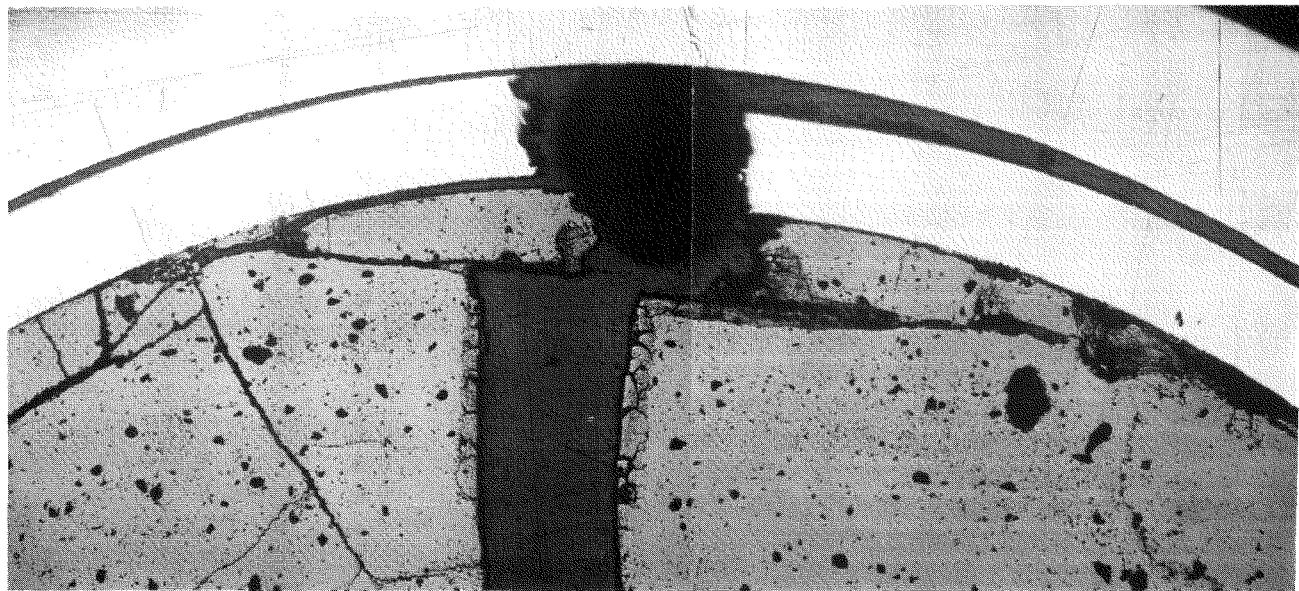
FIGURE 26. AREA OF TIGHT THRUWALL CRACK IN FAILED ROD 013E03 SHOWING CHIP IN GAP

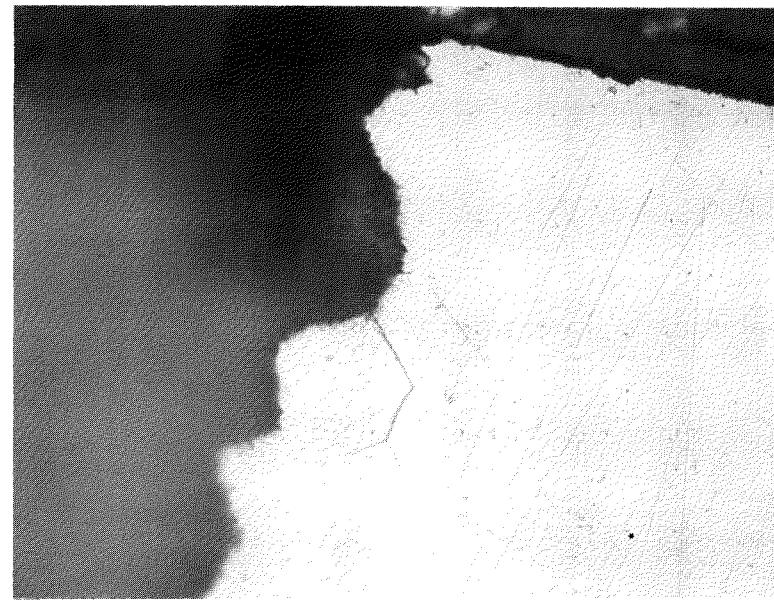
FIGURE 27. Photograph Showing A Crack Branch Propagating Inward Suggesting The Origin Of The Crack Shown In Figure 26 To Be At The Fuel Rod Outer Surface

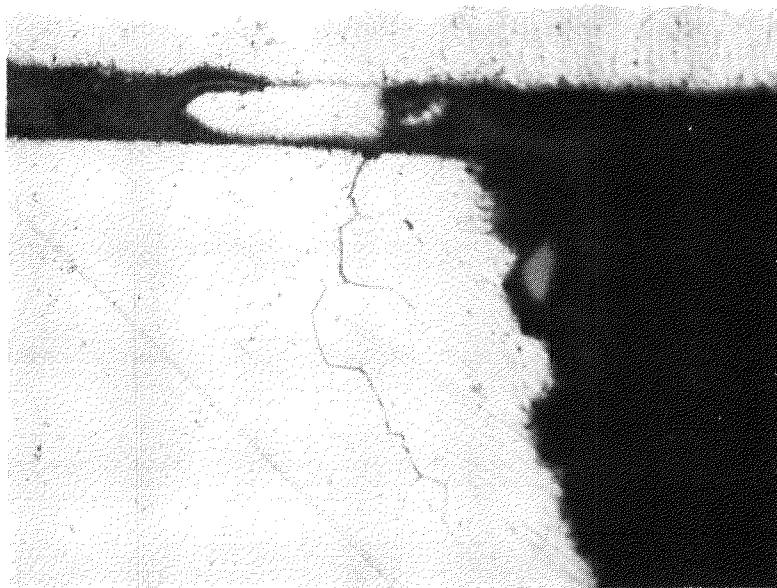
FIGURE 28. SMALL TIGHT CRACK ORIGINATING AT OD ADJACENT TO THE CLADDING SPLIT SHOWN IN FIGURE 26.

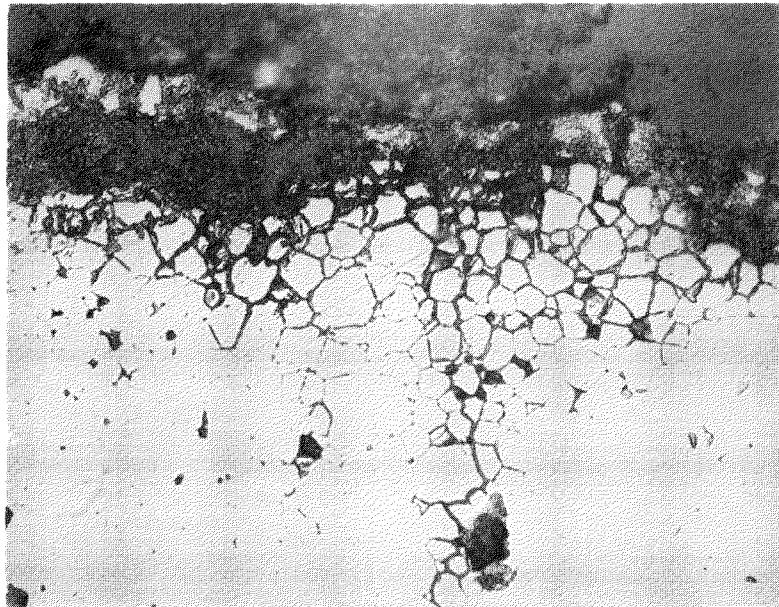
**FIGURE 29. Oxidized UO₂ Fuel At The Grain Boundaries In The Vicinity
Of Cladding Split In Failed Fuel Rod 013E03**

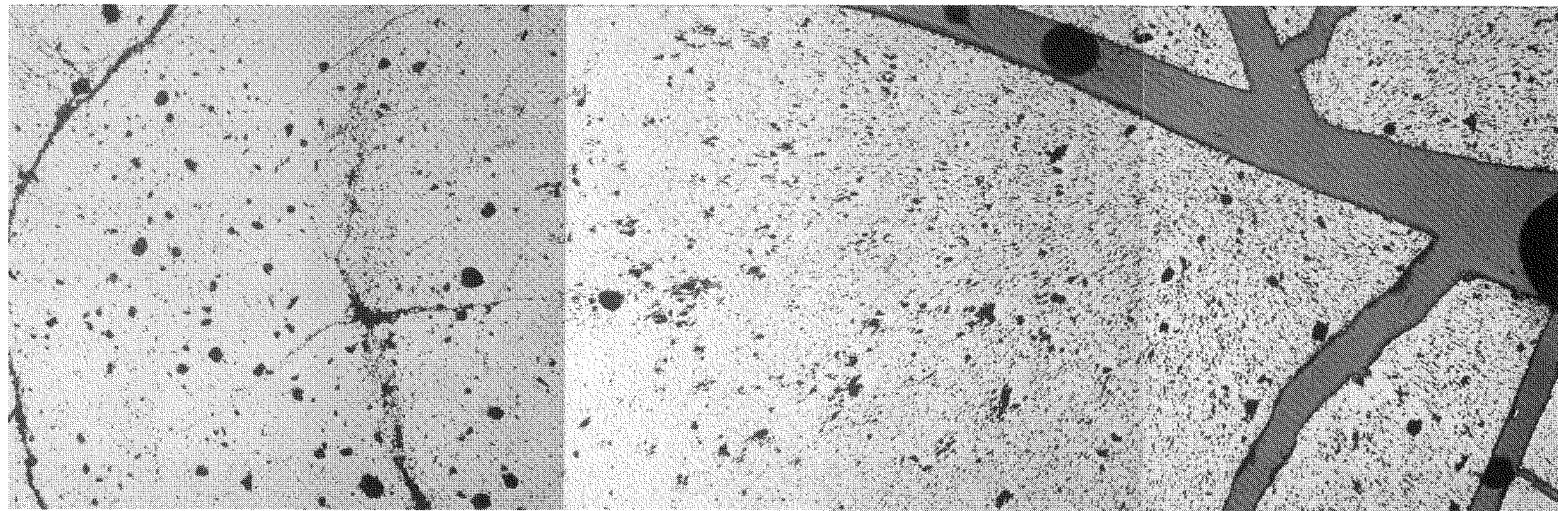
FIGURE 30. Appearance Of Fuel Porosity At The Location Of Cladding Failure In Rod 013E03

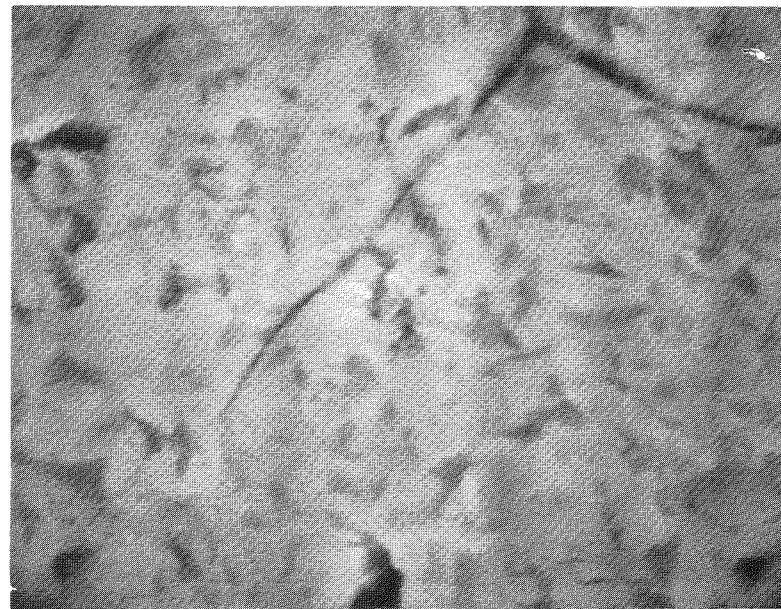
FIGURE 31. HIGHER MAGNIFICATION APPEARANCE OF CRACK BRANCH TIP

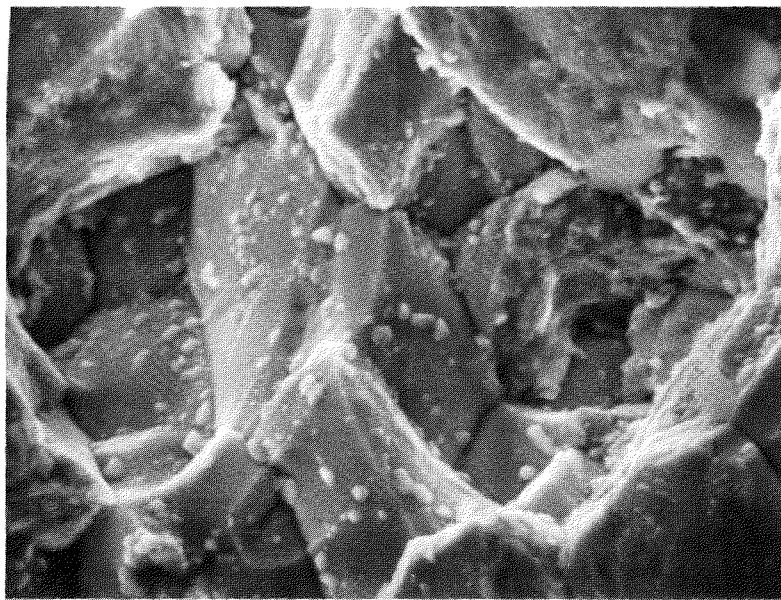
**FIGURE 32. HIGHER MAGNIFICATION APPEARANCE OF
BRITTLE FRACTURE SURFACE**

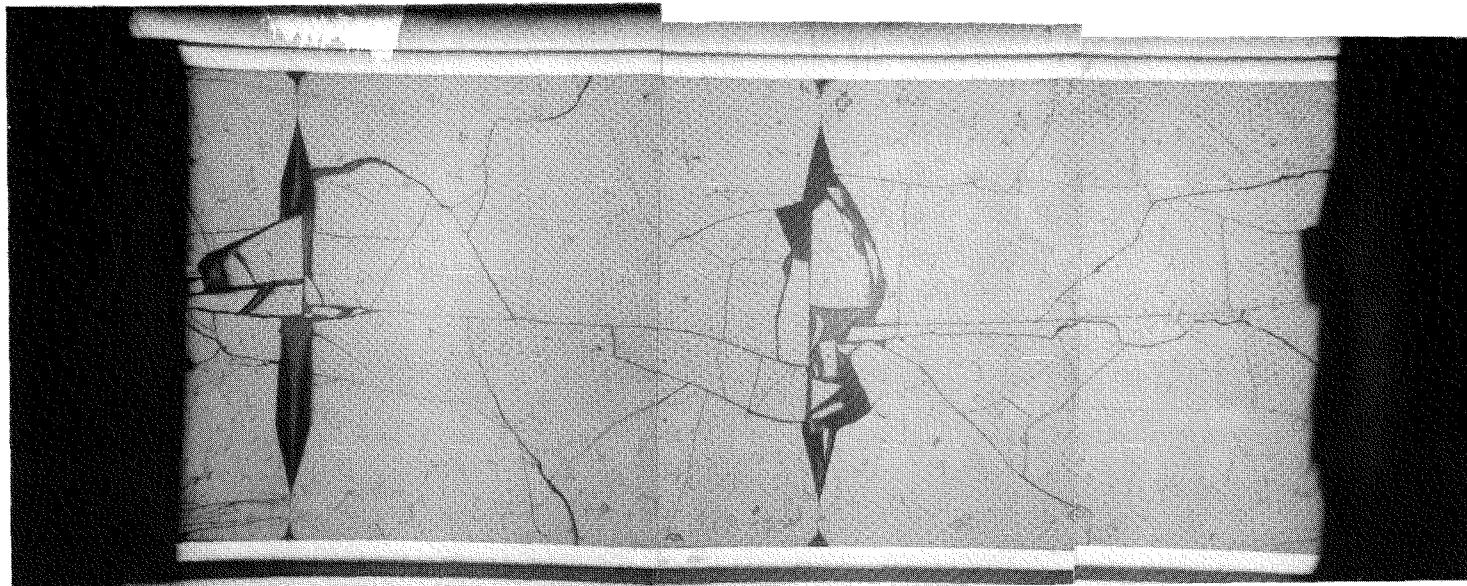
FIGURE 33. Photomacrograph Of Longitudinal Sample From Batch 7 Fuel Rod 595A10 Showing Axial Relocation Of Fuel Pieces Into The Dish

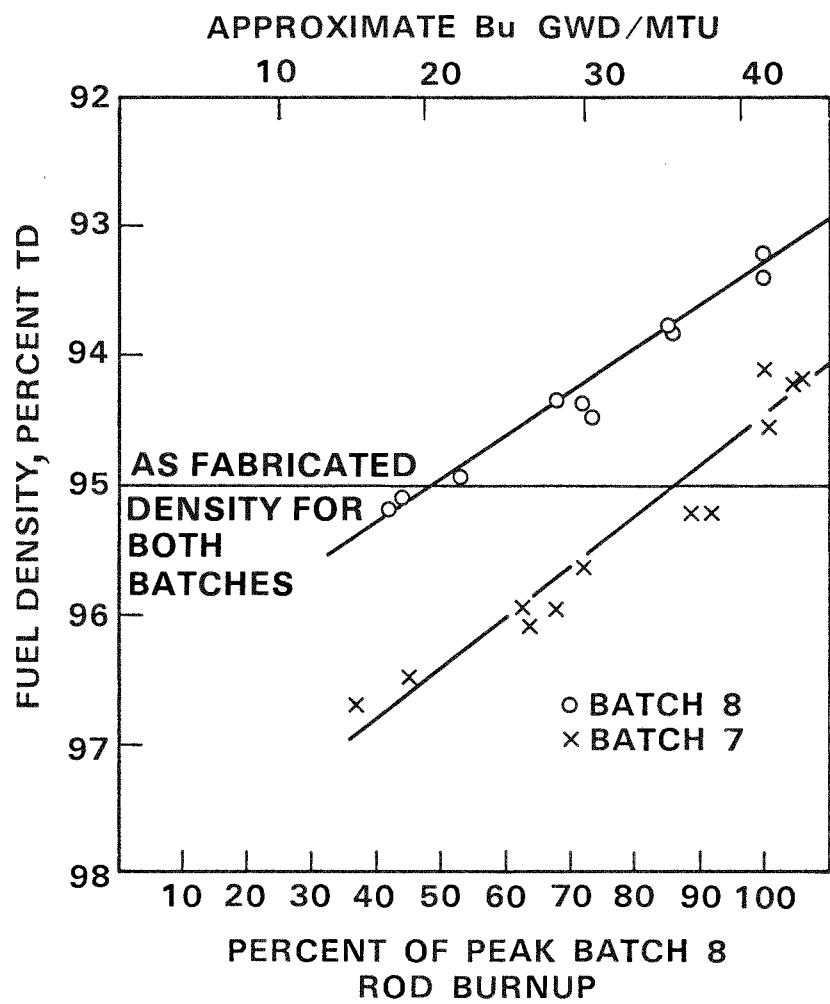
Figure 34 shows the results of density measurements on both batch 7 and batch 8 fuel samples. Results are shown as a function of burnup, in terms of percent of peak burnup in the batch 8 rod based on gamma scan profile. Also shown are approximate sample burnups. The data obtained are also shown in Table 8. It can be seen that for a given burnup level the batch 8 fuel samples consistently show lower densities (by about 1 percent). The data also suggest that the batch 7 samples may have densified more than batch 8 fuel early in life. The rate of swelling as determined from the data appears to be about 1 percent per 10,000 MWD/MTU, which is consistent with that reported by others(7).

FIGURE 34. Results Of Irradiated Fuel Density Measurements On Samples From Batches 7 And 8 Fuel Rods
