Failure Mechanisms of Polycrystalline-Diamond Compact Drill Bits in Geothermal Environments

Ed R. Hoover, Larry E. Pope

SAND81-1404
Unlimited Release
Printed November 1981

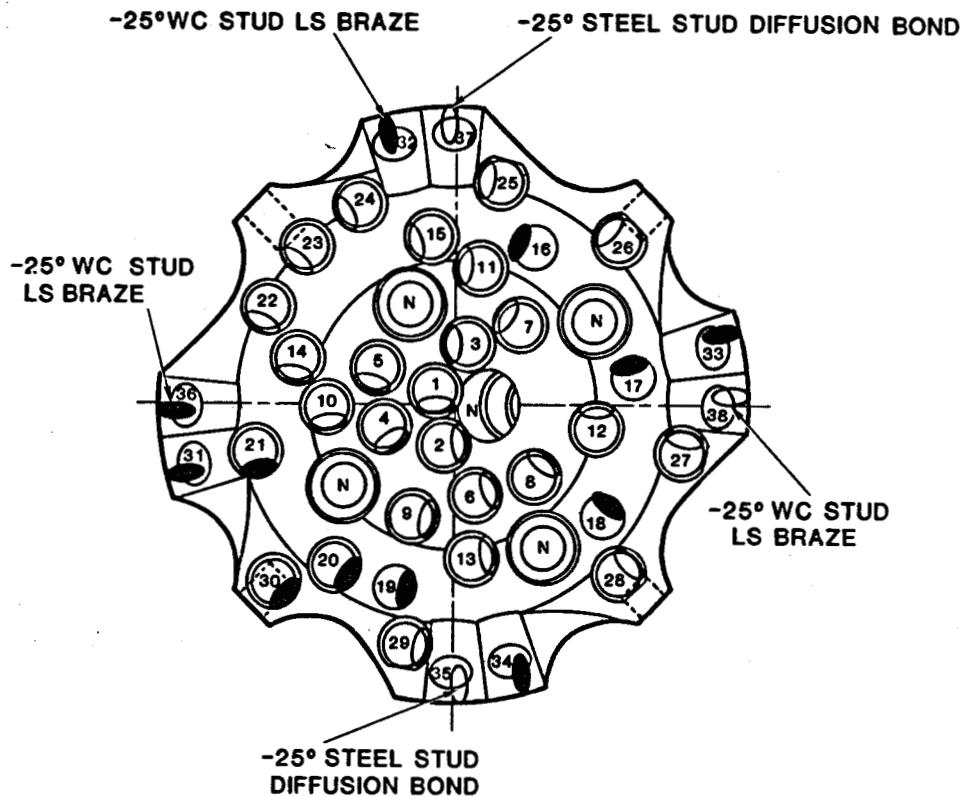
Figure 2. Modified GE/Smith bit which lost twelve PDC drill blanks during the hot air laboratory test.

The GE/Smith bit was then tested in Sierra White granite which had an unconfined compressive strength of 24,000 psi and a relatively large grain structure. After drilling the first 30 inch hole, examination showed significant wear of many of the outer cutters. In addition, there was some localized high frictional heating indicating inadequate cooling by the air drilling fluid. The procedures used to drill the first hole in the granite were repeated for the next hole. While drilling only 6 ft/hr at 50 RPM with a bit weight of 35,000 lbs, the bit failed catastrophically. Twelve LS brazed PDC drill blanks were detached from their stud support structures. Eleven of these compacts were recovered intact from the parking lot, where the hot air exhaust had ejected them.

The cutters that lost their PDC drill blanks are shaded in Figure 2. Both of the diffusion bonded -25° steel cutters remained intact even though they were worn severely.

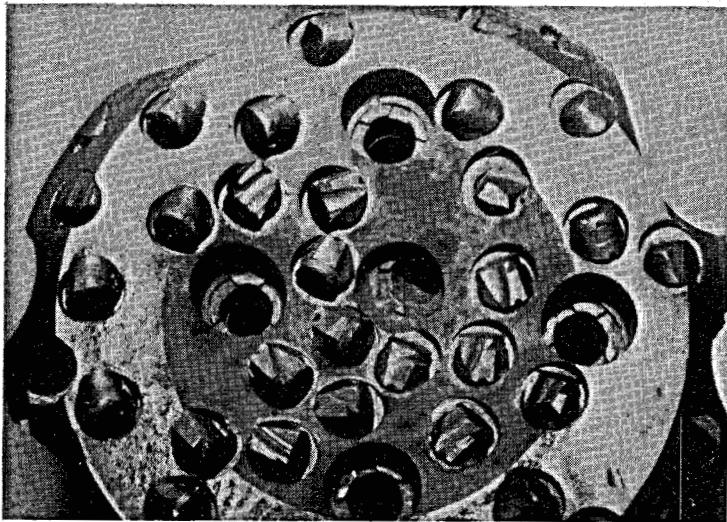
Figure 3. GE/Smith bit after the Geysers air test

Inspection of the bit revealed that 14 of the outermost -25° studs had lost their polycrystalline diamond compacts and were severely worn. The tungsten carbide studs of the nine outermost cutters were actually worn flush with the steel bit body (refer to Figure 3). The other five studs were worn progressively less toward the center of the bit. None of these 14 studs appeared to have been fractured or broken. In addition, three of the four gauge trimmers mounted on the side of the bit had also lost their PDC drill blanks.

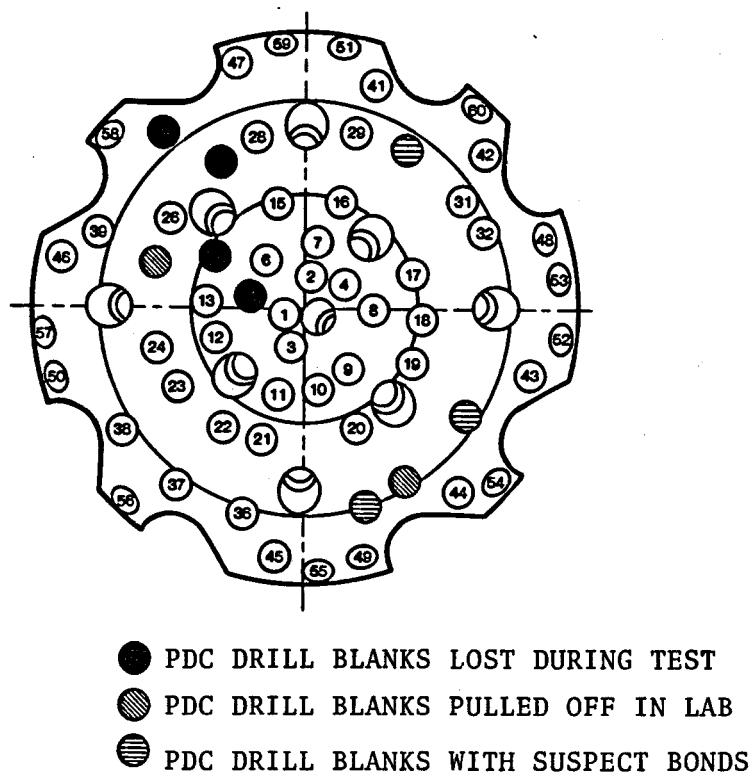
Figure 4. Location of cutters on Strata Bit Corp. drill bit lost or damaged during the turbine test at the Geysers.

Initial inspection of the Strata Bit PDC drill bit revealed that four cutters had lost their PDC drill blanks while the other cutters appeared to be in excellent condition with very little spalling or wear. Later, in the laboratory, all of the remaining cutters were examined ultrasonically to evaluate the braze joint integrity; five braze joints were suspected to be weak. Two of these suspect bonds were so poor that the PDC drill blanks were easily removed using a pair of vise grips. The locations of these cutters are shown in Figure 4.

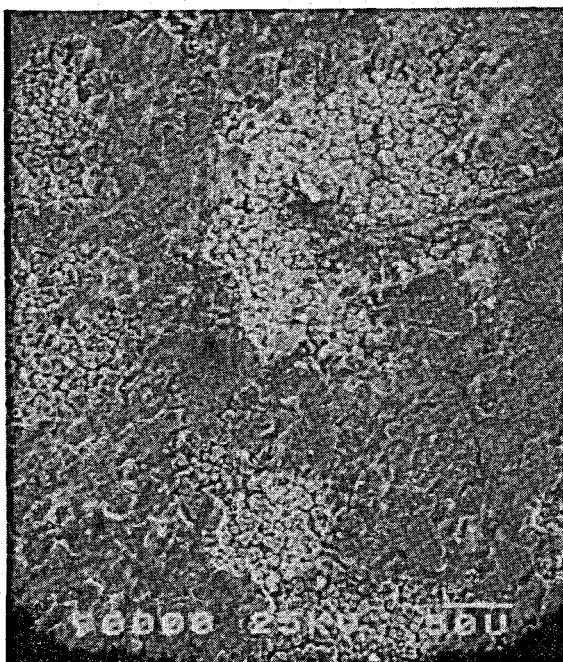
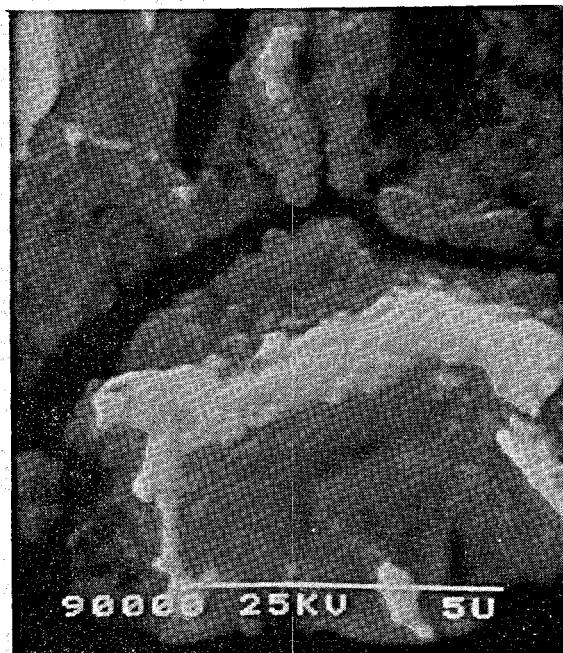
Figure 5. Typical hot shortness observed on PDC drill blanks used in the hot air laboratory test; (a) 200x (b) 10,000x

The PDC bit tested in the laboratory with hot air failed catastrophically due to grain boundary melting, i.e., hot shortness. The existence of extensive hot-short regions precludes the possibility that these hot-short regions existed prior to testing; the bit would not have survived the initial test cycles and regions of ductile failure would have been found where bit integrity had existed. The test was considered a success in that it defined drilling conditions and strata where the bit performed well. Drilling conditions used for Sierra White granite pushed the bit beyond its temperature capability, which helps define regions where PDC cutter bits using copper-manganese-cobalt brazes will not perform well.

Hot shortness developed during brazing could be eliminated either by substituting a braze alloy with a tighter melting range or by incorporating a temperature feedback loop in the braze cycle. Important factors to consider in selecting a new braze are hot shortness ten-

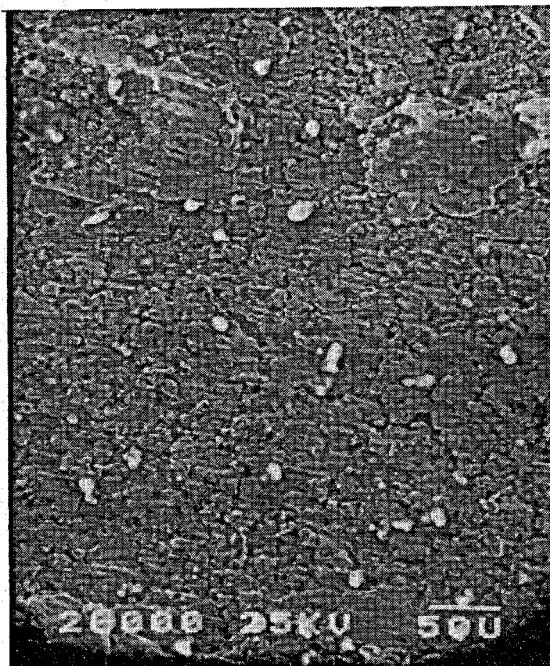
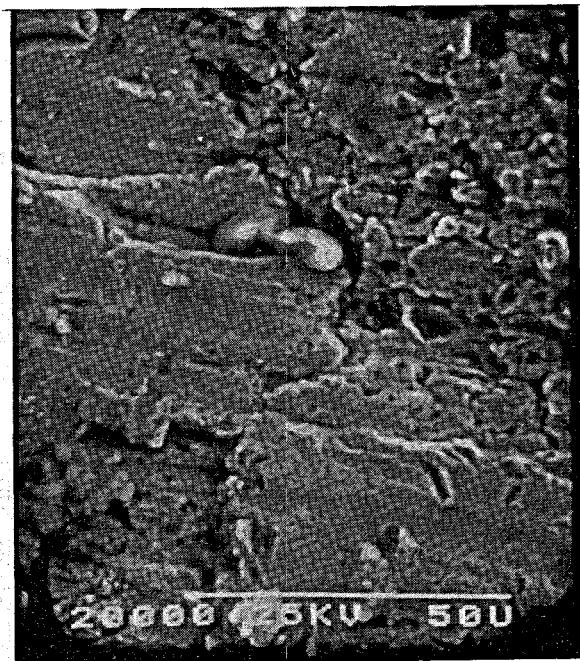
Figure 6. Less common hot shortness observed on PDC drill blanks in the hot air laboratory test; (a) 200x (b) 1000x

were compared. Similar differences existed between nodules and the matrix near the nodules. The rather wide melting range (185°F) and the low melting phase field could cause hot shortness. Hot shortness has been documented in a similar alloy where nickel was substituted for the cobalt. [9].

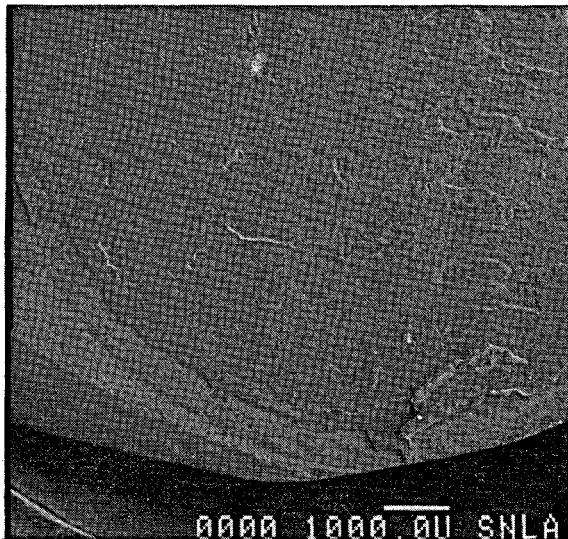
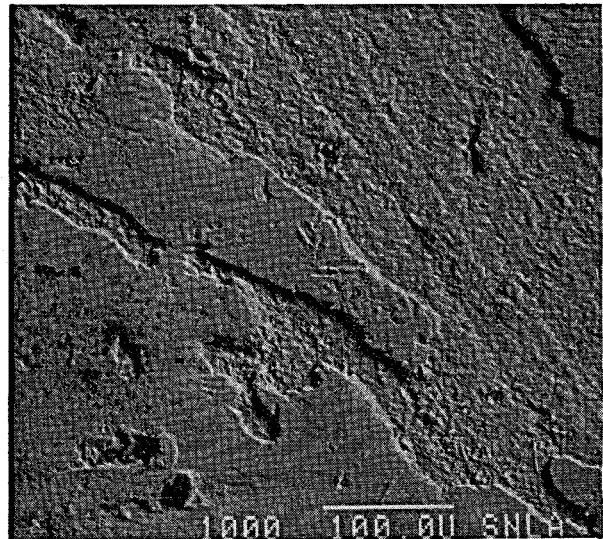
Figure 7. Failure surface of studs which lost PDC drill blanks during the Geysers air test. (a) 10x (b) 200x

The SEM examination of the two studs also revealed three characteristic areas on each failure surface: (1) a periphery region where no bonding had occurred between the braze and the stud, on the average 23% of the bond area, (2) a ductile failure region within the braze which had a set of parallel lines remarkably similar to the ground surface finish of an unbonded cemented carbide stud, on the average 25% of the bond area, and (3) a relatively smooth region with little evidence of ductility which is typical of braze joints which had not bonded because of surface contamination, on the average 52% of the bond area.

Figure 7(a) shows a periphery region while Figure 7(b) shows a ductile area surrounded by the smooth unbonded region.

Premature failure of the GE/Smith Geysers' bit is attributed to two factors: (1) the lack of bonding around the periphery, most probably due to oxidation during brazing, and (2) large regions where the braze did not bond to the cemented carbide substrate of the PDC drill blanks, most probably due to contaminated surfaces. For the two studs examined these two factors reduced the load carrying capacity to 20%-30% of the normal value. Since the Geysers test occurred in a steam producing well, it can be presumed that the formation was fractured. Impact loading could easily detach one or both of these cutters, and loss of a PDC cutter would result in rapid wear of the carbide stud. Remaining cutters would be loaded nonuniformly to ever increasing magnitudes until, one by one, fourteen PDC drill blanks were lost sequentially from the outside toward the center of the bit.

Oxidation related poor bonding around the PDC drill blank periphery could be improved by modification of the protective atmosphere delivery system and by temperature control. If the cover gas was introduced at two or three locations around the periphery, the atmosphere protection gas could more efficiently purge the oxygen from the braze joint volume. Temperature control would limit excessively high temperatures which enhance oxide penetration.

Elimination of bond defects caused by contamination prior to brazing can be accomplished by tightening the cemented carbide surface preparation, braze and assembly procedures.

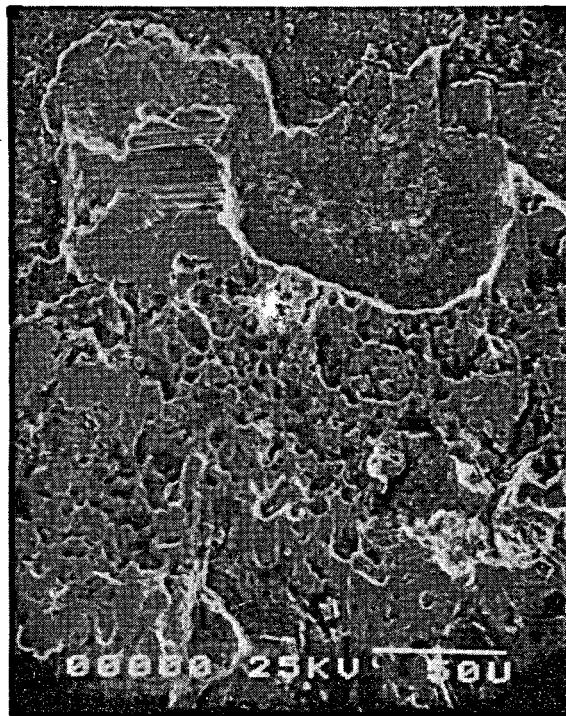
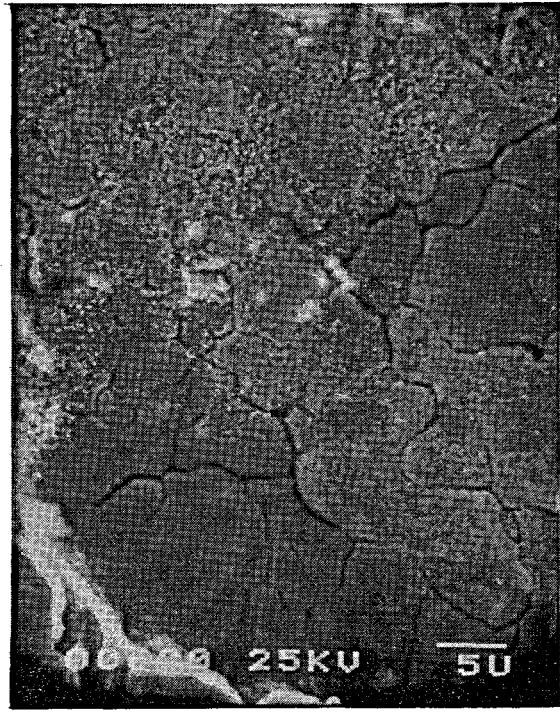
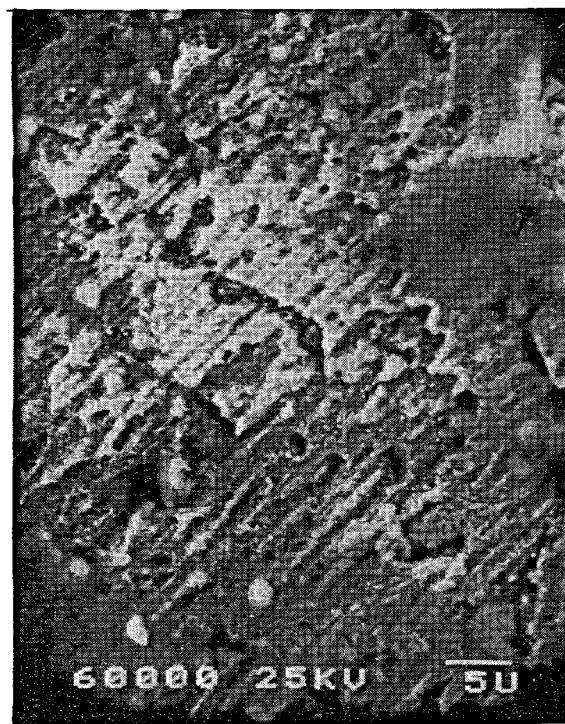
Figure 8. Failure surfaces of the PDC drill blanks removed from the Strata Bit Corp. drill bit after the mud cooled turbine test at the Geysers; (a) 400x (b) 2000x (c) 2000x

The two PDC drill blanks that had been removed with a pair of vise grips were examined in the SEM. Chemical analysis by EDS established that failures occurred within the braze or at braze-stud interfaces; no tungsten was detected. Many areas are present in Figure 8(a) where the braze was smooth, which is characteristic when no bond was formed between the braze and the stud. A higher magnification photomicrograph of the upper part of Figure 8(a) shows a well developed region of hot shortness, see Figure 8(b). Even regions showing ductile shear rupture had nodules dispersed across the surface with smaller areas where cracks had developed at grain boundaries, and this is depicted in Figure 8(c).

Failure was, therefore, due to hot shortness and smaller regions of defective bonding between the braze and the cemented carbide stud. These defects reduced the load capacity of PDC cutters resulting in loss of PDC drill blanks. The mud cooling fluid should have maintained the braze temperature blow levels where hot shortness would have been developed during drilling. Furthermore, small wear flats existed on PDC cutters, so frictional heating was minimal. These points suggest that hot shortness was developed during the brazing step. To support this suggestion, an evaluation of a second GE/Smith bit is included here. This bit was assembled but had not been used in a drilling test.

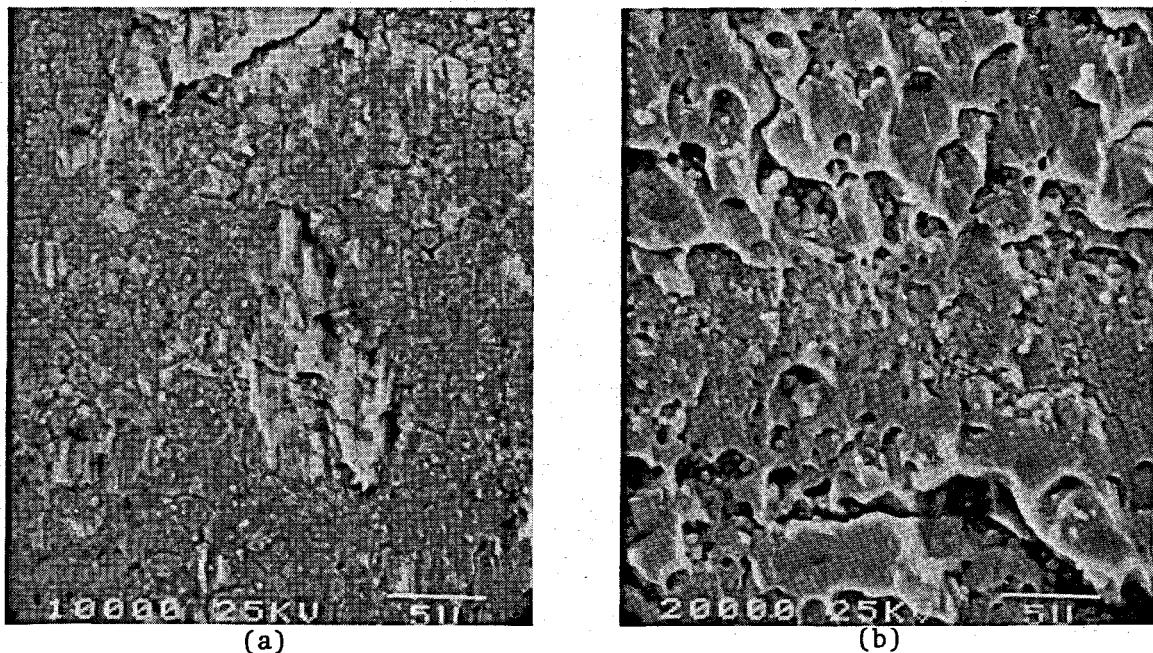
Figure 9. Hot shortness present on the PDC drill blanks removed from the untested GE/Smith bit.

PDC drill blanks removed in the hammer test were examined in the SEM. EDS established that all of these failures occurred within the braze or at braze-stud interfaces. No regions indicating lack of wetting of the stud by the braze were found. The failure mechanism was hot shortness which was spatially distributed throughout the braze. Two typical photomicrographs are shown in Figure 9. Hot shortness decreased the braze joint load carrying capacity to levels that PDC drill blanks were removed from the stud with a two pound hammer. The hot shortness must have developed during brazing, since the drill bit had not been tested. An improper time-temperature braze cycle can be

responsible for the development of hot shortness during brazing.

The reader is reminded that all of the PDC cutters were tested ultrasonically before the hammer test. The supplier also 100% ultrasonically tests PDC cutters before delivery. Neither of these tests found any defects; hence, ultrasonic testing does not detect hot shortness, even when the hot shortness is extensive.

dencies, fatigue strength, impact toughness and oxidation resistance. The recommended GE braze procedure uses an induction heater power source. A temperature control feedback loop to the induction heater, utilizing for example an infrared radcometer, would give production consistency; the effects of operator error, ferromagnetic coupling variations due to shifts in cobalt content and changes in the bond joint configuration, and power supply inconsistencies would be eliminated. All of these factors can contribute to the development of hot shortness during brazing.
