POSTIRRADIATION EXAMINATION RESULTS FOR THE IRRADIATION EFFECTS TEST SERIES IE-ST-2 ROD IE-002

TREE-NUREG-177

POSTIRRADIATION EXAMINATION RESULTS FOR THE IRRADIATION
EFFECTS TEST IE-ST-2 ROD IE-002

December 1977

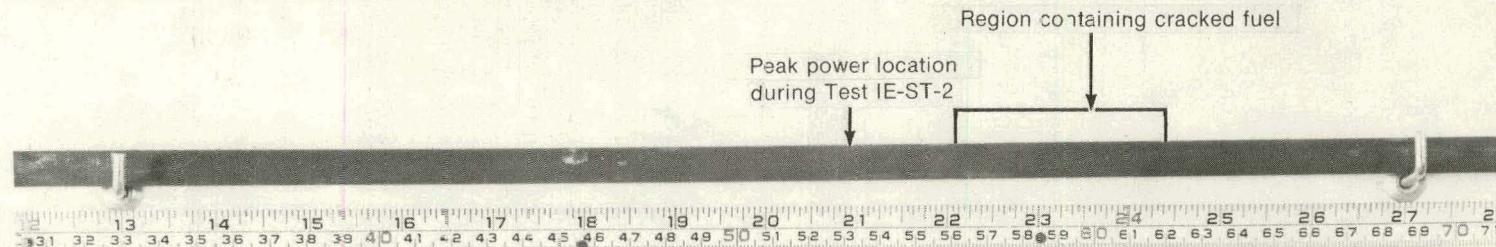
Fig. 3 Rod IE-002 at zero degrees.

Rod IE-002 was examined to establish the overall posttest condition of the rod. The entire rod was covered with a thin, dark oxide. A wear mark at the 0.46-m elevation resulted from contact with one of the fuel rod centering screws.

Figures 3 and 4 show the rod at 0 and 180 degrees, respectively. The peak power location (0.492 m) and the region which contained cracked fuel (0.55 to 0.62 m) (Section III, 2) are indicated in the figures. Some ¹³⁷Cs migrated away from this region (Section III, 4) and wall thinning also occurred in this region (Section III, 3.2). No discoloration or other obvious change was seen in the cladding outer surface at this location, which confirmed the instrumentation indications that the rod did not operate in film boiling as a result of the flow reduction.

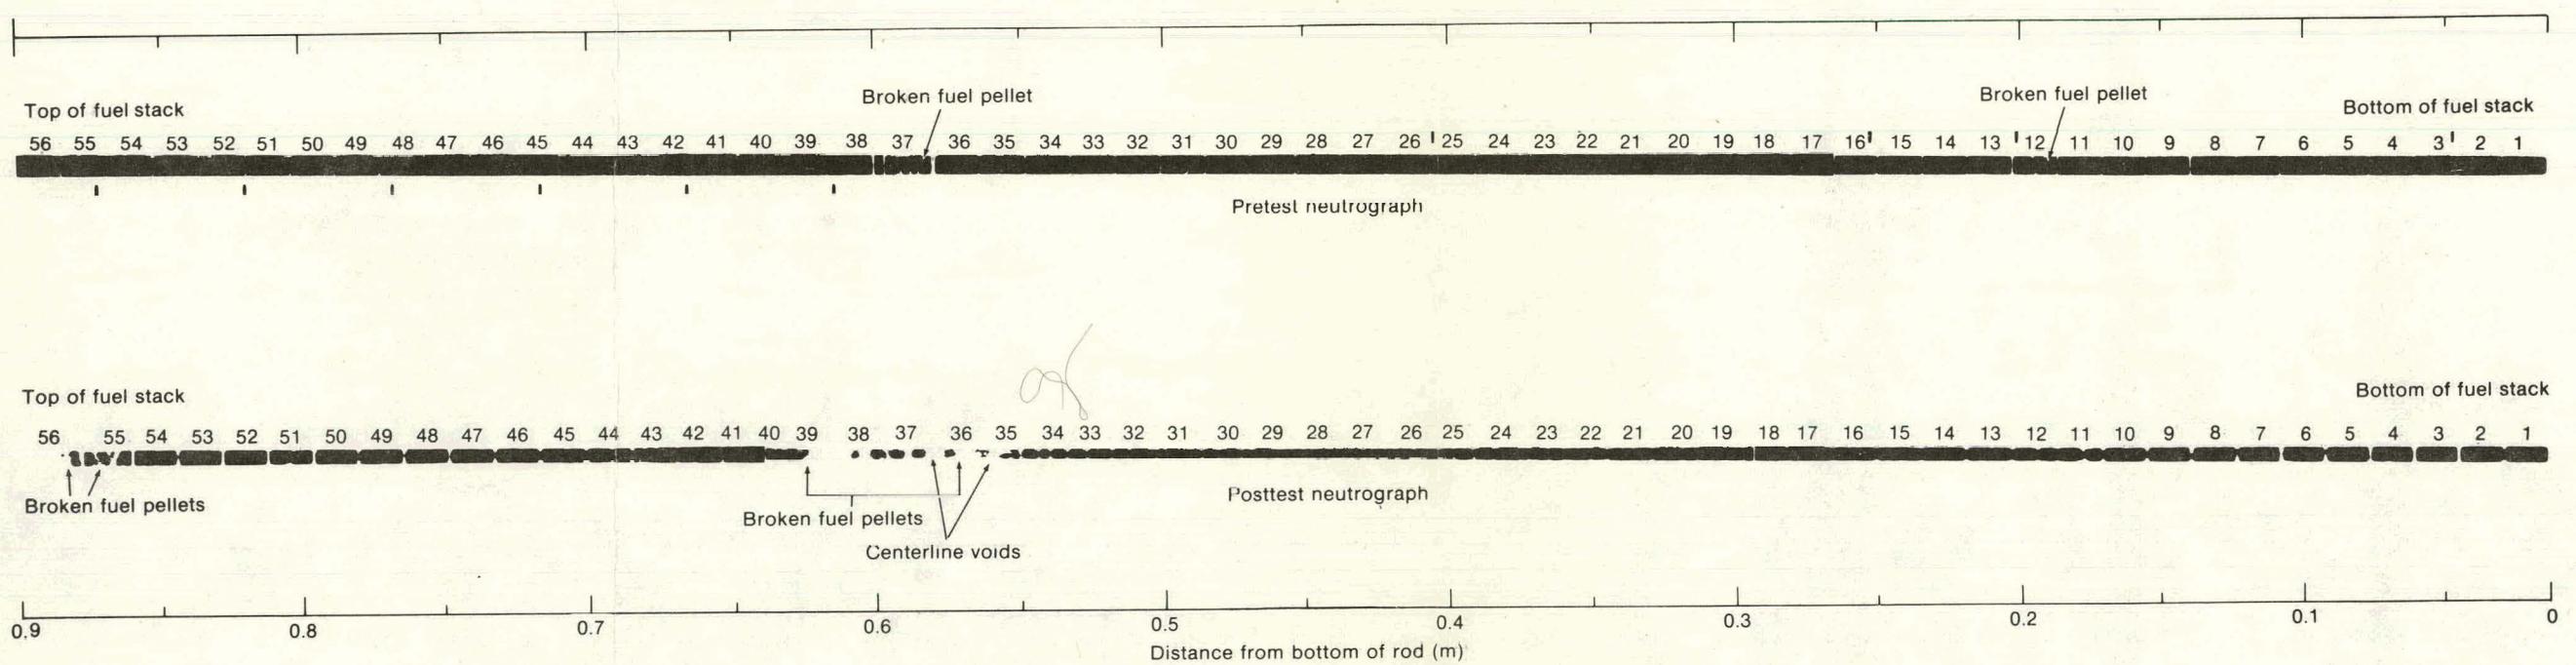
Fig. 5 Pre- and posttest neutron radiographs of Rod IE-002.

The GE neutrograph shows greater definition of individual pellet-to-pellet gaps and cracks, whereas these features appear exaggerated in the TREAT neutrograph. The pretest neutrograph shows fuel cracking resulting from operation in the Saxton reactor. Pellet number 37, located about 0.8 m from the bottom of the fuel rod, [a] was severely cracked. In the same general region (Pellets 36 through 39), the posttest neutrograph shows four pellets that were severely fractured. The degree of cracking appears somewhat exaggerated by the TREAT neutrograph. Whether this fuel breakup is a result of handling while the rod was being modified for use in the test or whether it is a result of the test is not clear. Two pellets at the top of the fuel stack were also broken. This breakage was probably due to handling when the end cap was installed. Pellet 12 at 0.20 m was cracked as shown in the pretest neutrograph; however, no additional cracking of this pellet occurred as a result of testing.

Some indication of centerline void formation which may be associated with fuel melting was noted in the region from 0.55 to 0.62 m. Destructive examination would be required to verify this assumption; however, the migration of ^{137}Cs , as reported in Section III, 4, is an indication of elevated fuel temperatures which, again, may be associated with fuel melting.

Fuel Rod IE-002 was gamma scanned pre- and posttest. These data are presented in Appendix B. A decrease in gross gamma activity in both scans correlates well with the area of broken fuel shown in Figure 5.

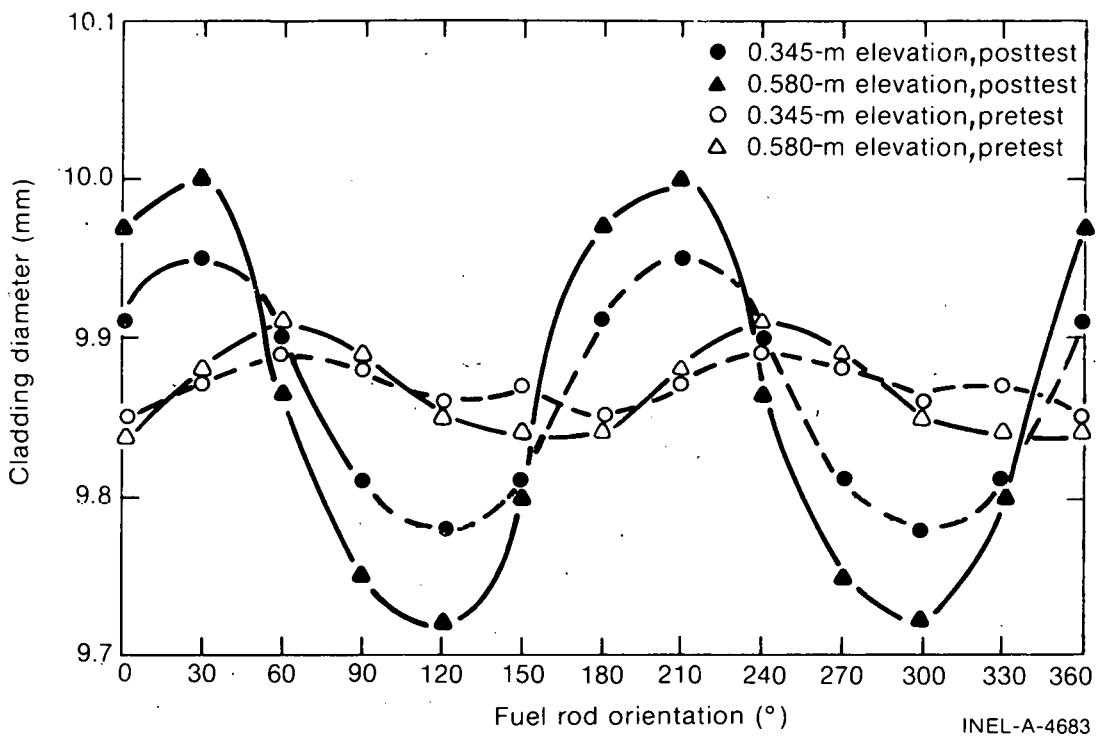
Fig. 6 Pre- and posttest cladding diameters of Rod IE-002.

The cladding outer diameter was generally unchanged from the pretest condition, except for two axial locations: 0.345 and 0.580 m. Figure 6 shows the cladding pre- and posttest outer diameter at these locations. The pretest diameter measurements showed some ovality, with the maximum diameter at 60 degrees and the minimum diameter at 150 degrees. (Ovality is defined as the ratio of maximum diameter to the diameter at 90 degrees from the location of the maximum diameter.) The maximum pretest ovality was 1.007, occurring at the 0.58-m elevation. Posttest results indicated the circumferential location of the maximum diameter had shifted to 30 degrees, with the minimum diameter at 120 degrees. The maximum posttest ovality was 1.029, also located at 0.58 m.

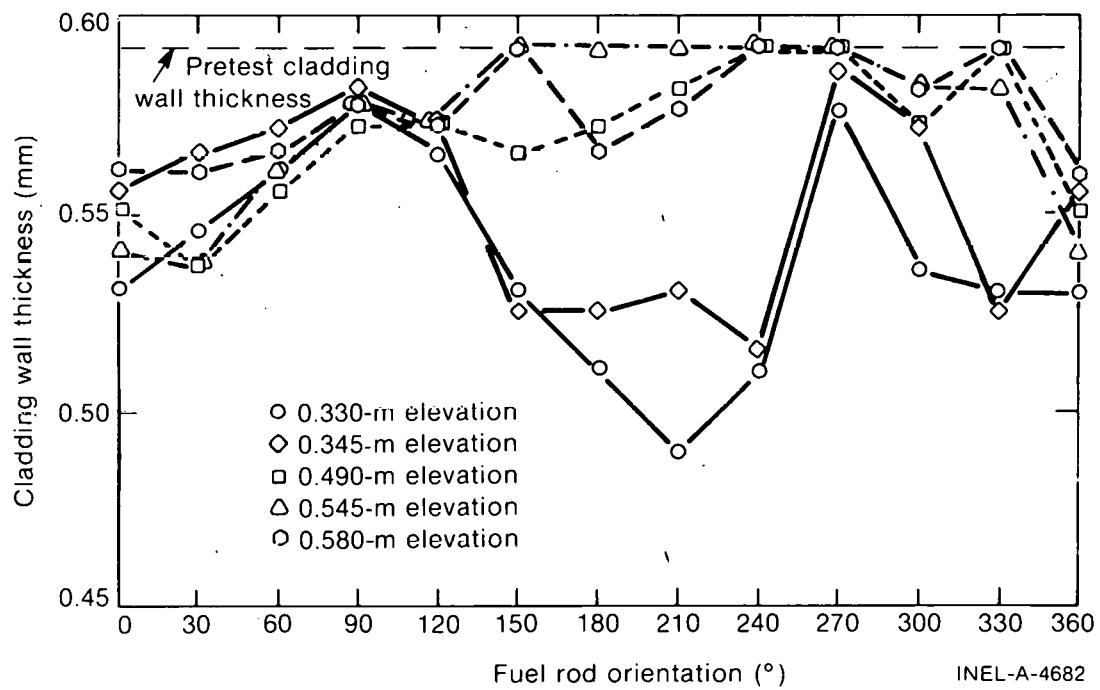
Fig. 7 Posttest cladding wall thickness at several axial locations of Rod IE-002.

Cladding wall thickness was uniform over the length of the fuel rod after irradiation in the Saxton reactor. However, after irradiation in Test IE-ST-2, decreases in wall thickness were measured at two regions: 0.22- to 0.36-m elevation, the region of maximum power in the Saxton reactor; and 0.42- to 0.62-m elevation, the region of maximum power in PBF operation. Figure 7 shows the wall thickness as a function of orientation for two elevations in the lower region and three elevations in the upper region. The maximum decrease in wall thickness, 0.102 mm (17%), occurs at 0.330 m. The average wall thickness in the lower region was 0.546 mm, a reduction of 0.046 mm (8%). The average wall thickness in the upper region was 0.575 mm, a reduction of 0.017 mm (3%). No evidence of cladding ridging was observed at pellet interfaces.

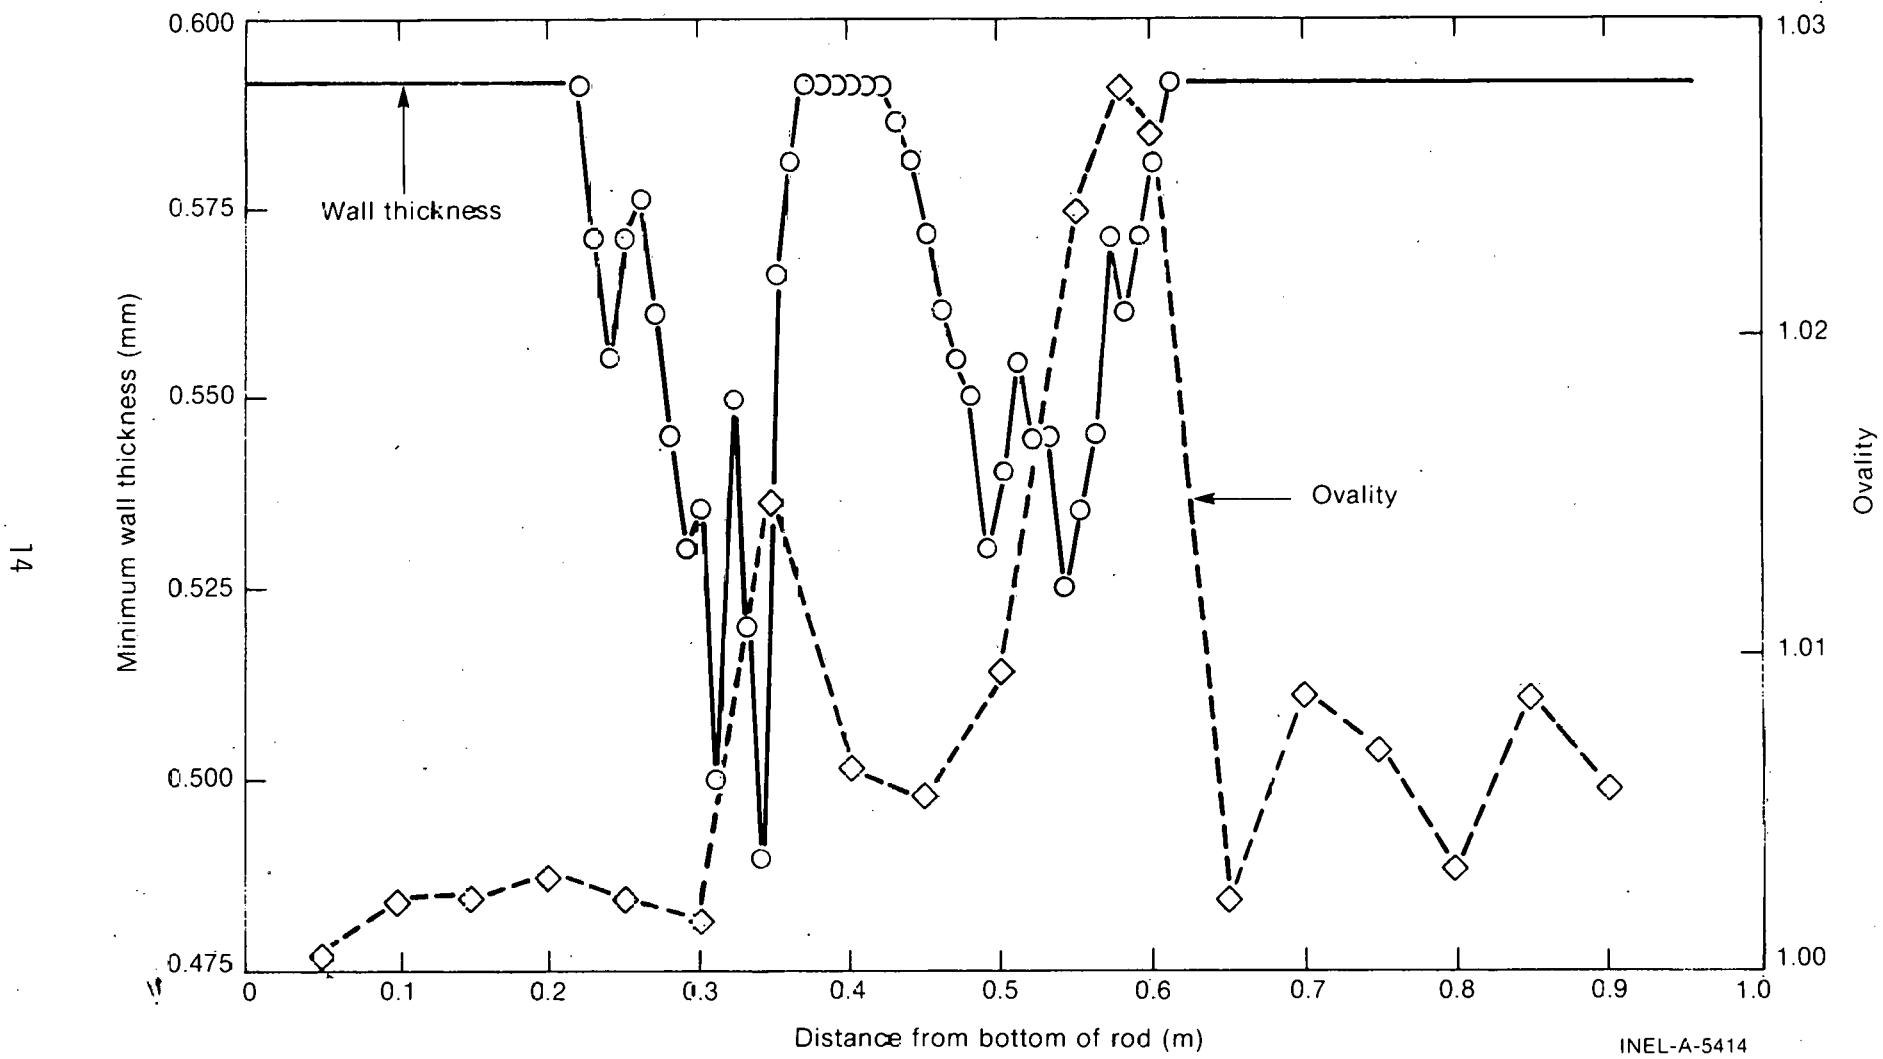
Fig. 8 Minimum wall thickness and maximum ovality along the length of Rod IE-002.

The minimum wall thickness and maximum ovality were determined along the length of the fuel rod. These data, plotted in Figure 8, show two regions of cladding deformation. However, from the plot it can be seen that the regions of diameter change are offset axially from the regions of wall thinning by approximately 0.05 m, upward.

In this same region, relatively large cladding deformations occurred with maximum cladding wall thickness locally decreasing by about 9% at the 0.58-m rod elevation as compared with wall thickness measured after operation in the Saxton Reactor. Cladding deformations also occurred from the 0.22- to 0.36-m rod elevation, the region of maximum rod power.

during Saxton operation. A maximum wall thickness decrease of 17% occurred at the 0.33-m rod elevation. Prior to PBF operation wall thickness was relatively uniform, with no regions showing evidence of cladding wall thinning.

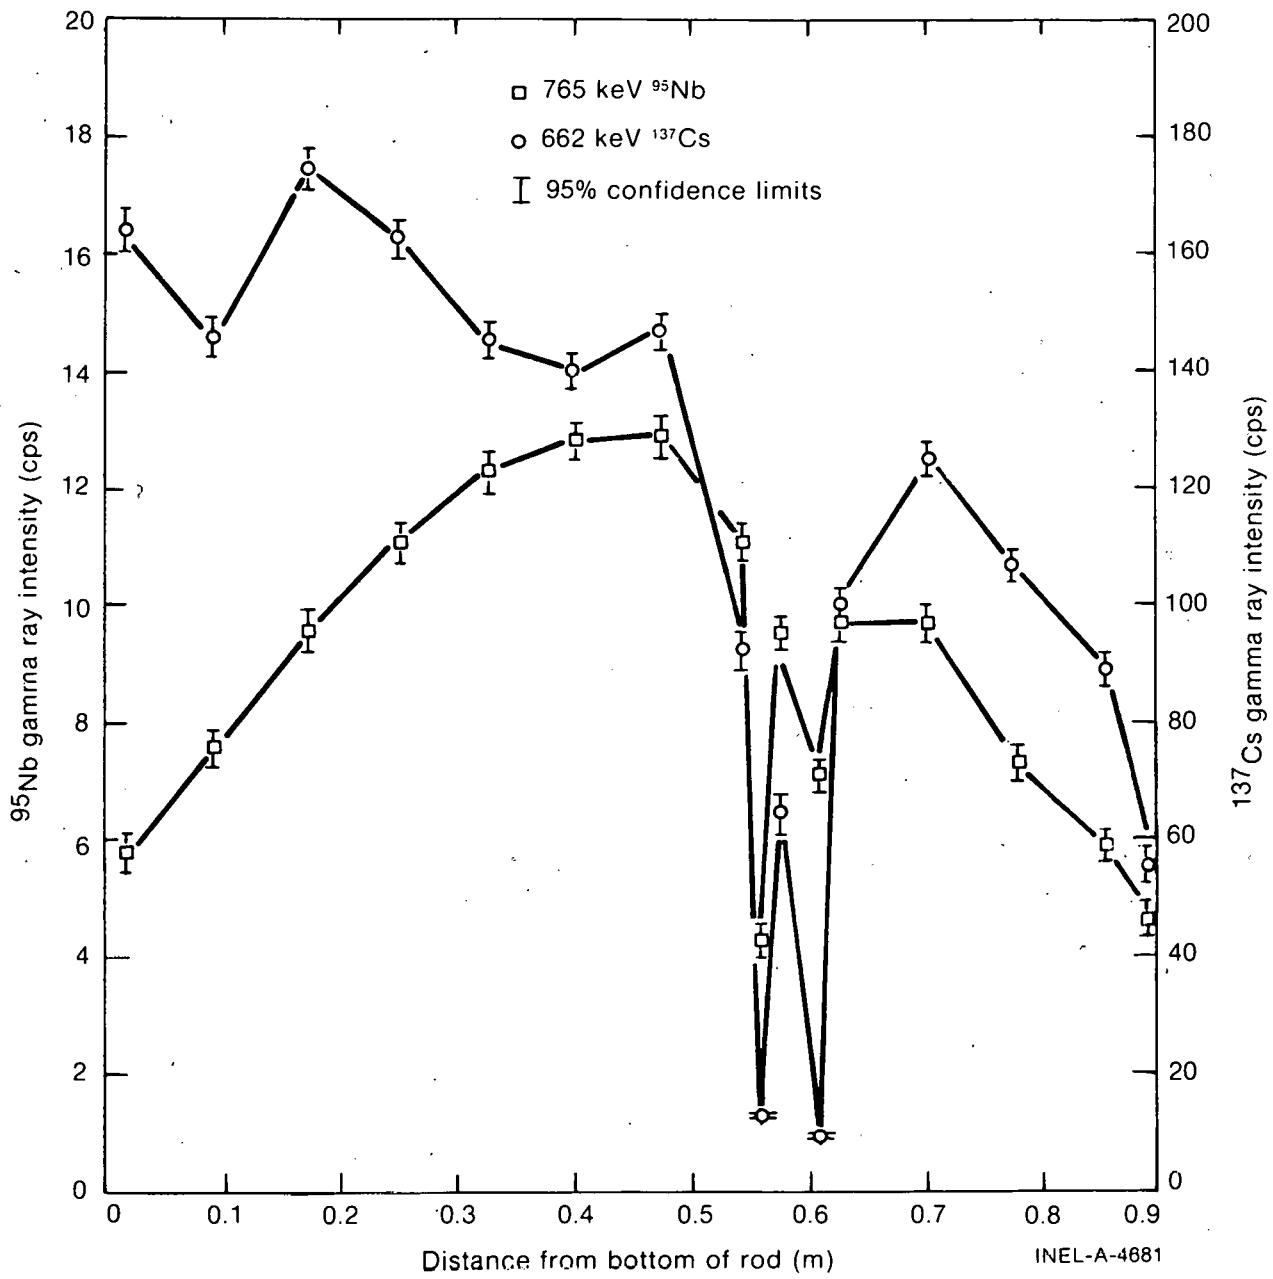
Fig. 9 Gamma ray intensities from Rod IE-002.

The fuel rod was also spectral gamma scanned for the following: 497 keV ^{103}Ru , 622 keV ^{106}Rh , 662 keV ^{137}Cs , 724 keV ^{95}Zr , 756 keV ^{95}Zr , 765 keV ^{95}Nb , and 2186 keV ^{144}Ce . Results are presented in Table 1. The 765 keV ^{95}Nb , and 662 keV ^{137}Cs gamma intensities are plotted as a function of axial location in Figure 9. Both the ^{95}Nb and ^{137}Cs intensities decrease in the region containing broken fuel (0.55 to 0.62 m). The ^{137}Cs intensity increases toward the bottom of the rod. Figure 10 shows the ratio of 662 keV ^{137}Cs intensity to the 765 keV ^{95}Nb intensity as a function of axial location. This plot shows the migration of ^{137}Cs from the 0.55- to 0.61-m region, above the power peak location, toward the bottom 0.2 m of the fuel rod.

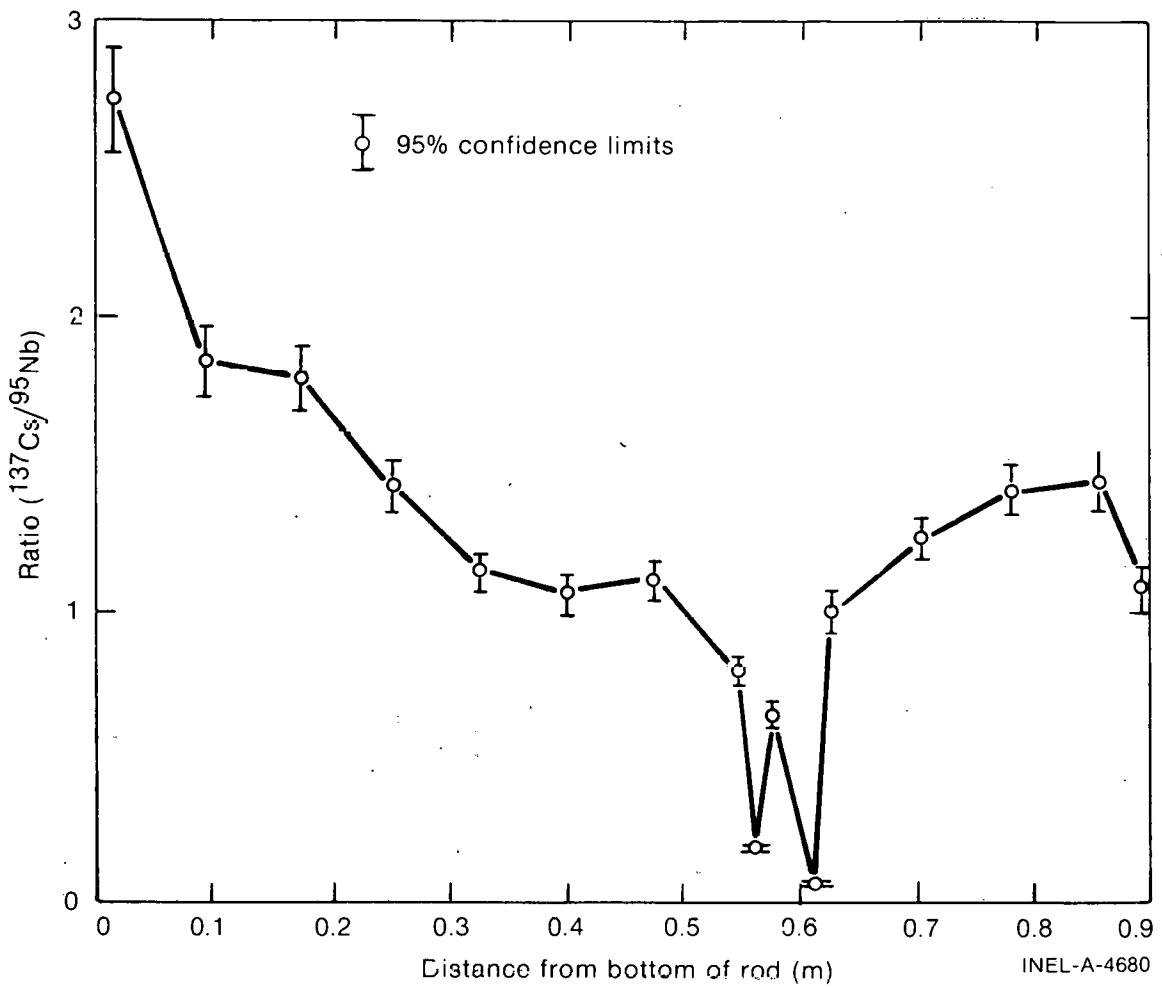
Fig. 10 Ratio of 662 keV ^{137}Cs to 765 keV ^{95}Nb gamma ray intensities.

A spectral gamma scan detected gross migration of fission product ¹³⁷Cs from the 0.55- to 0.62-m region toward the bottom of the rod. In this same region, indications of void formation at the center of the pellets were observed in the posttest neutrograph. These findings indicate that fuel temperatures were very high in this region and possibly some fuel melting had occurred. This same region is the location expected to operate in film boiling during the flow reduction phase of the test. However, on-line instrumentation, the visual appearance of the rod, and the absence of cladding collapse all indicate that the rod did not operate in film boiling. The cause of the anomalously high fuel temperature cannot be explained at this time.

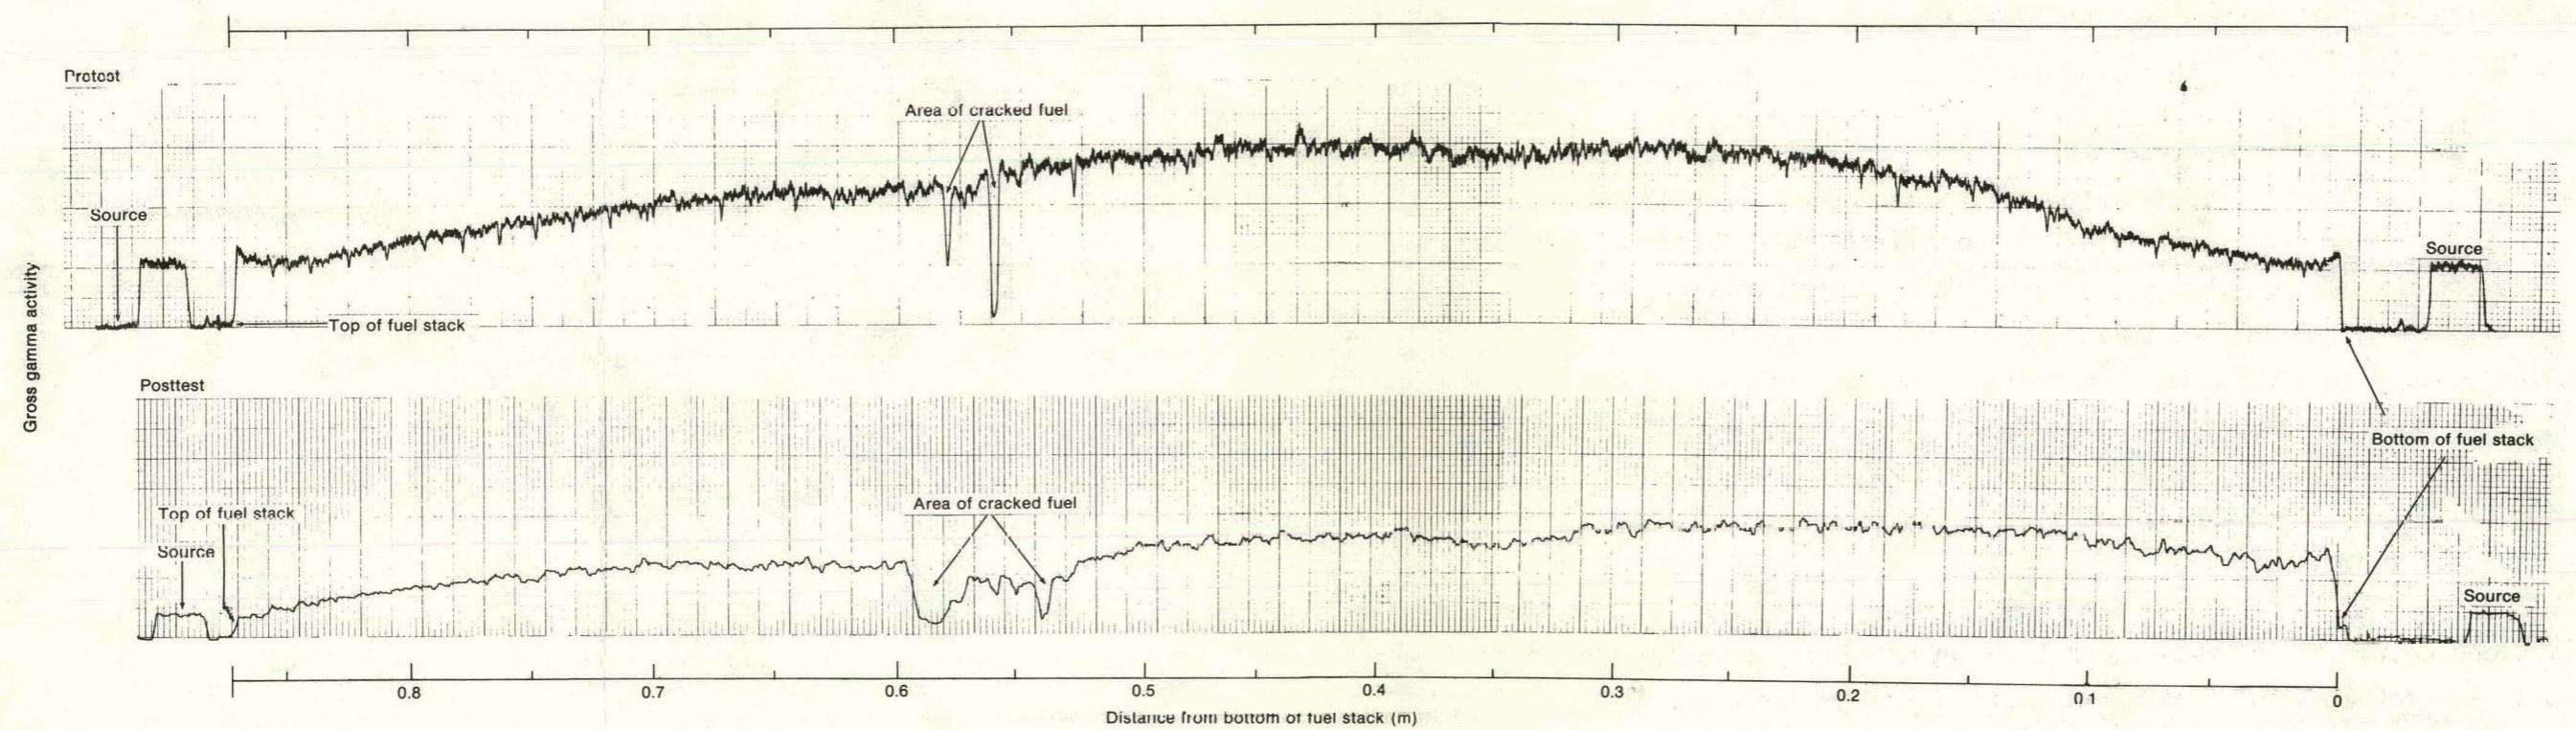
Fig. B-1 Pre- and posttest gross gamma scans of Rod IE-002.

Figure B-1 shows the pre- and posttest gross gamma scans. A different scale was used for the two scans, as shown in the figure by the ^{137}Cs source run before and after each scan. The pretest scan shows a decrease in activity at the area of cracked fuel located 0.546 to 0.577 m from the bottom of the fuel stack. The decrease in posttest activity from 0.55 to 0.62 m indicates more extensive fuel cracking as a result of the test. This activity decrease was also found to be a result of ^{137}Cs migration away from this area.
