FAILURE ANALYSIS OF GLASS-CERAMIC INSULATORS OF SHOCK TESTED VACUUM (NEUTRON) TUBES

R. K. Spears
Metallurgy and Ceramics Laboratory

August 25, 1980

General Electric Company
Neutron Devices Department
P. O. Box 11508
St. Petersburg, Florida 33733

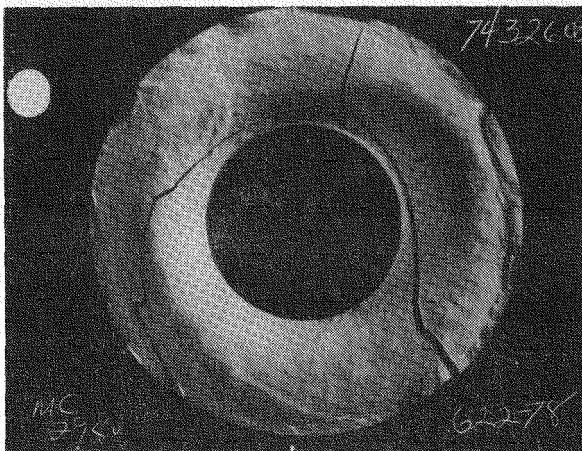
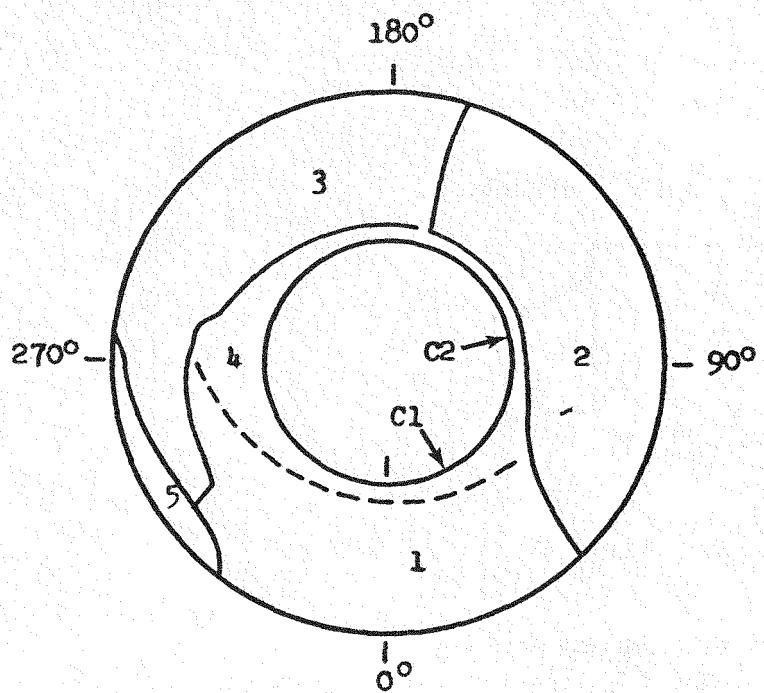
Figure 2. Bottom View of Insulator A
(Looking From Inside of Tube)

The bottom view of this insulator (looking from the inside of the tube out) with the molybdenum removed is shown in Figure 2-A. A crack shown by dotted lines of Figure 2-B was present in the insulator but separation did not occur until manually forced. Five pieces (as noted in Figure 2-B) were available for visual examination. Crack origins were observed at two locations (C1 and C2, Figure 2-B) near the top surface of the insulator.

A. Photograph. (The molybdenum has been etched away.)

B. Schematic. (The cracks originated at C1 and C2 near the top surface.)

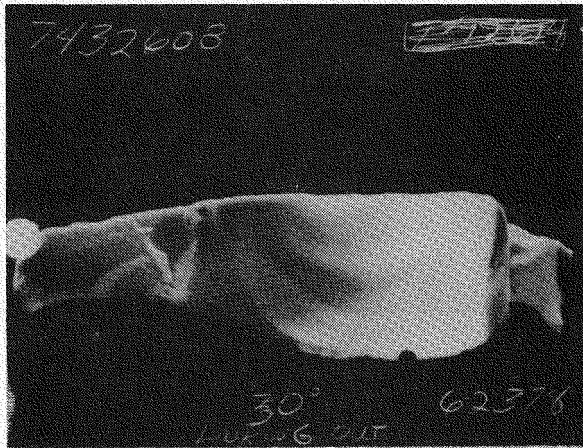
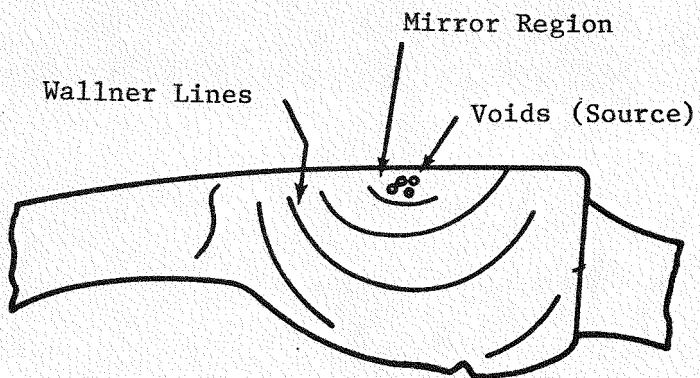
Figure 3. Photograph and Schematic, Crack C1, Insulator A

Figure 3 shows views of crack C1. This crack occurred very near the inner sleeve and originated at a cluster of interface voids of 0.005 to 0.015 in. diameter. The second crack originated approximately 80 to 90° from the first (see Figure 4). Voids were also evident at the point of initiation. This crack was more typical of fracture patterns observed in brittle materials in that a mirror region, a mist region (with Wallner lines) and hackel was clearly evident. The glass adhered adequately to the molybdenum and only in the region where the crack initiated was unbonding evident.

A. Photograph Showing Voids at Origin. (Wallner lines are also evident.)

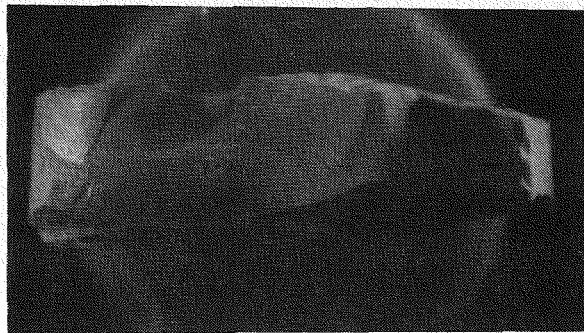
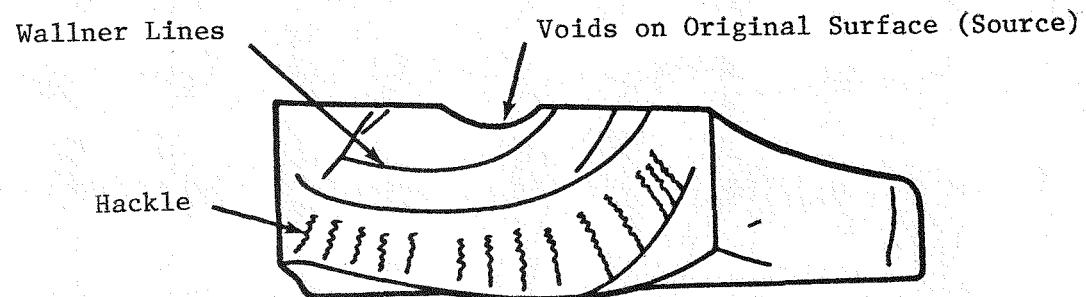
Figure 4. Photograph and Schematic, Crack C2, Insulator A

A. Photograph. (Void area has been broken off. Wallner lines and hackle area shown.)

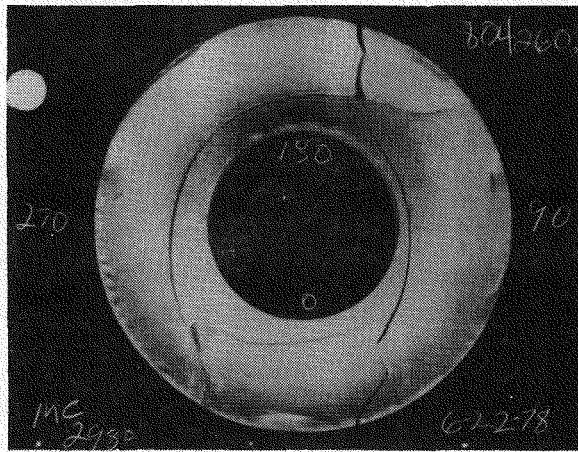
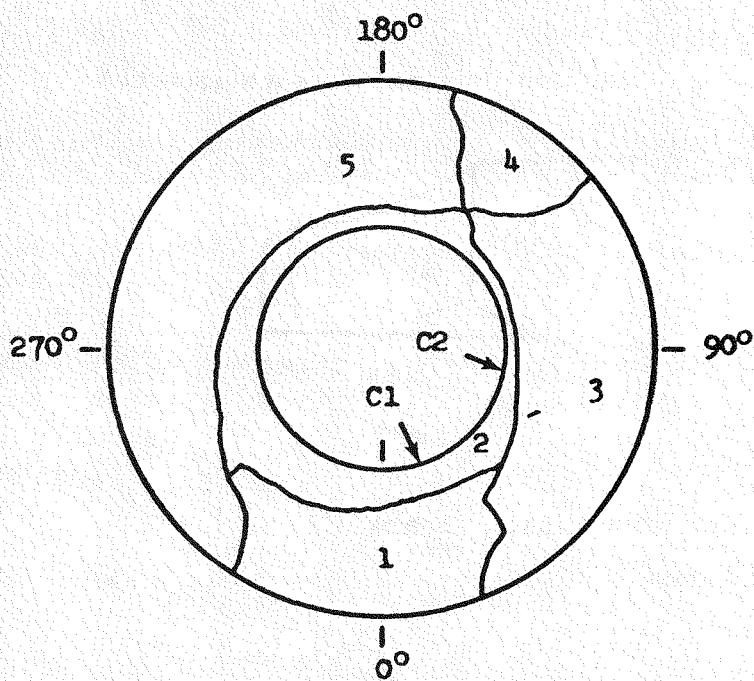
Figure 5. Photograph and Schematic Bottom View, Insulator B

The bottom view of this insulator, after the cracked portions were manually separated, is shown in Figure 5. Five pieces (marked in Figure 5-B) were available for investigation. As with the previous insulator, two cracks were evident, one at 5° and the other at 80°. These cracks originated close to the inner sleeve but near the bottom surface of the tube rather than the top surface as was observed on Insulator A. Voids at the point of crack origin were not apparent in either crack. A photograph of crack no. 1 at 5° from the origin is shown in Figure 6. Figure 7 is a similar photograph of crack no. 2 at 80° from the origin.

B. Schematic Showing Origin of Cracks C1 and C2. (These originated near the bottom surface.)

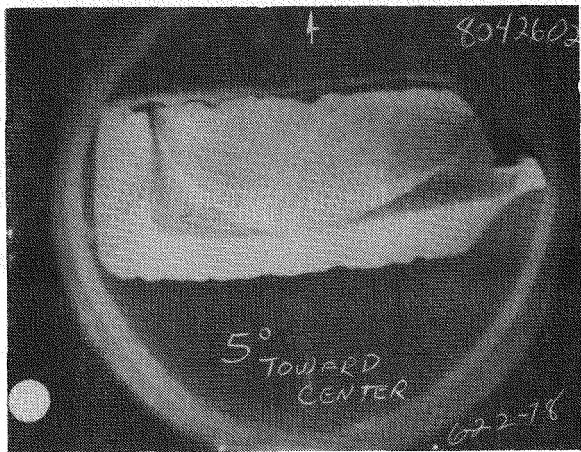
Figure 6. Photograph of Crack No. 1. Insulator B. (Photograph taken at 5° from origin [see Figure 4-B]. The crack originated at the insulator-inner sleeve interface near the bottom [inside tube] surface.)

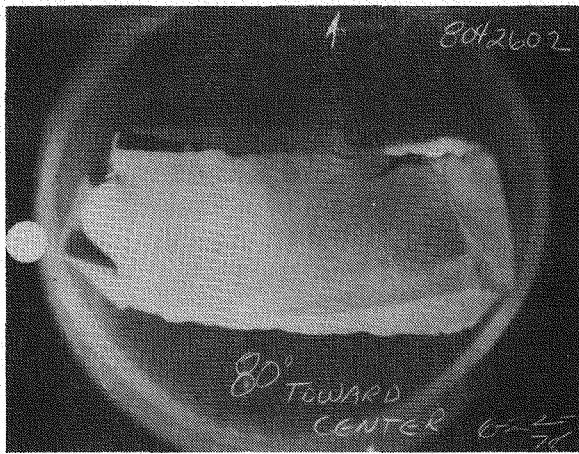
Figure 7. Photograph of Crack No. 2. Insulator B. (Photograph taken at 80° from origin [see Figure 4-B]. This crack originated at the insulator-inner sleeve interface near the bottom [inside tube] surface.)

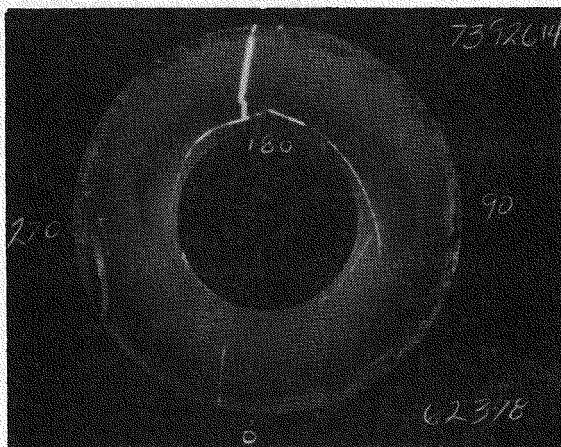
Apparently during the tube removal processing this insulator had cracked but individual pieces had not separated. A photograph of the insulator in which Zyglo was used to detect cracks is shown in Figure 8. Photographs of the inside surface of the insulator after separation of the cracked pieces are shown in Figure 9. Three pieces were available for inspection.

Figure 8. Photograph of Bottom Surface, Insulator C. (Photograph taken under ultraviolet light showing adsorption of Zyglo in the cracked portion.)

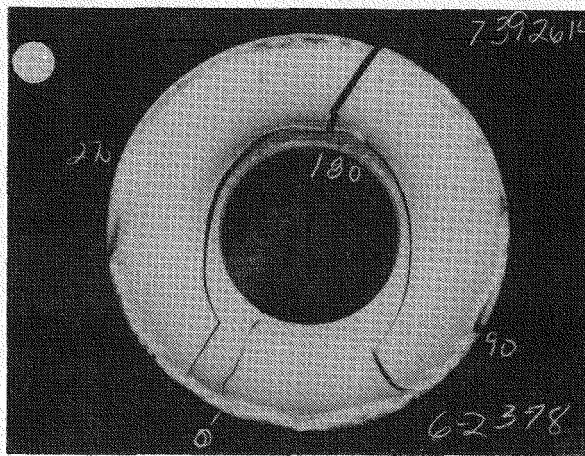
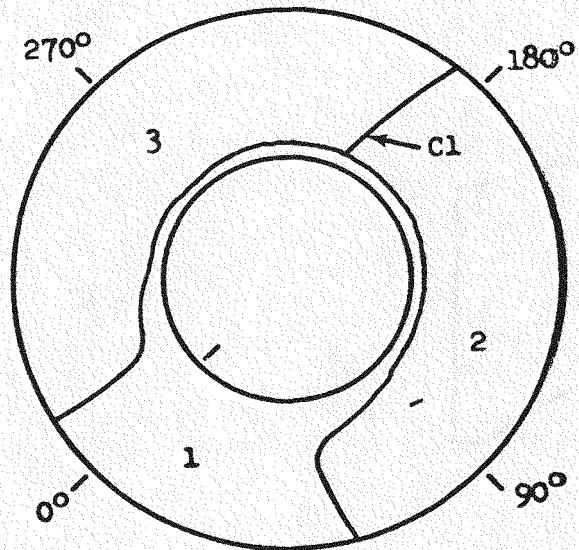
Figure 9. Photograph and Schematic, Bottom View, Insulator C

B. Schematic. (The crack originated at C1 about midway between the upper and lower surfaces of the insulator.)

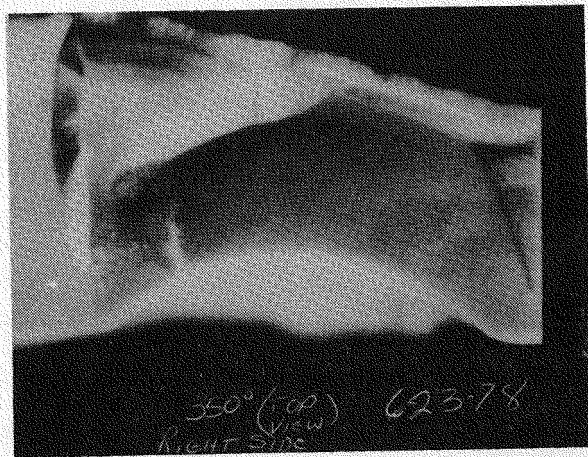
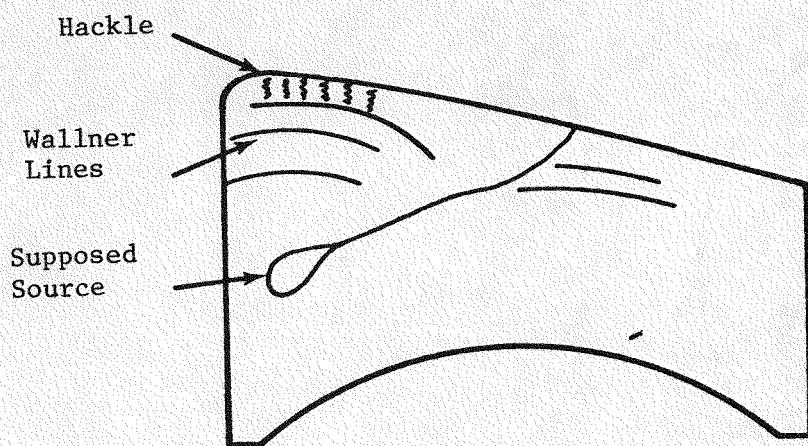
Figure 10. Photograph and Schematic,
Fracture in Insulator C

The initiation point was found to be within the insulator approximately 0.050 in. from the inner sleeve and midway between the top and bottom surfaces (see Figure 10).

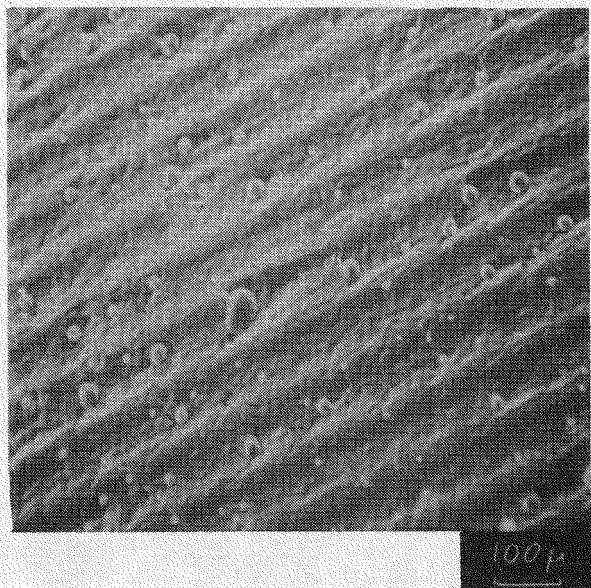
Replicas of the inner sleeves of these units showed extensive defects (voids) at the interface of all three parts. Deep machine grooves (Figure 11) were observed on the replicas of Insulator A and Insulator C. Defects at these interfaces were spherical in shape for the most part and smooth with an exception shown in Figure 12--a smooth but irregular shaped defect from Insulator A. A substructure surface pattern appears on this defect. Flaws at the interface of Insulator B were also smooth but many were nonspherical (see Figures 13 and 14). All of the glass-ceramic residue was not removed from this replica. None of the flaws observed were as large in diameter as 0.020 in., which is the approximate size detectable by ultrasonic scanning. The maximum defect size appeared to be no larger than 0.010 in. However, clusters of voids of this size certainly should be detectable with ultrasonic examination. This examination was made of approximately 20 percent of the entire seal area. Thus, defects larger in diameter than 0.010 in. could be present at these interfaces.

Figure 11. SEM Photograph, Insulator-Sleeve Interface.
Insulator A. 100X Magnification. (A similar condition was present on Insulator C.)

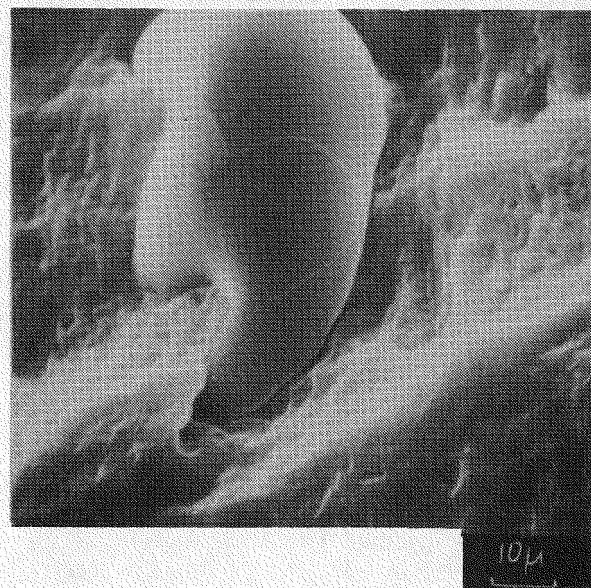
Figure 12. SEM Photograph, Insulator-Sleeve Interface.
Insulator A. 1000X Magnification. (Not surface structure on defect.)

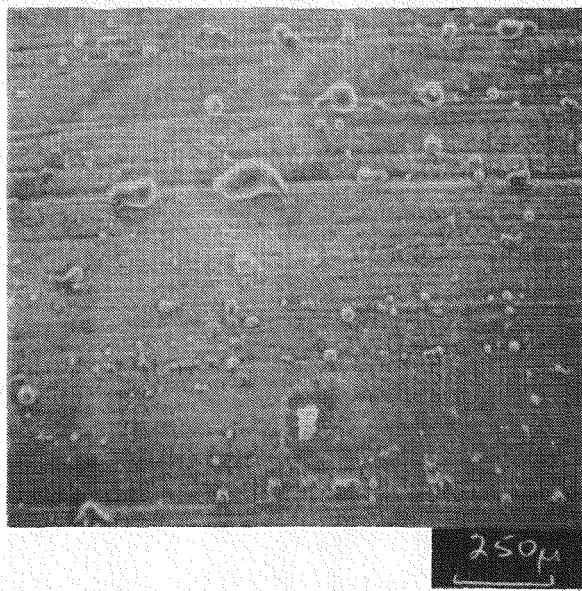
Figure 13. SEM Photograph,
Insulator-Sleeve
Interface.
Insulator B.
60X Magnification.

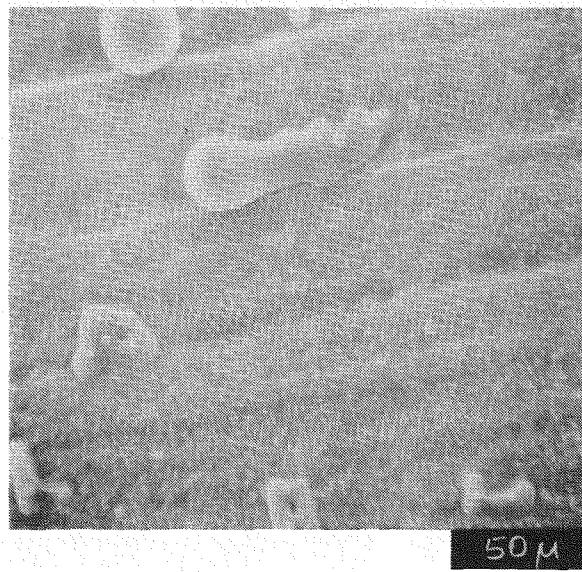
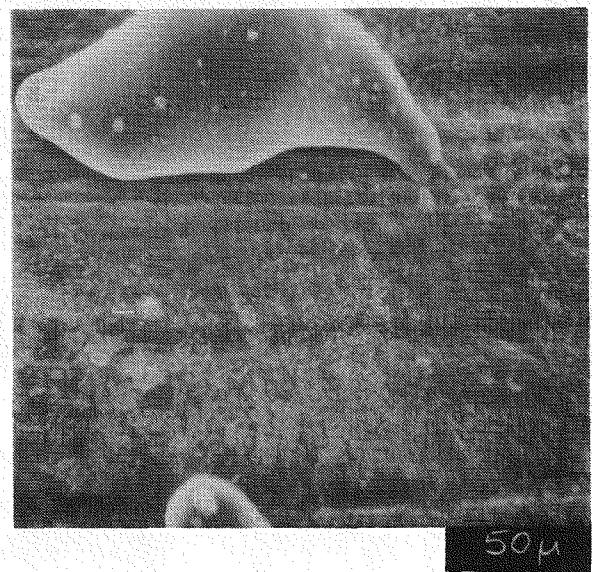
Figure 14. SEM Photographs, Insulator-Sleeve Interface.
Insulator B. 300X Magnification.

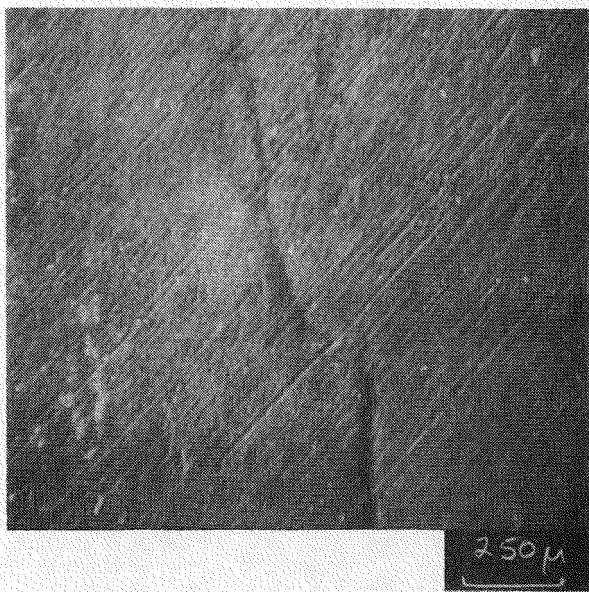
The outer interfaces on all three units showed smooth, spherical voids with a maximum size of about 0.002 in. Thus, these flaws were much smaller than those at the inner sleeve interface. Interesting flaws that appeared to be due to creases or scratches in the molybdenum were evident on Insulator B (Figures 15 and 16) and Insulator B (Figure 17). In Figure 15, void defects are lodged within a "scratch." Smaller scratch marks due to polishing (typical of those seen in Figures 15, 16 and 17) were seen on the interface replicas of all three units. A cluster of voids was observed at the interface of Insulator B (see Figure 18 at 100X and Figure 19 at 1000X). These smooth, spherical nodules are typical of the defects observed at all three interfaces. As mentioned in previous reports, the cause of these defects is not precisely known but evolution of gas from the molybdenum is strongly suspected to be the source.

Figure 15. SEM Photograph
Showing Large
Scratch and
Smaller Polishing
Scratches.
Insulator B.
60X Magnification.

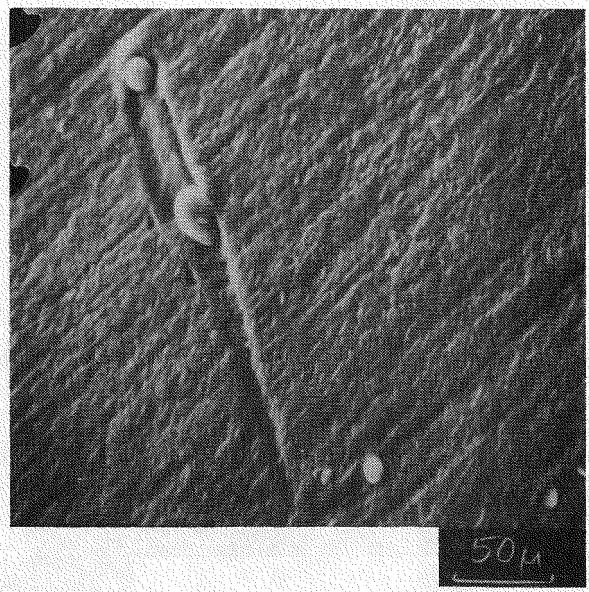
Figure 16. SEM Photograph
Showing Scratch
and Voids Lodged
in Scratches.
Insulator B.
300X Magnification.

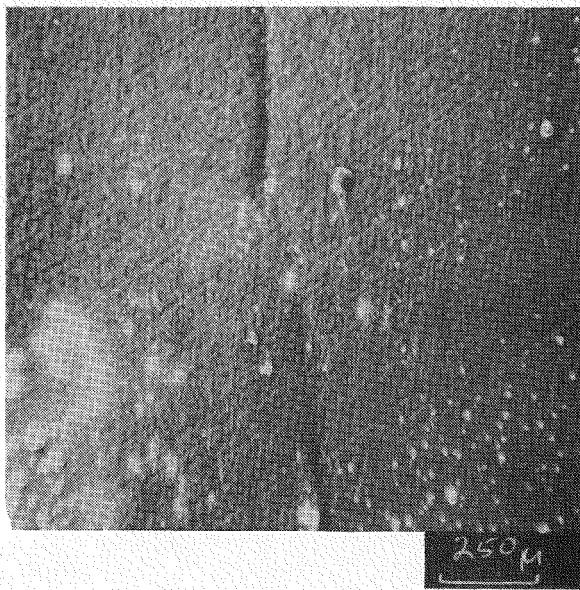
Figure 17. SEM Photograph
Showing Scratches.
Insulator A.
60X Magnification.

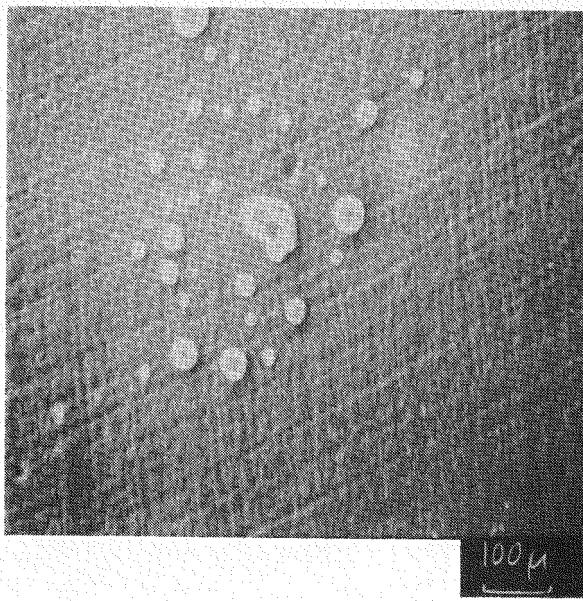
Figure 18. SEM Photograph
Showing Cluster of
Voids. Insulator A.
100X Magnification.

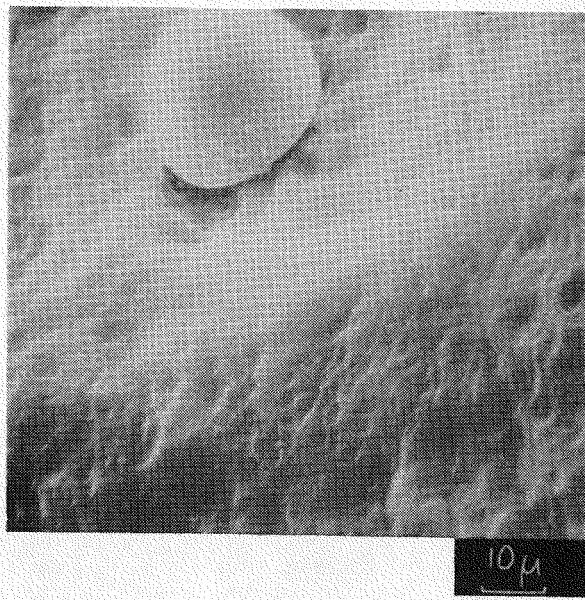
Figure 19. SEM Photograph
Magnified View
of Cluster Shown
in Figure 18.
Insulator A.
1000X Magnification.
