SAND81-7028/1  
Unlimited Release  
UC-62

# Final Report Solar-Collector-Materials Exposure to the IPH Site Environment

## Volume 1

V. L. Morris  
Huntington Beach, CA 92647

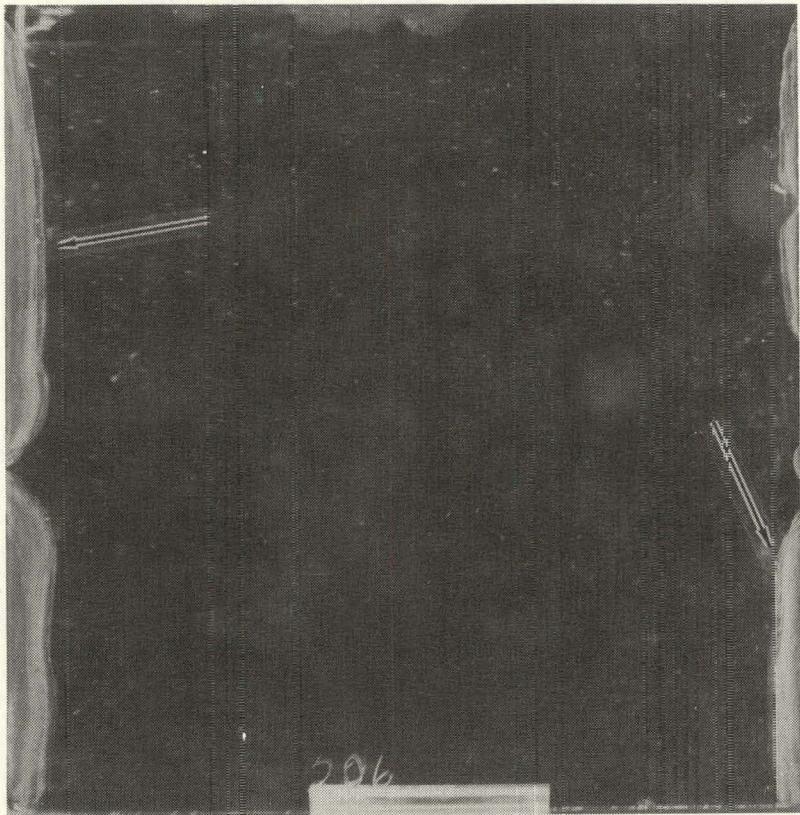
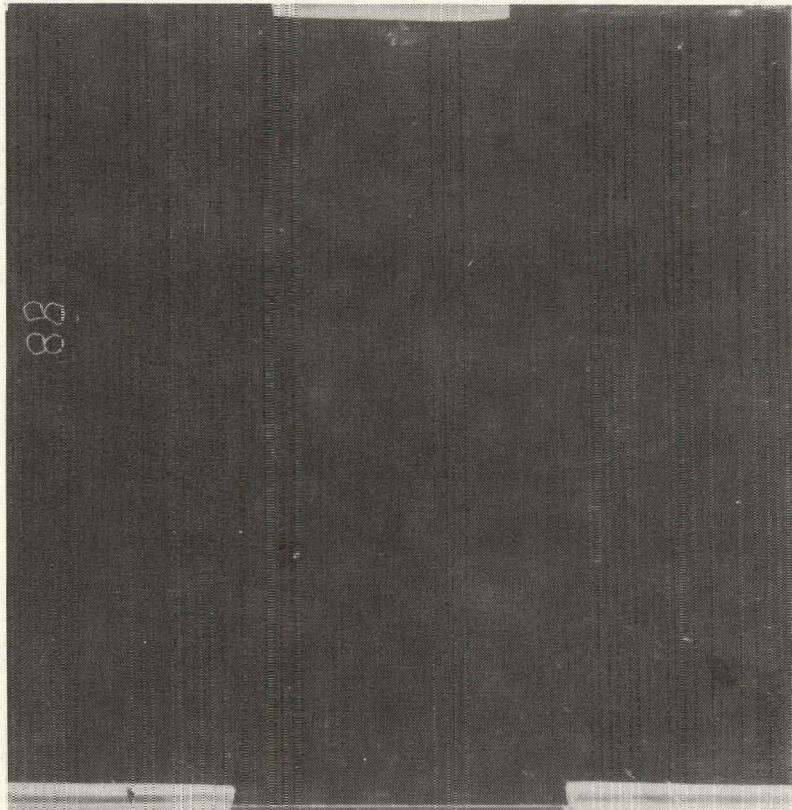
The three additional protective backings added to the glass specimens did not prove totally effective in withstanding the micro-climate at this site, particularly along the unprotected edges of the reflector specimen, i.e., those edges not covered by the sample retainers. The paints chipped, blistered, and peeled, and the vinyl sheet lost adhesion around the exposed edges to a depth of 0.50 inch. The silver was corroded in the areas where the protective backing failed on the unprotected edges (Figure 5). Six months of exposure was required to reach the 0.50-inch corrosion depth. However, continued exposure from 6 to 12 months did not produce further degradation of the silver, and corrosion in the center areas of the specimen was not observed. It is not clear whether continued exposure would further degrade the paint backings and allow penetration of the corrosive material into the silver layer, thus resulting in corrosion across the surface of the reflector.

Figure 5. Glass Specimen with Epoxy Backing. Specimen 206 was exposed 6 months, X-plane at Stauffer Chemical Co. Arrows indicate silver corrosion along sample edges. Specimen 88 is a control specimen maintained in a desiccated laboratory environment. Specimen 206 has been cleaned.

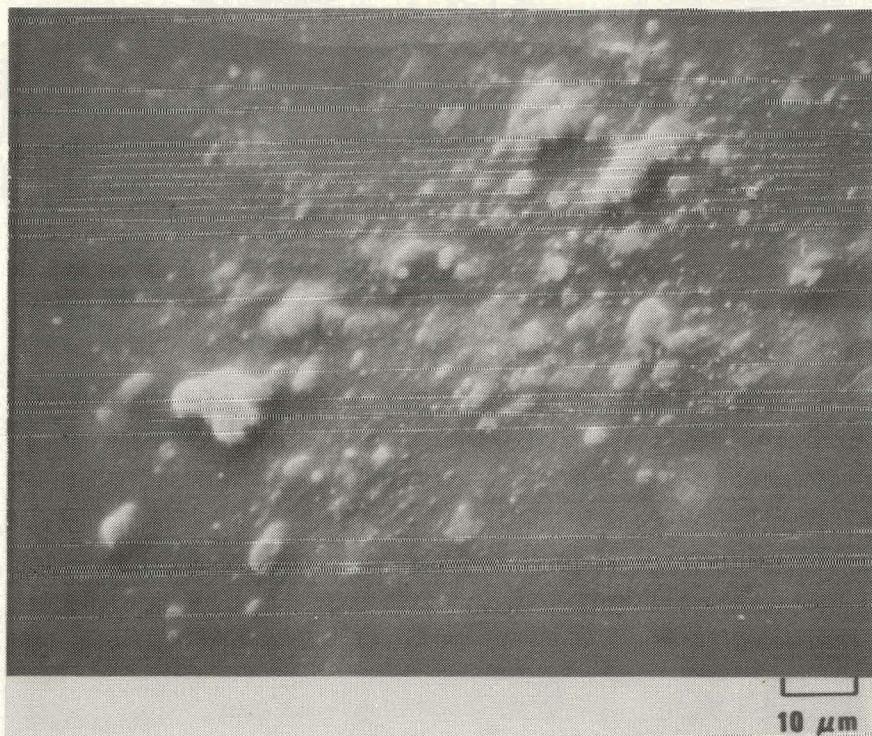
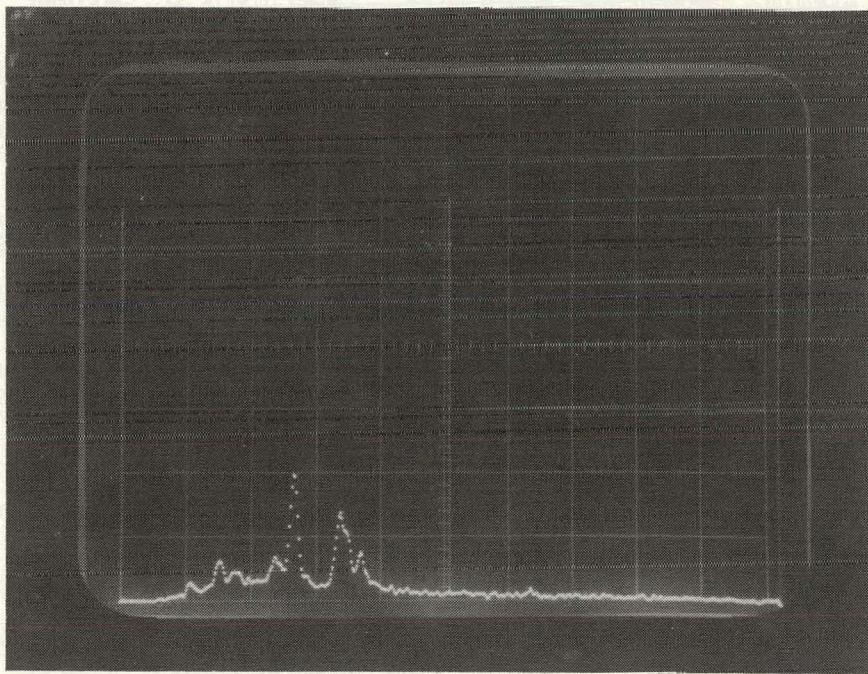
(Figure 6A). It is, however, difficult to say conclusively that this is a true embedment phenomenon, because the high-intensity source of the SEM-EDAX instrument caused the acrylic film to bubble, which tended to obscure the data. EDAX analysis of the soil particles on the specimen surface showed aluminum, silica, sulfur, calcium, and iron, which are typical of most soils, in addition to lead and tin (Figure 6B). One particle was isolated that was composed primarily of lead and tin and was probably airborne from the adjacent Kerr-McGee plant (Figure 7).

A. FEK-244 specimen (ID 318) exposed 8 months at Stauffer Chemical Co.

B. EDAX analysis of surface soil showing, respectively, Na, Al Si, Pb, Cl, K, Sn

Figure 6. Soil Embedment. Apparent in acrylic layer of FEK-244 specimen.

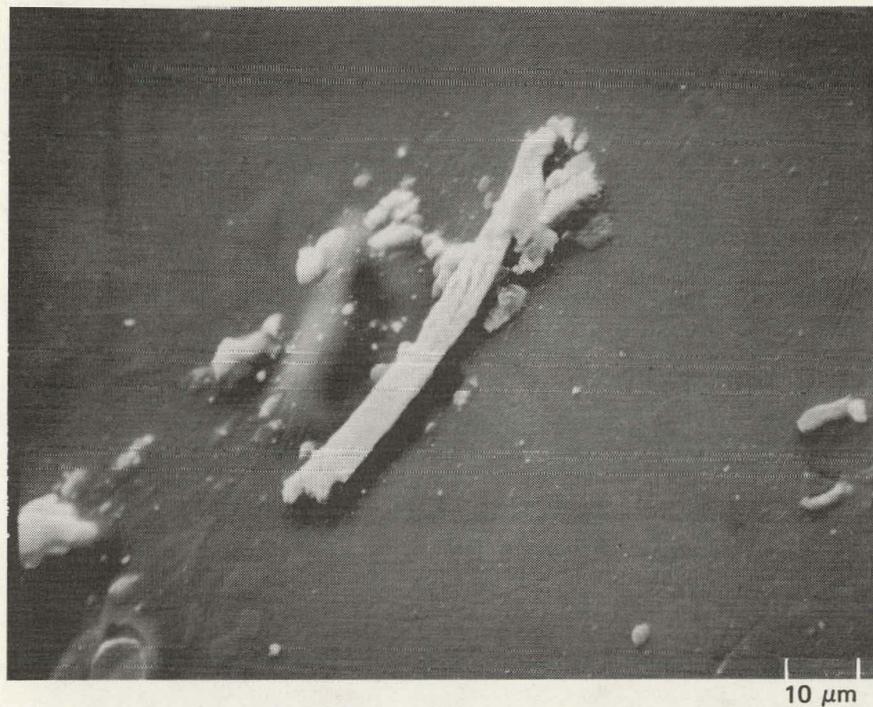
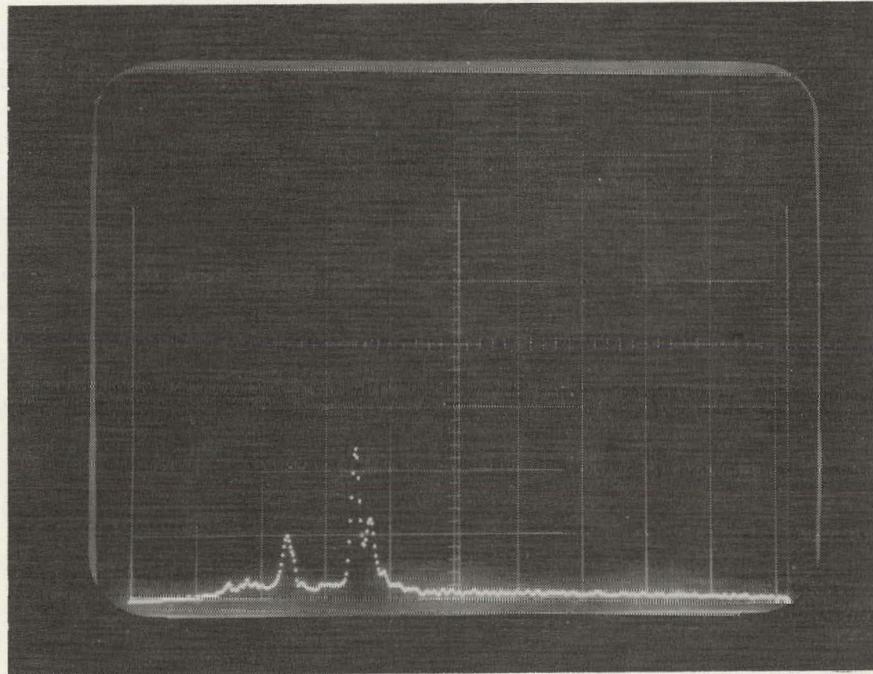
A. FEK-244 specimen (ID 318) exposed 8 months at Stauffer Chemical Co.

B. EDAX analysis of discrete particle shown in A. Particle is primarily lead and tin.

Figure 7. Lead-Tin Contaminant. Photomicrograph of reflector specimen from Stauffer Chemical Co.

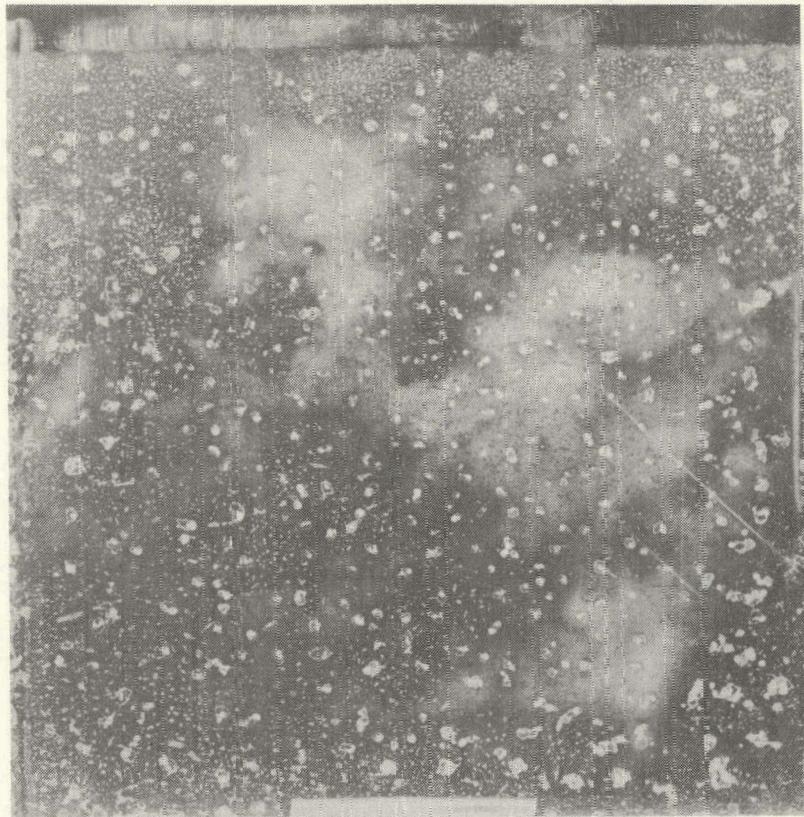
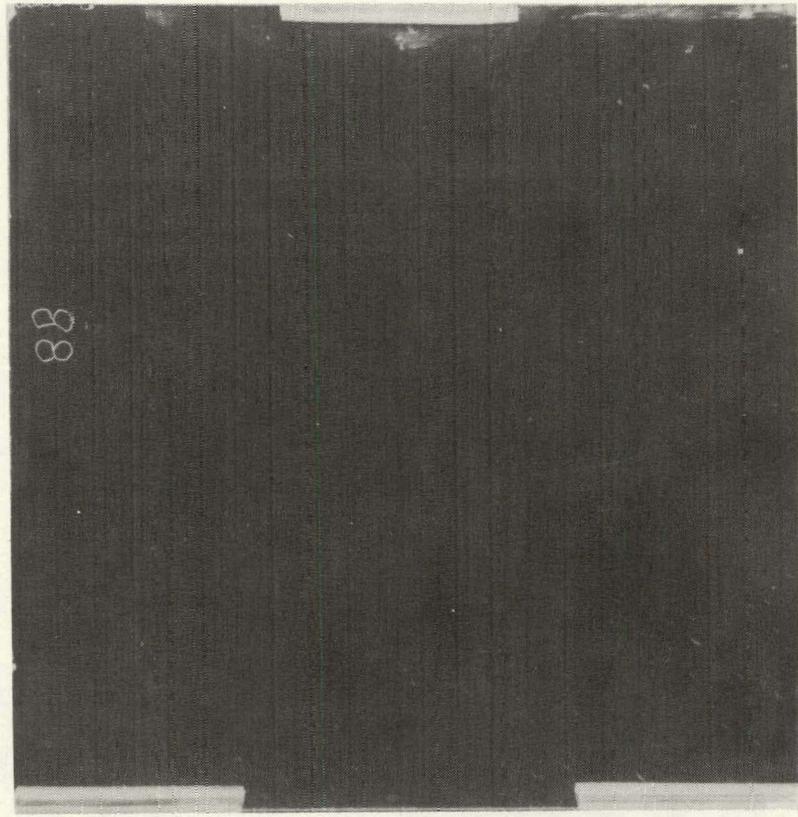
The Alzak specimens fared the poorest at this location, with soil accumulation causing losses of up to 100% specular reflectance for 3 months of continuous exposure. Specimens exposed 4 months to 1 year generally showed reflectance losses of 70 to 90% because of corrosion and soiling of the aluminum surface. Figure 8 shows a clean Alzak specimen exposed 7 months in the horizontal facedown (Z) plane, whose surface is uniformly pitted by corrosion. After 5 months, the losses in specular reflectance leveled off, apparently because the soil accumulation passivated the surface and protected the material from further corrosion.

SEM-EDAX and X-ray diffraction analyses of the Alzak surface were conducted. Results from these studies confirmed that degradation of the surface was due to chlorine attack, and also revealed the presence of titanium dioxide, probably as airborne particulate from the adjacent Kerr-McGee plant.

Figure 8. Alzak Corrosion. Specimen 638 (Alzak) exposed 3 months, X-plane, at Stauffer Chemical Co. Specimen 88 is a control maintained in a desiccated laboratory environment. Specimen 638 has been cleaned.

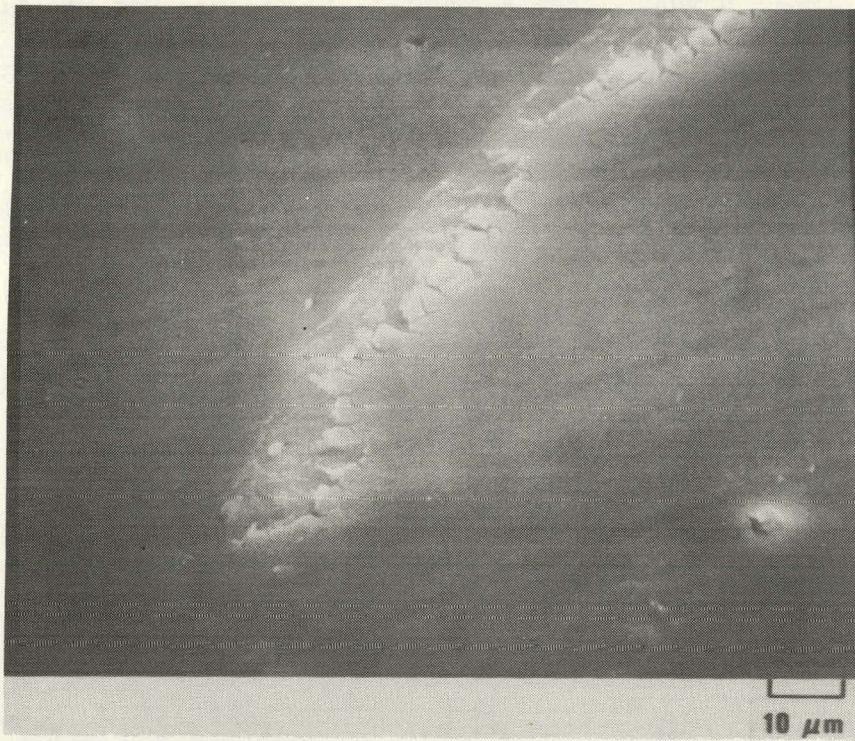
The microscopic examination of the reflector specimens following cleaning of the surface showed soil adhering to the mirror surfaces in small (up to 0.25 inch) elliptical patterns resembling water droplets. Figure 9A shows soil encrustation along a partial perimeter

A. 1000X magnification of soil encrustation along perimeter of water droplet.

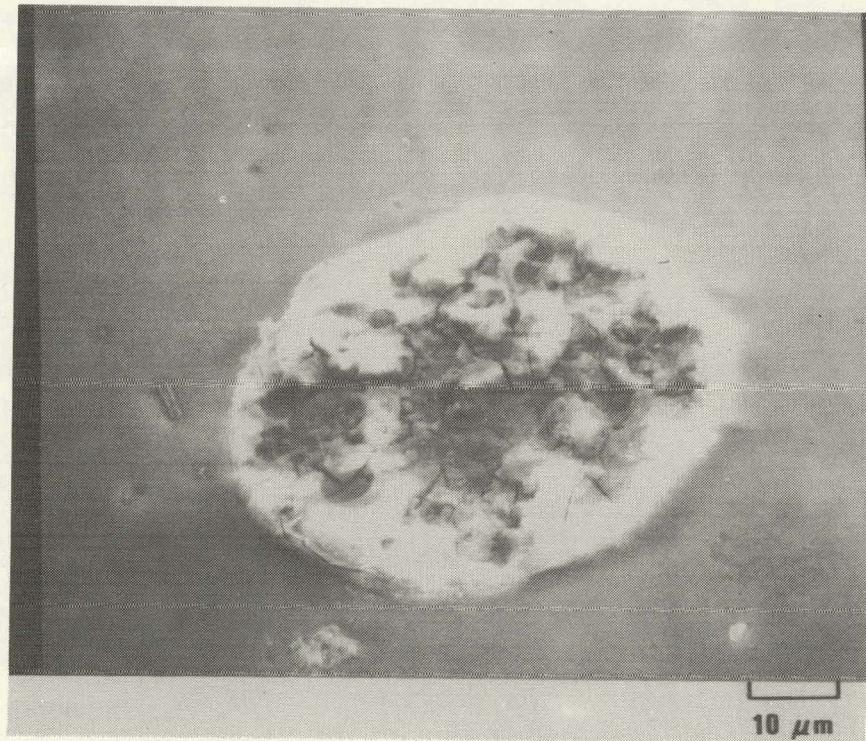
B. 1000X magnification of soil encrustation over entirety of water droplet.

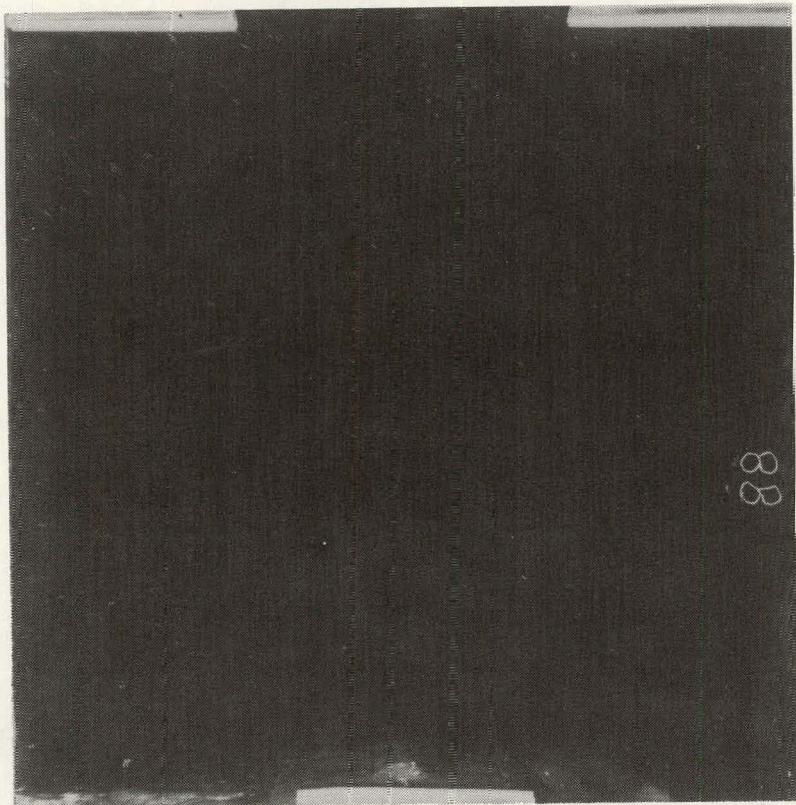
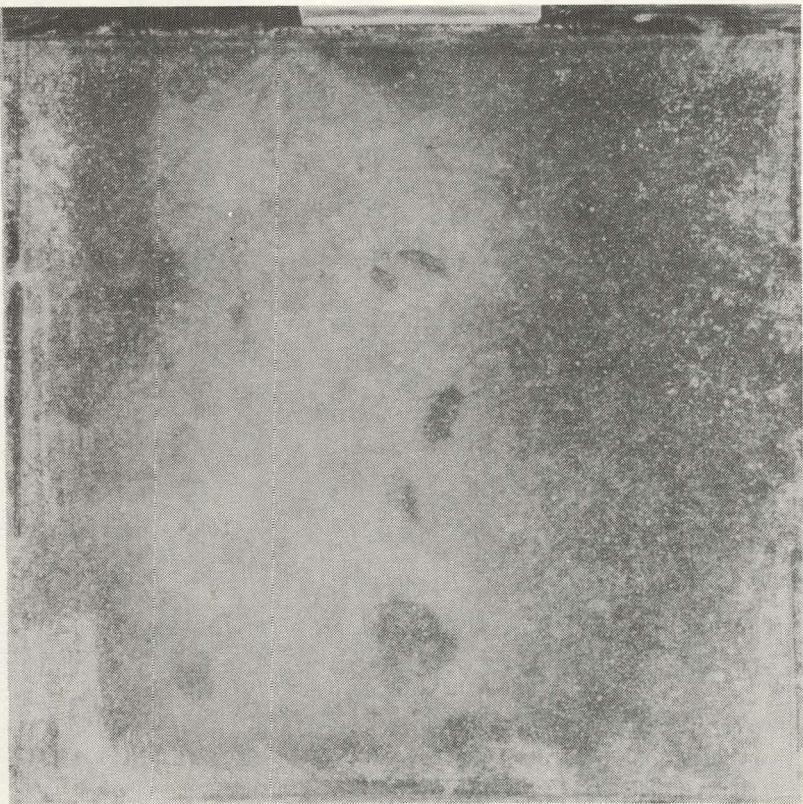
**Figure 10. Specimen 470 FEK-244, X-Plane. Specimen 88 is a control specimen maintained in a desiccated laboratory environment. Specimen 470 is a cleaned specimen.**

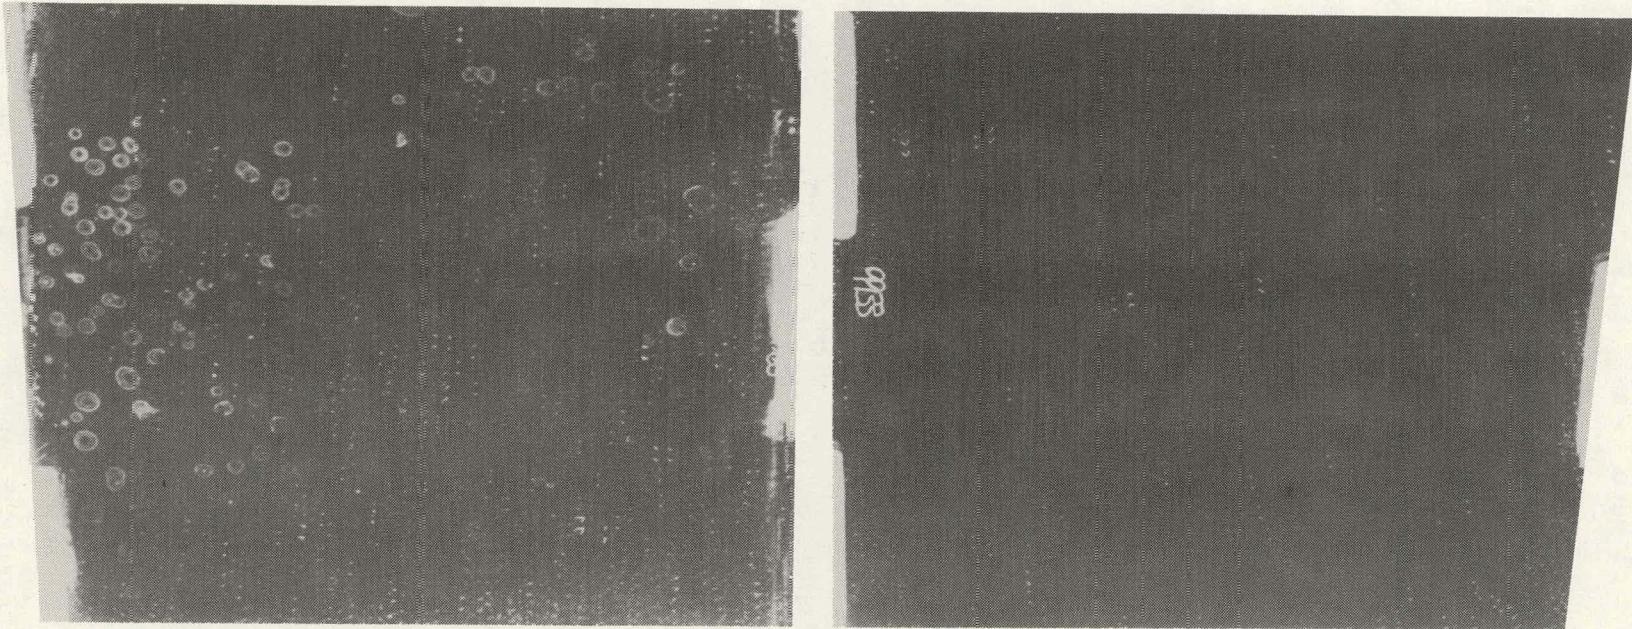
Figure 11. 'Through the Backing' Corrosion. Specimen 84 (glass, DuPont Imron backing) exposed 4 months, X-plane, at Hilo Coast Processing. Arrows indicate corrosion. Specimen 93 is a control specimen maintained in a desiccated laboratory environment. Specimen 84 has been cleaned.

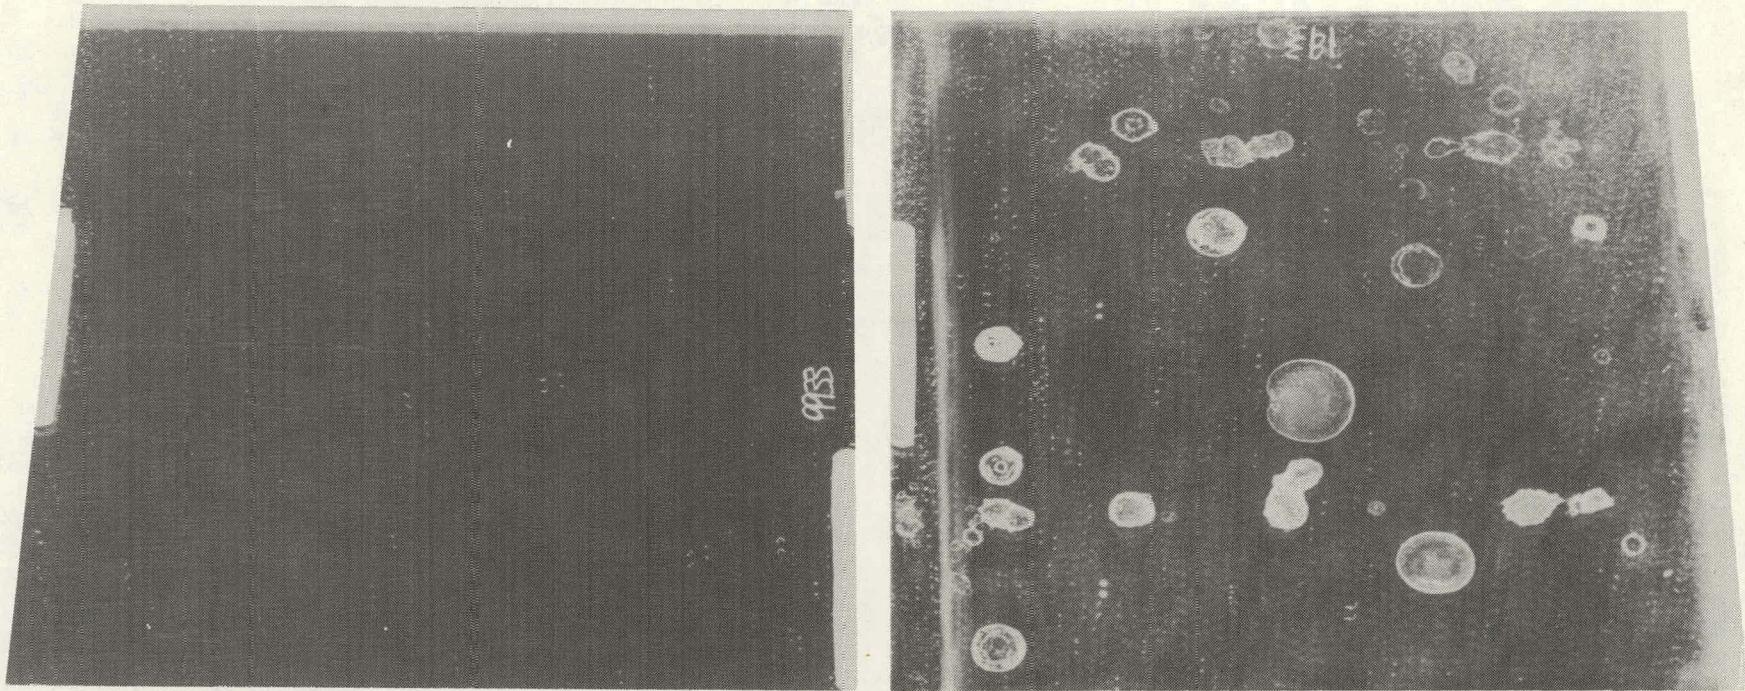
Figure 12. Glass Specimen with Epoxy Backing. Exposed 8 months, Y-Plane, at U.S. Steel Chemical Co.  
Specimen 93 is a control maintained in a desiccated laboratory environment. Specimen 193 has been cleaned.

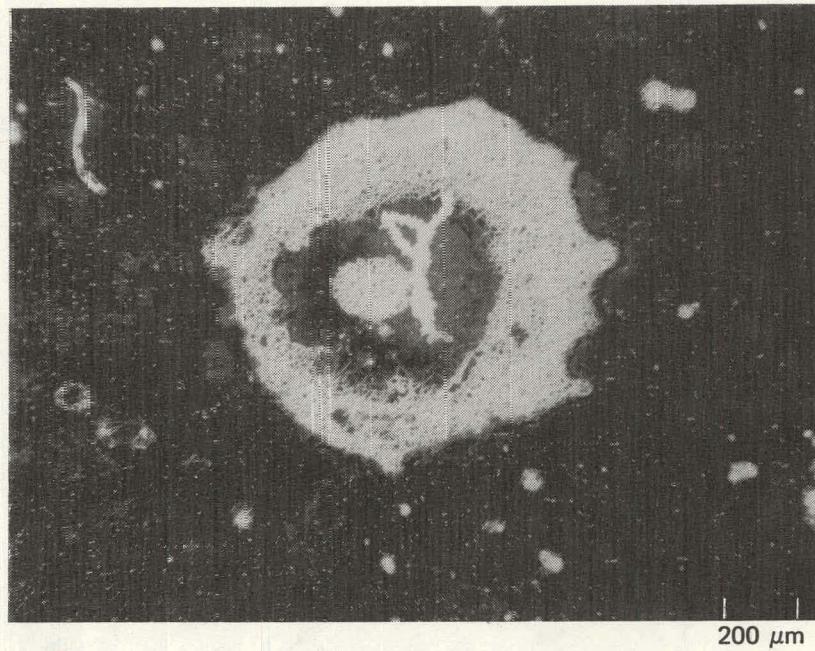
A. Control Alzak specimen maintained in a desiccated laboratory environment.

B. Photomicrograph of cleaned Alzak specimen exposed 5 months at U.S. Steel Chemical Co.

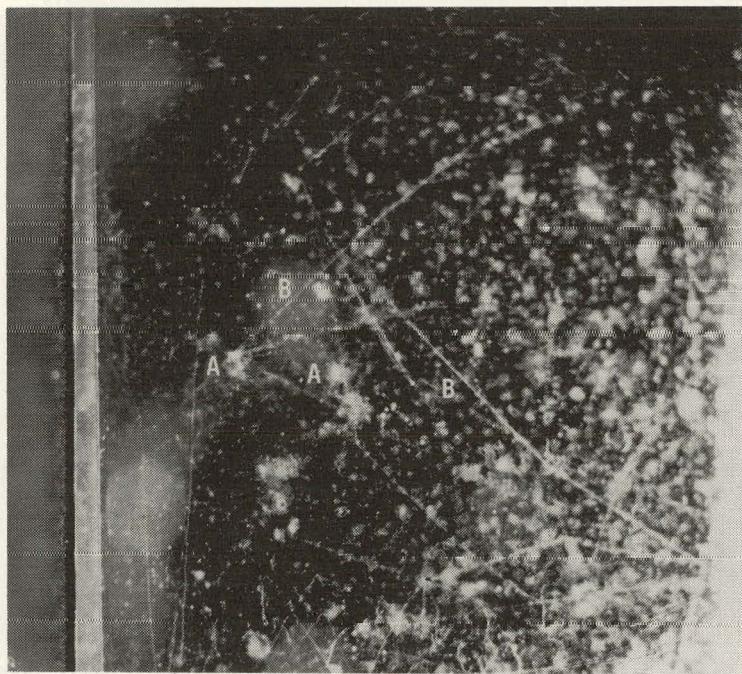
The FEK-244 specimens, when evaluated in the "as-received" condition before any cleaning, had developed what appeared to be 2.5- to 6-in.-long cracks in the acrylic layer. A significant number of these "cracks" originated from localized white, cloudy areas on the specimen surface, and the total specimen surface was involved (Figure 14). There were, however, areas where the "cracks" were more dense. The potential seriousness of acrylic damage prompted an in-depth analysis of the surface phenomena, with contributing analyses by Drs. R. B. Pettit and E. P. Roth of Sandia National Laboratory, Mr. B. A. Benson of 3M Corp., and the McDonnell Douglas Astronautics Company.

Figure 14. Specimen FEK-244 (ID 488). Exposed 12 months, Z-Plane, U.S. Steel Chemical Co. (A) Localized cloudy areas; (B) Fibers encrusted with siliceous materials (Photo courtesy Dr. R. B. Pettit, SNLA. 1/2 sec., f5.6)

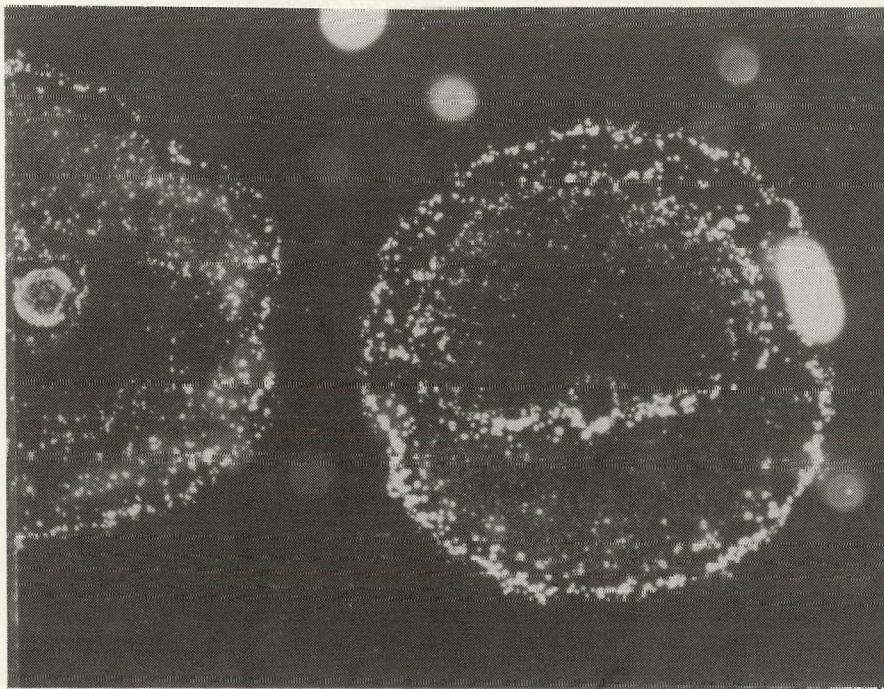
The second-surface silver/glass mirrors did show corrosion effects at several of the exposure sites. There were two primary modes of corrosive attack on the silver reflective layer. The first mode was "edge attack", where the corrosive material would diffuse into the silver layer from the edges of mirror (Figure 5). This phenomenon occurred primarily along the unprotected edges of the reflector specimen (i.e., those edges not covered by sample retainers on the test hardware) and appeared to be self-regulating. The corrosion penetrated to a maximum depth of 0.5 in. Further exposure did not produce continued penetration depth of the corrosion. The second mode of corrosive failure for the silvered glass mirrors (second-surface) was "through the backing" attack. In this failure mode, the corrosive material would diffuse through the permeable paint or vinyl sheet mirror backings and attack the silver in discrete circular patterns (Figure 11). These patterns usually corresponded to bubbling or blistering of the protective backings, which appeared to be caused by liquid droplets falling or condensing on these backings and diffusing through. Figure 53 shows a 17X magnification of one of the circular corrosion patterns on the reflector specimen shown in Figure 11.

Figure 53. Circular Corrosion Pattern (17X magnification). Specimen 84, (glass, Dupont Imron backing), X-Plane, exposed 4 months at Hilo Coast Processing. Specimen 84 has been cleaned.

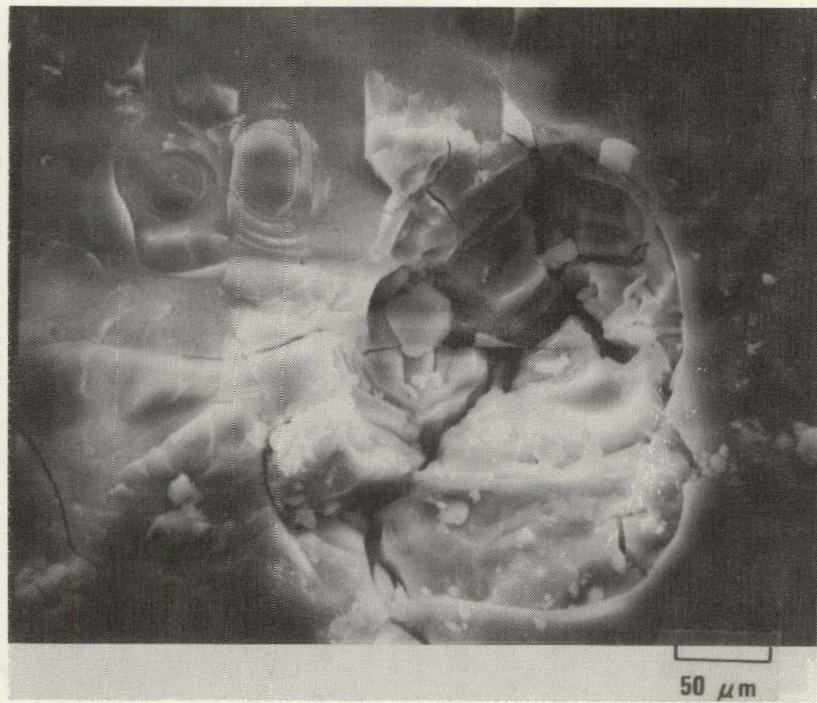
A. Control Alzak reflector specimen maintained in a desiccated laboratory environment

B. Photomicrograph of cleaned Alzak specimen exposed 12 months at Stauffer Chemical Co. Deep corrosion pits are partially filled with soil deposits.

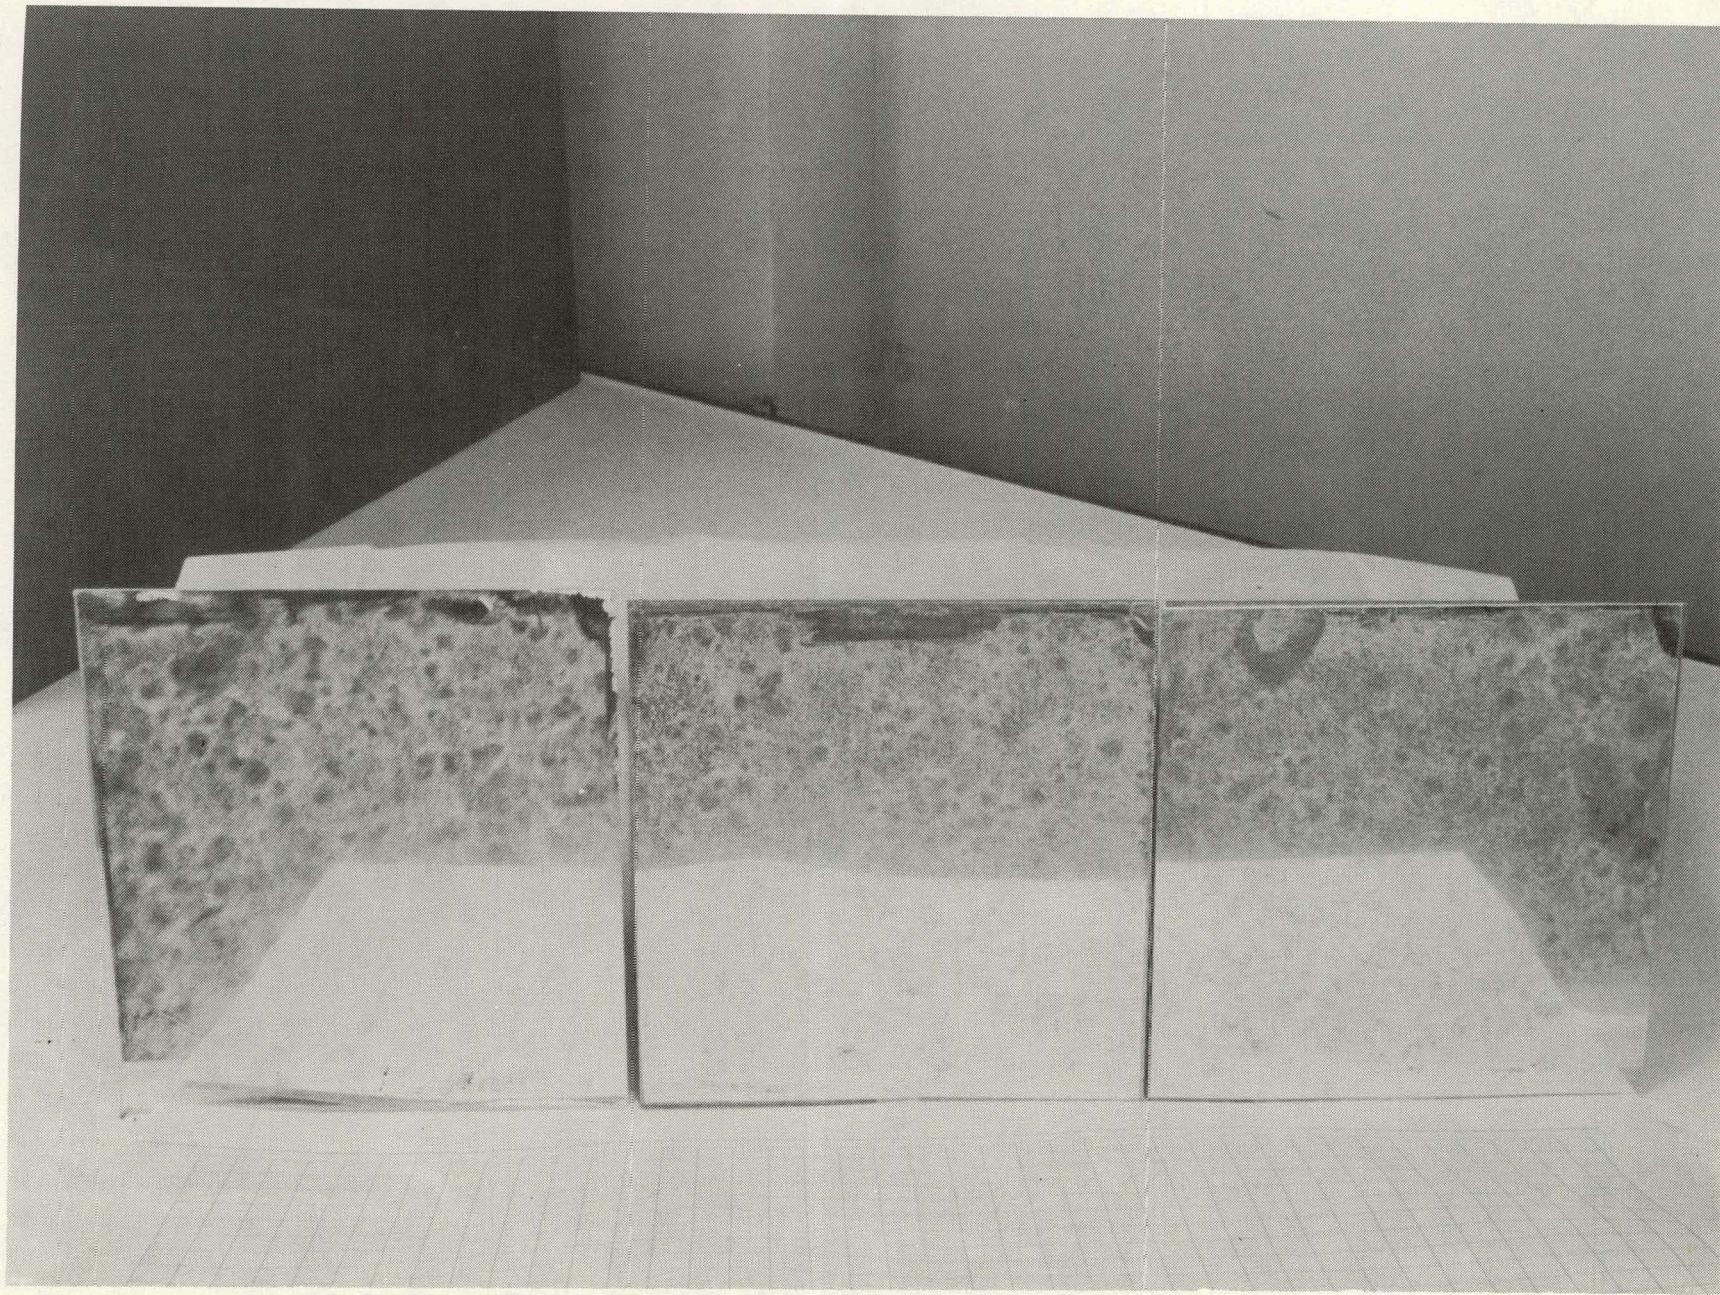
Figure 55. Second-Surface Silvered Glass. FEK-244 and Alzak Specimen "as received" following 1 month exposure at Lone Star Brewing Site.

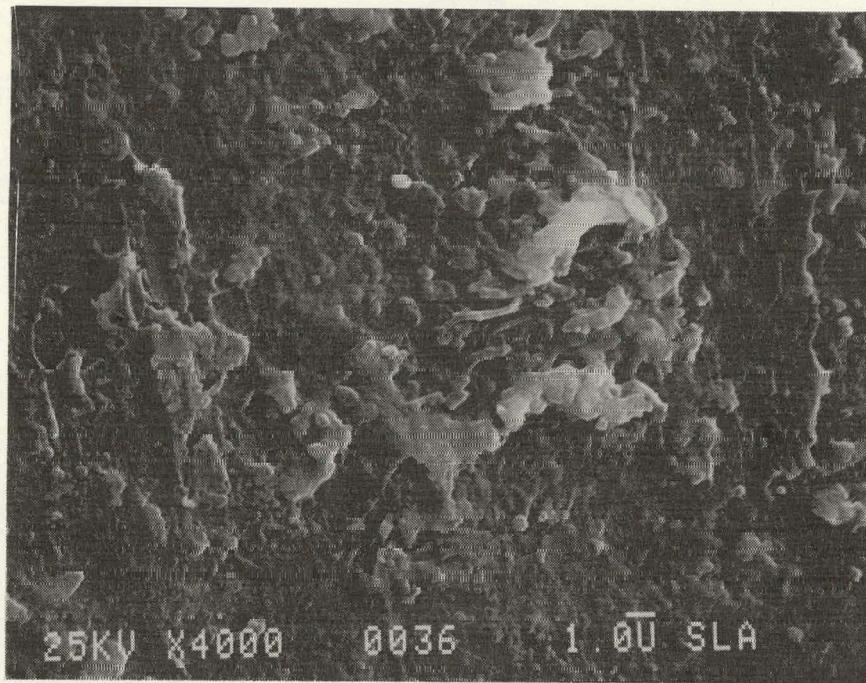
A. 4000X magnification of residual soil layer of a cleaned specimen exposed 6 months at Southern Union Refining Co.

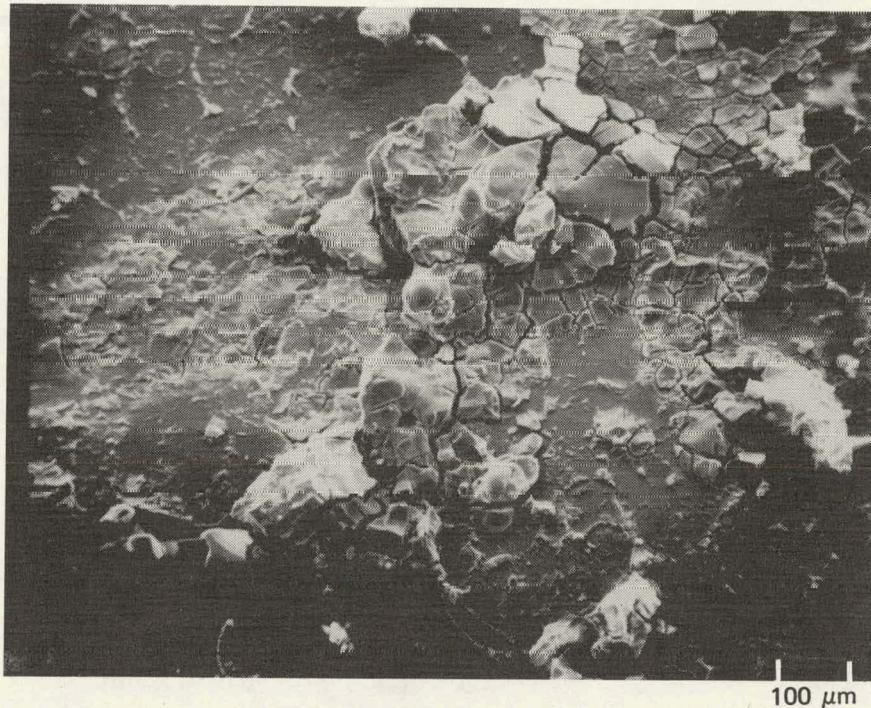
B. 100X magnification of residual soil layer of a cleaned specimen exposed 12 months at Stauffer Chemical Co.

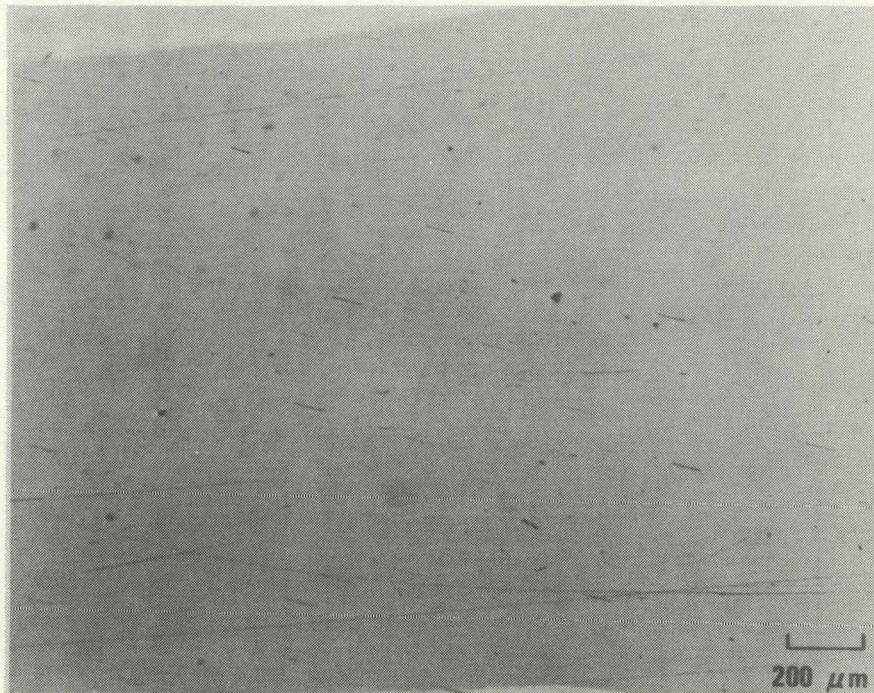
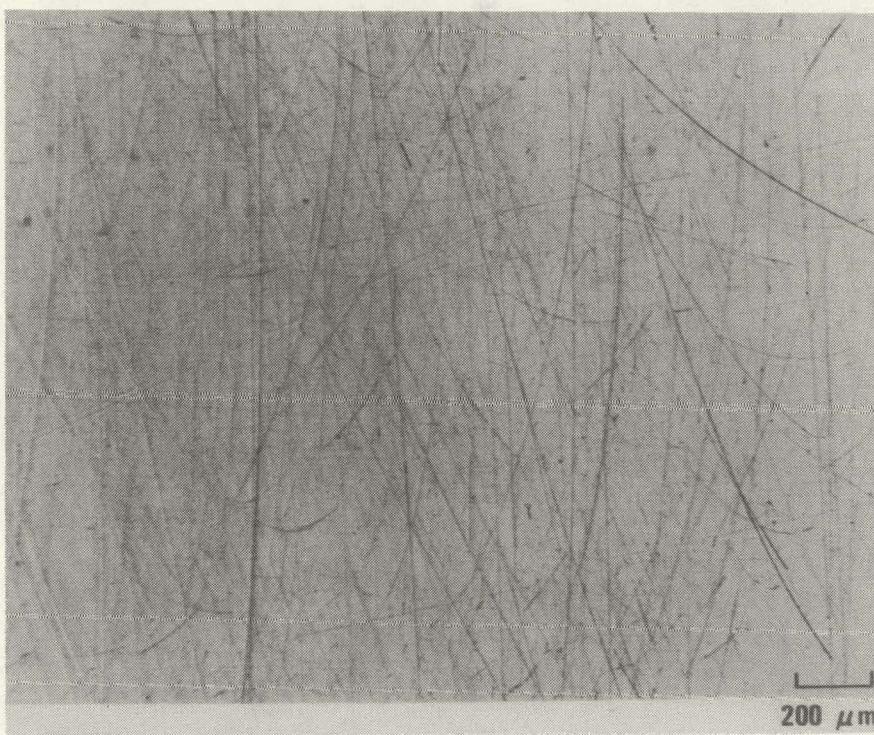
A. Control FEK-244 aluminized acrylic sample maintained in a desiccated laboratory environment

B. FEK-244 aluminized acrylic specimen exposed 1 month, X-Plane, at Stauffer Chemical Co.

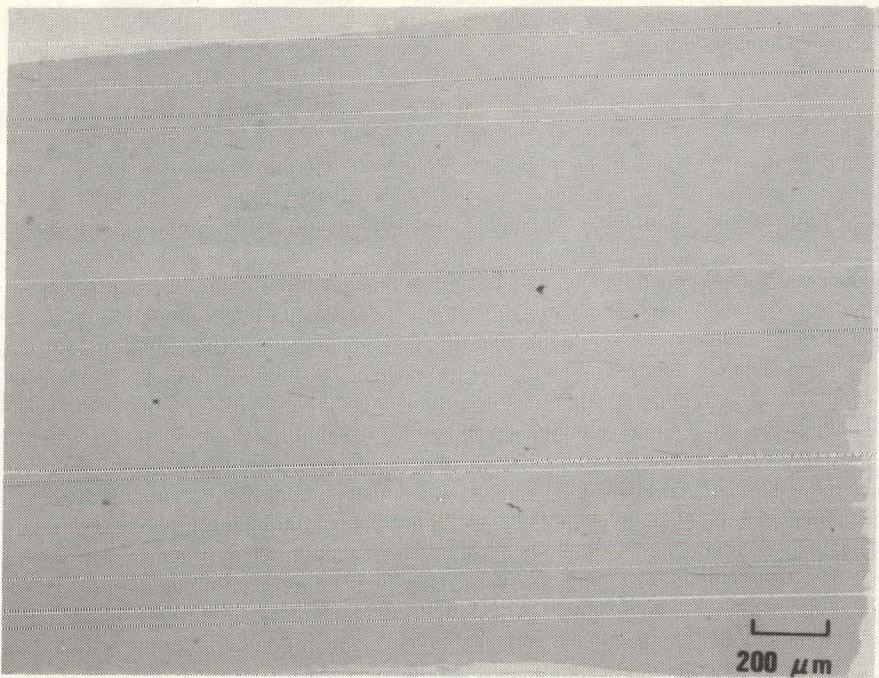
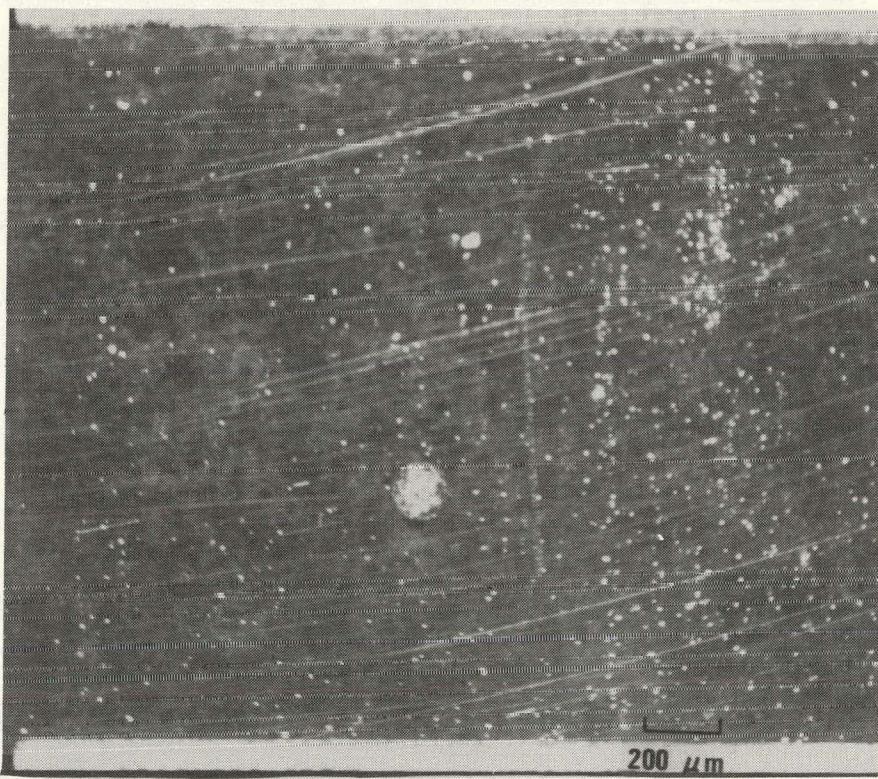
A. Control FEK-244 aluminized acrylic specimen maintained in a desiccated laboratory environment

B. FEK-244 aluminized acrylic specimen exposed 8 months, X-plane, at Stauffer Chemical Co.
