NUREG/CR-5334
SAND89-0327

Severe Accident Testing of Electrical Penetration Assemblies

Prepared by D. B. Claus

Sandia National Laboratories

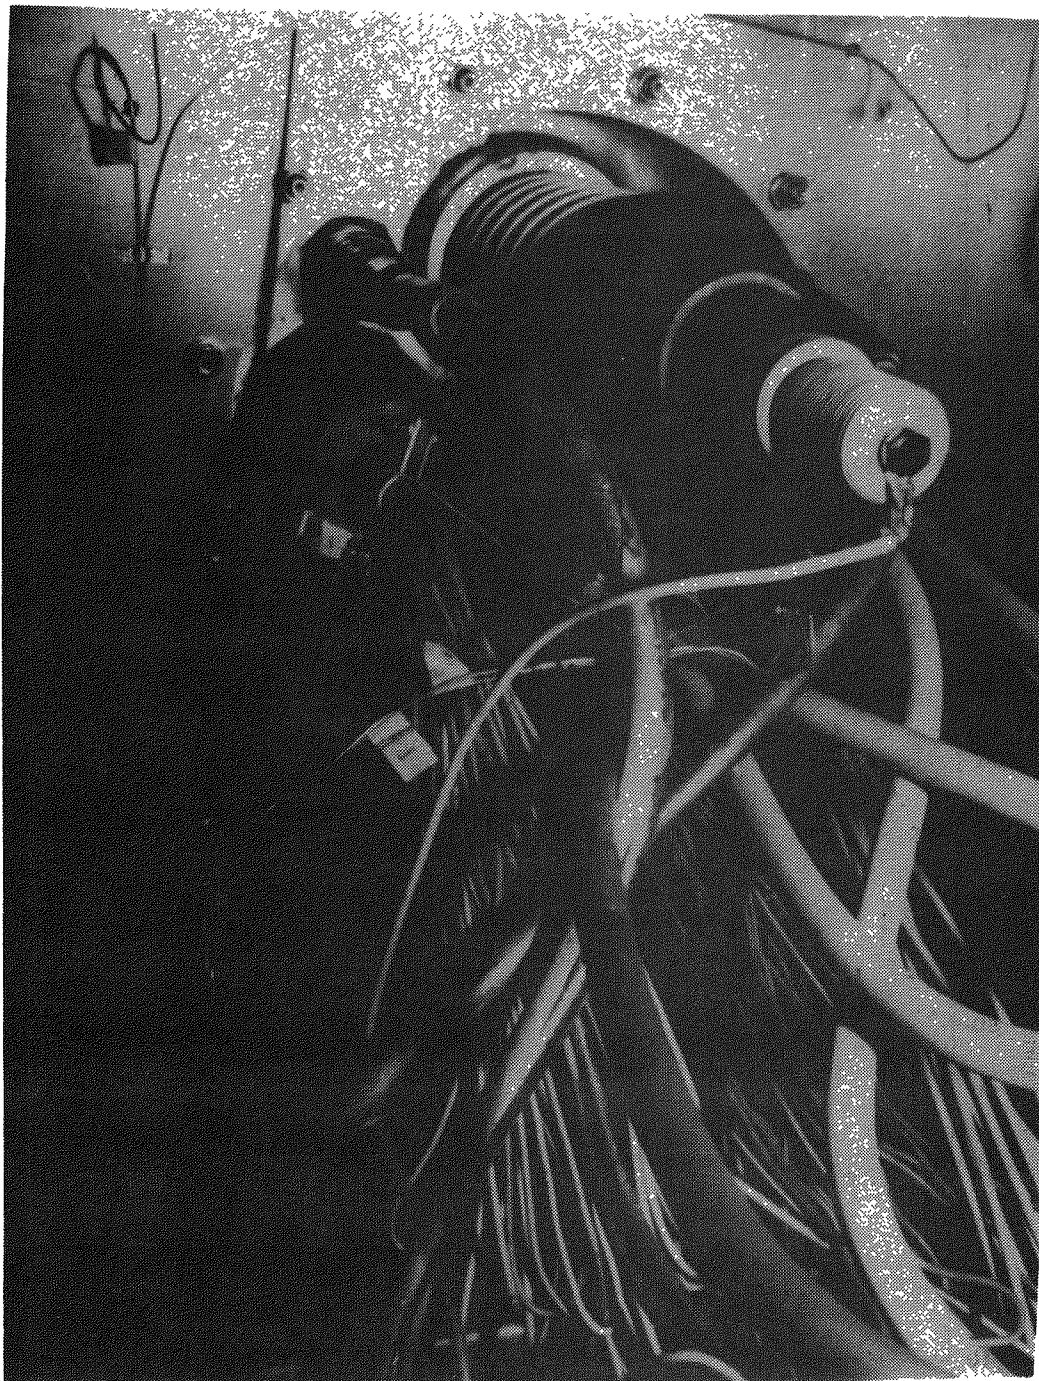
Figure 4-34 Damage to Triax Cable After Thermal Aging

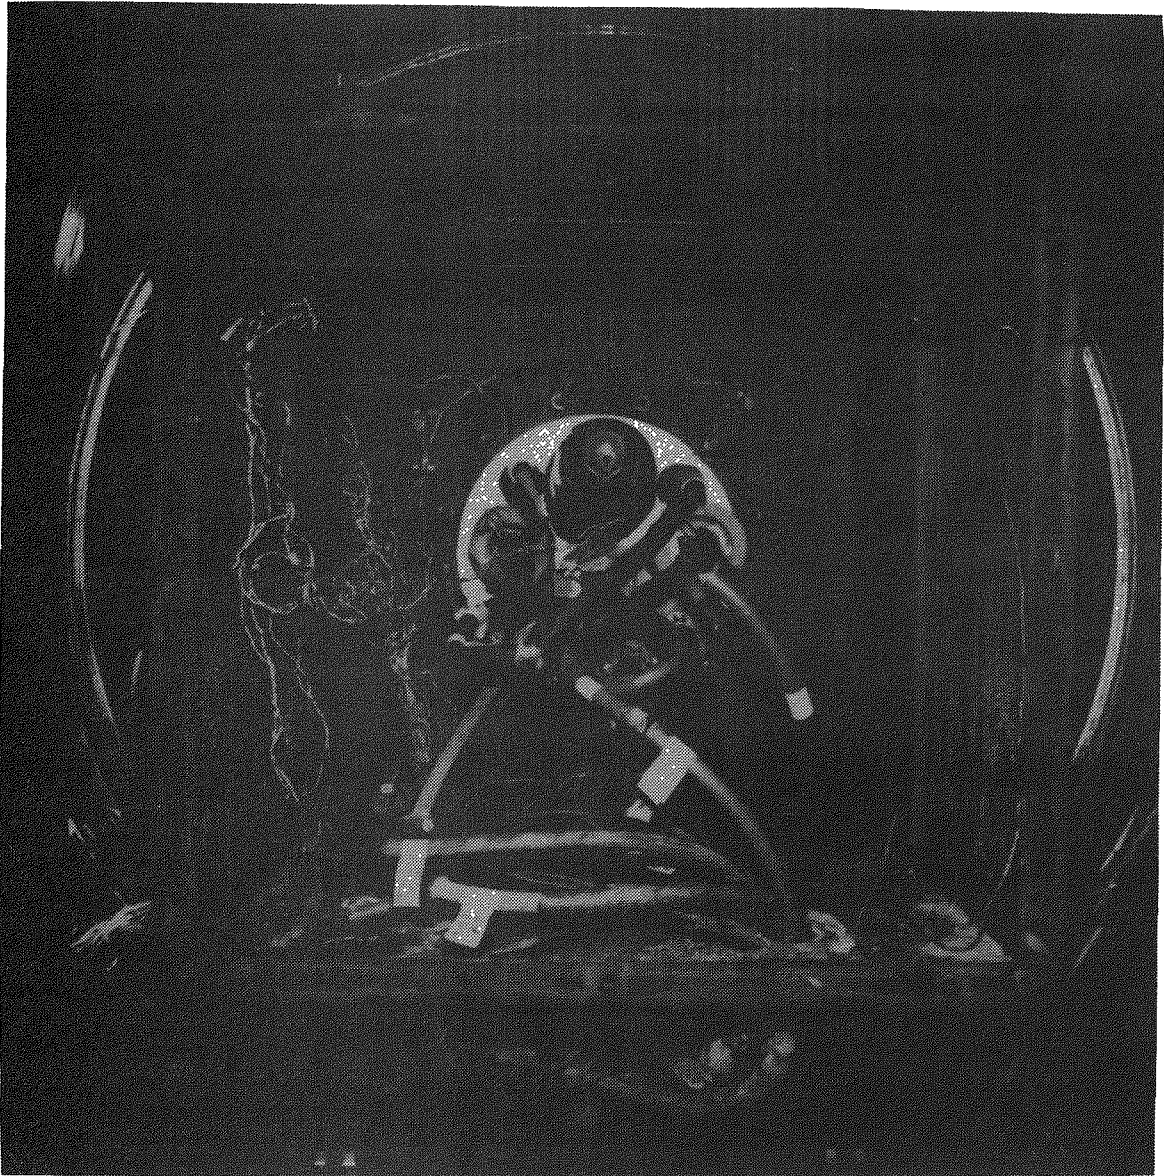
Figure 4-62 Post-SAC Test : Damage to Triax Jacket and Thermocouples

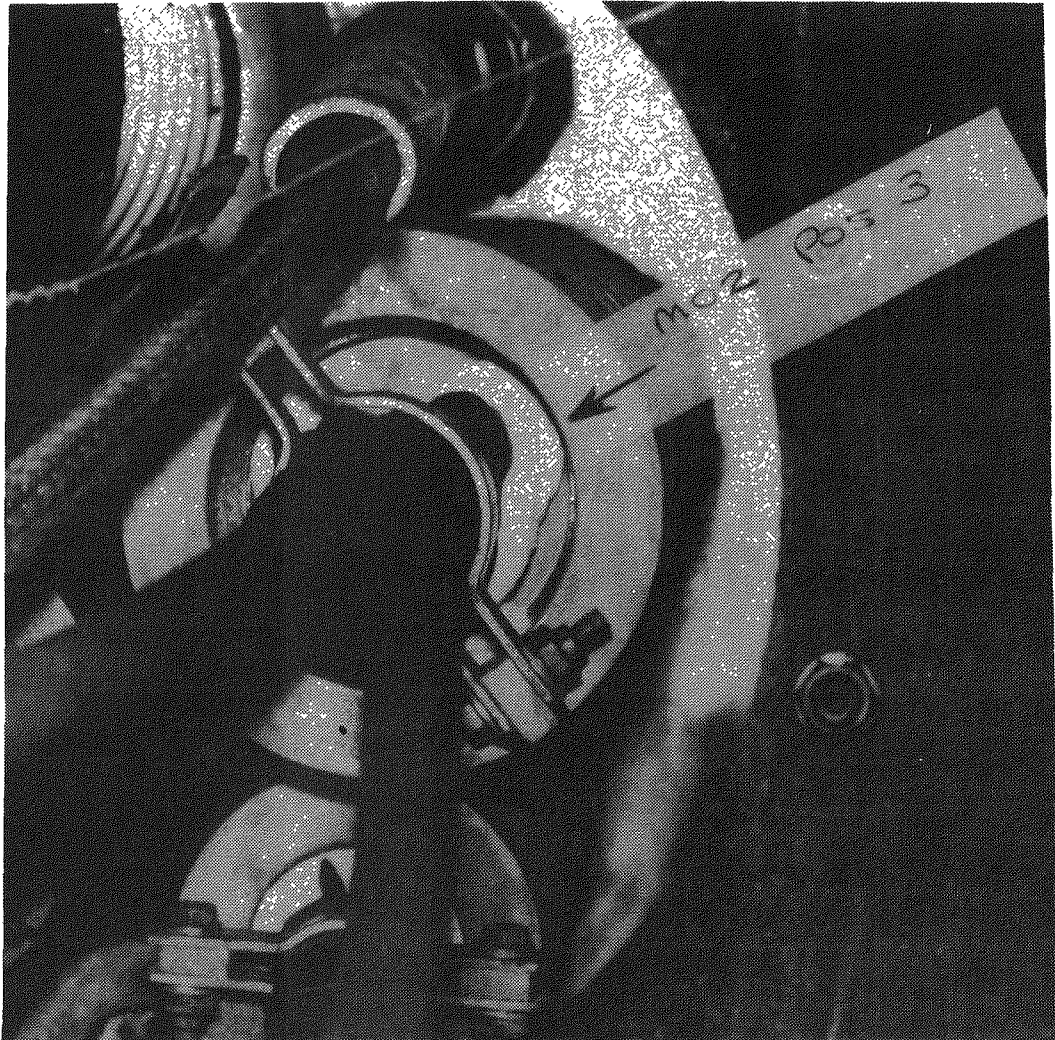
Figure 4-63 Post-SAC Test : Material Extruding from M02 Connector

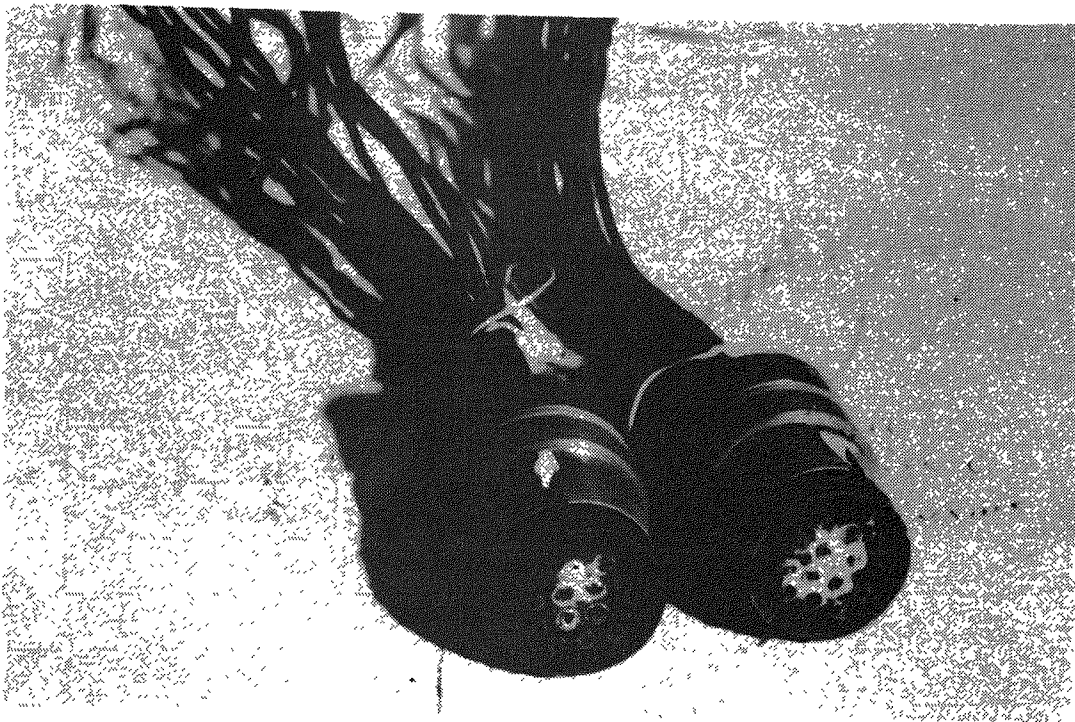
The electrical performance of the EPA modules degraded over the first 2 days of the test to the point that the insulation resistance to ground for all conductors was less than 1 M Ω , and after 10 days, five out of the eight circuits were passing 0.5 amp to ground, which was the maximum current possible in this test. The earliest short to ground occurred about 13 hours into the test. Insulation resistances fell below 1 k Ω before the shorts to ground occurred. The posttest inspection showed that all but one module was electrically faulty because of moisture that had traveled through the connector and provided a ground between the module pins and the metal mask that surrounds each pin. This bridging with moisture or contaminants is believed to have caused the electrical shorts to ground.

Figure 4-65 Post-SAC Test : Signs of Moisture Intrusion on M16 Connectors

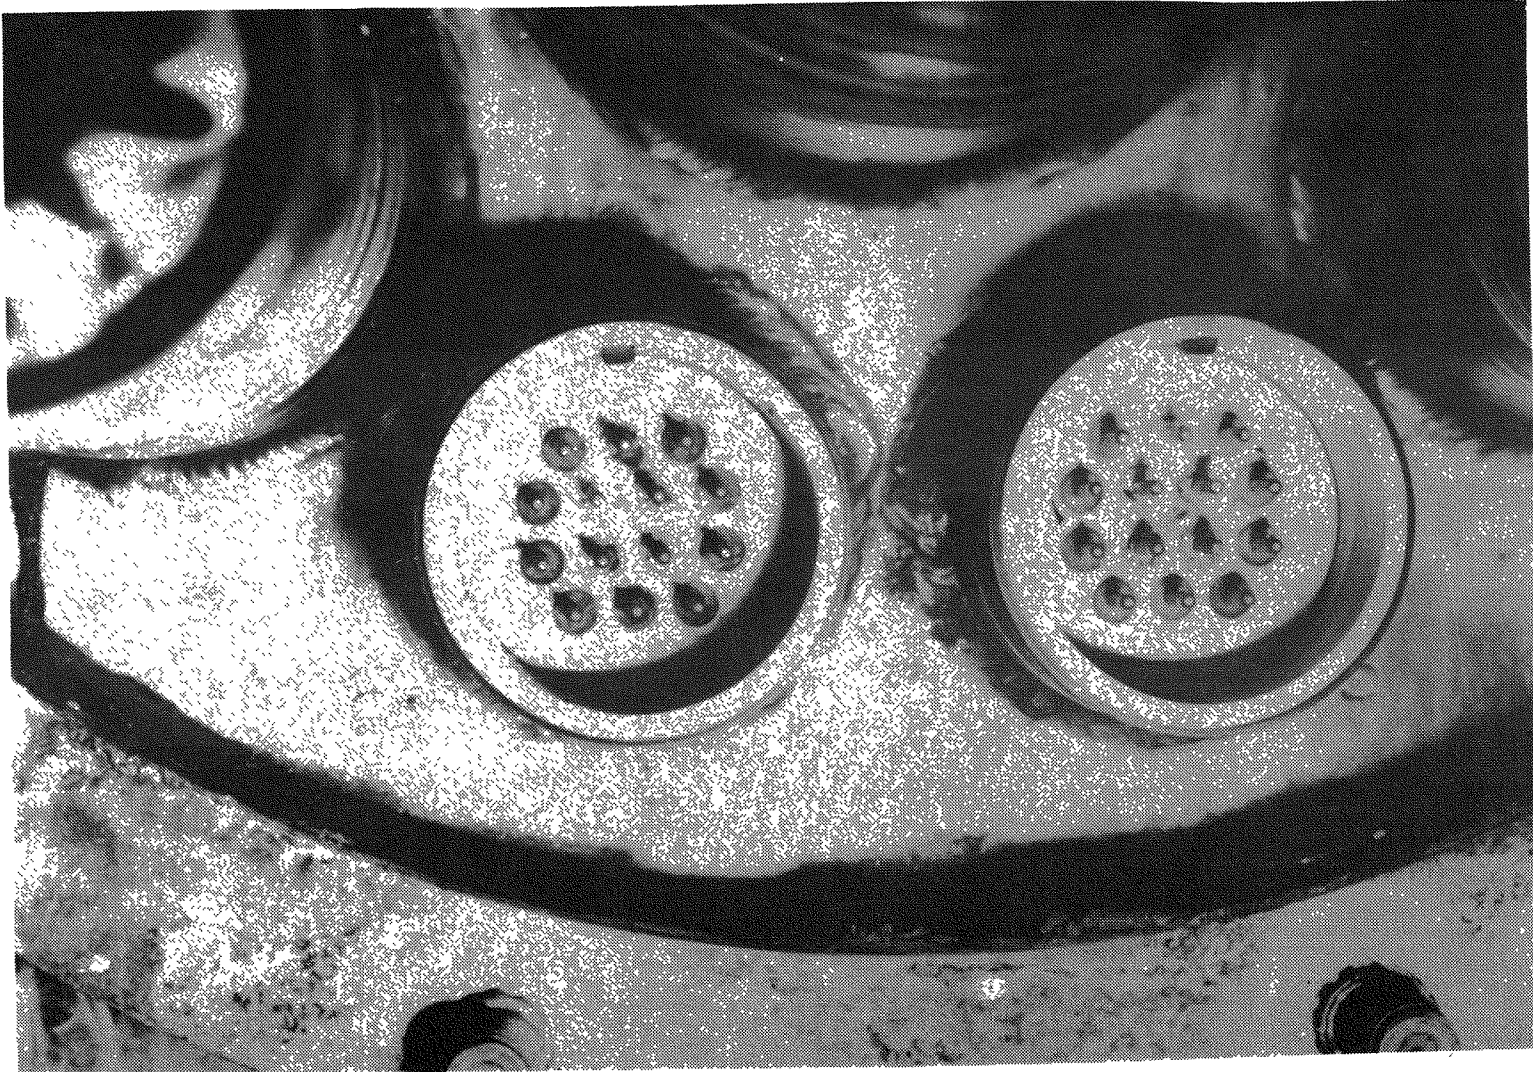
Figure 4-66 Post-SAC Test : Contaminants Around Pins of M16 Modules

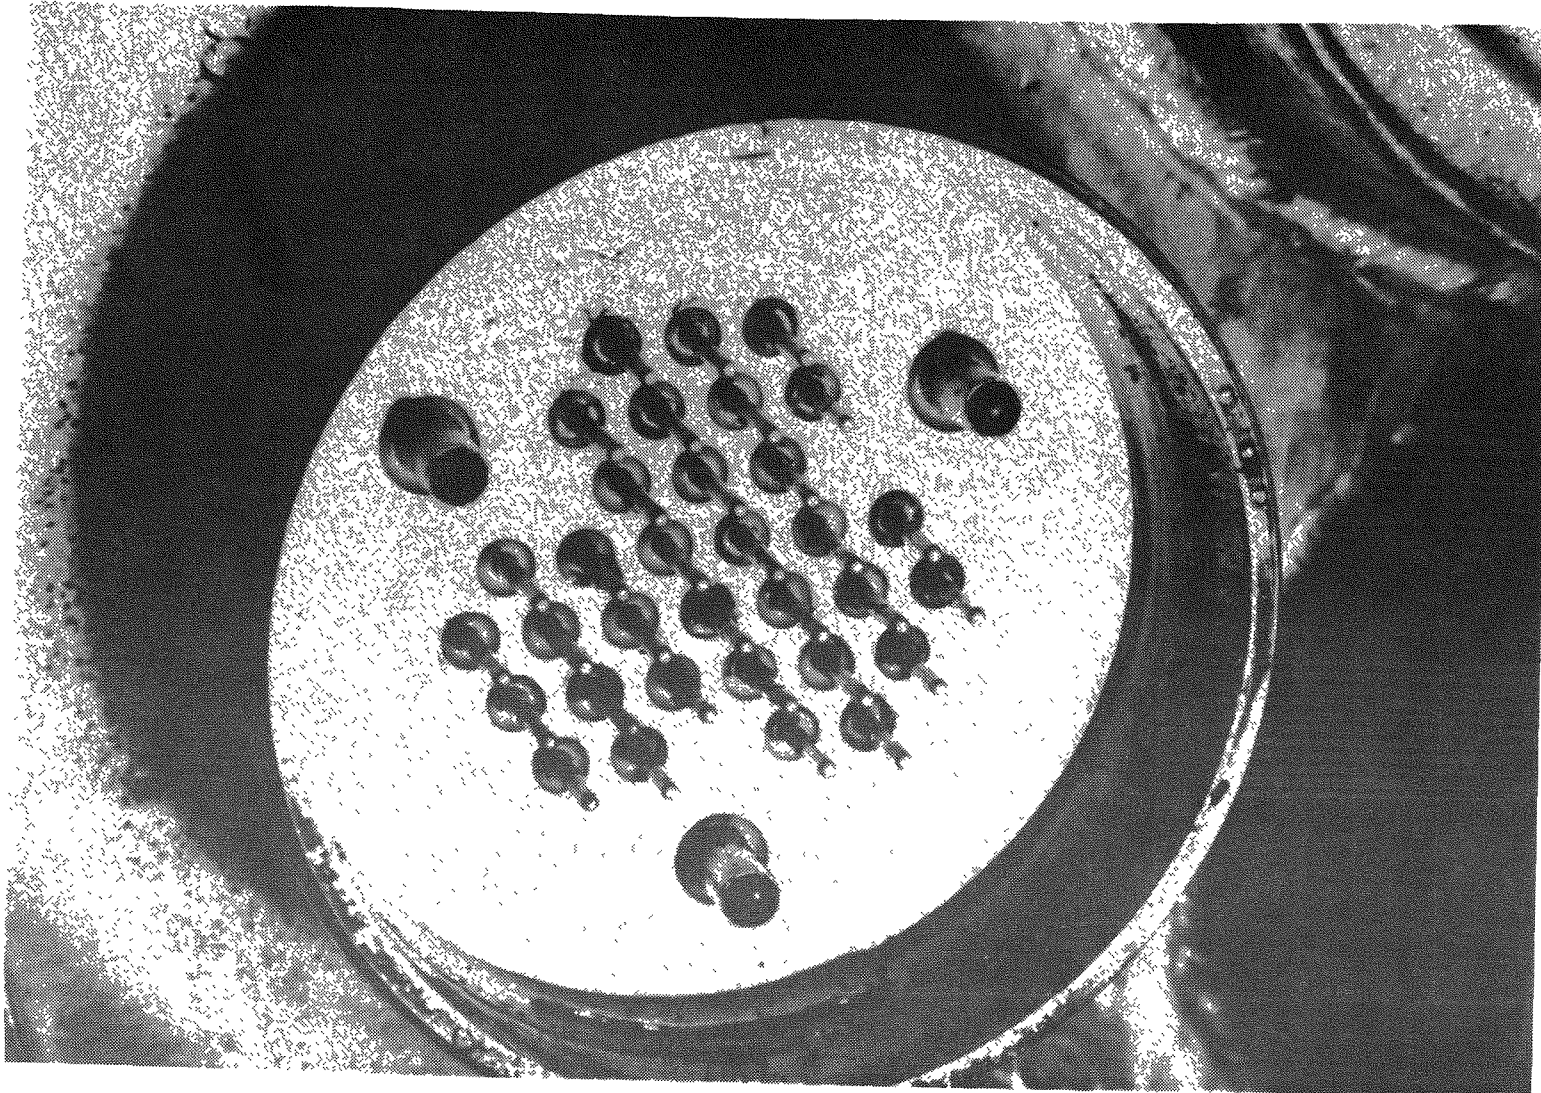
Figure 4-67 Post-SAC Test : Contaminants Around Pins of M19 Module

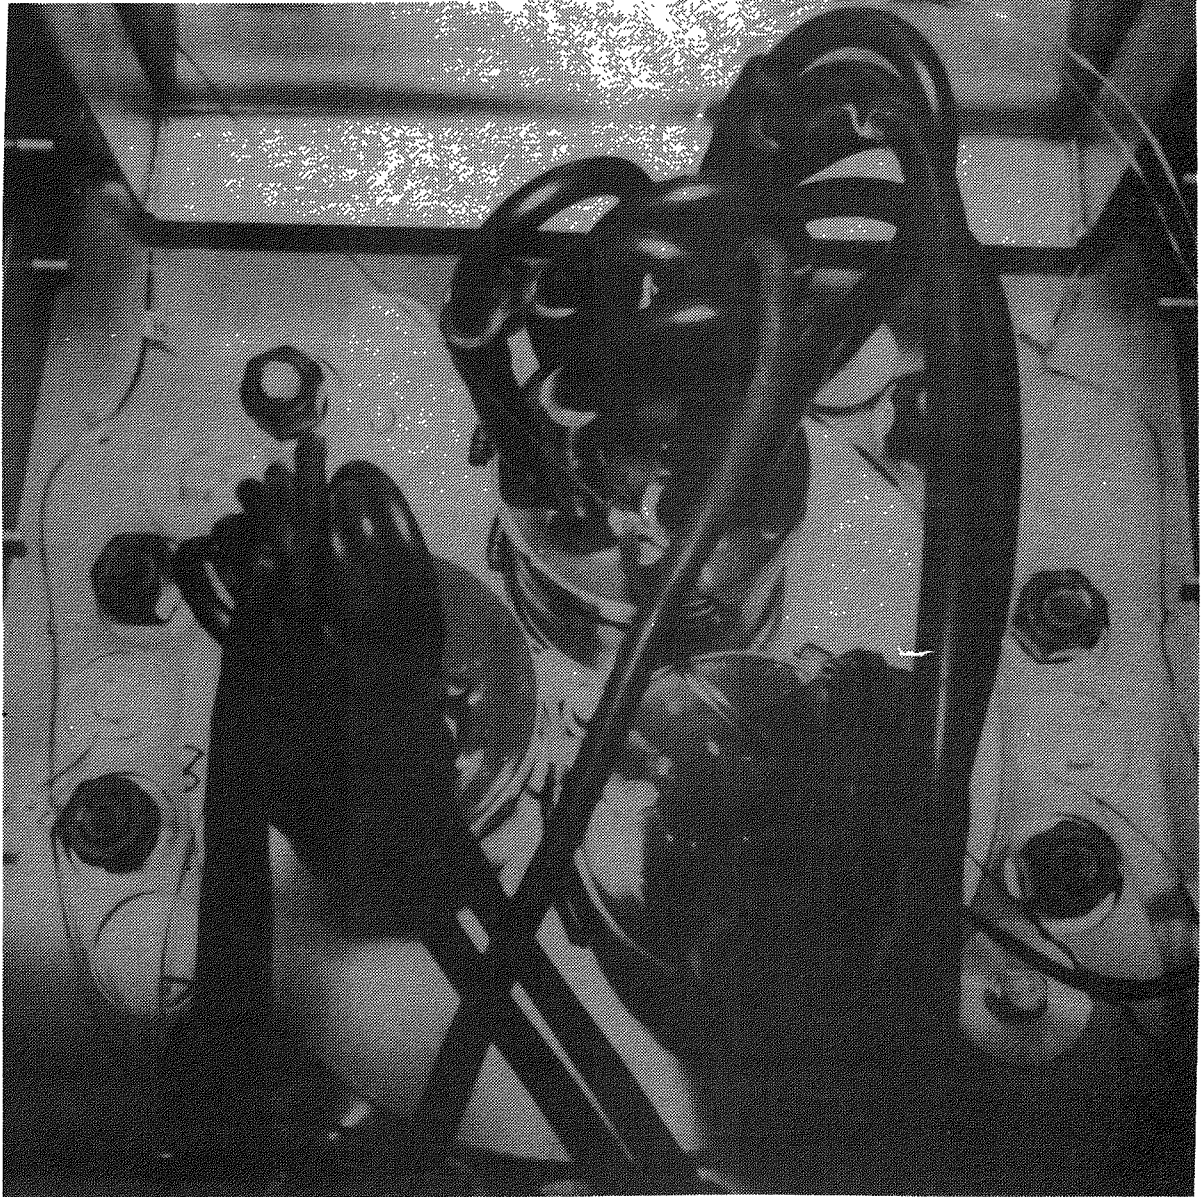
Figure 5-9 Condition of Modules and Cables After Irradiation

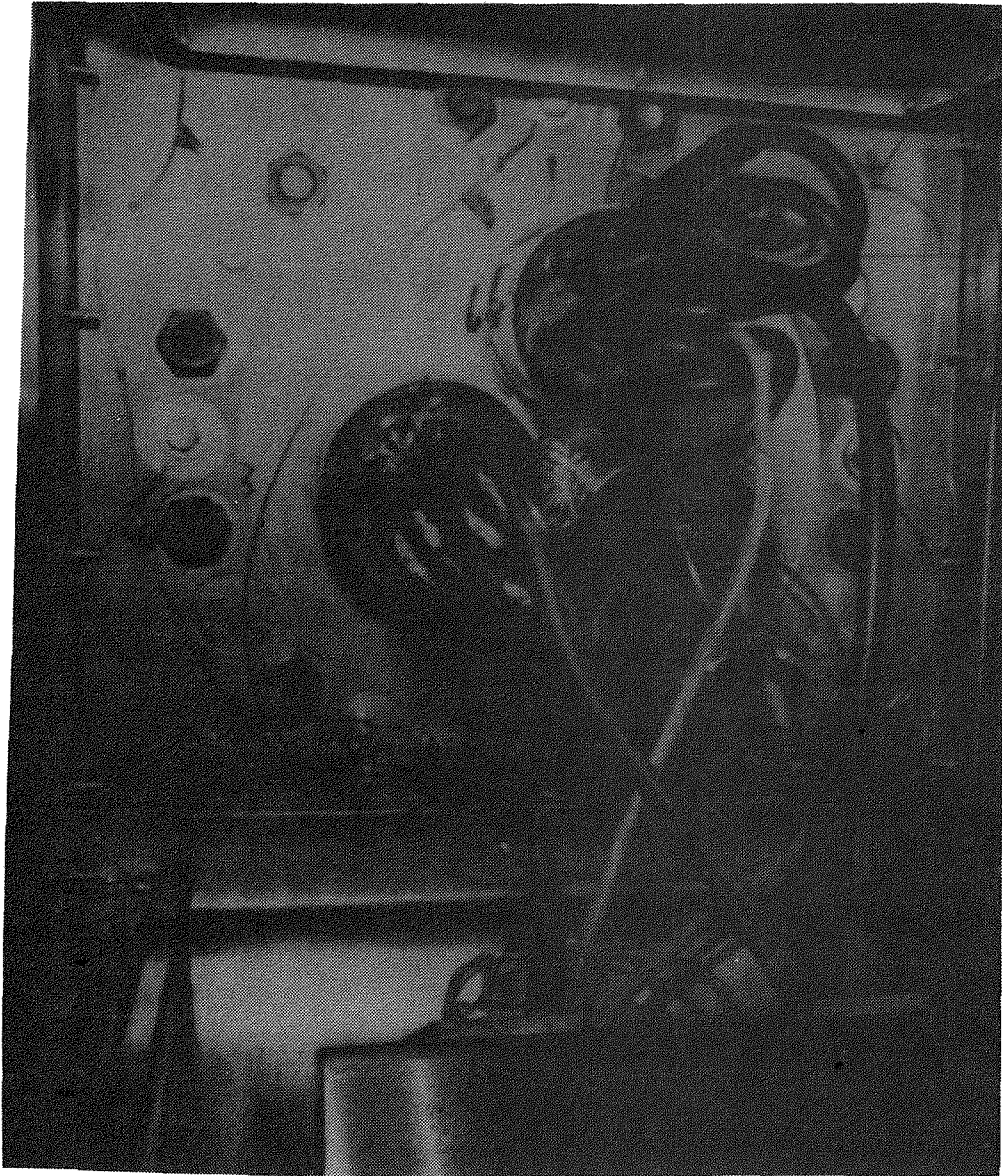
Figure 5-25 Intentional Cuts and Condition of Cables after Thermal Aging

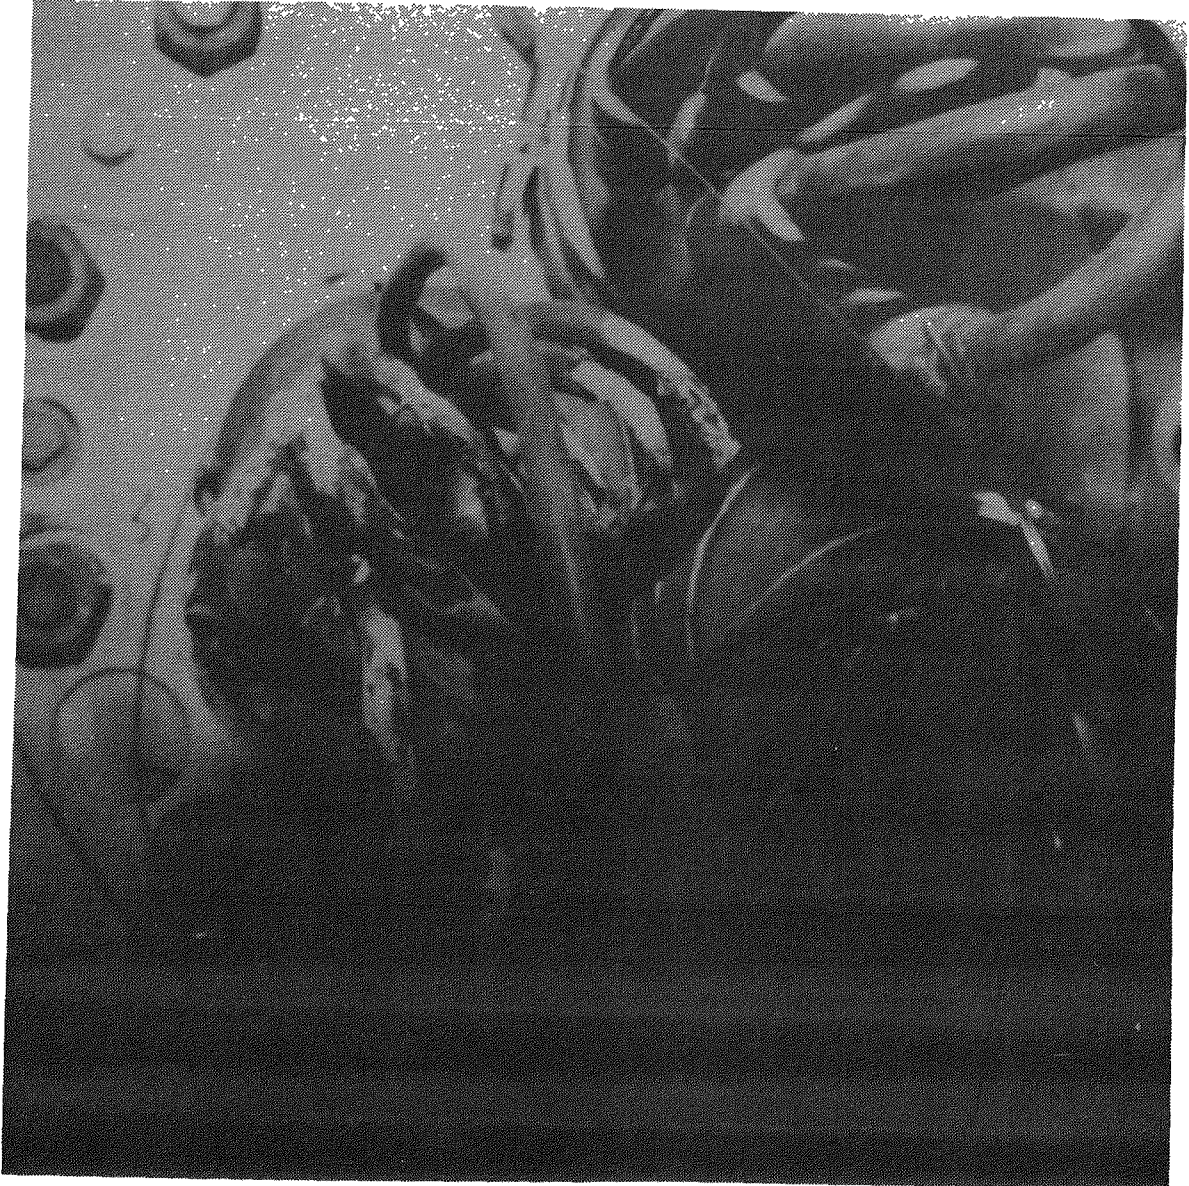
Figure 5-49 Post-SAC Test: Condition of Cables Inside Junction Box

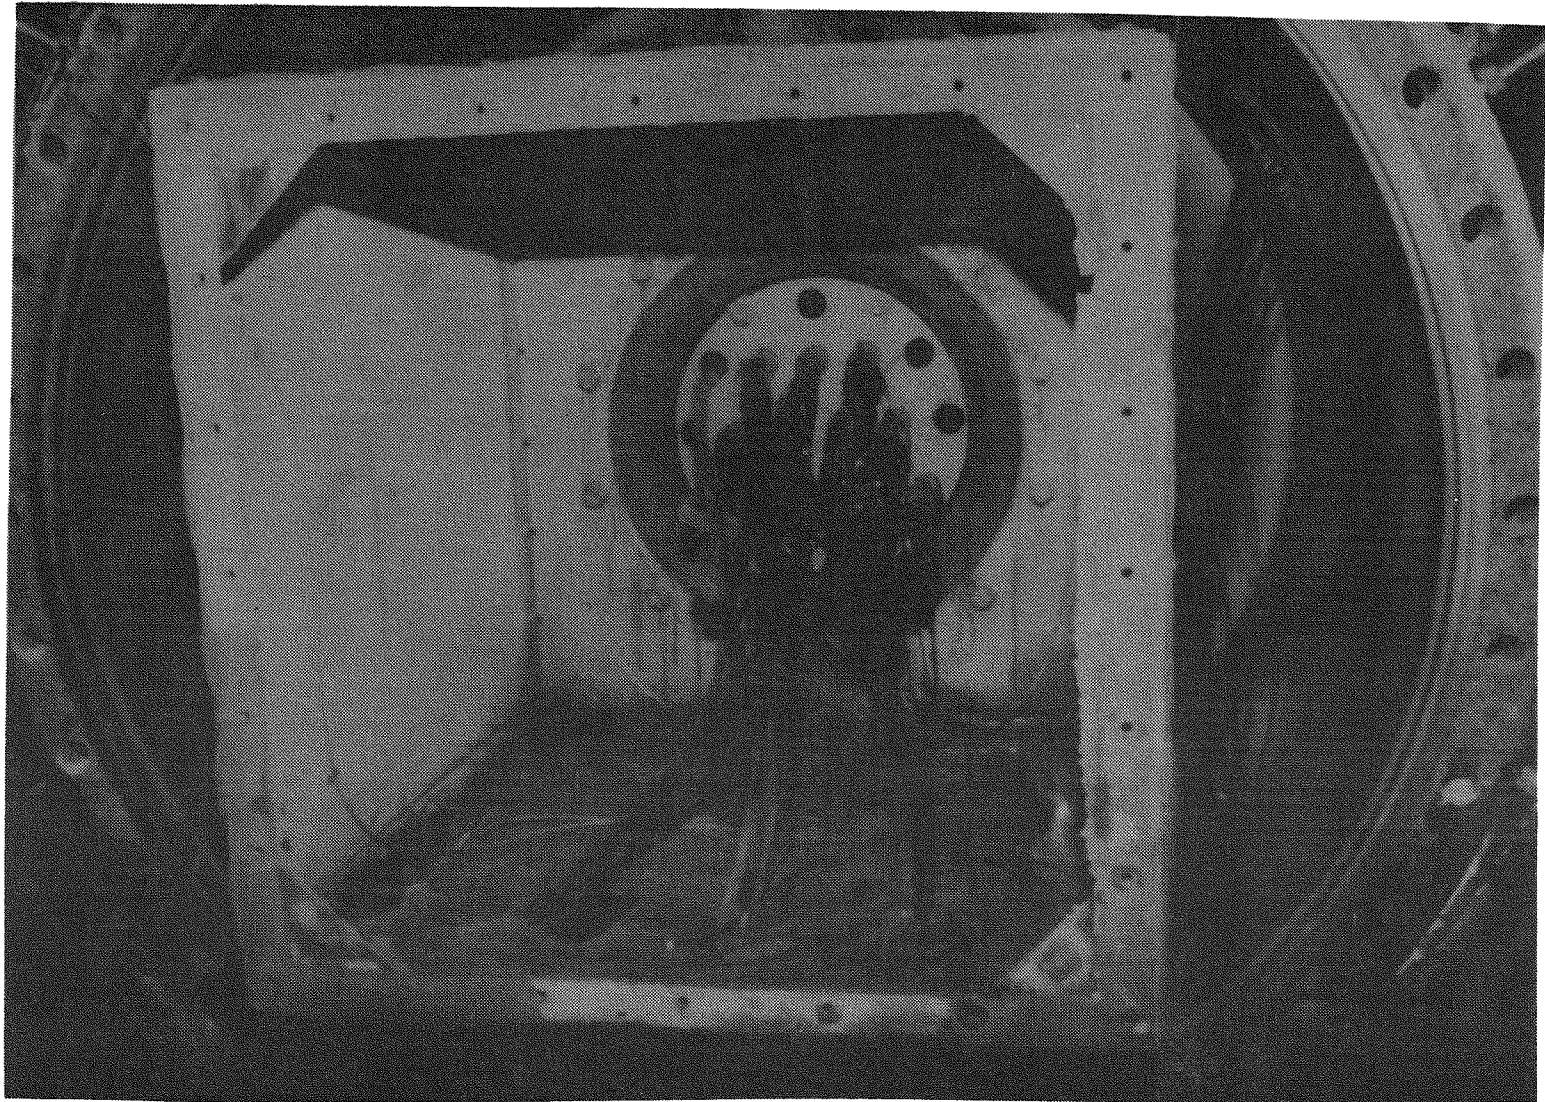
Figure 6-40b Photograph of Inside Junction Box, After SAC Test

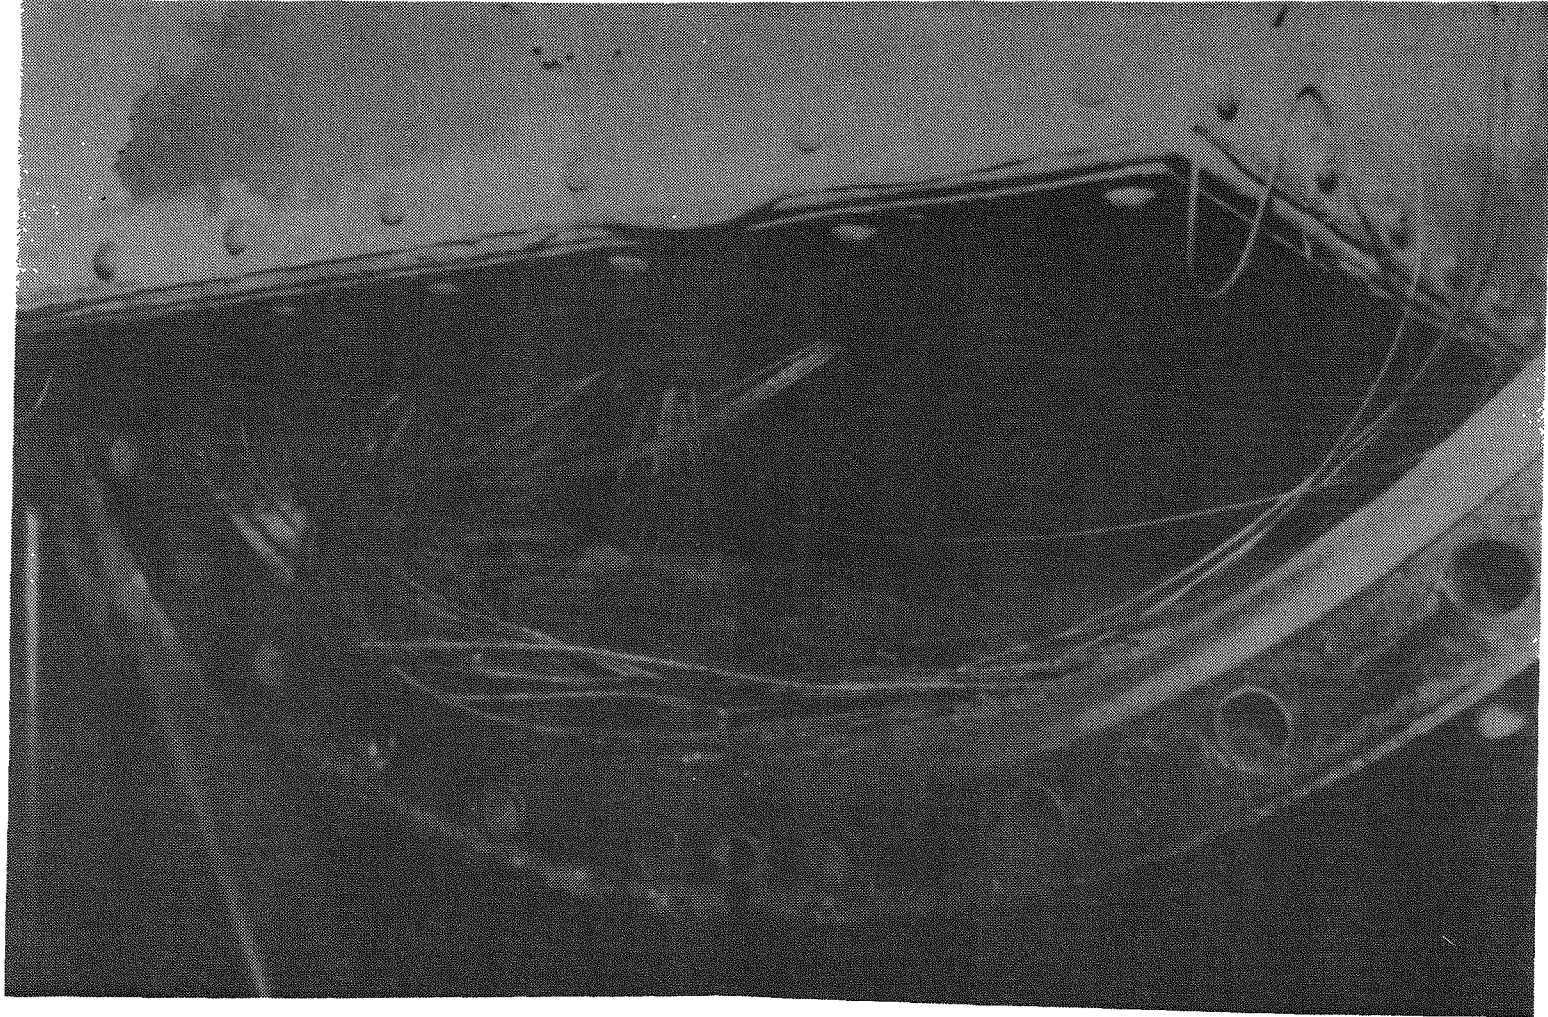
Figure 6-41b Photograph of Outside Junction Box, After SAC Test

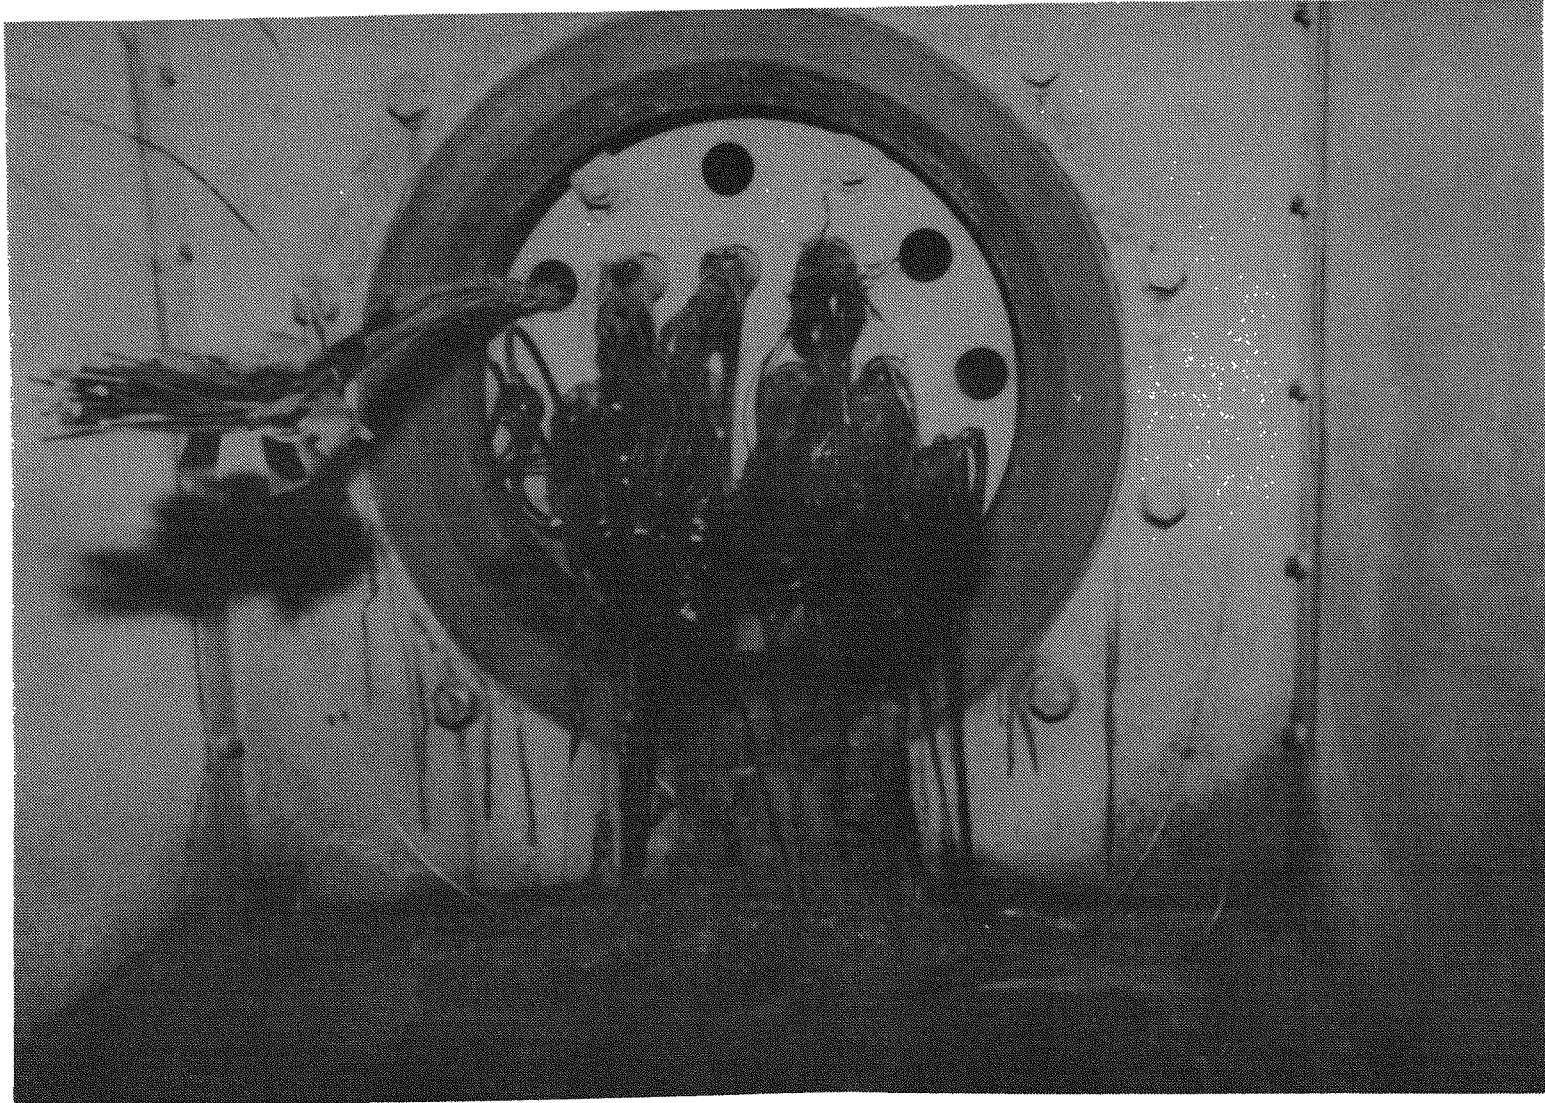
Figure 6-42 Post-SAC Test Photo of Inside Junction Box with Cables Removed

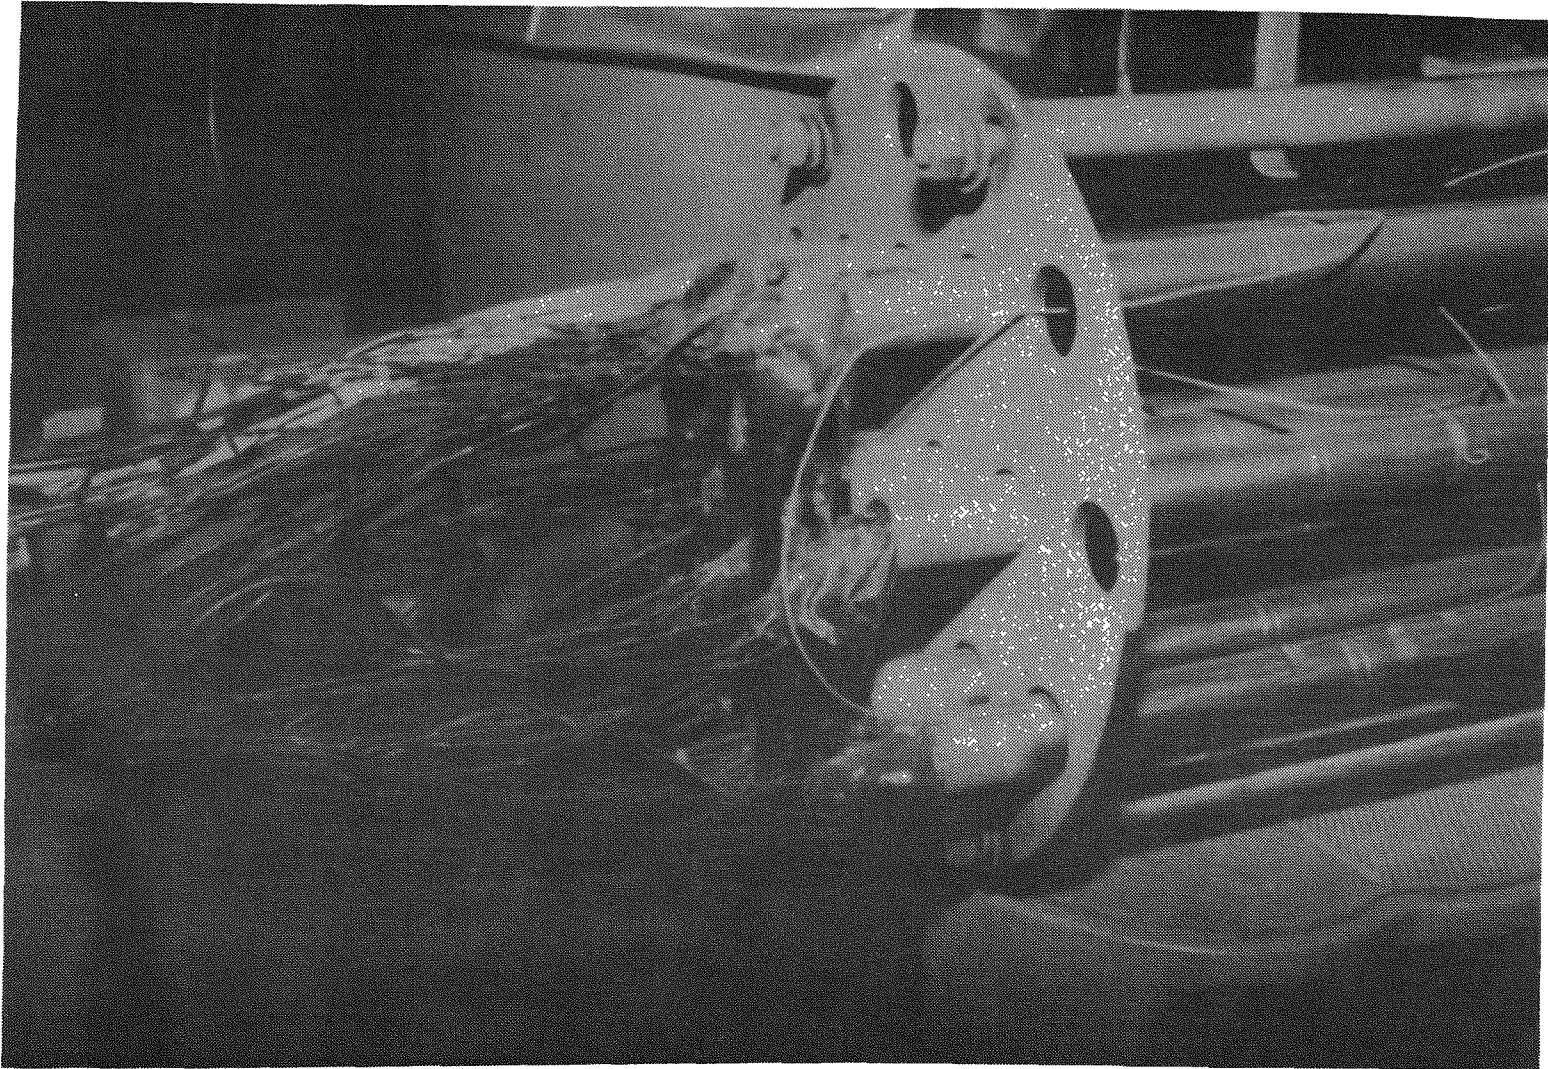
Figure 6-43 Post-SAC Test Photo of Inboard Module Seals

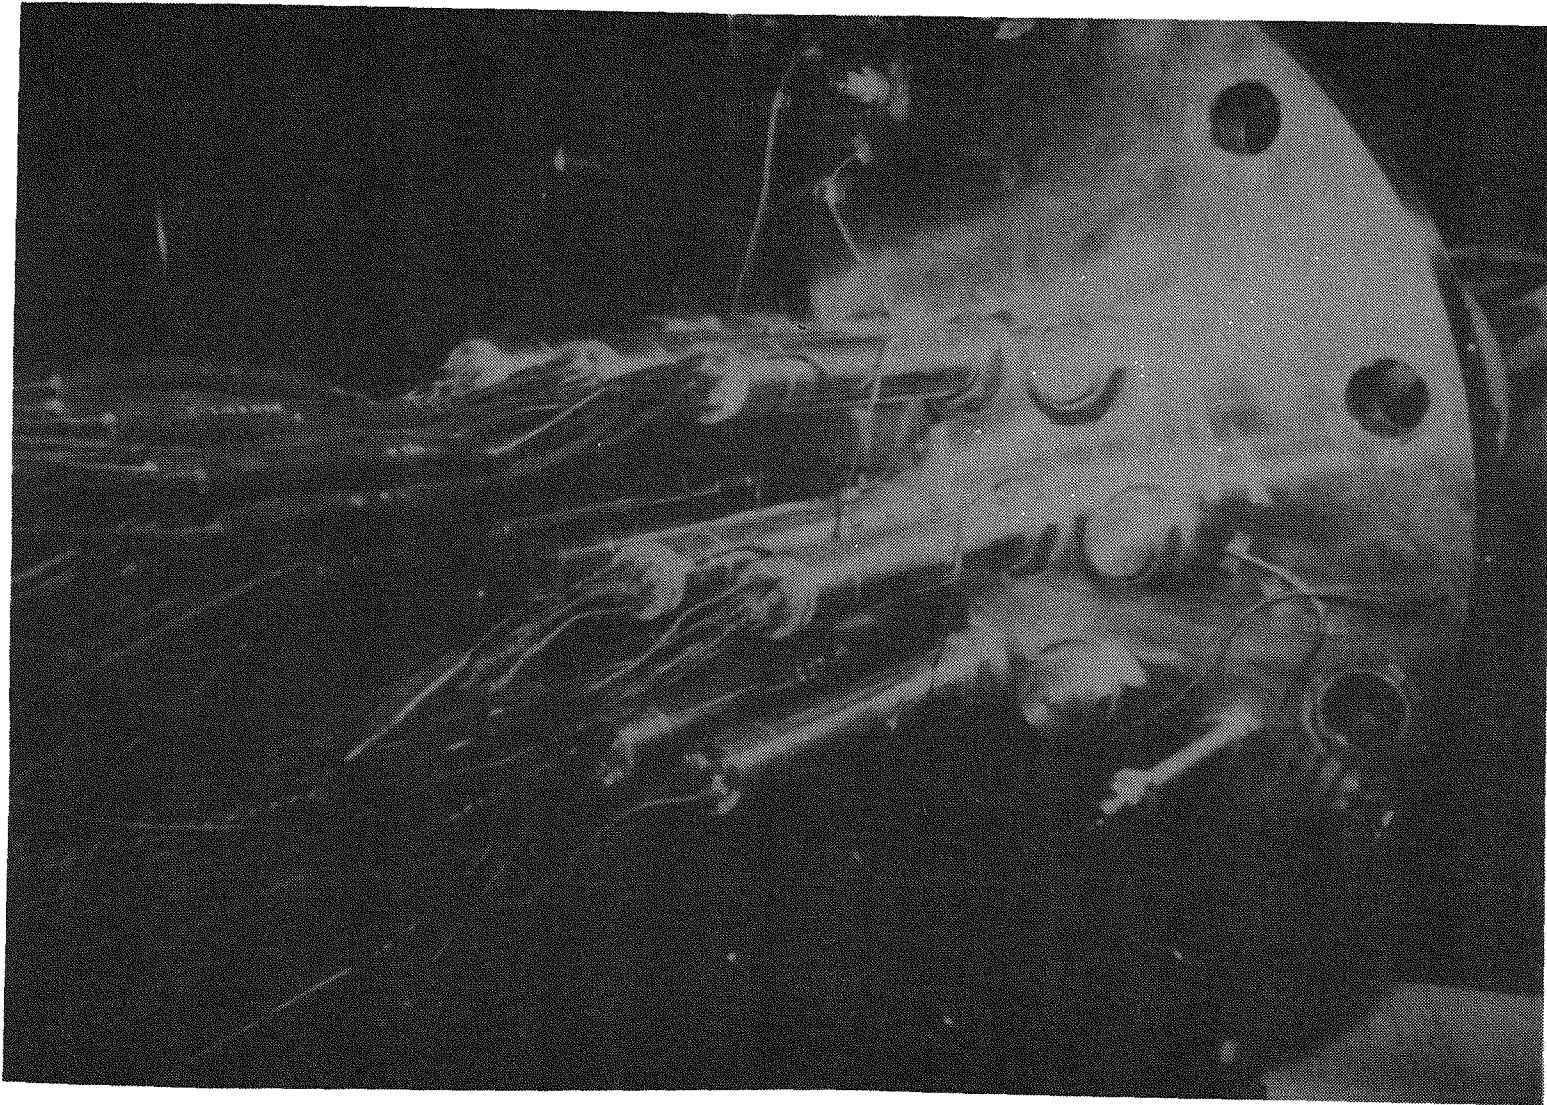
Figure 6-44 Post-SAC Test Photo of Outboard Module Seals
