**FLUIDIZED BED COMBUSTION 1000 HOUR TEST PROGRAM**

**Volume IV—Engineering Details and Post Test Inspections**

September 1981

NCB/Coal Utilization Research Laboratory  
Leatherhead, England

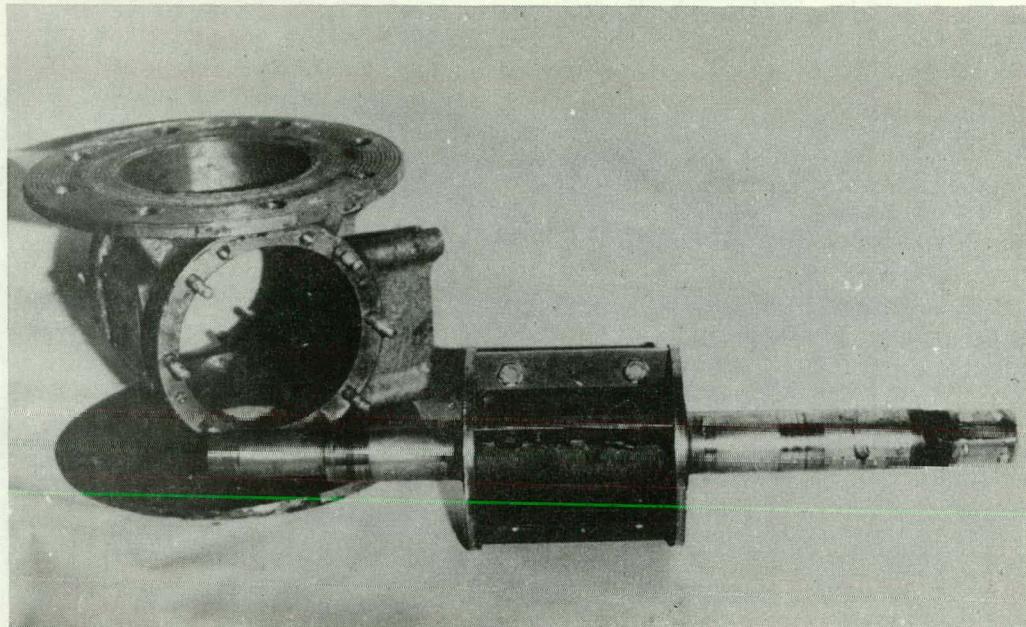
**Fig.15 Coal feed rotary valve – Casing and rotor**

There was no leakage from the glands of the valves. However, on inspection after the first 250 hours operation the shafts were found to be grooved in the seal areas. These areas were hardened and reground after which the problem did not reappear. Failure to harden the shafts initially was an error on the part of the manufacturers. Blade wear was minimal (Figs. L.15 and L.16) and no wear of the body could be detected.

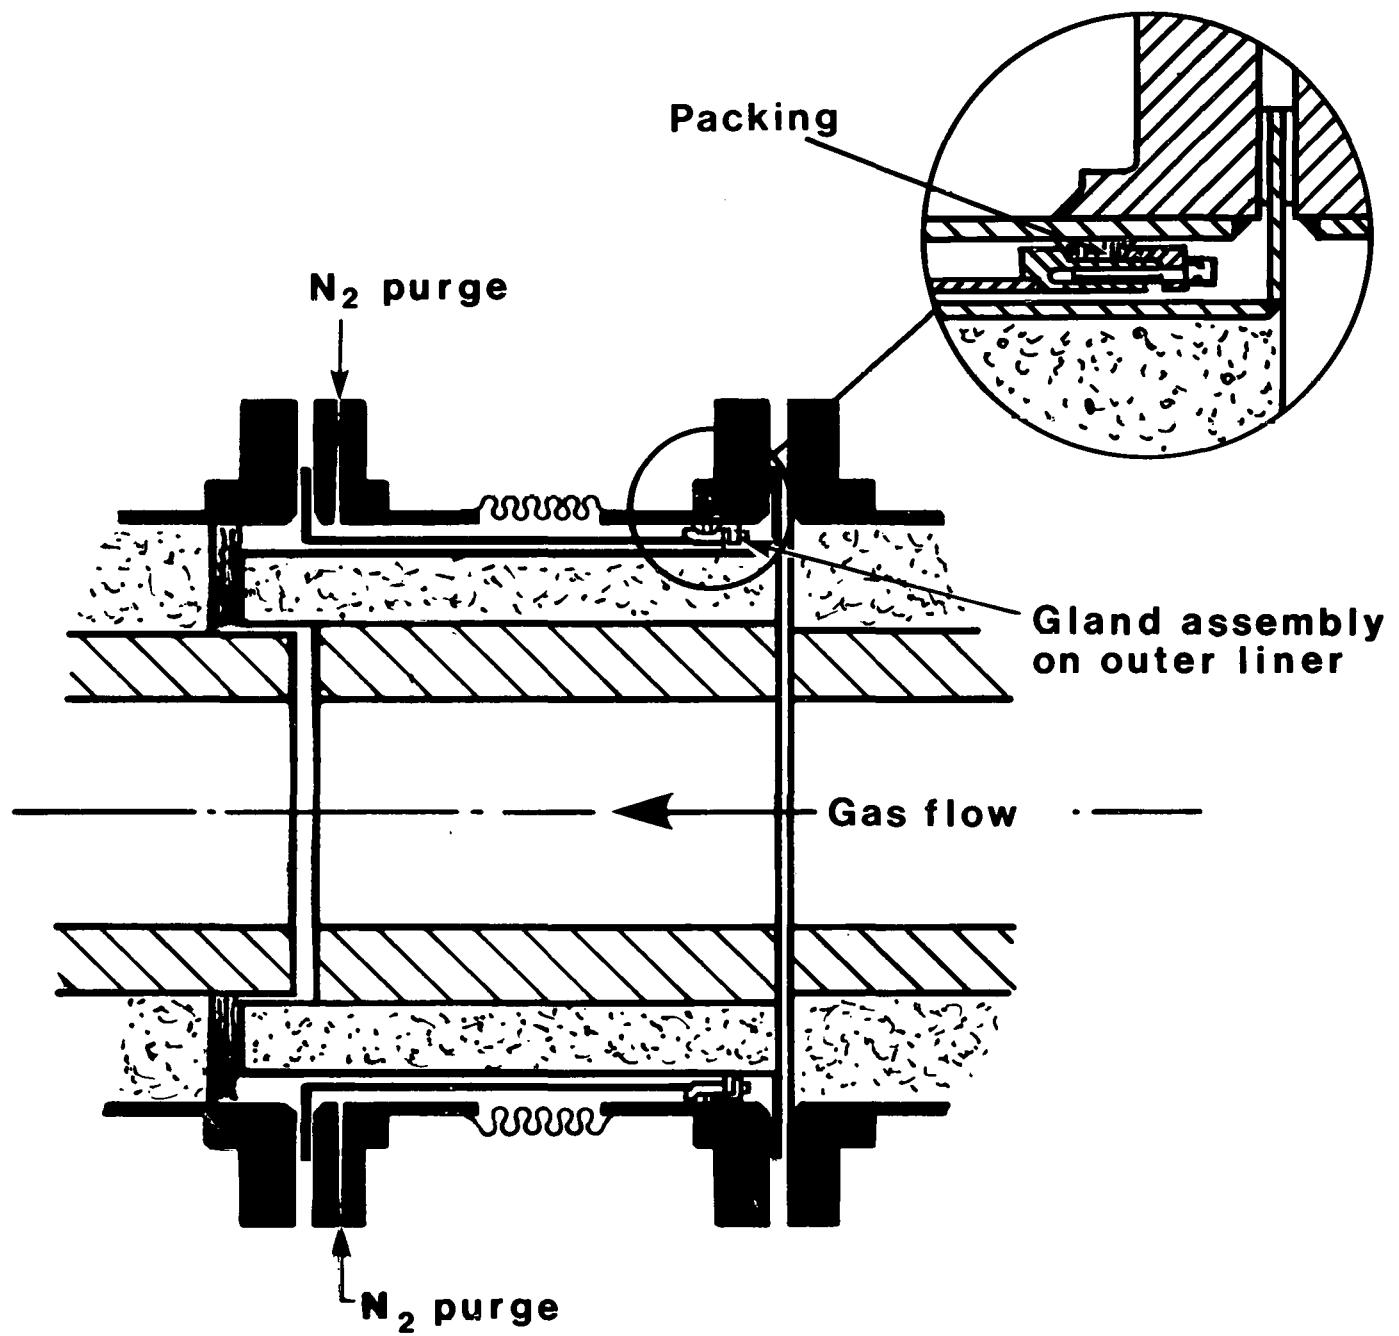
**Fig. L 20      Stream 2 500mm pressure casing bellows**

Fig. L.20 shows the final arrangement of the bellows. The two-ply corrugated section of 321 stainless steel was welded to mild steel stubbs with flanges for mounting in the duct. Originally, the unit had a mild steel liner mounted from one end and a two-layer refractory liner, mounted on a sandwiched flange from the other. This construction, used during a previous programme (G.E. Tests 8 and 9) in the same situation had suffered severe local stress corrosion of the 321 stainless steel with the result that longitudinal cracks appeared in two places across the corrugations, forcing a plant shut-down.

A small concentration of chlorine in the combustor off-gas condensing on the relatively cool corrugations was identified by inspection and analyses carried out by the manufacturers as being the most likely instigator of the corrosion. Consequently, a change in the material of construction of the corrugations was recommended for the 1000 hour programme. Incoloy 825 was thought to provide more resistance to such attack. However the extremely long delivery of a replacement set of corrugations in this material and the small possibility that similar, albeit less rapid corrosion may still occur, because of the sub-dewpoint operating temperature, prompted a small modification to the design of the unit which is shown in Fig. L.20. This took the form of a gland assembly welded to the free end of the existing mild steel liner, and bearing on the inside surface of one of the stubb ends, thus providing a sealed cavity around the inside of the corrugations. The gland packing was not expected to form a gas tight seal but merely to provide sufficient restriction to allow the cavity to be filled by a small flow of nitrogen. In practice a very efficient seal was provided by the gland once the unit had reached operating temperatures and marking of the inside surface of the bellows stubb end, seen on inspection after 265 hours operation, indicated that the packing had compensated well for lack of concentricity of the pipe whilst allowing bellows compression of about half an inch. This marking, and the very clean conditions of the inside surface of the corrugations (321 SS), can be seen in Figs. L.53, a photograph taken after 1000 hours of operation. A spare bellows in Incoloy 825 was delivered part way through the programme, but was not used.

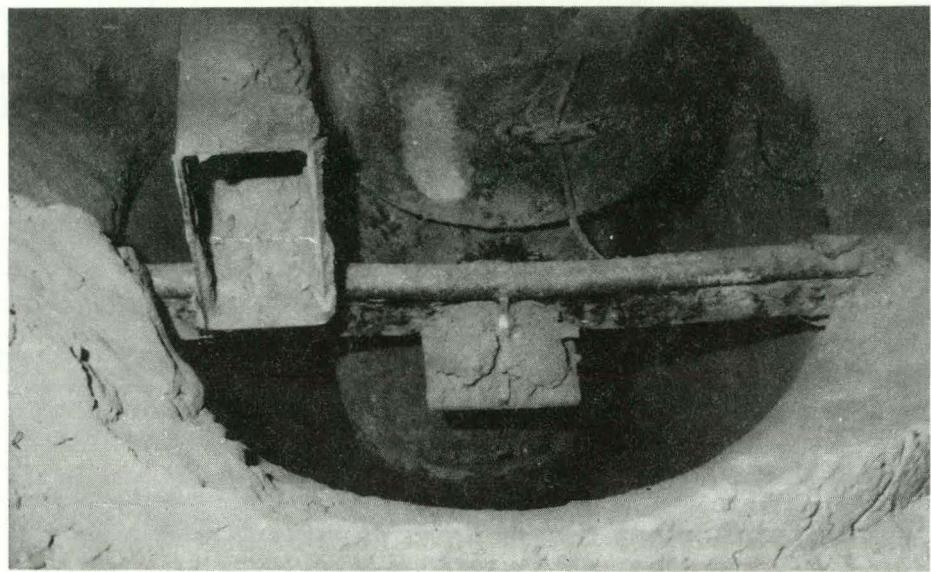
**Fig.L46 Stream 2 secondary stage cyclone in primary stage outlet after 1000 hrs.**

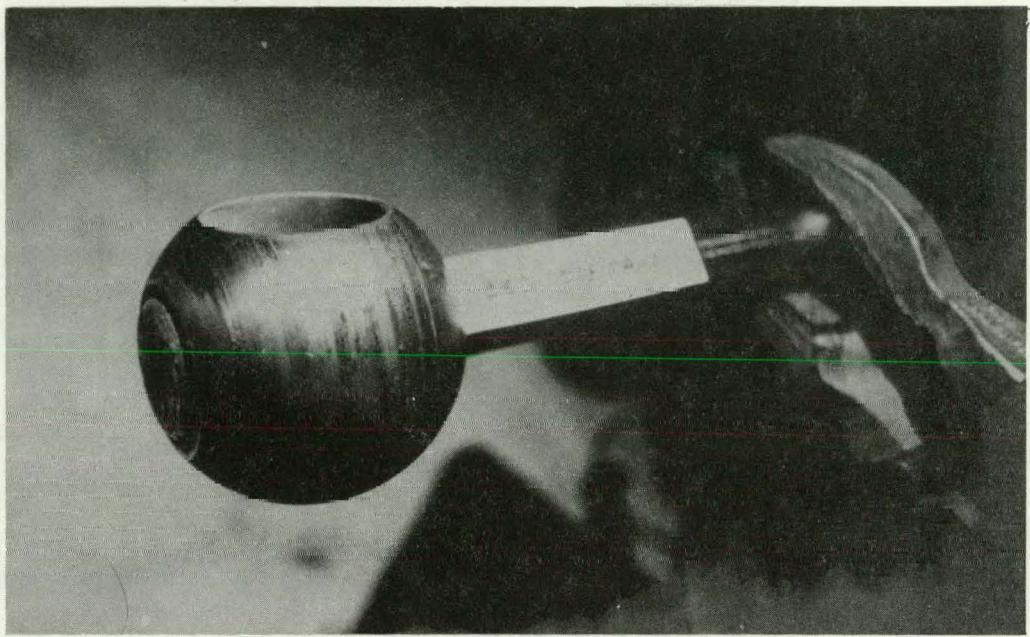
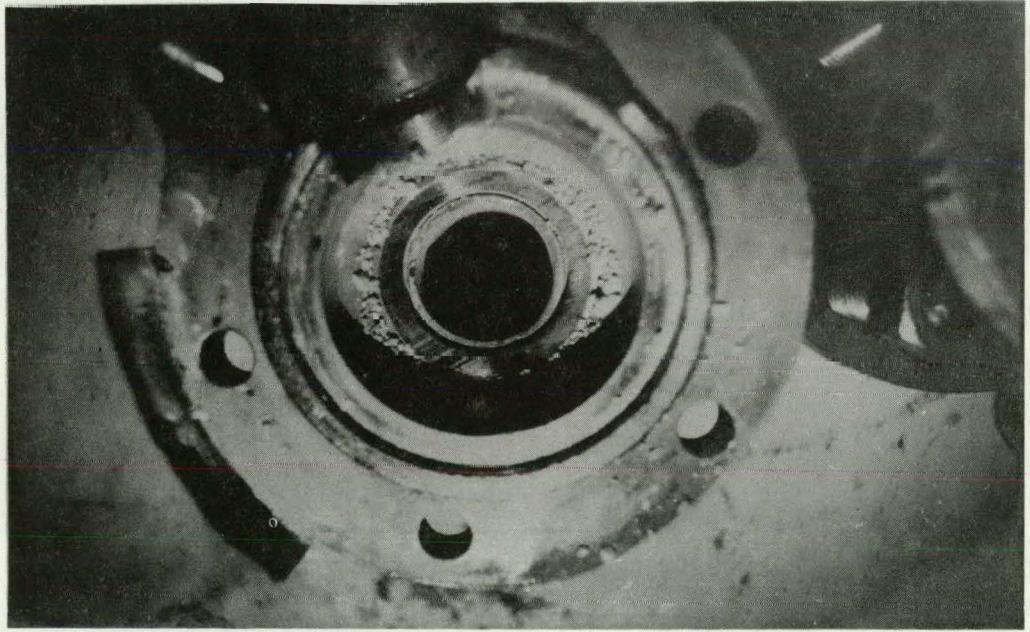
**Fig.L48 Ball and one seat of 25mm Neles valve used on bed removal leg.**

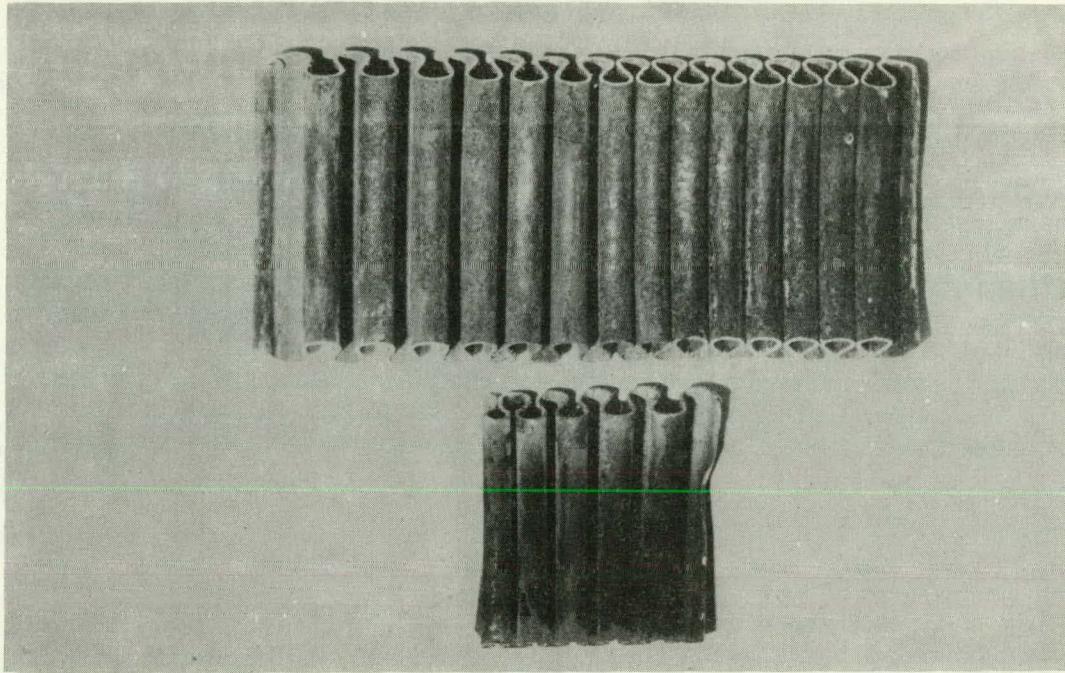
**Fig.L50 Inside surface condition of ash leg bellows and gas path bellows (Top – Stream 1 secondary ash leg, Bottom – Stream 2 tertiary cyclone gas path.)**

Pitting corrosion around weld zones was most noticeable on ash leg bellows, i.e. those which operated at generally lower temperatures

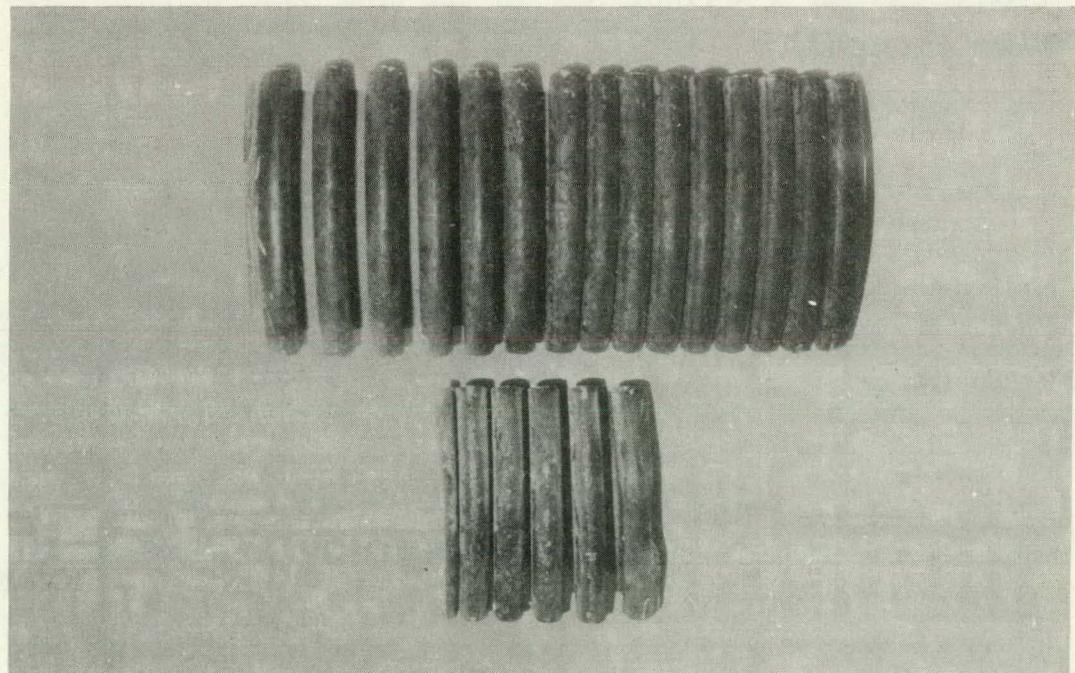
**Fig.L51 Outside surface of sectioned bellows units as above**

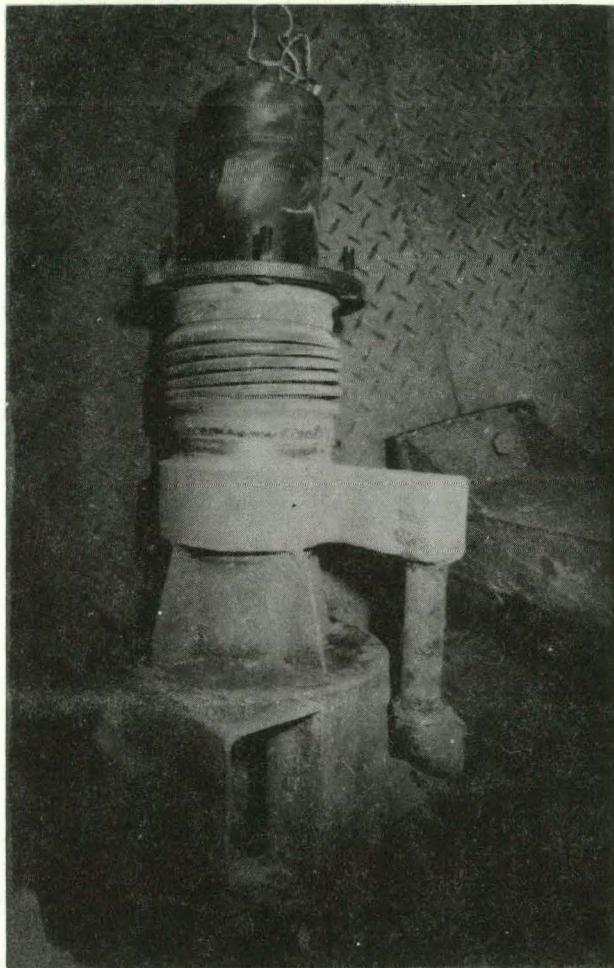
**Fig.L52** Top of Stream 2  
tertiary cyclone showing  
cyclone inlet, shave-off  
volute and expansion  
bellows after 1000 hrs.

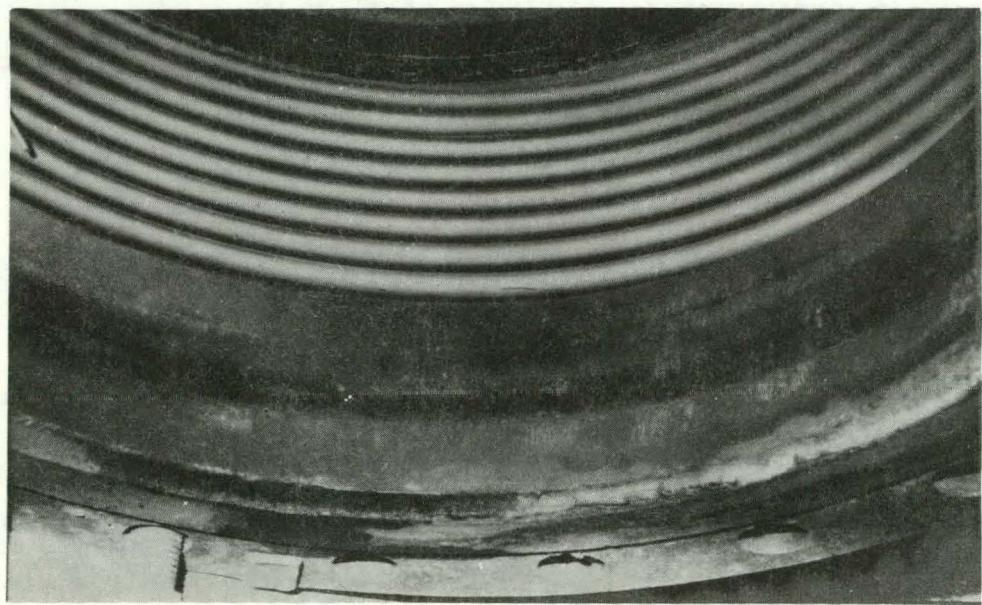
**Fig.L53** Inside of 500mm casing bellows of Stream 2  
showing gland sealing area.

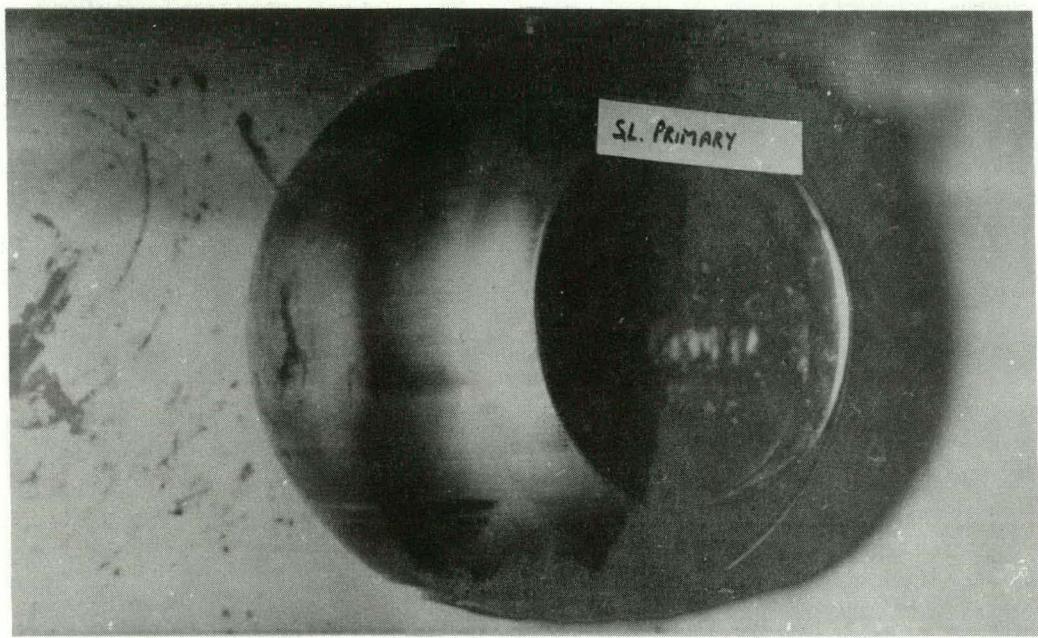
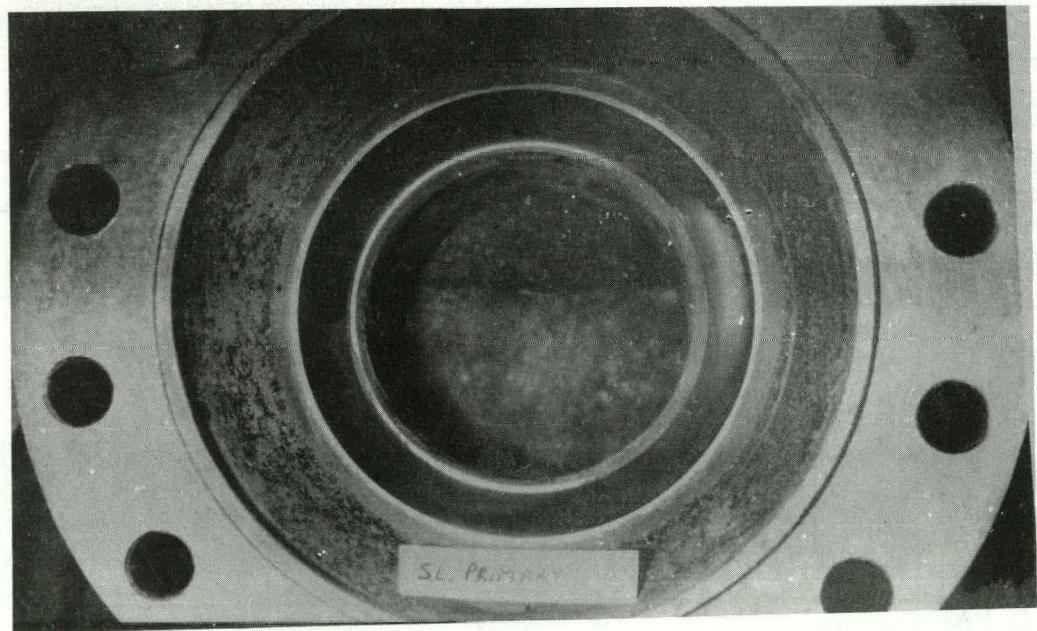
This was one of the two high-temperature valves on the dust system which had a stellited ball as well as stellited seats (all other Kamyr/Neles types had chromium-plated balls). No appreciable leakage between ball and seat was detected after Test 1 but by the end of Test 2 the leakage was significant. Inspection

**Fig.L54 Ball and seat of Stream 1 primary dust system isolation valve after 1000 hrs.**

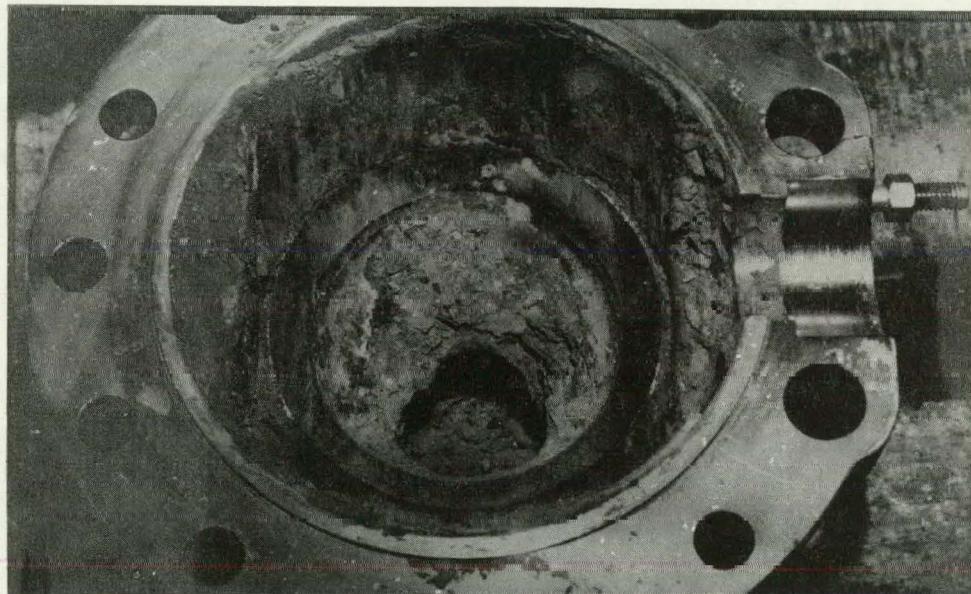
**Fig.L55 Condition of Stream 2 primary and secondary dust system isolation valves after Test 2.**

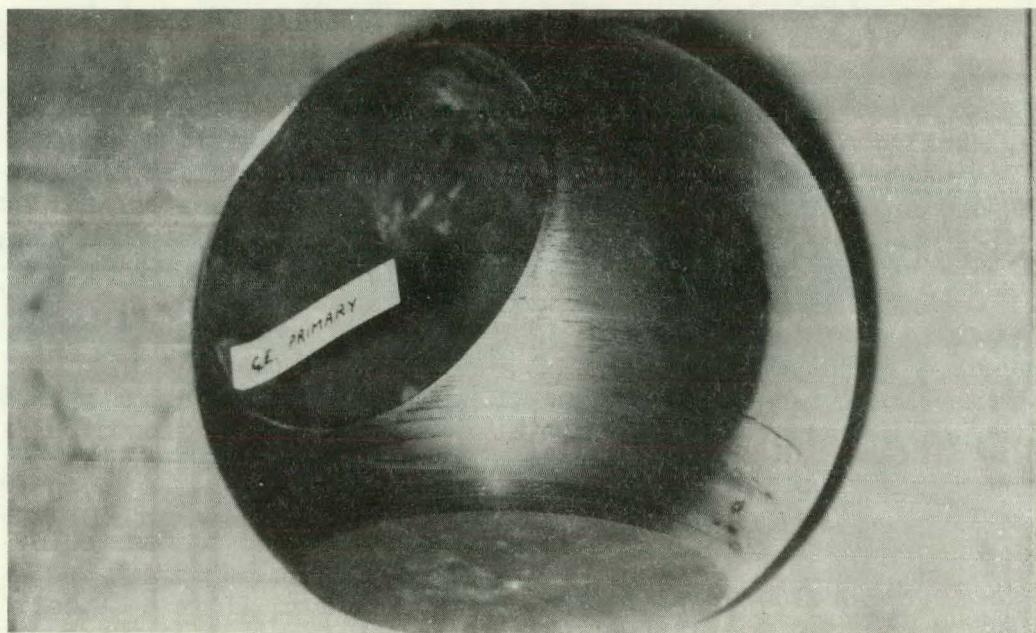
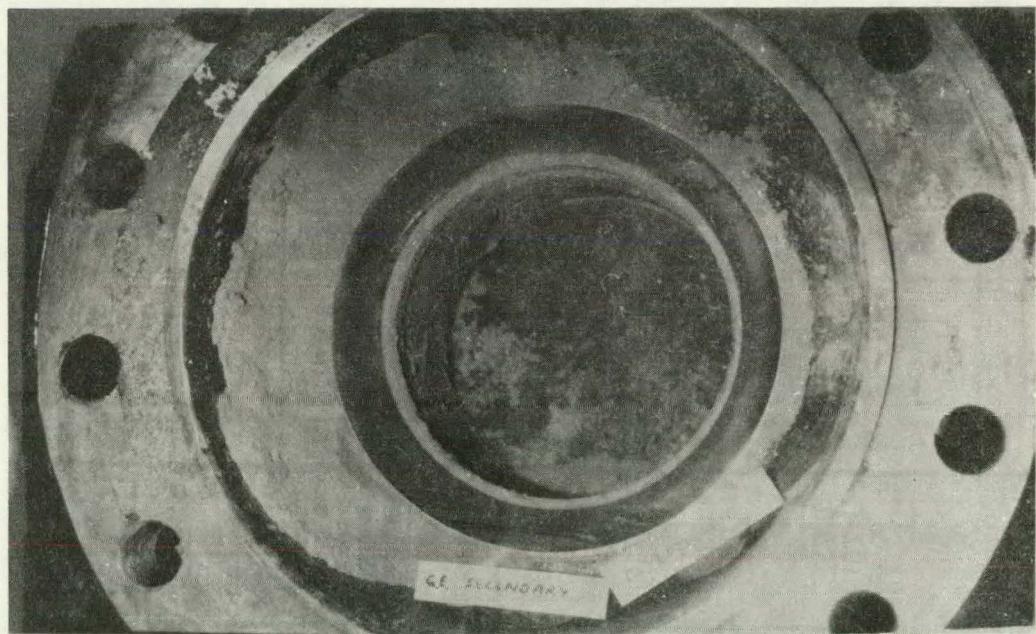
This was identical to that on the primary dust system of Stream 2 and showed slight leakage between ball and seats after about 250 hours. On strip down after Test 2, it was found to be in

**Fig.L56 Stream 2 dust system isolation valves after 1000h**  
**Top - Ball of primary system valves.**  
**Bottom - Lower seat of secondary system valve**

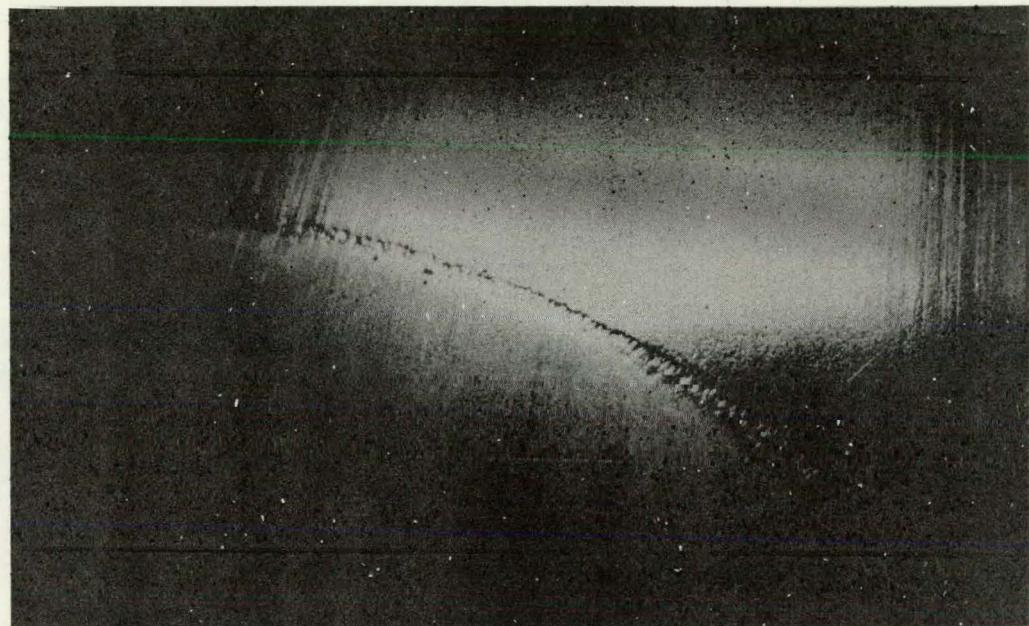
**Fig.L59** Typical surface damage on Kamyr/Neles ball  
(chromium plated 316 ss)

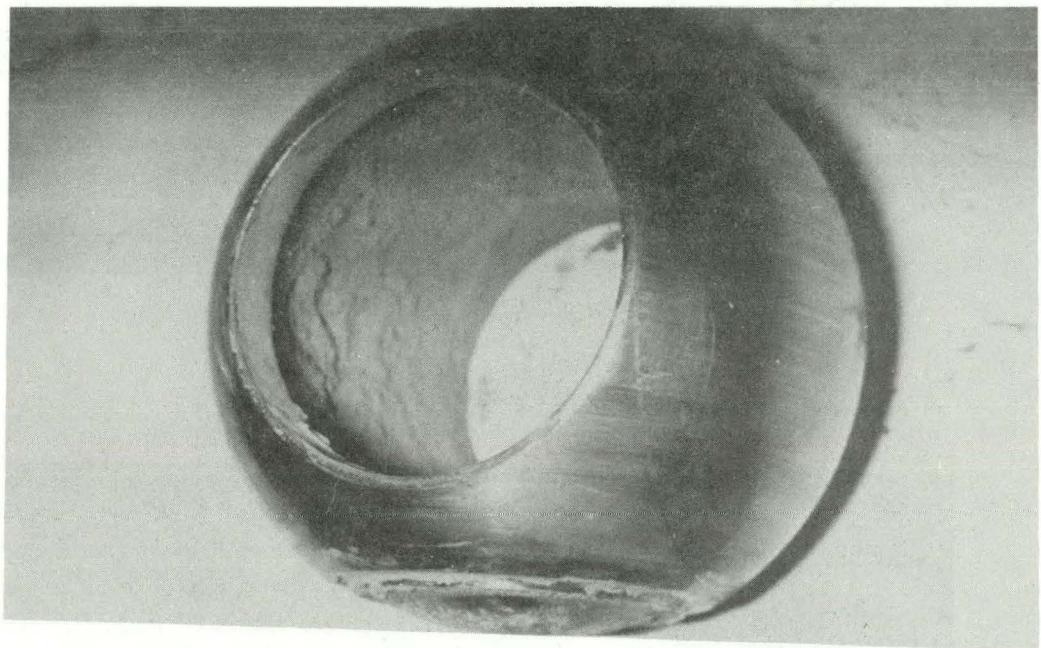
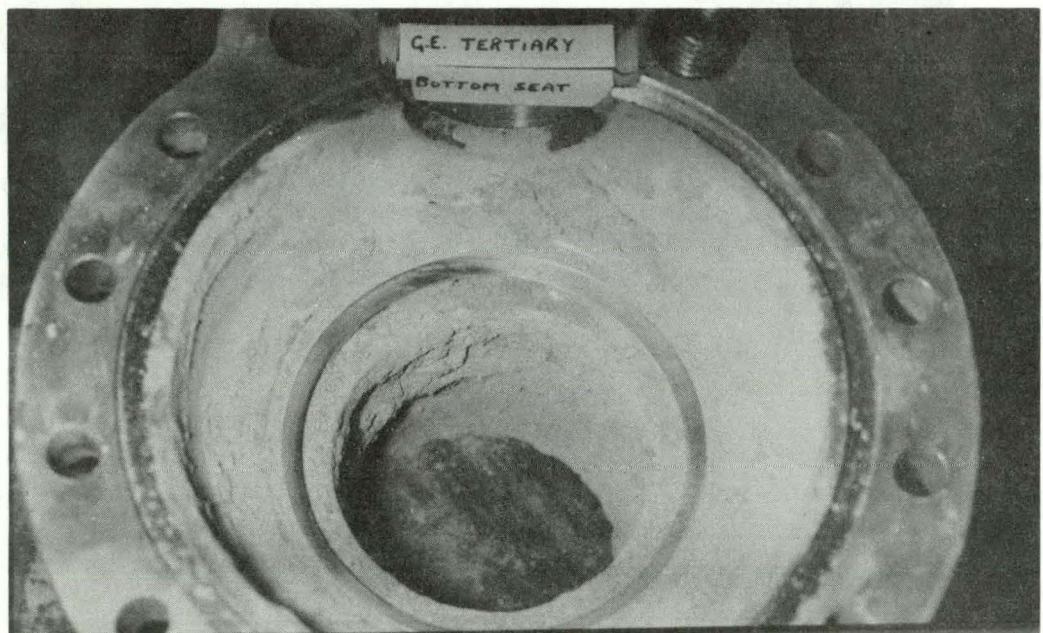
Inspection after 1000 hours showed material build-up still evident in the polar region of the seats. The ball seemed to have sustained no more damage than that noticed after 265 hours but there was some "blueing" of the surface of what was the top face of the ball in the closed position (Fig. L.60).

**Fig.L60 Ball and lower scraper seat of Stream 2 tertiary dust system isolation valve after 1000 hrs.**

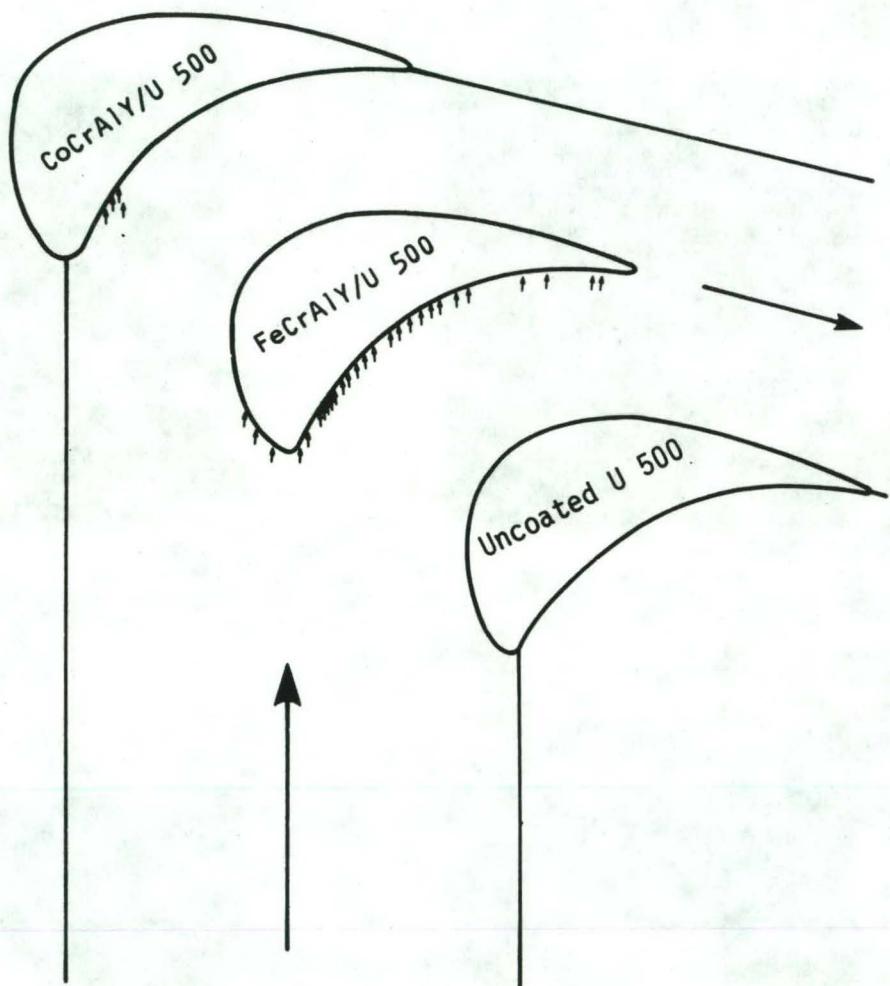
Figure 8. Distribution of sharp-edged particles at the surface of cascade blades. Composition of blade materials and direction of gas flow are shown.

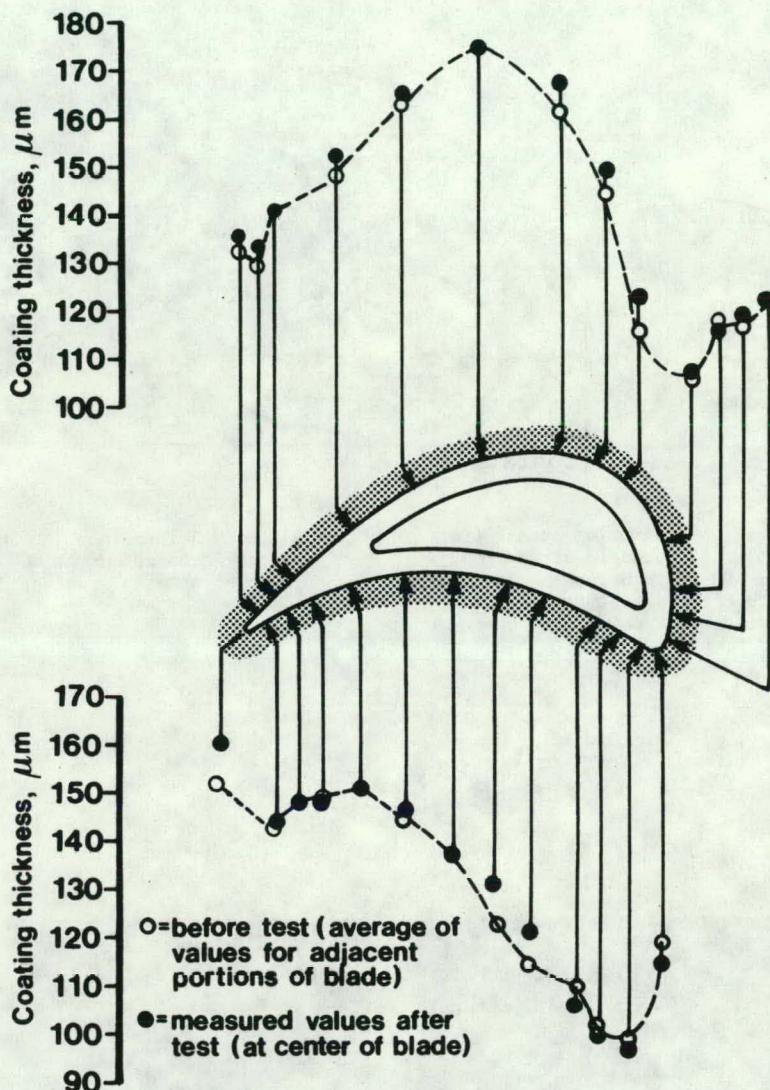
Figure 9. PFBC 1000 hour test. FeCrAlY coating thickness on cascade turbine blade.

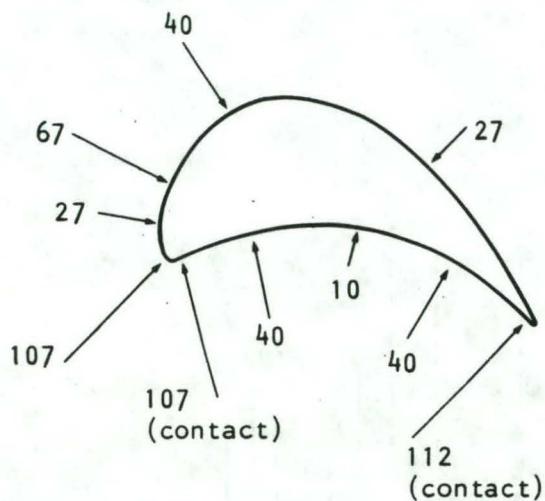
Figure 10. Maximum observed corrosion attack (in  $\mu\text{m}$  and including subscale attack) on uncooled U-500 blade after 950 hours exposure to PFBC combustion gases. "Contact" indicates point of contact with blade mounting device.

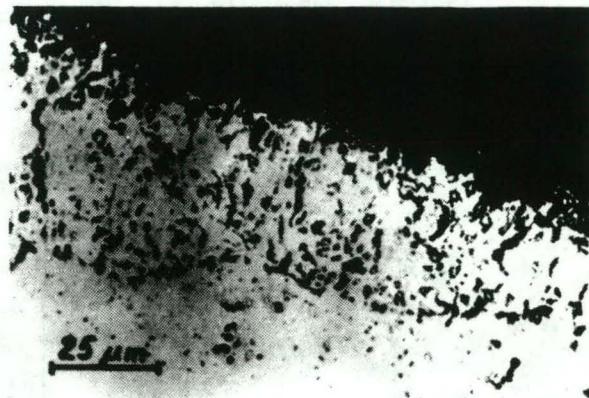
Figure 11. Light micrograph showing corrosion attack on uncoated Udiment 500 blade at point of contact with mounting device.

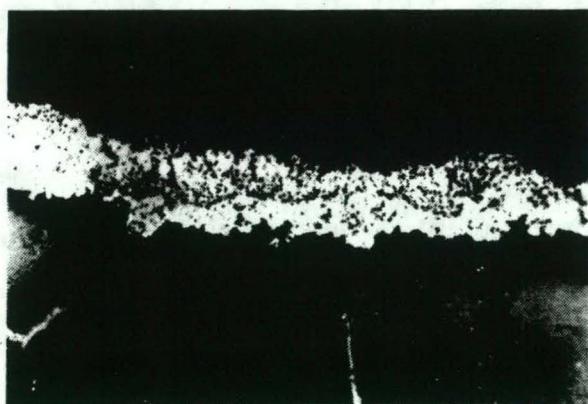
Figure 12. Light micrograph of the same part of the uncoated Udiment 500 blade. Electrolytic etching in oxalic acid shows a compositionally changed surface layer.
