GEND-INF-023

**INVESTIGATION OF HYDROGEN-BURN DAMAGE IN  
THE THREE MILE ISLAND UNIT 2 REACTOR BUILDING**

N. J. Alvares and D. G. Beason  
Lawrence Livermore National Laboratory  
and  
G. R. Eidam  
EG&G Idaho, Inc.

Published June 1982

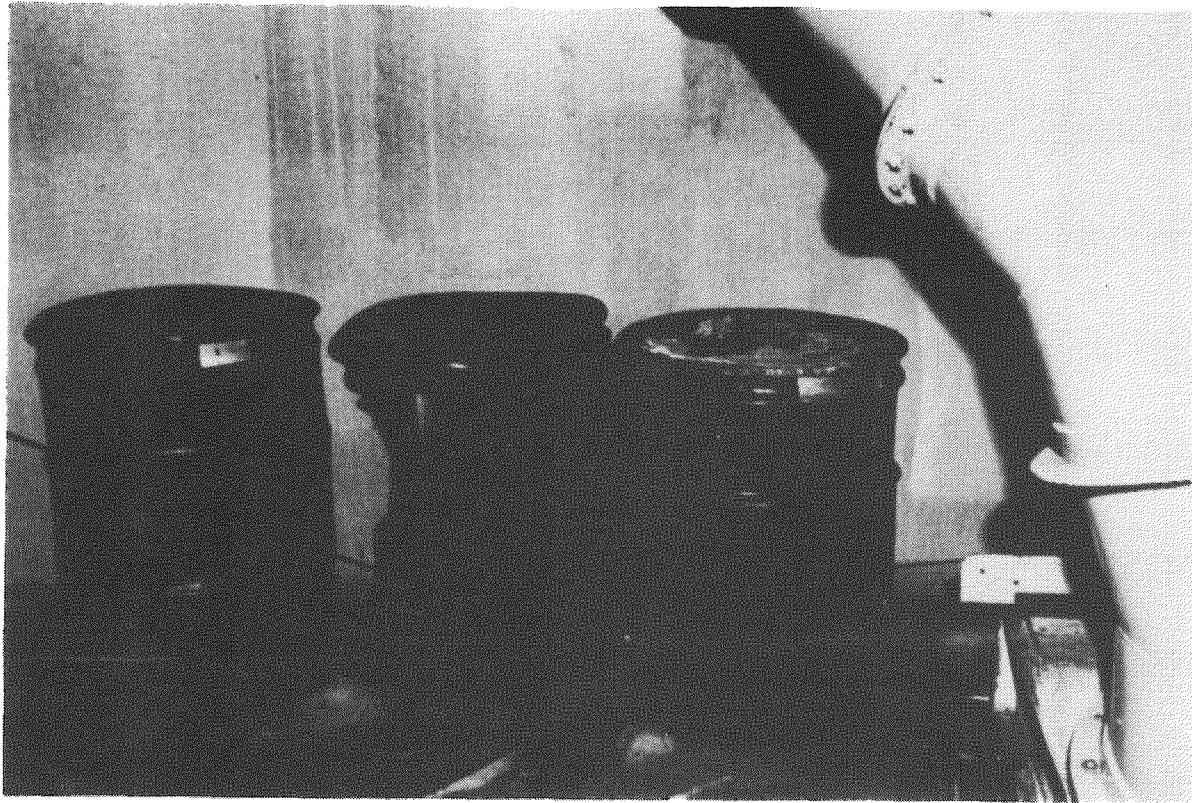
Figure 1 shows apparently crushed barrels (content unknown) found on both sides of the elevator and enclosed stairwell complex on the 347-foot elevation. Such damage could result from a pressure pulse, or possibly from heating followed by rapid cooling. Other items in proximity did not appear displaced (except for fallen circumferential bus bars from the reactor building polar crane). Pending closer examination, the cause for barrel distortion will remain undefined.

Figure 1. Crushed barrels near the elevator door and enclosed stairwell on the 347-foot elevation.

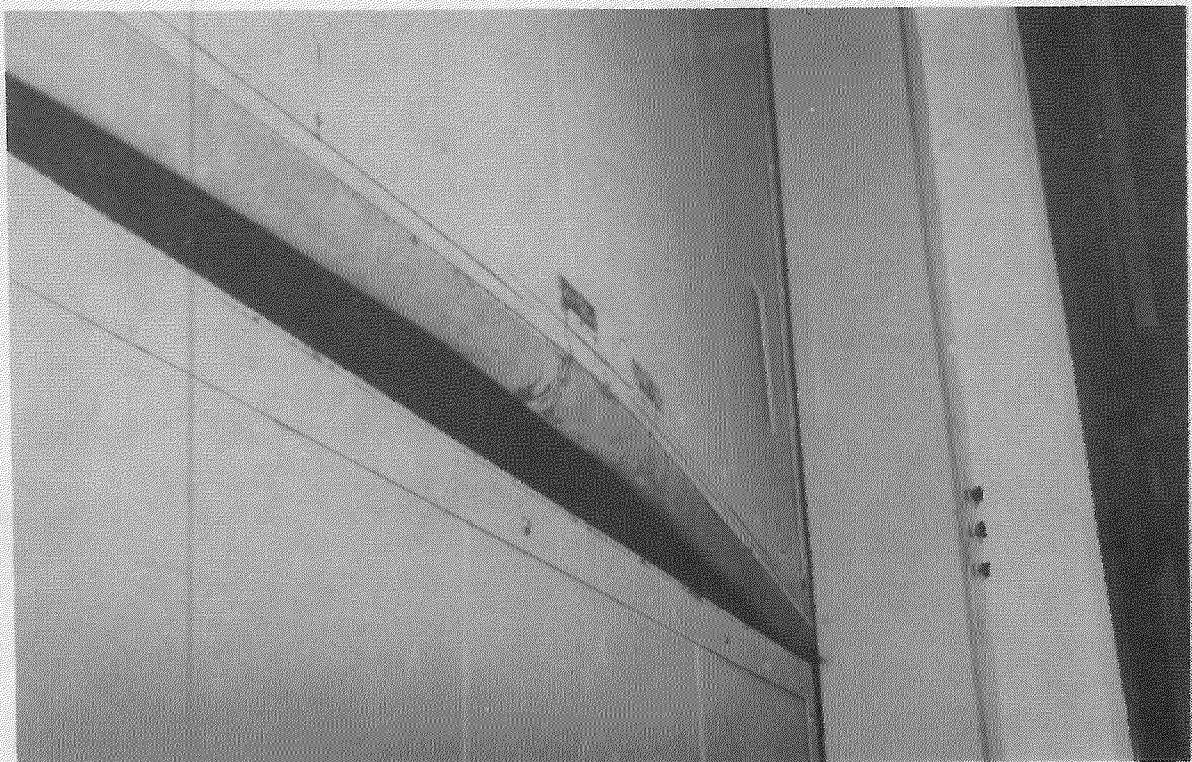
Figure 2. Elevator door on the 347-foot elevation indicating overpressure damage.

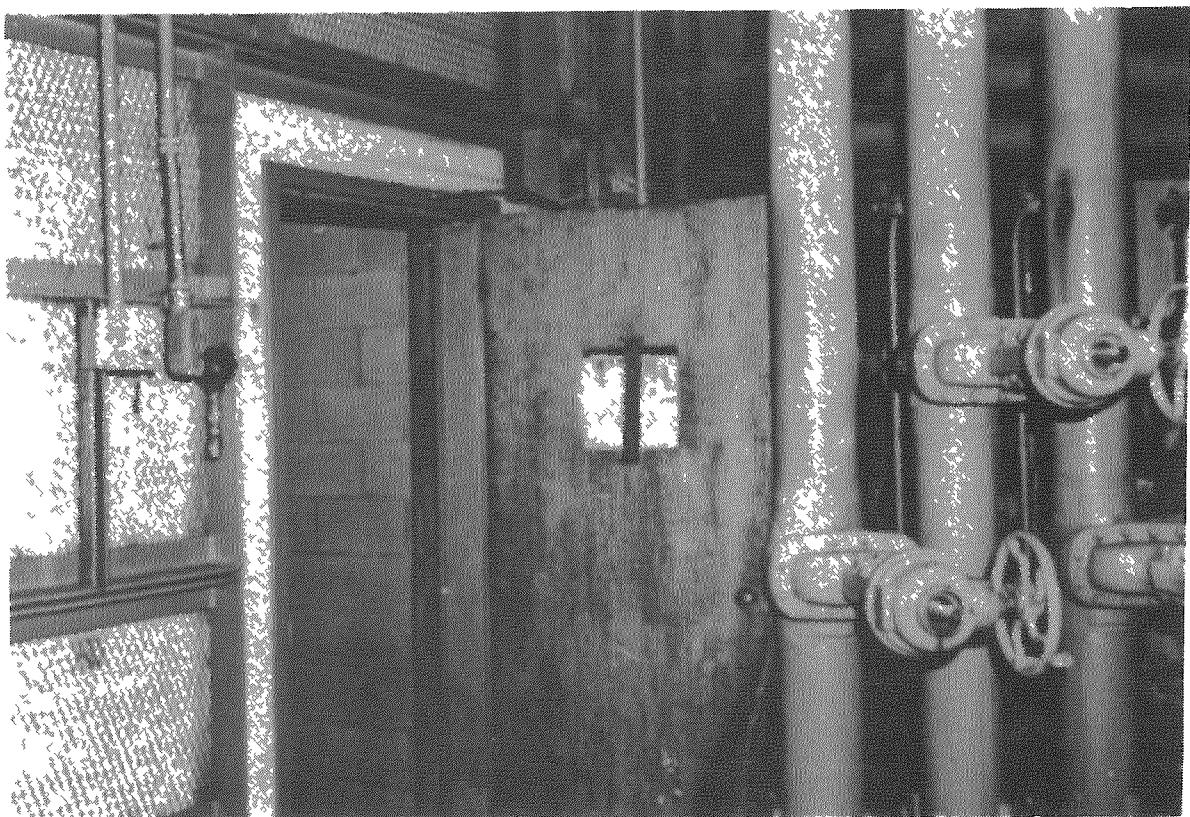
Figure 3. Enclosed stairwell door on the 305-foot elevation indicating overpressure damage.

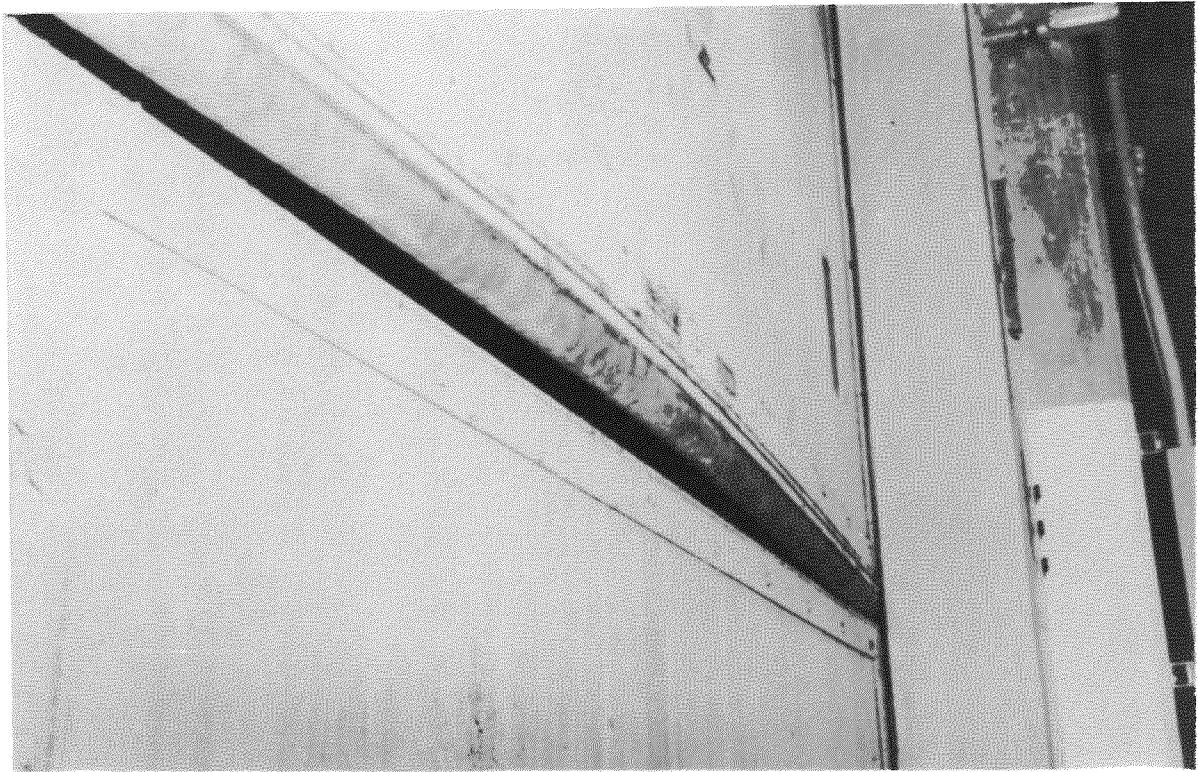
Figure 4. Elevator door on the 305-foot elevation indicating overpressure damage.

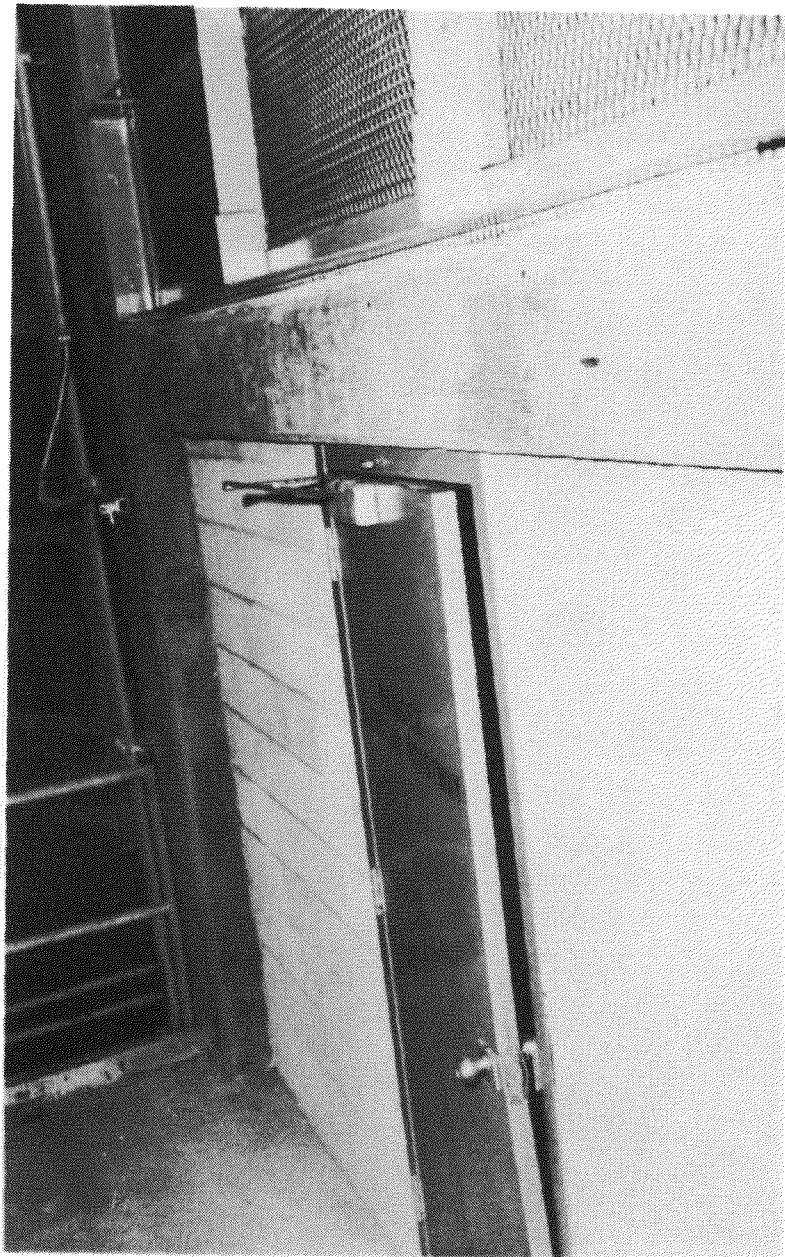
Figure 5. Door on 325-foot elevation with broken latch; door forced open by overpressure.

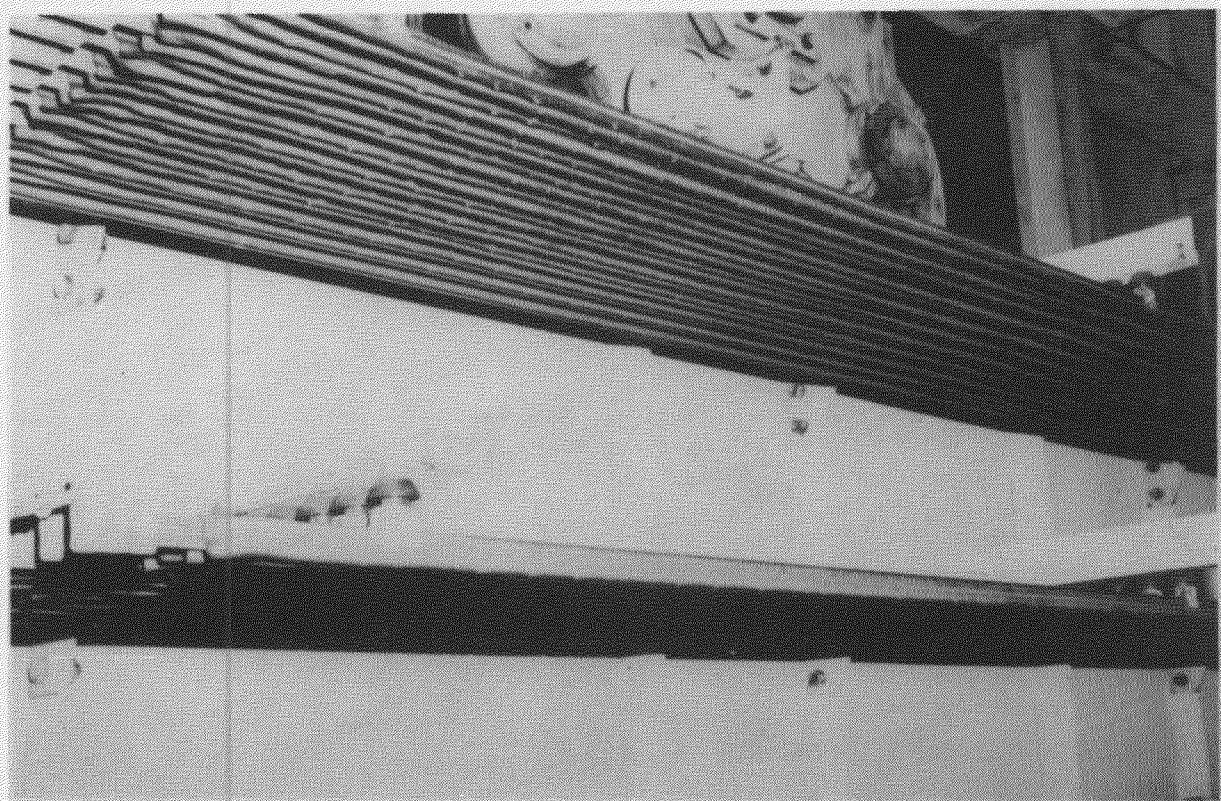
Figure 6. Burned and melted insulation on the polar crane bus bars.

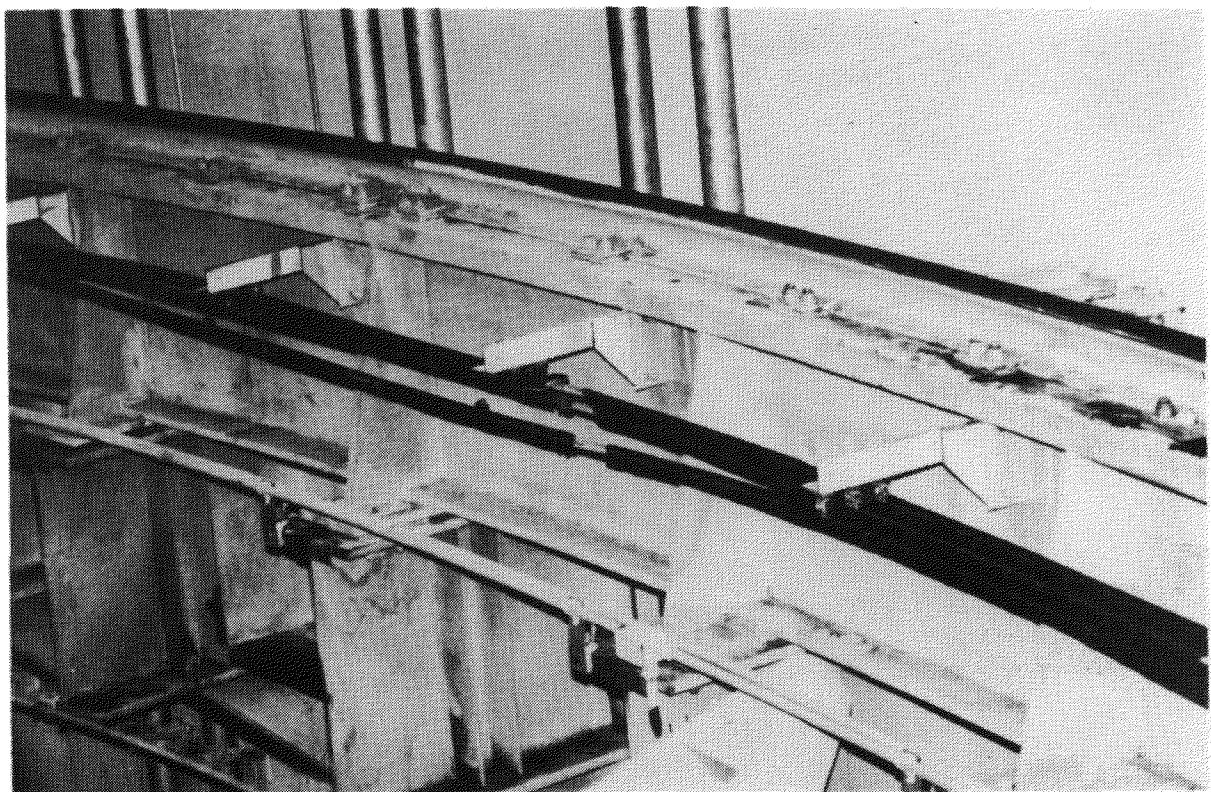
Figure 7. Charred insulation on the containment bus.

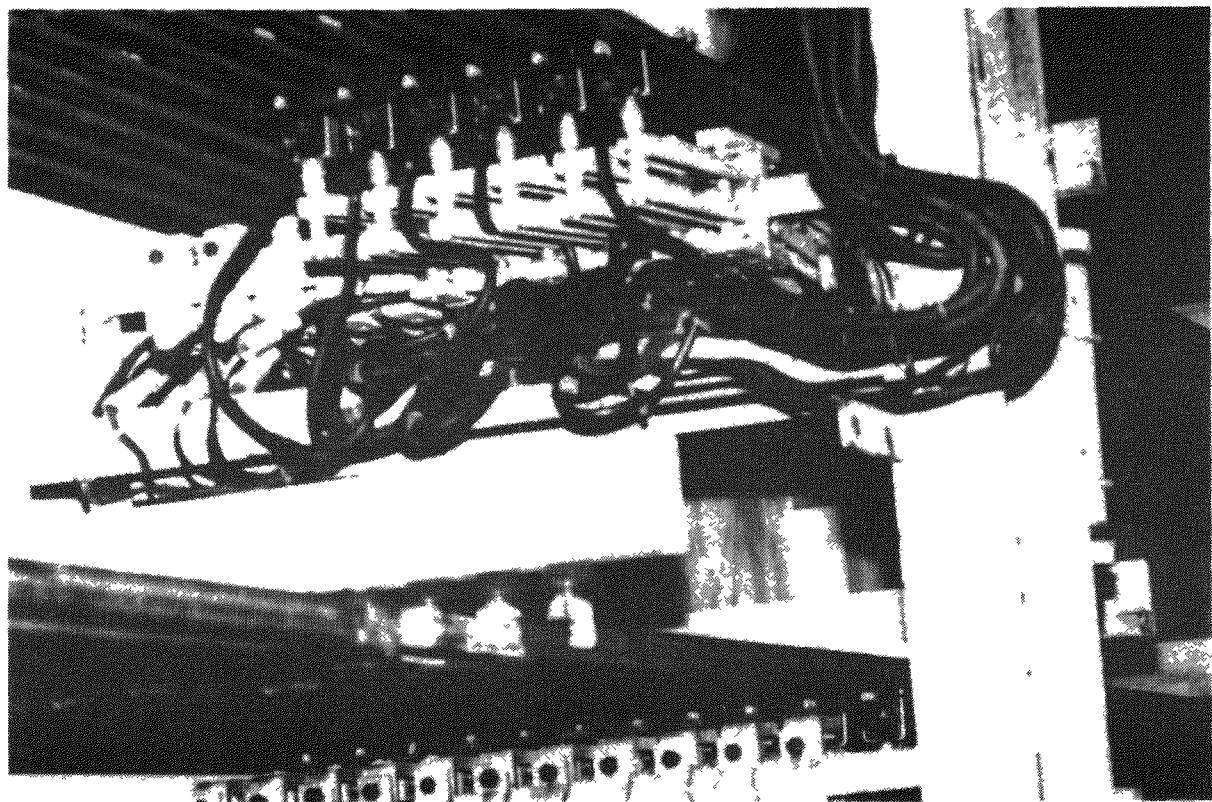
Figure 9. "Scalloped" damage to polar crane bus insulation; appears to decrease close to crane.

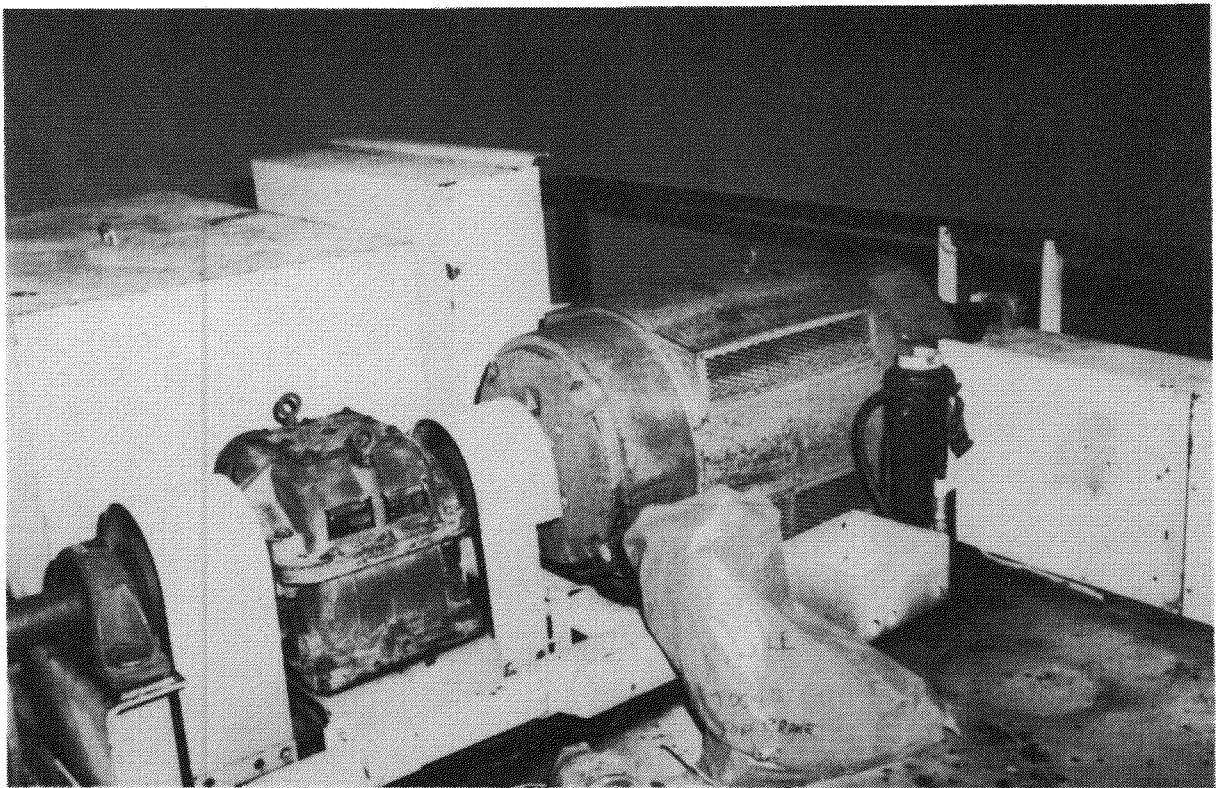
Figure 10. Charred hose and charred label on fire extinguisher.

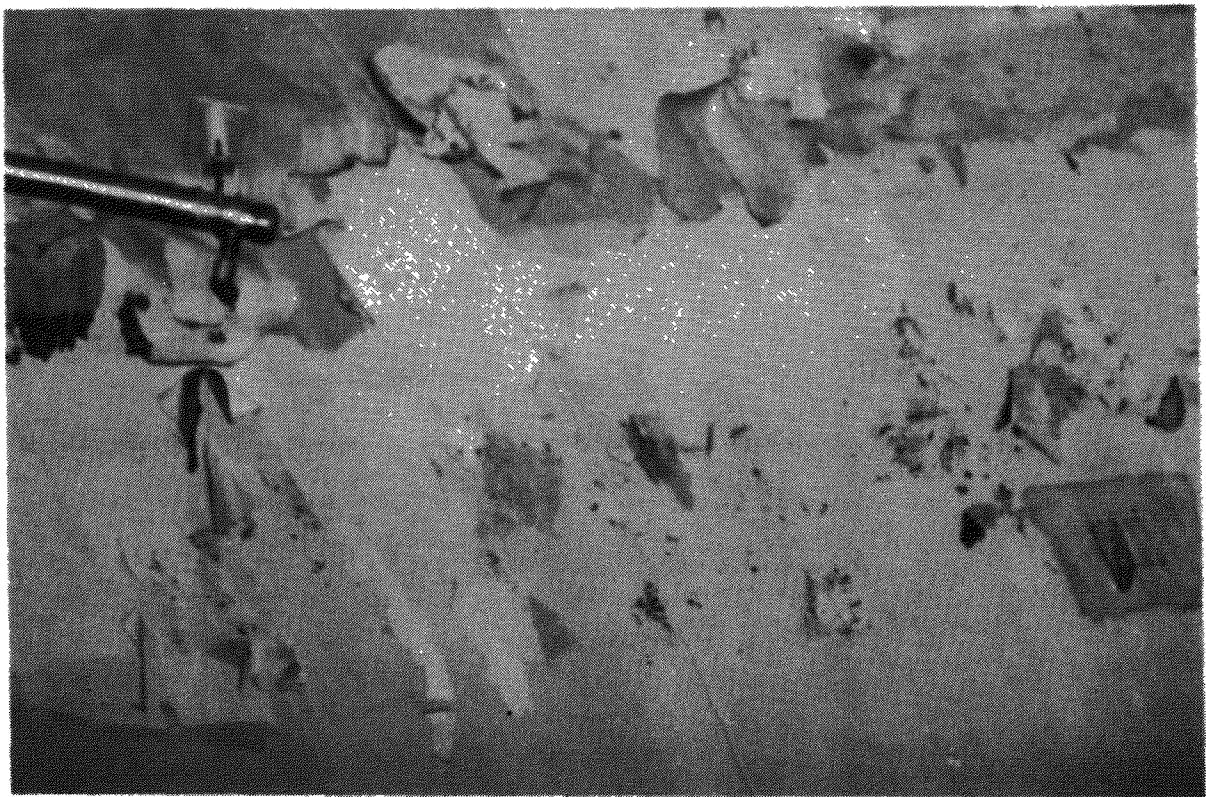
Figure 12. Stripped, charred, and blistered paint in the polar crane region.

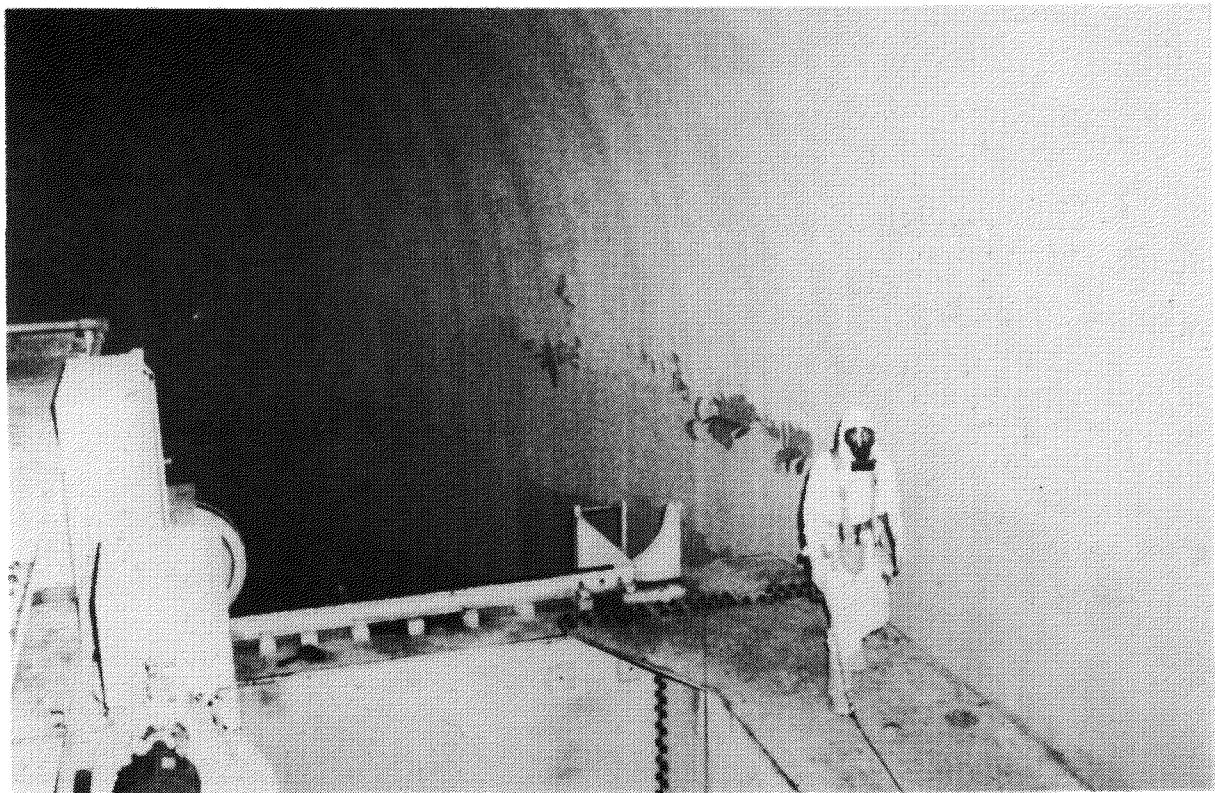
Figure 13. Peeling paint on containment wall (behind man) in polar crane region.

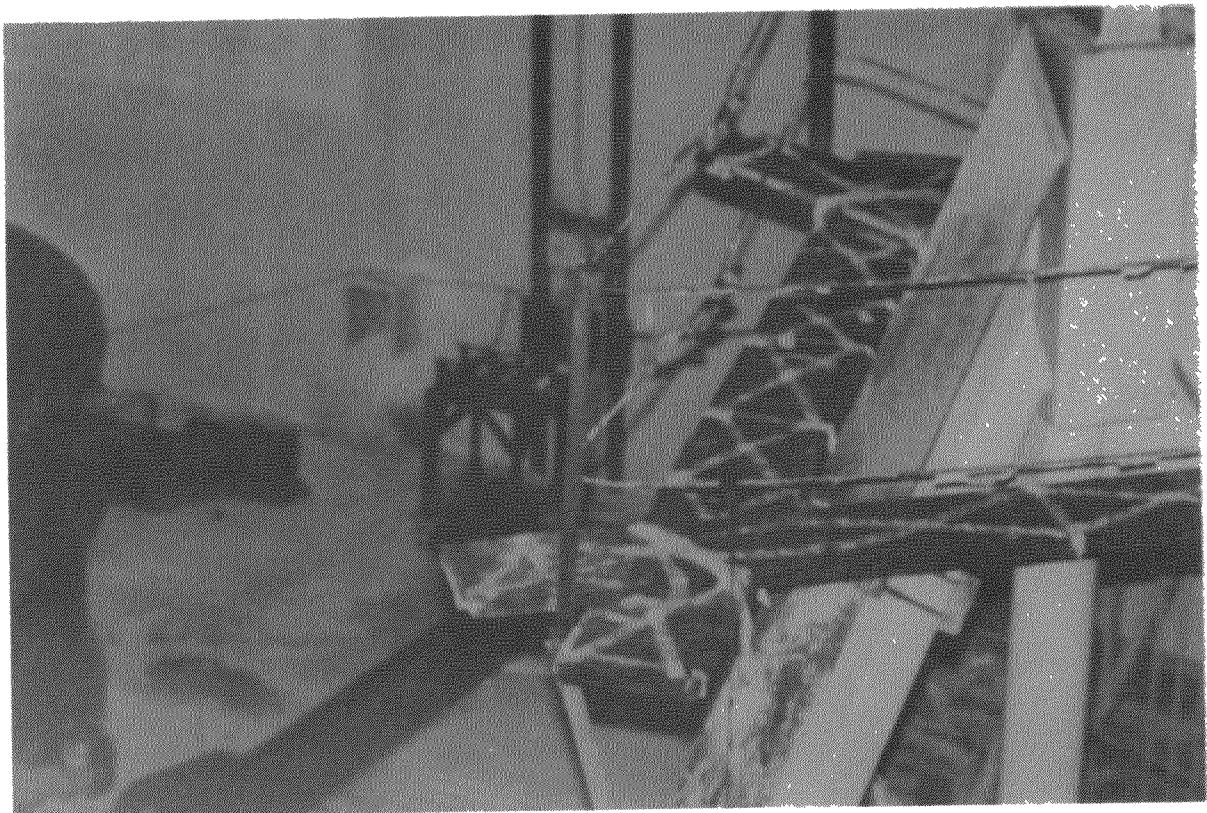
Figure 14. Top view of charred scaffolding with tape shields showing and polyethylene cover melted off. Note phone table in background: front surface of plywood backing against south wall is charred.

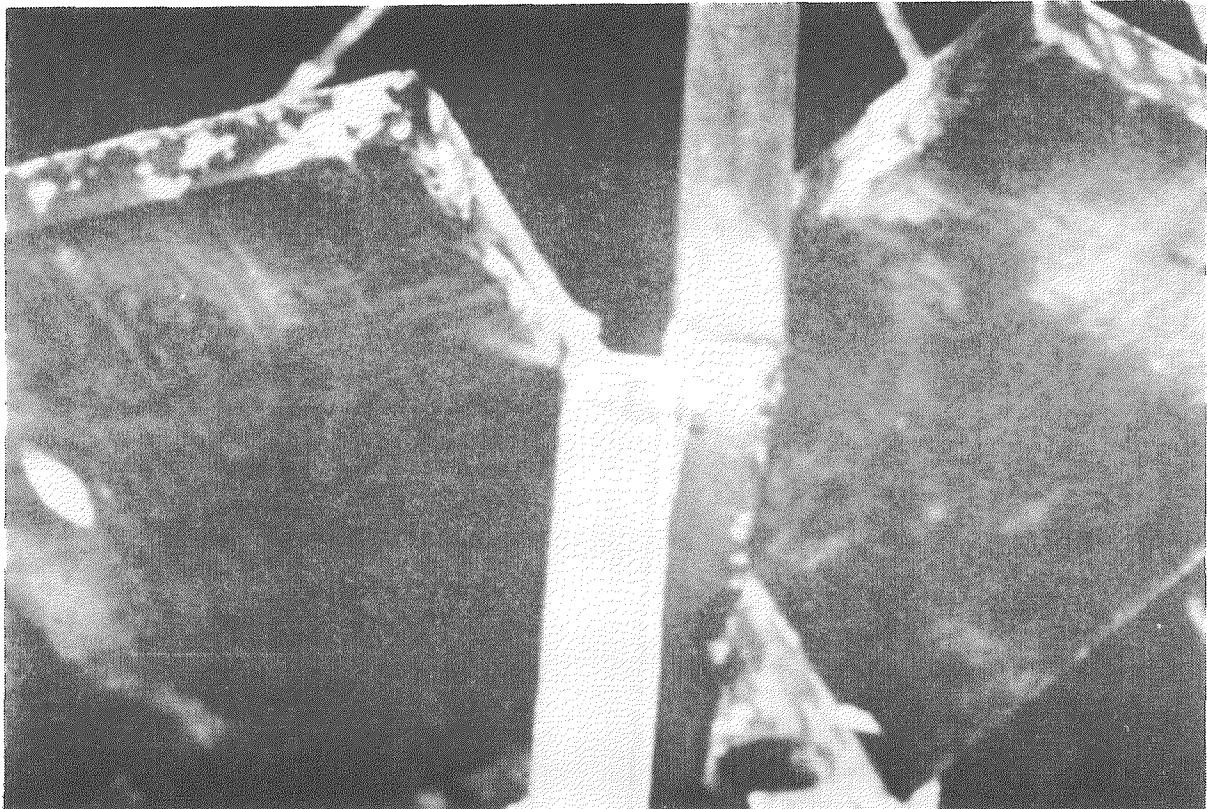
Figure 15. Bottom view of charred scaffolding showing tape shields, and with polyethylene cover melted off.

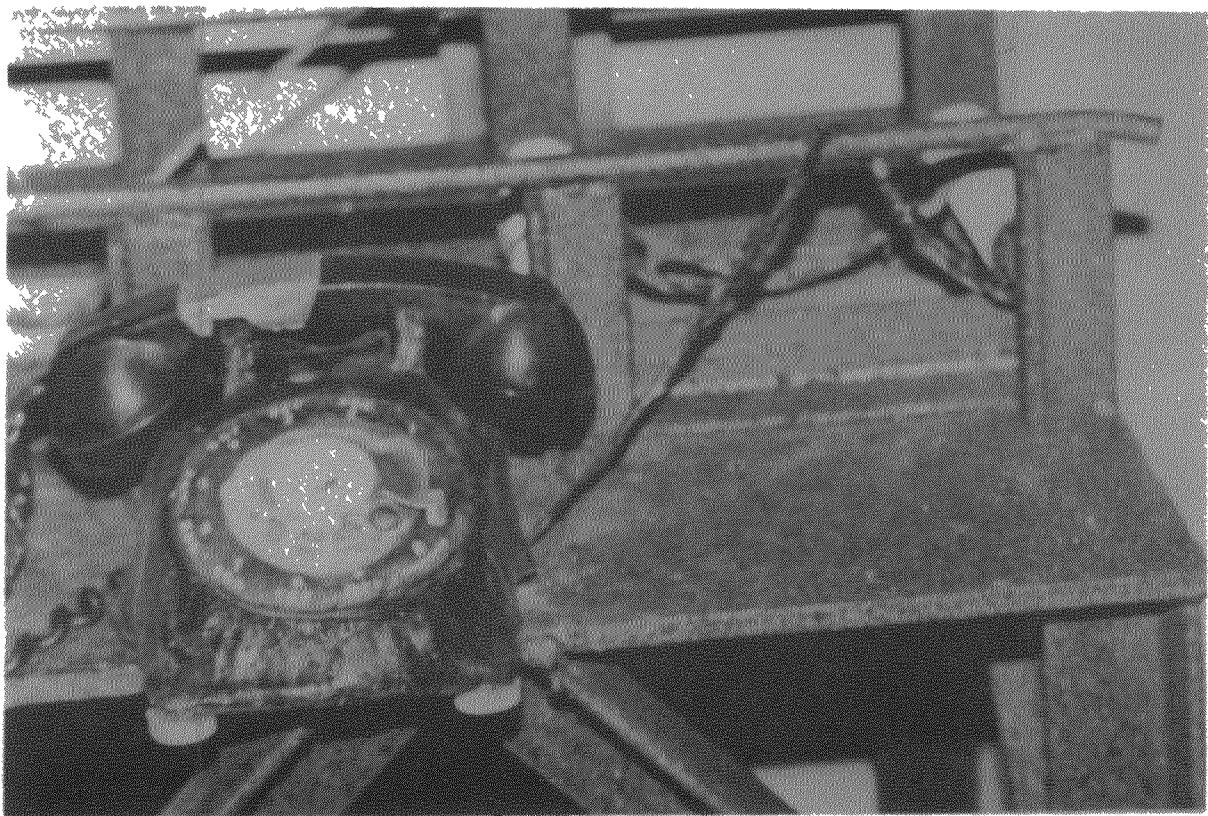
Figure 16. Melted telephone with charred cord along the south wall of the 347-foot elevation.

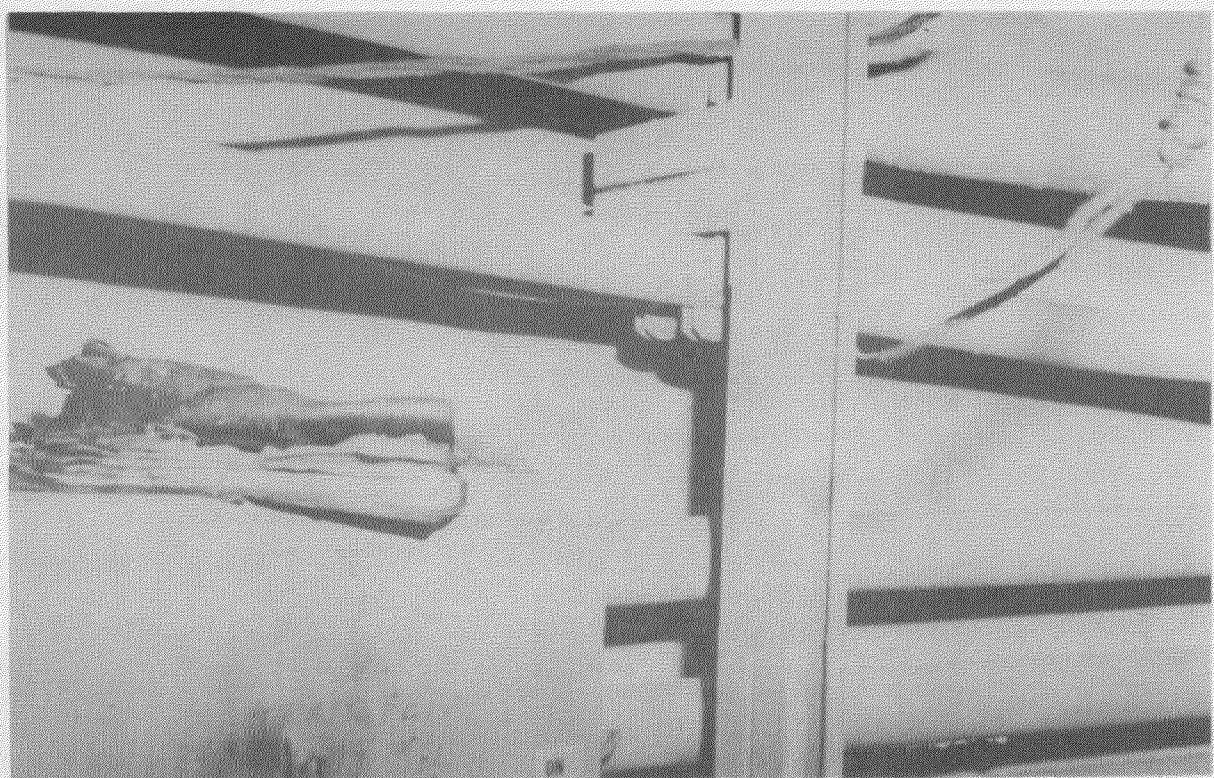
Uniform thermal damage to a plywood box next to the northeast arc of the east D-ring and melted polymers on the east side of the reactor building contrast sharply with lack of thermal damage to the extension of the open stairwell "chicken wire" support, a wood 2 x 4 inch frame which restricts access to the top of the west D-ring. Similarly, the partially burned manual on the north containment wall (Figure 17) appears to be the

Figure 17. Charred manual along north containment wall on 347-foot elevation.

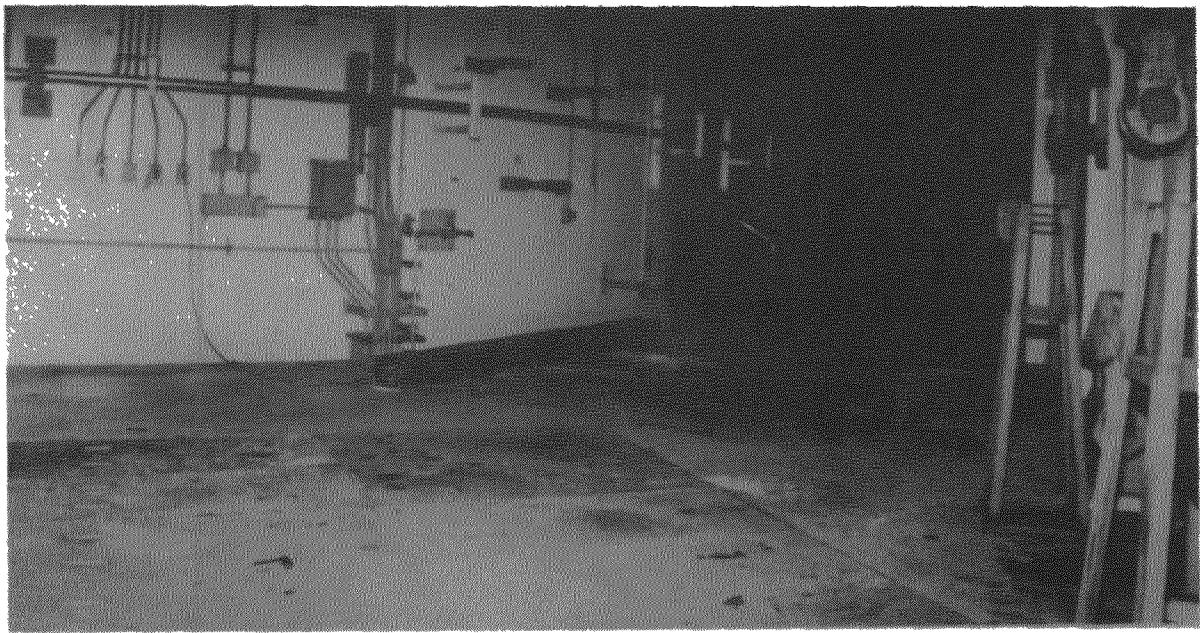
Figure 18. Uniformly charred plywood box against D-ring wall in the southeast area of the 347-foot elevation.

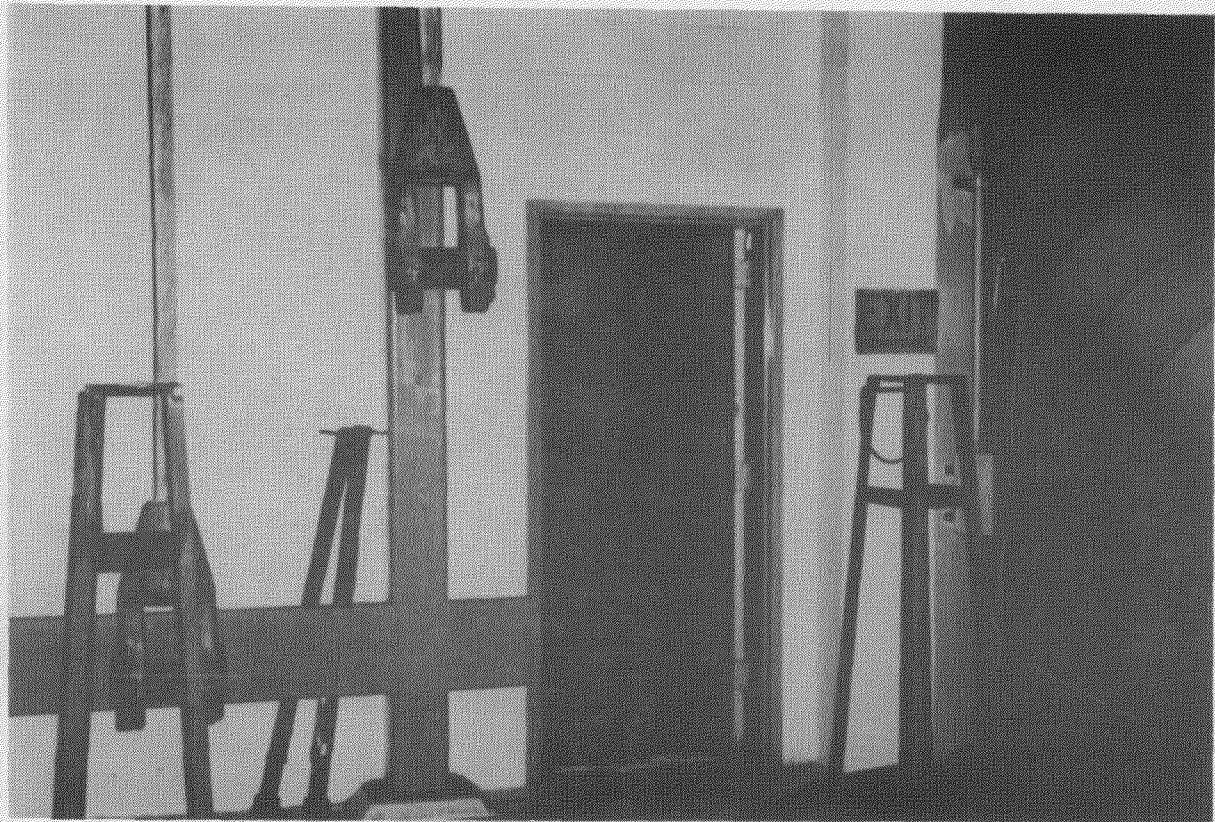
Figure 19. Discolored exit sign, burned in right top corner; located in the southeast area of the 347-foot elevation.

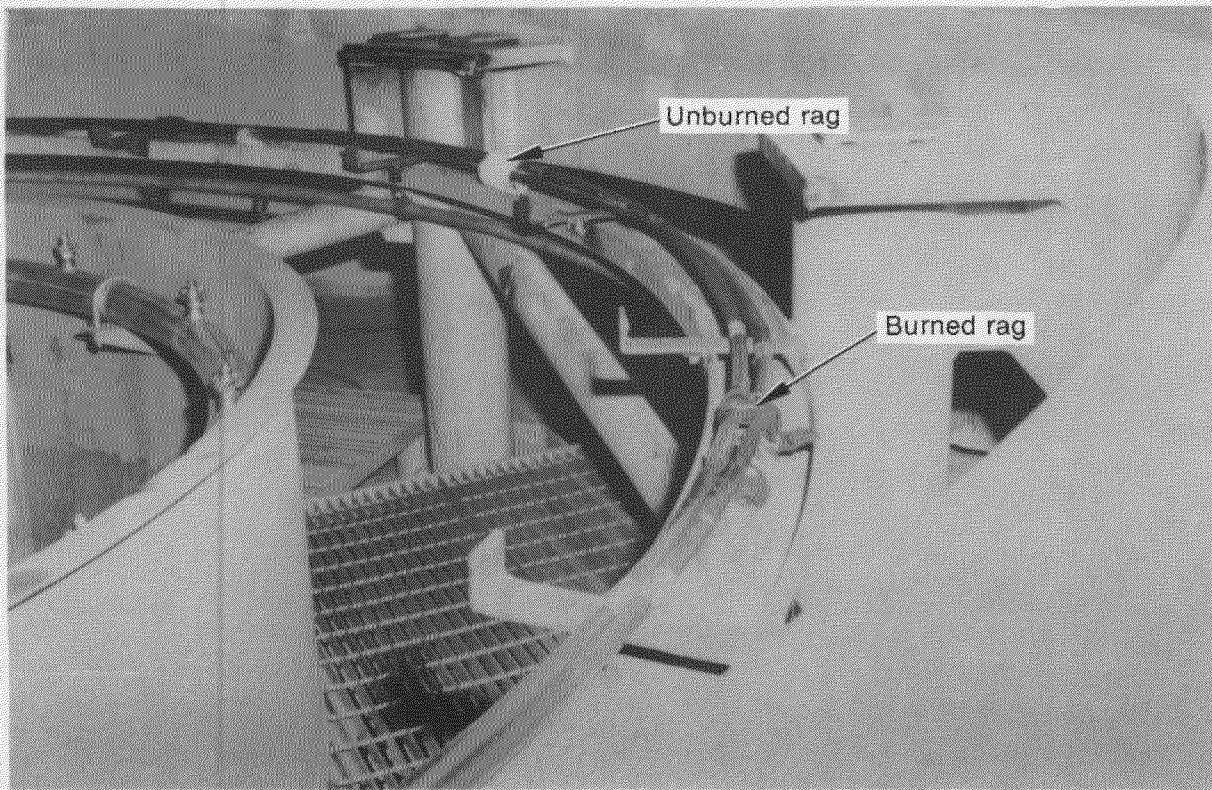
Figure 20. Random fabric char inside the head storage stand on the 347-foot elevation.

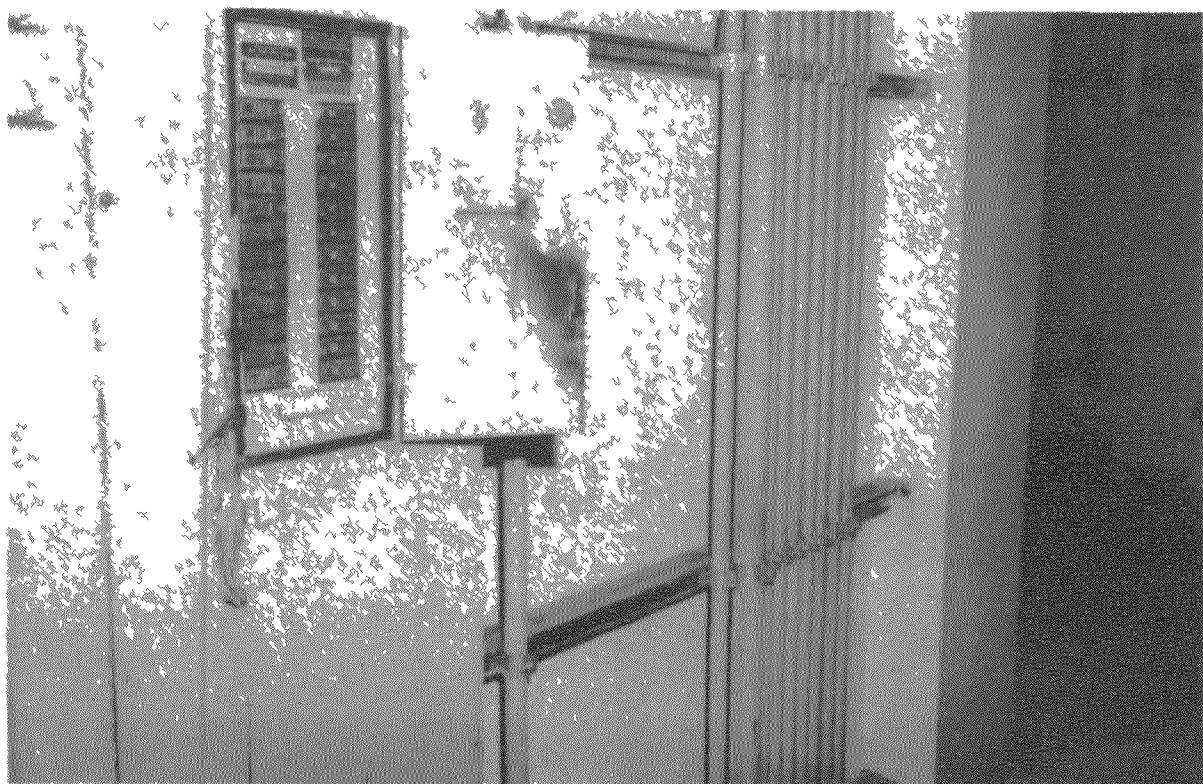
Figure 22. Charring and melted door seal material on electrical panel in southeast area of the 347-foot elevation.

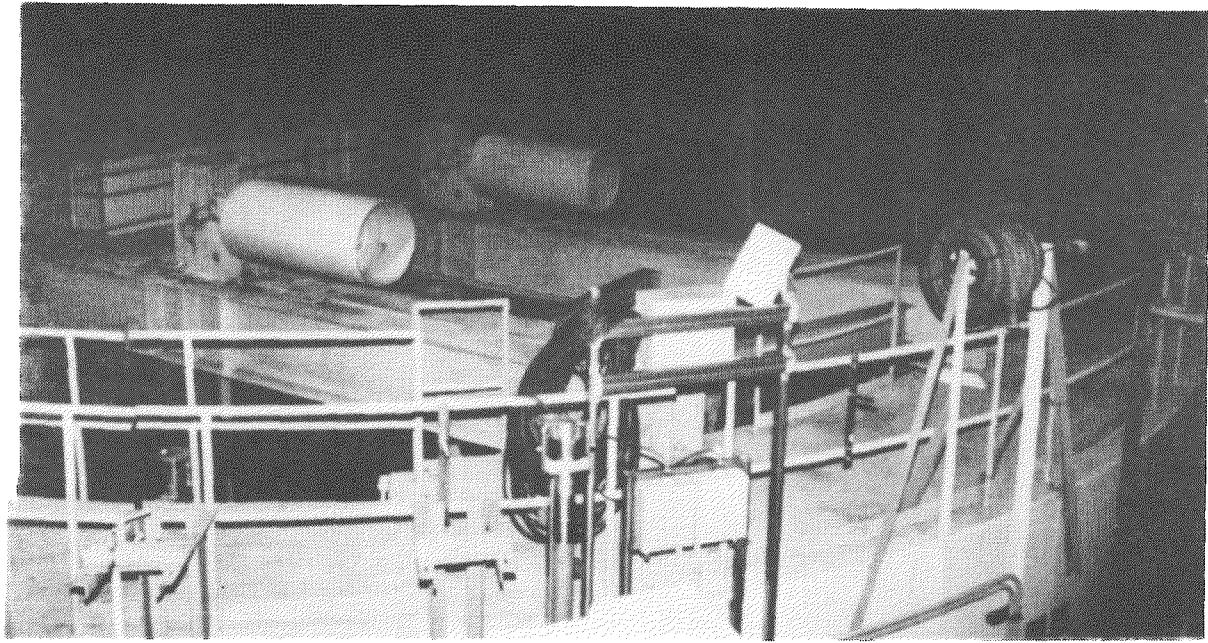
Figure 23. Charred paper in metal box in the east D-ring on the 347-foot elevation.

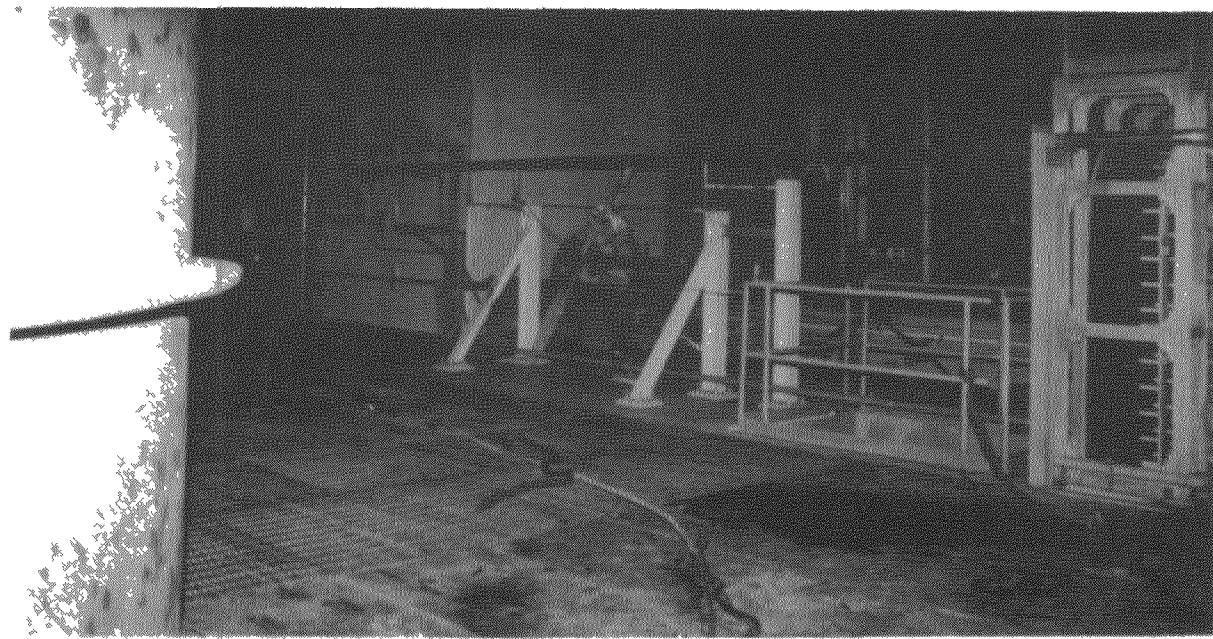
Figure 24. View towards the refueling canal on 347-foot elevation showing fallen bus bar from polar crane and charred electrical insulation.

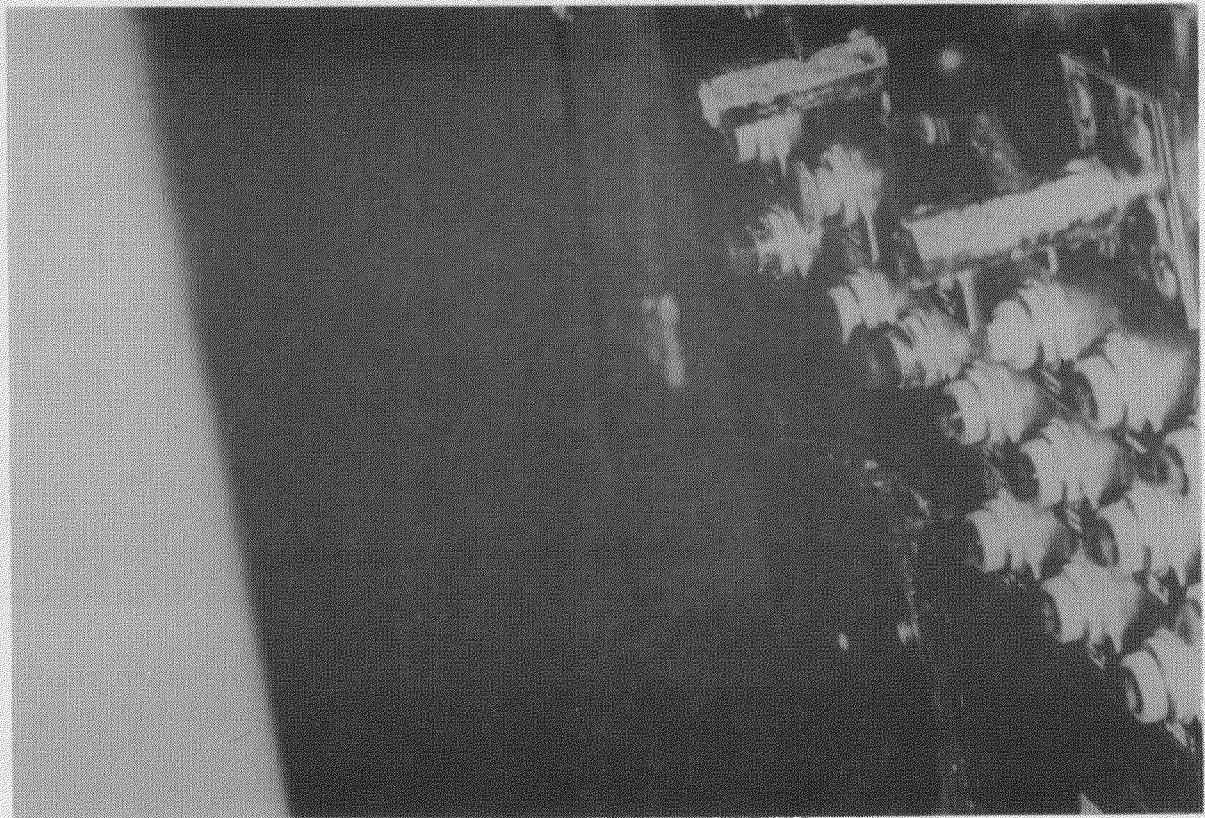
Figure 25. Burned and melted buttons on the auxiliary fuel handling bridge on the 347-foot elevation.

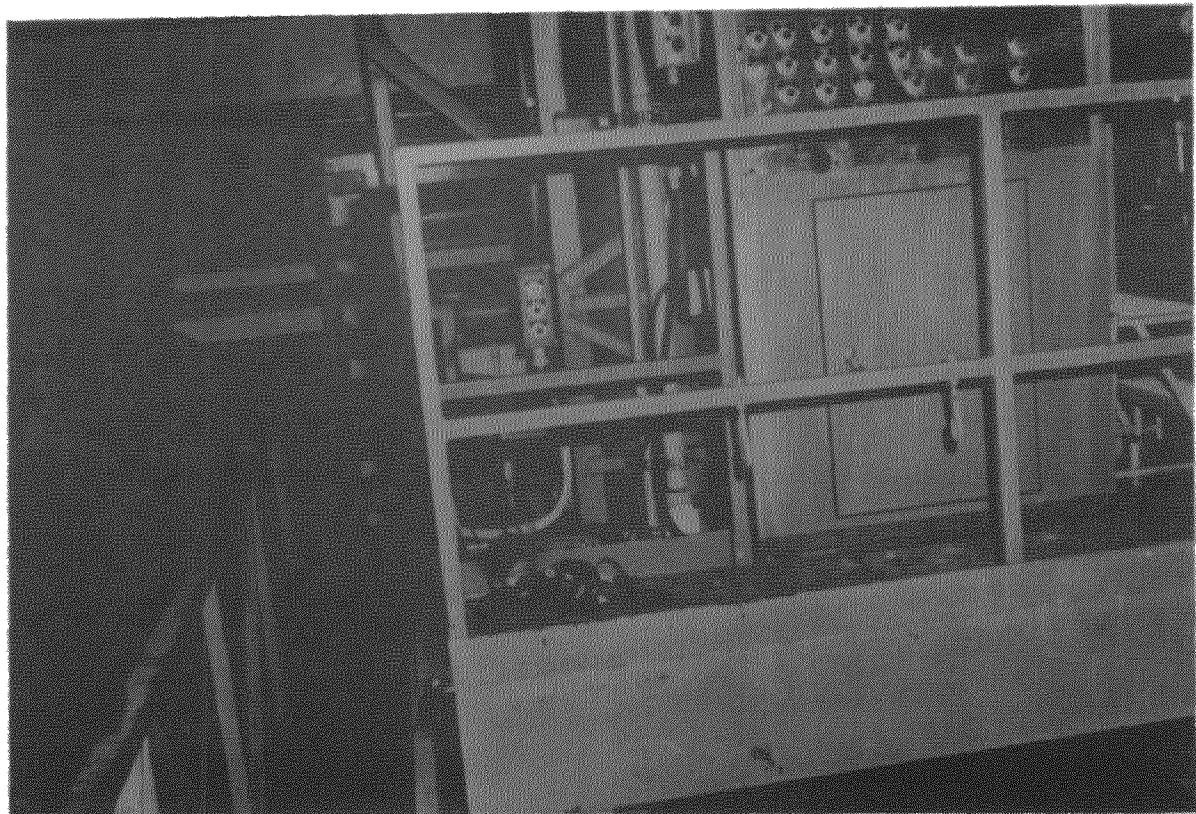
Figure 26. Burned manual and melted earphones on the auxiliary fuel handling bridge on the 347-foot elevation; just below view in Figure 25.
