GEND-INF-023

**INVESTIGATION OF HYDROGEN-BURN DAMAGE IN  
THE THREE MILE ISLAND UNIT 2 REACTOR BUILDING**

N. J. Alvares and D. G. Beason  
Lawrence Livermore National Laboratory  
and  
G. R. Eidam  
EG&G Idaho, Inc.

Published June 1982

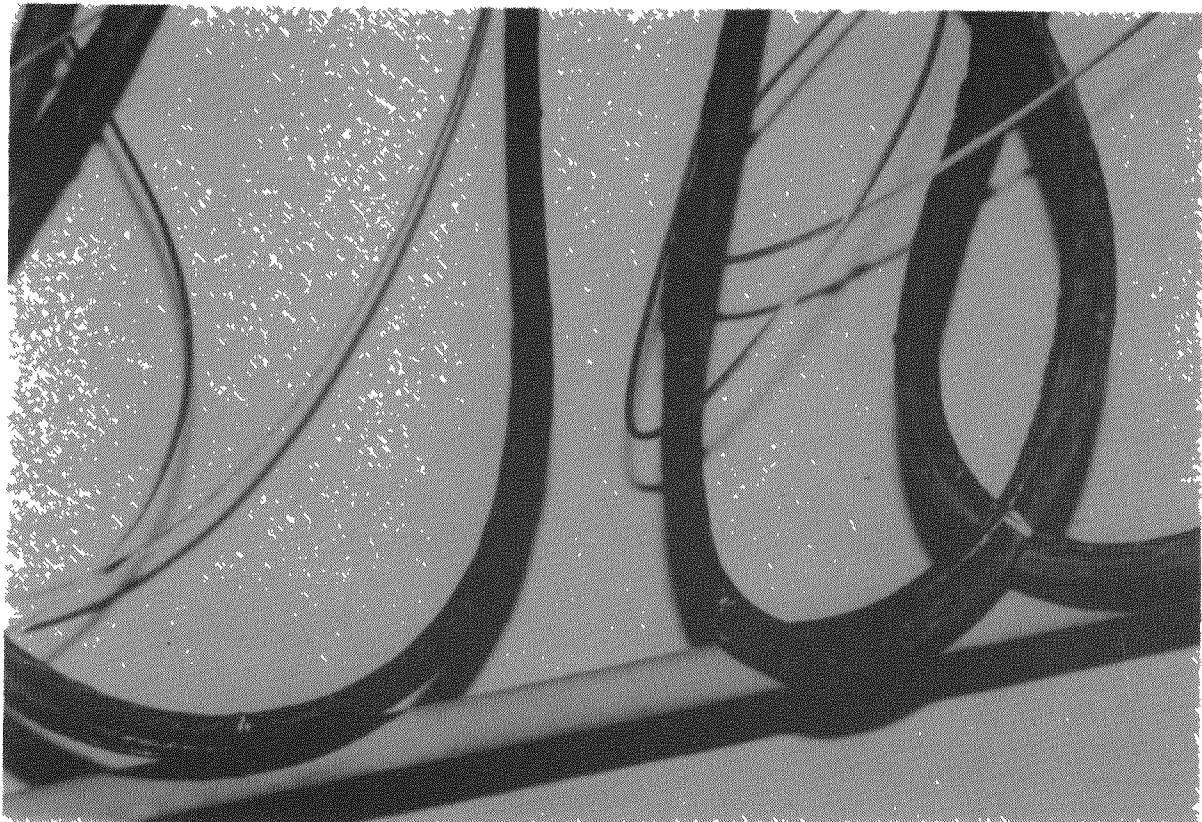
Figure 27. Electrical festoon for fuel handling bridge, on the 347-foot elevation; charred on the exposed surface.

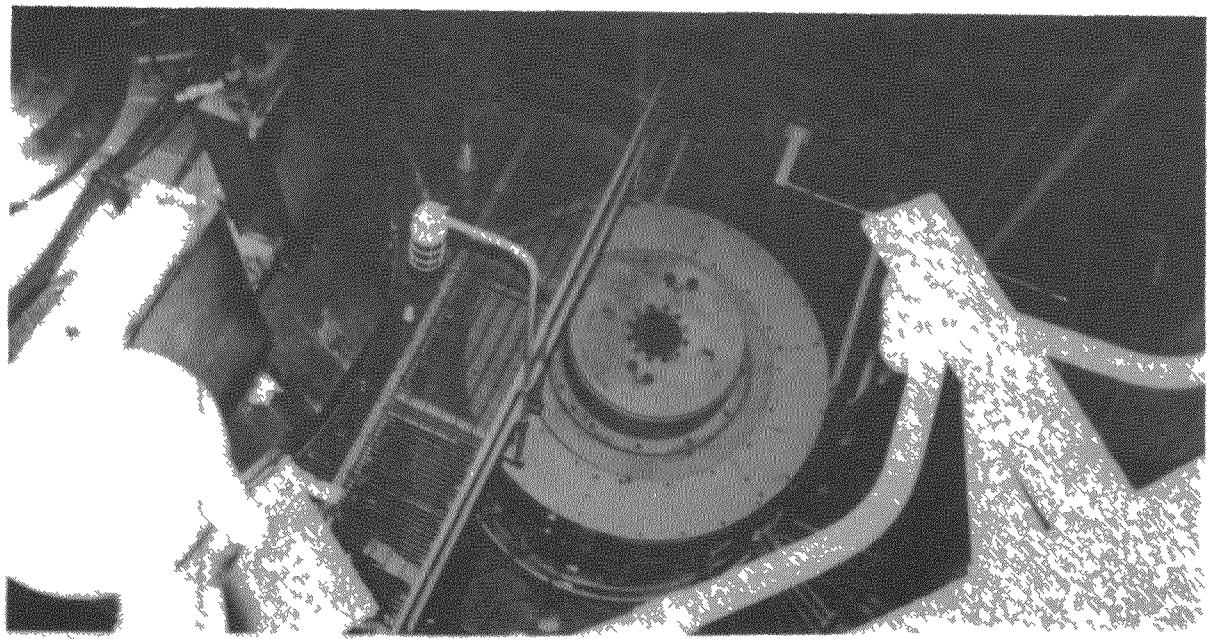
Figure 28. Darkened edge of junction box inside east side of west D-ring.

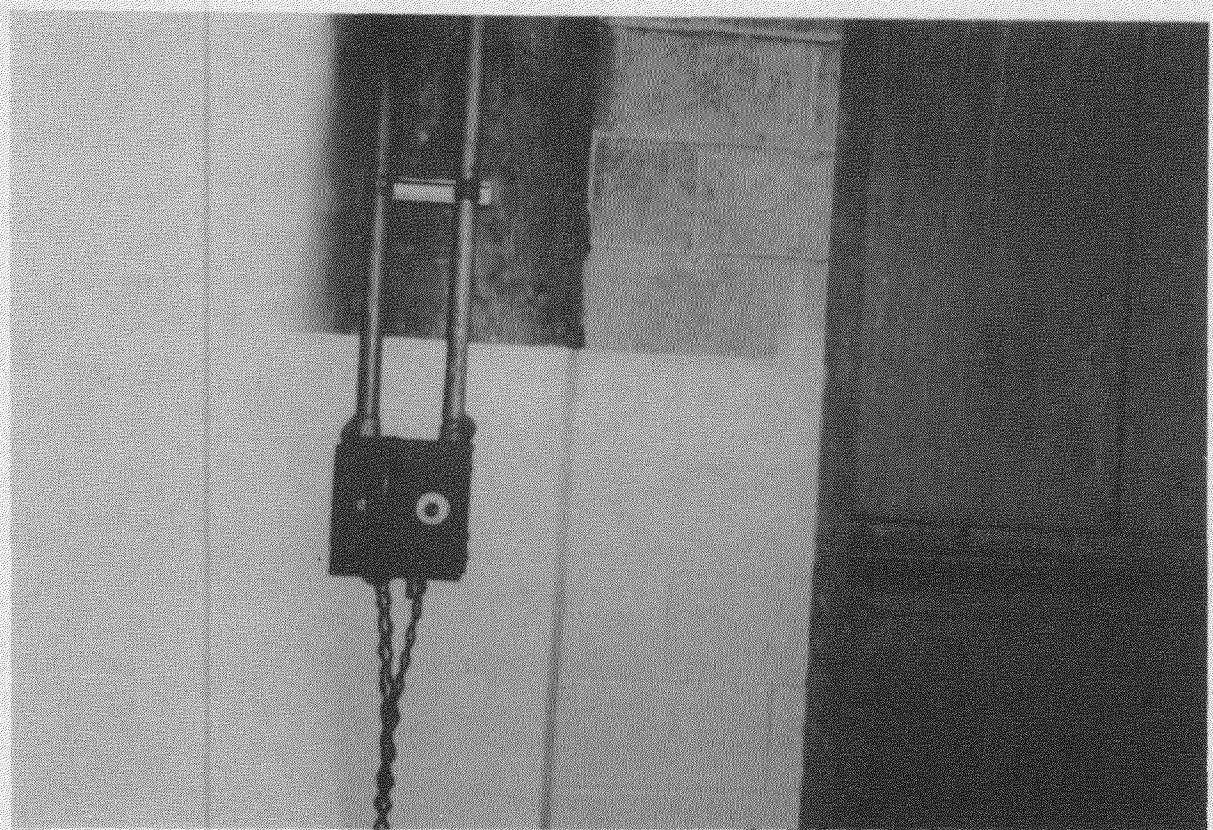
Figure 29 shows one of the only indications of possible thermal damage on the 305-foot elevation level. Here the telephone cord relaxed and may exhibit some charring on the front surface. The control buttons for the

elevator were also thermally deformed. However, a wooden stepladder to the left of this telephone had no thermal damage. Figure 30 shows undamaged shoring wood located in the northwest area of the 305-foot elevation.

Figure 29. Thermally relaxed telephone cord on 305-foot elevation.

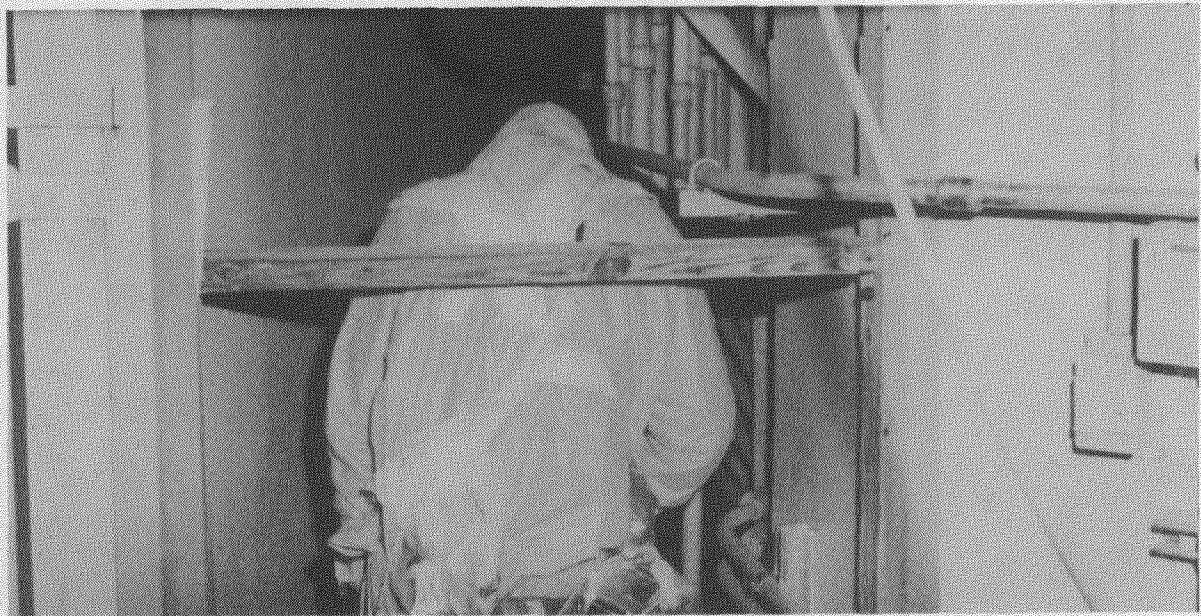
Figure 30. Undamaged wood shoring on 305-foot elevation.
