September 1985

# **TMI-2 REACTOR VESSEL HEAD REMOVAL**

This report describes the safe removal and storage of the Three Mile Island Unit 2 (TMI-2) reactor vessel head. The head was removed in July 1984 to permit the removal of the plenum and the reactor core, which were damaged during the 1979 accident. From July 1982, plans and preparations were made using a standard head removal procedure modified by the necessary precautions and changes to account for conditions caused by the accident. After data acquisition, equipment and structure modifications, and training, the head was safely removed and stored; and the internals indexing fixture and a work platform were installed on top of the vessel. Dose rates during and after the operation were lower than expected; lessons were learned from the operation which will be applied to the continuing fuel removal operations activities.

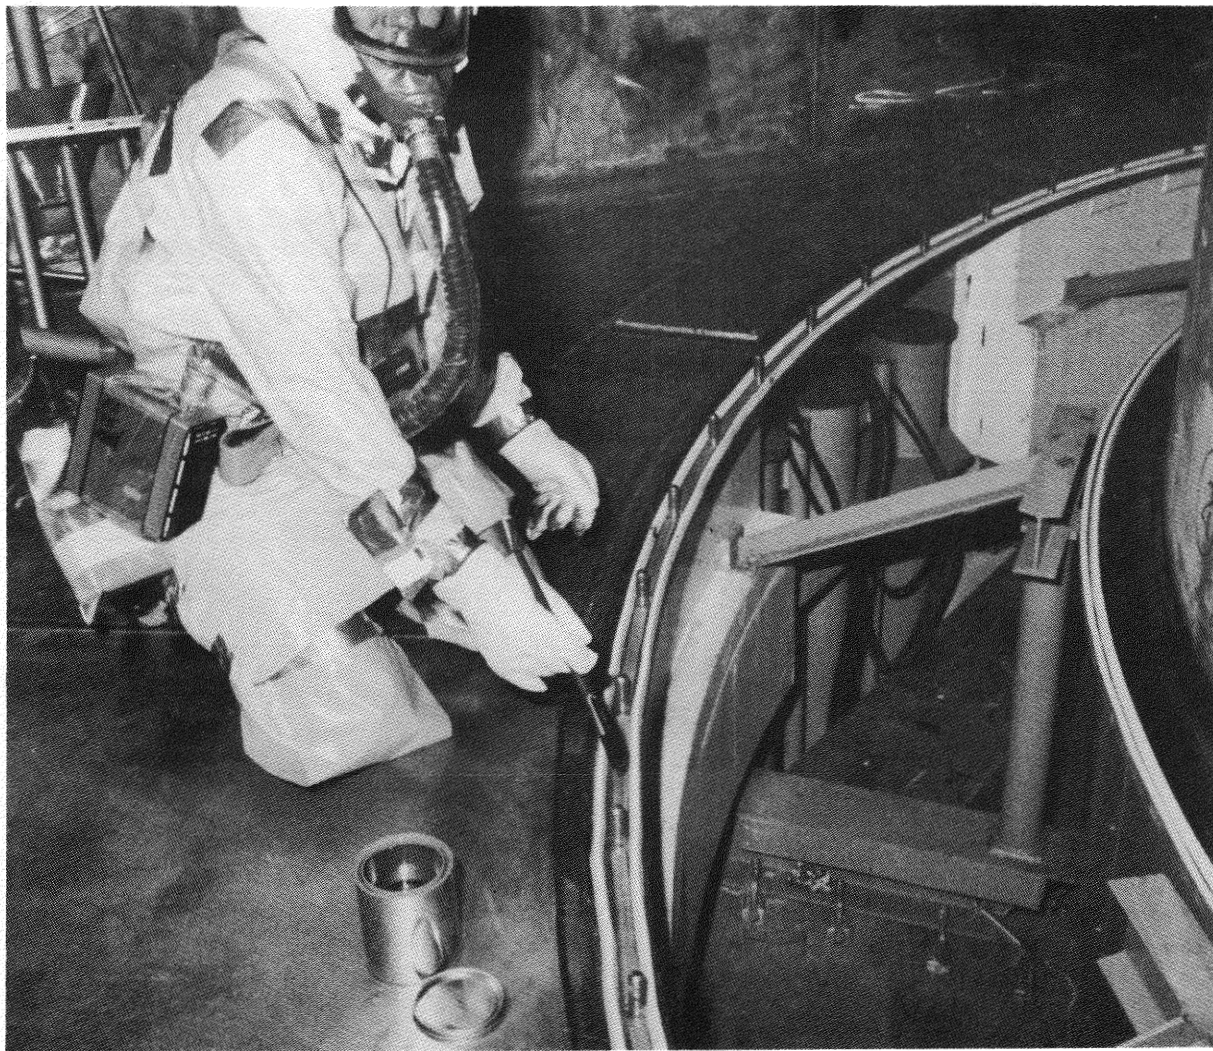
Figure 10. Canal seal plate cleaning and gasket installation.

Mockups and training sessions were conducted to prove methods for installing the gaskets (Figure 10), injecting the sealant into the small (less than 3 mm) cracks (Figure 11), and pouring the sealant into the barrier angles. Tests were conducted on the sealant primer using cure times varying from one hour up to four days. The best adhesion occurred when the primer was at least two days old. This information allowed the schedule of work activities to fit normal entry schedules without any impact on the quality of the seal.

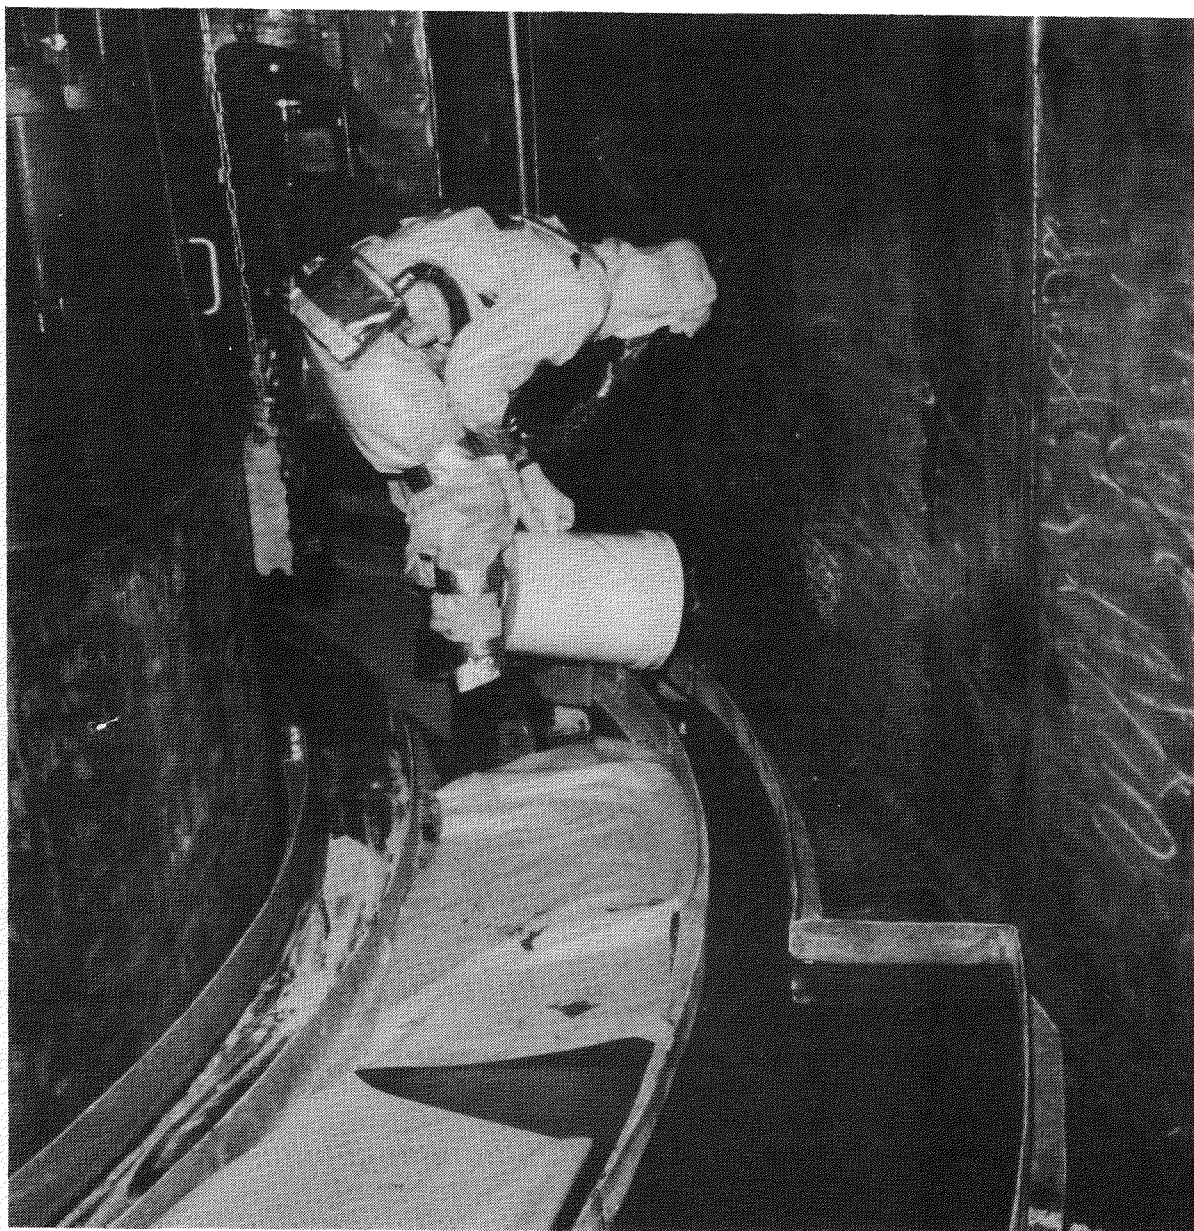
Figure 11. Canal seal plate—pouring sealant in barrier angles.

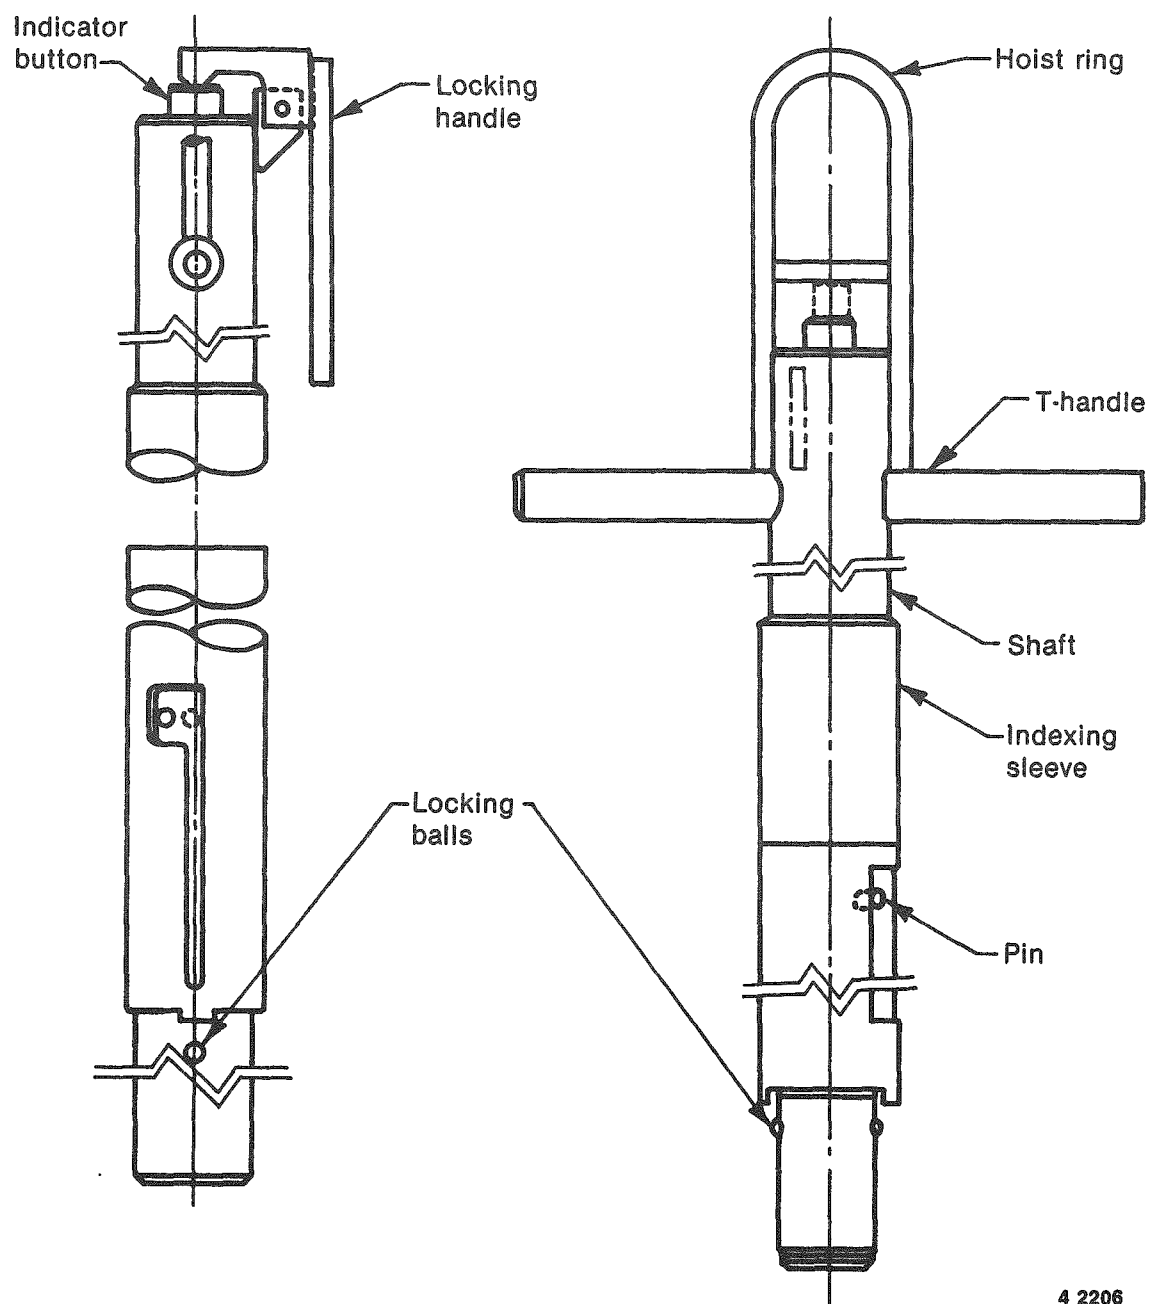
One of the lead screws, while being lifted with the lifting tool, became bound 1/2 m short of the parked position and disengaged from the tool when the binding occurred. However, the binding prevented it from dropping back to the inserted position, so the lifting tool was re-engaged. Visual inspections prior to re-engagement verified no apparent damage to the tool or lead screw. After reattaching the lifting tool, the lead screw was parked in the normal manner.

Figure 13. Lead screw lifting tool.

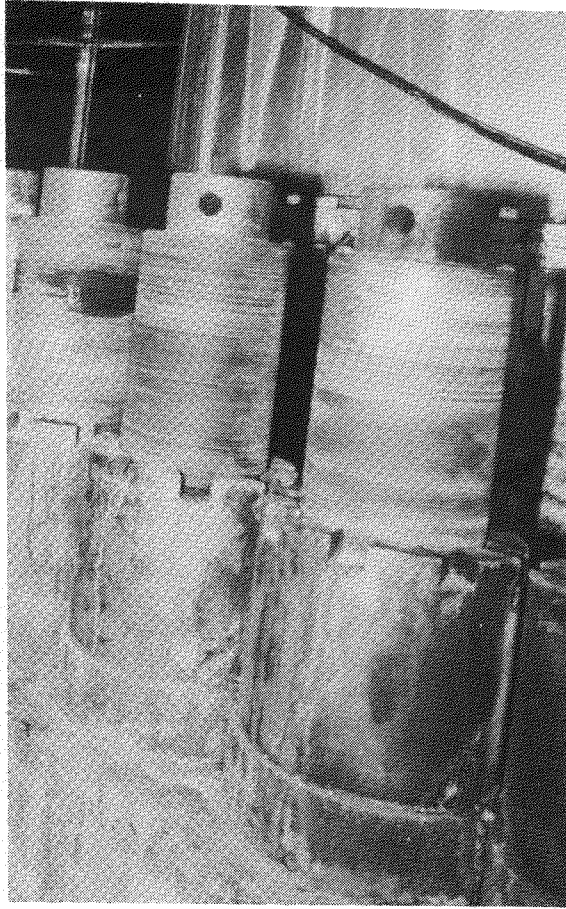
Figure 16. Reactor vessel studs before cleaning.
