NUREG-1154

Loss of Main and Auxiliary Feedwater Event at the Davis-Besse Plant on June 9, 1985

U.S. Nuclear Regulatory Commission

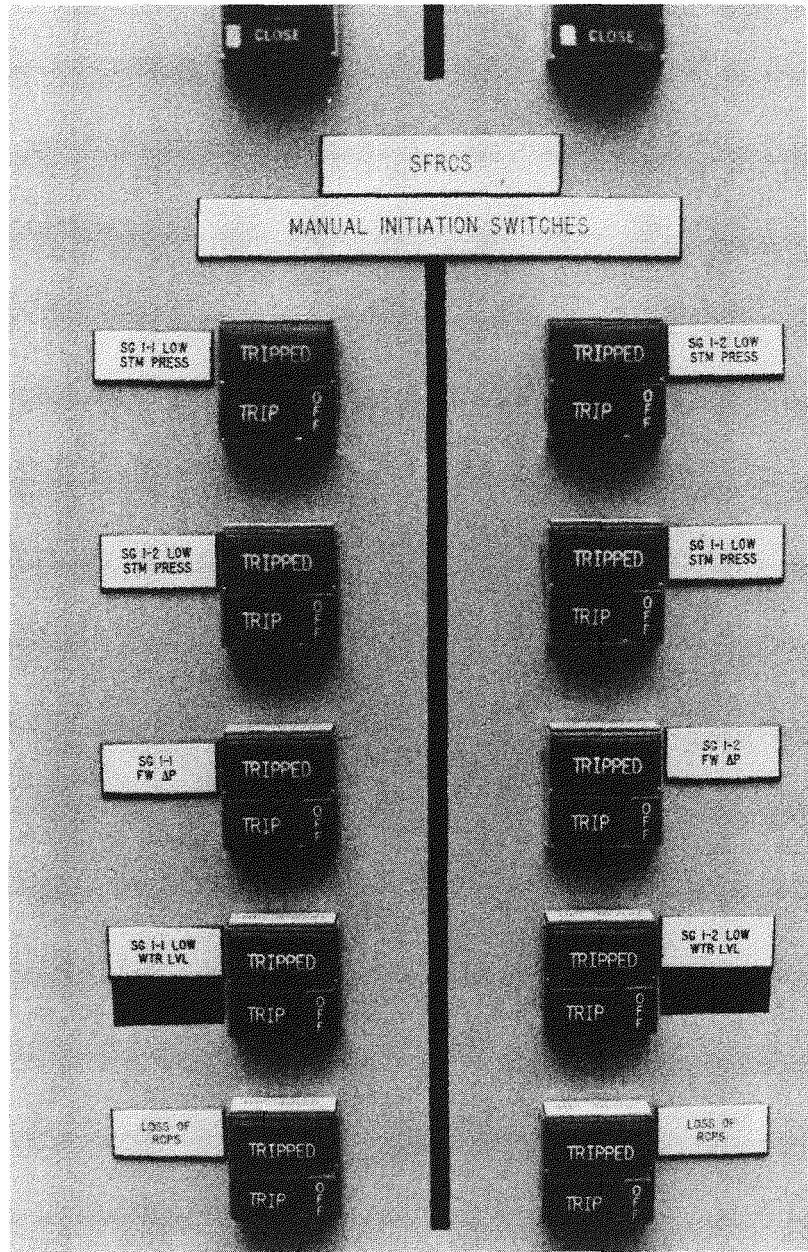
Figure 3.6 Manual Initiation Switches for SFRCS

He went to the manual initiation switches at the back panel and pushed two buttons to trip the SFRCS. (The SFRCS control panel is shown in Figure 3.6.) He inadvertently pushed the wrong two buttons and, as a result, both steam generators were isolated from the emergency feedwater supply. He had activated the SFRCS on low pressure (the top pair of buttons in Figure 3.6) for each steam generator instead of on low level (the fourth pair of buttons from the top). By manually actuating the SFRCS on low pressure, the SFRCS was signalled that both generators had experienced a steamline break or leak and the system responded, as designed, to isolate both steam generators. The operator's anticipatory action defeated the safety function of the auxiliary feedwater system--a common-mode failure and the third abnormality to occur within 6 minutes after the reactor trip.

The operator returned to the auxiliary feedwater station expecting the AFWS to actuate and provide the much-needed feedwater to the steam generators that were boiling dry. Instead, he first saw the No. 1 AFW pump, followed by the No. 2 AFW pump trip on overspeed--a second common-mode failure of the auxiliary feedwater system and abnormalities four and five. He returned to the SFRCS panel to find that he had pushed the wrong two buttons.

The shift supervisor quickly determined that the valves in the AFWS were improperly aligned. He reset the SFRCS, tripped it on low level, and corrected the operator's error about one minute after it occurred. This action commanded the SFRCS to realign itself such that each AFW pump delivered flow to its associated steam generator. Thus, had both systems (the AFWS and SFRCS) operated properly, the operator's mistake would have had no significant consequences on plant safety.

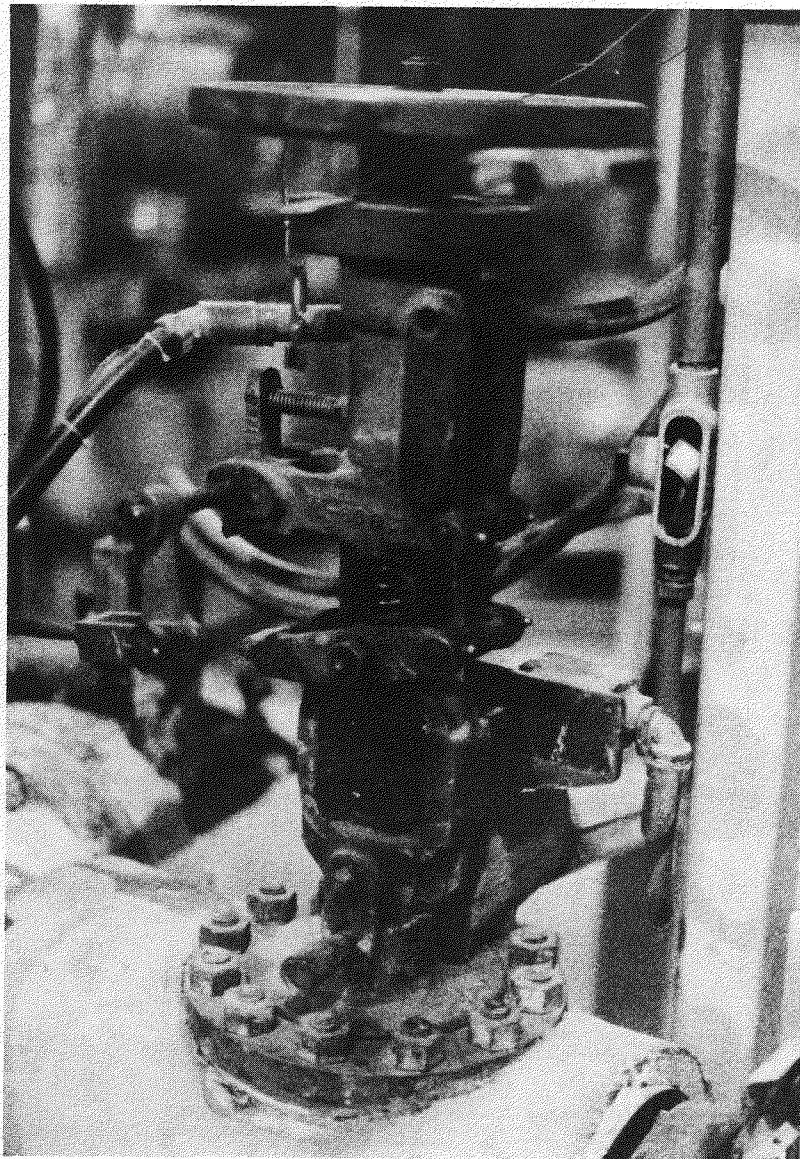
Figure 3.8 Trip Throttle Valve

The operators descended the steep stairs resembling a ladder into the No. 2 AFW pump room. They recognized immediately that the trip throttle valve had tripped (see Figure 3.8). One operator started to remove the lock wire on the handwheel while the other operator opened the water-tight door to the No. 1 AFW pump. He also found the trip throttle valve tripped and began to remove the lock wire from the handwheel.
