PNL-SA-7529

X-RAY MONITORING OF 230-KV CABLE
POTHEADS FOR MAINTENANCE INSPECTIONS

Robert C. Lawrence
Pacific Northwest Laboratory
Richland, Washington

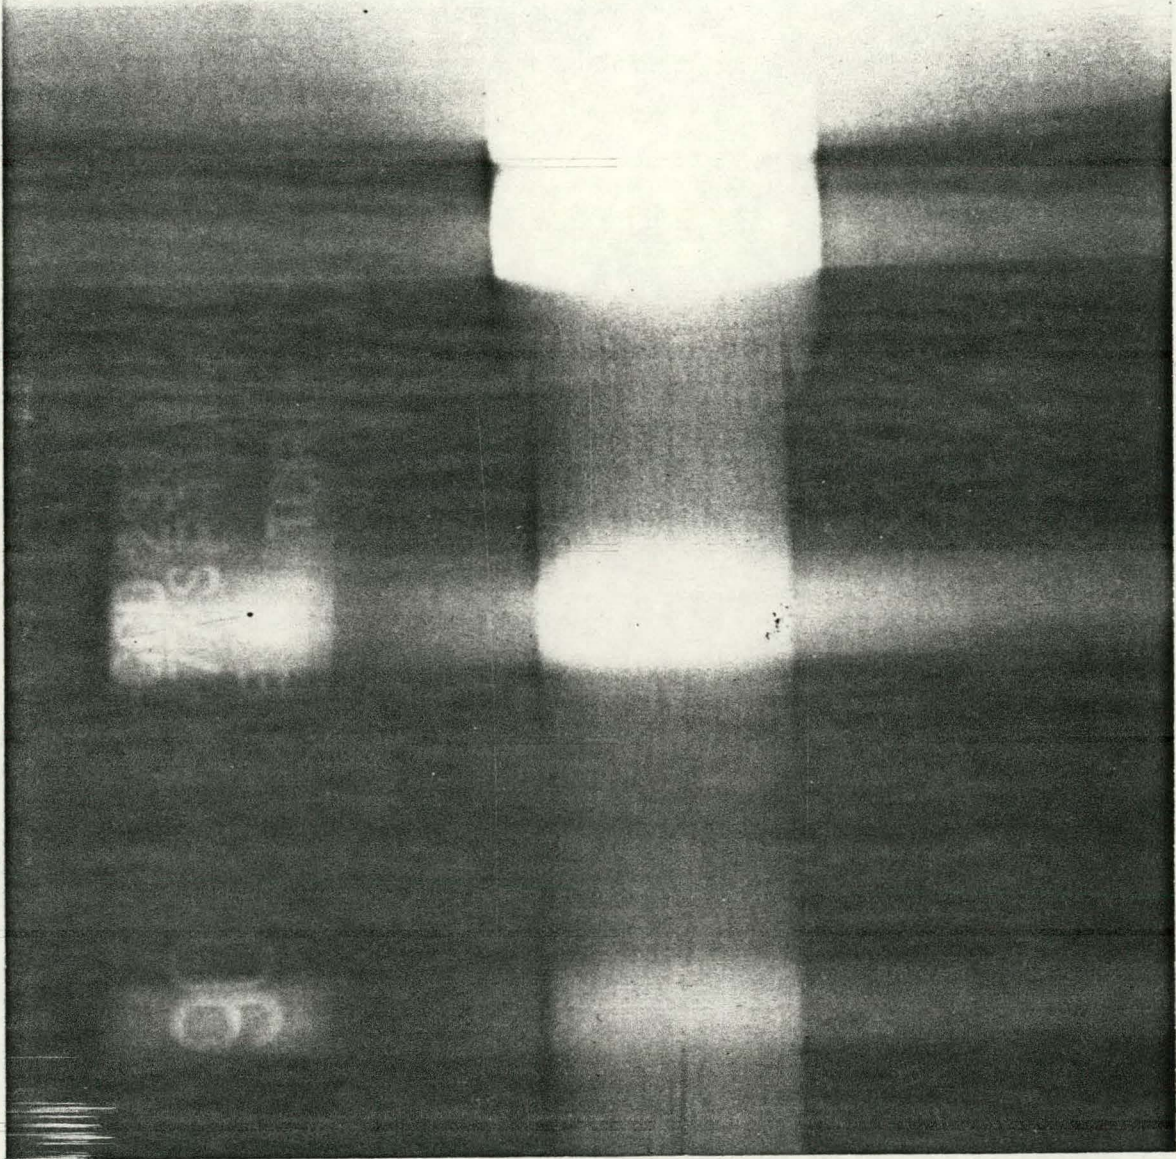
FIGURE 3. Radiograph

CABLE TERMINATION
INTO POTHEAD
CONNECTOR FOR
CONNECTION INTEGRITY

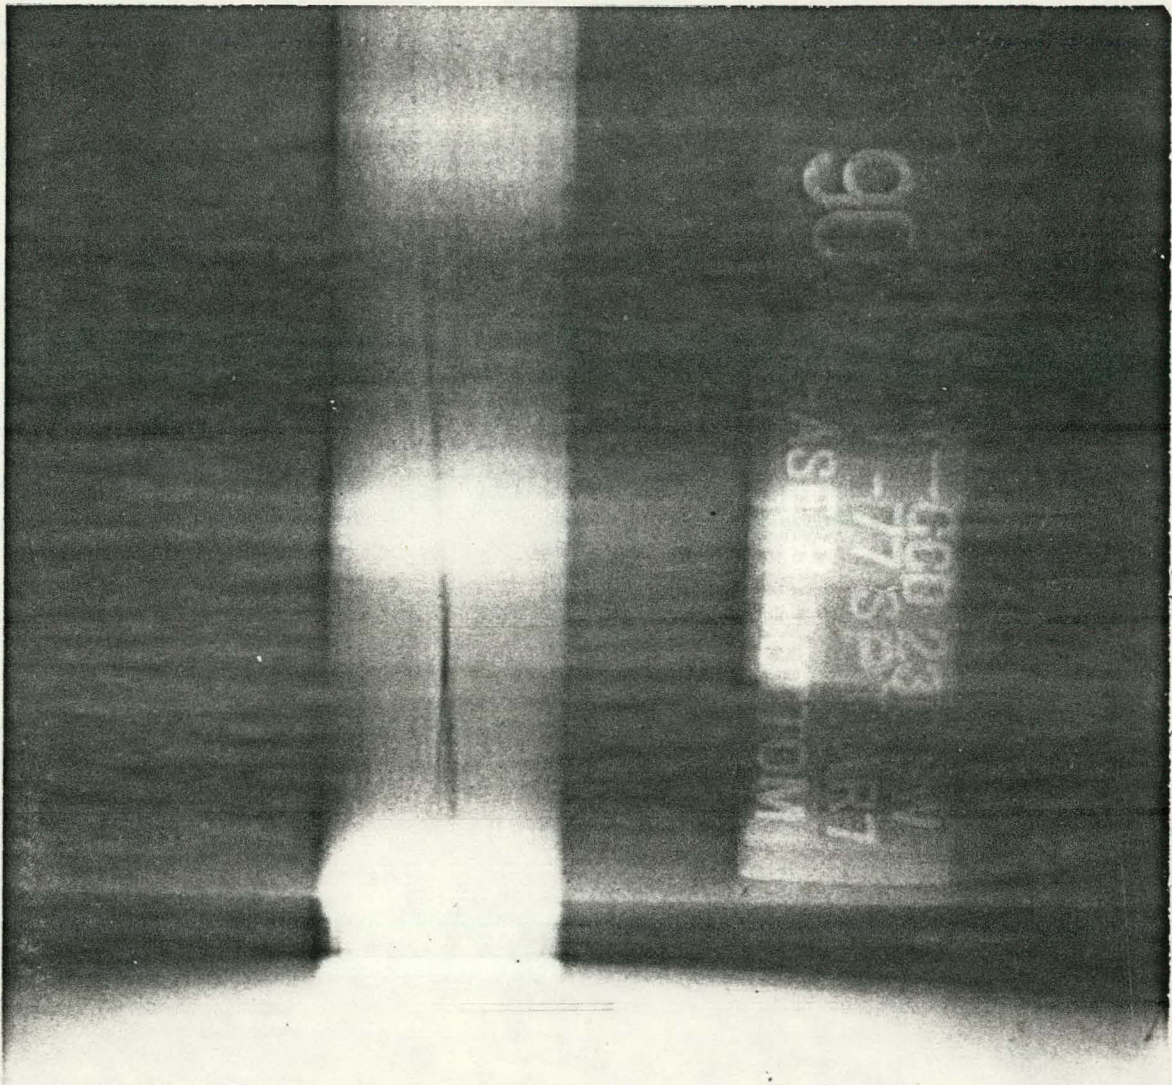
FIGURE 4. Radiograph

SWITCHYARD POTHEAD - "B" PHASE.
POSITION - PORCELAIN INSULATOR -
BOTTOM FLANGE
AXIS - 90°

EXPOSED FOR CABLE STRANDING "GAP"

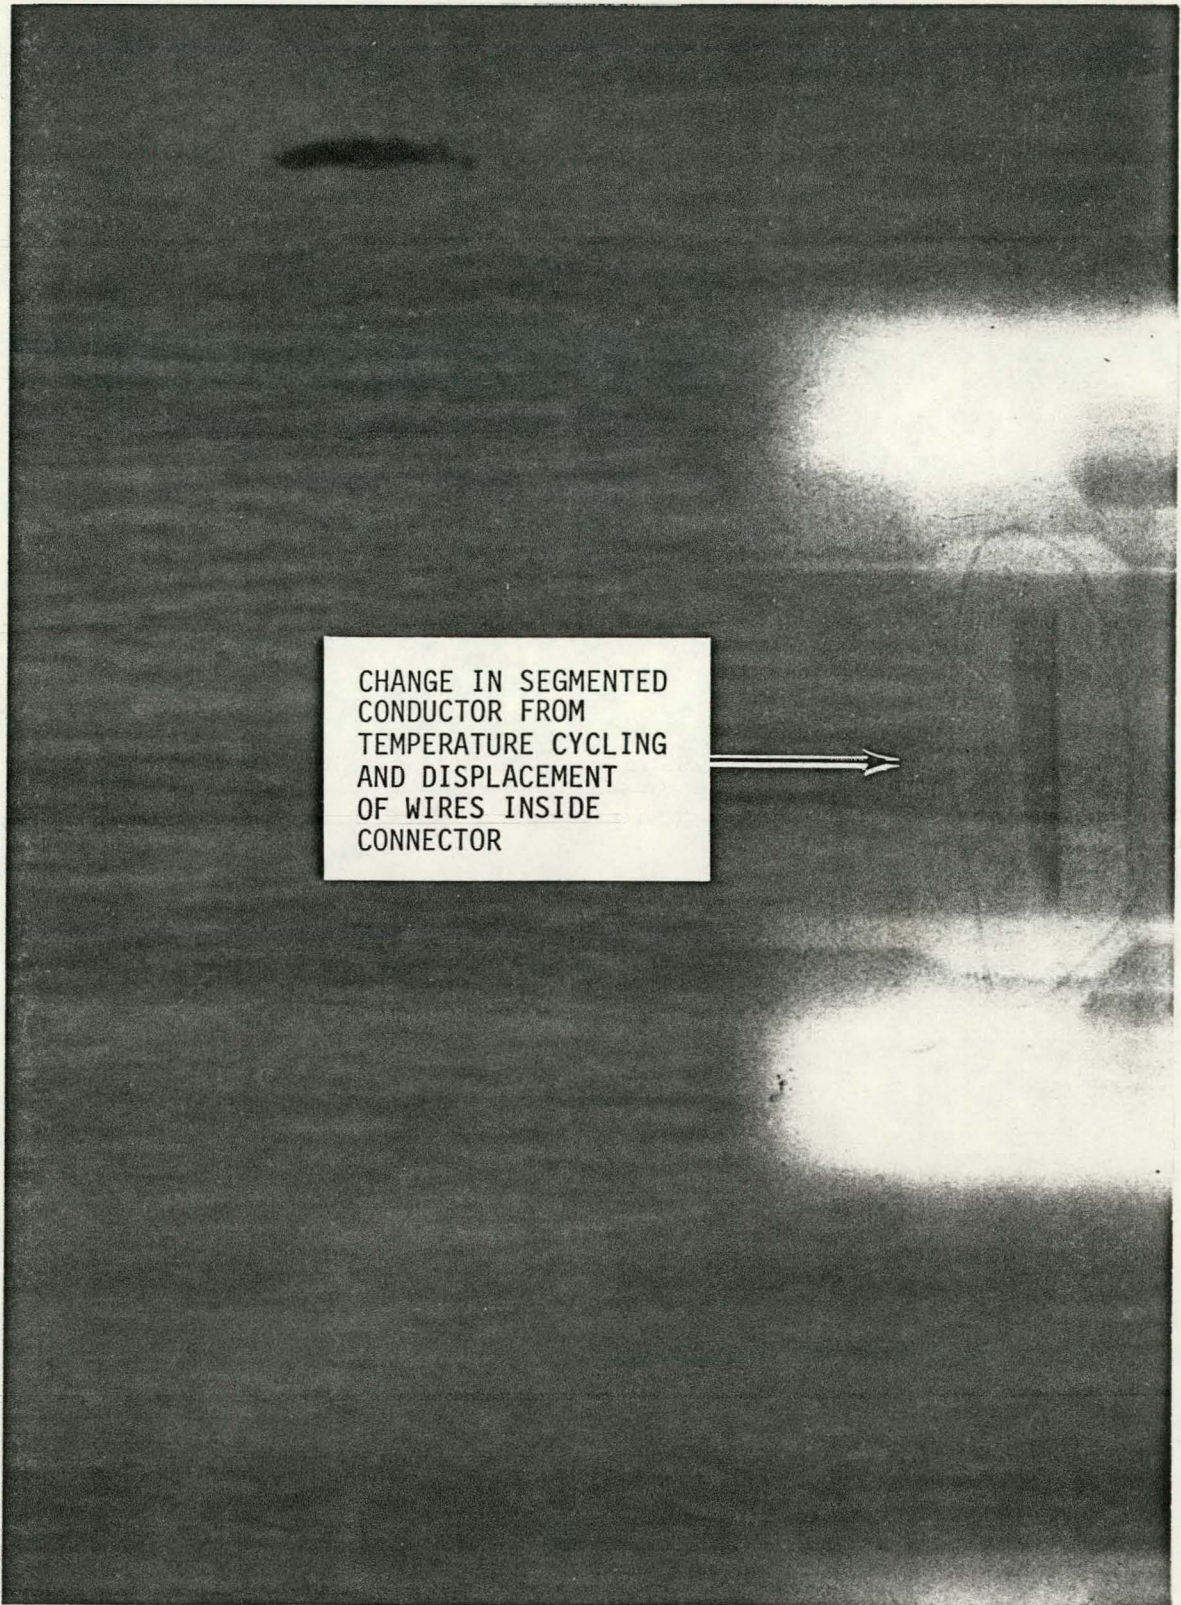
Preliminary radiographs were made to determine the best position at which to locate the radiation source. Figures 3 through 5 show some of the radiographs. This experimentation was needed to find optimum exposure times and the proper thicknesses of the lead filters to obtain the best film resolution for an accurate view of specific components inside the potheads. Exposing double film loads with films of different speeds in a single cassette provided radiographs with differing depths of field. This allows a single exposure to produce radiographs with their best definitions at different areas of interest. Figure 6 shows an example of a conductor in the crimped area of a 230 kV connector inside a pothead.

FIGURE 6. Conductor in Crimped Area of 230 kV Connector
