ZINC/BROMINE BATTERY EVALUATION AT SNL

SAND--89-1852C

S. L. Lott, P. C. Butler, J. M. Freese  
Sandia National Laboratories

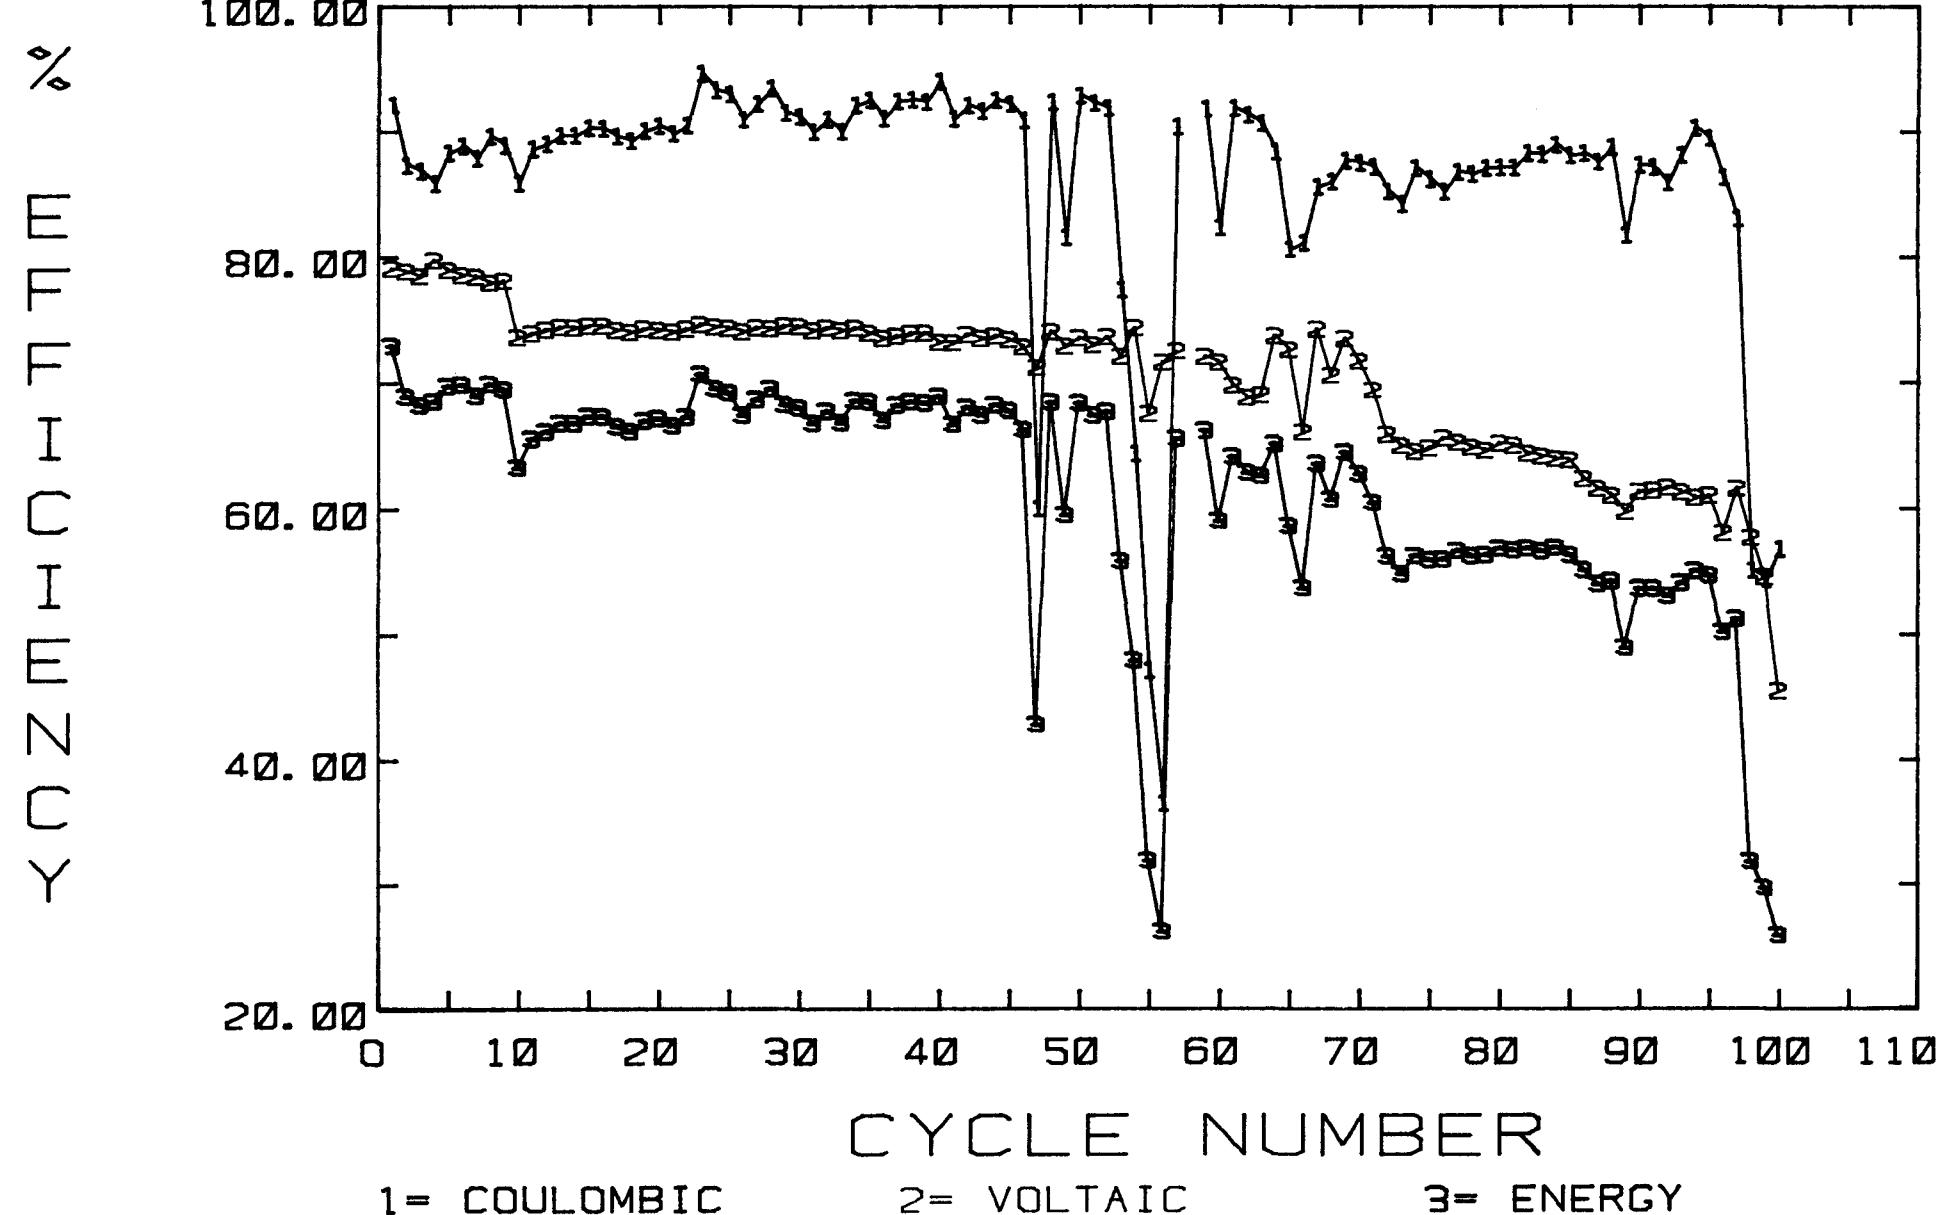
**Figure 1**  
SANDIA DATA FOR BATTERY 456

One 5-cell battery, number 456, completed 100 cycles at Sandia. Efficiency data are shown in Figure 1. Charge and discharge rates were varied from 34 to  $43 \text{ mA/cm}^2$  and zinc loading on charge ranged from  $137\text{--}170 \text{ mAh/cm}^2$ . The slight drop in voltaic efficiency after Cycle 9 was due to an increase in the charge and discharge rates. The fluctuation in coulombic efficiency from Cycles 47 to 53 was due to self-discharge testing described below. Performance was inconsistent on subsequent cycles but stabilized at reduced efficiency levels after Cycle 70. One cell was identified as limiting battery capacity and voltage performance at this point. Performance then dropped substantially at Cycle 98 to below the failure criteria.

The battery was disassembled and the cause of failure determined. A gasket used to seal the end electrode to the end block had enlarged during exposure to bromine. By enlarging, it partially blocked the flow of electrolyte to the end cell, thus limiting its capacity. ERC had also observed this degradation mechanism. Subsequently, ERC redesigned the battery end blocks to eliminate the gasket completely.

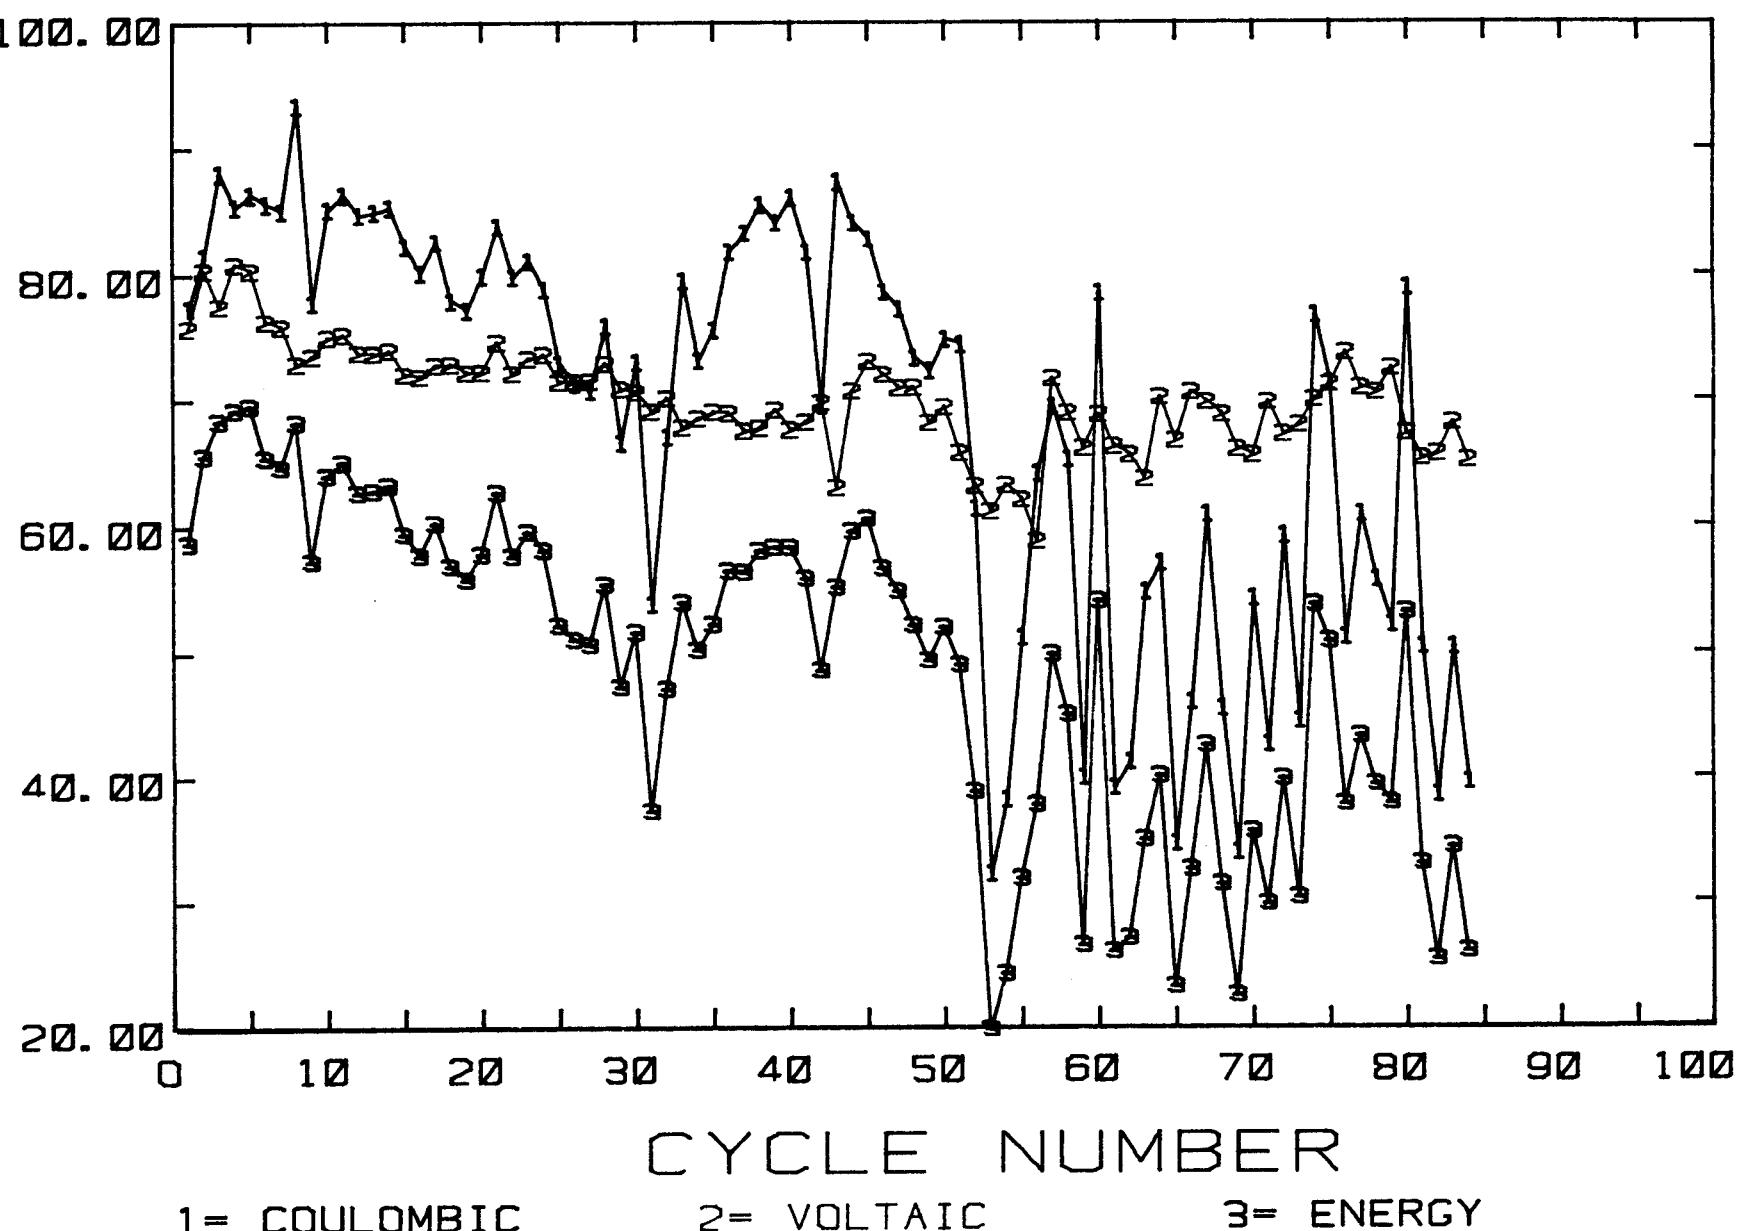
**Figure 2**  
SANDIA DATA FOR BATTERY 459

The 30-cell battery, Number 459, had completed 84 cycles by the end of July 1989. Charge and discharge currents and zinc loadings were similar to those described above for Battery 456. Battery performance is shown in Figure 2. Initially, battery performance was comparable with the 5-cell battery. However, after about 20

cycles, the coulombic efficiency began to vary significantly. After 52 cycles, coulombic efficiency decreased sharply, and battery performance dropped below the failure level. Electrolyte analysis indicated that the battery was not deficient in zinc or bromine. However, rapid and uncontrollable increases in electrolyte pH required frequent additions of hydrobromic acid. Over 270 milliliters of acid was added per cycle between Cycles 60 and 66.

The battery was disassembled after 73 cycles to determine the cause of the observed performance. The loss in performance was due to a swollen gasket which blocked electrolyte flow as described above for Battery 456. The end blocks were replaced by parts built with the new design which eliminated the gasket. Several electrodes and separators were also replaced, and the battery was reassembled and placed back on test. Performance improved substantially at first, and then dropped off again. This performance decline will be investigated during the next few months.

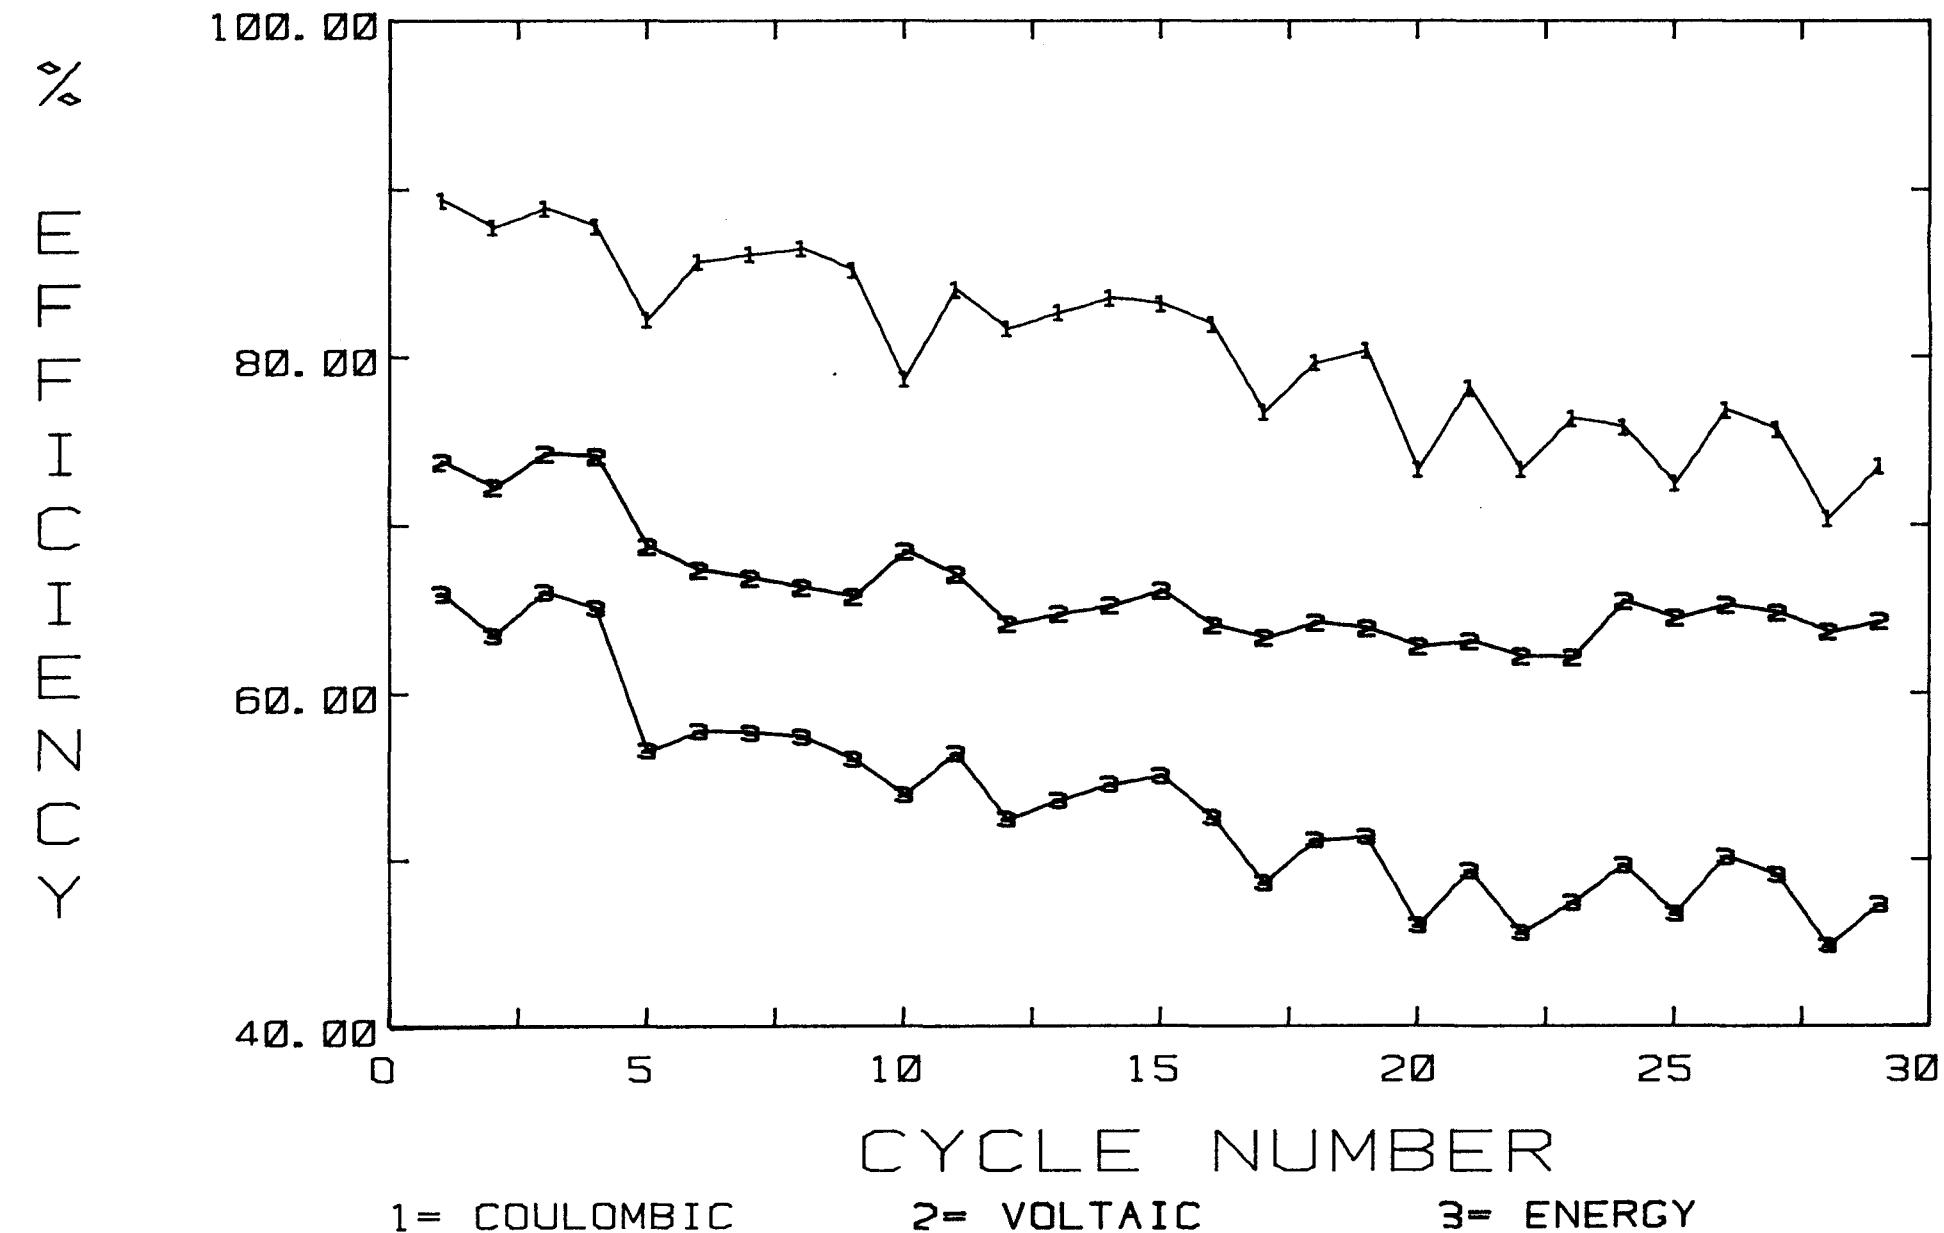
**Figure 3**

Finally, another 5-cell battery, Number 481, was placed on test in late May 1989. This unit contained larger electrodes, flow frames with improved electrolyte distribution features, and improved bromine mixing in the catholyte reservoir. This battery had completed 29 cycles by the end of July 1989. Its performance is illustrated in Figure 3. While initial efficiency values were close to the expected levels, voltaic performance dropped approximately 10% during the testing. Coulombic efficiency also decreased significantly during this period. Adjustments were made to the electrolyte flow rates in an attempt to reverse this behavior. Further testing will be conducted to fully characterize this new design.
