Final Battery Evaluation Report
Energy Research Corporation
Zinc/Bromine Battery

P. C. Butler, D. W. Miller, C. E. Robinson,
Anthony Leo

Prepared by
Sandia National Laboratories
Albuquerque, New Mexico 87185 and Livermore, California 94550
for the United States Department of Energy
under Contract DE-AC04-76DP00789

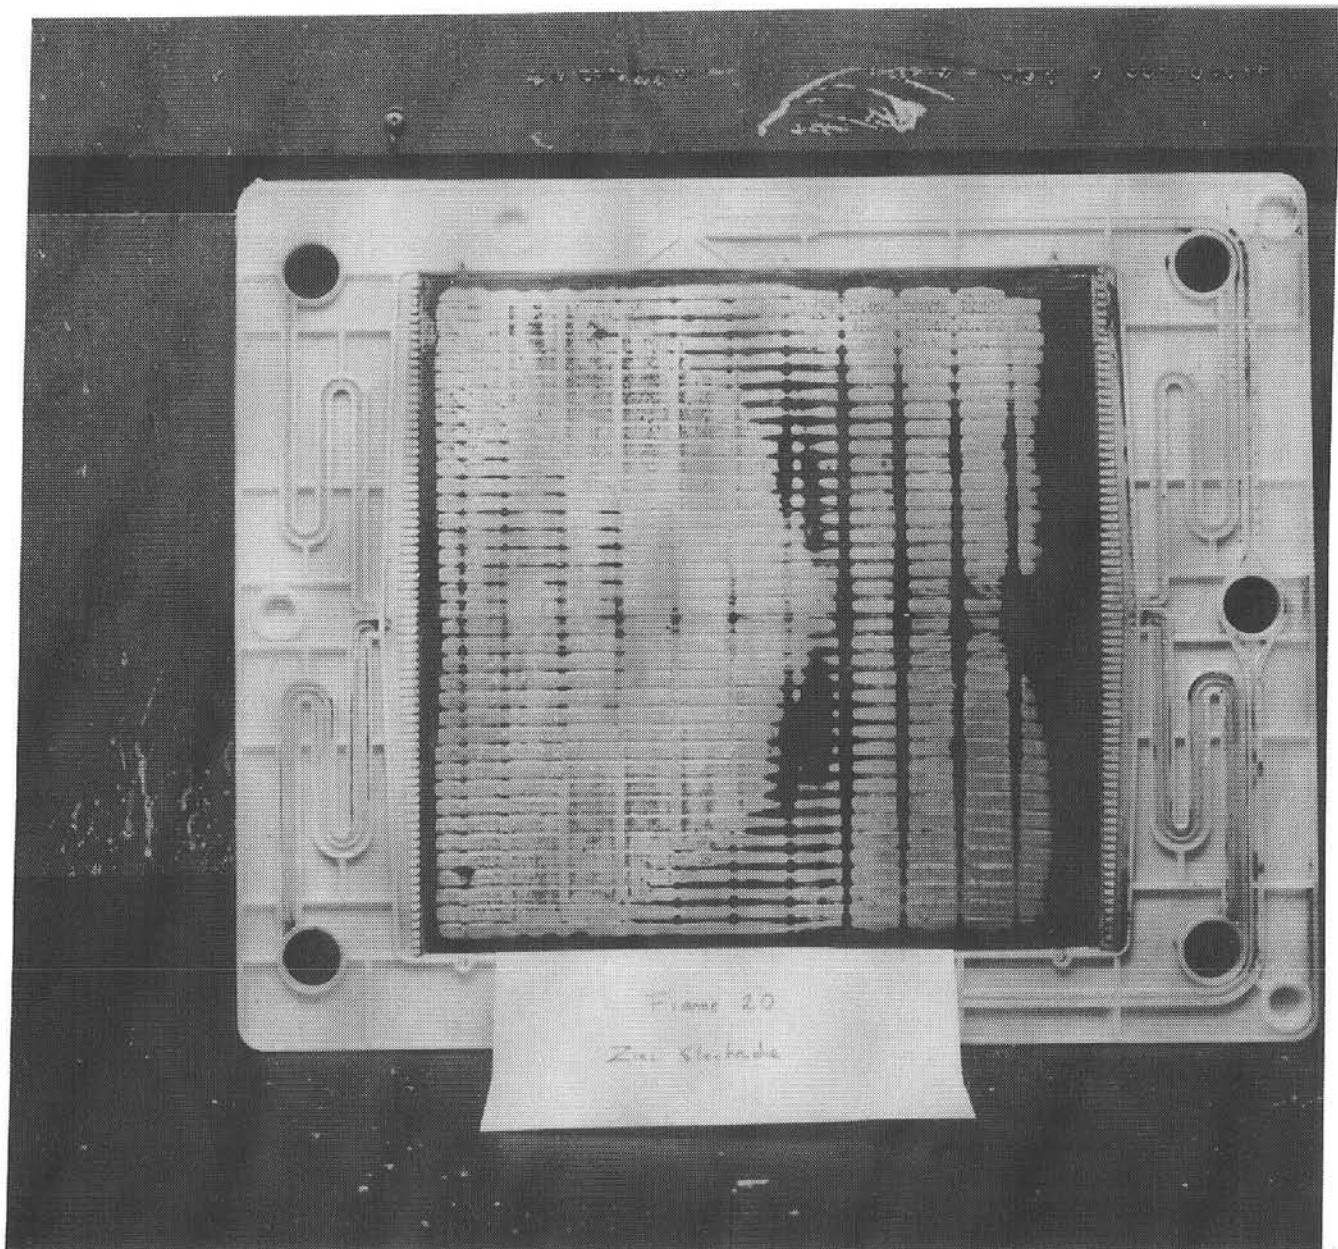
Frame 20
Zinc Electrode

Small dentrites (< 1/32" high) were observed on electrodes 3, 18 and 20. Major zinc growth was seen on plate 19 (frame 20), with dendrites extending to the separator layer. In all cases where zinc had penetrated the separator, the separator had been deformed and roughened by the penetration.

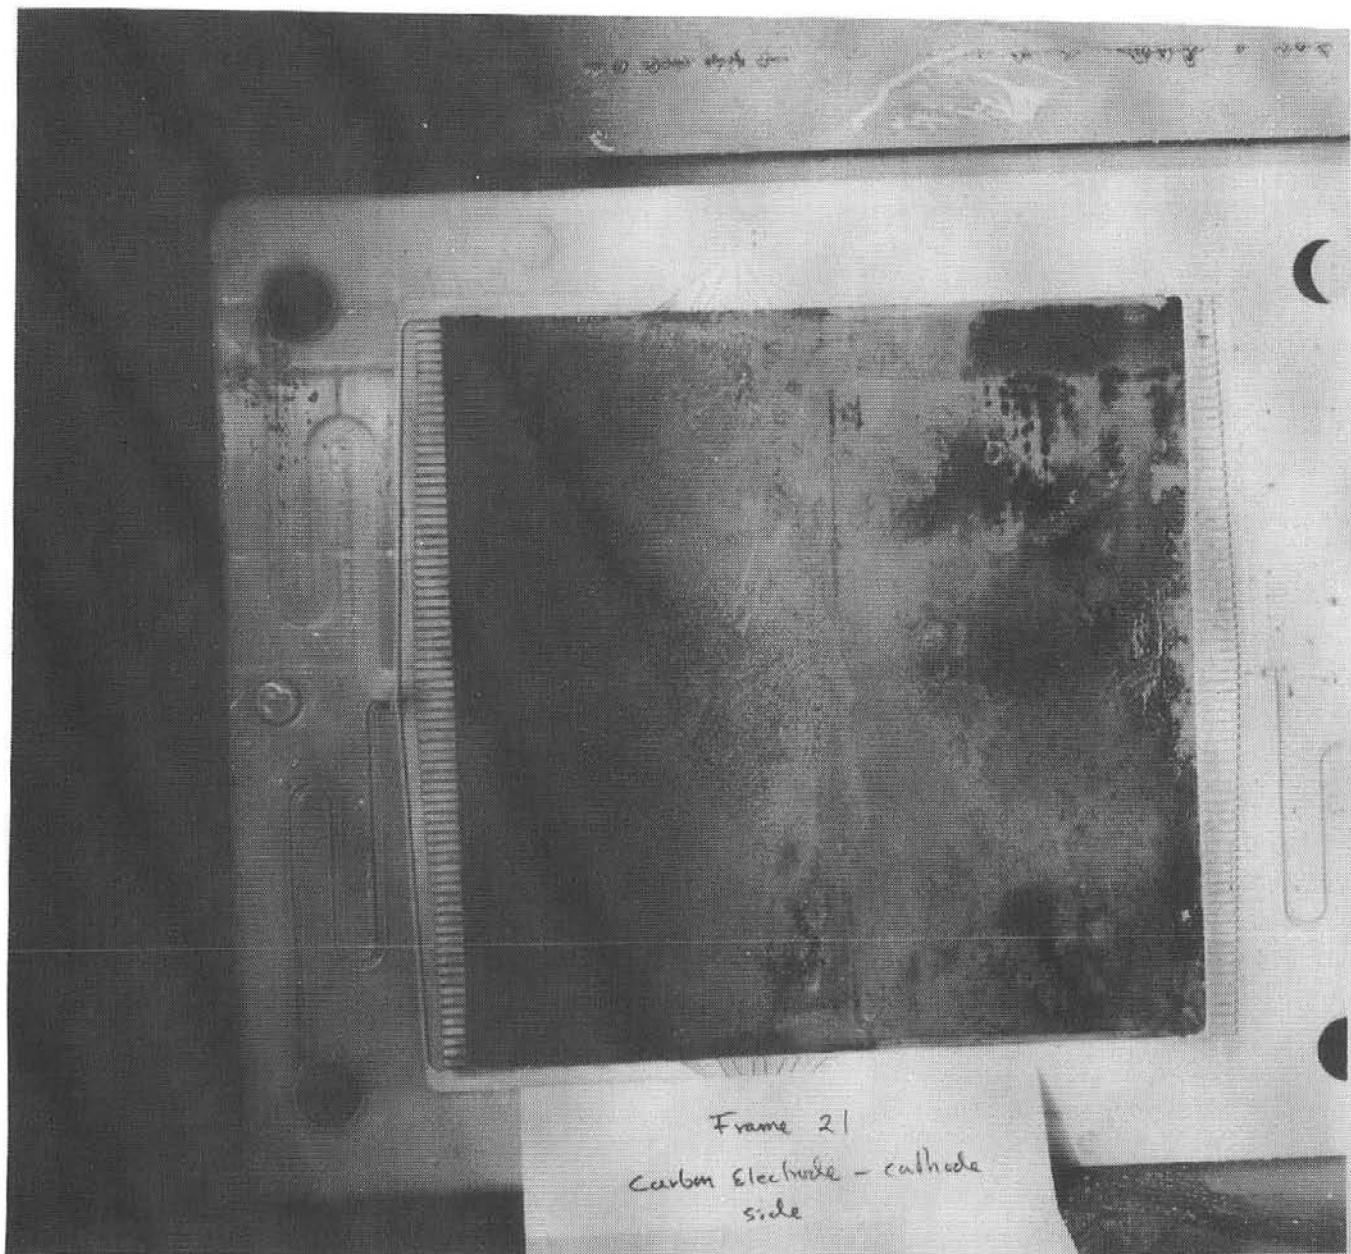
Frame 21
Carbon Electrode - cathode
side

The carbon electrodes were in excellent condition, with the exception of the plate in frame 21. This electrode appeared to have become roughened in a section in the upper half of the electrode. The roughened area was on the cathode side of the plate. All other electrodes had smooth surfaces.
