# **Examination, Evaluation, and Repair of Laminated Wood Blades After Service on the Mod-0A Wind Turbine**

James R. Faddoul  
National Aeronautics and Space Administration  
Lewis Research Center

Prepared for  
National Conference of the American Wind Energy Association  
San Francisco, California, October 16-19, 1983

DOE/NASA/20320--53  
DE84 001931

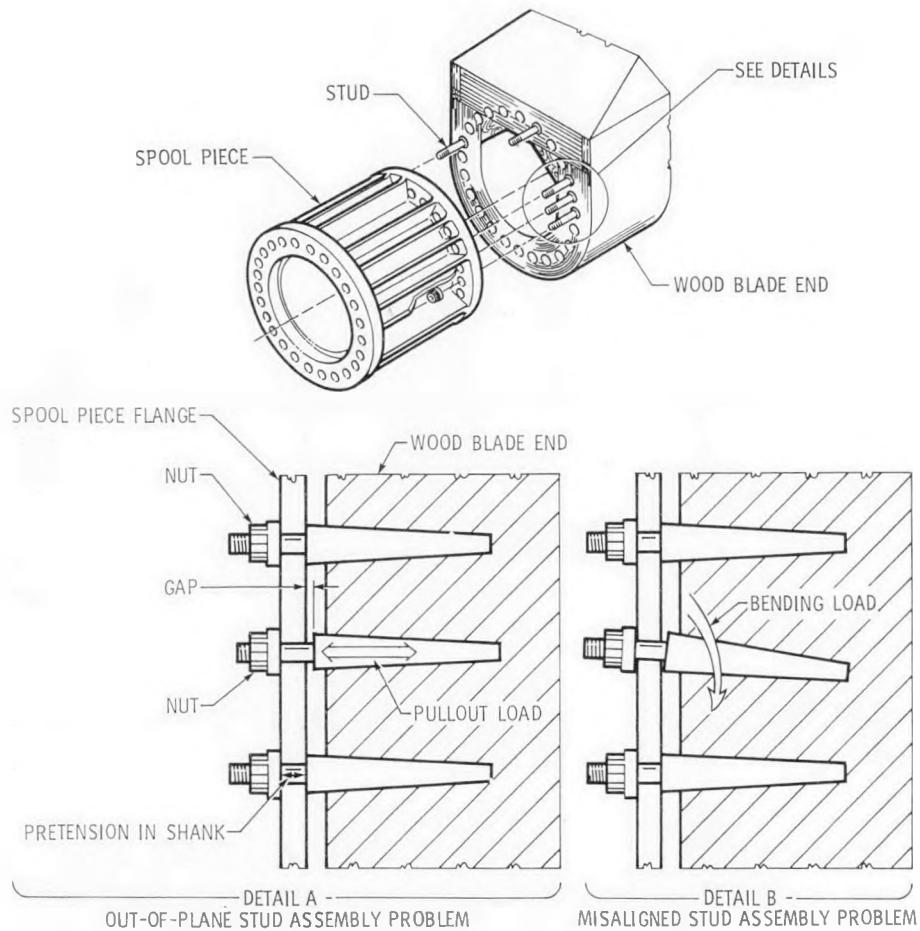
allowable weight by 1.4 kg (3 lb) and the allowable gravity moment by 5152 N-m (3800 ft-lb). The other deviation involved a misalignment of the blade retention studs on blade 1011, shown schematically in figure 1. Special shim washers were manufactured and were used to correct the out-of-plane condition of the stud faces of blade 1011. The out-of-plane condition of blade 1010 was found to be within design limits and the shim washers were not used on that blade. Some of the more important events in the history of the blade set are as follows:

Figure 1. - Wood blade root end/stud/spool-piece assembly.

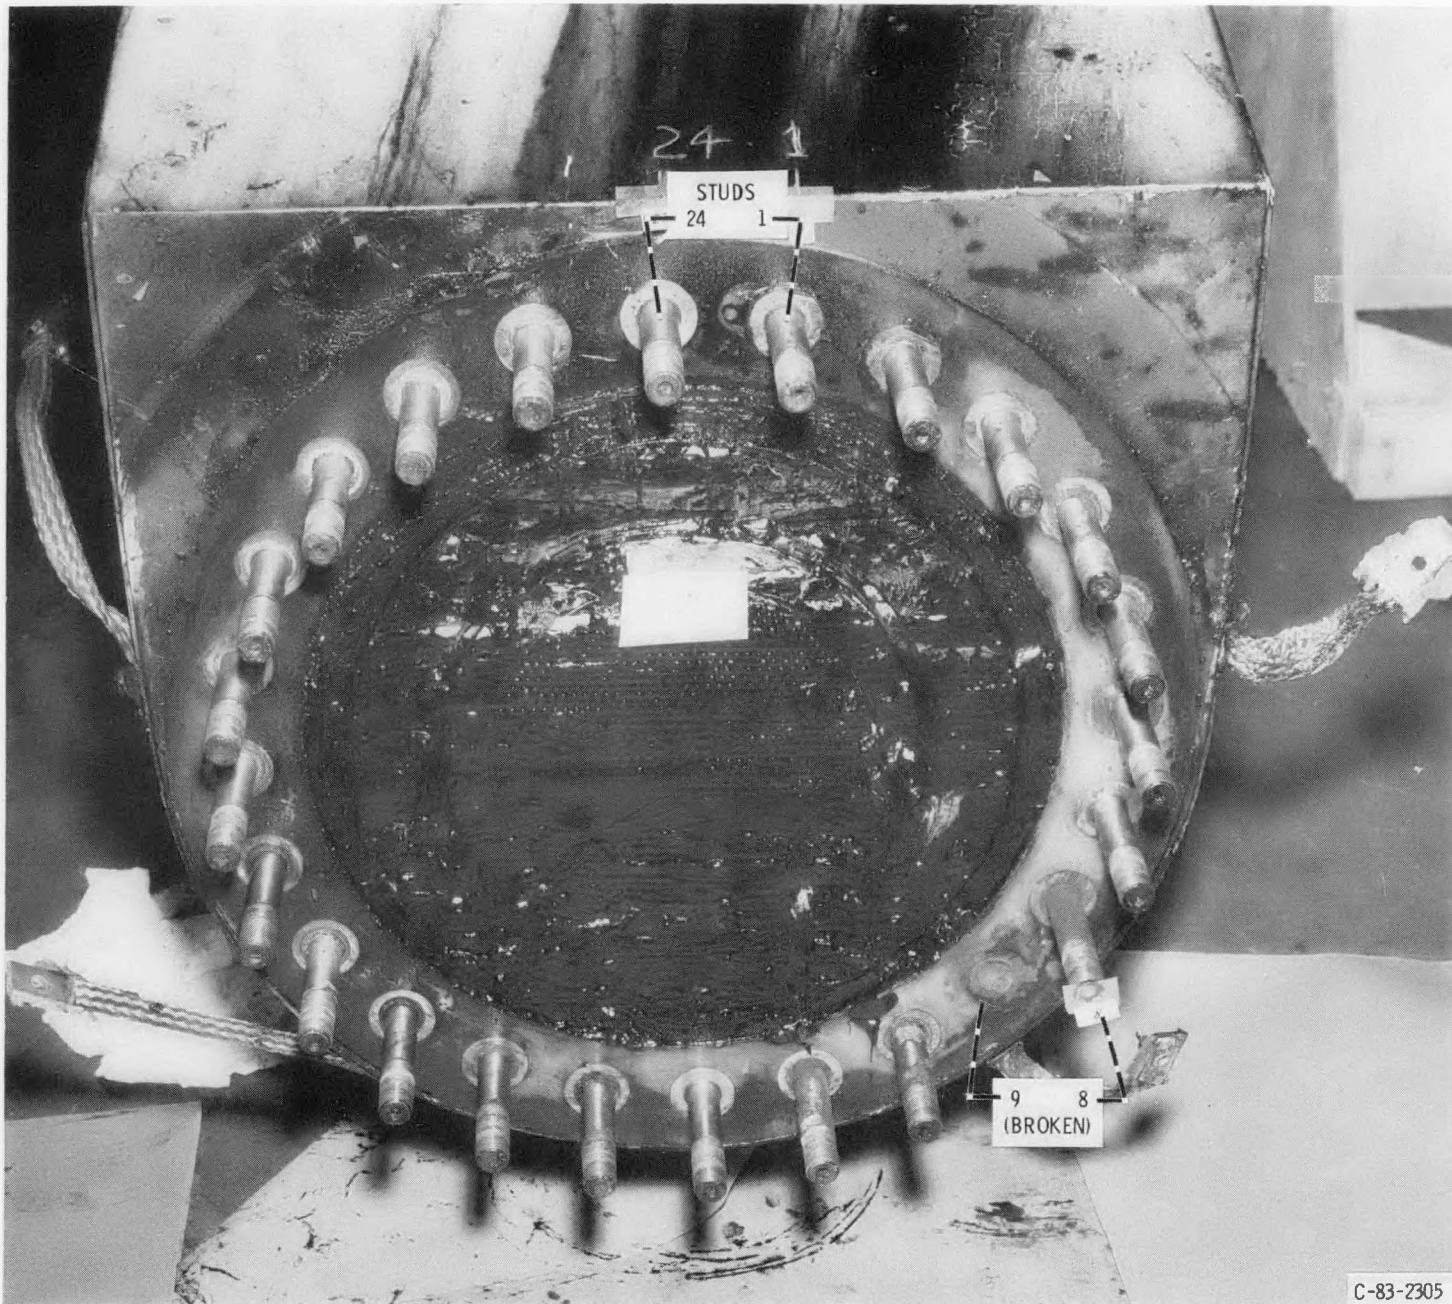
Figure 2. - Root end of blade 1011 showing bolt circle and stud numbering sequence.

This process was used to replace five studs in blade 1011 and required only 2 days for two workers (4 worker-days), not including the time to make the studs, the fixtures, and the tapered wood cores. The specific studs replaced are designated by numbers 8, 9, 10, 14, and 15 in figure 2. No significant problems were encountered during this operation and the blade set, SN 1010 and SN 1011, is now considered to be ready for operation on a Mod-0A wind turbine.

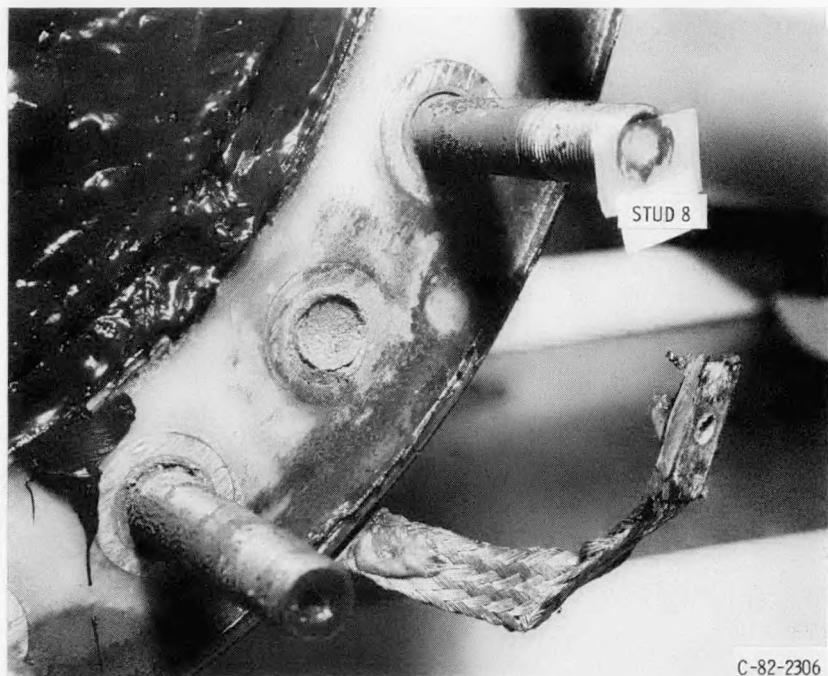
Once the visual and "rough" weight checks were made, the spool pieces were removed from both blades, and the stud/spool piece interface was visually inspected. During removal of the spools the torque on each nut was checked and none were found to have loosened. Observation of the studs indicated that significant corrosion had taken place on blade 1011 only and only on a stud-selective basis (figs. 2 to 4). Blade 1010 (figs. 5 and 6) had no serious corrosion.

(a) Studs 8 and 10 plus remains of 9.

Figure 3. - Corrosion of and around stud 9 on blade 1011.

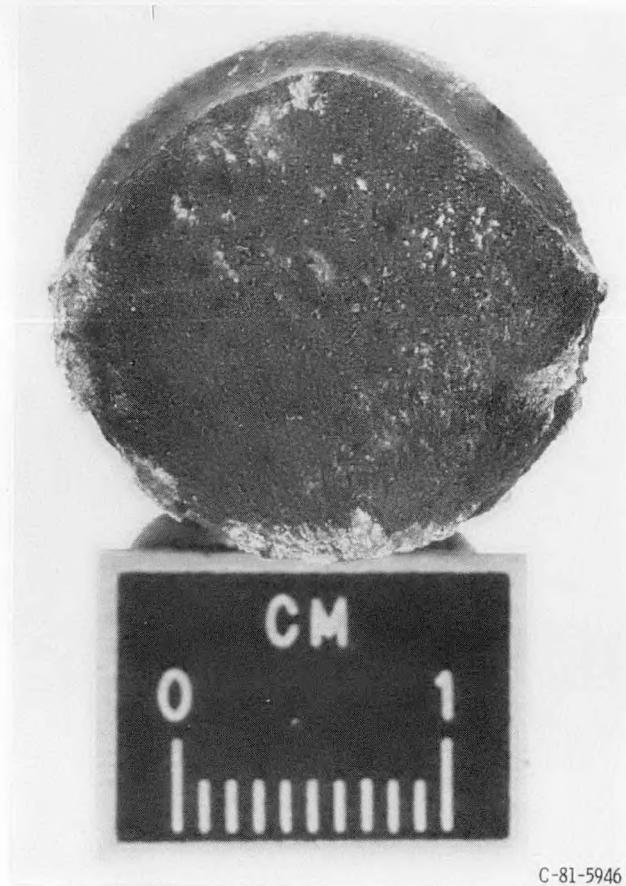
(5) The cause of failure was stress corrosion fatigue.

(b) Fractured face of stud 9 blade 1011.

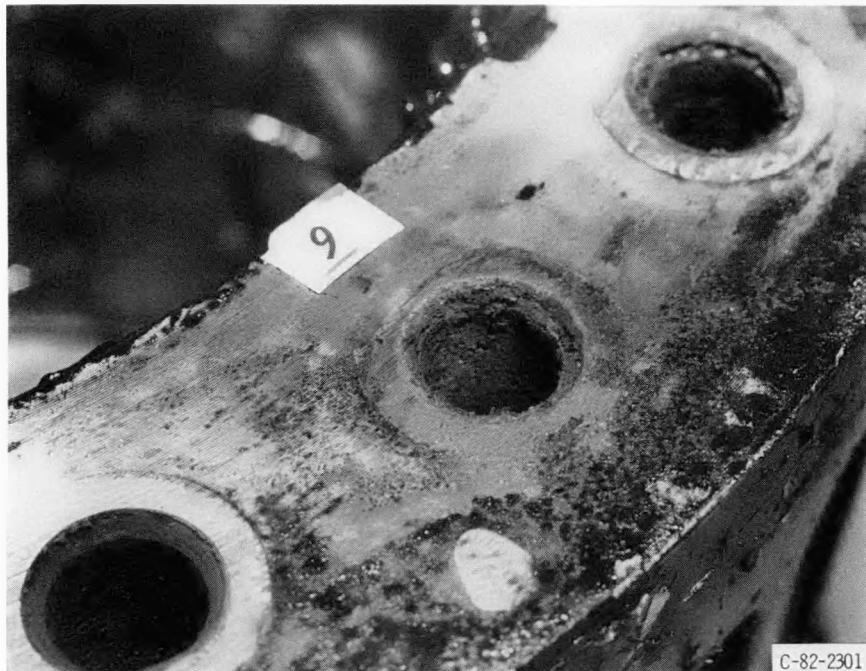
(2) Metal-to-metal contact between the stud shoulder and the spool was not consistent. When full contact was achieved, little or no rusting or corrosion had occurred. The broken stud had less contact and more corrosion than any other stud.

(c) Corrosion of spool piece in location of stud 9, blade 1011.

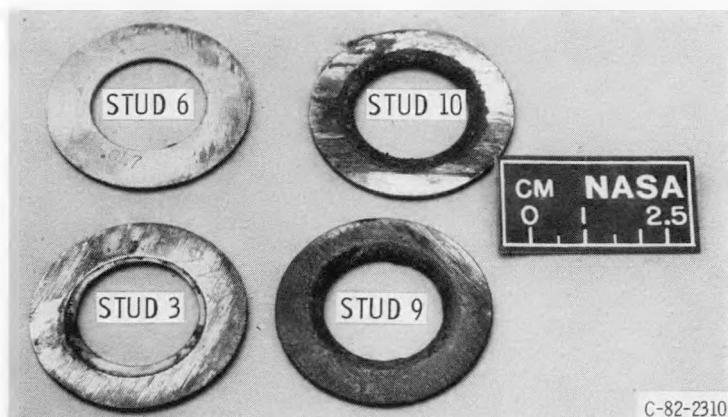
(4) Although the shim washers on blade 1011 had corrected the out-of-plane condition of the stud shoulders, there was evidence that a nonperpendicular condition (misalignment) also existed that could not be corrected with shims. This condition led to lack of metal-to-metal contact between the stud shoulder and the spool. This, in turn, created two problems. First, the misalignment prevented the preload of the stud from being fully effective in reducing the cyclic component of the applied load. And, second, the absence of full metal-to-metal contact allowed the corrosive moist salt air to attack the radius area of the stud, where failure ultimately occurred.

(d) Shim washers removed from four studs on blade 1011.

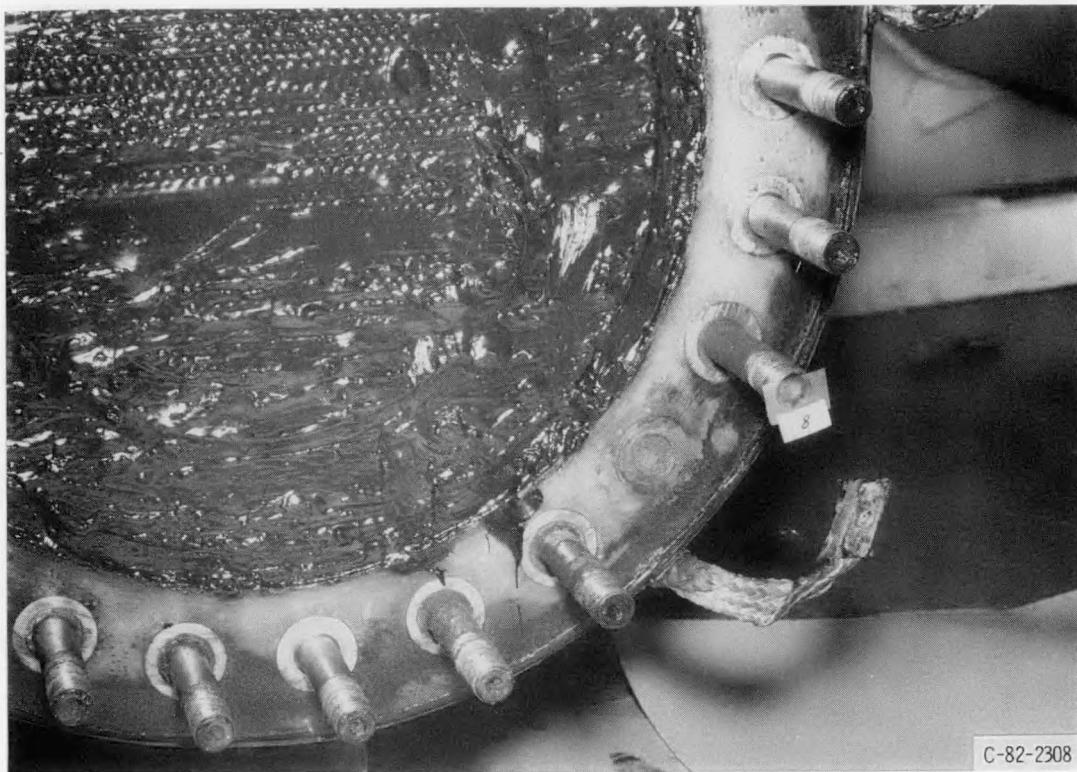
Figure 4. - Variability of corrosion of blade 1011.

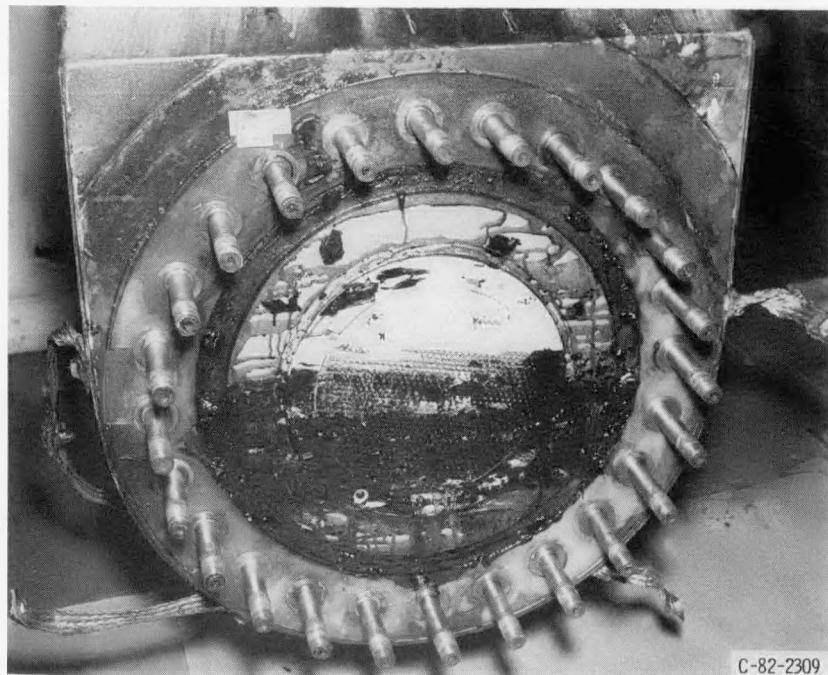
Figure 5. - Root end of blade 1010 showing very little significant corrosion.

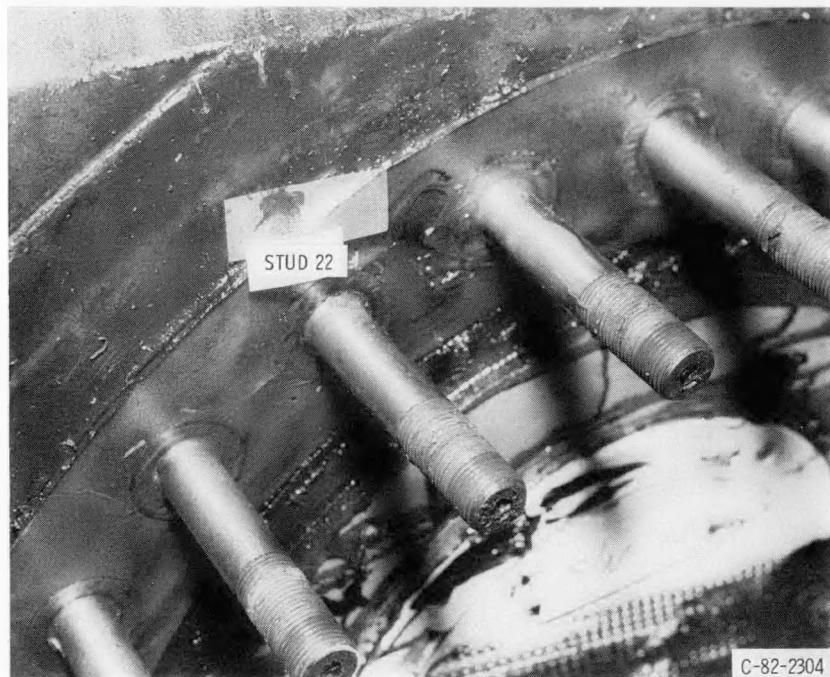
Figure 6. - Section of blade 1010 showing worst area of corrosion.

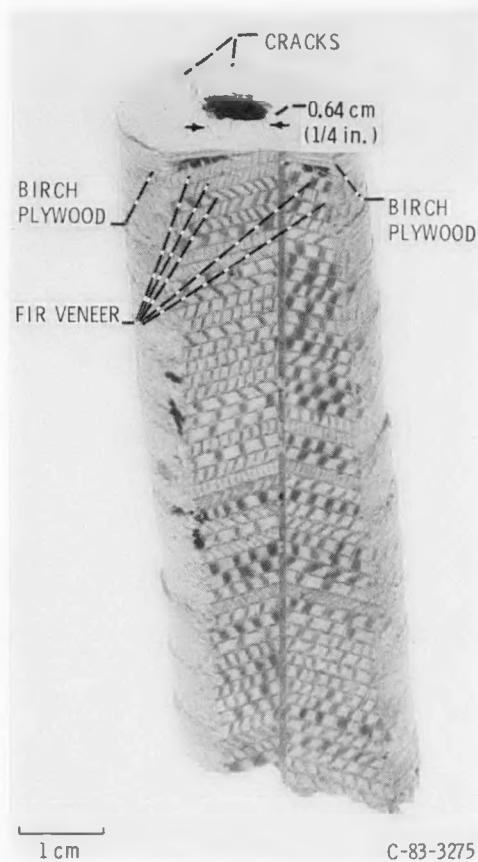
Also evident on blade 1012 was the leading-edge crack, which ran the entire length of the blade and seemed to be in the joint between the upper and lower blade halves. Figure 12 shows a plug section from blade 1012 that has two cracks separated by about 0.64 cm (1/4 in.). Less than 10 percent of the blade had this condition, but there were areas where the crack was discontinuous and would jump back and forth from one location to the other. Depth of the crack was estimated by inserting a thin "feeler gage" and proved to be less than 0.64 cm (1/4 in.). In some areas the crack appeared to be only superficial. At the tip of the blade from station 700 to 750, there was also a great deal of pitting and erosion of the leading edge (fig. 13). Both the leading-edge crack and erosion at the tip were unique to blade 1012. Neither of the Hawaii blades nor the other Block Island blade showed any signs of similar problems.

Figure 12. - Plug section from blade 1012 showing two leading-edge cracks.

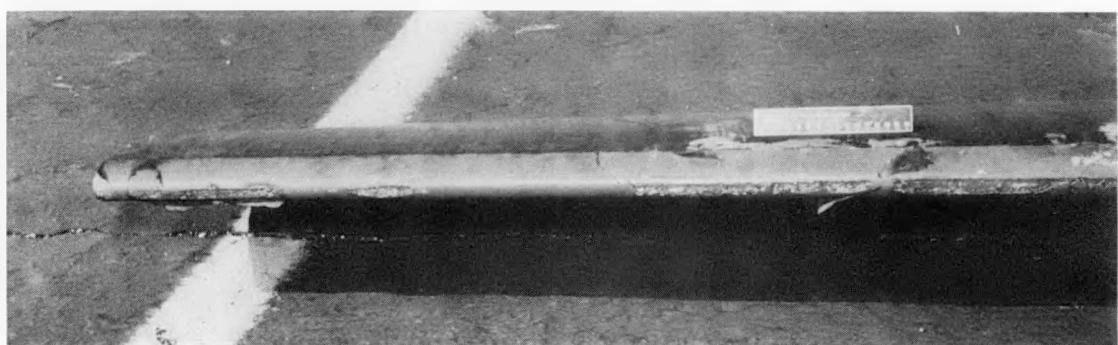
**Tip erosion:** Erosion and cratering at the tip of blade 1012 were very severe, as shown in figure 13. Unfortunately, since the machine was operating at a reduced power level, it is impossible to determine the effect on aero-dynamic performance, but it would, of course, be expected to be a large (5 percent minimum) penalty. When sections were cut through the blade at the tip, the cause of the erosion problem was easily visualized. Figure 28 shows that neither the plywood blade exterior nor the fir veneer conformed to the mold surface in the outboard sections of the blade. Consequently an epoxy filler material was used to provide the exterior airfoil surface. This condition is not unique to blade 1012, however; so it is not sufficient to cause the erosion. What is unique about blade 1012 is that a leading-edge crack developed because of other manufacturing problems. The crack eventually grew large enough at the blade tip to cause splitting of the leading-edge protection tape, a 7.6-cm (3-in.) wide self-adhesive polymeric material. The tape splitting (cracking) was promoted by embrittlement caused by ultraviolet and weathering effects. Once the tape had split, direct impingement of wind and rain at high velocity quickly eroded the epoxy filler. The erosion process was further accelerated by the epoxy filler being a low-density material as a result of the frothing and bubbling created by the vacuum bag manufacturing process. The erosion process removed only the epoxy filler and stopped when a wood surface was reached.

Figure 13. - Leading-edge erosion and pitting of blade 1012 after return from Block Island (7564 operating hr.).

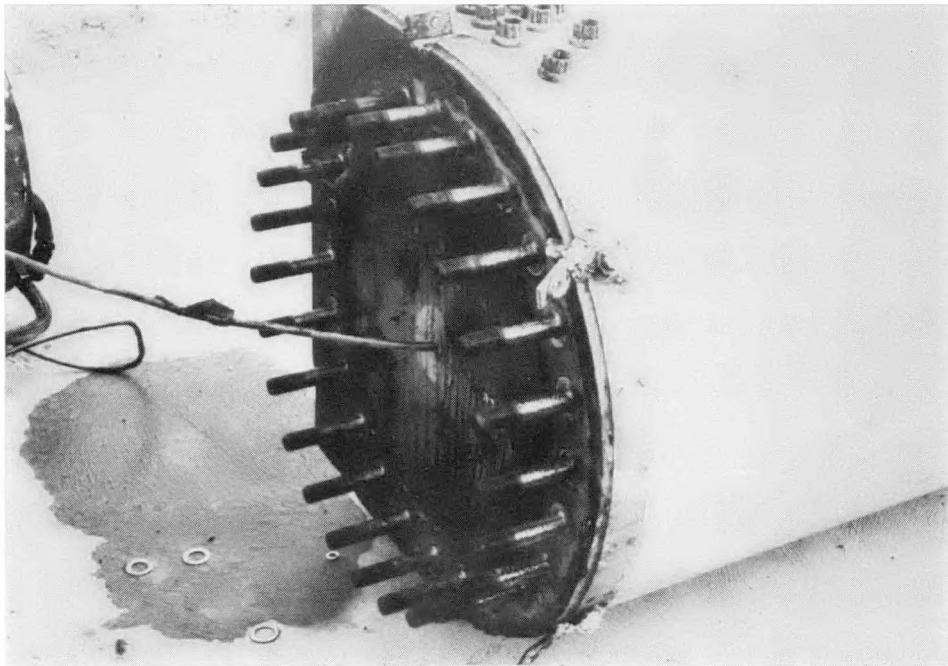
Spool pieces were then removed from both blades to determine the amount of corrosion that had occurred on the studs. As shown in figures 14 to 17, there was light-to-moderate rust but no significant pitting as had been found on blade 1010 from Hawaii. Stud-to-spool contact appeared to be complete and uniform, indicating that the studs had been installed properly with correct alignment and depth of insertion. No cracking or evidence of structural fatigue could be found by visual examination.

(a) Blade 1012.

Figure 14. - Root end studs of blades 1012 and 1013 after return from Block Island.

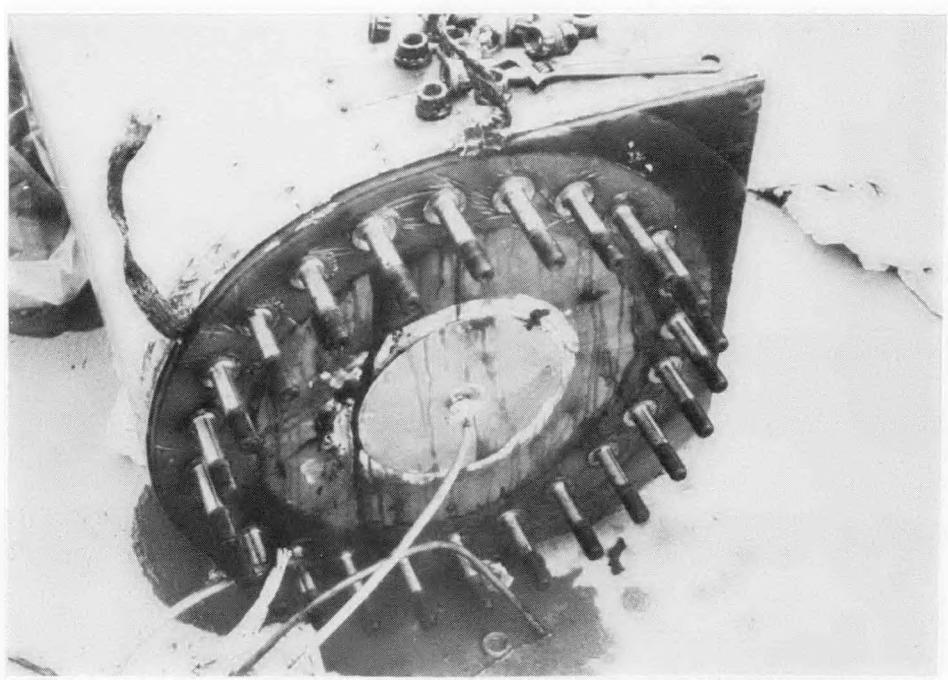
(b) Blade 1013.

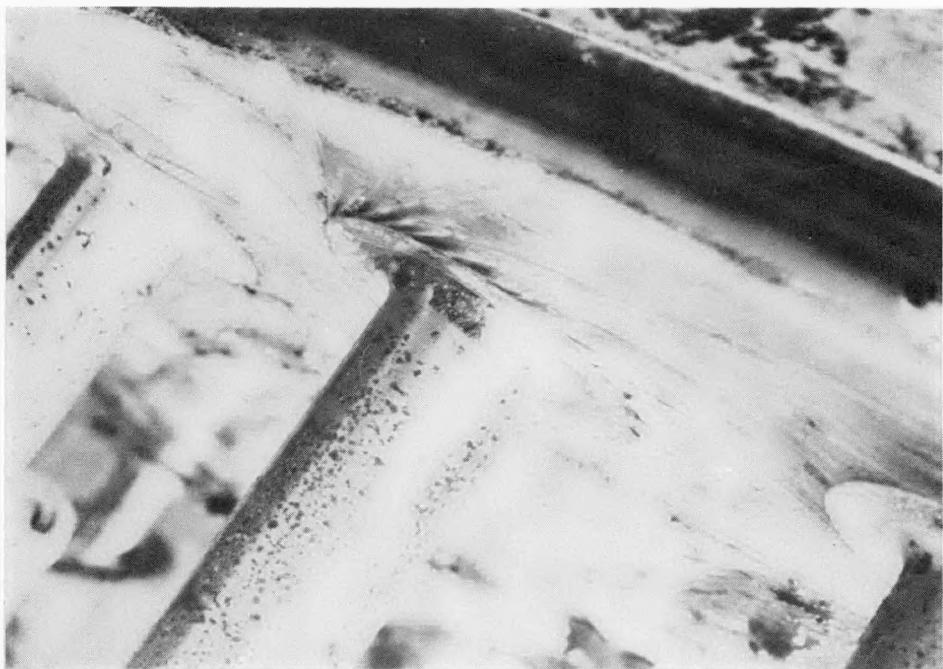
(a) Corrosion and pitting at radius of stud.

Figure 15. - Most corroded stud and matching spool piece position for blade 1013.

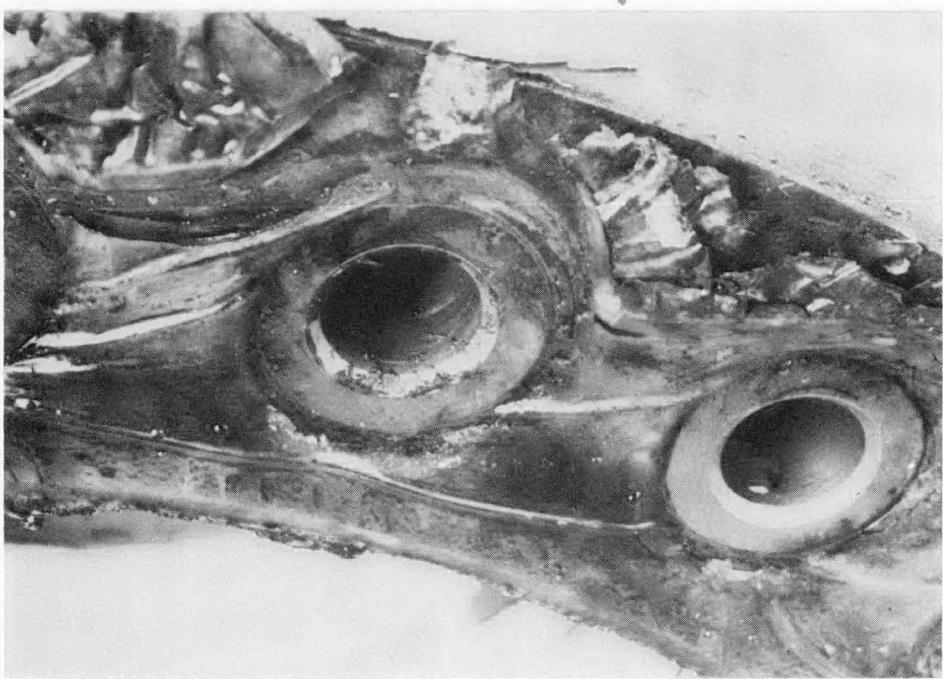
(b) Corrosion of face of spool piece.

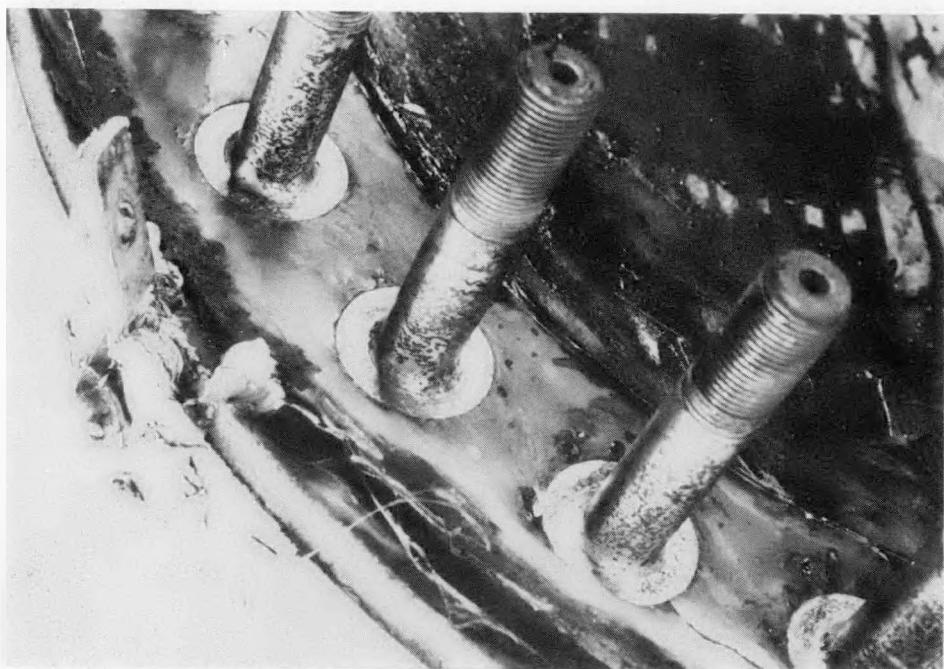
Figure 16. - General condition of moderate corrosion of studs from blade 1013.

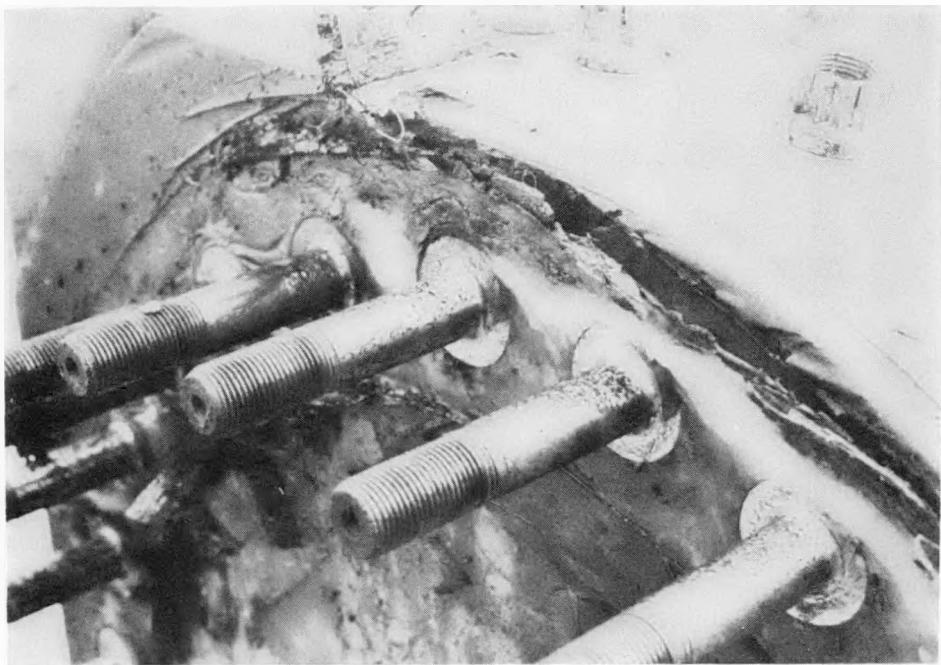
(a) Overall view of stud condition.

Figure 17. - Corrosion of studs from blade 1012.

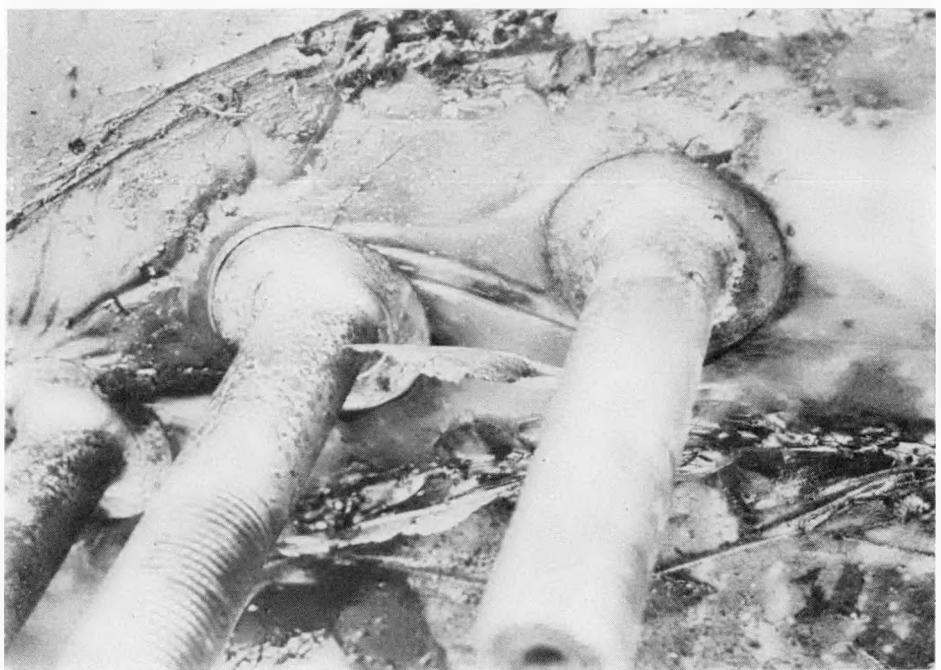
(b) Closeup of general corrosion.

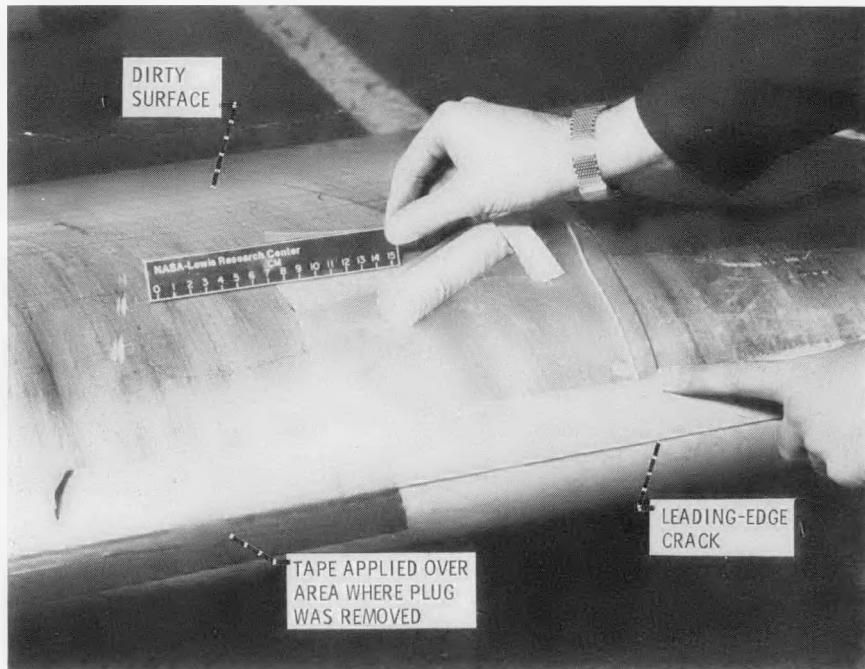
Figure 19. - Wood core specimen for blade 1012 and leading-edge crack. (Note condition of surface finish.)

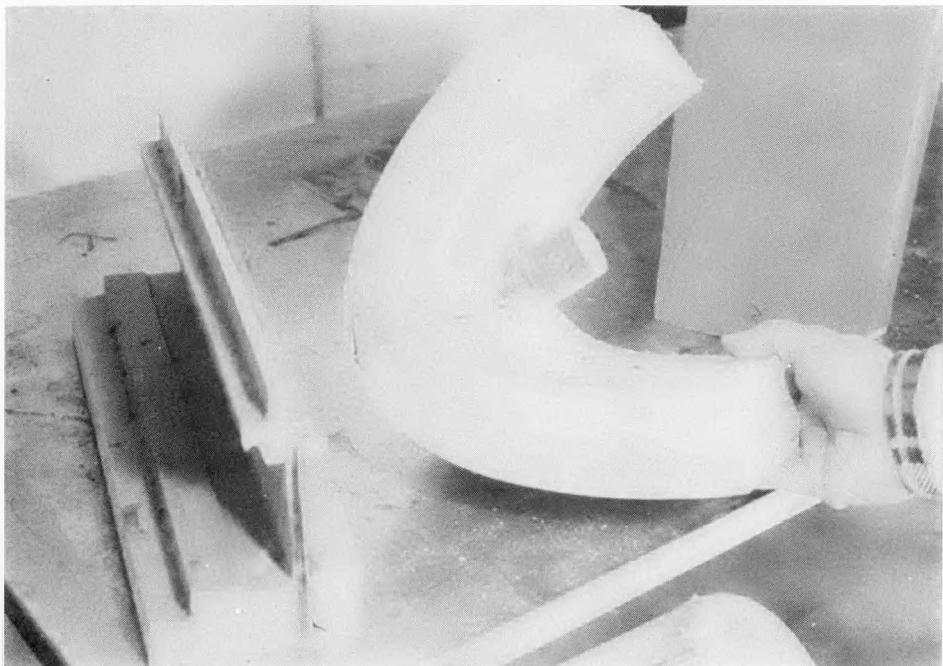
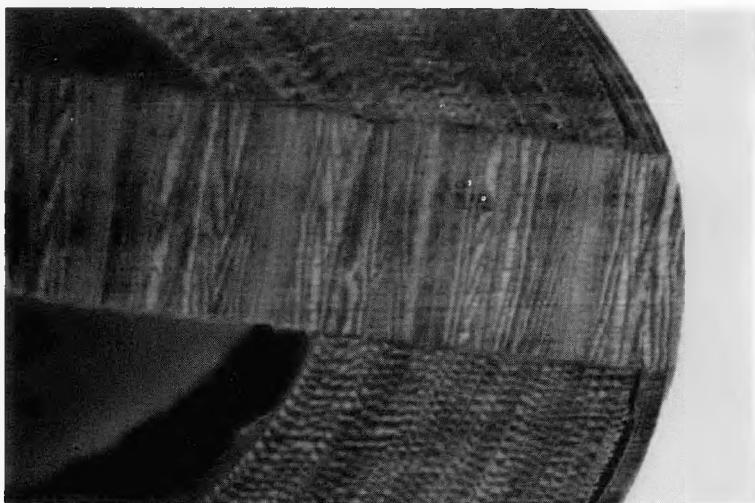
(a) Plug repair cut from leading edge.

(b) Cross section cut through bonded-in plug repair.

Plug studies. - To evaluate what had happened in the cracked area of the leading edge and to investigate any pattern of moisture absorption, a special plug cutter similar to the tool used to remove cores from the Hawaii blades was developed. This tool removed plugs approximately 2.5 cm (1 in.) in diameter, as shown in figure 19. This technique proved valuable in quickly determining what had happened to blade 1012. In addition, it was found that the holes could be easily repaired by tapering the hole with a tapered reamer and bonding in a properly oriented plug of material with a matching taper. A repaired and sectioned plug is shown in figure 20.

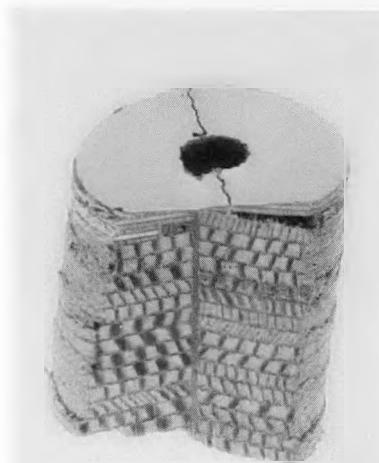
The plugs quickly showed the leading-edge crack to be a manufacturing defect. As shown in figure 21, the upper blade half had slid too far forward during bonding, leaving an overlap of 0.48 to 0.64 cm (3/16 to 1/4 in.). When the bonded blade section was removed from the mold, the overlap was sanded off to a smooth and fair surface. Unfortunately, this left the veneers of the upper blade half edge-glued to the plywood skin on the lower blade half. The combination of (1) thermal expansion and contraction, (2) dimensional changes due to moisture pickup and loss, (3) the grossly different moduli of the two materials, and (4) the very low cross-grain strength of the fir veneers caused the fir veneer to crack at the edge of the plywood layer. The cracks seemed to stabilize as they penetrated the thickness of the D-spar, and nowhere had they progressed to more than about 0.64-cm (1/4-in.) depth. However, over a period of 10 or 20 years, this would probably cause blade deterioration and ultimately lead to failure if left unrepaired. A repair can be conjectured as a trivial operation in which a low-tolerance slot would be routed in the leading edge and then a solid fir strip bonded into the slot and covered with 2 or 3 plies of fiberglass to provide cross-grain stability to the fir. The routed slot would have roughly square dimensions of 1.27 x 1.27 cm (1/2 x 1/2 in.), and the entire cracked section would be removed. Of course the problem could be avoided in the first place through more careful alignment of parts during the bonding operation. As shown in figure 21(d), with good fit, cracks do not develop.

(b) Blade 1012 plug with crack displaced from bond line.

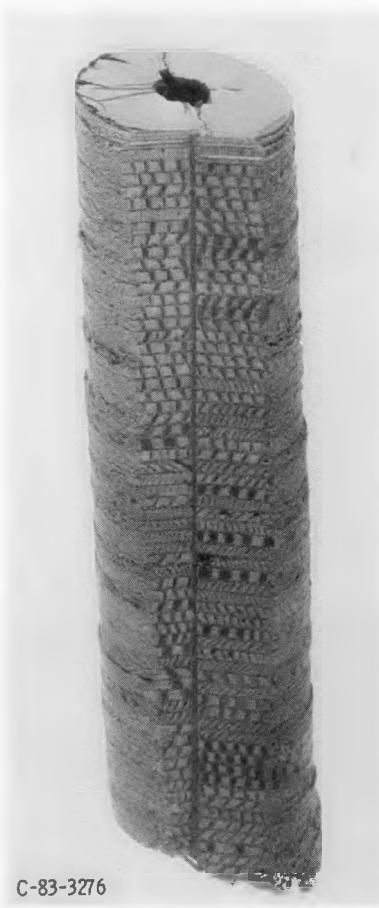
(c) Blade 1012 plug with crack at bond line.

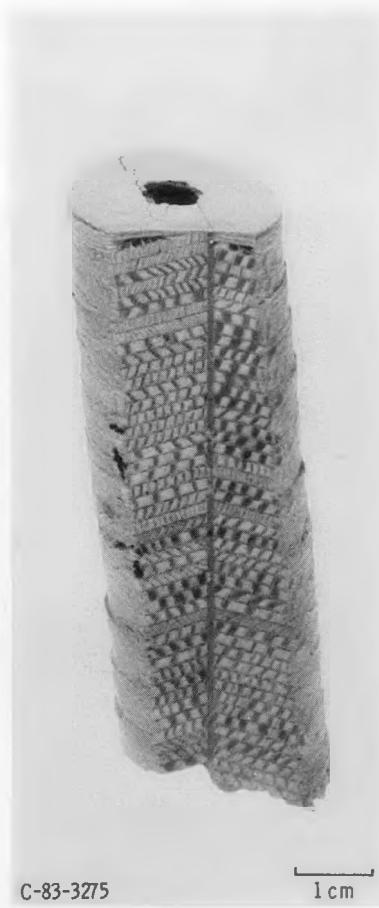
(d) Blade 1012 plug with crack at bond line and 1/4 in. away.

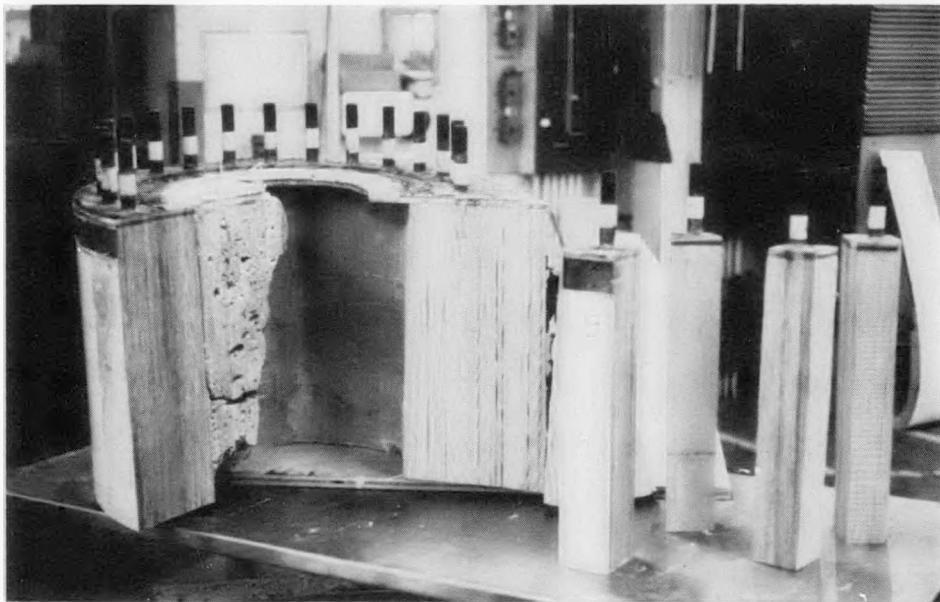
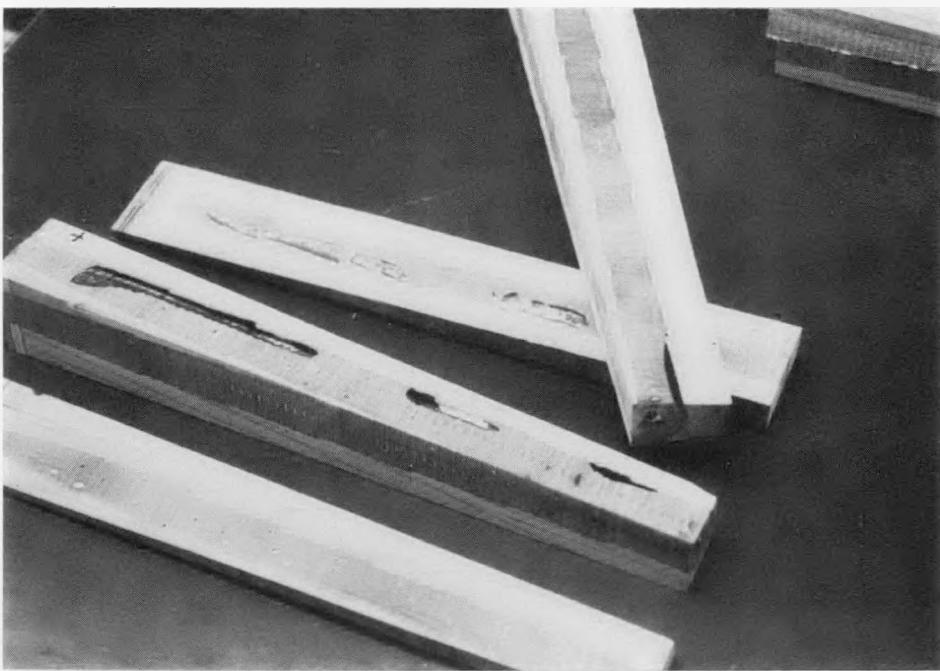
Stud bond: The four most highly loaded studs were removed from the root of the blade by cutting out the stud and an accompanying block of wood, as shown figure 23(a). Each of the four stud/wood block specimens was then cut on two sides with a band saw that followed the stud taper and exposed the tip of the thread tooth and the epoxy bond. It was immediately obvious that two studs had been poorly bonded as major voids were found in the epoxy (figs. 23(b) and (c)). The other two studs were reasonably void free. The voids, however, did not seem to have an adverse effect on the structure. No cracking or crazing of the epoxy matrix could be found at any stud location. Figure 23(d) shows a stud taken from a fatigue test specimen that had failed (in the wood away from the stud area) after more than a million high-load cycles. As can be seen, the extent of cracking of the epoxy matrix around the stud is quite evident, albeit inconsequential to the performance of the stud. From the evidence, it can be concluded that while a very undesirable situation (large voids in the stud bond) existed in blade 1012, failure of the structure had not resulted nor was it imminent. However, it is also obvious that more care must be taken and nondestructive inspection techniques must be developed to assure that good stud bonds exist in future laminated wood blades.

(a) Stud blocks as cut from root.

(b) Voids in stud bonds.

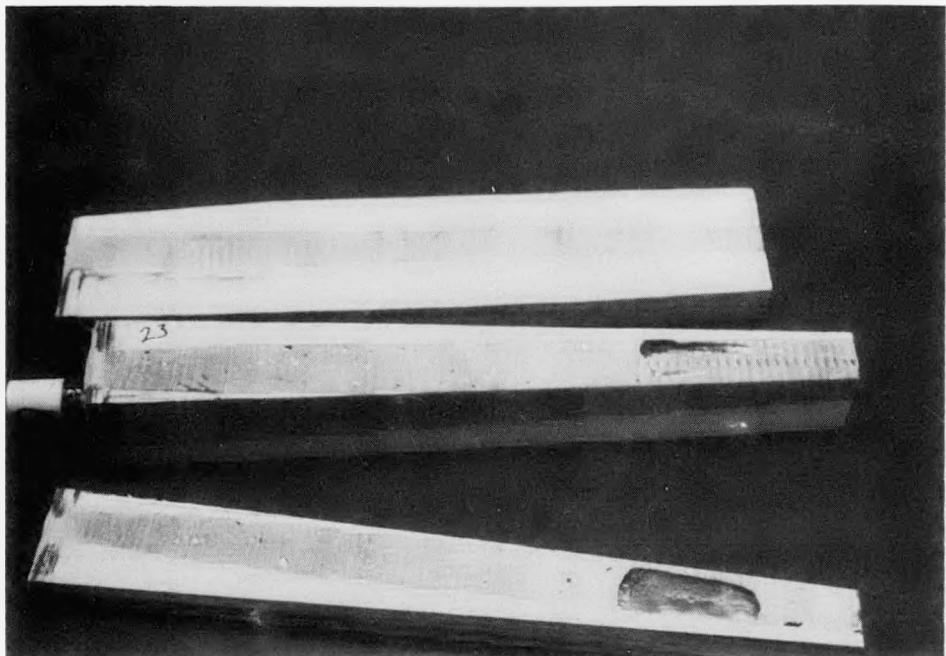
(c) Void in bond for stud 23.

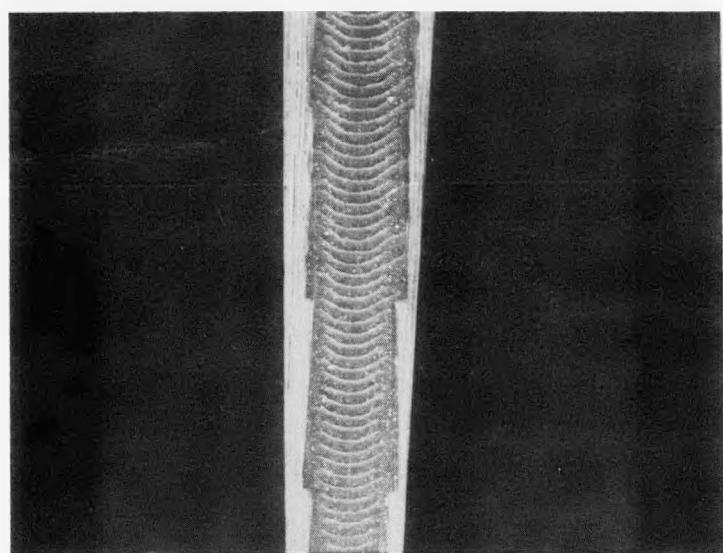
(d) Stud from wood-fatigue test specimen showing complete cracking of epoxy matrix.

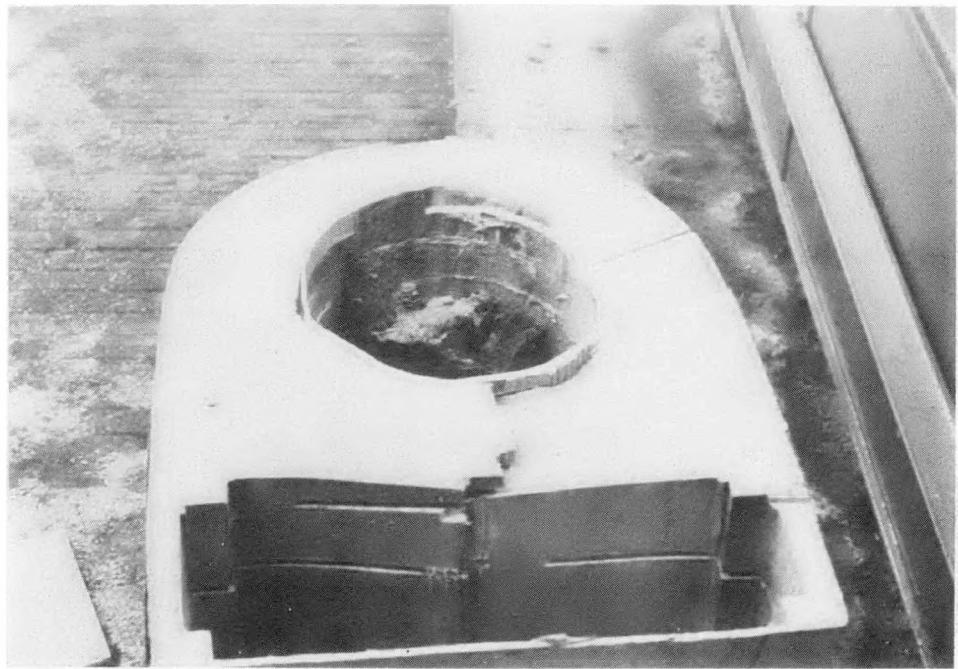
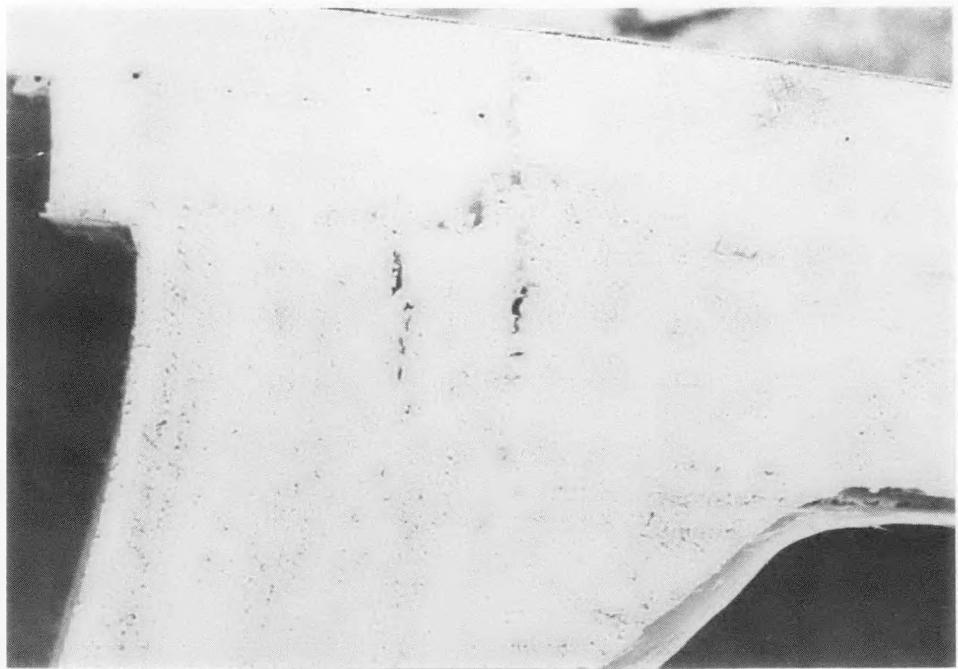
Root blocking: Visual examination and evidence from the stud blocks removed from the root end indicated that the ply-to-ply compaction and bonding was excellent. No gaps or unbonded areas were found in this area of the blade. Some curvature of the laminated root blocking was noted previously in the plies that made up the back side of the "D." This can be seen in figure 24. This problem had been identified during fabrication, and subsequent blades used a premolded, thick, flat panel to build up the blade root.

Figure 24. - Curvature of root blocking from blade 1012.

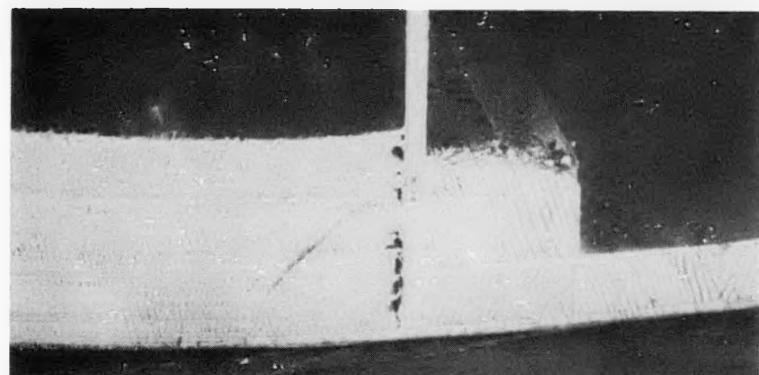
Shear web bond: As shown in figure 25, the bond of the shear web to the D-spar plies on the high-pressure surface was extremely porous. This condition existed from station 240 all the way to the tip (station 750). Inboard of station 240, and on the low-pressure side, the bond was satisfactory. It had been noted during fabrication that there was a potential problem in obtaining good adhesive fill in the shear web to the D-spar point. On at least one blade, an attempt was made to fill voids by drilling into the area and injecting epoxy resin. However, this technique was either not used on blade 1012 or was totally ineffective. Why the bond problem occurred on only one side of the blade is unknown. And, although structural failure had not occurred, nor was there evidence of any significant structural effect, the degree and extent of the problem is such that new procedures would be required for future blade fabrication.

(b) Poor bond area on one-half of station 252.

Figure 25. - Shear web bond problem.

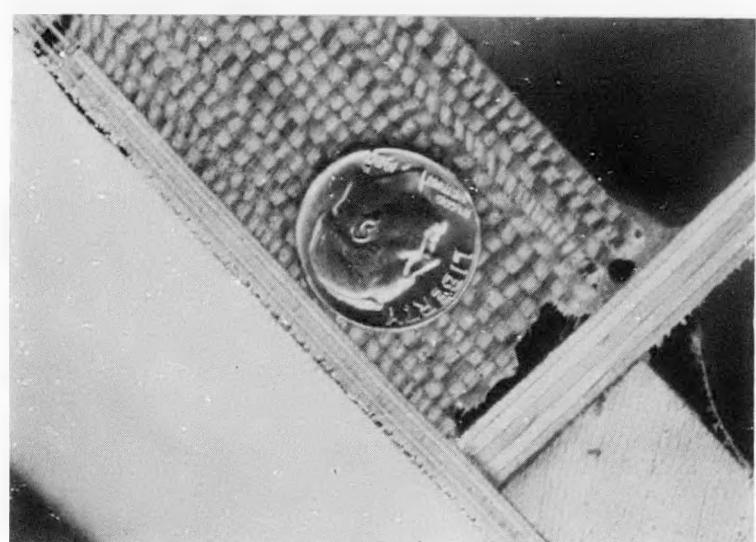
(c) Voids at station 612.
