# **Examination, Evaluation, and Repair of Laminated Wood Blades After Service on the Mod-0A Wind Turbine**

James R. Faddoul  
National Aeronautics and Space Administration  
Lewis Research Center

Prepared for  
National Conference of the American Wind Energy Association  
San Francisco, California, October 16-19, 1983

DOE/NASA/20320--53  
DE84 001931

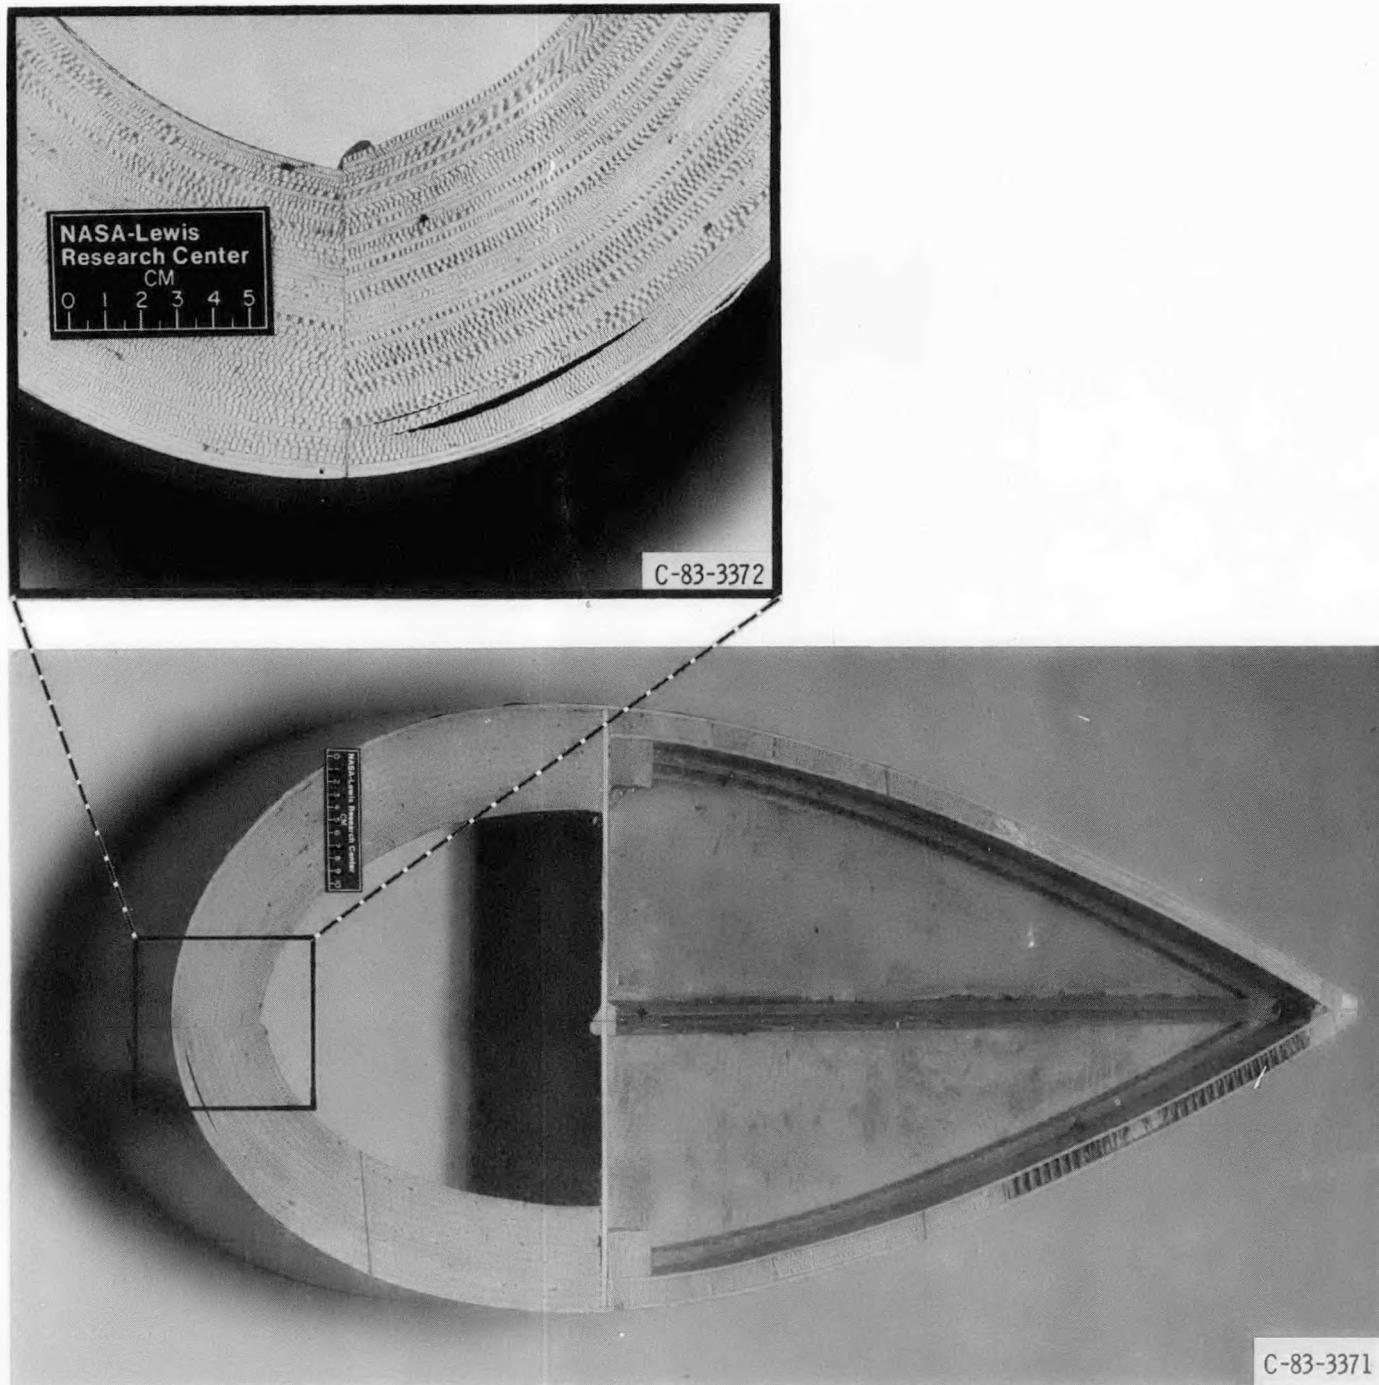
**Leading-edge crack:** As determined from the plug studies, the leading-edge crack was due to a mismatch in the alignment of the upper and lower blade halves. This conclusion was further supported by the cross sectioning of blade 1012, as shown in figure 27. In addition, it was evident that the crack had not contributed to any significant loss in structural capability and that the crack did not progress past the external plywood nor did it turn and run along the layers. Even in areas where the ply-to-ply bonding was of poor quality the crack showed no tendency for enlargement. Preventing the crack is expected to be as simple as maintaining the alignment of the leading edges of the two blade halves during bonding.

Figure 27. - Mismatch of leading edge (manufacturing defect) on blade 1012.

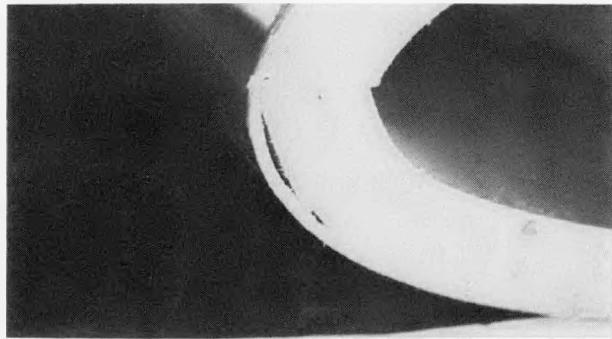
**General laminate bond quality:** In a number of areas of the blade individual plies had not bonded together, and in a few places plies had split or overlapped. A sequence of these events is shown in figure 29. As a percentage of volume, however, the defects were minimal and in no case was there any evidence that a structural failure had occurred, or would result, because of

(a) Nose delamination at station 492.

the defect. In most cases, the problem could be eliminated in future production by using a slightly thicker (15 percent) epoxy coating on the wood. The extra epoxy would assure that layers were bonded together and would tend to flow and fill the few void areas that were found. In general, the wood laminate quality was considered to be excellent.

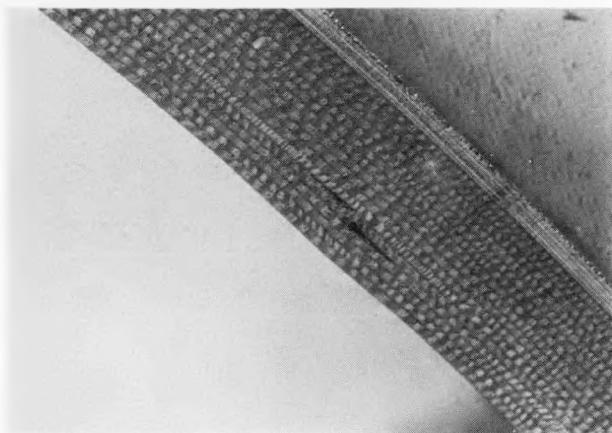
(b) Veneer overlap from sections near top.

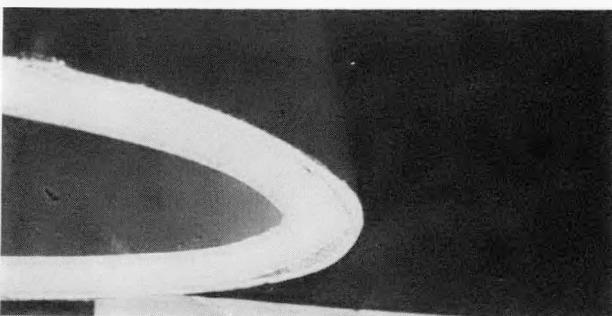
(c) Lack of ply conformance to mold from station 550 outboard.

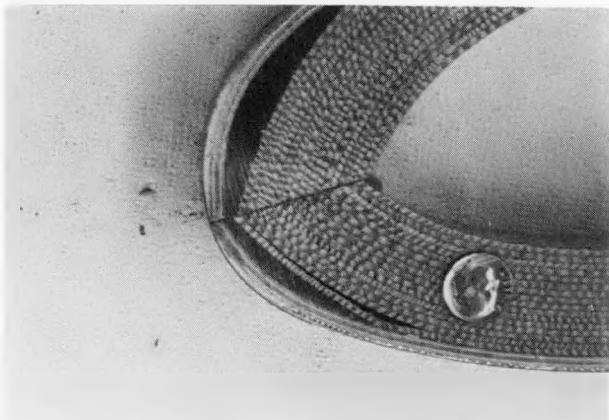
(d) Leading-edge crack, disbond, and nonconformance to mold at station 650.

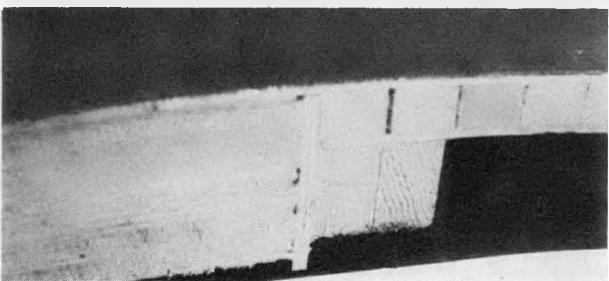
(e) Gaping between blocking at station 252.
