MADISONVILLE AREA WIDE SUBSIDENCE INVESTIGATION (1986). 181 pp.
(USDOI-Office of Surface Mining and Enforcement, Pittsburgh PA)

MADISONVILLE AREA WIDE SUBSIDENCE INVESTIGATION

OFFICE OF SURFACE MINING RECLAMATION AND ENFORCEMENT
EASTERN TECHNICAL CENTER
TEN PARKWAY CENTER
PITTSBURGH, PA 15220

SEPTEMBER, 1986

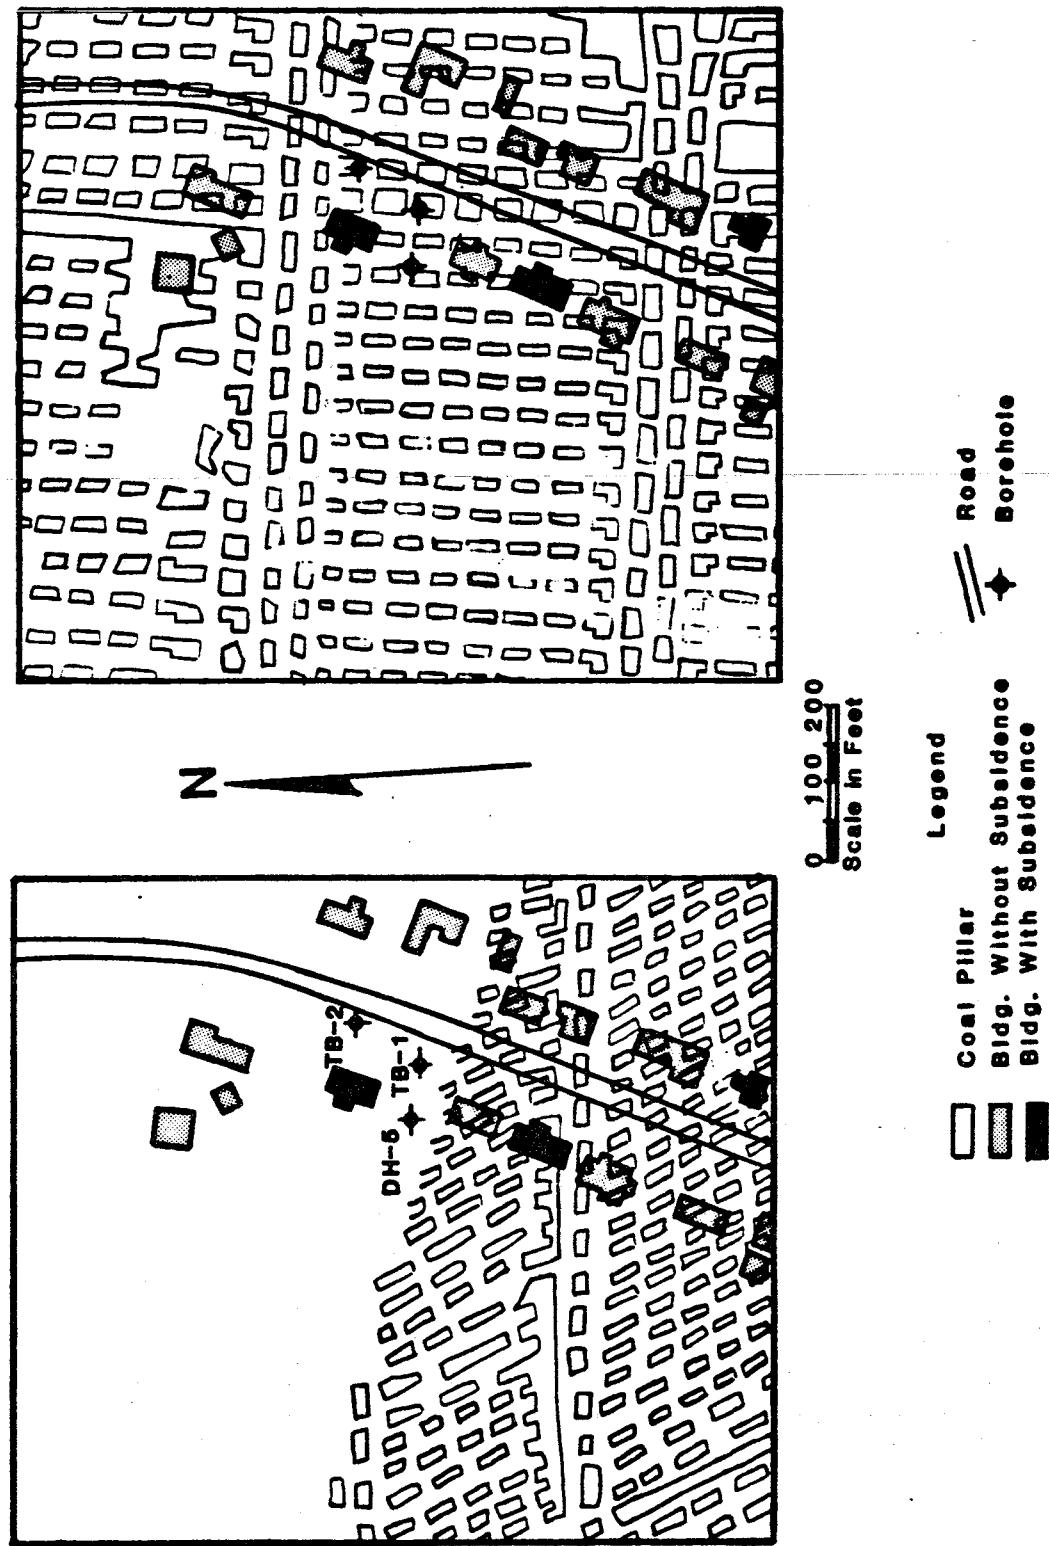
Figure 12. Mine map of Number 11 Coal (right) and Number 9 Coal (left) with cultural features and location of drill holes (DH-5, TB-1 and TB-2). For more detailed information see Number 9 Coal Map 2C, Number 11 Coal Map 2B and Topographic Map 2A.

Continued damage to 541 Park Avenue prompted the drilling of two additional drill holes (TB-1 and TB-2; Figure 12) in September of 1983 to augment the findings from DH-5. Both drill holes penetrated pillars in the Sunset Mine at the Number 11 Coal level. Only minor fracturing of strata above was observed in either core (Etue and others, 1984). Damage continued in this locality and two more holes were drilled in the fall of 1984. Voids of 4 feet at the Number 11 Coal and 3 feet at the Number 9 Coal were penetrated (Etue and others, 1984).

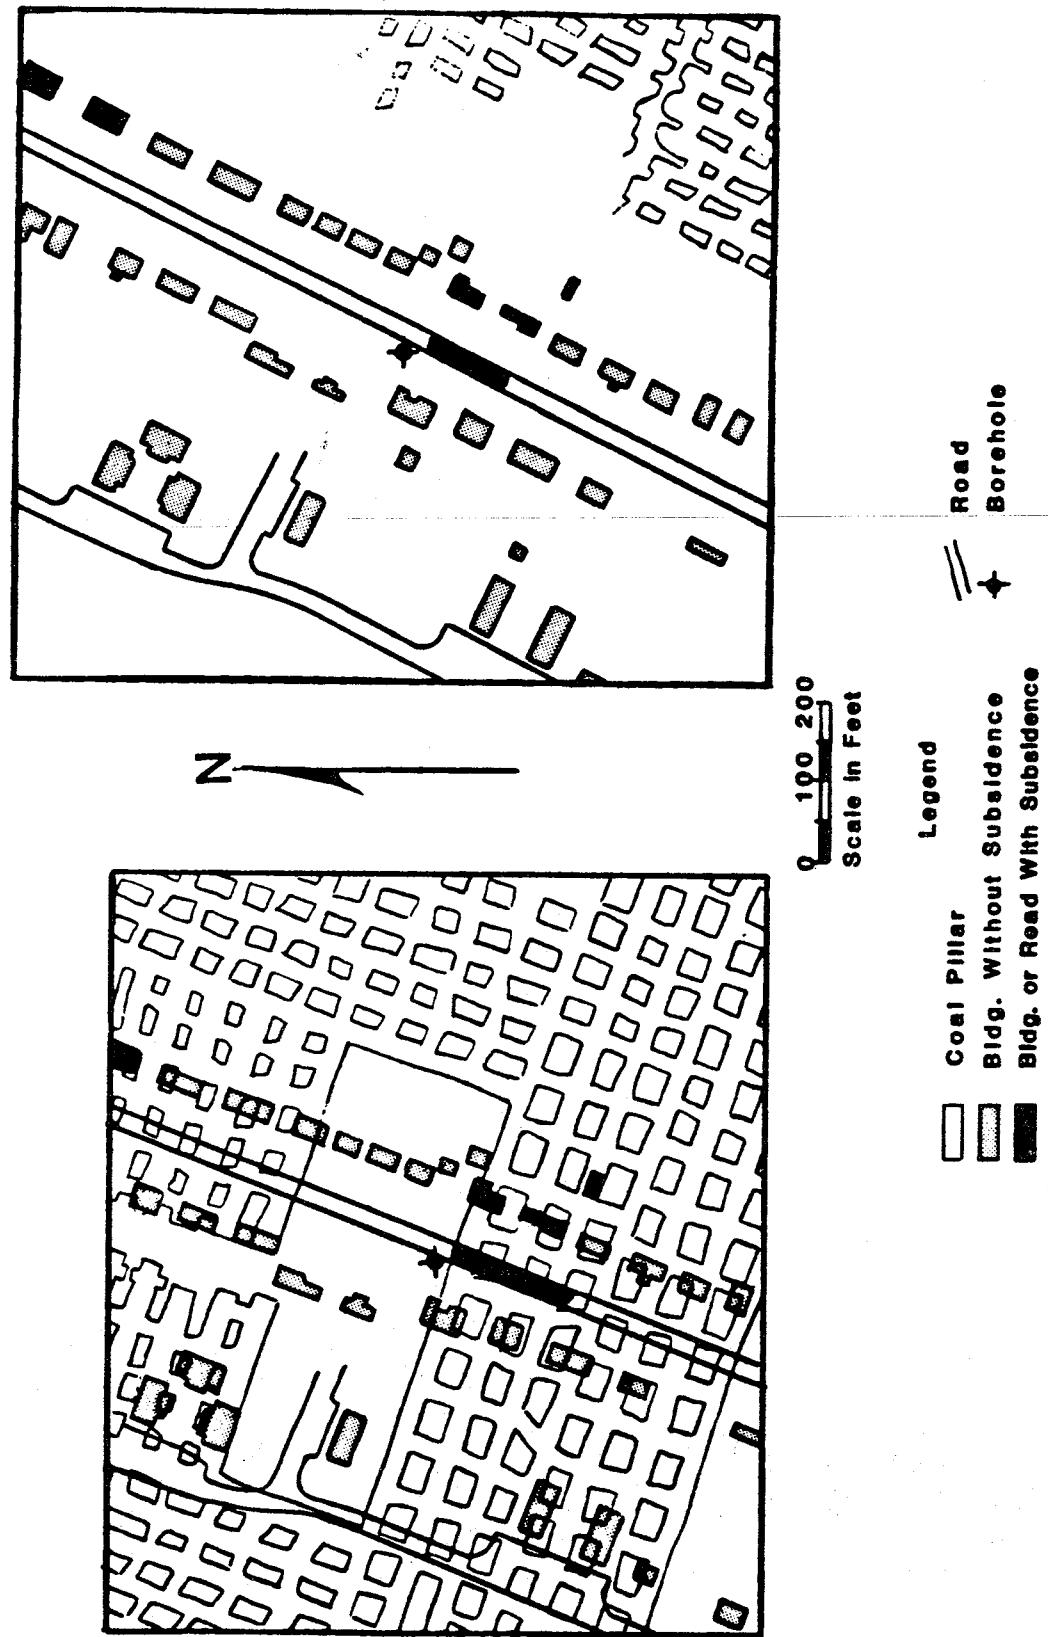
Figure 16. Mine map of Number 11 Coal (right) and Number 9 Coal (left) with cultural features and location of drill hole (DH-11). For more detailed information see Number 11 Coal Map 5B, Number 9 Coal Map 5C and Topographic Map 5A. Number 11 Coal map is incomplete.

Gas trapped in DH-11 was of sufficient pressure to blow the borehole cap 20 feet into the air when it was removed for the television camera inspection. The television survey showed gas bubbles escaping from porous rock strata and fracture zones. The surface elevation of the water in the borehole was difficult to determine because gas rising in the borehole caused frothing and 20-30 foot surges of the water surface level within the drill hole; however, the water level is estimated to be at least 150 feet above the flooded mine. Local residents who worked in these mines recall that excessive gas buildup was also a problem during mining.

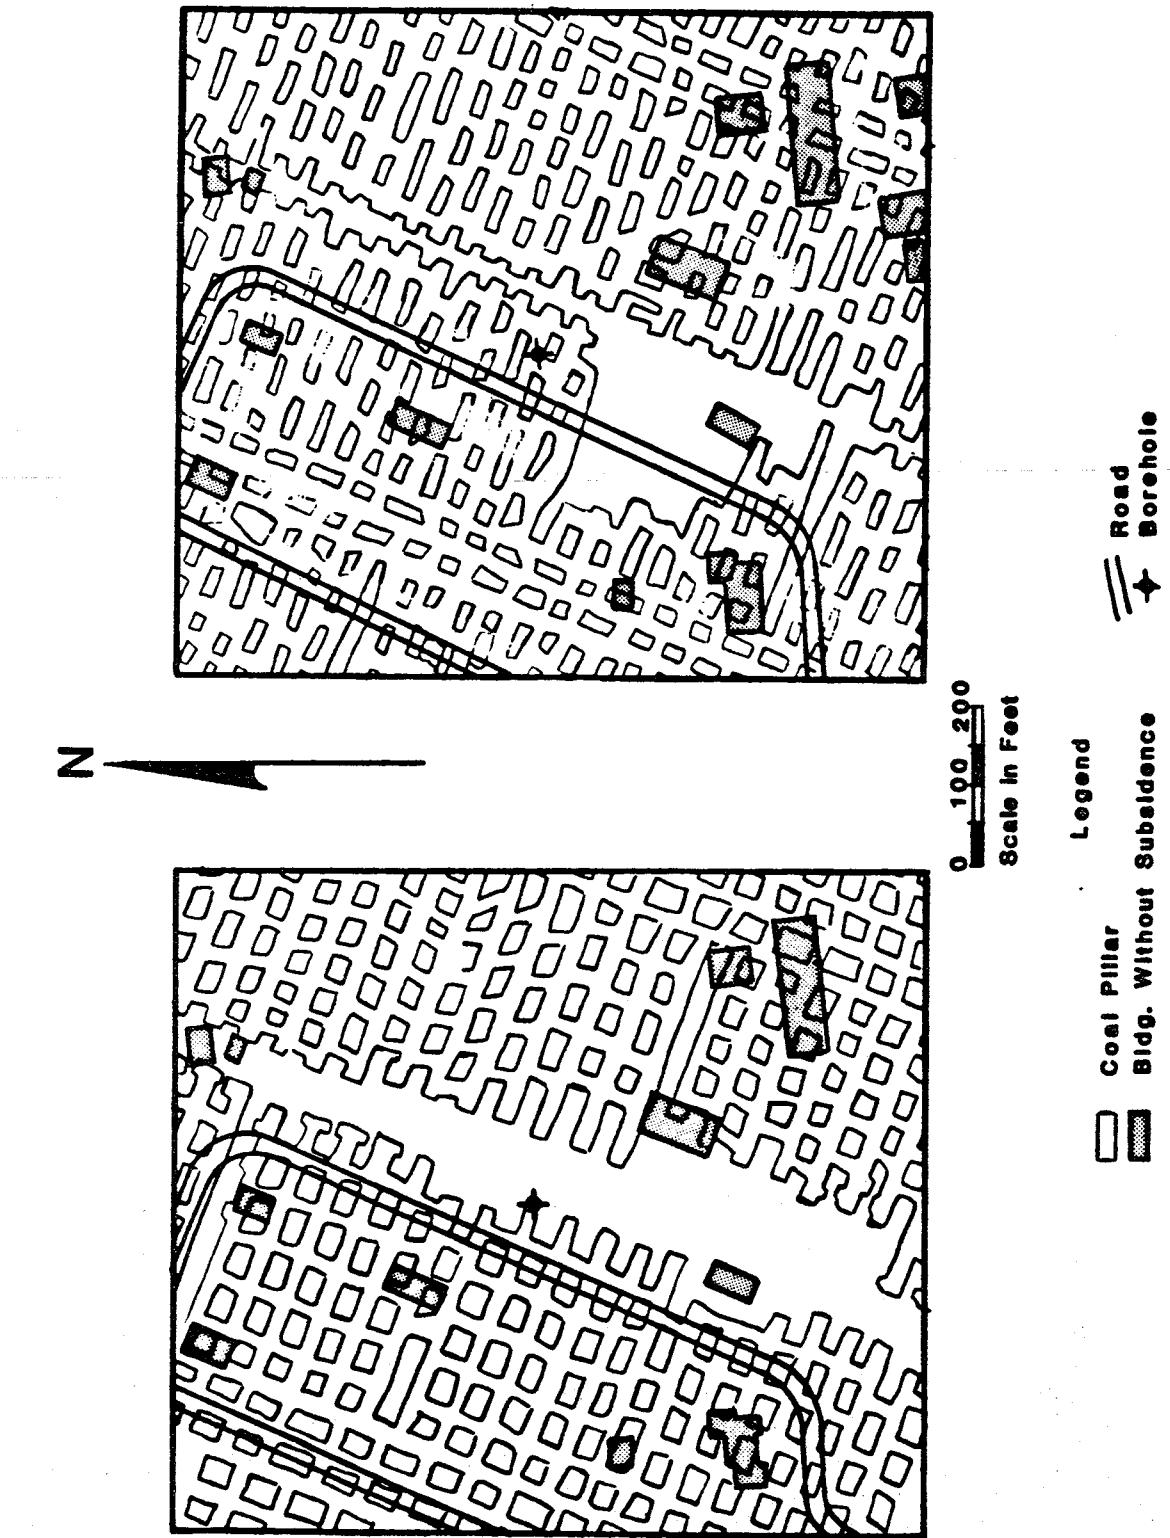
Figure 17. Mine map of Number 11 Coal (left) and Number 9 Coal (right) with cultural features and location of drill hole (DH-14). For more detailed information see Number 11 Coal Map 5B, Number 9 Coal Map 5C and Topographic Map 5A.

One exploratory hole (DH-14) was drilled in the Scanfield Addition (Figure 17) to determine subsurface conditions. This hole was sited near a northeast trending surface crack along the east side of the Scanfield Addition. The drill hole core data (Table 2) indicated broken and collapsed rock in the East Diamond Mine in the Number 11 Coal and fractures extending upwards in the rock overburden above the mine. The Number 9 Coal was in place with only a few fractures in the rock immediately above the coal (Table 2). No holes were drilled in the Sharpe Addition during this study since the landowners were in litigation against the coal companies.

Pillar strength calculations (Table 8) indicate that the smaller pillars in the East Diamond Mines in both the Number 9 and 11 Coals should crush under the existing overburden loads. The pillars in the entry areas of both mines show strengths slightly above the overburden loads and would be capable of supporting the loads until pillar deterioration reduce the strength of the pillar to the point of failure.

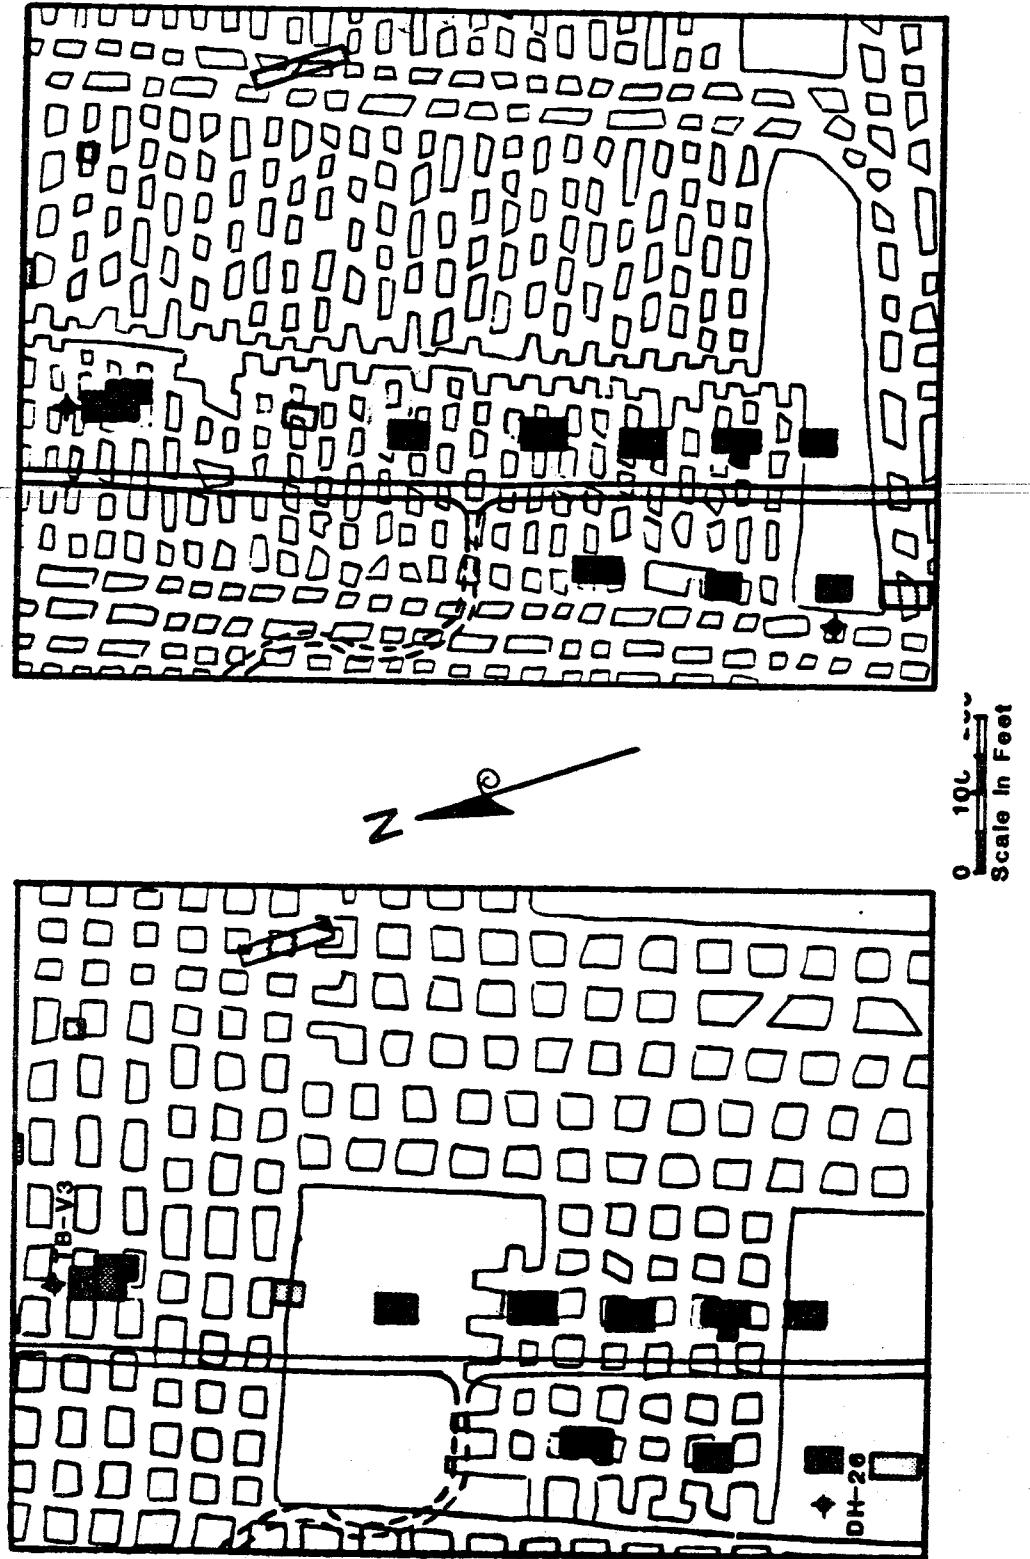
Figure 18. Mine map of Number 11 Coal (right) and Number 9 Coal (left) with cultural features and location of drill holes (DH-26 and TB-V3). For more detailed information see Number 11 Coal Map 6B, Number 9 Coal Map 6C and Topographic Map 6A.

Numerous holes were drilled throughout the Continental Drive area during the initial drilling to investigate the emergency subsidence event and during the subsidence stabilization program. Two drill holes were analyzed to establish conditions occurring in the mine; DH-26, drilled during the present investigation at the south end of the project, and TB-V3 (Kilburg and Alvi, 1982) at the north end of the project (Figure 18). Drill hole 26 penetrated solid coal in the Number 11 Coal, so the condition of the mine void could not

be evaluated. Drill hole TB-V3 penetrated a roof fall area with a two foot void.

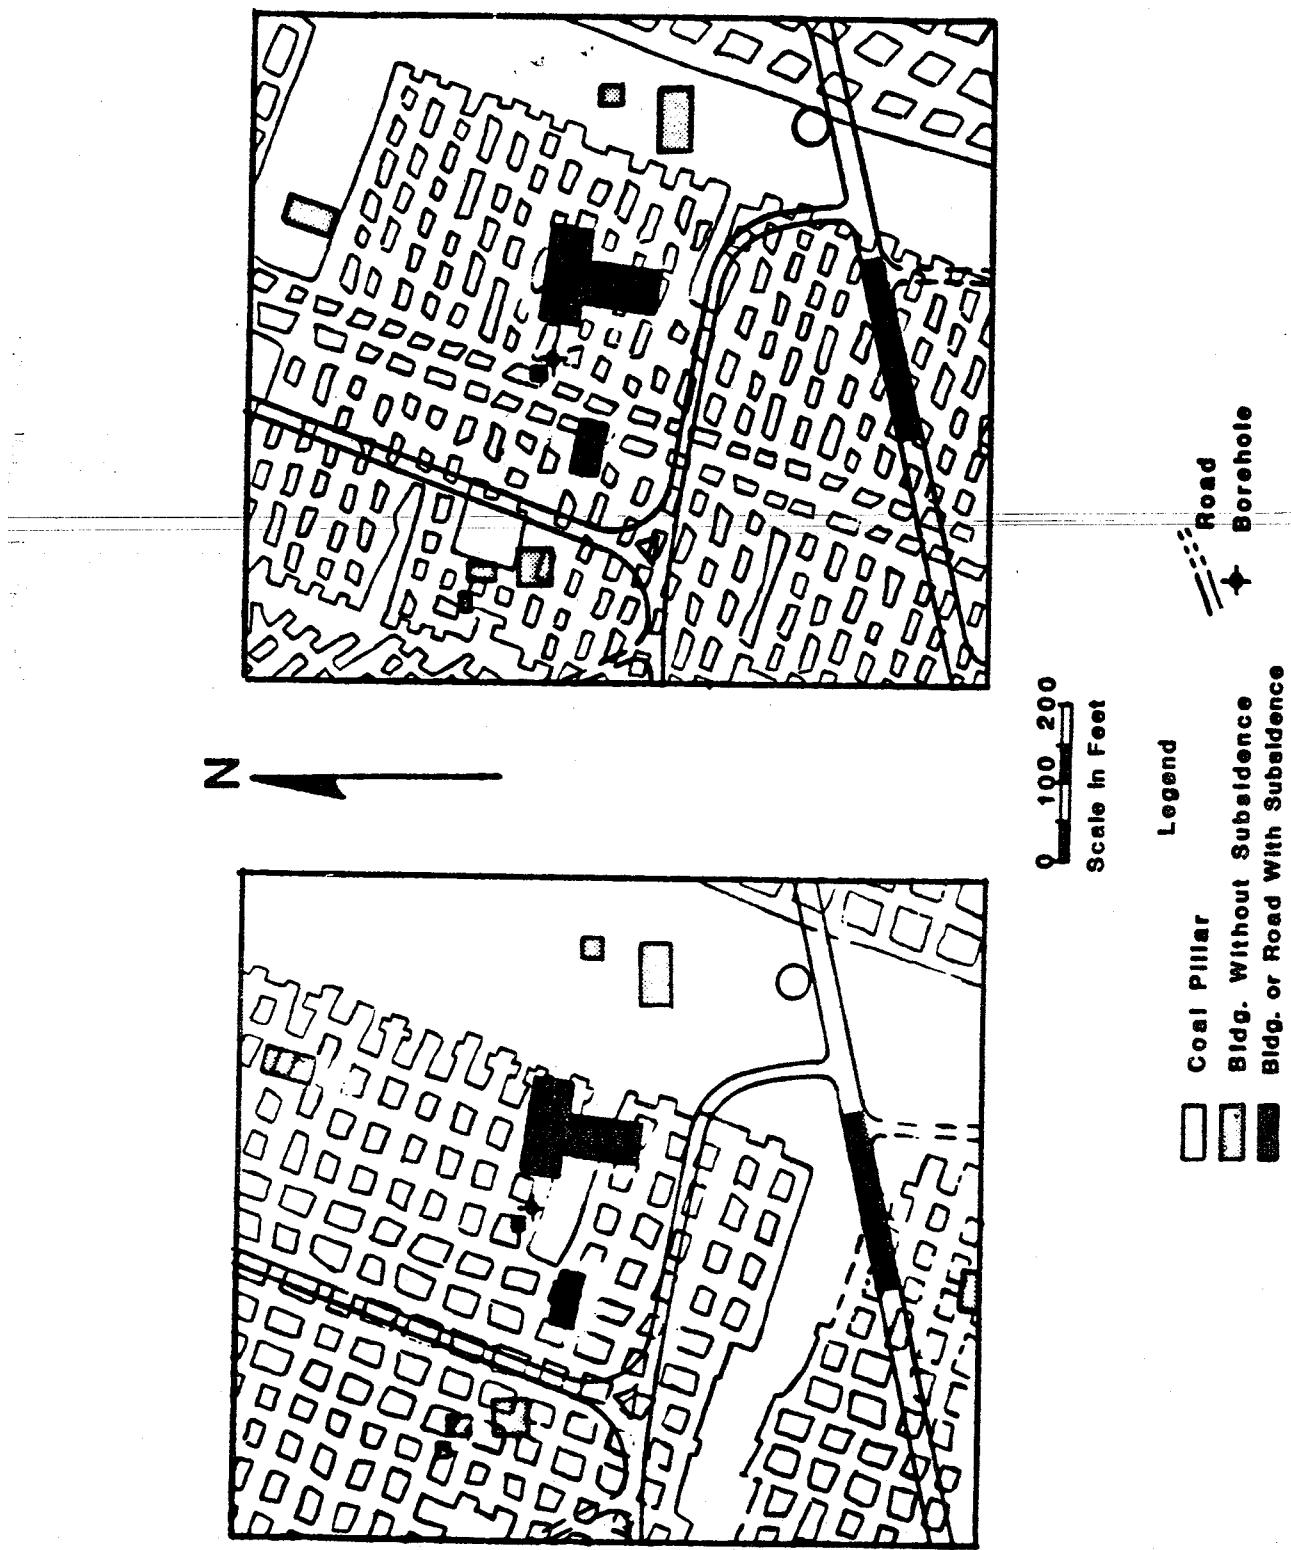
Figure 20. Mine map of Number 11 Coal (left) and Number 9 Coal (right) with cultural features and location of drill hole (DH-15). For more detailed information see Number 11 Coal Map 6B, Number 9 Coal Map 6C and Topographic Map 6A.

Analysis of the maps showing mining beneath the Liberty Baptist Church (Figure 20) indicates that part of the church is protected by a larger set of pillars in the Number 11 Coal. The core analysis of drill hole 15 (DH-15, Table 2) shows the Number 11 Coal is crushed. Fracturing extends from the Number 11 Coal to the surface. Extraction ratios are fairly typical for this part of the mine; approximately 80 percent in the panels and 70 percent in the entry system (Table 10). Pillar strength calculations show that the smaller panel pillars should crush at depths greater than 175 feet. The Number 11 Coal is at a depth of 269 feet at this site. The entry pillars are larger than panel pillars and extraction ratios are lower, so these pillars should be capable of supporting the overburden.

The church is sited (Figure 20) above a panel close to the entry pillars in the Number 9 Coal. Core data from DH-15 (Table 2) shows roof collapse in the East Diamond Mine in the Number 9 Coal. Thirteen feet of caved and broken rock were found above the roof. Route 85/70 south of the church shows surface depressions which are typical of sag/trough subsidence.

The information above suggests that the larger pillars in the Number 11 Coal beneath the church (Figure 20) and the somewhat stronger cross entry pillars under the parsonage have resisted crushing, at least temporarily. However, the panel pillars, and possibly some cross entry pillars, have apparently crushed causing a sag subsidence.
