CENTRAL RECEIVER SOLAR THERMAL POWER SYSTEM

Collector Subsystem Extended Life Test. Final Report

May 18, 1979

**Boeing Engineering and Construction Company
Seattle, Washington**

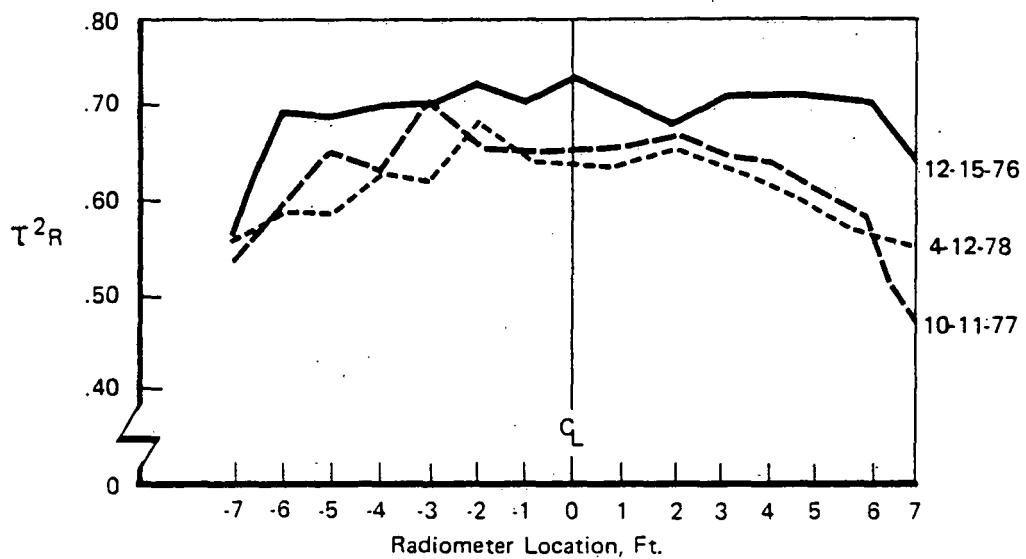
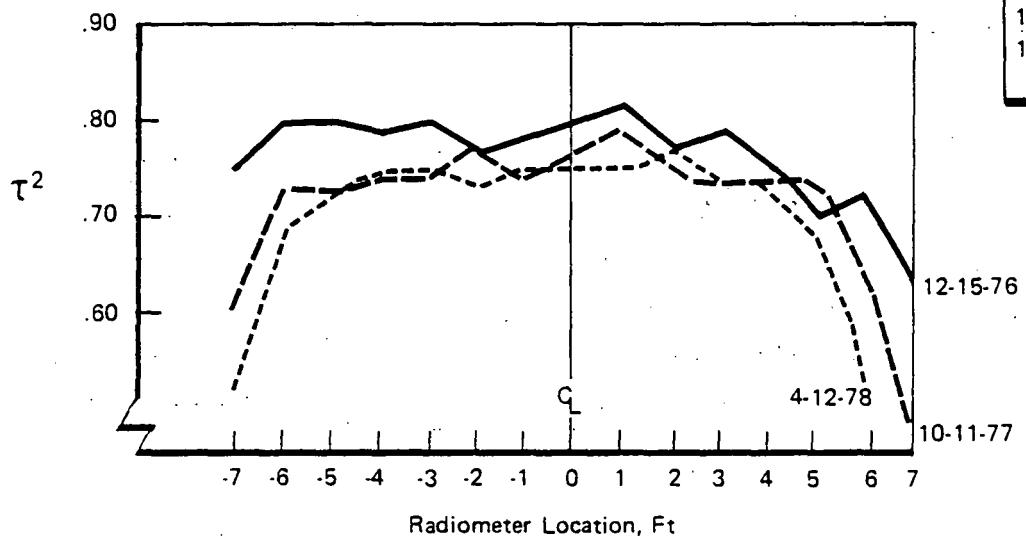
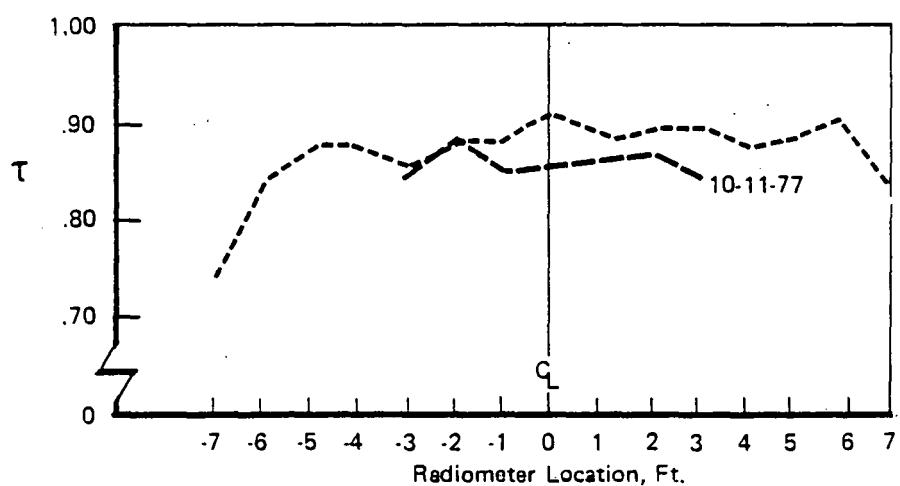
Figure 2-1 Transmittance/Reflectance Tests

The loss in transmittance observed in the first 12 months is believed to be due to dust and dirt accumulation on the outside of the enclosure, and to some extent on the inside. During the 6 months from October 11, 1977 and April 12, 1978, the blower filters required more frequent changing due to rodent damage and considerably greater dust ingestion was observed. Dust was visibly apparent on the reflector surface and gauze wipes revealed some dust had been settling on the inside surface of the enclosure. This loss of overall heliostat reflectance (T^2R) due to internal contamination emphasizes the need for reduced air flow and adequate dust filtration for future heliostat enclosure designs.

It should be emphasized that this heliostat enclosure had not been cleaned since April 3, 1977 and the reflector had never been cleaned since its installation on November 1, 1976. The degradation described above is attributed primarily to dust and dirt contamination. This is substantiated in Section 3.1 where coupons cut from the enclosure are optically evaluated in the laboratory before and after cleaning.

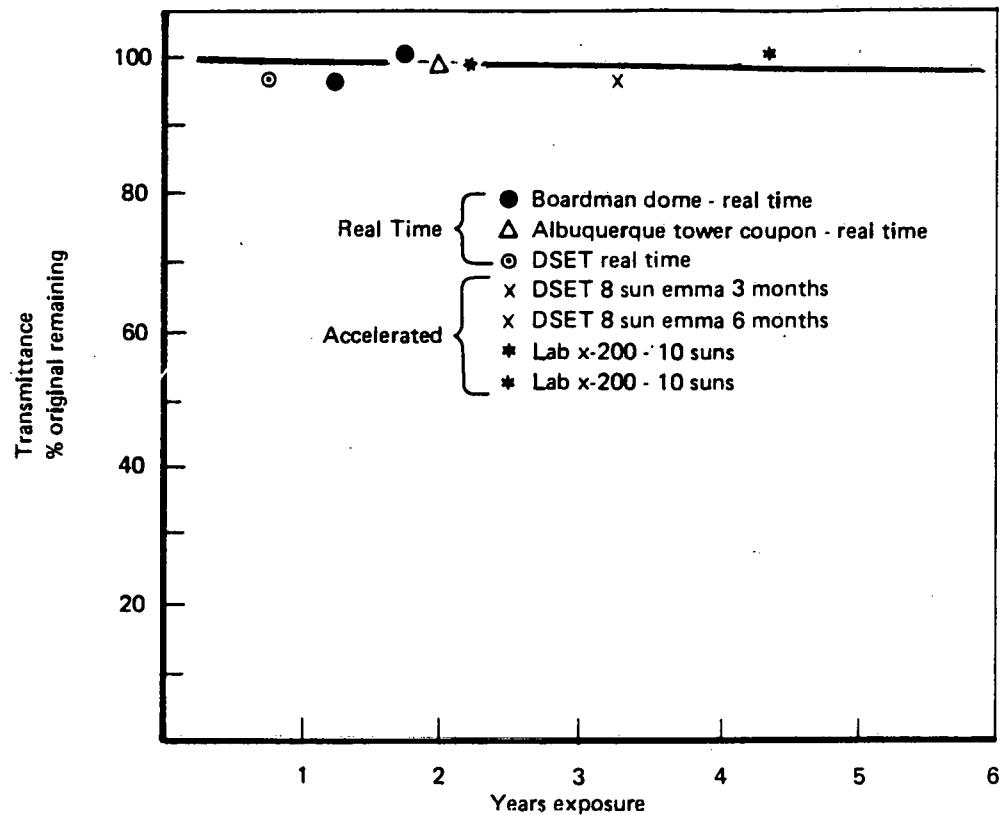
Figure 2-2 Residual Transmittance vs. Exposure

The plot of Figure 2-2 suggests that the transmittance would remain at 96% of its original value for up to 5 years. (Under the real time/acceleration ratio assumptions discussed in the previous paragraph).

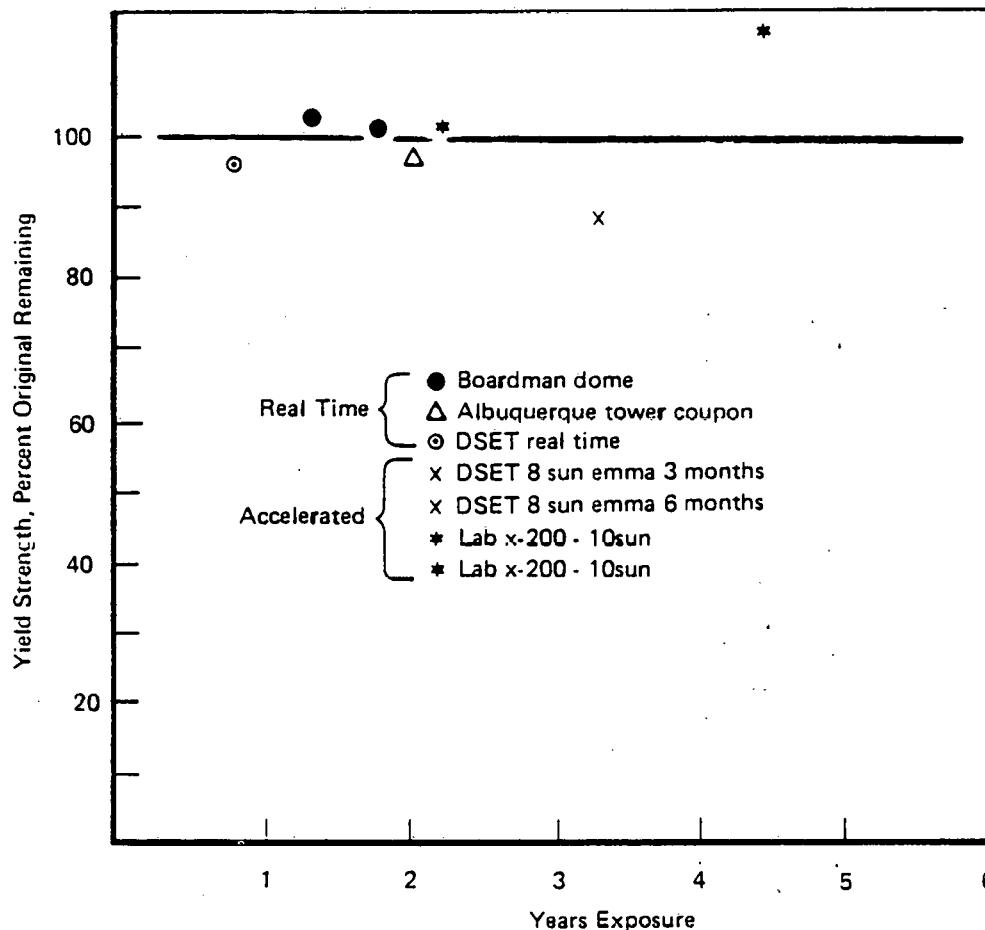
Figure 3-1 Residual Yield Strength vs. Exposure

Figure 3-1 suggests that the yield strength was not detrimentally affected by exposure, and would remain at a high level for at least 6 years. (Assuming the 1:1 acceleration/real time correlation used here; i.e., X Langleys for 1 day = 1 Langley for X days.) Ultimate strength and % elongation (Figure 3-2 and 3-3) appear to roll off with time, but would likely retain sufficient values well in excess of 6 years, particularly in view of film stress margins used in the enclosure design.

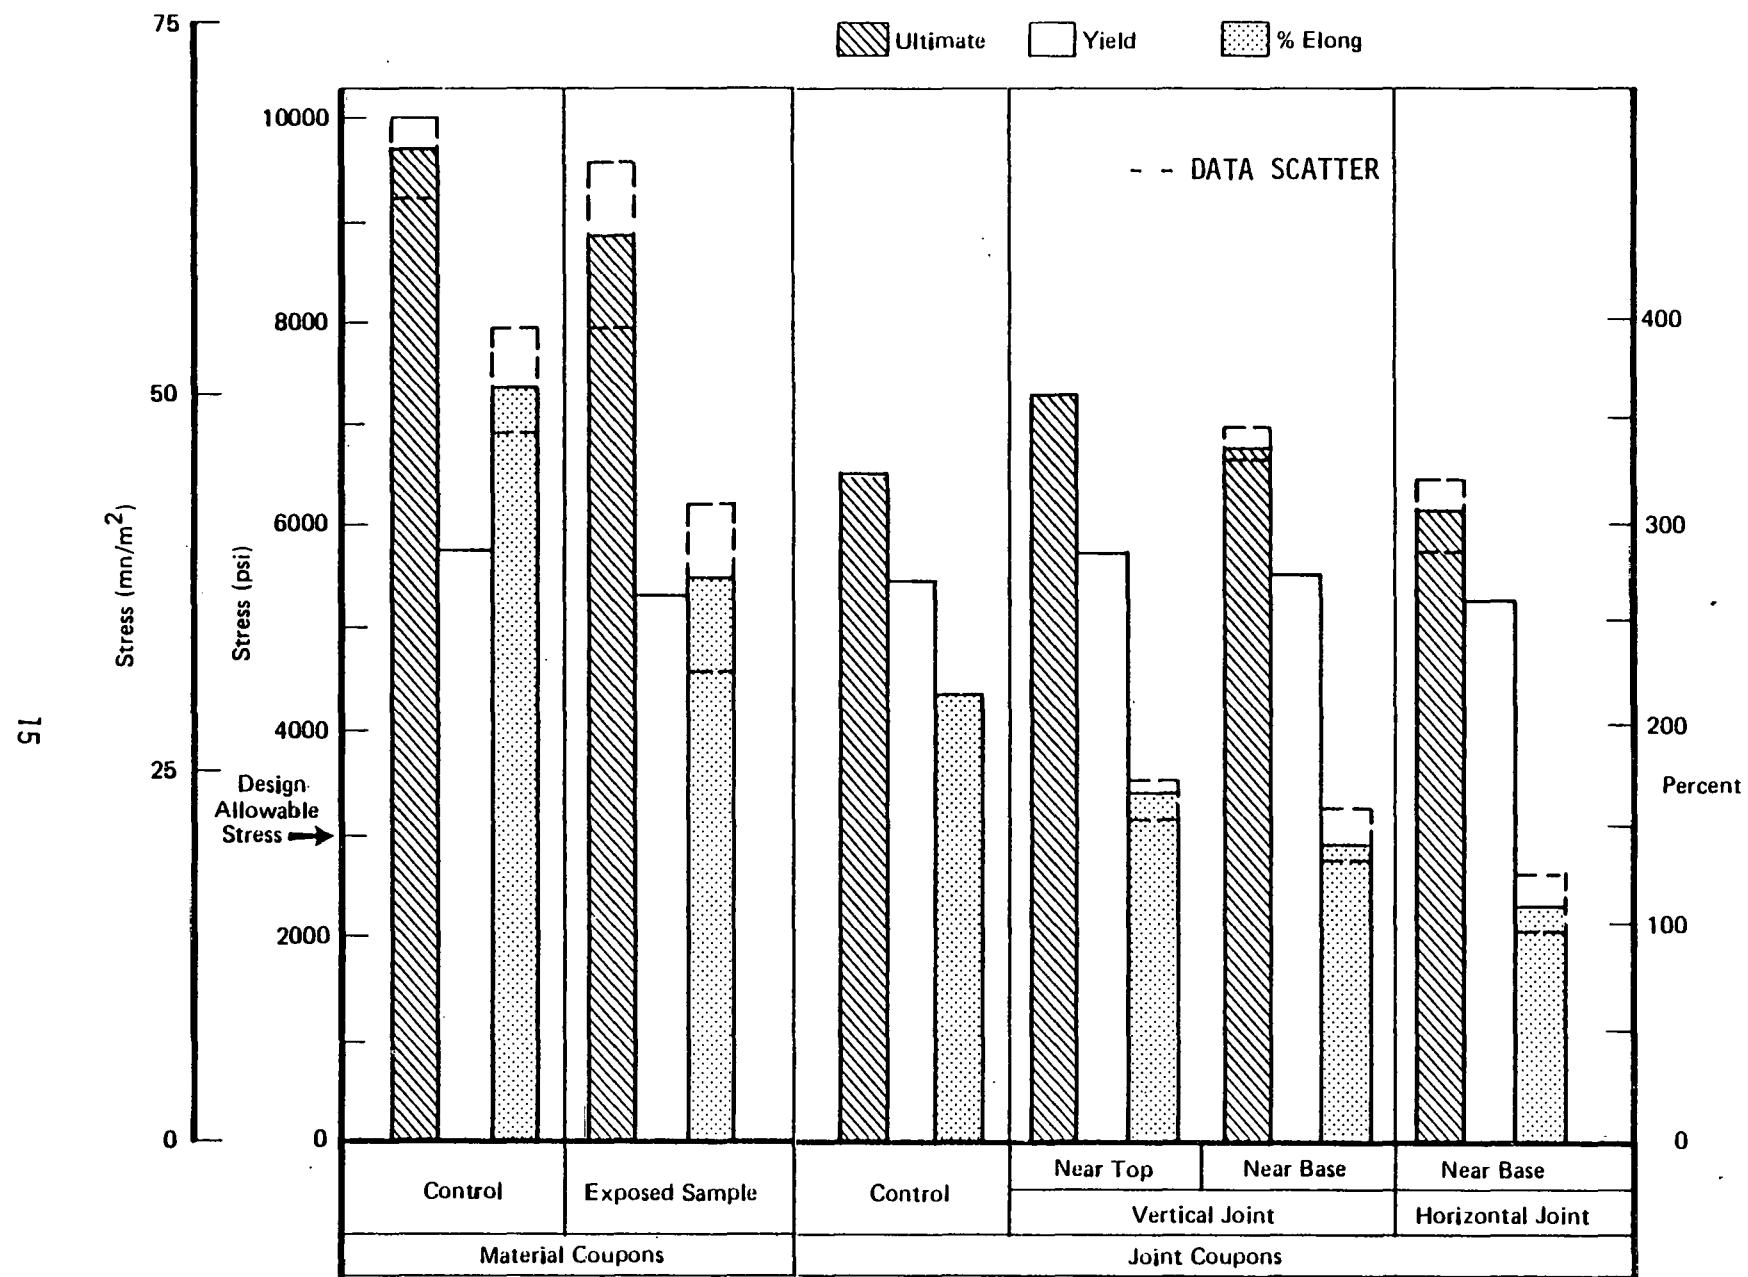
Figure 3-4 HO Enclosure Tensile Test Data

Representative material was cut from H0 enclosure at Boardman and returned to the laboratory for mechanical testing. Tensile tests were performed on material specimens and joint specimens removed from vertical gore seams near the top and bottom of the enclosure and from the horizontal seam near the steel base. In addition, tensile tests were conducted on unexposed material and material with joints for control purposes. Figure 3-4 presents the test results graphically.

While small losses in ultimate and yield strengths of the material were observed, the yield strength was greater than the allowable stress by 1.5:1. The ultimate strength was approximately 3 times the allowable stress. These data strongly suggest that the material strength was adequate at the time of enclosure failure. Attention to joint data reveals a similar situation. Only slight loss in yield margin occurred and the ultimate failure margin was equal to at least 2:1 in all cases. The most obvious change was the nearly 2:1 loss in ultimate elongation observed in the horizontal seam joint. However, over 100% elongation still remained at the weakest joint; certainly not indicative of a brittle material.

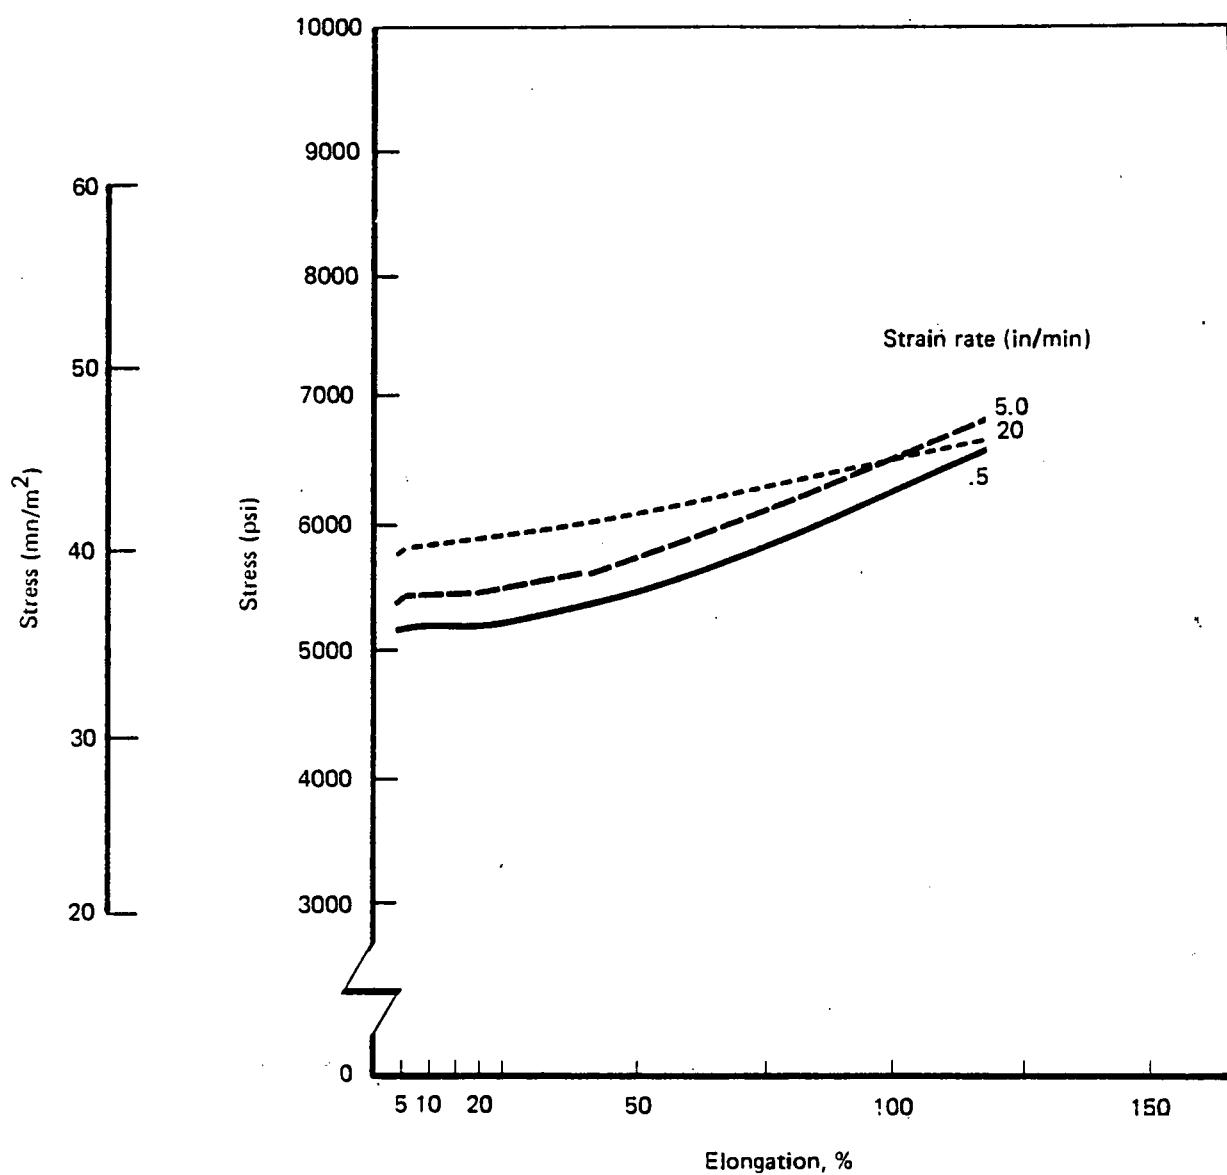
Figure 3-5 Unexposed Tedlar Joint Stress/Elongation Data Variable Strain Rate

Because the failure of the enclosures occurred in a gusting wind condition, the possibility of increased strain rate sensitivity with exposure was considered. Joint samples were subjected to strain rates of .5, 5 and 20 inches per minute on a tensile test machine. Figure 3-5 and 3-6 present the results. The curves show two effects. One effect is the apparent higher strength corresponding to the higher strain rate. The other effect was a slight decrease in strength at all strain rates for the exposed material. However, all curves are well above (1.6:1) the material allowable of 20.7 mn/m^2 (3000 PSI), and reveal no significant decrease in elongation attributable to strain rate variation.

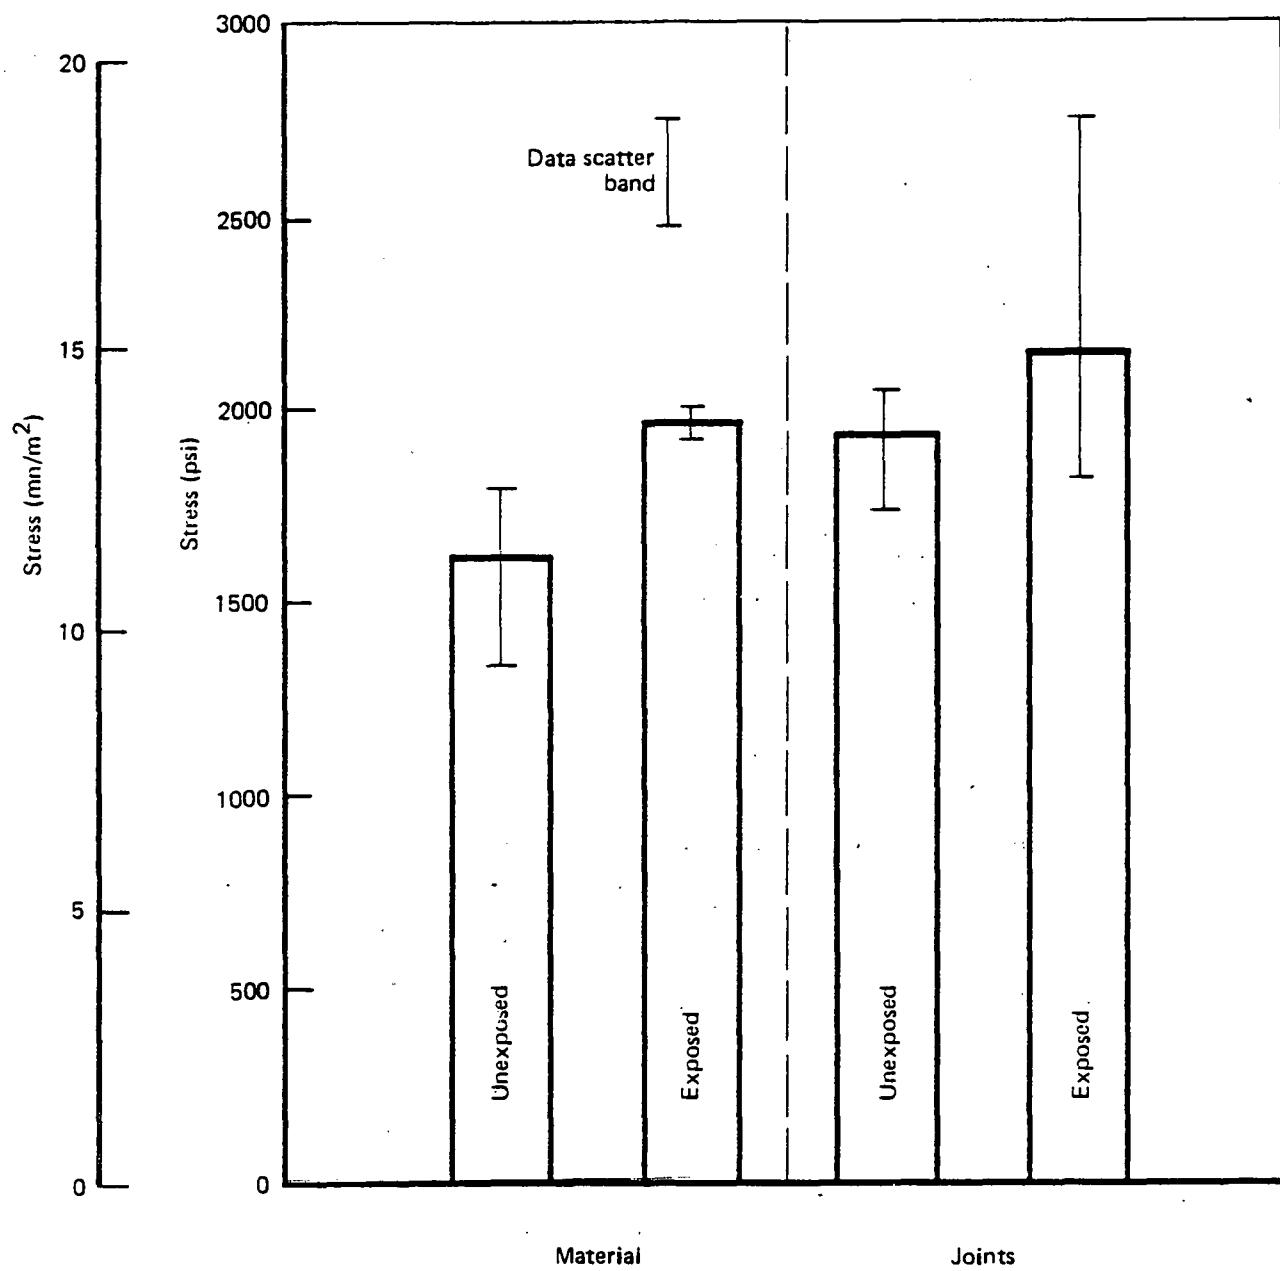
Figure 3-7 Average Tear Initiation Strengths

As mentioned earlier, the failure mode was tearing along the seam. Data has verified that the enclosure material and seams had more than adequate strength to withstand the wind velocities experienced during failure. Examination of the failed seams reveals that the material tore along the seam edge rather than within the seam. Tear samples were cut from exposed material and joints and tear tested per ASTM D1004 (Graves). This test is primarily useful for determining tear initiation. The results are shown in Figure 3-7. Apparently the exposure had no effect on the tear initiation strength. Furthermore, the joints are no weaker than the base material for tear initiation. (However, once the tear is started the joint is observed to be weaker than the base material. This is believed to be the result of the heat sealing process, which locally thins the material as well as removing some of the tear propagation resistance). The testing discussed above reveals nothing that clearly indicates the cause of failure.

It is felt that fatigue in the material adjacent to heat sealed joints is the most likely mechanism of failure. However, because of limited funding no experiments were performed to verify this hypothesis. It is recommended that a research program be undertaken to develop an understanding of the mechanism of failure of Tedlar domes. The research work should include long term exposure of statically and dynamically loaded joint samples to environments of moisture and ultraviolet radiation (individually and combined). Periodic non-destructive and destructive tests would be performed on samples immediately after unloading to avoid suspected "healing effects".
