WRIGHT-PATTERSON AIR FORCE BASE
PCB INVENTORY, ASSESSMENT, AND
CLEANUP PROJECT SUMMARY

Ann M. Boehmer and Doug C. Freund

April 1991

PCB Forum 1991

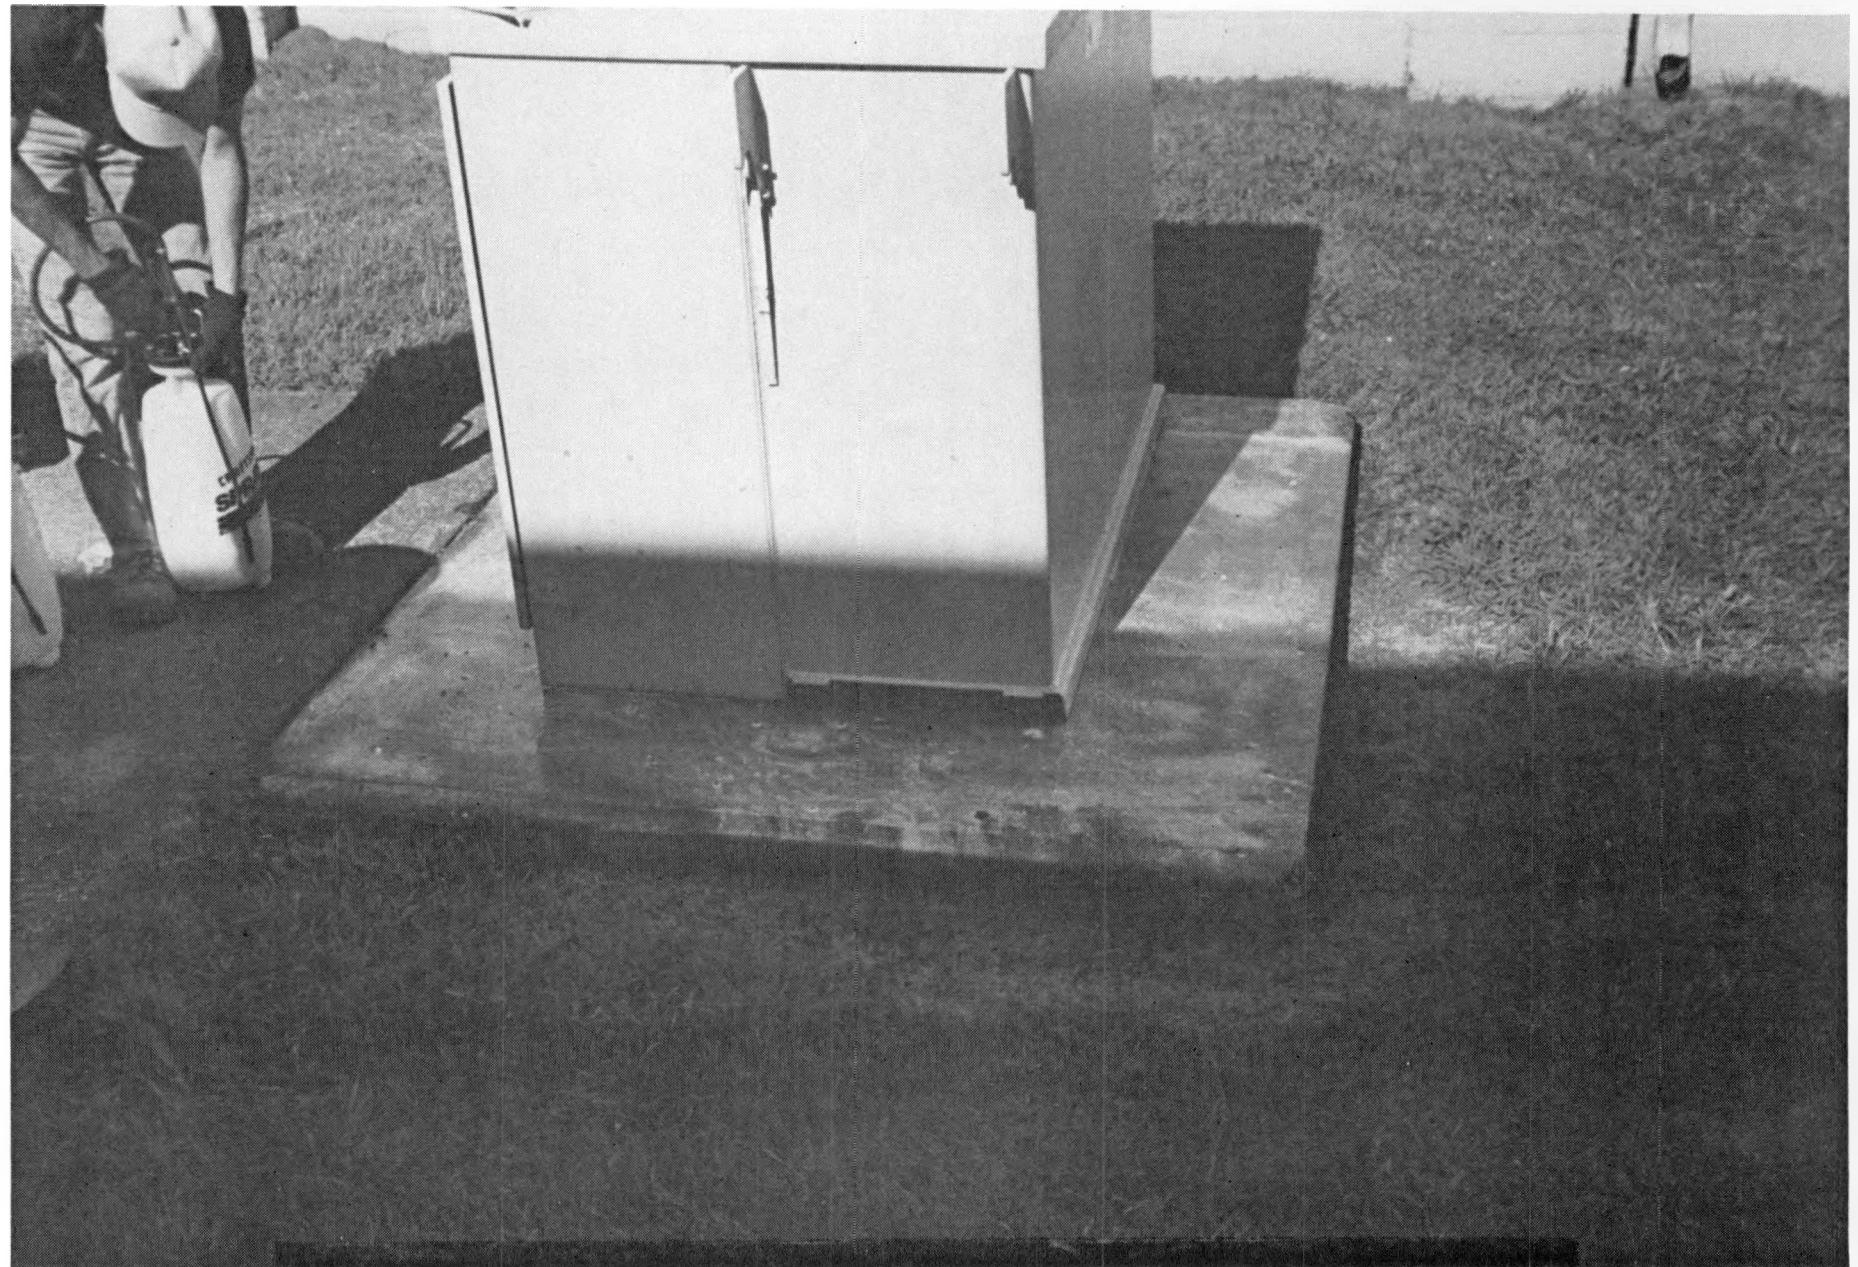
Figure 1. Solvent washing concrete pad with Citrikleen.

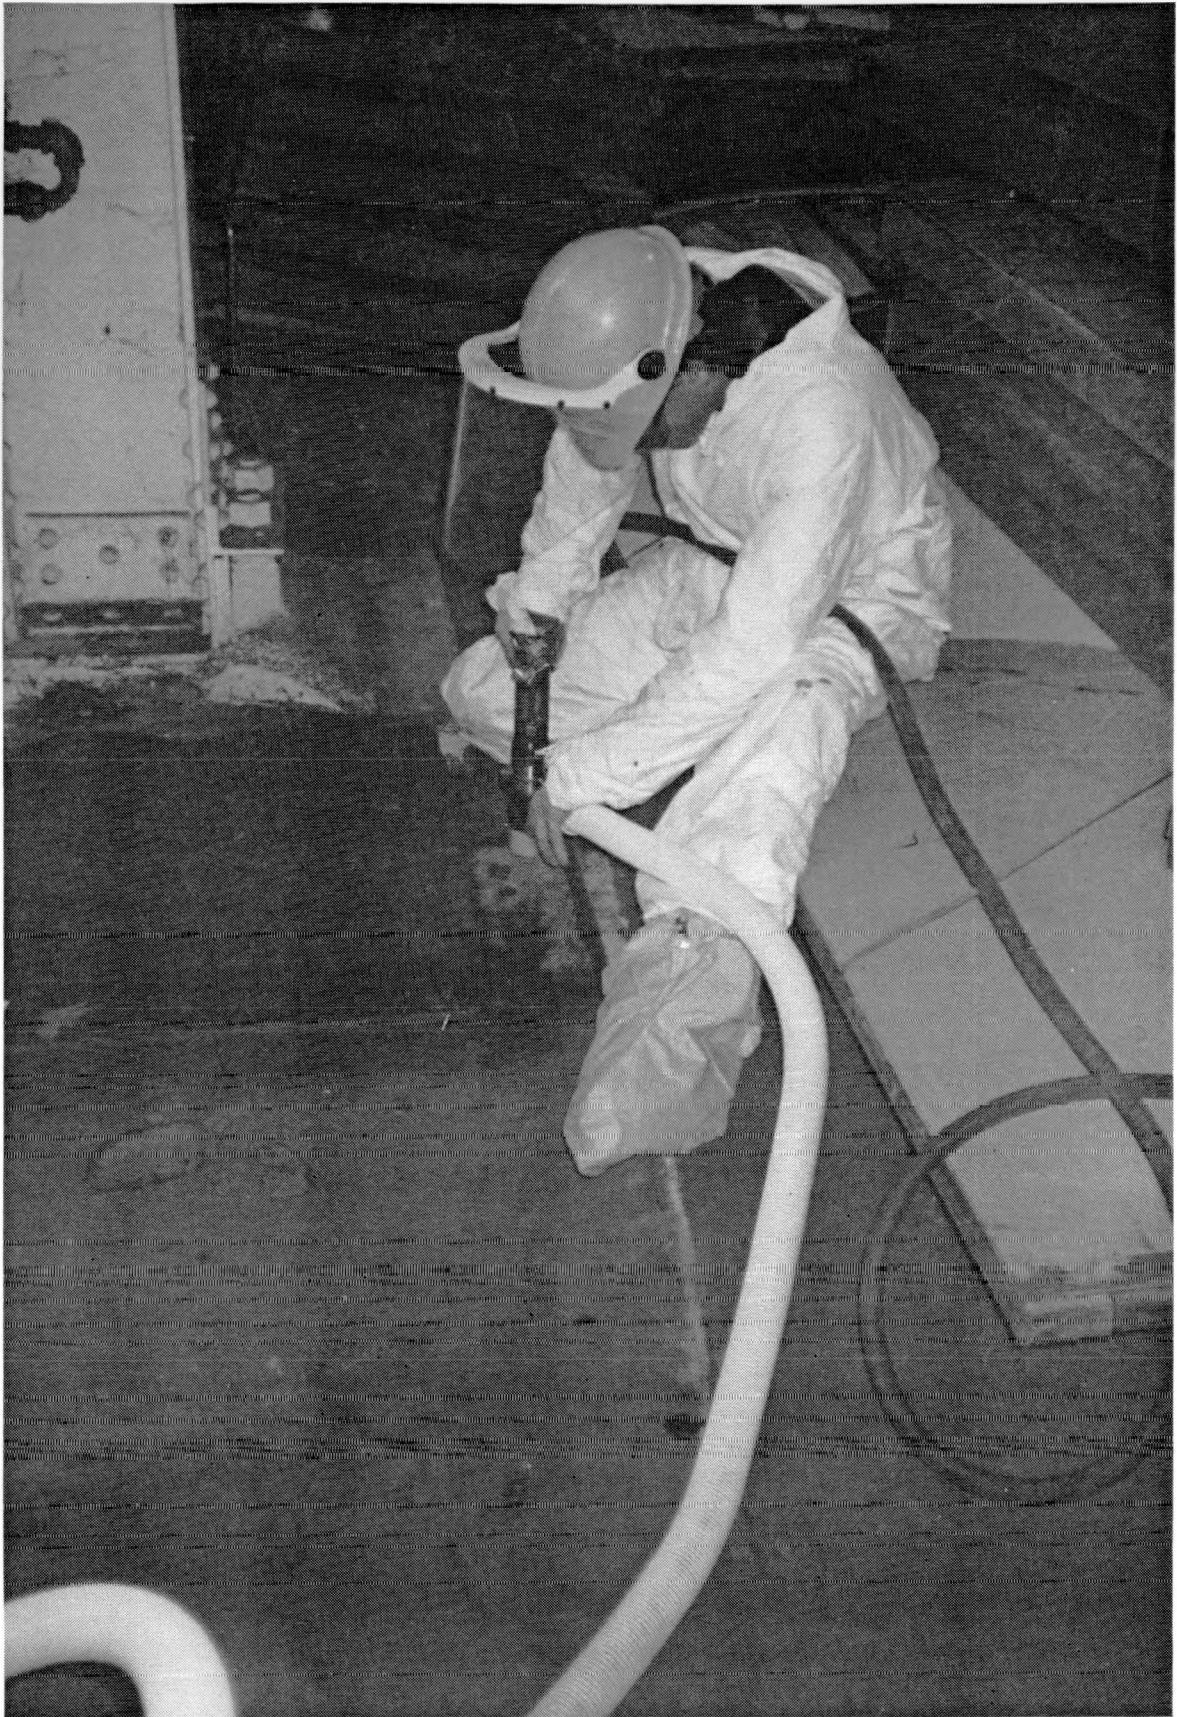
Figure 2. Concrete scarification using corner cutter.

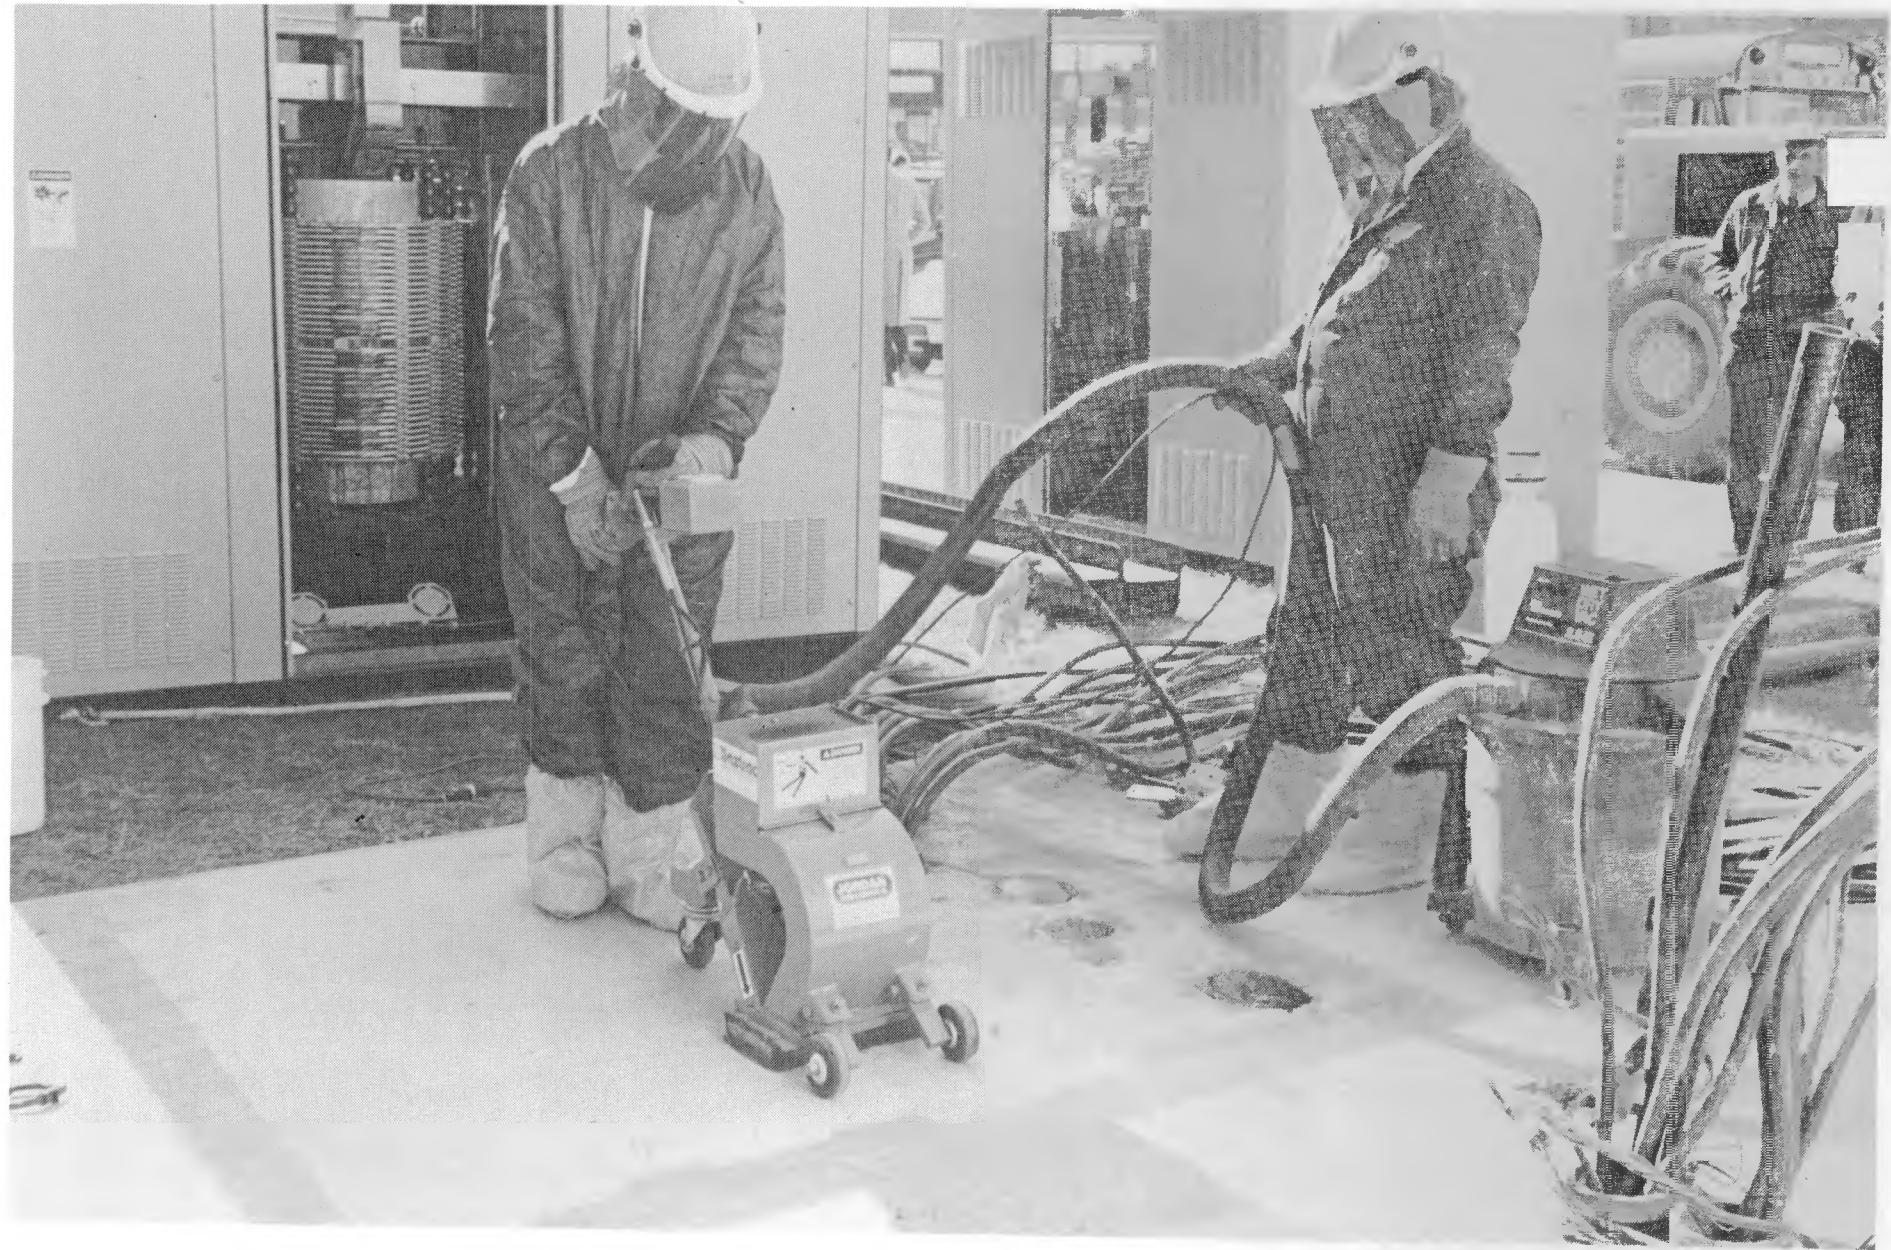
Figure 3. Concrete scarification using shotblaster.

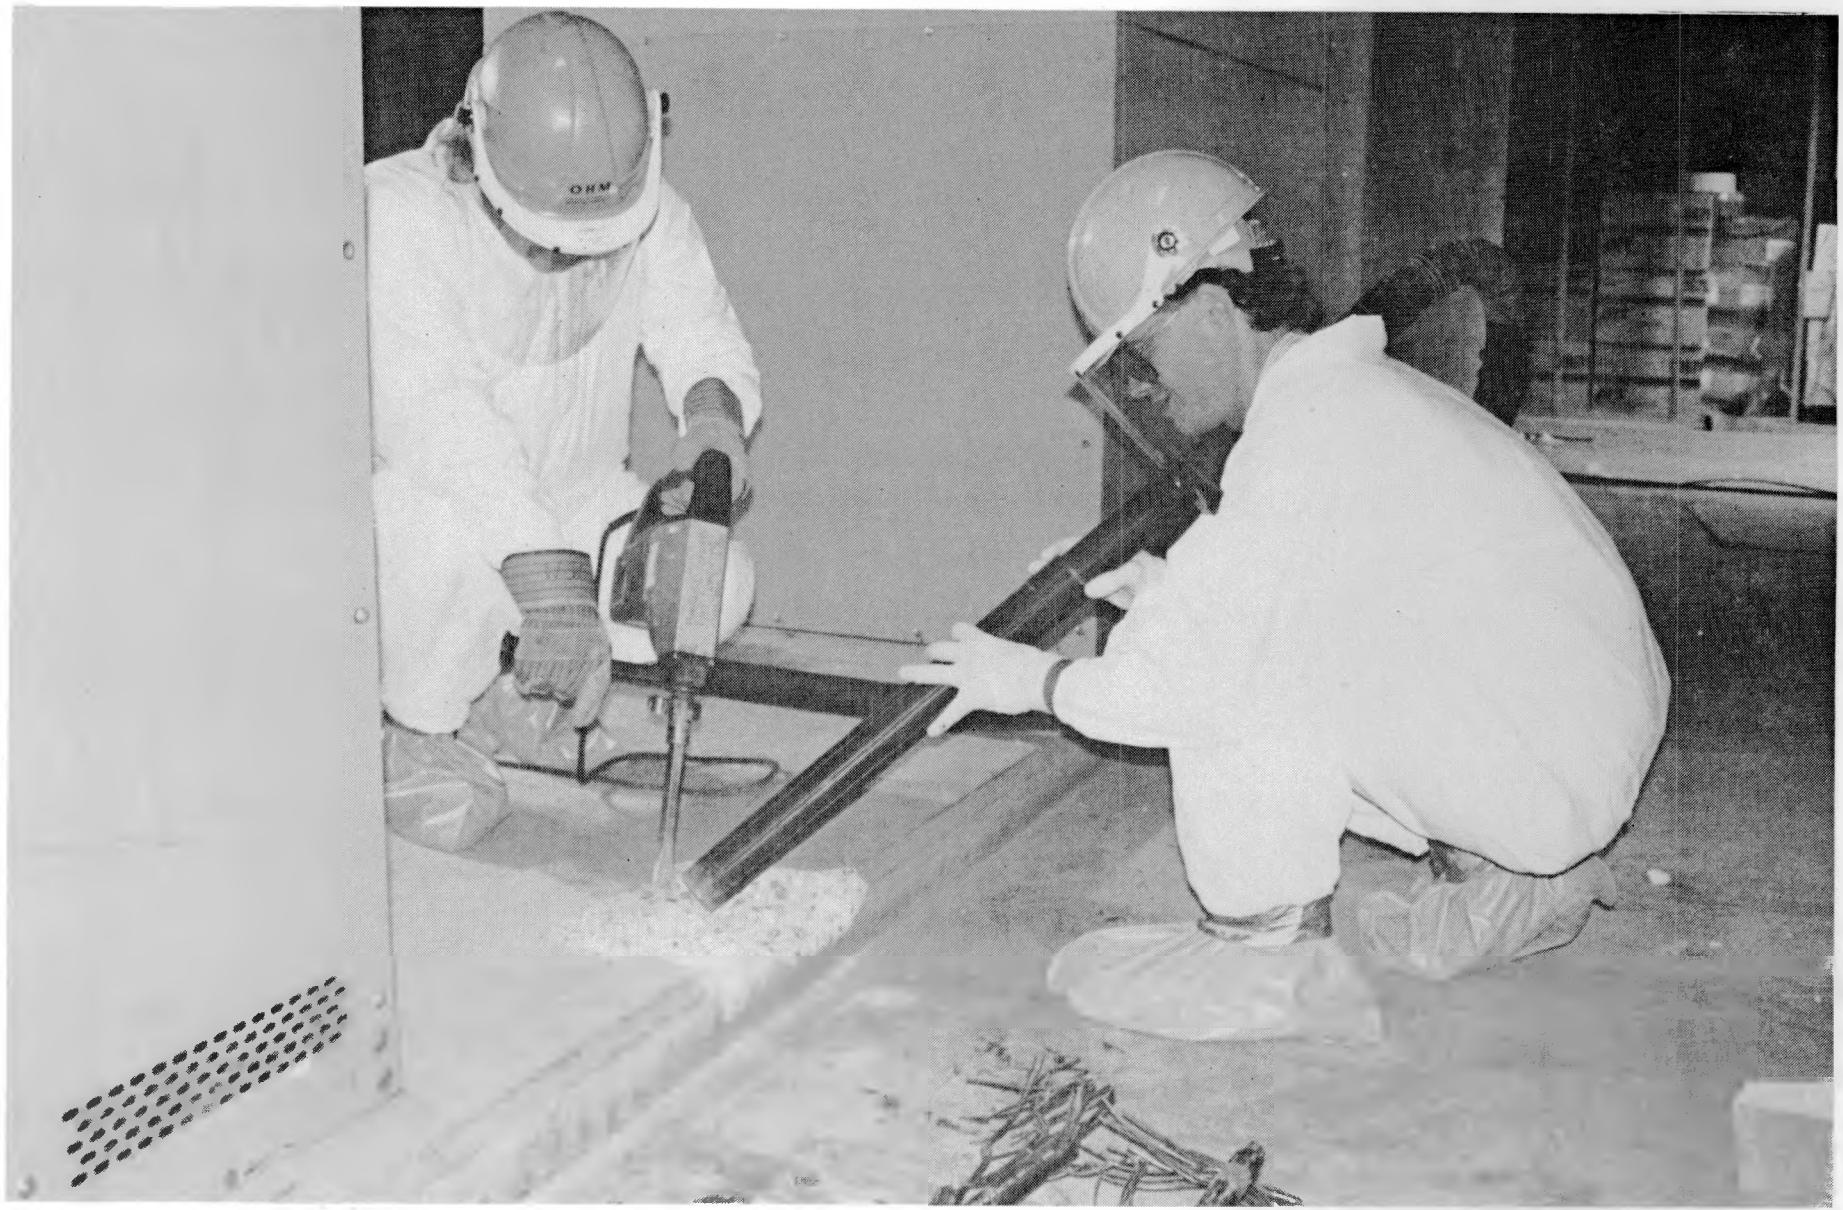
Figure 4. Concrete removal using bosch hammer.

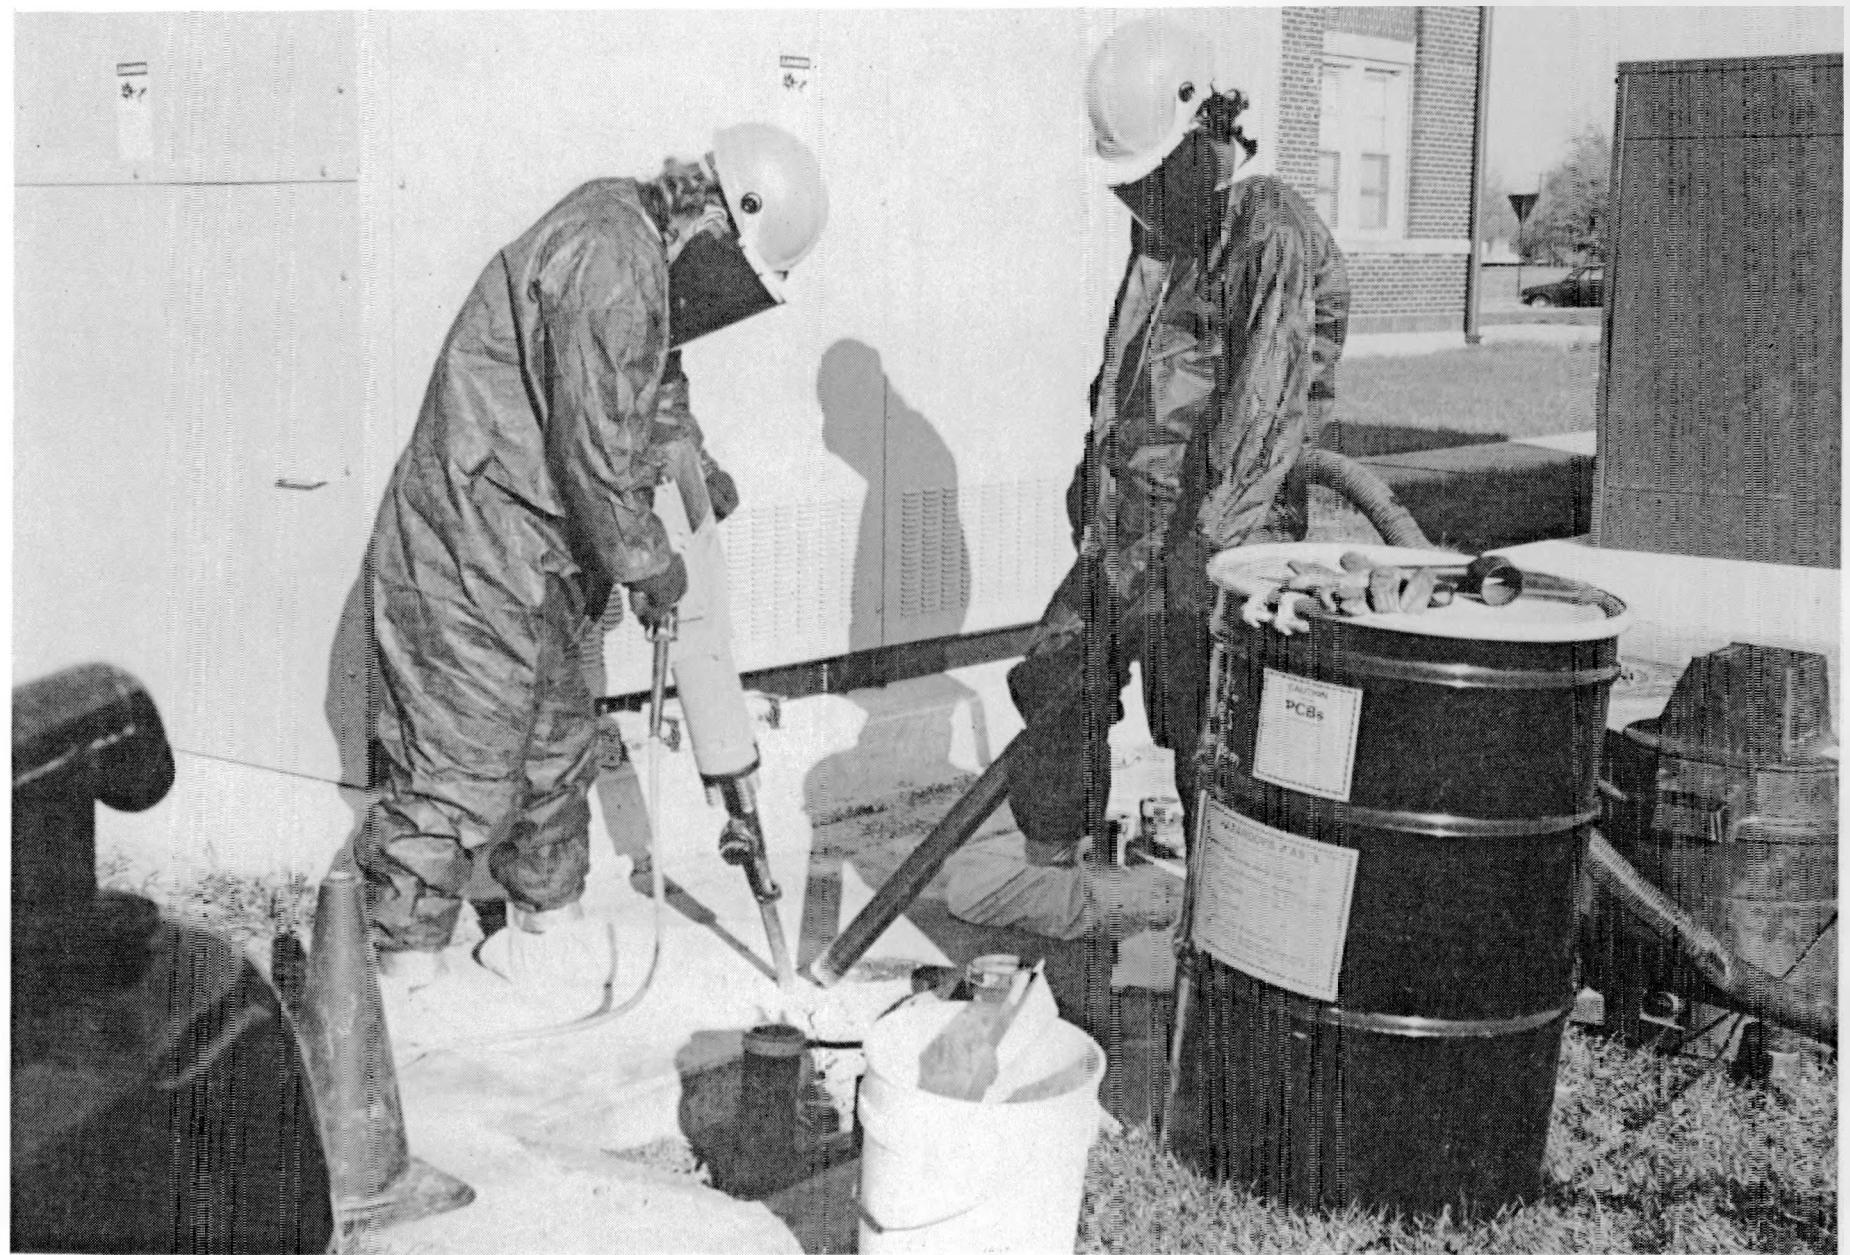
Figure 5. Concrete removal using jack hammer.

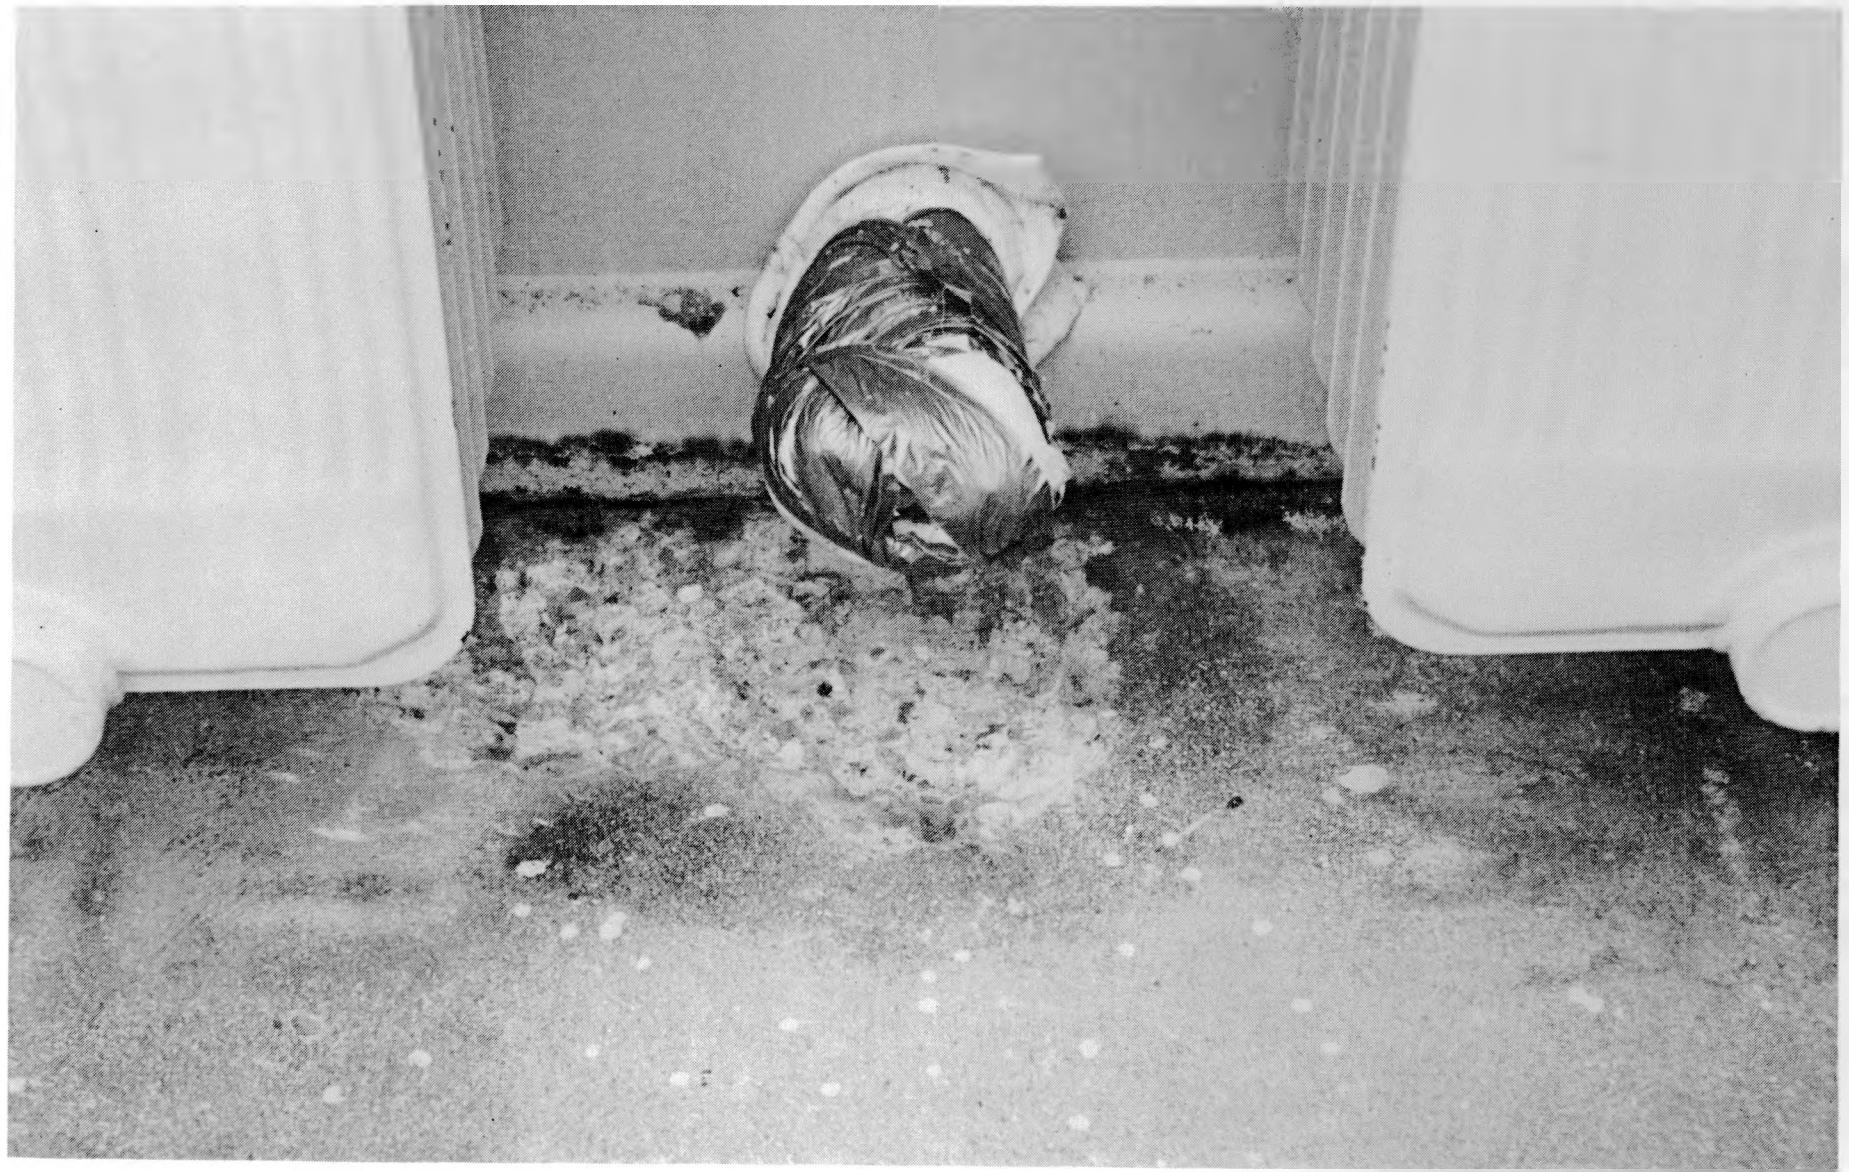
Figure 6. Small concrete remedial site (3-inch diameter spill).

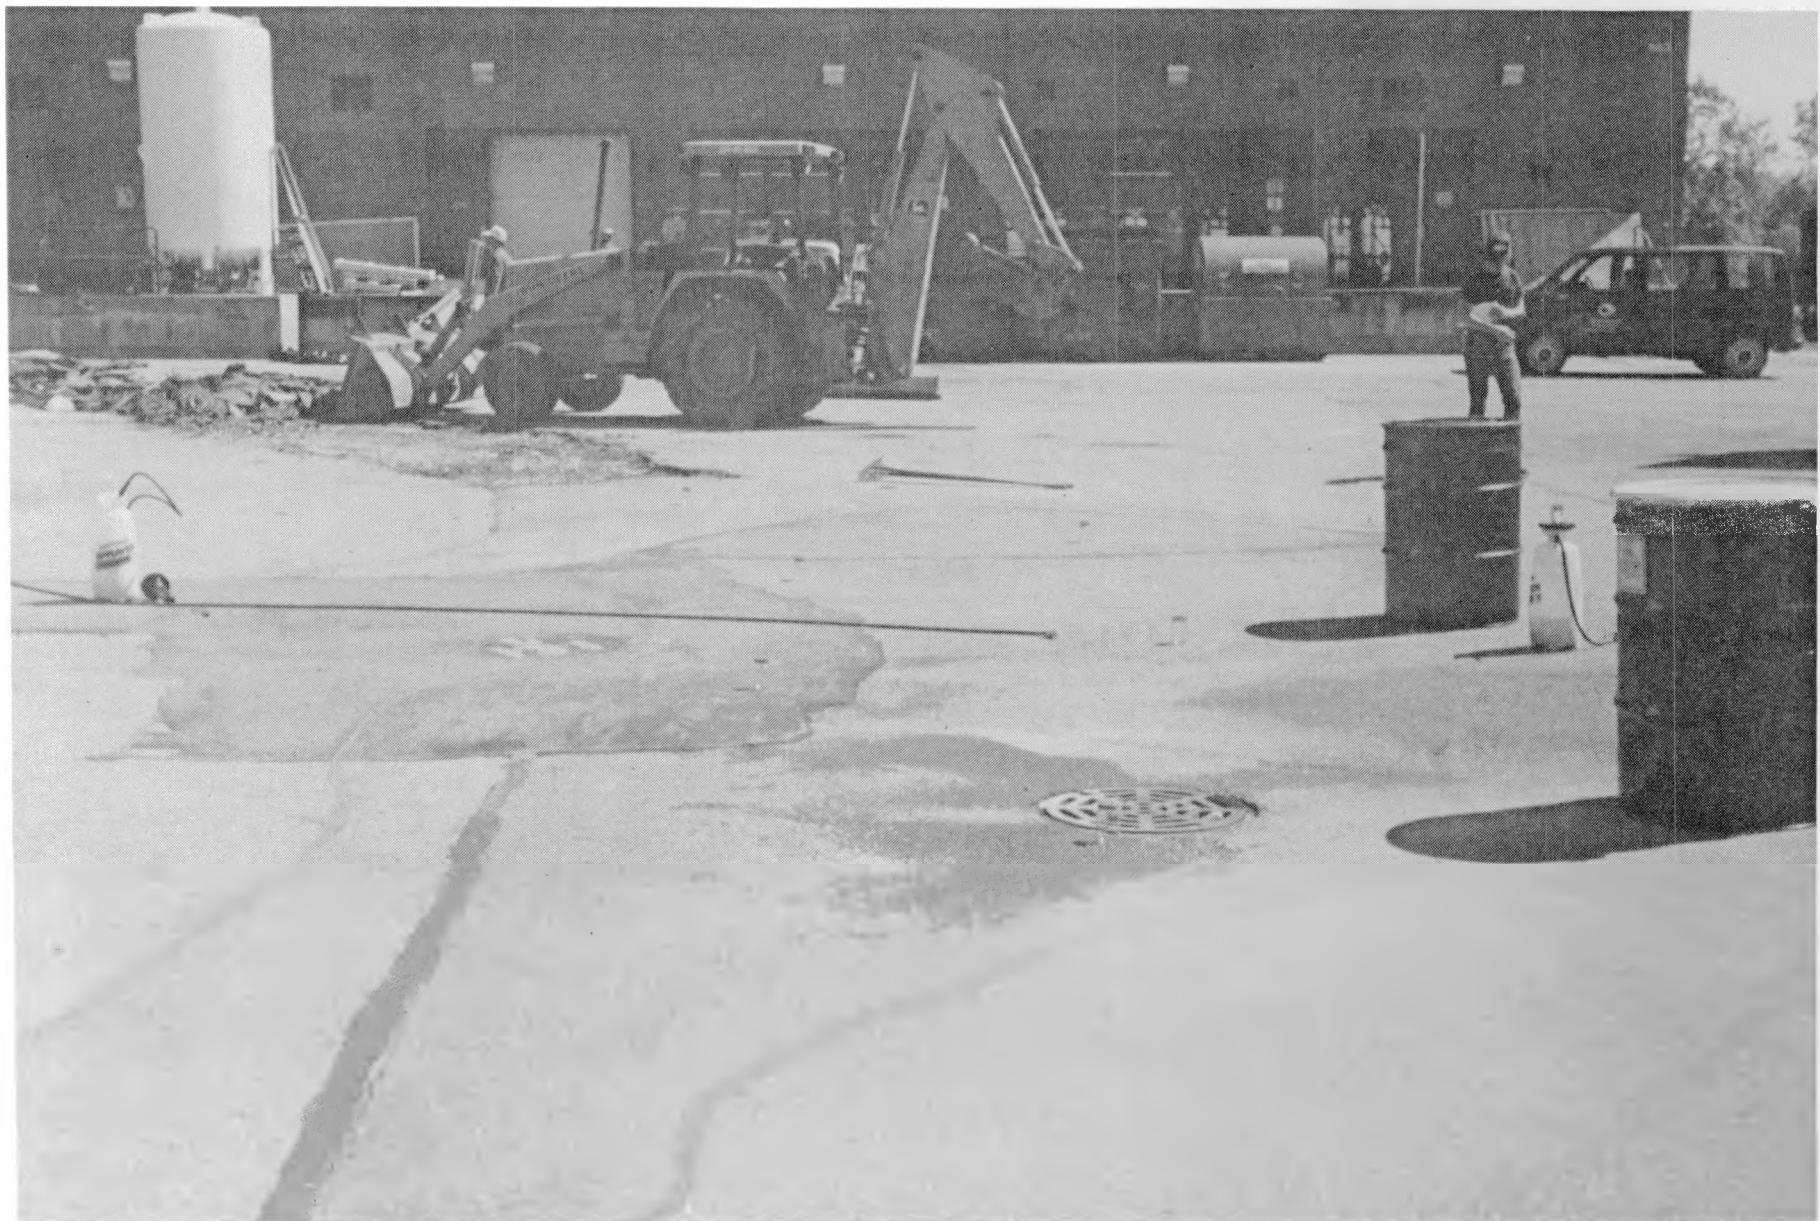
Figure 7. Pavement removal in parking area for spill cleanup.

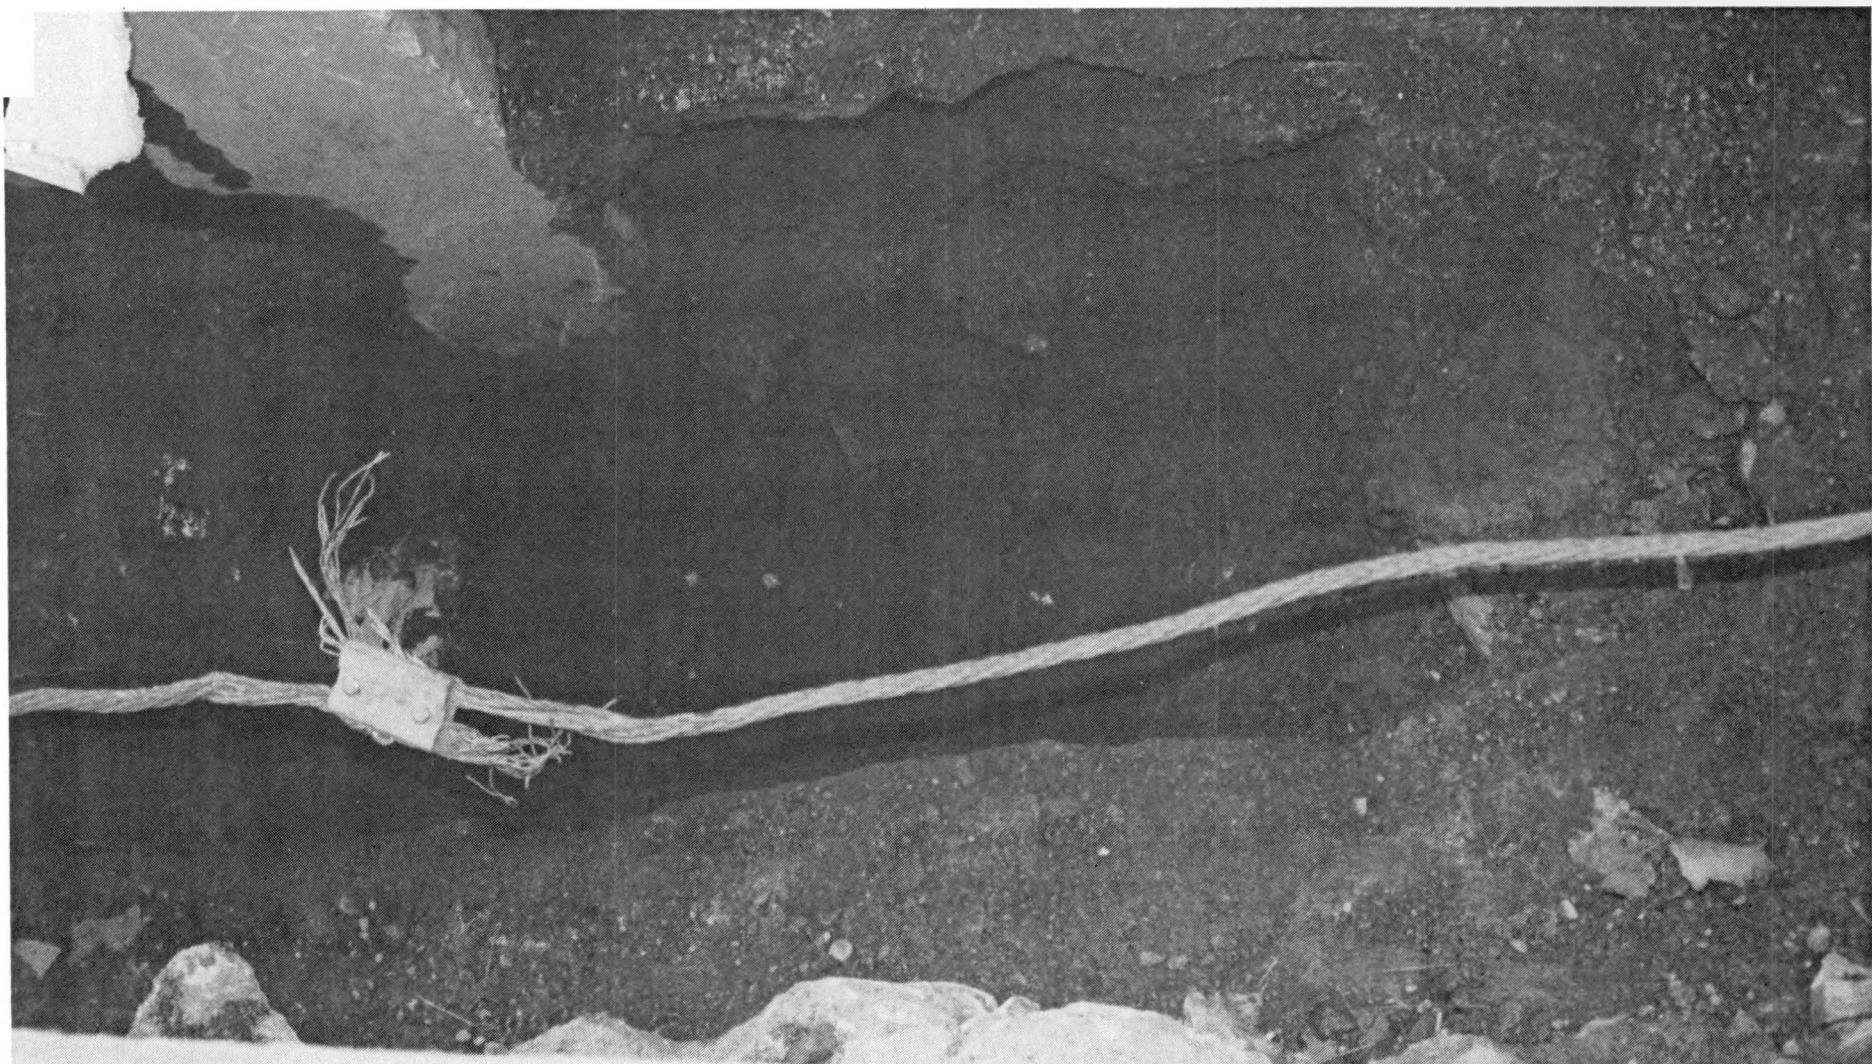
Figure 8. Excavated area for spill cleanup.

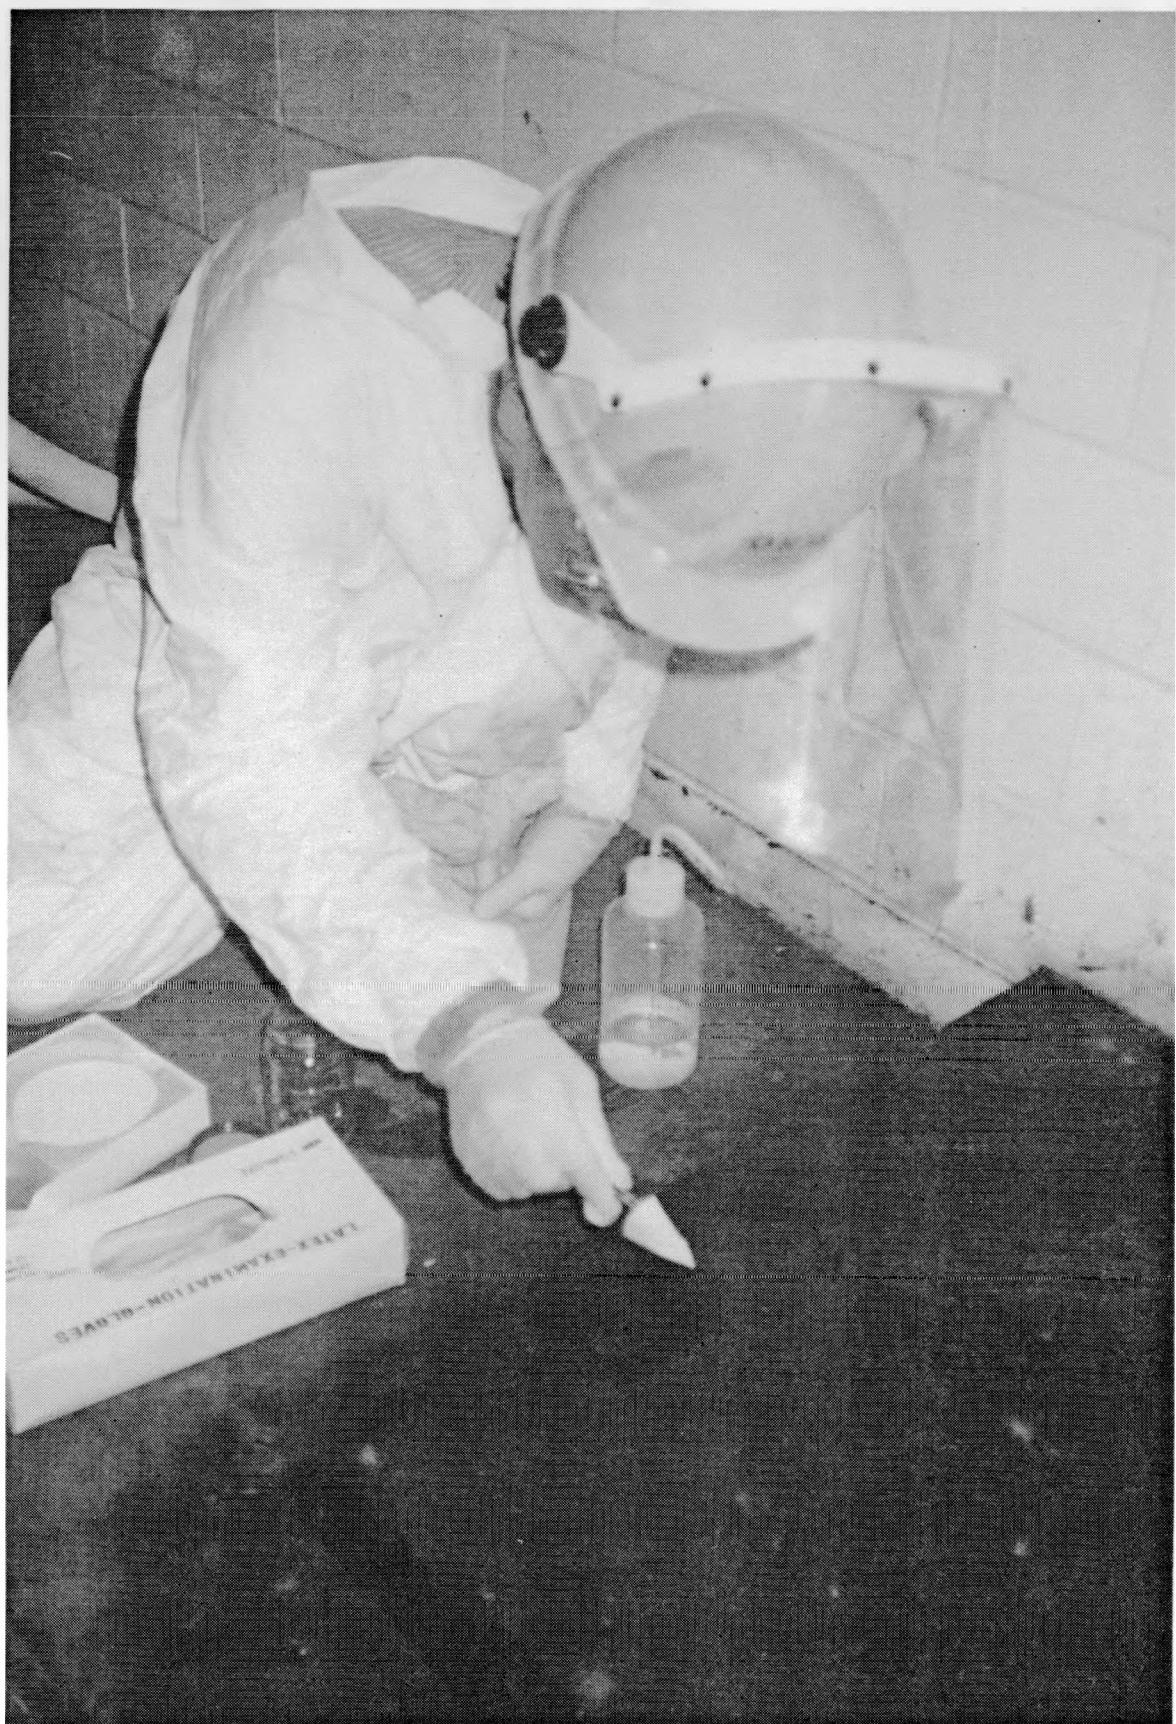
Figure 9. Wipe sampling.

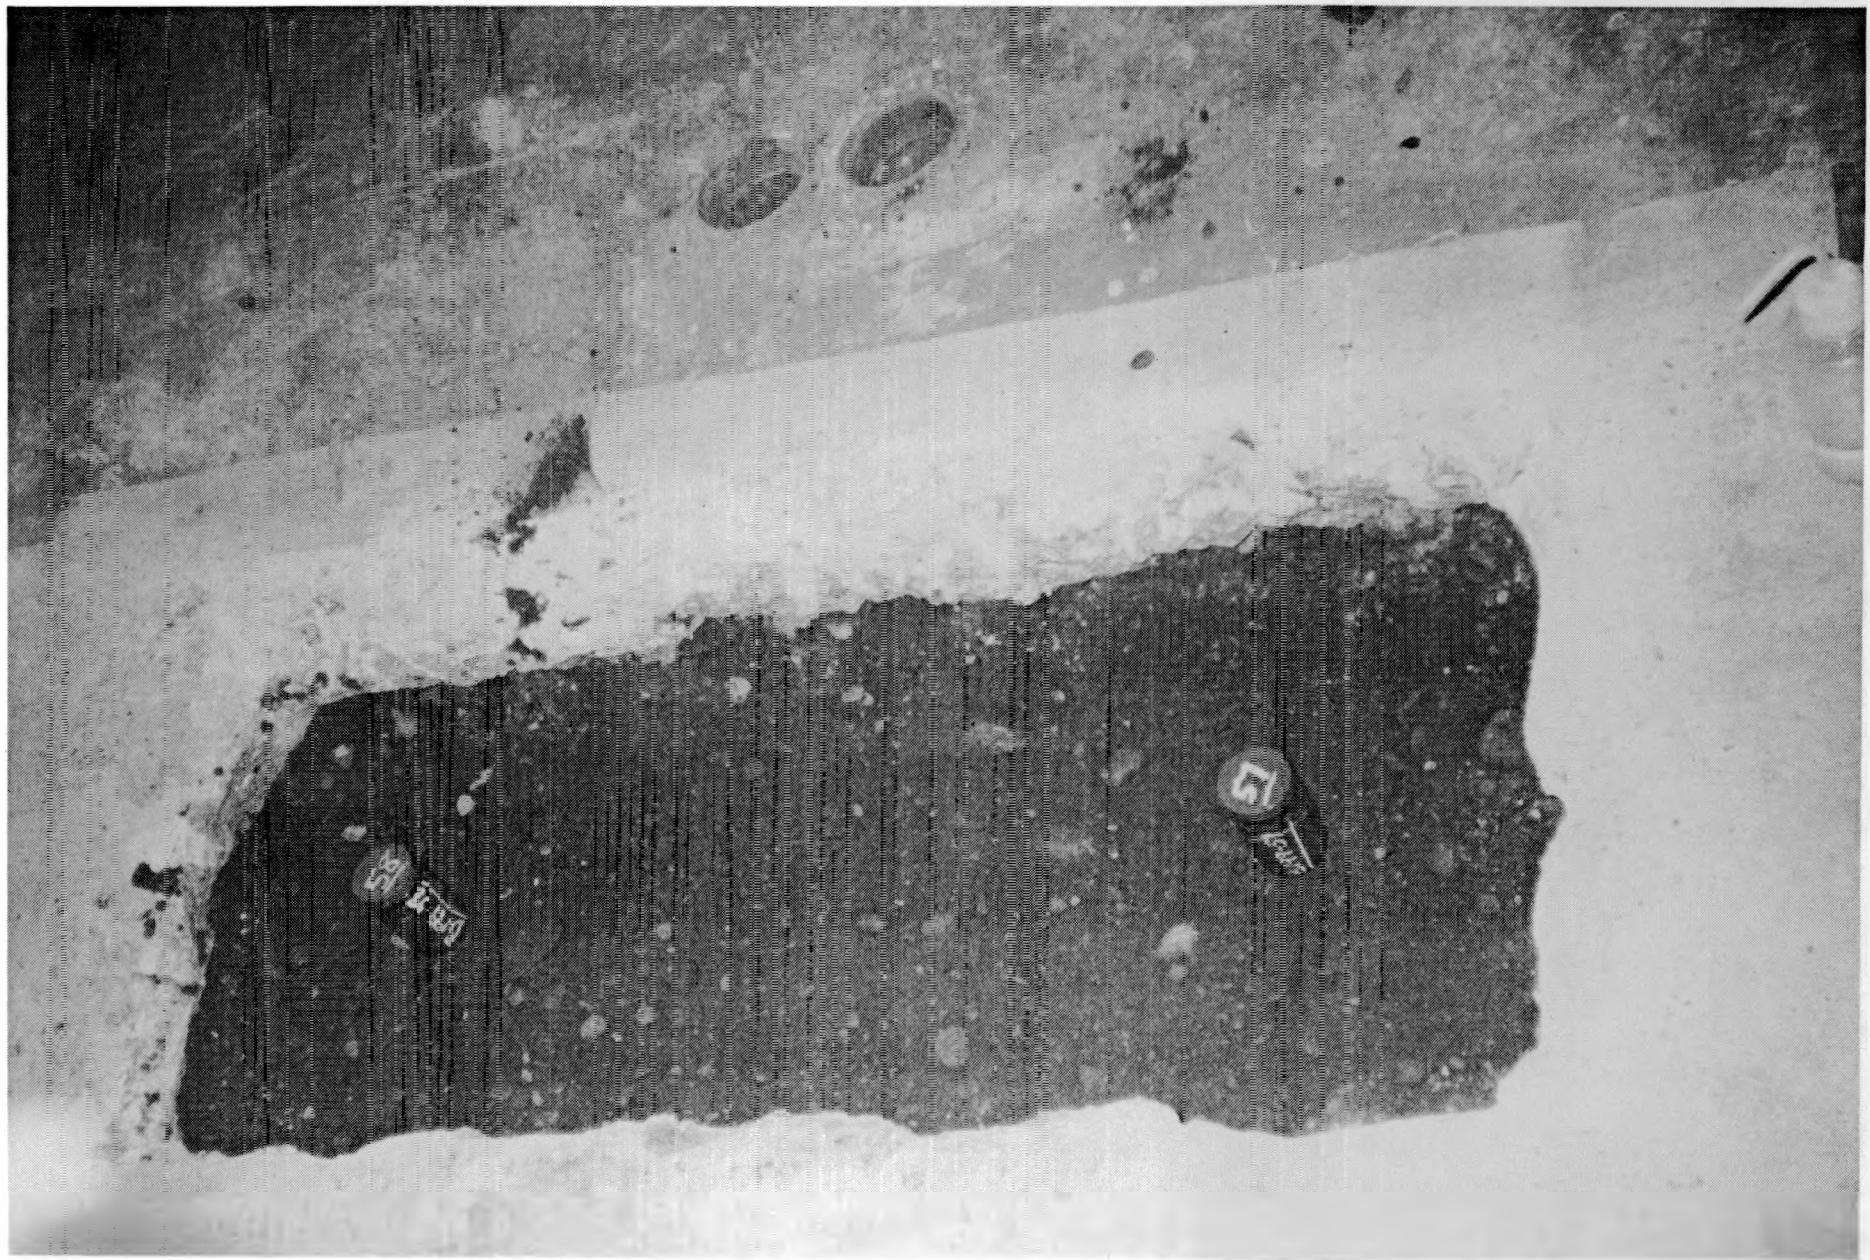
Figure 10. Soil sampling.
