# Pulverizer Failure Cause Analysis

FP-1226  
Research Project 1265-1

Final Report, December 1979

KVB, INC.  
1732 Irvine Blvd.  
Tustin, California 92680

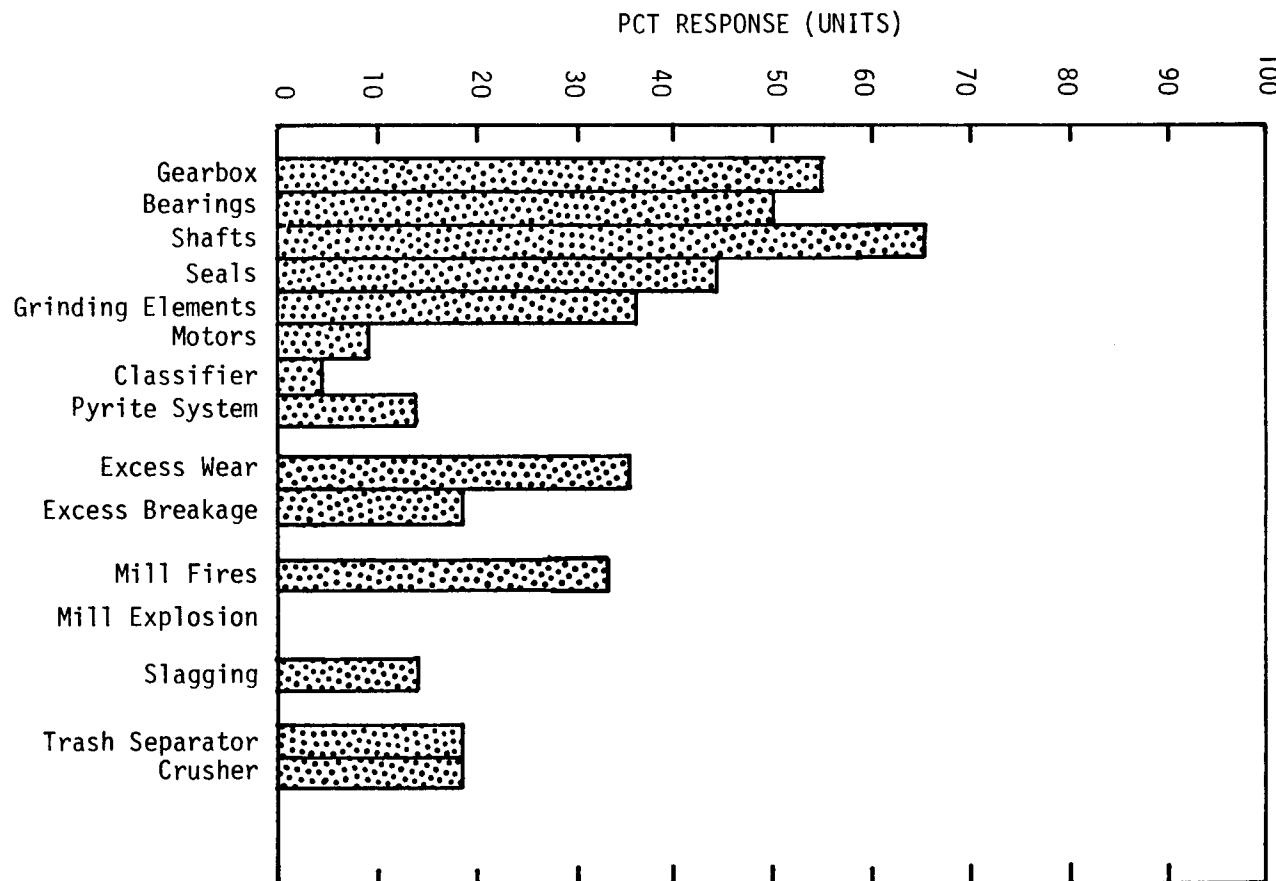
Figure 4-2. Pressurized Bowl Mills--Problem Areas.

Solutions to the vertical shaft breakage problem have included journal spring adjustment and frequent spring checks. At one plant, the journal spring compression was reduced from twenty to fifteen tons and straps were welded on the spring adjusting and jam nuts to the spring stud to prevent loss of spring loading during operation. Units C,D of Plant ID 5 have instituted spring checks at three month intervals to insure proper spring adjustment and have not experienced problems with shaft breakage since this maintenance check was instituted.

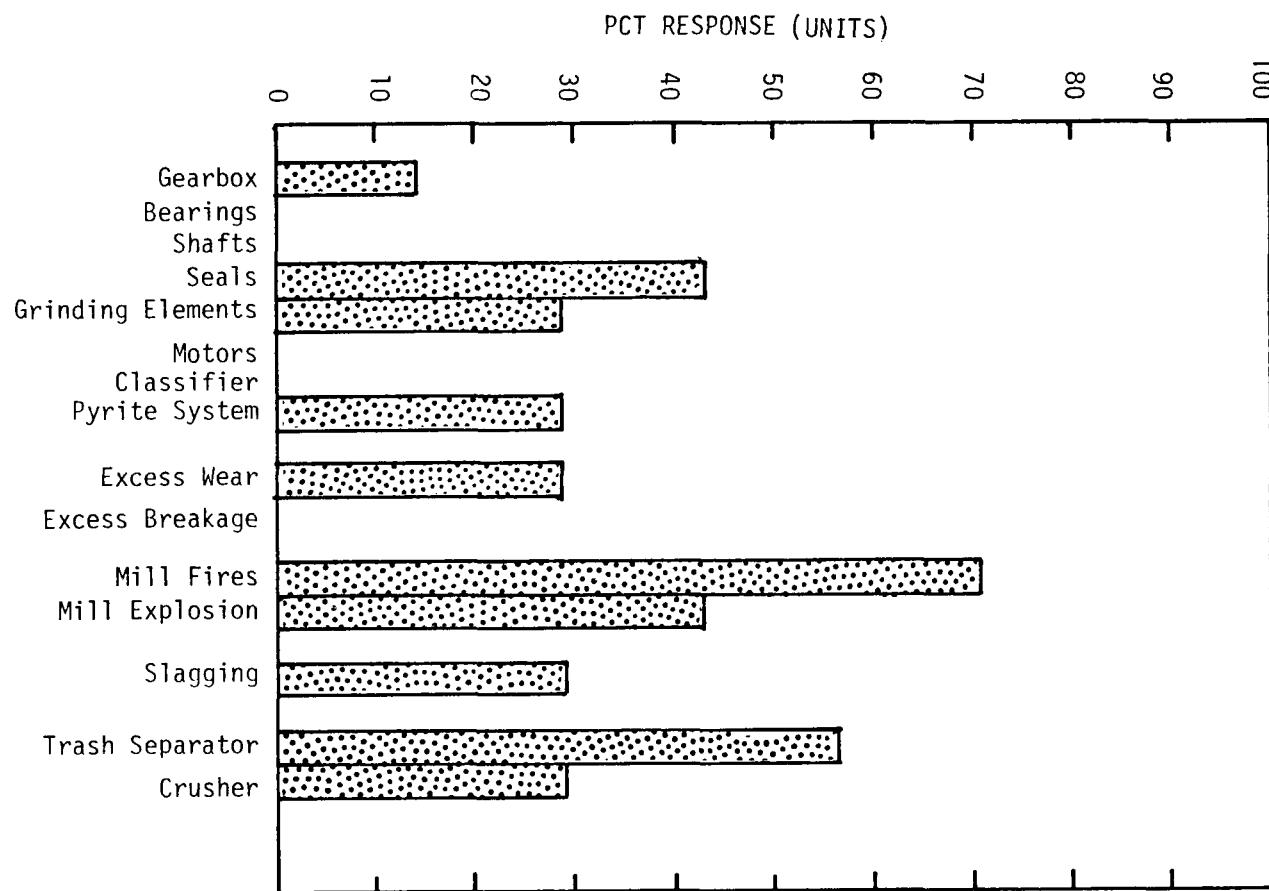
Figure 5-2. RoII-Race Mills-Problem Areas

The long grinding life of the roll-race tires is attributed to the volume of wear metal (Elverite) used with the roll-race tires and the ability to reverse the tires. Wear life of the rolls is projected to be approximately one million tons or more at Plant ID 25. The rolls were expected to grind about 850,000 tons of coal but the wear rate has actually decreased with use. This decrease in wear is due to the flattening of the roll wear contour.

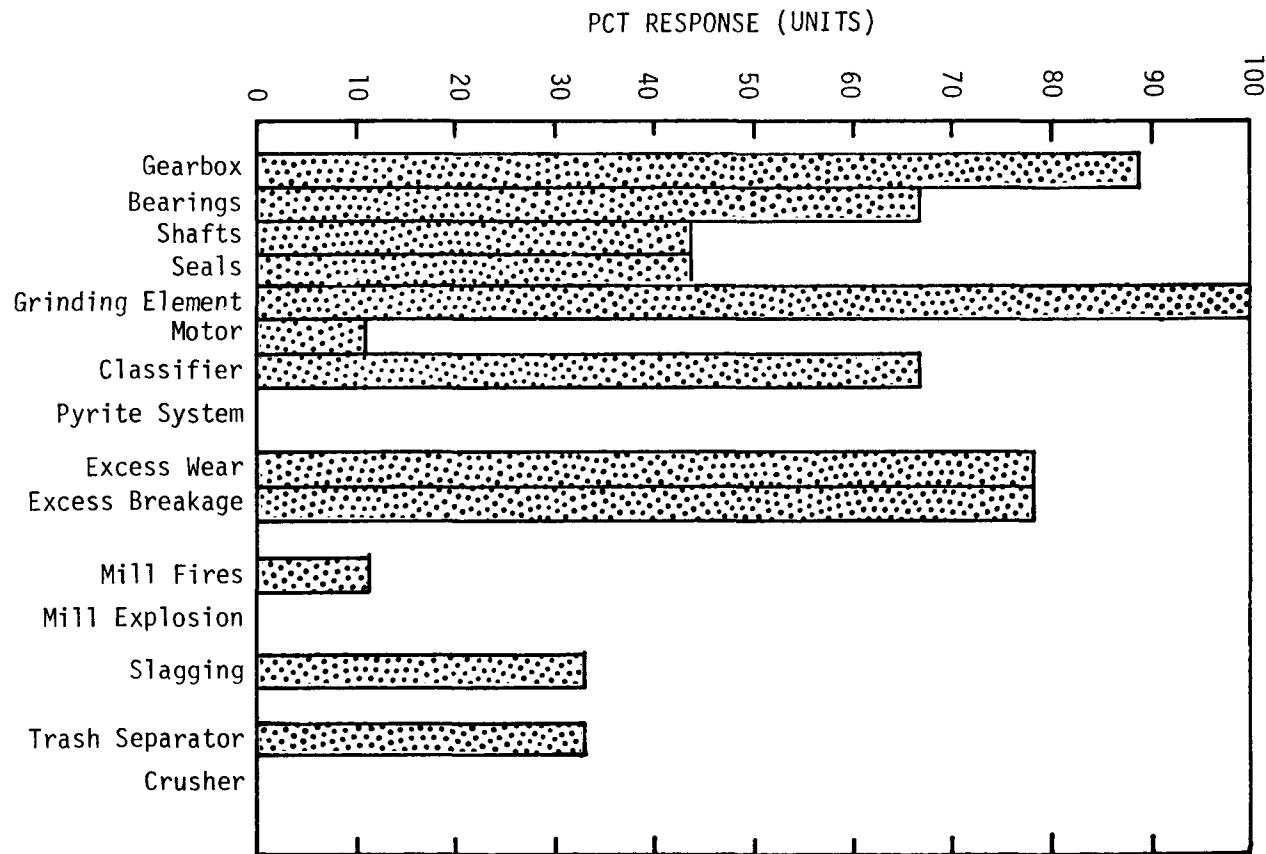
Figure 6-2. Planetizing Roll Mills--Problem Areas.

Table 6-3 presents problem areas associated with the grinding zone. Thrust ring failure has been a recurrent problem with nearly all mills in the survey. Thrust ring replacement has been as frequent as once every month for three consecutive months at one plant. The frequency of such failures has spurred work to improve thrust ring lifetime. At one plant, a high carbon steel is being tried as the thrust ring material rather than the normal NiHard material. The material is expected to wear faster than the NiHard, but the carbon steel tensile properties should enable it to eliminate the thrust ring cracking problem. At Plant ID 29 A,B, the NiHard thrust ring material has been changed and this has seemed to solve the breakage problem. Information concerning the thrust ring material at this plant was not reported.
