**SUMMARY REPORT
FOR
1990 INSERVICE INSPECTION (ISI)
OF
SRS 100-K REACTOR TANK (U)**

Savannah River Laboratory
Equipment Engineering Section
Reactor Tank Inspection Program

Issued: May 15, 1990

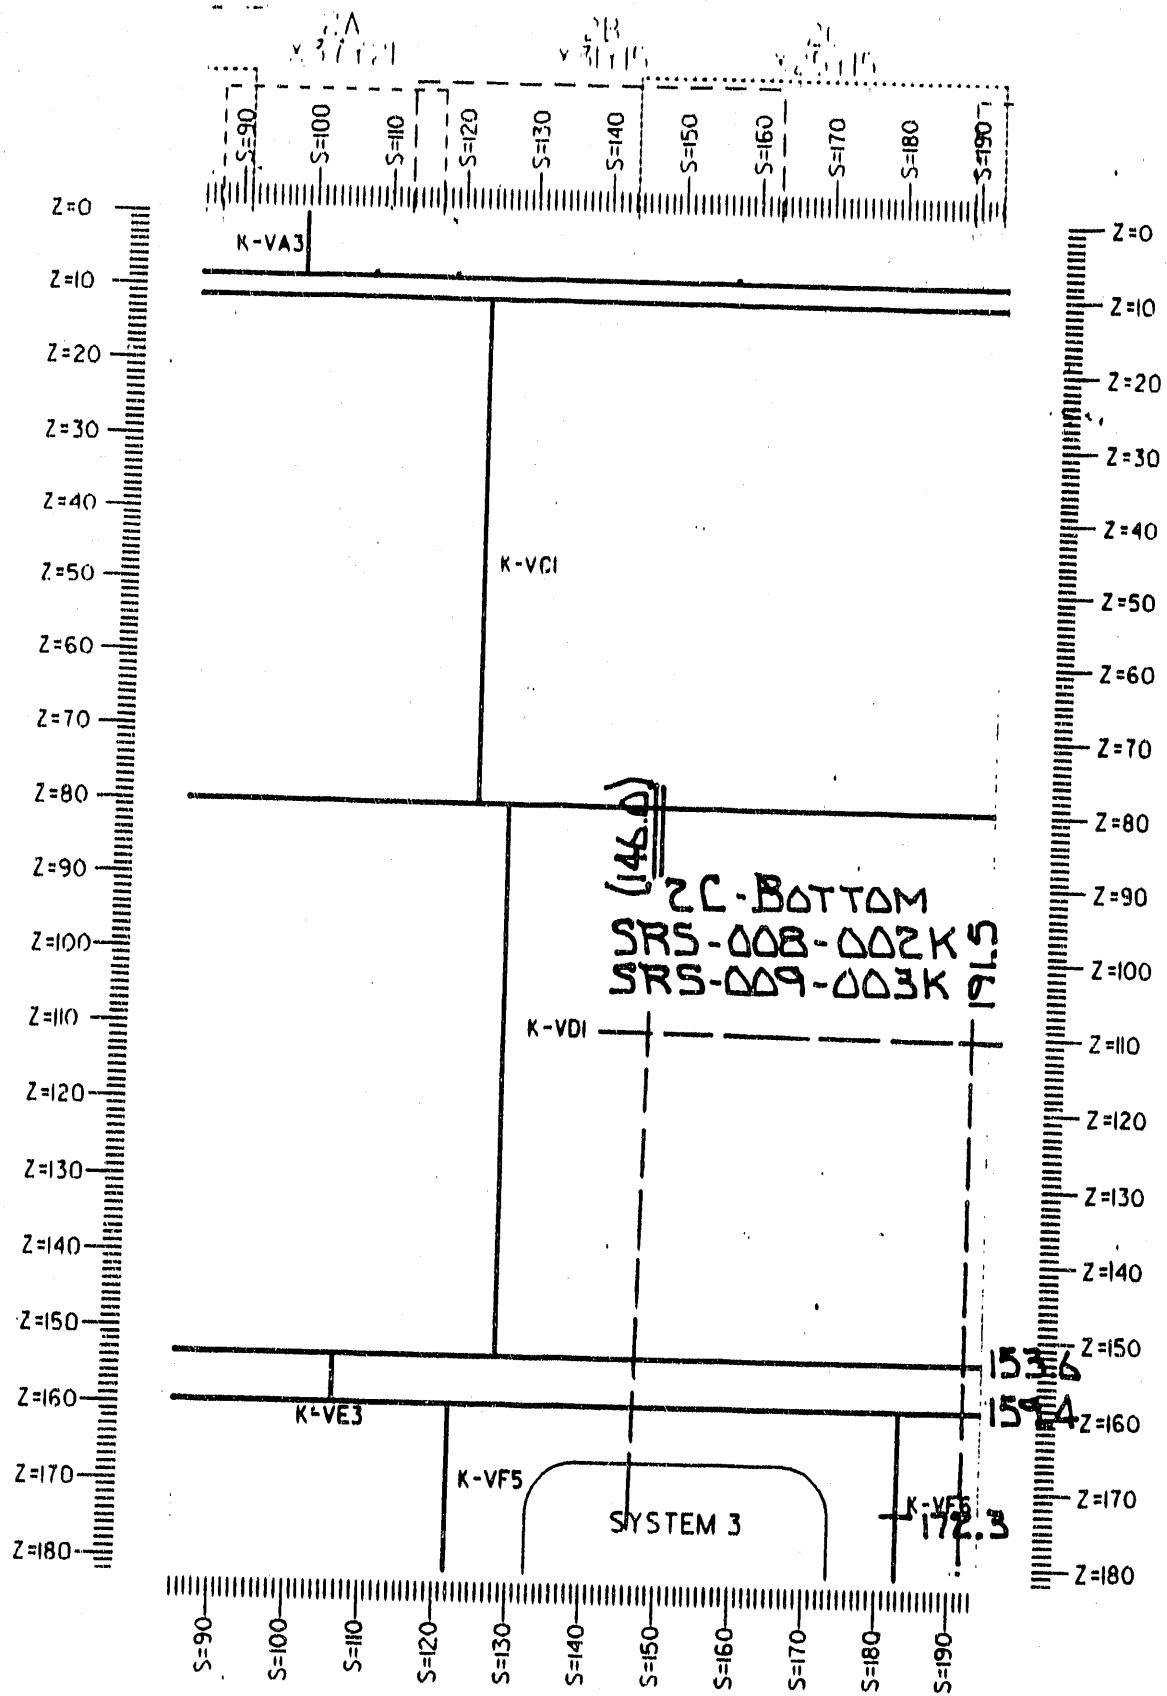
K REACTOR TANK
WALL WELD MAP

Comments: Several indications of interest were: 2 former attachments on O.D. of K-H4; a slight gouge above K-H4-indicative of a weld deposit subsequently removed; a weld repair area on K-H4 about 5 inches long, on both I.D. and O.D.; 2 small spot (possibly punchmarks) above K-H5 with no depth; and an embedded weld anomaly about 11 inches long in weld K-VF6, about 0.20 to 0.25 inches below the I.D. ^{Page 6 of 6} not breaking either surface. Weld contours are generally very round.

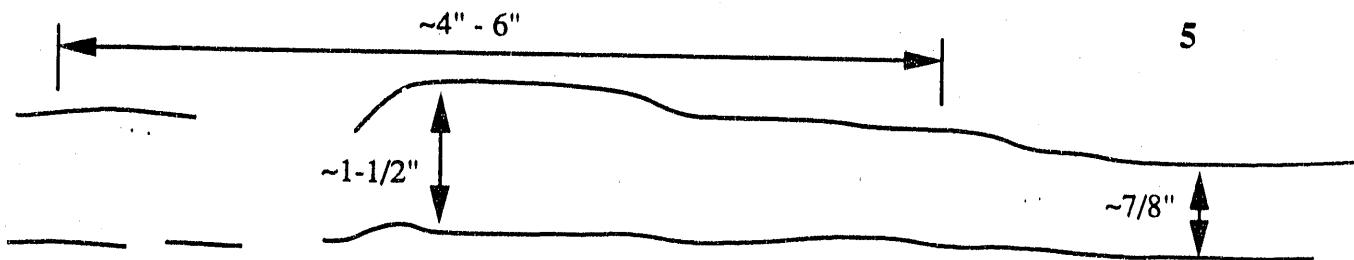
FIGURE 1

There is an area 4-6 inches long approximately 40-45 inches left of a main tank vertical weld that could cause ultrasonic indications to appear slightly above the assumed normal upper weld edge. The area corresponding to exposure interval 4-5 of the radiographs was repaired 3 times and the outline of the weld edges (as reconstructed from the repair radiographs) fits the data provided by the eddy current weld profiles and the ultrasonic test data.

Simulated tracing from original final radiograph of Repair 3 to exposure interval 4-5 of Weld K-H4

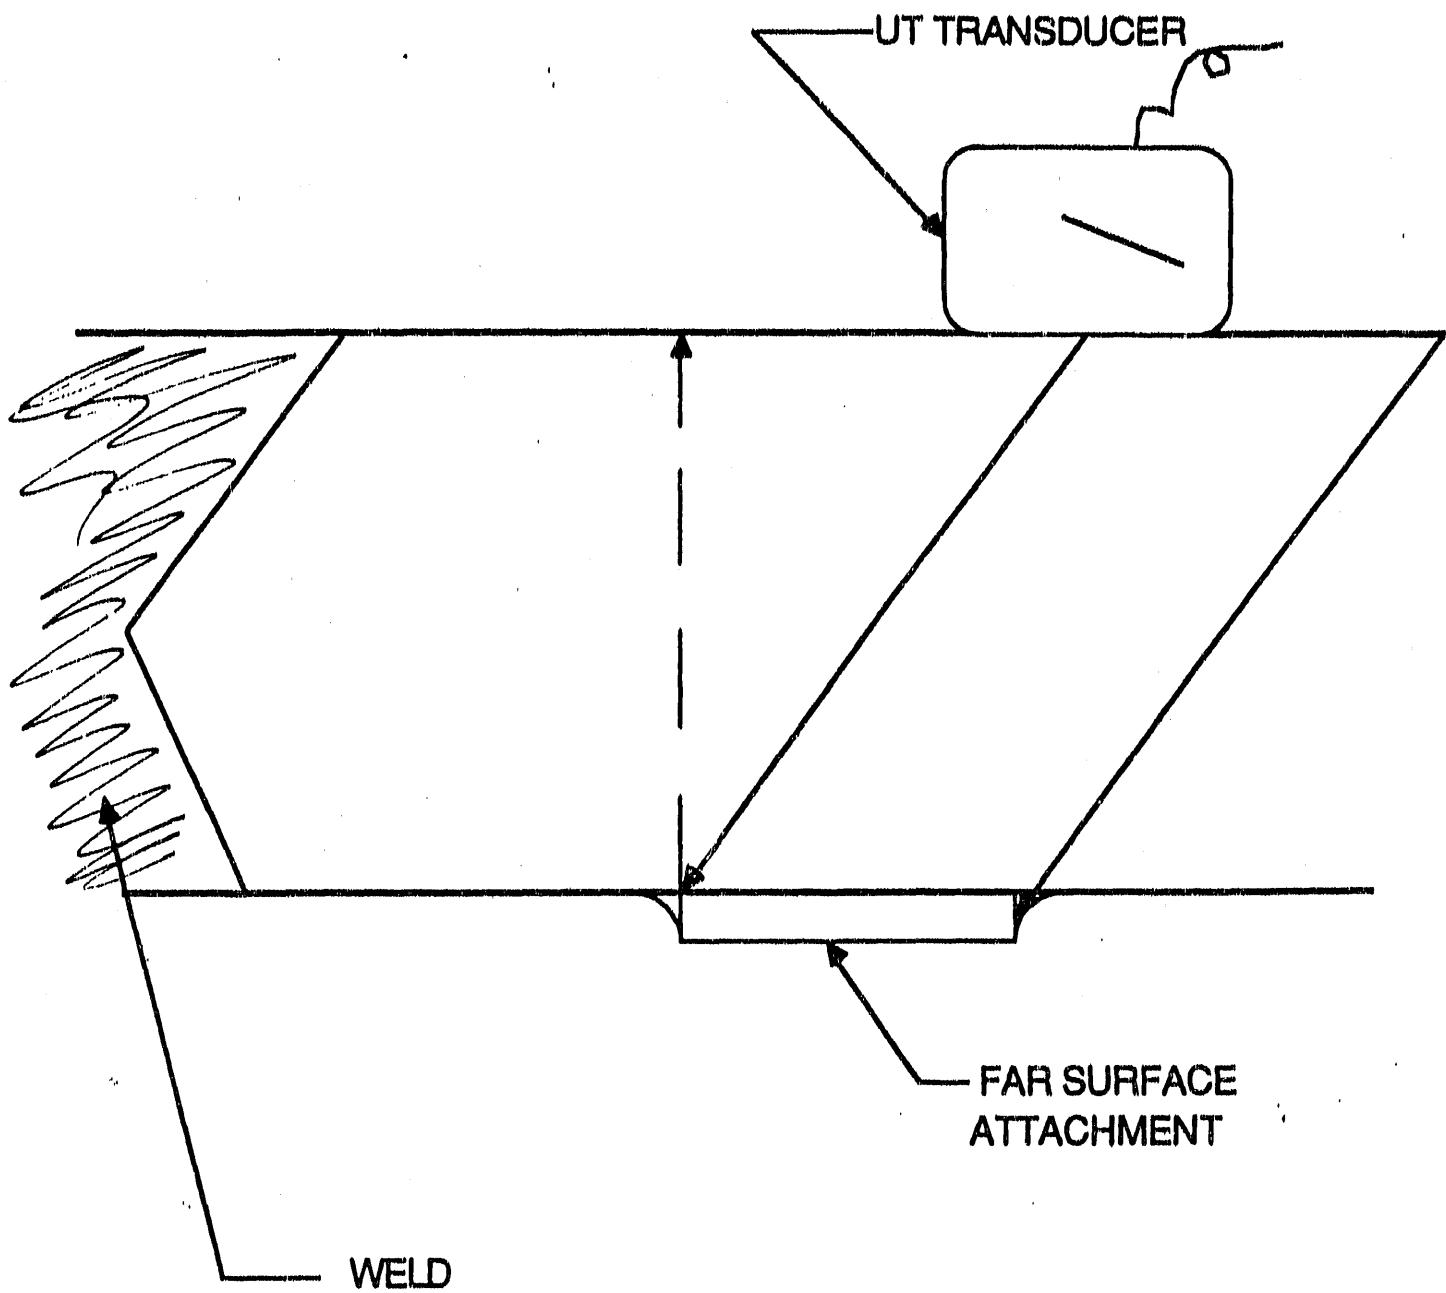
WELD K-H5 X (S) = 101.8" TO 102.9"

1. Location on O.D. $1\frac{1}{2}$ -inches from weld
2. Apparent shift in location when interrogated in opposing directions, i.e., beam redirection with mode conversion.
3. Only observed in 2nd half vee - no 1st half vee response
4. I.D. ET inspection revealed no indication of flaw but verified I.D. surface irregularities
5. Multiple attachment welds on O.D. and I.D. surfaces in near region.

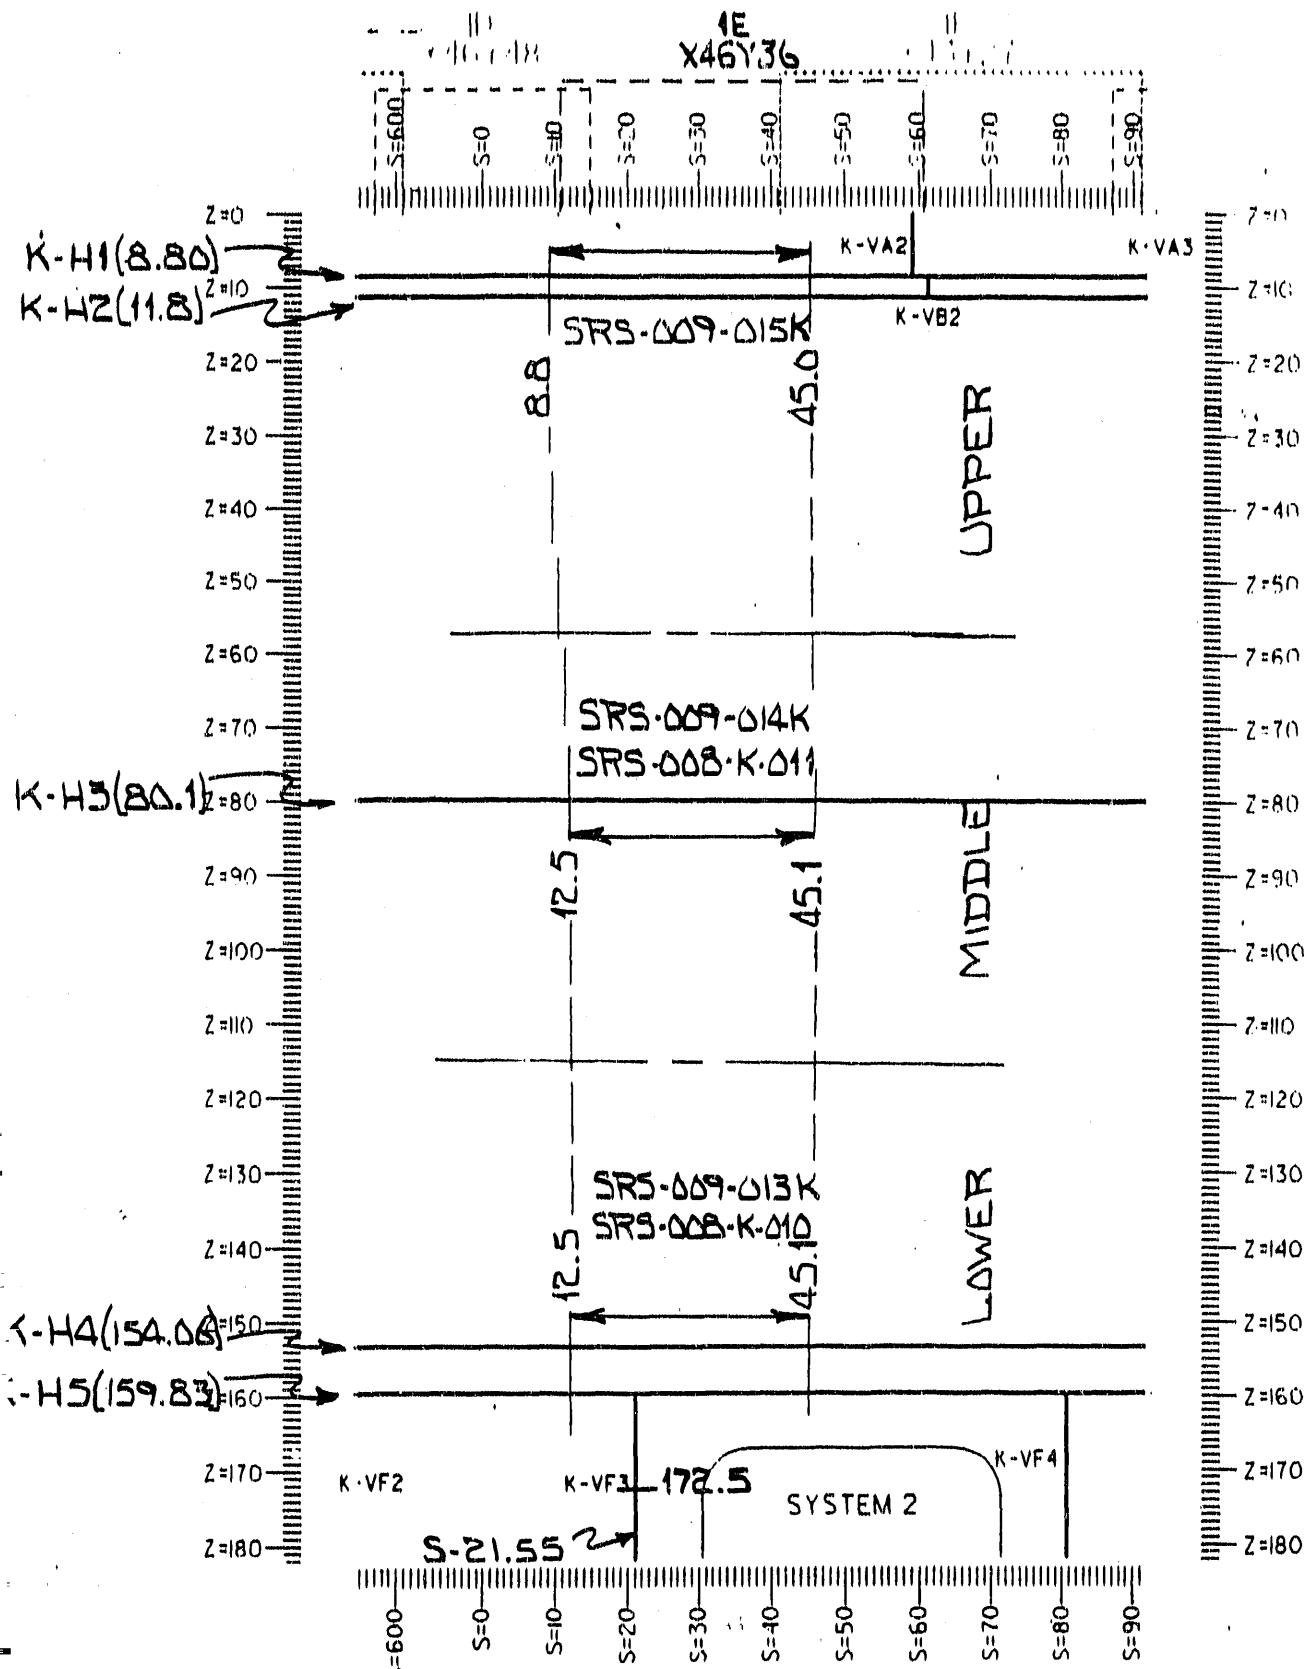
2-20-90
K REACTOR TANK
WALL WELD MAP

NCR No.:		
Comments: Several attachment/ removal areas on I.D. above weld K-H5 and others below K-H4; also one on O.D. below K-H5. Embedded flaw in K-VF3, indeterminate length, running beyond scan area, acceptable within acceptance criteria.

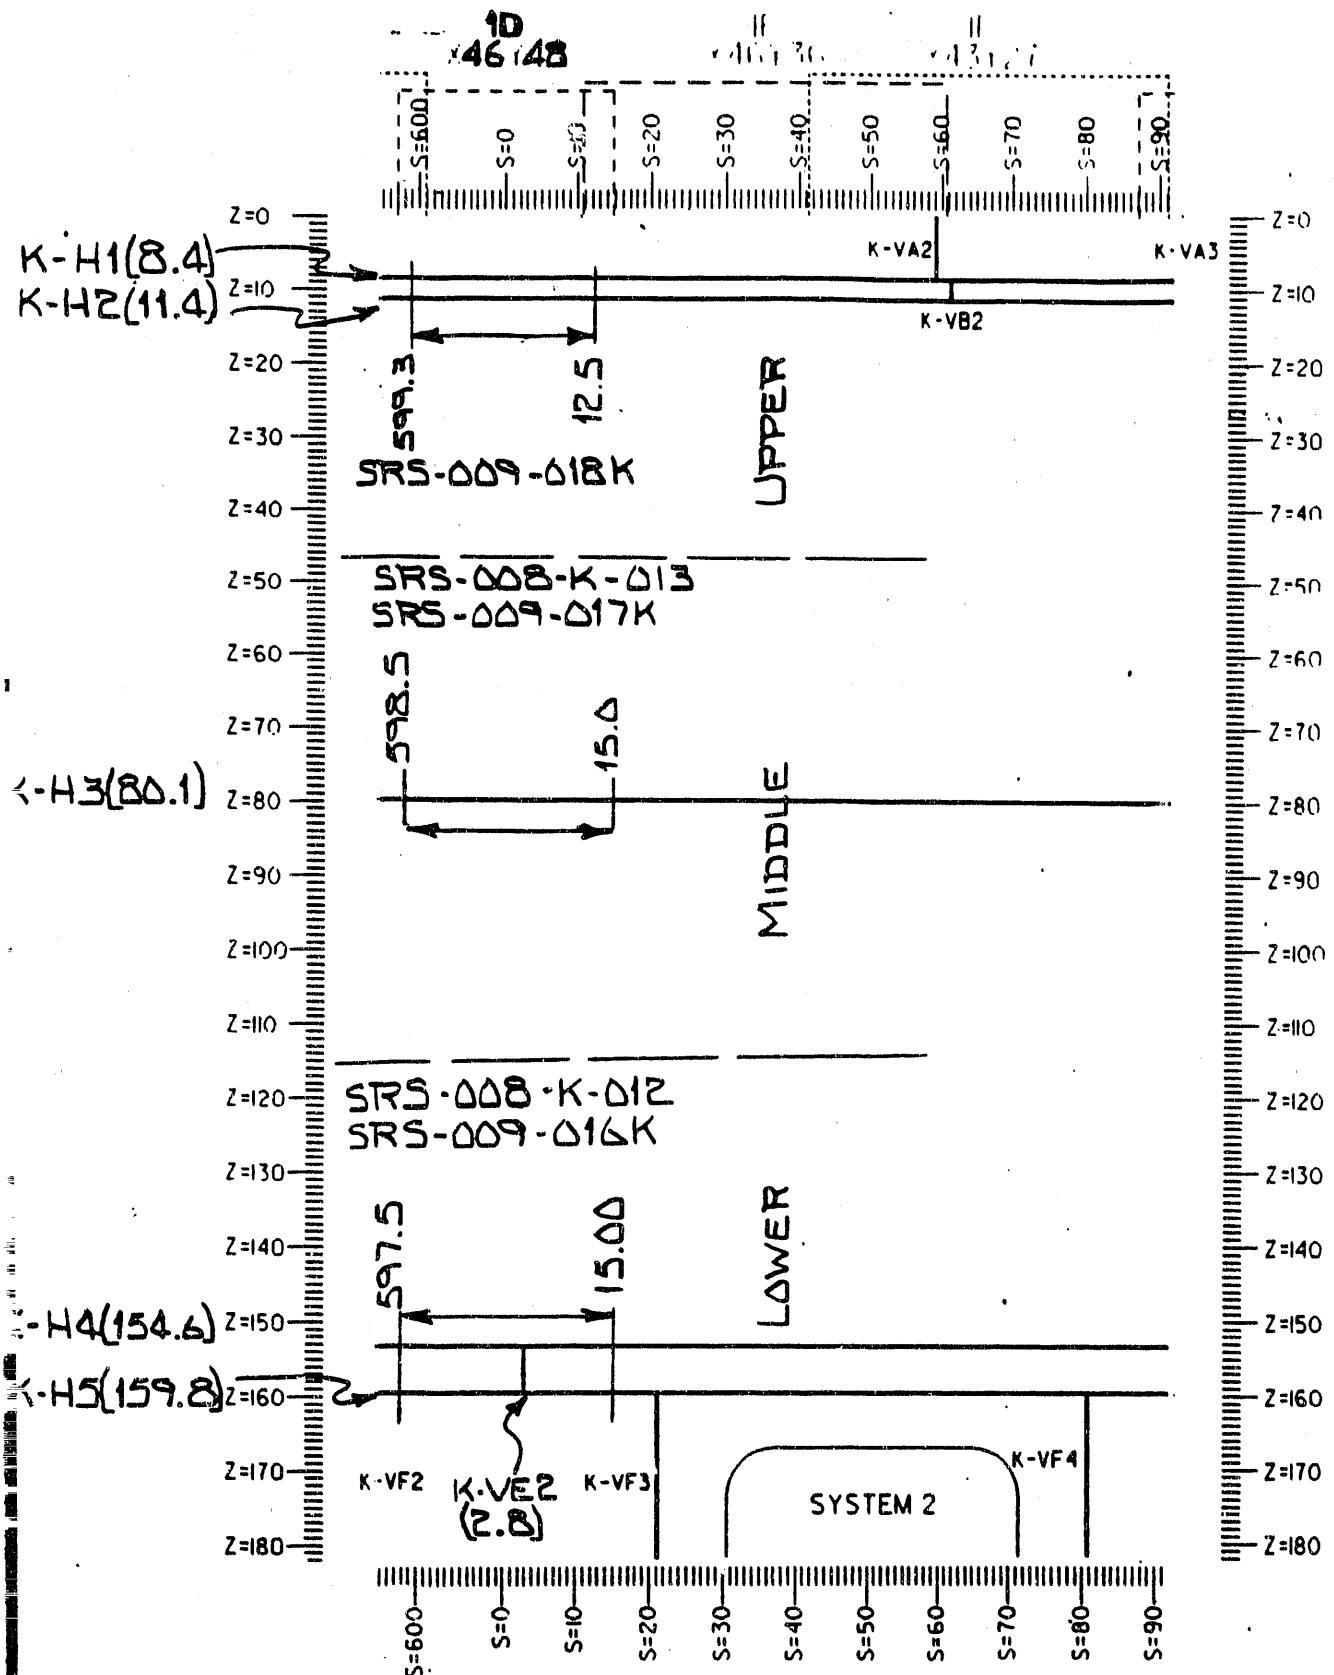
K REACTOR TANK
WALL WELD MAP

Comments: Vertical weld located between K-H4 and K-H5, designated K-VE2. A number of attachment removal areas were evident, on the inside of the top window, on the O.D. of weld K-H3 on the middle window, and both O.D. and I.D. of weld K-H4. An

embedded flaw exists over approximately 28-inch length of K-H5 in this window, about 0.40 inch beneath inside surface with no opening to either surface, within acceptance page 6 of 6 criteria.

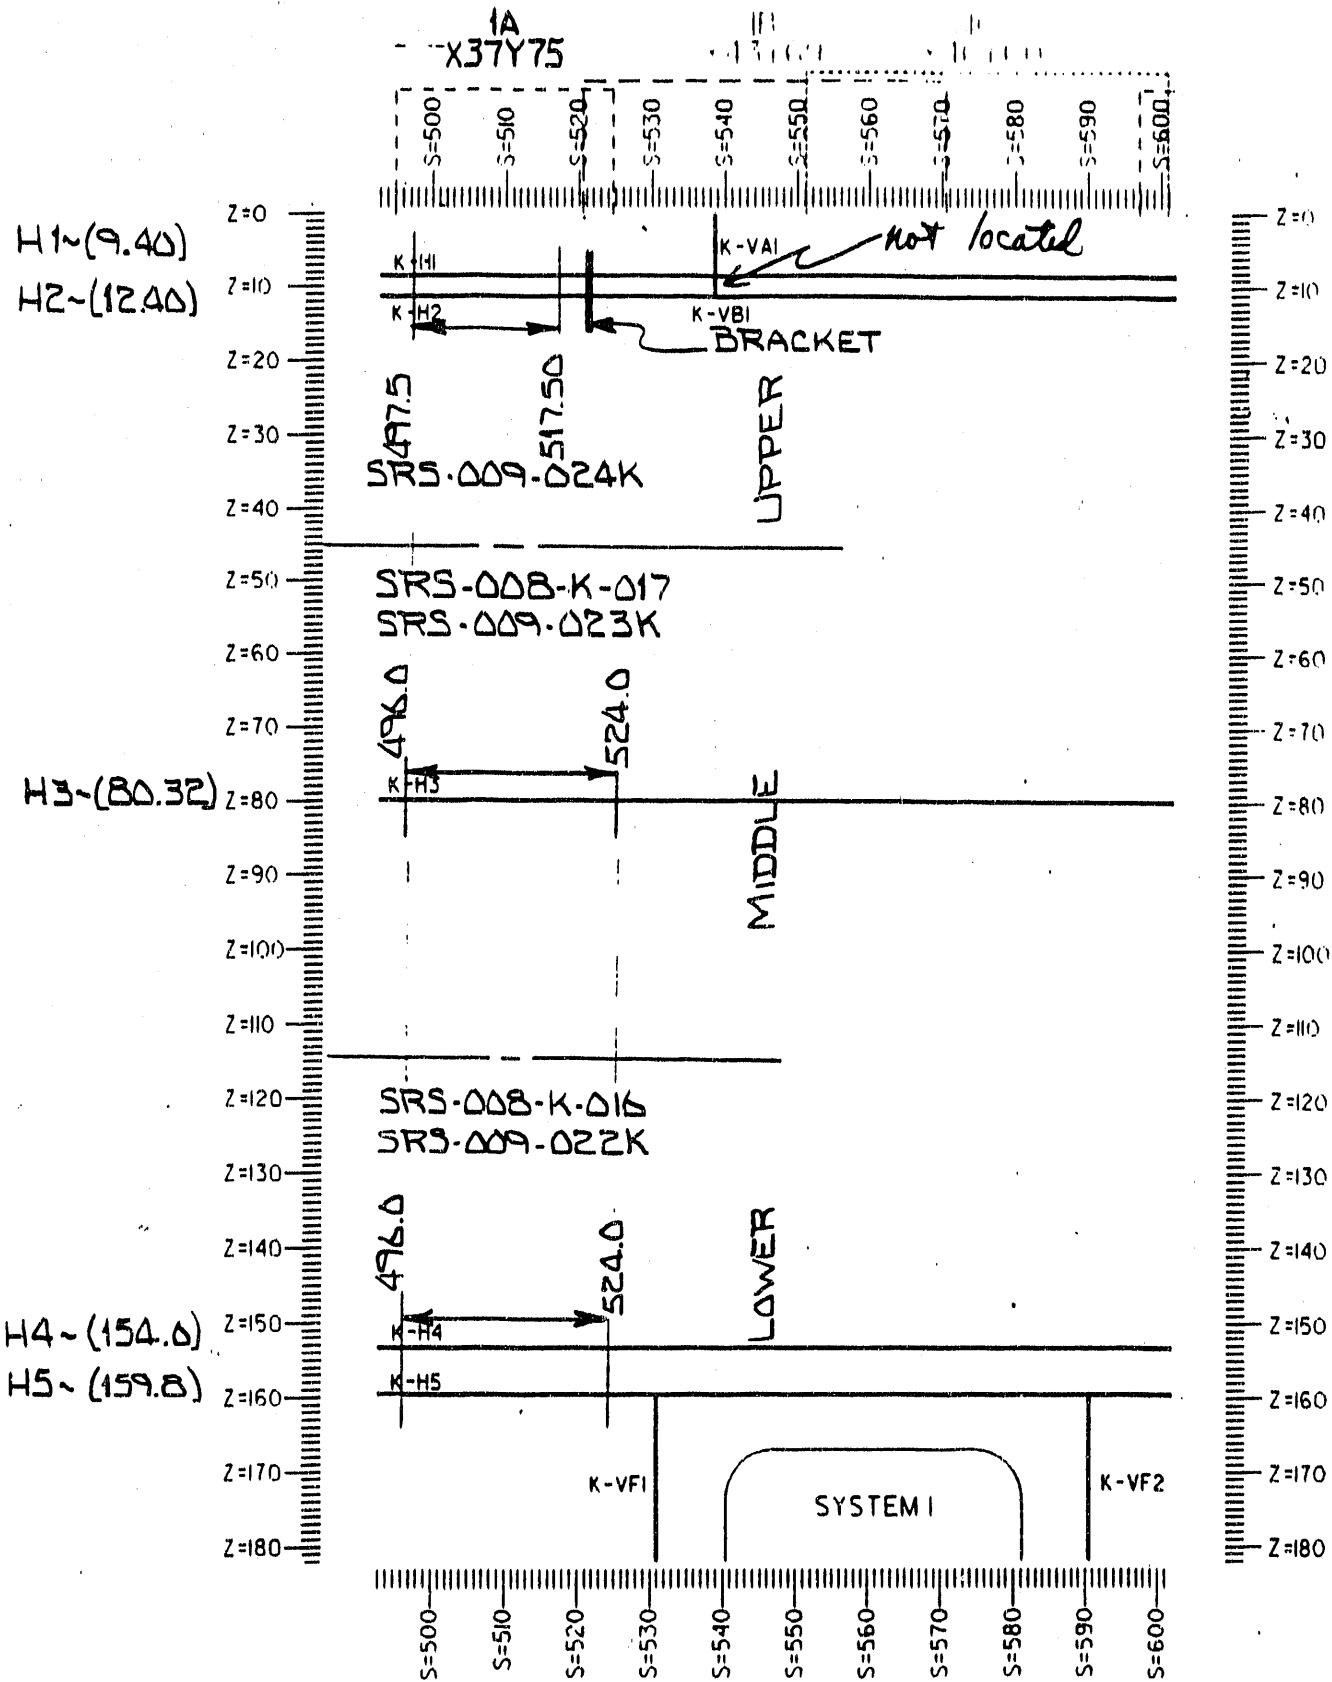
K REACTOR TANK
WALL WELD MAP

Comments: Numerous attachment/attachment removal areas located. One attachment apparent on O.D. about 1.5 inches from weld K-H3. On welds K-H4 and K-H5, attachment removal areas on both O.D. and I.D. Evidence of wide (1.5 inches) repair area beginning at left end of K-H4, possibly extending into Sector 3 F. JET report SRS-009-024 K has not yet been reviewed by second analyst, is promised by next IRC meeting.

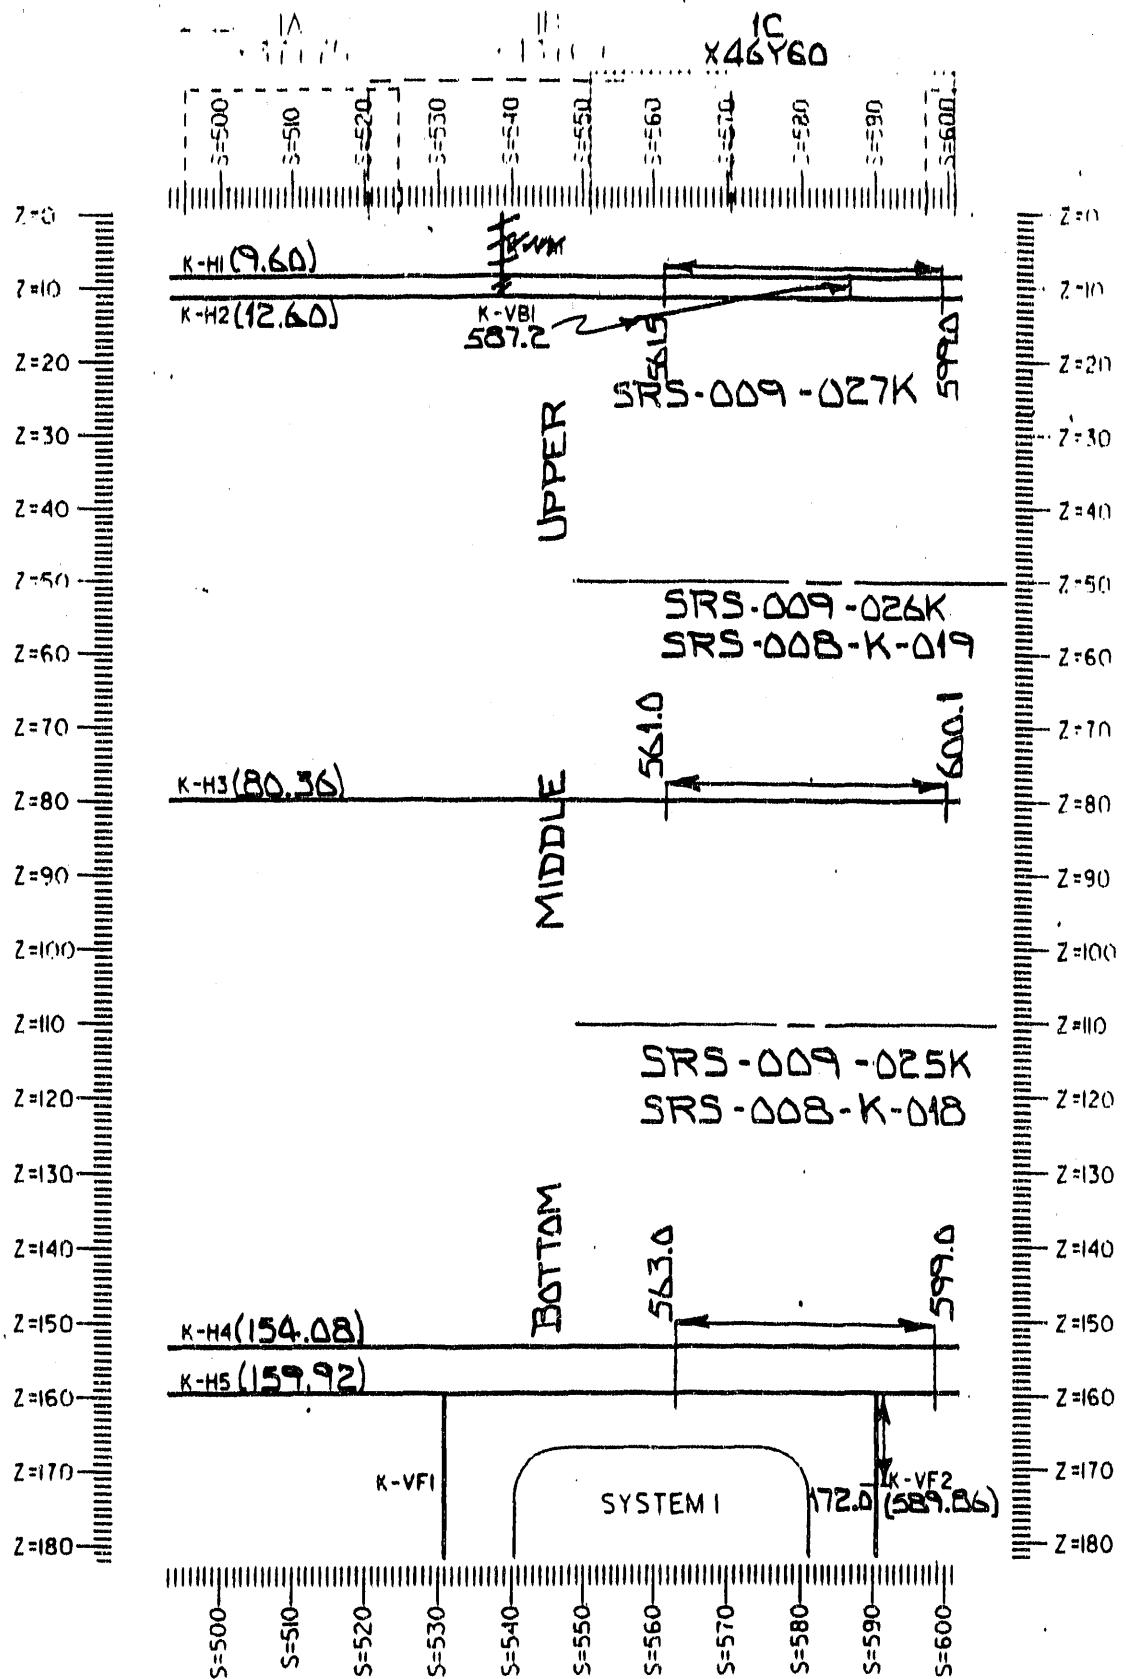
K REACTOR TANK
WALL WELD MAP

Comments: Located vertical weld K-VF1 in expansion ring. Embedded reflector previously found in Sector 1D, K-H5, trickled out just first 0.5-inches of Sector 1C, therefore length is estimated as 27.5 inches total. A number of attachment removal areas on/near K-H4: On O.D., one above weld and three below (No ID attachment). Vertical weld K-VF2 in this sector, some bulge in weld at junction with K-H5.
