UCRL-JC-127891
PREPRINT

Aerial and Ground-Based Inspections of Mine Sites in the Western U.S.-Implications for On-Site Inspection Overflights, Under the CTBT

François E. Heuze

July 1997

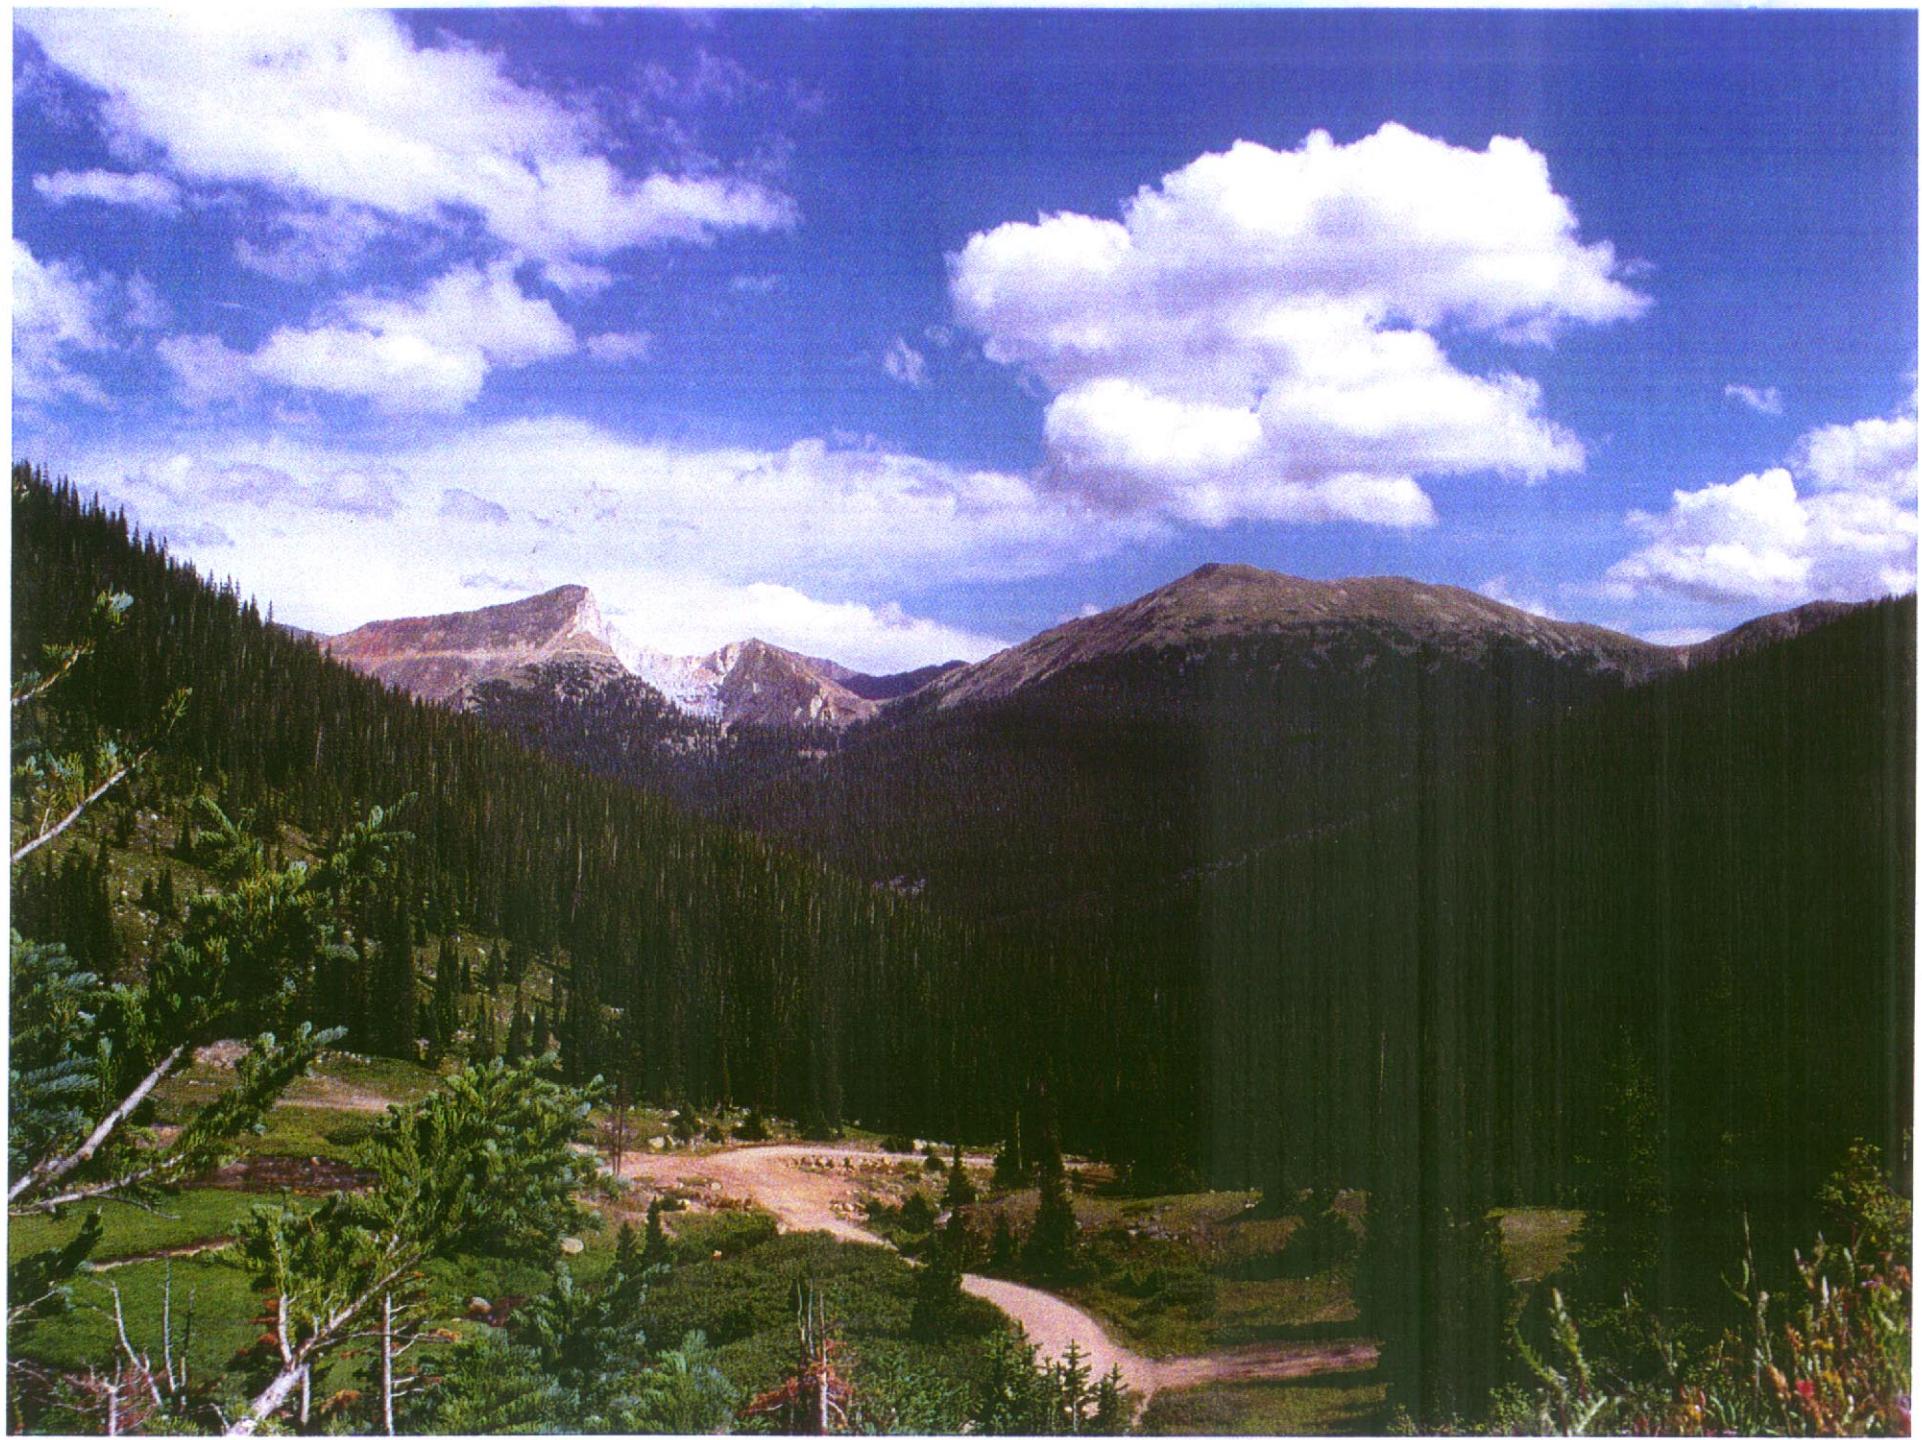
The block-caving activities at Henderson have left a very large "glory-hole" which overlies the cave area. It is shown in Figures 2* and 3, as viewed from more than 10 km away. This is a much larger feature than would ever be created by a clandestine nuclear explosion. But block-caving mines can provide very large, open subsurface cavities, under the cave area, which may be considered for decoupling nuclear explosions. If such a mine became a candidate for an OSI it would be advisable to install radionuclide sensors in the cave area. As shown in Figures 2 and 3, this could only be done with transport by helicopters. The helicopters may not even be able to land. The instruments, as well as the operators, may have to be lowered with a harness and winch.

Figure 2: Cave above the Henderson Mine, CO, from 14 km away.

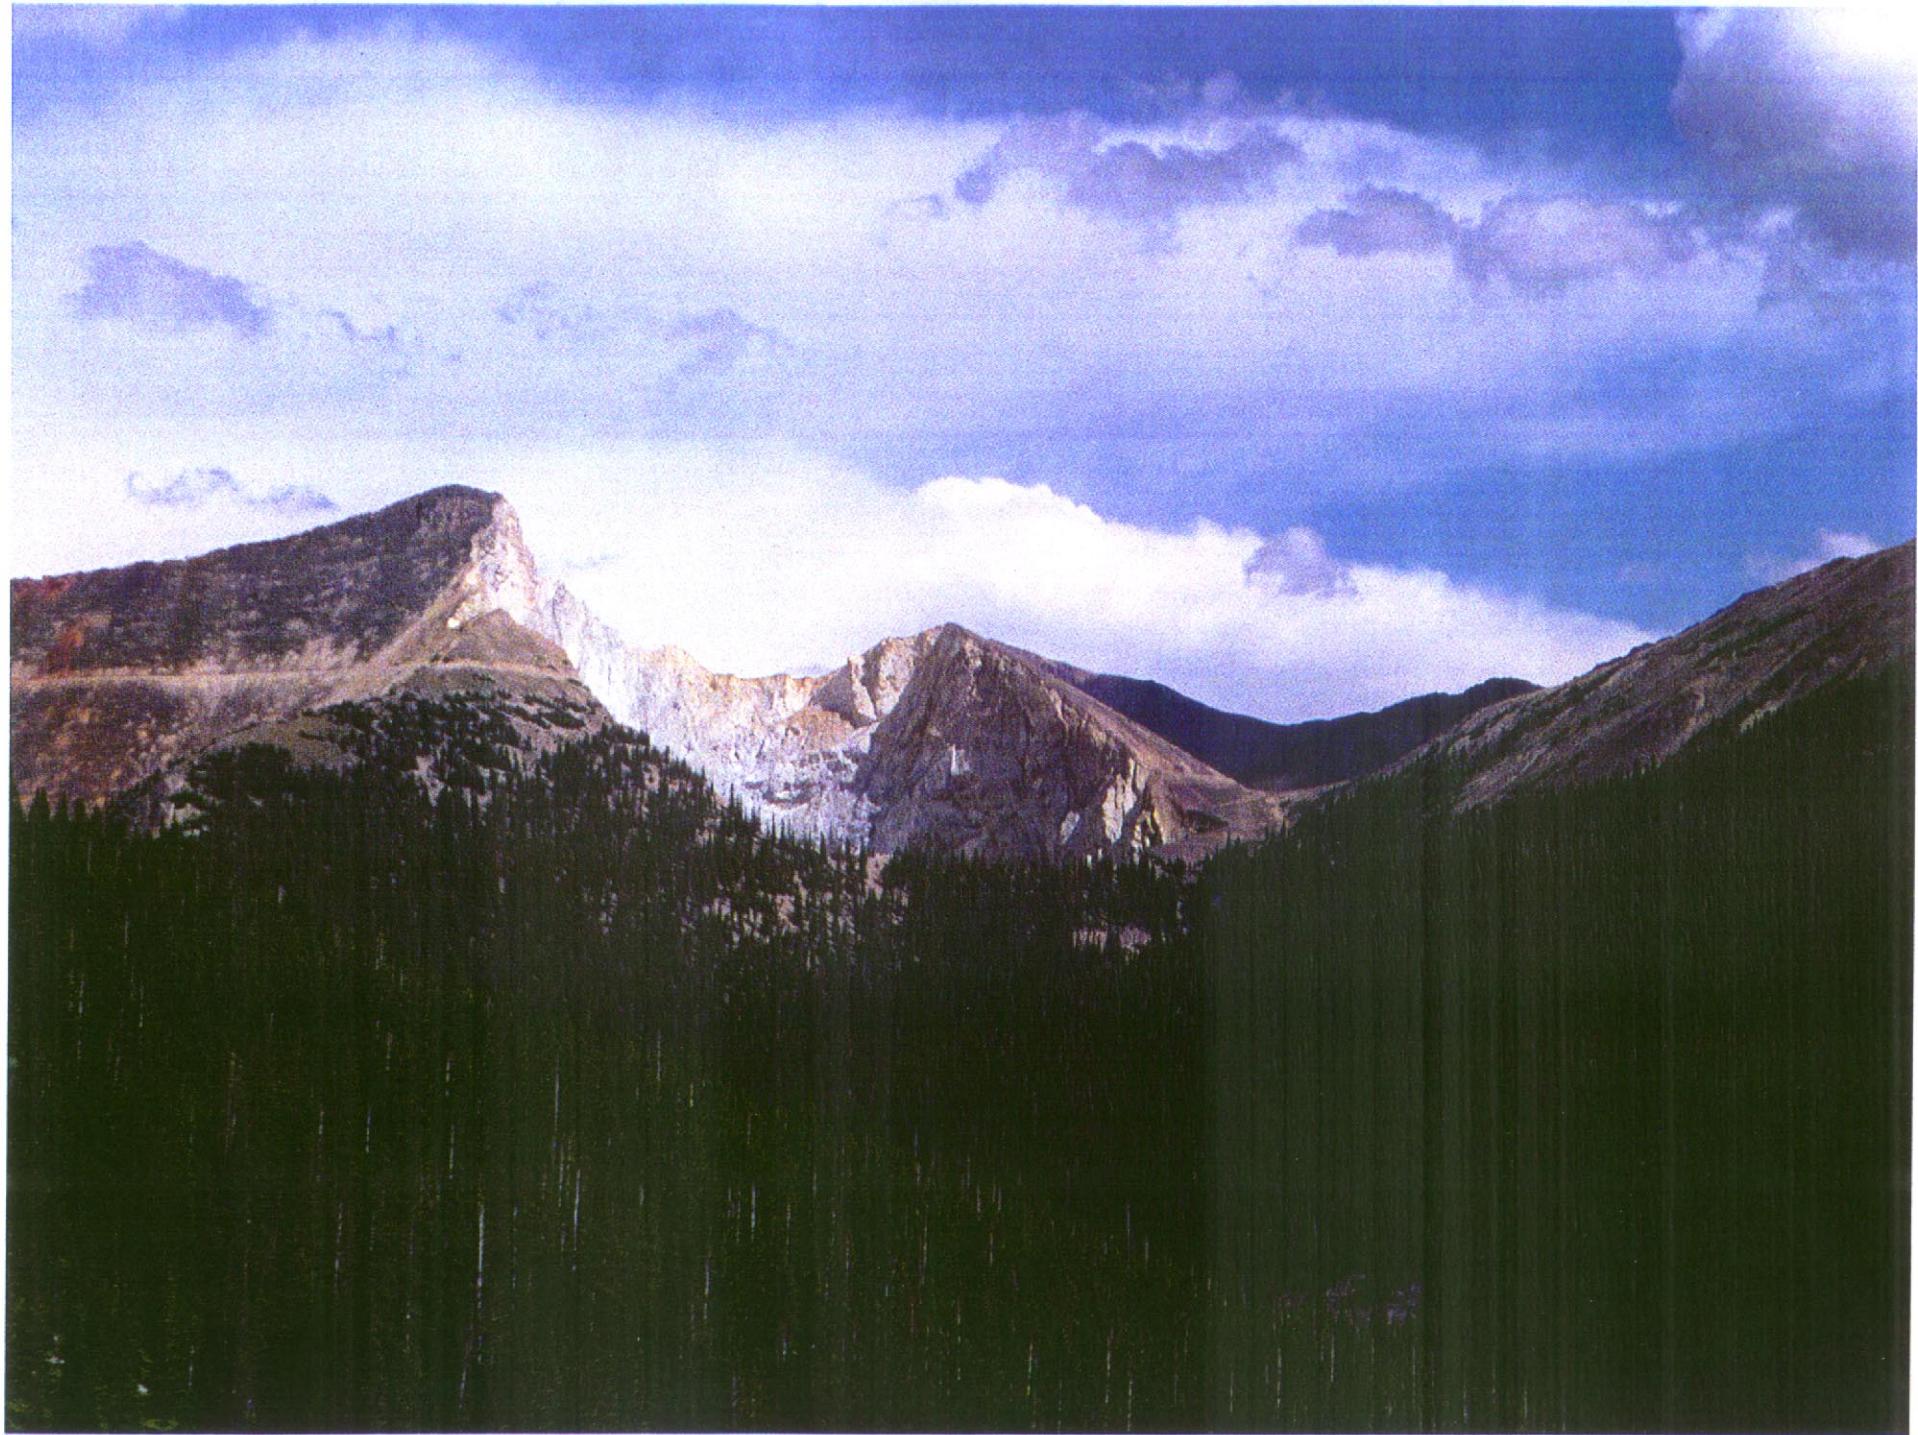
Figure 3: Close-up of cave above the Henderson Mine, CO.

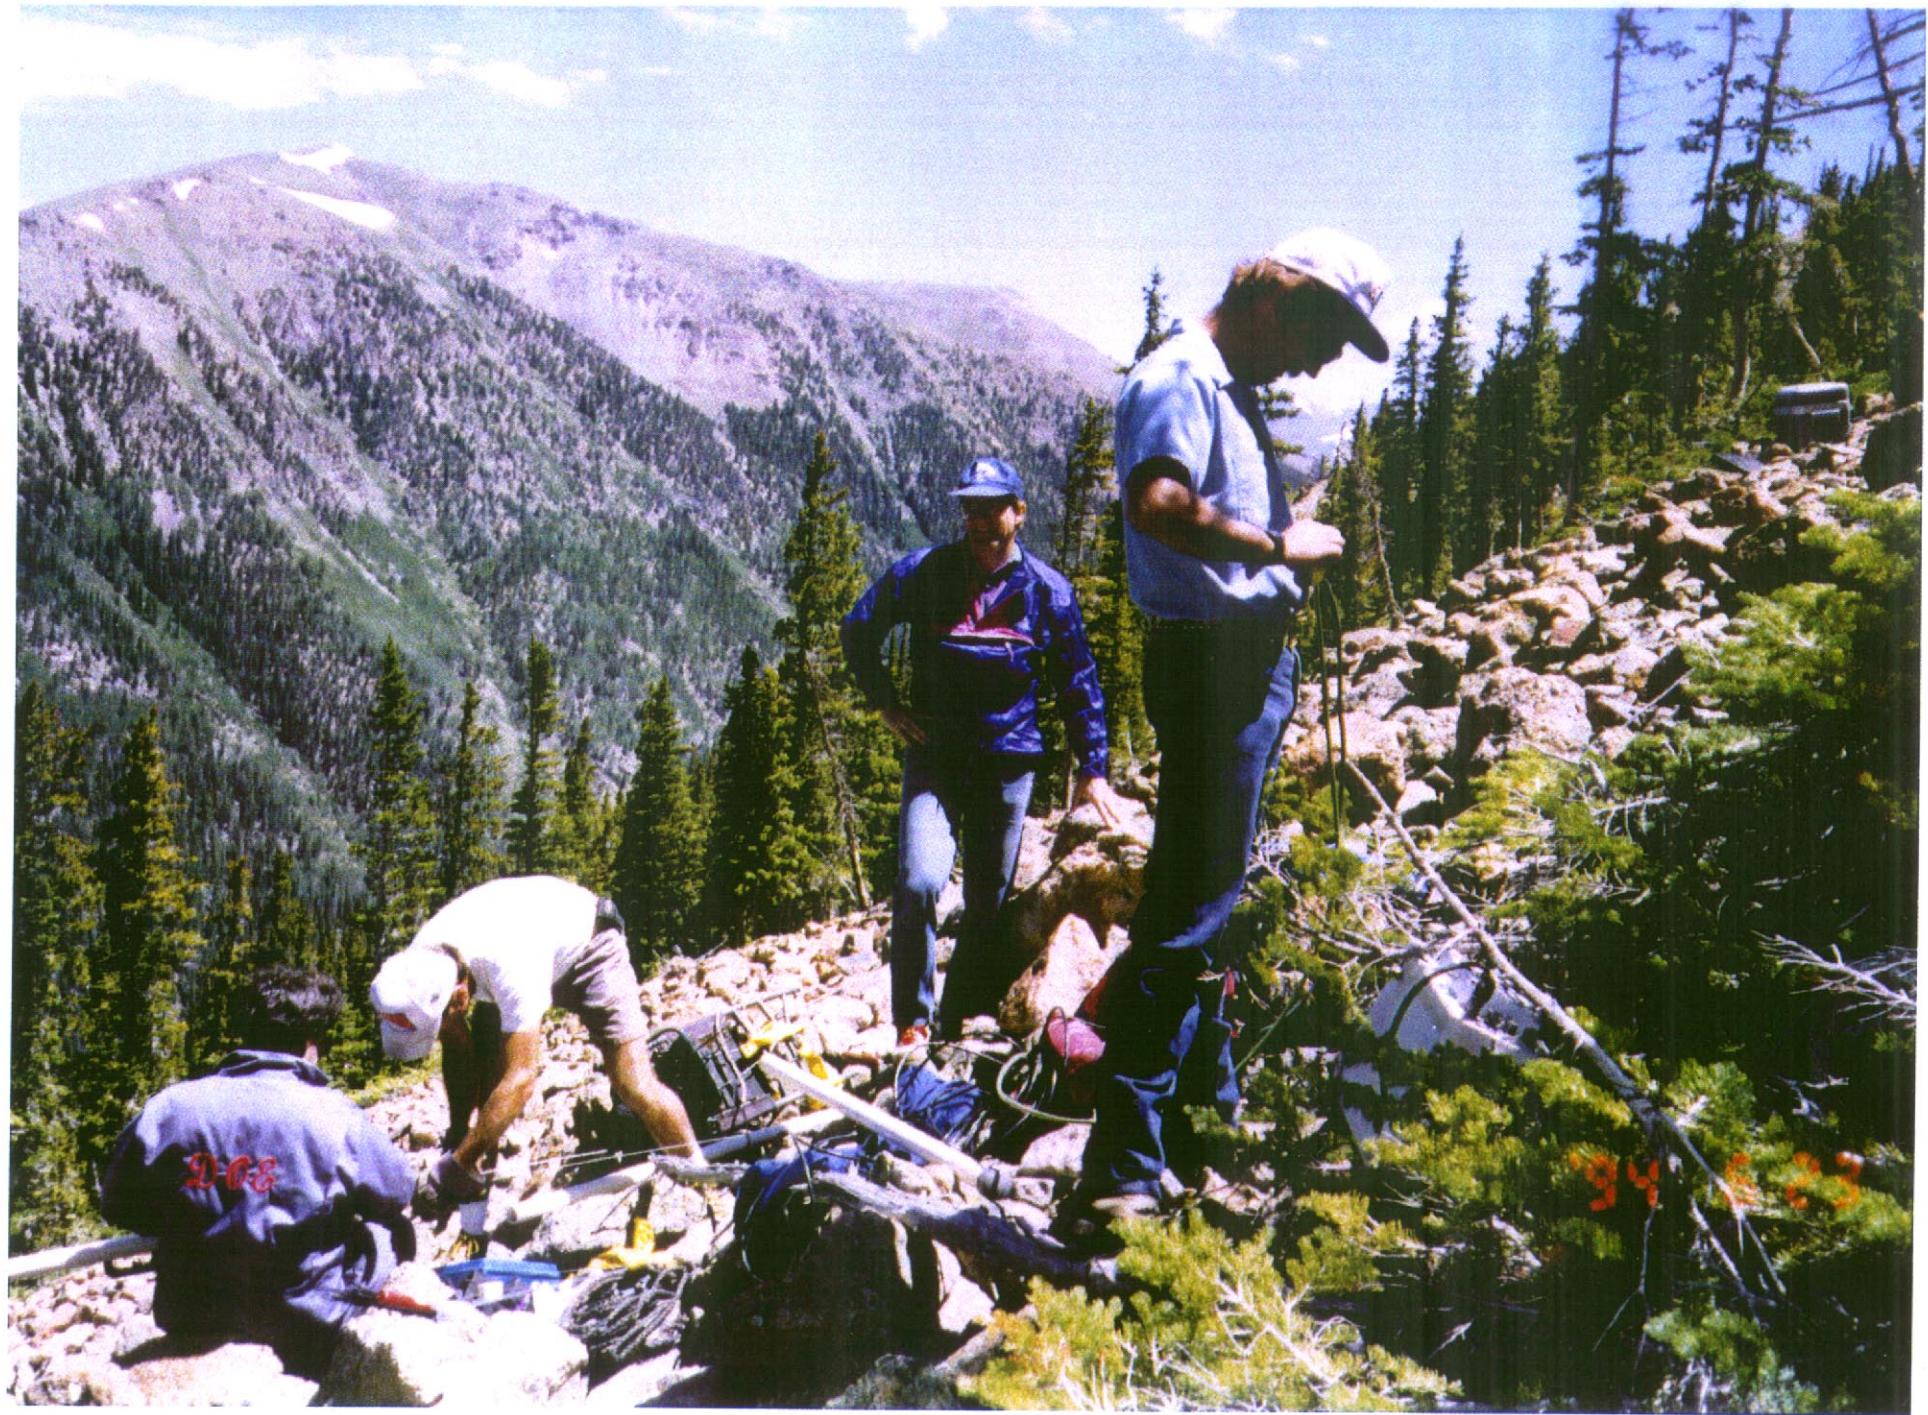
The same problem may arise in the deployment of sensors to monitoring seismic aftershocks. This is precisely what Figure 4 illustrates. The Lawrence Livermore National Laboratory (LLNL) deployed a series of passive seismometers on the flanks of the mountain to listen for caving activity [3]. Deployment was achieved by an arduous climb on foot. Figure 4 shows one of the listening sites. It is not adequate for helicopter landing, although a low-altitude hover could have been considered.

Figure 4: Seismic station deployment at the Henderson Mine, CO. (Courtesy of A. Smith)

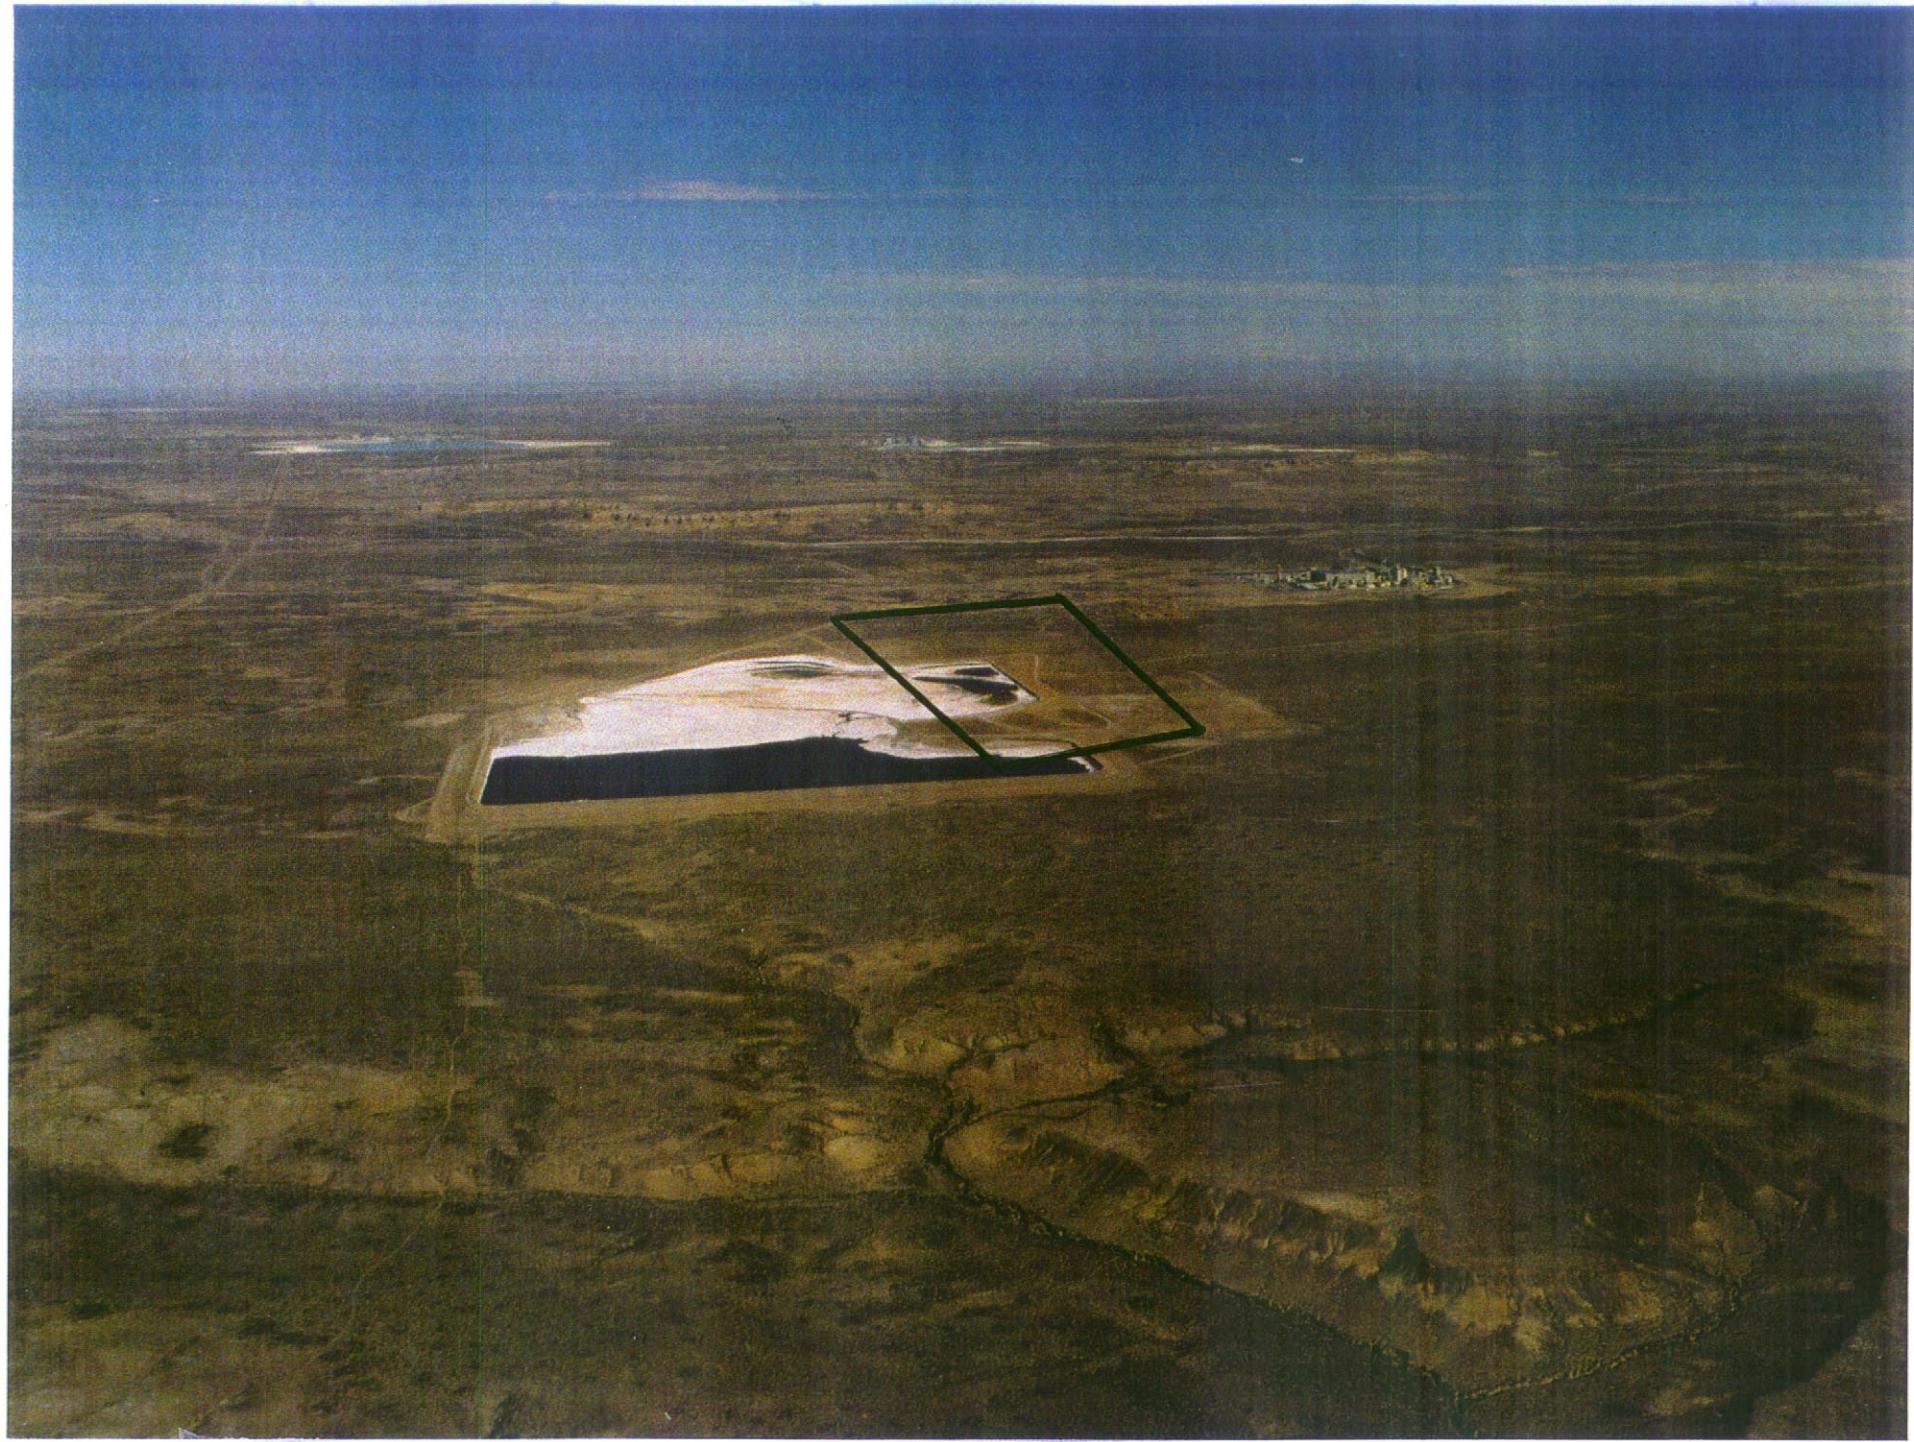
On February 3, 1995 a seismic event of magnitude $M_L=5.1$ originated from this mine site, upon the collapse of a 2 km^2 area of 3-meter high pillars, at a depth of 420 m [4]. An overflight of the site was performed on October 1995. A broad view of the site is given in Figure 5, where the scale is shown by the 2 km^2 hatched area overlying the underground collapse. The figure also shows in the distance the presence of other

Figure 5: Solvay mine site, WY, looking north. Overview, with other mine sites.

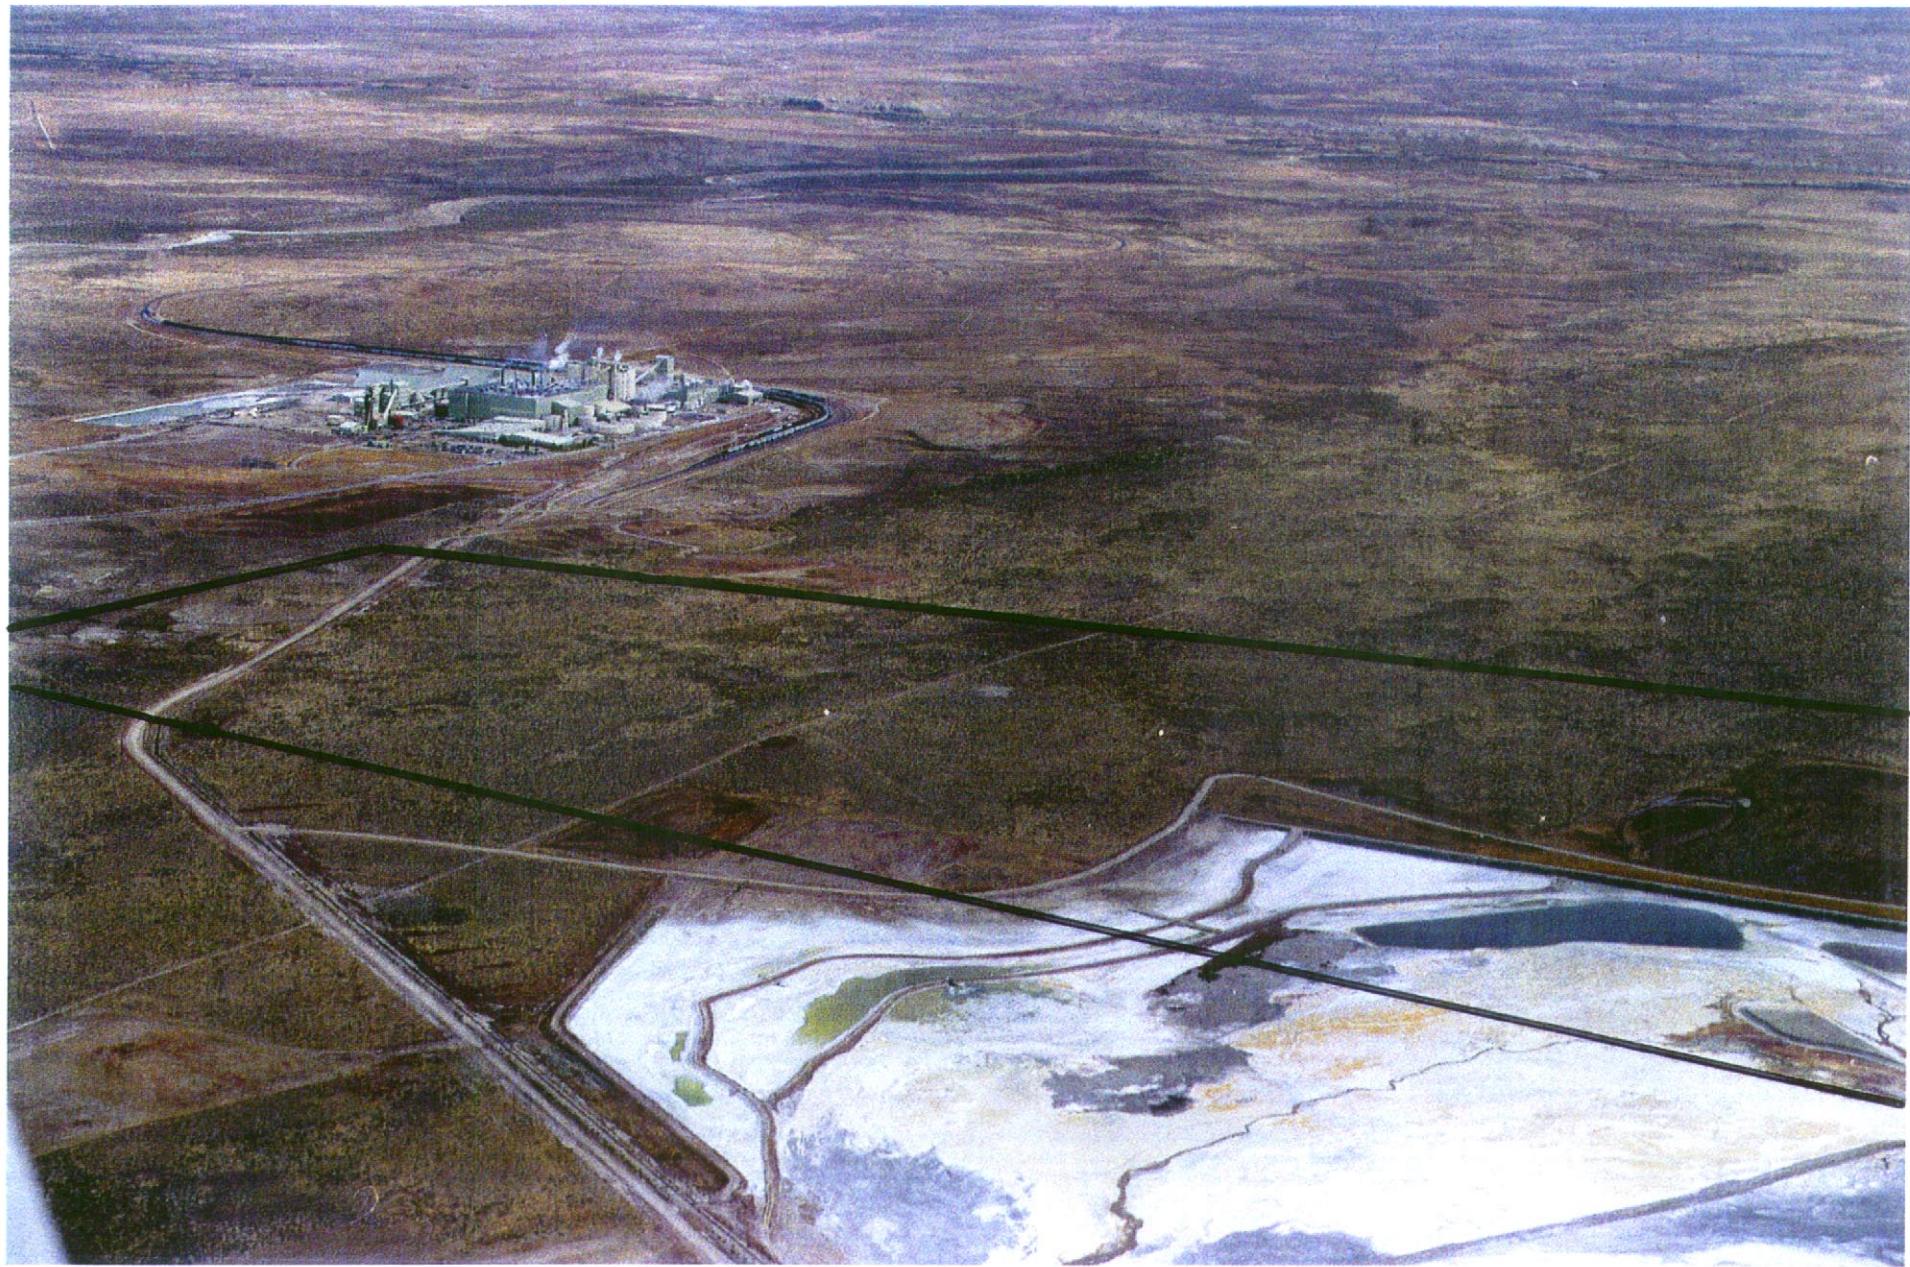
However, from an OSI point of view the event did leave a significant mark. The levee, which dammed the retaining pond, shown in Figures 5 to 9, was broken by its subsidence. The fluids spilled out of the original pond and evaporated, thus leaving the extensive discoloration of the ground which can be seen from the air.

Figure 6: The Solvay site looking north, with spillage of pond fluids in the foreground.

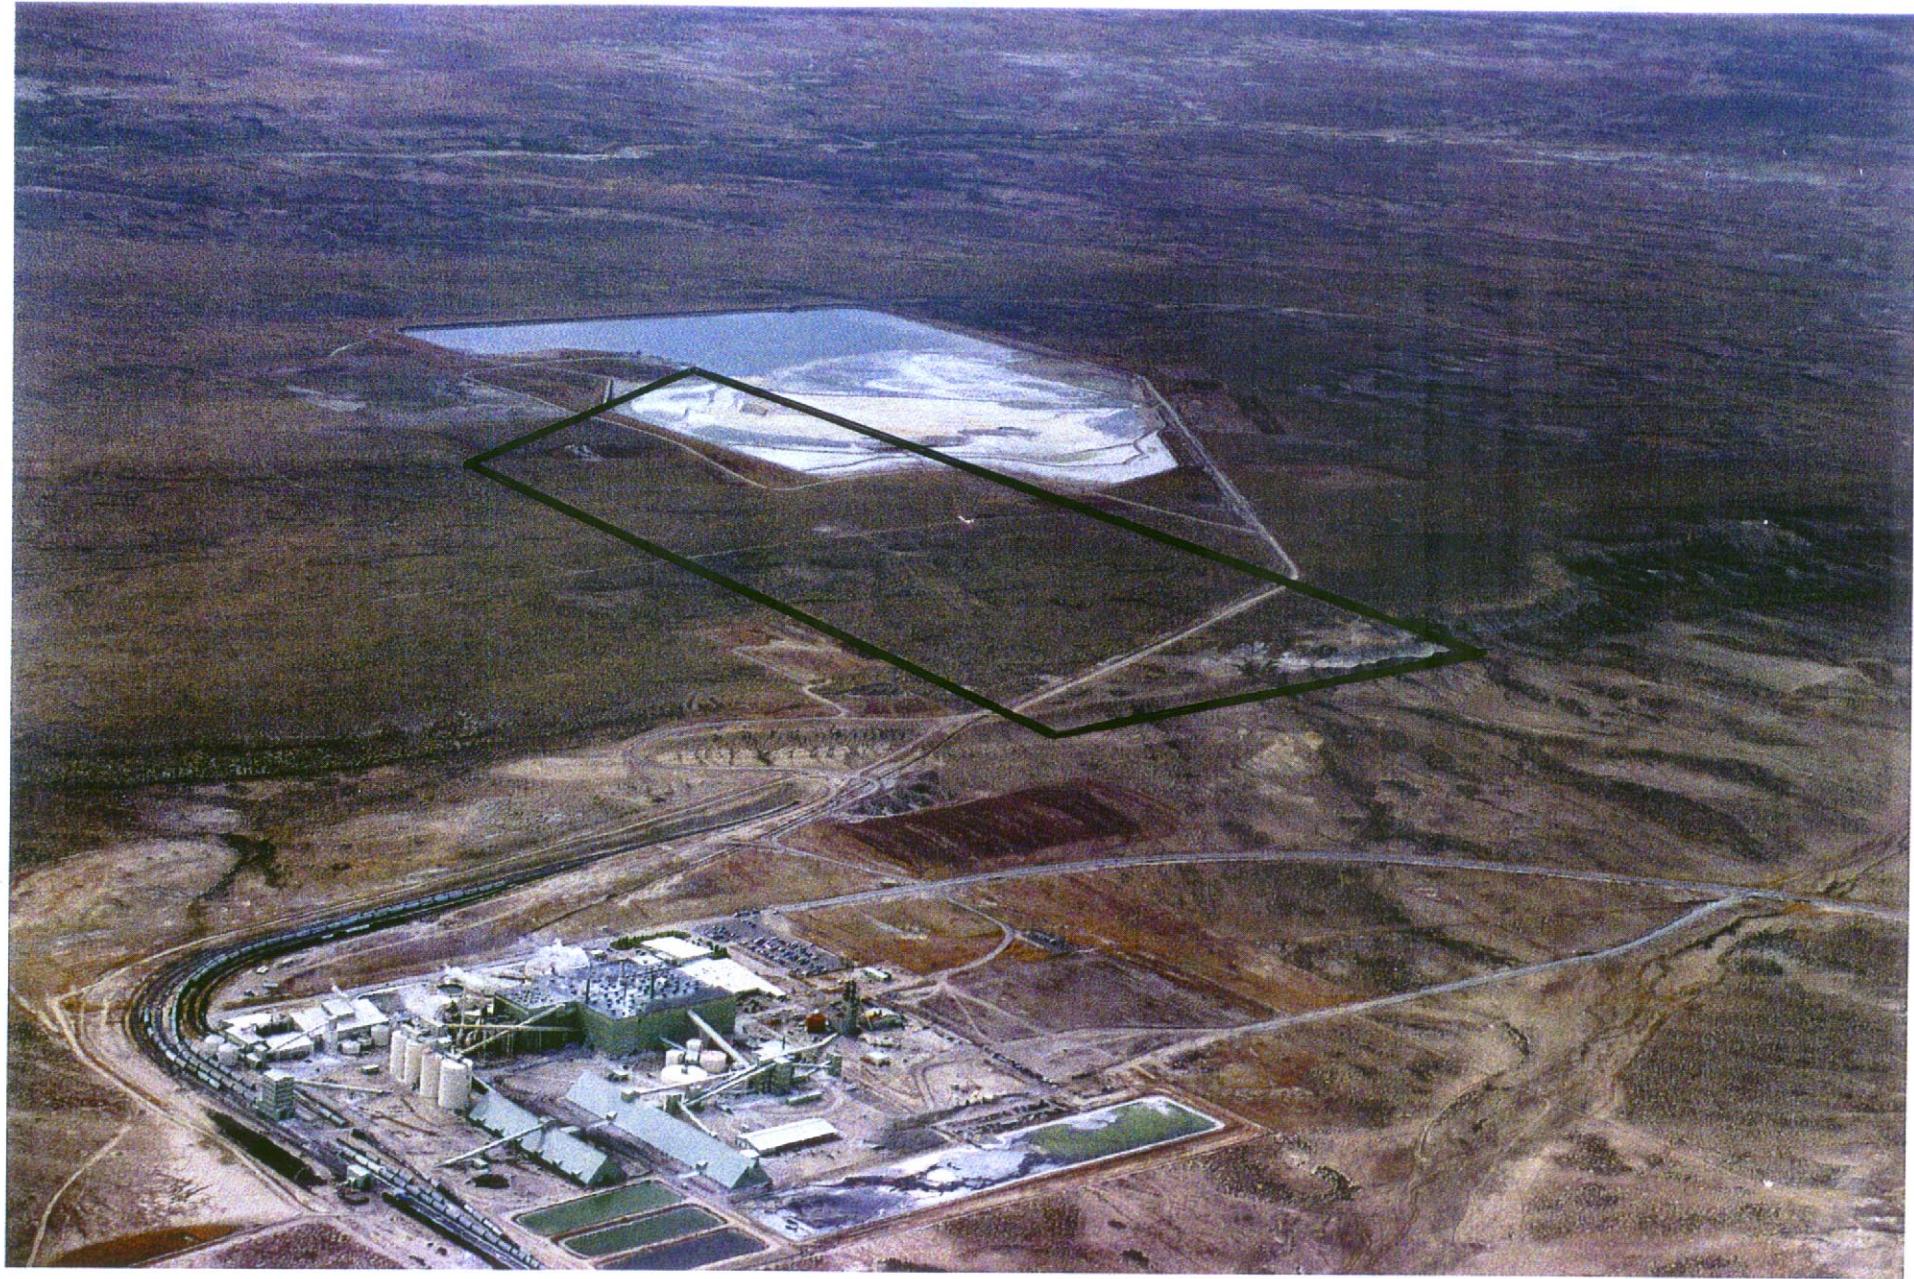
Figure 7: The Solvay site, WY, looking south.

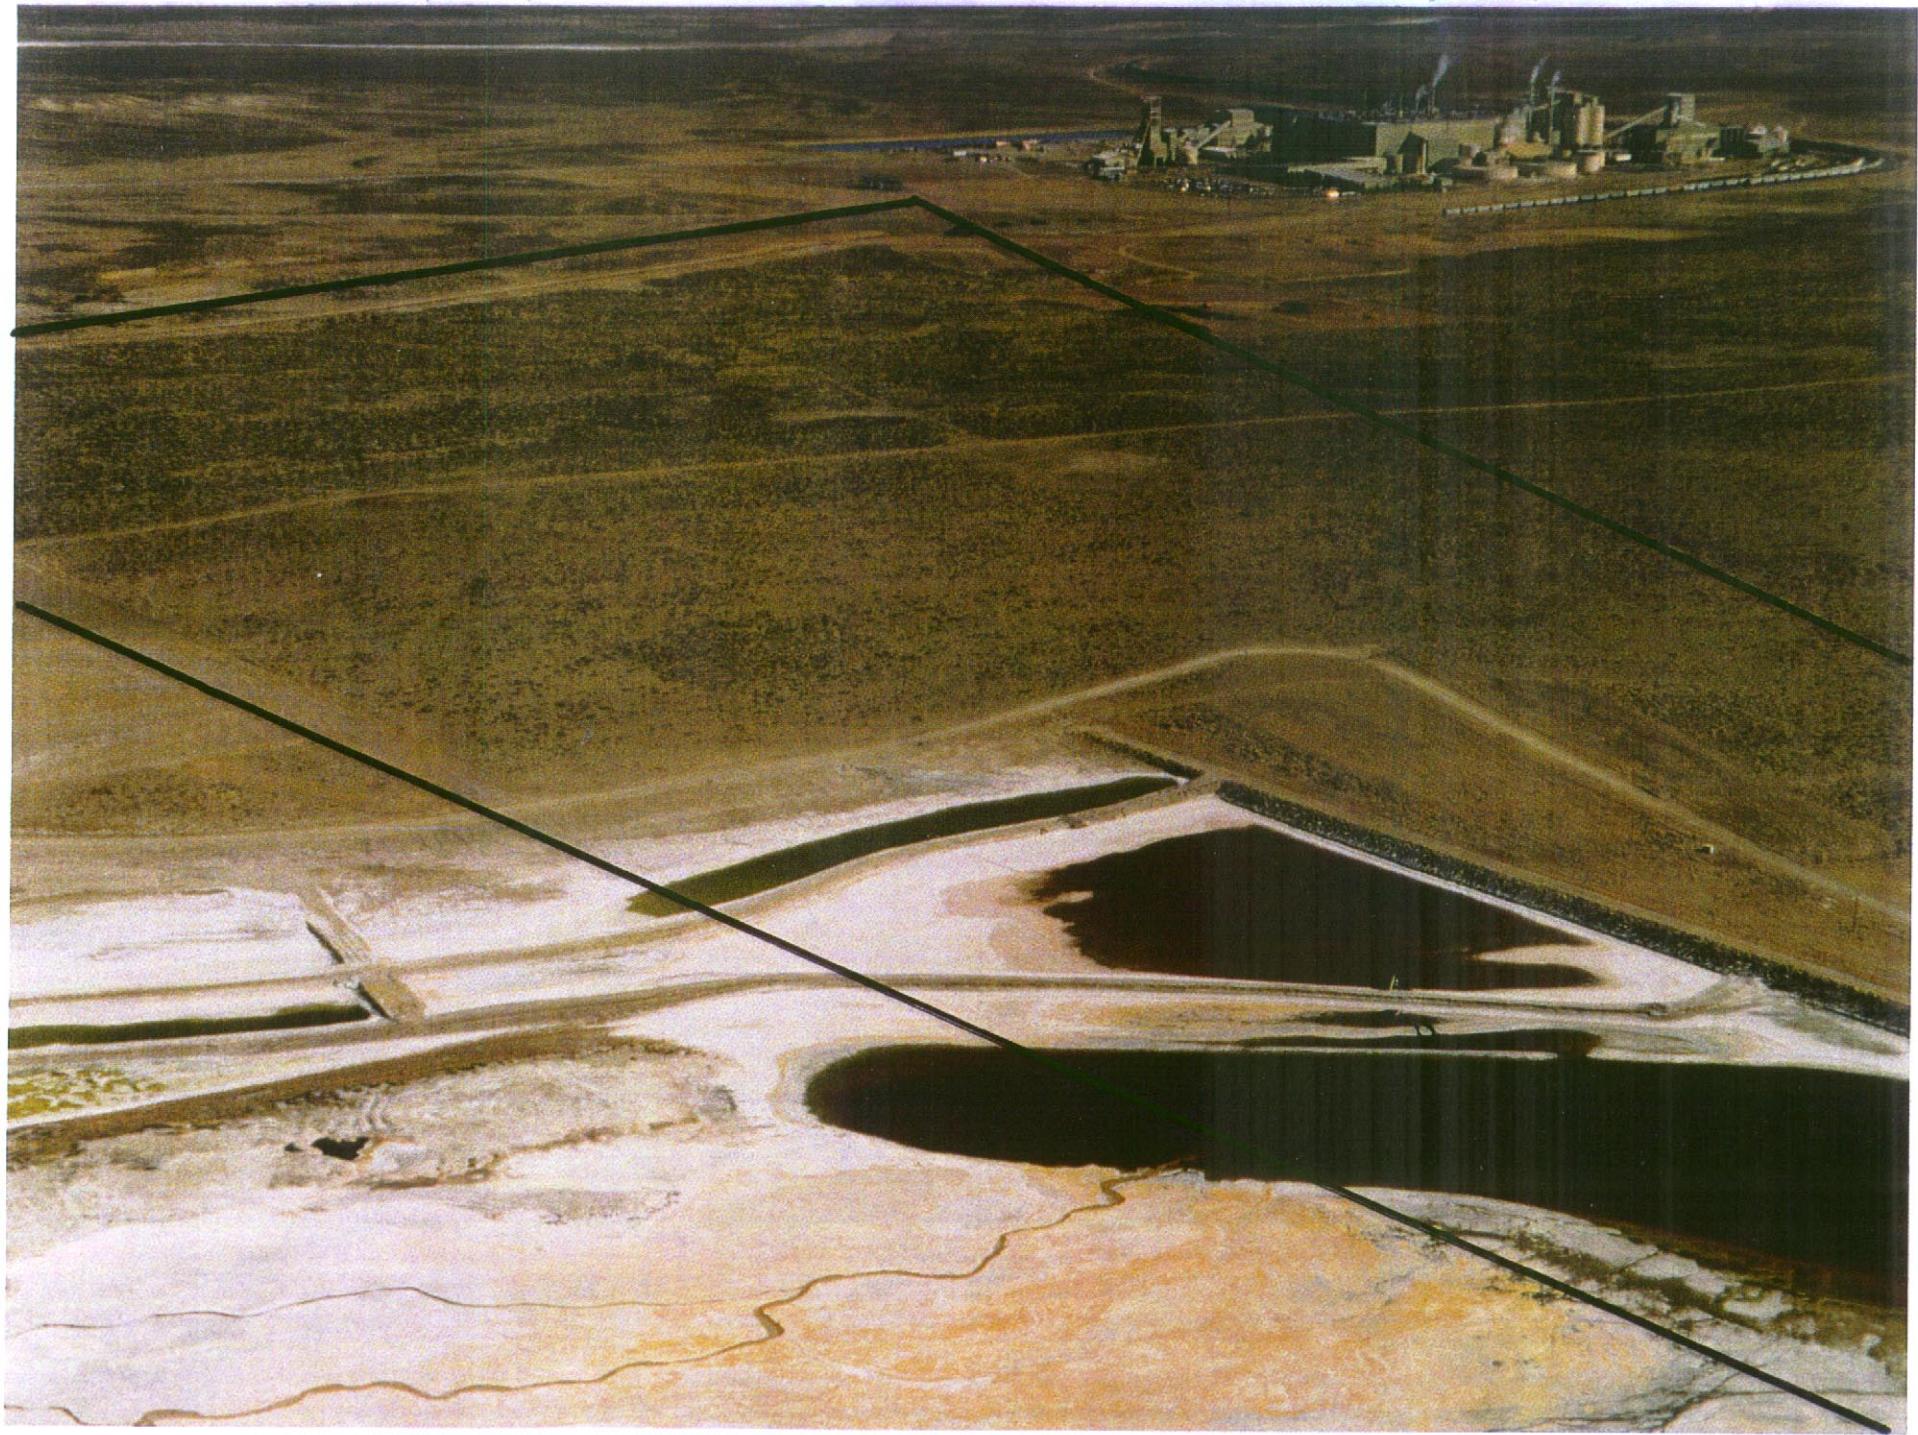
Figure 8: Solvay, WY. Close-up of the pond area, looking north.

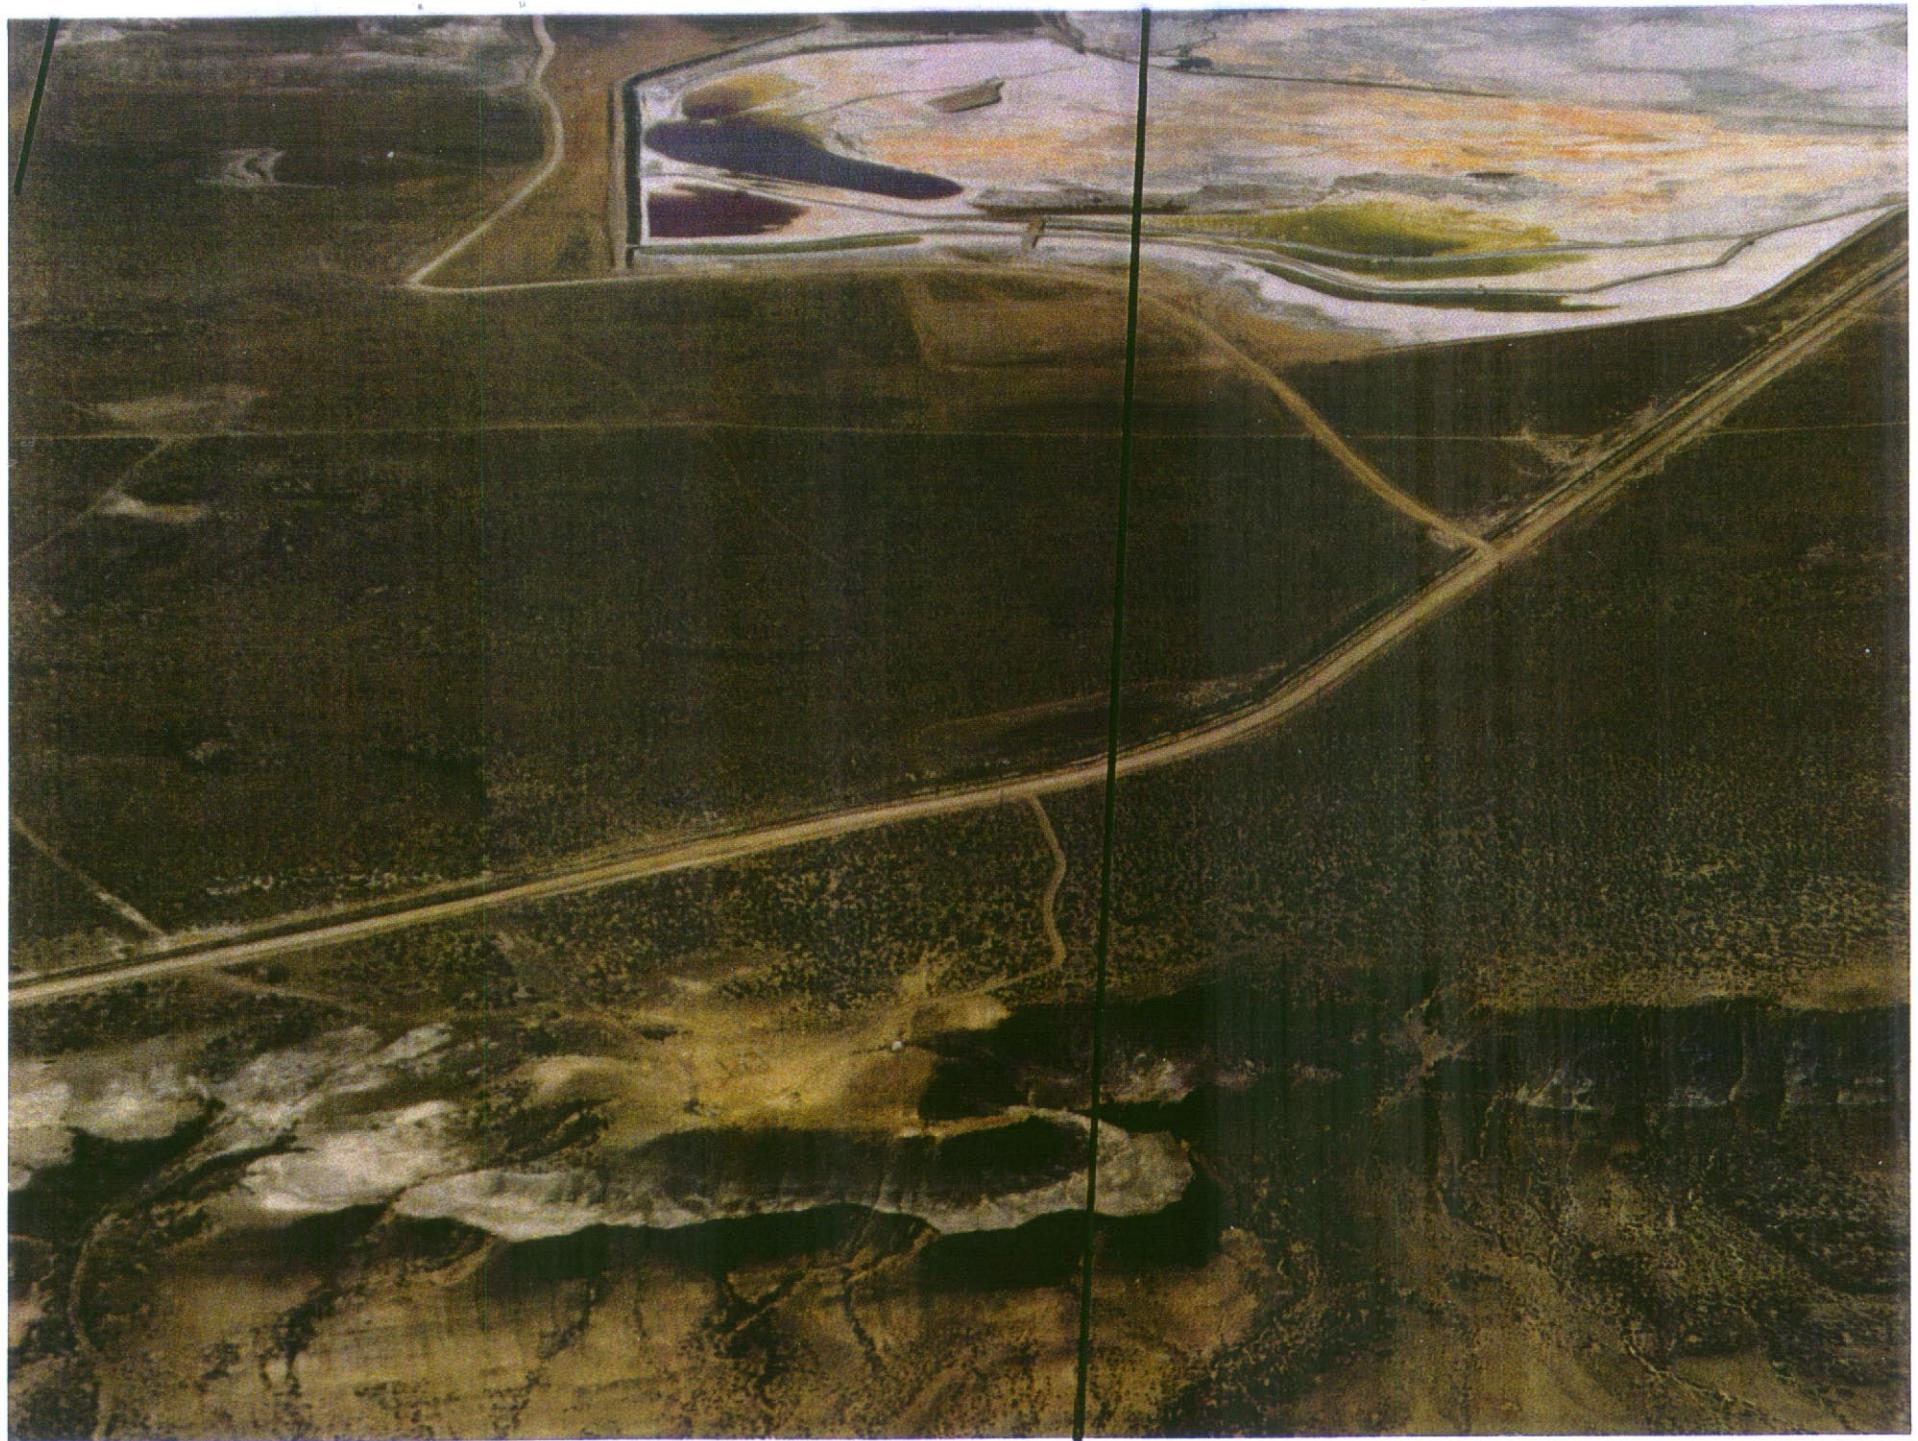
Figure 9: Solvay, WY. Pond and bluff area, looking south.
