UCRL-JC-127891
PREPRINT

Aerial and Ground-Based Inspections of Mine Sites in the Western U.S.-Implications for On-Site Inspection Overflights, Under the CTBT

François E. Heuze

July 1997

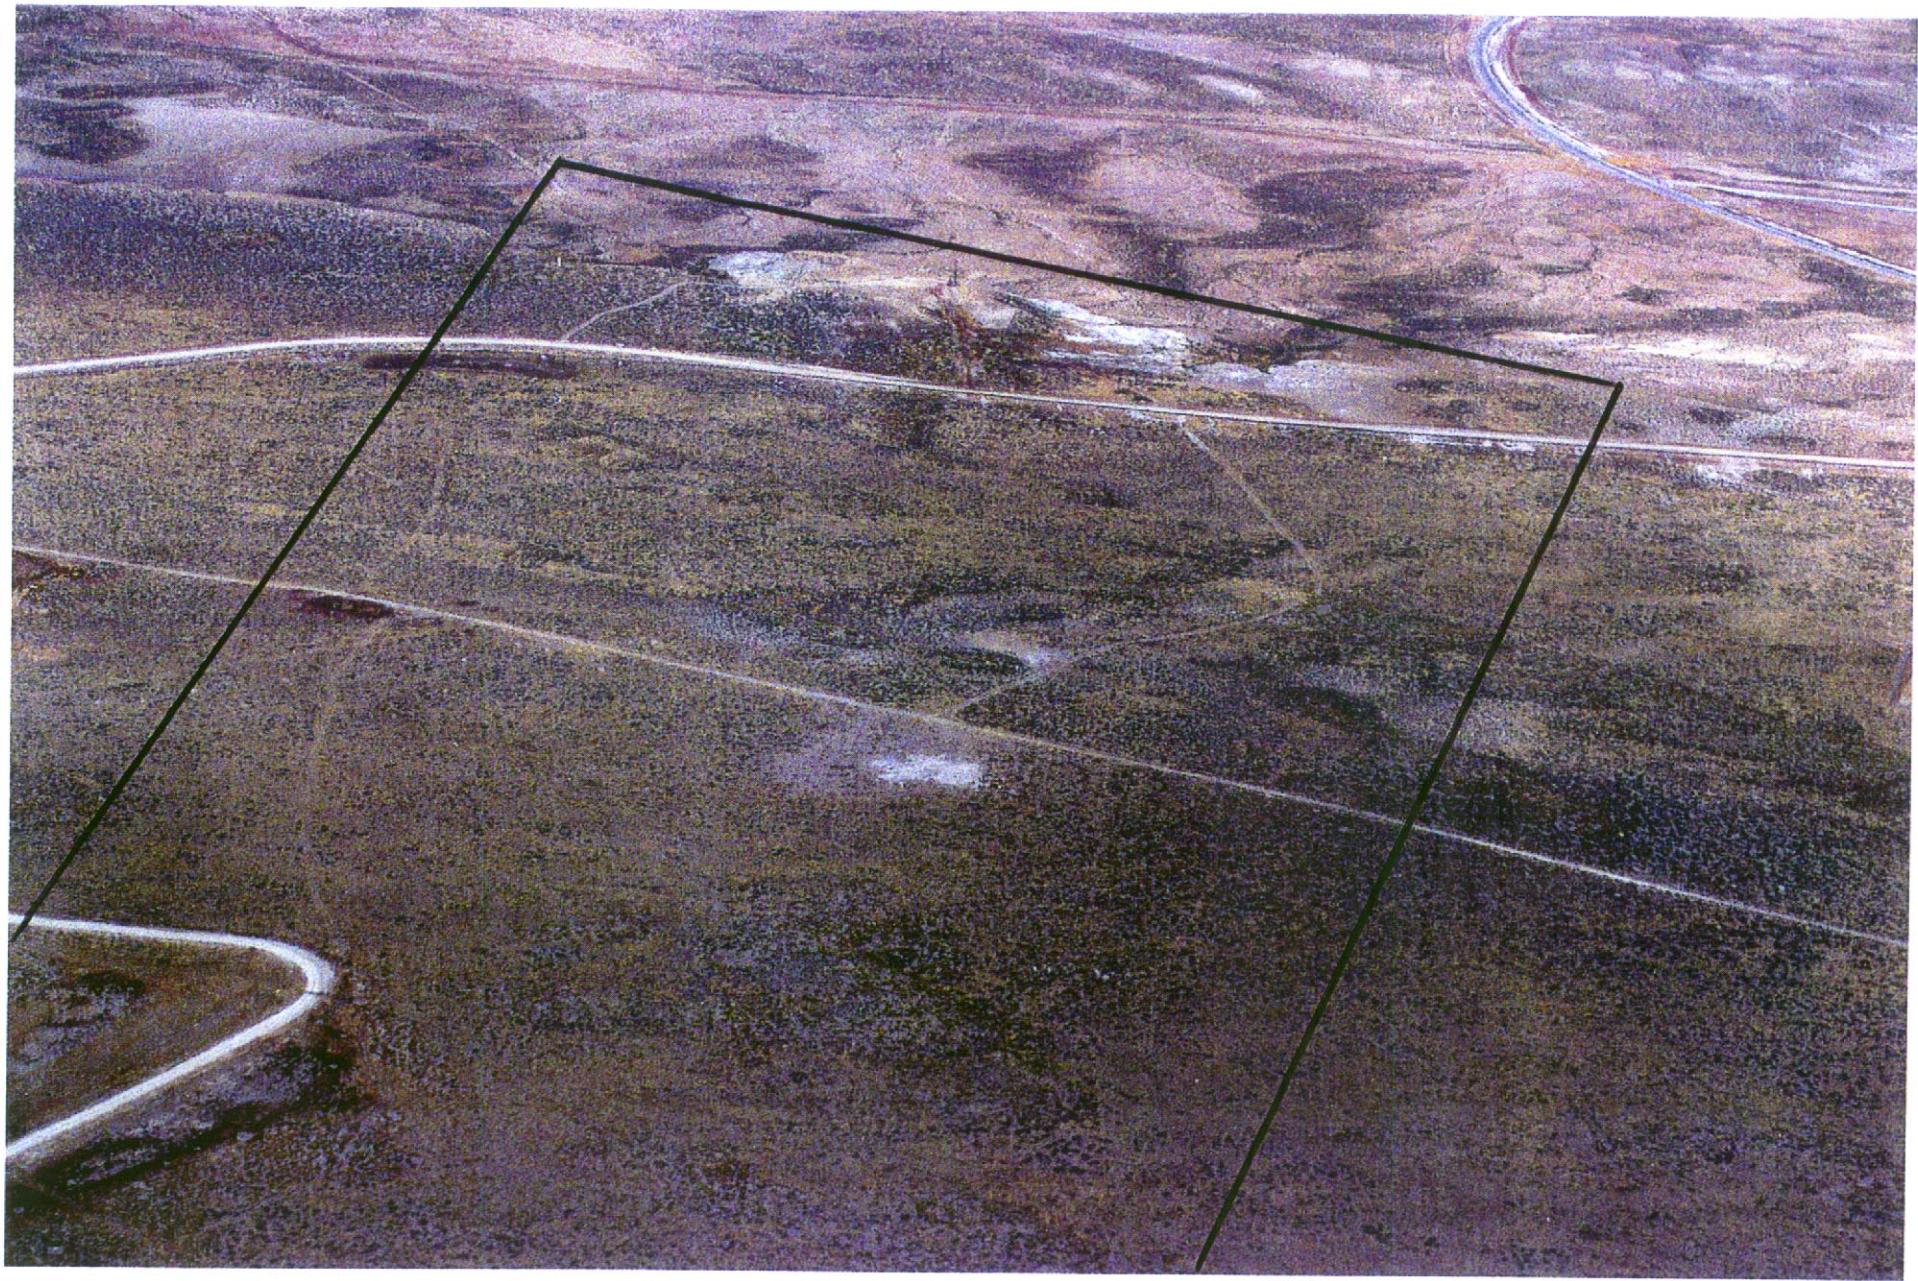
The aerial inspection was repeated in October 1996. Figures 6 through 11 are from both inspections, at descending altitudes from 1000 m to less than 100 m. The trace of the underground caving is shown in each frame. Nowhere are there cracks on the ground that would be attributed to the subsidence due to the underground collapse, although a surface survey by the mine personnel indicated up to 90 cm of such subsidence. The sedimentary formations overlying the mine horizon were compliant enough not to show surface cracking.

Figure 10: Solvay, WY. Close-up of the surface above the north end of the collapse area. No surface indications.

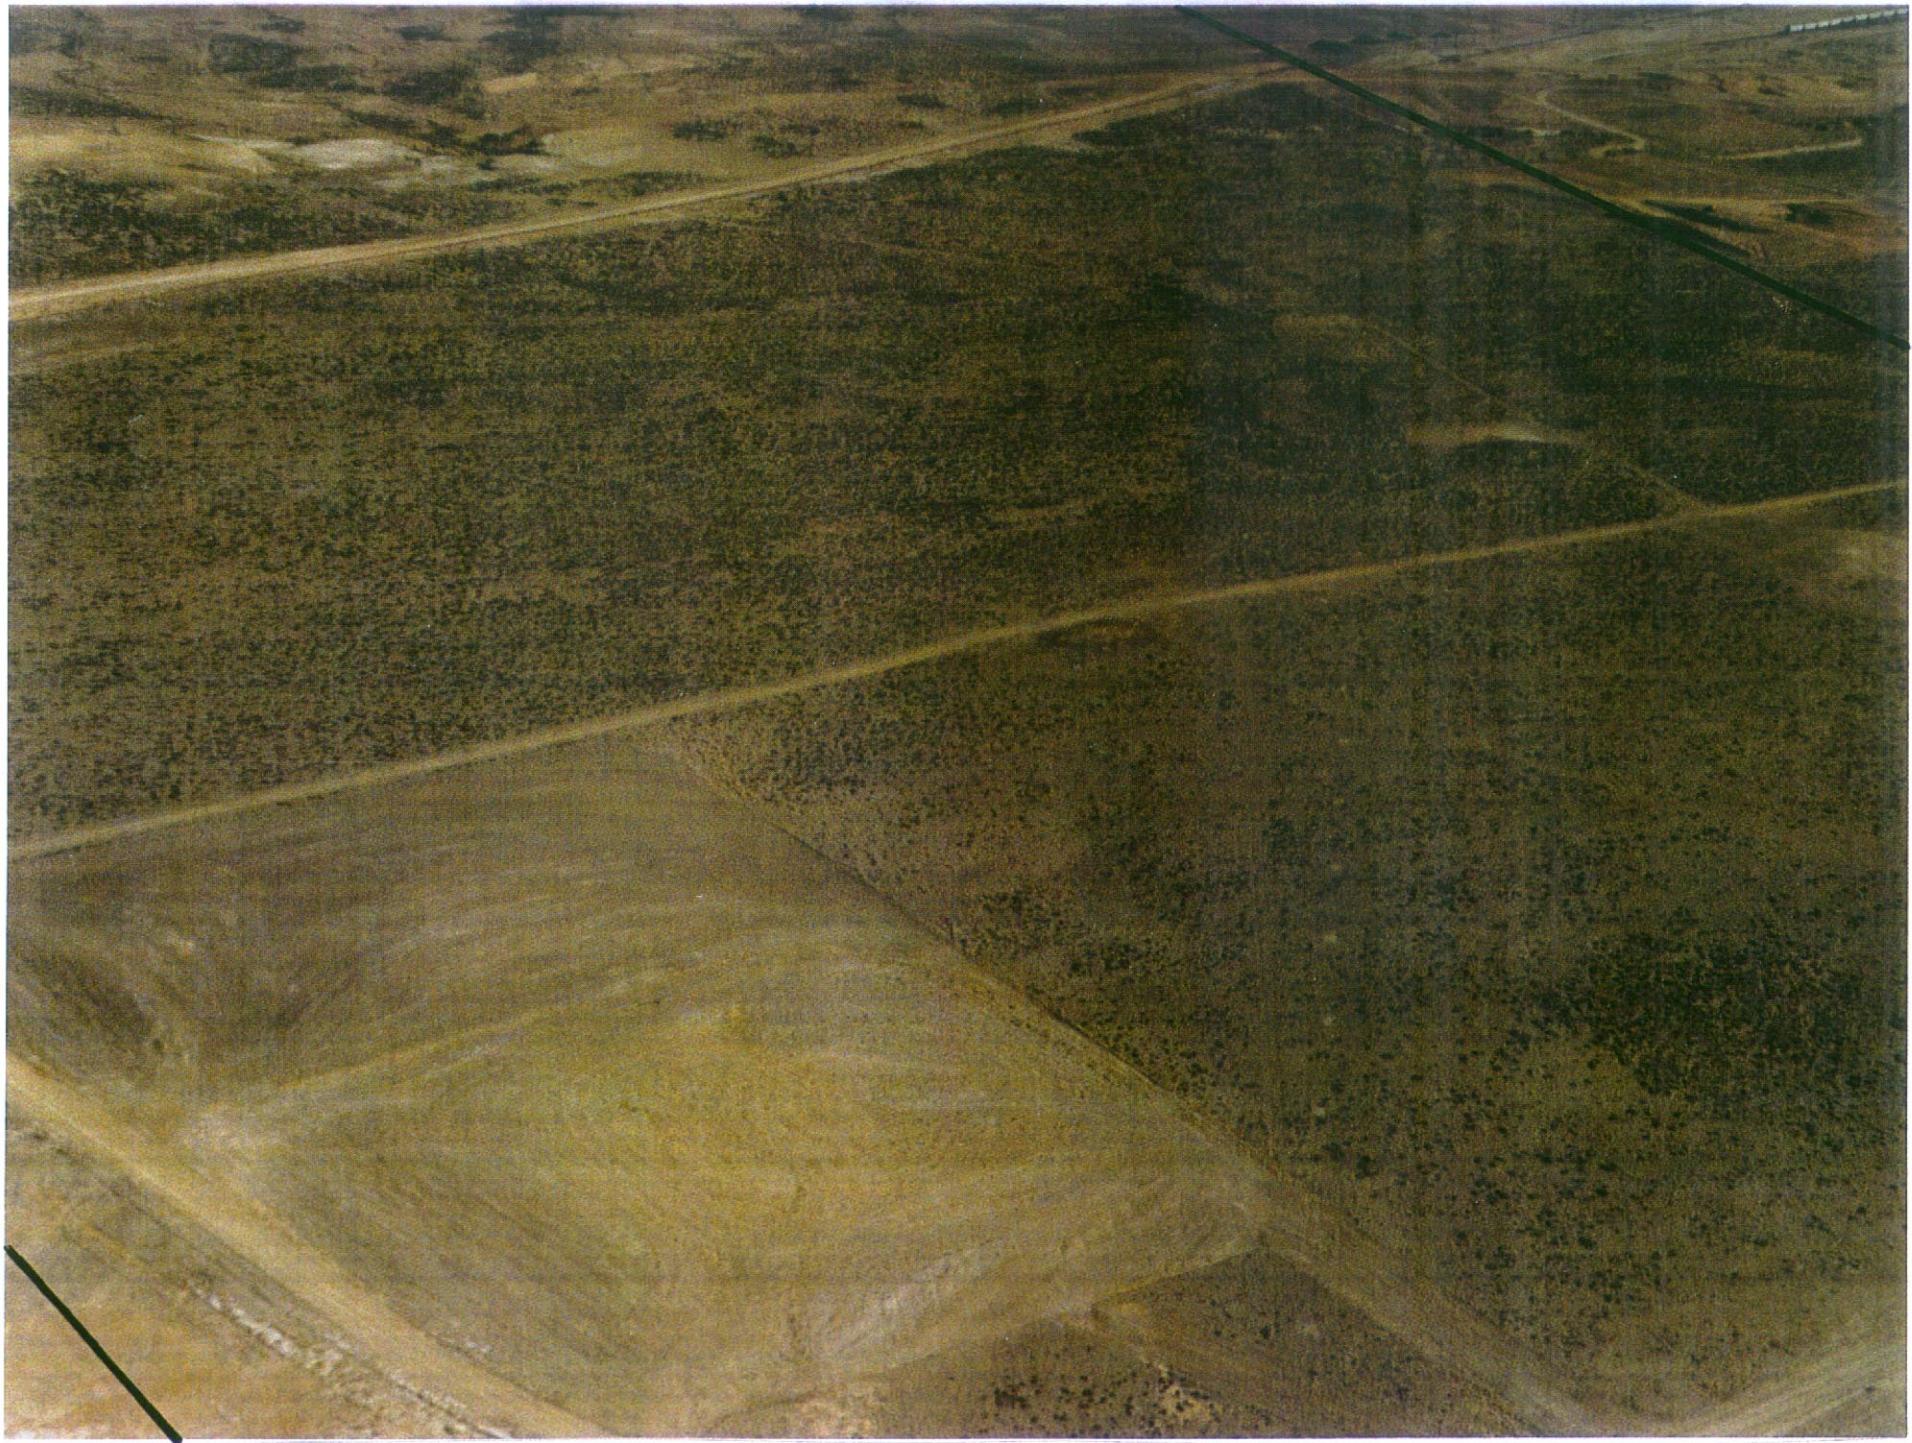
Figure 11: Solvay, WY. Ground surface between pond and plant. No visible subsidence feature from 300 m high.

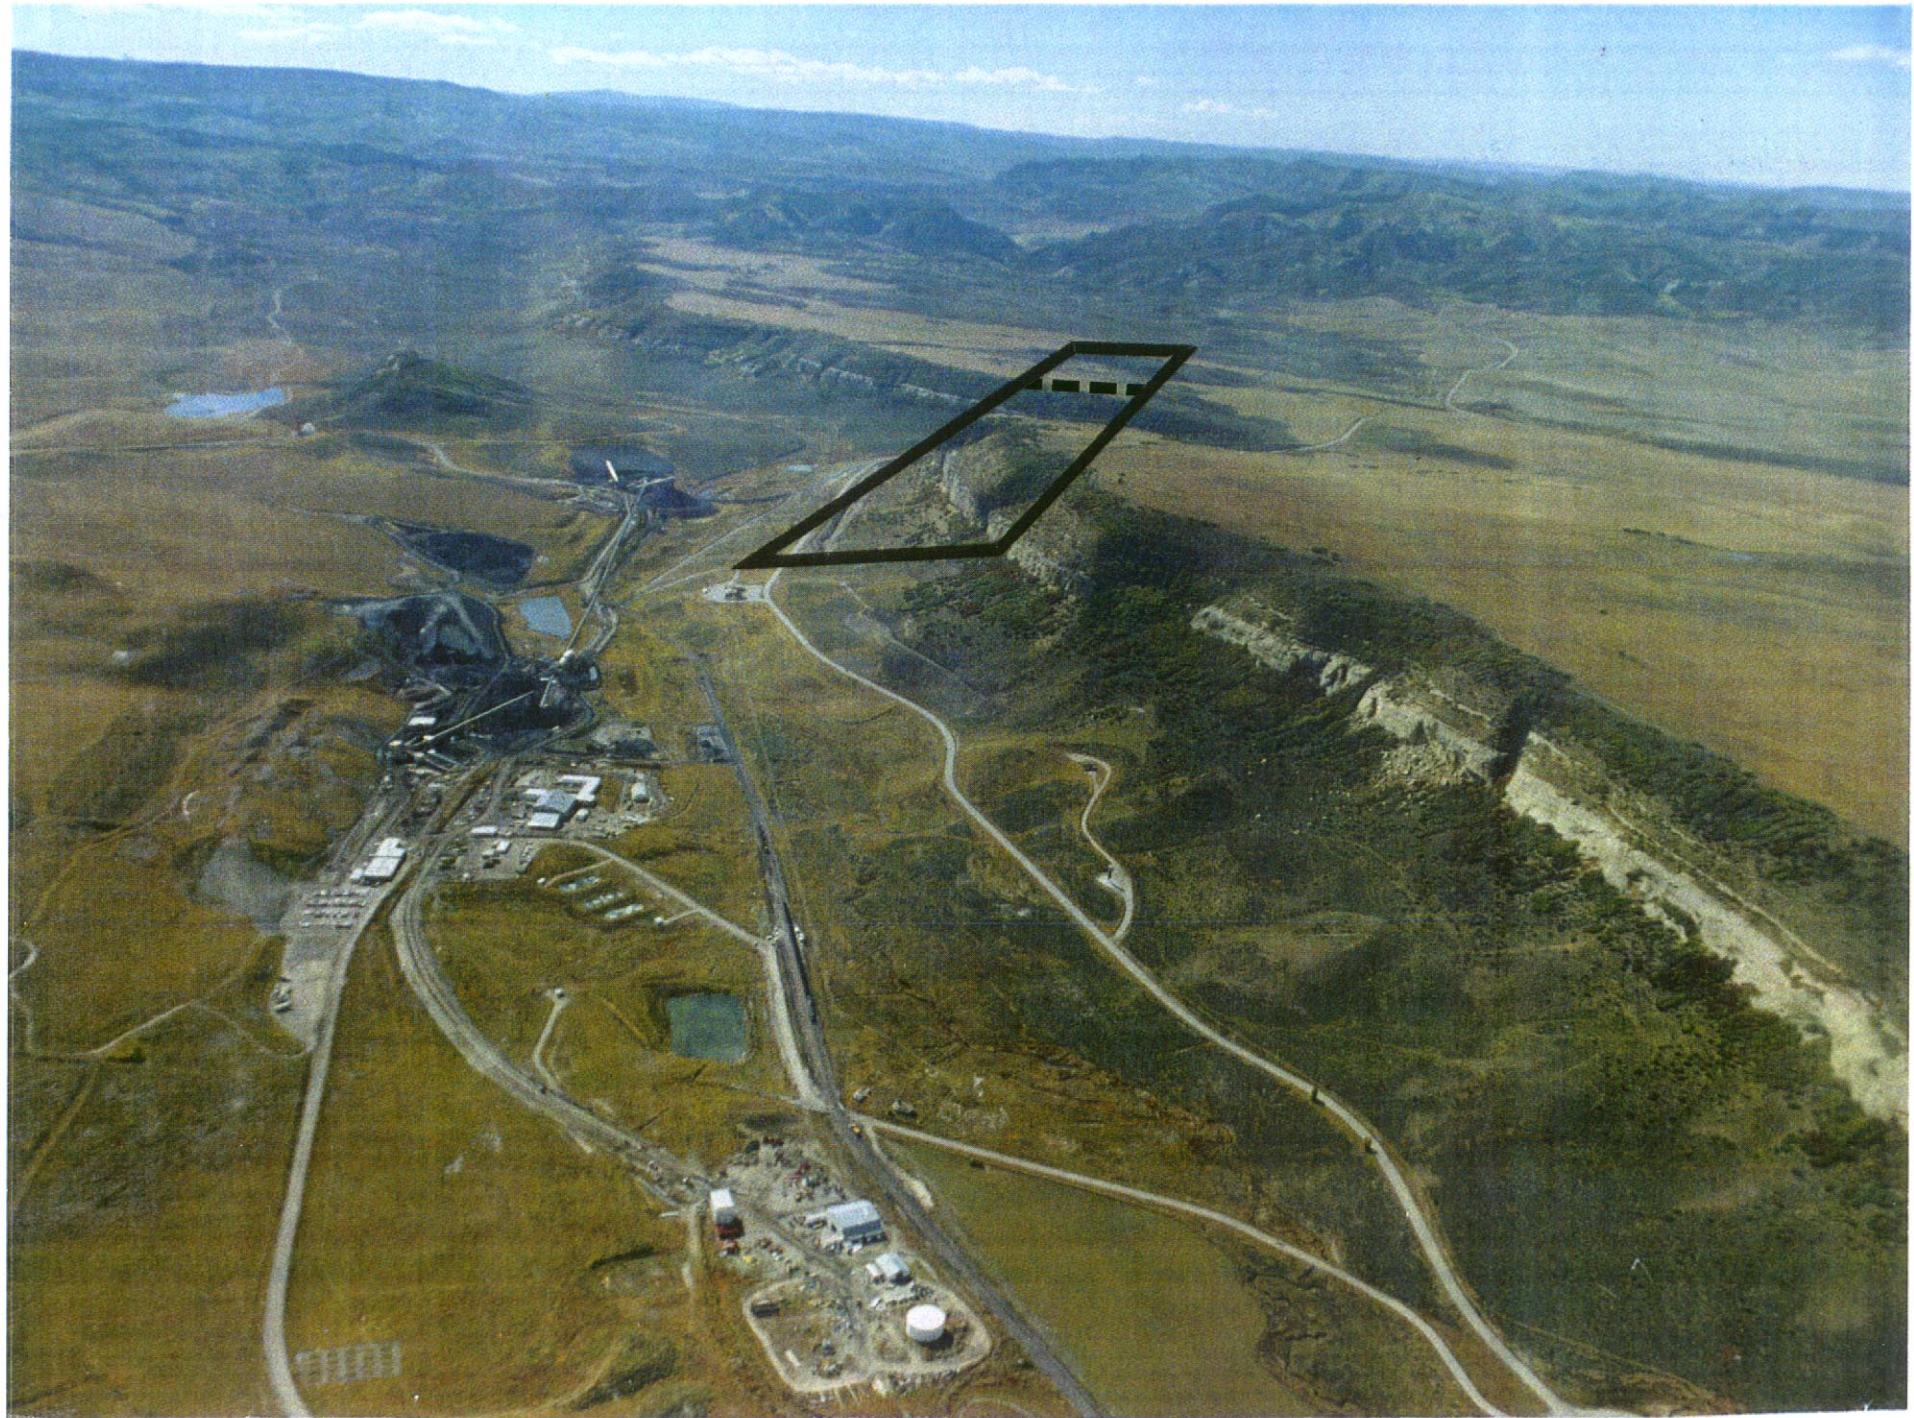
The results of the 1995 overflights are shown in Figures 12 to 14. Figure 12 gives an overview of the site and of the panel, at a depth of 420 m. By then the face had only progressed to the dashed line and was moving towards the observer. Figures 12 to 14 (1995) represent the baseline observations prior to the passage of the panel. Figures 15 to 17 (1996) show the extensive cliff collapses due to surface subsidence after panel passage. This is due to the fact that the thick-bedded Twentymile sandstone, shown also in Figures 13 and 14, could not accommodate being undermined without unraveling. On the other hand, Figure 18 shows that this particular location with less brittle rock beds did not reveal the passage of the panel under it. Clearly, the massive ground failures shown at Twentymile would provide guidance for narrowing the site of an inspection area.

Figure 12: Overview of Twentymile Coal mine site, CO, looking west.

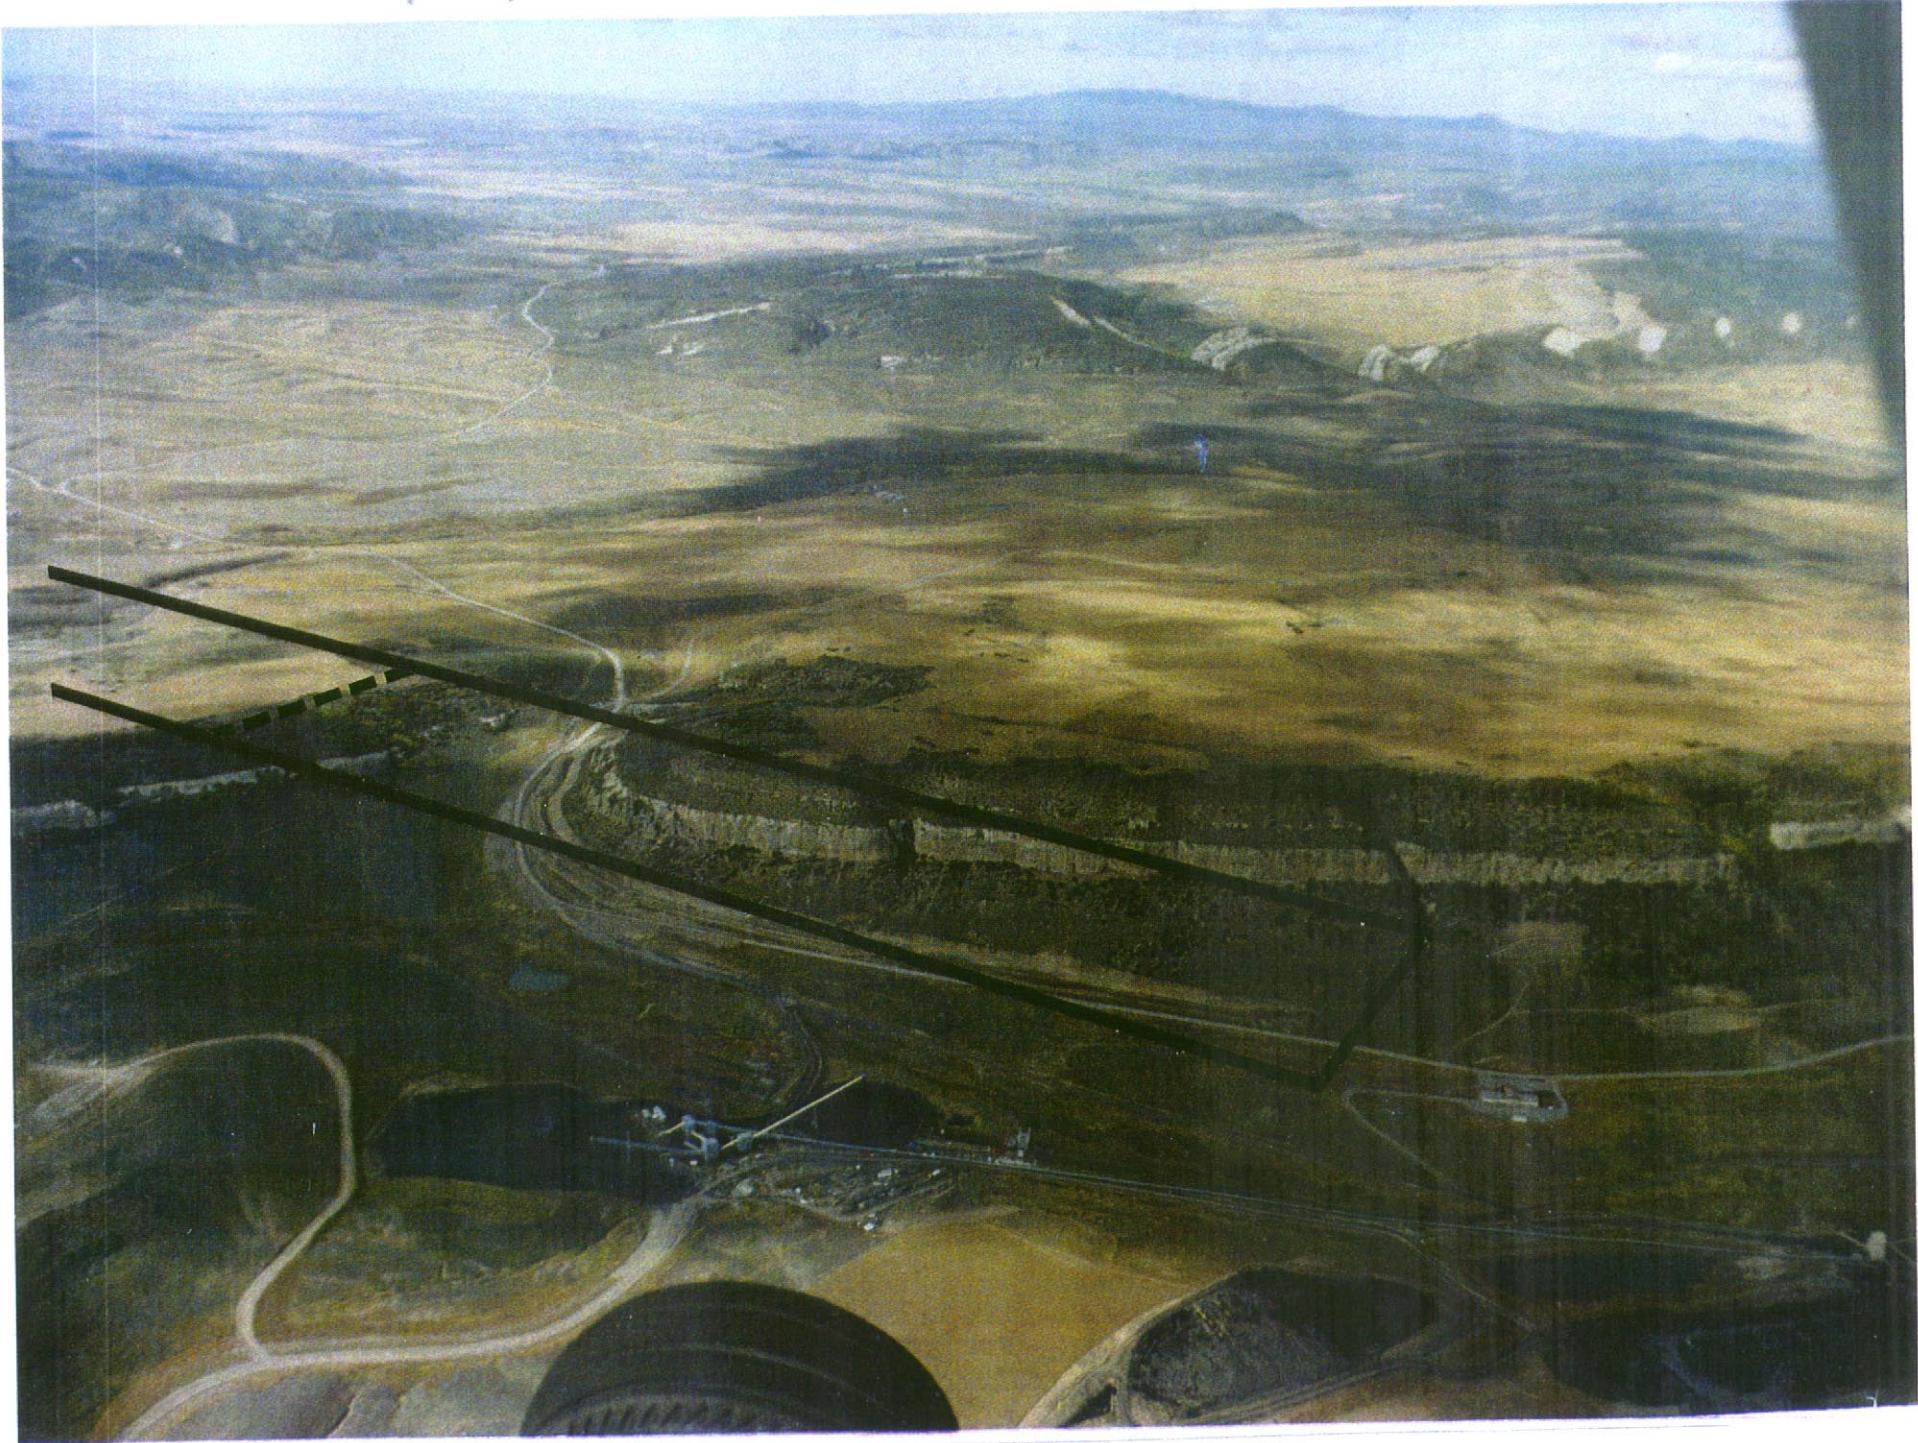
Figure 13: Twentymile site, CO. Cliffs of the Twentymile sandstone; no failures, October 1995.

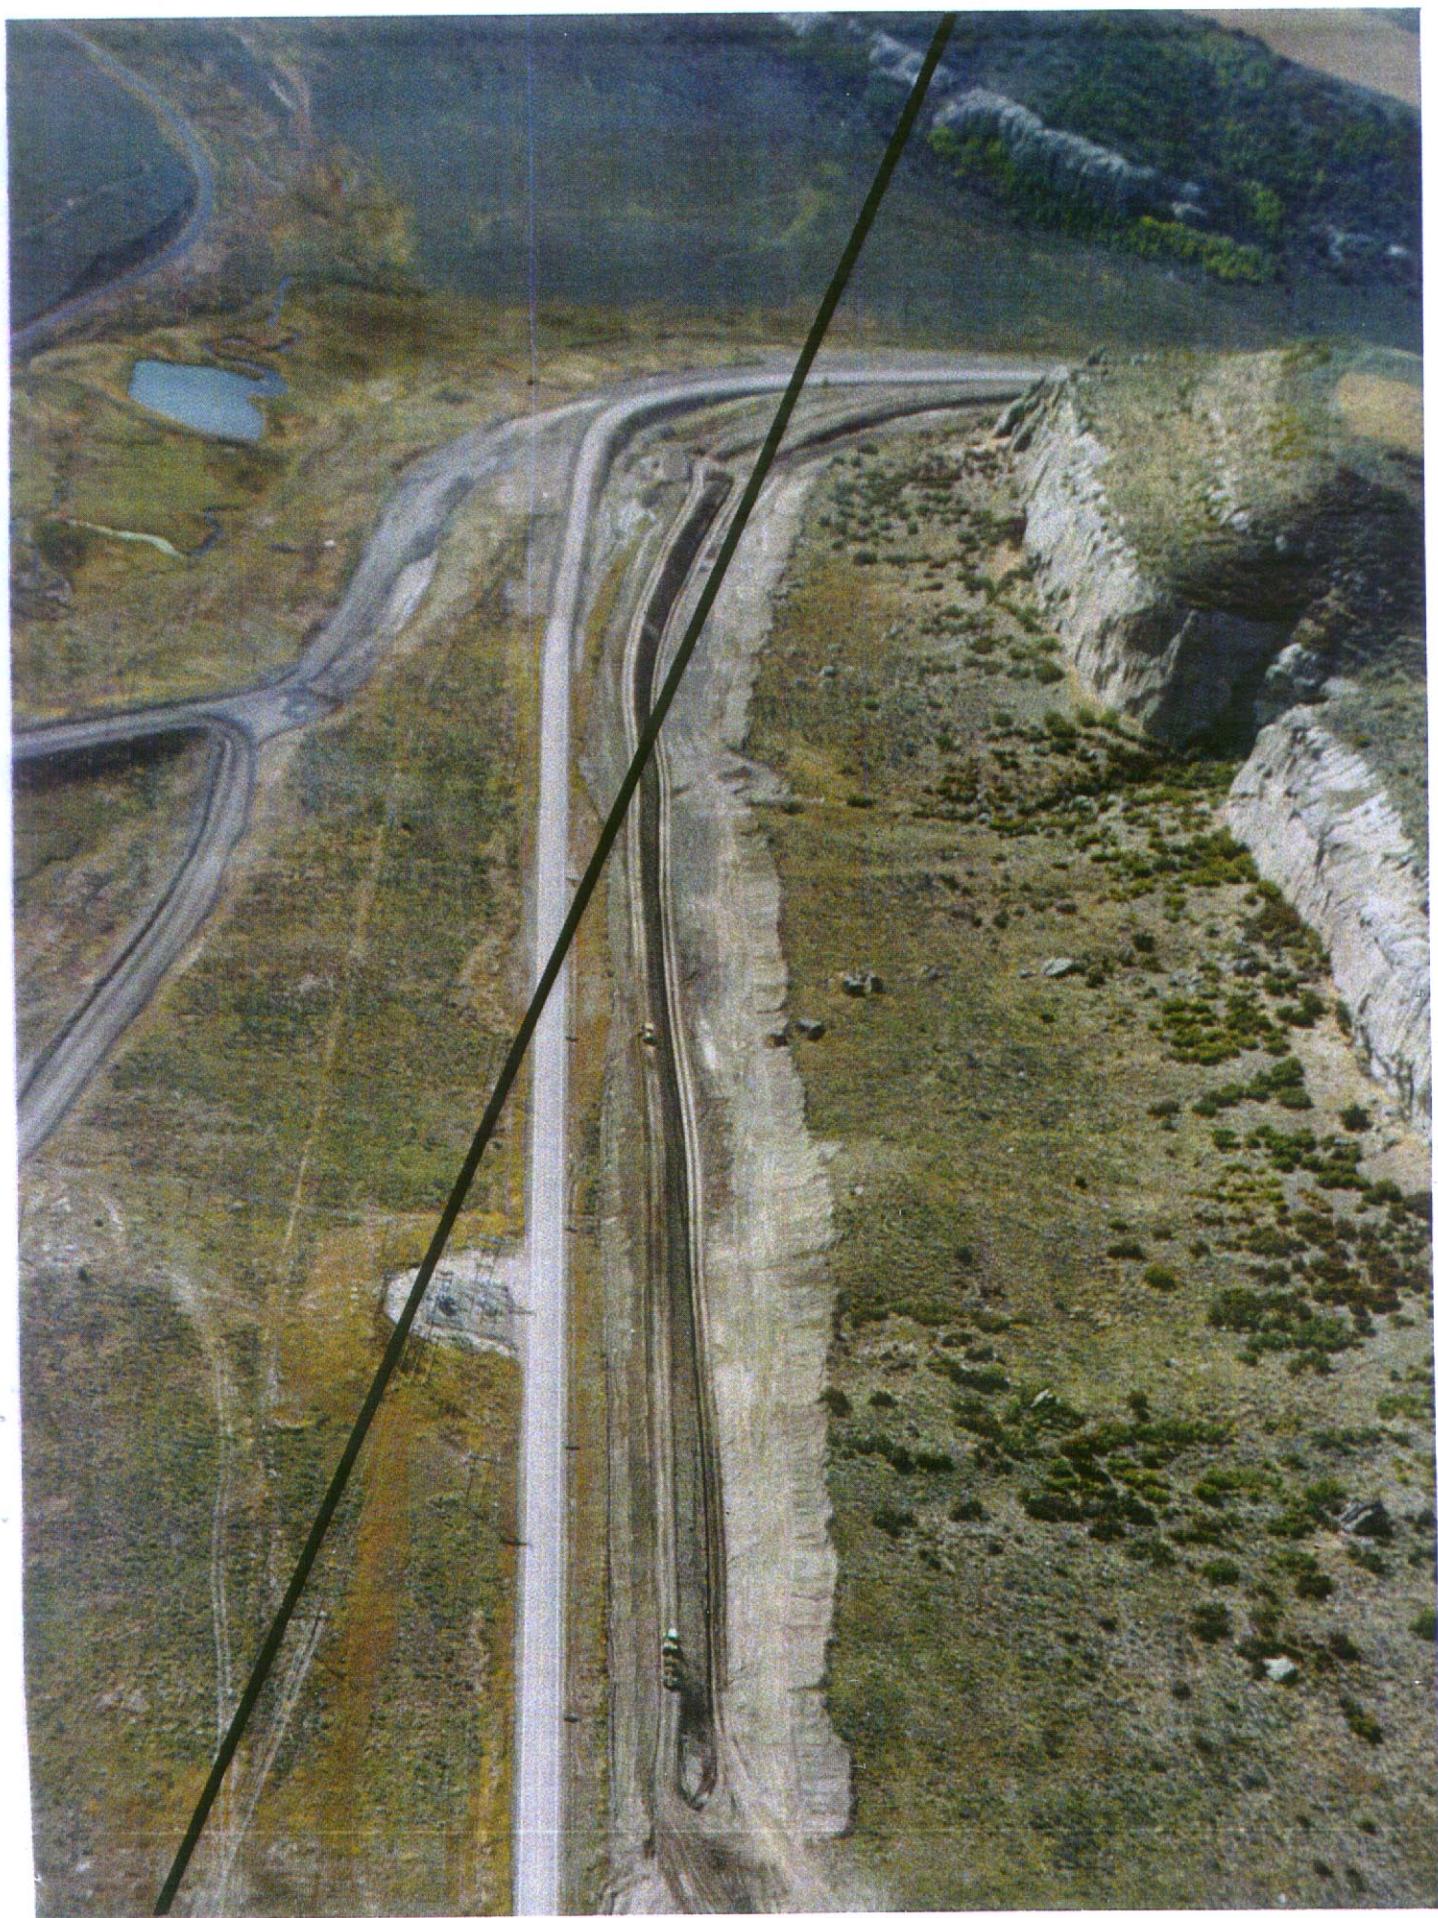
Figure 14: Twentymile site, CO. Twentymile sandstone cliffs close-up; no failure, October 1995.

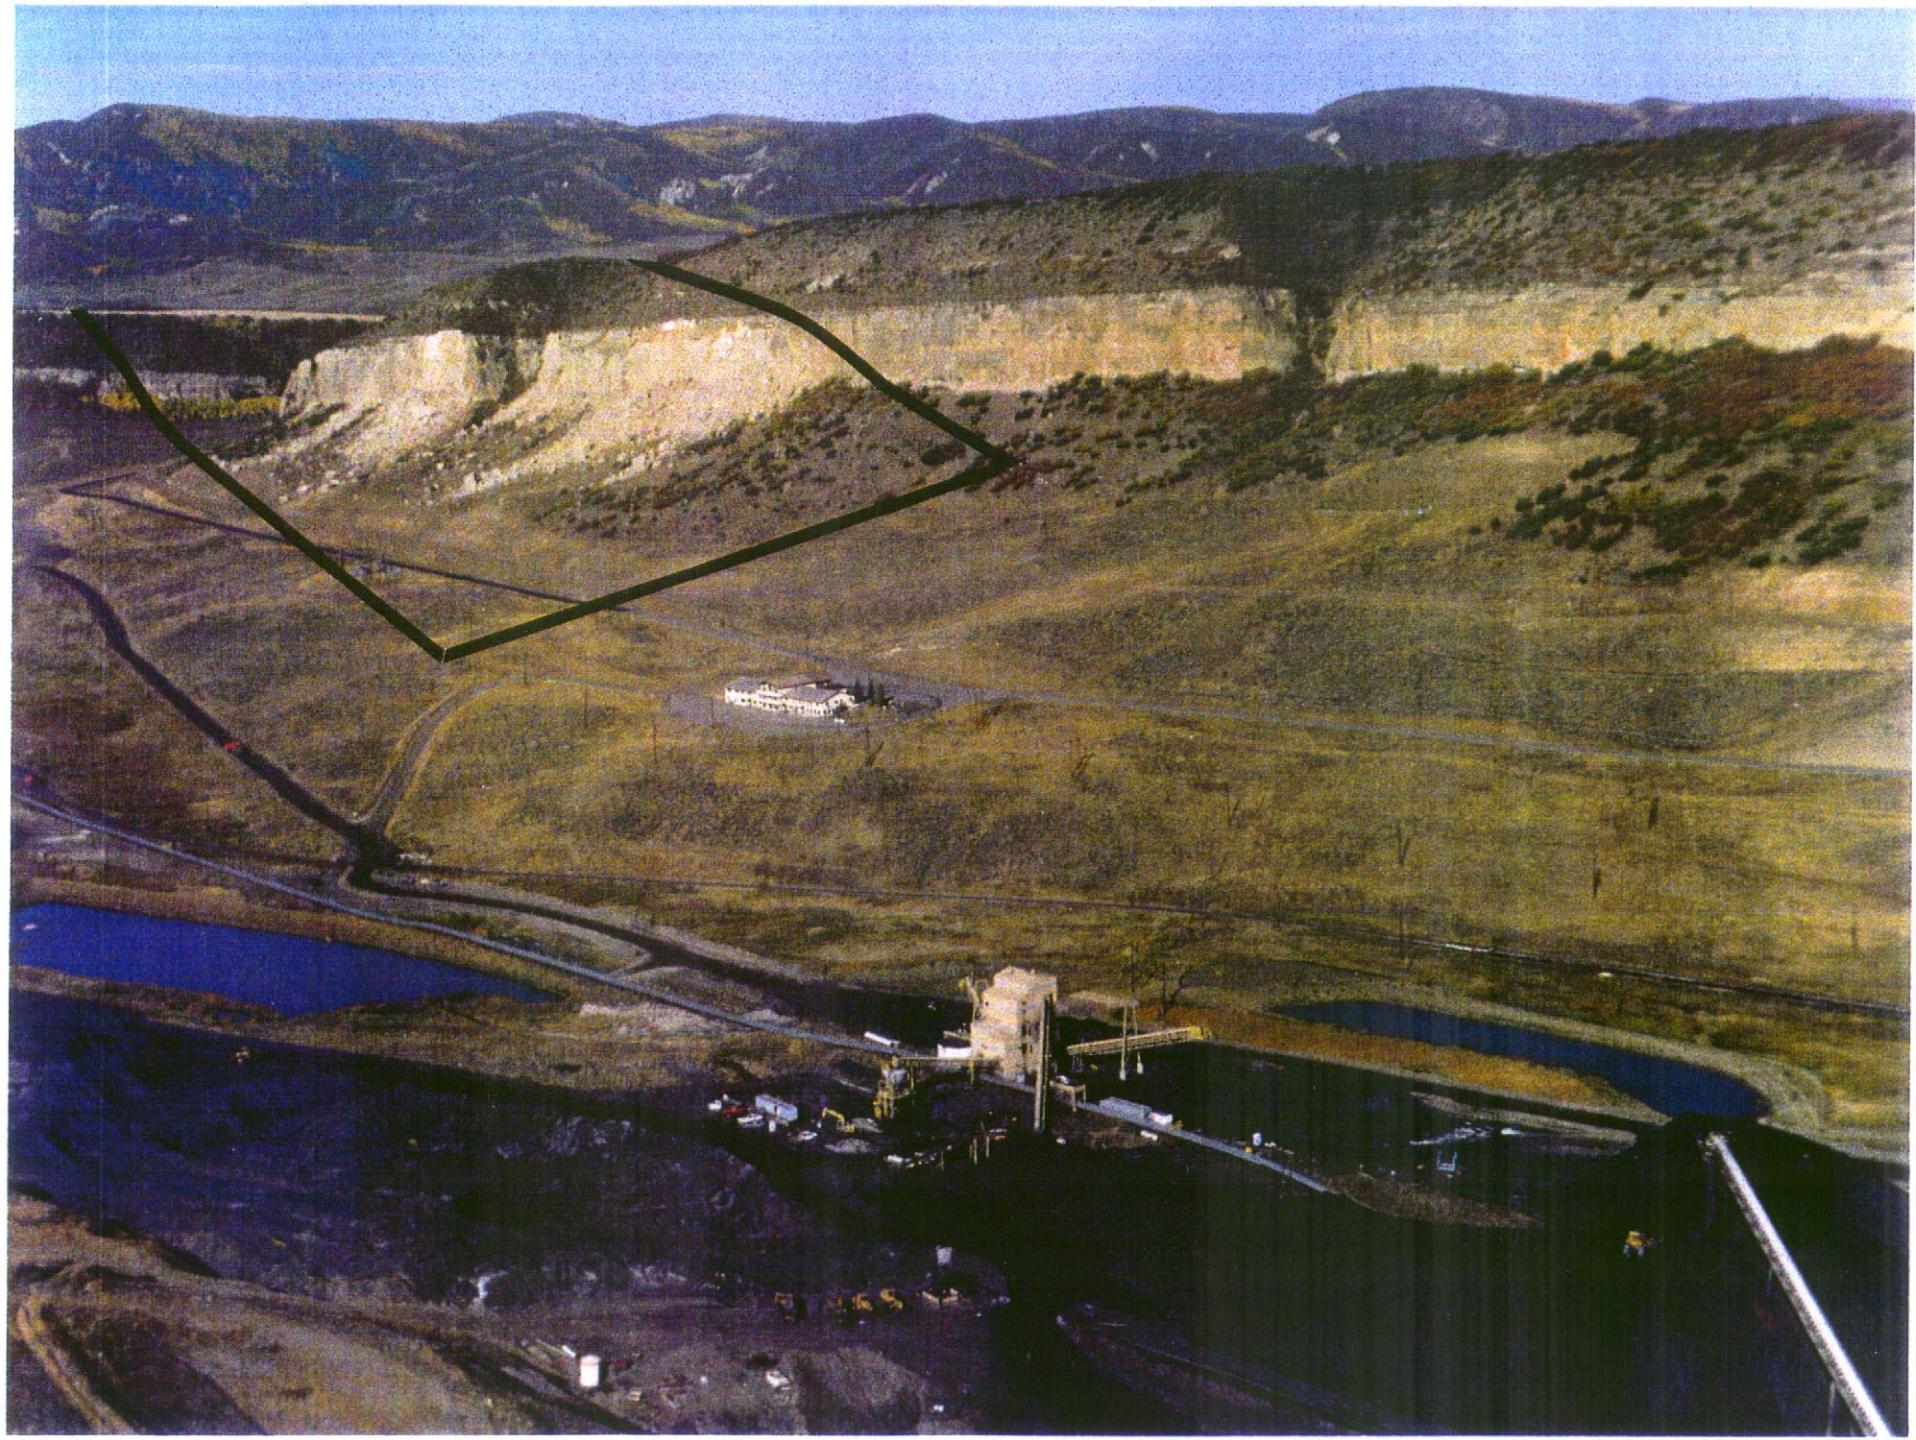
Figure 15: Twentymile site, CO. Sandstone cliff failures, October 1996, looking northwest.

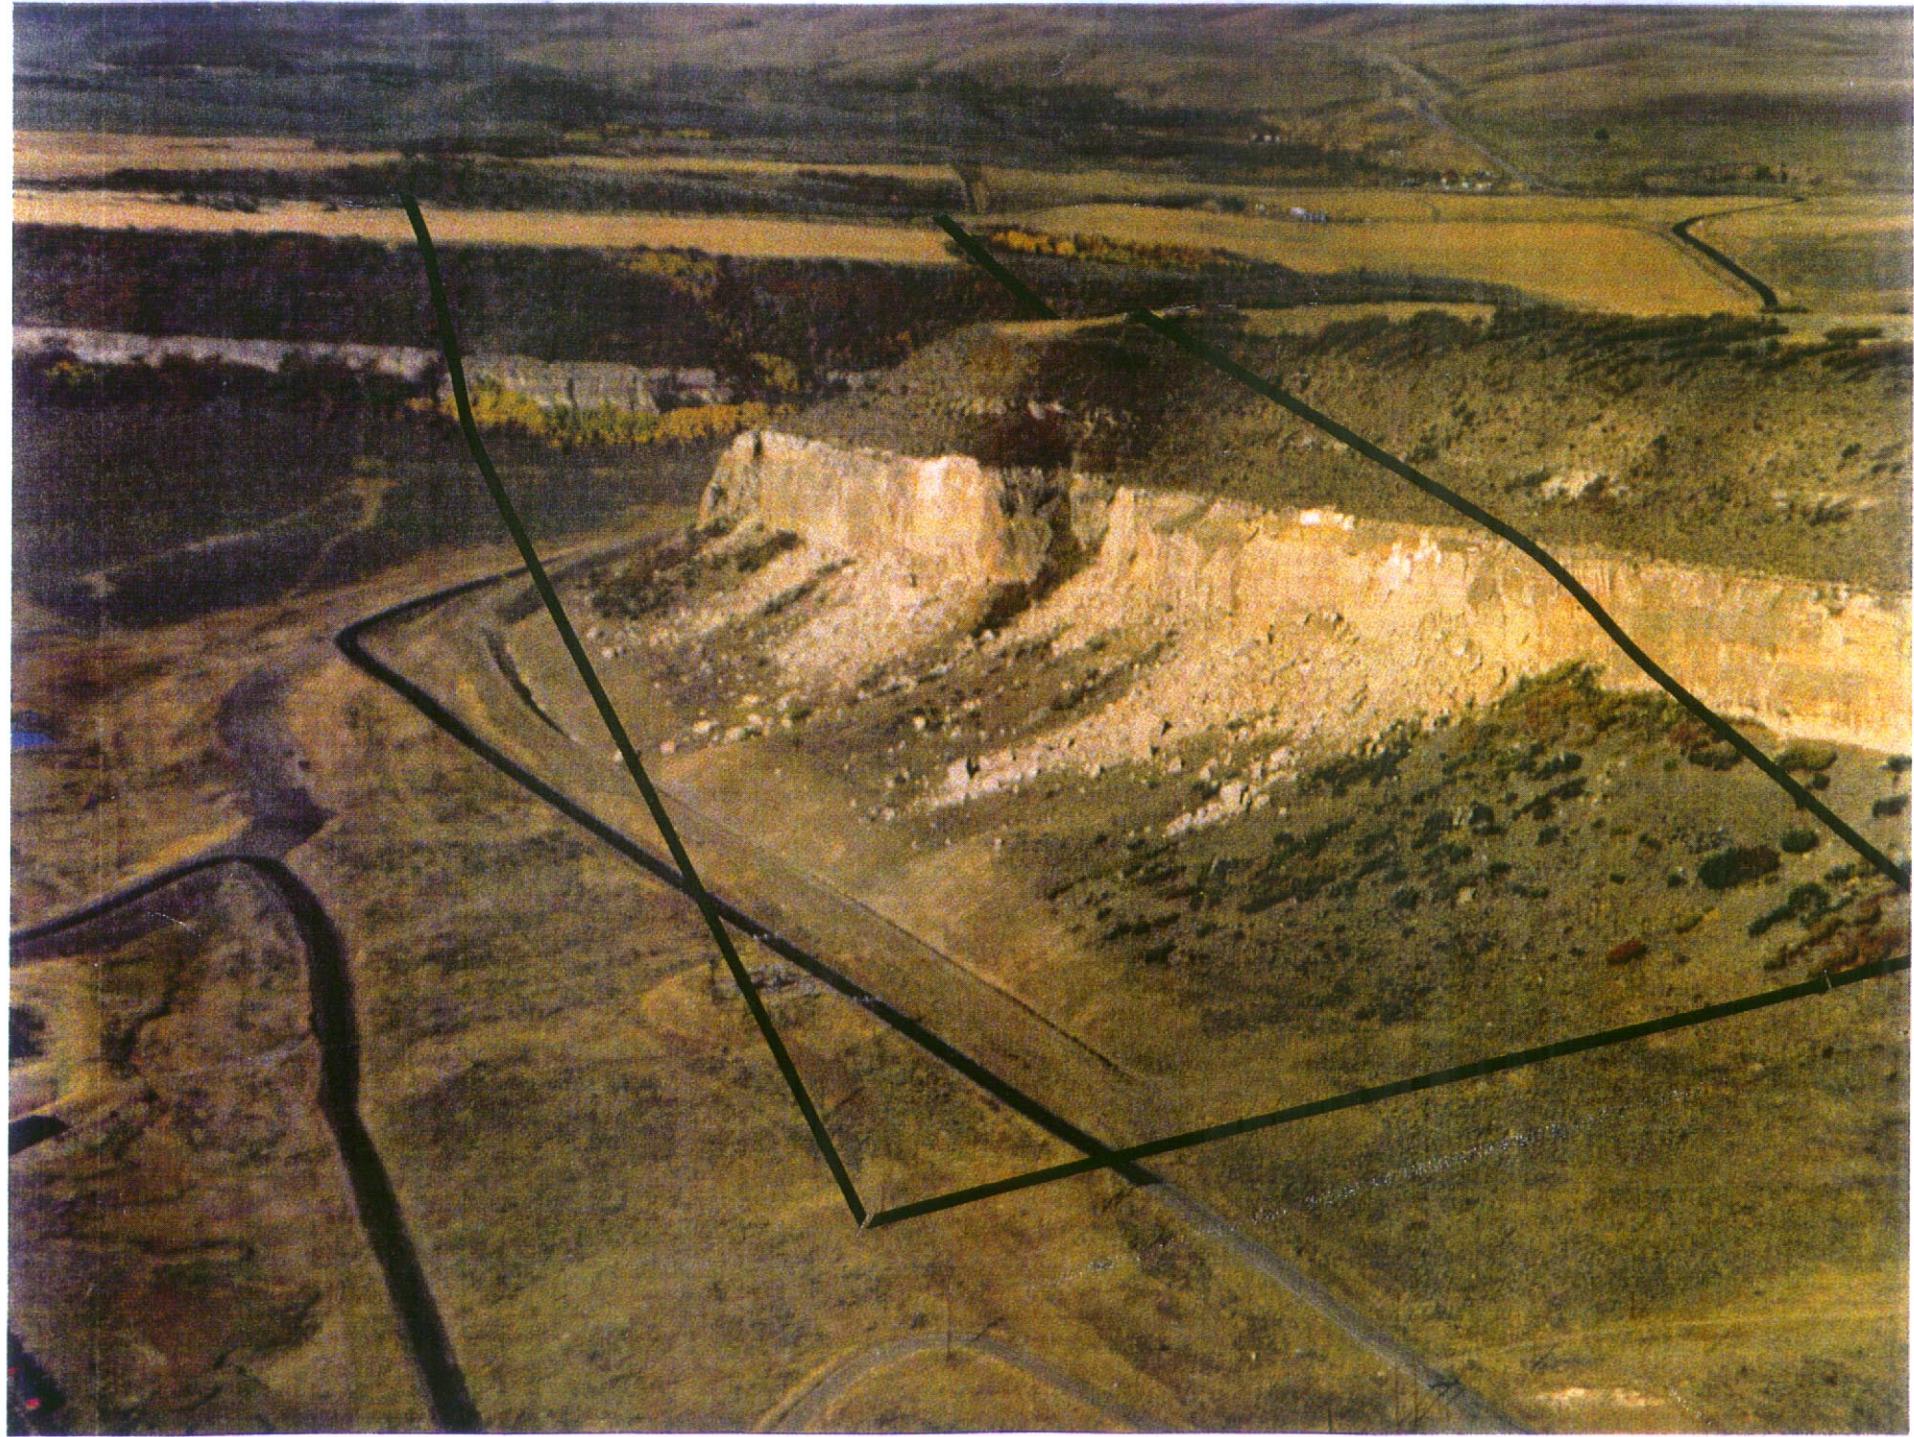
Figure 16: Twentymile site, CO. Close-up of Twentymile sandstone cliff failures looking northwest.

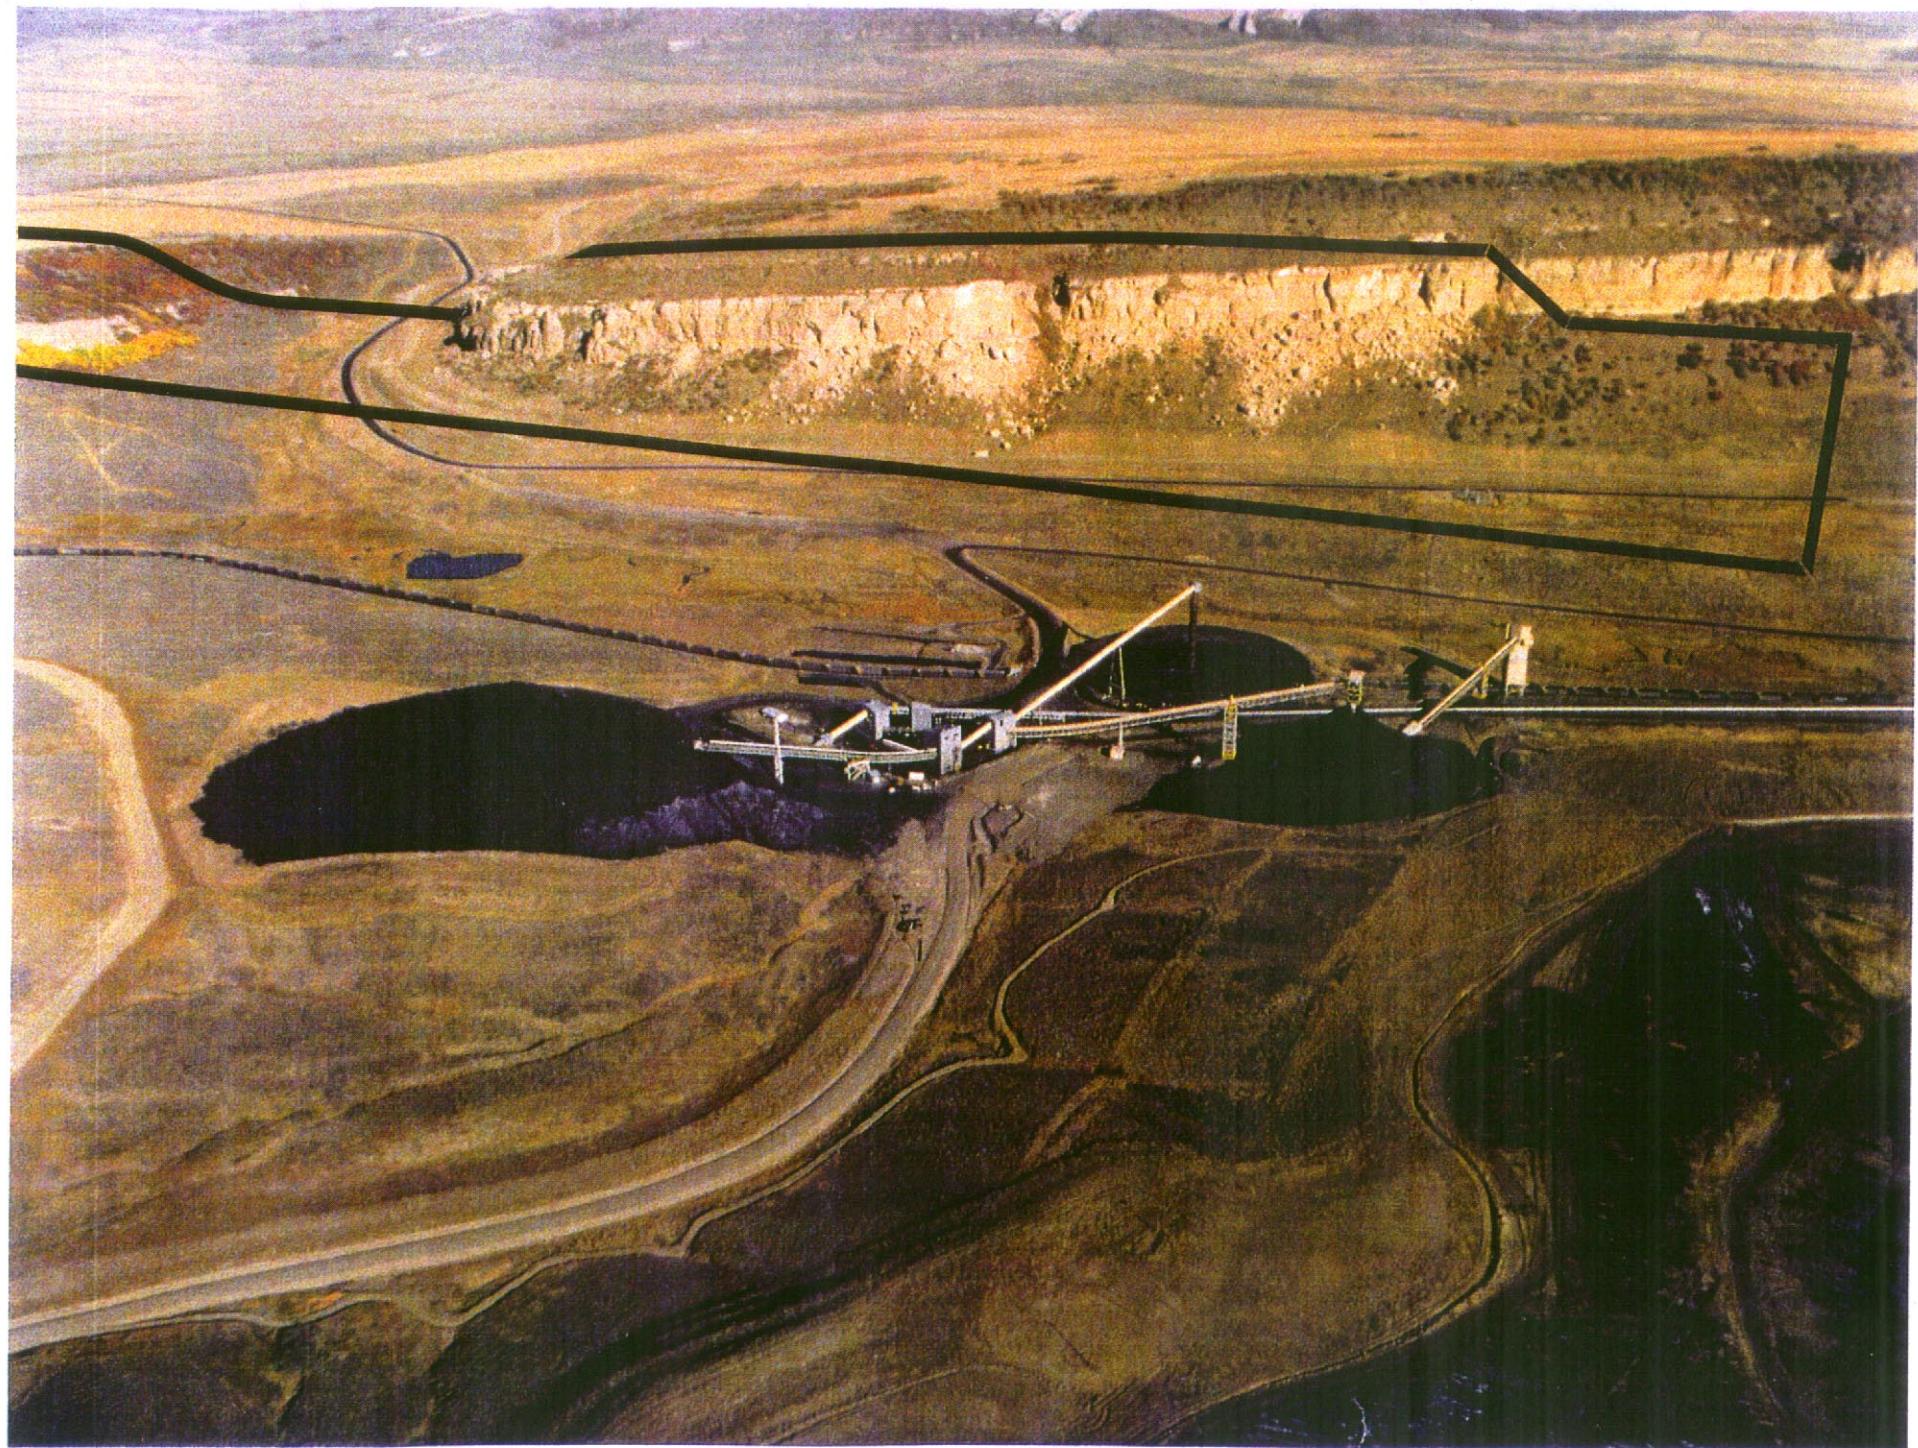
Figure 17: Twentymile site, CO. Sandstone cliff failures, looking north.
