UCRL-JC-127891
PREPRINT

Aerial and Ground-Based Inspections of Mine Sites in the Western U.S.-Implications for On-Site Inspection Overflights, Under the CTBT

François E. Heuze

July 1997

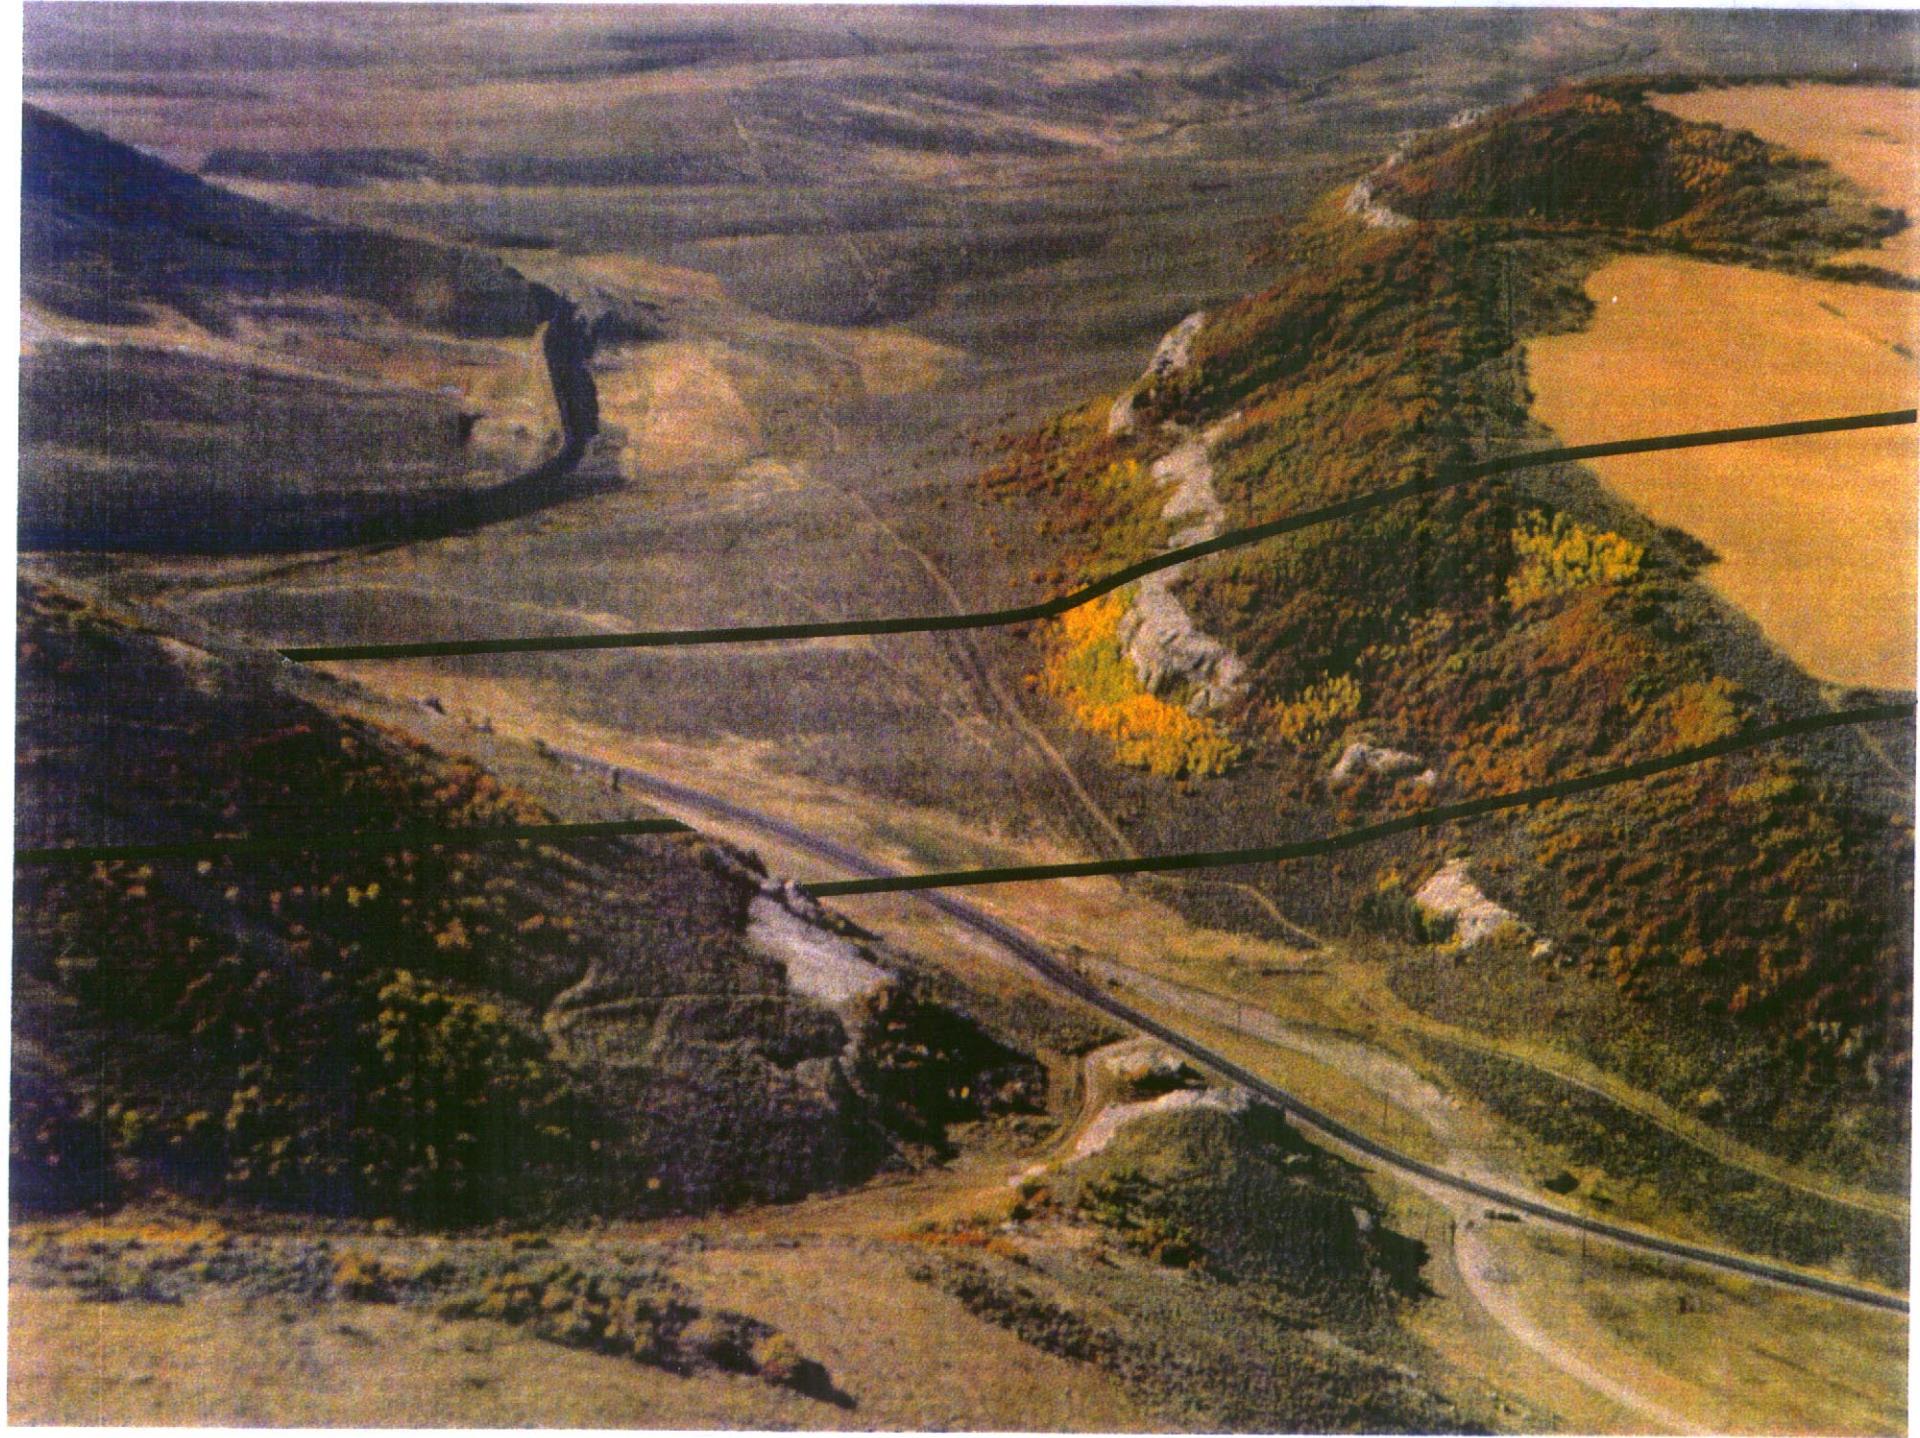
Figure 18: Twentymile site, CO. Ground above west-end of panel, between cliff areas; no failure, October, 1996.

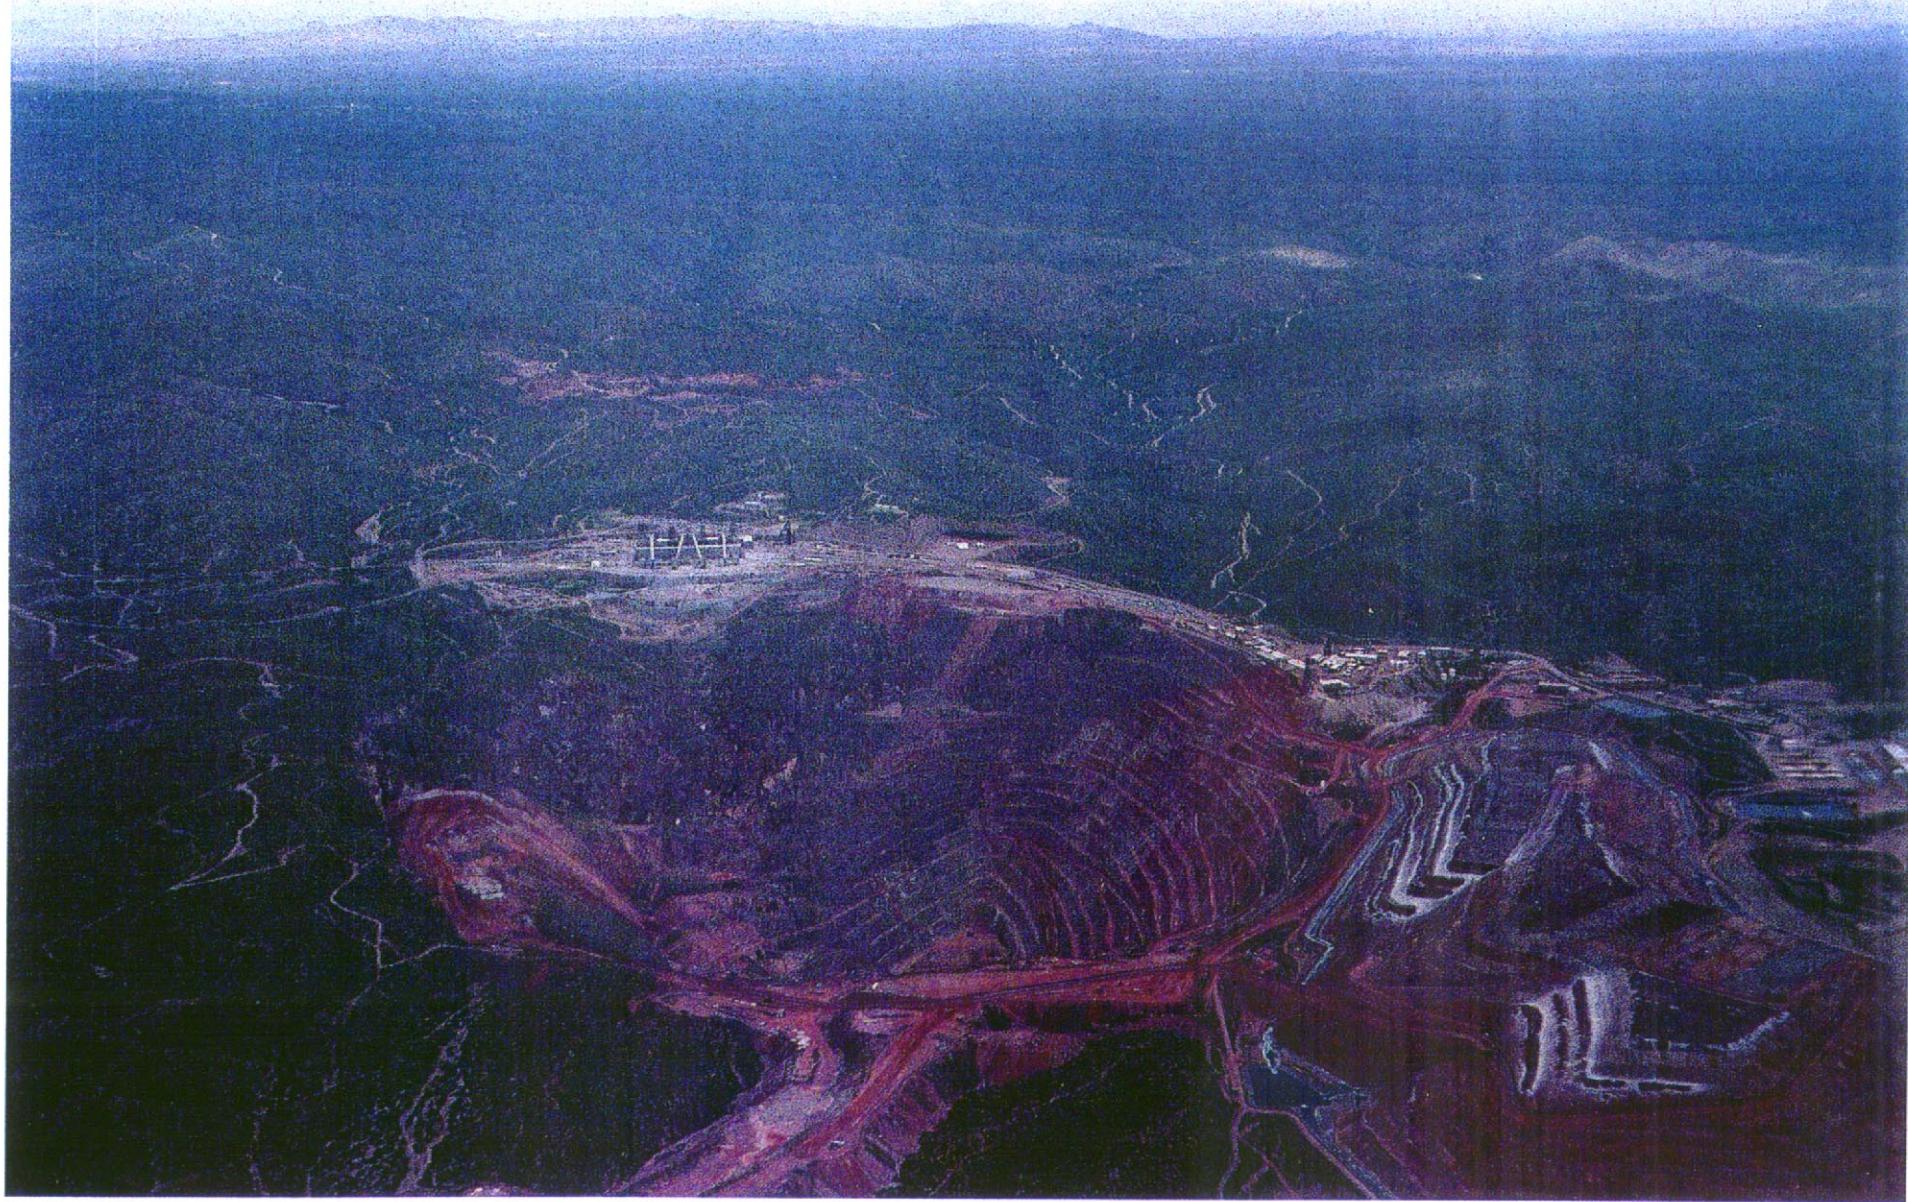
That overflight is described in Figures 19 to 22. The peculiarity of this mine is that it combined open-pit and underground caving operations. The block-caving, in fact, undermined a portion of the pit. This can be clearly seen in the left-center portions of Figures 19 and 20, where a jumble of large rock blocks shows the surface effects of the cave. A side view is given in Figure 21.

Figure 19: San Manuel copper mine, AZ. Pit overview, looking west.

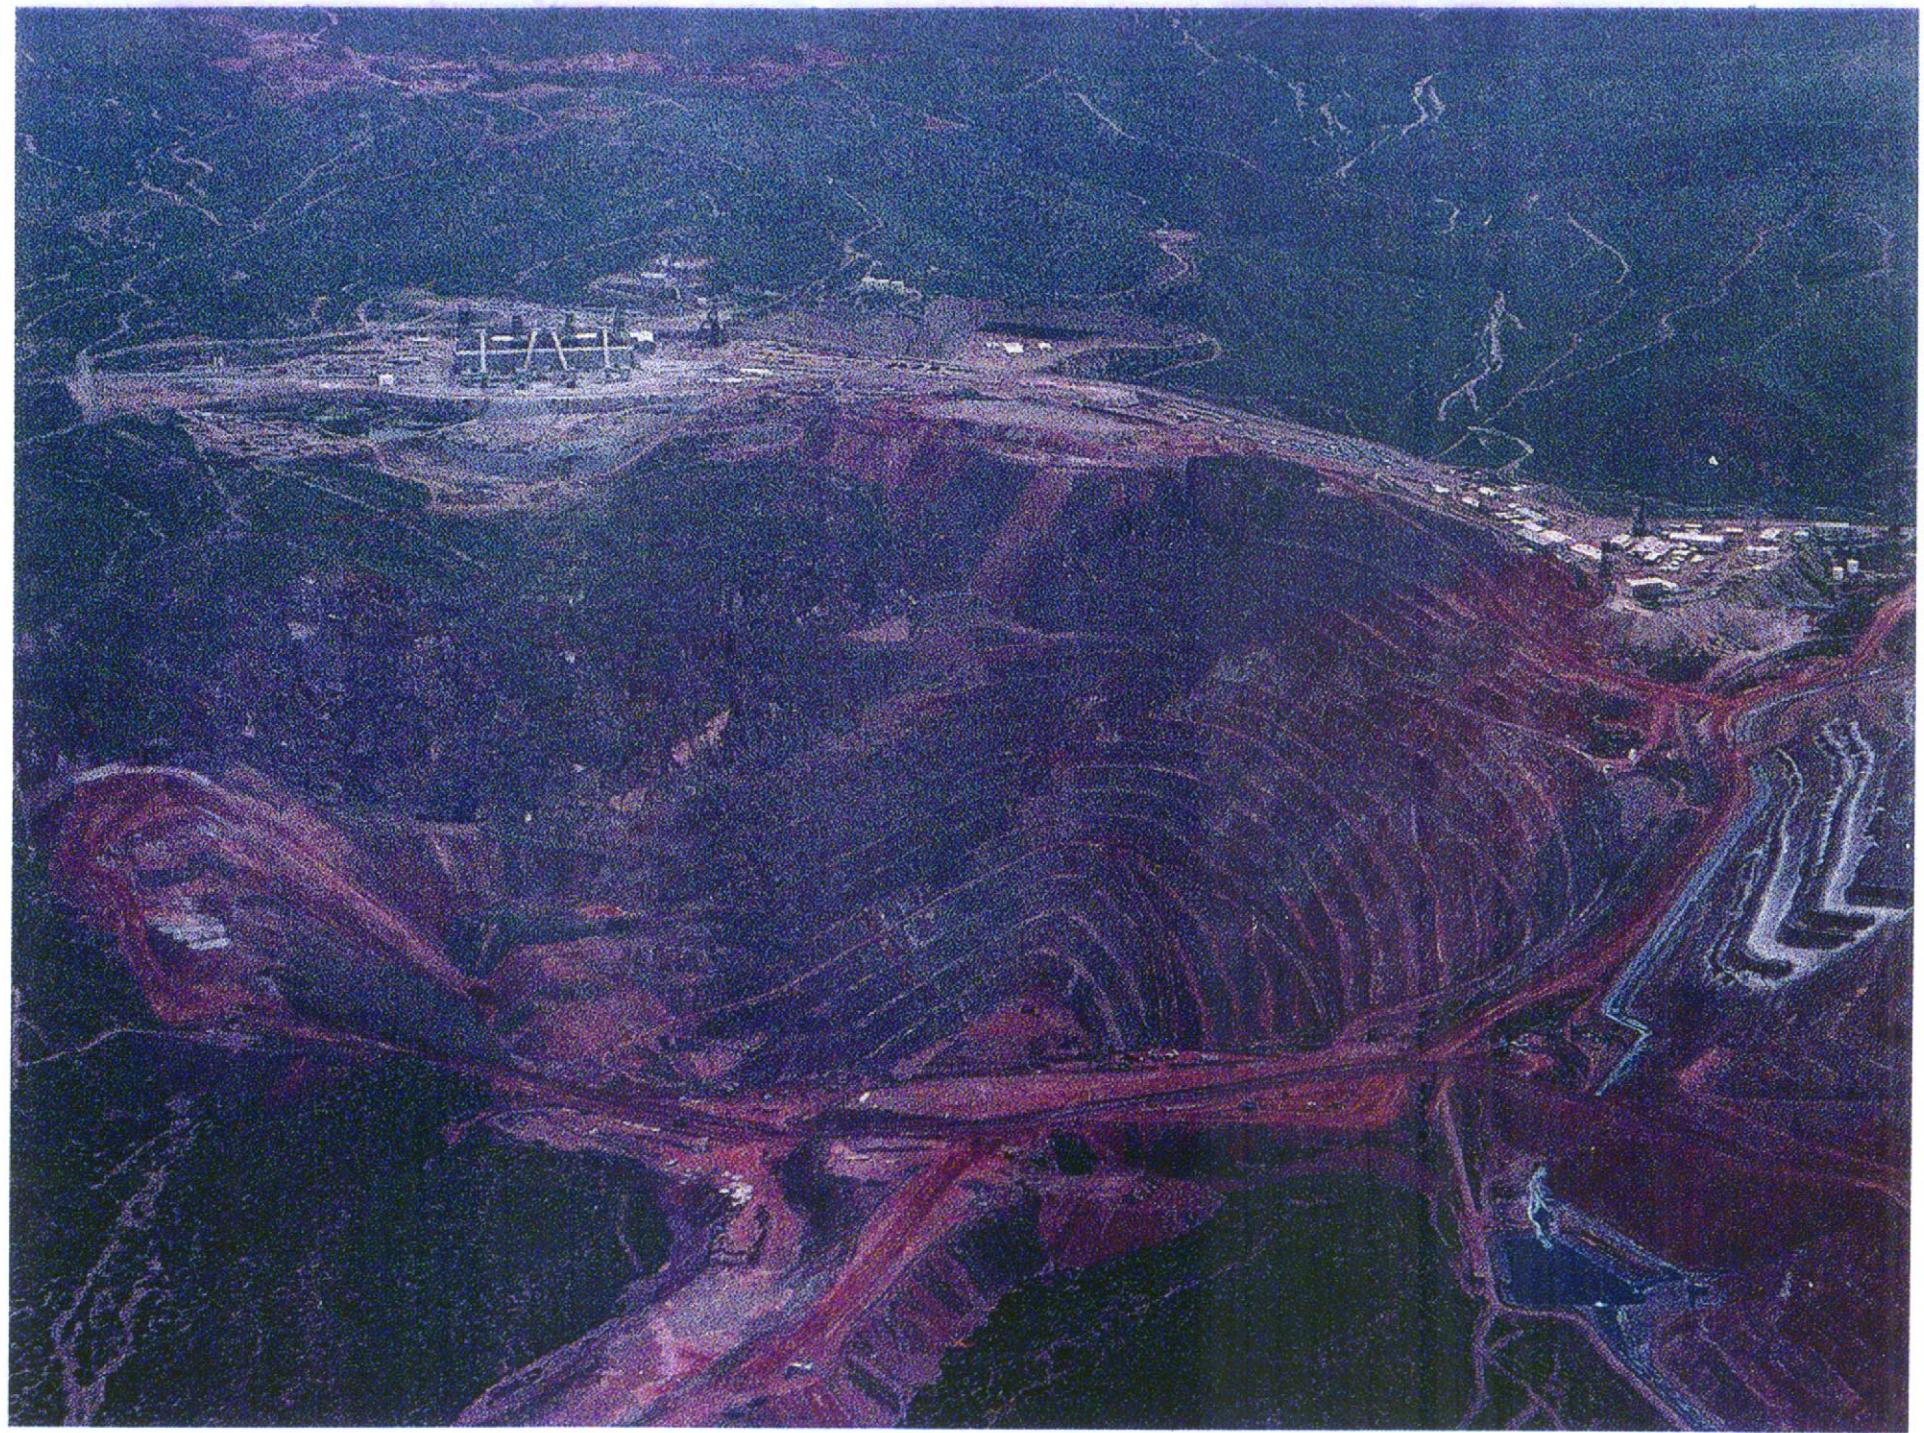
Figure 20: San Manuel site, AZ. Close-up of pit, with ground broken by undermining, on the left center.

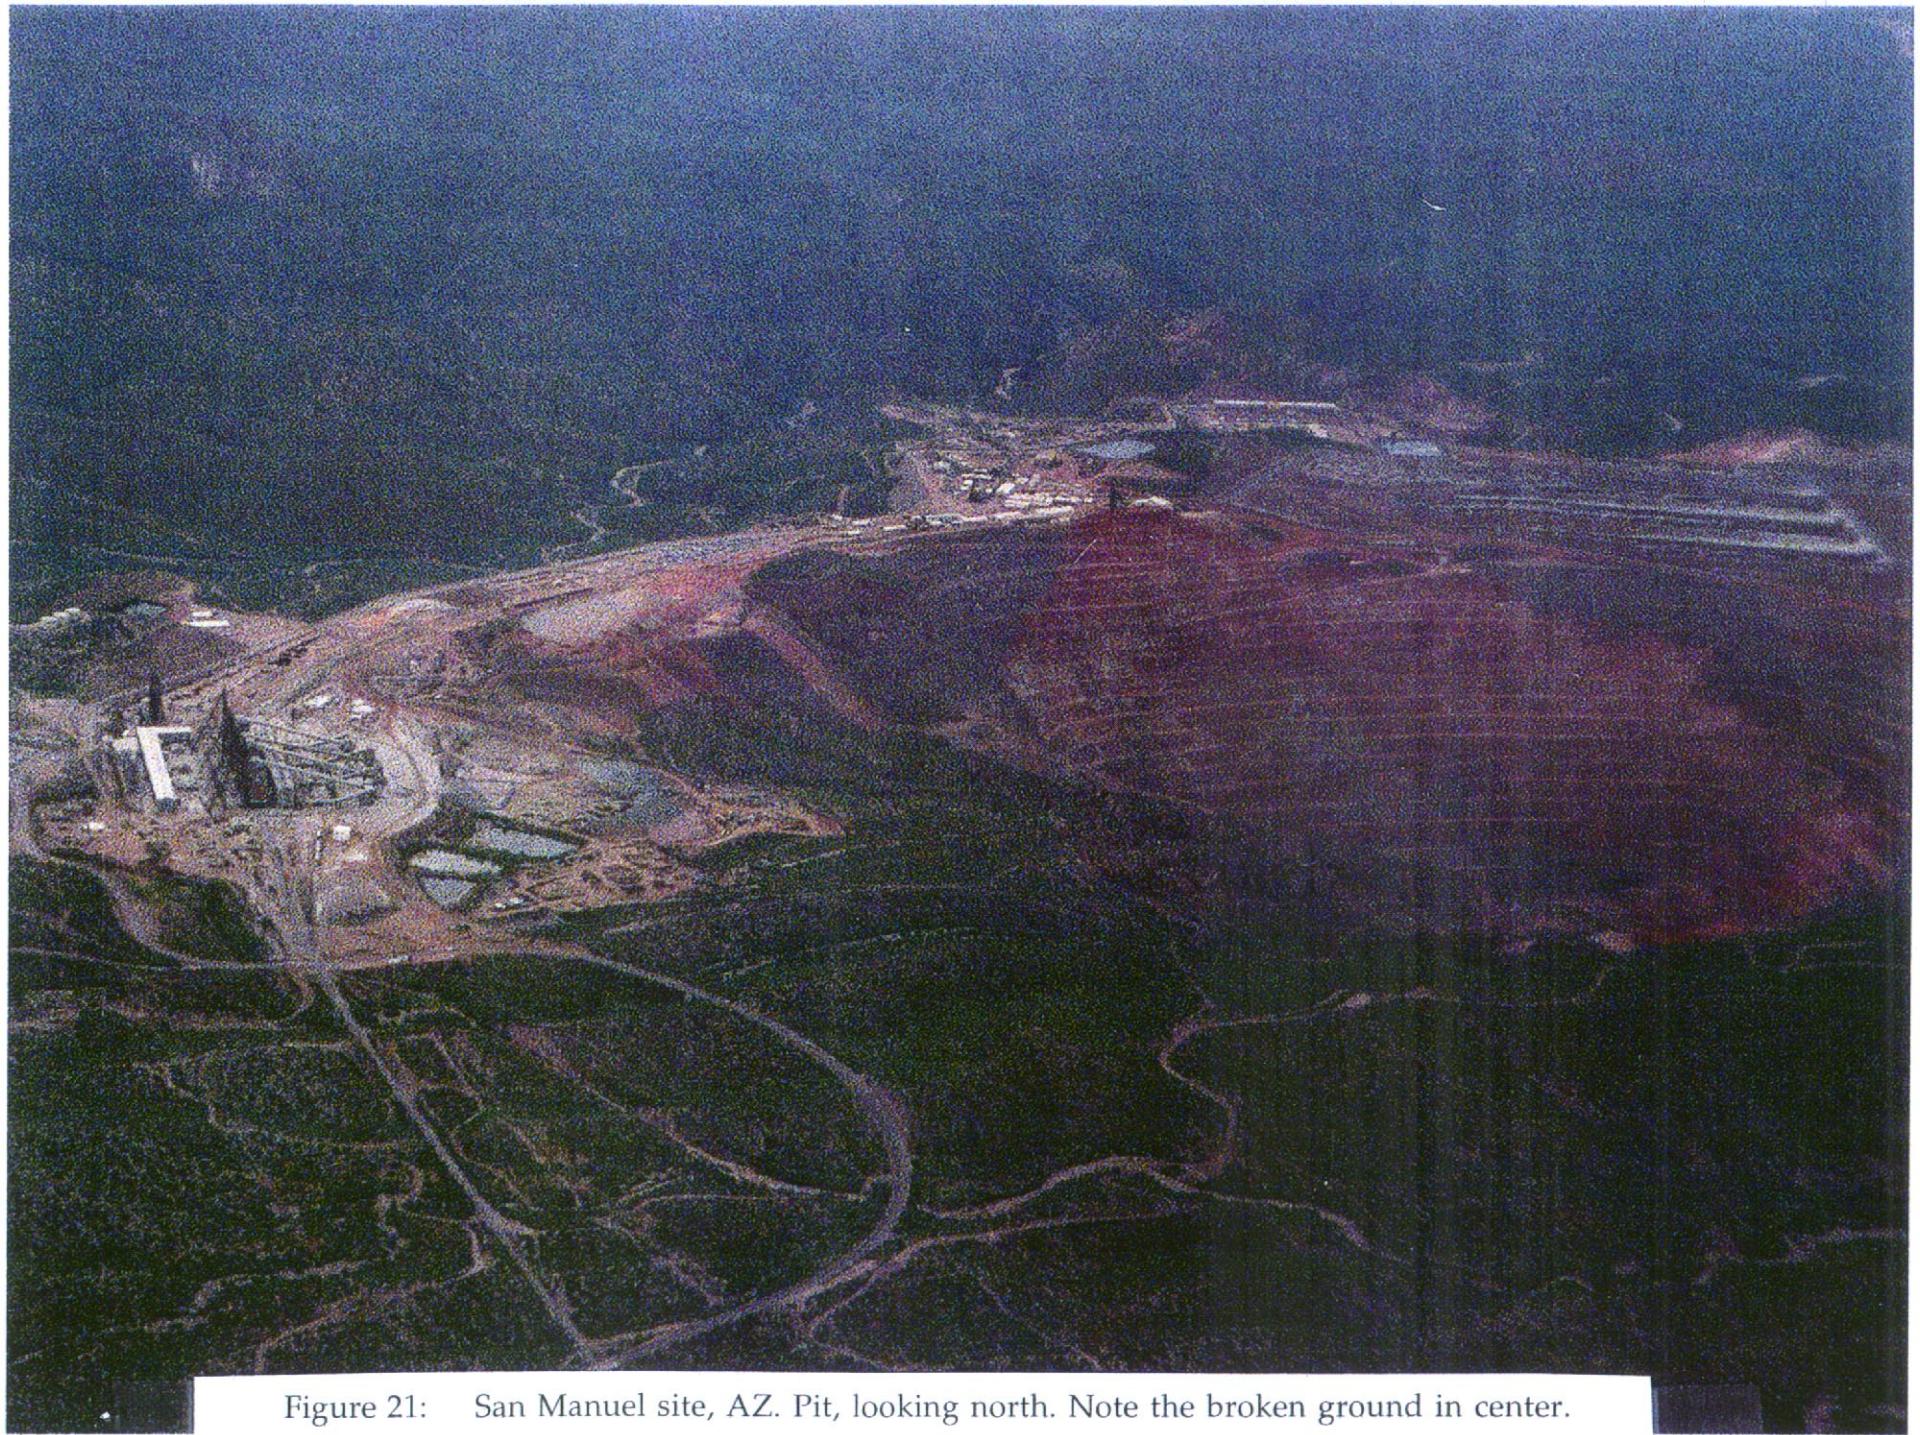
Figure 21: San Manuel site, AZ. Pit, looking north. Note the broken ground in center.

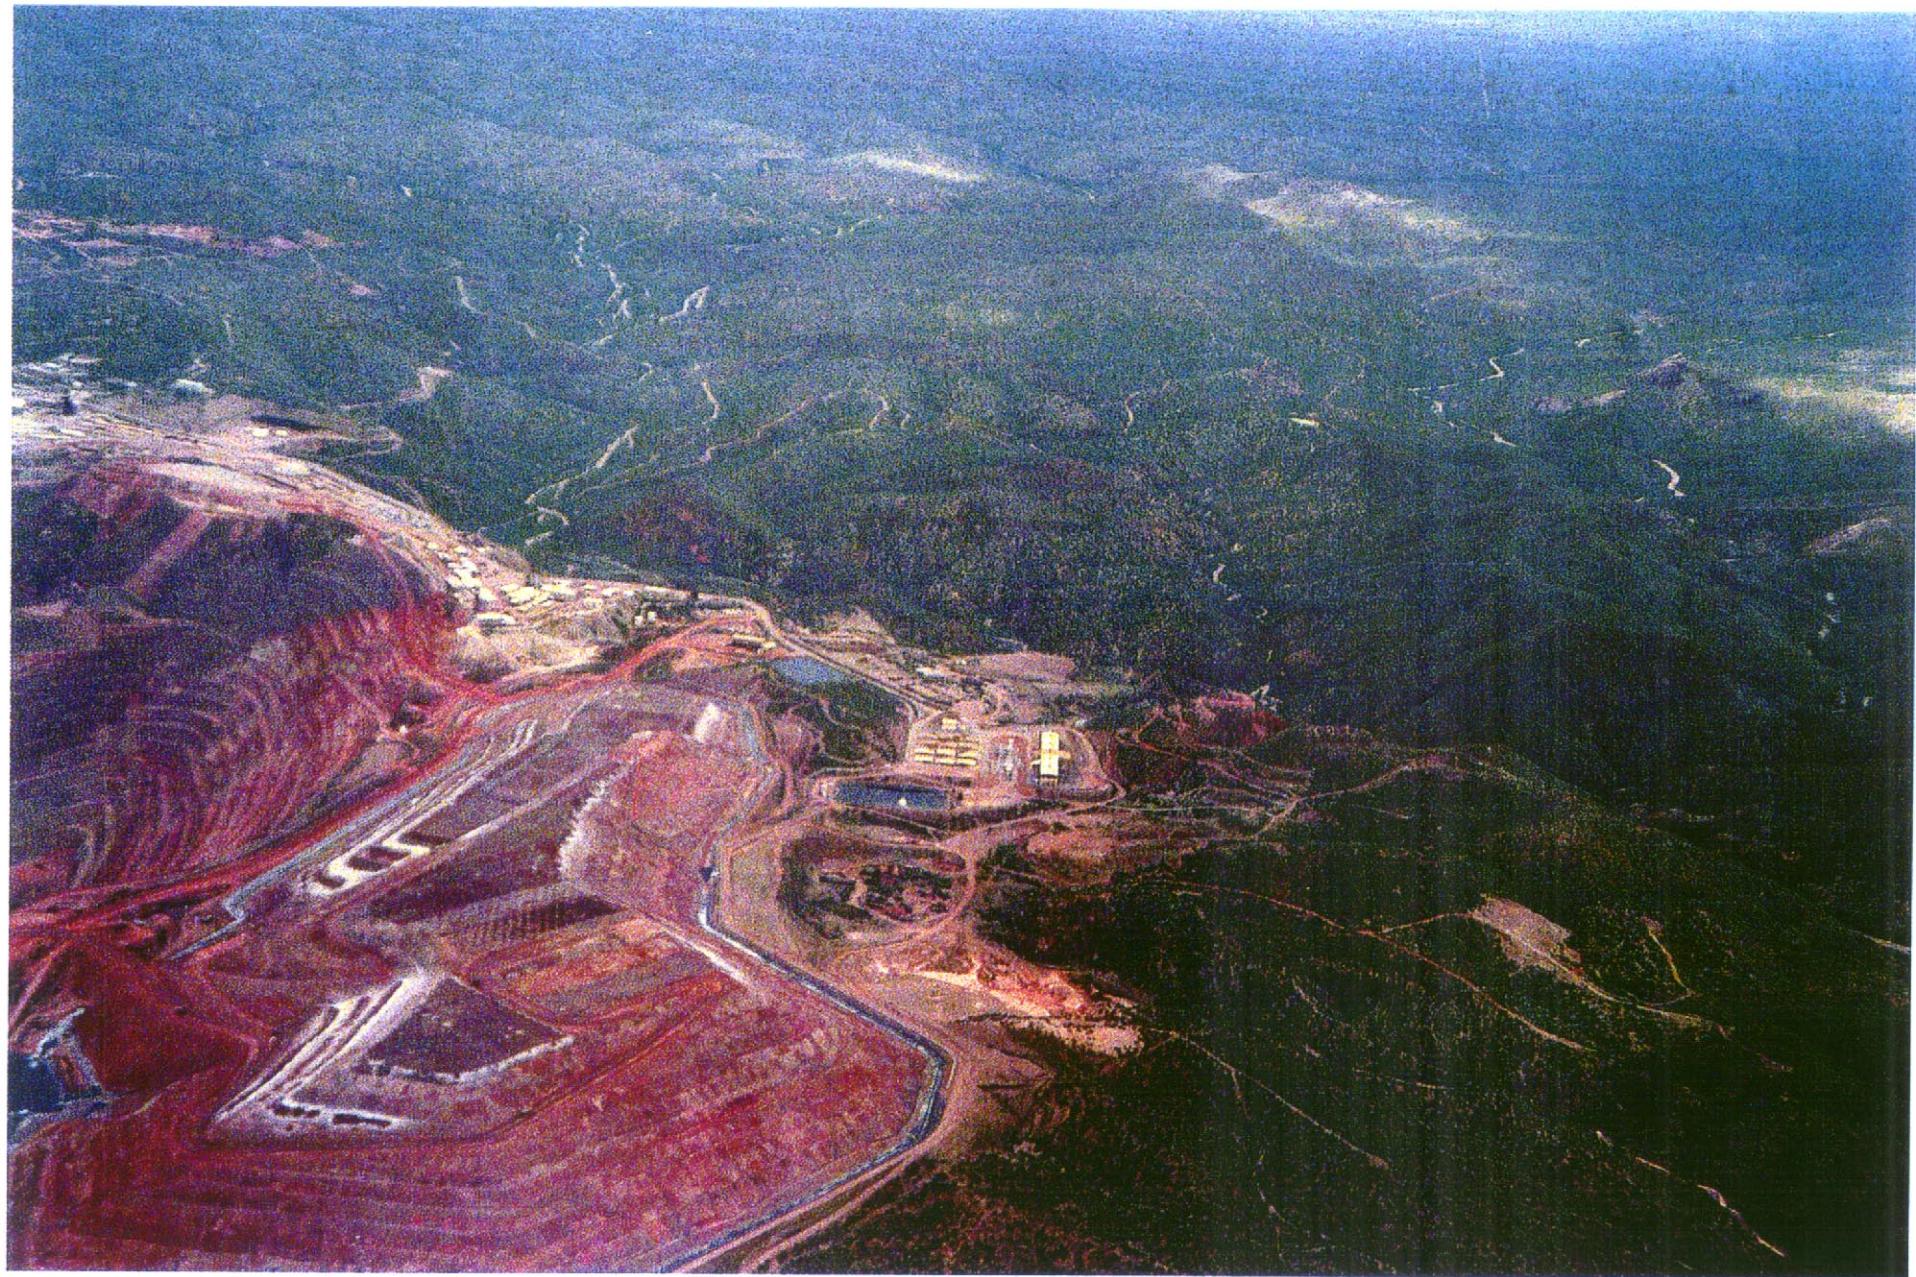
Figure 22 shows the rugged terrain surrounding the open-pit and a network of roads and man-made features. It is conceivable that a sizable underground excavation could have been hidden in the adjacent regions of a comparable open-pit and that the open-pit itself should not be the exclusive focus of attention during an OSI.

Figure 22: San Manuel site, AZ. East-end of pit area.

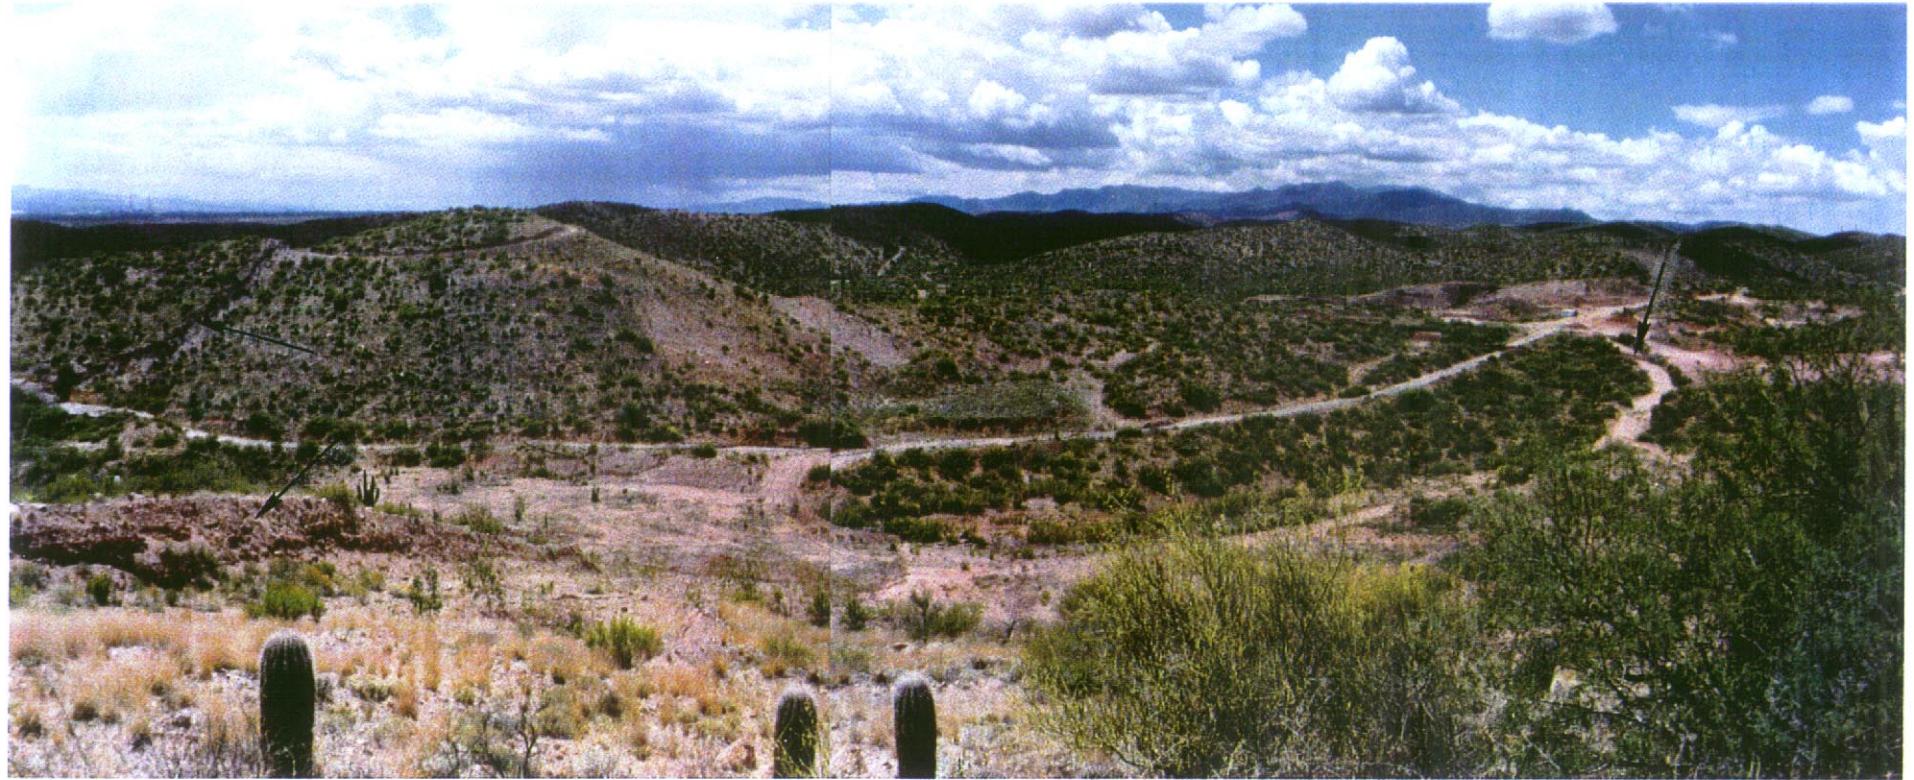
Figure 23 shows an examination of another part of the mine site from the ground. This area was a former block-caving zone. It created extensive fracturing of the ground. Large scarps can be seen on the left side, right side, and left foreground of the picture. Access by foot to those scarps appears readily available.

Figure 23: San Manuel site, AZ. Note the pronounced ground failures over the large cave area.

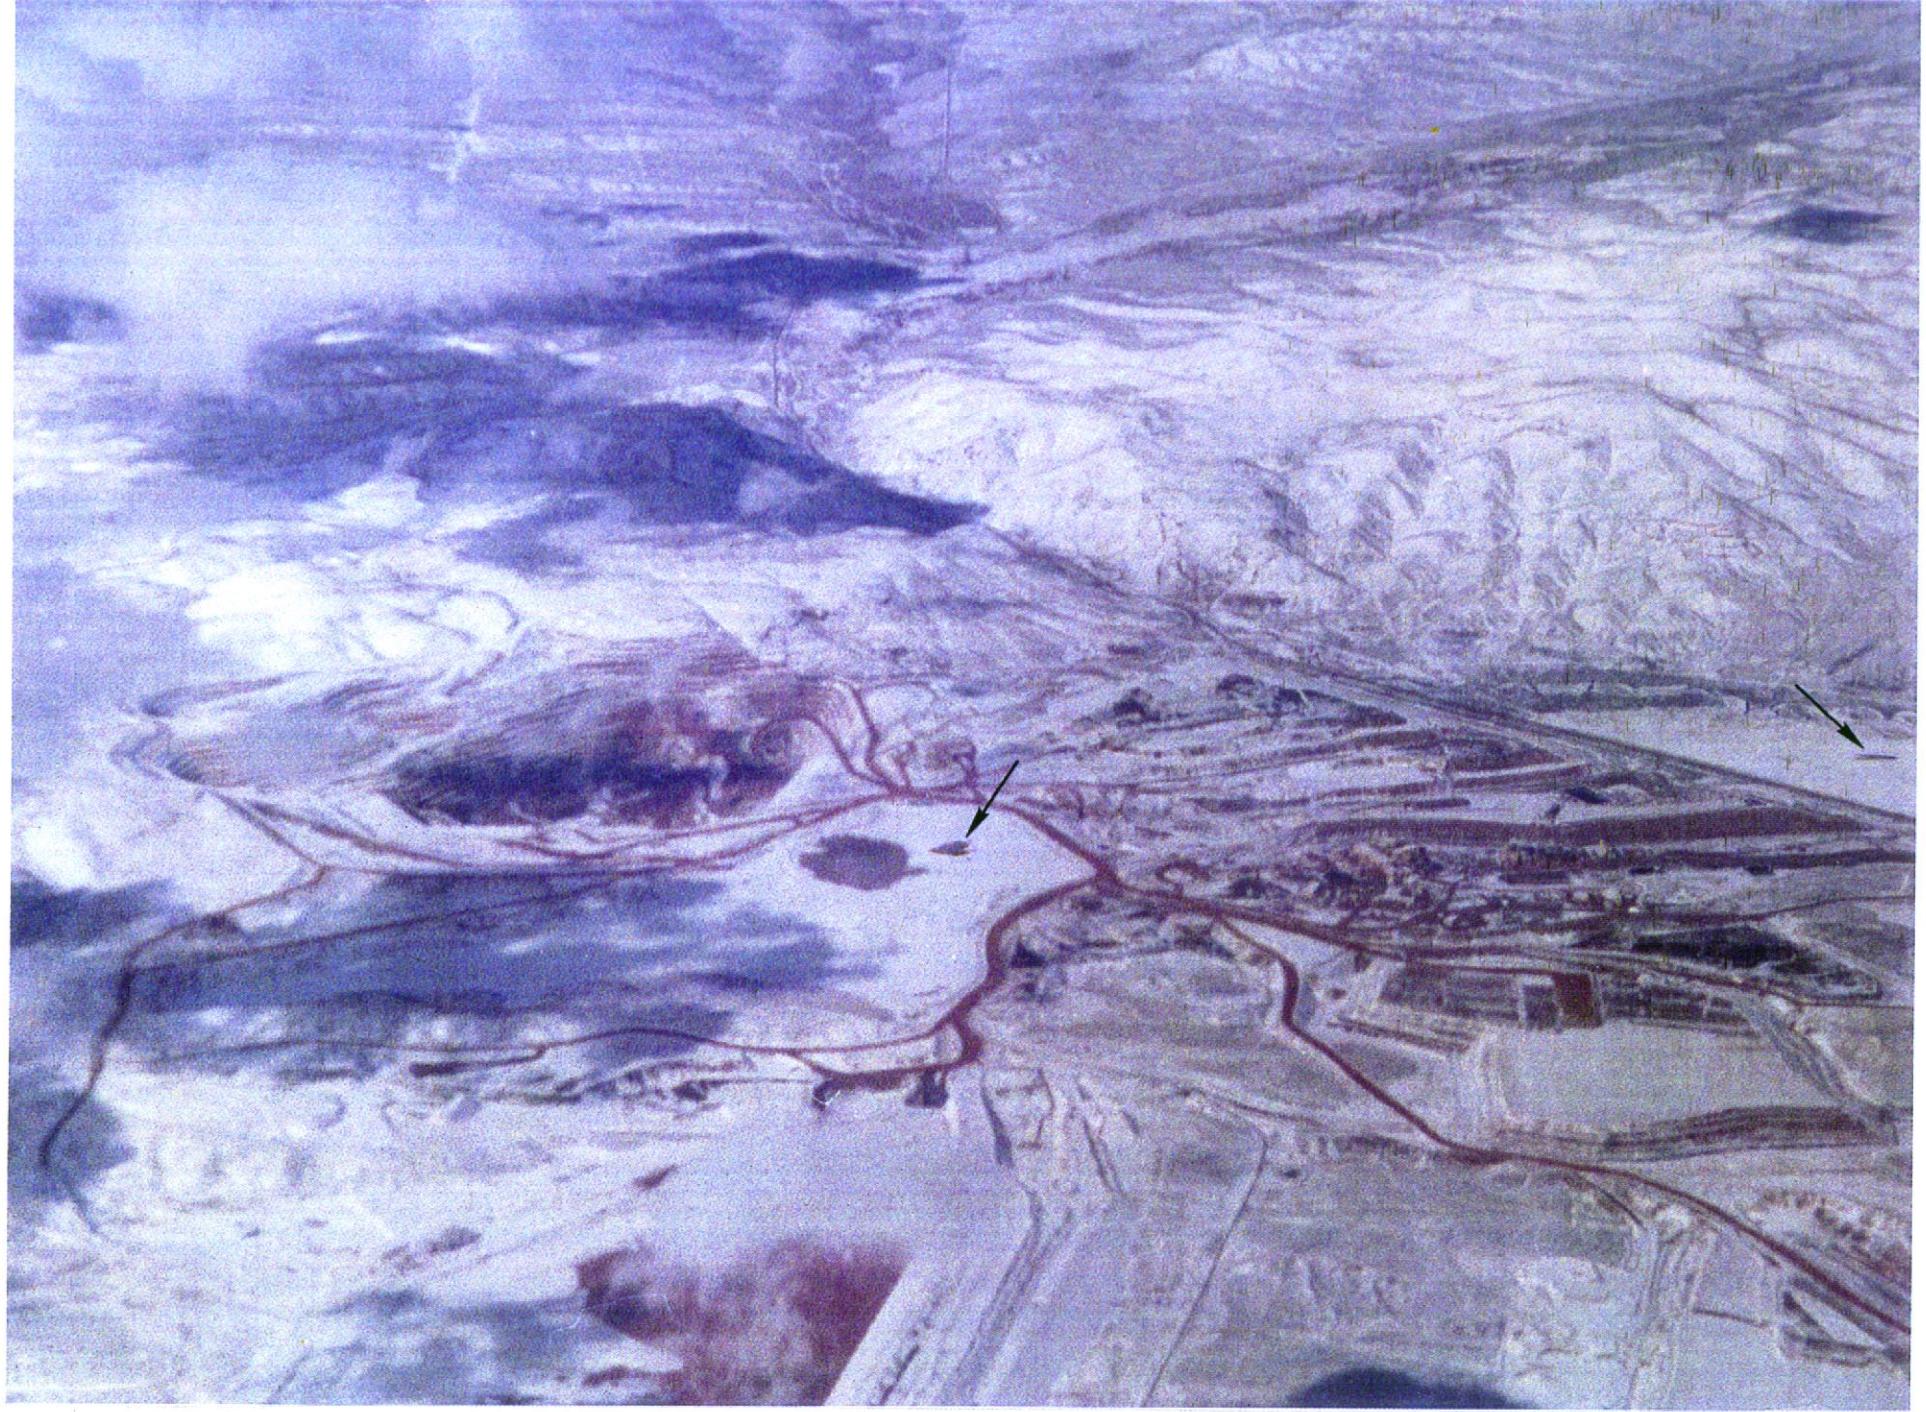
However, a **hypothetical situation**^{*} is outlined in Figure 31. The figure is very similar, but not identical to Figure 28. It has 2 additional features, denoted by the arrows: they are subsidence craters from nuclear tests, which have been borrowed from a picture of Yucca Flats at the Nevada Test Site (Figure 32), and overlayed on to Figure 27. The wintry scene of Figures 28, 31 and 32 helps to subdue the ground features. Note that the crater in the center of Figure 31 would not necessarily be very conspicuous at the altitude of the picture (~3000 m), as it is near the large pond which is part of regular mining. At a lower altitude the difference may be clear.

Figure 31: Newmont Gold site, NV, with two crater features added to it (a hypothetical situation).

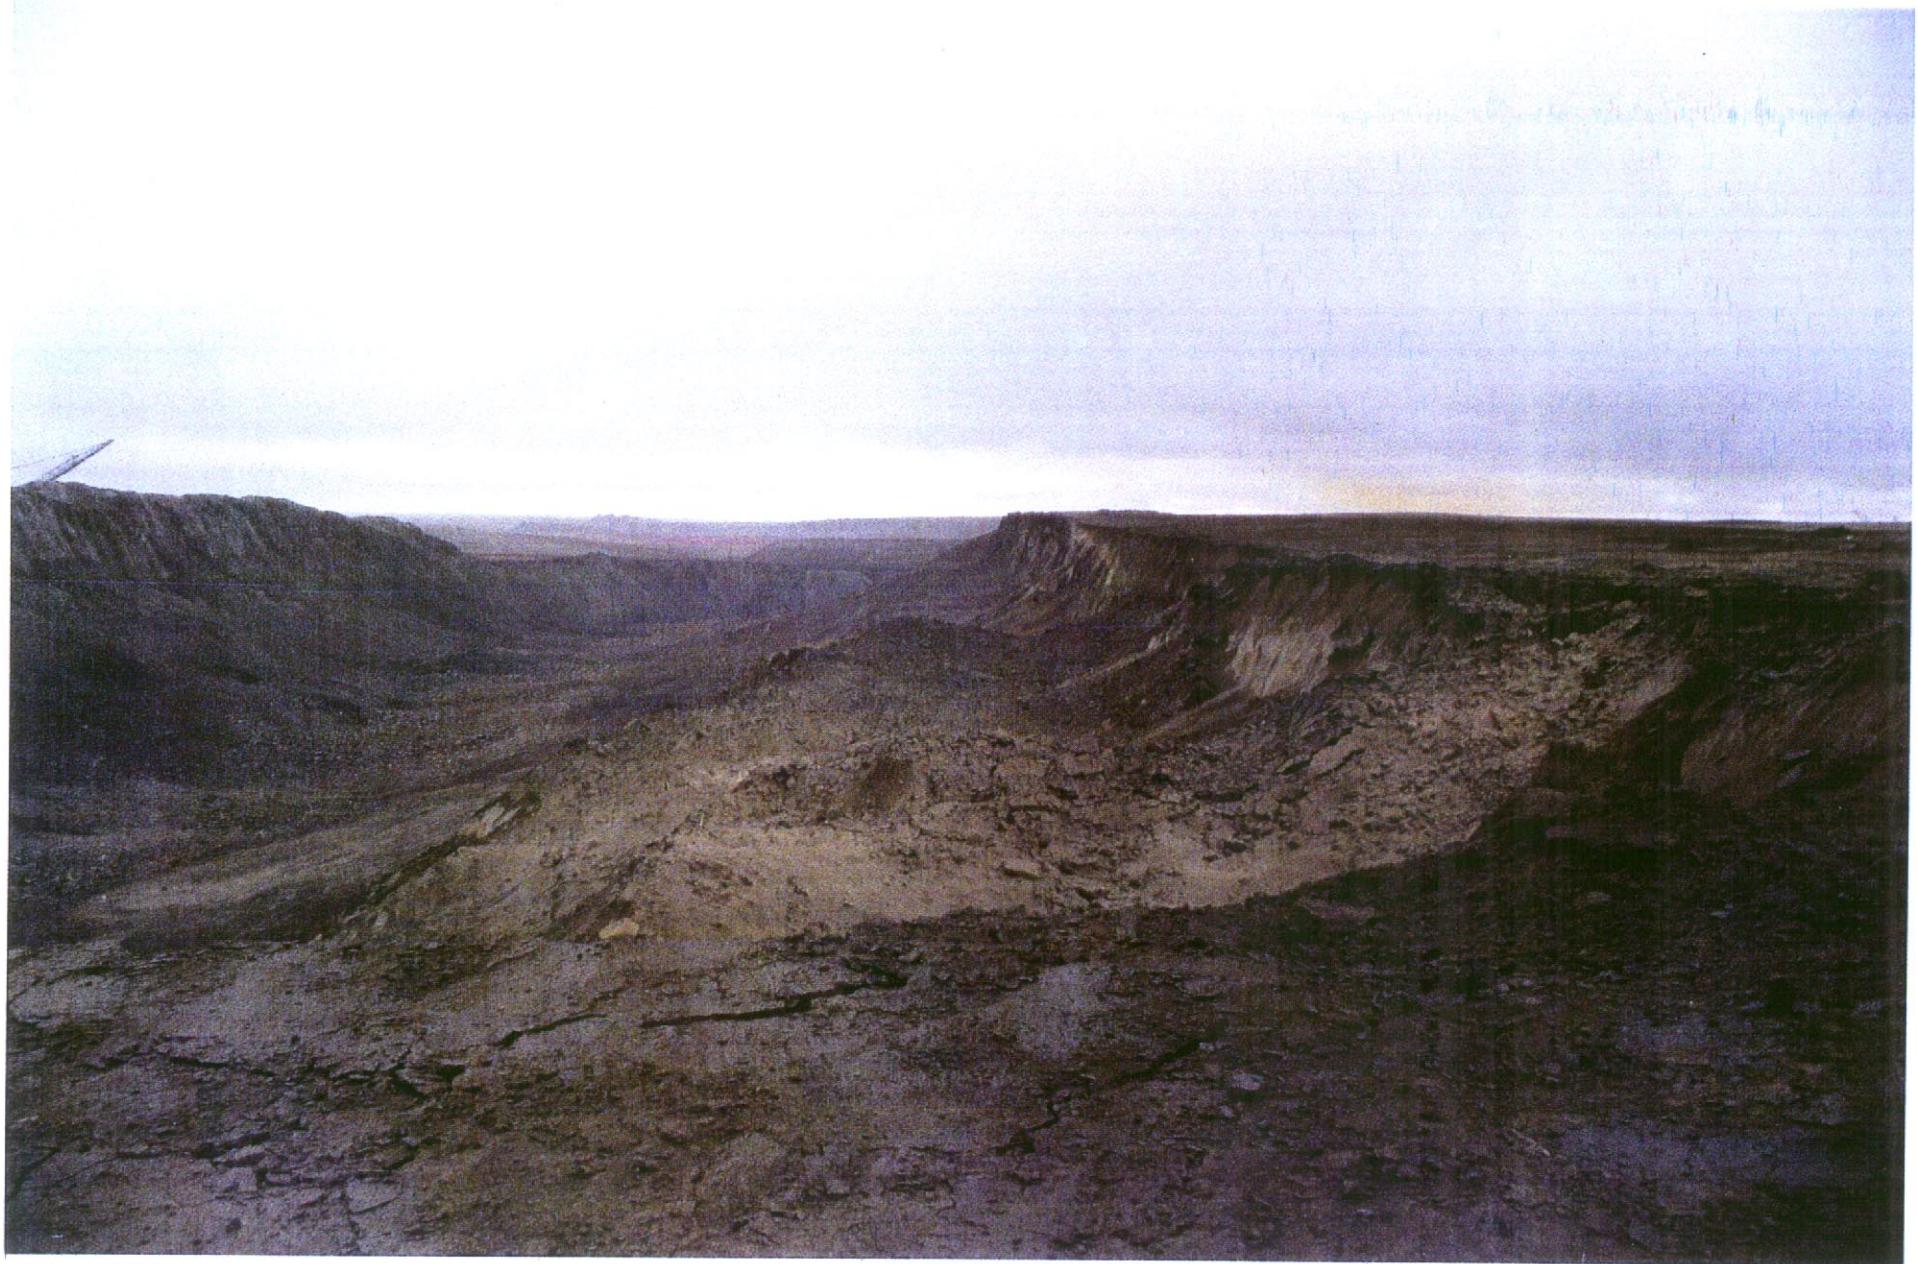
Figure 35: Black Thunder site, WY. Ground broken and thrown after a 1,600-ton ANFO cast shot.
