TUBING WASTAGE IN FLUIDIZED-BED COAL COMBUSTORS  
(TVA, 20 megawatt AFBC Pilot Plant)

By  
Charles E. Witherell

Prepared by  
Lawrence Livermore National Laboratory  
Livermore, California 94550-0808

April 7, 1989

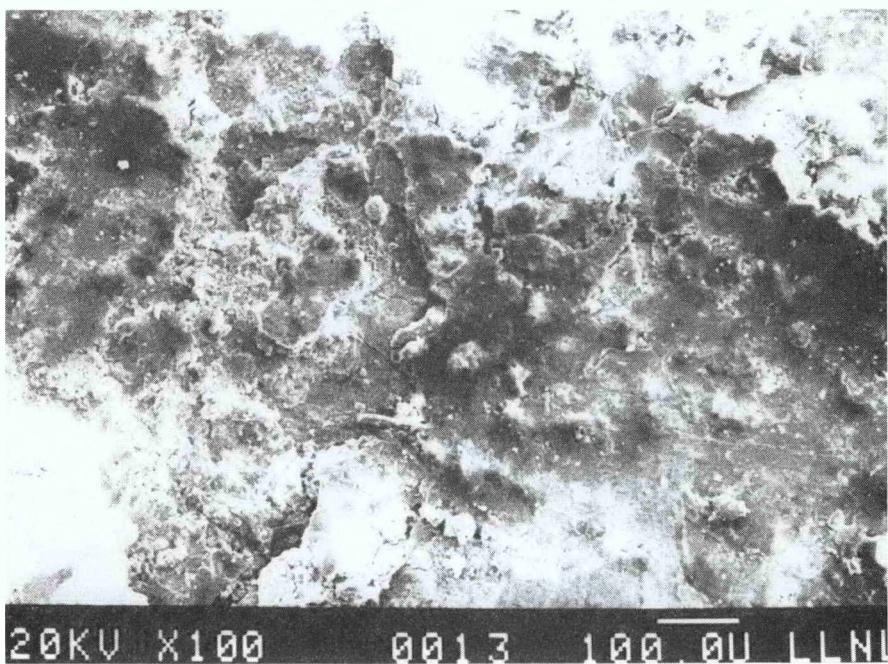
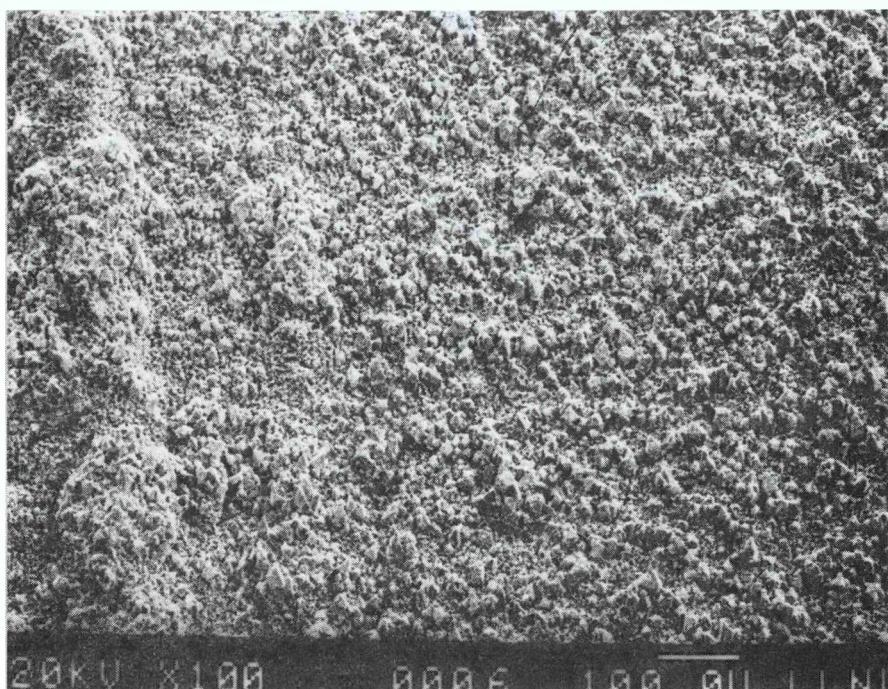
FIGURE 6

For example, non-wasted surfaces of tubes 27-A-1 and 27-A-4 (Figure 6 and 7, respectively) have similar appearance, with rough heavy-appearing scales, showing evidence of fractures and exfoliated layers. Wasted regions are quite different in appearance – both from each other and from non-wasted regions. The wasted region of 27-A-1 (Figure 6) has a fine granular texture that appears to be a coating of agglomerated particulates that are adhering to the tubing surface. This is more clearly evident in the higher magnifications of Figure 10. Wasted surfaces of tubing sample 27-A-4 do not have this appearance. Figure 11 shows the appearance of the wasted region at a higher magnification than Figure 7. While the scale appears more dense, there are some scattered particulates similar to those in Figure 10 on the surface. Also, cracks in the scale are present in these areas devoid of the coating of fine particles.

Typical Appearance of Fireside Surface of Tubing Sample 27-A-1  
(SEM Photomicrographs)

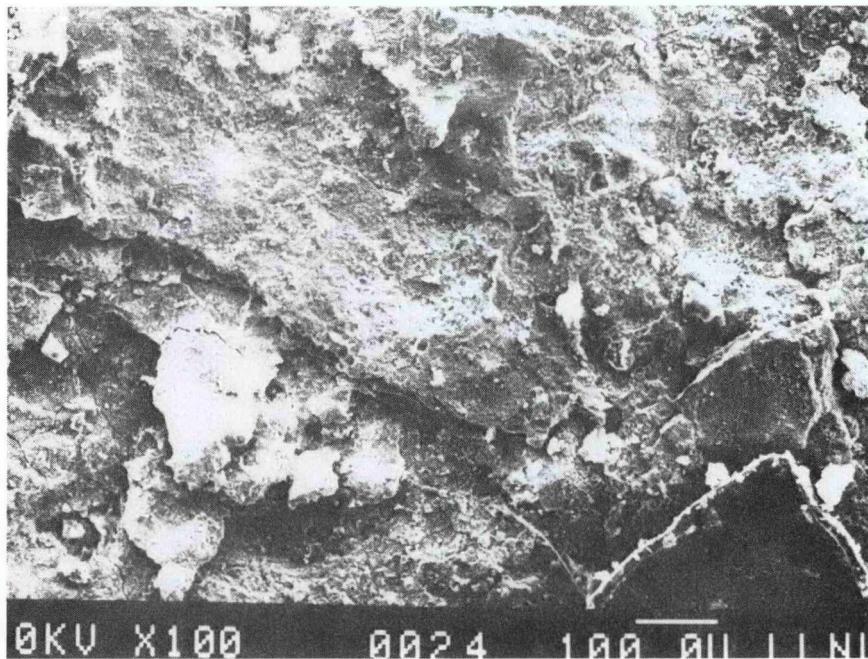
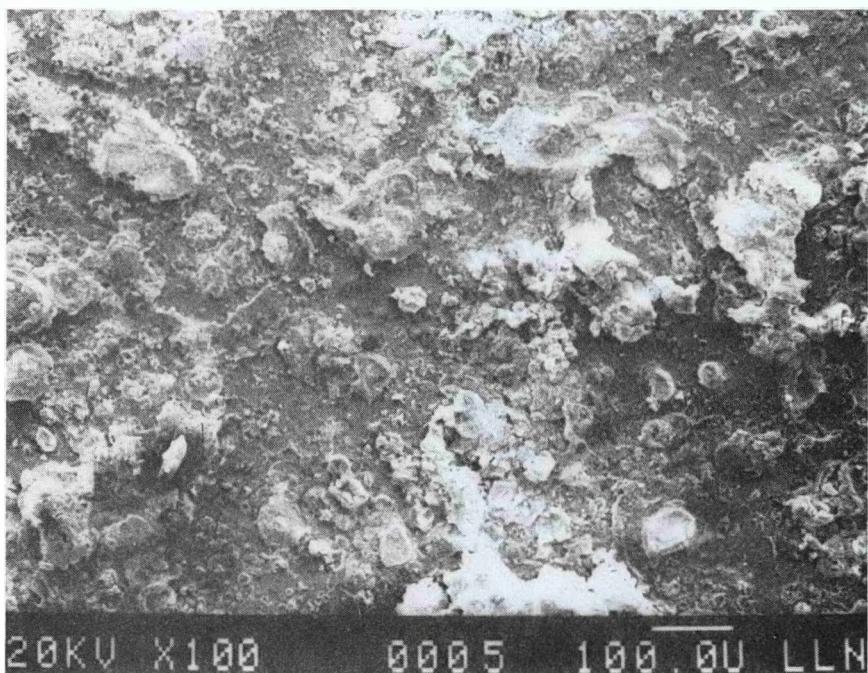
FIGURE 7

Typical Appearance of Fireside Surface of Tubing Sample 27-A-4  
(SEM Photomicrographs)

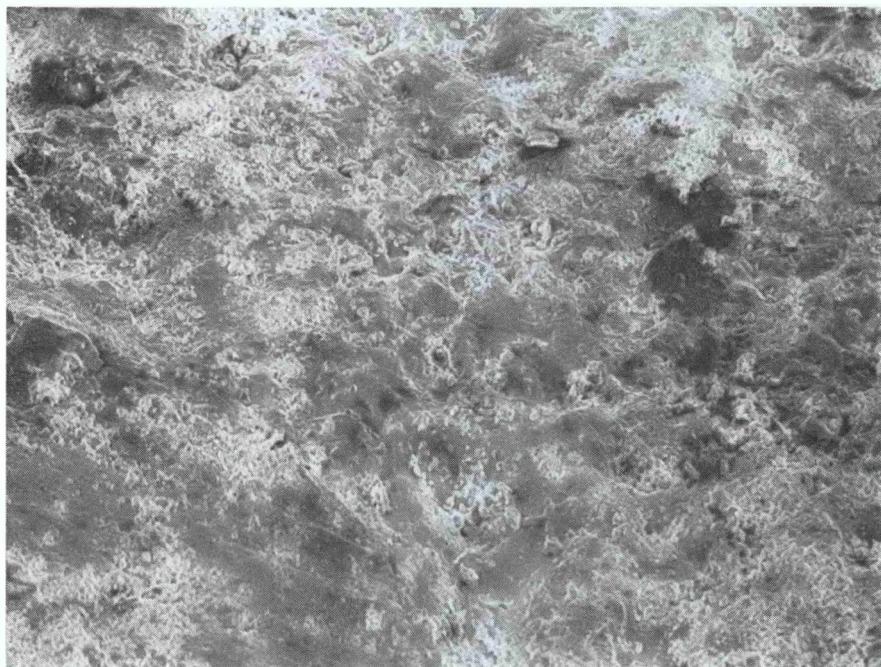
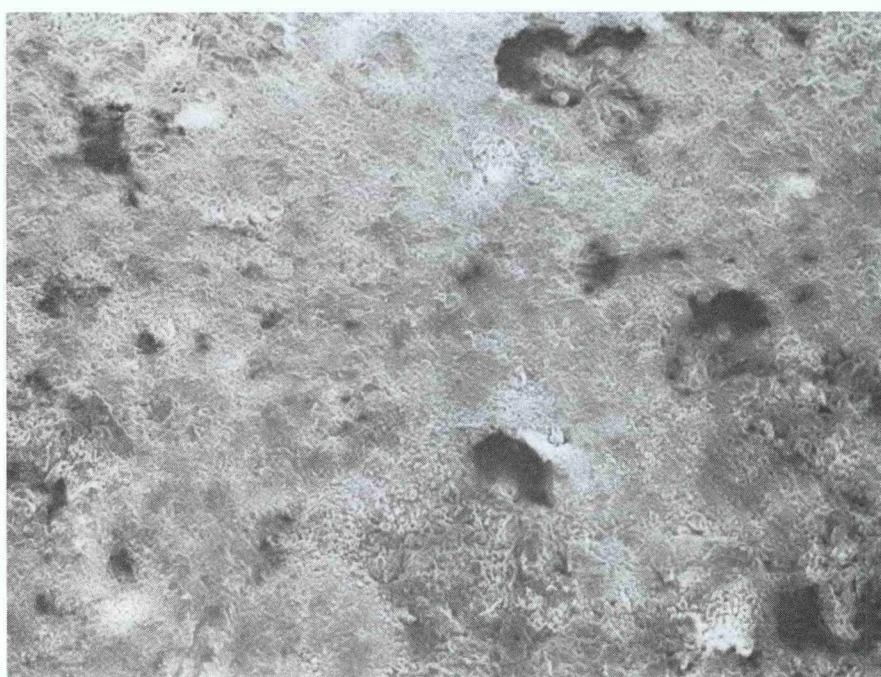
FIGURE 8

Surface appearance and texture of the scales on tubing 8-1 again were different. Here, the surfaces are generally smoother and not as coarse as tubing samples 27-A-1 and 27-A-4, although the tendency for the wasted region to be smoother than the non-wasted region is observed in this tube, as well. Combustor location may be related to the differences in appearance of this tube in contrast to 27-A-1 and 27-A-4. In this respect, it may be relevant to note that tubing 8-1 had somewhat different exposure in the combustor (see Table I), including use of different coals for the last exposure period.

Typical Appearance of Fireside Surface of Tubing Sample 8-1  
(SEM Photomicrographs)

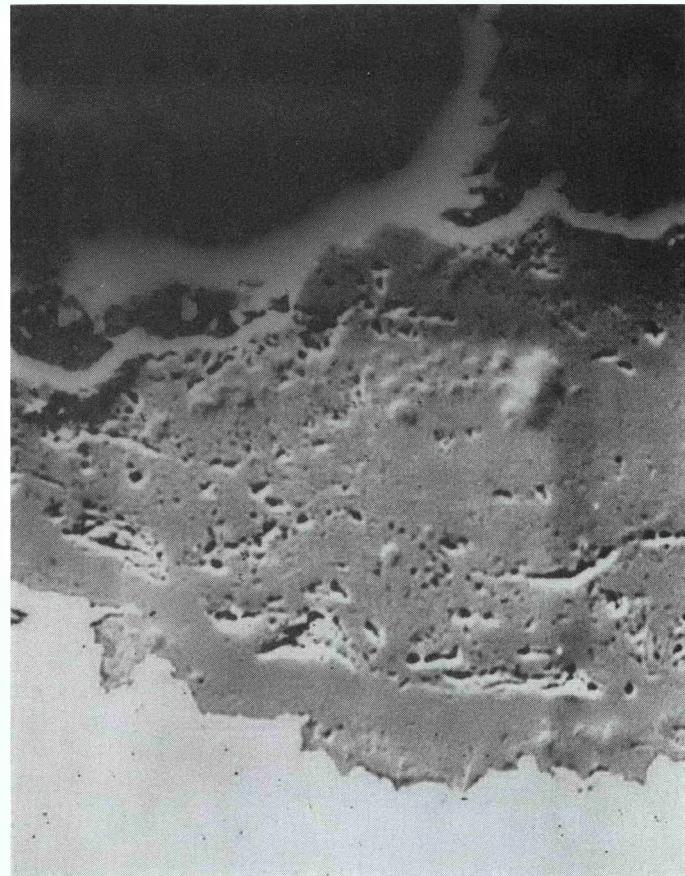
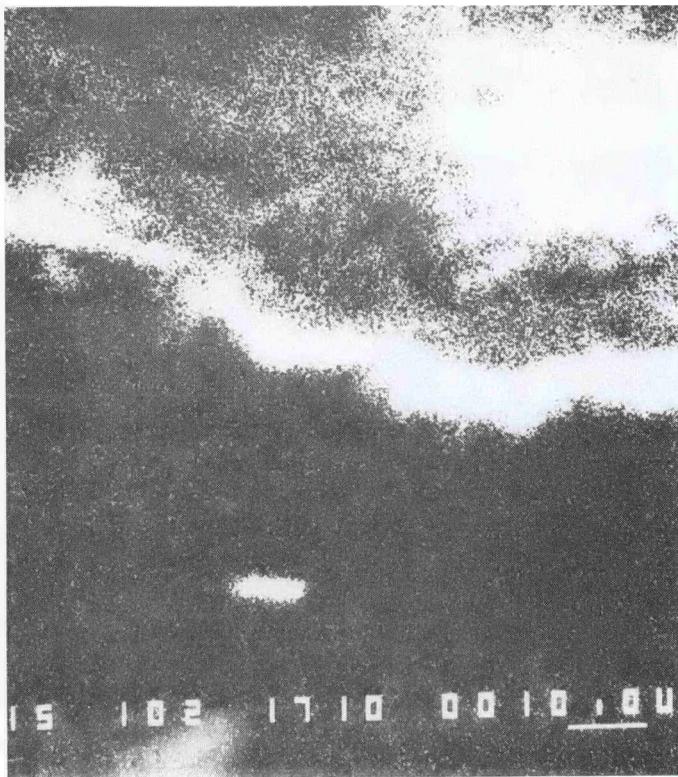
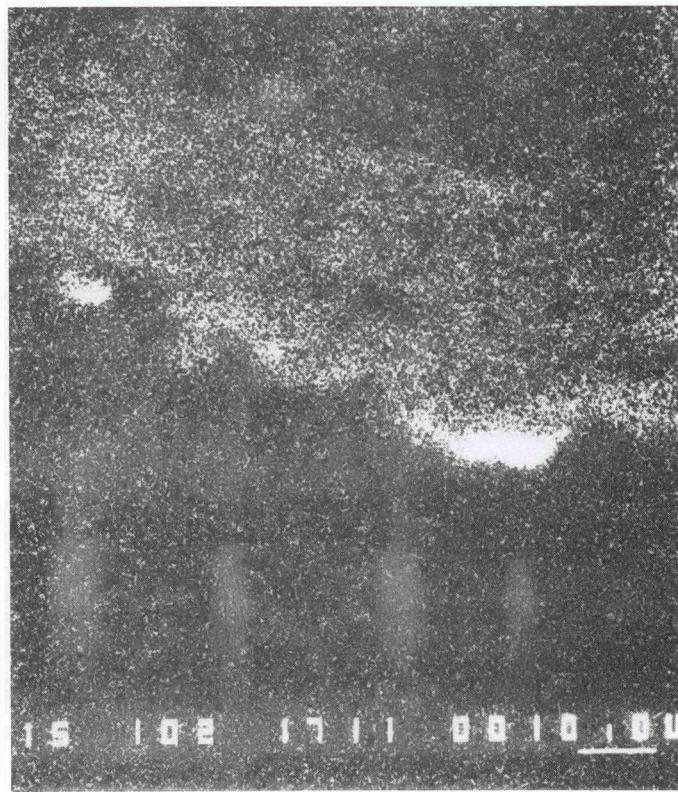
FIGURE 14-A

For tube sample 27-A-4 (Figures 14 and 15), elemental concentrations generally are more intensive in non-wasted regions. This was observed consistently on all analytical runs; although preferred locations for the various elemental concentrations do not change from wasted to non-wasted region. That is, sulfur and chlorine seem to concentrate preferentially along the scale/metal interface while potassium and calcium are more diffused throughout the scale. Sulfur, however, was the dominant element of the four with high concentrations in the scale along the interface and within pores and crevices. This was always much more pronounced in non-wasted regions as shown by a comparison of Figures 14 and 15 (non-wasted and wasted regions, respectively).

Cross Section of Non-Wasted Region of Tubing Sample 27-A-4  
(SEM Secondary Electron Image of Area Used for XRF Maps of Figure 14-B)

XRF Element Maps of Cross Section of Non-Wasted Region  
of Tubing Sample 27-A-4

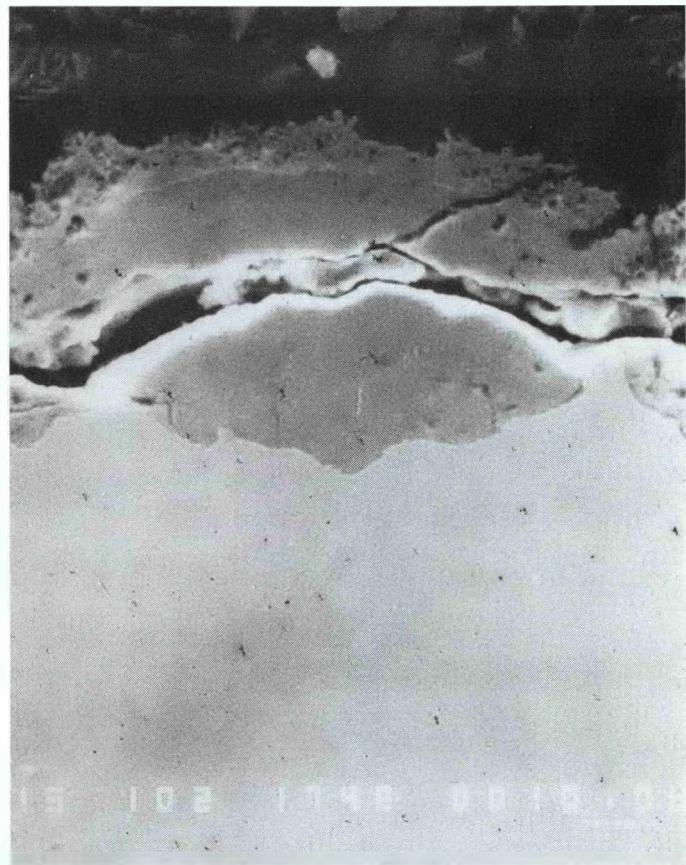
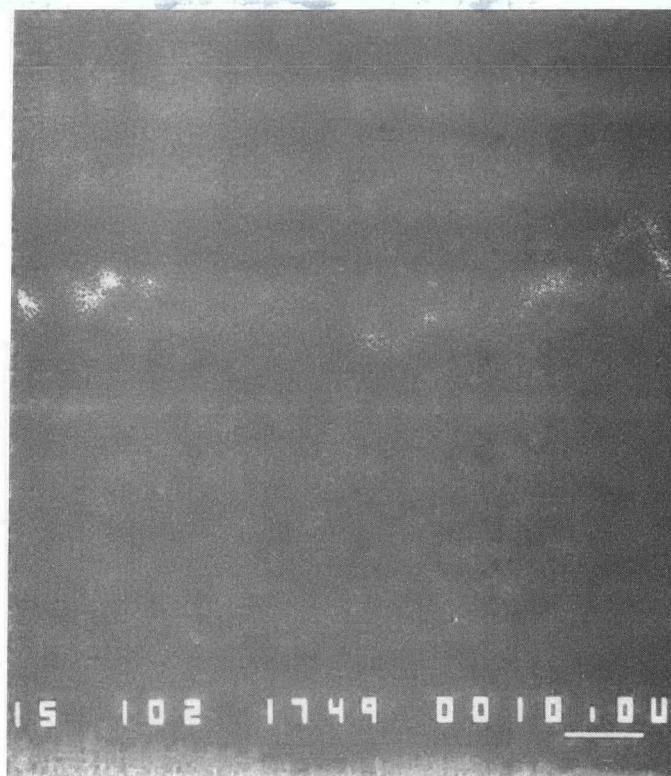
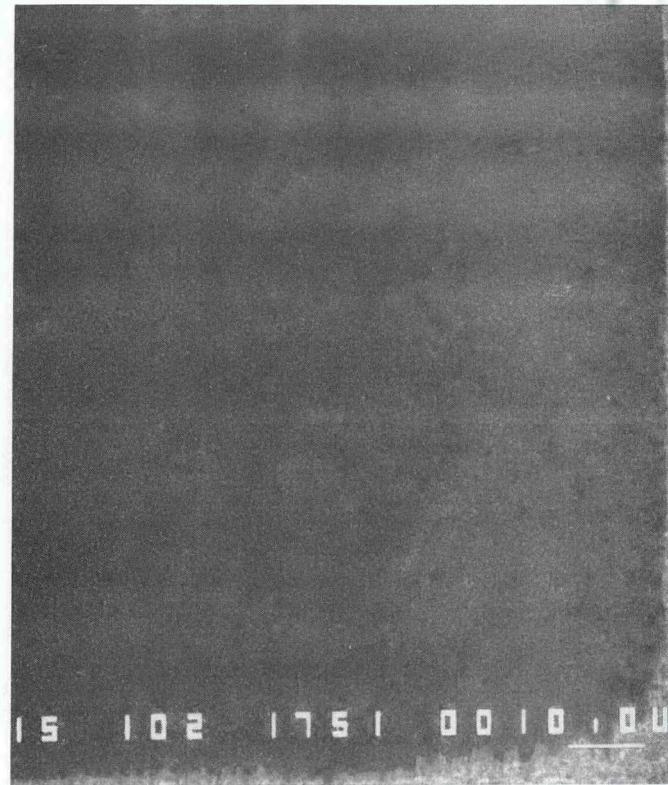
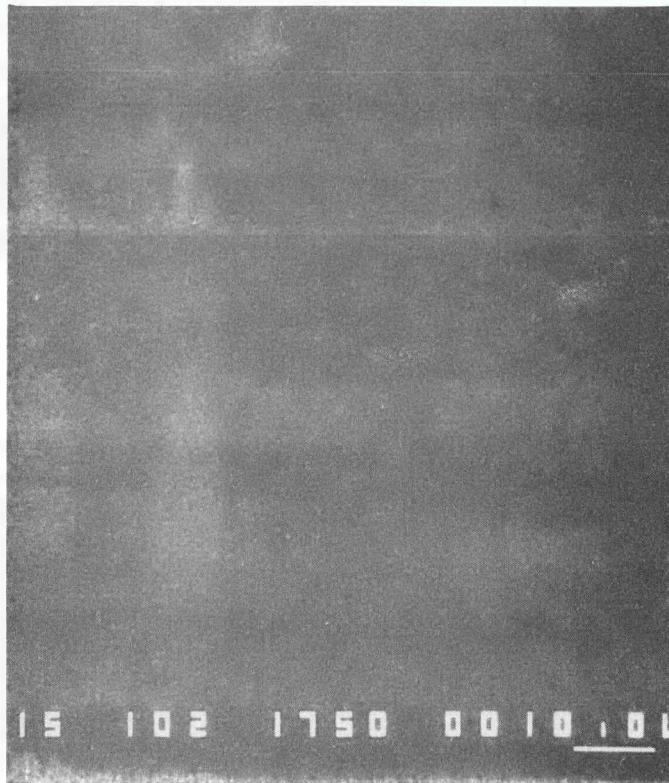
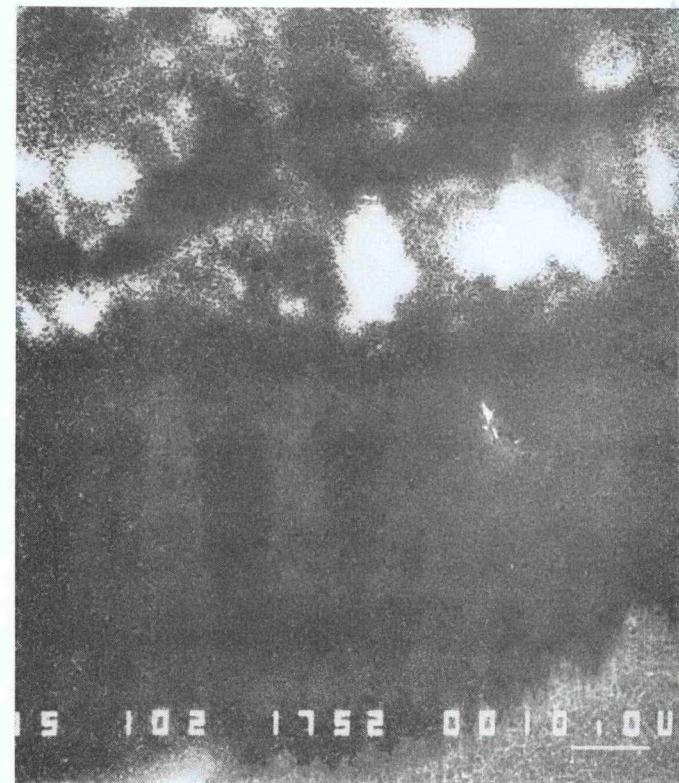
FIGURE 15-A

Cross Section of Wasted Region of Tubing Sample 27-A-4  
(SEM Secondary Electron Image of Area Used for XRF Maps of Figure 15-B)

XRF Element Maps of Cross Section of Wasted Region  
of Tubing Sample 27-A-4

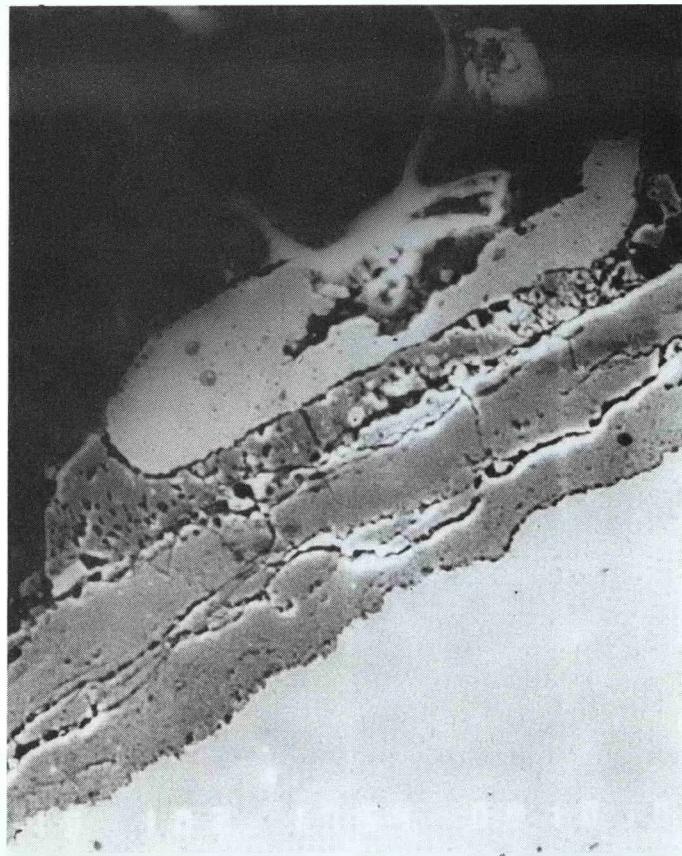
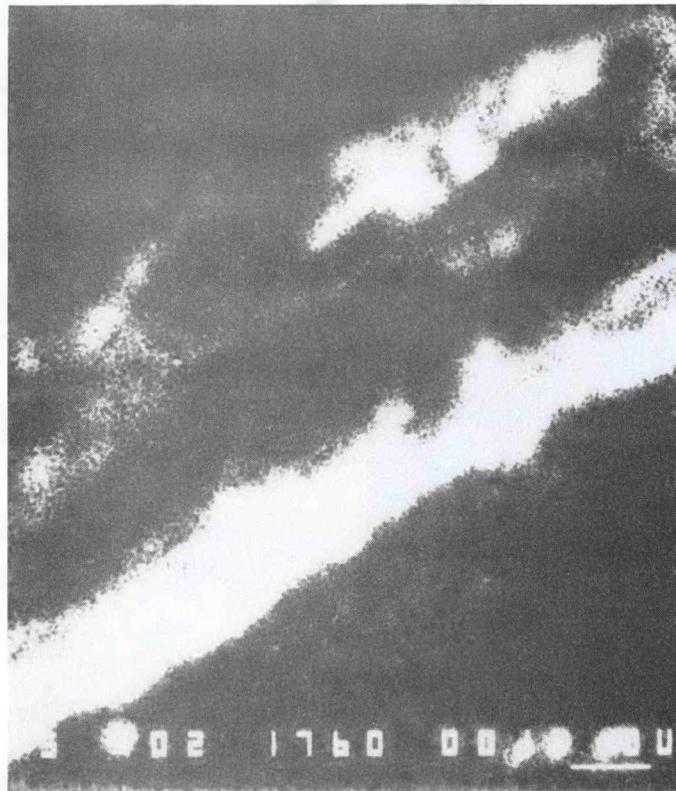
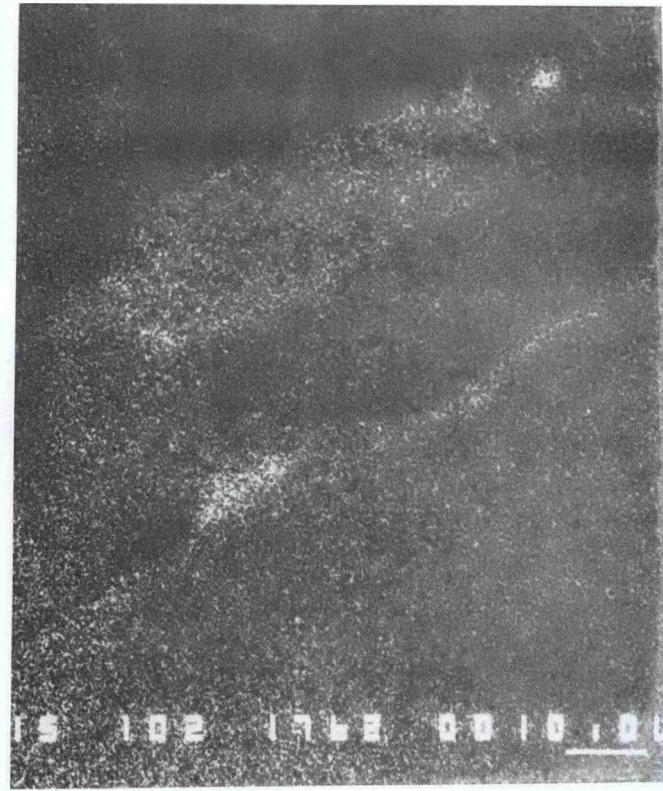
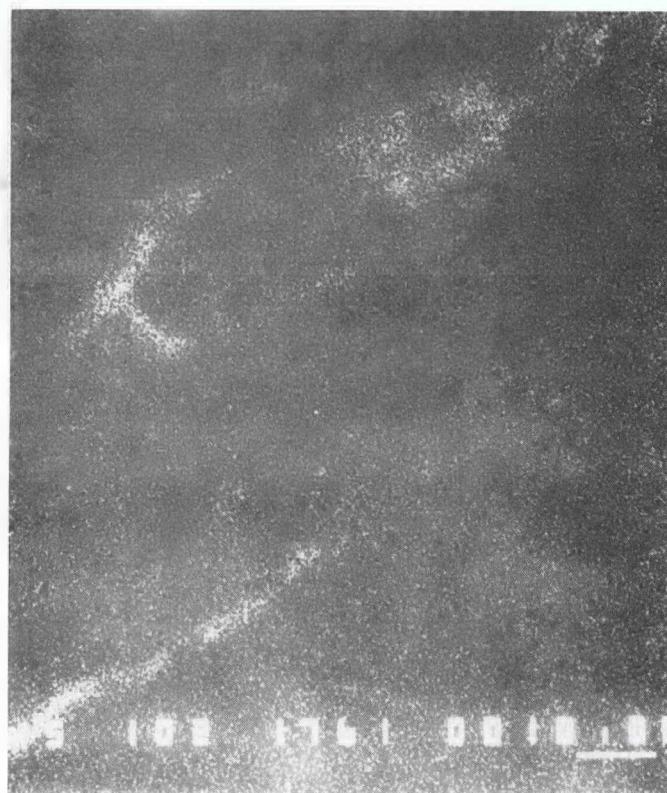
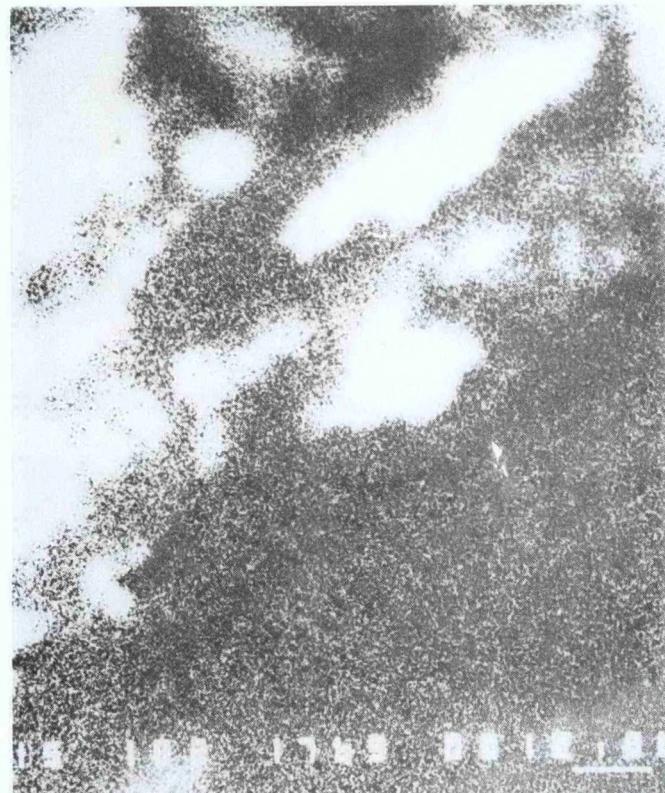
FIGURE 16-A

These trends were generally the same for the same two corresponding regions of tube sample 10-3-105 (Figures 16-17). However, in that tube, the chlorine concentration (along the interface) in the scale at the underside was greater than it was at the topside, or in either region of tube sample 27-A-4. Potassium, also, tended to concentrate more along the interface at the underside and more, again, than was observed in Sample 27-A-4. Sulfur, however, was heavily concentrated along the interface at the topside and more diffused in the scale at the bottomside (although preferring pores and crevices), as in sample 27-A-4. As noted in previous studies, sulfur and calcium concentrations are not associated with one another.

Cross Section at Top-Side of Tubing Sample 10-3-105  
(SEM Secondary Electron Image of Area Used for XRF Maps of Figure 16-B)

XRF Element Maps of Cross Section at Top-Side  
of Tubing Sample 10-3-105

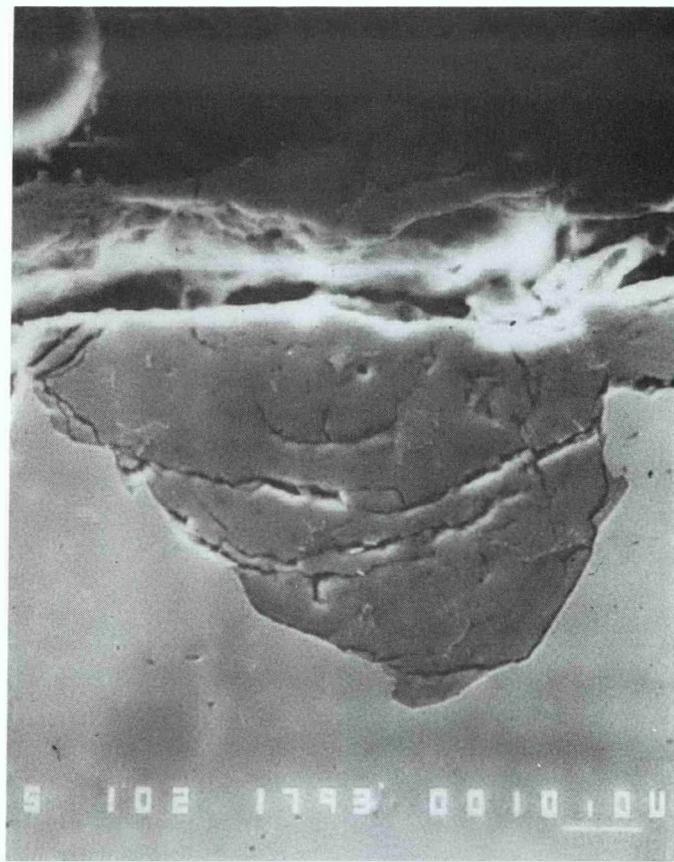
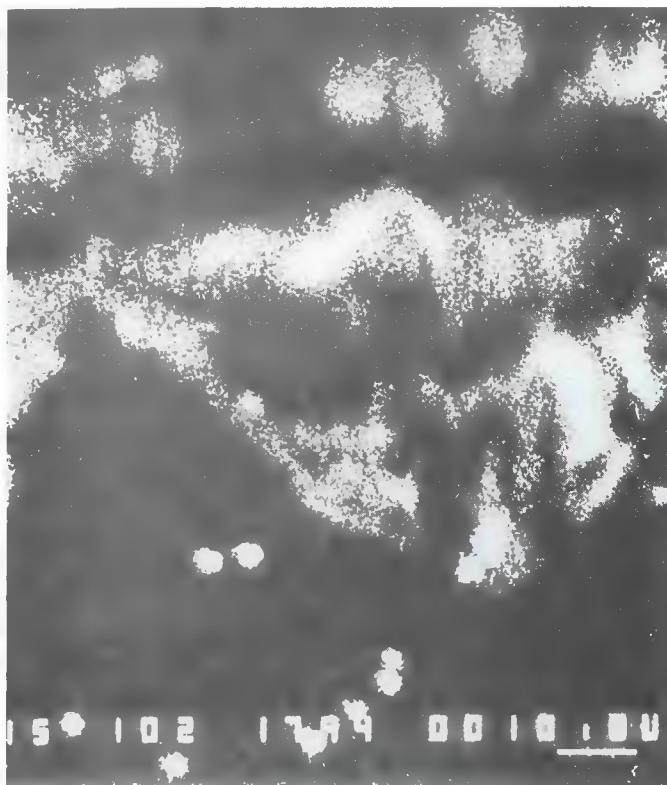
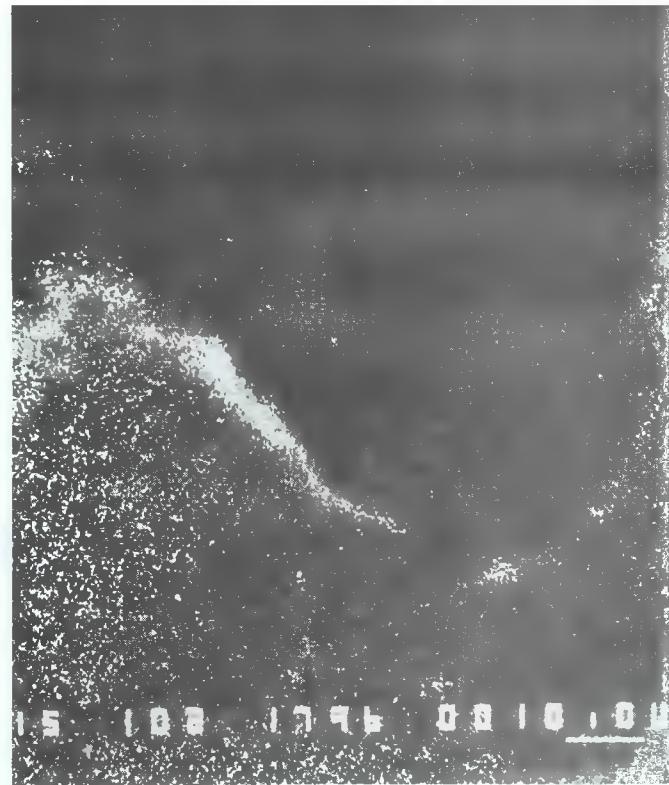
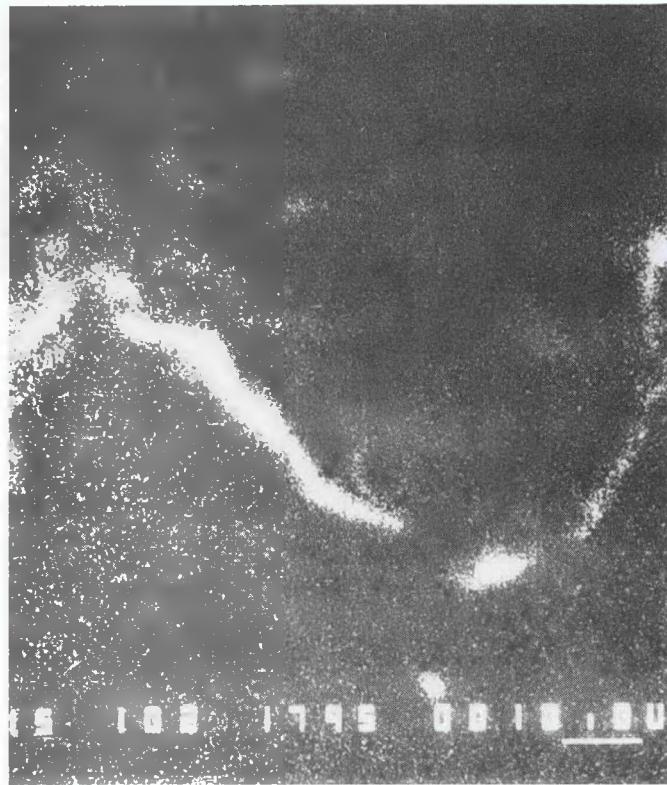
FIGURE 17-A

Cross Section at Underside of Tubing Sample 10-3-105  
(SEM Secondary Electron Image of Area Used for XRF Maps of Figure 17-B)

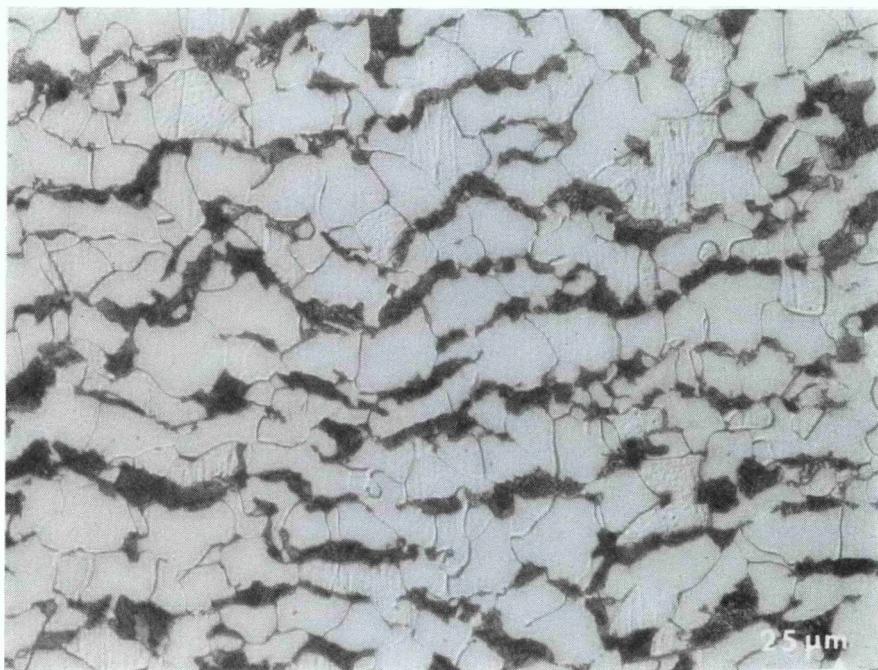
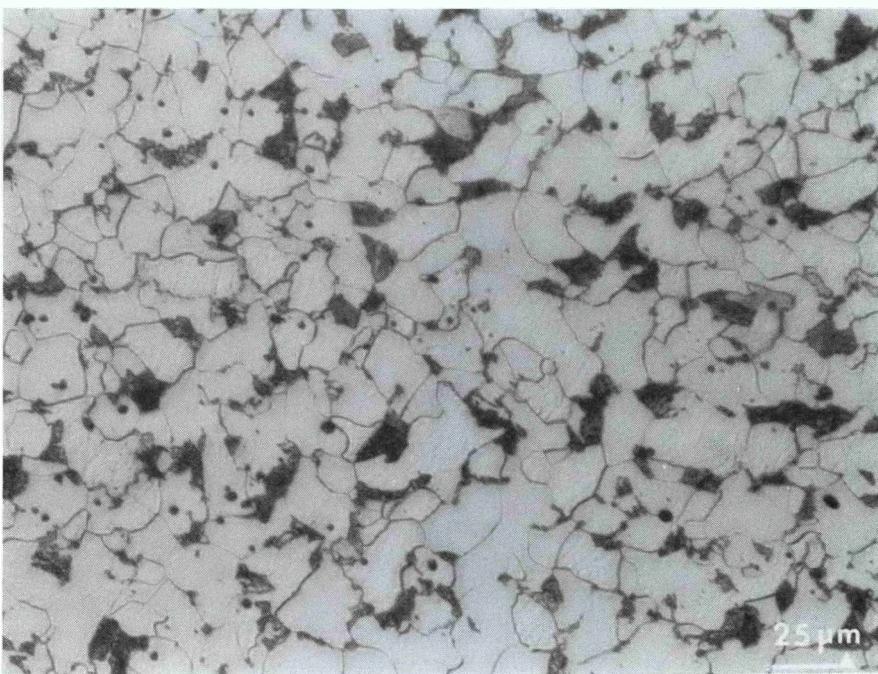
FIGURE 18

**7.2.3 Microstructure.** Examinations of metallographically-prepared specimens of steels from the two tube banks revealed a number of differences. The most pronounced was the banded microstructure of the C-E tubes and a more uniformly distributed microstructure in the B&W tube. The pearlite bands in the C-E steel were generally parallel but undulating, and spaced fairly equidistant from one another by the separating ferrite matrix and, for the most part, interconnected. They tended to run in circular concentric patterns around the tube and parallel to its inner and outer cylindrical surfaces. They also tended to follow ferrite grain boundaries, and the pearlite lamellae were generally distinct. The ferrite matrix in the C-E steel was exceptionally clean and generally featureless with virtually no non-metallic inclusions. Grain size was somewhat larger than in the B&W tube.

Besides being more uniformly distributed, the pearlite islands in the microstructure of the B&W steel were not interconnected but, as in the C-E steel, tended to favor ferrite grain boundaries, yet were usually well separated and surrounded by the ferrite matrix. The pearlite lamellae, again, were distinct and had not become decomposed. Unlike the C-E steel, the ferrite matrix of the B&W steel had a moderate distribution of fairly large non-metallic inclusions scattered throughout the microstructure. Microstructures of the two steels at the same magnification are shown in Figure 18.

Microstructures of Steel Evaporator Tubes from Two Tube Banks  
Experiencing Different Wastage Response  
(Optical Photomicrographs, Etchant: 2% Nital)

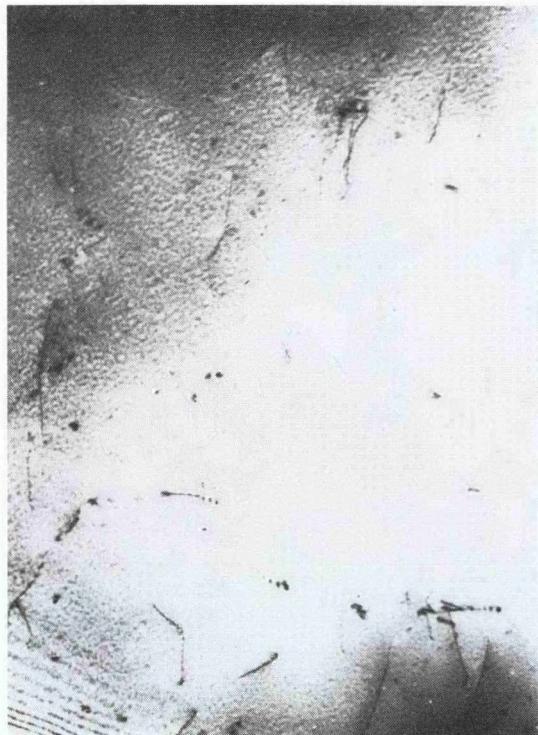
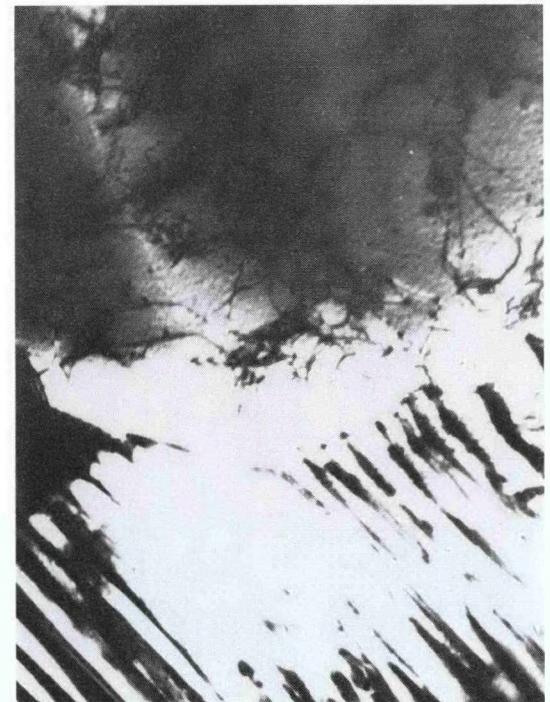
FIGURE 19

Photomicrographs of TEM microstructures of these three regions are shown in Figure 19. There are a number of observations to make in evaluating these microstructures. One, is that the photomicrographs at the center and left side represent metal from not only the same tube sample but from the same location within the tube wall (same radial distance from tube bore or central axis). The left-hand photo represents material at the wasted surface and the center photo represents material in its as-produced state (the original state of the metal at the same location as that shown in the left-hand photo, but before exposure to FBC environments). The difference in density of dislocations – an indication of extent of mechanical deformation – is clearly evident. This indicates that the wastage process involves, at least to some degree, mechanical surface forces that produce deformation.

TEM Microstructures of Tubing Sample 8-1  
(Magnification: about 50,000x)

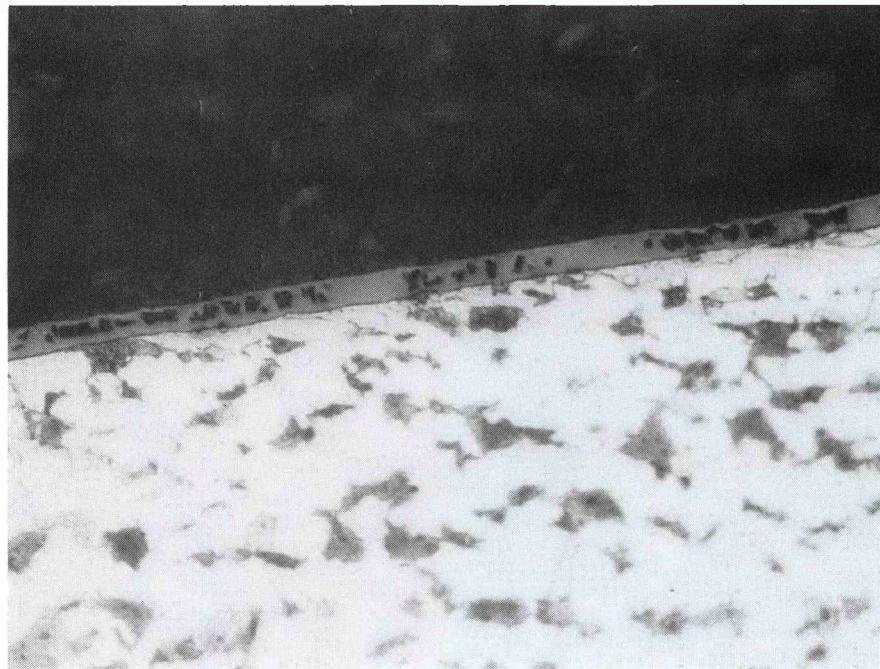
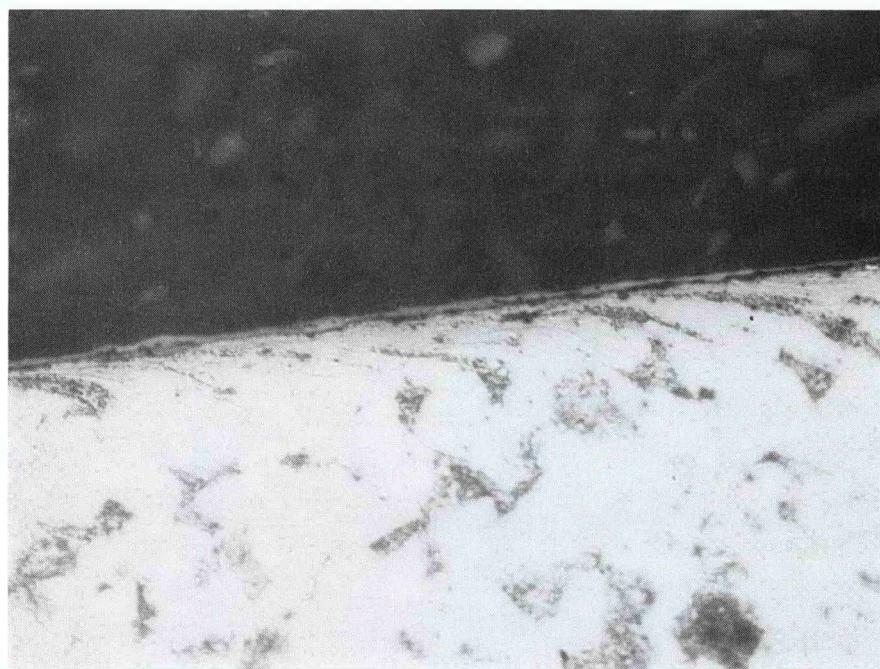
FIGURE 21

The oxide scales formed on the two steels during the 100-hour laboratory exposure at 450 C (842 F) had significant differences, as shown in Figure 21. The scale on the C-E (tube sample 8-1) steel was not only thicker, but more porous and appeared to grow directly from the substrate without an intervening sub-layer. Scale on the B&W steel (tube sample 10-3-105) was thinner, less porous, and had a distinctive, thin, pebbly-appearing band located a micron or two from the steel substrate. This band was fractured continuously along its entire length; although this fracture may have occurred during preparation of the sample cross-sections. Details of the scale interface are more clearly evident at the higher magnification of the scanning electron micrographs of Figure 22.

Cross Sections of Tubing Steel Showing the Scale/Substrate  
Interface after Laboratory Oxidation Test at 450 C  
(Optical Photomicrographs)
