Instrumentation Report No. 2: Identification, Evaluation, and Remedial Actions Related to Transducer Failures at the Spent-Fuel Test—Climax

Manuscript Date: November 30, 1981

LAWRENCE LIVERMORE LABORATORY

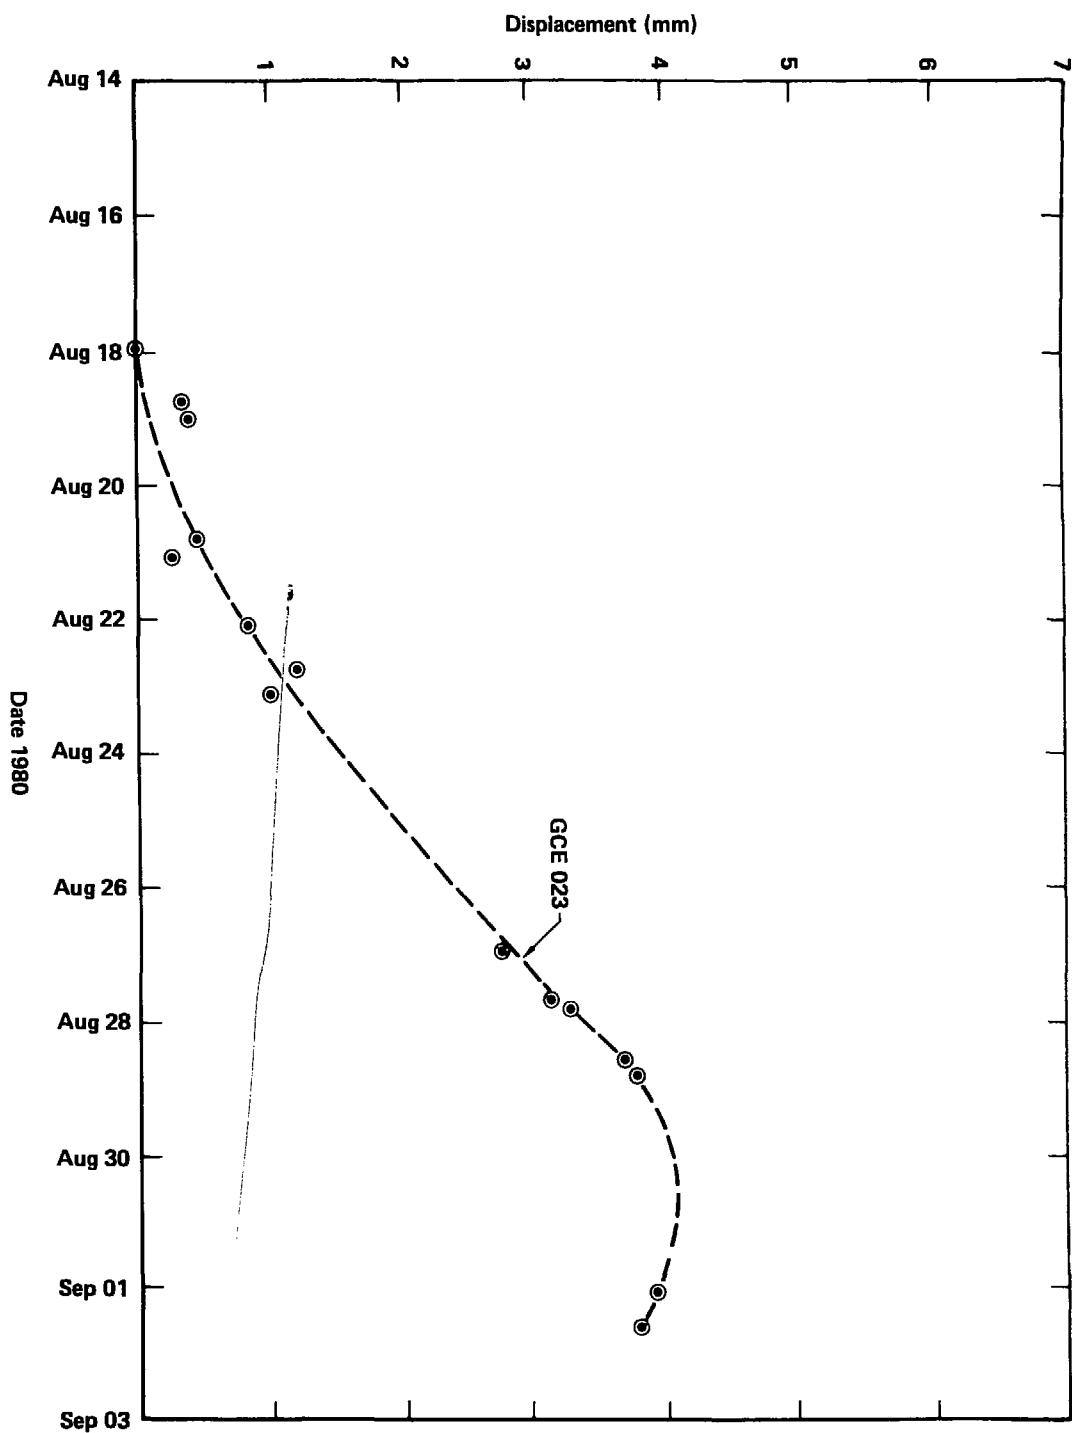
Computer-recorded readings of relative displacement at one extensometer (GCE023) began to be significant in late August 1980 (see Fig. 3). The recorded displacements caused no concern since they were reasonable by at

FIG. 3. Preliminary data plots.

least three criteria. First, they were in the correct direction for early-time displacements in that they reflected relative compression between the anchor point and the head assembly, reflecting thermal expansion and upward motion of the rock near the anchor. Second, they were in the range of expected displacements. Third, they were following a familiar S-shaped response curve.

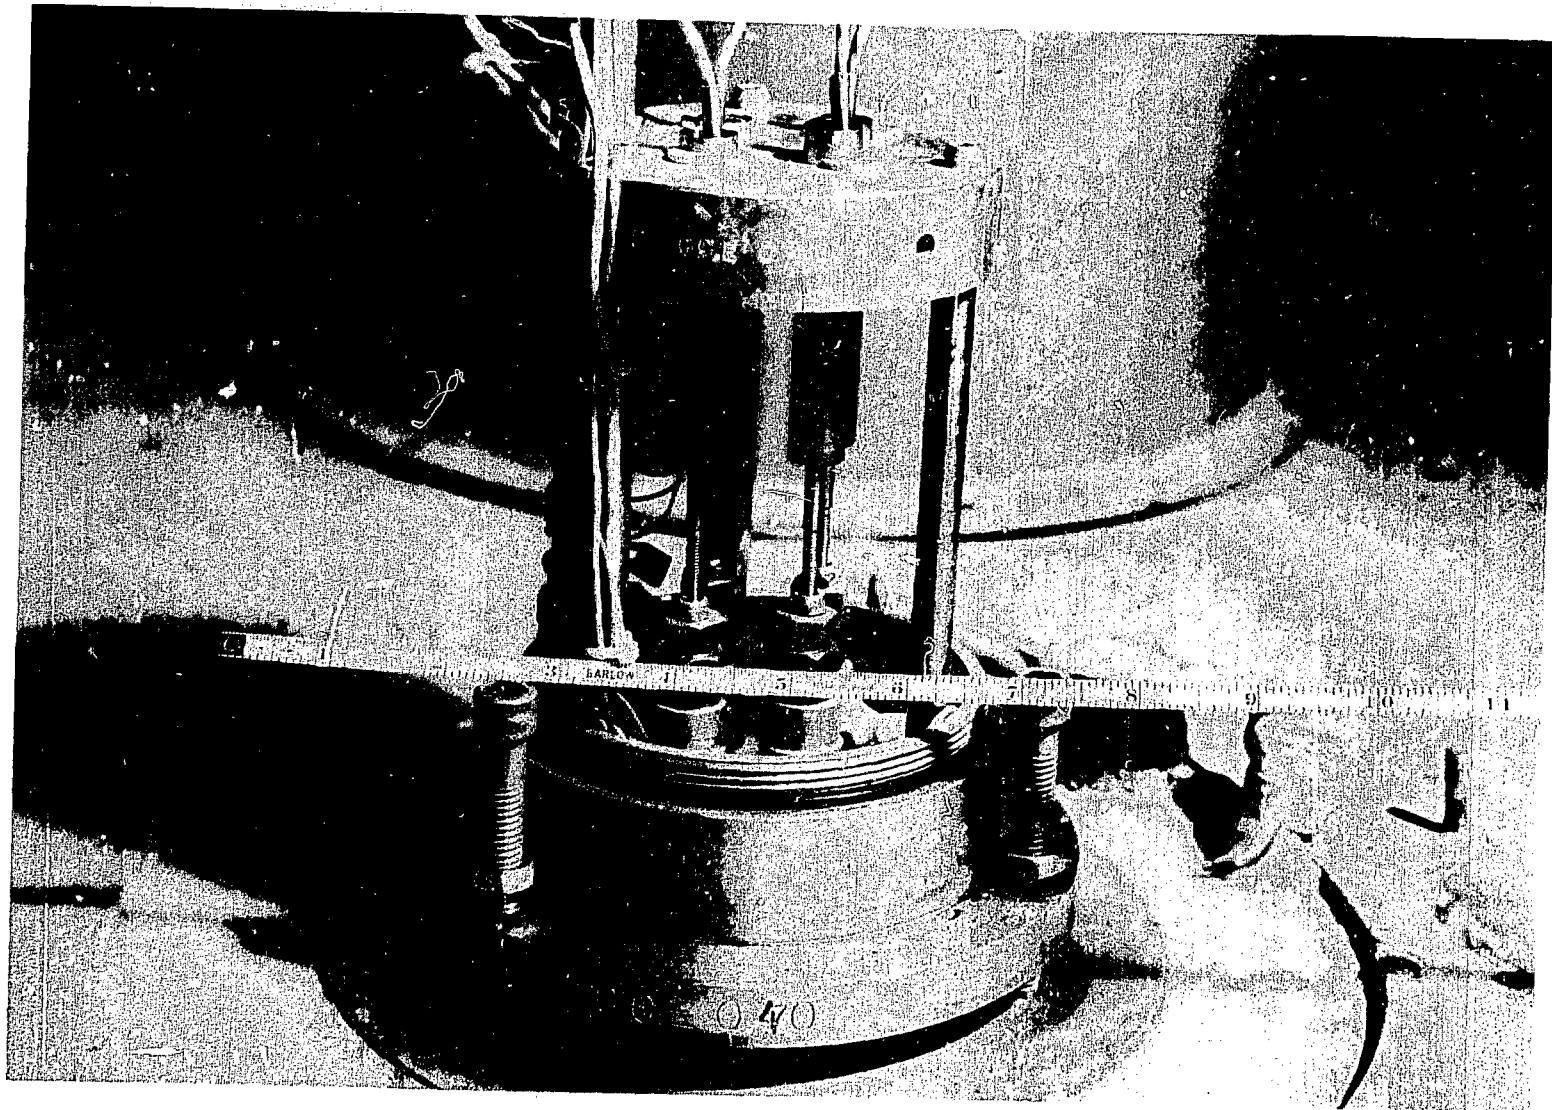
FIG. 5. GCE extensometer with Bourns potentiometers and screw couplings.

These three considerations led to selection of four transducers to replace the 48 GBE- and GCE-series units where all failures have occurred to date (see Fig. 1). Each group of three extensometers received one type of transducer. Bourns Model 5184 rectilinear potentiometers were reinstalled in GBE24x, GBE25x, and GBE26x. Vernitron Model 113 rectilinear potentiometers were installed in GCE24x, GCE25x, and GCE26x. Schaevitz Model 250HCD linear variable differential transformers (LVDT/DCDT) were installed in GBE21x, GBE22x, and GBE23x. Kaman Model KD-2310-6U electromagnetic proximeters were installed in GCE21x, GCE22x, and GCE23x. Table 5 summarizes the characteristics of the selected transducers. Each of the three alternates compares favorably in several ways with the original Bourns potentiometers (see Fig. 5).

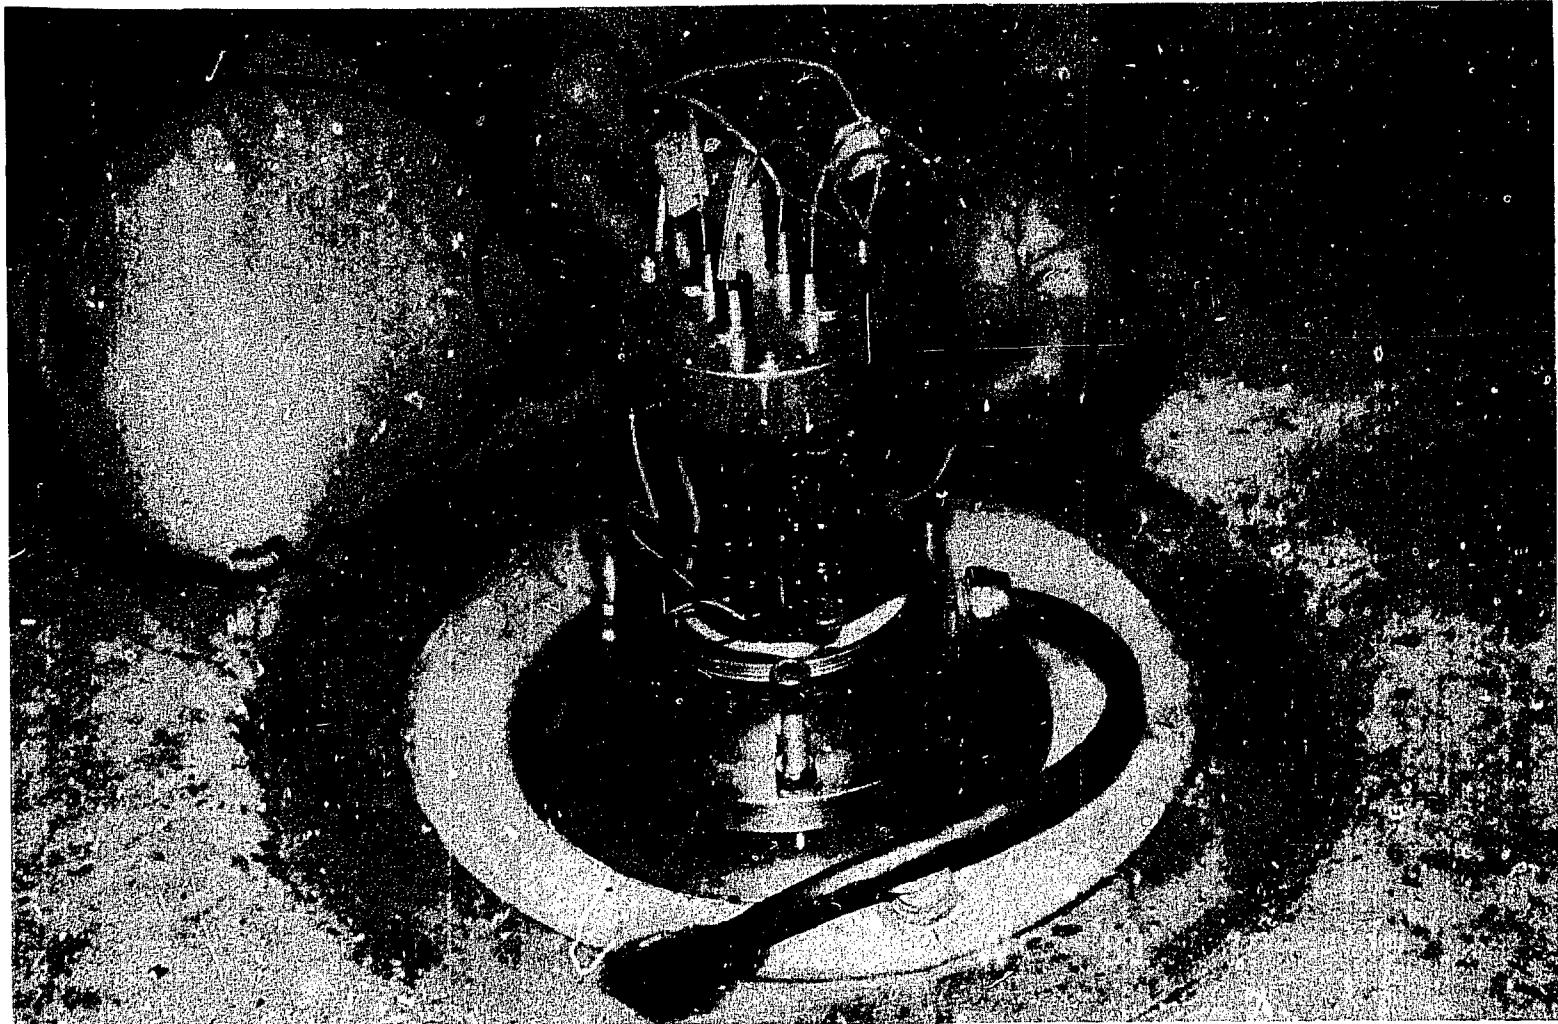
FIG. 6. G-series extensometer showing spring-loaded couplings used with Vernitron and replacement Bourns potentiometers.

We had observed in previous installations that some nonconcentricity existed between potentiometer shafts and the rods to which they were coupled. This condition introduces side loading which causes binding of the shaft and body of the potentiometers. This phenomenon may be responsible for some of the "stick-slip" type motion observed in the rod extensometers. During replacement operations, a modification was introduced to circumvent this problem. All screw couplings of potentiometer and DCDT shafts to rods were replaced by spring loading the shaft against a flat smooth stainless steel fitting attached to the rod (see Figs. 5-7). A stainless steel sphere screwed onto the shaft provides essentially a point contact against the stainless steel fitting attached to the rod. This modification was implemented on both potentiometer types and the DCDT. The proximeter is a noncontacting device which utilizes a 19-mm-diam by 6.4-mm-thick aluminum target attached to the rod. These modifications are expected to enhance the quality of the acquired data.

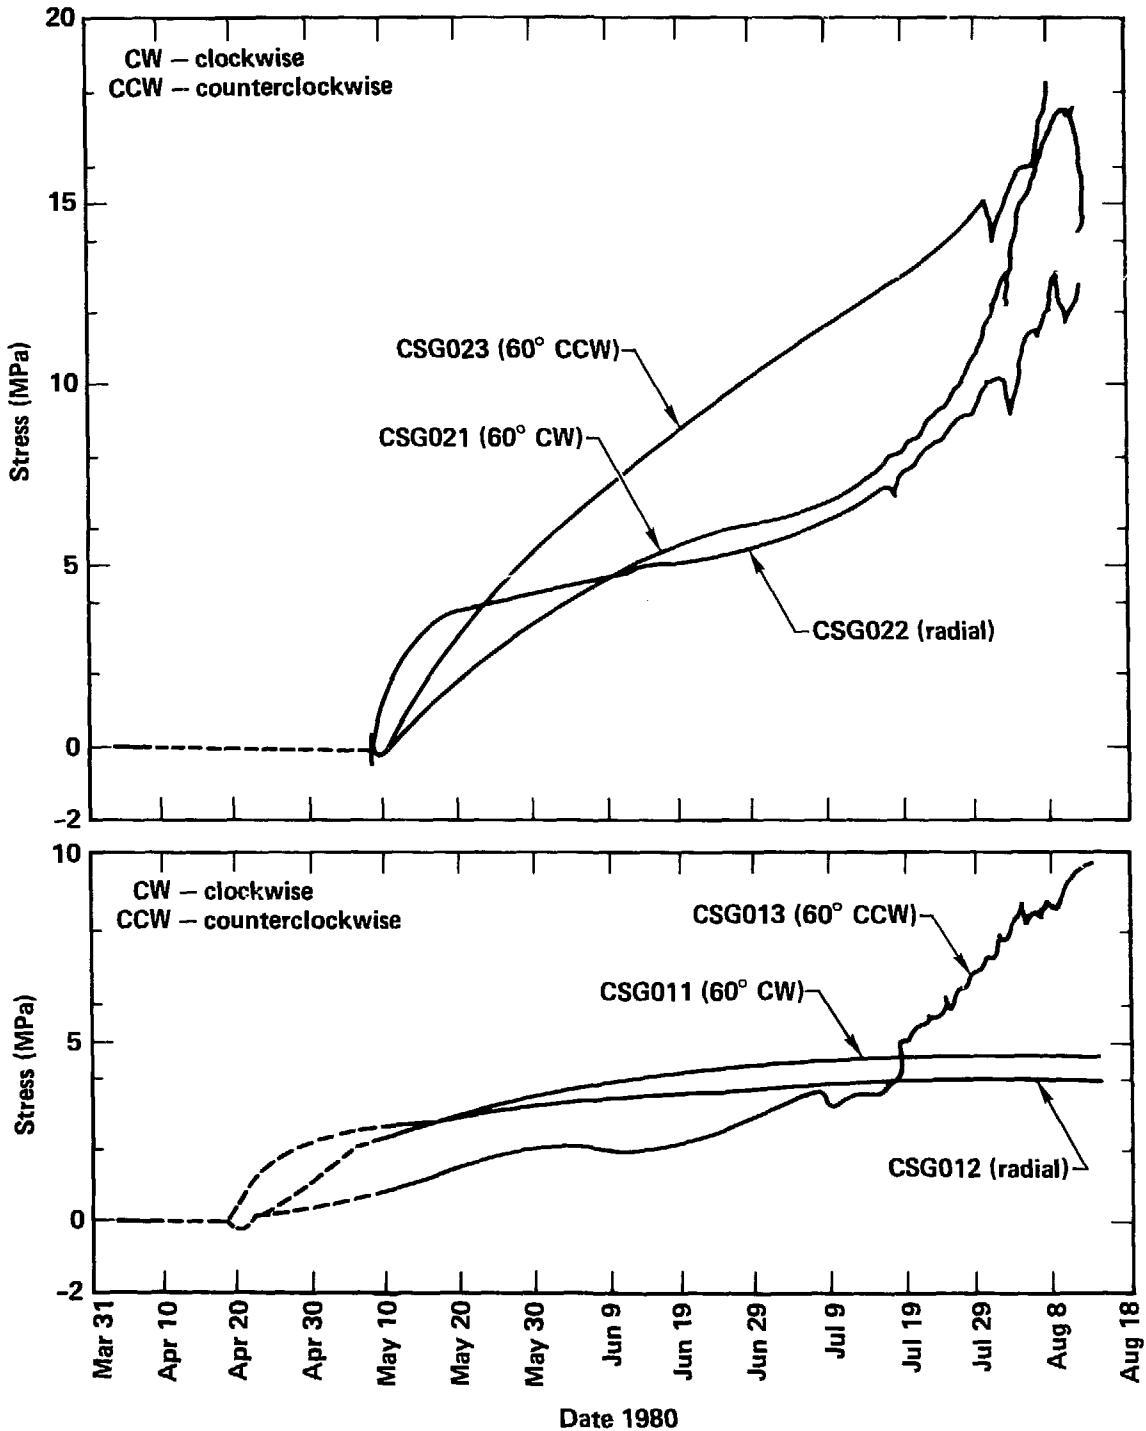
By 22 August, the TTY data had been punched on cards, and codes had been written to convert it to a form readable by a plot program. Figure 12 shows the plottable form of the data for the last few days before the system take-down. Figure 13 shows the plotted data in units of stress for the four suspect gauges and two "normal" gauges. Note that the normal curves are smooth and approach a constant stress value of 0.4 MPa, while the suspect units show stress and erratic behavior increasing with time until they failed. The TTY readout system was re-established at 14:11 PDT on 29 August (day 242). At this time all four suspect channels (15, 16, 17, and 18) were reading 0000.

FIG. 13. Plots of data from selected gauges.

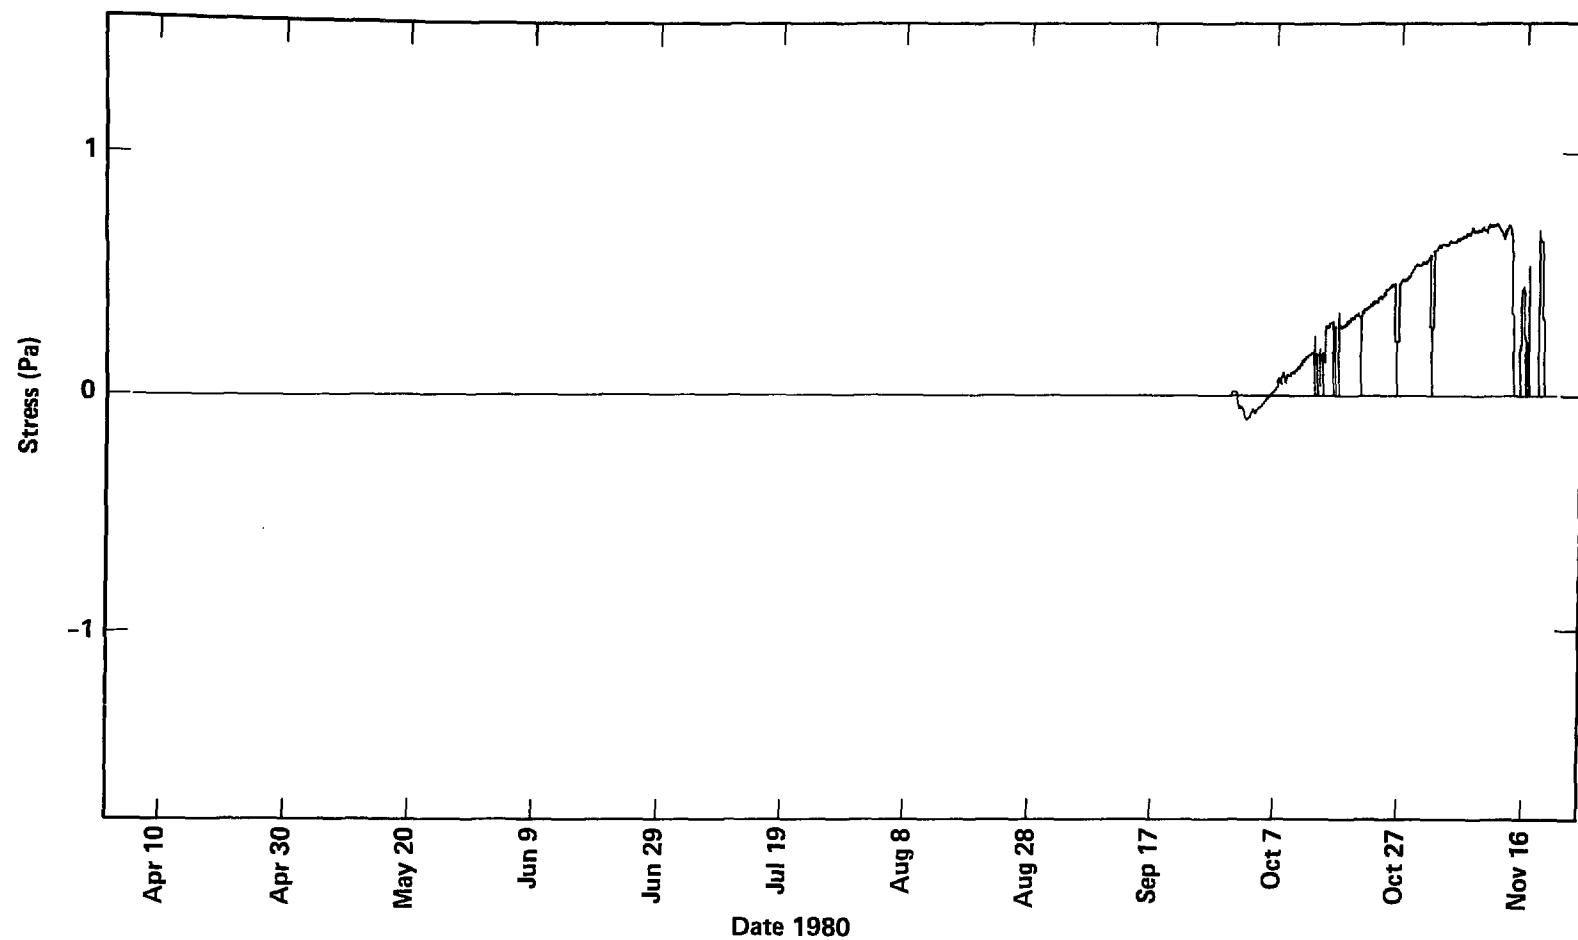
FIG. 14. Data from "free" gauge in CSG02.

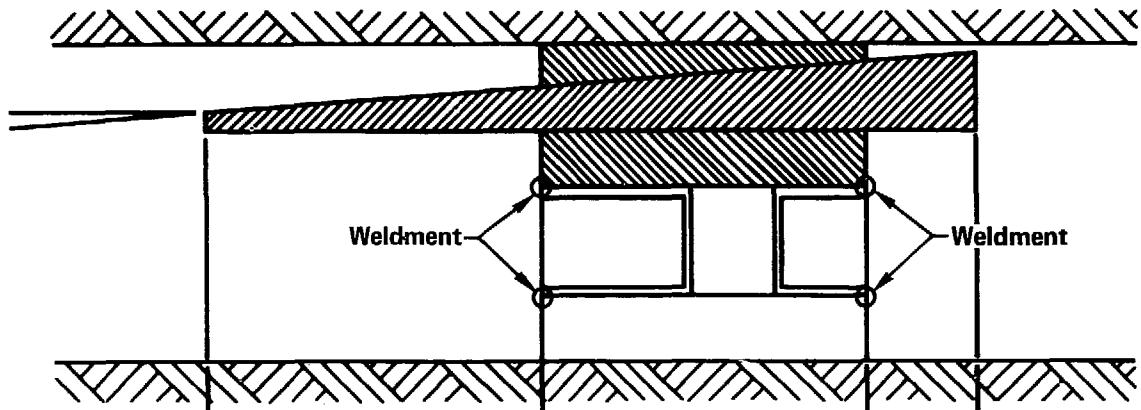
FIG. 16. Use of thin stainless cups in the new gauge.

Under independent funding, IRAD subsequently designed and tested a hermetically sealed version of the gauge. In the new version, sealing is accomplished by thin stainless steel cups welded to the gauge body around the perimeter of the hole at the ends of the gauge (see Fig. 16). Since the welding is done by electron beam, the interior of the gauge is a hard vacuum, eliminating any moisture entry at assembly.
