HEDL-TME 79-23  
UC 79, b, h

RESULTS FROM THE  
RUN-BEYOND-CLADDING-BREACH IRRADIATION  
OF A PREDEFECTED FUEL PIN (RBCB-6)

**D. C. Langstaff  
M. Y. Almassy  
D. F. Washburn**

**August 1979**

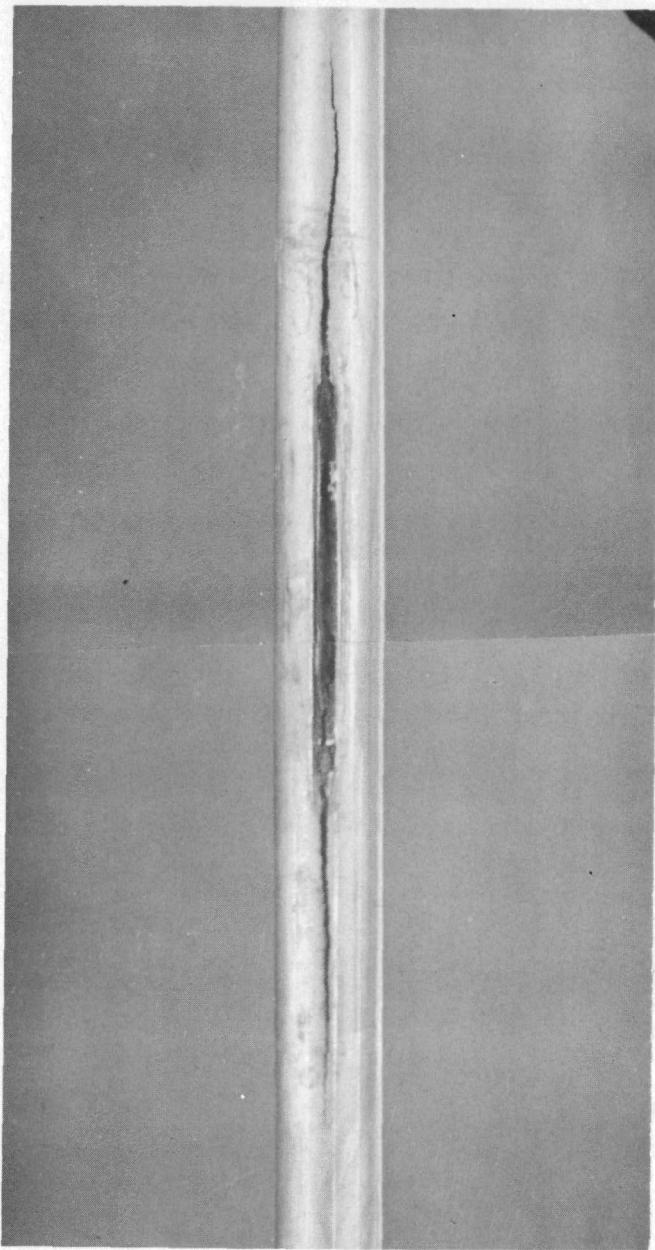
Visual examination of the predefected fuel pin showed that the slit had extended equally upward and downward. Initial and final dimensions of the defect are shown in Table 3; final appearance of the defect is shown in Figure 10. The total area of the defect increased from  $0.19 \text{ cm}^2$  to  $0.28 \text{ cm}^2$ -- an increase of 47%.

<u>Before RBCB Irradiation</u>	<u>After RBCB Irradiation</u>
Width	0.61 mm	0.79 mm
Length	2.08 cm	6.17 cm
Area	$0.19 \text{ cm}^2$	$0.28 \text{ cm}^2$

FIGURE 10. Final Appearance of the Defect. The only visible effect of R irradiation was the upward and downward extension of the slit

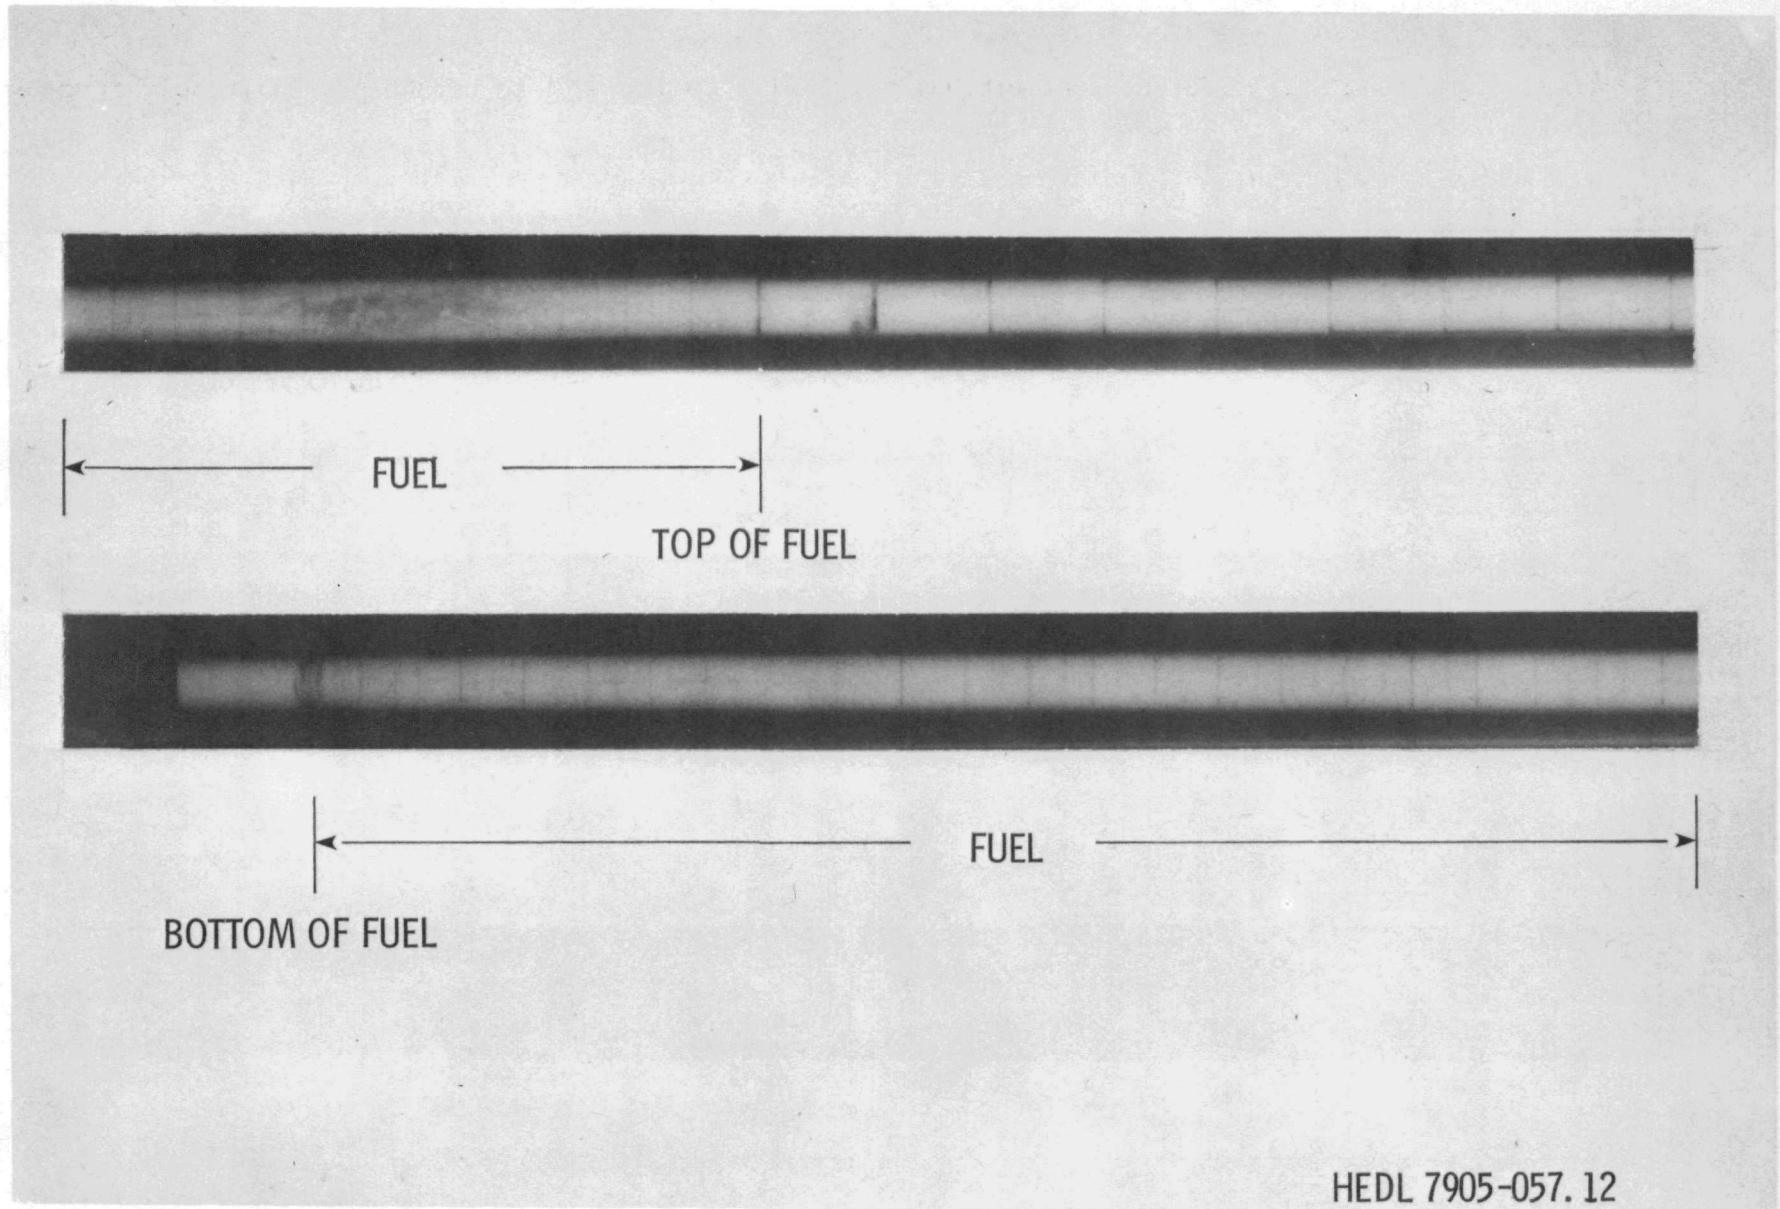
FIGURE 14. Betatron Radiograph of Pin ZP-8-24 After RBCB Irradiation Looking Directly at the Breach.

Structural irregularities in the fuel and insulator pellets were clearly evident from the radiographs. A large chip left a void when it came out of the top corner of the first upper insulator pellet; this observation was later verified by destructive examination. Neutron radiographs prior to RBCB irradiation revealed no structural defects in that pellet. Extensive reaction between sodium or cesium and fuel at the bottom fuel pellet-insulator interface was evident and was later confirmed by destructive examination. An area of decreased fuel density was coincident with the area of the cladding slit and slit extensions. This region of low density may have been due to sodium-fuel reaction product formation or to loss of fuel. To use betatron radiography for estimating fuel loss would require additional calibration to differentiate between sodium-fuel reaction and fuel loss.

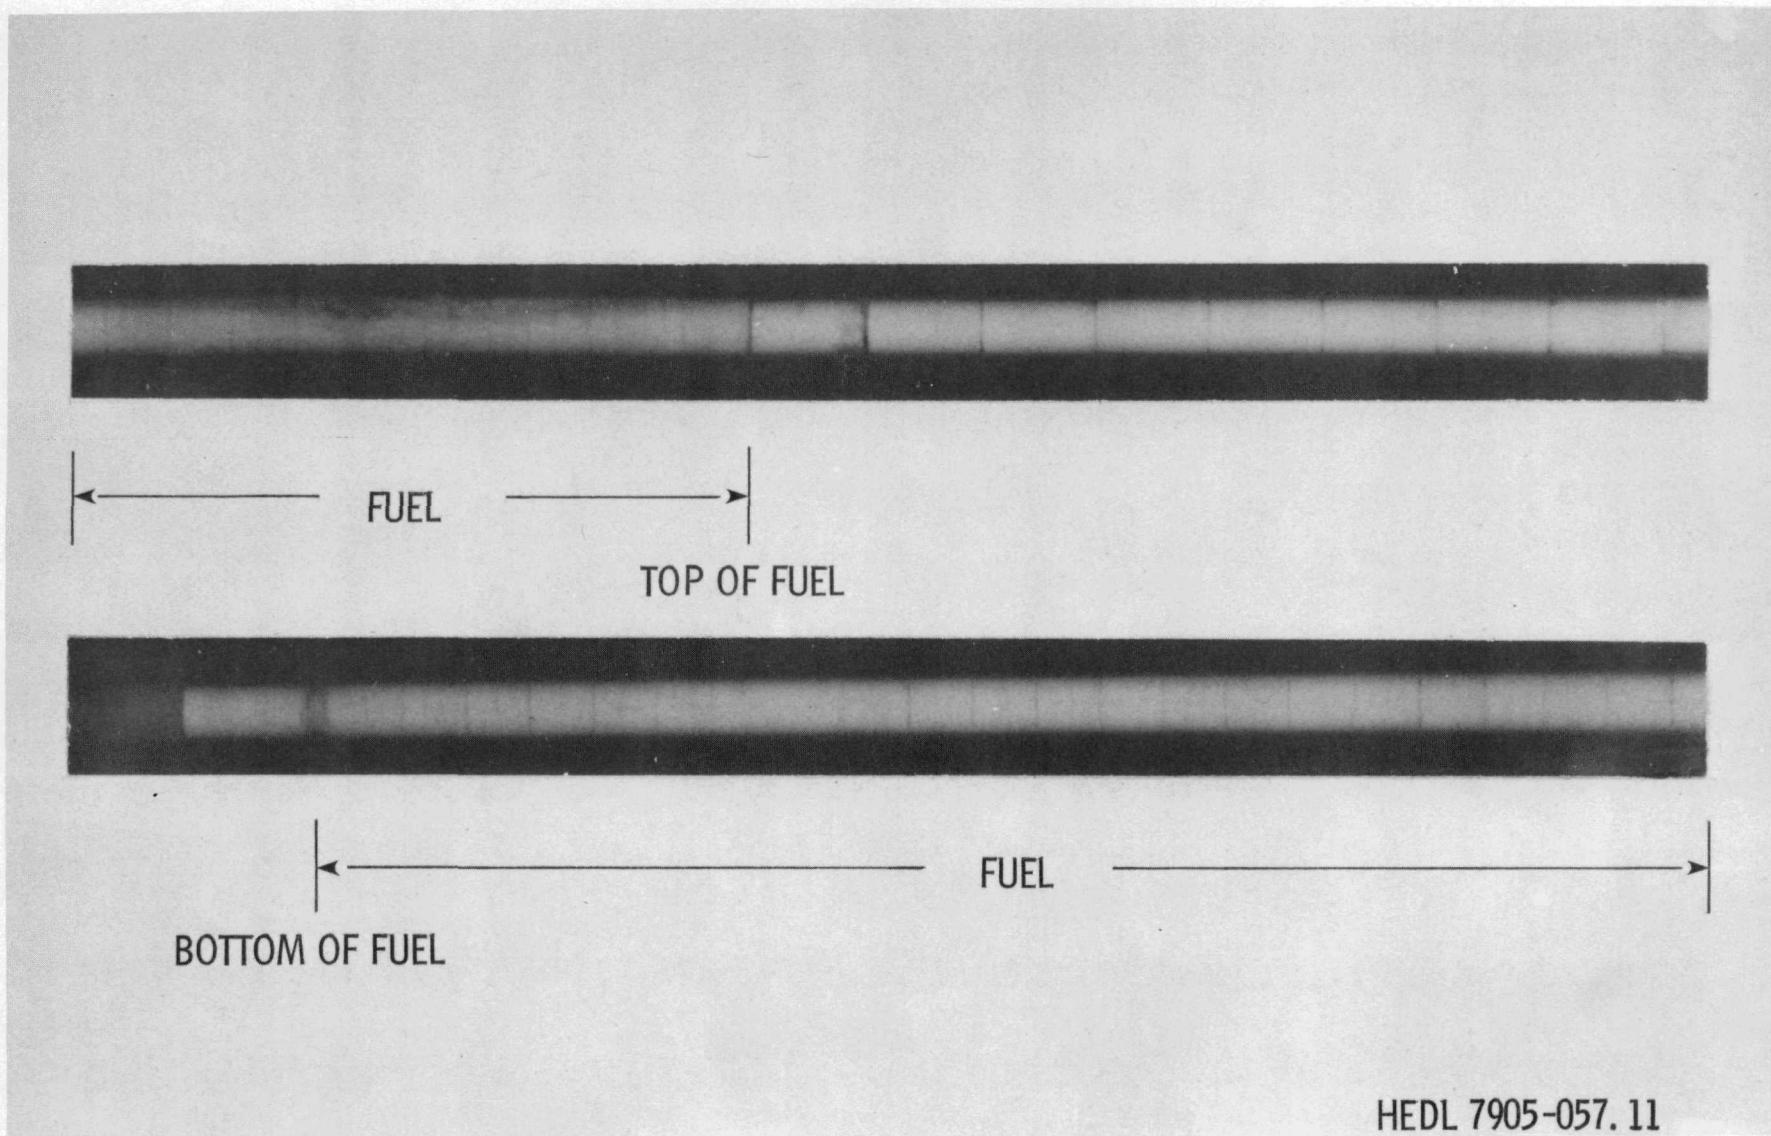
FIGURE 15. Betatron Radiograph of Pin ZP-8-24 After RBCB Irradiation Looking at the Breach Profile.

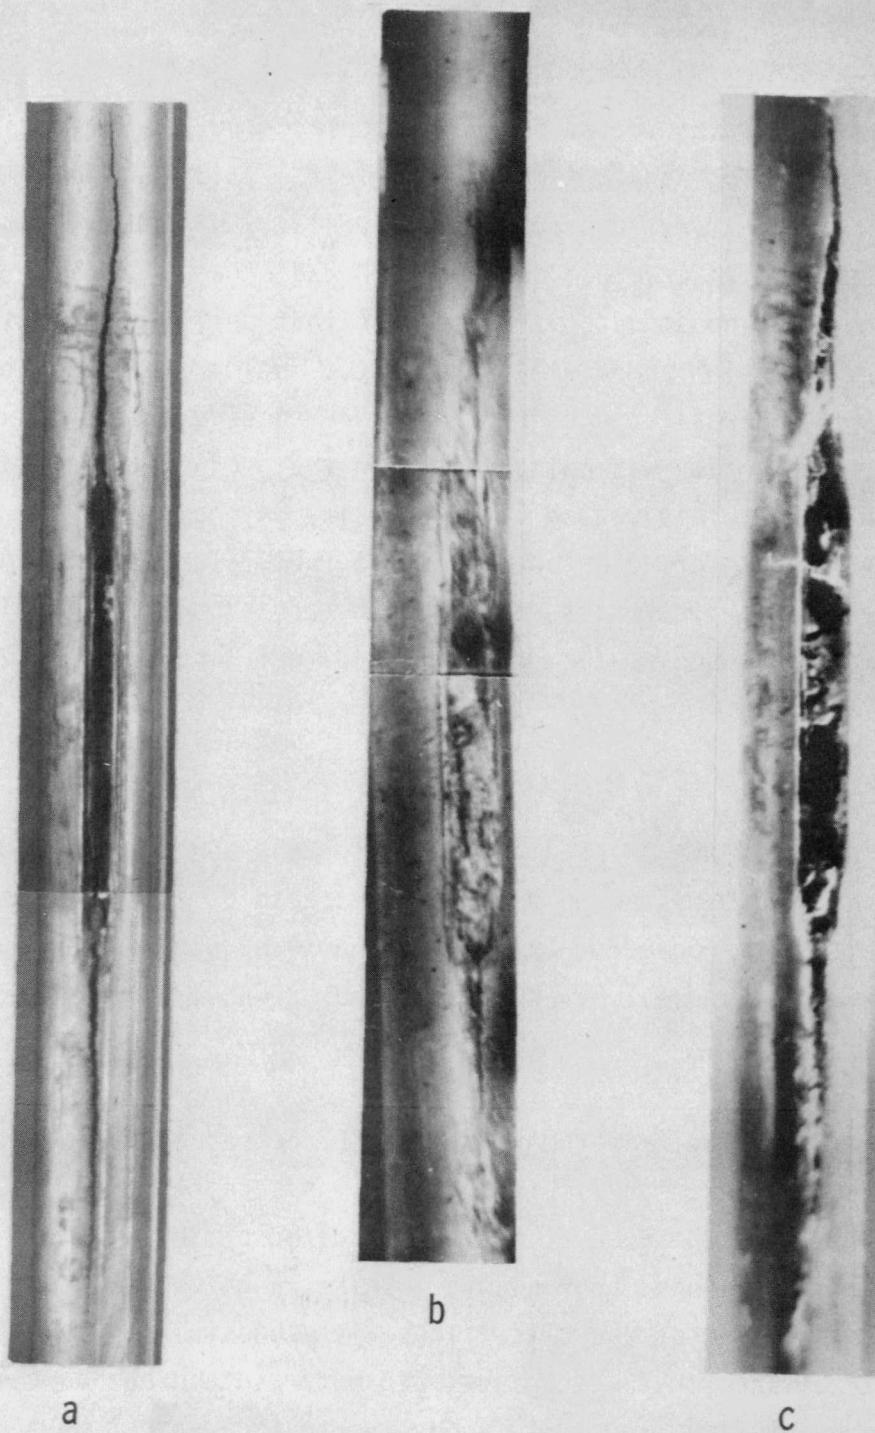
The defected fuel pin was shipped from HFEF to LASL and then to HEDL in a closed tube that was designed to prevent the spread of alpha contamination and maintain an inert environment. Figure 16a shows the pin defect region as it appeared at HFEF/N; Figure 16b, as it appeared at LASL; and Figure 16c, as it appeared at HEDL.

When the pin was removed from the tube at LASL for radiography, several unexpected observations were made. First, there was a highly gamma-active deposit on the inside wall of the tube at the axial height of the defect. Second, the cladding defect had widened appreciably. Third, a blister-like deposit covered the lower third of the slit. There is a possibility that the tube was not thoroughly cleaned or that the seal did not maintain an inert environment within the tube. In any event, it is obvious that care must be taken to protect exposed sodium-fuel reaction product.

The pin was placed in a new tube for shipment to HEDL. During shipment from LASL to HEDL or during handling at LASL the blister-like deposit was broken and some material was lost.

FIGURE 16. Cladding Breach Appearance During Initial Examination at a) HFFE/N,  
b) LASL, and c) HEDL.

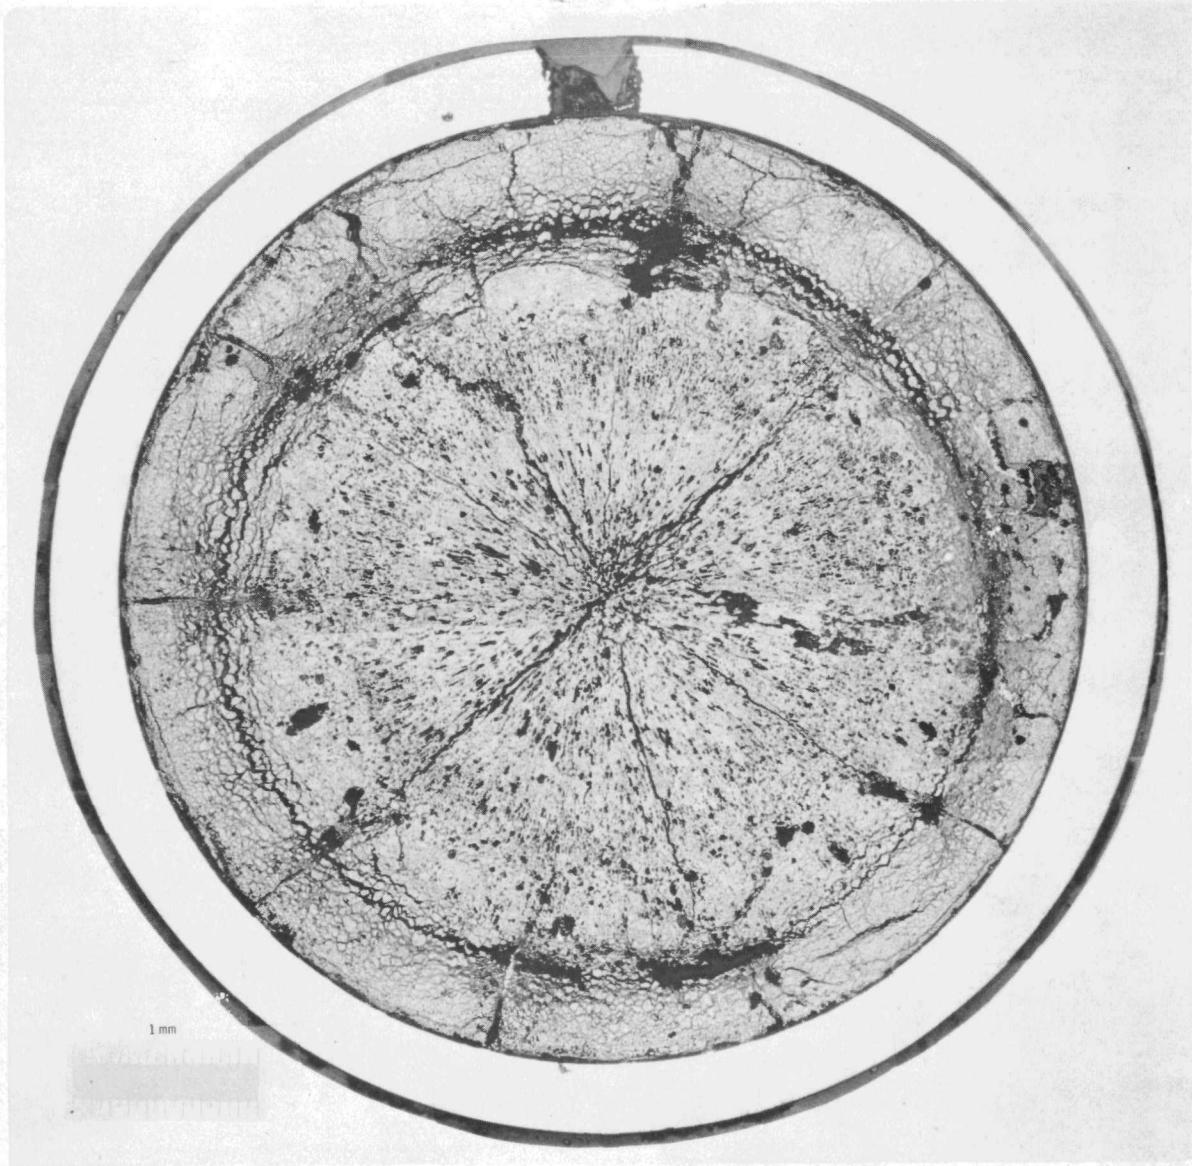
The three transverse sections--Figures 19, 20, and 21--and the two longitudinal sections--Figures 22 and 23--showed an outer ring of fuel that contained a distinct and nearly continuous grain boundary phase presumed to be sodium-fuel reaction product. During shutdown, this layer, which was estimated to have a maximum thickness of 0.75 mm (0.03 inch), was separated from the inner fuel core by a circumferential crack. The outermost surface of the fuel (to a depth of several microns) was almost completely reacted with sodium and had a structureless appearance. A grain boundary phase that gradually increased in width toward the center of the fuel existed below the outermost surface. The widest part of the grain boundary phase occurred at the circumferential crack. There was little, if any, sodium-fuel reaction inward from the circumferential crack.

FIGURE 19. Microstructure of Pin ZP-8-24, Section L.

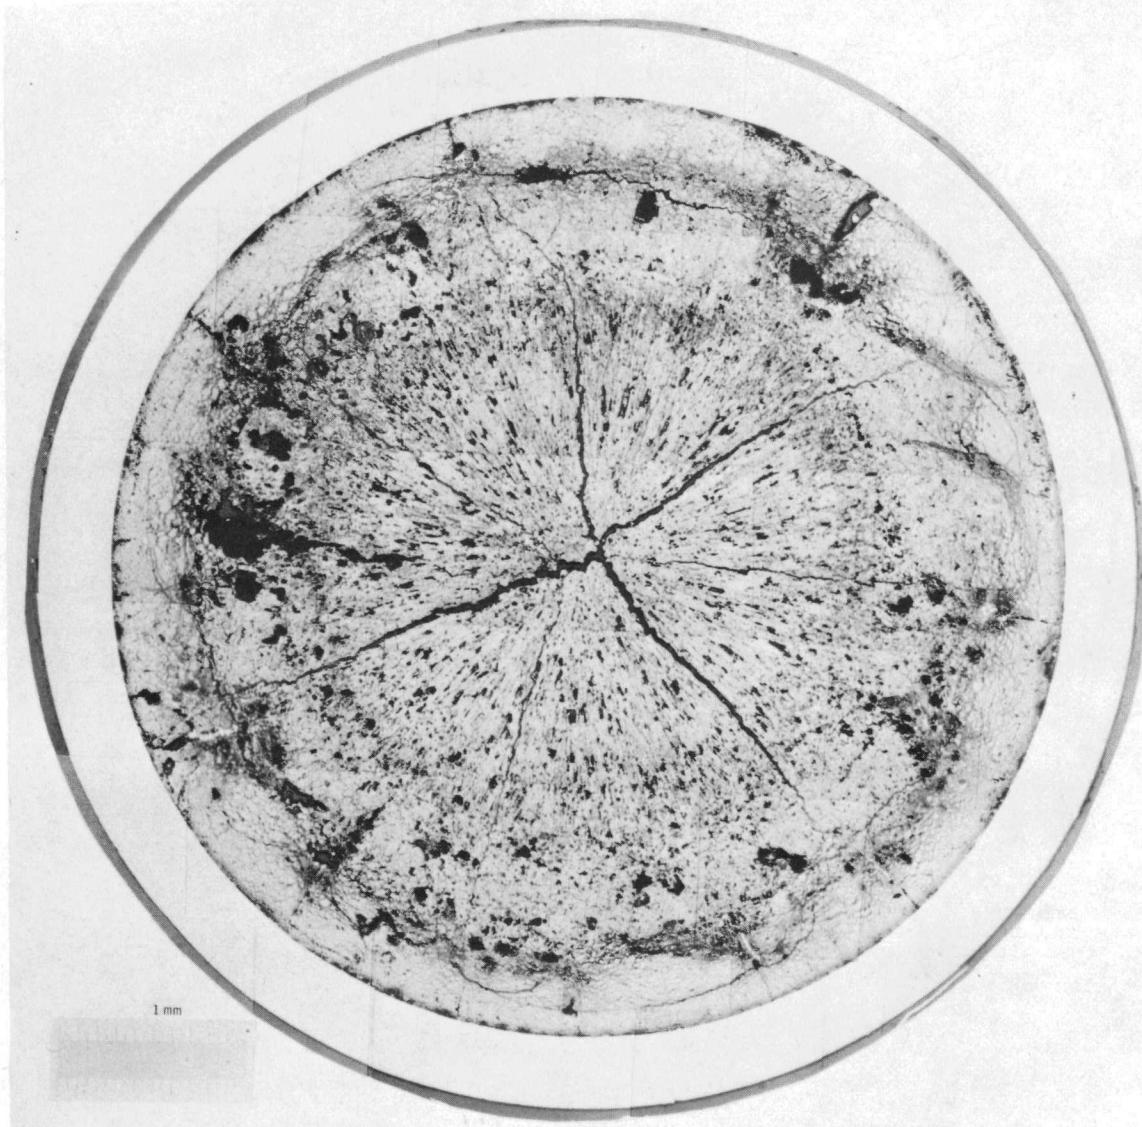
FIGURE 20. Microstructure of Pin ZP-8-24, Section K.

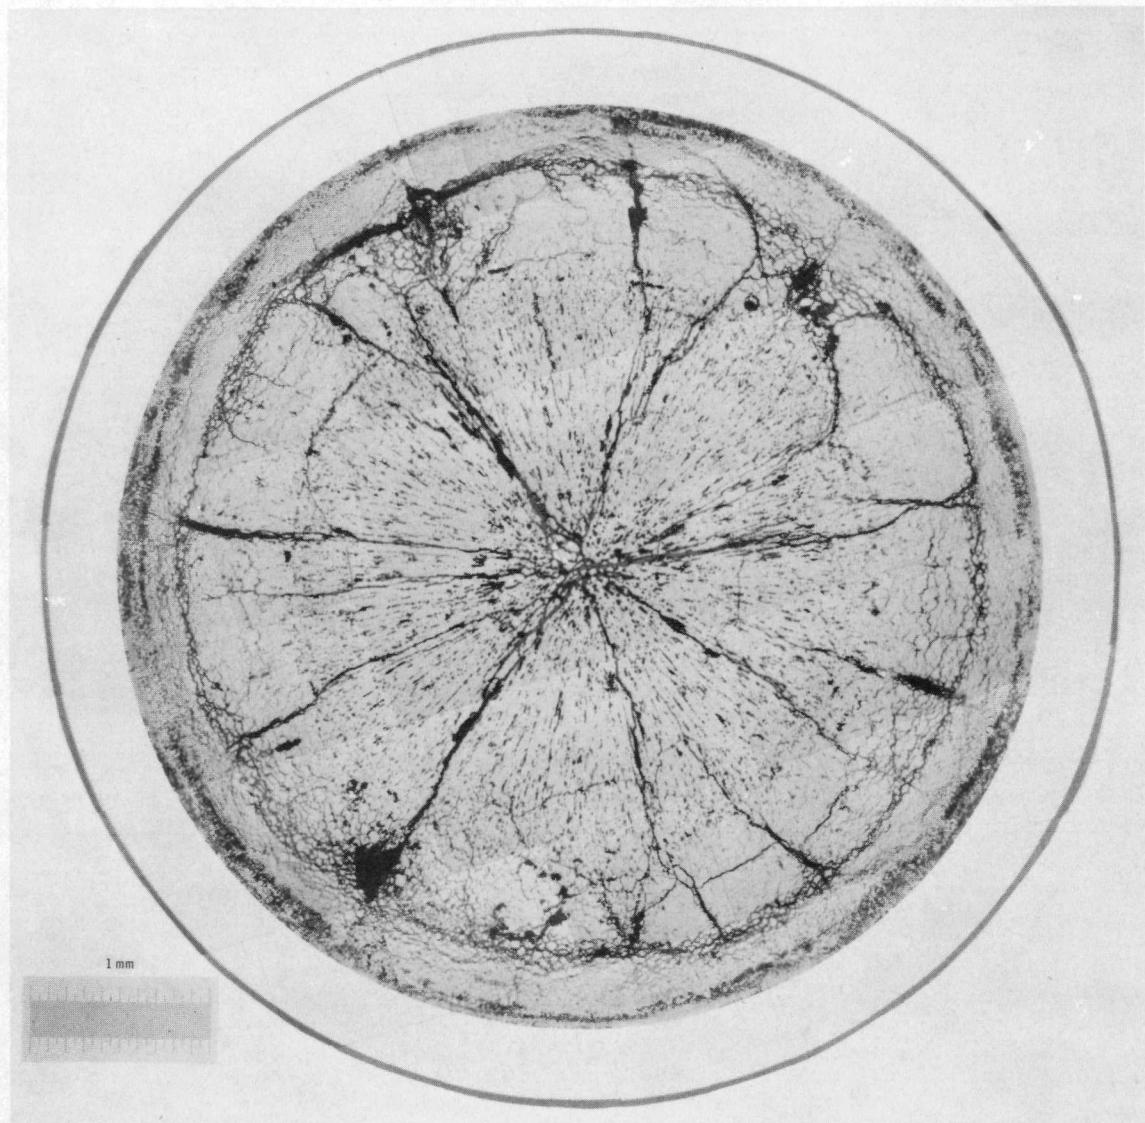
FIGURE 21. Microstructure of Pin ZP-8-24, Section E.

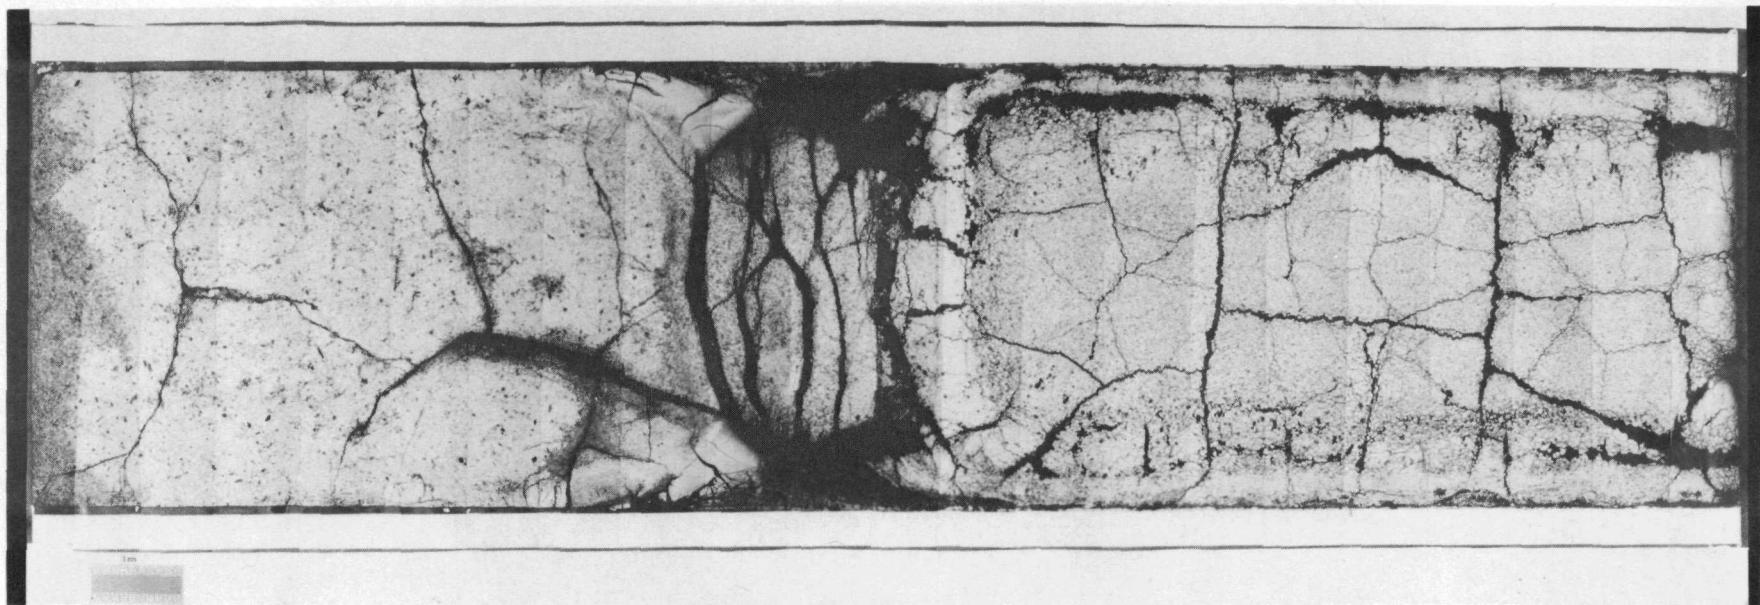
FIGURE 22. Microstructure of Pin ZP-8-24, Section B.

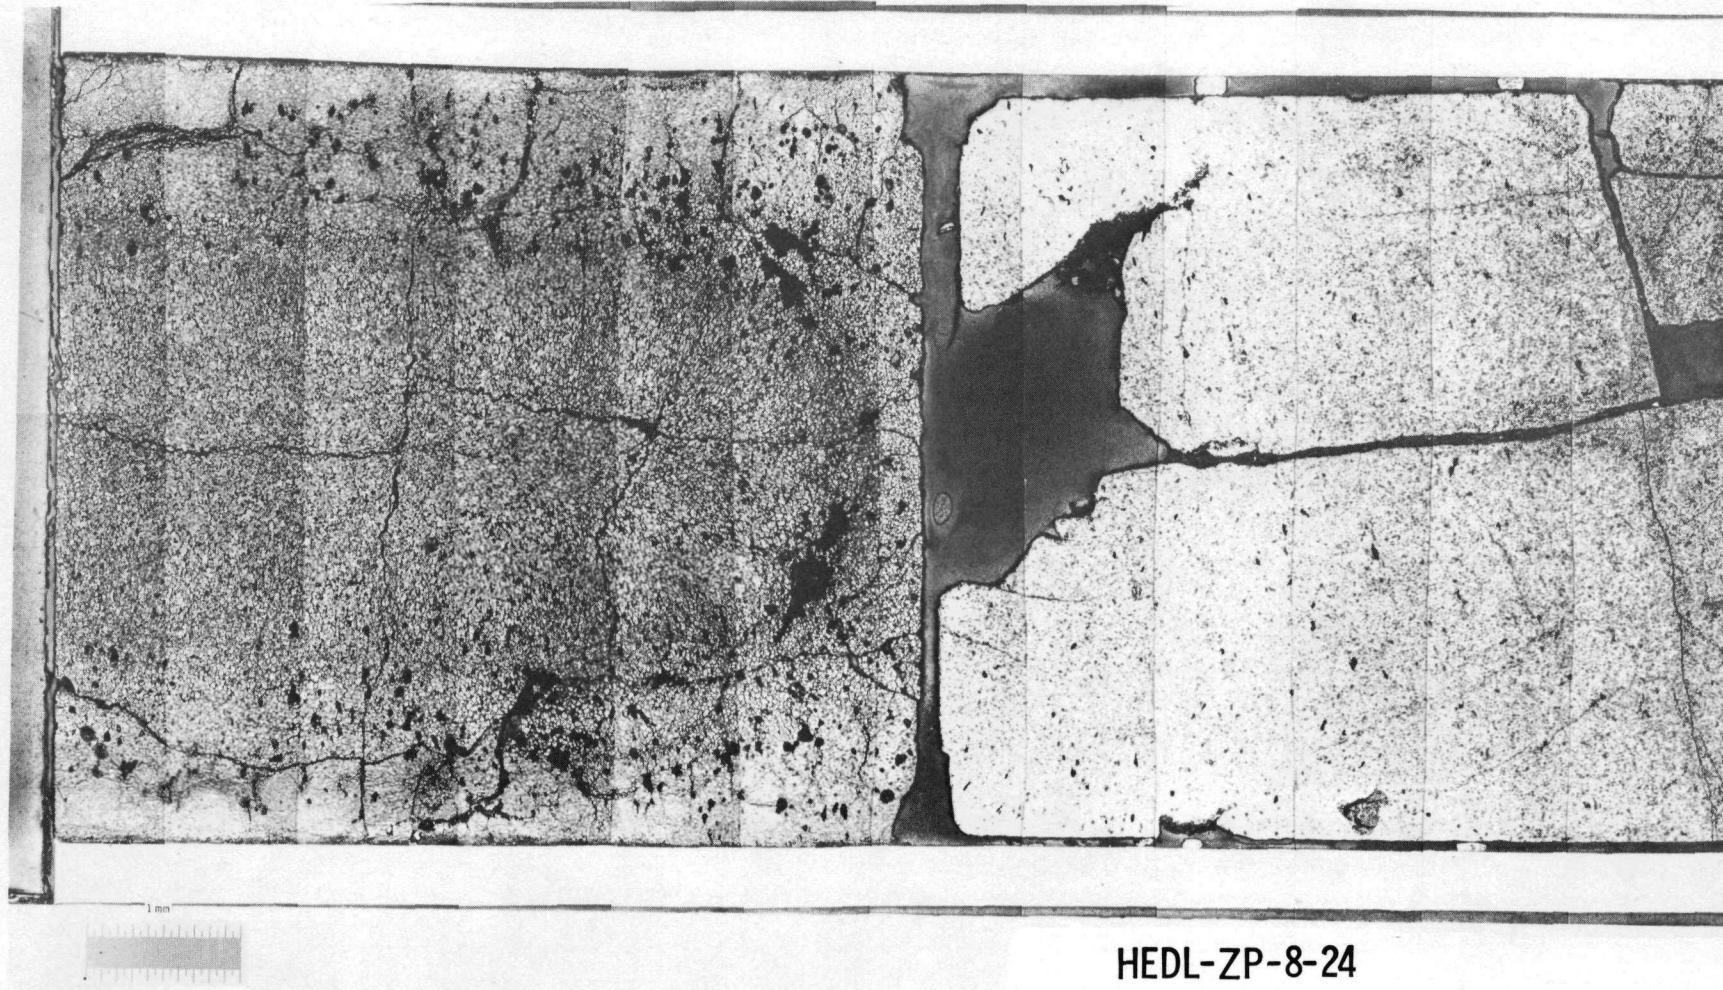
FIGURE 23. Microstructure of Pin ZP-8-24, Section P.

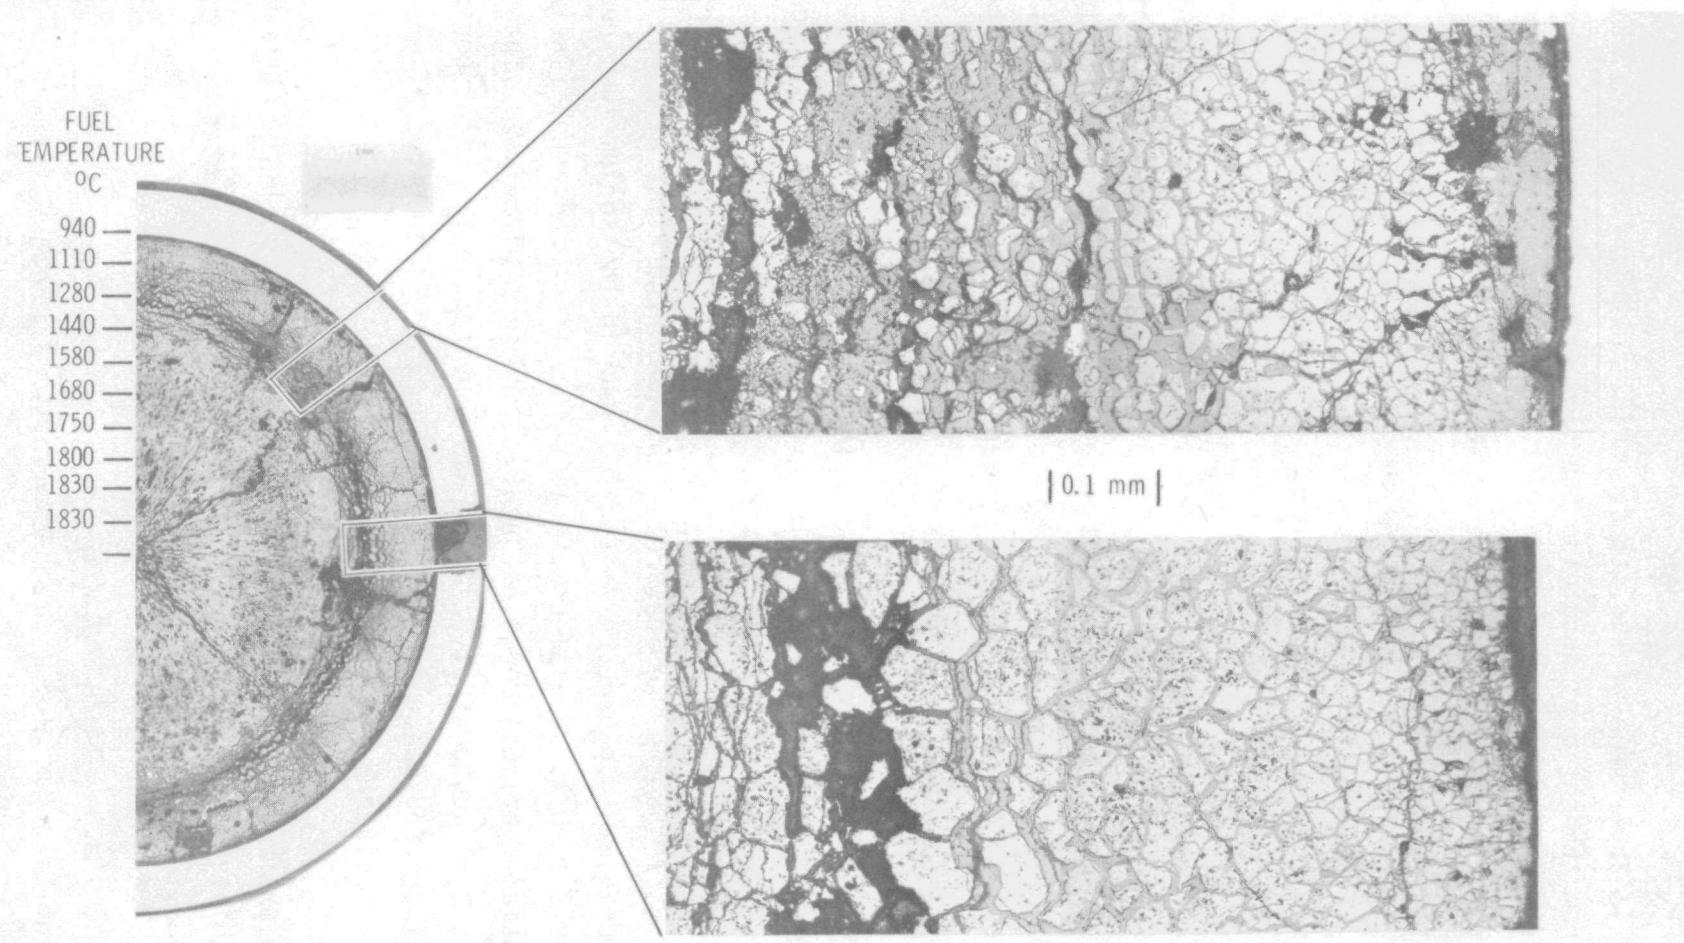
The surface through the lower slit extension (Figure 19, p. 36) was examined with the shielded electron microprobe. The grain boundary phase in the outer fuel rim (outside the circumferential cracking) was sodium-fuel reaction product. Semiquantitative analysis showed no segregation of plutonium from the fuel attributable to the chemical reaction, i.e., the ratio of x-ray intensities of uranium to plutonium in the fuel and in the sodium-fuel reaction product was  $2.2 \pm 0.1$ . Radial cracks in the restructured zones (inside the circumferential cracking) contained sodium unreacted with fuel. These results indicate that sodium-fuel reaction was confined to the outer periphery of the fuel during irradiation and further sodium ingress occurred after termination of irradiation.

The destructive examination of the fuel pin was completed with the observation of typical irradiated microstructure in the AISI Type 316 SS 20% CW cladding. The slit extended intergranularly through the cladding.

FIGURE 24. RBCB-6 Transverse Surface Through Lower Slit Extension. The appearance of the sodium-fuel reaction product under the slit extension is characteristic of the appearance away from the slit extension.

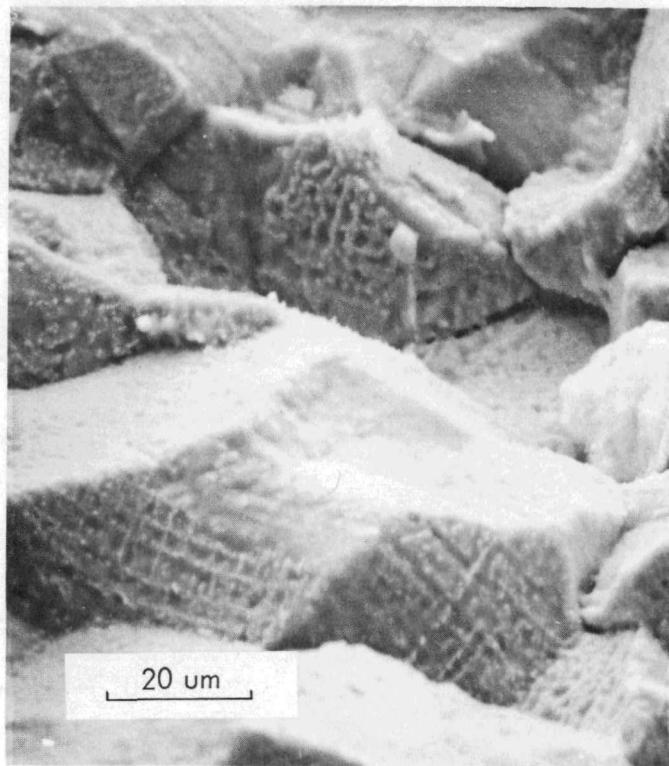
Scanning electron microscopy examination of one surface of the upper slit extension confirmed that the extension was intergranular. The surfaces of individual grains in the fracture showed distinct lattice-like features not generally observed in intergranular fracture (see Figure 25). The fracture surface also contained what appeared to be intergranular cracks between the grains. This secondary cracking gives the impression that grains are about to fall out. The profuse intergranular cracking may be indicative of a fracture process that is environmentally assisted.

The fine geometric patterns observed on the surface of numerous grains may be crystallographic in origin. The pattern spacing is of the same order of magnitude as the carbide-decorated slip traces determined from cladding metallography samples. The time when the geometric pattern developed is not clear; however, it is believed to have developed to a limited extent in the reactor and then developed further after removal from the reactor.

FIGURE 25. Lattice-Like Pattern on Grain Surfaces in Upper Slit Extension in Pin ZP-8-24 Cladding.
