SAND--88-3442C

Electrical for  
Physical Measurements on CMOS IC Stuck-Open Faults

Jerry M. Soden, R. Keith Treece,  
Michael R. Taylor and Charles F. Hawkins

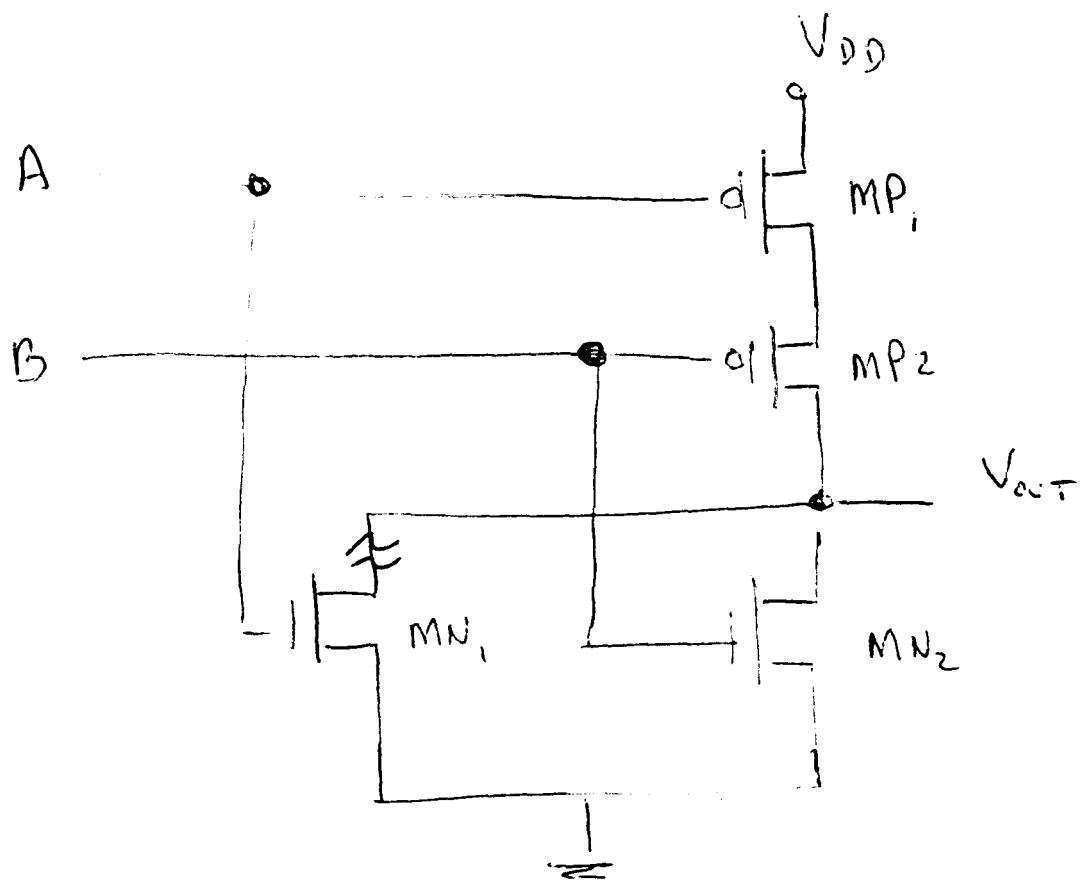
FIGURE 1

The CMOS stuck-open fault is a failure mechanism associated with loss of charge transfer capability in one of the transistors in a CMOS combinational logic circuit. This fault causes a high impedance or floating node at the output terminal for one of the logic states. For example, the 2-NOR shown in Figure 1 exhibits the stuck-open fault response if the marked location represents a defective open circuit. Activation of transistor  $MN_1$  and inactivation of  $MN_2$  removes active pull down to the output node. If  $AB=10$ , then the output drain node is put into a high impedance state with the drain voltage remaining that of the previous logic state.

Figure 1. 2-NOR logic gate showing an open drain defect location.

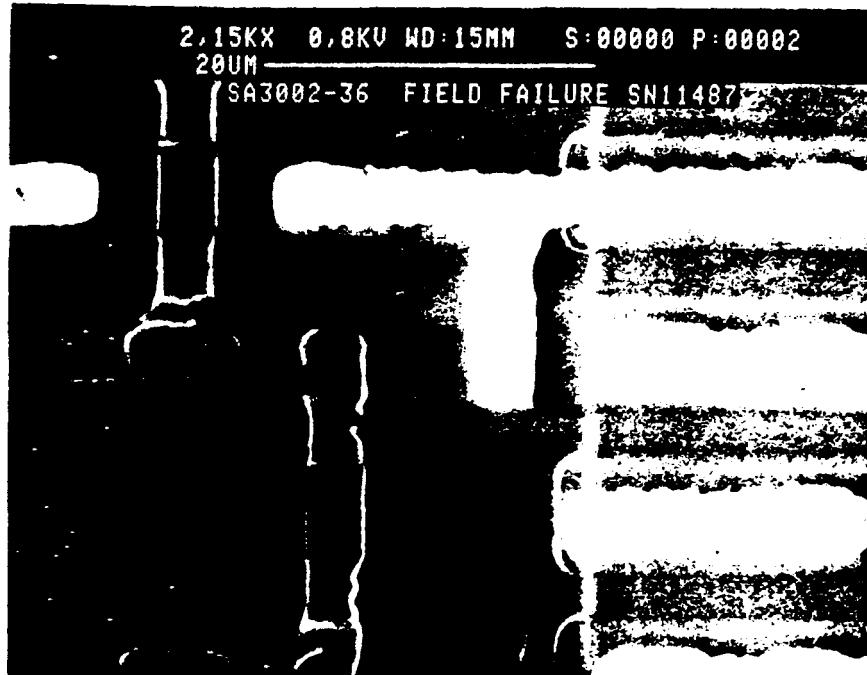
Measurements on IC<sub>A</sub> The stuck-open fault in IC<sub>A</sub> was caused by the absence of a 10  $\mu\text{m}$  section of metal in the decoder circuitry for memory row address 18. Figure 2(a,b) show the normal metal pattern and the defective metal patterning that caused the stuck-open failure mode. The features of this defect indicate that it was created during wafer fabrication. The metal is completely missing in a 10  $\mu\text{m}$  long section on top of polysilicon (and intermediate oxide) that ends abruptly at the edges of the polysilicon. Other die from the same wafer lot did not show this defect and no defects were found in the mask. It is believed that the photoresist failed to adhere in this region, resulting in removal of this section of metal during reactive ion etching (RIE) patterning. Figure 3(a) shows the row decoder subcircuit schematic that includes the defective 2-NOR gate. Figure 3(b) shows the location of the open metal break in the drain interconnect of one of the n-MOS pulldown transistors.

Figure 2. Voltage contrast SEM picture of a ROM decoder 2-NOR circuit showing (a) A normal drain connection and (b) a missing drain drain section.

SA3002 SN 11487  
Failure site with missing metal.  
(missing section is indicated in the  
photo below)

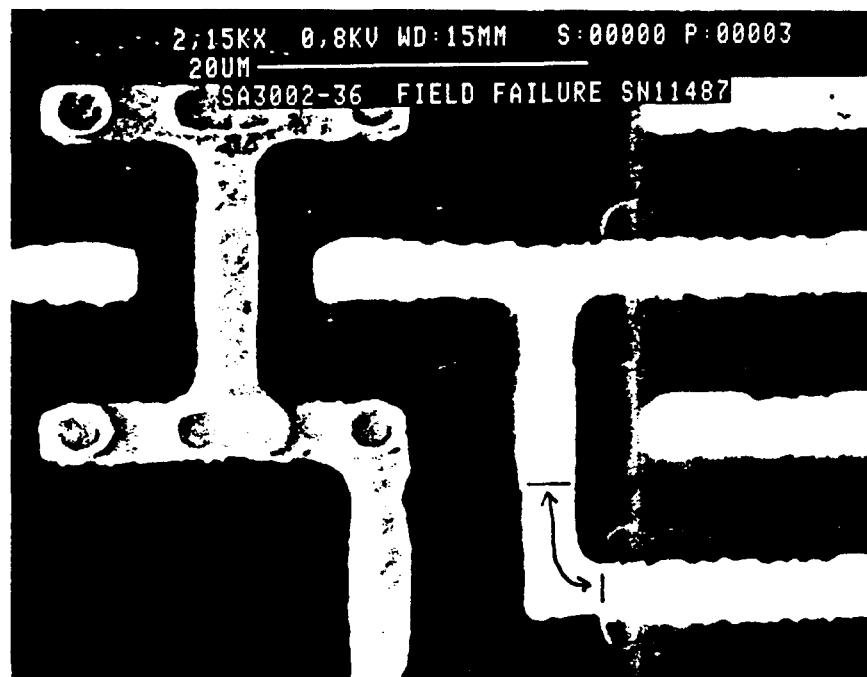
(a)

SA3002 SN 11487  
Adjacent site with correct patterning.

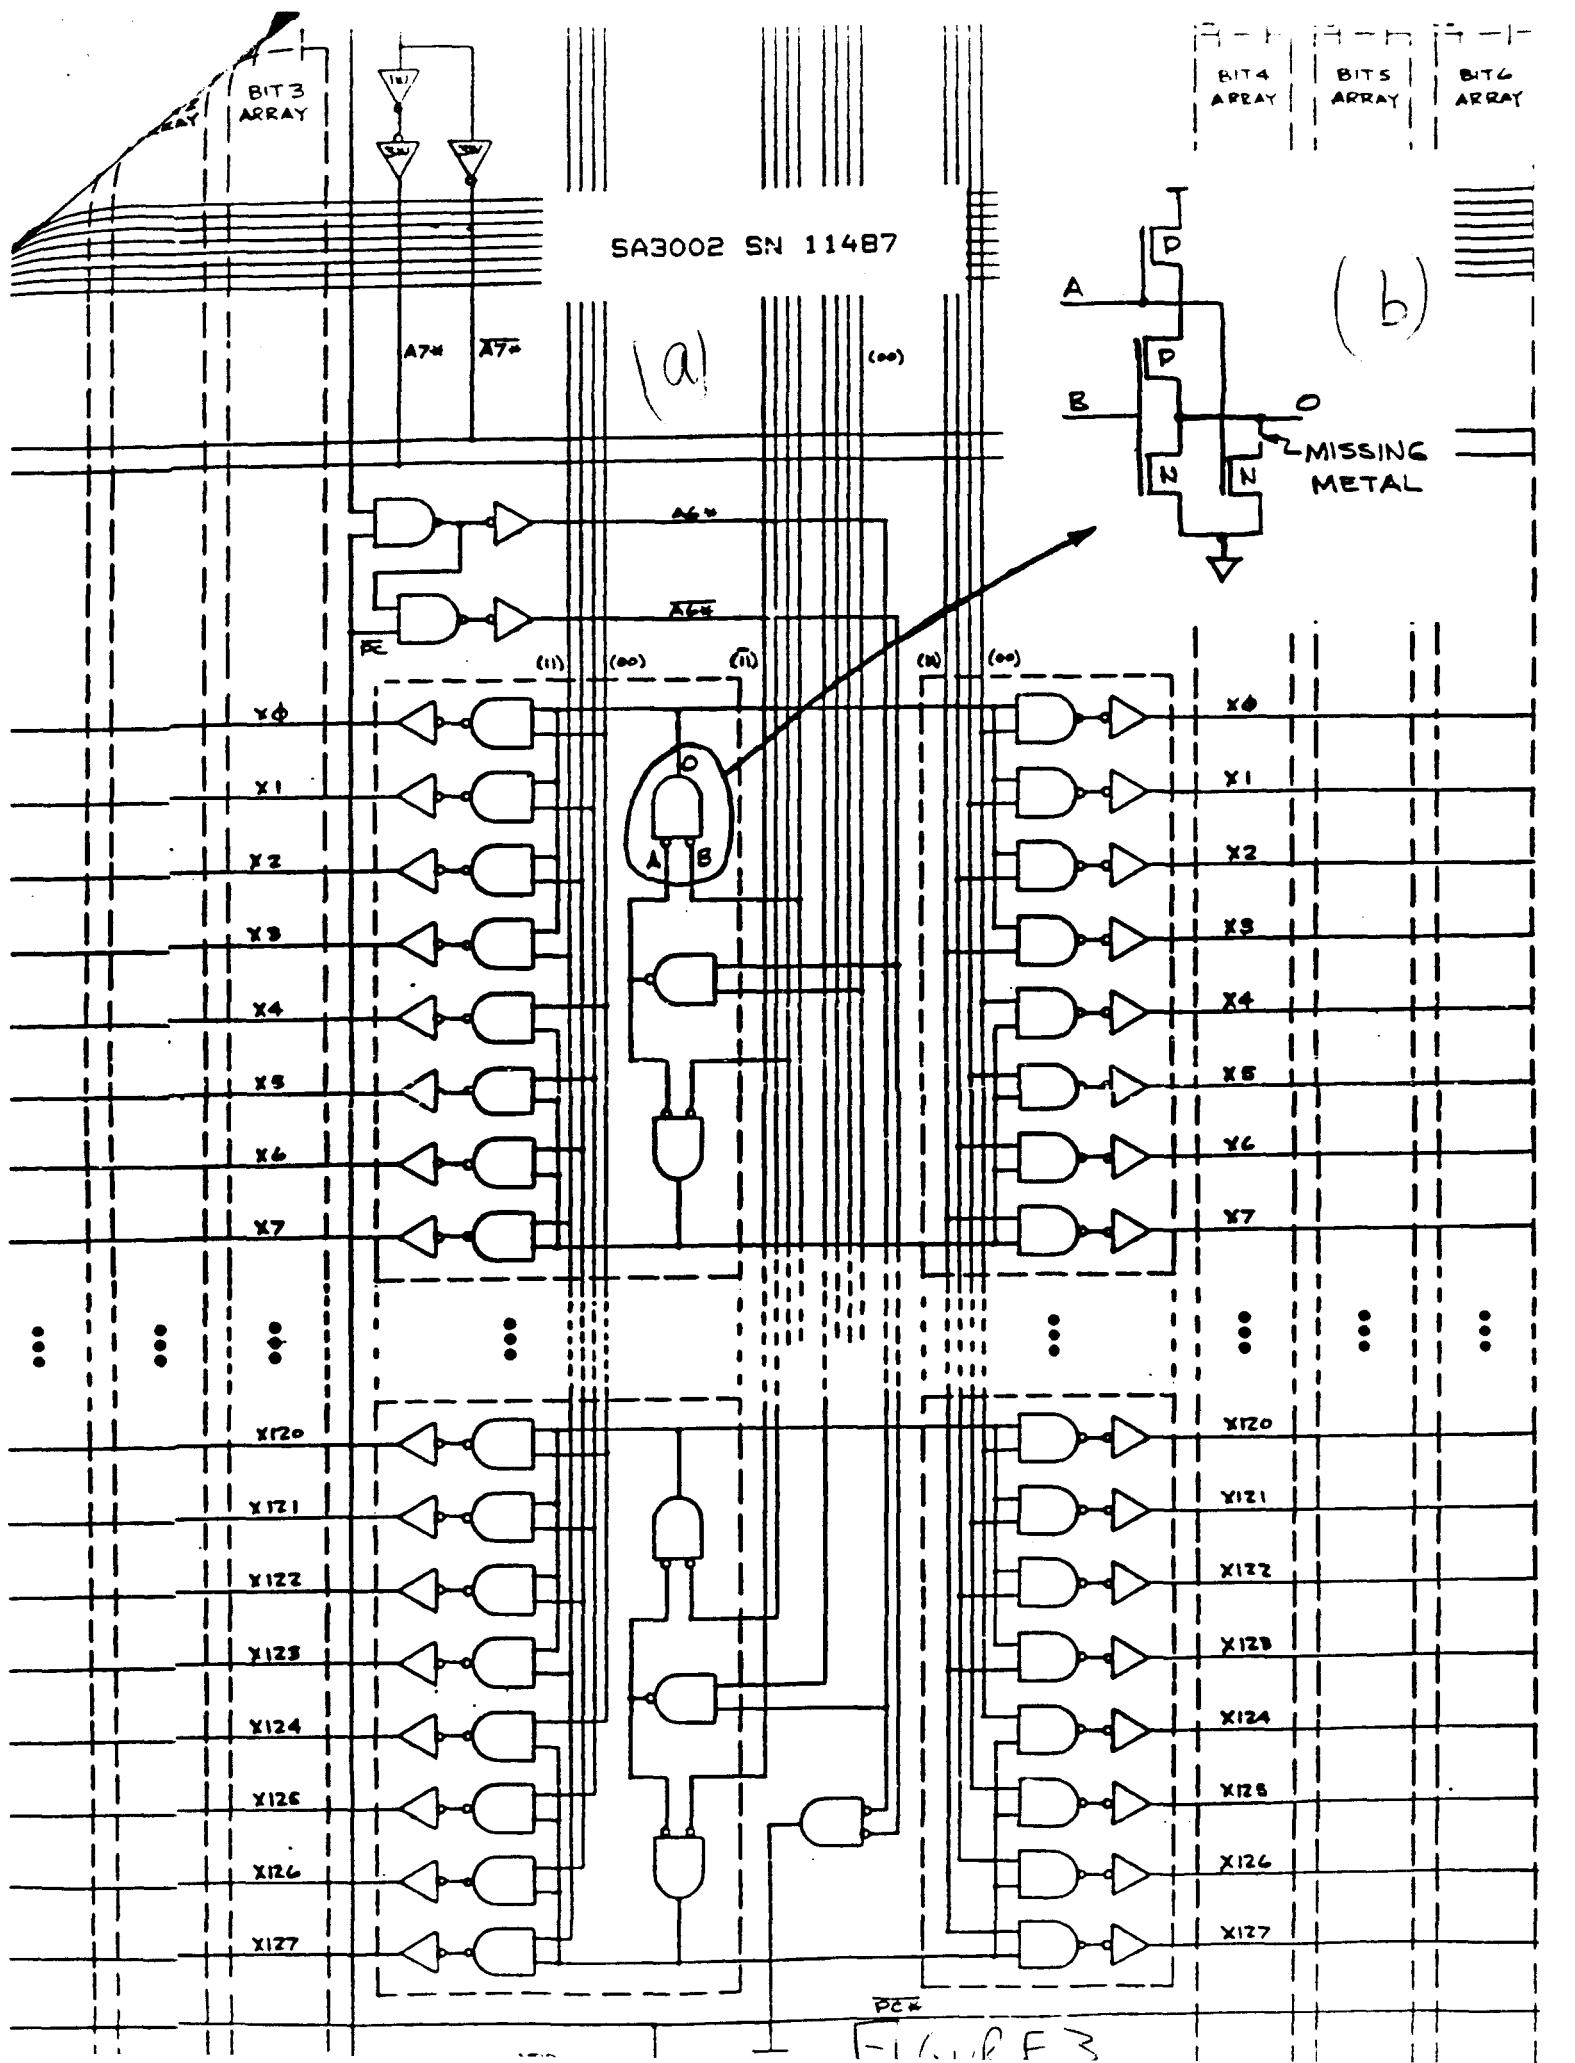
Figure 3. (a) ROM row decoder and memory array subcircuit showing the location of the defective 2-NOR gate. (b) 2-NOR gate showing the break in the drain metal interconnect of transistor MN<sub>B</sub>.

The defect properties were consistent with the observed failing test vectors and with elevated I<sub>DDQ</sub> in these states. A logic one driven to node B on the defective 2-NOR gate shown in Figure 3 should have pulled the NOR gate output (node C) and the ROM array transistor to 0

V. However, the metal break in the n-MOS pulldown transistor allowed node C to be put in a high impedance state. For those logic states in which failure was observed, the previous state on node C was a logic one. This meant that all array transistors connected to that memory address line were activated for several seconds when they should have been off. These erroneously activated array transistors were put in contention with the p-channel bit-line precharge transistors causing elevated  $IDDQ$  for this state.  $IDDQ$  was indirectly elevated by the stuck-open fault due to the nature of the design.

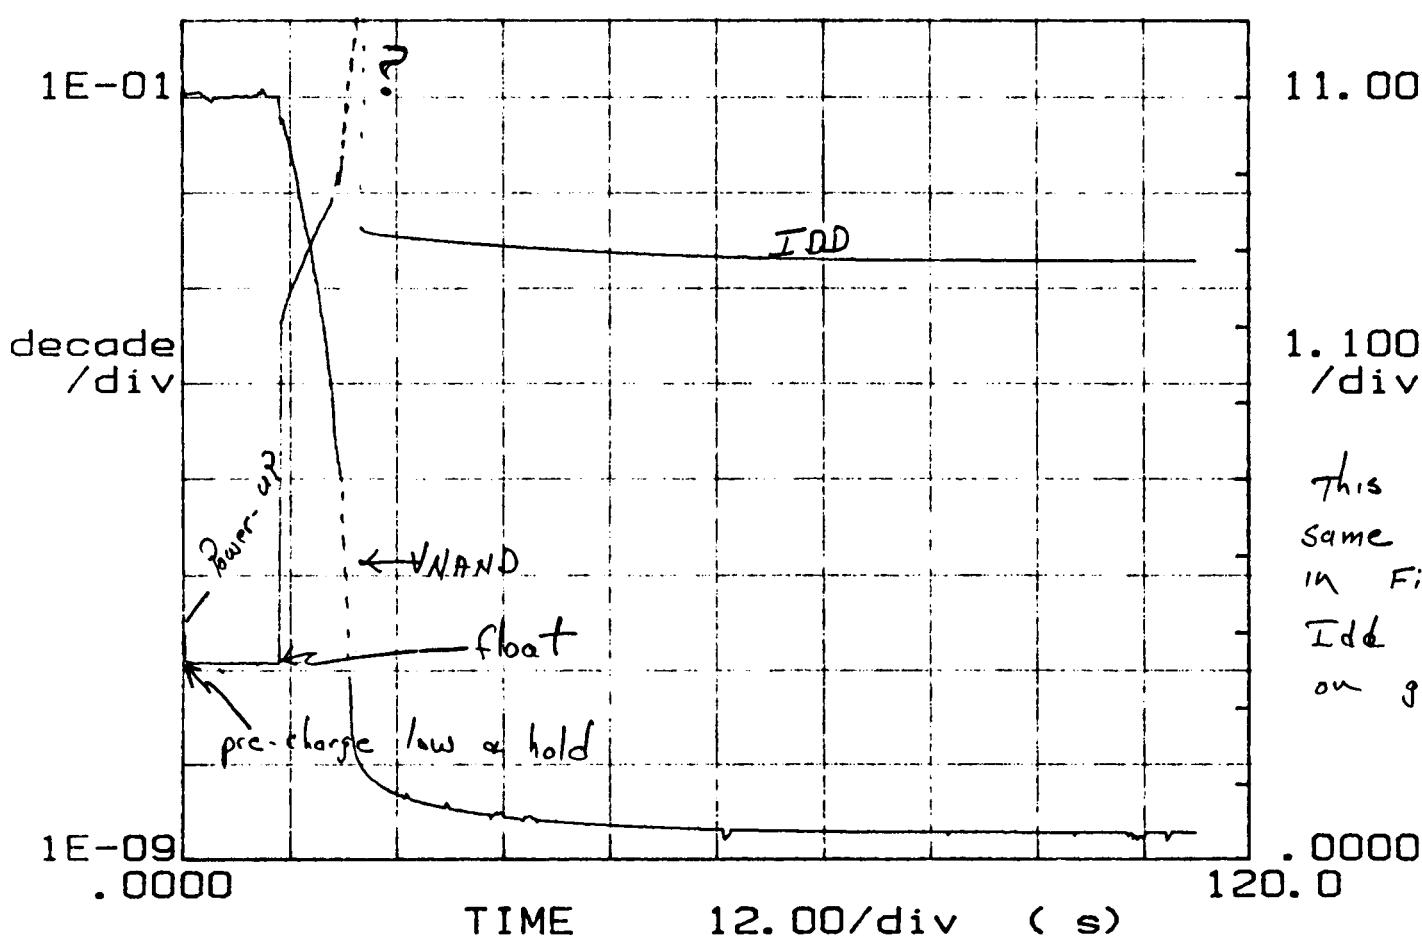
FIGURE 4

Figure 4 shows the timing response when node C was precharged to 0 V ( $AB = 11$ ) prior to putting it in the high impedance state ( $AB = 10$ ). The voltage at node F,  $v_F(t)$  decayed to about 0.4 V over a time period of about 60 s.  $IDDQ$  was 147 pA at  $AB = 11$  just prior to setting the high impedance state. When  $AB$  was then set to the high impedance state ( $AB = 10$ ),  $i_{DD}(t)$  increased to about 22 mA within an 8 s period and then decreased to about 2 mA over the next approximate 50 s. The timing response of  $v_F$  and  $i_{DD}(t)$  appear similar over the last approximate 90 s of Figure 4. The shape of  $v_F(t)$  in Figure 4 implies that the floating node voltage at node C increased from the precharge value of 0 V to a value high enough to cause the 2-NAND output voltage to drop to 0.4 V. The steady state voltage at node C during the high impedance state was obtained by placing a second metal probe down at node C and measuring a voltage transfer curve for the 2-NAND gate. The steady state voltage of the floating node was then estimated from the transfer curve at 5.5 V.

Figure 4. Timing response of  $i_{DD}(t)$  and the voltage at node F  $v_F(t)$  when node C was precharged to 0 V prior to setting node C in a high impedance state.

The curves shown in Figure 4 are interpreted as due primarily to a drift in the floating node voltage to an equilibrium value that was above the logic threshold of the 2-NAND gate, but not high enough to cut off the p-MOSFET. Consequently,  $i_{DD}(t)$  increased as the floating node voltage drifted from a low of about 1 mV to the final equilibrium value of 5.5 V. The peak in  $i_{DD}(t)$  occurred as the load inverter was first turned on then off during the transition.

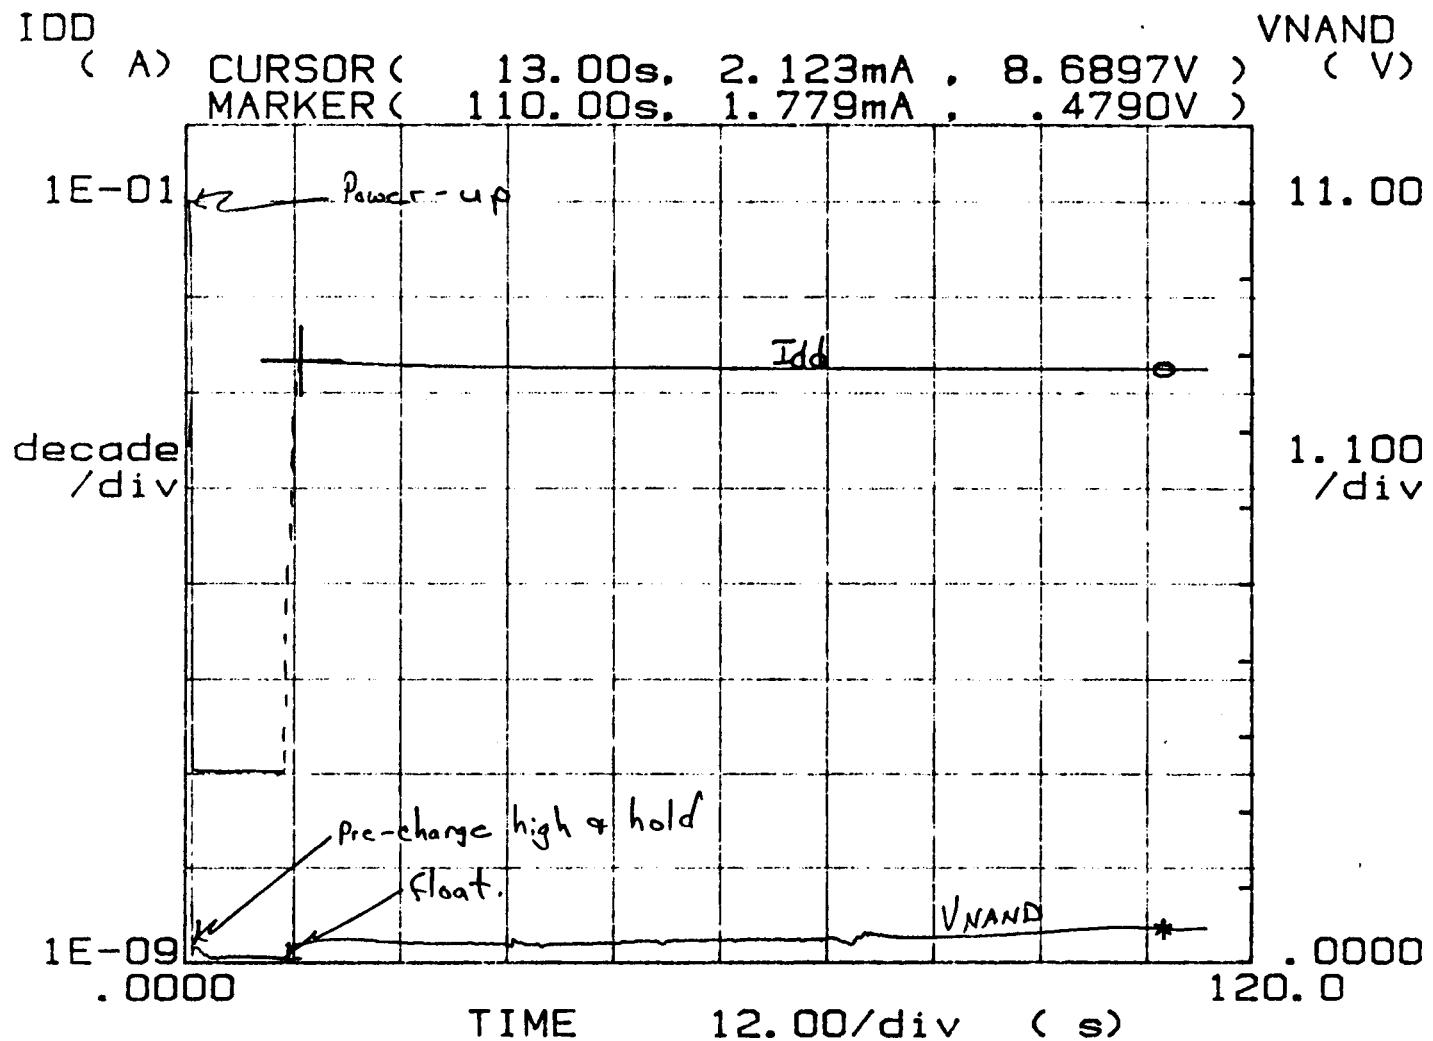
FIGURES

Figure 5 shows the timing response when node C was precharged to a logic high of 11 V (AB = 00) prior to putting it in the high impedance state (AB = 01). The voltage at node F,  $v_F(t)$  increased slightly from 0 V to about 0.4 V while  $i_{DDQ}(t)$  increased from 147 pA to about 2 mA. The steady state values are the same as measured for the low state precharge of node C as shown in Figure 4.

Figure 5. Timing response of  $i_{DD}(t)$  and the voltage at node F  $v_F(t)$  when node C when node C was precharged to 11 V prior to setting node C in a high impedance state.

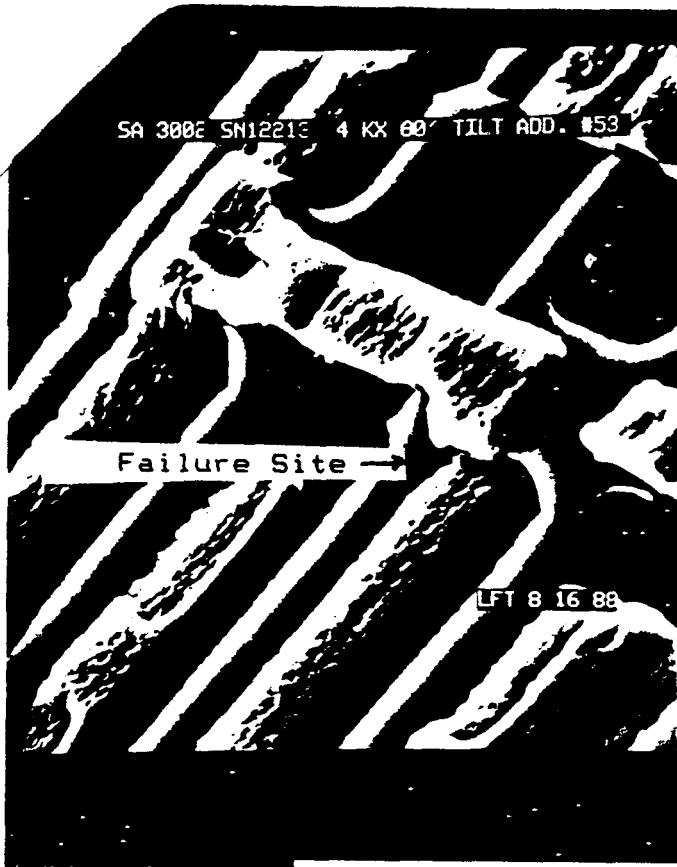
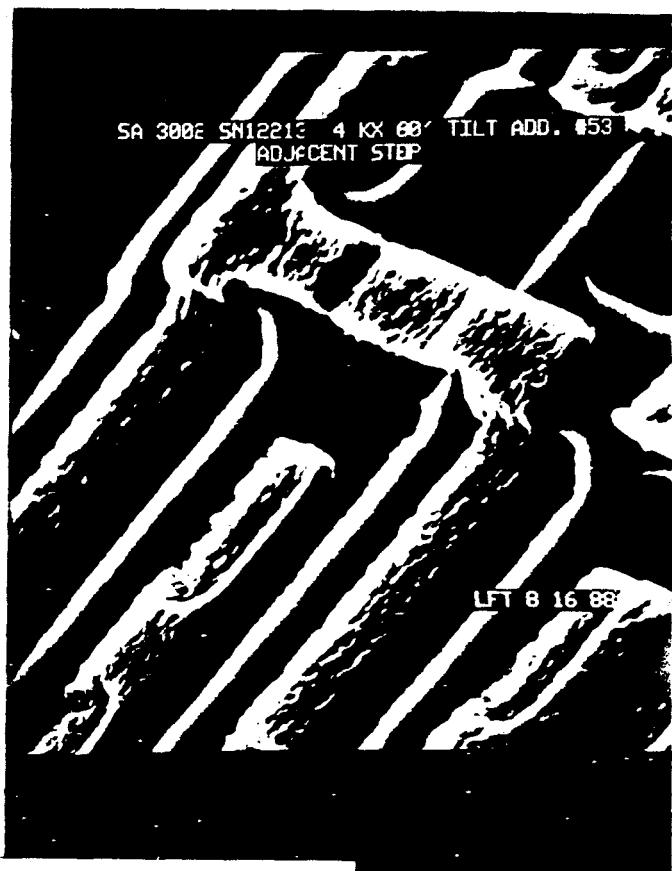
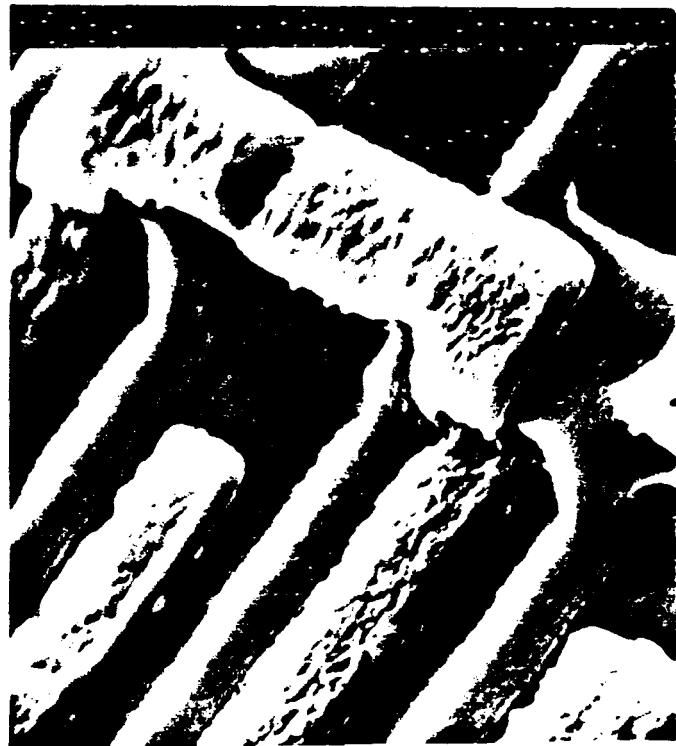
FIGURE 6

Measurements on  $IC_B$  The stuck-open faults in  $IC_B$  were caused by failure of step metal coverage in three locations involving the 2-NOR gates of the decoder section of the ROM. Figure 6 shows a SEM photograph of one of these metal breaks that are believed to have occurred during wafer fabrication. These open circuits occurred where the metal for the 2-NOR gate n-channel drain connection made a step over polysilicon and field oxide. These steps were coincident creating a very steep topography that is usually not covered well by evaporated metallization. This has been referred to as a "double step".

Figure 6. Voltage contrast SEM picture of a ROM decoder 2-NOR circuit showing an open crack in the step of the drain line to one of the n-channel transistors.

One of the other NOR gate design rule violation locations  
which did not fail but is nearly open.

A third factor in reducing stuck-open fault failure rates is to consider alternate manufacturing and design techniques. The metal process must be stabilized to reduce the probability of metal breaks due to step coverage, thermally induced metallization voids, electromigration or mask particle defects[20,21]. Another important factor is to consider alternate layout styles that replace the drain metal interconnect material with either diffusion or polysilicon material[22,14]. The intent is to use a conducting material that has a lower probability of an open circuit. Koeppe demonstrated a CMOS circuit layout using a ring geometry for the drain interconnect diffusion material that had a typical 2% degradation in timing signal[22]. The area overhead in this alternate design was zero. Studies remain to be done for larger circuits that use such layout techniques to reduce stuck-open failure rates. In addition, it should be noted that although metal cracks due to steps, thermally induced voids and electromigration failures are eliminated, random particle defects on the mask still exist for any conducting material.
