PHYSICAL AND ELECTRICAL DEGRADATION OF PHOTOVOLTAIC MODULES AFTER EXPOSURE IN TERRESTRIAL ENVIRONMENTS<sup>†</sup>

S. E. Forman and M. P. Themelis  
MIT/Lincoln Laboratory  
Lexington, Massachusetts 02173

## MEAD, NEBRASKA TEST SITE

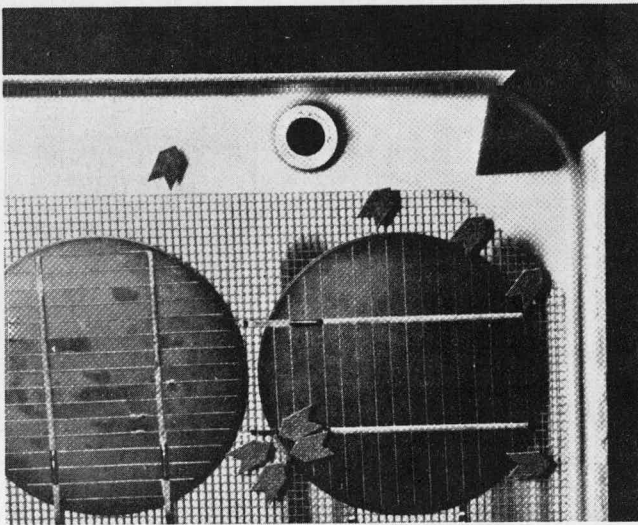
Fig. 1

Encapsulant delamination of varying degrees was found on almost all observed modules. The various types of delamination are enumerated by model in Table 1. An example of edge-seal delamination is shown in Fig. 1. The large arrow is under the entire layer of encapsulant, and dirt has penetrated up to the smaller arrows. An example of delamination over a cell is shown in Fig. 2, where a repair area over a cell has delaminated.

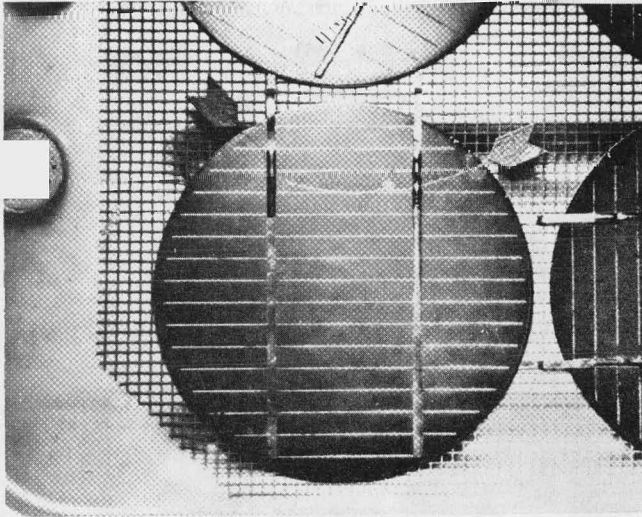
Fig. 3

Two typical cracked cells on a Model B module are shown in Figs. 3 and 4. In the former, the crack crosses both interconnects and may ultimately cause a failure if it penetrates through the thickness. In the latter, a zigzag crack splits the cell in half. In Fig. 5, a cracked cell on a Model C module is shown. If it penetrates through the thickness, it may cut an edge off a cell and reduce the active cell area.

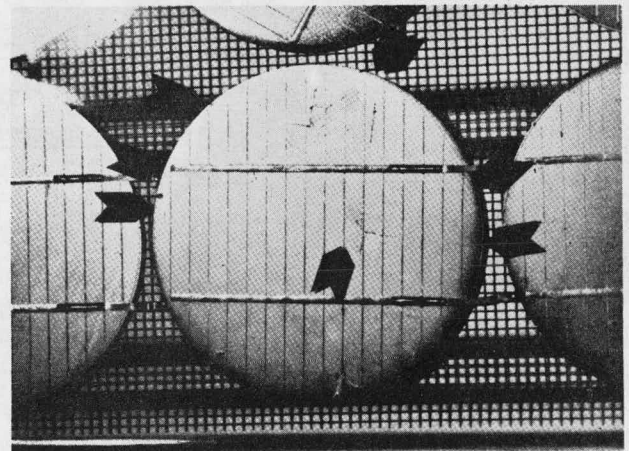
Fig. 6

Many of the cracked cells were found with impact damage such as what might have been caused by an airborne projectile. A typical example is shown in Fig. 6, where a cell on a Model B module has sustained two impact hits. These impact cracks were caused by a hailstorm in May. On-site observers reported that one inch of rain fell in a 15-minute period, along with five minutes of hail, and that hailstones 1/4 inch to 3/4 inch in diameter were found. The modules appeared to have marks in the surface dirt, with a density of approximately 5-10 marks/ft<sup>2</sup>. The high incidence of cracked cells has caused many modules to operate at reduced short-circuit current.

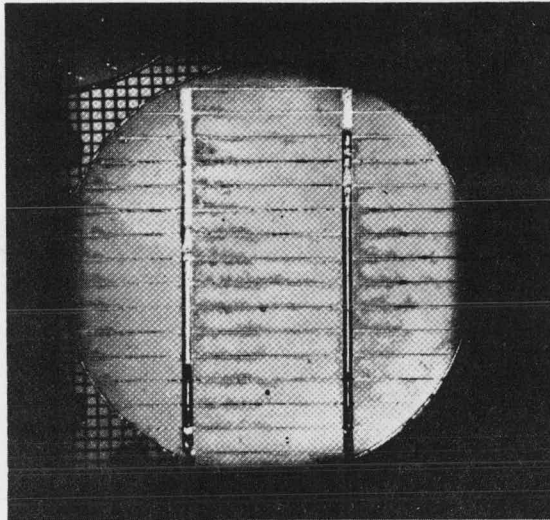
Fig. 7

These types of degradation parallel those described in Reference 1 and reported in the field inspection. The staining along collector lines in the Model B module appears to be more prevalent than previously observed. An example of this is shown in Fig. 7. Here the anti-reflective coating has changed from the normal dark blue color to a rusty brown color. In Fig. 8, there appears to be a crystalline residue with some dendritic growth between grid lines. Delamination also seems to be more prevalent in Model B than in Model C modules.
