QUARTERLY REPORT
SOLAR PHOTOVOLTAIC PROJECT,
MATERIALS, PROCESSES, AND TESTING ACTIVITIES,
FOR THE PERIOD
1 JANUARY TO 31 MARCH 1979

S.E. Forman
M.P. Themelis

COO-4094-55
30 June 1979

Massachusetts Institute of Technology
Lincoln Laboratory
Lexington, Massachusetts 02173

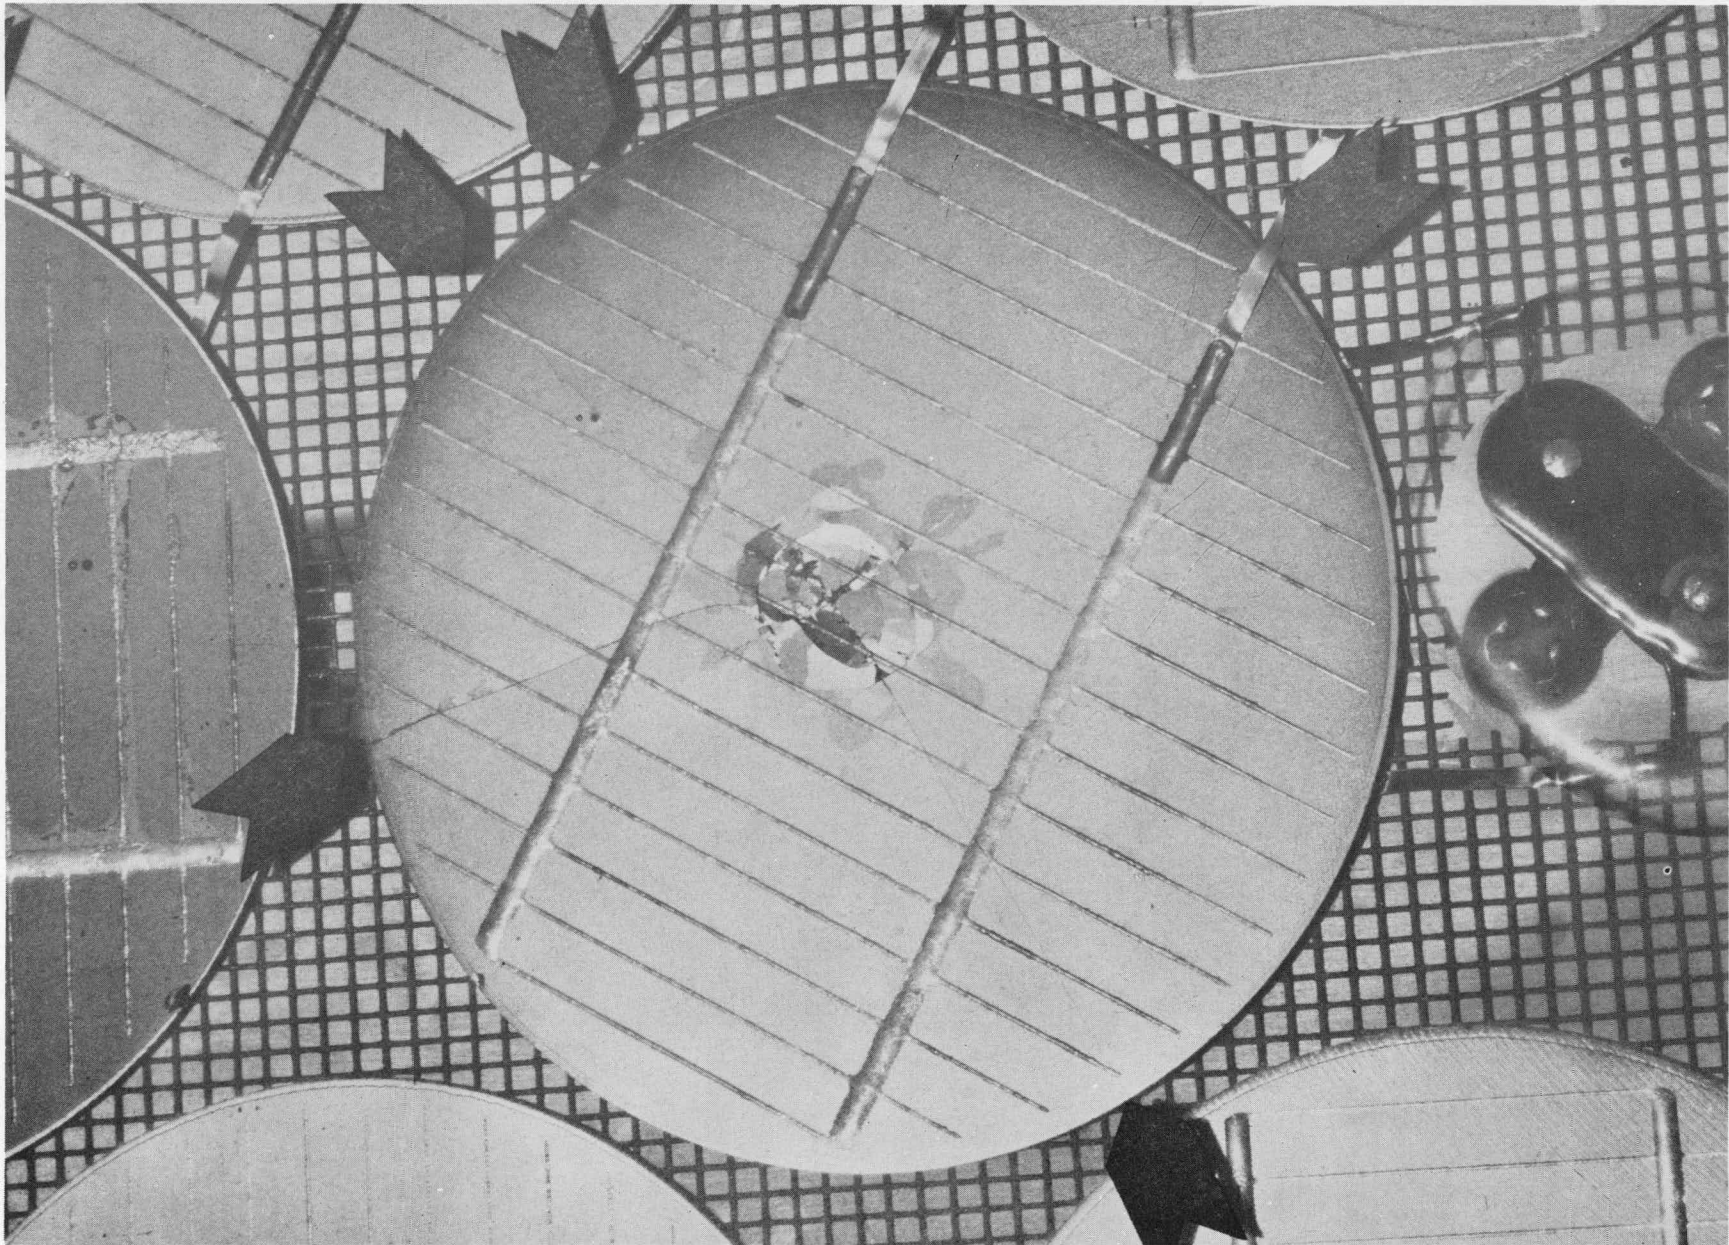
Of the seven modules exposed for two months and then an additional twelve, no cracked cells were found during the first analysis. However, six modules, with a total of ten cracked cells, were found during the latest analysis. All cracks were of the impact variety. Of five modules exposed for five months and then an additional twelve, only one was found with a cracked cell during the first analysis. Two more modules, however, with a total of three cracked cells, were found during the second analysis. The new cracks were all due to impact, caused by a hailstorm which occurred during May, 1978.

Figure 4. Impact-cracked cell.

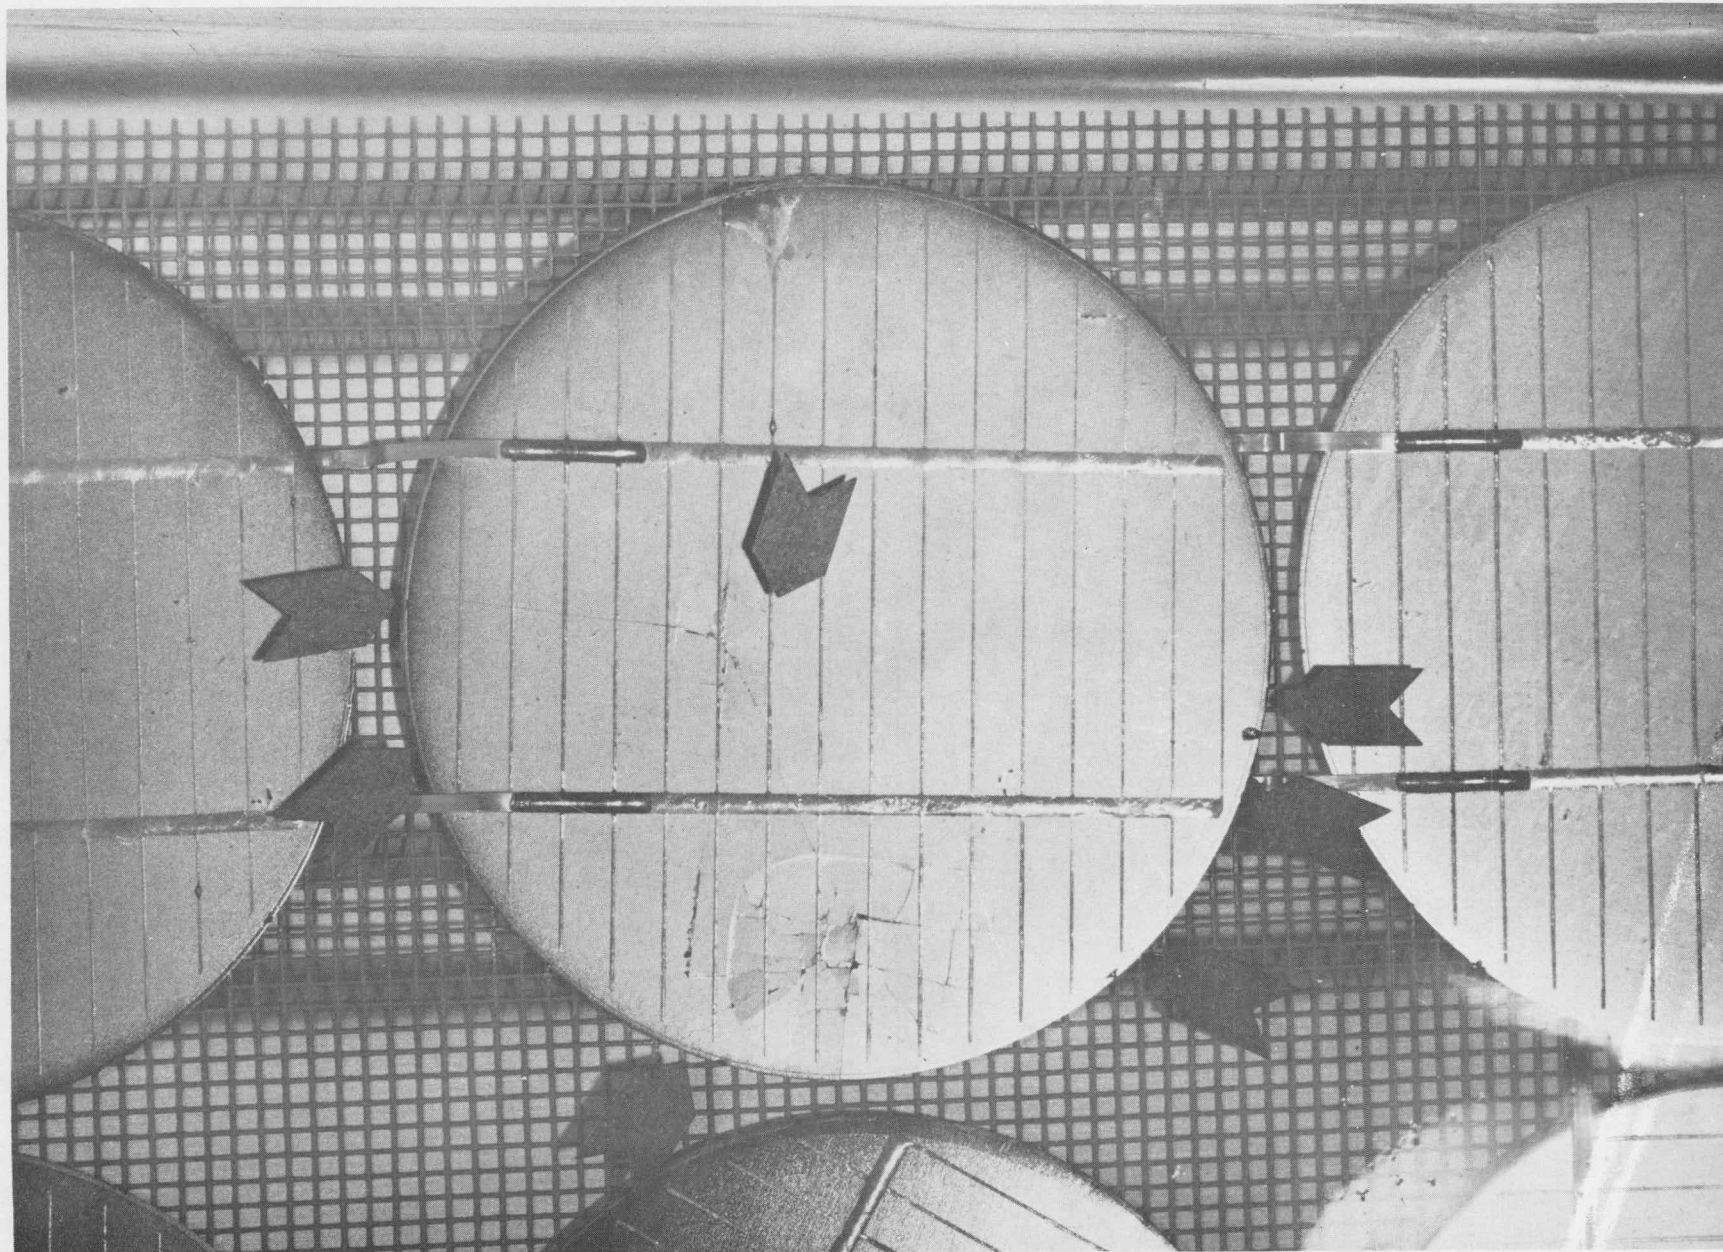
Figure 5. Impact-cracked cell.

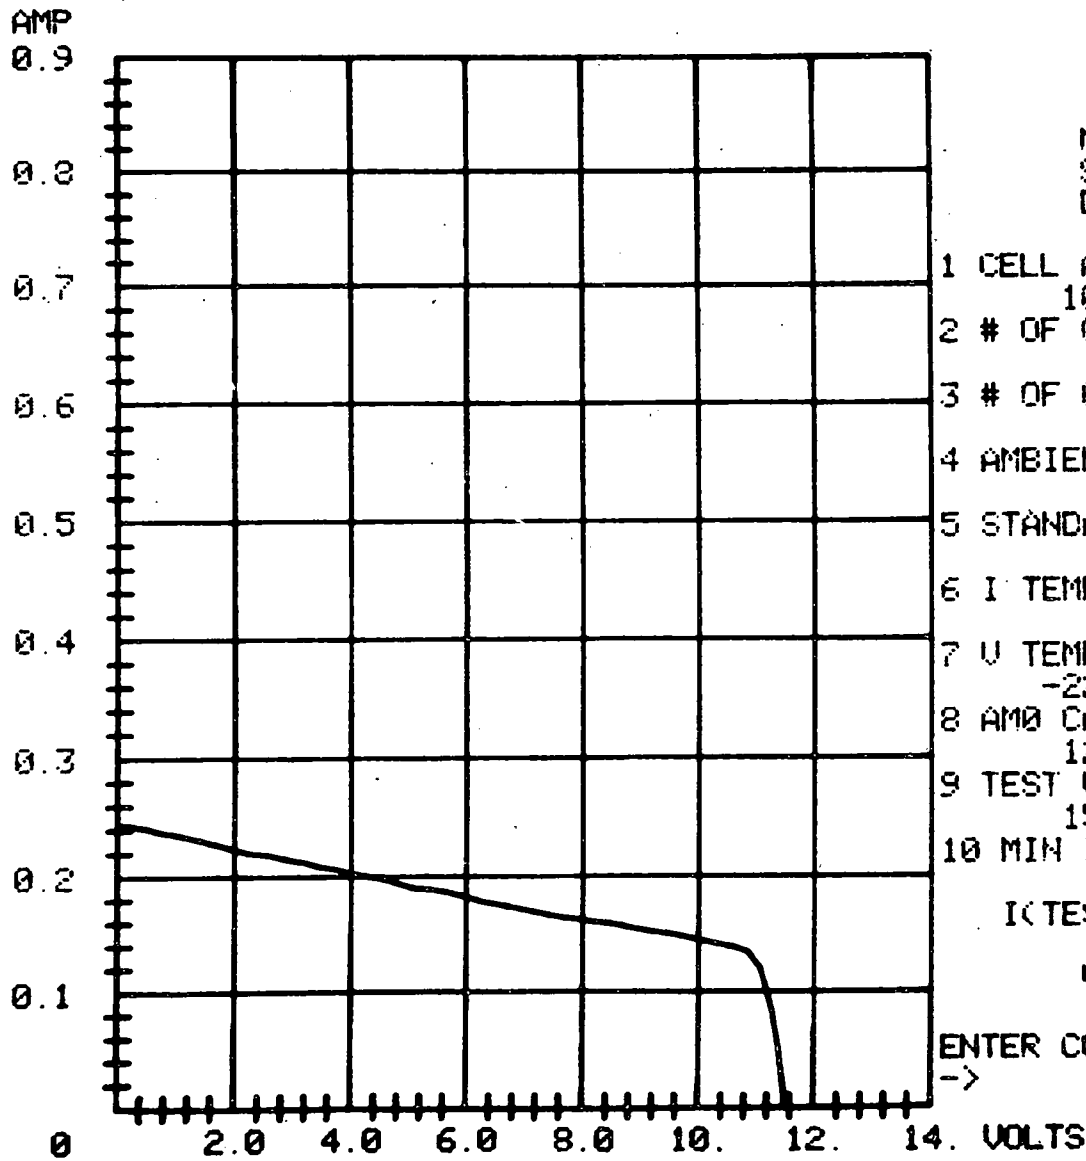
Closer examination under a microscope showed the module to have four cells that contained partial cracks, none of which could cause reduced short-circuit current. However, a fifth cell was found with an edge-to-edge crack that cut across both main collectors and the circular grid.

A ridge in the RTV was obvious along the cracked area. It appears that as the cell heated up, it pushed up from the substrate. As delamination was found along the lower edge of the cell, it is believed that air entrapped under the cell expanded, causing the cell to crack.

Figure 6. Model B - 52% reduction of ISC.

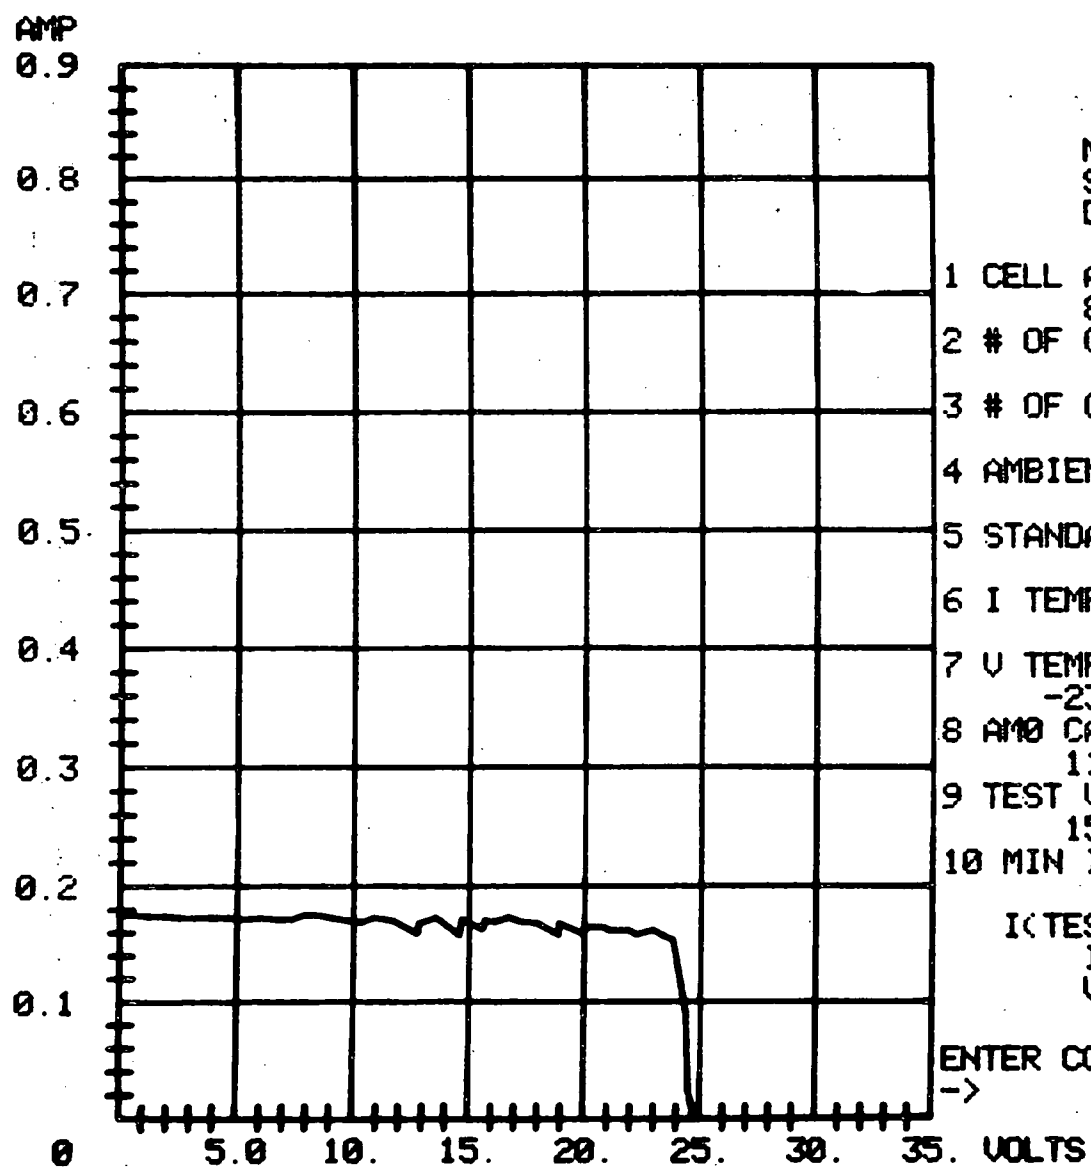
During February, six Block II Model A modules at the Residential Test Bed were found to have zero short-circuit current after only two months of service. Upon visual examination of each module, there was no visible evidence of the cause of failure. Each module was flashed in the LAPSS and had a

Figure 8. Model A - ISC reduced to 1/3 the normal value (1).

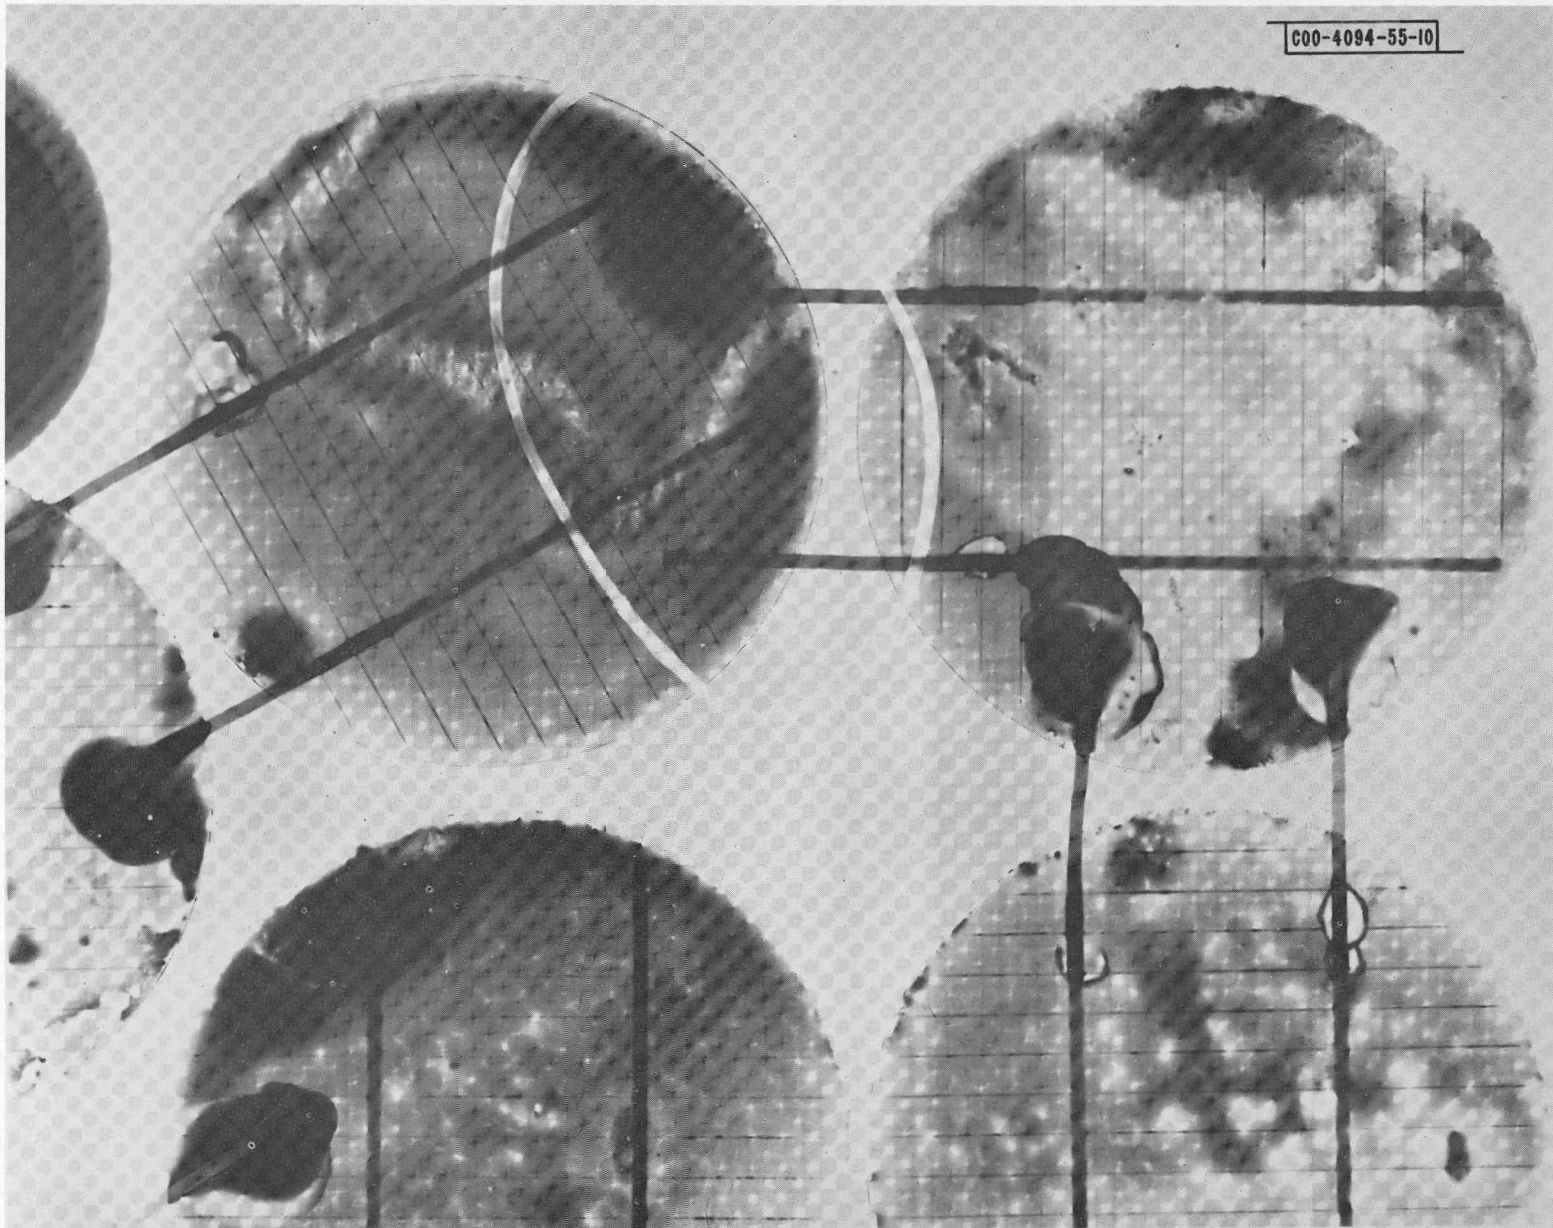
Figure 10. X-ray of unsoldered interconnect.
