**Effects of Alternate Fuels Report No. 7:
Analysis of Failure of a Mullite-Based
Refractory Brick in an Industrial
Oil-Fired Burner**

EFFECTS OF ALTERNATE FUELS REPORT NO. 7: ANALYSIS OF FAILURE OF A
MULLITE-BASED REFRACTORY BRICK IN AN INDUSTRIAL OIL-FIRED BURNER

Date Published: July 1979

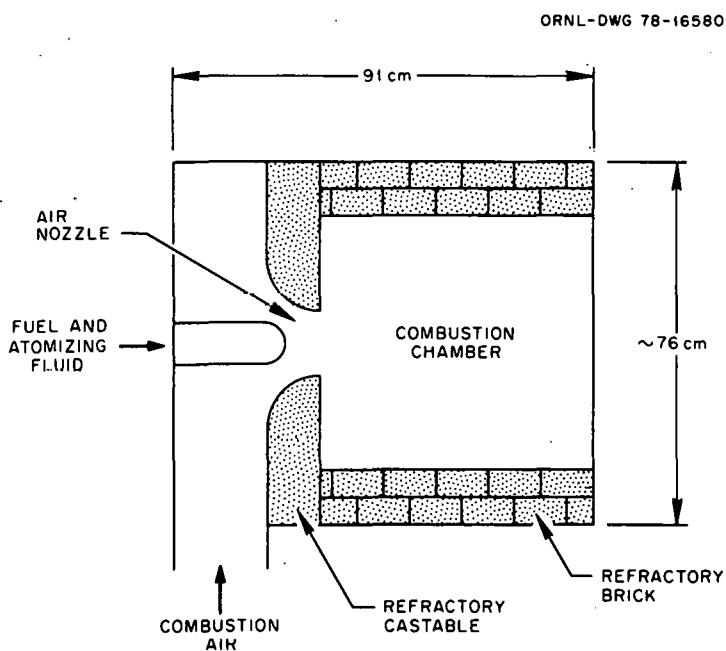
Fig. 1. Failed Oil Burner.

The refractory failed in the combustion chamber of an oil-fired industrial burner being used to calcine CaSO_4 in a lime kiln. The burner, shown schematically in Fig. 1, heated the kiln for 8 h per day for about 6 months. The estimated maximum hot-face temperature of the refractories in the burner was about 1750°C . The fuel was a No. 6 residual oil, which was burned with about 15% excess air. Under these conditions the refractory lining of the combustion chamber severely degraded in about 1000 h of service.

The burner lining, as shown in Fig. 1, consisted of three refractory materials: aluminosilicate castable located around the air nozzle, high-alumina (mullite-based) brick around the cylindrical wall, and aluminosilicate mortar for joining the bricks. The castable and some adjacent bricks deteriorated during service to the extent that detached pieces collected on the bottom of the burner. When the pieces were recovered, the original identity of the refractory from which they came could not be determined by casual inspection. However, the pieces could be separated by appearance into two groups, degraded brick and degraded castable. No effort was made by the industrial firm at the time of the failure to select or analyze identifiable samples of the refractory materials. The burner was subsequently repaired by using materials selected for greater refractoriness.

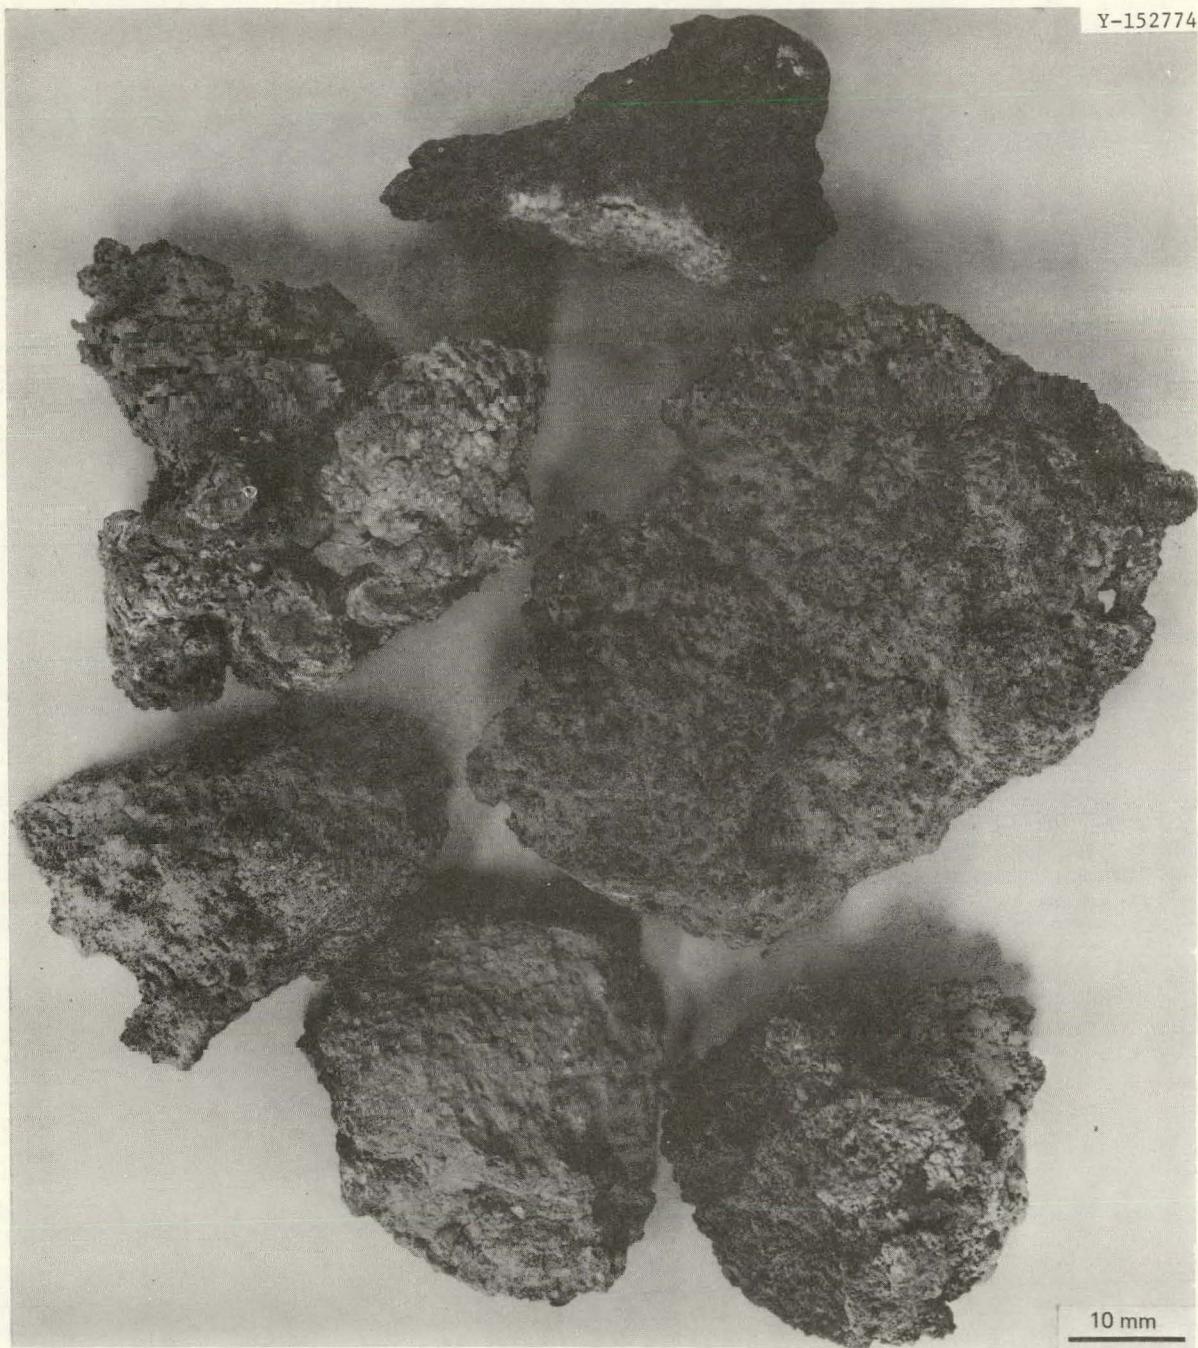
Fig. 3. Pieces of Degraded Brick.

An example of the original brick is shown in Fig. 2, and pieces of the degraded brick are shown in Fig. 3. Specimens were cut or broken from pieces shown in Fig. 3 to provide samples for chemical analysis, ceramography, scanning electron microscopy, electron microprobe, and x-ray diffraction.

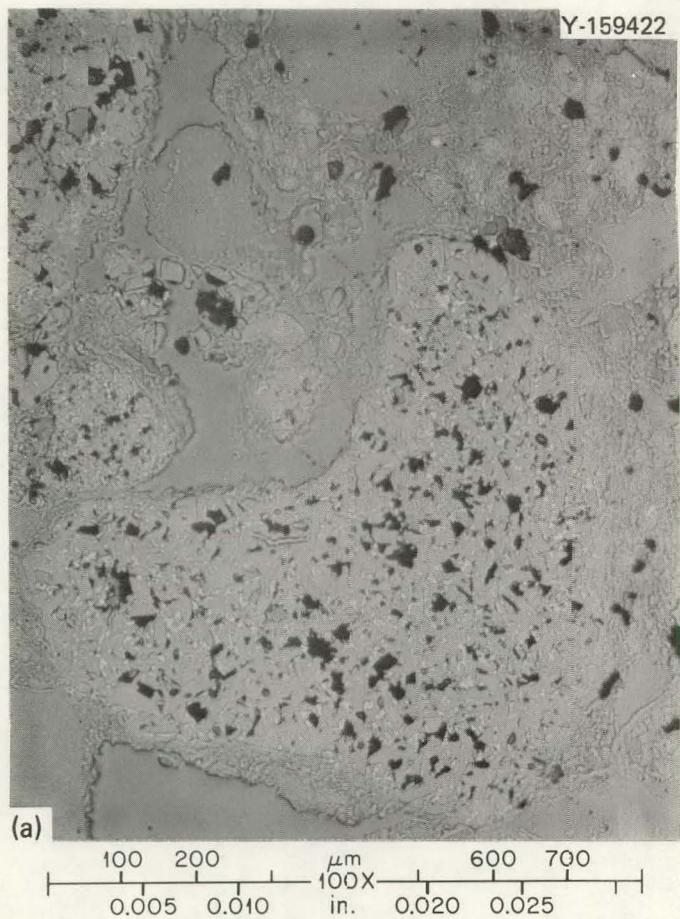
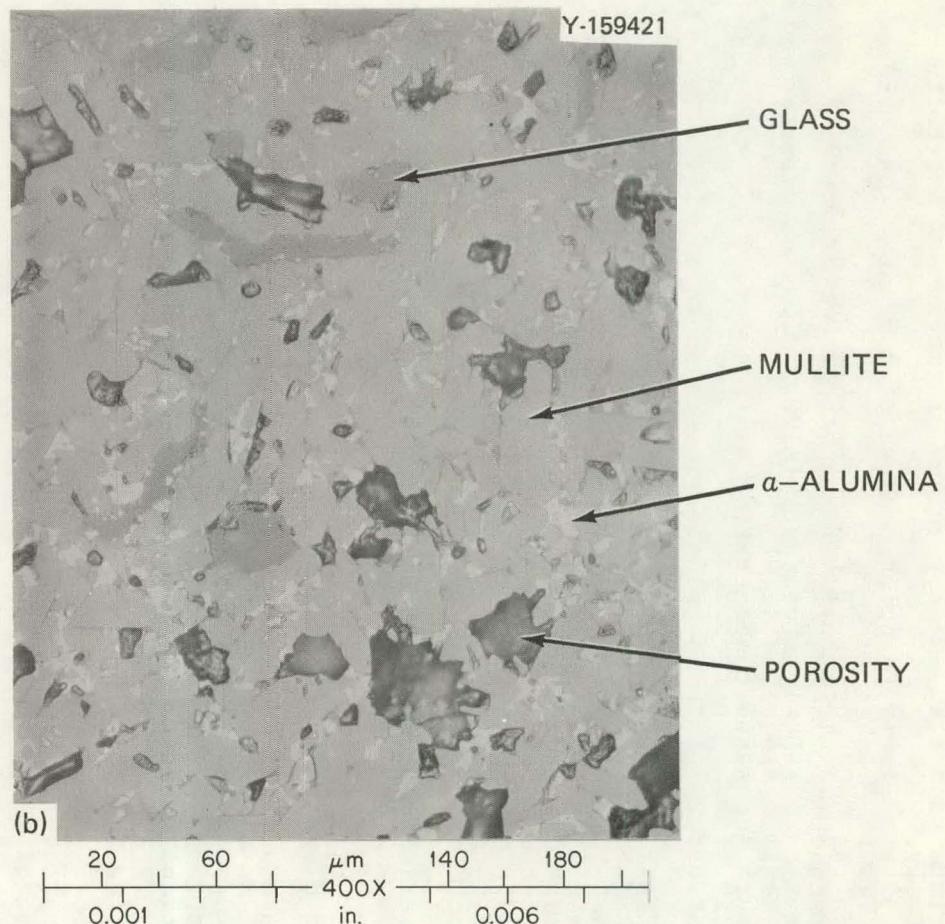
Fig. 4. Microstructure of the Original Brick. (a) Typical area showing grains in a glassy matrix. (b) Higher magnification showing that grains are an aggregate of crystals.

brick, as determined by the diffraction line intensities, were α -alumina, mullite, sillimanite, and tridymite. The microstructure of the original brick, as shown in Fig. 4, consisted of porous grains in a glassy matrix. Figure 4(b) shows that the grains are an aggregate of randomly oriented mullite crystals, α -alumina, glass, and porosity. Table 2 shows that the degraded brick contained α -alumina, mullite, sillimanite,

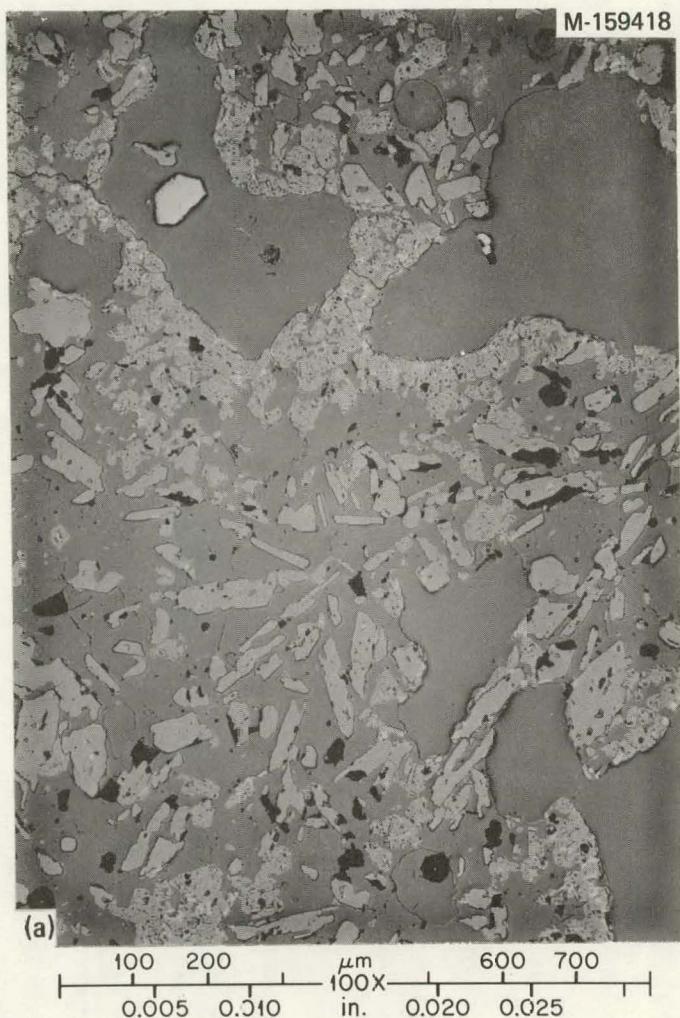
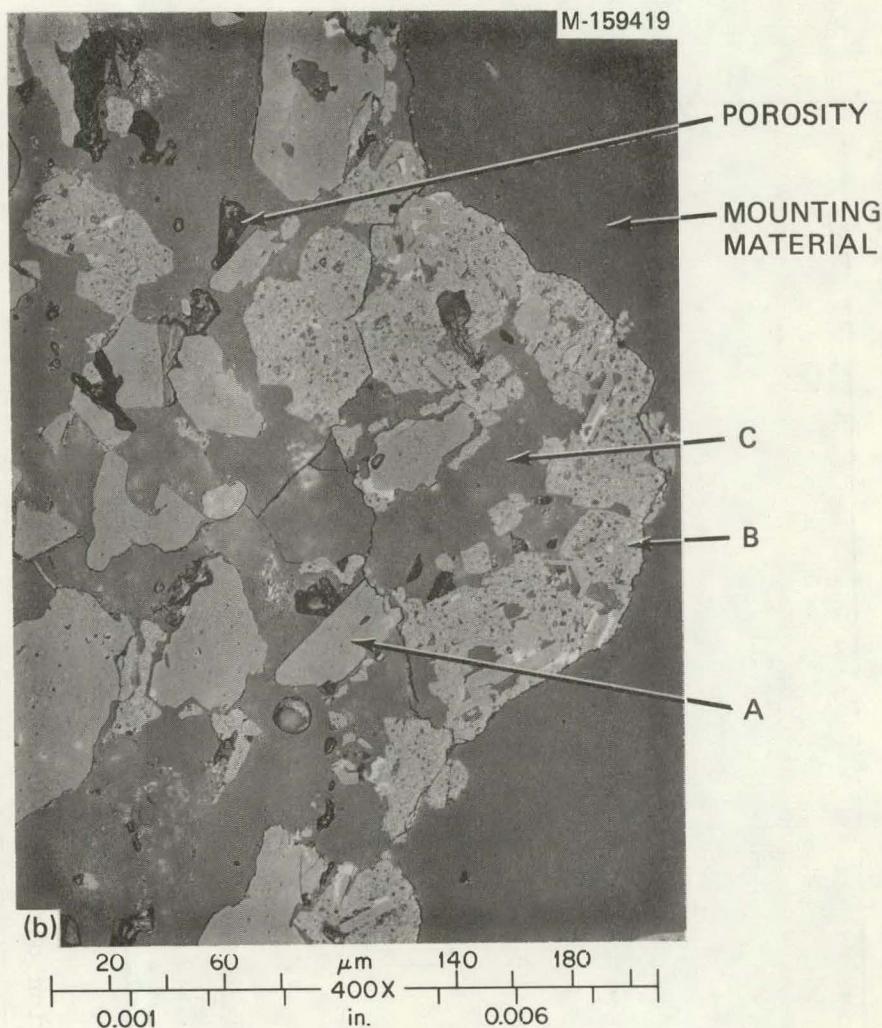
Fig. 5. Microstructure of the Degraded Brick. (a) Typical area showing crystals in a glassy matrix. (b) Higher magnification of a selected area. Phases identified: A - α -alumina and aluminum vanadate; B - α -alumina, hercynite, aluminum vanadate; C - glass containing anorthite and cristobalite.

The microstructure of the degraded brick is shown in Fig. 5. Comparison of Fig. 5 with Fig. 4 (the microstructure of the original brick) shows that the microconstituents are extensively redistributed. The microstructure of the degraded brick, shown at a higher magnification in Fig. 5(b), appears to consist of at least four phases: (1) a light-gray phase having little or no substructure; (2) another light-gray crystalline material containing porosity, possibly an aggregate of small crystals; (3) a highly reflective phase; and (4) a glassy matrix. The distribution of elements in the microstructure was determined with an electron microprobe. Characteristic x-ray energy spectra of areas A, B, and C in Fig. 5 are shown in Figs. 6, 7, and 8, respectively. The electron microprobe could not detect elements below atomic number 11; therefore, oxygen, though present in abundance, is not indicated. The information obtained with the microprobe permits determination of the location of some of the phases shown to be present by x-ray diffraction.

Each area A, B, and C contained Al, Ca, and V. Silicon, however, was found only in area C, the glassy matrix. The crystalline material in area A contained Al, Ca, and V with a small amount of Fe, making possible a mixture of α -alumina, aluminum vanadate, and possibly a calcium aluminate, although no $\text{CaO}\text{-Al}_2\text{O}_3$ phases were identified by x-ray diffraction. Area B contained Al, Ca, Fe, Mg, Ni, and V and likely consisted of a mixture of α -alumina, aluminum vanadate, hercynite, and possibly unidentified compounds containing Ca, Mg, and Ni. The glassy matrix, area C, contained Al, Ca, Si, and a small amount of V. This material probably consisted of amorphous glass, anorthite, and high cristobalite. Silicon, which was not revealed by microprobe on a polished section through the crystals, was shown by energy dispersive x-ray analysis to be present in substantial amounts on the surface of these crystals in a fracture section. We believe, therefore, that

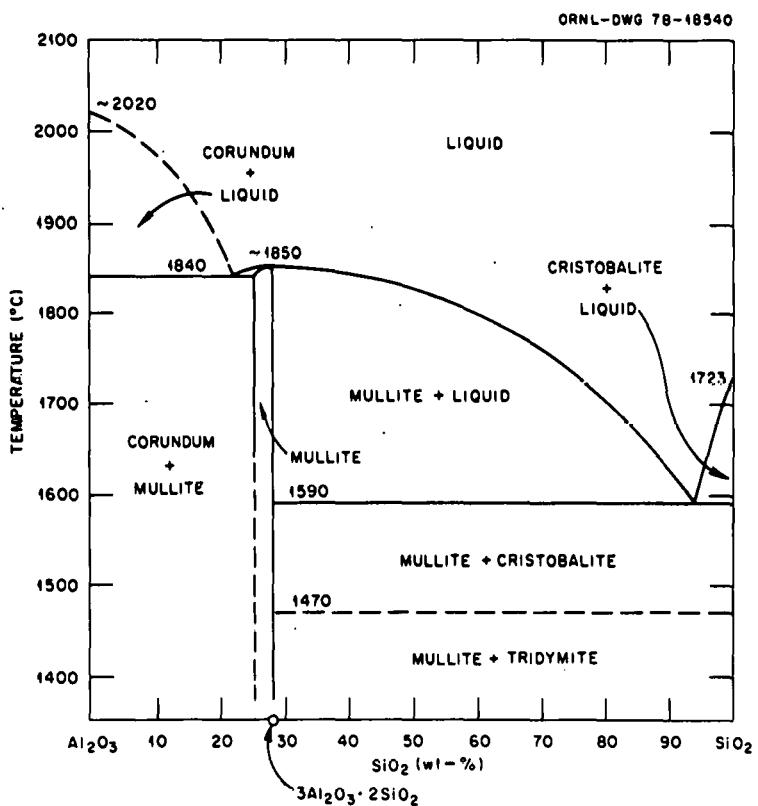
Fig. 9. The $\text{Al}_2\text{O}_3\text{-SiO}_2$ Phase Diagram.

Mullite and sillimanite were major phases in the original brick. Sillimanite, which is not stable at the high temperatures to which the refractory was exposed, would (under equilibrium conditions) decompose to mullite and cristobalite on heating.⁸ The fact that mullite, in particular, was not readily identified as a discrete crystalline phase in the degraded brick suggests that this phase disassociated or dissolved in the liquid, resulting from melting of the less refractory castable and mortar. Any compositional combination of castable and/or mortar with the brick would, according to the Al_2O_3 - SiO_2 phase diagram⁹ shown in Fig. 9, produce a composition that would form liquid at 1590°C under equilibrium conditions. Thus, decomposition of mullite would be anticipated at the operating temperature of the burner. The new phases present after solidification of the melt would be determined by both the composition of the melt and the approach to equilibrium during cooling.

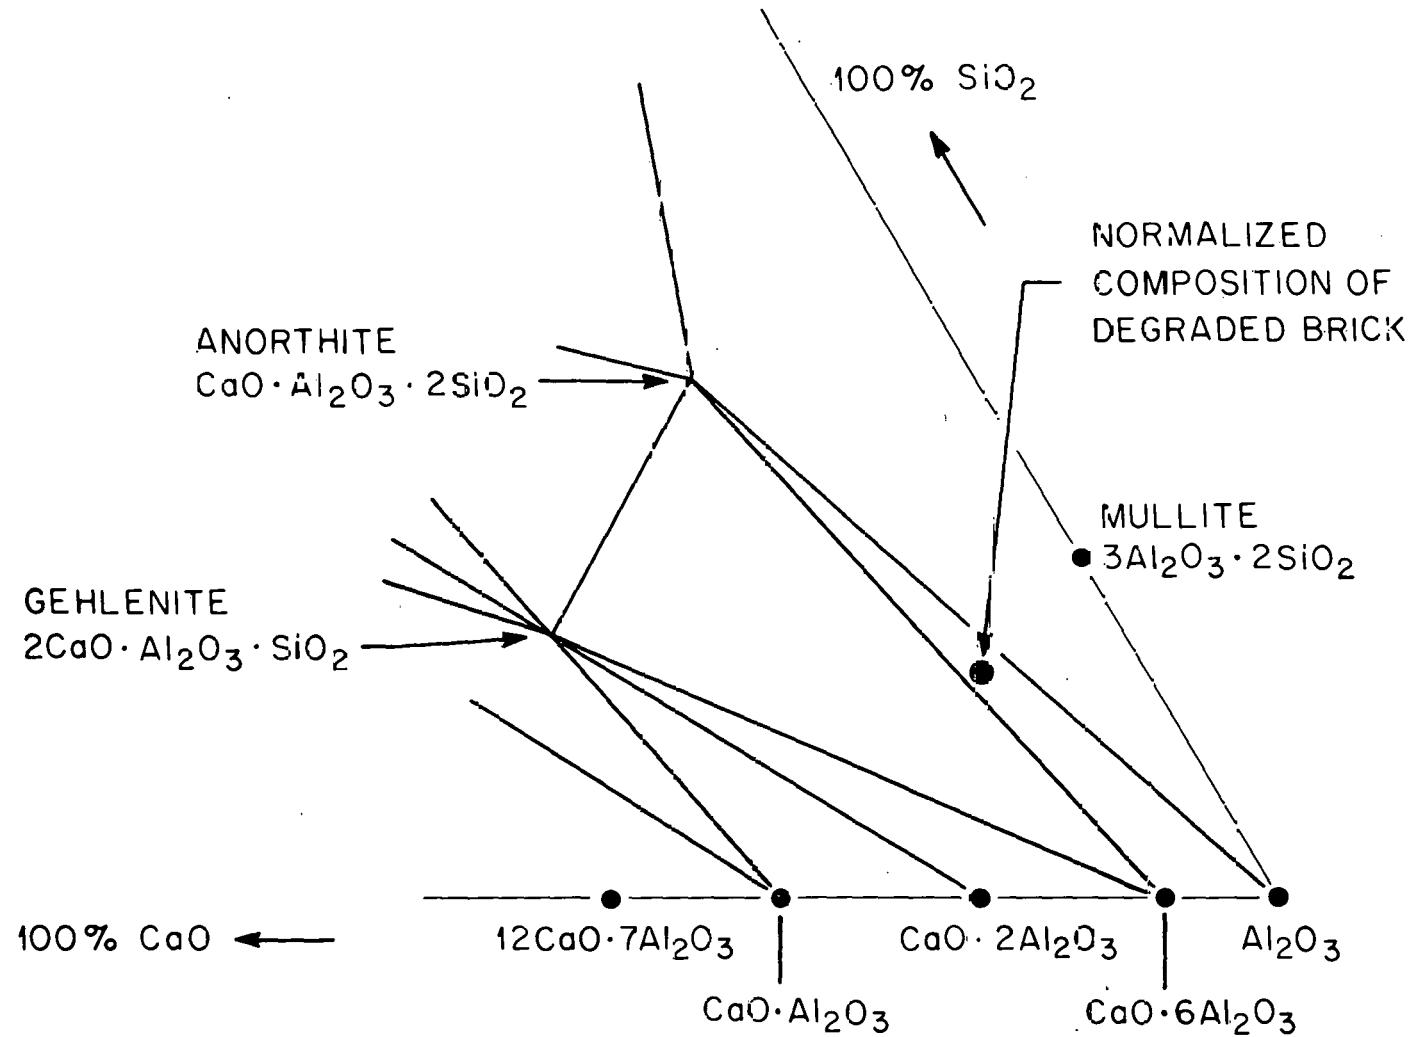
Fig. 10. A Portion of the $\text{Al}_2\text{O}_3\text{-SiO}_2\text{-CaO}$ Phase Diagram.

The principal oxide equivalent components of the degraded brick were Al_2O_3 , SiO_2 , and CaO . The normalized concentrations of these oxides (neglecting other oxides) are 69% Al_2O_3 , 18% SiO_2 , and 13% CaO . An examination of the $\text{Al}_2\text{O}_3\text{-SiO}_2\text{-CaO}$ phase diagram¹⁰ in Fig. 10 reveals that this composition lies within a field consisting of alumina, anorthite, and hibonite ($\text{CaO}\cdot 6\text{Al}_2\text{O}_3$) at the temperatures of interest. We cannot explain why hibonite was not found by x-ray diffraction despite the fact that calcium was found in each of the three microstructural areas analyzed with the electron microprobe. This may be due to lack of attainment of phase equilibrium, or possibly the presence of vanadium in relatively small amounts prevents the appearance of hibonite.
