## A Fractographic Study Of A Thick Wall Pressure Vessel Failure

D. A. Canonico, R. S. Crouse and T. J. Henson

The vessel described in this paper is identified as Intermediate Test Vessel 1 (ITV-1) and was fabricated of SA508, Class 2 Steel. It was tested to failure at 54°C (130°F). The gross failure appeared to be a brittle fracture although accompanied by a measured strain of 0.9%. Seven regions of the fracture were examined in detail and the observed surfaces were compared to Charpy V-notch ( $C_V$ ) specimens of SA508, Class 2 steel broken at temperatures above and below the ductile to brittle transition temperature. Three samples from the vessel were taken in the region around the fatigue notch and four from areas well removed from the notch. All these were carefully examined both optically and by scanning electron microscopy (SEM).

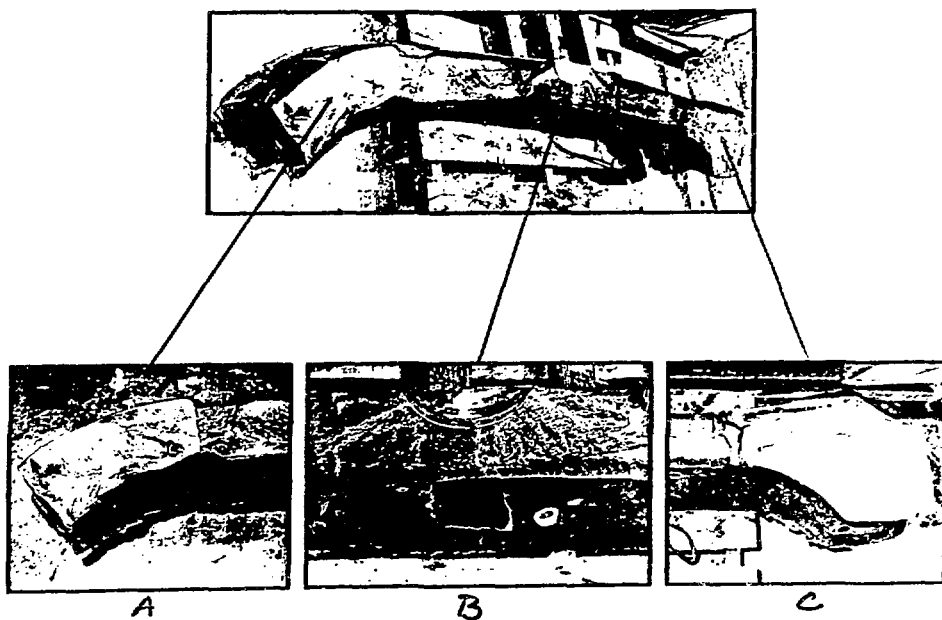
Seven regions of the fracture surface shown in Figure 5 were studied. One is located in the transition piece, five are located in the cylindrical test section, and one is located in the hemihead. In order to relate the fracture morphology in ITV-1 to that exhibited by the same steel at the lower and upper Charpy V-notch ( $C_V$ ) energy levels a SEM examination of  $C_V$  specimens was conducted. Figure 6 contains the results of the SEM study on  $C_V$  specimens whose precise test conditions are known. The steel from which the  $C_V$  specimens were prepared was SA-508 and was heat treated in precisely the same manner as the

The third region investigated is just under the steel rope shown in Figure 5. On a macro scale this location exhibited a change

in appearance and coloration. The dark "ductile" coloration seems to terminate in a V, with chevron lines, somewhat lighter in color, originating from this apex. This is usually indicative of an initiation site for fracture propagation. A fractographic study of this region (see Figure 9) was carried out. The first area studied was located close to the center of the fracture surface and was within an area that was visually similar to the regions shown in Figures 7 and 8. It has a fracture appearance (dimple mode) nearly identical to those previously shown. Therefore, this area is ductile (tough). The second area studied was outside the V-shaped area and in the more shiny, bright area. The SEM examination of this area revealed a cleavage mode of failure similar to those seen for the low temperature (frangible) specimens seen in Figure 6. This area has undergone brittle failure.

FIG. 5. THIS IS ONE HALF OF THE FINAL FRACTURE REMOVED FROM THE REST OF THE VESSEL. AREAS A, B AND C WERE CHOSEN FROM WHICH TO REMOVE SAMPLES FOR SCANNING ELECTRON MICROSCOPY.

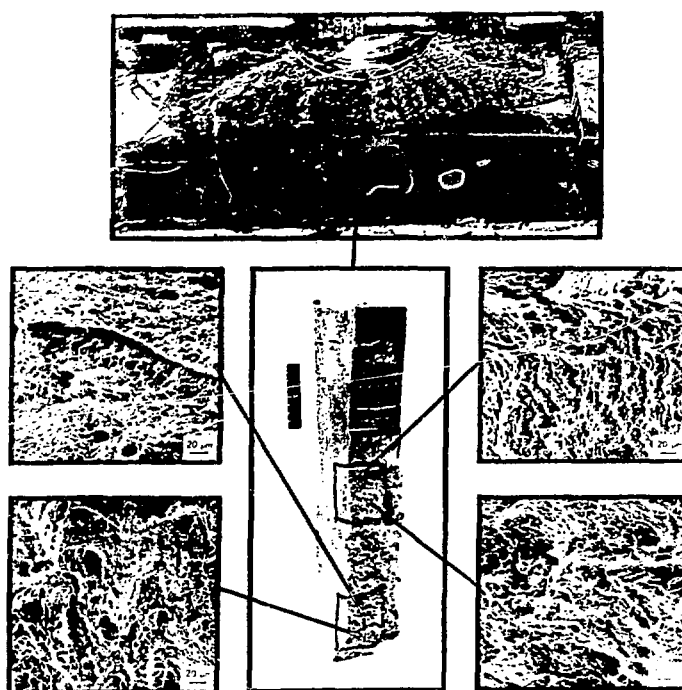
The first ITV-1 specimen examined was from the region below the deepest point of the fatigue crack. Figure 7 shows two locations where specimens were taken and also illustrates the results of scanning electron microscopy studies of these fracture surfaces. Note the appearance of the surface of the two specimens is quite similar to that shown for the tough specimen ( $C_V$  energy of 83 ft-lb) in Figure 6. This region of the cylindrical test section exhibited a dimple fracture mode.

FIG. 7. FRACTOGRAPHIC SAMPLES WERE TAKEN FROM BELOW THE DEEPEST PENETRATION OF THE FLAW. THE FAILURE WAS IN THE DUCTILE MODE.

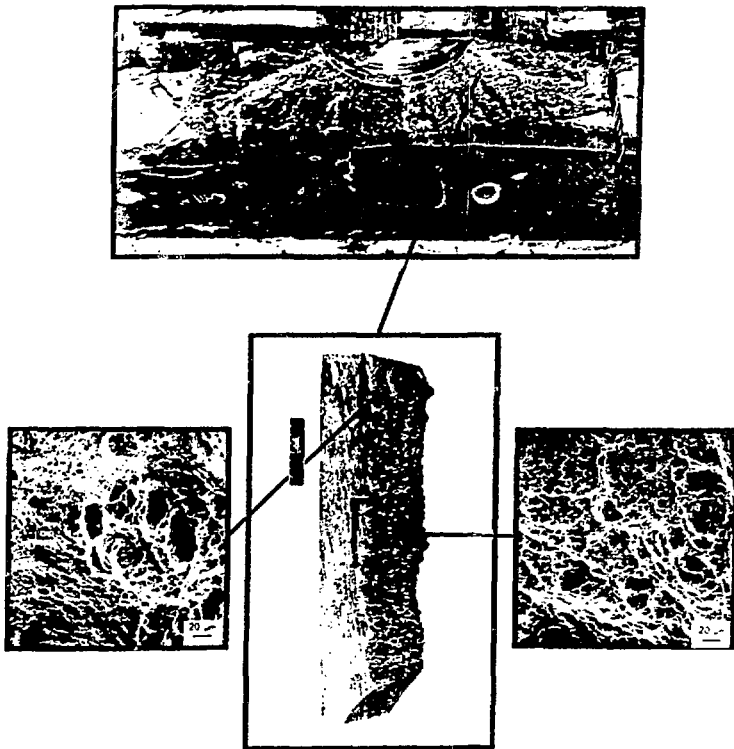
Figure 8 shows the results of the fractographic study from the region just adjacent to the fatigue crack. Two areas within this region were studied. (The corner of the flaw can be seen.) They, too, are similar in appearance to the ductile failures shown in Figure 6. This region also exhibited dimple (tough) fracture mode.

FIG. 8. THE REGION ADJACENT TO THE FATIGUE CRACK WAS STUDIED IN THE SEM. THIS AREA EXHIBITED ALL DUCTILE FAILURE.

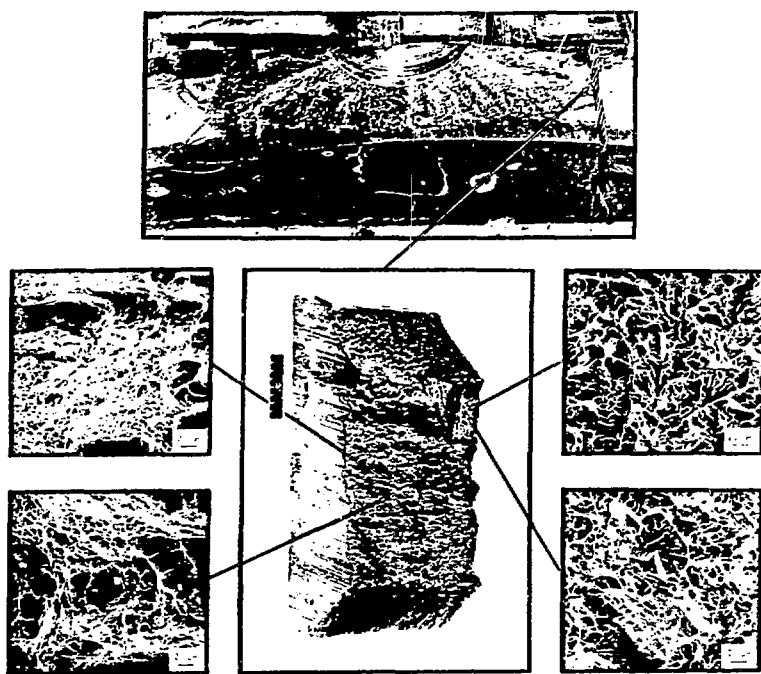
FIG. 9. FRACTOGRAPHIC SAMPLES AT THE POINT WHERE THE SURFACE APPEARANCE OF THE FRACTURE CHANGED SHOWED A TRANSITION FROM DUCTILE TO BRITTLE FRACTURE.

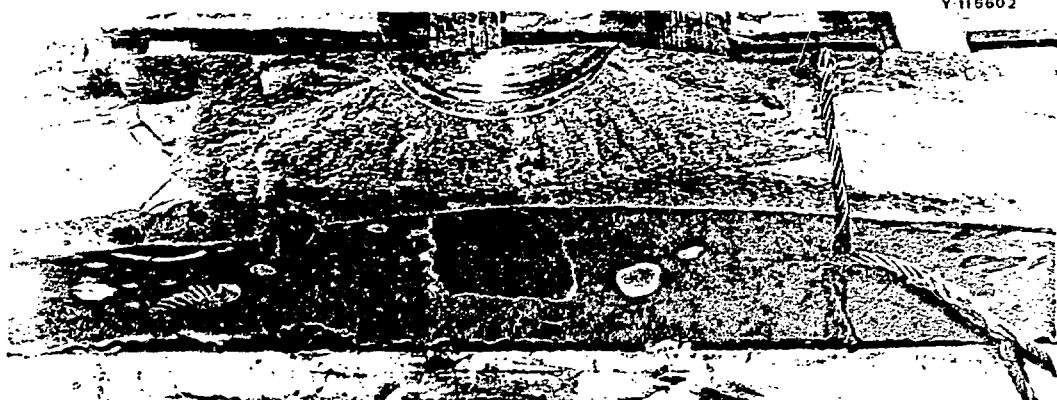
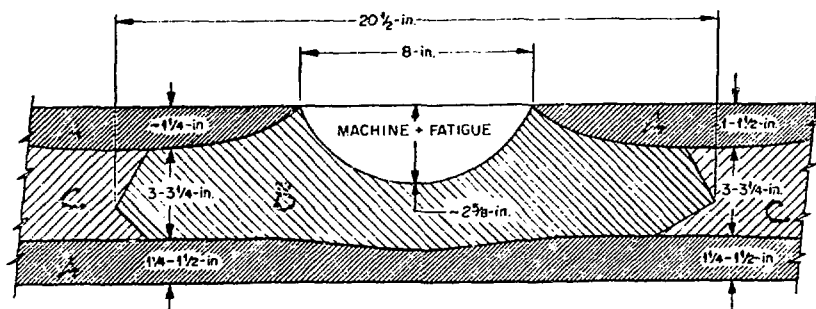
An inspection of the exposed fracture surfaces showed that a shear lip of approximately 25-38 mm exists at both surfaces of the cylindrical test section. A sketch (Figure 10) was prepared showing the dimensional relationship of the various topographical aspects of the region around the manmade flaw. The dark tough region (dimple fracture mode, (see Figures 7,8 and 9) is approximately 520 mm long and 76 to 83 mm wide. Beyond this region the surface exhibits a cleavage fracture mode.

This SEM study proved that the fatigue crack grew by ductile tearing until the flaw approached 500 mm in length and 83 mm in width. This extension, because of the stronger and perhaps tougher at 54<sup>0</sup>C surface material, was by internal tunneling. Slow crack propagation continued until the flaw became quite large and could no longer sustain the internal pressure which imposed a stress on the remaining vessel section that approached limit load. At this point fast fracture was initiated and crack extension was by cleavage mode.

FIG. 10 THIS ILLUSTRATES THE LOCATION AND EXTENT OF THE VARIOUS TYPES OF FRACTURE SURFACES. A-SHEAR LIP, B-DUCTILE, C-CLEAVAGE. (1 INCH = 0.0254 METER)
